Summary of Case Studies and Observations on Airport Experience with Pavement Surface Treatments

August 2023

DOT/FAA/TC-TN23/49

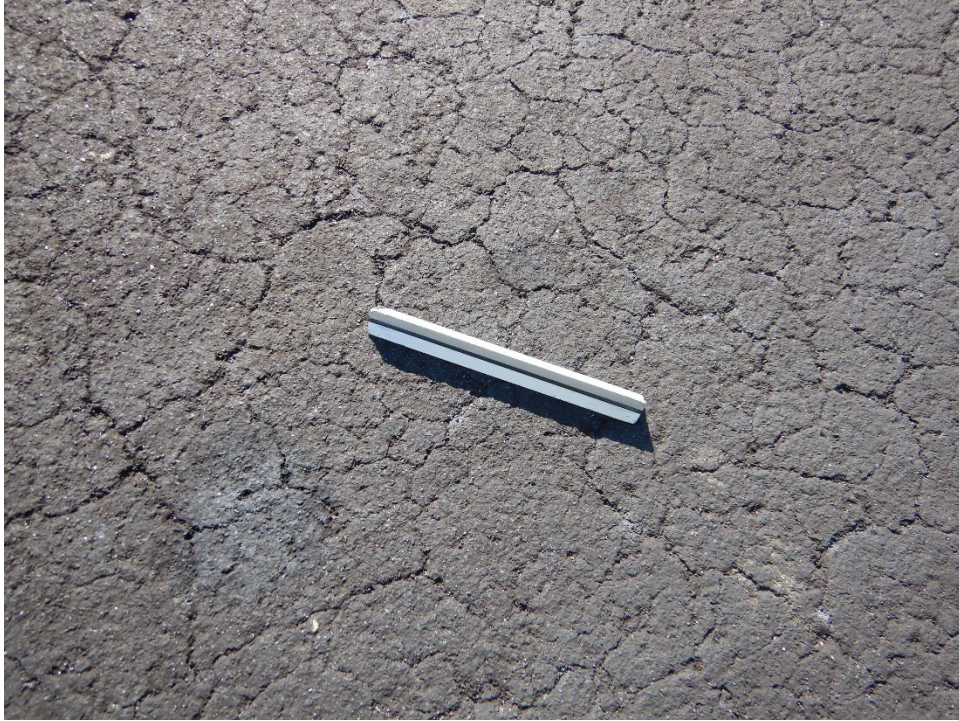
Figure LUG-15. Map Cracking on Apron

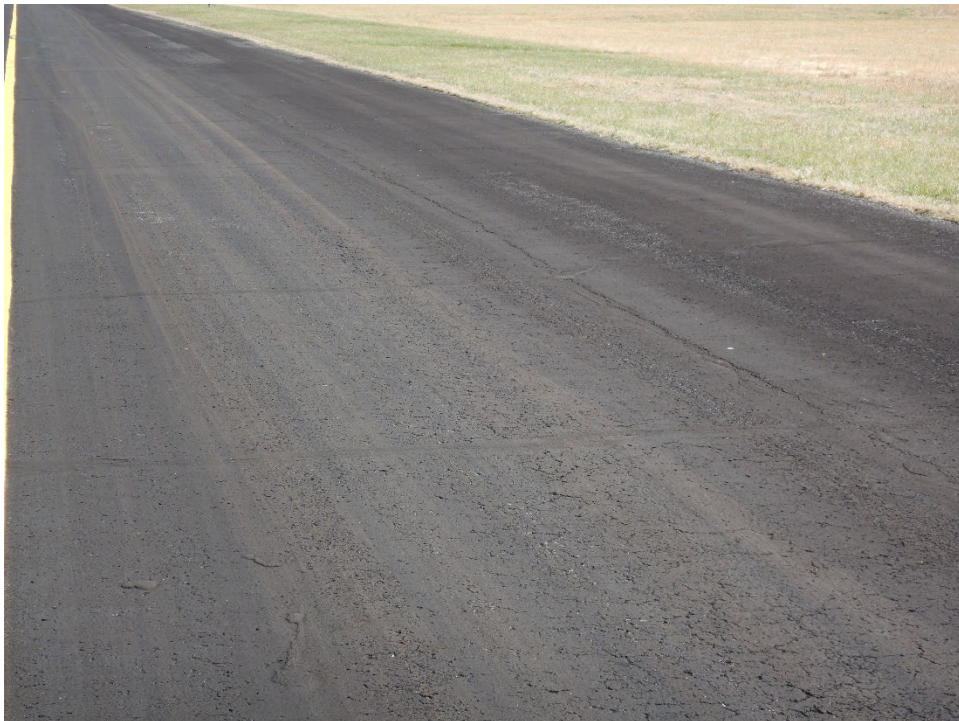
Figure LUG-21. Tire Tracks on Taxiway A in High Age Area

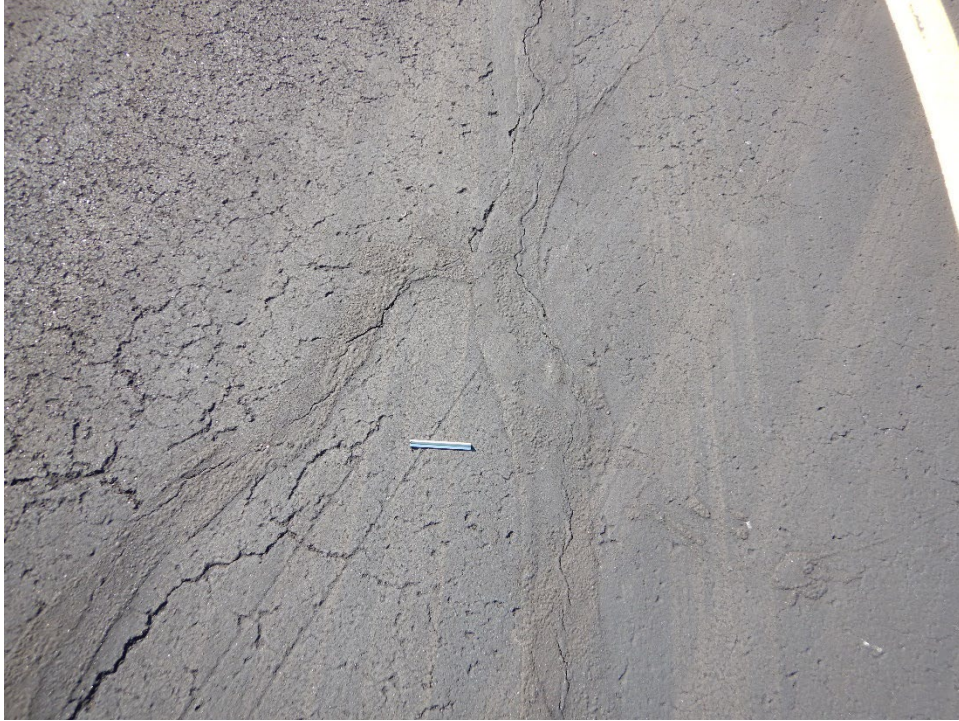
Figure LUG-22. Crack Sealant on Taxiway A in High-Age Area

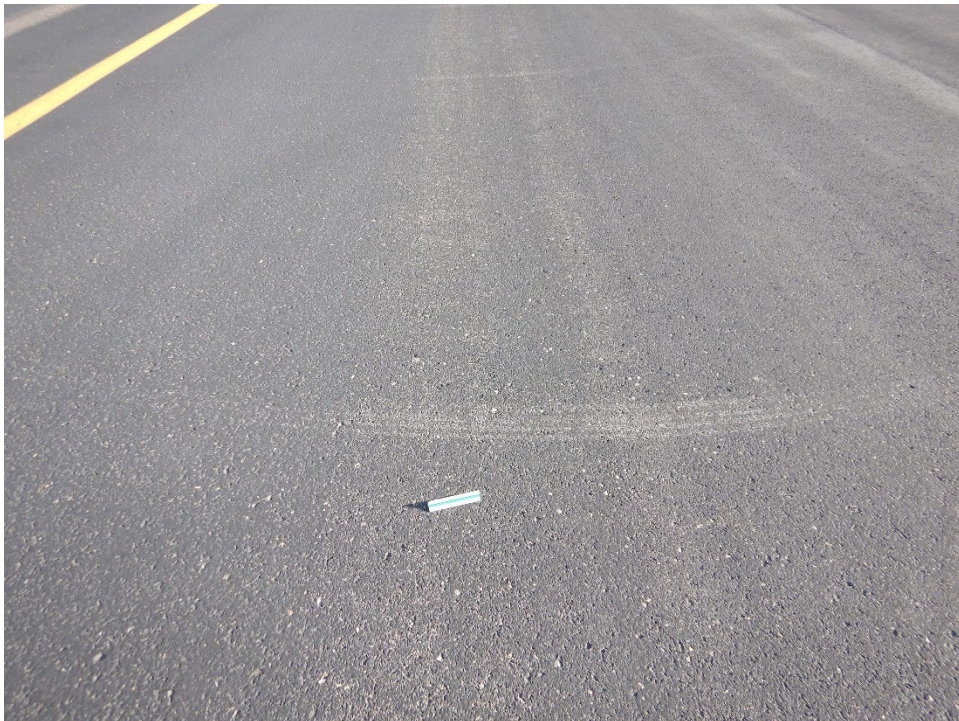
Longitudinal paving joints on the runway were mostly closed, but a few were open. On the surface, very slight wear was observed in a few higher traffic areas. FOD production was not a concern at the time of inspection. Pavement markings had not been reapplied and remained clearly delineated.

Figure UDOT-6. Slight Wear of Onyx on BTF Runway 17/35

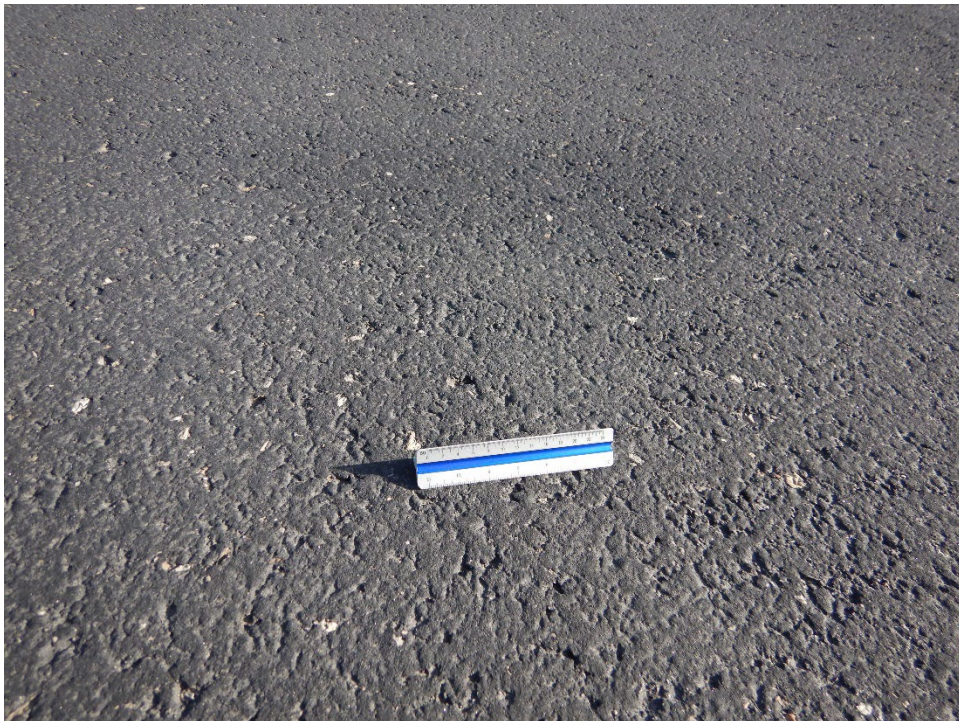
The inspection showed that the runway macrotexture mostly reflected the texture of the aggregate. Some areas had slightly less macrotexture where the application was thicker. The surface had a “grit”-like feeling, due to the sand mixed into the treatment. The coverage of the Onyx on coarse aggregate varied, with coarse aggregate being exposed approximately 0–5%. Fine aggregates were well covered in all areas. The Runway 35 end had the highest concentration of exposed aggregate. In spots where the coarse aggregate was exposed, some aggregates were in fractured condition while others were missing. In some instances, the surface treatment had filled in locations of missing coarse aggregate. Overall, the coverage of Onyx appeared to be uniform.

Figure UDOT-8. Exposed Coarse Aggregate on BTF Runway 17/35

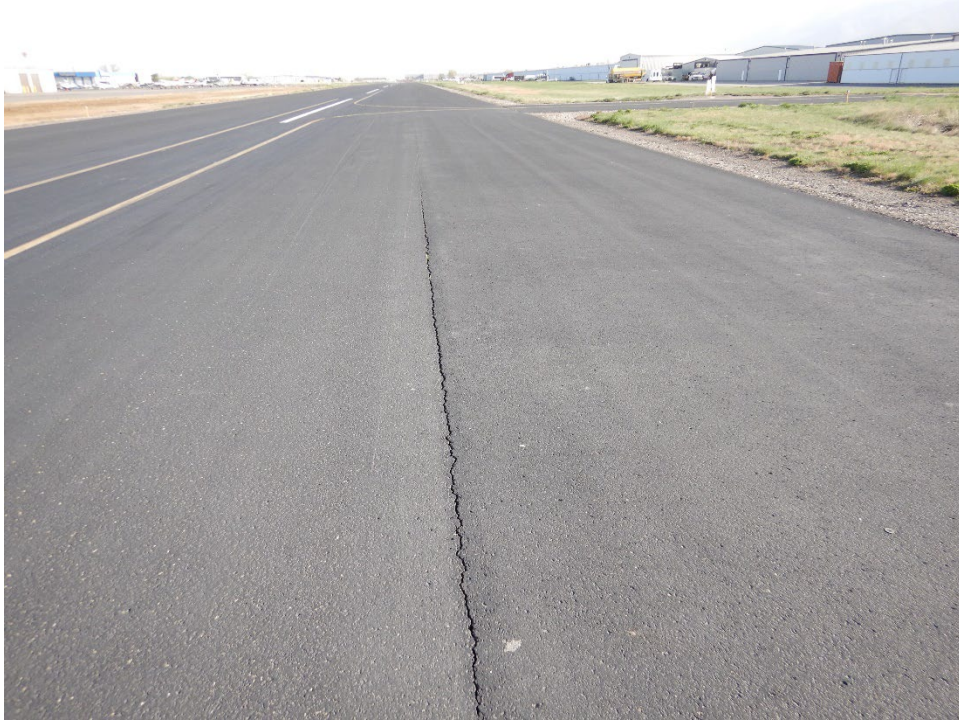
Figure UDOT-9. Opened Longitudinal Paving Joint on BTF Runway 17/35

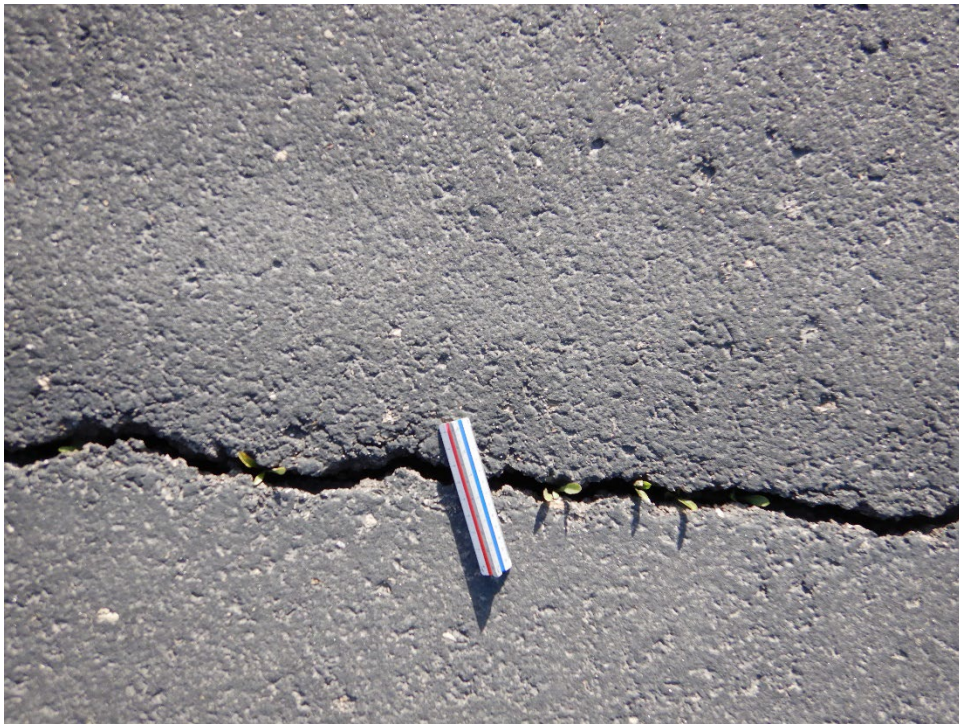
Figure UDOT-10. Closeup of Opened Longitudinal Paving Joint

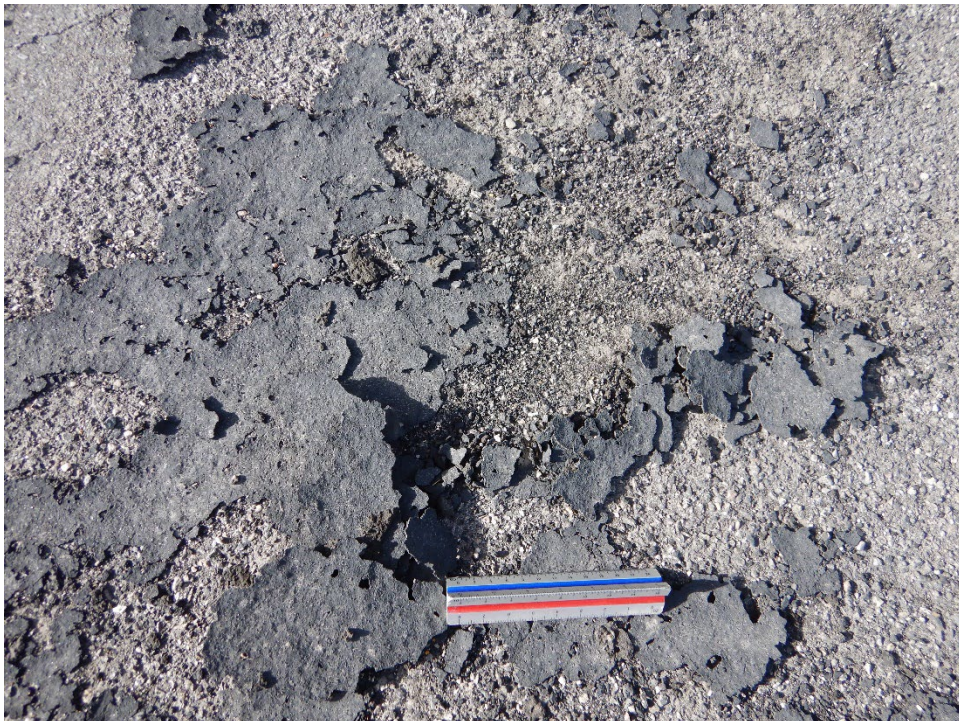
Some tenant aprons also received Onyx, but the pavements in the apron areas were already in poor condition at the time of application and were not good candidates for any type of surface treatment. Additionally, the apron surfaces were not well prepared before application of the treatment and exhibited substantial debonding/flaking distress. Onyx did not perform well on these pavements.

Figure UDOT-14. Debonding on BTF Apron

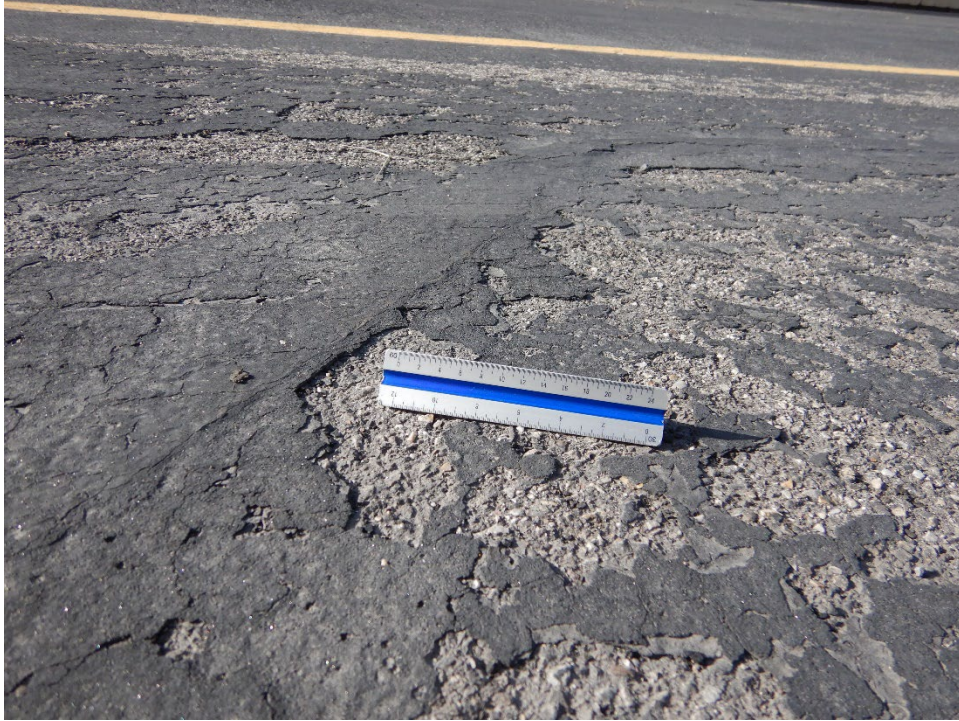
Figure UDOT-15. Raveling on BTF Apron

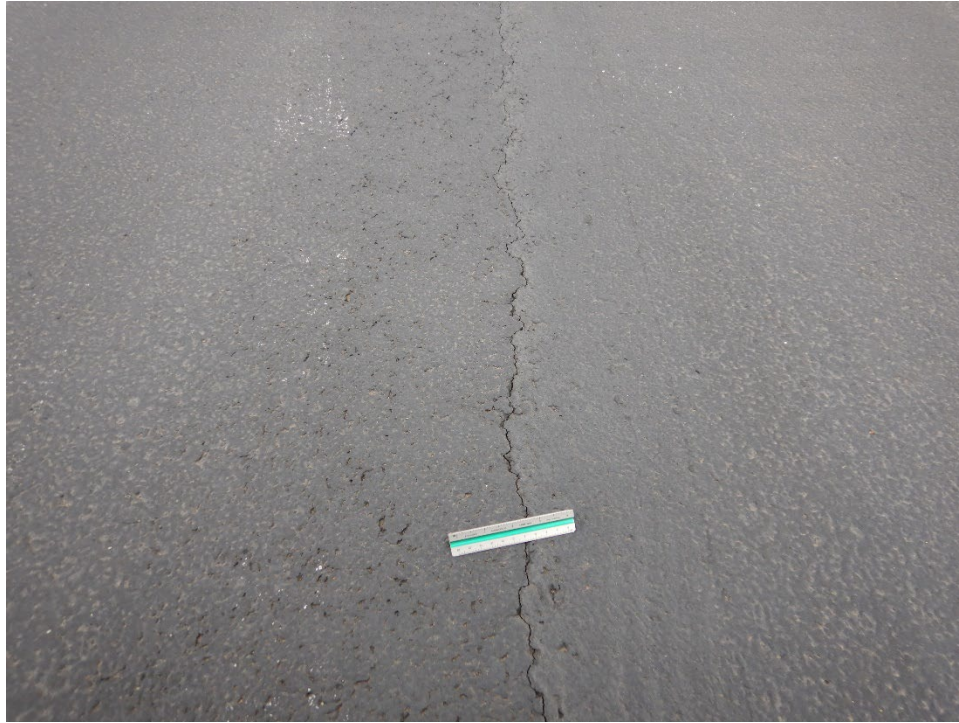
Prior to the application of Onyx in 2020, edge cracking and at least one longitudinal paving joint on the runway were crack sealed with overband. The longitudinal paving joints on the runway were mostly closed, although there were a few in open condition. The runway had fewer distresses than the taxiway or apron pavements, which had both sealed transverse cracks and edge cracks. Previously placed crack seals were starting to fail. Sealant in some transverse cracks was re-applied after the treatment work. There were also some unsealed cracks on these pavements that likely occurred after the Onyx application. Smoothed surfaces were observed in some areas, which may have been caused by snowplow steel blades. No traffic-induced wearing was observed. The pavement markings had not been reapplied and remained well delineated. FOD production was not a concern at the time of inspection. However, some of the edge cracking on the taxiway was fragmented, which could become a concern for FOD production in the future. Wider transverse cracks can also become an FOD concern if they continue to develop.

Figure UDOT-21. Closeup of Longitudinal Paving Joint on 42U Runway 03/21

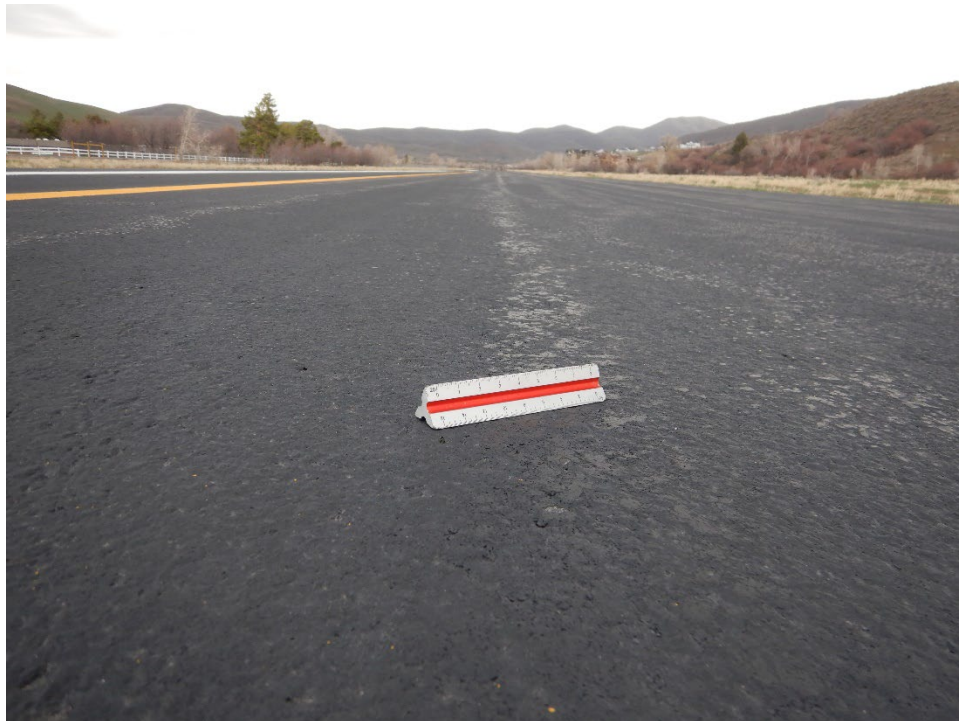
Figure UDOT-22. Surface Smoothing Due to Snowplowing on 42U Runway 03/21

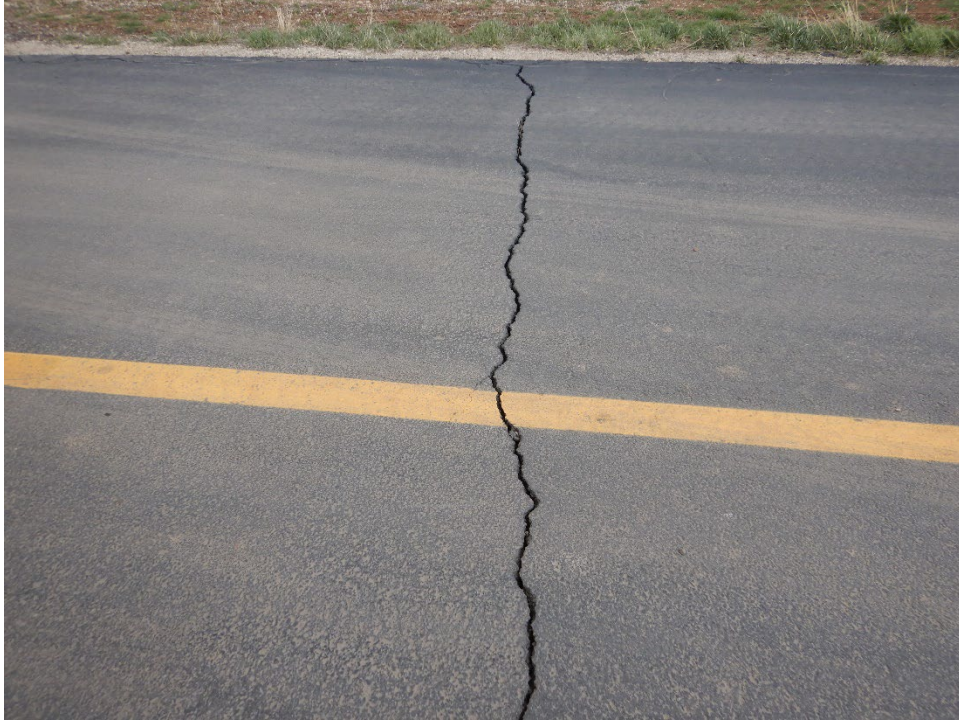
Figure UDOT-25. Transverse Crack on 42U Taxiway

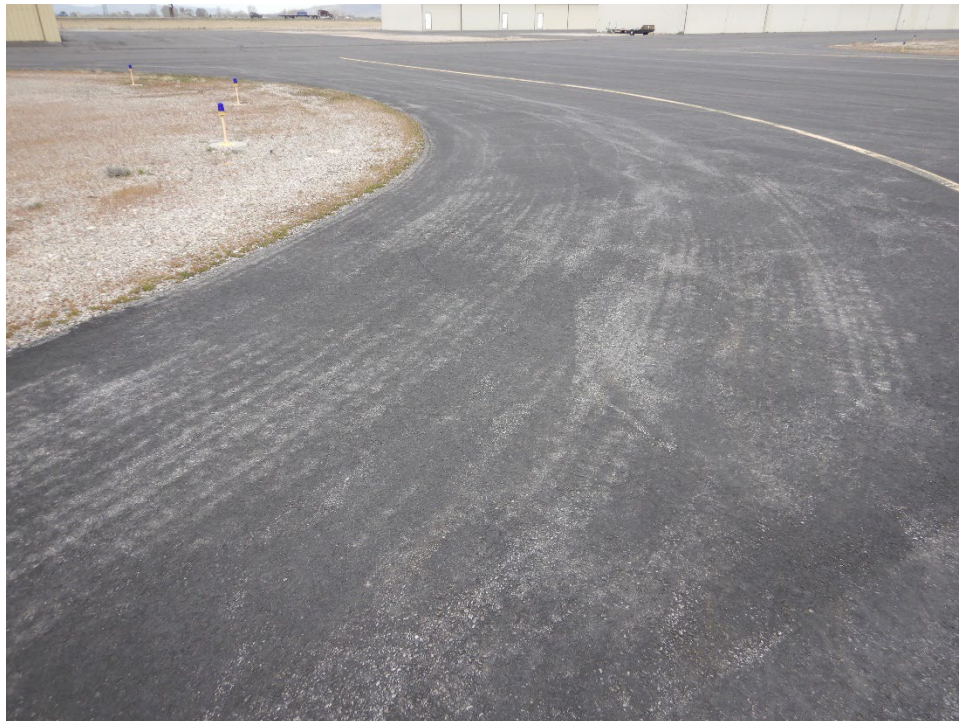
Longitudinal paving joints on the 14-year-old taxiway were mostly closed; joints were partially open on the 16-year-old taxiway, which also had occasional centerline cracking. Additionally, longitudinal wheel path cracking had started to form in one location on the older pavement. Areas were observed where the treatment had been scraped off the coarse aggregate from snowplow operations. Fading was also observed on the surface. No wearing due to aircraft traffic was observed. FOD production was not a concern at the time of inspection. Pavement markings had not been reapplied and were in poor condition, mostly due to snowplow scraping. The delineation of pavement markings was fair.

Figure UDOT-32. BMC Taxiway (Rehabilitated in 2008) Showing Uneven Coverage of Coal Tar Fog Seal

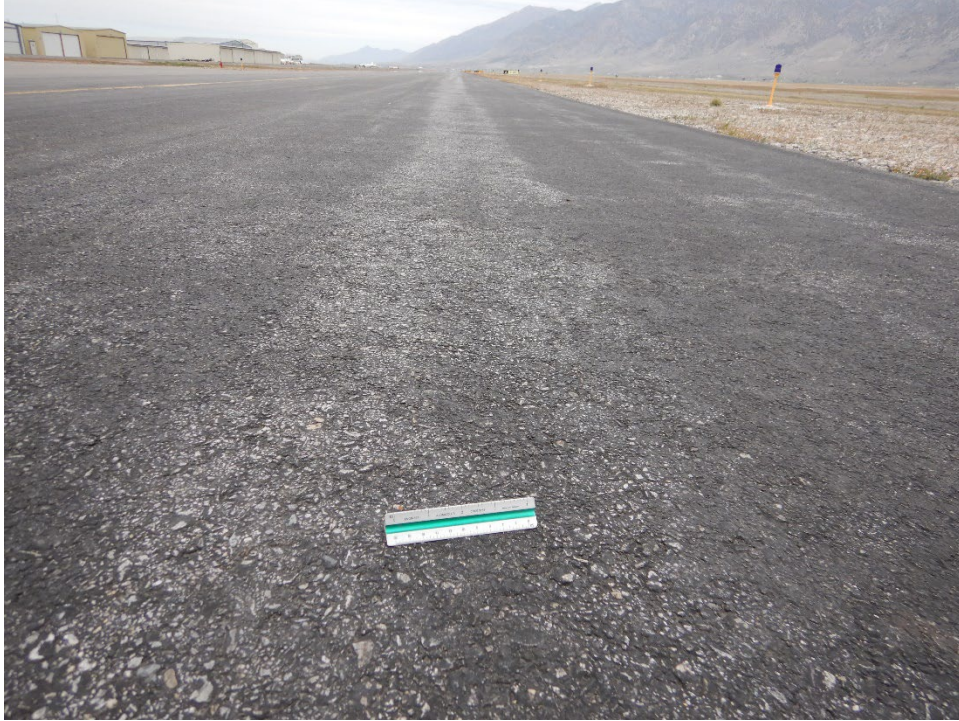
Figure UDOT-33. Snowplow Wear on BMC Taxiway (Rehabilitated in 2008)

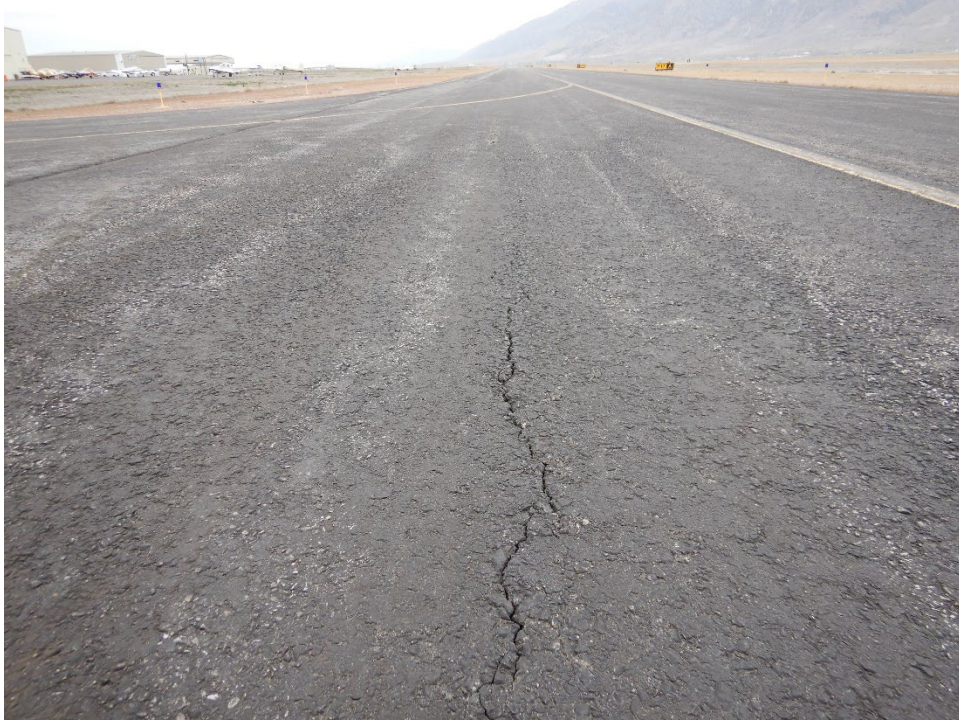
Figure UDOT-37. Wheelpath Cracking on BMC Taxiway (Rehabilitated in 2006)

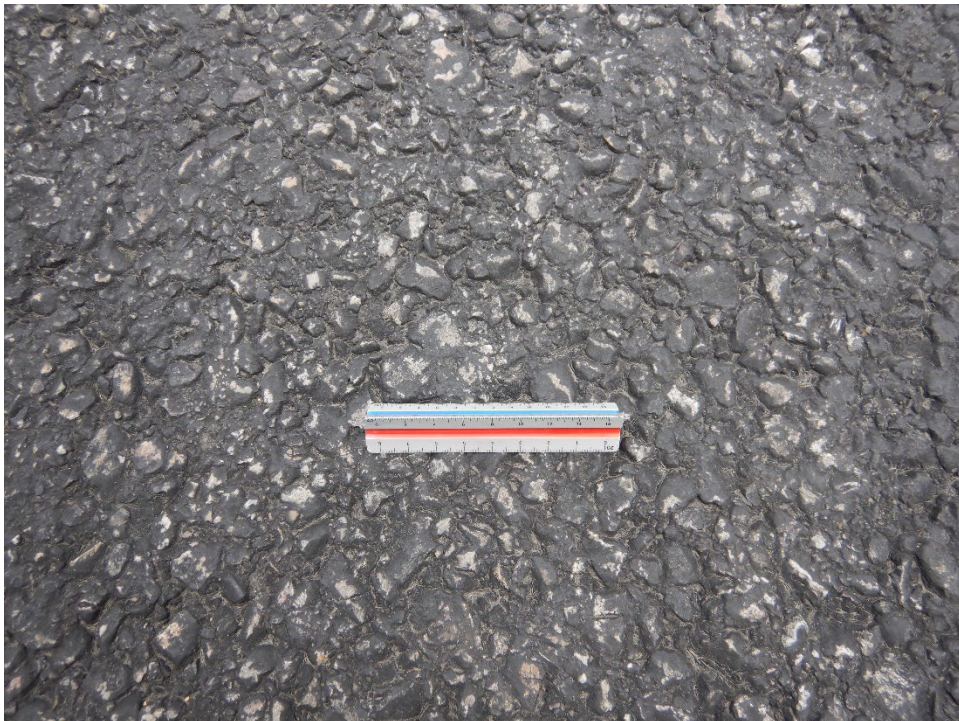
Figure UDOT-38. Snowplow Wear on BMC Taxiway (Rehabilitated in 2006)

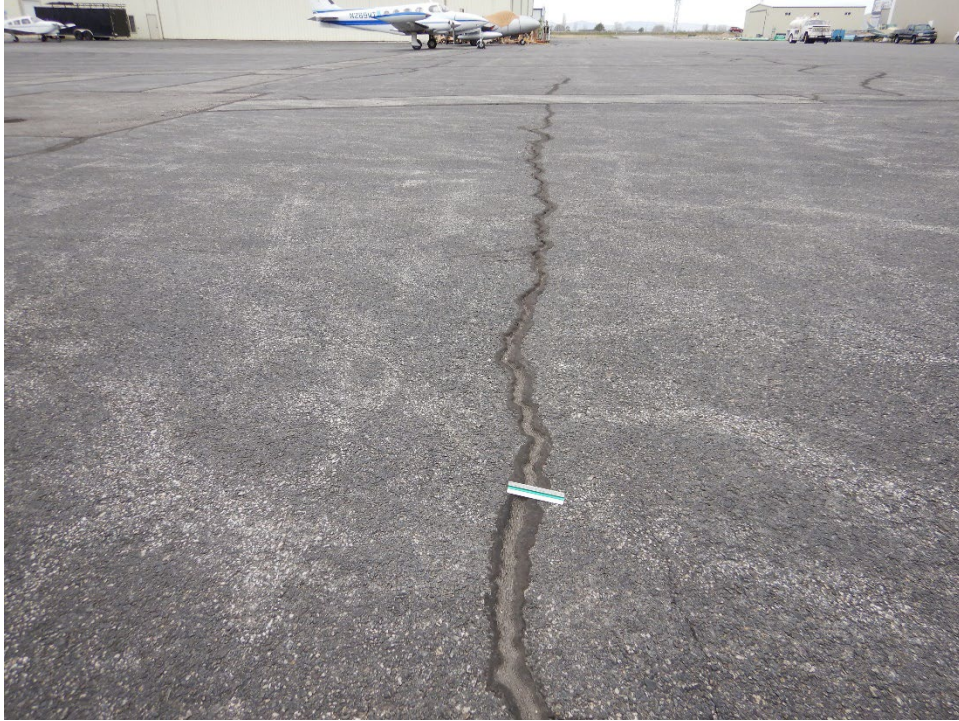
L&T cracking and patching were common throughout the apron area. Block cracking was also defined in some areas, and continued development of new cracking was noted. Previously placed overband crack sealant was mostly failed. Areas were observed where the treatment had been scraped off coarse aggregate from snowplow operations. Additionally, the surface color had faded. Wearing due to aircraft traffic was not observed in any location. FOD production was not a concern at the time of inspection. Pavement markings had not been reapplied and were in poor condition, again mostly due to wear from snowplow operations. Pavement marking delineation was fair, but there were limited markings on the apron.

Figure UDOT-42. L&T Cracking on BMC Apron

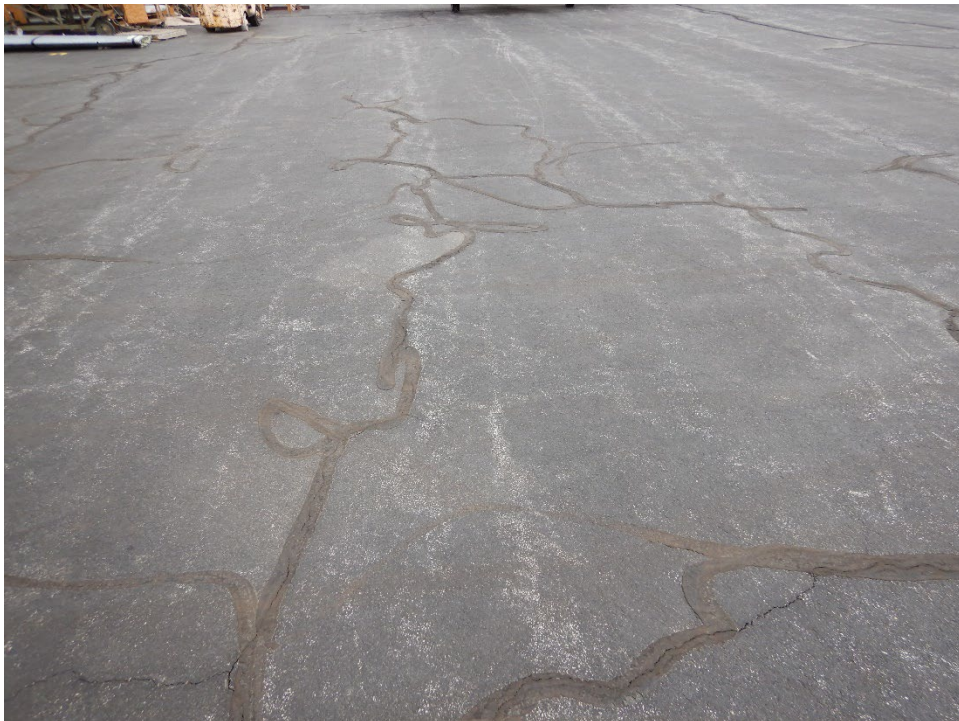
Figure UDOT-43. Block Cracking on BMC Apron

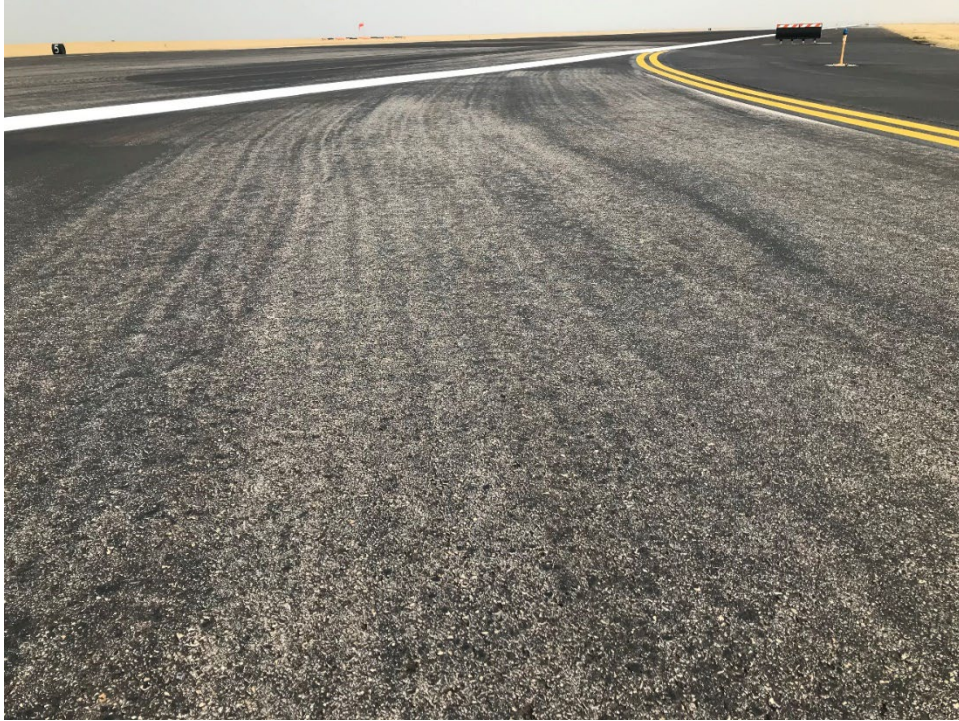
WYDOT did not have a positive experience with a P-608-R application at Casper/Natrona County International Airport (CPR). The product was applied to a runway, taxiway, and aprons in September 2020. The P-608-R did not properly adhere to the surface of the runway and taxiways and peeled away shortly after application. The treatment on the apron areas performed as desired. Within one month of application, the underlying pavement was clearly visible in many locations, as shown in figures WYDOT-2 and WYDOT-3. On-site observations by the manufacturer concluded that the treatment did penetrate the top layer of pavement, which should have led to adhesion. The manufacturer concluded that the issue stemmed from a rapid cure component from one specific truck load. The manufacturer resealed the failed areas in 2021 at no additional cost, and no further issues were reported by the airport regarding adhesion during or after re-application of P-608-R in 2021.

Figure WYDOT-2. P-608-R Shortly After Initial Application—September 2020

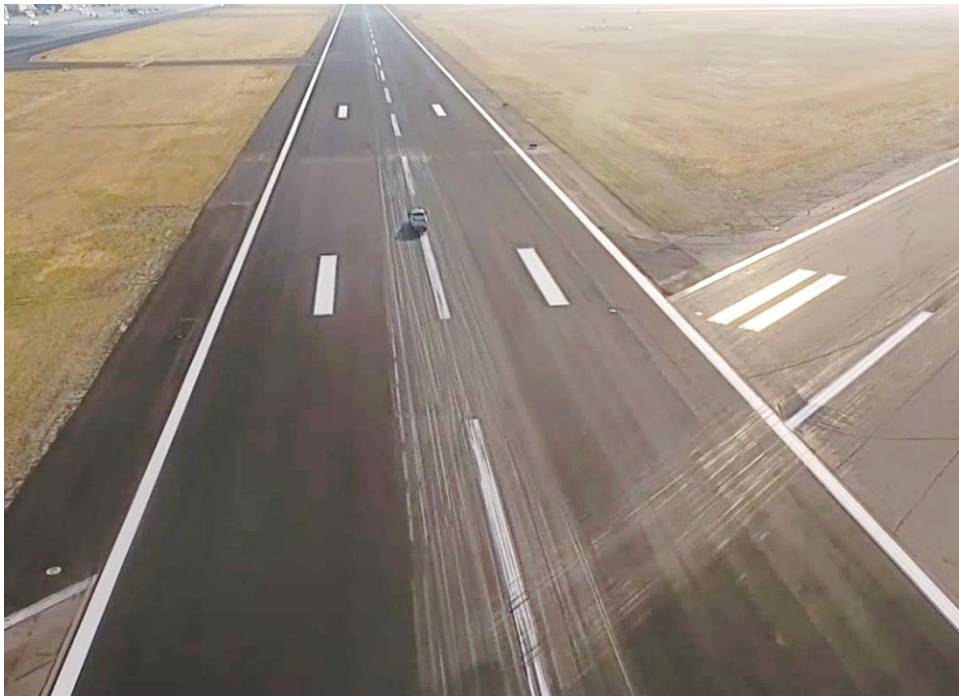
Figure WYDOT-3. Drone View of P-608-R Shortly After Initial Application—October 2020
