AC NO: AC 20-52

MAINTENANCE INSPECTION NOTES FOR
DOUGLAS DC-6/7 SERIES AIRCRAFT

AUGUST 24, 1967

DEPARTMENT OF TRANSPORTATION
Federal Aviation Administration

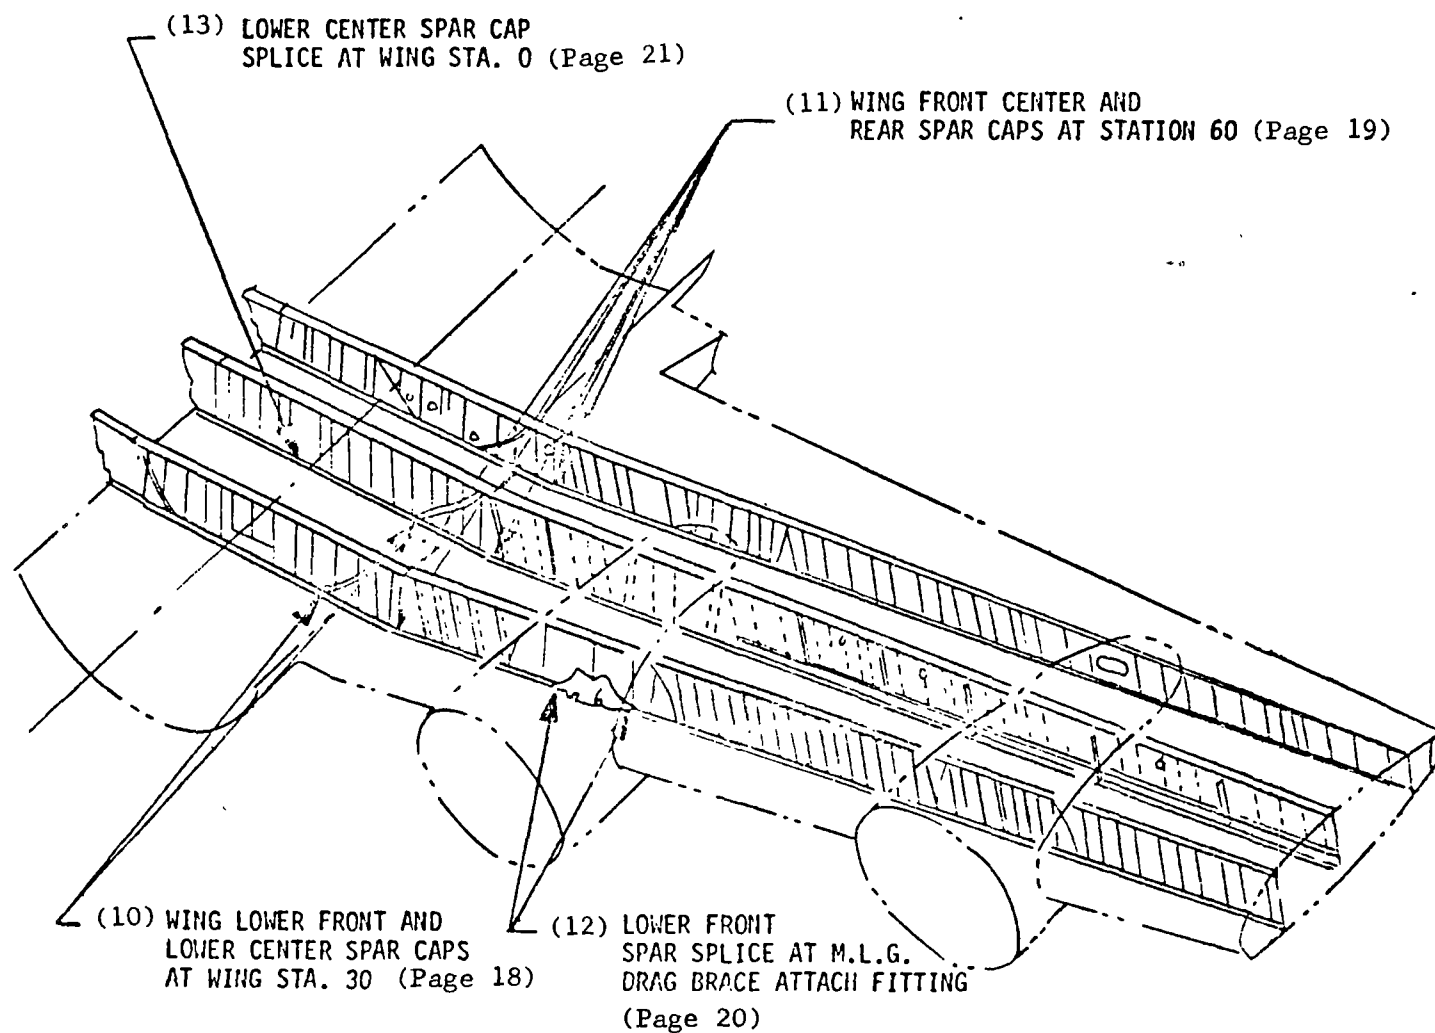
FIGURE G-2. DC-6/7 CENTER WING

DC-6/-7 CENTER WING STRUCTURAL INSPECTION LOCATIONS

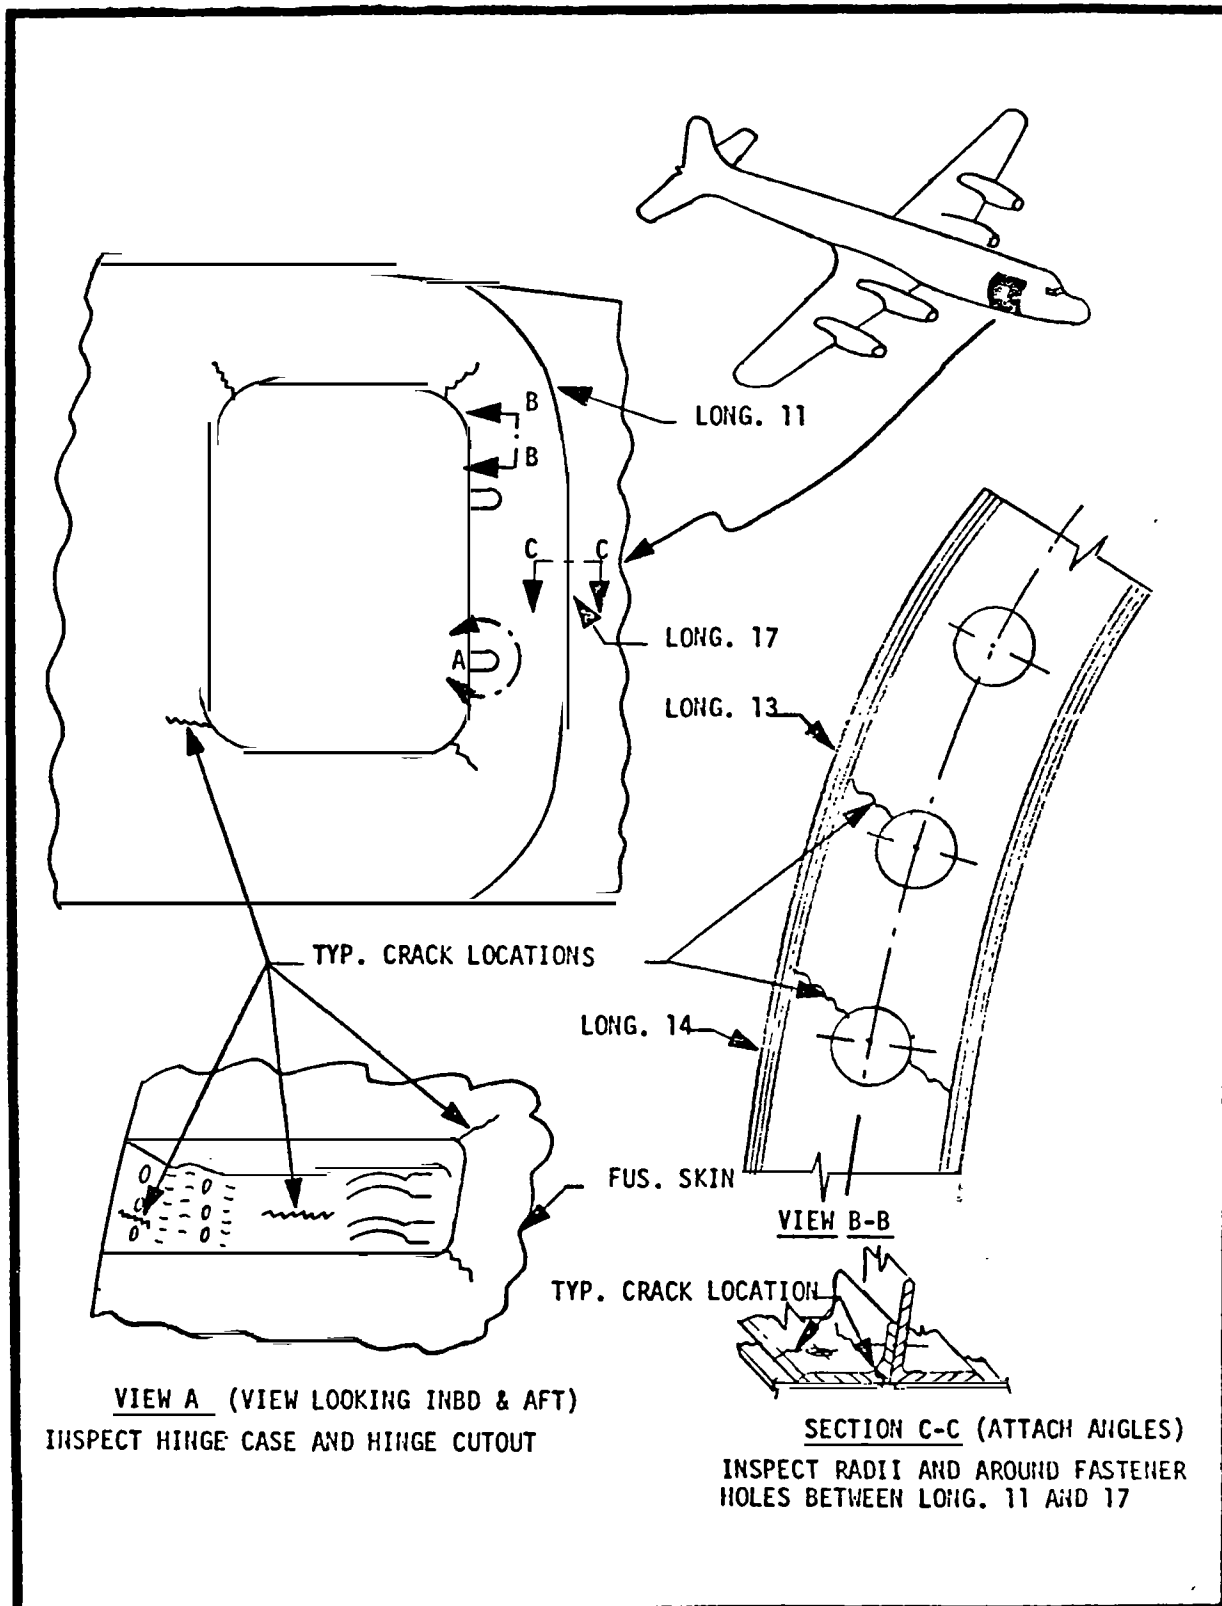
FIGURE G-5. CREW AND CARGO DOOR AREA

FUSELAGE STATION	DESCRIPTION	INSPECT FOR	COMMENTS	INSPECTION TOOL	REMARKS
F.S. 69 to 134	Crew door	Rigging	Critical	Visual	(1) Particular attention should be given to rigging of bayonets and rollers. (2) Improper rigging results in excessive wear, cracks, and pressurization leaks.
F.S. 69 to 134	Front crew door frame, and door hinges	Cracks/Corrosion	Remove fuselage around door frame	Dye Penetrant Visual	(1) <u>Critical Area</u> - Cracks are located in the aft section, upper section down midway of door. Most critical point is located between stringer Nos. 10 and 11 approximately to 17" from floor line. Also, cracks occur in a lower corner of door sill. Area prone to severe corrosion.
F.S. 69 to 134	Front crew door hinge case	Cracks	None	Visual 10-power glass, Dye Penetrant	(1) Crack location - hinge line. Area should receive close and frequent attention.

FUSELAGE STATION	DESCRIPTION	INSPECT FOR	COMMENTS	INSPECTION TOOLS	REMARKS
F.S. 69 to 134	Intercostals below crew door	Cracks/Corrosion	(Ref: DSBs 407 & 858)	Visual and/or as required	(1) Close and frequent attention should be given to this area.
F.S. 69 to 134	Crew door	Cracks/wear	None	Visual	(1)*Cracks start in the bayonet cutouts in the door intercostals. (NOTE 1)
F.S. 69 to 134	Crew entrance door jamb	Cracks	Remove lining above door	Visual Dye Penetrant and X-ray	(1) Crack location No. 1 upper forward and No. 2 upper aft latch cutouts. (2) Close and frequent inspections.
F.S. 89 to 100	Stringer No. 31 left and right side-fuselage	Cracks/Corrosion	(Ref: DSBs 407 & 858)	X-ray and/or as required	(1) Frequent and close attention should be given to this area.
F.S. 101 to 118	Nosewheel well tunnel	Cracks/Corrosion	Thorough cleaning prior to inspection	Visual	(1) Crack location - aft lower corners.

NOTE:	Typical repair instructions may be found in the manufacturer's manual.				
NOTE 1.*	Rigging of the crew door bayonets and rollers is critical. Improper rigging results in excessive wear, cracks and pressurization leaks.
