AC NO: 20-78

ADVISORY CIRCULAR

DEPARTMENT OF TRANSPORTATION FEDERAL AVIATION ADMINISTRATION

SUBJECT: MAINTENANCE INSPECTION NOTES FOR McDONNELL DOUGLAS DC-8
SERIES AIRCRAFT

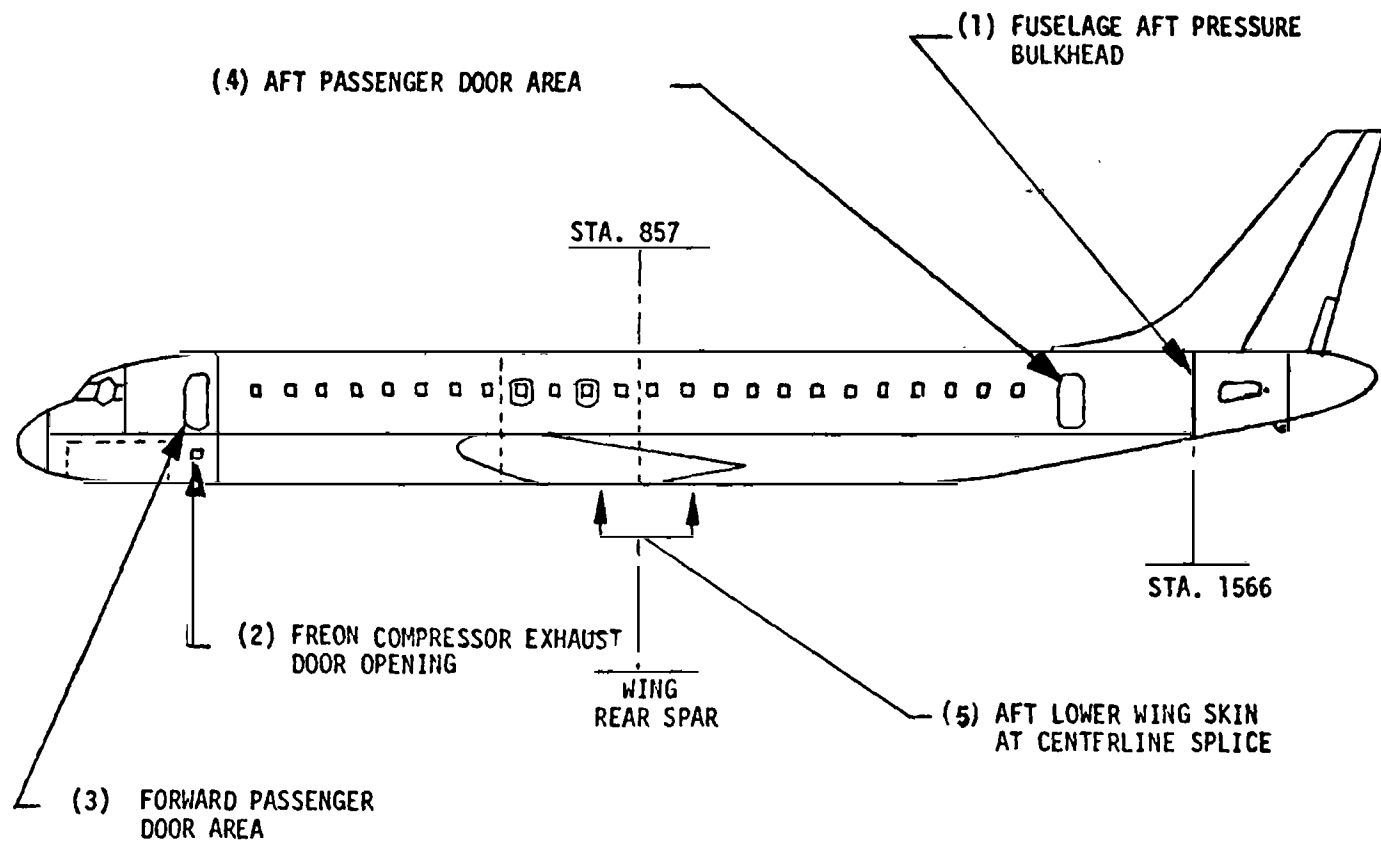
Fig. 7 DC-8 Structural Inspection Locations

1. DESCRIPTION. Five significant structural items are discussed in this appendix. If in a high time DC-8 aircraft a crack occurs in one of these items and is allowed to exist for an extended period of time, the continued airworthiness of the aircraft may be adversely affected. In Figure 7, the general location of these items are described.

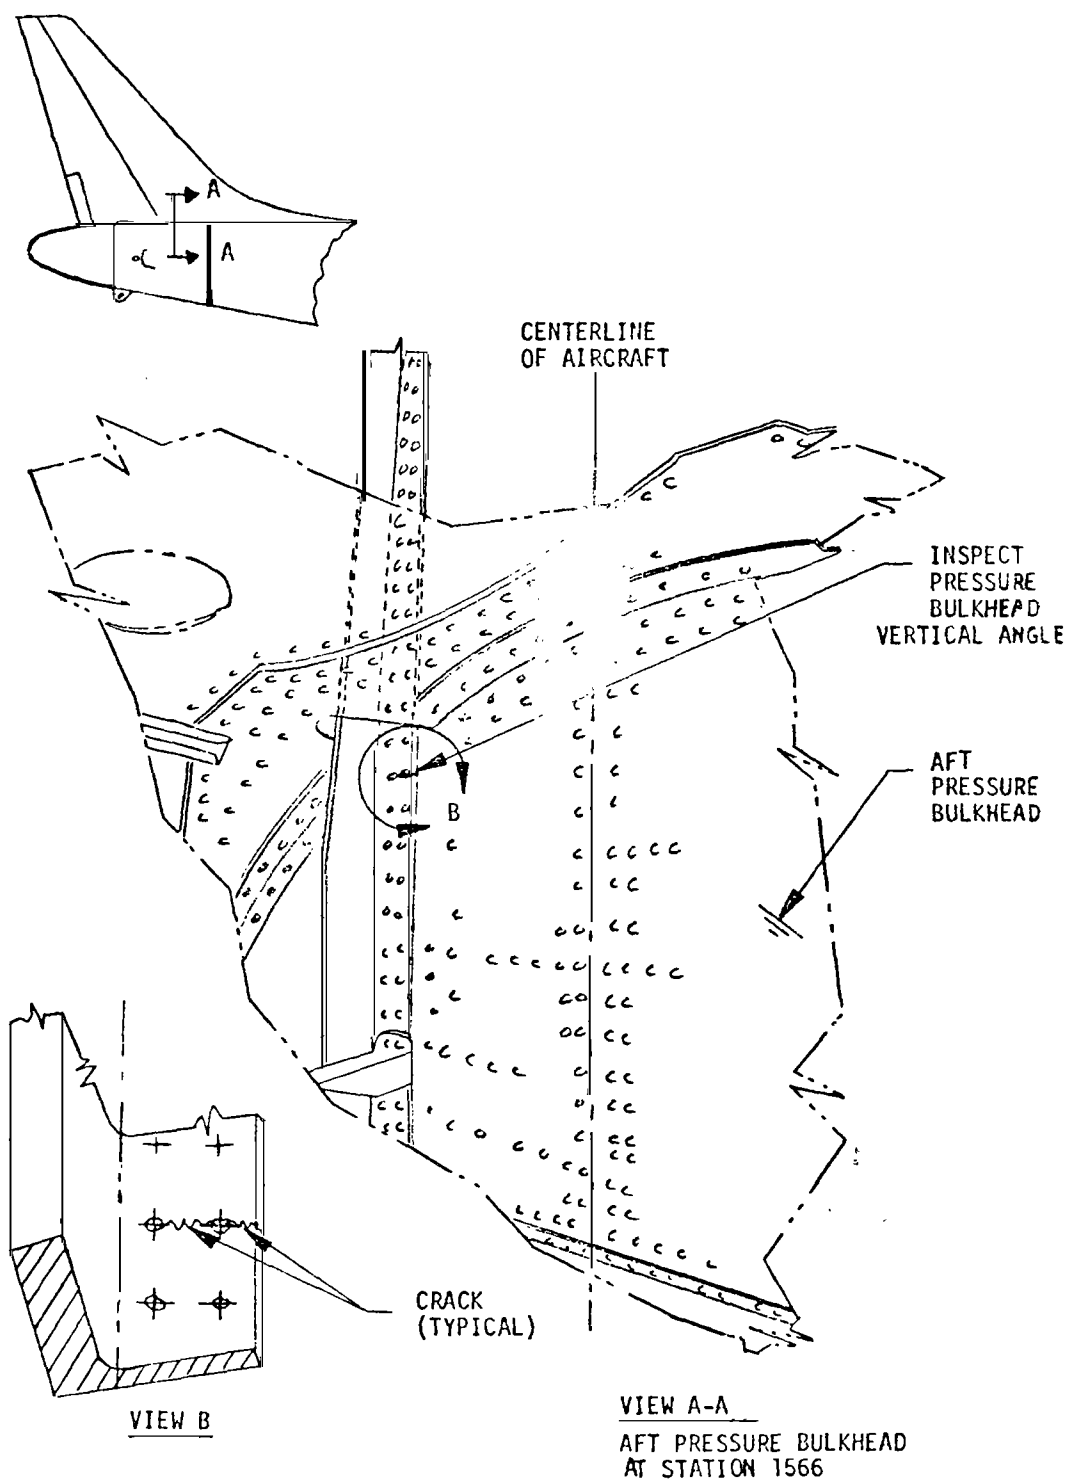
Fig. 8 Fuselage Aft Pressure Bulkhead

- (1) Location. Aft flat pressure bulkhead vertical angles. (See Figure 8, Appendix 3).
- (2) Applicable Airworthiness Directive. None
- (3) Other Reference Documents.
 - (a) Service Bulletin 53-46.
- (4) Recommendations
 - (a) Accomplish Service Bulletin 53-46.
 - (b) Perform subsequent periodic inspections starting at a later date to insure continued structural integrity.

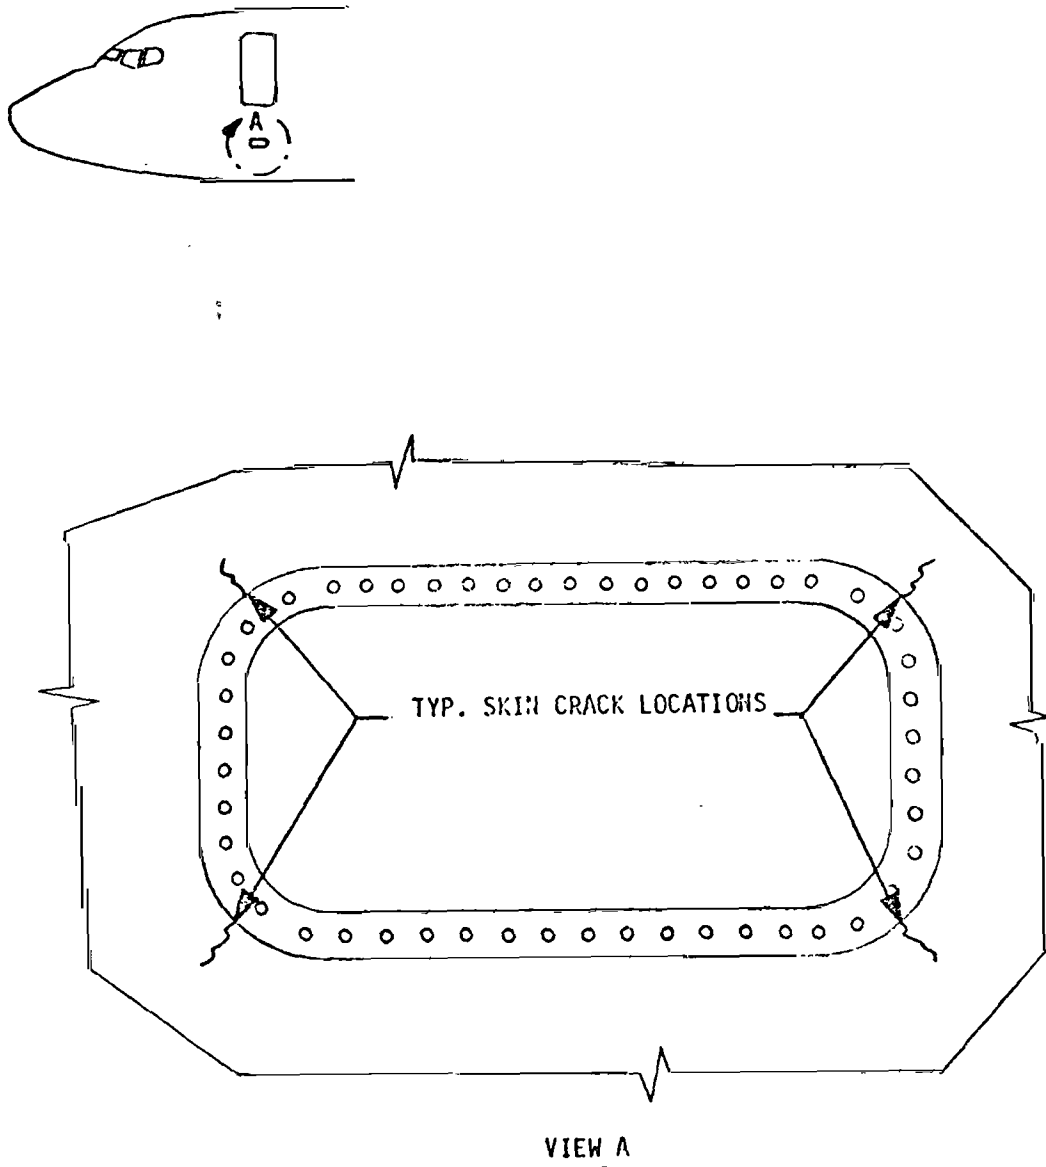
Fig. 9 Freon Compressor Exhaust Door Opening

- (1) Location. Below forward passenger door at longeron 29 (See Figure 9, Appendix 3).
- (2) Applicable Airworthiness Directive. None
- (3) Other Reference Data. None
- (4) Probable Consequences. Extensive cracking around the freon compressor exhaust door opening may lead to more serious structural damage.
- (5) Recommendations. Periodically inspect to assure continued structural integrity.

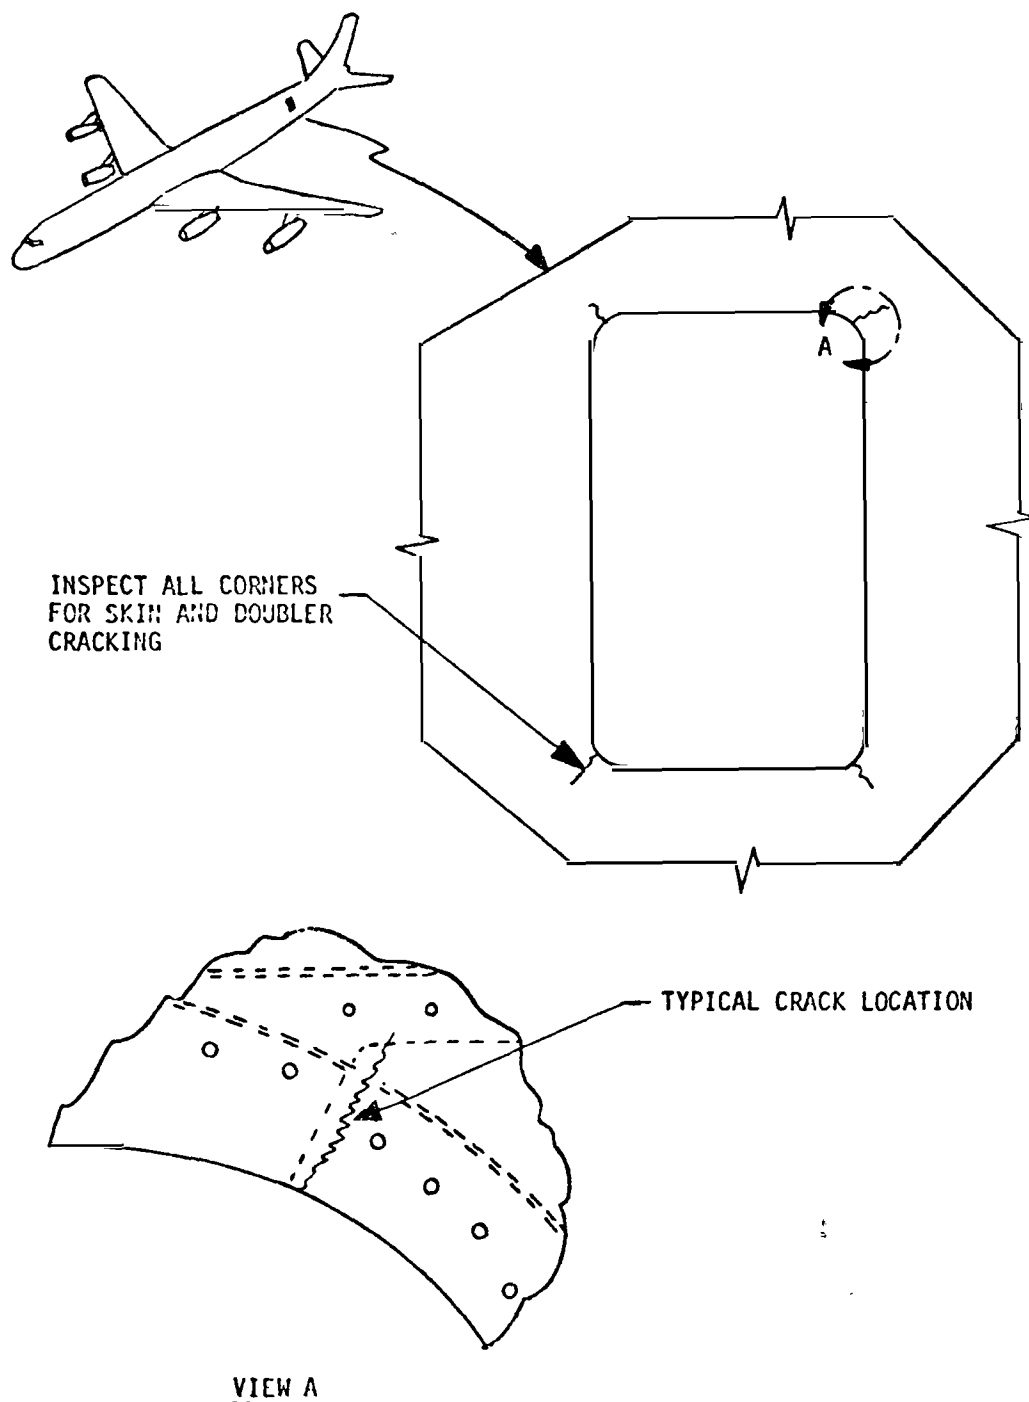
Fig. 11 Aft Passenger Door Area

- (1) Location. Aft fuselage, left hand side(see Figure 11, Appendix 3)
- (2) Applicable Airworthiness Directive. None
- (3) Other Reference Data. None
- (4) Probable Consequence. Extensive fuselage cracks in this may lead to more serious damage.
- (5) Recommendation. Periodically inspect fuselage skin around door cutout to assure continued structural integrity.
