GENERAL AVIATION
inspection

SUPPLEMENT NO. 1

SEPTEMBER 1976

U.S. DEPARTMENT OF TRANSPORTATION
FEDERAL AVIATION ADMINISTRATION

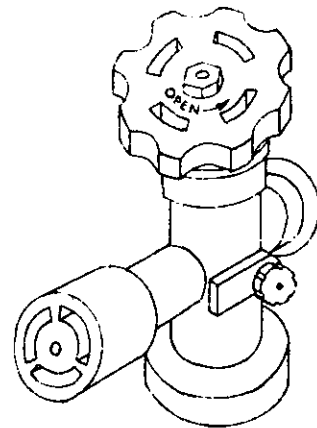
Tank Valve

The operator attempted to shut off the gas supply to the pilot light. Instead of turning the valve in the normal clockwise direction, he turned it counterclockwise. The valve stem and packing came out, releasing propane. The propane caught fire destroying the balloon and tanks.

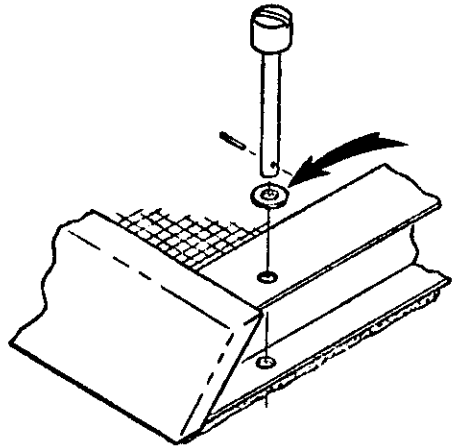
Washers may be added under the head of induction air filter attach studs, as required, to insure proper fit of the filter and improve the air filter seal.

Addition of washers (AN960-10) is recommended whenever excessive filter looseness is experienced. Cessna has issued Service Letter No. SE76-12 providing instructions.

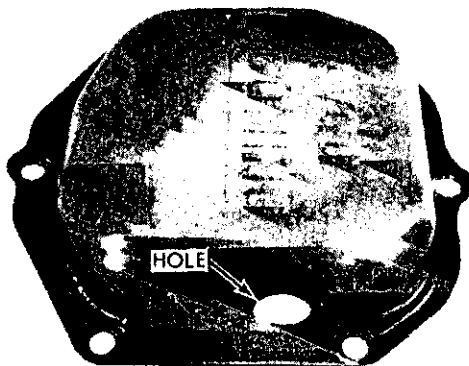
Cylinder Rocker Box Cover

Reports have been received of oil leakage caused by rocker shafts wearing holes through cylinder rocker box covers. Avco Lycoming Service Instruction No. 1176, dated October 27, 1987, advised that any nicks, roughness or other damage on the ends of valve rocker shafts would cause rapid wear-through of the rocker box cover. Service Bulletin No. 400, issued June 4, 1976, calls for the installation of teflon thrust buttons in the ends of valve rocker arm shafts which should eliminate the wear problem.

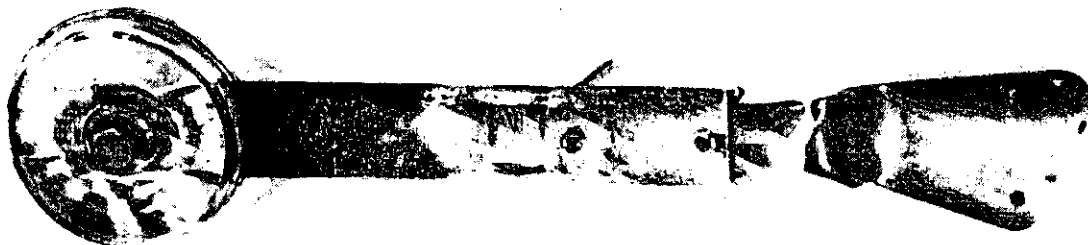
Landing Gear Control
Lever, P/N 752303

Several instances have been reported where the landing gear control lever has failed when attempting to retract the landing gear. If these failures had occurred after the landing gear had retracted, a serious accident may have resulted. Reports indicate the failures occur at the first bend radius forward of the control lever knob. Close examination of this area of the control lever for evidence of cracks is recommended at each aircraft inspection period.

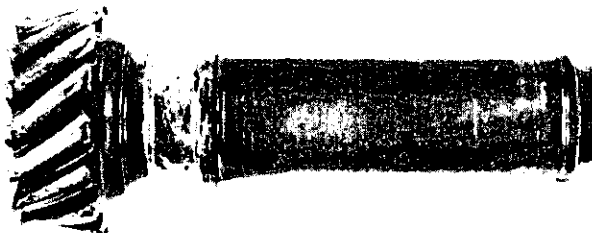
Tail Rotor Drive Pinion
Gear, P/N 47-620-568-1

The tail rotor drive pinion gear failed resulting in loss of tail rotor drive. Investigation disclosed that the shaft was worn severely permitting the gear to disengage. Bell Service Instruction No. 428 relates to this subject.

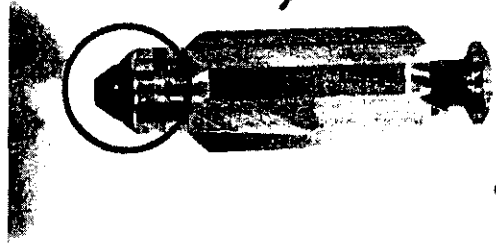
Needle Valve and
Seat Assembly, P/N A233-615

The cause for carburetor flooding, rough running and inflight engine stoppage, has been traced to fuel leakage past the carburetor needle valve. In several instances, disassembly inspection revealed the leakage to be caused by wear of the needle valve rubber tip or insert. Contact of the needle valve with the seat sometimes wears a groove 360 degrees around the rubber tip permitting fuel to pass into the float chamber when the valve is in the closed position. This condition has been reported with needle valve and seat assemblies with as little as 300 hours time in service.

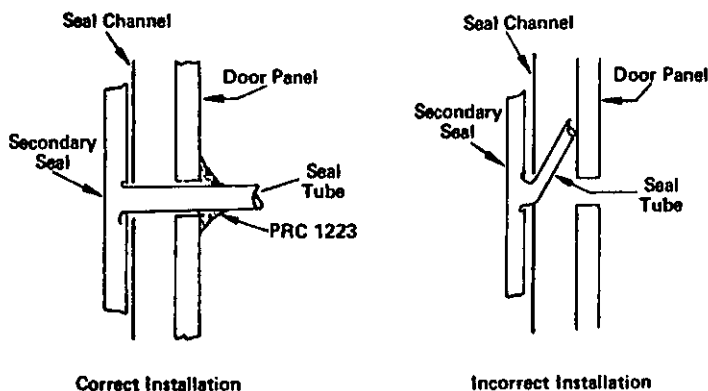
SABRELINER DOOR SEAL INSTALLATION

We have had reports that on some Sabreliners the secondary door seal is being incorrectly installed. Perhaps this tip will help you

When pressing the door seal into the channel, insert the seal tube into the hole in the channel and guide the tube through the hole in the door panel. The tube should be visible when looking inside the door from the interior door handle opening. PRC 1223 (or equivalent) pressure sealant should be used around the tube on the door panel as shown.

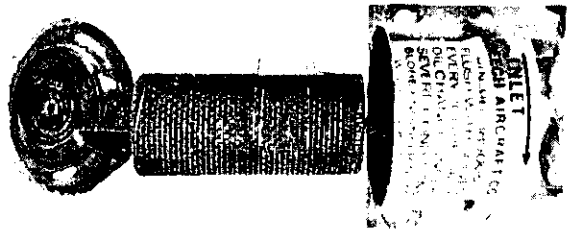
Oil Separator,
P/N 96-389006-1

An investigation to determine the cause of metal in the engine oil screen disclosed that the oil separator screen was coming apart. Total time in service - 1300 hours.
