AC NO. 20-7P

GENERAL AVIATION
inspection
AIDS

SUMMARY

AUGUST 1977

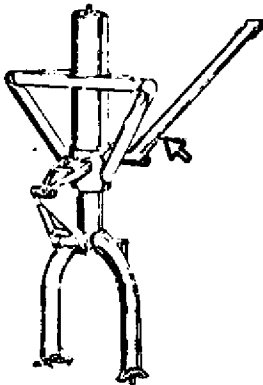
Main Landing Gear
Drag Leg, P/N 404-188405-6

Cracks and complete failures of the main landing gear drag leg have been reported. The failures usually occur at the lower end of the tube and are generally attributable to corrosion. It is suggested the drag legs be carefully examined on a periodic basis. Defects in the paint should be given special attention to determine whether they are corrosion pits or merely stone chips, etc. Probing questionable areas with an ice pick or cotter key extractor is also suggested as a method to determine if corrosion has progressed through the tube.

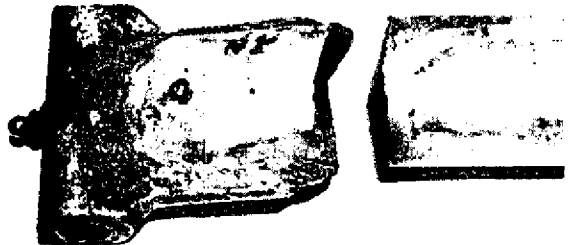
Tail Wheel Installation

An airplane was substantially damaged during a ground loop following collapse of the tail wheel assembly upon landing.

The tail wheel support structure incorporates a vertical cross brace member in the aft fuselage above the tail wheel truss attach fittings. The upper right member of the cross brace support was found separated and evidence of a pre-existing crack was observed. Failure of the cross brace support resulted in loss of structural support to the tail wheel assembly, allowing it to collapse when side loads were encountered.

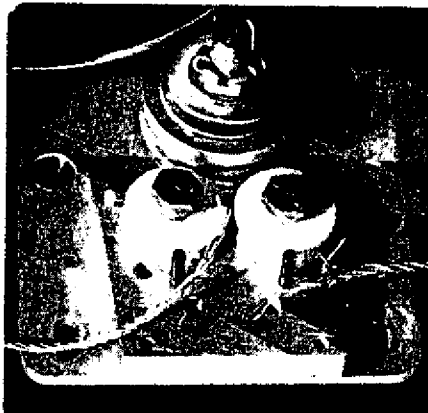
Several reports have been received which indicate that the elevator trim cable has loosened and failed at the electric trim/autopilot actuator located in the vicinity of the cockpit pedestal. This results in the loss of trim capability. In at least one instance, the failed cable unreel from the actuator capstan and contacted electrical connections on the subpanel feeder diodes causing sparks and smoke in the cockpit; however, no electrical failure occurred.

Edo-Aire Mitchell has issued Service Letters Nos. ML-39 and ML-42 which describe inspection and modification procedures to prevent this type failure.

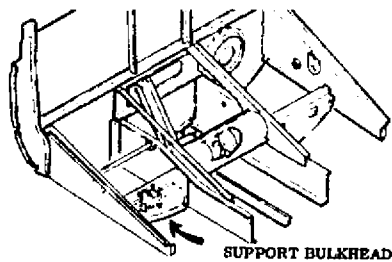
Rudder Bellcrank Support
Bulkhead, P/N's 35-400366-2
or 96-420001-9

The bulkhead, located on the left side of the fuselage at Station 49.0, has been found cracked or broken. When this bulkhead fails, partial loss of rudder travel may occur as the rudder bellcrank support, P/N 35-424136, is mounted on this bulkhead. These failures are believed to be attributable to ground handling of the aircraft using a tow bar and tow tractor when the aircraft gust locks are installed.

Beech Class II Service Instructions No. 0869-154 announced the availability of two kits which were developed to provide more durable cast-type supports. Kit No. 55-4029-1S pertains to Model 95-B55, S/N's TC-502 through TC-1944. Kit No. 55-4029-3S affects Model 95-C55, S/N's TE-1 through TE-300.

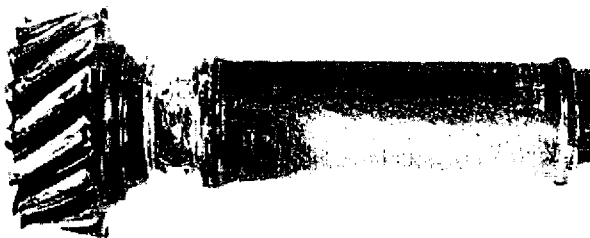
Tail Rotor Drive Pinion
Gear, P/N 47-620-568-1

The tail rotor drive pinion gear failed resulting in loss of tail rotor drive. Investigation disclosed that the shaft was worn severely permitting the gear to disengage. Bell Service Instruction No. 428 relates to this subject.

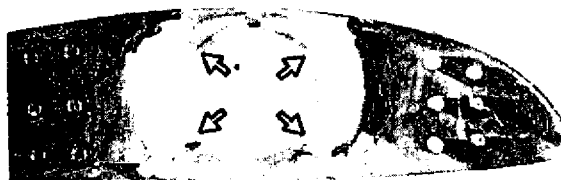
Horizontal Stabilizer
Rib, P/N 206-020-119-52

During inspection, the right horizontal stabilizer inboard rib was found to be cracked. Total time in service - 590 hours. A doubler had been installed in compliance with AD 76-05-01, however, the doubler was cracked also.

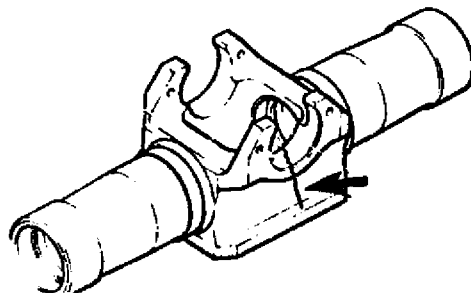
Main Rotor Hub
Yoke, P/N 206-010-101-9

The main rotor hub yoke was found to be cracked at the trunnion support bore. The crack was approximately 1 - 1/4 inches deep, extending into the square section at the bottom of the yoke. Bell Service Bulletin No. 206-04-1-74-1 was complied with 9/1/74. Airworthiness Directive 76-04-9 was complied with 10/9/75 and again on 11/23/76 which was 561 hours prior to discovery of the crack.

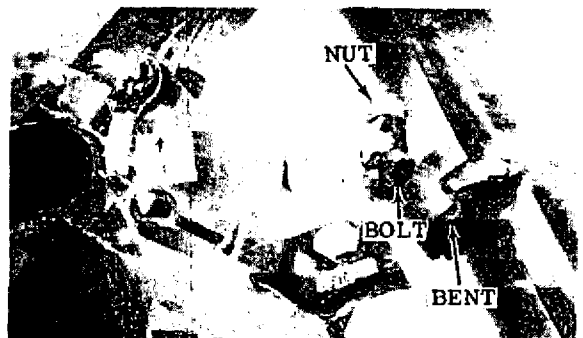
Elevator Bellcrank Stop

The elevator down stop has been found deformed, bent downward and concave, as shown in photo No. 1. The correct condition of the stop, perpendicular to the vertical stabilizer tube and flat, is shown in photo No. 2. The optional bolt, installed in the bellcrank is to adjust for proper elevator travel, and should not be filed flat.

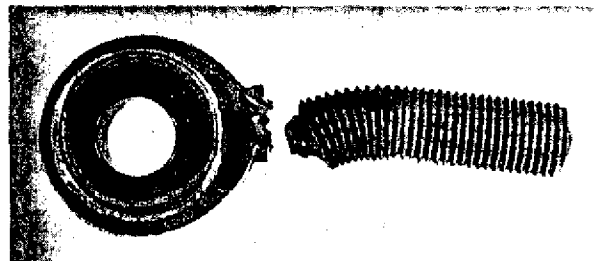
Nose Gear Actuator Rod End

The nose gear actuator rod end failed during gear extension. Inspection disclosed that the ball joint was seized due to the lack of lubrication.

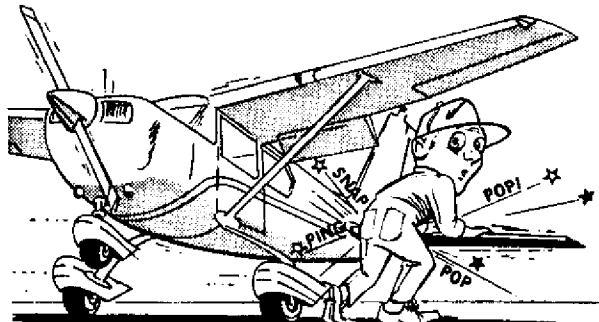
Horizontal Stabilizer
Attach Stiffeners

Service experience and engineering tests indicate that cracks in the forward attachment stiffener can be caused by excessive loads being imposed on the horizontal stabilizer if improper procedures are used during ground handling. It is important that pushing forces be applied close to the fuselage when moving an aircraft by the horizontal stabilizer (reference Model 150 Service Manual, Section 2, Ground Handling).

Cessna has issued Service Letter No. SE71-23 which supersedes Service Letter No. SE68-32. The current service information provides additional modification instructions and information relative to a modification kit designed to reinforce the present stiffener or replace the stiffener and bulkhead assemblies with improved parts.

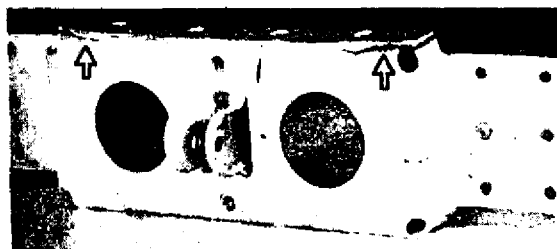
Elevator Bellcrank
Bracket Assembly,
P/N 0432004-1

The elevator bellcrank bracket assembly was found to be cracked. Total time in service - 6275 hours. A second aircraft was inspected and the same condition was found.

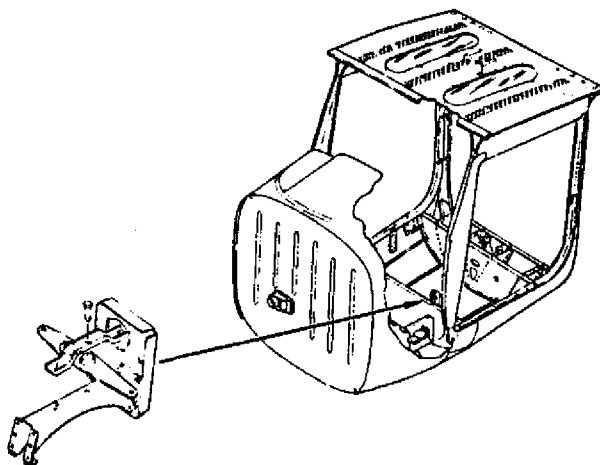
Forward Elevator
Bellcrank Assembly,
P/N 0411288

In one case, the cracks were found when investigating the cause of stiff elevator control movement. In another instance, popping sounds were heard when the elevators were moved, and in at least one other case, the elevator system was reported as being extremely loose.

It is recommended that this area be thoroughly inspected at each annual inspection and whenever any peculiar elevator control condition exists.

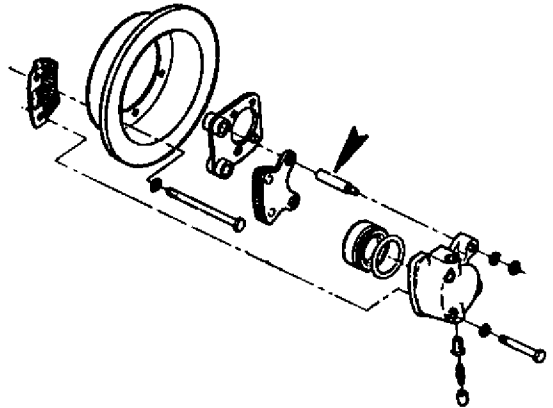
The guide pins in the brake cylinder are reported to be corroding and seizing in the torque plate. This condition is more likely to exist if the aircraft has been inactive for an extended period. The brake manufacturer advises that the plating on later guide pins has been improved which reduces this problem.

It is suggested that these brake assembly guide pins be inspected each 50 hours of operation. Aircraft affected are: Model 150, S/N's 15072004 and on; Model A150, S/N's 1500227 and on; and Model 172, S/N's 17260835 and on.

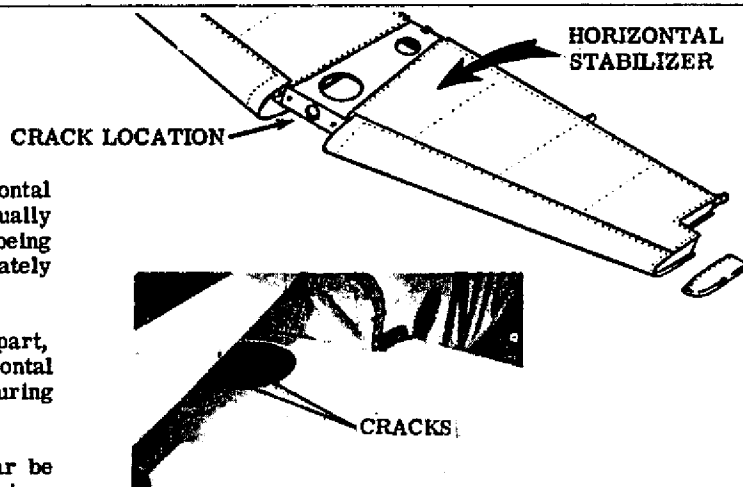
This condition is believed attributable, at least in part, to the malpractice of pushing down on the horizontal stabilizer to lift the nose wheel off the ground during ground movement of the aircraft.

It is suggested the horizontal stabilizer front spar be examined for this condition whenever the tail fairings are removed.

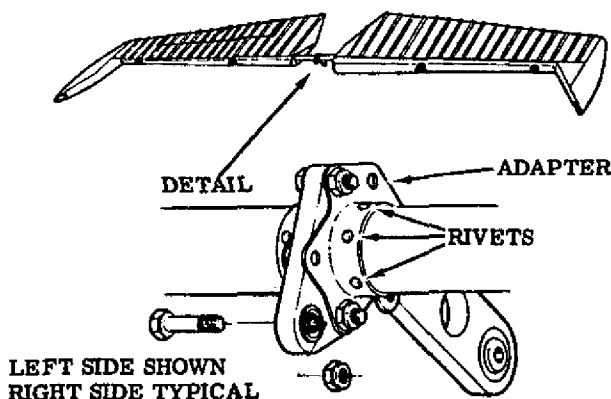
There have been several recent reports which indicate the rivets, used to secure the adapters to the elevator torque tube, have been found loose or sheared off. This condition can usually be detected by holding one elevator immobile while attempting to move the other. Any movement indicates that looseness is present.

It is suggested that these model aircraft be checked periodically for this problem.

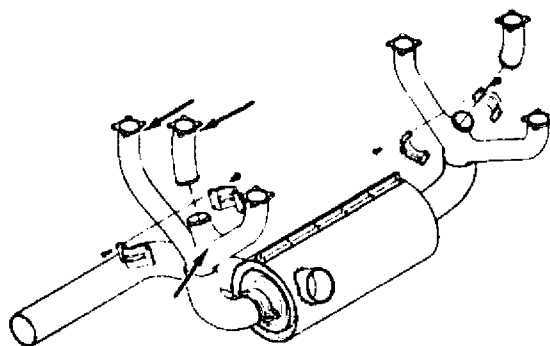
Reports have been received of cracks being found in the exhaust stacks of low-time aircraft. The cracks generally occur in the "Y" section of the stack assembly; however, some cracking in the flanges which bolt to the cylinders have also been reported.

It is suggested that the exhaust stacks of aircraft having less than 100 hours time in service be examined immediately for cracks in these areas. It is also recommended that replacement stacks be mounted on the engine before the stack clamps are tightened. This will prevent the stacks from being installed in a "preloaded" condition and, in addition, will allow the stacks to adjust to any differences in cylinder exhaust ports caused by machining tolerances.

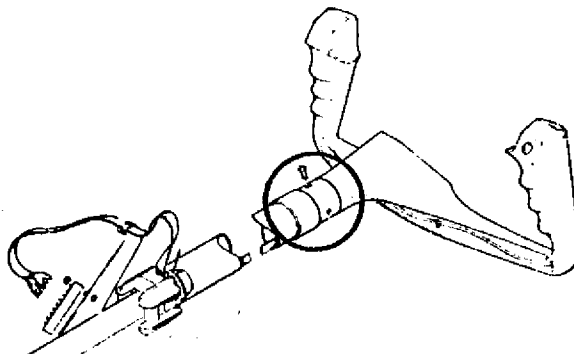
Several reports have been received which describe loose or missing screws which attach the control wheel adapter to the tube assembly.

It is recommended that the control wheel adapter cover be pulled back and the attaching screws periodically checked for tightness. The screws should be tightened to 20-25 inch pounds torque or as an alternate method, a thread locking material such as "Loc-tite" can be used.

The use of screws for this application was discontinued on the Model 210, beginning with the 1972 model year and on; Models 182, 206 and 207 at the beginning of the 1976 model year. These newer model airplanes use AN3 bolts instead of screws. The proper torque value for these bolts is 30 inch pounds.

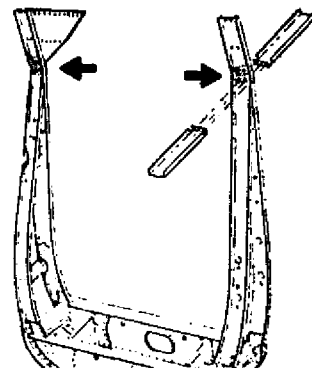
Inspections have revealed cracks emanating from the door post bulkhead (fuselage frame) upper attach rivets. The cracks have been found in the front and rear door posts on both the left and right sides of the aircraft. The area involved is adjacent to the location described in AD No. 63-20-2. Any previous involvement in a ground loop or other operational damage to the wing tip could have transmitted excessive loads to this area. Cessna Service Letter SE 73-15 dated June 22, 1973 outlines an inspection procedure.

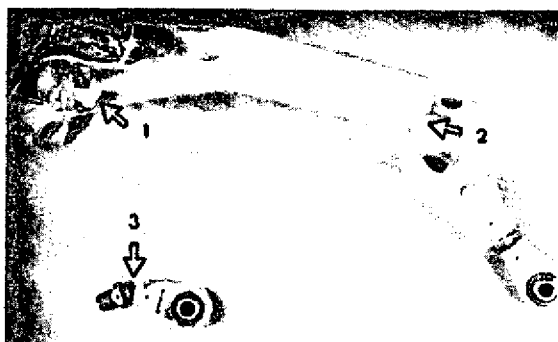
Main Landing
Gear Downlock Links

Reports continue to be received regarding collapse of the main landing gear of these aircraft. One of the most common causes of landing gear collapse is that the downlocks do not snap fully over center into the locked position. Improper lubrication and/or rigging almost always contributes to this situation. The photograph illustrates the type failures which can occur due to overload when the weight of the airplane is put on a landing gear which is not in the fully locked position.

1. Mounting lug breaks off main gear trunnion and/or bolt fails.
2. Ear breaks off downlock bellcrank.
3. Eyebolt lug breaks in the threaded area.

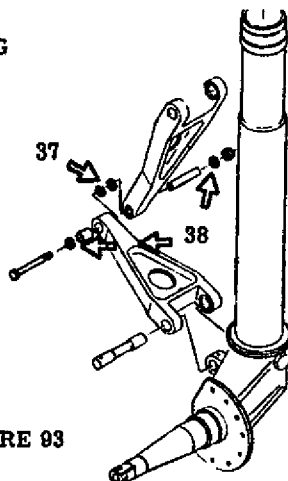
FIGURE 93

Figure 93 of the Cessna Model 310P and 310Q parts catalog is misleading as to the proper assembly sequence of the main landing gear torque link center pivot. The AN960-716 washers called out by Index 38 in the parts catalog should be installed between the links. The washers, P/N 5045018-1, (Index 37) are to be used on each side of the links. Cessna plans to revise the parts catalog (Manual No. P497-12) to reflect this change.

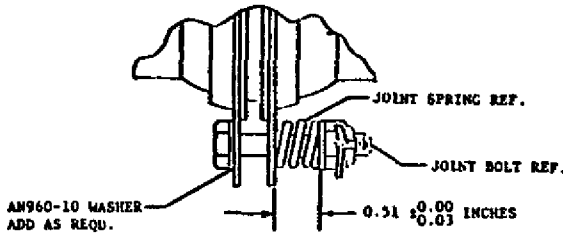
Typical Exhaust Joint Spring Installation

The exhaust joint spring tension relaxed permitting the ball socket to separate approximately 1/8-inch. The escaping exhaust damaged the right engine compartment, hoses, and wiring. AD 75-23-08 relates to this subject.

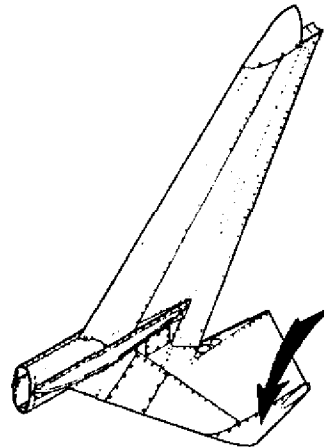
Vertical Fin, Lower Tip, P/N's
1431001-4, 1431001-6, and
1431001-11

There is a report that water collected in the lower tip fiberglass fairing of the vertical fin. As much as two gallons of water have been found in one fuselage boom fairing. Drain holes should be present in the lower part of the fin. It is recommended that periodic checks be made to assure the drain holes are open.

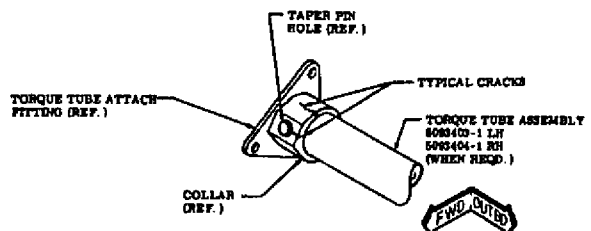
Elevator Torque
Tube Fittings

There have been several reports of cracks found in the torque tube fittings, especially at the taper pinholes. Cracking at these holes is believed to be caused by overtightening the taper pins. The recommended torque value for these pins is 50 ± 10 inch-pounds.

It is suggested that these fittings be checked for cracks and corrosion at each annual or 100-hour inspection, or whenever the tail cone is removed for any reason. Cessna Service Letter No. ME71-8 provides additional information on this subject.

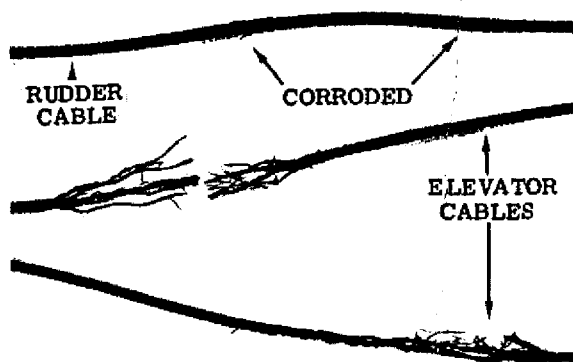
Elevator and Rudder
Control Cables

A pilot reported loss of elevator control during takeoff roll. Investigation revealed separation of the elevator control cable and severe corrosion of both the elevator and rudder cables between fuselage stations 353 and 377. The aircraft time in service was 9300 hours. Inspection of another aircraft with 8400 hours time in service disclosed control cable corrosion in the same area, but not as severe.

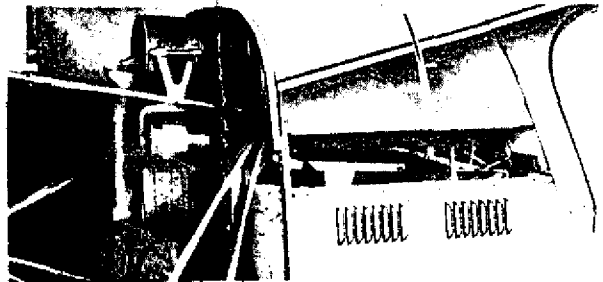
Main Drive Belt

The main drive belt tension was found to be unequal across the pulley. The belt was also found to be deteriorated. Total time in service - 100 hours.

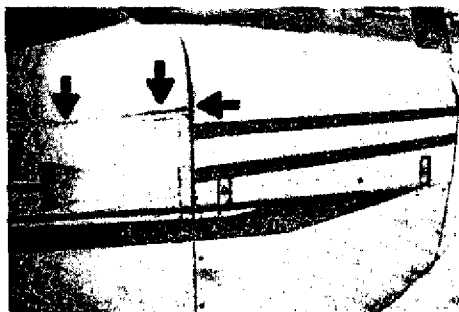
Grumman-American Exhaust Gasket, Lycoming,
Model AA-1B P/N 65321

It has been reported that exhaust fumes enter the cabin through the outside air vents. Investigation revealed that the exhaust flange gasket leaks, permitting fumes to build up in the engine compartment. These fumes escape between the cowl and fuselage and enter the cabin through the outside air vents.

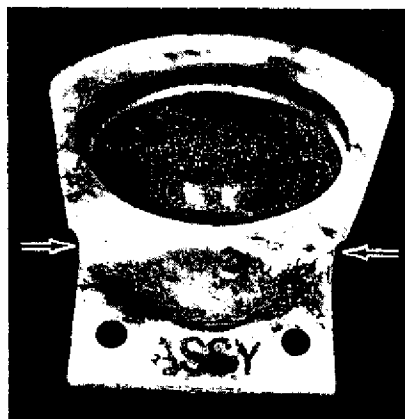
Grumman-American Aileron Bearing Support
Model AA-5 Bracket, P/N 902010-501

During inspection, the right aileron outboard hinge bearing support bracket was found to be cracked in the bend radius. These cracks were not visible until the bracket was removed from the aircraft.

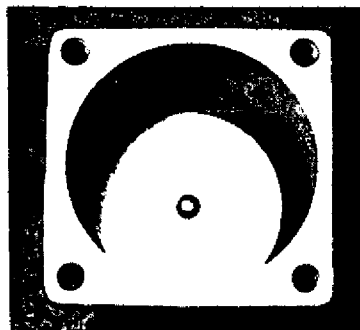
Fuel Injector Pump

The fuel injector pump inlet flapper valve separated at the hinge and lodged in the throat of the pump, rendering the pump inoperative. Total time in service - 1521 hours.

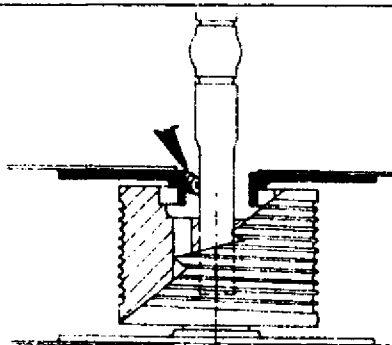
STA 88.75

The elevator trim tab system jammed in the neutral position shortly after takeoff. After landing, an inspection disclosed that a nut, washer and rivet were jamming the trim cable shaft under the cockpit floor at the control pedestal. Further checks disclosed that an opening in the cockpit floor at the control pedestal, permitted debris to fall through. Grumman Alert Customer Bulletin No. 13, Amendment 1, dated January 1977 relates to this subject.

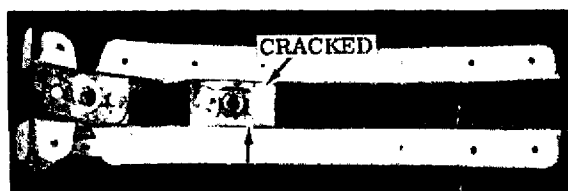
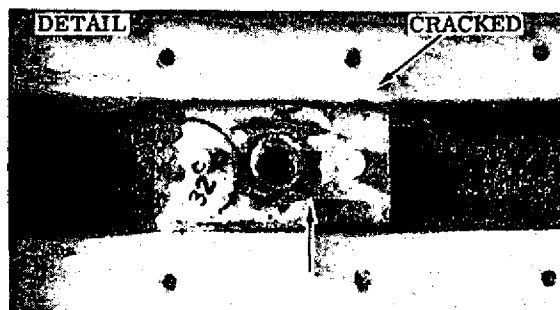
Helio Wing Leading Edge Rib Model H-391B

The wing leading edge rib assemblies were found to be cracked and corroded.

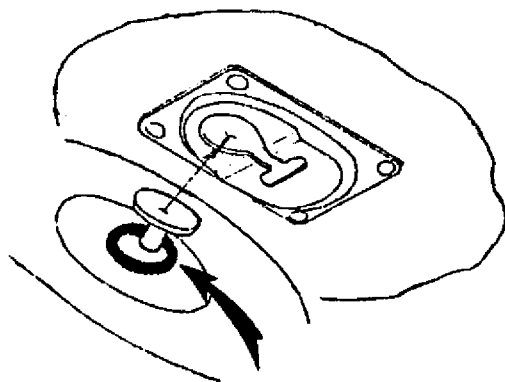
Fuel Cell,
P/N 8701

The fuel cell upper hanger buttons have been found to be disconnected due to the buttons being too long. The addition of an "o" ring around the button neck will provide the necessary tight fit. Lake Service Bulletin No. B58 relates to this subject.

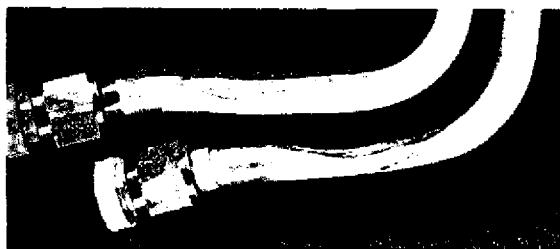
Tube Assemblies,
P/N's 2388154-029 and -030

The tube assemblies routed through the wing tip fuel tanks were severely scraped and collapsed. These tubes contain electrical wiring for the strobe and navigation lights. It is believed that the tubes are being damaged by fuel nozzels during fueling operations.

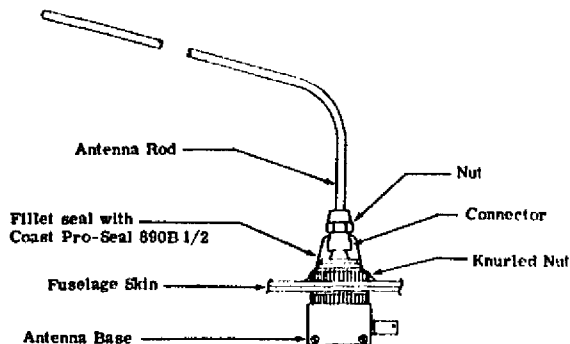
Gates Learjet has issued service information intended to provide instructions for an inspection to assure that the communications antennas are properly sealed to prevent entry of moisture. Instructions for sealing the antennas are also provided should such action be necessary. This information is contained in Service Bulletins SB 23/24/25-263A and SB 35/36-23-1A. Serial numbers of the affected airplanes are contained in these bulletins.

Note: Antennas presently installed on any of these model aircraft which have a vendor I.D. placard installed should be reidentified by Lear P/N 2380050-6.

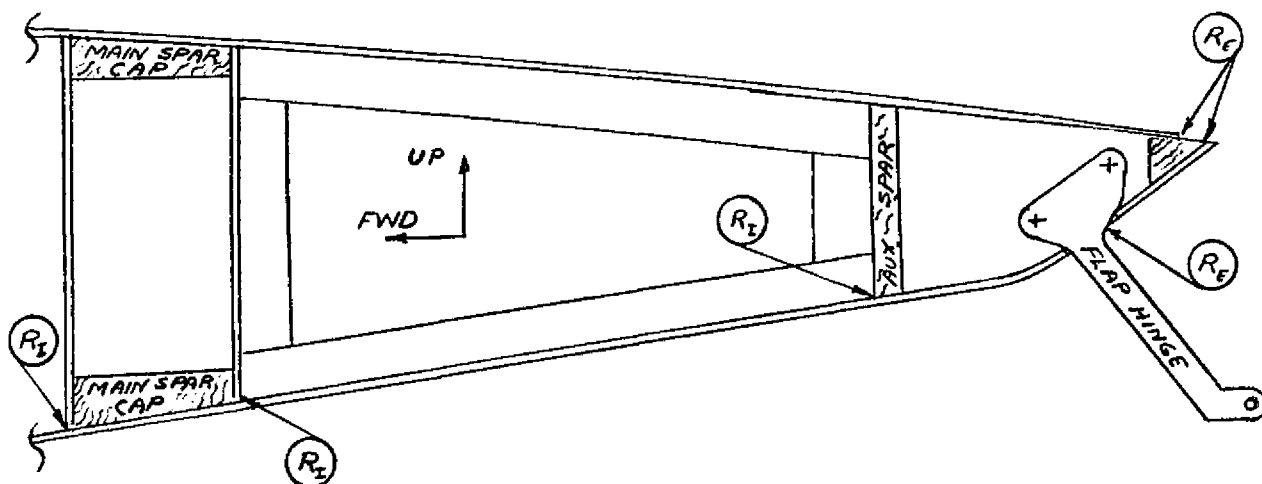
FIG. 2 WING RIB, STATION 147.8 (LOOKING INBOARD)

During an accident investigation, extensive wood rot, weathering, and glue joint separation were found in the wing structure. Airworthiness Directive 76-15-01 and Service Bulletin No. M20-170A require inspections of the wing wood structure as well as the empennage wood structure. When required inspections are made, particular attention should be directed to the wing areas shown in Figures 1 and 2. The areas marked R_E can be visually inspected externally without removing access plates. The areas marked R_I require removal of access plates for inspections. The flap support ribs of Stations 18, 59, 103.5, and 147.8 can all be inspected externally. The flap support ribs should be gently flexed during visual inspections for evidence of rot near the flap hinge and for glue joint separation. If evidence of wood deterioration is observed (such as wood discoloration or weather cracks) the fabric (and skin as necessary) should be removed until the extent of wood deterioration is determined. All wood and wood-joint deterioration should be repaired in accordance with the provisions of AD 76-15-01. Malfunction or defect report (FAA Form 8330-2) should be submitted for each instance of wood deterioration requiring repair.

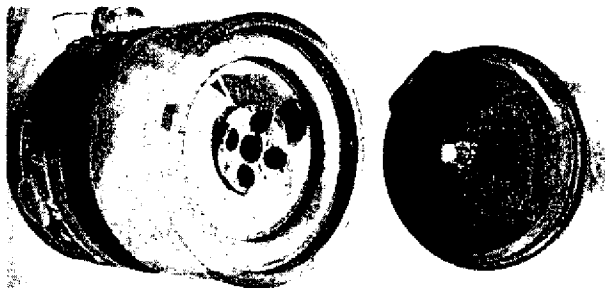
Fuel Strainer
Assembly, P/N HE-769

The fuel strainer assembly was found to be leaking. Investigation revealed that the strainer upper casting was broken in the threaded area at the lower portion attachment.

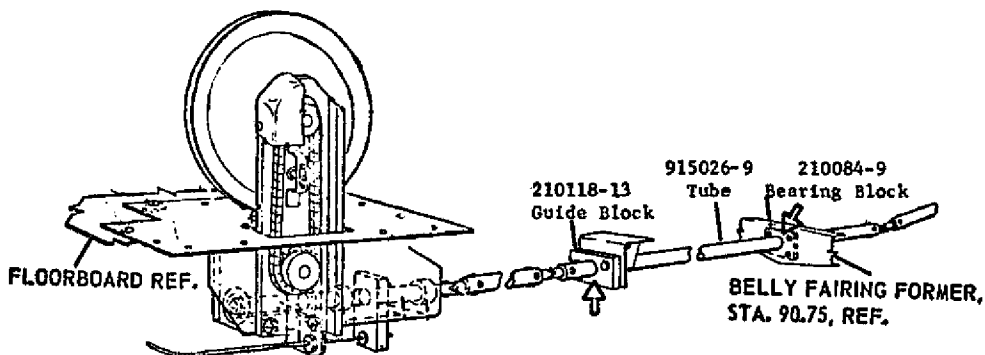
Elevator Trim Tab Control
Tube, P/N 915026-9

The elevator trim tab control tube was found to be severely worn at both ends where it rubs on the guide blocks.

Mooney Service Bulletin No. M20-185 provides information for inspection in this area and describes a kit which protects the trim tube from wear.

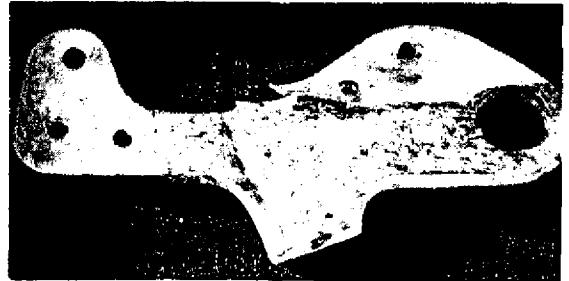
Flap Hinge Bracket,
P/N's 240015-000, -501,
and -502

Five of the eight flap hinge brackets were found severely corroded. Mooney Aircraft Corporation Service Bulletin No. M20-186A, dated 1/14/75, relates to the subject.

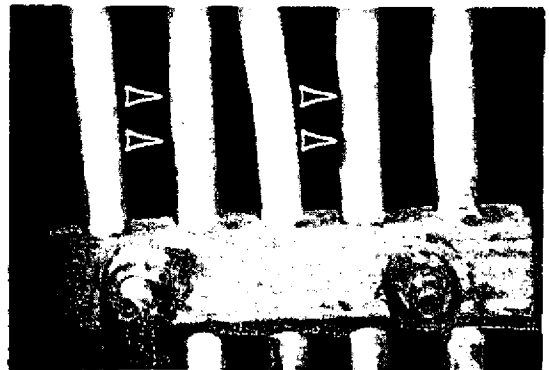
Hydraulic Lines

Five metal hydraulic lines are secured by a wood clamp block aft of the nose wheel well. A leak developed from corrosion damage that formed at the wood clamp block. This clamp should be removed for proper inspection of the hydraulic lines.

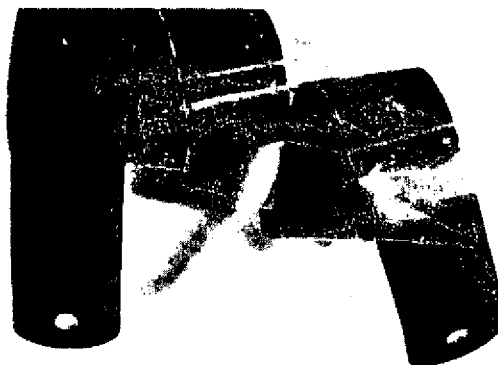
Control Column Balance
Spring, P/N 16891-00

A pilot reported having trouble moving the elevator controls and advised he felt something holding them. Inspection revealed the control column balance spring had failed and caused interference with movement of the control column. This was the second spring failure reported with this aircraft during approximately 1800 hours of operation.

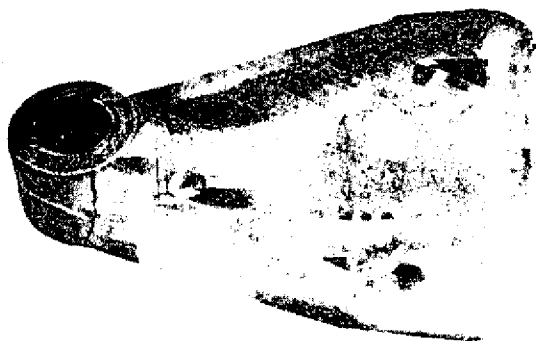
Rudder Hinge Bracket,
P/N 20707

Three instances of cracked upper and center rudder hinge brackets have been reported with PA-24-250 and PA-24-260 aircraft. Aircraft time in service varied from 1018 to 1550 hours. The cracks originated at the outer race of the pressed-in bearing and progressed to the edge of the brackets. Similar problems may possibly be experienced with PA-30 and PA-39 series aircraft.

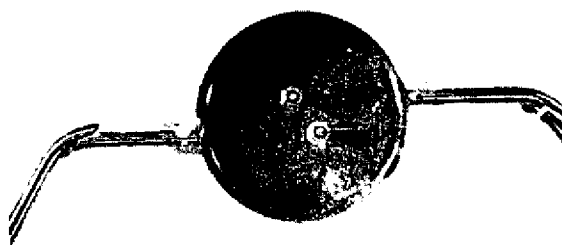
Piper Model PA-25-235	Wing Spar, P/N 6115602	During inspection, the front spar of the right wing was to be cracked. The crack extended from the wing attach- ment bolt hole to the edge of the spar.
Piper Model PA-28 Series	Nav Antenna, P/N 451-273	During inspection, cracks were noted in the bend radius of both elements of the nav antenna installed on the air- craft vertical stabilizer. Identical conditions were found during inspection of six other aircraft.
Piper Models PA-28, PA-32, and PA-34	Stabilator Hinge Attach Bolts	The stabilator hinge attach bolts were found loose on several Piper Model PA-34 aircraft. It is recommended that on Models PA-28, PA-32, and PA-34 aircraft be inspected for this condition and the bolts be retorqued to the manufacturer's specification.
Piper Model PA-28-140	Oil Cooler Hose Assembly P/N's 61413-2 and 63794-16	Airworthiness Directive 72-4-3 and Piper Service Letter 604, require a 100-hour repetitive inspection of the oil hose assemblies. In addition, Piper PA-28 Cherokee Service Manual requires an inspection. It also requires replacement of these hoses at 1000-hours time in service. Hoses can deteriorate by heat; therefore, compliance with these require- ments could prevent hose failure.

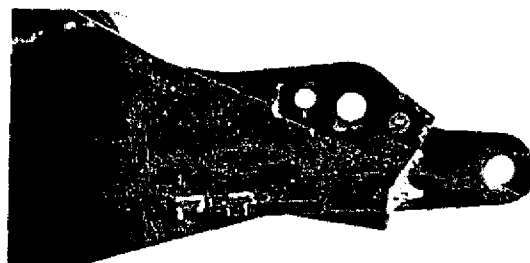
Alternator Mounting Bracket,
P/N 99089-00

The alternator mounting bracket forward ear failed approximately 1-3/4-inches from center of the bolthole. The required shims had been installed between alternator and bracket ears. Total time in service - 97 hours.

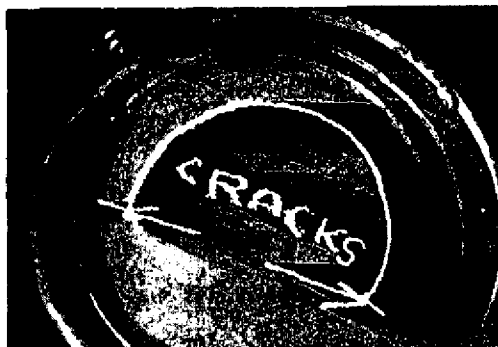
Cabin Heater
Combustion Chamber

The cause of reported exhaust fumes in the cabin was determined to be a cracked heater combustion chamber. The aft end of the combustion chamber was cracked in excess of 180 degrees around its circumference permitting combustion gases to mix with heated air entering the cabin.

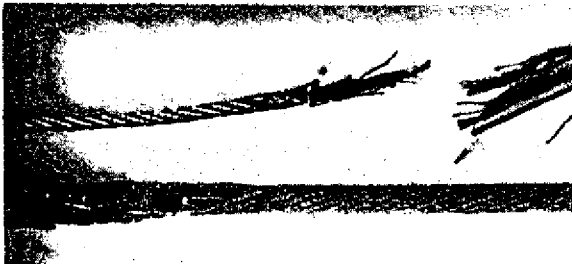
Piper Model PA-31	Wing Ribs, P/N's 40490-04 and -05	During inspection, the wing ribs located at station 147.5 of the left and right wings, were found to be cracked. The cracks were located in the flange radius where the ribs are attached to the rear wing spar immediately forward of the outboard wing flap track assembly.
Piper Model PA-31 Series	Control Cables	<p>Two instances have been reported whereby the left aileron balance cable and the rudder interconnect cable have short circuited against the wing flap motor solenoid, P/N 26898-04, terminal at fuselage station 174 under the cabin floor. The rubber insulator boot did not completely cover the terminal and contact resulted in complete burn-through of the interconnect cable and approximately 50 percent burn-through of the balance cable. This condition was found when the pilot reported sloppy control action. In one instance, the wing flap circuit breaker tripped as a result of the short circuit.</p>

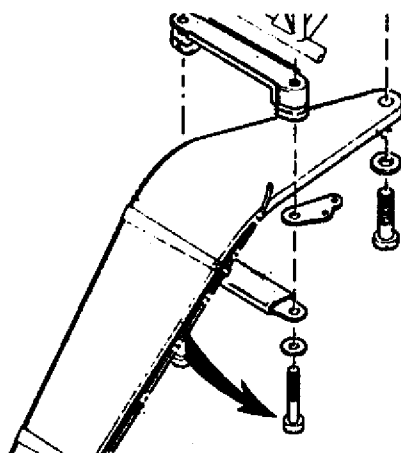
Landing Gear Mount
Bolt, P/N 553232
(NAS-148-84)

The head of a landing gear mount bolt was found to be missing during annual inspection. Two of these bolts secure each of the two main gear springs to the aircraft fuselage. Removal and inspection of the remaining three bolts revealed grooves worn in the shank radius beneath the bolt heads from contact with the inside diameter of the installed plain washers. The aircraft parts catalog calls for installation of washers with a beveled inside diameter.

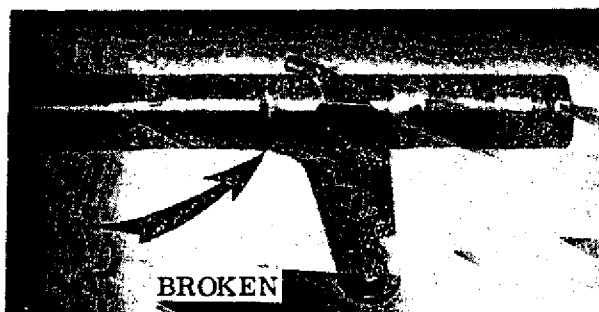
Rockwell International Rudder Bar
Model 112A

The right rudder bar cable bracket separated in flight. Examination of the rudder bar disclosed that the failure occurred in the weld attaching the cable bracket to the bar.

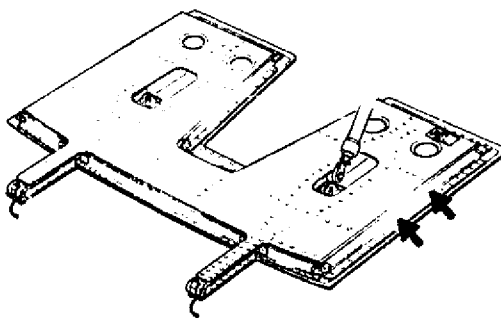
Rockwell International Speed Brake Door, Model NA-285-40 P/N 265-390004-3

During inspection, the speed brake door was found to be cracked. The crack extended fourteen inches along the bend radius of the inner skin on the left side.

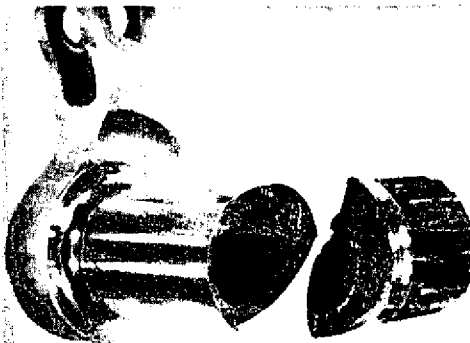
Rockwell International Nosewheel Steering Model NA-265-60 Bellcrank, P/N 3010812-5

The nosewheel steering bellcrank was found to be sheared at the serrated end. Also, a radial crack was found which extended two-thirds of the way around the shaft and into the machined radius. Total time in service - 1337 hours.

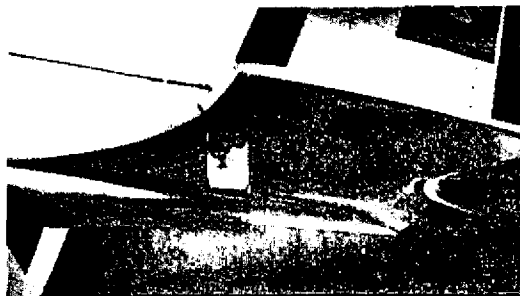
Rockwell International Vertical Stabilizer Fairing Model 685

The vertical stabilizer fairing failed at the ADF sense antenna attach point. Total time in service - 1300 hours.

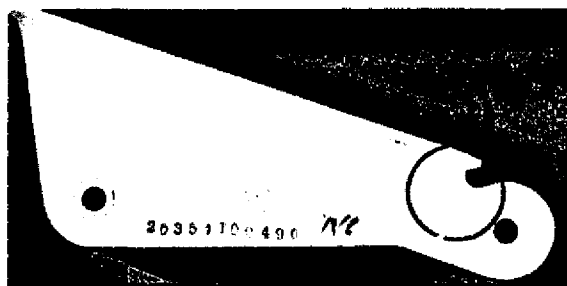
Rockwell International Aileron Hinge Bracket, Model S-2R P/N's 20354T-1, -2, -3, and -4

Several aileron hinge brackets were found to be cracked. Total time in service range from 342 hours to 1004 hours.

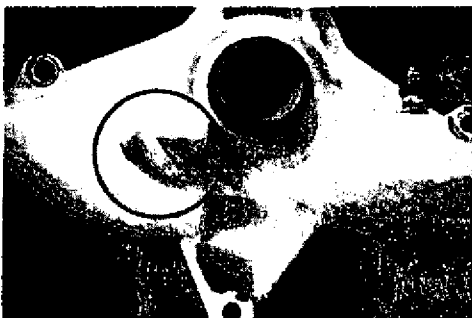
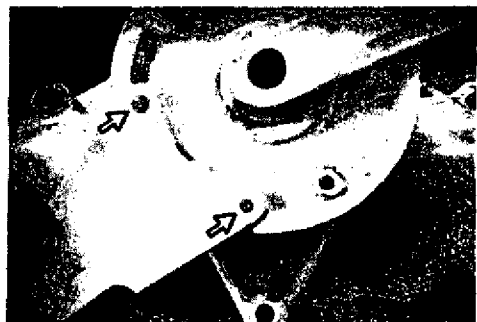
Landing Gear

The landing gear actuator assembly was found to be worn. Inspection disclosed that the round head rivets, which attach the landing gear brace arm to the pulley assembly, P/N 16031, were chafing against the actuator assembly.

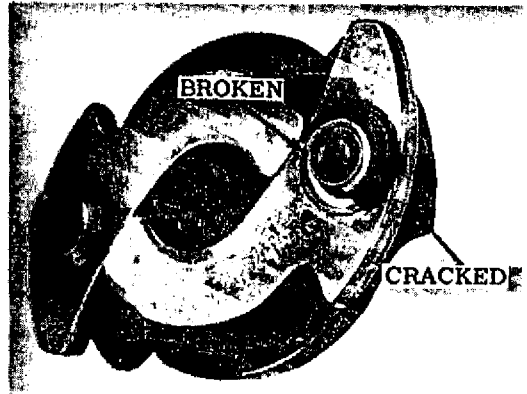
The inattention and mishandling many magneto impulse couplings receive is substantiated by service difficulty reports. In some instances, when magnetos are removed for maintenance/overhaul the couplings are not disassembled for inspection and receive no more attention than a "wash down." They are then reinstalled in an "as is" condition. This situation is further magnified by the abuse the unit receives through various unorthodox removal methods. Quite often this results in hidden damage which if not detected can lead to in-flight engine failure.

Sometimes impulse couplings are found broken and cracked as shown in the accompanying picture. In this instance, the damage is believed to have resulted from the use of gear pullers. Careful attachment of pullers used to remove the impulse coupling must be exercised to avoid damage.

To help all persons to better understand the purpose, operation, and care of aircraft magneto impulse couplings, the Bendix Corporation has prepared a booklet related to this subject. The title of the publication is "I Am Your Impulse Coupling." The caption on the booklet face is "Nobody Pays Any Attention to Me." Copies of the publication may be procured free from: The Bendix Corporation, Electrical Components Division, Product Support Department, Sidney, New York 13838.

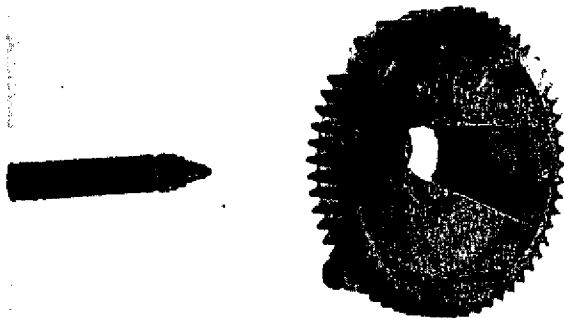
Distributor Gear

A recent report, which is typical of other reports received, advised of a distributor gear failure at approximately 215 hours time since magneto overhaul. The gear shaft was heat discolored, and the nylon gear had melted allowing separation of the gear from its shaft. In order to prevent this type failure, Bendix Service Bulletin No. 566, was issued in January 1974. This bulletin called for rework of the distributor block and installation of a steel skid washer and a nylon insulating washer between the gear shaft and the distributor block bushing, to reduce the possibility of lubricant deterioration and seizure of the shaft within the bushing.

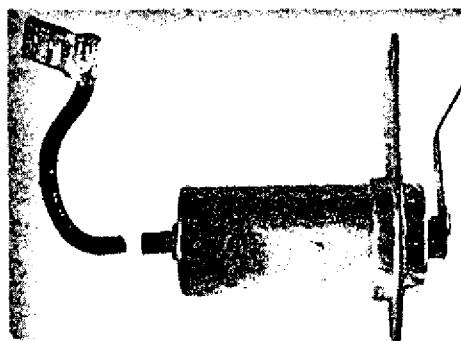
Condenser P/N 10-163131JG

An inspection to determine the cause for intermittent magneto operation disclosed that the condenser wire was broken. Total time in service - 300 hours.

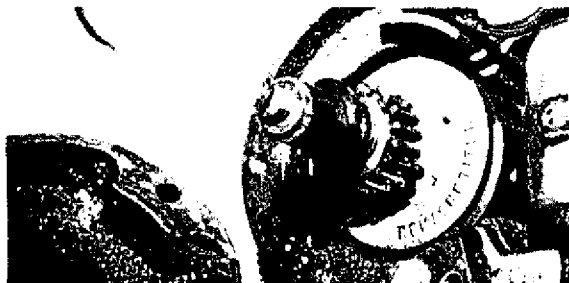
Rotor Shaft Bearing, P/N 2-202

When performing a 100 hour inspection of the engine installed in a Bell Model 47G-2 helicopter, the left magneto breaker point compartment was found to contain bronze metal particles. Further investigation revealed that the ball bearing at the cam end of the magneto rotor shaft had disintegrated. The operator advised that this was the third occurrence of this type experienced with low-time new or factory overhauled magnetos.

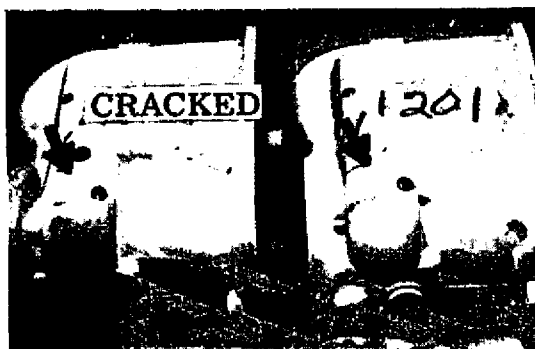
Case, P/N 10-349394-3

Several reports have been received regarding magneto case cracks.

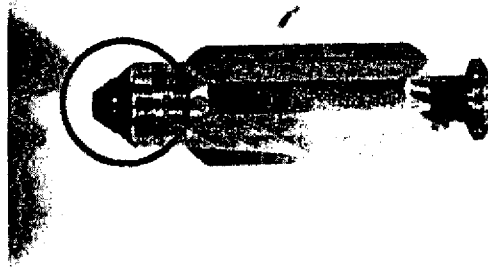
Needle Valve and
Seat Assembly, P/N A233-615

The cause for carburetor flooding, rough running and inflight engine stoppage, has been traced to fuel leakage past the carburetor needle valve. In several instances, disassembly inspection revealed the leakage to be caused by wear of the needle valve rubber tip or insert. Contact of the needle valve with the seat sometimes wears a groove 360 degrees around the rubber tip permitting fuel to pass into the float chamber when the valve is in the closed position. This condition has been reported with needle valve and seat assemblies with as little as 300 hours time in service.

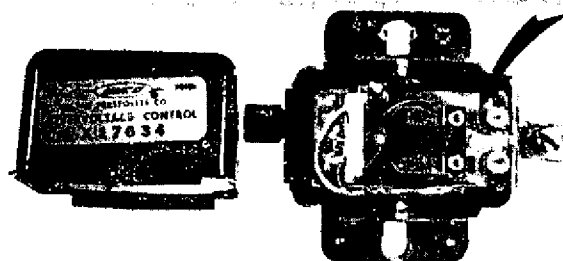
Contact Plate

The overvoltage control failed. Investigation disclosed that the contact plate was broken.

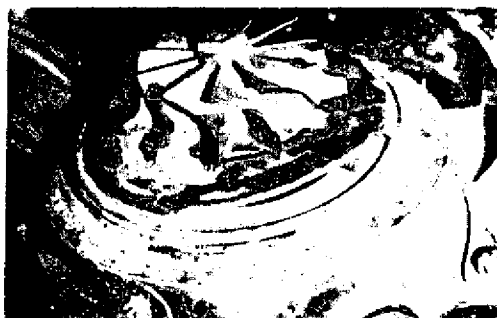
Heat Shield

The turbocharger heat shield was found to be broken. Total time in service - 416 hours.

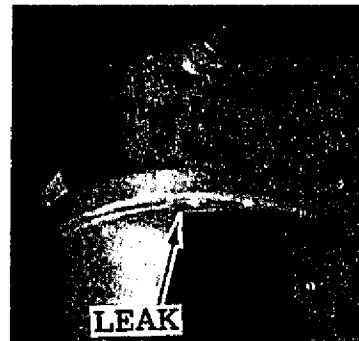
Canister

The water type extinguisher, P/N 892480, canister was found to be leaking at the seam.

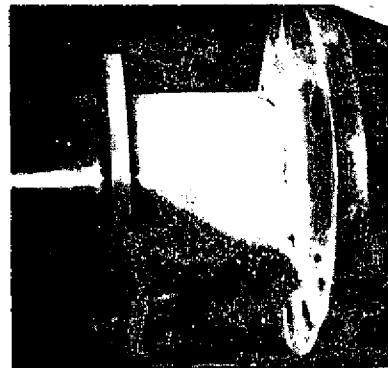
Crankshaft,
P/N 631716

An inspection to determine the source of an oil leak revealed that the crankshaft was cracked behind the propeller flange. The crack extended approximately 3/4 of the way around the shaft.

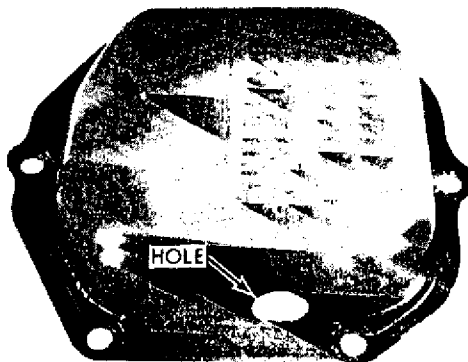
Cylinder Rocker Box Cover

Reports have been received of oil leakage caused by rocker shafts wearing holes through cylinder rocker box covers. Avco Lycoming Service Instruction No. 1176, dated October 27, 1967, advised that any nicks, roughness or other damage on the ends of valve rocker shafts would cause rapid wear-through of the rocker box cover. Service Bulletin No. 400, issued June 4, 1976, calls for the installation of teflon thrust buttons in the ends of valve rocker arm shafts which should eliminate the wear problem.

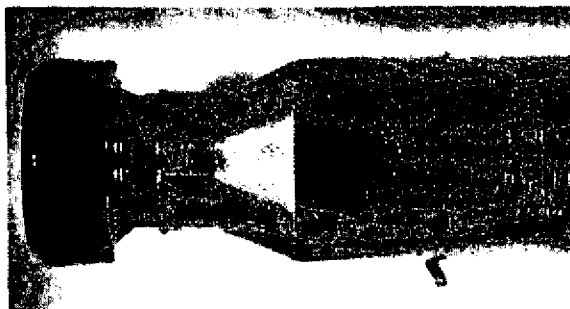
Exhaust Valve

An engine was removed for overhaul due to metal particles found in the oil system. Tear-down inspection revealed excessive wear in the keeper grooves of all exhaust valve stems. The manufacturer has advised such wear is indicative of engine over-speeding.

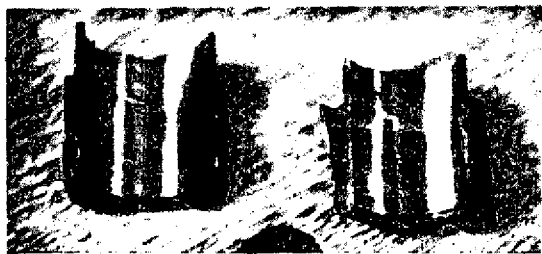
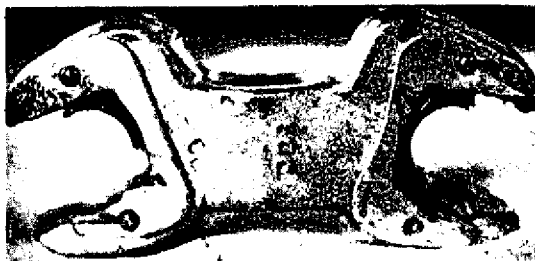
Hartzell Pitch Change
Model HC-C2YK-1BF Block, P/N A-2217-3

Both pitch change blocks were found to be broken and working in the fork and on the pitch change knob.

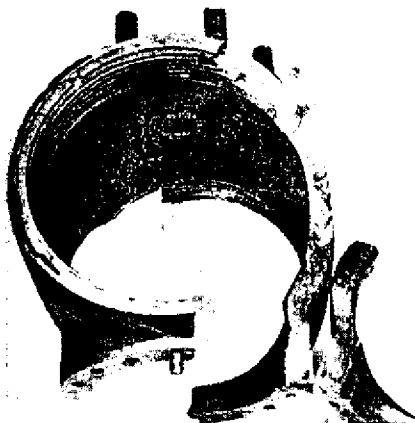
Hub

The propeller hub failed at the blade retention sockets permitting the blades to separate from the hub.

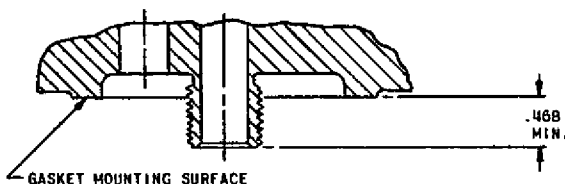
When installing spin-on type oil filters, regardless of make or manufacturer, always check the engine oil filter adapter stud for security and minimum dimensional protrusion as illustrated.

If this dimension is below referenced minimum, remove the filter adapter from the engine and inspect for cause of trouble and correct as needed.

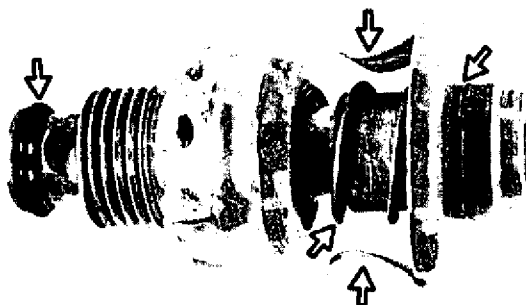
Numerous reports have been received which indicate a variety of difficulties are being encountered with engine oil quick drain valves. When required inspections are made, it is suggested that the following items be examined:

1. Check the "O" ring seal for condition and proper sealing.
2. Check the spring for condition and tension.
3. Examine the spring keeper for wear, cracks, and grip strength.
4. If the quick drain valve is removed or replaced, check for clearance with the engine cowling.
5. Anytime the quick drain valve is replaced on single engine aircraft that have a retractable nose landing gear, a gear retraction should be accomplished, to assure clearance between the valve and the nose gear.

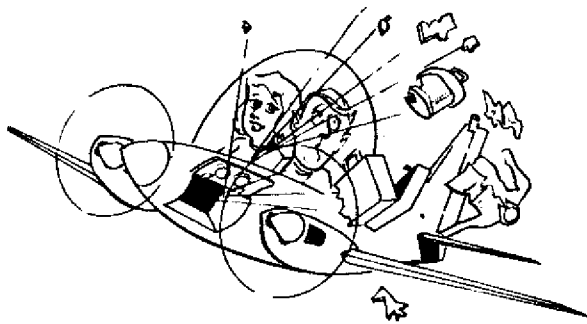
NOSE CARGO DOORS

Instances of in-flight opening of nose cargo doors continue to be reported. These occurrences are attributed to improper latch adjustments and/or failure to secure the door properly. The in-flight opening of nose cargo doors is not confined to any one model but may be a general problem on all light twin-engine aircraft. The necessity for proper locking of nose cargo doors cannot be overemphasized. It is recommended that owners/operators of aircraft having nose cargo doors reevaluate their maintenance procedures to include the inspection, cleaning, and lubrication of locking mechanisms.

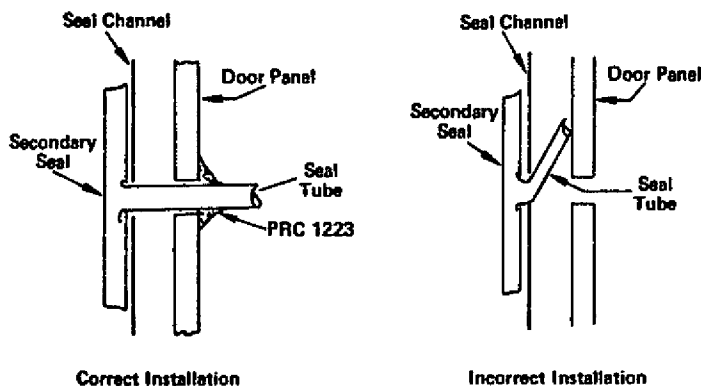
We have had reports that on some Sabreliners the secondary door seal is being incorrectly installed. Perhaps this tip will help you

When pressing the door seal into the channel, insert the seal tube into the hole in the channel and guide the tube through the hole in the door panel. The tube should be visible when looking inside the door from the interior door handle opening. PRC 1223 (or equivalent) pressure sealant should be used around the tube on the door panel as shown.

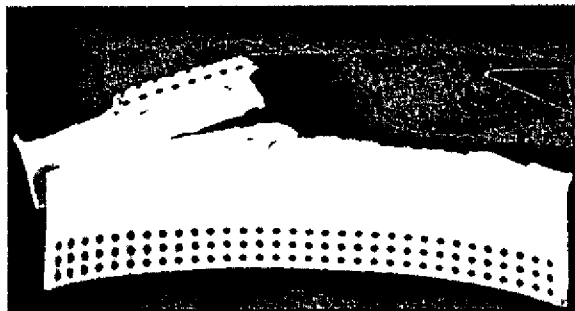
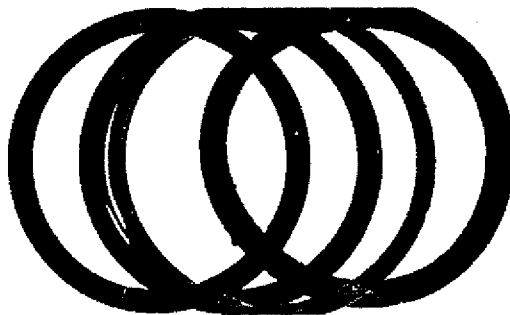
The weather in central Illinois was cold in January, and the airplane owner preheated his engine before attempting a start. In this case, a hot air blower was used, but too much heat was directed around the top portion of the nose gear oleo strut resulting in the "o" ring seals and plastic stop being overheated and melted.

Extreme caution should always be exercised to ensure that heat sensitive components are protected when using a hot air blower to preheat engines.

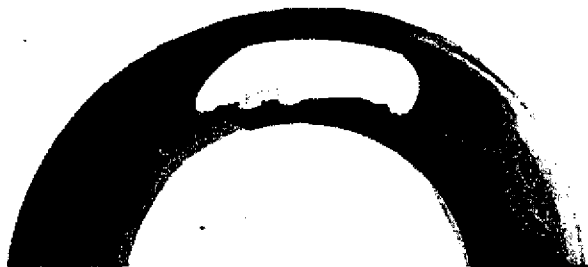
Compressor Inlet
Duct, P/N 24-76102-1

The compressor inlet duct was found to be deteriorated. The missing portion of the duct may have been ingested into the engine compressor, however, no foreign object damage was found. Total time in service - 730 hours.

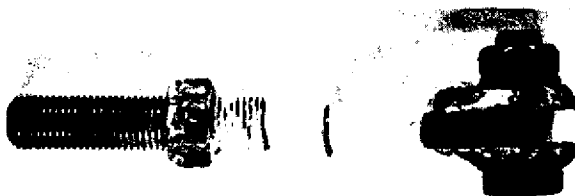
Piper Lift Strut Fork,
Model J-5 P/N 14481-00

The left wing rear lift strut fork fitting failed in flight. Examination of the part revealed a fatigue-type failure originating in the first thread radius from the fork end. Slight bending of the fitting shank indicates possible use as a step when entering and exiting the aircraft. This part had been in service 830 hours since compliance with AD 58-10-2.

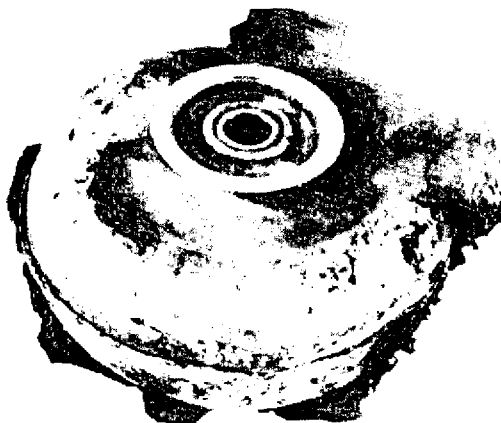
Tailwheel,
P/N 1-H

During landing, the tailwheel started to lose rubber which caused the tailwheel spring bracket to break. The aircraft then ground looped causing minor damage to the wing tip. Total time in service - 20 hours.

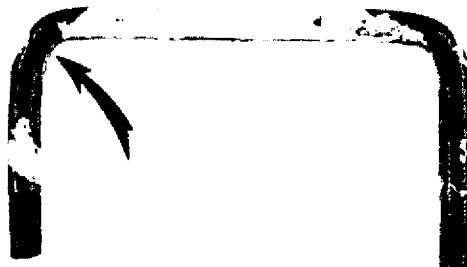
Main Landing Gear "U" Bolt,
P/N 1-9805

The left main landing gear "U" bolt failed at the aft bend radius. The break appeared to be a progressive type failure. Total time in service - 250 hours.
