AC NO. 20-7P

GENERAL AVIATION
inspection
AIDS

SUMMARY

AUGUST 1977

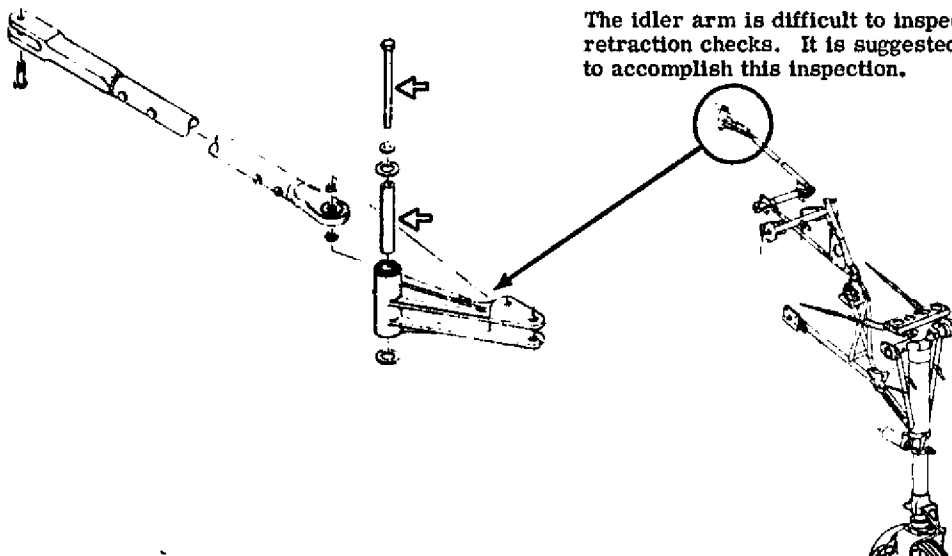
An investigation to determine why the nose landing gear collapsed revealed that the idler bellcrank pivot bolt and bushing were worn. The wear permitted the mechanism to sag and contact the nearby structure, preventing the nose gear from extending completely.

The idler arm is difficult to inspect during landing gear retraction checks. It is suggested that special effort be made to accomplish this inspection.

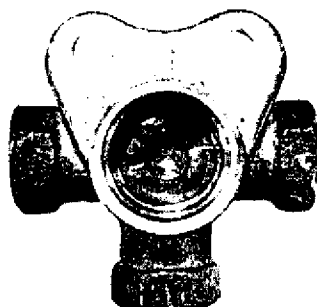
Grumman-American Fuel Selector Valve,
Model AA-1 P/N X670401

The fuel selector valve plastic core failed permitting misalignment of the ports. Total time in service - 650 hours.

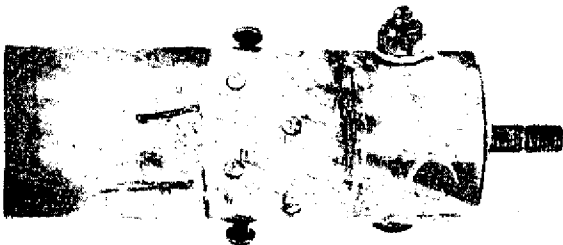
P/N 420082-1

The rudder torque tube fitting failed through the two steel rivet holes. The 10 aluminum rivets were sheared, and the steel rivet holes in the torque tube were elongated.

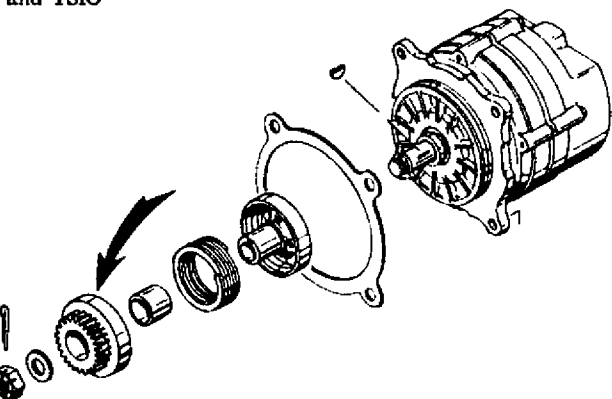
There are at least two different types of clutch assemblies identical in outward appearance, but not interchangeable. One has a clutch spring wound in a clockwise direction designed for use on the TSIO engines, and one has a clutch spring wound in a counterclockwise direction, designed for use on the GTSIO engines. These assemblies are not a part of the alternator and are supplied by the engine manufacturer.

Regardless of the assembly being used, a torque value of 450 to 500 inch pounds is required for attachment to the alternator shaft. The torque values can be found in Continental Teledyne engine publications and the aircraft maintenance manuals. An improper torque value or assembly type could lead to damaged alternator bearings, failed alternators, and most importantly, engine damage.

Persons installing this type of alternator should ensure that all installation instructions are followed. Check part numbers and torque values before installing the alternator.

Persons repairing or overhauling alternators with a clutch and hub assembly affixed should not replace these assemblies if removed during overhaul unless technical information relative to the clutch assembly is available and followed.

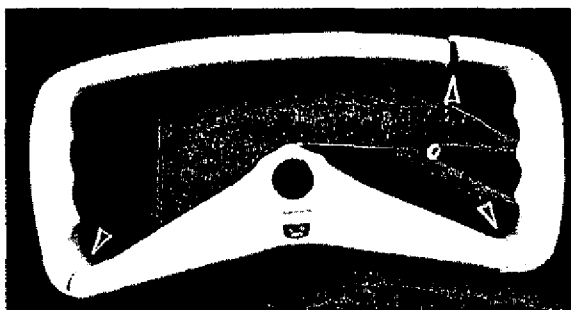
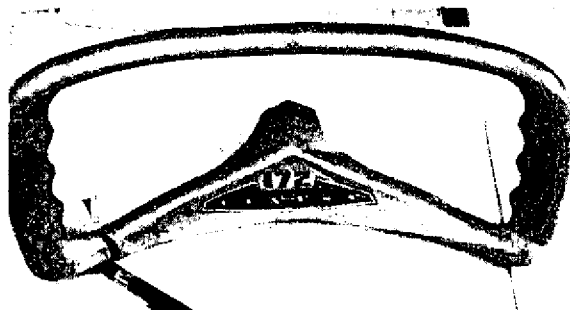
Cracking of the plastic control wheels continues to be a problem. Replacement of these control wheels would eliminate the problem; however, periodic examination will provide the assurance of finding cracks and/or other deformities before a failure occurs. It is suggested the one-time inspection procedure for the plastic control wheels contained in Cessna Service Letter No. 64-8 be conducted on an annual basis.

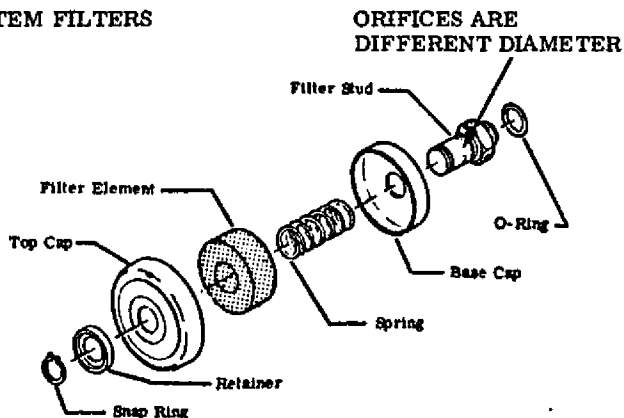
"Maintenance personnel are reminded not to interchange the three (3) filters installed in the Garrett Pressurization System during the filter cleaning process each 300 flight hours. The orifices in each filter are of a different size and reinstallation of a filter in the wrong place will drastically affect system operation.

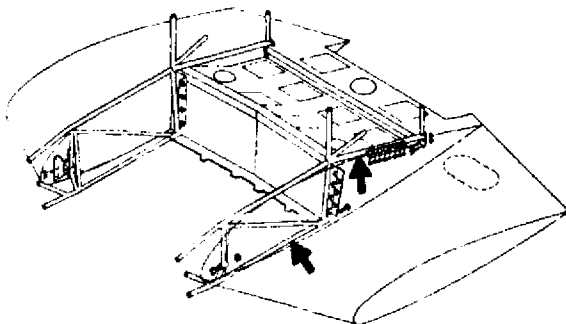
Fuselage Longerons Tubes,
P/N's 340117-107 and -119

The fuselage longeron tubes have been found to be corroded and split.

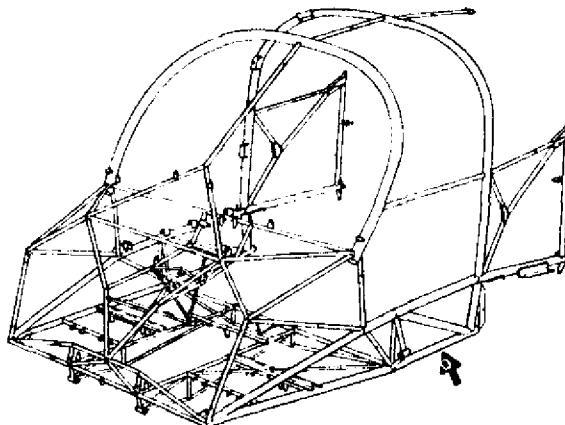
Fuselage Longerons,
P/N 340117119

During repairs after a belly landing and after removal of the fuselage lower skin, the lower left longeron tube was found to contain water and rust. In addition, the tube had a rupture three inches in length. Total time in service - 1803 hours. A second aircraft (Model M20B) was inspected and the tube was also found to contain water and rust. Total time in service - 1100 hours.

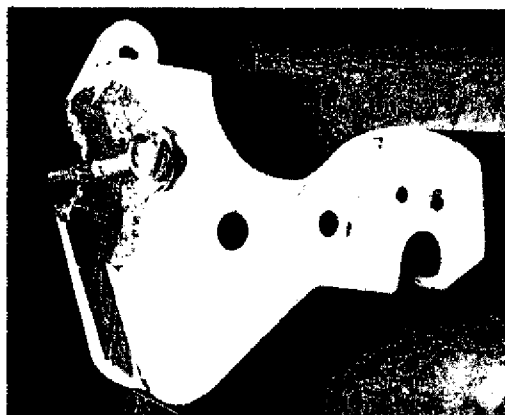
Nose Gear Downlock,
P/N 67150-03

The top portion of the nose landing gear downlock hook was found to be broken. Total time in service - 48 hours.

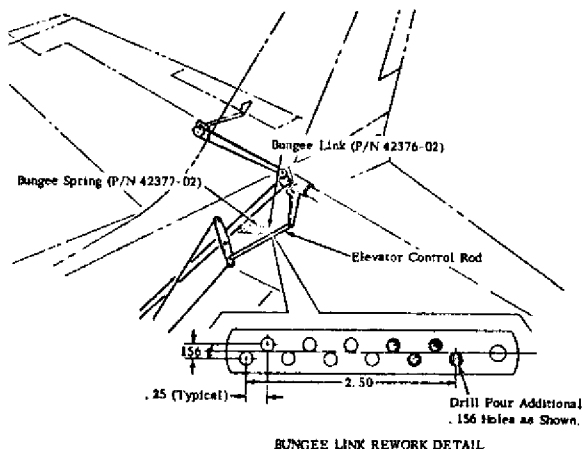
Elevator Bungee Link,
P/N 42376-02

In some instances, the prescribed elevator bungee ("down") spring tension could not be obtained due to insufficient adjustment provided at the bungee link. Piper Service Bulletin No. 549, dated February 16, 1977, provides instructions for modification of the subject link by incorporation of additional adjustment holes and for checking bungee spring tension. Compliance is recommended within the next 50 hours of operation for certain serial number aircraft.

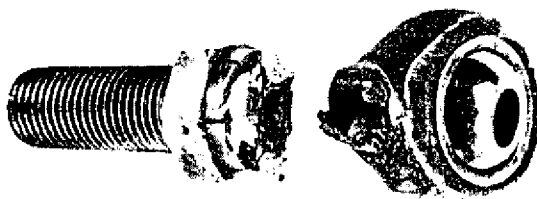
Main Landing Gear Actuator
Bearing, P/N 452 383

After takeoff, the right main landing gear would not retract or indicate "down and locked." Investigation revealed that the landing gear actuator rod end bearing had failed. Total time in service - 479 hours. Piper Service Bulletin No. 570, dated June 22, 1977, pertains to replacement of hollow rod end bearings.

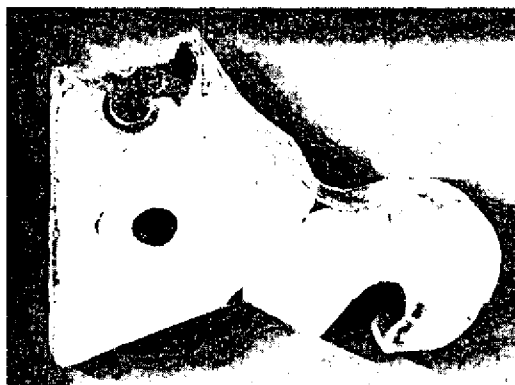
Nose Gear Downlock,
P/N 38078-02

An investigation to determine why a landing gear green light indication could not be obtained during a landing approach revealed that the top portion of the nose gear downlock hook assembly was completely broken out. Total time in service - 89 hours.

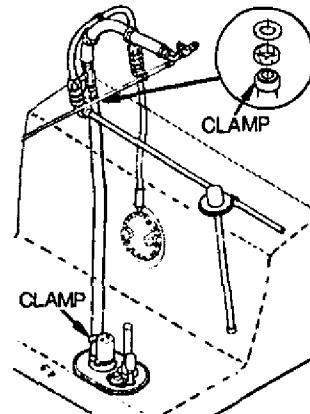
Three engine failures on Bell Model 206 (OH-58) aircraft have been reported recently. In each instance, the cause was traced to fuel starvation. Specifically, the upper and lower clamps that attach the rubber fuel hose between the boost pump and the upper fuel fitting inside the fuel tank are losing torque, allowing air to be drawn into the fuel line. The result is fuel starvation and engine failure. This problem appears to be widespread - 22 percent of the aircraft inspected at one unit were grounded because of this condition.

The problem stems from the tendency of the synthetic rubber to cold flow from under the clamping area over a period of time, causing a loss of effective clamp torque - even though the clamps were properly tightened at installation.

Because of the serious nature of this problem, it is imperative that all maintenance and inspections of these clamps and hoses be performed by the book, and that fuel servicing be accomplished with extreme care.

Aircraft hose constructed with synthetic compound has a tendency to cold flow; therefore, when new hose is installed, clamps should, after a time, be retightened to maintain original torque value. This is caused by synthetic rubber flowing from under clamping area and not from loosening of clamps.

1. Clamps on self-sealing hose. Hose clamps on self-sealing hose shall be tightened to a torque of 25 inch-pounds minimum to 30 inch-pounds maximum for original installation, and maintained at this torque value. When sealing is not effective at 30 inch-pounds, component parts of connection shall be examined, and unserviceable parts replaced. Under no circumstances shall hose clamp be tightened in excess of 30 inch-pounds in an attempt to effect sealing. This added torque will reduce safety factor of hose clamps as well as destroy hose and connection.
2. Clamps on nonself-sealing hose. Hose clamps installed on nonself-sealing hose shall be installed and maintained at a torque of 25 inch-pounds minimum to 30 inch-pounds maximum. If satisfactory sealing is not accomplished at a torque of 30 inch-pounds, component parts of connection shall be examined and unserviceable parts replaced.

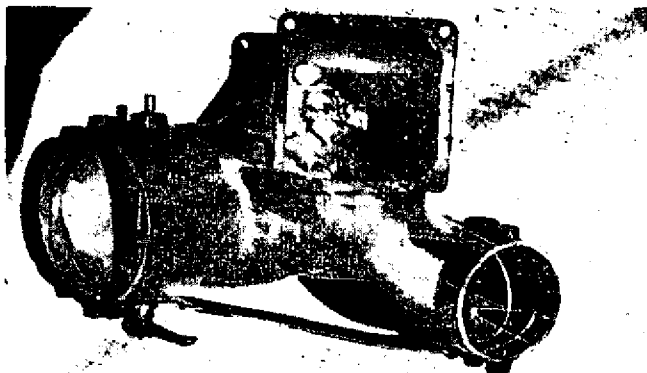
Alternate Air Gasket

An investigation to determine why the engine quit during takeoff revealed that the asbestos gasket which is installed between the exhaust collector and the alternate air manifold had separated and was blocking the carburetor screen. Further checks disclosed that the type of asbestos used was plain sheeting. The type that should be used is wire reinforced asbestos.

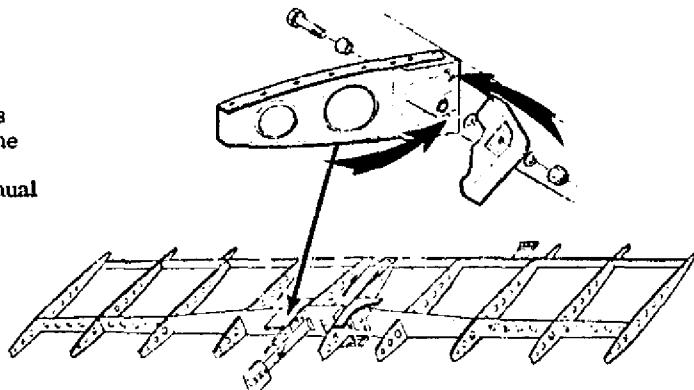
Stabilator Pivot
Mount Fitting,
P/N 1732001-1

There have been reports which indicate that the bolts used to attach the stabilator pivot mount fittings to the stabilator main spar have been found loose. It is recommended that these bolts be checked at each annual inspection for proper torque.

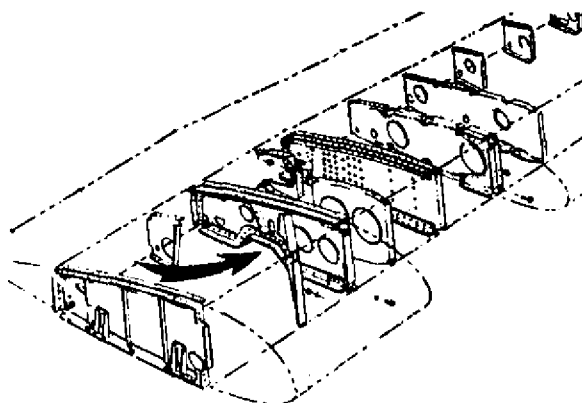
The wing rib onto which the main landing gear side brace attaches has been found cracked on high time, heavy usage aircraft. Reinforcement plates and angles have recently been added to production Model 340 and 400 series airplanes.

Cessna Multi-Engine Service Letter No. ME76-2 has been issued and recommends the wing ribs located within the main wheel wells be inspected for cracks and the main gear upper side brace support be checked for looseness. If cracks are found, the rib can be repaired using Service Kit No. SK414-8E.

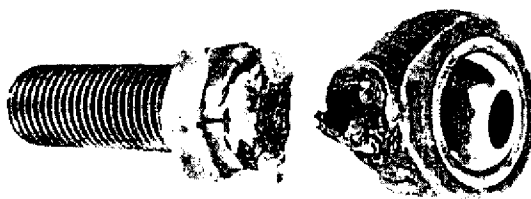
Main Landing Gear
Actuating Cylinder Rod
End Bearing Assemblies

The right main landing gear would not retract after takeoff and would not show a down and locked indication during subsequent gear extension. Investigation revealed that the right gear actuating cylinder rod end bearing assembly had failed through the first thread of the shank at the bearing end. Both the failed assembly and the rod end bearing assembly removed from the left actuating cylinder were found to have hollow shanks rather than solid shanks. Piper Service Bulletin No. 570, dated June 22, 1977, pertains to the subject and calls for inspection of certain serial number PA-31T aircraft within the next 50 hours of operation, and replacement of main gear actuating cylinder rod end bearing assemblies not marked "MXK 46-16A," and those with illegible part numbers found to have hollow shanks.

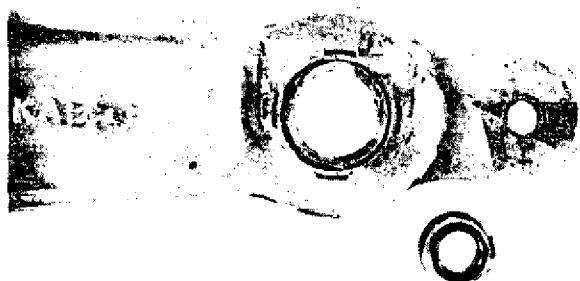
Elevator Bellcrank
Bearing, P/N 452360

Investigation to determine the cause for excessive play in the elevator control system revealed extensive wear of the elevator bellcrank bearing. This bearing accommodates the forward attachment bolt of the elevator control tube assembly. Total time in service - 300 hours. At 600 hours time in service another PA-31T aircraft was checked and the P/N 452360 bearing outer race was found to be worn to an extent that allowed the ball to fall out when the control tube assembly was disconnected from the elevator bellcrank. An identical condition had previously been reported at 700 hours operating time with a third aircraft.

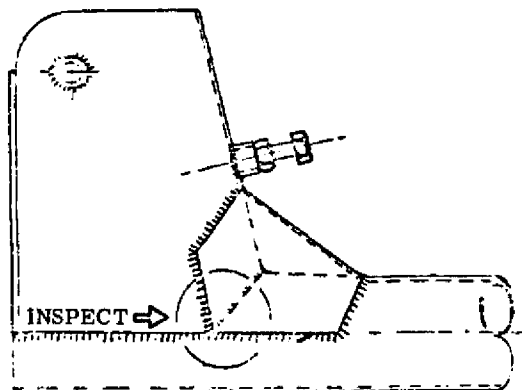
Pitts
Model S-2A Control Tube,
P/N 2-5100

The aileron control tube was found to be cracked where the vertical tube interconnects with the horizontal tube. Total time in service - 650 hours. Pitts Service Letter No. 5, dated May 1, 1975, relates to this subject.

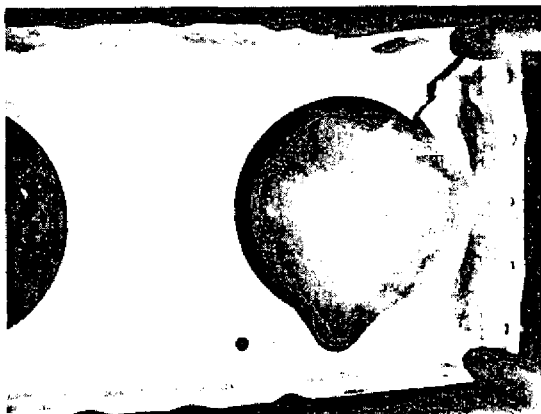
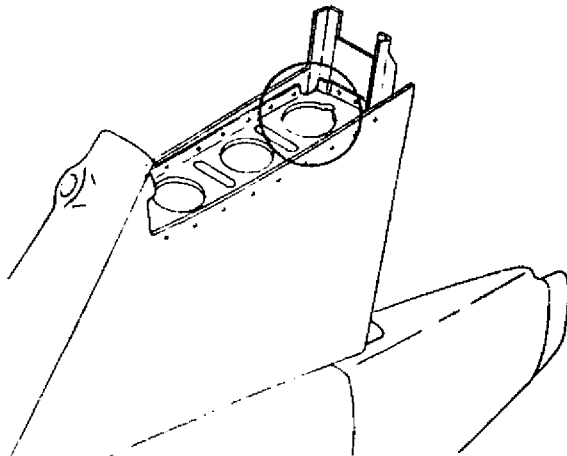
Rockwell International Vertical Stabilizer
Model 112A Rib, P/N 44222-3

There have been several reports of vertical stabilizer ribs being found cracked between the aft lightening hole and radii of the corners at the aft end of the rib. Rockwell International Service Letter No. SL-114-10 pertains to this subject.

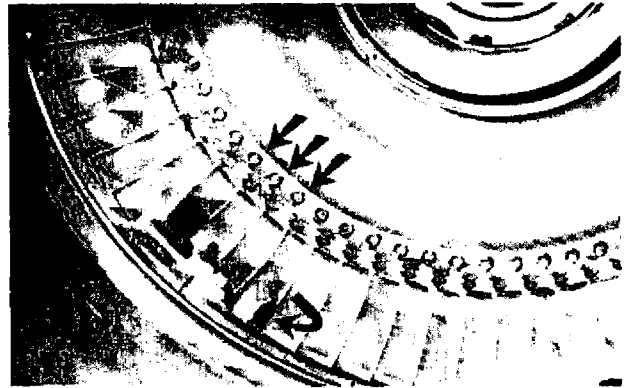
High Turbine
Blade, P/N 3019001

The engine was removed because of reported vibration and metal found in the exhaust duct. Disassembly inspection disclosed the cause of difficulty to be (N2) high turbine blade failure. Pieces of the broken blade(s) entered the gas path causing damage to both the N1 and N2 stationary and rotating blades.

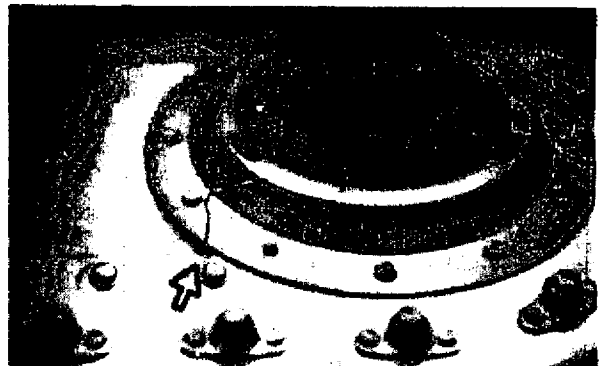
Fuel Tank Plate,
P/N 610036-007

During inspection, the fuel tank plates on the bottom of the left wing were found to be leaking. When the plates were removed for resealing, water and corrosion were found in the tank. Further checks disclosed that the sealant was missing from around the fuel filler cap well. In addition, corrosion had progressed through the tank in two places in the filler cap well, permitting water to enter the tank.

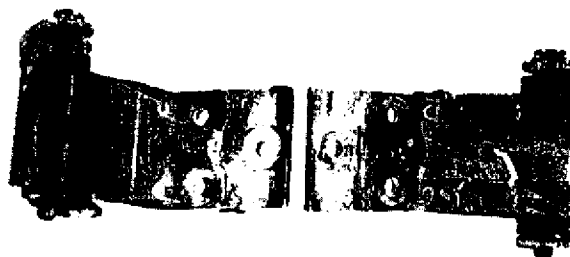
Cabin Door Hinges,
P/N 18094-00 and 01

During annual inspection, the cabin door hinges were found badly deteriorated from intergranular corrosion. The discrepancy was detected at 2600 hours and 19 years of aircraft time in service.

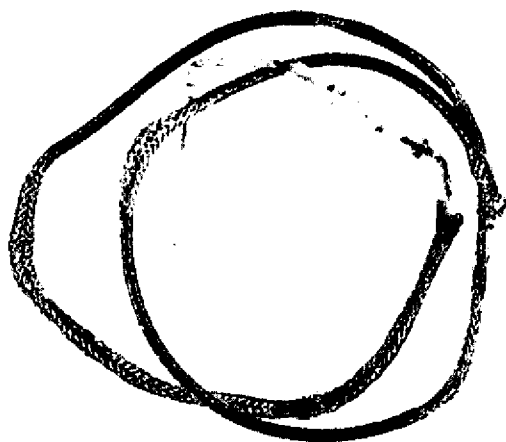
Magneto Primary
"P" Leads J16FB, J17FB,
and J18FB

The cause for loss of engine magneto output was traced to short-circuiting of the "P" leads forward of the fire wall. The subject leads are routed over and in close proximity to the engine turbocharger, resulting in burning and deterioration of the wire insulation.

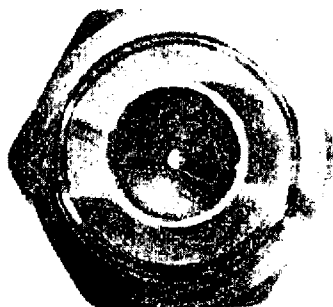
Piper Fuel System Fitting,
Model PA-36-285 P/N 491-053 (AN815-8D)

During engine conversion work, inspection disclosed that fuel would not flow to the engine from the forward or auxiliary fuel system. Investigation revealed the fitting installed in the outlet side of the fuel shutoff valve, P/N 98494-00, was completely blocked. Further examination disclosed the inside diameter of the fitting had not been bored completely through during manufacture. The aircraft was reported to have operated 25 hours before the fitting blockage was discovered.

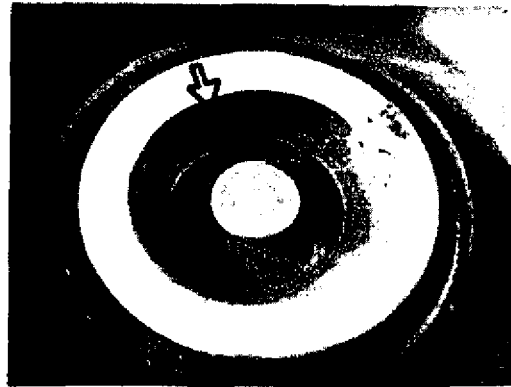
Rotocoll Assembly,
P/N 637790

Several exhaust valve rotocoll assemblies were found to be cracked during engine disassembly. Total time in service - 704 hours.

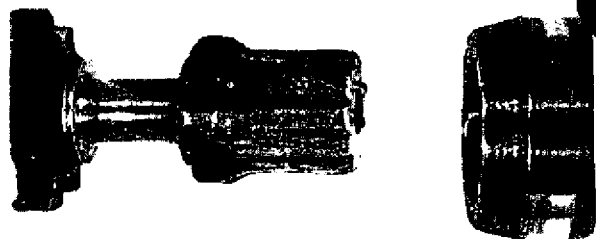
Fuel Pump Drive
Shaftgear Assembly, P/N 72972

The internal splines of the engine fuel pump drive shaftgear assembly were found almost worn away. The external splines of the Lear-Romac Model RG-17980-0 engine-driven fuel pump drive coupling, P/N RB7779-4, which engage the internal splines of the shaftgear, were also severely worn. The shaftgear assembly total time in service was approximately 3372 hours.

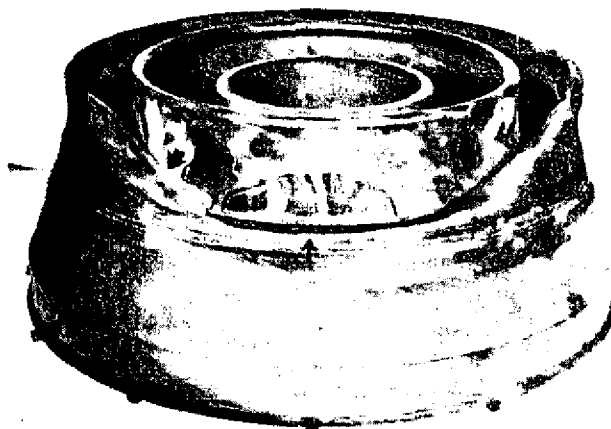
Low Turbine Stator,
P/N 3021762

Disassembly of an engine following a report that it had "boomed or banged" revealed approximately one-third of the outer shroud of the low turbine stator had collapsed. The discrepancy was found at 1075 hours engine time in service.

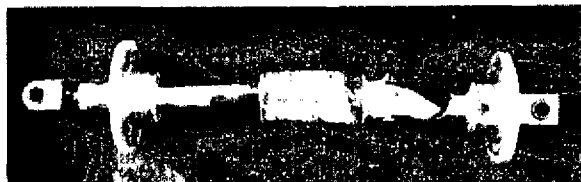
Rockwell International Nose Gear Bungee
Model 500-B Assembly, P/N 375055-503

The nose landing gear bungee assembly (rod) failed. It is suggested that the bungee assembly (rod) be inspected periodically. Total time in service - 6505 hours.

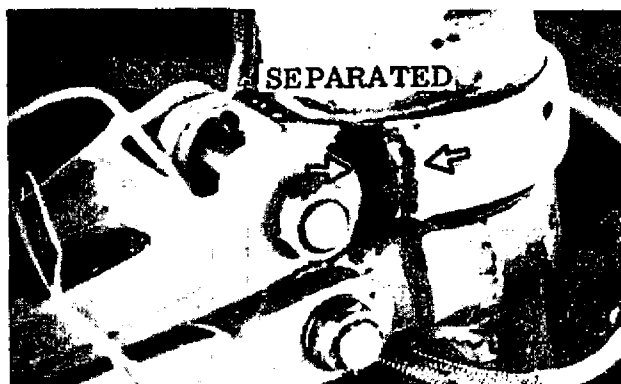
Smith Main Landing Gear
Model 600 Cylinder Assembly,
P/N 400054-2

The right main landing gear turned 90 degrees to the right during landing. Investigation disclosed that the landing gear scissors attaching collar was broken and had turned. Total time in service - 5612 hours.

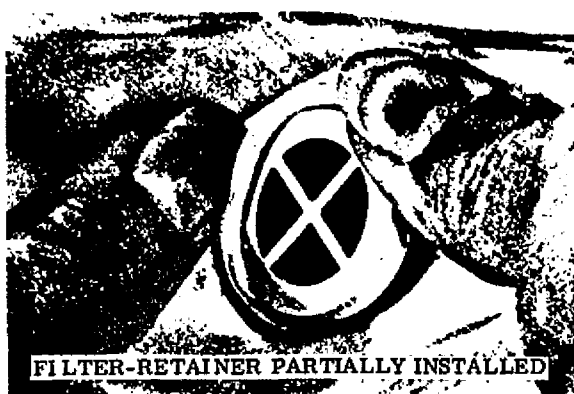
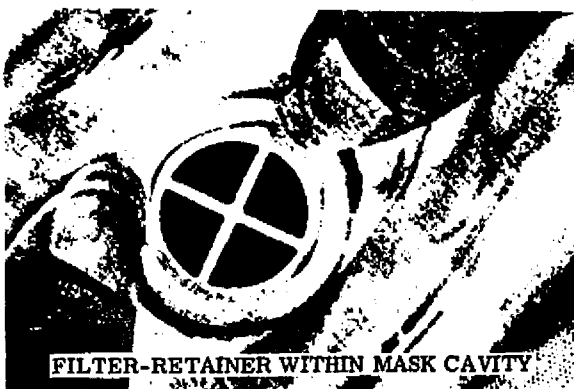
Immediately after donning his oxygen mask, the copilot of a Piper PA-23 aircraft began to choke because an object had lodged in his throat. With great difficulty, he managed to cough free and swallow the object. Subsequent investigation revealed the circular sponge rubber dilution valve filter was missing from the face of the copilot's mask, and the filter in the pilot's mask was partially dislodged.

Examination of other masks disclosed the filter could easily be dislodged by squeezing the pliable face piece and/or by exerting relatively slight pressure with the index finger against the filter inlet opening of the mask. It was concluded filter displacement could occur during normal donning or adjustment of a mask to fit facial contours.

In order to rectify the condition, Scott Aviation has developed a filter retainer, P/N 10005489, that can easily be installed without use of special tools. The filter retainers may be obtained, free of charge, through Scott Aviation distributors, or by contacting Scott Aviation, 225 Erie Street, Attention: Manager Distributor Sales (Aviation), Lancaster, New York (14086).

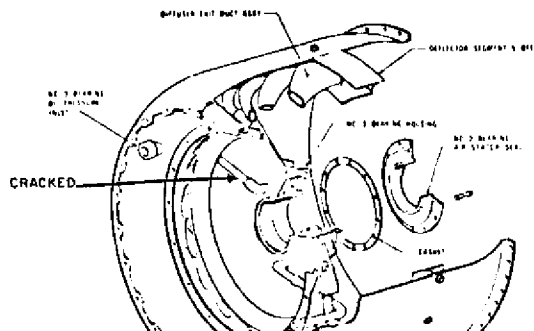
Pratt & Whitney
Model JT15D-1 Bearing Oil
Transfer Tube

The cause for reported smoke in the cockpit of a Cessna Citation aircraft was traced to a cracked oil inlet transfer tube to the No. 3 bearing. Engine disassembly inspection revealed an oily gas path forward of the impeller rotor, and a pressure check of the oil tube revealed the crack.

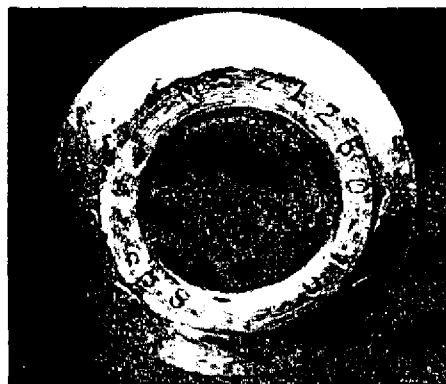
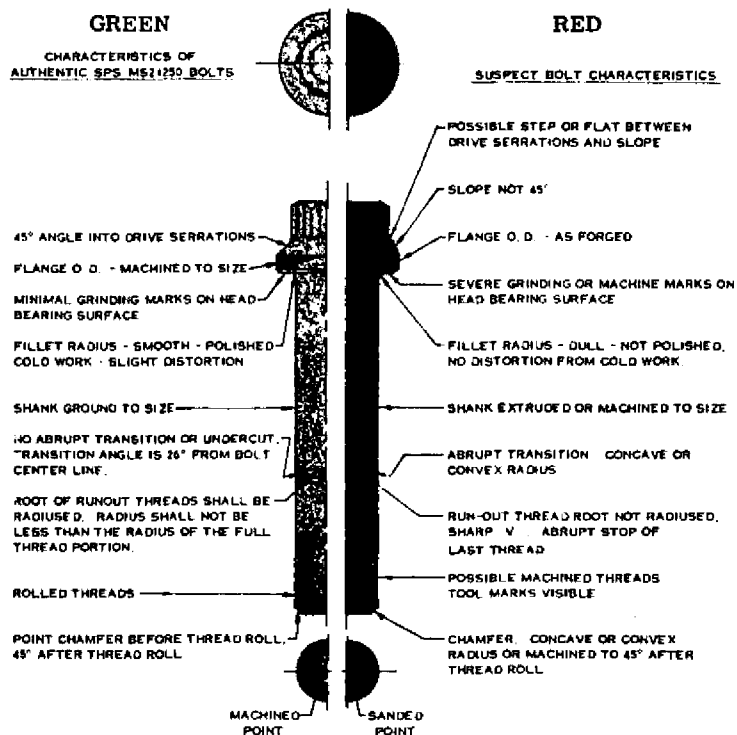
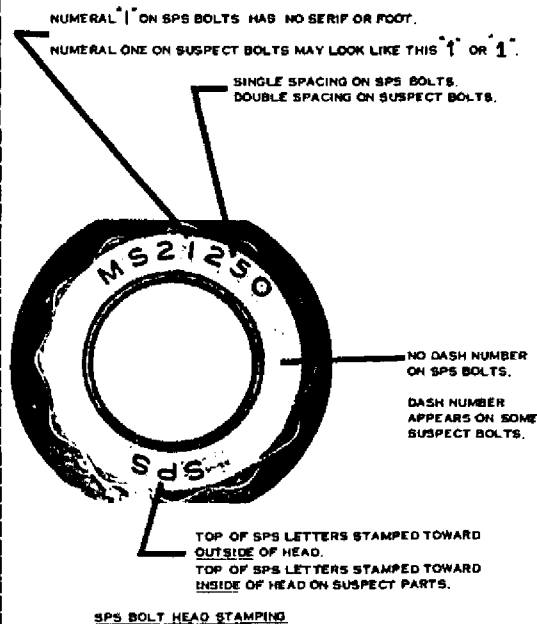
COMPARISON - SPS BOLTS VS. SUSPECT BOLTS - MS21250 ONLY

Bogus bolts, P/N MS21250, have been found installed in a Bell Model 214B/B1 helicopter, and also in the manufacturer's stock. The bolt is used to attach the tail boom to the fuselage. This bolt may have applicability to other make and model aircraft. Bogus bolts can usually be identified by reference to the following:

NOTE
A GENUINE SPS BOLT WOULD HAVE ALL OF THE CHARACTERISTICS OF THE GREEN SECTION. A SUSPECT BOLT MAY HAVE ONE OR MORE OF THE CHARACTERISTICS IN THE RED SECTION. CONFORMITY OF THE HEAD STAMPING SHOULD NOT BE THE SOLE BASIS FOR CONCLUDING THAT A BOLT IS AUTHENTIC. NONE OF THE RED SECTION CHARACTERISTICS OR HEAD STAMPING DEVIATIONS SHOULD BE PRESENT IN AN AUTHENTIC SPS BOLT.

NOTE
IF A BOLT IS SUSPECT, CONTACT THOMAS ROACH, STANDARD PRESSED STEEL CO., JENKINTOWN, PENNSYLVANIA 19046, PHONE (215) 884-7300, EXT. 503

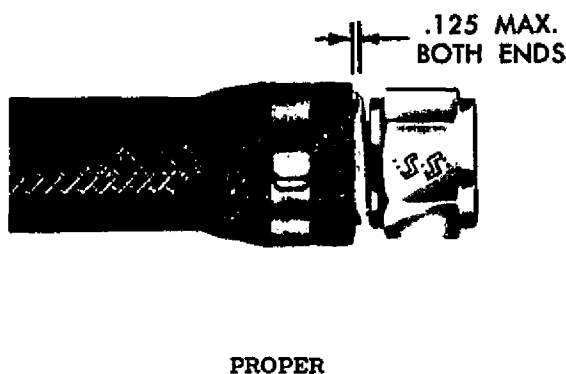
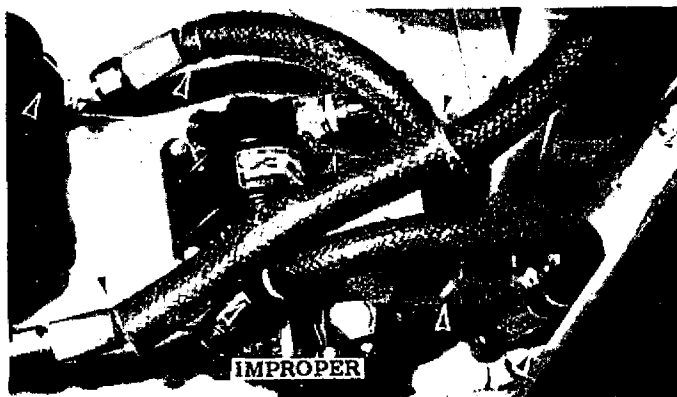
Hose assemblies that utilize a fire sleeve will not provide the proper level of fire protection unless the sleeving is properly installed. Examples of proper and improper sleeving installations are shown below.

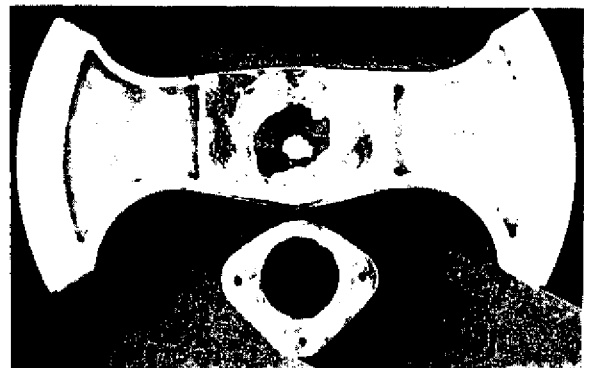
Rudder Bellcrank,
P/N 50-524327-1

During inspection, the rudder control bellcrank was found severely corroded. The rudder lower fitting, P/N 50-630015, was also corroded in the area of attachment to the bellcrank. Total time in service - 2502 hours.

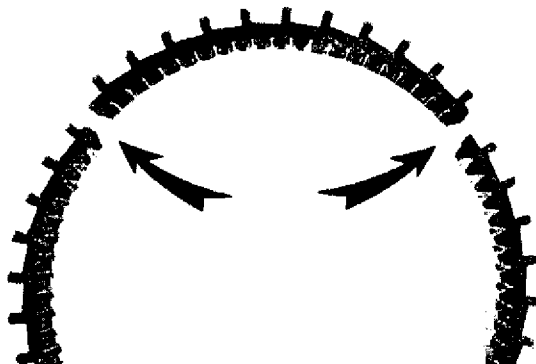
Transmission Inner Race
Gear, P/N 47-620-965-1

During disassembly for overhaul, the main rotor transmission inner race gear was found broken in two places. Total time in service - 2400 hours.

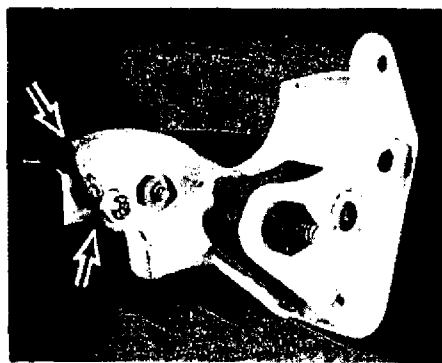
Piper Nose Landing Gear
Model PA-28R-180 Downlock, P/N 67150-03

During landing, the nose gear collapsed. Inspection disclosed that the nose landing gear downlock was broken adjacent to the hook. Total time in service - 2272 hours.

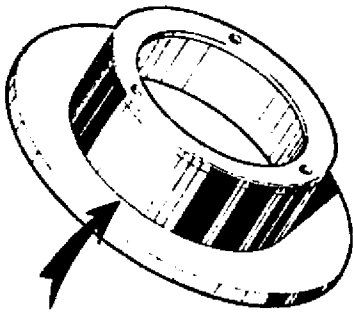
CLEVELAND--BRAKE DISC, P/N 164-22A, Piper P/N 754-554

Several reports have been received regarding separation of the brake disc from the attaching flange. It is suggested that the brake disc assembly be inspected for cracks in the weld attaching the disc to the flange.

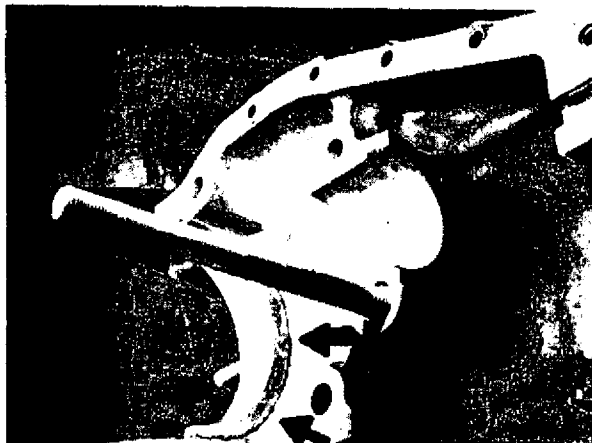
Lycoming Crankcase Assembly,
Model TIGO-541-E1A P/N LW-13082

Disassembly inspection, at 885 hours engine time in service, disclosed both the right and left crankcase halves were cracked in the propeller shaft thrust bearing cavity. The cracks ran circumferentially 5 to 6 inches in the radius of the bearing cavity aft flange.

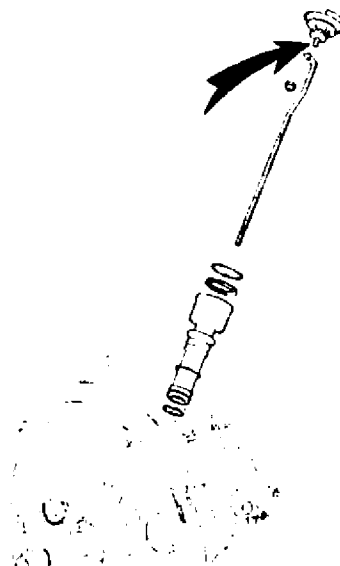
Oil Filler Cap and
Dipstick Assembly,
P/N 3020908

A recent report advised that the stud which secures the dipstick to the oil filler cap portion of the subject assembly had failed. The break occurred through the first thread of the stud at the filler cap end. This was a later type assembly installed per United Aircraft of Canada Service Bulletin No. 1183, and was identified in the Malfunction or Defect Report as "Shaw Aero Model 99321, Code ID, S/N 417-390-1."

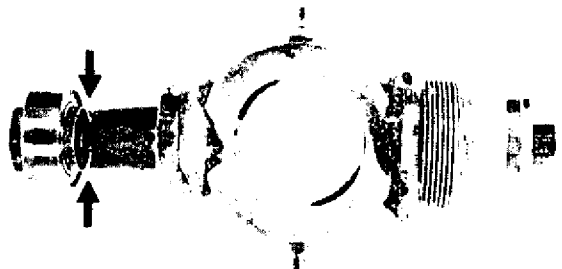
Tail Rotor Yoke,
P/N 47-641-057-9

During hover operation, the tail rotor separated from the aircraft. Investigation revealed the rotor yoke had failed near the thrust bearing. Total time in service - 1696 hours.

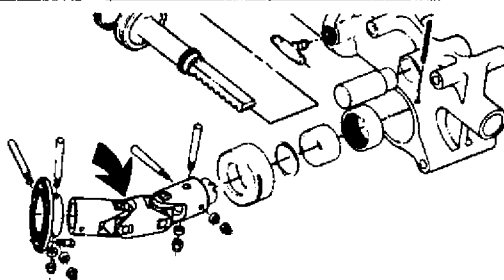
Cessna Model 337	Main Gear Adapter and U-Joint Assembly
---------------------	---

Seizing, corrosion, and sheared pins in the U-joint assemblies (P/N's 1541037-1 and 1541037-2) continue to be a problem. The Cessna Service Manual contains the recommendation that these assemblies be inspected and lubricated at each 100-hour interval.

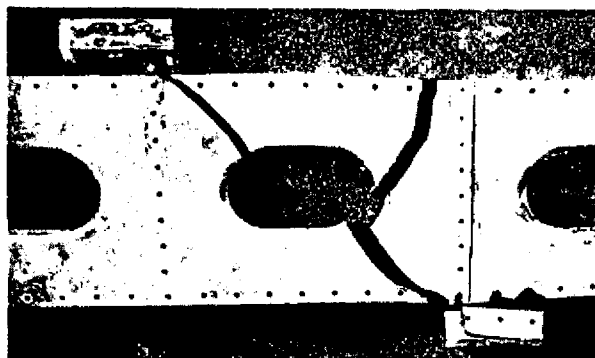
Fairchild Industries Model FH-227-B	Horizontal Stabilizer Spar Assembly, P/N 27-211000-72
--	--

When performing X-ray inspection of the horizontal stabilizers in accordance with Fairchild Service Bulletin No. FH227-55-9 and AD 66-27-05, a cracked stringer was found in the right stabilizer. The stabilizer leading edge was removed to gain access for repair, at which time the front spar web was found cracked completely through between stations 104 and 111; the front spar upper cap was cracked at station 112, and the lower cap was cracked almost completely through at station 103. The service bulletin does not call for inspection of the area where the spar defects were found, and the condition most likely would not have been detected if the stabilizer leading edge had not been removed.

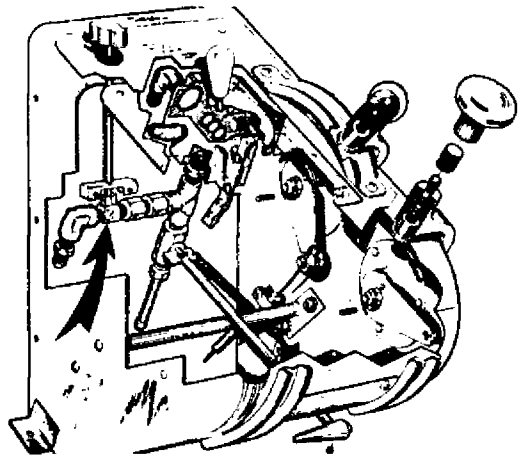
Piper
Model PA-23-250 Heater Shutoff Valve
Assembly, P/N 19460-00

The source of fuel and fuel fumes in the cockpit and aircraft belly was traced to a leaking heater fuel shutoff valve. The subject valve is located inside the cockpit mounted fuel system control box.

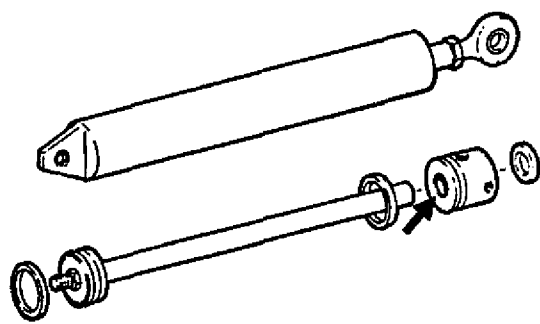
Piper Model PA-23-250	Flap Control Rod Assembly, P/N 18316-00	Failure of the right wing flap to actuate was attributed to a broken control rod end fitting. The end fitting bearing seized, resulting in overloading of the fitting threaded shank and subsequent failure. The control rod connects the flap to the torque tube bellcrank assembly.
Piper Model PA-23-250	Induction Air Box Drain Hose, P/N 16633-51	A fire occurred during engine start because of residual fuel trapped in the left engine induction air box. Investigation revealed the air box drain line was plugged with dead bugs and other foreign matter.
Piper Model PA-23-250	Landing Gear Actuating Cylinder Assembly, P/N 35030-02	<p>Flight personnel had reported slight fluid leakage from the right main landing gear actuating cylinder. Gear swing during annual inspection revealed a massive leak from the left cylinder. The cause of difficulty was attributed to excessive wear of the piston rod bore in the cylinder end plug, P/N 751691.</p>

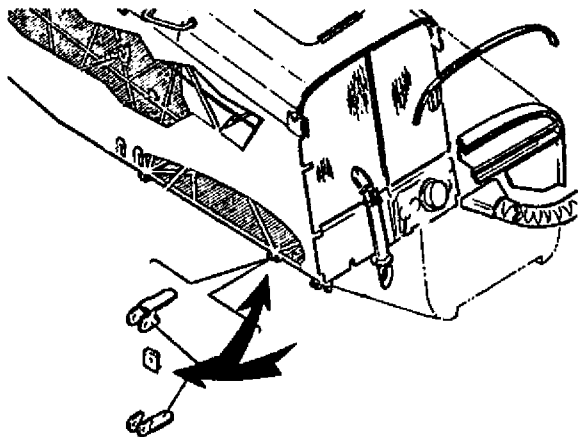
Fuselage Lower Longeron

When the filler spacer between both the right and left wing forward spar-to-fuselage fitting assemblies, P/N 64412-00, were removed, the lower longerons were found rusted completely through. The condition could not be detected without removal of the welded filler spacers.

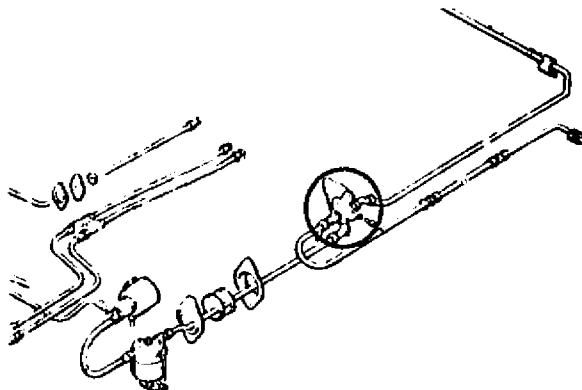
Fuel Line Fittings

The fuel line fittings which connect the right tank to the fuel selector were found leaking. Two additional aircraft were inspected and the same condition was discovered. These discrepancies were found on new aircraft during radio equipment installation.

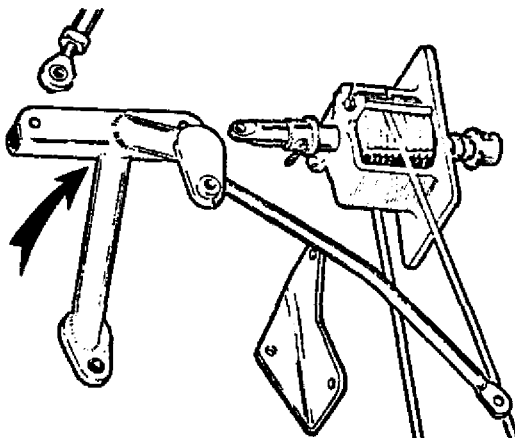
Stabilator Tab Control
Bellcrank Assembly,
P/N 22887-00

During routine inspection, at approximately 3150 hours aircraft time in service, the subject bellcrank assembly was found cracked. The crack was through the left tubular member of the assembly, adjacent to its weld to the vertical rectangular member.

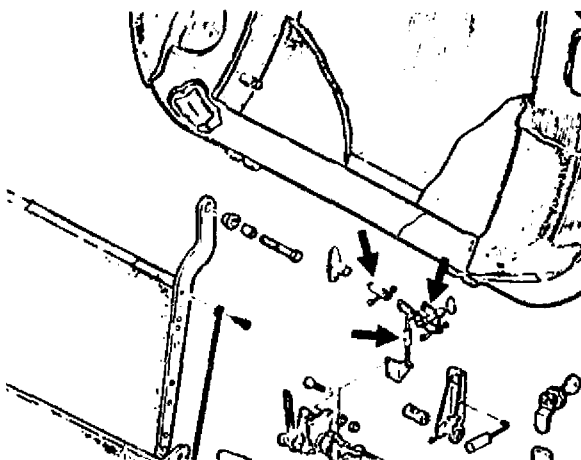
Entrance Door
Assembly, P/N 41668-06

The upper half of the cabin entrance door separated from the aircraft and struck the left horizontal stabilizer. Subsequent inspection of the lower door latching mechanism revealed the door latch safety pin, P/N 54242-02, (installed in aircraft above S/N 7552052) was not engaged with its latch plate. The bellcrank assembly, P/N 54243-02, was dislodged from its bearing plate, P/N 54237-02, and the latch rod, P/N 54244-02, was bent. These are components of the safety pin actuating mechanism. Although the upper door assembly has not been recovered, it is believed the safety bolt, P/N 54263-02, provided to prevent inadvertent inflight opening of the upper door, had not been engaged.

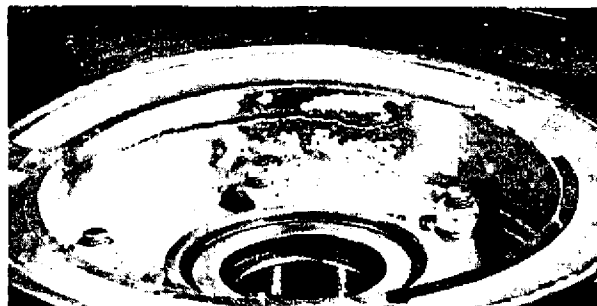
Nose Wheel Assembly,
P/N 551778 (Cleveland Model
40-120A)

The ground crew noticed the aircraft nose wheel wobbled slightly when towing the aircraft. Inspection revealed an open crack completely through the wheel flange, which had progressed circumferentially approximately 8 inches. The discrepancy was detected at 253 hours aircraft time in service.

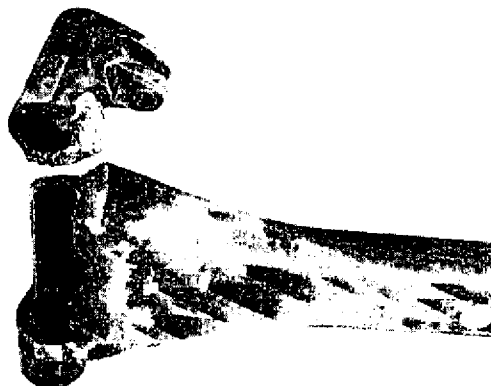
Rockwell International Nose Landing Gear
Model 112A Arm, P/N P-242-1

The nose landing gear arm failed during takeoff. Total time in service - 1200 hours.

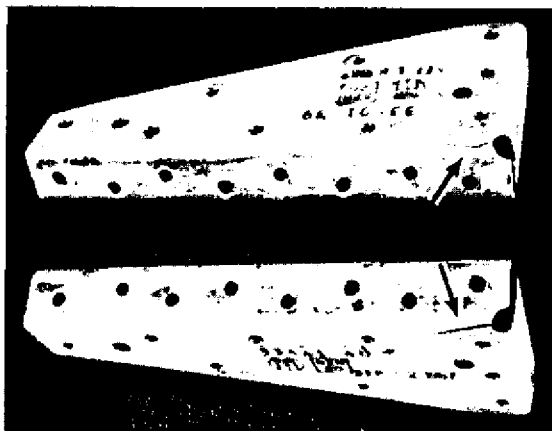
During routine annual inspection, both left and right aileron horn reinforcement doublers were found cracked along the upper flange bend radius. This condition was found with gliders having 1000 hours to 5000 hours time in service.

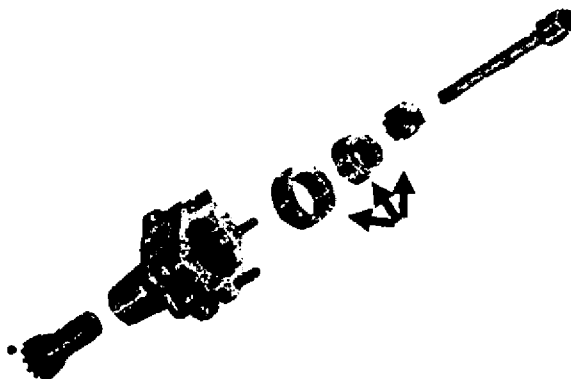
Turbocharger Scavenge
Pump Assembly,
P/N 77835

The right propeller of a Piper Model PA-23-250 aircraft was feathered during flight due to loss of engine oil pressure. Investigation disclosed the engine-driven turbocharger scavenge pump gerotor assembly, P/N 76302, had failed, causing loss of engine oil through the turbocharger oil seal. The engine had been in service for 175 hours.

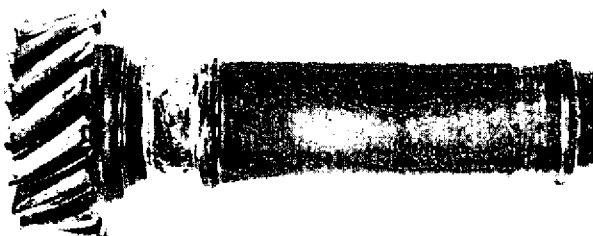
Tail Rotor Drive Pinion
Gear, P/N 47-620-568-1

The tail rotor drive pinion gear failed resulting in loss of tail rotor drive. Investigation disclosed that the shaft was worn severely permitting the gear to disengage. Bell Service Instruction No. 428 relates to this subject.

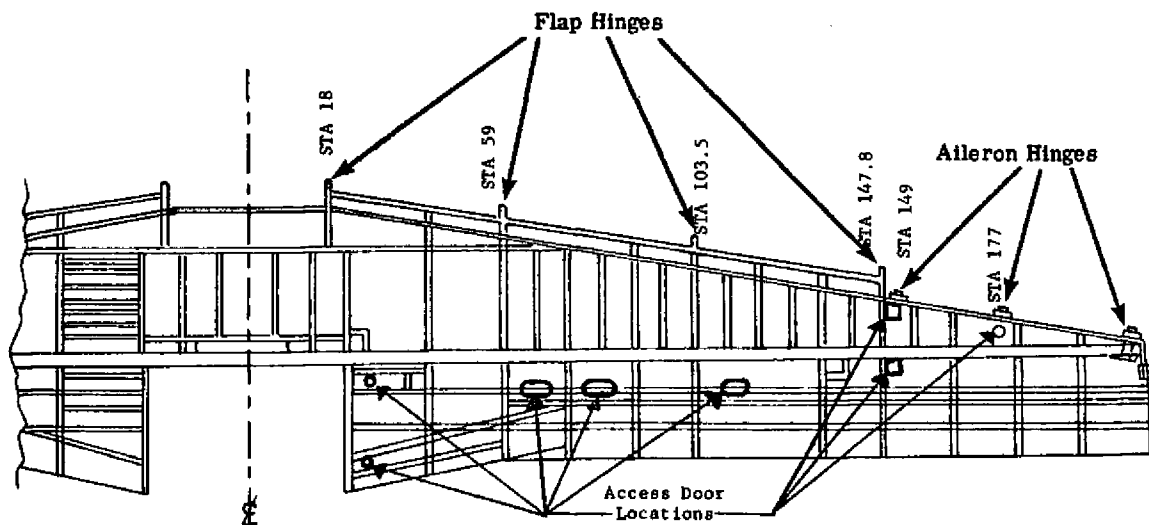
FIG. 1 WING STRUCTURE BOTTOM VIEW

During an accident investigation, extensive wood rot, weathering, and glue joint separation were found in the wing structure. Airworthiness Directive 76-15-01 and Service Bulletin No. M20-170A require inspections of the wing wood structure as well as the empennage wood structure. When required inspections are made, particular attention should be directed to the wing areas shown in Figures 1 and 2. The areas marked R_E can be visually inspected externally without removing access plates. The areas marked R_I require removal of access plates for inspections. The flap support ribs of Stations 18, 59, 103.5, and 147.8 can all be inspected externally. The flap support ribs should be gently flexed during visual inspections for evidence of rot near the flap hinge and for glue joint separation. If evidence of wood deterioration is observed (such as wood discoloration or weather cracks) the fabric (and skin as necessary) should be removed until the extent of wood deterioration is determined. All wood and wood-joint deterioration should be repaired in accordance with the provisions of AD 76-15-01. Malfunction or defect report (FAA Form 8330-2) should be submitted for each instance of wood deterioration requiring repair.

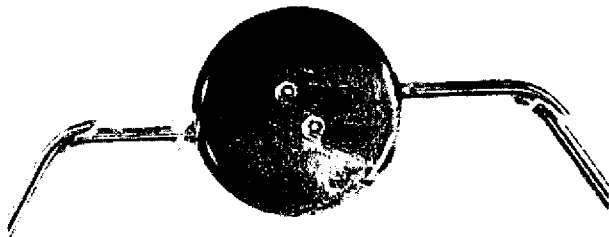
**Nav Antenna,
P/N 451-273**

During inspection, cracks were noted in the bend radius of both elements of the nav antenna installed on the aircraft vertical stabilizer. Identical conditions were found during inspection of six other aircraft.

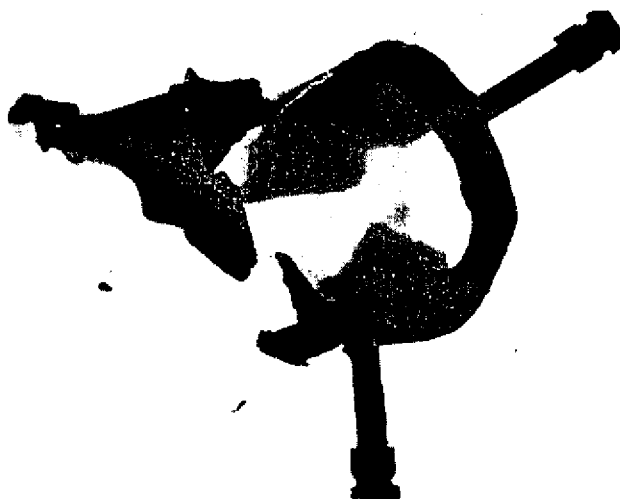
Venturi, P/N A46-A33

Inspection to determine the cause for reported intermittent engine roughness during level flight revealed the carburetor venturi was severely distorted. Examination revealed that heat from a previous induction system fire evidently caused the venturi to burn and melt. Further checks revealed a worn and leaking carburetor needle valve and evidence of carburetor flooding.

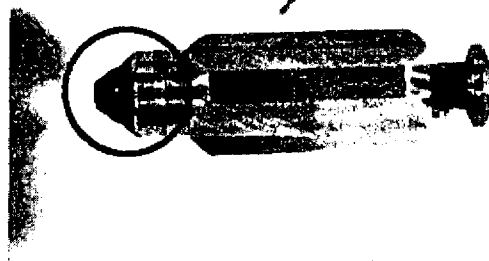
Marvel-Schebler Carburetor Model MA-4SPA	Needle Valve and Seat Assembly, P/N A233-615
--	---

The cause for carburetor flooding, rough running and inflight engine stoppage, has been traced to fuel leakage past the carburetor needle valve. In several instances, disassembly inspection revealed the leakage to be caused by wear of the needle valve rubber tip or insert. Contact of the needle valve with the seat sometimes wears a groove 360 degrees around the rubber tip permitting fuel to pass into the float chamber when the valve is in the closed position. This condition has been reported with needle valve and seat assemblies with as little as 300 hours time in service.

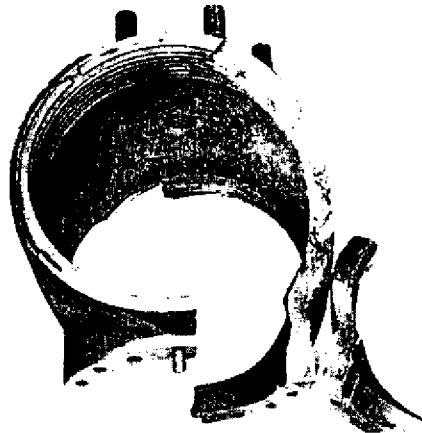
Hub

The propeller hub failed at the blade retention sockets permitting the blades to separate from the hub.

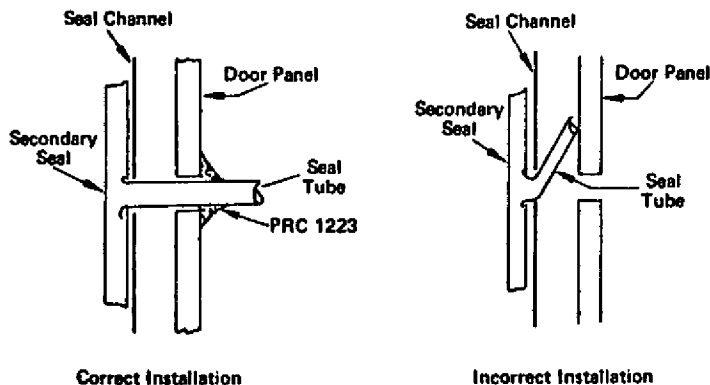
SABRELINER DOOR SEAL INSTALLATION

We have had reports that on some Sabreliners the secondary door seal is being incorrectly installed. Perhaps this tip will help you

When pressing the door seal into the channel, insert the seal tube into the hole in the channel and guide the tube through the hole in the door panel. The tube should be visible when looking inside the door from the interior door handle opening. PRC 1223 (or equivalent) pressure sealant should be used around the tube on the door panel as shown.
