Rapid Pothole Repair in Concrete Bridge Decks

Report Number: KTC-23-02/SPR21-607-1F

Research Report

November 2022

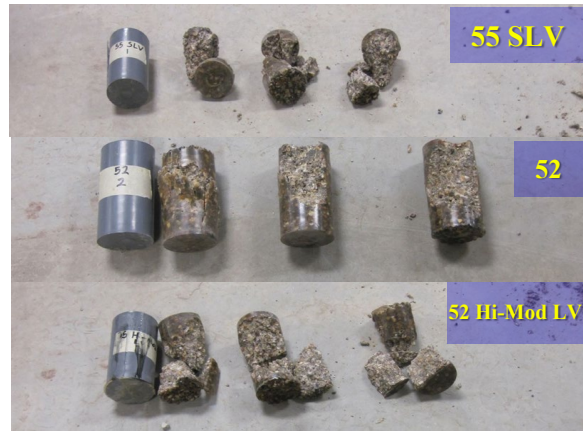
(b) Failure of tested cylinders

Figure 2.6a illustrates the 14-day compressive strength test for one of the Sikadur 55 SLV specimens. All tested specimens for the three epoxies are presented in Figure 2.6b. All specimens of Sikadur 55 SLV and 35 Hi-Mod LV had explosive failures, while the Sikadur 52 specimens showed a gradual splitting failure. All three epoxy mortars had compressive strengths greater than 9,000 psi (Figure 2.7), with the Sikadur 35 Hi-Mod LV specimens having the highest average compressive strength of 11,895 psi. All three epoxy mortars were sufficiently strong in compression and are good candidates for repairing damaged bridge decks.

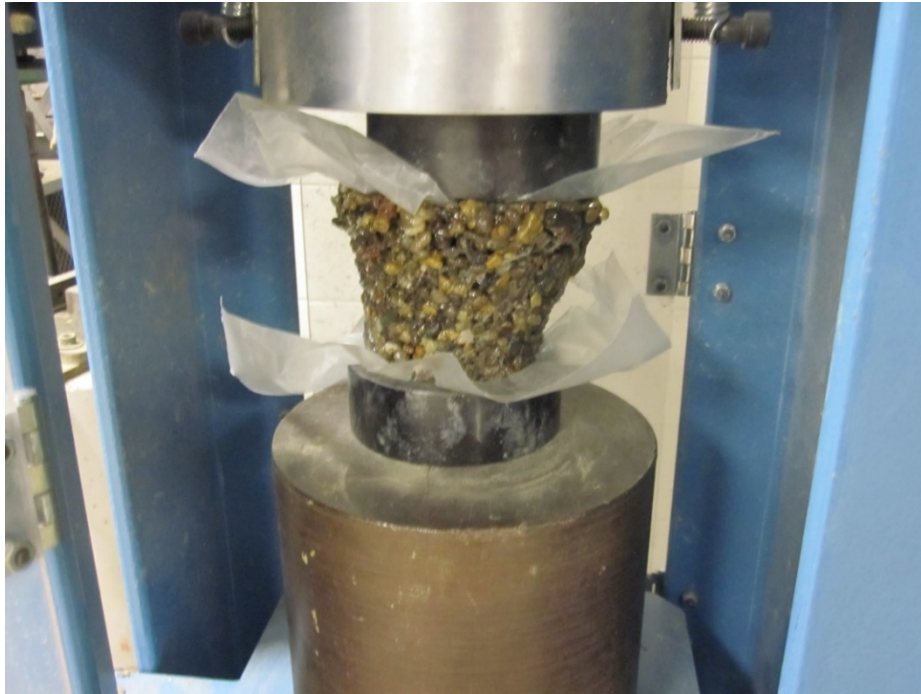
Figure 2.13 Epoxy Mortar Compressive Strength Test at 3 Hours After Placing the Mortar in Cylinder Molds

Specimens of all three epoxy mortar types were difficult to remove from the molds three (3) hours after casting. Figure 2.13 shows that the three-hour test specimens were easily compressed. The bottoms of all three specimens were still tacky when removed from the molds for the five-hour tests.

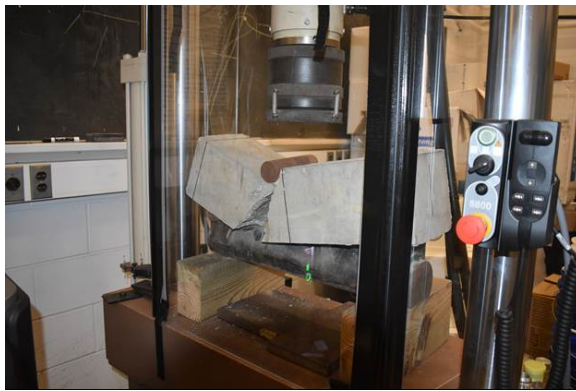
(a) Failure of control beam (P1-B1)

Failure of the control beam (P1-B1) under three-point loading is shown in Figure 3.5a. A crack was observed just before 8,000 lbs. of loading, after which the crack widened, steel rods ruptured, and the beam failed. The failure of Beam P1-B4, where the patch was filled with pea gravel resin mortar, and tested after one day of curing, is shown

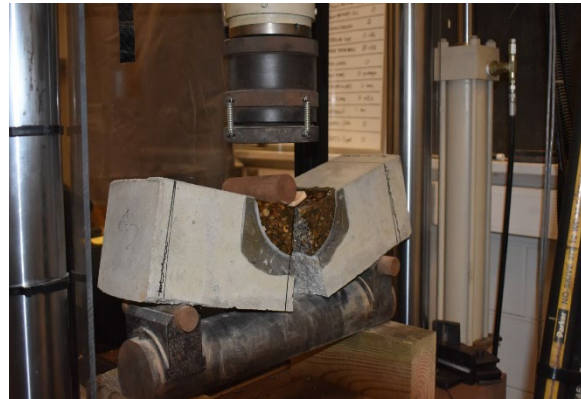
(b) Failure of Beam 4 (P1-B4)

in Figure 3.5b. Similar failures were observed in Phase 1 for all beams that had a repaired patch. A crack would initiate soon after loading at or near midspan and move up toward the line load while going through the repair patch. Although the line though the repair patch was relatively straight for pea gravel patches (as seen in Figure 3.5b), the patch repaired with concrete aggregate resin mortar saw crack displacement of two inches along the concrete patch surface after reaching the cured mortar followed by propagation toward the line load location. Load-displacement curves for all Phase 1 beams are shown in Figure 3.6, while the failure load, displacement, and description of the observed failure is tabulated in Table 3.2.

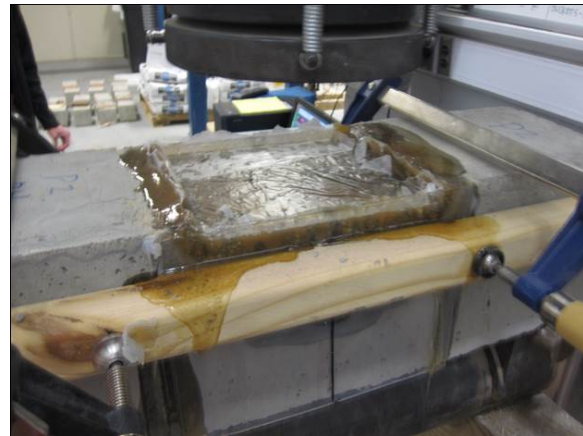
(b) Repair patch following dynamic loading in Beam 4 (P2-B4)

Beam P2-B4, shown in Figure 3.7b, had the lowest cure time of one hour; some uncured epoxy spilled over the sides during dynamic testing. At the end of the dynamic testing, the patch height was approximately 0.25" lower than the top concrete surface due to uncured epoxy spillover. Yet, the beam attained a failure load slightly higher than the control beam.

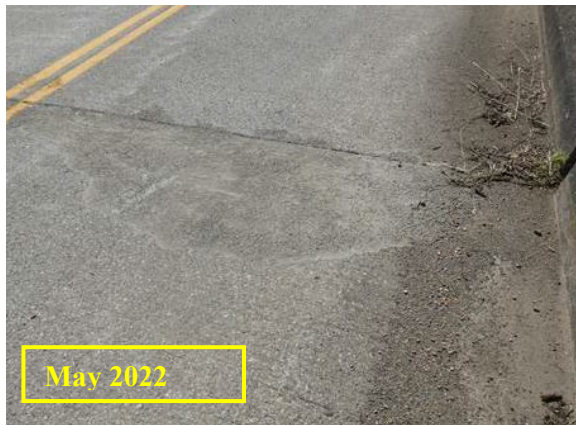
(c) Southbound lane over joint at Pier 2

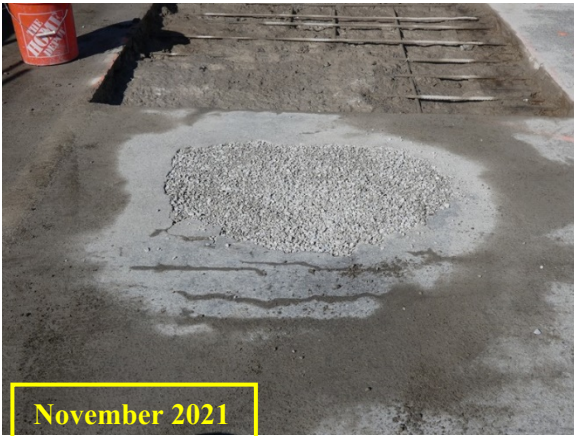
(a) Pothole filled with #8 aggregate
