Test Report No. 440822-01

**EVALUATION OF ATTACHMENTS TO CONCRETE BARRIER
SYSTEMS TO DETER PEDESTRIANS**

Texas Department of Transportation
<https://tti.tamu.edu/documents/0-7082-R1-Vol2.pdf>

| 4. Title and Subtitle EVALUATION OF ATTACHMENTS TO CONCRETE BARRIER SYSTEMS TO DETER PEDESTRIANS—VOLUME 2: CRASH REPORT | | | | 5. Report Date Published: August 2023 | |

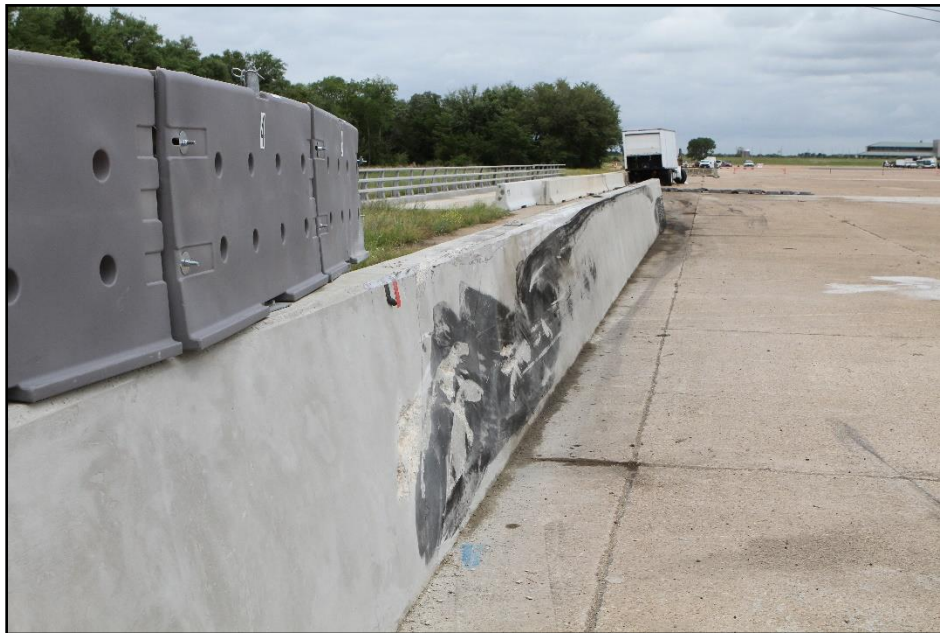
Figure 5.6. Armorcast® Gawk Screen on Single-Slope Barrier after Test at Impact Location, Test 440822-01-1.

Table 5.6 describes the damage to the Armorcast[®] gawk screen on the single-slope barrier. Figure 5.6 and Figure 5.7 show the damage to the Armorcast[®] gawk screen on the single-slope barrier.

| Test Parameter | Measured |
|---|---|
| Working Width ^a and Height | Dislodged Screen panels at 129.9 inches, at a height of 27.7 inches |

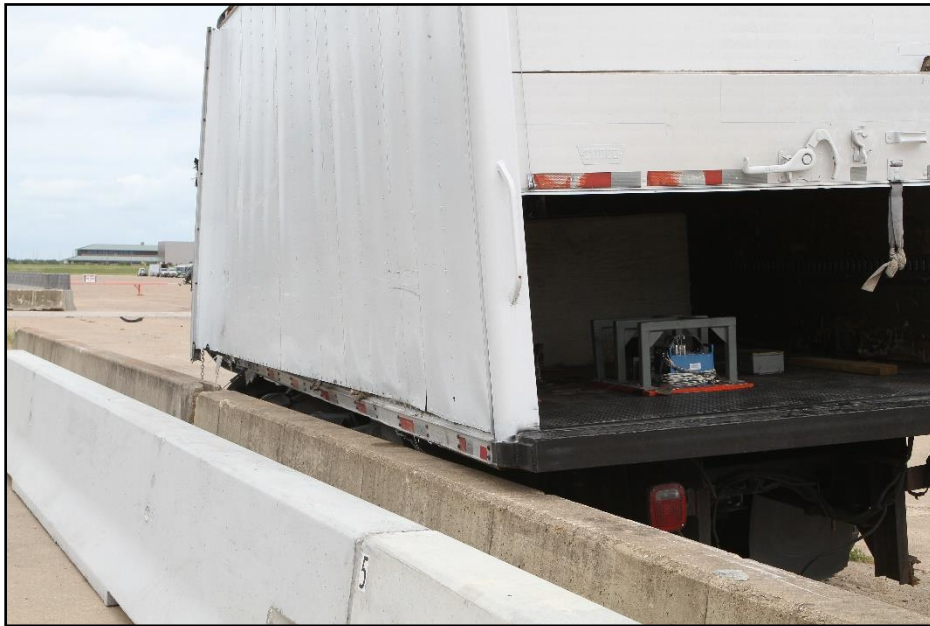
Figure 5.10. Rear Impact Side of Test Vehicle after Test 440822-01-1.

Figure 5.9 and Figure 5.10 show the damage sustained by the vehicle. Figure 5.11 and Figure 5.12 show the interior of the test vehicle. Table 5.7 and Table 5.8 provide details on the occupant compartment deformation and exterior vehicle damage.

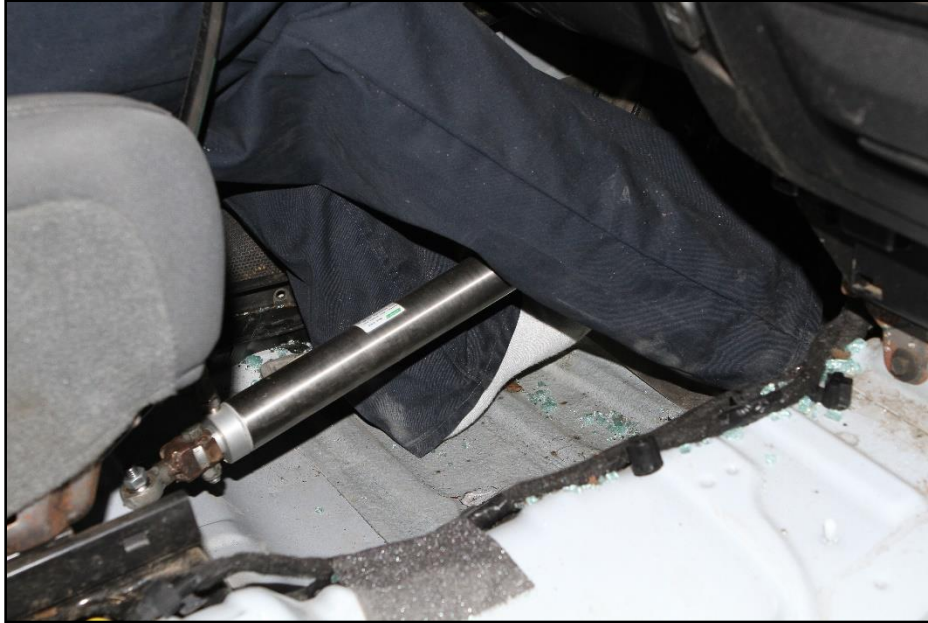
Figure 7.11. Interior of Test Vehicle on Impact Side after Test 440822-01-3.

| Side Windows | The side window shattered due to the flex of the door and was not caused by the test article impacting or penetrating the vehicle. |

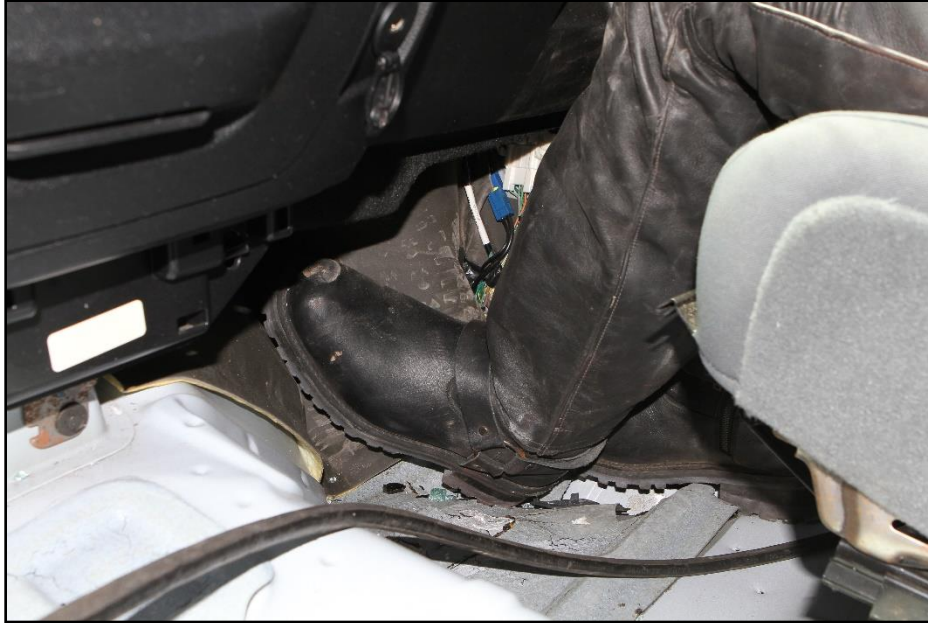
Figure 8.11. Interior of Test Vehicle on Impact Side after Test 440822-01-4.

| Side Windows | The right passenger's side window shattered due to the deformation of the door and was not caused by penetration of the test article. |

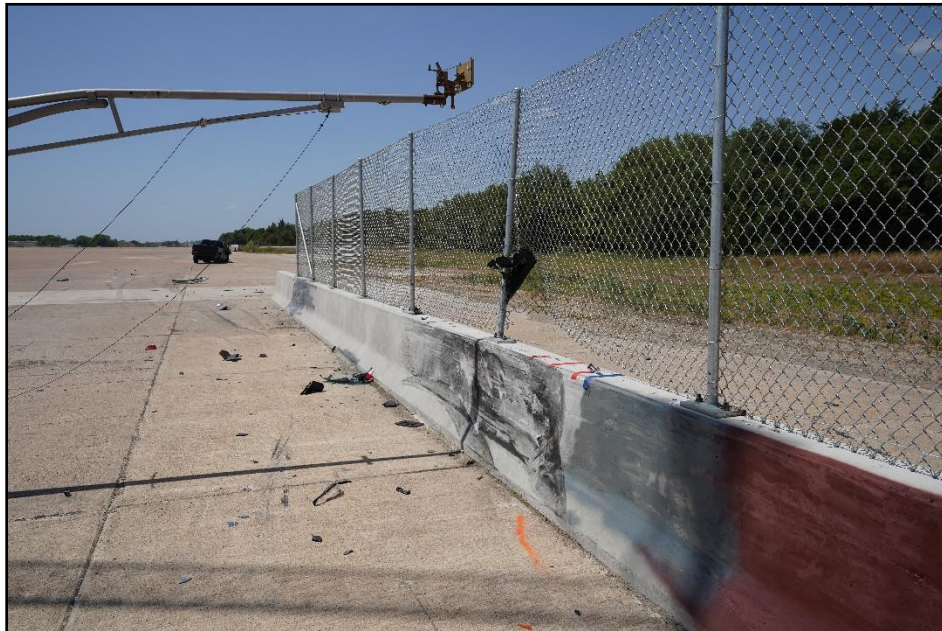
There was some scuffing and gouging at the impact location on the concrete barrier. The chain link was pulled loose from the bottom wire from post 5 to post 7. The chain link was pushed up 10 inches and back 12 inches just upstream of post 6. Post 6 was bent at 20 inches from the bottom, and the weld securing the pipe to the base plate failed ¾ of the way around the pipe.

Figure 9.6. Chain-Link Fence on F-Shape Barrier after Test at Impact Location, Test 440822-01-5.

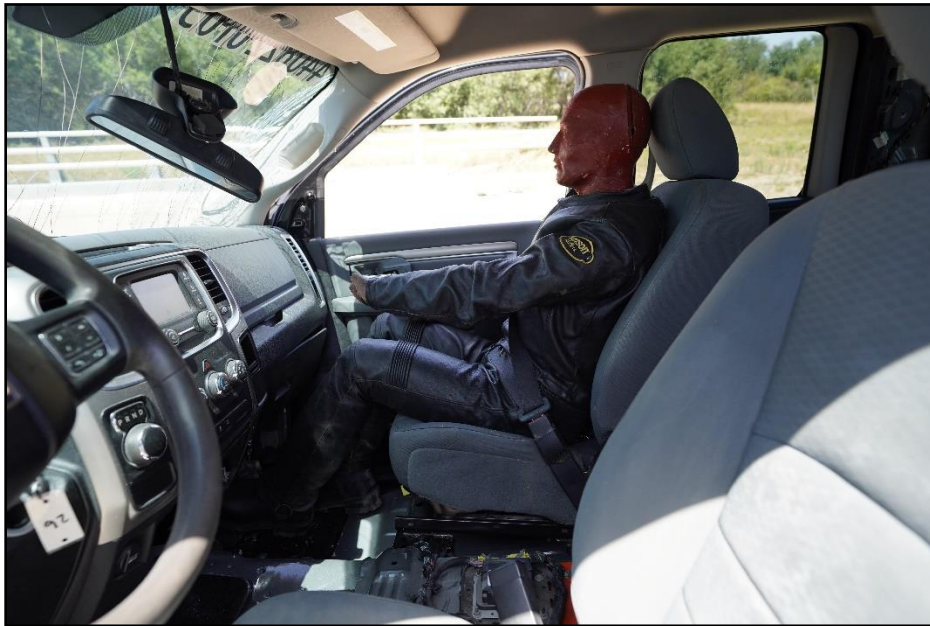
Figure 9.10. Overall Interior of Test Vehicle after Test 440822-01-5.

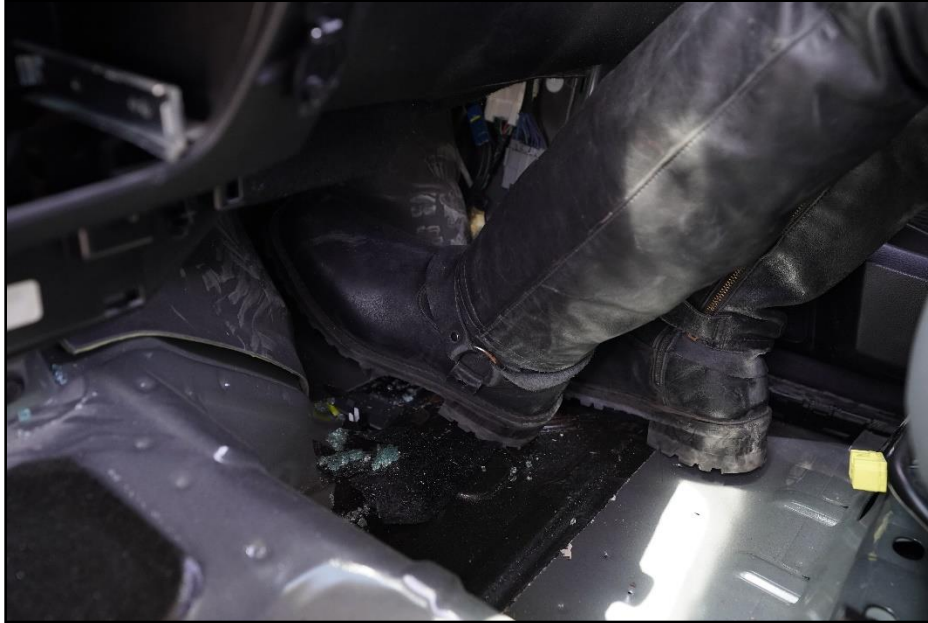
Figure 9.11. Interior of Test Vehicle on Impact Side after Test 440822-01-5.
