Methodology for Load Rating Double-Tee Bridges

Study SD2016-01

Final Report

**Department of Civil & Environmental Engineering
South Dakota State University
Brookings, SD 57007**

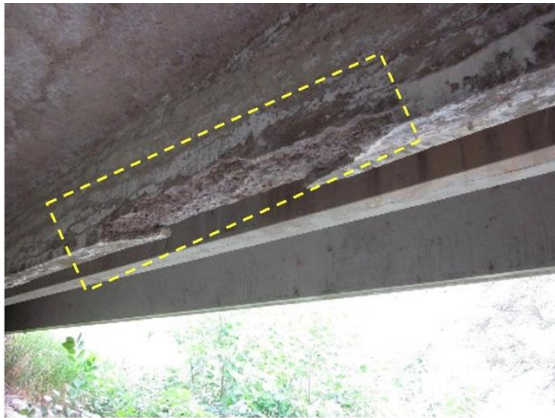
(a) Stem Cover Deterioration

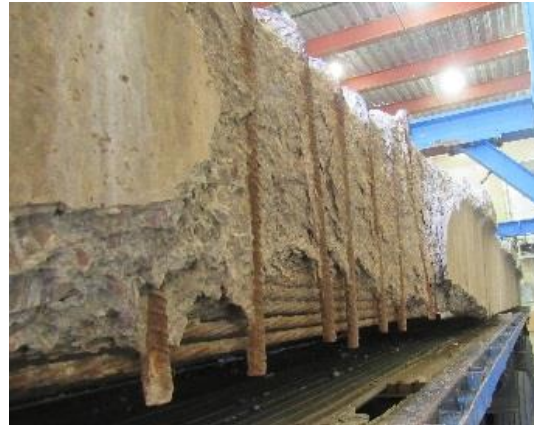
(b) Stem Reinforcement Exposure

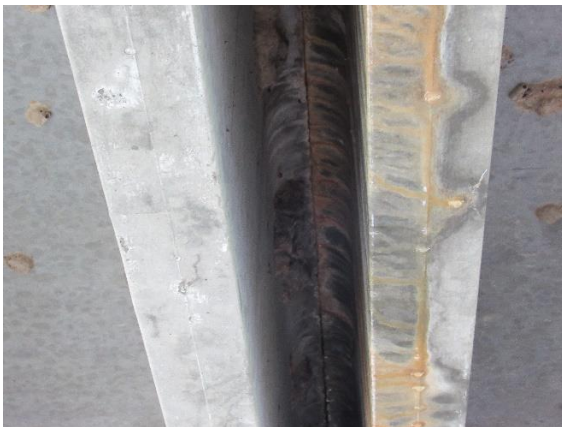
(c) Girder-to-Girder Damage

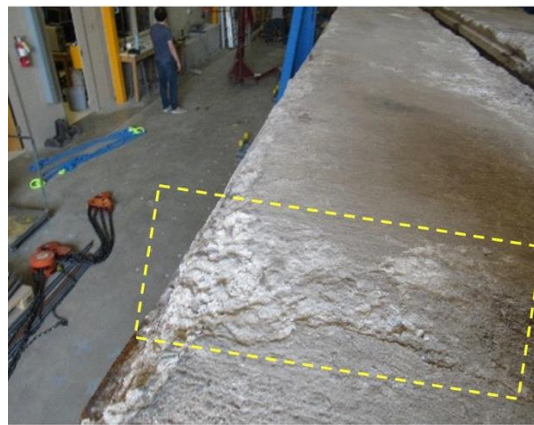
(d) Flange Cover Deterioration

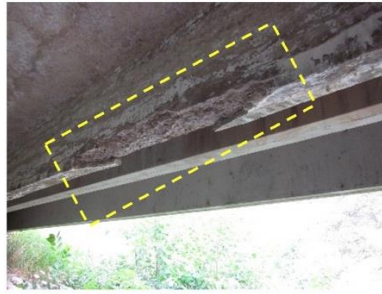
(b) Stem Cover Deterioration (CS-3)

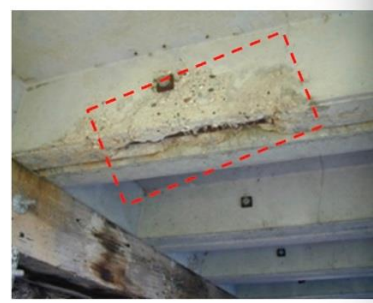
(c) Stem Cover Deterioration (CS-4)

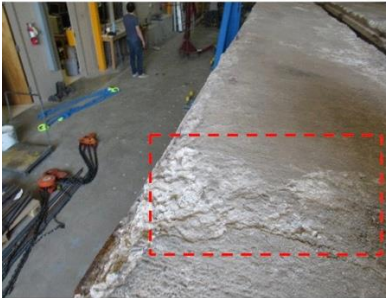
(d) Flange Cover Deterioration (CS-2)

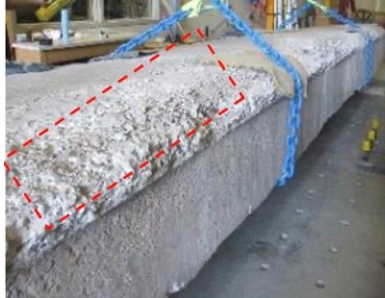
(e) Flange Cover Deterioration (CS-3)

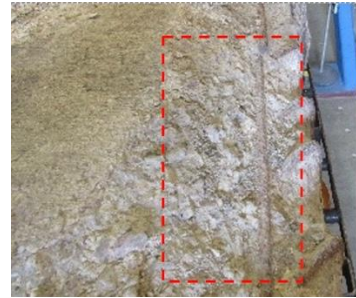
(f) Flange Cover Deterioration (CS-4)

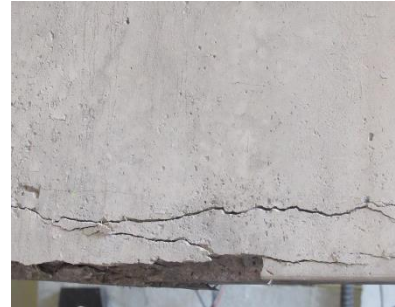
(i) Stem Cracking (CS-4)

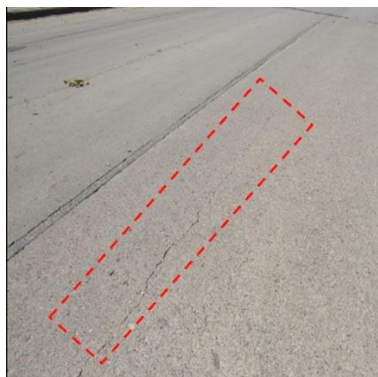
(j) Flange Cracking (CS-2)

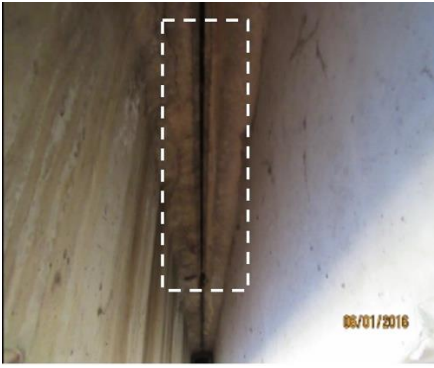
(m) Flange Girder to Girder Longitudinal Deterioration (CS-2)

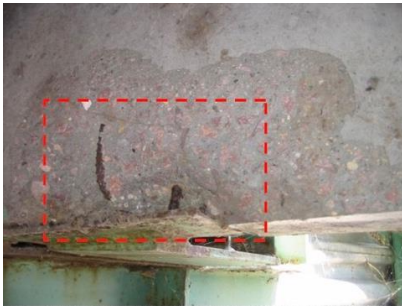
(s) Stem Exposure of Transverse Rebar (CS-1)/Stem Cover Deterioration CS (4)

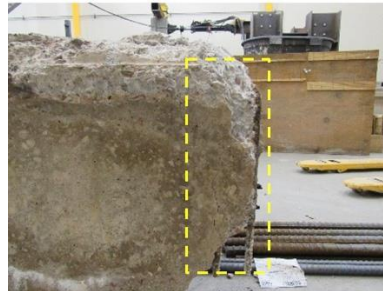
(t) Stem Exposure of Transverse Rebar (CS-2)

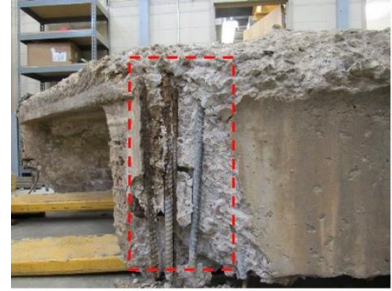
(u) Stem Exposure of Transvers Rebar (CS-3)

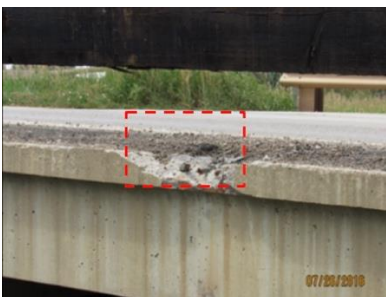
(v) Flange Exposure of Rebar (CS-1) & Flange Cover Deterioration (CS-4)

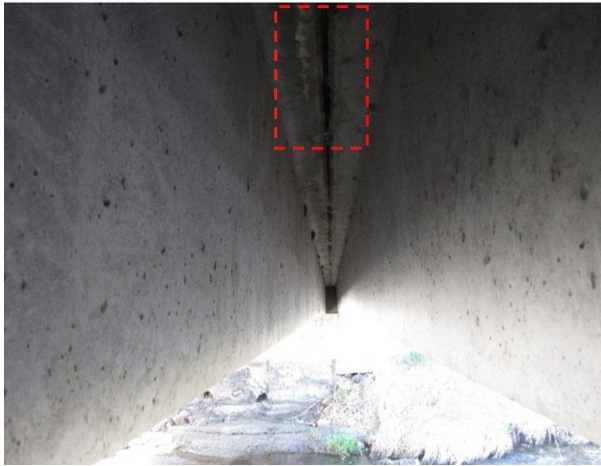
(a) Efflorescence in Joint

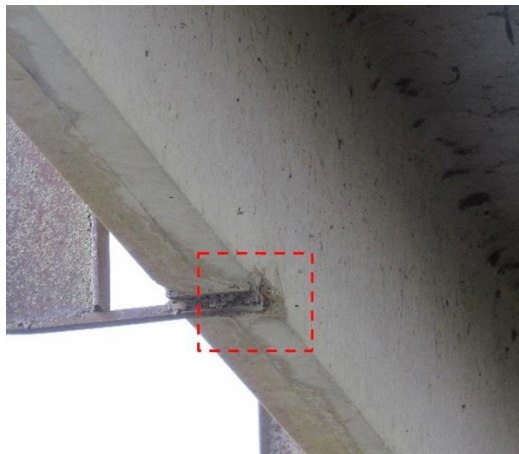
(d) Concrete Spalling at Railing

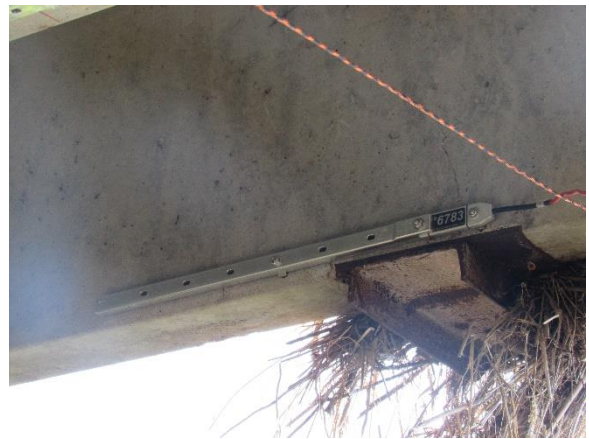
(b) Strain Gauges at Side due to Railing

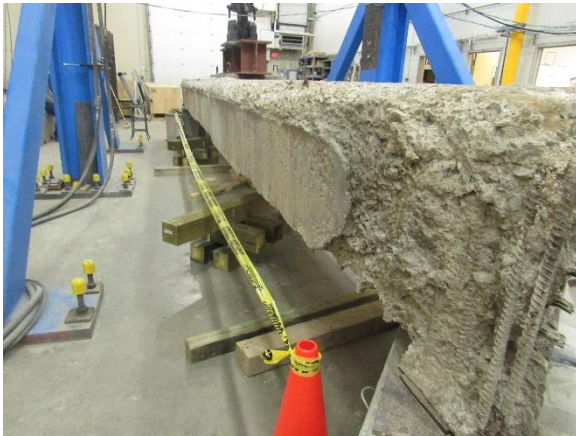
Girder Depth, in. (mm)	Girder Length, ft (m)	As-received Girder Damage Type and Condition State
23 (584)	30 (9.14)	Spalling of stem concrete cover (with a condition state of Severe, Fig. 8.4a), exposure of stem transverse reinforcement (with a condition state of Severe, Fig. 8.4a & c), and leakage of girder-to-girder joints (with a condition state of Poor).
23 (584)	50 (15.24)	Deterioration of concrete cover (with condition state of severe, Fig. 8.4b), exposure of transverse rebar (with a condition state of Severe, 8.4f), exposure of longitudinal prestressing (with a condition state of Severe, Fig. 8.4f), and leakage of girder-to-girder joints (with a condition state of Poor).

(a) Stem Cover Deterioration for 30-ft (9.14-m) Girder

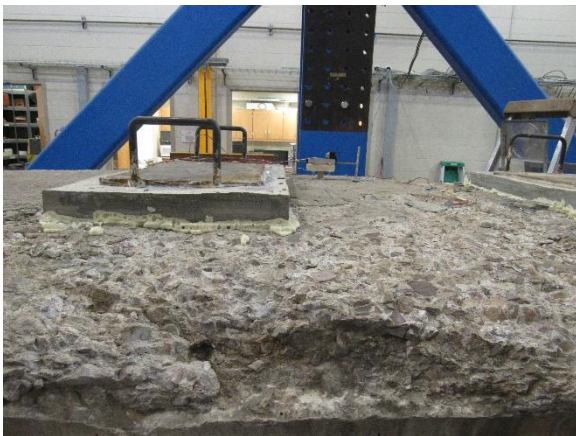
(c) Flange Cover Deterioration of 30-ft (9.14-m) Girder

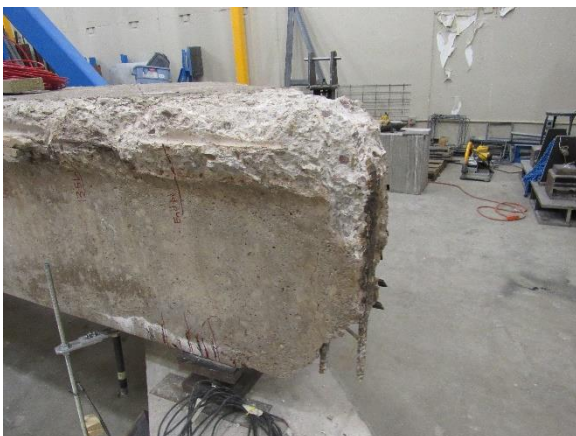
(e) Reinforcement Exposure of 30-ft (9.14-m) Girder

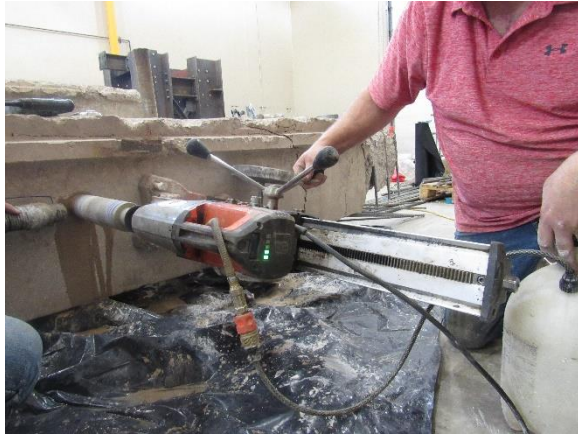
Figure 8.22 – Concrete Coring and Testing for Salvaged Girders

Figure 8.22 shows a sample core, which was obtained following ASTM C42 (2003), and the test setup, which was in accordance to ASTM C39 (2012). Table 8.4 presents a summary of the results. The concrete compressive strength for the 50-ft (15.24-m) long girder stem and flange was 3.15 ksi (21.7

MPa) and 1.92 ksi (13.2 MPa), respectively. Both strengths were significantly lower than that specified in shop drawings found for South Dakota double-tee girders.

Unfortunately, concrete in the 30-ft (9.14-m) long girder was severely deteriorated thus no samples could be obtained (all samples crushed during coring). The only core sample that was extracted from this girder had a short height that was not acceptable by ASTM C42 (2003). Due to a lack of test data, the compressive strength of the 30-ft (9.14-m) long girder is assumed to be the same as that in the 50-ft (15.24-m) long girder.

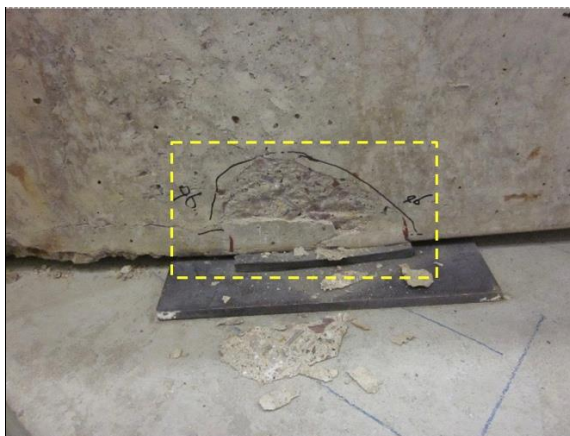
(c) Concrete Spalling at Support

The 45-year old girder had several damages prior to testing (Fig. 8.4). As was mentioned in Sec. 8.1, this girder was cracked at the midspan during unloading from the delivery truck. The first flexural crack was observed at the midspan at a 24.9-kip (110.7-kN) load as shown in Fig. 8.26 (marked as Run No. 78). New flexural cracks developed at the midspan at higher loads (Fig. 8.26b) and the concrete spalled at the north support (Fig. 8.26c). Finally, the girder failed at the midspan in a brittle manner (Fig. 8.26d). It was concluded from the analytical study (Sec. 8.7) that the girder failure was due to the failure of the flange concrete.

Figure 8.26 – Observed Damage of 50-ft (15.24-m) Long Girder during Strength Testing

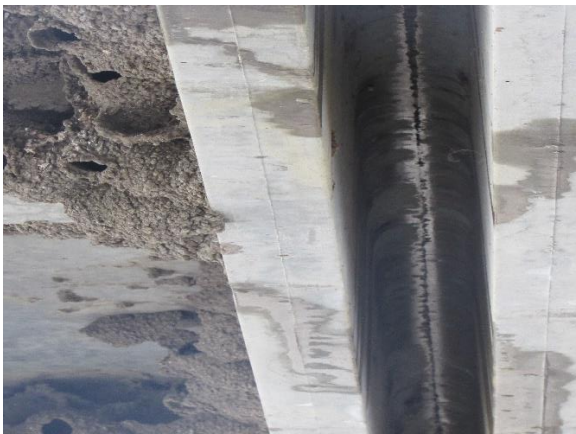
(e) Efflorescence in joint

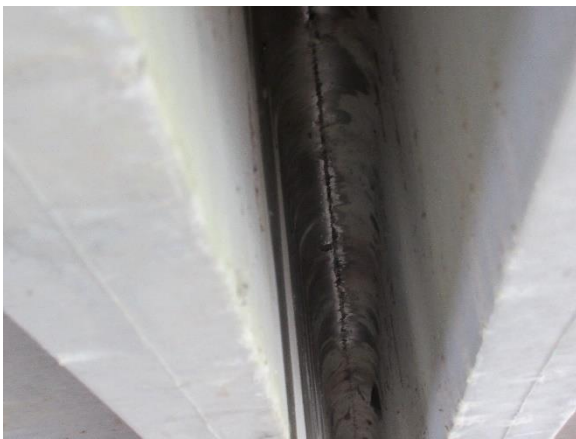
(c) Efflorescence in joint

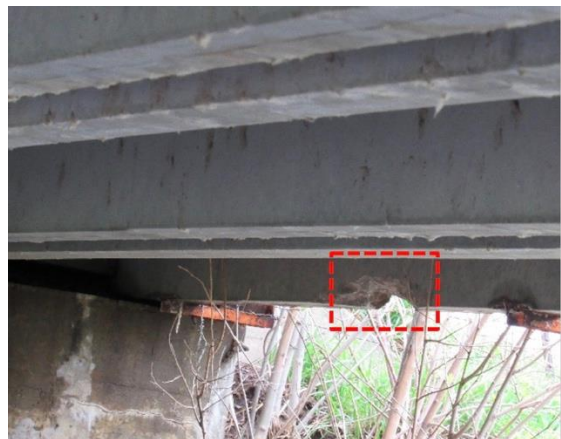
(d) Deterioration at bottom of stem

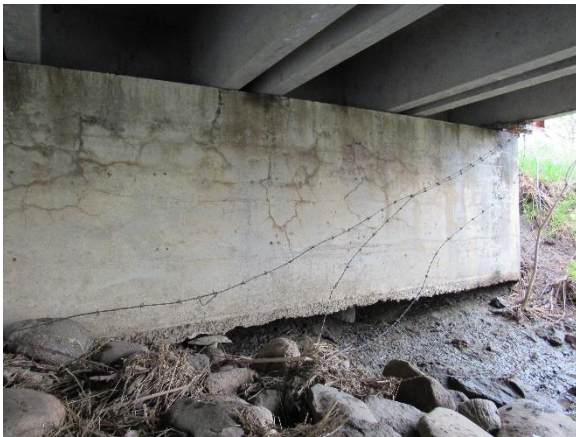
(e) Scouring from bottom of abutment

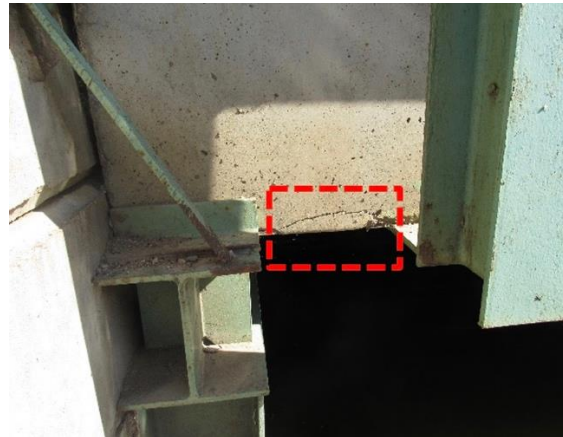
(b) Cracking at bottom of exterior girder

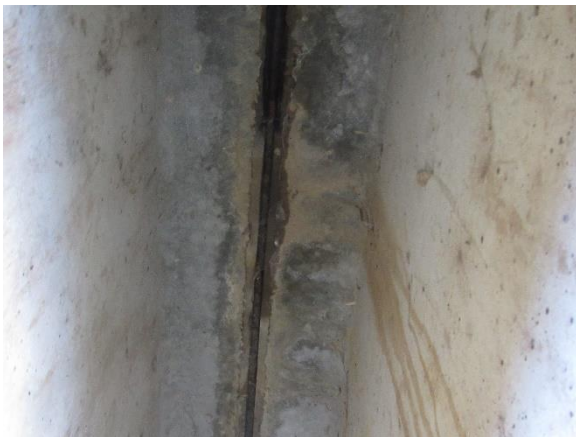
(e) Leakage from joint

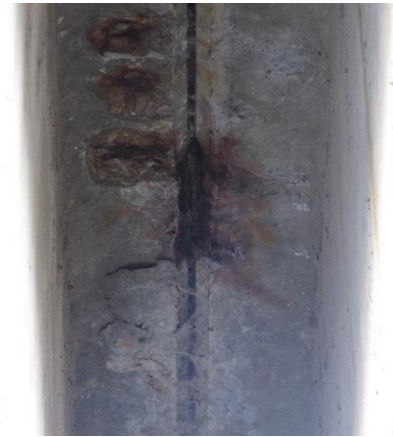
(b) Corrosion in joint

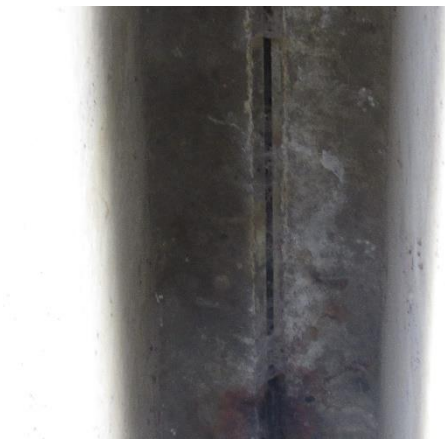
(c) Efflorescence in joint

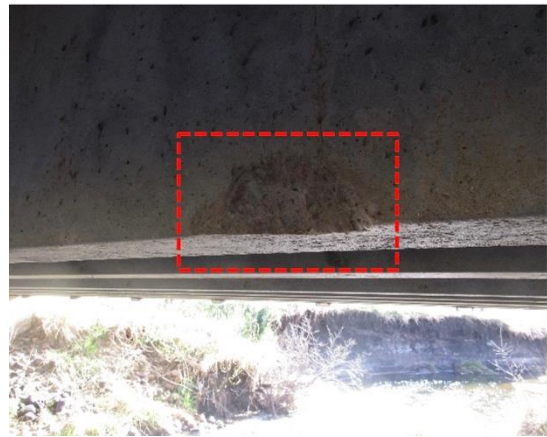
(b) Spalling at stem of bridge

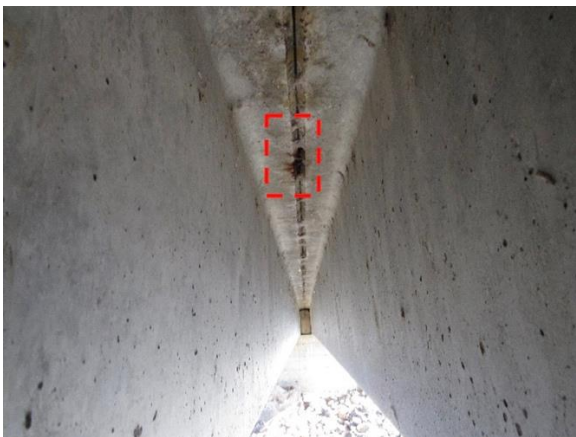
(c) Corrosion in the joint

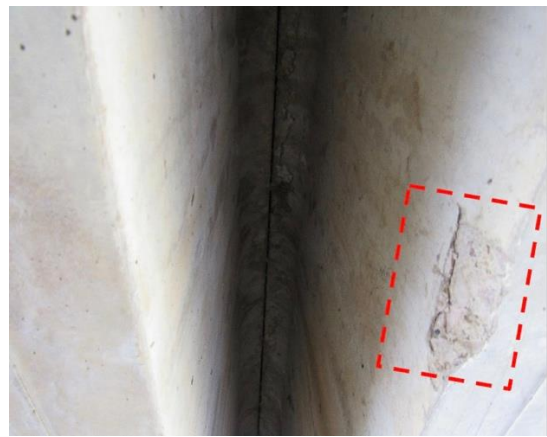
(d) Deterioration at bottom of stem

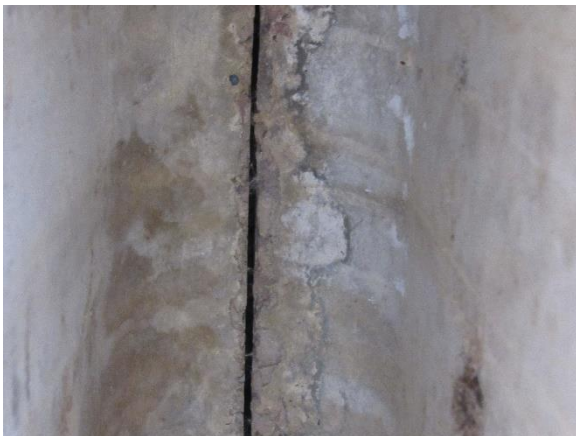
(e) Efflorescence at joint

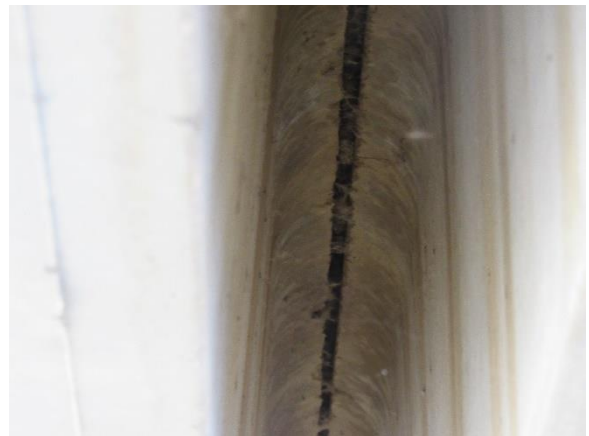
(f) Wide gap in joint

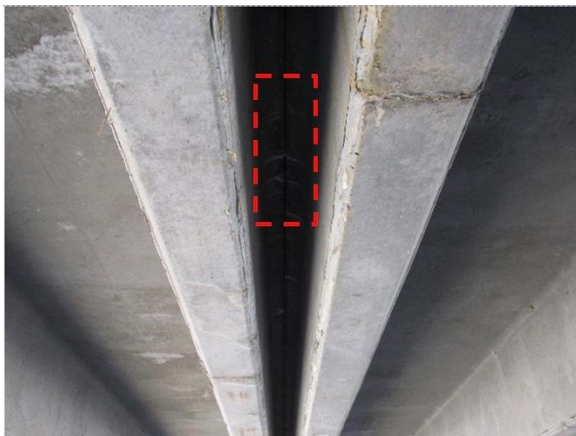
(e) Efflorescence at joint

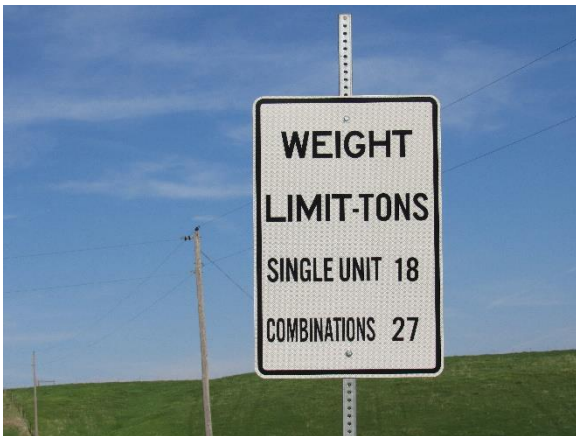
(e) Posting of bridge

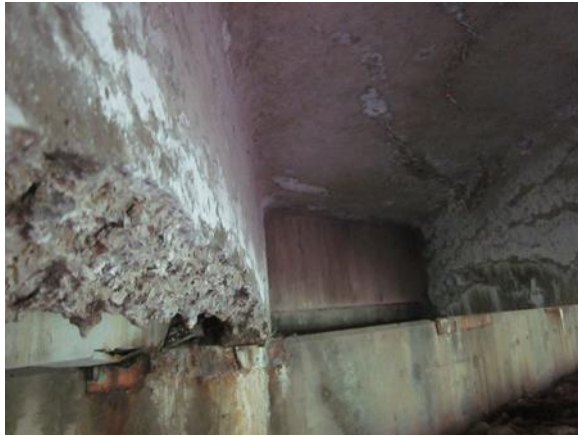
(a) Underneath View of Girder

Girder Depth, in. (mm)	Girder Length, ft (m)	Damage Type and Condition State
23 (584)	30 (9.14)	Spalling of stem concrete cover (CS-4), exposure of stem transverse reinforcement (CS-3), flange cover deterioration (CS-4), exposure of flange rebar (CS-2) and cracking at stem and flange joint (CS-1).

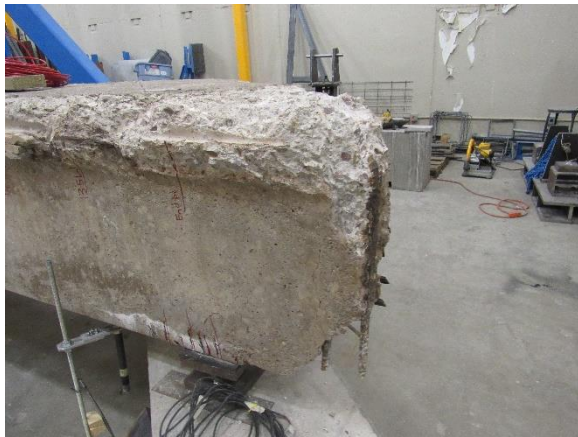
(c) Reinforcement Exposure

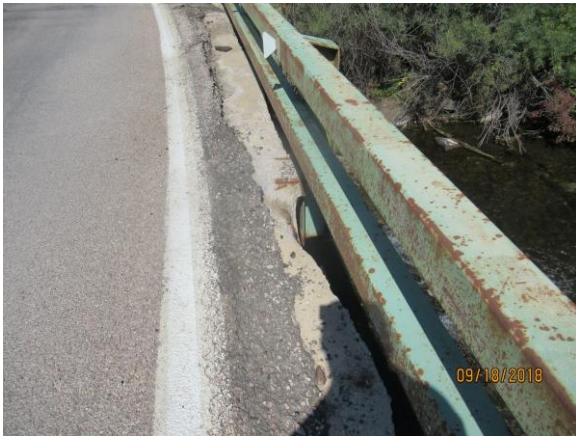
(a) Deterioration of Concrete on Top of East Deck Unit

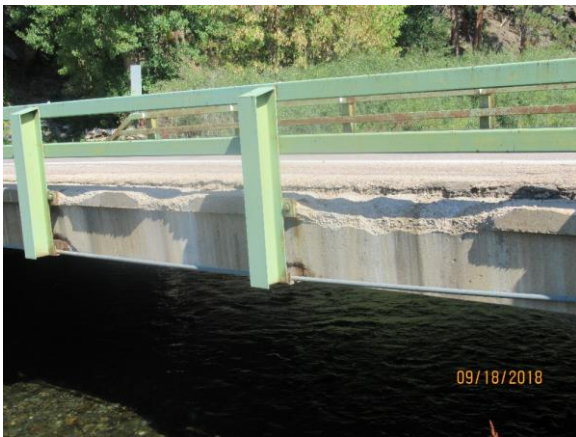
(c) Deterioration of West Side of West Deck Unit

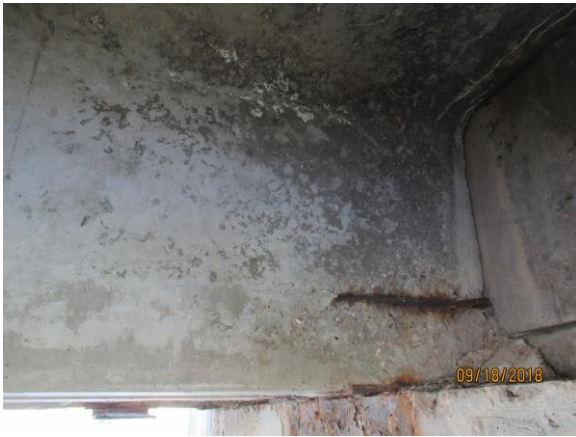
(f) Spall with Prestressing Strand Exposed – South End of East Stem of Deck Unit 6

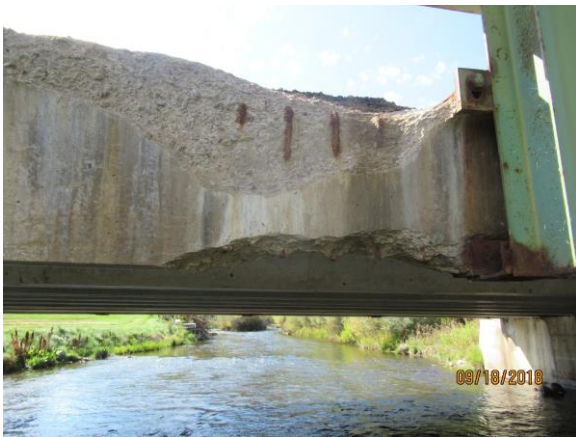
(h) Spall with Exposed Rebar Near Post 4 – Deck Unit 7

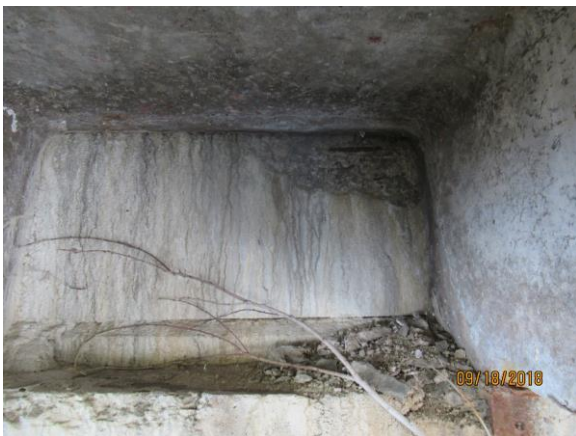
(k) Spall in North Backwall with Exposed Rebar Beneath Deck Unit 7
