DOT/FAA/TC-22/20

Post Small-Flame Forensic Analysis of Aerospace Composites

January 2024

Final report

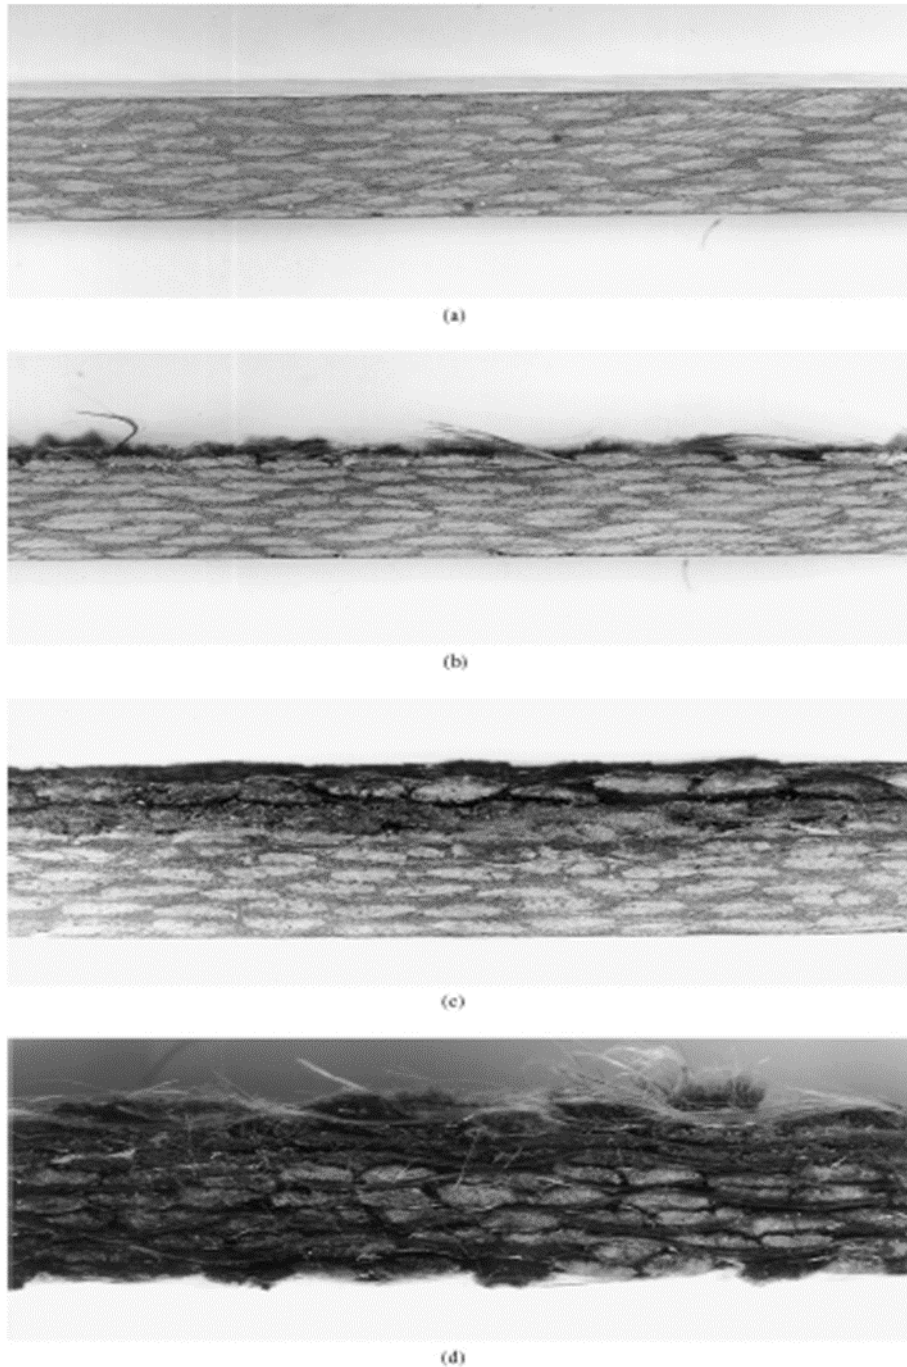
Due to its low thermal conductivity, char formed at the exposed surface of the burned composite material may serve as a protective layer that impedes further burning (Mouritz & Gibson, 2007). Mouritz and Mathys (2001) used cone calorimetry to investigate the effect of through-thickness heat flux and fire exposure duration on the char formation in an 11.5 mm thick E-glass woven roving fabric isophthalic polyester composite laminate. Figure 2 (Mouritz & Mathys, 2001) shows the cross-section of the woven composite after being exposed to an upper surface heat flux of 50 kW/m^2 for four different durations in seconds: (a) 0 s, (b) 85 s, (c) 325 s, and (d) 1800 s. As shown in the figure, the char layer thickness increased with the increase in heat flux exposure- duration. Moreover, the char developed through the entire 11.5 mm specimen thickness due to the total thermal decomposition and combustion of the polyester matrix.

Figure 2. Woven E-glass/polyester composite cross-section after heat flux exposure

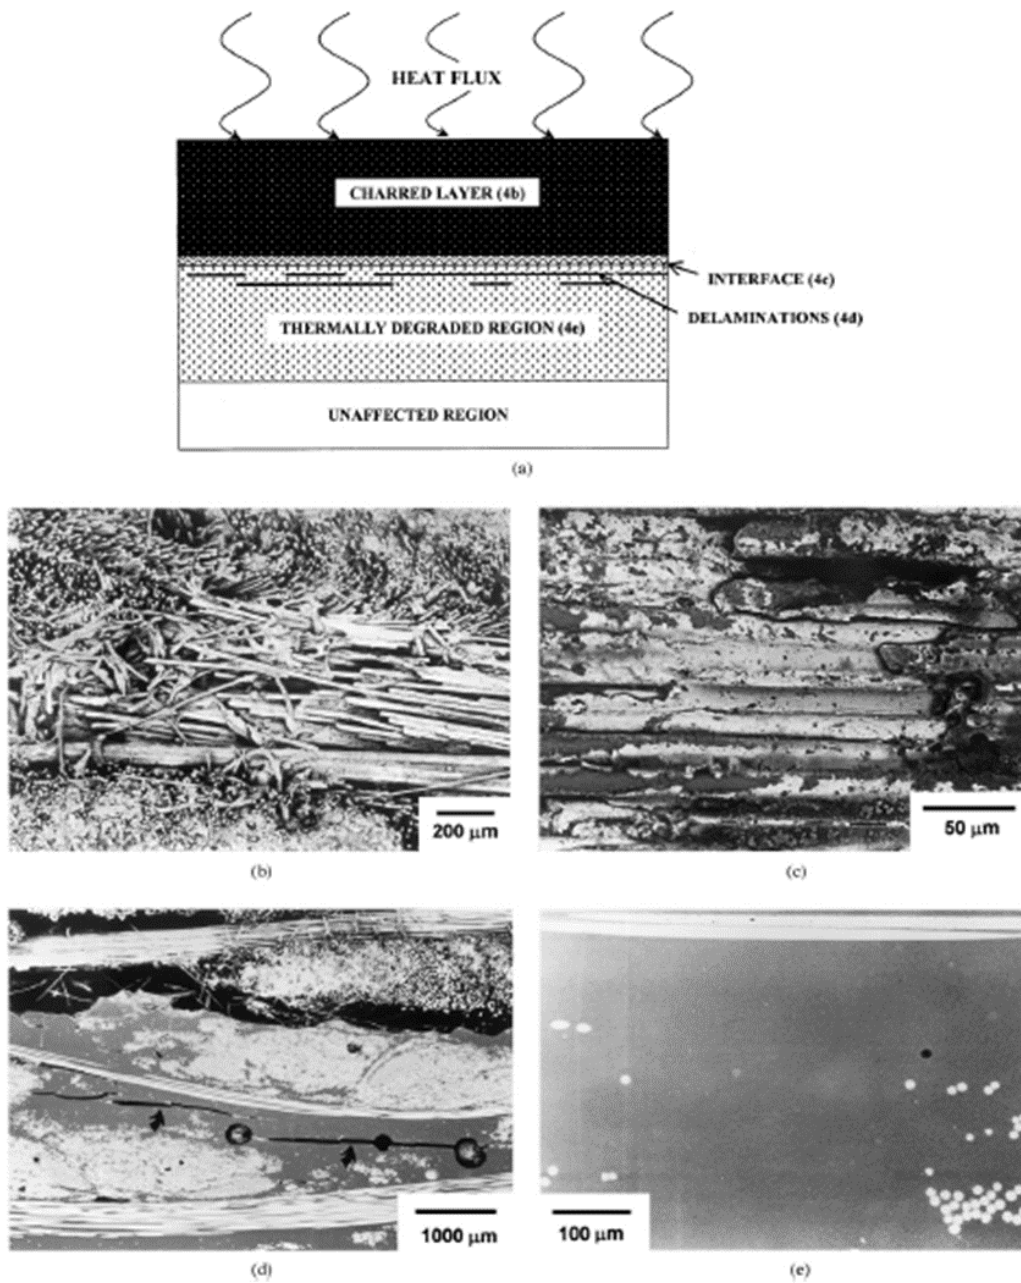
In general, composite fire damage involves extensive matrix thermal decomposition, soot deposition, char formation, severe fire-induced delamination, matrix cracking, residual thickness increases, and fiber-matrix debonding (Mouritz, et al., 2009). Scanning electron microscopy (SEM) images of the fire damage induced in an E-glass woven roving fabric and an isophthalic polyester composite are presented in Figure 3 (Mouritz & Mathys, 2001). Figure 3(a) shows a through-thickness schematic of the fire damage in the specimen. Figure 3(a) through 3(e) show representative SEM images of the char layer, an interfacial region (combustion front) between the char layer and unburned composite, delamination cracks, and a matrix-rich region in the unburned part of the composite, respectively. The char region primarily comprised burned fibers since the matrix was mostly decomposed. In the combustion front shown in Figure 3(c), many fibers displayed longitudinal cracking and were generally detached from the matrix.

Delamination occurred between the underlying unburned layers. The delamination was assumed to be due to the significant difference in thermal conductivities (and coefficients of thermal expansion) between the char and underlying composite layers. Finally, the unburned region of the composite was thermally degraded and contained some matrix-rich pockets (Mouritz & Mathys, 2001). This research sought to identify appropriate char removal procedures that enhance the analysis of the specimen damage assessment.

Figure 3. Comparison of (a) fire-damaged region (b) char layer (c) area between char layer and unburned composite (d) delamination cracks (e) unburned composite resin-rich area.

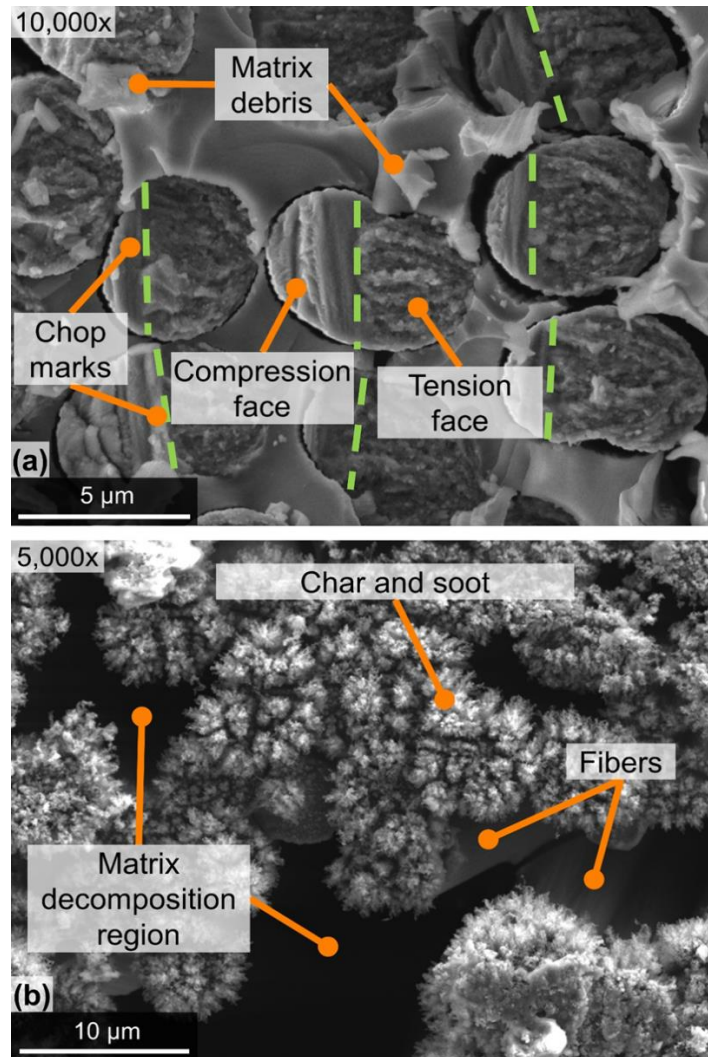
Figure 4. Comparison of 21-ply cross-ply Cytec specimen failed in compression after vertical burning

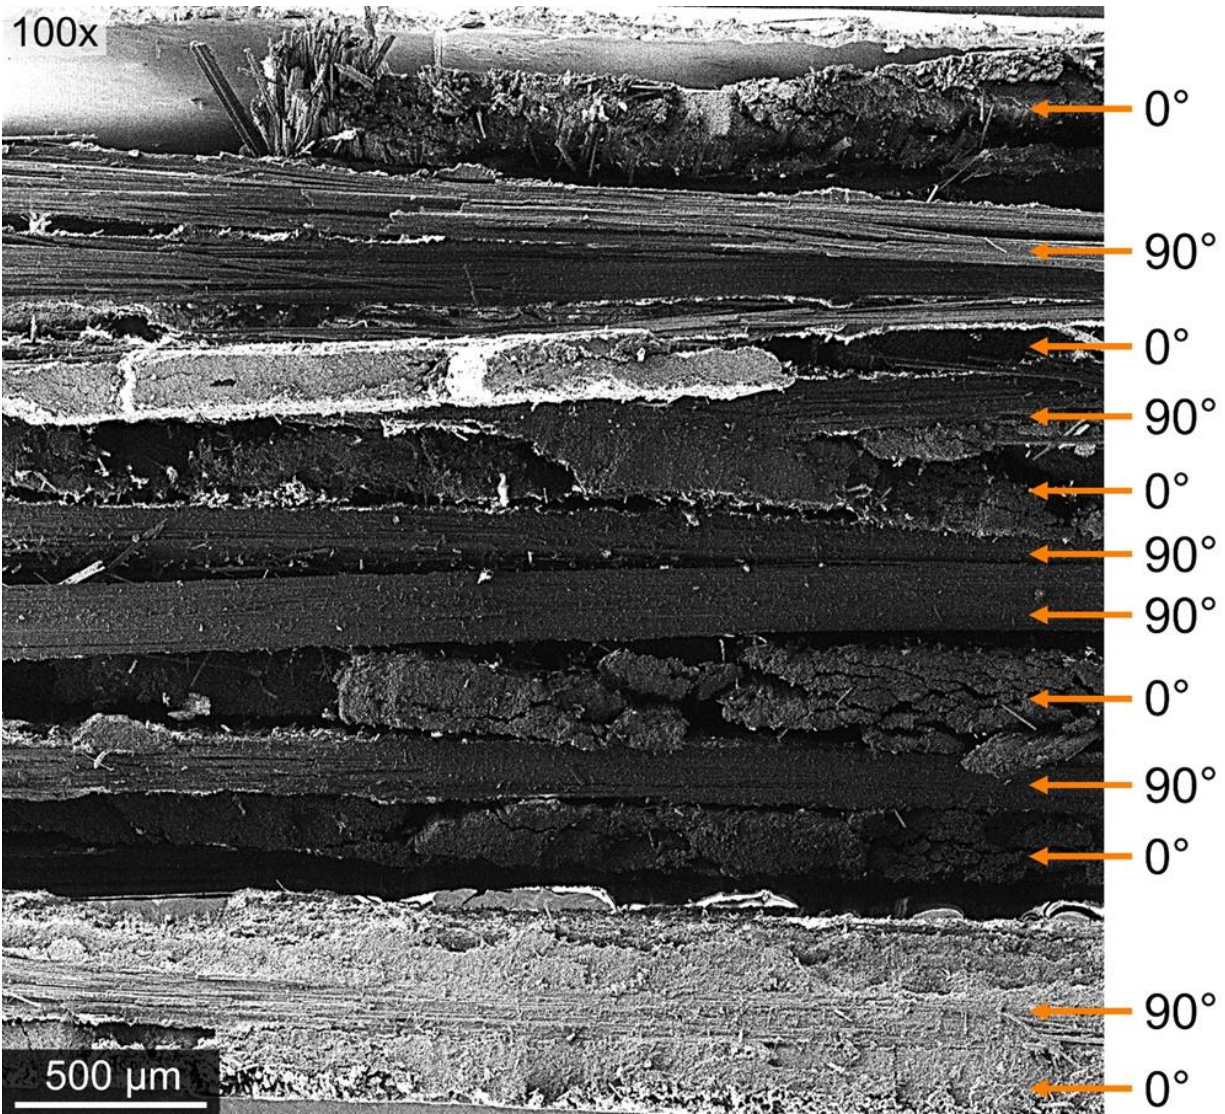
In contrast, tensile failure of the 90° -plies tended to result in relatively flat fracture surfaces parallel to the fiber directions. For UNT0 cross-ply specimens, the 90° -plies do not contribute significantly to the load-carrying capability of the composite and become susceptible to transverse cracking before laminate failure. As the axial load is monotonically increased, the 0° -plies carry most of the applied load, whereas the 90° -plies progressively fail due to transverse matrix cracking. This process will typically continue until a saturation density of transverse cracks occurs, followed by the onset of delamination between 0° - and 90° -plies (or ply splitting), subsequent fiber fractures in 0° -plies, and ultimate composite failure. Figure 8 shows a $2500\times$ magnification SEM image of a UNT0 specimen fracture surface. Tensile fractures of 0° -fibers are visible, with evidence of 0° -fiber pull-outs and ply splitting.

Figure 7. Low magnification SEM micrograph of graphite/epoxy UNT0 specimen fracture surface

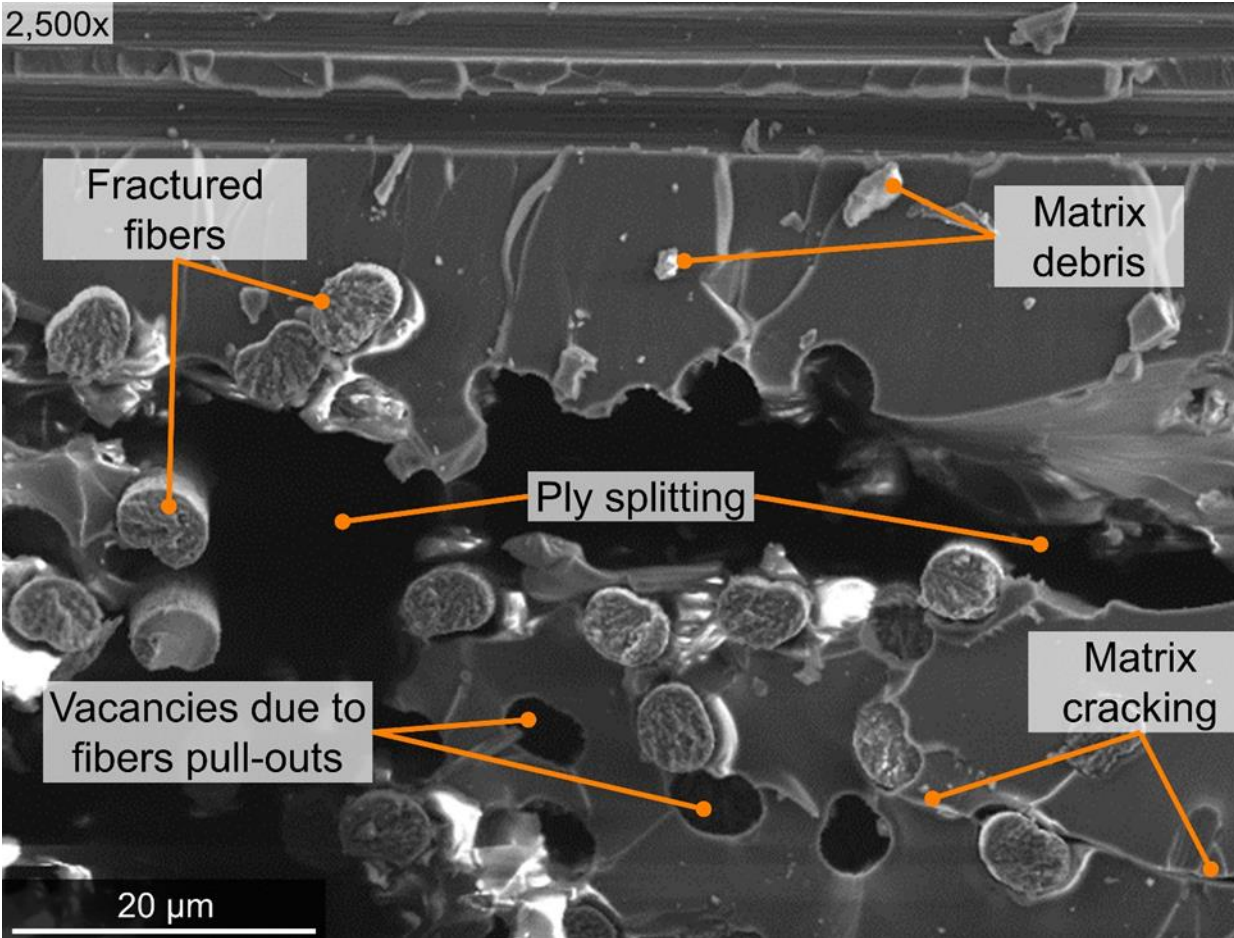
Figure 8. SEM micrograph of a graphite/epoxy UNT0 specimen showing tensile failure features

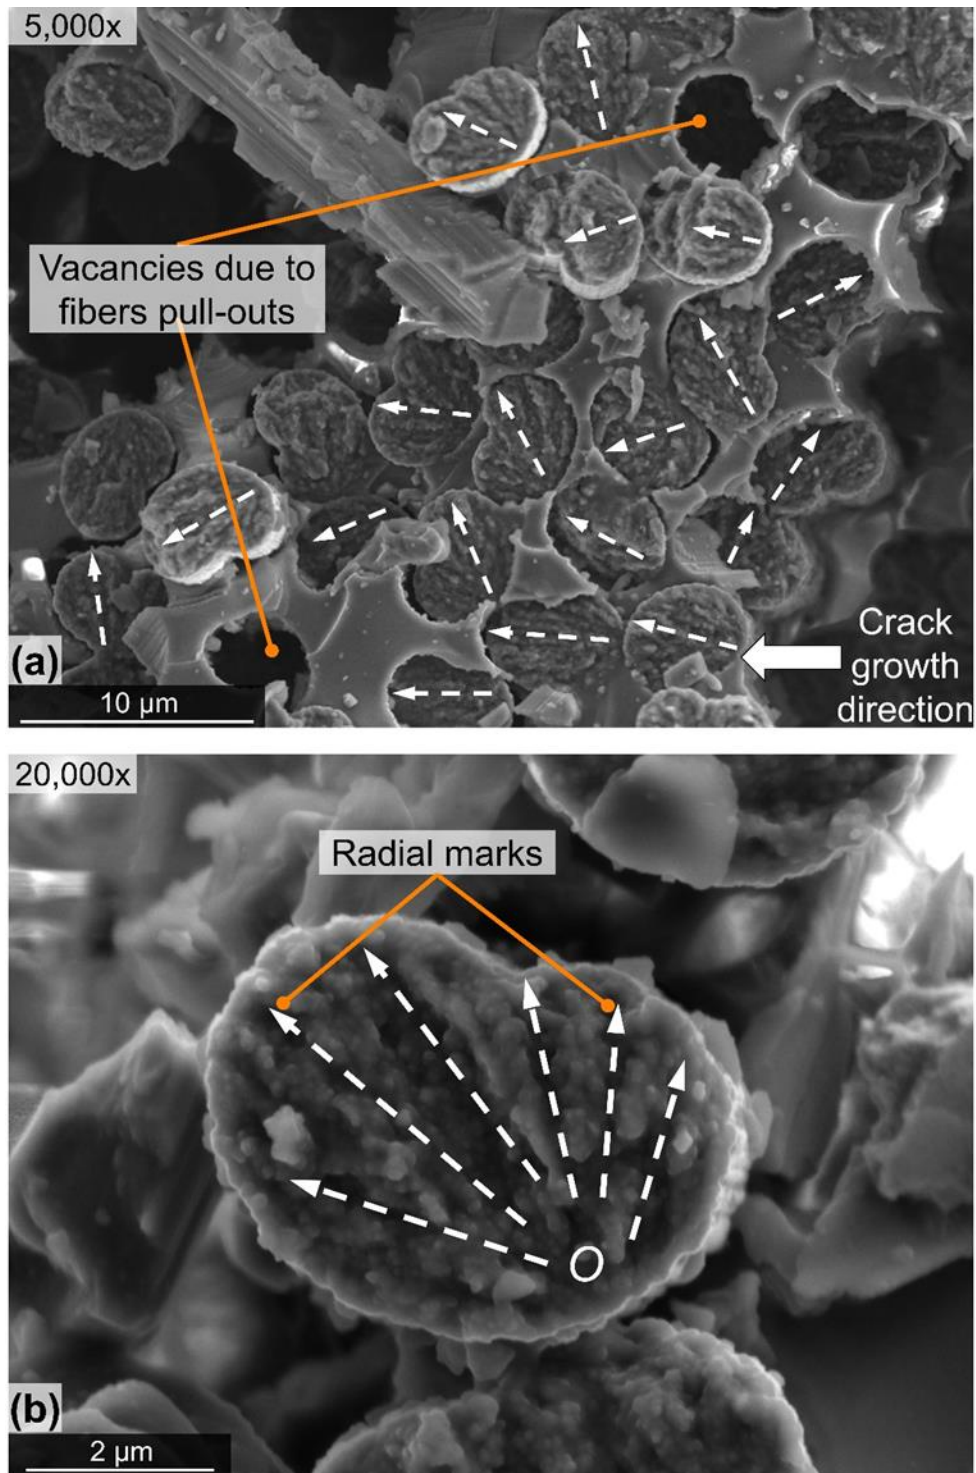
Tensile cleavage failure of individual 0° -fibers generally involves crack initiation at a local defect along the fiber outer circumferential surface, followed by brittle crack propagation across the fiber's diameter. Such fibers will tend to fail in local clusters about a common fracture plane. For example, Figure 9 shows typical fracture surfaces from a 0° -ply in a UNT0 graphite/epoxy specimen. The white arrows shown in Figure 9a indicate the crack propagation directions for a family of fractured graphite fibers. Figure 9(b) shows a magnified view ($20,000\times$) of an individual broken graphite filament. The tensile fracture surface is characterized by a rough appearance with radial lines emanating from the crack initiation site (o) and oriented along the local crack growth path, as suggested by the white arrows shown in Figure 9(b). Such radial marks are typical of tensile graphite or carbon fiber failures in laminated continuous fiber composites (Kar, 1992).

Figure 9. SEM micrographs of a graphite/epoxy UNT0 specimen tensile failure with (a) fibers pull-outs and (b) radial marks

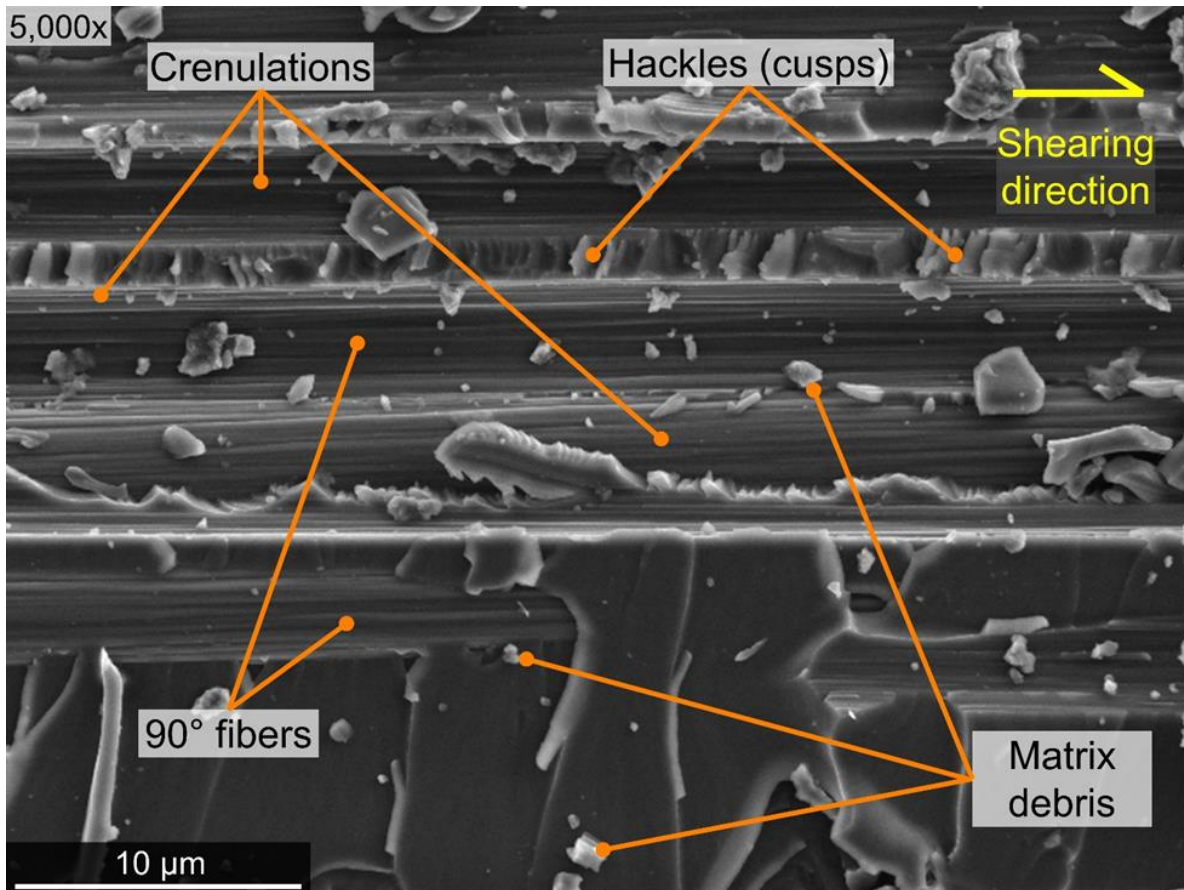
Similarly, Figure 10 shows a micrograph of a failed 90°-ply in a UNT0 specimen. Such failure surfaces typically contain transverse cracking, troughs where individual 90° fibers have been pulled away from the underlying matrix, along with shear-induced ‘hackles’ where the matrix has failed in-between the fibers (Gilchrist & Svensson, 1995). The individual hackles (cusps) have a flake-like appearance. Groups of hackles can overlap in a shingle-like fashion in a direction parallel to the fibers (Liechti, Masters, Ulman, & Lehman, 1982). The direction of overlaps is indicative of the local shearing deformation in the matrix during failure. Hackles form on both fracture surfaces and have a consistent tilt inclination direction on each surface. For example, the yellow half-arrow shown in Figure 10 defines the hackles’ tilt orientation on one fracture surface, which indicates the relative local shearing direction. The local shearing direction on the mating fracture surface would have the opposite sense to the one shown in the figure. The cusps can be used to identify the crack propagation direction in the laminate. The presence of shear-hackles in failed UNT0 specimens is generally less pronounced than for IPS or SBS specimens.

Crenulations can be observed along the 90° fiber circumferential topology in Figure 10. The T40-800 graphite fibers were produced from polyacrylonitrile (PAN) precursors. Such fibers exhibit irregular non-circular bean-like cross-sectional shapes (cf., Figure 9(b)) with narrow parallel grooves (crenulations) along the length of the fibers. These crenulations result from the PAN solution out-diffusion during the wet spinning process of the fibers.

Figure 10. SEM micrograph of shear-hackles in 90°-plies of a UNT0 specimen

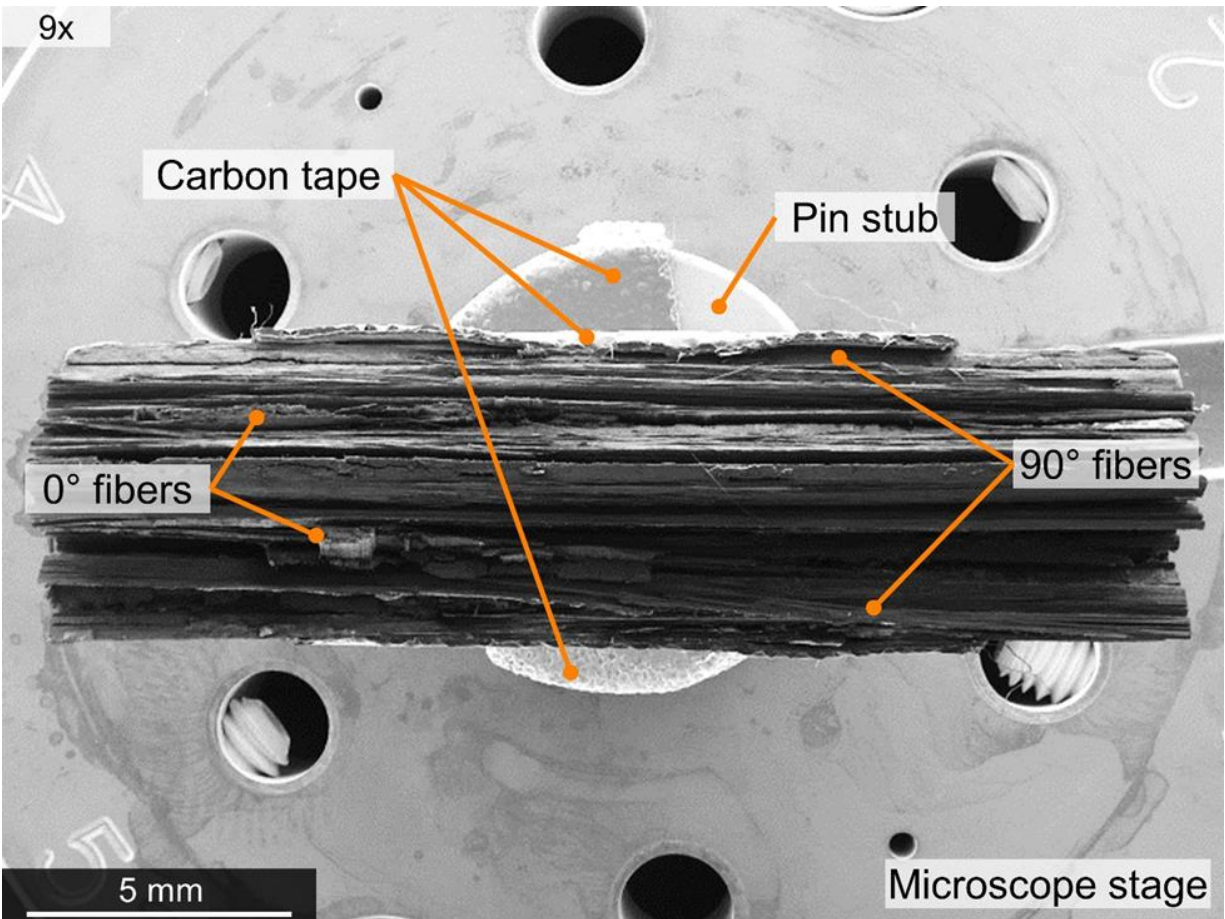
Figure 11. Micrograph of representative graphite/epoxy UNCO specimen fracture surface

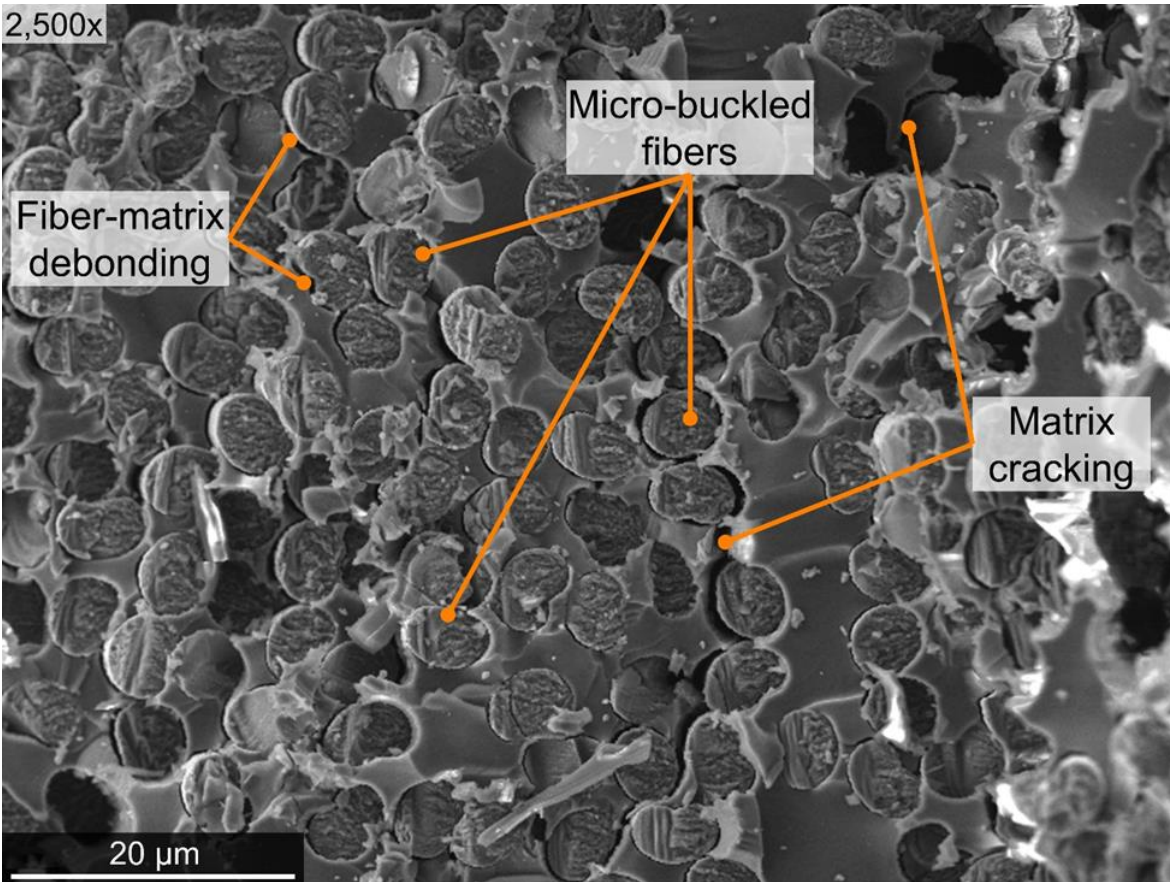
ASTM standard D6641 compression testing was carried out at NIAR on cross-ply [90/0/90]₇ T40-800/5215 graphite/epoxy UNC0 specimens at ambient conditions (Clarkson, 2012; Man, Ng, Tomblin, & Hooper, 2012). In this work, scanning electron microscopy was performed on UNC0 half-specimens to identify compressive failure features. The purpose of these fractographic assessments was to compare the fracture surface morphologies of UNC0 specimens before/after fire testing and after char removal to validate the fire forensic analyses. Figure 11 shows a low magnification (9×) wide field of view SEM image of a representative UNC0 specimen fracture surface. As previously discussed, the tensile fracture surface in a UNT0 specimen is characterized by a rough appearance because of protruding broken fibers as shown in Figure 7. In contrast, a compressive fracture surface in a UNC0 specimen is smooth and slightly angled to the loading direction due to the induced in-plane shear, as shown in Figure 12.

Figure 12. SEM micrograph of a typical compressive fracture surface in a graphite/epoxy UNC0 specimen

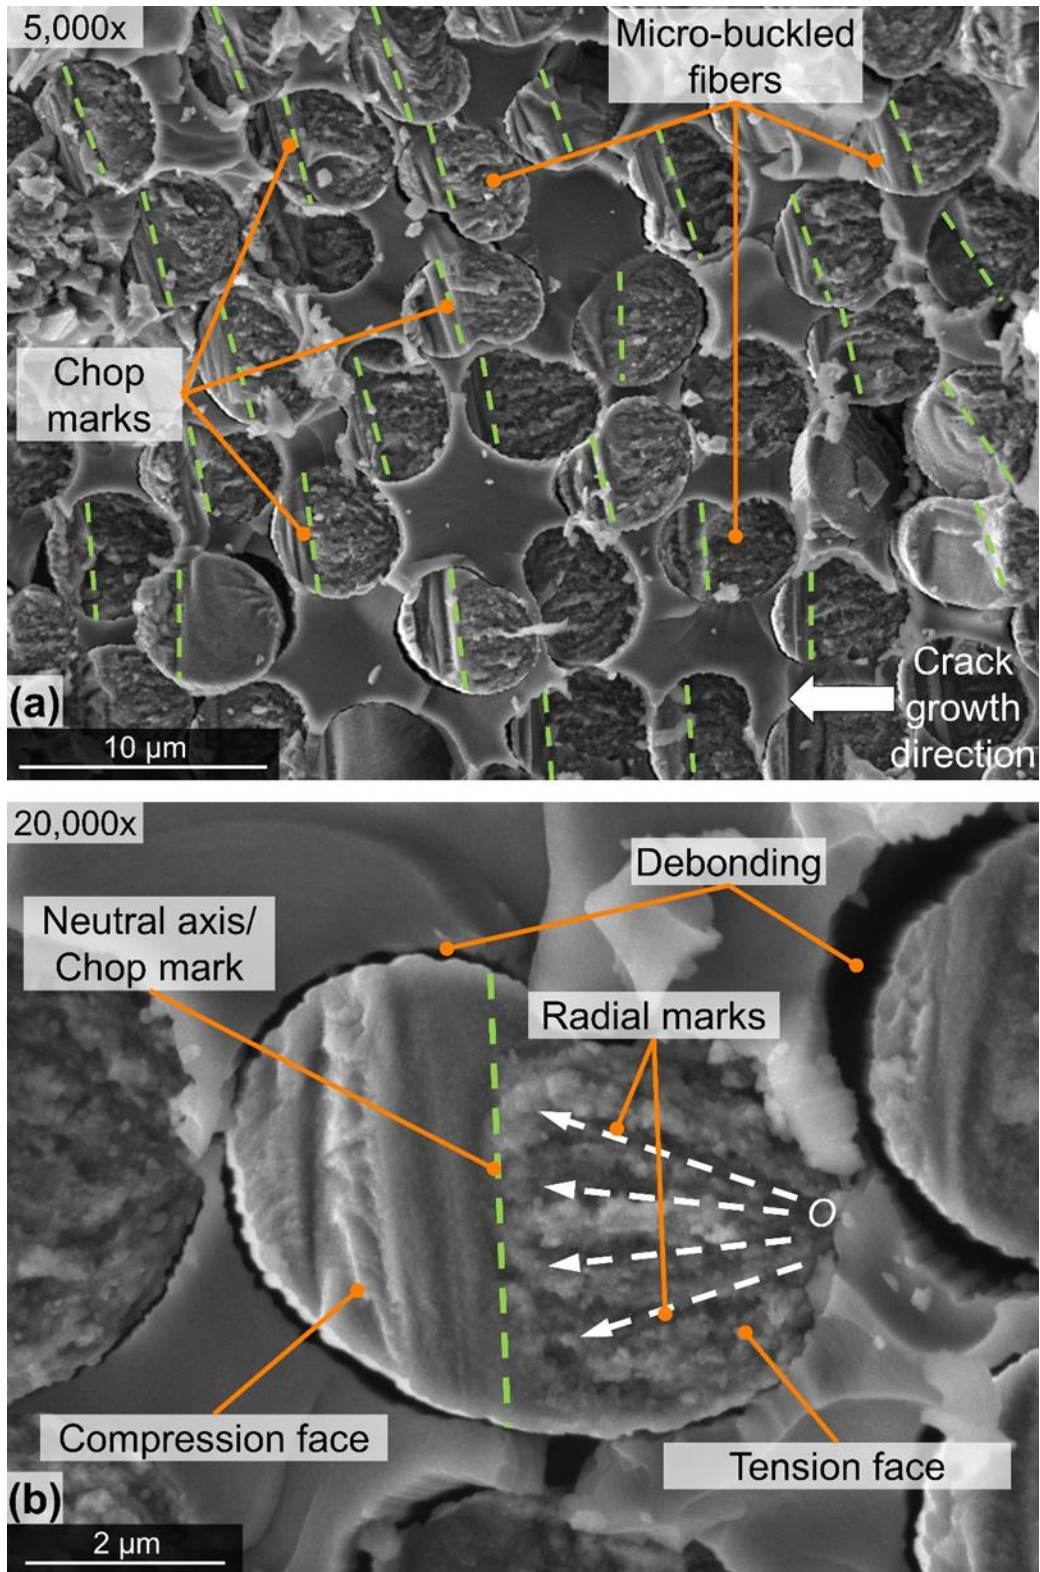
SEM imaging of a UNC0 specimen fracture surface showed evidence of fiber micro-buckling characterized by chop mark formation on individual filament ends, as indicated by the dashed green lines in Figure 13(a). These chop marks demarcate a transition from the tensile face (rough appearance with radial marks) to compressive face (smooth surface with parallel longitudinal splits) on the fiber fracture surfaces. A high magnification ($20,000\times$) micrograph (Figure 13(b)) of an individual graphite filament suggests that the chop mark coincides with the neutral axis, where individual fibers experience combined tension and compression failures as they undergo local bending/buckling. These chop marks can be used to identify the laminate crack growth direction, as indicated by the white arrow shown in Figure 13(a).

Figure 13. SEM micrographs of graphite/epoxy UNC0 showing (a) chop marks (b) individual fractured filament end

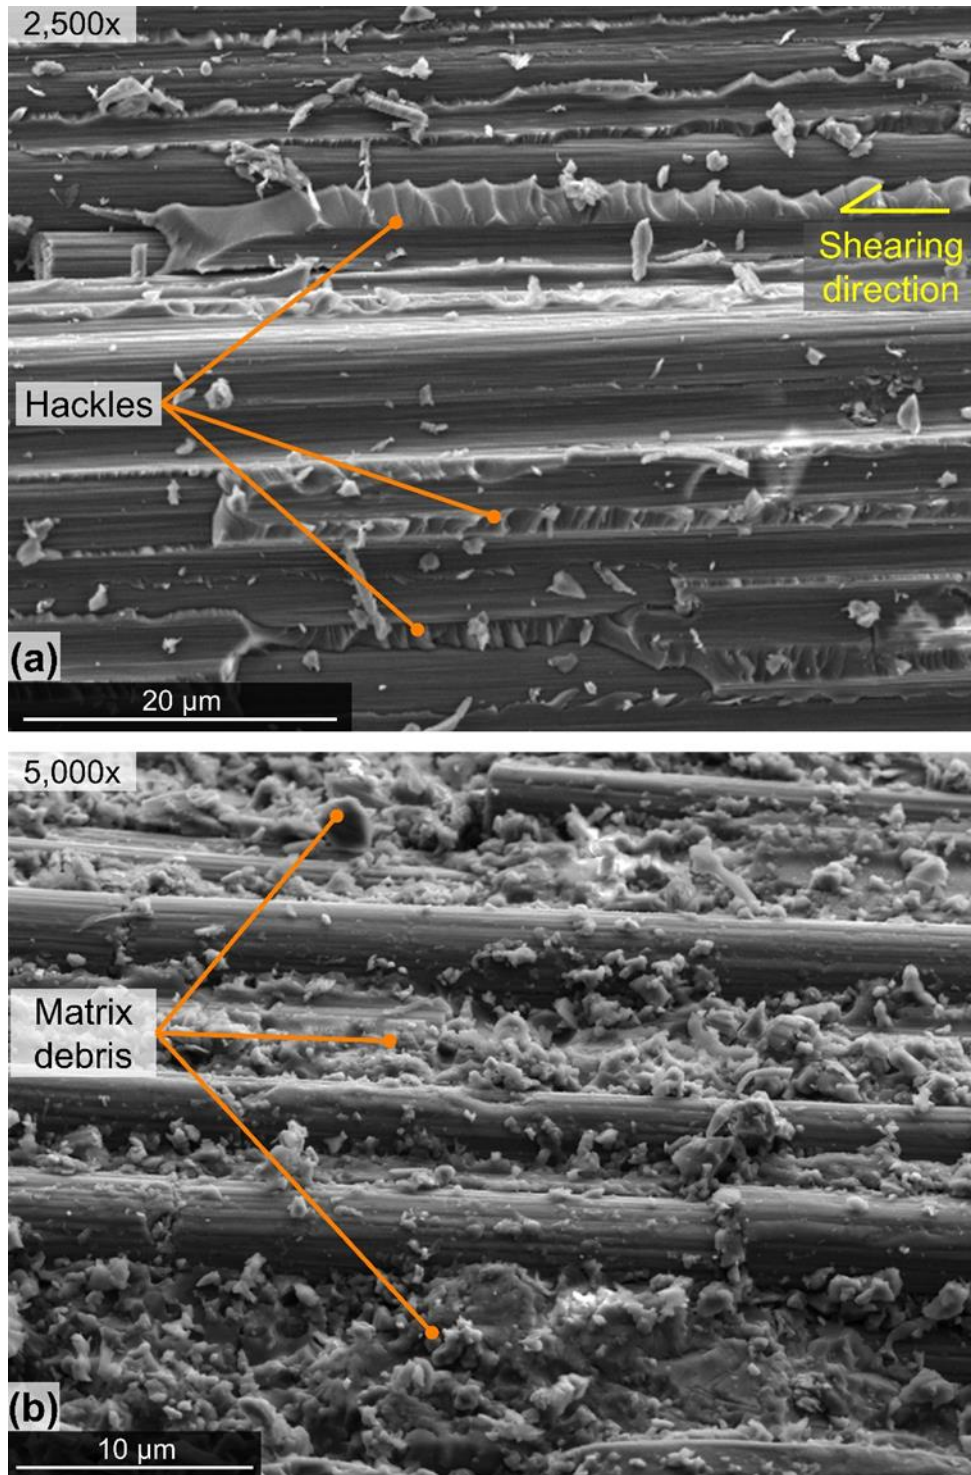
Further examination of fractured 90°-plies in UNC0 specimen shows rows of overlapping hackles that form parallel to the fibers as shown in Figure 14(a); the direction of overlap opposes the local shearing direction. Hackles indicate the existence of locally induced shearing deformation during failure of specimens subjected to macroscale compression. Unlike the tensile fracture of UNT0 specimens, compressive failure of UNC0 specimens generated an extensive amount of matrix debris, as shown in Figure 14(b), resulting from relative sliding of the mating surfaces due to compression-induced shear. Such pulverized matrix fragments can partially obscure chop marks, cusps, microcracking, fiber-matrix debonding, and other compressive damage. As will be discussed in the following sections, this debris can decompose when subjected to fire, forming a thick gooey layer over the entire fracture surface, inhibiting forensic fractography.

Figure 14. SEM micrographs of 90°-plies in graphite/epoxy UNC0 specimen with (a) shear-hackles and (b) compressive failure matrix debris

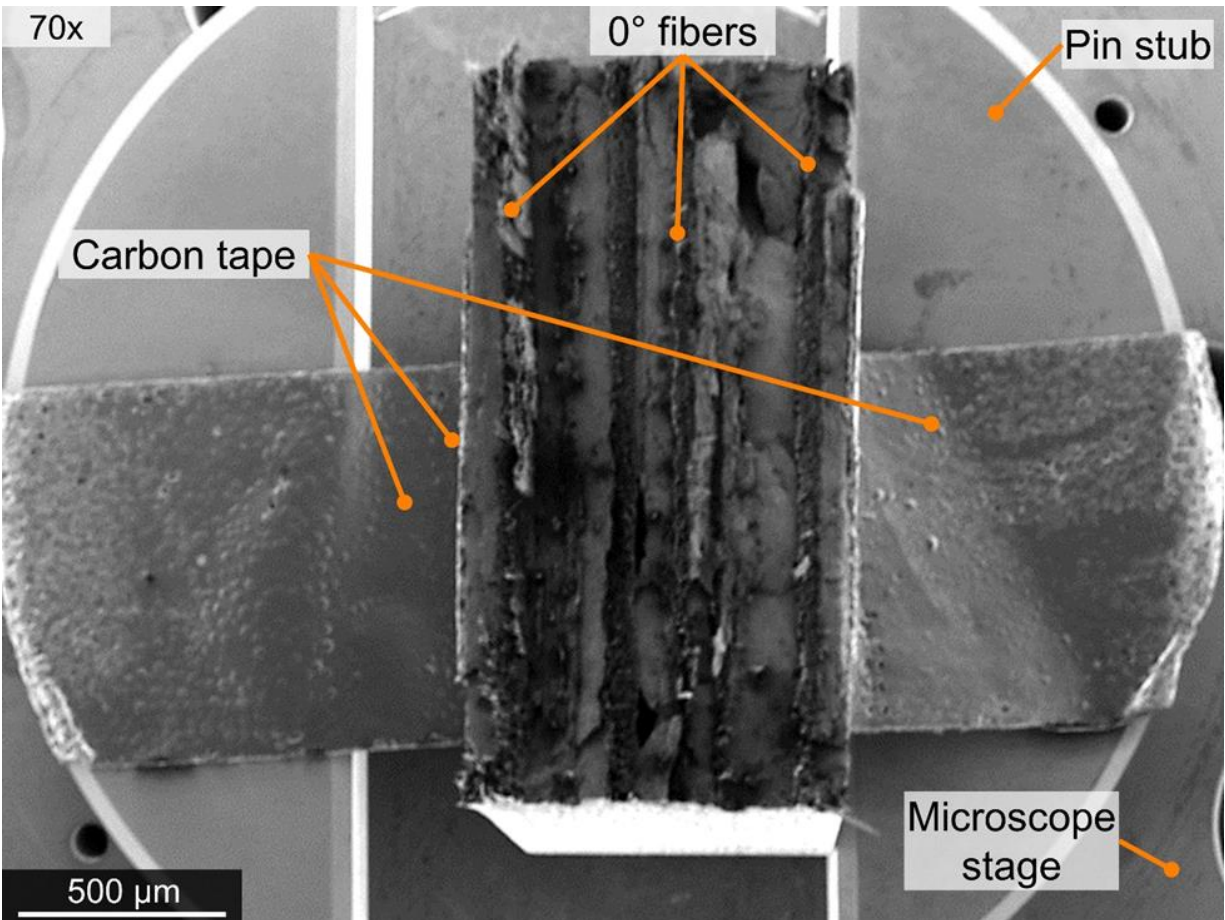
Figure 15. Low magnification (70×) SEM micrograph of representative graphite/epoxy SBS specimen fracture surface

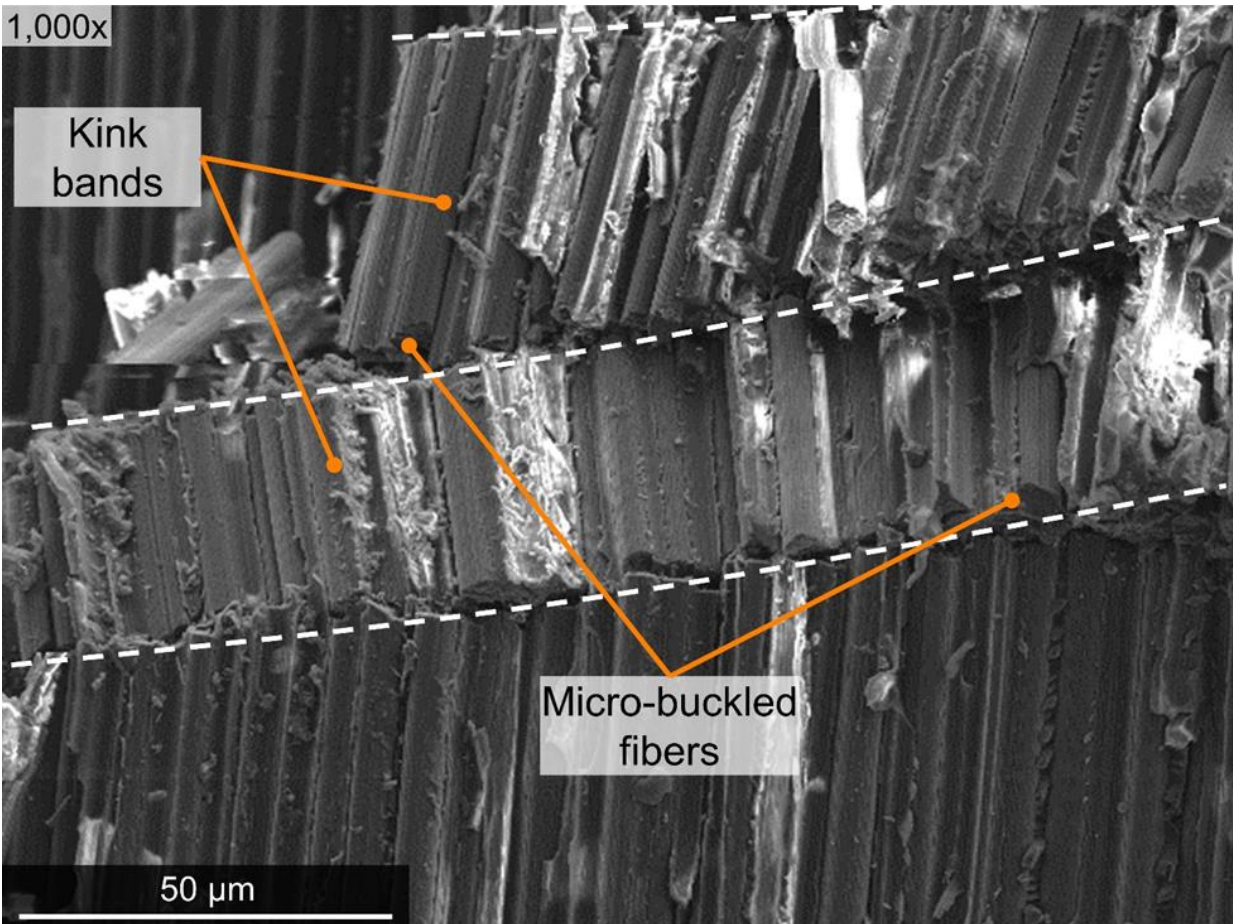
SEM imaging was used to assess damage in SBS specimens along the outer ply (in-plane) surfaces, as well as through-the-thickness along the fracture surface. For example, Figure 16 shows an SEM micrograph of the outermost ply in an SBS specimen that experienced translaminar compression. Compressive kink bands were visible; the dashed white lines demarcate the kink band boundaries. Kink bands form due to local compressive instabilities involving a combination of compressive matrix failure, local fiber micro-buckling, and fiber fracture. Once an individual filament and surrounding matrix fail, local load shedding occurs that can cause adjacent fibers to fail in roughly the same plane, leading to kink band formation (Greenhalgh, 2009). The kink band thickness typically is on the order of the fiber micro-buckling wavelength, roughly 5-10 fiber diameters. Kink bands can form in multiple adjacent parallel planes in the composite laminate, giving rise to a series of step-like terraces of micro-buckled fibers, as shown in Figure 17. In addition to large-scale matrix cracking and fiber ruptures in the kink band planes, matrix cracks can also form parallel to the fibers, resulting in the longitudinal splitting of the terraces as shown in Figure 17(b).

Figure 16. SEM micrograph of outermost ply surface of graphite/epoxy SBS specimen showing kink bands

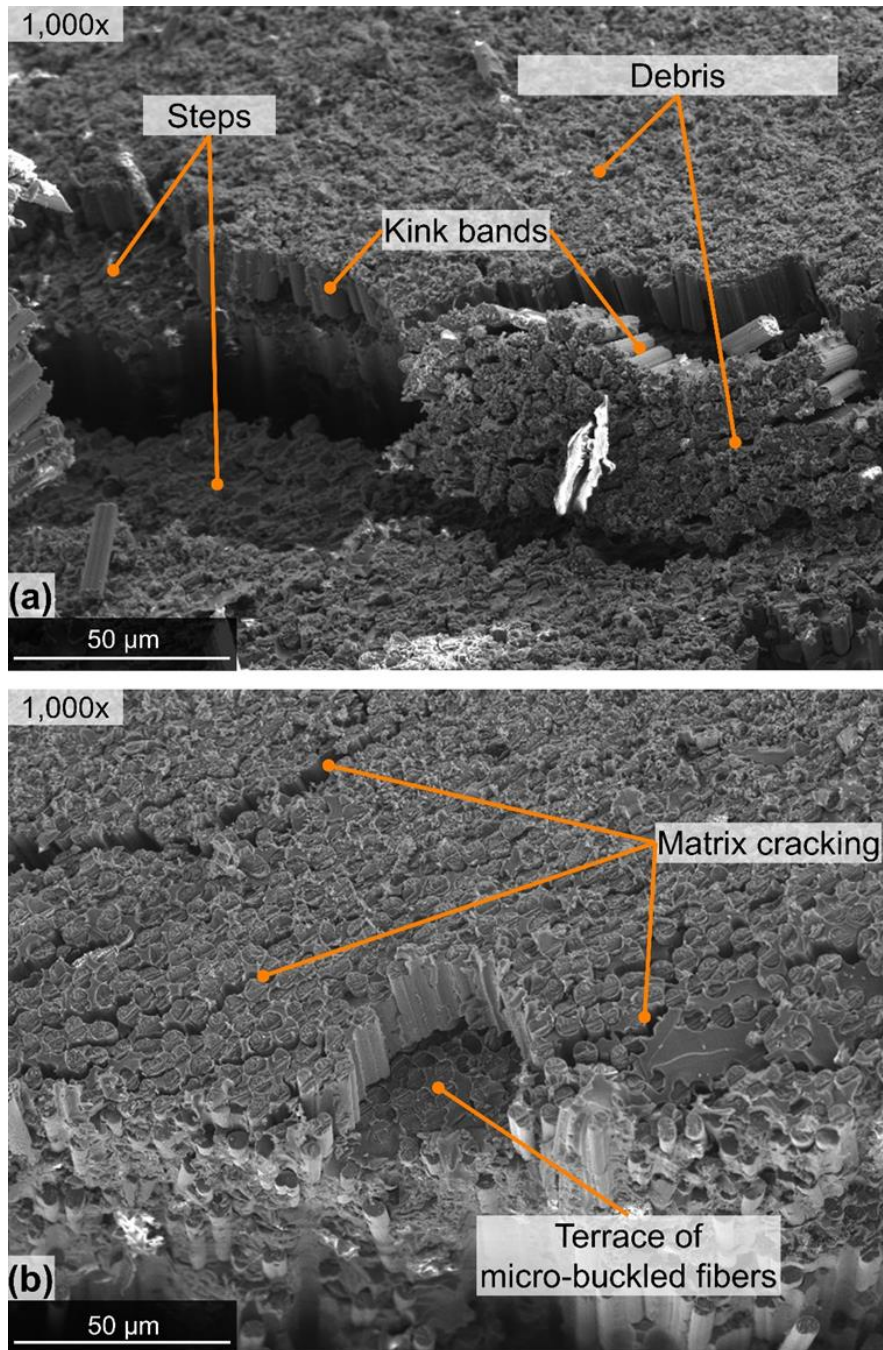
Figure 17. SEM micrographs of graphite/epoxy SBS specimen fracture surface with (a) kink bands (b) terrace of micro-buckled fibers

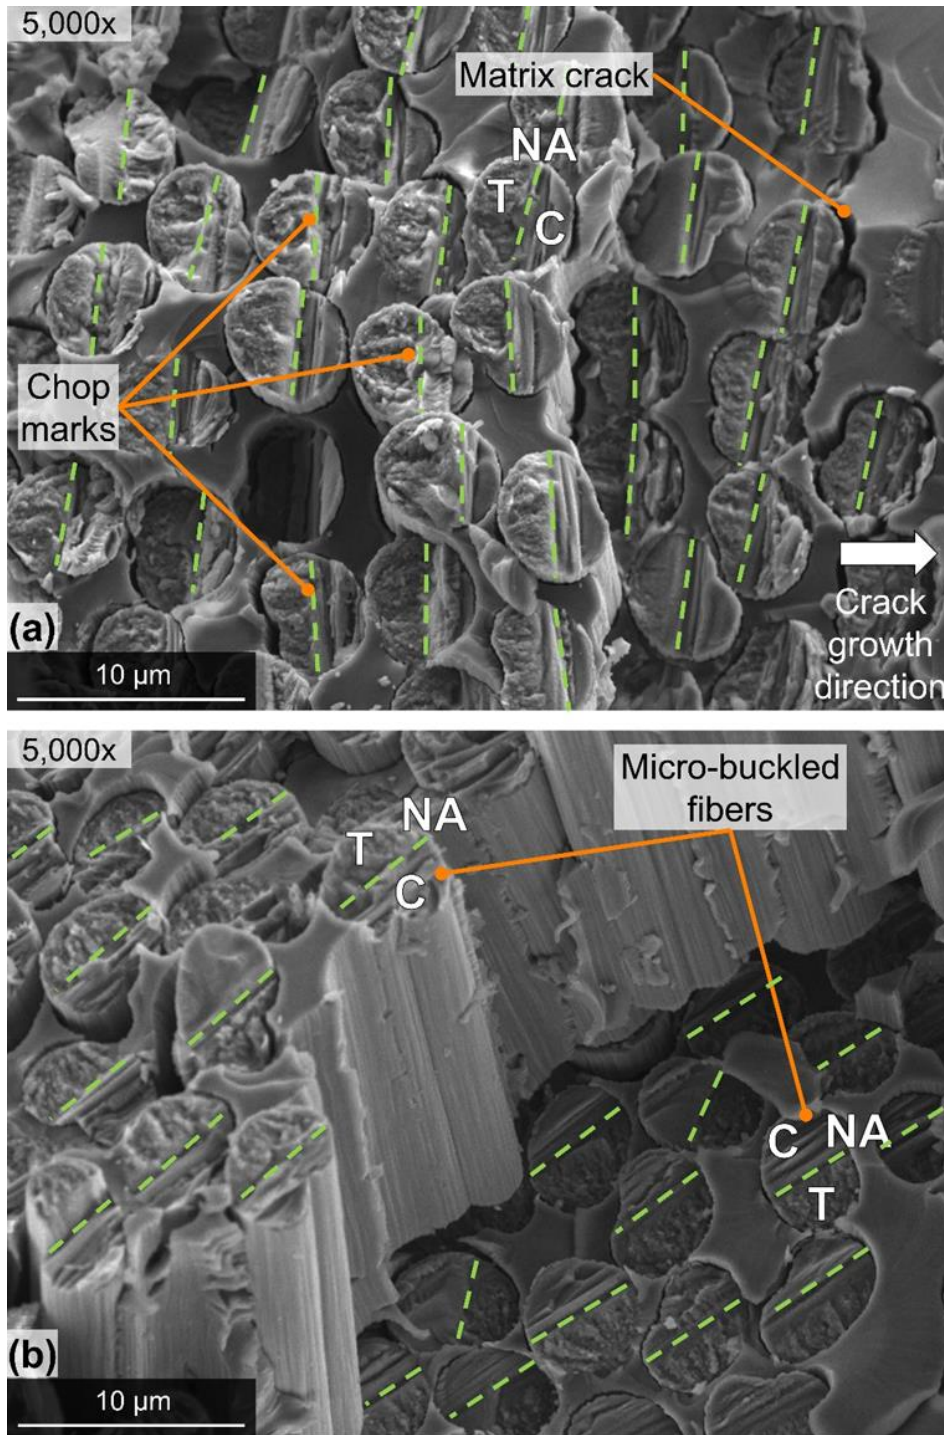
Fractographic inspection of typical SBS specimen terrace structures revealed clear evidence of local compressive stability-related fiber failures (i.e., micro-buckling/fracture). For example, Figure 18 shows SEM micrographs from an SBS specimen failure surface subjected to translaminal compression. In the figure, each broken filament appeared to fail in local flexure, consistent with micro-buckling. Chop marks were visible at each fiber's neutral axis (NA) that demarcated the transition from tensile to compressive failure, labelled (T) and (C) respectively in some figures. These results are consistent with those observed for fractured 0° fibers in UNCO specimens as shown in Figure 13. Since the neutral axes for this set of fibers were roughly parallel, the local crack propagation in the kink plane occurred perpendicular to these axes in a direction proceeding from local fiber tensile failure to local fiber compressive failure as shown in Figure 18(a). Figure 18(b) contains a similar SEM image of an SBS failure surface associated with a terrace of micro-buckled fibers, along with the exposed failure surface of the underlying (adjacent) terrace. While the chop marks defining the orientations of the fiber-neutral-axes for both surfaces are roughly parallel, the relative positions of the tensile and compressive fiber

regions for each terrace surface are opposite. This suggests that the local crack propagation direction in each kink plane is also opposite from one another, which is consistent with significant transverse shearing deformation. This makes sense given that the three-point bend SBS specimens have a relatively low span-to-thickness ratio and are primarily loaded in shear, and to a lesser degree, flexure.

Figure 18. SEM micrographs of graphite/epoxy SBS specimen with (a) chop marks (b) micro-buckled fibers
