DOT/FAA/TC-22/20

Post Small-Flame Forensic Analysis of Aerospace Composites

January 2024

Final report

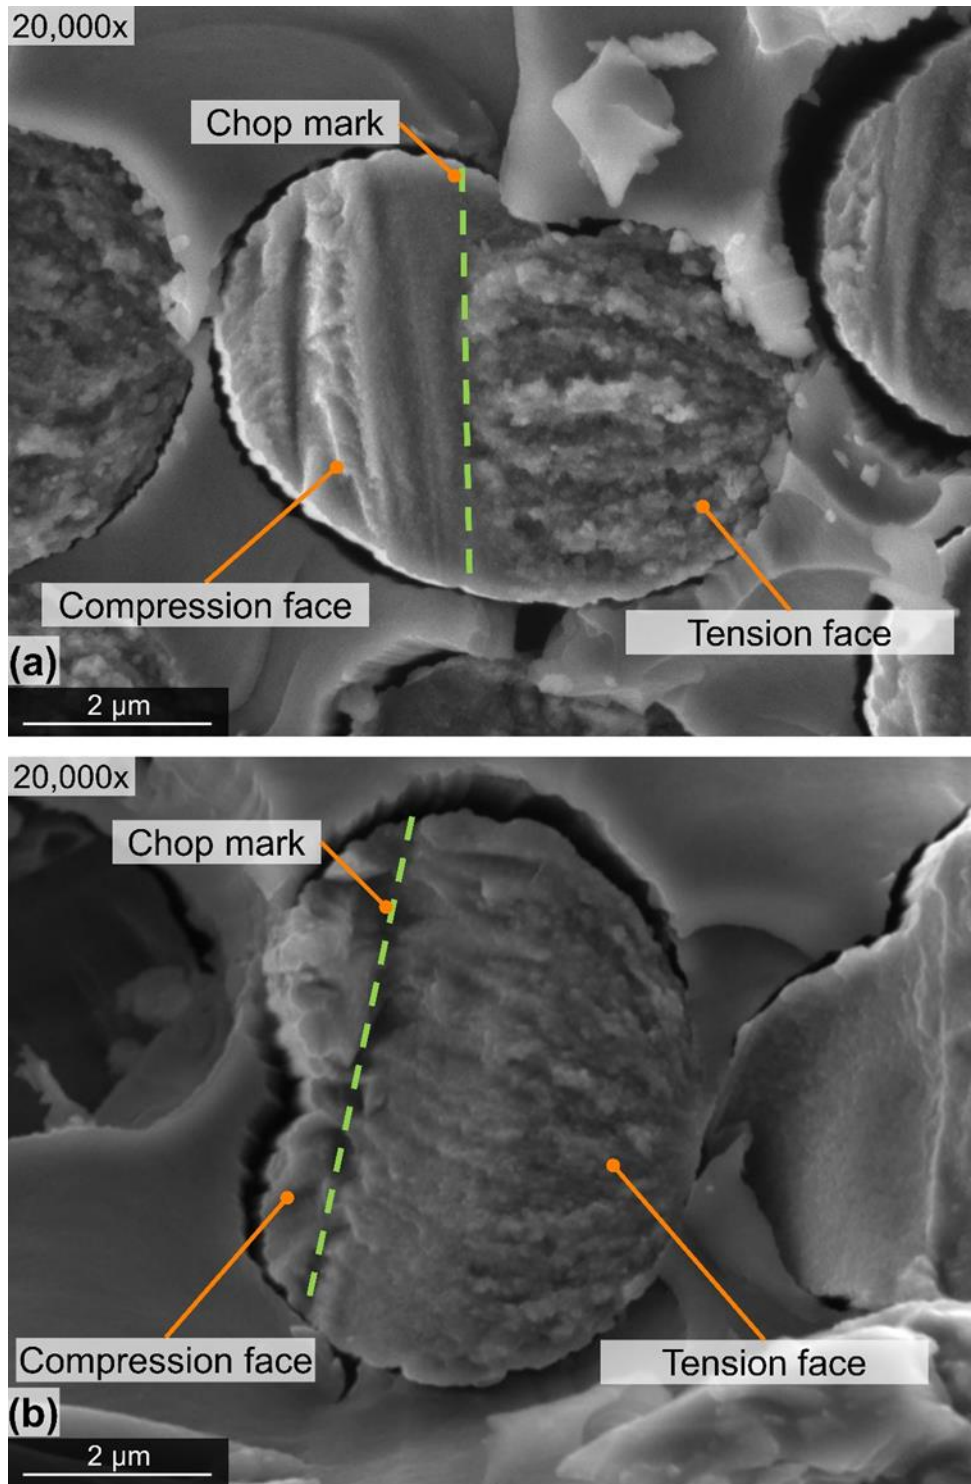
direction than that for tension. In the three-point bending SBS experiments, material points near the laminate upper surface will be loaded in pure compression. Once the compressive strength in the fiber direction is exceeded, a combination of distributed matrix cracking and fiber micro-buckling will occur. As demonstrated previously, fiber micro-buckling failures are readily identifiable by the presence of chop marks that separate the compressive and tensile failure regions on a given filament fracture surface. Figure 19(a) shows a failed graphite fiber located near the upper surface of an SBS specimen where the fiber was subjected to nearly pure compression. The chop mark roughly passes through the fiber centroid, indicating that the fiber failed primarily due to micro-buckling/flexure, as the tensile and compressive faces are approximately the same size. Before the laminate failure, material points located closer to the laminate neutral axis will experience proportionally lower compressive axial stresses and significant transverse shear stresses. This should manifest itself in a smooth appearance of the broken fiber ends. Figure 19(b) shows a failed fiber located near the lower surface of an SBS specimen (i.e., the fiber was subjected to axial tension). The location of the chop mark suggests that the fiber failed primarily in tension.

Figure 19. SEM micrographs of SBS specimen micro-buckled fibers (a) above laminate neutral axis (b) below laminate neutral axis

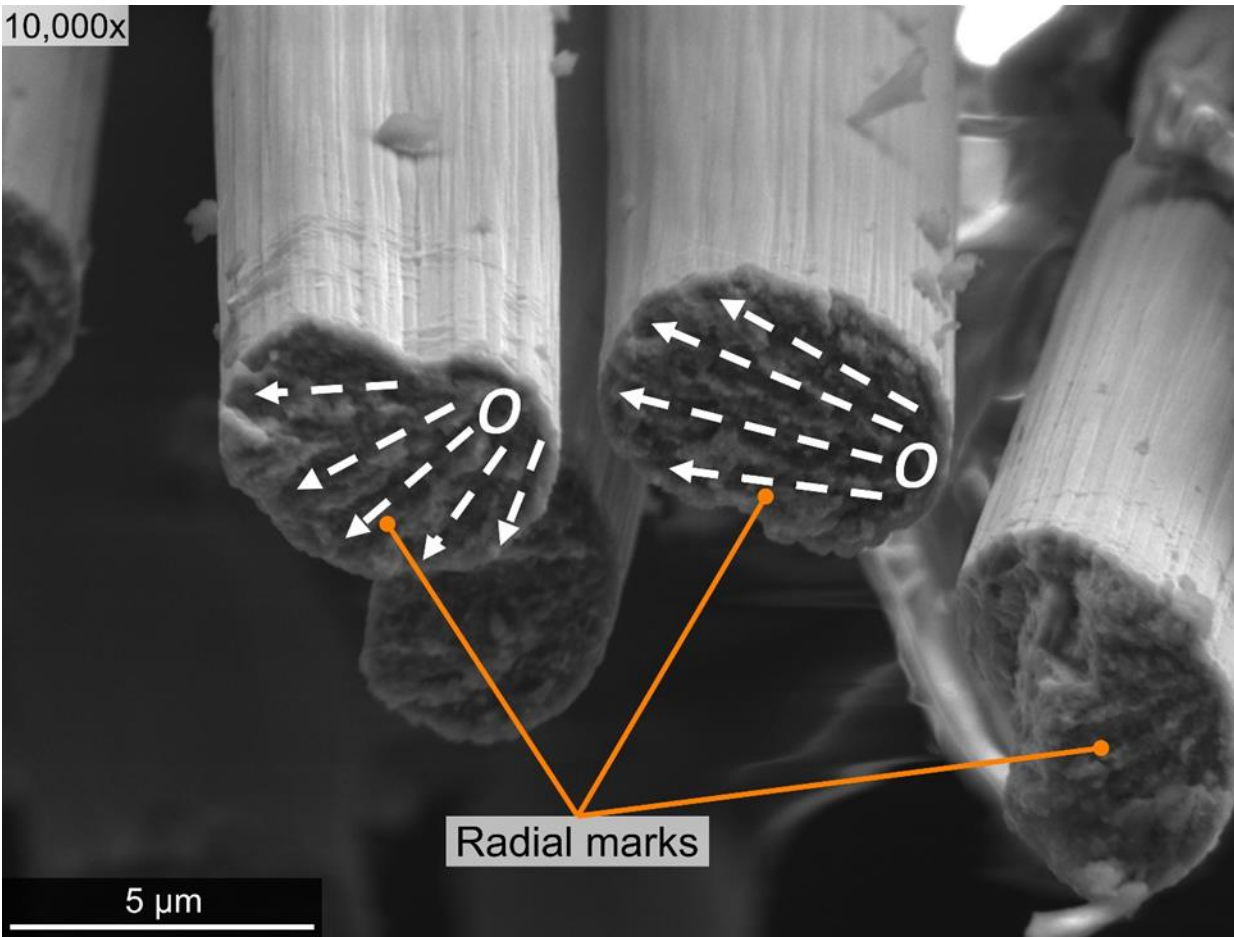
Similarly, Figure 20 shows an SEM image of a cluster of protruding broken fibers located near the bottom of an SBS specimen. Each fiber failure surface included several radial marks emanating from the site of fracture initiation; such features are consistent with those seen in failed UNT0 specimens such as those shown in Figure 9. The relative sizes of the tensile and compressive failure zones for individual filaments indicate the local state of flexural stress at the time of fracture (Greenhalgh, 2009).

Figure 20. SEM micrograph near lower surface of graphite/epoxy SBS specimen showing radial lines on fractured fiber ends

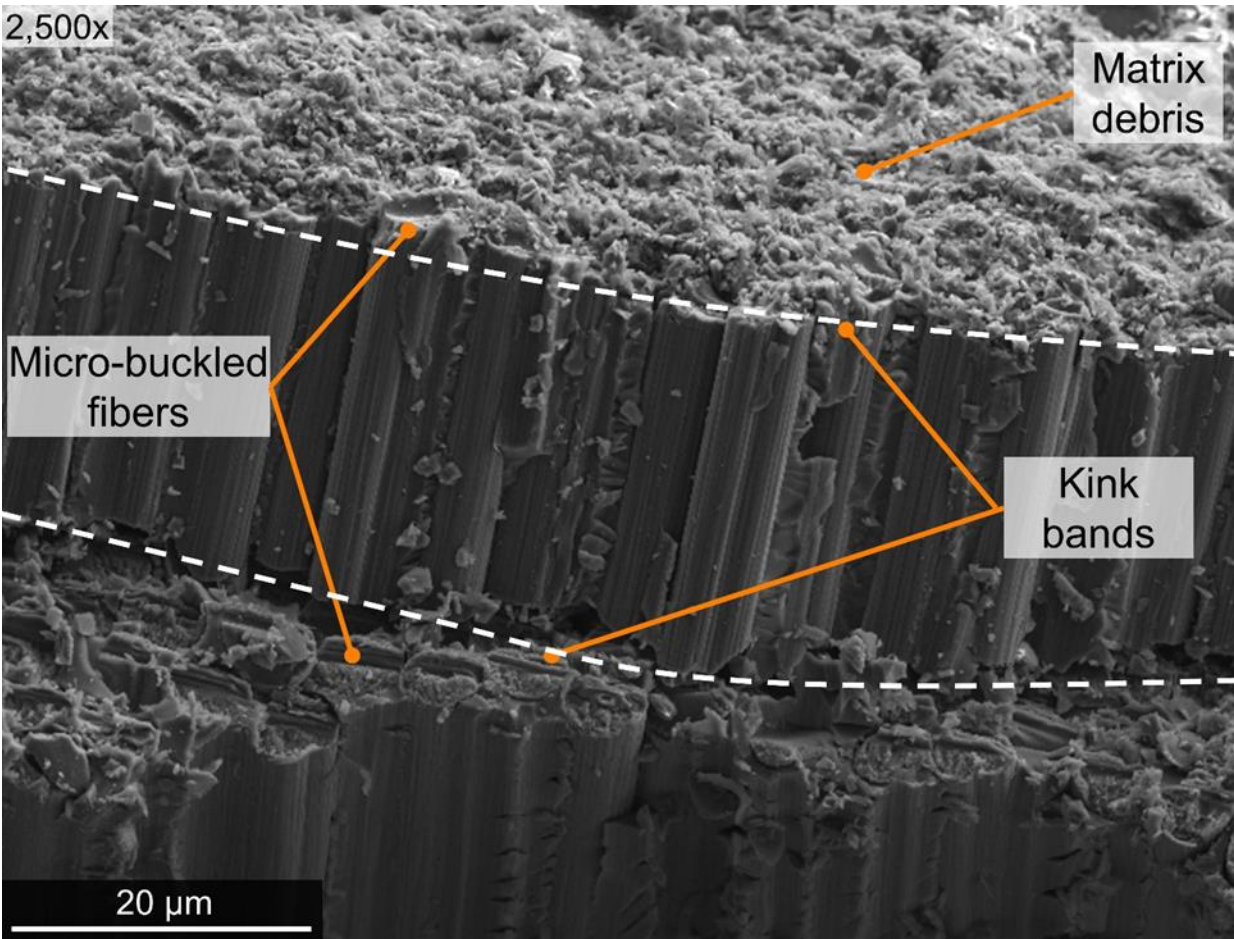
These preceding results for SBS specimens suggest that SEM imaging can be used to assess differences in the local state of stress at failure in laminated graphite/epoxy composites. However, the specifics of failure surface morphology can be obscured by significant amounts of crushed matrix debris and broken fiber segments generated during matrix cracking, fiber micro-buckling, and kink band formation. For example, Figure 21 contains an SEM image of the massive amounts of debris that can accumulate on the surfaces of micro-buckled terrace structures common in failed SBS specimens; these results are similar to those for UNCO specimens shown in Figure 14(b). When exposed to flame, such debris can decompose, pyrolyze, and/or burn. This can result in melt dripping and char deposits on the failure surface that can dramatically impede forensic fractography to identify specific mechanical failure mechanisms.

Figure 21. SEM micrograph of graphite/epoxy SBS specimen fracture surface covered with matrix debris

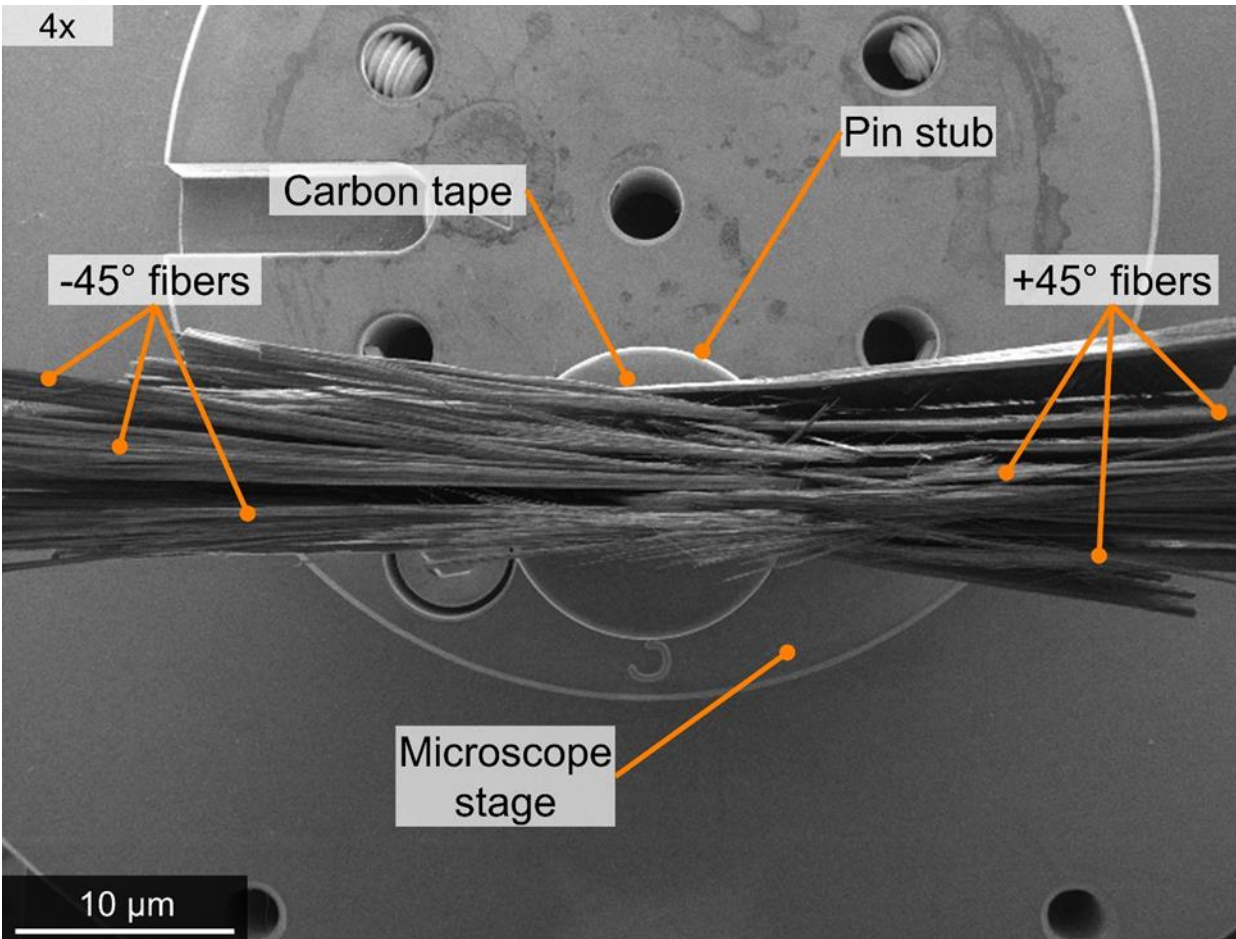
The presence of widespread and diffuse failure surfaces made the fractography of IPS specimens extremely challenging. The IPS specimen failure surfaces were examined using a FERA-3 microscope. Figure 22 shows a low magnification (4×) wide-field-of-view SEM image of a representative failed graphite/epoxy IPS half-specimen that illustrates the extensive nature of the damage in the IPS specimens. In order to assess interlaminar shear failures between $\pm 45^\circ$ plies (i.e., delamination), IPS specimens were placed on top of the microscope stage with the laminate mid-plane oriented orthogonal to the microscope lens. Figure 23 shows a typical SEM micrograph of an IPS specimen interlaminar shear failure surface delamination with fiber imprints, cracking, and local residual deformation in the matrix-rich region between the $\pm 45^\circ$ plies. The IPS delamination surface contained clear evidence of fiber-matrix decohesion, longitudinal splitting between fibers, and intense local shearing deformation in the matrix, as indicated by the presence of hackles/cusps, riverlines, scallops, and crenulation imprints. In addition, a significant amount of debris (crushed matrix fragments and small broken fiber segments) was visible on the delamination surfaces. Forensic assessment of the IPS interlaminar failure surfaces depends heavily on information gleaned from the features contained in the epoxy matrix; such information would be irrevocably lost if these surfaces are exposed to direct flame.

Figure 22. SEM micrograph of representative failed graphite/epoxy IPS specimen

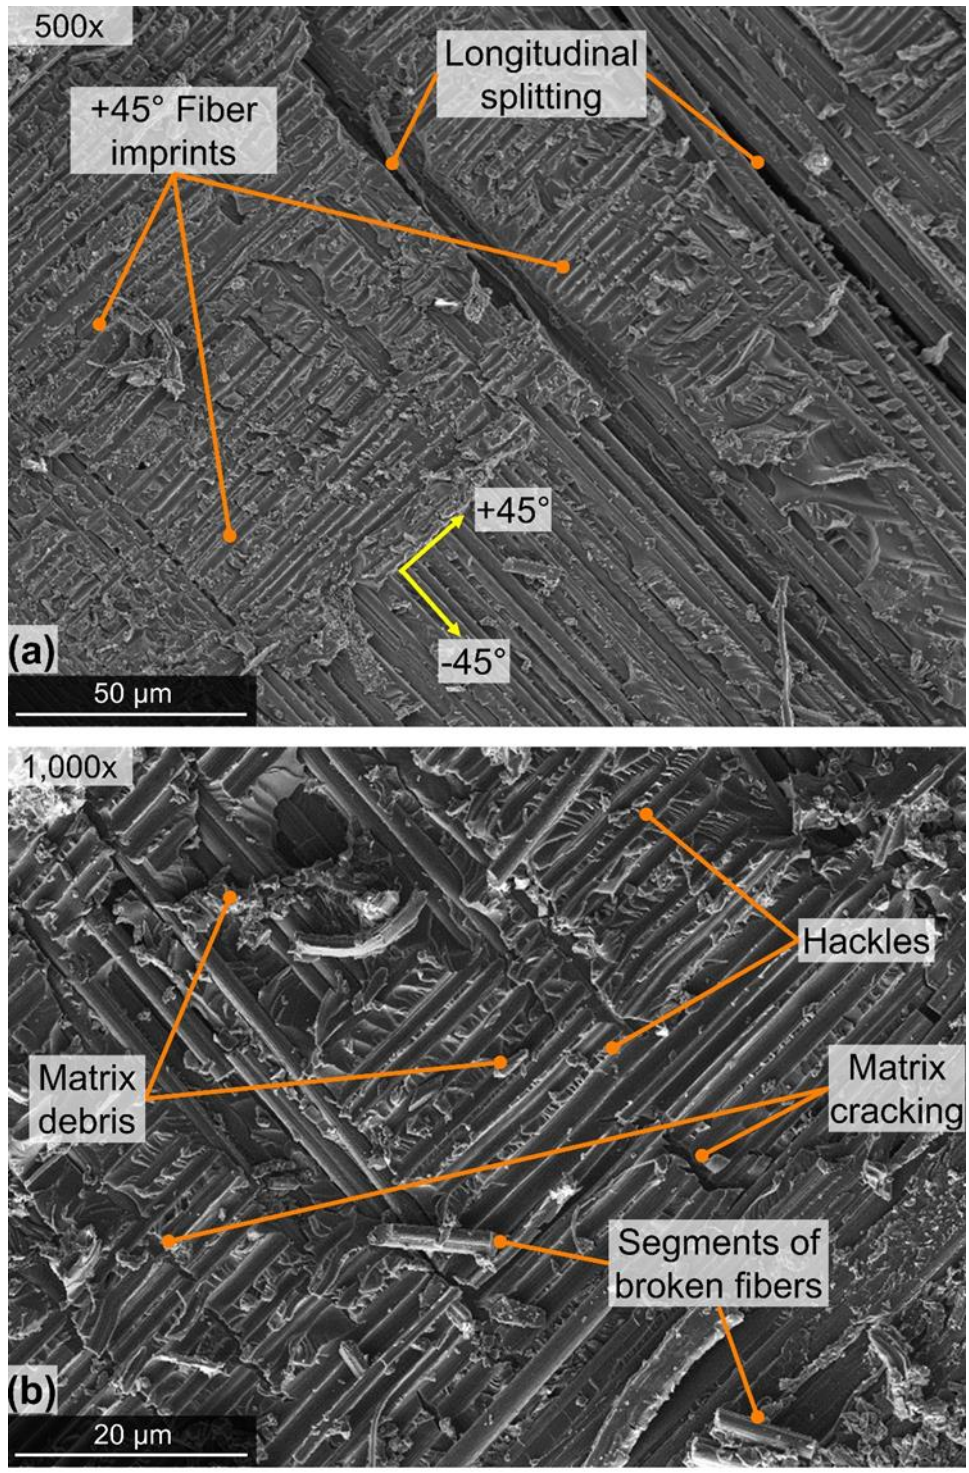
Figure 23. SEM micrographs of IPS specimen in-plane fracture surface

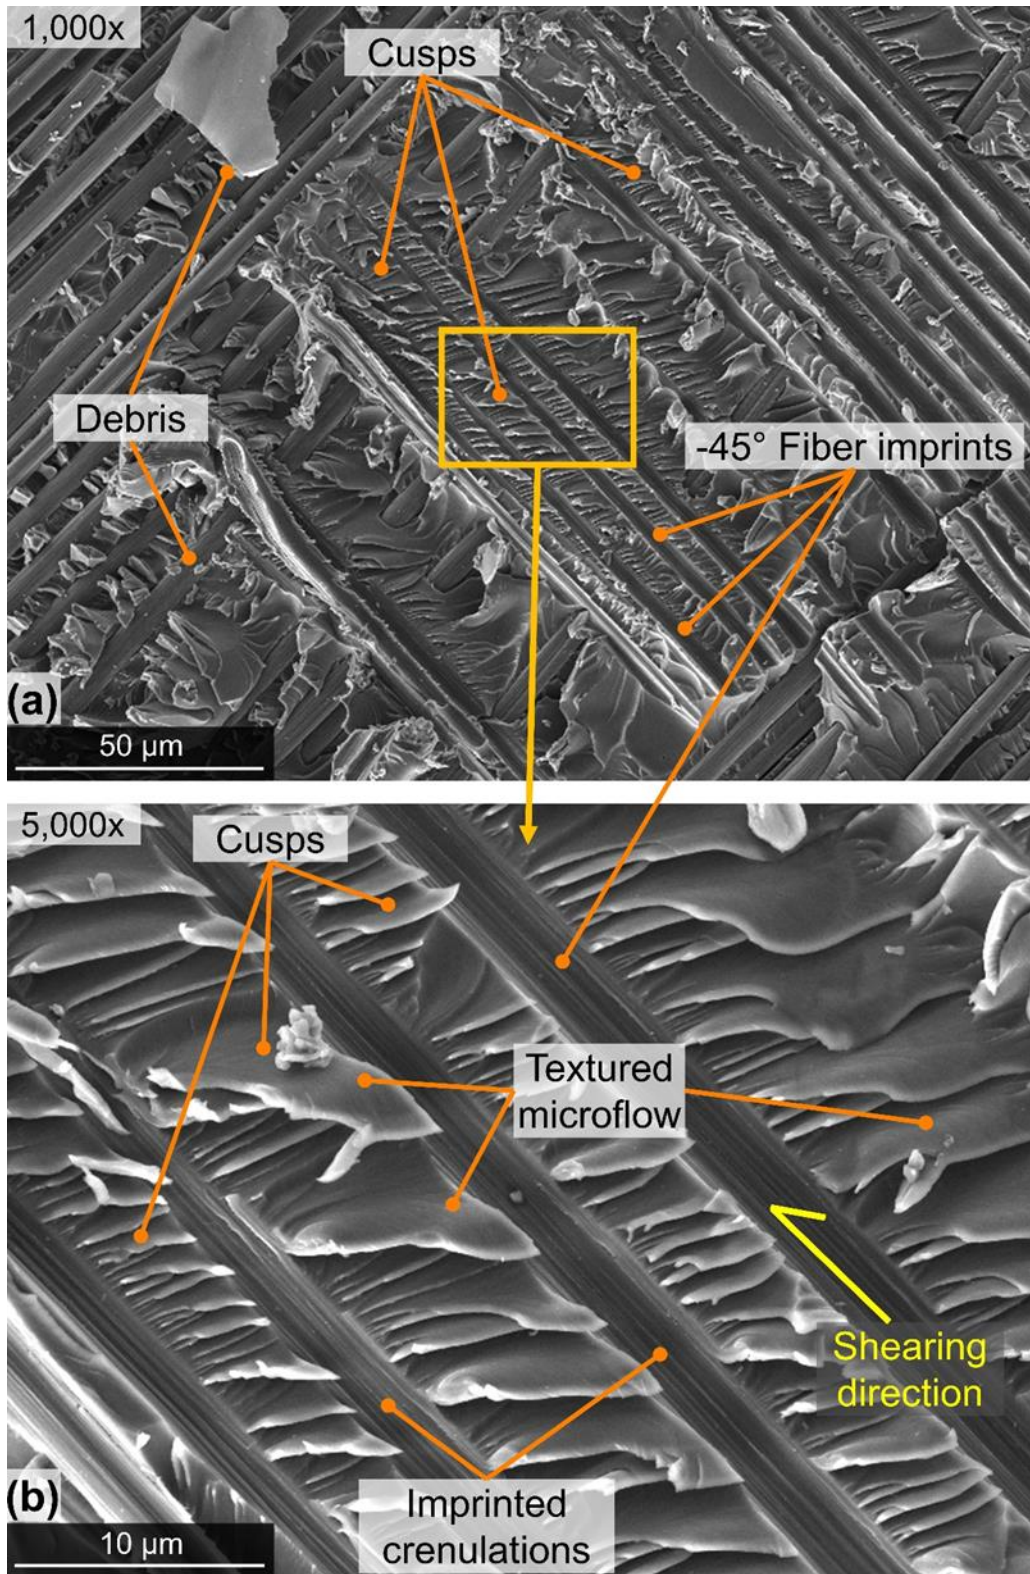
IPS specimen interlaminar shear failures are characterized by the formation of matrix cusps (i.e., inclined platelets), as shown in Figure 24 and Figure 25. Cusps are the most dominant fractographic feature in fiber-reinforced composite matrix shear failures (Greenhalgh, 2009; Purslow, 1986). The IPS interlaminar failure surfaces contained well-defined sharp cusps as

shown in Figure 24(b) and large triangular-shaped cusps as shown in Figure 25(b). While not visible here, more rounded and less distinct cusps can form due to the relative rotations between adjacent angle plies before coalescing into the primary delamination crack (Smith, Grove, & Munns, 1986). In addition, the size and distribution of cusps are influenced by the local fiber spacing and the crack propagation velocity; the greater the crack speed, the smaller the cusp (Smith, Grove, & Munns, 1986). The relative local shearing motion between adjacent $\pm 45^\circ$ plies can be determined by inspecting the tilt orientation of the cusps on the two mating surfaces as shown in Figure 24(b). Such surfaces will have cusps oriented in the opposite direction from one another (Greenhalgh, 2009). Cusps located on one surface will have corresponding “scallops” on the mating surface. Cusps and scallops have associated textured microflows and branched riverlines, as in Figure 24(b) and Figure 25(b) respectively. Such features appear to emanate from regions of fiber-matrix debonding and propagate in the direction of the local crack growth (Purslow, 1986). Lastly, imprints of T40-800 graphite fiber crenulations can be observed along the fiber troughs in Figure 24(b).

Figure 24. SEM micrographs of IPS specimen with (a) shear fracture surface (b) cusps

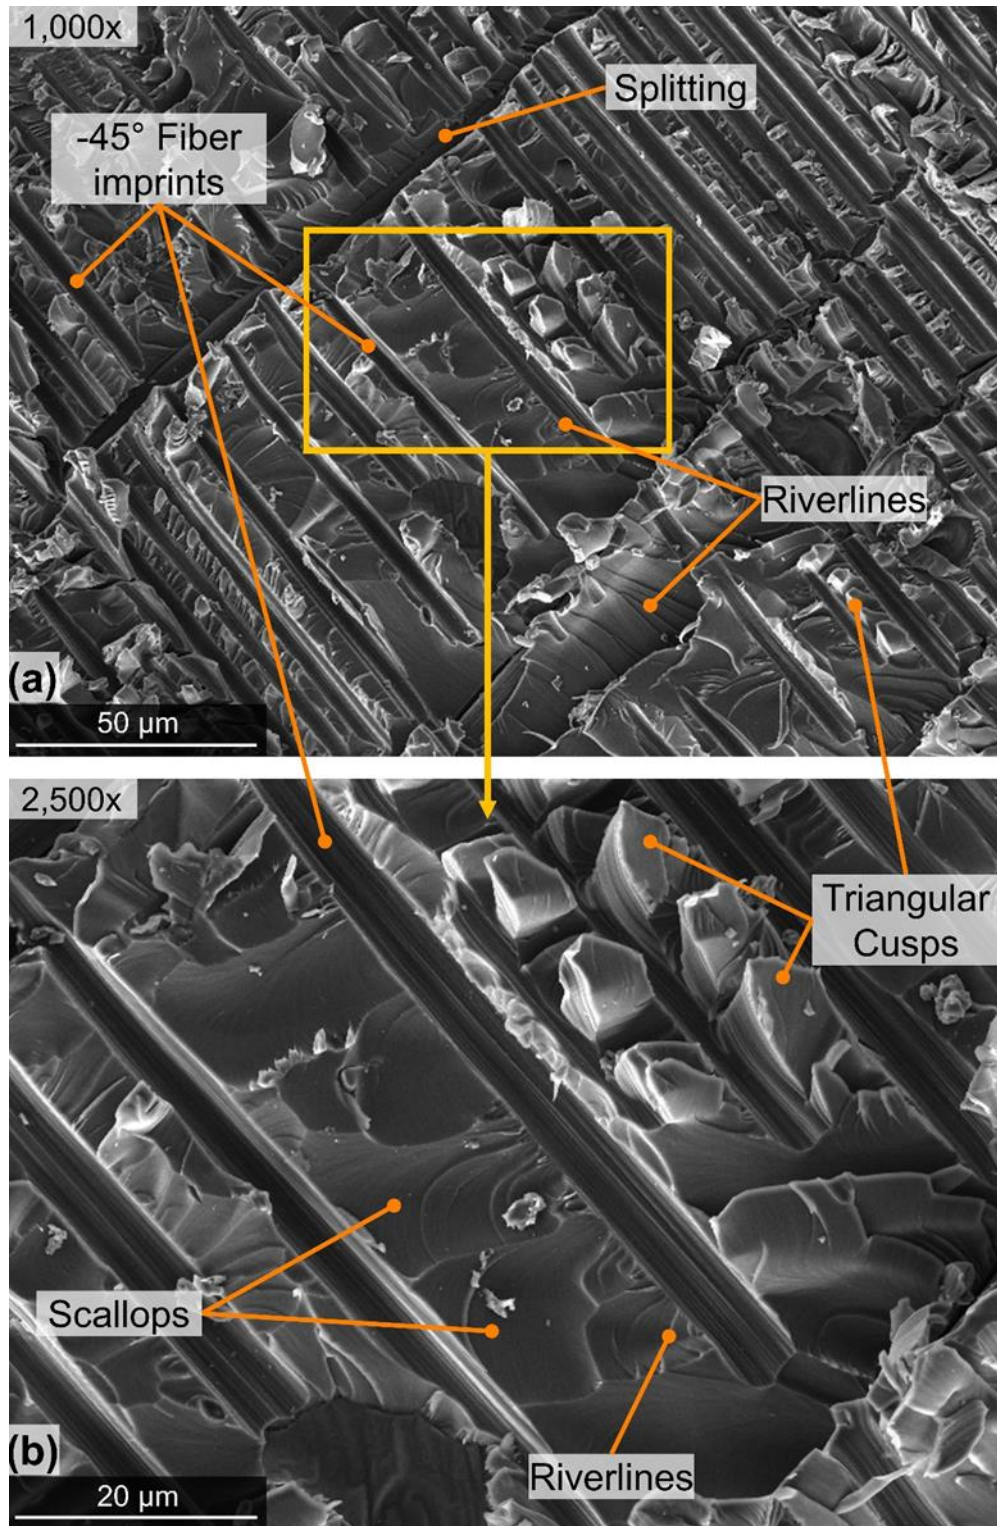
Figure 25. SEM micrographs of IPS specimen fracture surface with (a) gouges (b) triangular cusps

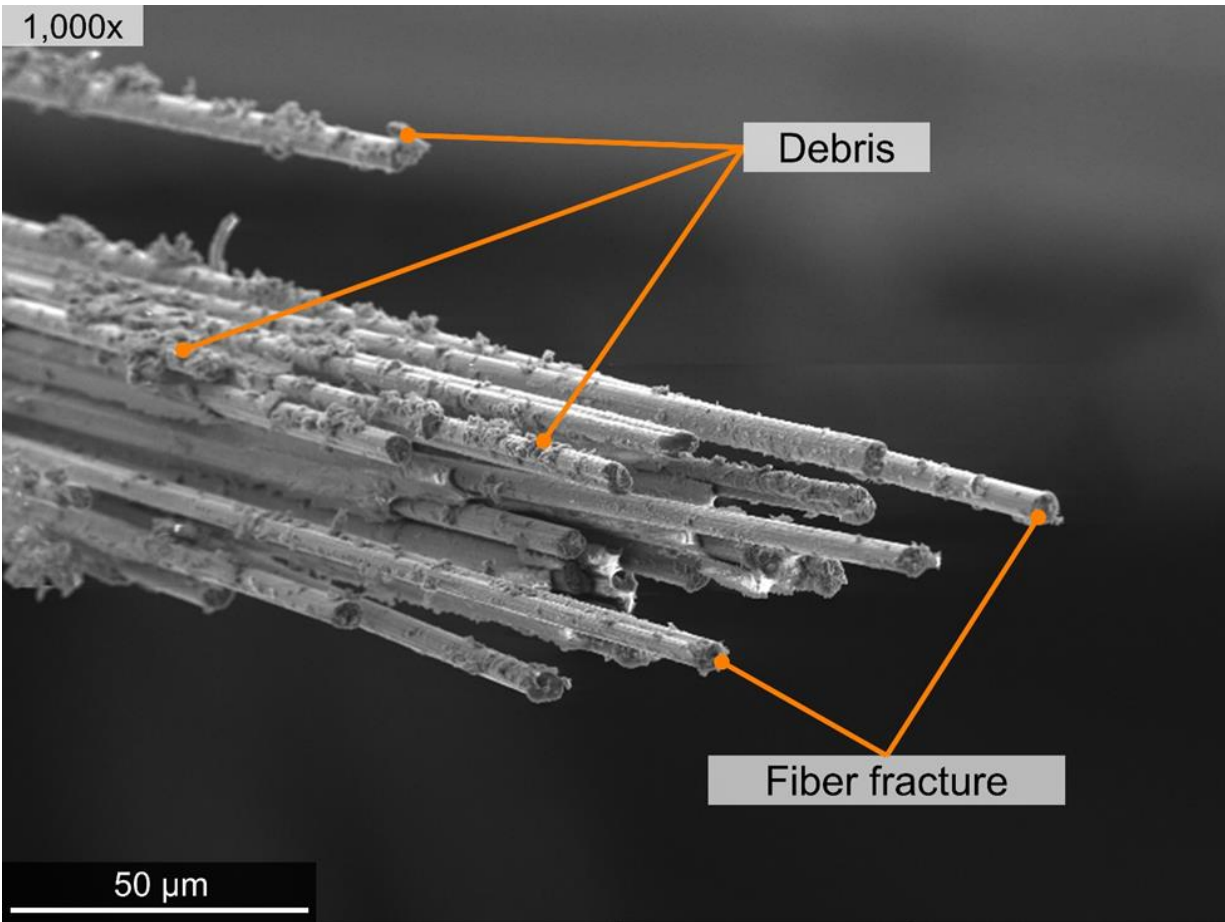
The sequential ply delamination, fiber-matrix debonding, and longitudinal fiber tow splitting during IPS specimen failure led to a loss in the surrounding matrix constraint. This allowed for some off-axis split fiber tows to rotate and partially align with the applied uniaxial tensile load, leading to tensile fiber fractures during laminate rupture. Figure 27 shows SEM micrographs of broken fiber ends in an IPS specimen fracture surface. In the figure, crenulations are visible. Figure 27(a) shows an individual filament that failed primarily in tension; the fracture surface was relatively flat with a rough topology consistent with that for failed 0° fibers in UNT0 specimens as shown in Figure 9.

Figure 26. SEM micrograph of longitudinally split fiber tows in mechanically failed IPS specimen

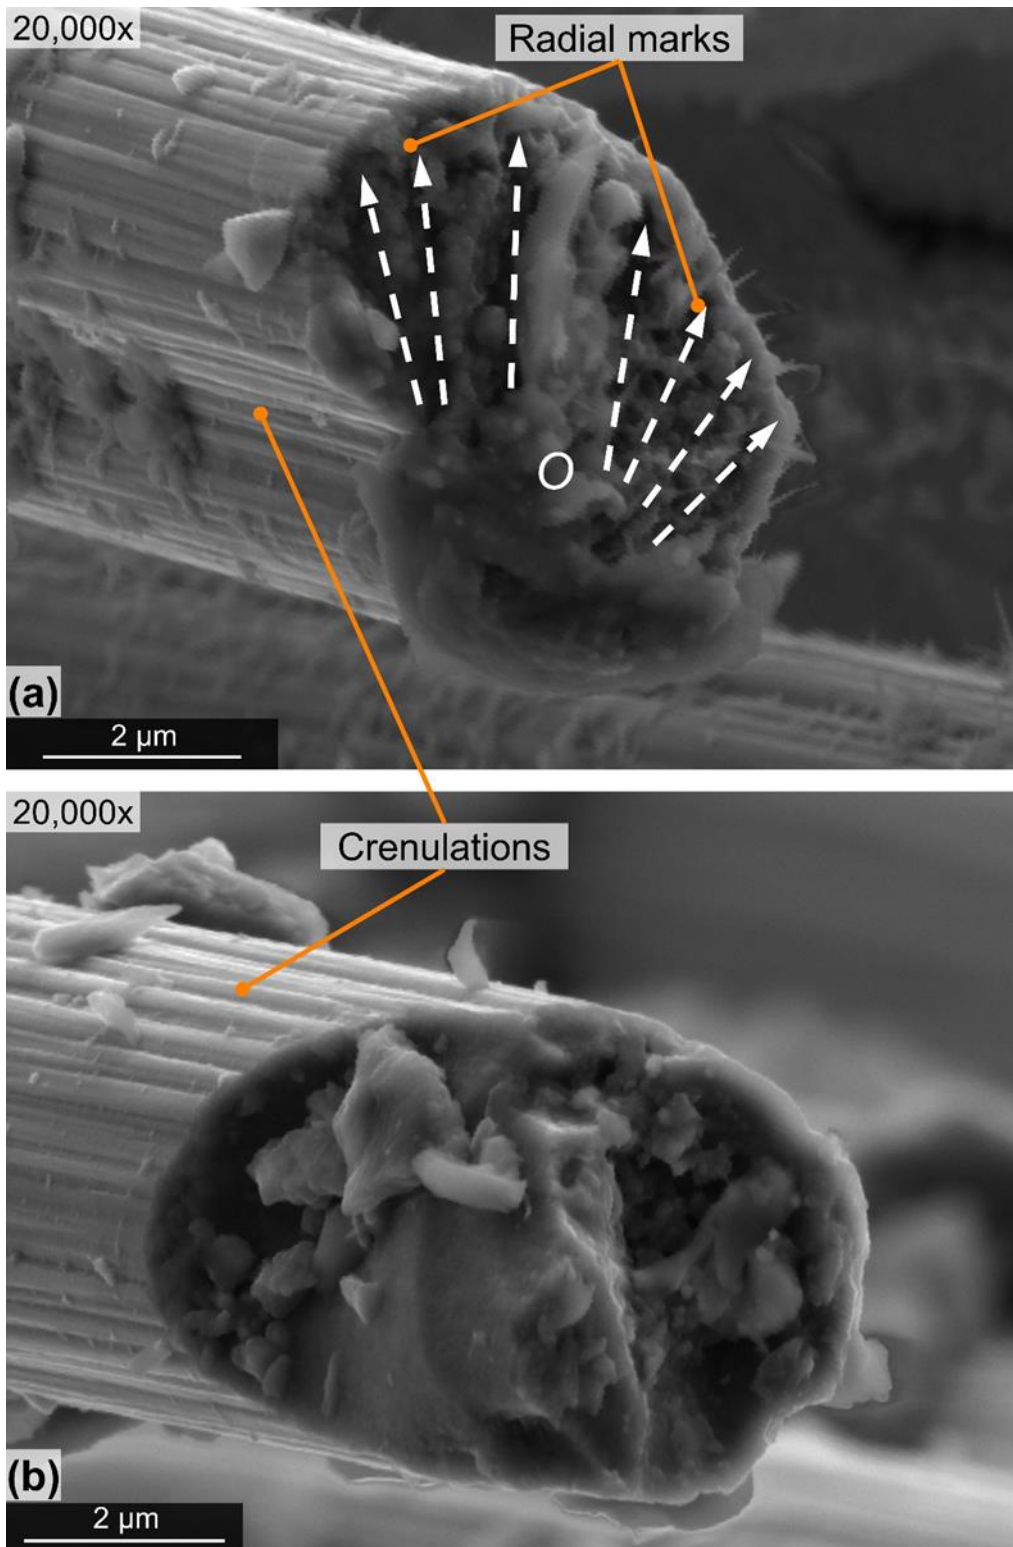
In contrast, Figure 27(b) shows a fiber that appeared to fail due to combined tension and transverse shear; the failure surface was not orthogonal to the fiber axis (i.e., slant fracture occurred). In the future, SEM images of failed fibers loaded in transverse shear (e.g., fibers located at the neutral axis in failed SBS specimens) should be examined to assess better the effects of off-axis loading on local fiber failures. These results show that SEM imaging of failed IPS specimens can be used to assess differences in the local state of stress at failure in laminated graphite/epoxy composites.

Figure 27. SEM micrographs of fractured graphite fibers in IPS specimen (a) under tension (b) under combined tension and transverse shear

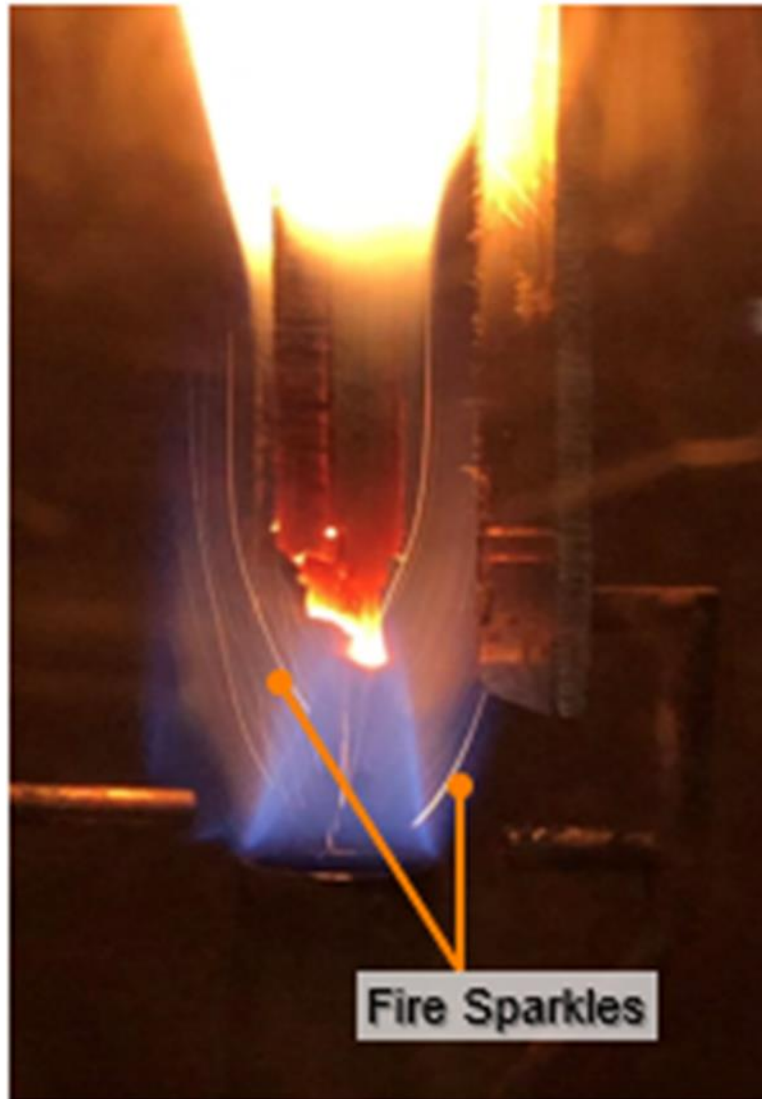
Melt dripping of the epoxy matrix was observed during the 12 s fire tests. This tar-like melt-dripping substance induced fire “sparkles” during specimen burning and leaked onto the tip of the Bunsen burner after the tests as shown in Figure 34. The melt dripping of a given polymer strongly depends on its glass transition temperature and the original polymer melt viscosity and degradation (Ray & Kuruma, 2019). Unlike matrix decomposition, which involves polymer bond breakage, during melt dripping, a solid-viscous liquid phase change takes place inside the material due to high-temperature exposure. The relative degree and extent of the melt dripping were undoubtedly affected by the vertical specimen orientation during fire testing. In essence, any epoxy-based melt dripping would tend to accumulate on the broken carbon filament ends extending from the fracture surface; this contributed to increased char deposits at and near these surfaces. Recessed broken fibers were somewhat less prone to large-scale char deposition. Based upon both visual inspection and SEM imaging, char and soot were clearly visible on the extended fractured fiber ends and at the fracture surface. In general, fire damage was more severe at and near the fracture surface compared to the lateral edges (sides) and outer planar surfaces of the composites. In addition, the severity of char and soot deposition was more pronounced around the perimeter of the fracture surface, where the airflow and oxygen availability were ostensibly greater. In contrast, the region of the fracture surface in close

Figure 34. Fire sparkles during 12 s vertical burn test on 21-ply cross-ply Cytec UNCO specimen

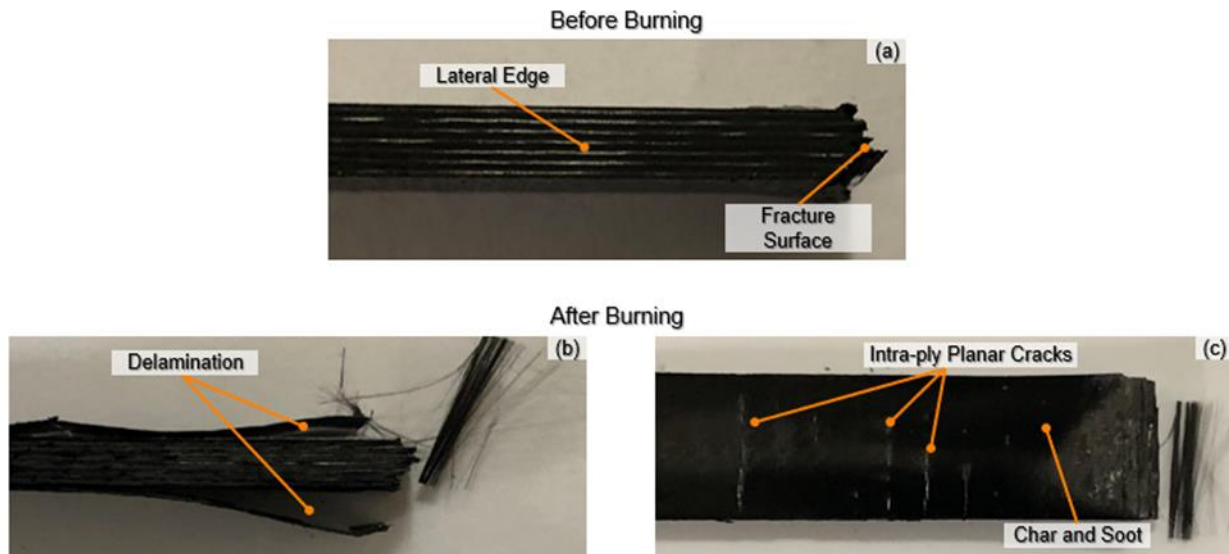
planar cracks formed in the outer 90°-plies of the specimens. Figure 35 shows typical macro-scale pictures of an UNC0 specimen before and after burning for 60 s. The fire damage includes char and soot deposition on the lateral edges and planar surfaces of the specimen and extensive intra-ply cracking and ply-delamination.

Figure 35. Comparison of 21-ply cross-ply Cytec UNC0 specimen (a) before (b) after and (c) after vertical burning for 60 s

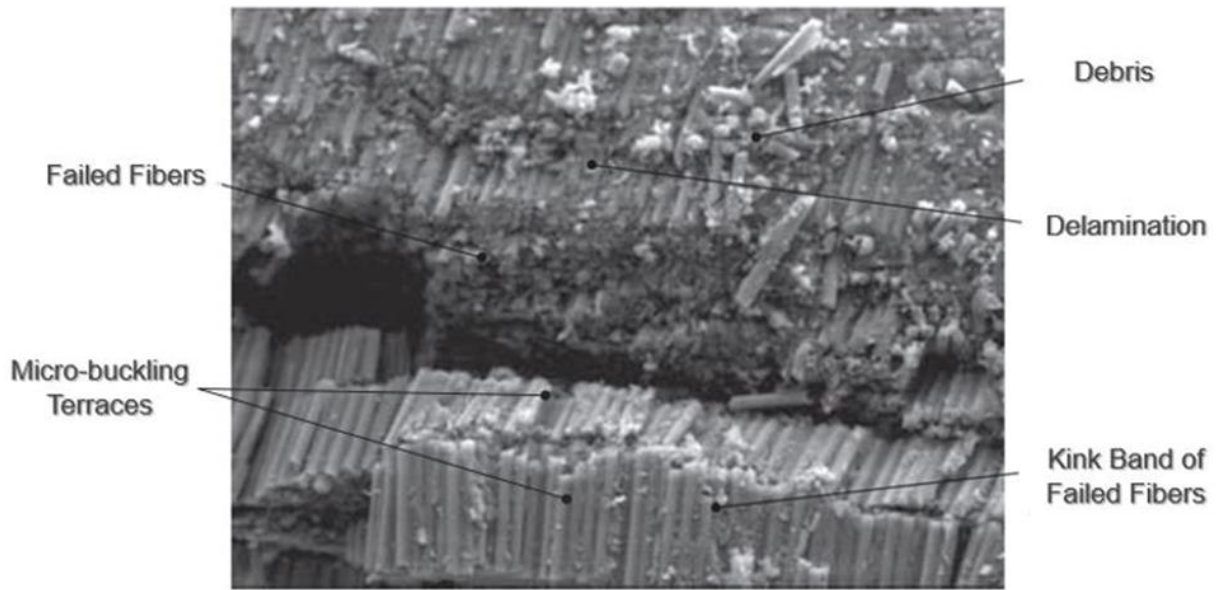
Fractured translaminar compression specimens may contain multiple thin “terraces” of failed and micro-buckled filaments (Greenhalgh, 2009). Essentially, local material instabilities can give rise to kink bands consisting of terraces of short fractured fibers of approximately the same length. The kink band thickness is inversely proportional to the matrix modulus and is typically on the order of multiple fiber diameters. Figure 39, adapted from Greenhalgh (2009), shows a micrographic image of micro-buckling terraces at the fracture surface of a carbon fiber-reinforced polymer (CFRP) composite specimen failed in compression. Similar terraces of micro-buckled fibers were also observed in SEM images of the fracture surface of UNCO specimens vertically burned for 60 s as shown in Figure 40. Even after extreme fire exposure, kink bands, micro-buckled fibers, and their fracture surfaces were clearly identifiable. Given the loose arrangement of terrace-like structures, it may be possible to dislodge severely burned layers to expose relatively unaffected interior surfaces.

Figure 39. Micro-buckling terraces on compression failed CFRP specimen (x700)

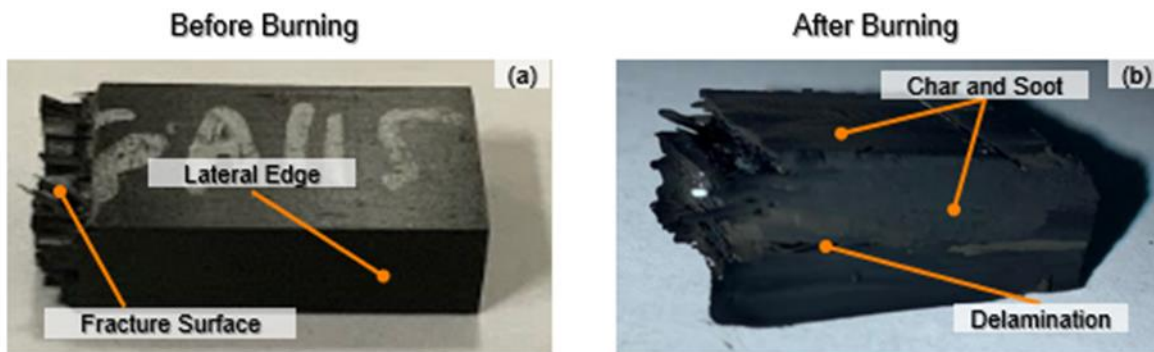
Vertical fire tests were performed on 45-ply unidirectional Cytec SBS specimens (layup: $[0]_{45}$) for durations of 12 s, 36 s, and 60 s to assess the effects of flame exposure time on char formation. Three repeats were performed for each fire exposure time. Fire damage (i.e., extensive fire matrix decomposition, soot, char, and residual thickness increase) observed was more severe for specimens subjected to the flame for 36 s and 60 s. The fire damage mechanisms generated in the vertical burning tests on the SBS specimens were similar to those in the UNCO specimens and extended throughout the length of the burned specimens. Again, the relatively thick SBS and UNCO specimens both display a more compact failure surface that inhibits oxygen flow to the interior of the specimens, resulting in more char formation around the perimeter of the cross-section. Char deposition at the SBS fracture surfaces also served as a thermal barrier that reduced fire damage penetration into the composite at the laminate interior; this is consistent with observations from the literature (Mouritz & Gibson, 2007; Mouritz & Mathys, 2001). As with prior tests, for all three fire exposure durations, the lateral specimen edges (sides) continued to burn after the flame was extinguished. Similar to UNCO specimens, SBS specimens exposed for 12 s took longer to self-extinguish than for 36 s and 60 s fire tests. Figure 44 shows typical macro-scale pictures of an SBS specimen before and after fire exposure for 60 s. The fire damage included local delamination near the fracture surface, char formation, and soot

deposition on the lateral edges and outer ply surfaces, and a significant increase in the residual thickness of the burned specimen.

Figure 44. Picture of 45-ply unidirectional Cytec SBS specimen (a) before and (b) after vertical burning for 60 s

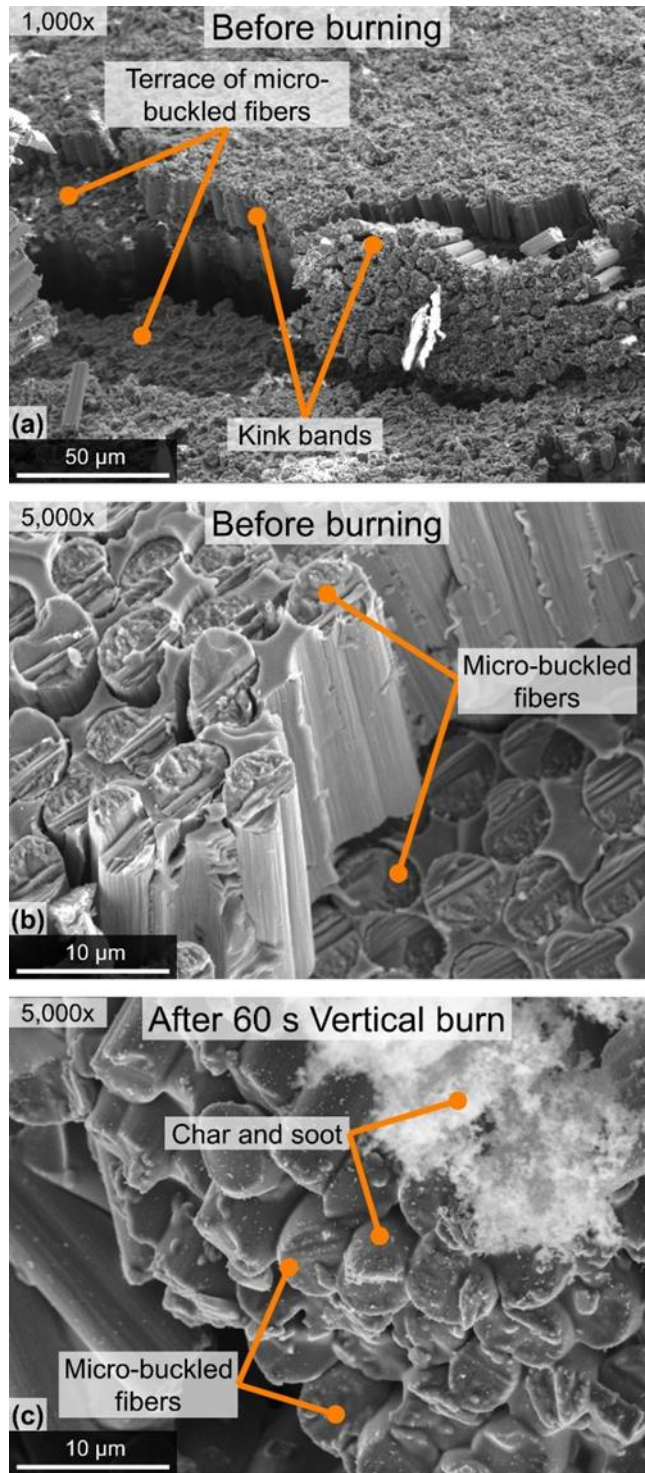
Similar to UNC0 specimens shown in Figure 39, adapted from Greenhalgh (2009), terraces of micro-buckled fibers formed in compressive regions of failed three-point bend SBS specimens. Figure 47(a) and Figure 47(b) show SEM images of micro-buckled fibers in a SBS specimen before fire exposure. Figure 48(c) shows the same specimen after vertical burning for 60 s. After burning, parallel clusters of micro-buckled fibers indicative of compressive failure were still visible, albeit covered in char; some slant-like fiber fracture features also remained. In nearby regions of the specimen, micro-buckled fibers in terrace structures were completely covered with melt dripping, as shown in Figure 49. This suggests that removal of the outer terraces may be desirable to identify operative mechanical failure mechanisms better.

Figure 48. Micro-buckled fibers in Cytec SBS specimens

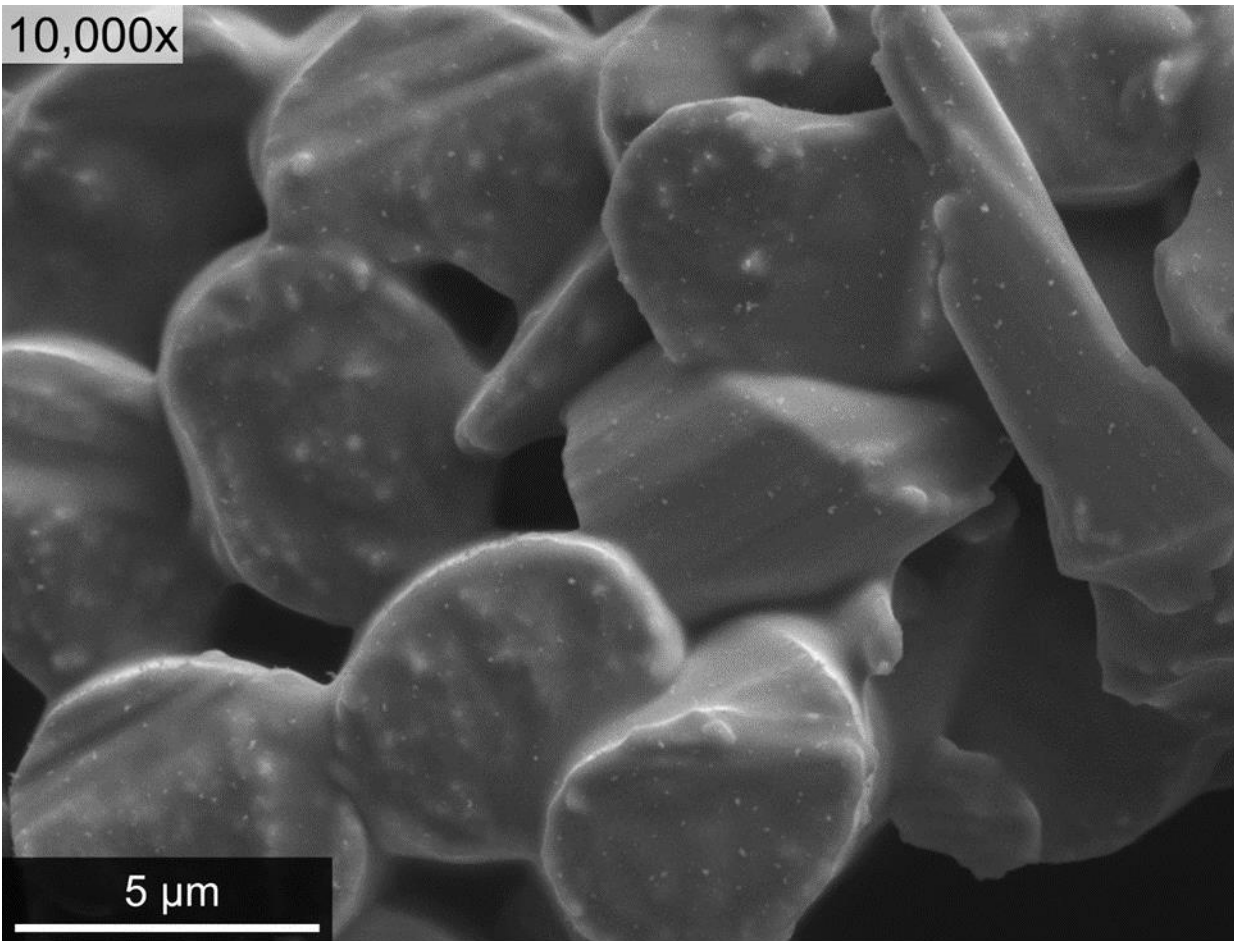
Figure 49. Micro-buckled fibers in Cytec SBS specimens completely covered in melt dripping

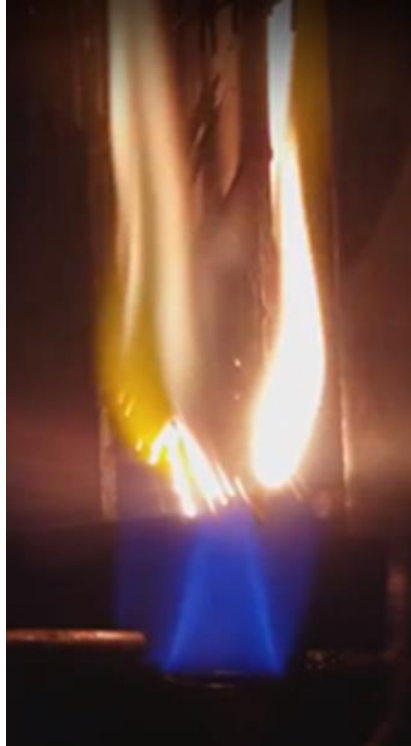
Due to their highly irregular fracture surface geometries, the IPS specimens were positioned above the Bunsen burner during fire tests such that the blue tip of the flame was at the same level as the fractured fibers at the longest lateral edge of the specimen, as shown in Figure 50 and

Figure 50. Positioning of IPS specimen during vertical burn tests

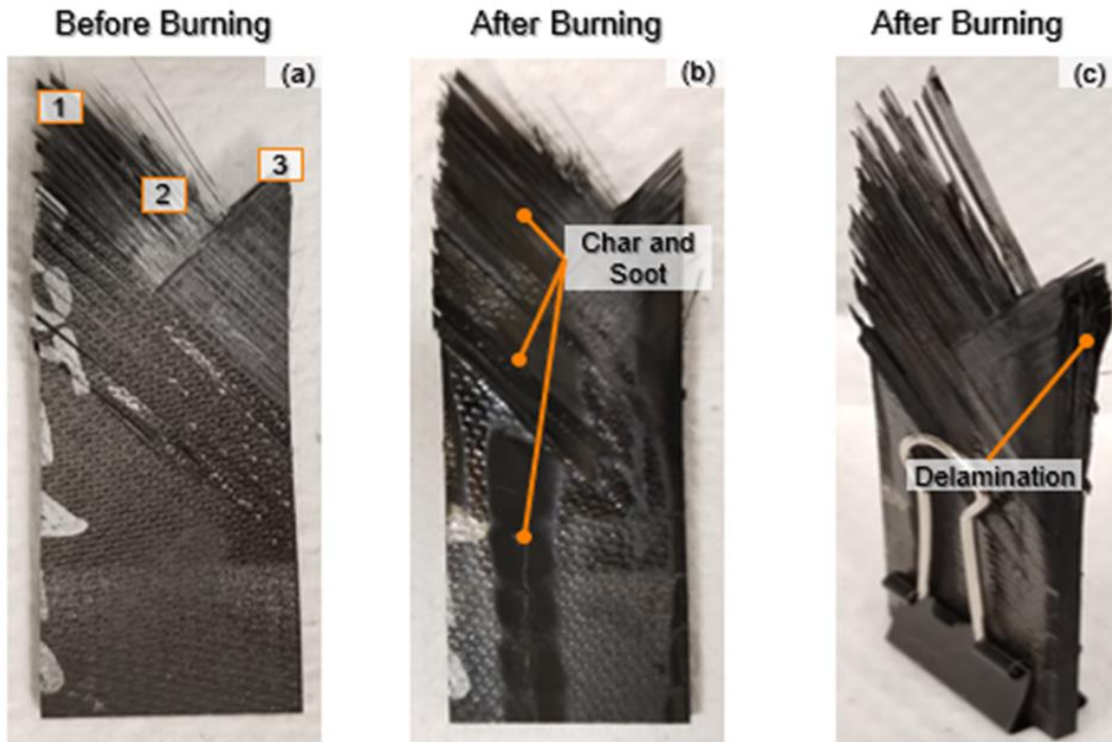
Figure 51 shows typical macro-scale pictures of an IPS specimen (a) before and (b, c) after fire exposure for 6 s. Char and soot were observed on the exposed filament ends, lateral specimen edges (sides), and on planar outer ply surfaces. Pre-existing mechanical delamination appeared to grow significantly after fire exposure. The locations 1 (longest lateral edge), 2 (laminar centerline), and 3 (shortest lateral edge), shown in Figure 51(a), define the approximate locations of SEM images taken of the failure surfaces. Figure 52 shows that IPS specimens burned for 6 s developed significant char on extended fibers at both lateral edges, as well as the laminar centerline.

Figure 51. 16-ply Cytec IPS specimen (a) before (b) after and (c) after vertical fire exposure for 6 s

For IPS specimens subjected to longer fire exposure times (i.e., 12, 36, and 60 s), virtually no residual char formed on fibers located near the longest lateral edge, shown in location 1 in Figure 51(a), or at the specimen centerline, shown in location 2 in Figure 51(a). In contrast, significant char only formed on broken fiber ends located near the shortest lateral edge, shown in location 3 in Figure 51(a); this location was farther removed from the blue flame tip than the other points considered. Figure 53(a) through Figure 55(a) show SEM images of the fracture surface at the

Exposed graphite filaments located near the mid-plane of the fracture surface along the IPS specimen centerline, shown in location 3 in Figure 51(a), were severely altered when specimens were burned for 12 s, 36 s, and 60 s. The fibers' thermal degradation was so severe that it eliminated any possibility of identifying fiber mechanical failure mechanisms. Figure 56 shows SEM images of broken fibers located along the centerline of IPS graphite/epoxy specimens burned for (a) 12 s, (b) 36 s, and (c) 60 s. In each case, the family of fibers became longitudinally thinner and developed needle-like shapes. Moreover, voids and cavities formed at the fiber-ends in specimens burned for 60 s (Figure 57). Graphite/carbon fiber ends thinning is mainly caused
