DOT/FAA/TC-22/20

Post Small-Flame Forensic Analysis of Aerospace Composites

January 2024

Final report

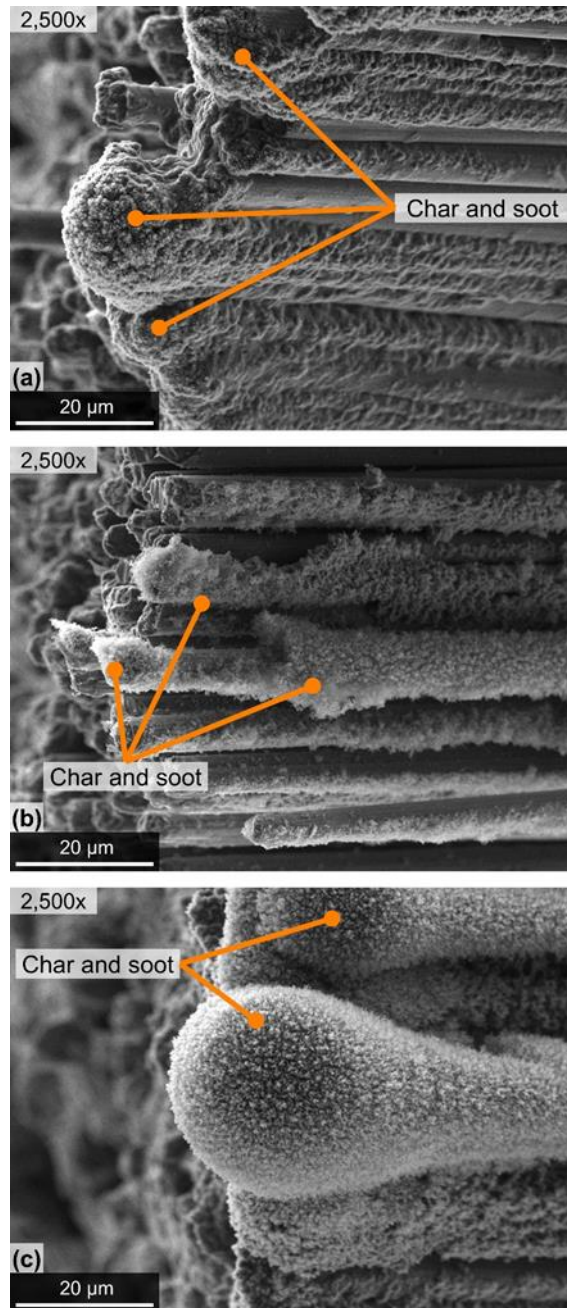
Figure 52. (a) longest lateral edge (b) center and (c) shortest lateral edge of 16-ply Cytec IPS specimens

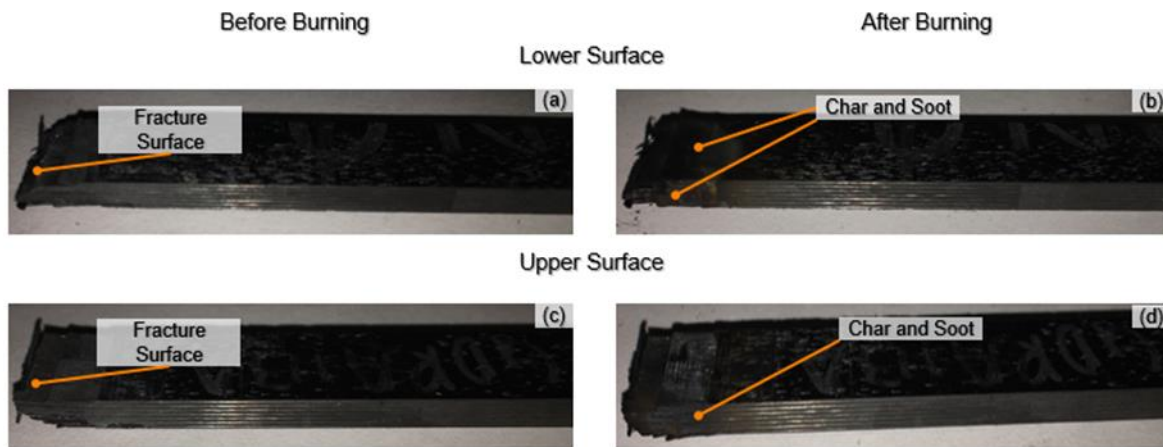
Fire tests on horizontally-oriented 21-ply cross-ply Cytec specimens (layup: $[90/0/90]_7$) were performed for durations of 15 s, 45 s, and 75 s to assess the effects of specimen orientation and flame exposure time on fire damage formation. Three repeat horizontal fire tests were performed for each exposure time. The horizontally-oriented specimens typically experienced *lower* degrees of thermal damage than vertically-oriented specimens since a much smaller fraction of the total specimen volume is located above the tip of the flame. In each horizontal test, the UNCO specimens self-extinguished as soon as the applied flame was stopped. The local matrix decomposition, surface char, and soot were more severe over the lower outer ply surface exposed to direct flame; such damage was more pronounced for the 45 s and 75 s fire tests. Unlike the case for vertical tests, no delamination or residual thickness increase occurred for all three fire exposure durations (i.e., 15 s, 45 s, and 75 s). Figure 58 shows typical macro-scale images of the lower and upper surfaces of an UNCO specimen before and after horizontal burning for 75 s. The lower surface of the specimen, shown in Figure 58(a) and Figure 58(b) suffered matrix

decomposition over the region exposed to direct flame. In contrast, the upper surface of the specimen, shown in Figure 58(c) and Figure 58(d) was not appreciably affected by the fire.

Figure 58. 21-ply cross-ply Cytec UNC0 specimen before and after horizontal burning for 75 s

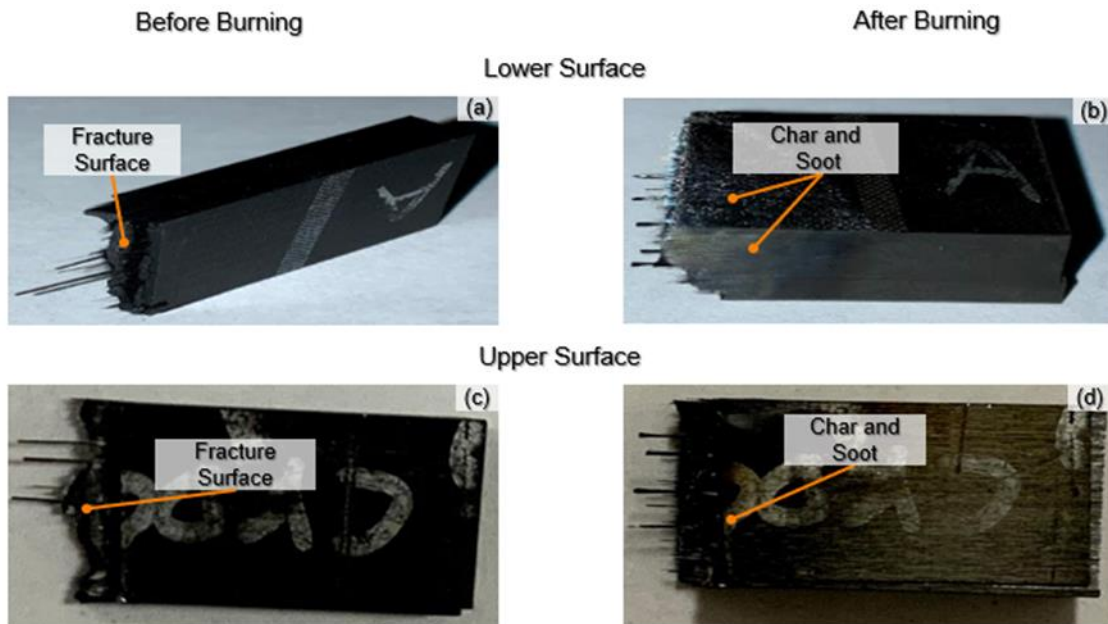
Figure 60 shows typical macro-scale pictures of the lower planar surface of a typical SBS specimen before and after horizontal burning for 75 s. The outermost ply exposed to direct

flame, shown in Figure 60(a) and Figure 60(b), sustained far more fire damage than did the interior plies. The lower edges of the fracture surface and lateral sides of the specimen also displayed proportionally more matrix decomposition than points more removed from the fire-exposed surface; this was particularly true for regions directly immersed in flame. In contrast, the upper outer ply and upper (unexposed) surface, shown in Figure 60(c) and Figure 60(d), showed little fire damage at the proximity of the fracture surface.

Figure 60. Comparison of 45-ply unidirectional Cytec SBS specimen before and after horizontal burning for 75 s

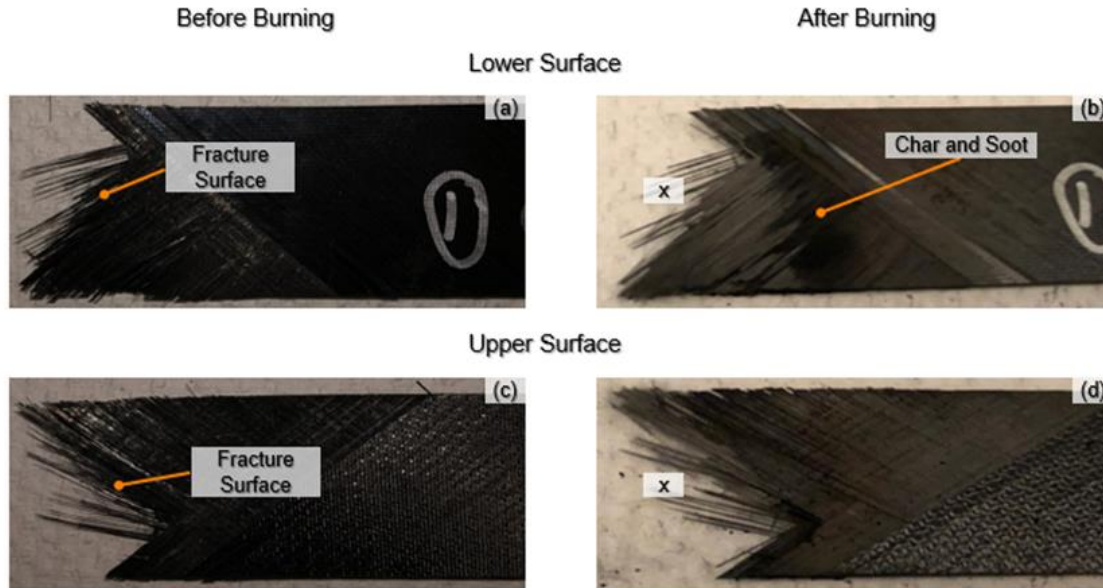
Figure 62 shows typical macro-scale images of the lower and upper surfaces of an IPS specimen before and after horizontal burning for 75 s. Soot and char were clearly visible on the lower, fire-exposed surface of the specimen, as shown in Figure 62(a) and Figure 62(b). In contrast, no significant soot/char was observed on the upper surface of the IPS specimen (Figure 62(c) and Figure 62(d)). In addition, no large-scale char or other fire damage was visible at the fractured fiber bundles protruding from the specimen fracture surface. The results from 15 s and 45 s horizontal tests were consistent with those shown in Figure 62.

Figure 62. 16-ply Cytec IPS specimen after horizontally burning for 75 s with approximate location of flame axis

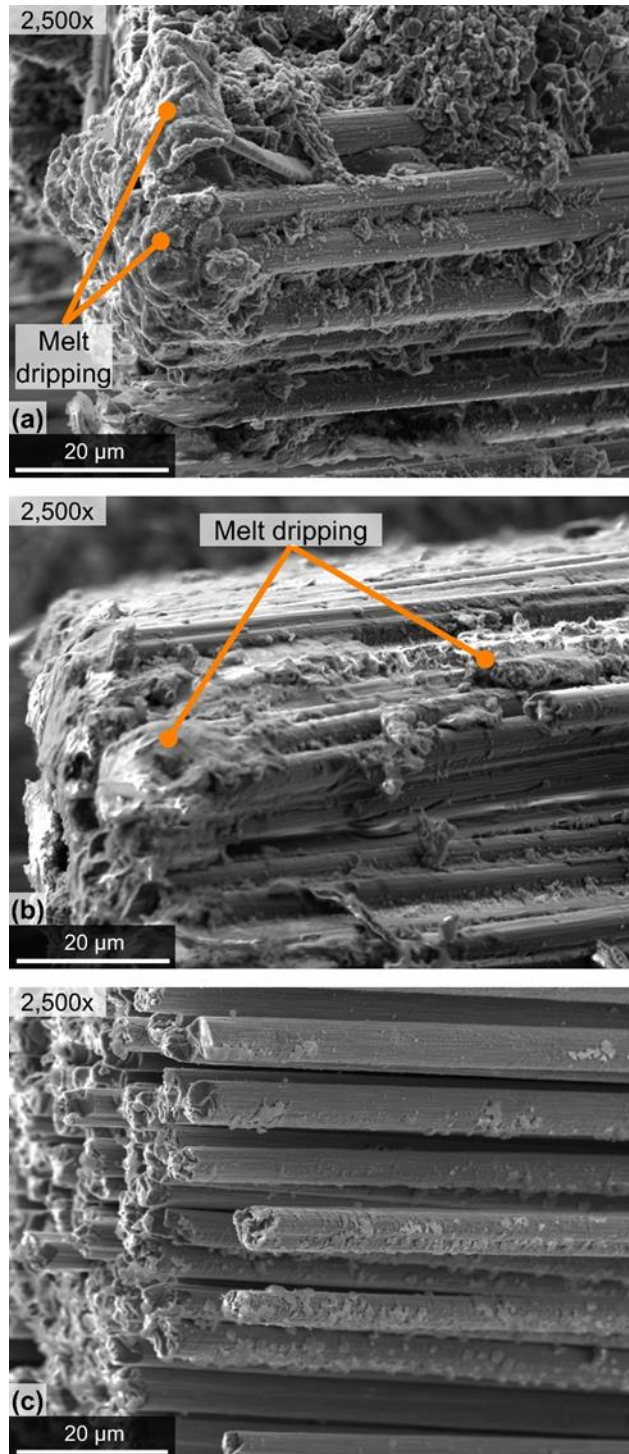
For vertical fire tests of IPS specimens, fibers located at the laminate centerline, shown in location 2 in Figure 51(a), suffered severe thermal degradation. In those cases, the matrix surrounding the fiber bundles was completely decomposed, and individual filaments experienced substantial oxidation damage and thinning (Figure 56). For horizontal fire tests, however, fiber bundles located along the laminate centerline were not as adversely affected by fire exposure. Figure 63 shows SEM images of fiber bundles located at the centerline of IPS specimens horizontally burned for (a) 15 s (b) 45 s and (c) 75 s. For the 15 s and 45 s fire exposures, individual fiber bundles remained encased in the epoxy matrix, and there was little evidence of char formation, see Figure 63(a) and Figure 63(b). For the 75 s tests, the epoxy matrix was largely decomposed, but the individual fibers appeared to remain relatively intact. Moreover, angled/slant fracture of individual filaments typical of in-plane shear failure was clearly visible, see Figure 63(c). It is obvious that horizontal testing of IPS specimens resulted in significant heat transfer due to convection that bypassed the specimen, resulting in far less thermal damage than for the case of vertical burning. These results suggest that under certain circumstances, post-crash fires may leave portions of composite aircraft structures relatively unaffected.

Figure 63. Fiber tows from centerline of 16-ply Cytec IPS specimens after horizontal burning for (a) 15 s (b) 45 s and (c) 75 s

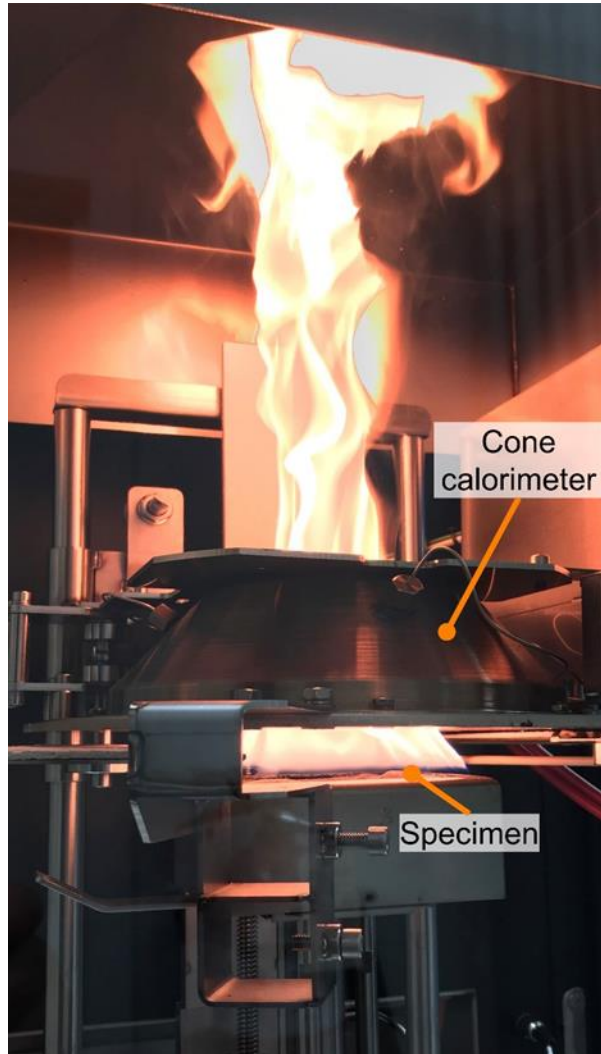
During cone calorimetry testing, the 4 x 4 in² CAI sample was positioned horizontally under the cone (i.e., indirect heat source), and a through-thickness heat flux of 50 kW/m² was applied continuously until the specimen self-extinguished. The specimen auto-ignited 81 s after initial heat flux exposure and self-extinguished 373 s after ignition. Figure 64 shows the CAI specimen after auto-ignition during cone calorimetry testing. During the test, large-scale matrix decomposition was initiated at the upper heat-exposed surface of the specimen and eventually penetrated the entire thickness. After testing, no epoxy matrix or char was visible at the heat-exposed upper surface of the sample; nearly complete matrix decomposition occurred (Figure 65(a)). The upper 45° ply of the composite appeared to consist of a blanket of loose bare graphite fibers (Figure 65(b)), which hindered SEM imaging of the upper surface. The unconfined loose arrangement of fibers at the composite outer surface made the broken and micro-buckled fibers at the CAI failure plane virtually indistinguishable from the surrounding fibers, based upon

visual inspection. As an aside, the inability to use visual inspections to precisely identify composite aircraft structural failure locations has the potential to limit the efficiency of fire forensic analysis seriously.

Figure 64. Cone calorimetry testing of 4 x 4 in² 2 32-ply Cytac CAI specimen

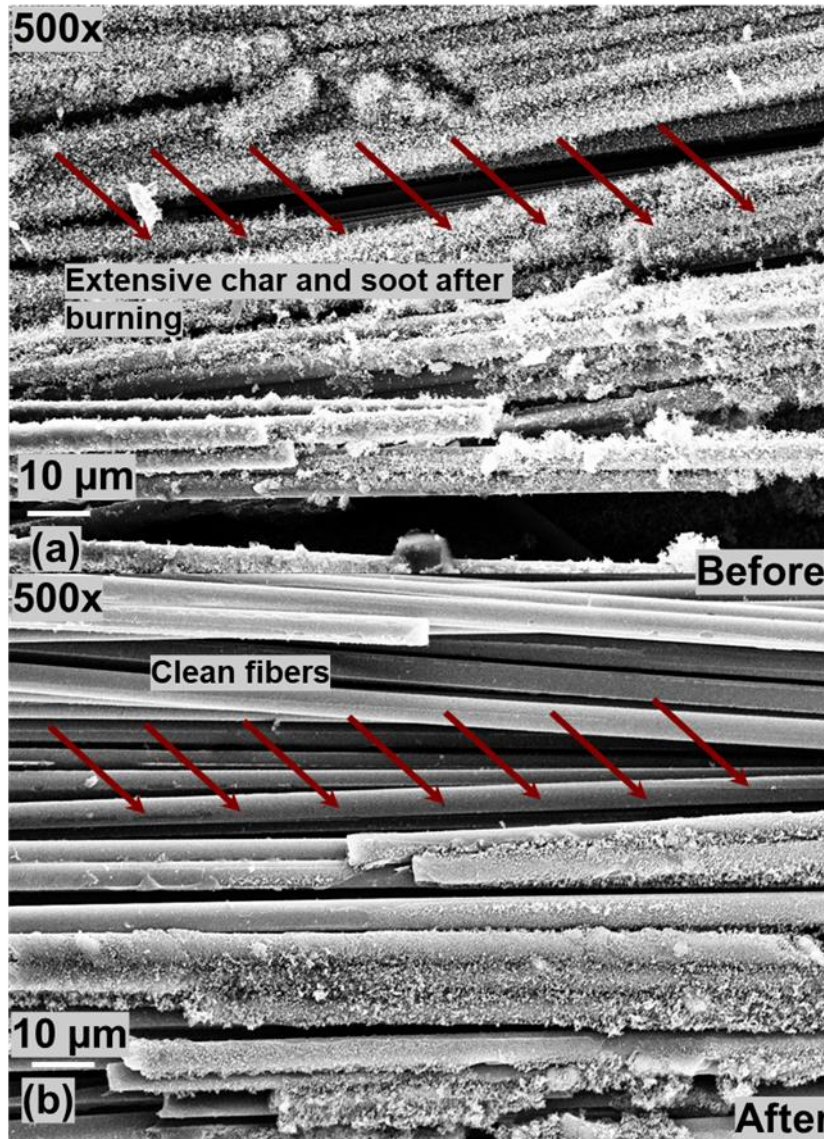
Figure 67. Sonication action along surface of in-plane fibers of burned pristine 4-ply cross-ply Hexcel specimens

There is a significant reduction in char along the lengths of the in-plane fibers in the upper section of Figure 67b. Clean fibers can be observed on the top half of the image, indicating an effective penetration of the cavitation bubbles about the char and fiber surface interface. However, the lower section of the micrograph remained unchanged. This could be attributed to 15 min being insufficient sonication time or inadequate sonication effects such as acoustic streaming, which promotes the transfer of the solvent into those specific regions, or free radical generation, which allows for oxidation/reduction reactions to occur to separate the char from the composite surface chemically. Therefore, additional ultrasonication experiments were performed

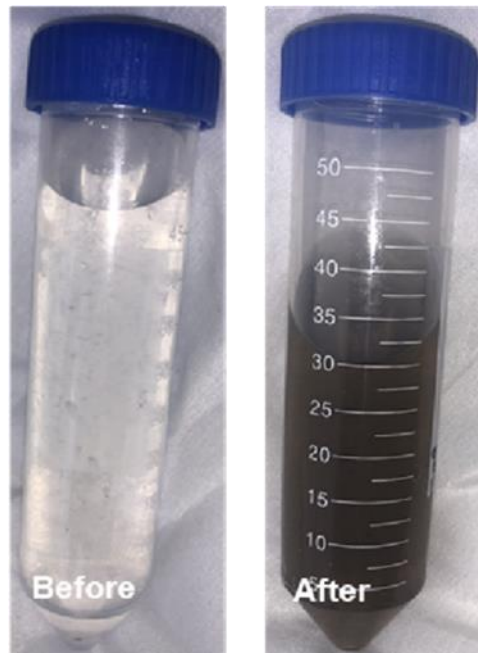
Representative specimens were selected for each test duration, and their surface characteristics were observed using the scanning electron microscope. The specimens subjected to ultrasonication for 30 min possessed similar surface characteristics to the specimens sonicated for 15 min. the color of the acetone after sonication was also similar. However, the sonication residues were more pronounced in the acetone after the burned Hexcel specimens were sonicated for 60 min, producing a darker shade of discoloration in the solvent after sonication as shown in Figure 68.

Figure 68. Color change of acetone before and after 60 min of ultrasonication of representative pristine burned Hexcel specimen

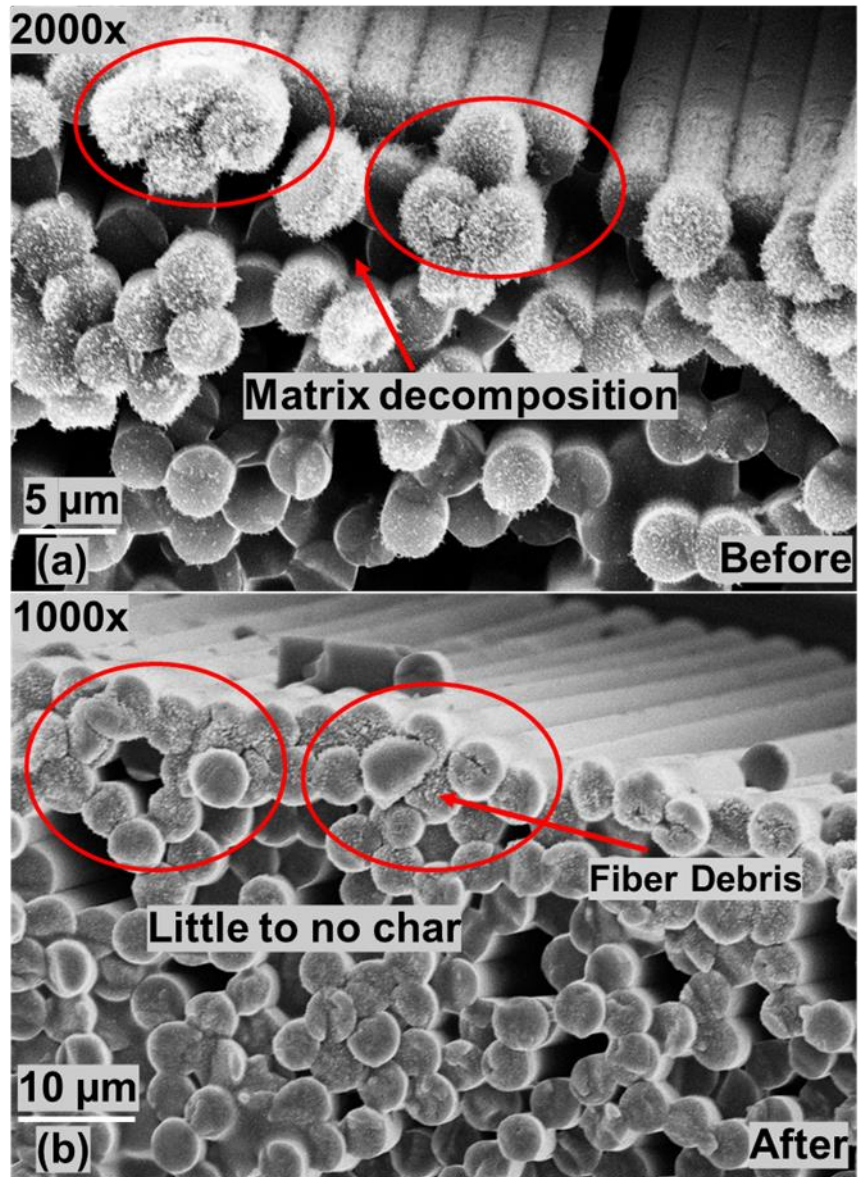
The fire-exposed ends of the out-of-plane 0° fibers possess highly dense and fuzzy char residue, as shown in the optical micrographs in Figure 69a. Similar structures were successfully identified as char in the preceding sections. In these out-of-plane 0° fibers, heat is conducted through the thickness of the composite. In this case, the interior in-plane plies can cut off the airflow required for heat conduction, resulting in the high-dense char on the fiber ends. Therefore, the surface char generated after burning is significant, with highly dense char on the fiber ends. Figure 69a and Figure 69b show representative SEM micrographs of the 0° fibers before and after ultrasonic cleaning. After 60 min of ultrasonic cleaning in acetone, the reduction in char on the fiber-ends is significant. Effective removal of char indicates that the cavitation bubbles successfully penetrated the char and the fiber surface interface (Figure 69(b)). The mechanical action of the agitation of solvent along areas closer to the charred regions could also contribute to the overall char removal process. The bulk movement of the liquid due to acoustic streaming around the sonicated regions would help transport the solvent into the char-dominated regions and transport the sonication residue away from the regions of interest.

Figure 69. Sonication results (60min, acetone) of 4-ply cross-ply Hexcel woven fabric

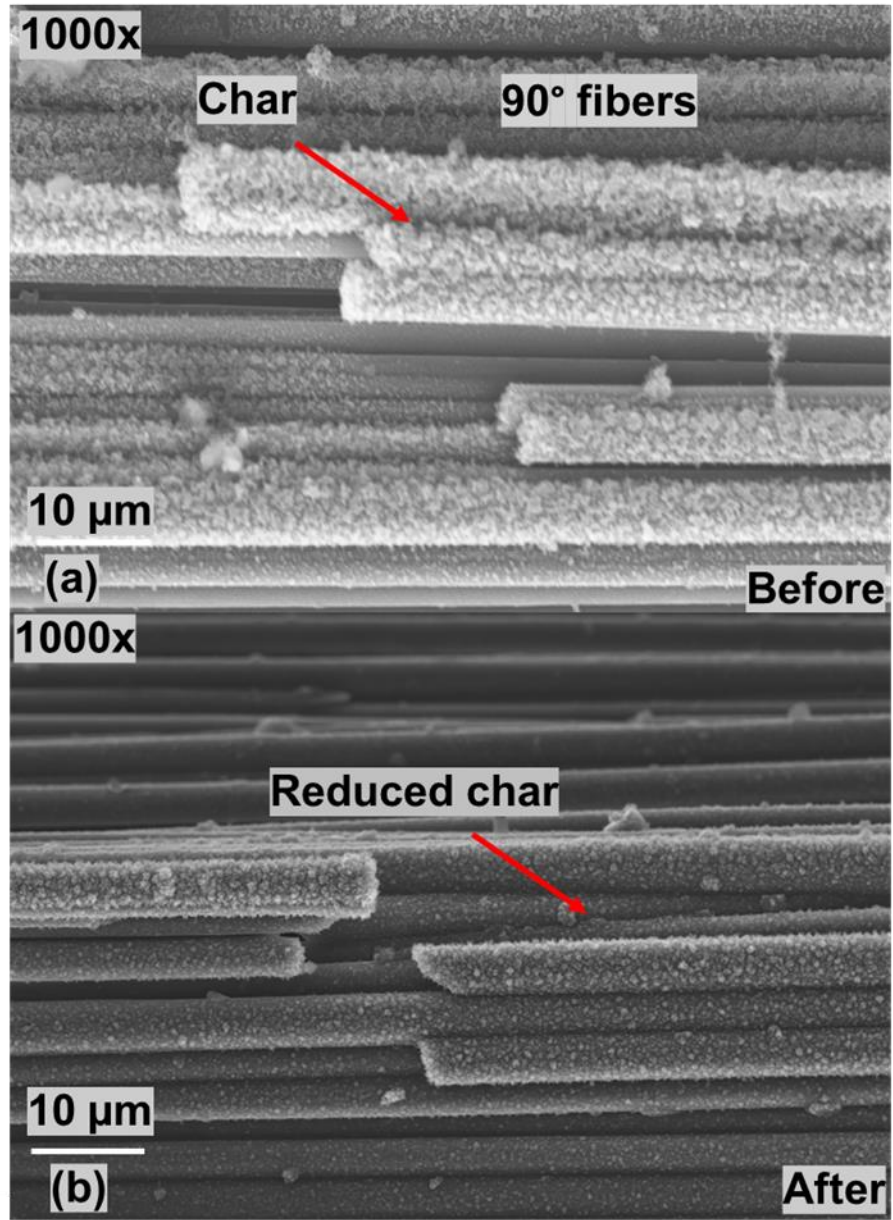
Figure 70(a) and Figure 70(b) show the surface characteristics of the in-plane 90° fibers for a burned pristine 4-ply cross-ply [0/90/90/0] Hexcel specimen before and after ultrasonic cleaning. The in-plane 90° fibers have a uniform distribution of a textured char along the fiber length. In these fibers, the heat is conducted along the lateral sides of the fiber. Prolonged fire exposure could result in the inhibition of heat conduction to lateral sides due to the lack of oxygen or combustible gaseous products resulting in the textured char morphology as seen in Figure 70(a). After 60 min of ultrasonic cleaning in acetone, the amount of char present on the fiber surface is markedly less. The fibers in the inner ply appear to be clean and devoid of surface char. The overall reduction in the surface char can be attributed to the acoustic streaming phenomenon during ultrasonication. The sound waves rapidly transfer fluid to the burned regions of the specimens. During this event, the fluid impinges onto the fiber surface, leading to increased sonication effects like cavitation and free-radical generation. In these conditions, char can be mechanically removed due to the high pressure and temperature conditions of cavitation-bubble implosion or chemically due to the oxidation-reduction pathways provided by the free radicals generated during sonication.

Figure 70. Sonication (60min, acetone) results of 4-ply cross-ply [0/90/90/0] Hexcel woven fabric

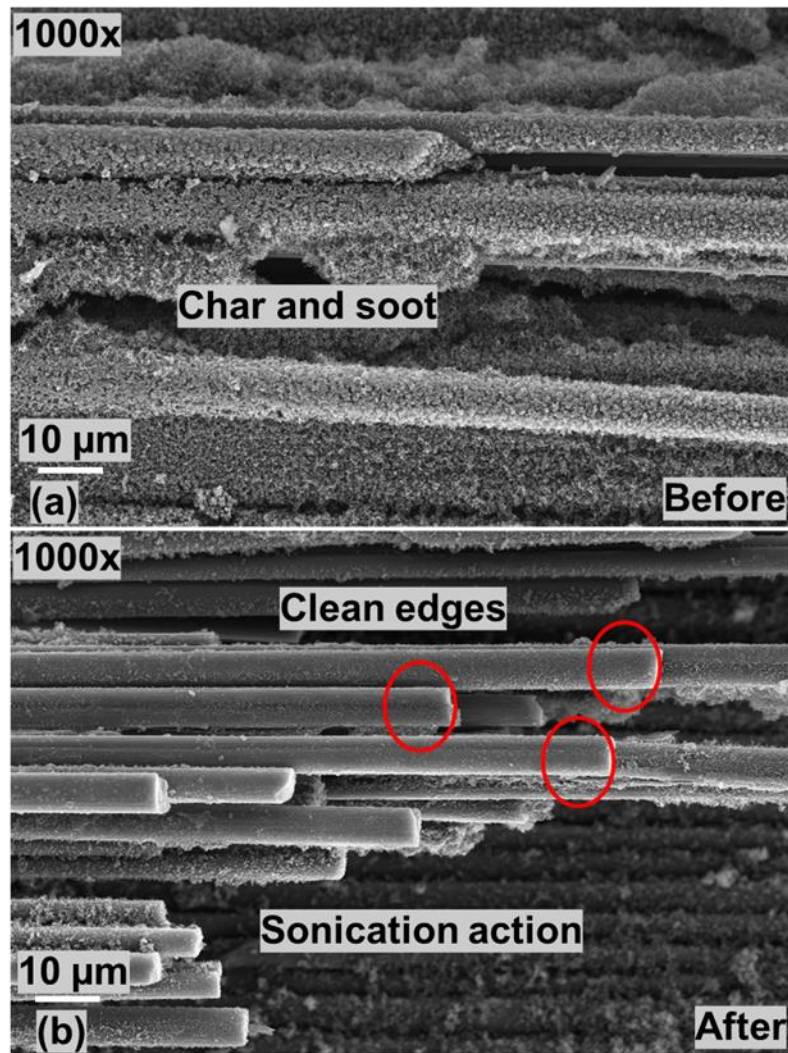
The SEM micrographs shown in Figure 71 demonstrate the surface char morphology on the in-plane fibers (90°) in the perimeter region of the fracture surface. The fibers of the inner plies are

visible in the background, indicating delamination between the two plies. The significant char and soot deposition and the visible space between adjacent fiber surfaces point to a high degree of matrix decomposition. The optical micrographs in Figure 71 belong to a representative vertically oriented Cytec half-specimen burned for 12 s followed by 60 min of ultrasonication in acetone. A pretreatment step was not adopted for this specimen to assess the effectiveness of pretreatment on char removal. Salient fiber-failure features like micro-buckling, chop marks, and recessed fibers can only be observed in the out-of-plane direction (Figure 72). However, excessive char and soot deposition was observed on the cylindrical surfaces, providing adequate regions for sonication action, shown in Figure 71(a).

Figure 71. Sonication (60min, acetone) results of Cytec UNCO

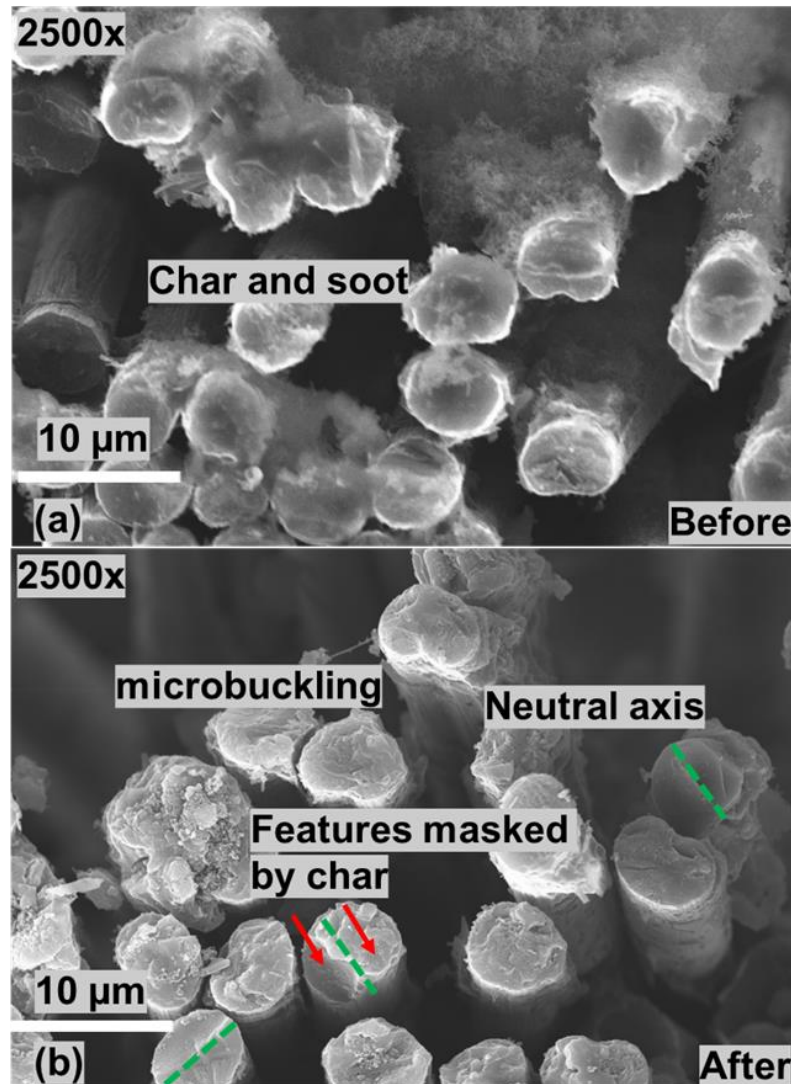
The char formation on the out-of-plane 0° fibers was markedly different from the fuzzy char globules noticed so far on the fiber ends. Char and soot deposition was found to be textured and present on the cylindrical lateral surfaces of the fibers (similar to the in-plane 90° fibers) at the perimeter of the fracture surface. This change in the char morphology could be attributed to incomplete combustion and inadequate air supply during combustion. Airflow could be restricted about the interface between consecutive fibers tightly arranged in tow, leading to the textured char along the fiber length. While micro-buckled fibers are visible in the micrograph, the char and soot deposits at the fiber-ends ostensibly masked the fracture features like chop marks on the fiber ends (Figure 72(a)). As shown in Figure 72(b), the optical micrographs point to a reduction in char on the cylindrical surfaces of the 0° fibers. Salient failure features like the chop marks on the compressive faced of the 0° fibers at the fiber ends are still masked by either char or melt dripping-like substance on these surfaces. This problem could be addressed by multiple ultrasonication passes or controlled pyrolysis of the fiber surfaces to burn off the surface depositions. It would be interesting to observe the effects of an additional pretreatment stage to 60 min of ultrasonic cleaning.

Figure 72. Sonication (60min, acetone) results of 21-ply cross-ply Cytec UNC0

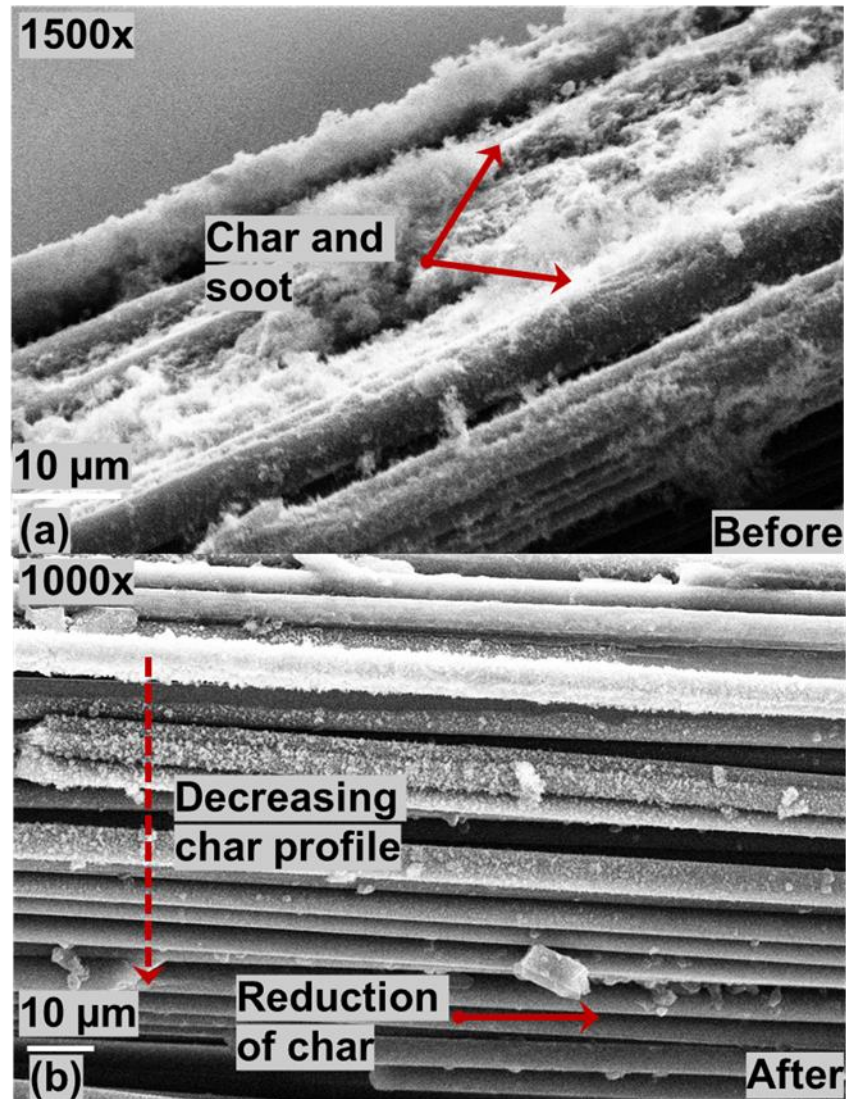
The optical micrographs in Figure 73(a) show representative images of a collection of in-plane 90° fibers with a significant amount of surface char and soot deposits on the cylindrical surfaces of the Cytec specimen. The angled orientation in the micrograph results from reorienting the specimen stub within the SEM chamber to get quality images. The presence of gaps between the inner and outer plies indicates a degree of inter-ply matrix decomposition.

After thermal shock and ultrasonication, a significant reduction was observed in the overall amount of char and soot deposits (Figure 73(a)). The fibers in the lower half of the image seem to be completely devoid of any surface char deposits. In contrast, the overall amount of char in the upper half of the micrograph was drastically reduced. Since the ultrasonication time used was 15 min for each cycle, it could be theorized that thermal cycling played a crucial role in weakening the interfacial bonding between the char and the underlying specimen. For a near-total removal of char, the specimen can be subjected to additional rounds of thermal cycling and higher duration of ultrasonication. However, care has to be taken to ensure that the composite surfaces are not damaged. Also, the effect of thermal shock on the fiber ends of the 0° fibers is an important factor to observe since the fiber ends often possess distinctive fracture surface features that help identify the nature of the failure. The effectiveness of thermal shocking assisted ultrasonic cleaning at higher sonication times in removing surface char from the fiber ends of the 0° fibers has to be studied to assess the viability of the cleaning process. Due to a technical difficulty, optical micrographs showing the effect of liquid N₂ induced thermal cycling (with subsequent sonication) on the 0° out-of-plane fiber ends and the accompanying salient fracture characteristics. The experiment will be repeated at a later date, and the SEM micrographs will be obtained.

Figure 73. Thermal cycling and sonication results of 21-ply cross-ply Cytec UNCO

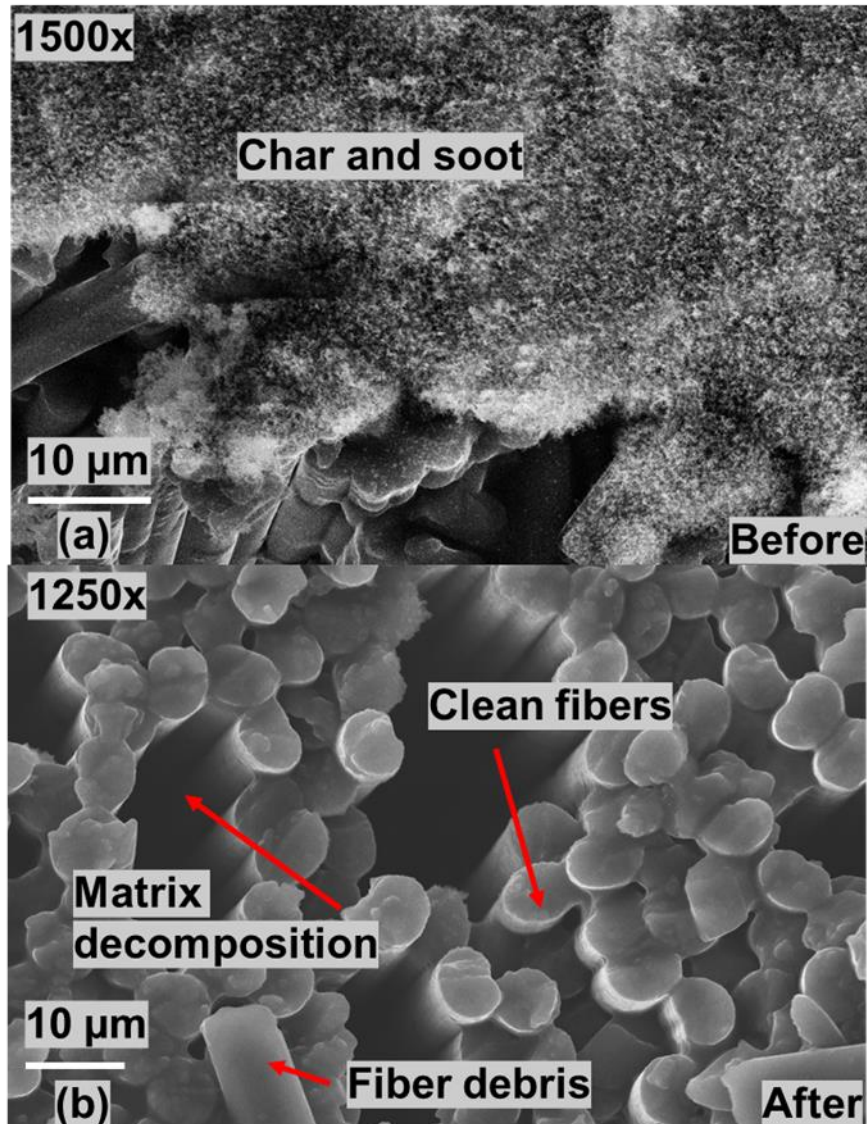
The SEM micrographs shown in Figure 74 represent the (out-of-plane) 0° fibers before and after surface cleaning for a representative Cytec specimen that has undergone thermal cycling due to boiling water and the subsequent ultrasonic cleaning. Before the surface cleaning, extensive char and soot deposits covering the fiber ends and spanning the image can be observed in Figure 74(a). In these (out-of-plane) 0° fibers, heat is conducted through the thickness of the composite. In this case, the interior in-plane plies can cut off the airflow required for heat conduction, resulting in the high-dense char on the fiber ends. Therefore, the surface char generated after burning is significant, with highly dense char on the fiber ends. However, after performing pretreatment in boiling water and ultrasonication, there seems to be a near-total reduction in the char and soot deposits on the fiber ends (Figure 74). Pretreatment with boiling water showed more promise than pretreatment with liquid N_2 . The fiber debris visible in the micrograph could result from mechanical failure, fire exposure, or surface cleaning. Multiple experiments with thermal cycling of the Cytec specimens in boiling water followed by ultrasonication will be conducted to investigate thermal cycling effectiveness.

Figure 74. Thermal cycling and sonication results of 21-ply cross-ply Cytec UNCO

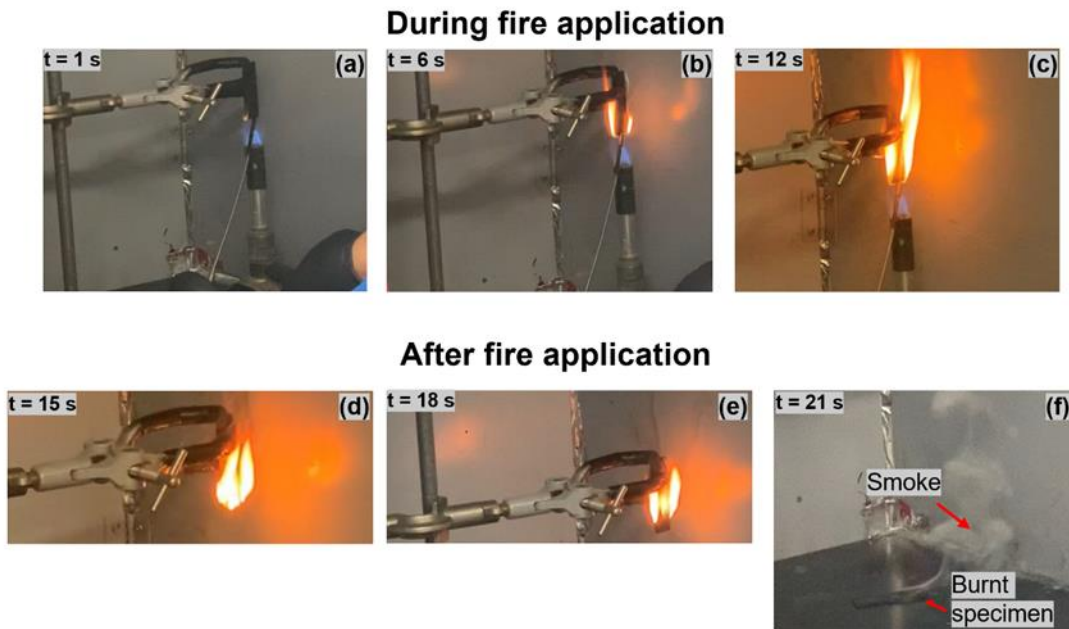
Figure B - 6. Flame evolution during 12 s vertical burn test of Hexcel specimens

The series of images in Figure B - 6 shows the flame evolution before and after initial fire exposure for a vertically oriented cross-ply [0/90/90/0] Hexcel specimen burned for 12 s. The flame spread is initiated first in the lateral edges till the entire specimen is engulfed in the fire. After the burner is turned off, the specimen continued to burn for 20 s, and the specimen broke free from the clamp with a loud bang. The expulsion of the specimen from the clamp could be attributed to the pressurized release of non-combustible gaseous products. Once on the ground, the specimen smoldered for about 15 s.

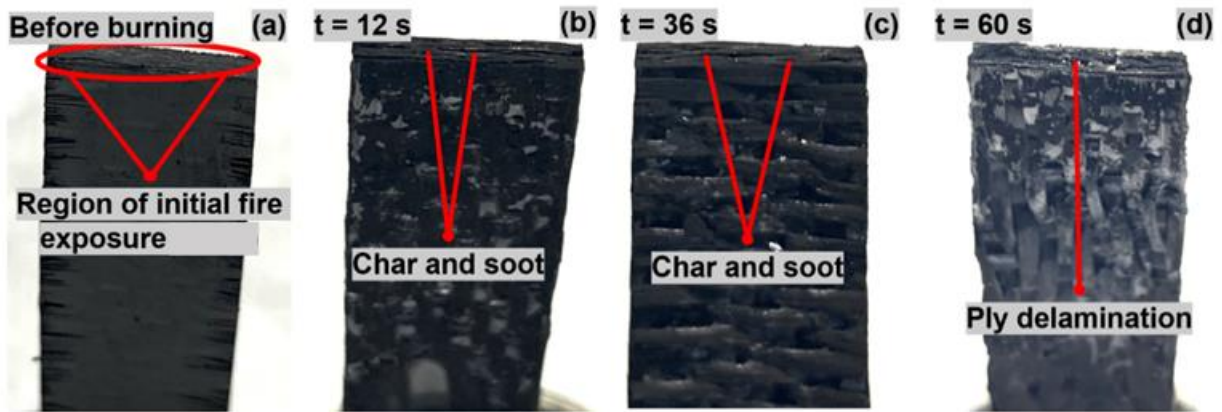
Figure B - 7. Initial fire exposed regions of 4-ply cross-ply [0/90/90/0] Hexcel specimens

Fire damage in the form of matrix decomposition, ply delamination, and residual thickness increase was more severe on specimens burned for 36 s and 60 s durations than for the 12 s fire exposure. In the case of the 60 s exposure duration, the 4-ply cross-ply [0/90/90/0] Hexcel specimens showed more significant through-thickness damage than the other exposure times, with excessive matrix decomposition. The lateral plies sustained a greater magnitude of delamination than the internal plies in all three cases, with the 60 s test yielding the highest

degree of ply-delamination. However, char formation was minimal on the fire-exposed region after burning for 60 s, possibly due to the excessive matrix decomposition since the specimen was exposed to the fire for a longer time. Char formation was more significant for the 12 s and 36 s exposure durations on both the fire-exposed region and the lateral surfaces of the specimens. The increase in the residual thickness was highest for the 60 s exposure duration, possibly due to a higher level of volatile outgassing and matrix decomposition. A similar trend was observed for the Cytec T40-800/Cycom[®] 5215 graphite/epoxy UNCO specimens. The fire damage on the lateral surfaces and the region of initial fire exposure is shown in Figure B - 7 and Figure B - 8. From the figures, that the ply-delamination was least for the vertically oriented specimen burned for 12 s. There is some fiber-tow separation, from the top plies on the lateral edges of the specimens, possibly due to pockets of matrix decomposition at those locations. Overall, char formation on the fire-exposed region was higher for the 36 s test specimen, followed by the 12 s test specimen.

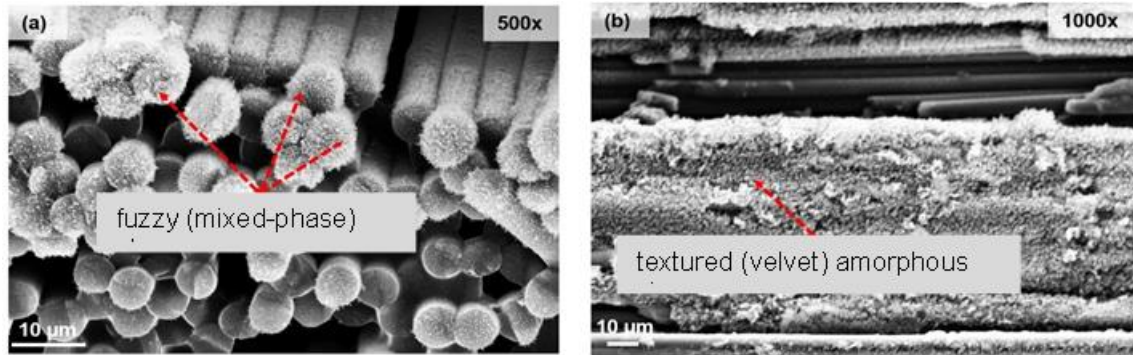
Figure B - 9. In-plane (0°) and out-of-plane (90°) fibers of burned 4-ply cross-ply [0/90/90/0] Hexcel specimens burned vertically for 12 s

The SEM micrograph in Figure B - 9 shows the fire damage on the fire-exposed region of a vertically oriented Hexcel specimen burned for 12 s. The fire-exposed region is marked with thermal damage, including matrix cracking, ply-delamination, char and soot deposition, matrix decomposition, and melt-dripping. The top ply [0/90/90/0] has a varied fire damage morphology. The lateral sides of the 0° fibers show strand-like fibers with near-complete matrix combustion and the middle portions undergoing incomplete burning with regions where the matrix was relatively untouched. The extreme decomposition at the lateral sides can be explained by the distribution of the flame, which tends to diffuse into the lateral sides of the specimen. The top ply also has pockets of matrix combustion with relatively low char on the fibers. The 90° fibers in the top ply showed signs of melt dripping across their surface in the middle regions of the ply.
