Mechanistic Investigation of Timber Crosstie Spike Fastener Failures – Phase I: The Magnitude of the Spike Failure Challenge

1. AGENCY USE ONLY (Leave blank)		2. REPORT DATE March 2021		3. REPORT TYPE AND DATES COVERED Technical Report
4. TITLE AND SUBTITLE Mechanistic Investigation of Timber Crosstie Spike Fastener Failures – Phase I: The Magnitude of the Spike Failure Challenge			5. FUNDING NUMBERS 6993JJ6-18-C-000005

6. AUTHOR(S) Tom Roadcap (0000-0001-5591-7922), Marcus S. Dersch P.E. (0000-0001-9262-3480), and J. Riley Edwards, P.E. (0000-0001-7112-0956)				
7. PERFORMING ORGANIZATION NAME(S) AND ADDRESS(ES) University of Illinois at Urbana-Champaign 205 North Mathews Avenue Urbana, Illinois 61801			8. PERFORMING ORGANIZATION REPORT NUMBER

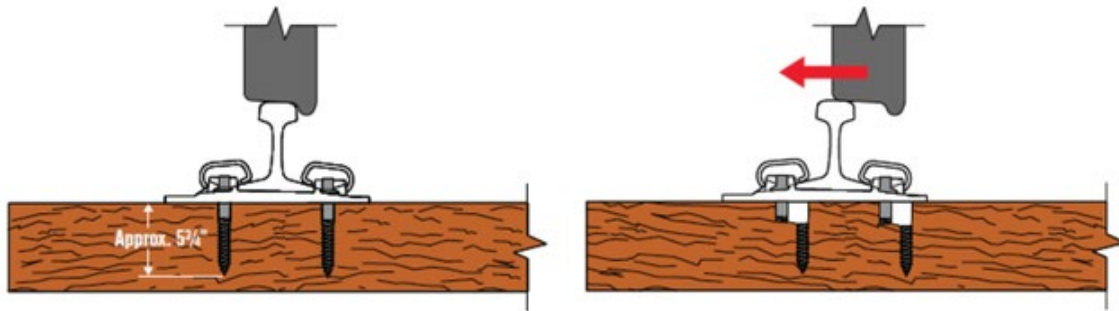
Figure 7. Union Pacific diagram showing spike failure and resulting wide gauge [7]

UP also published a diagram (reproduced by Oregon Public Radio), which can be seen in [Figure 7](#), to explain to the public how the wide gauge occurred. In the aftermath of the derailment, four tank cars caught fire and a significant amount of crude oil was spilled into the Columbia River Gorge. FRA initiated special inspections of the UP and BNSF track in the area and took enforcement action against UP.

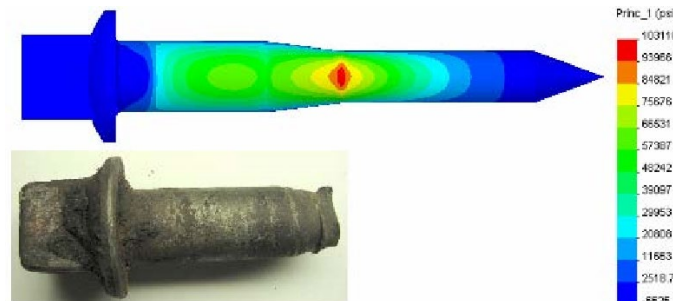
Figure 11. Comparison between location of peak tensile stress from the finite element model and a real failed spike [10]

FE analysis results, shown in [Figure 11](#), found that crosstie stiffness had a significant effect on the stress felt in the spikes, especially at lower crosstie stiffnesses. The authors report that “The FEA model predicted that a lateral load above 8,000 lbs. (35.6 kN) would create stresses above the endurance limit, no matter what the tie stiffness. Likewise, a lateral load below 3,500 lbs. (15.6 kN) would not create stresses above the endurance limit, no matter what the tie stiffness.”

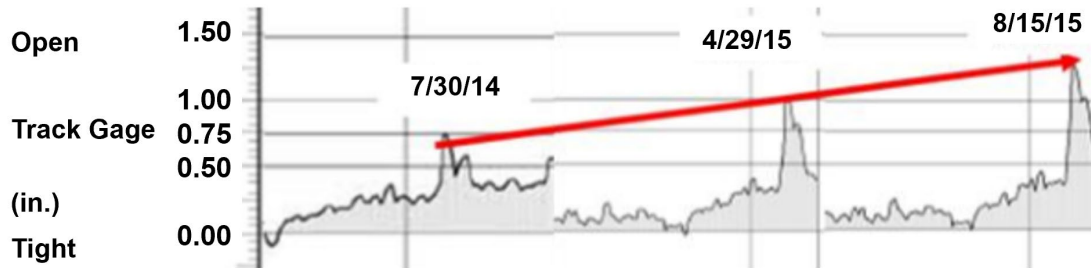
Figure 14. Gauge widening over time at a specific location due to broken spikes [11]

The investigation also found that gauge widening is directly proportional to the number of broken spikes, as shown in [Figure 14](#) below.

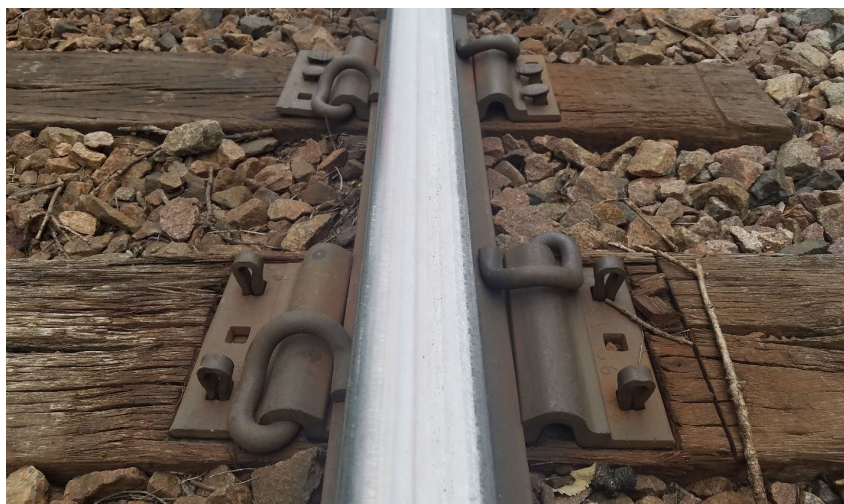
Figure 30. Pandrol plates using lock spikes (foreground) and cut spikes (background)

The premium fasteners examined on this visit were Pandrol rolled plates with e-clips. Some used cut spikes and some used lock spikes (“hairpins”), shown in Figure 31. The inspection party walked multiple curves with Pandrol plates and examined some curves with the newer curve blocks. The curves ranged from 2° to 4° on mainly level grades between 0 percent and 0.6 percent. Annual tonnage in the area was around 26 MGT.

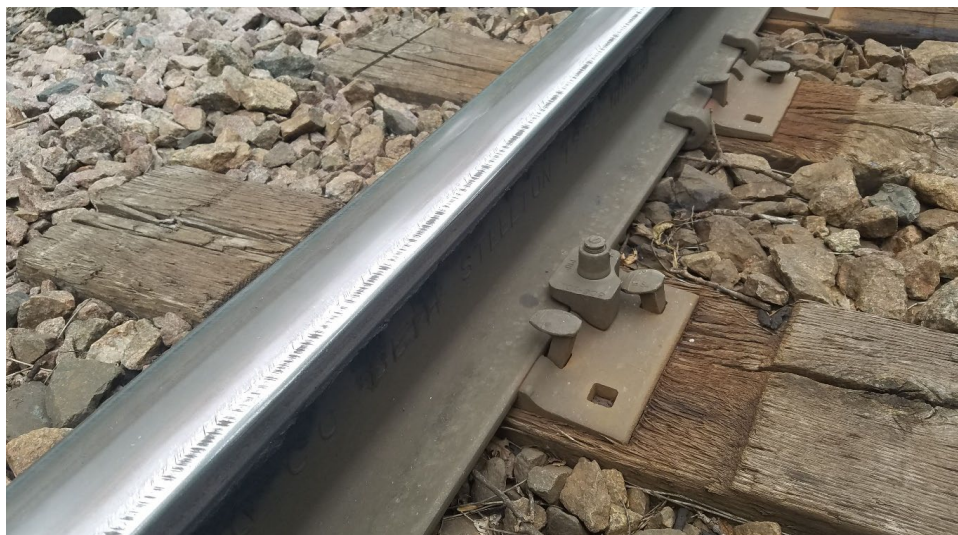
The Pandrol plates were all of 1990s vintage or older and showed signs of wear but did not have broken spikes. The local maintenance personnel reported that spike failure was not a major issue in their Pandrol plates, nor in any of their other fastening systems. Only one broken spike, a lock spike, was found in a Pandrol plate. However, it seemed that the movement of longitudinal force from plate to spikes had in some cases resulted in wear of the plate into the spikes instead of spike breakage, as shown in [Figure 32](#).

Figure 32. Example of a traditional tie plate with a curve block

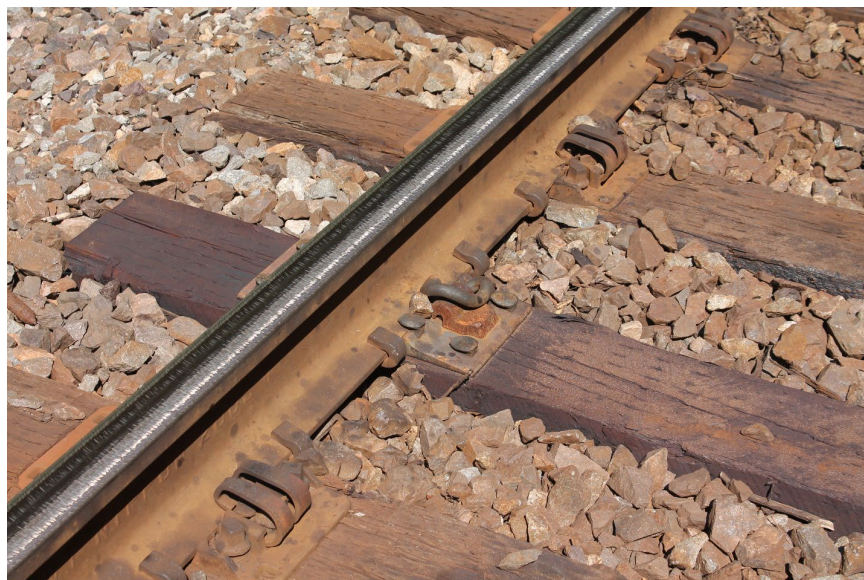
Maintenance confirmed that they have sometimes found clusters of broken lags where several are broken in a plate or there are several crossties in a row with at least one broken. Several locations were observed where new crossties with Victors had been installed to mitigate a cluster of broken spikes (Figure 38).

Figure 37. A new crosstie with Victor plate, spotted in where there was previously a crosstie with broken lags in the McKay system

UP personnel walk the curves with McKay clips at least once every 90 days, and any crossties found with broken lags in them are replaced with Victor plates with cut spikes. This aggressive maintenance strategy has led to replacement of around 100 crossties per month including one problematic curve with 250 new crossties installed.

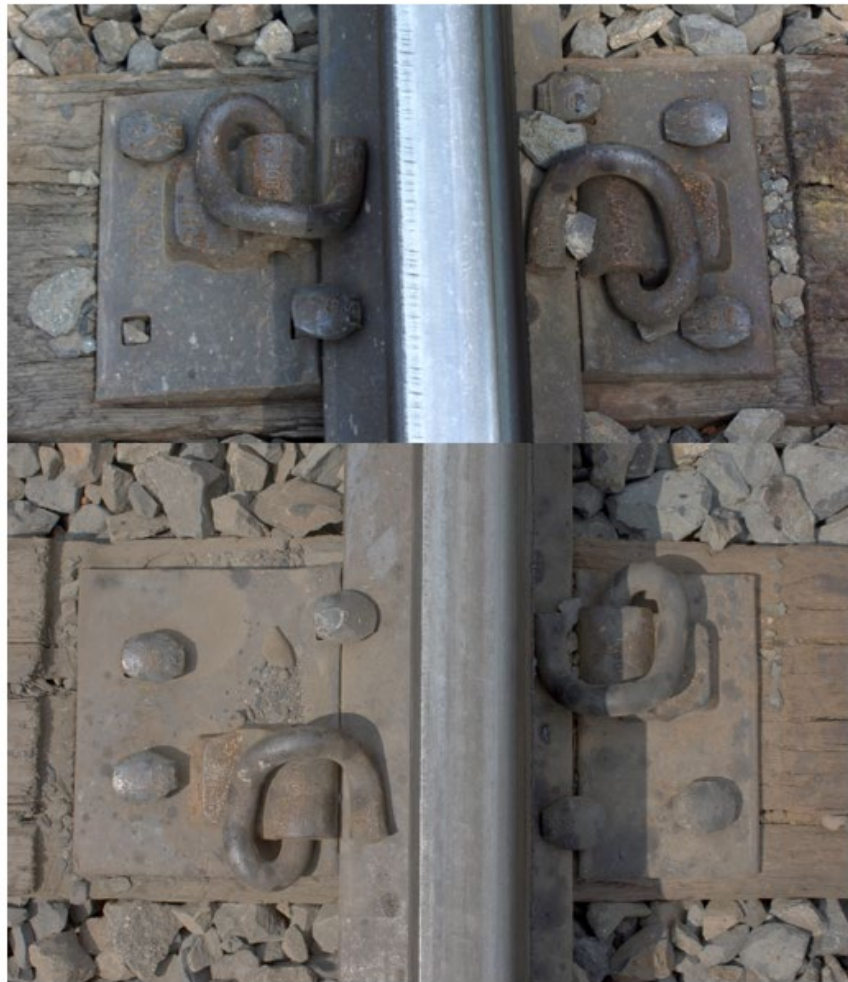
curves over 6° have 18-inch Victor plate. A comparison of both Victor plates can be seen in Figure 39.

Figure 38. Comparison between 16" Victor plate (top) and 18" Victor plate (bottom)

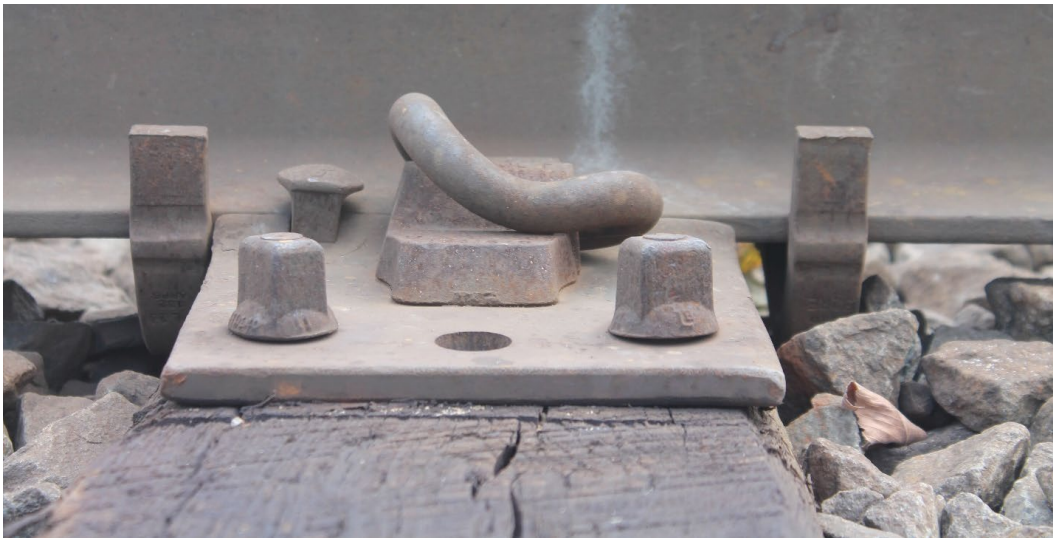
NS maintenance personnel stated that every 6 months, they replace 50 crossties in each track on the curve. In some cases, they use a “bridge Victor” (a Victor plate with screw spikes) on these crossties, which has been found to help alleviate broken spike problems, as shown in [Figure 43](#). Further, they recently box-anchored every other crosstie in the curves to try and further reduce spike failures. It is not possible to know whether the broken spikes found during the visit had already begun breaking before the anchors were installed.

Figure 42. New crosstie with "bridge Victors" and rail anchors to help alleviate spike failures

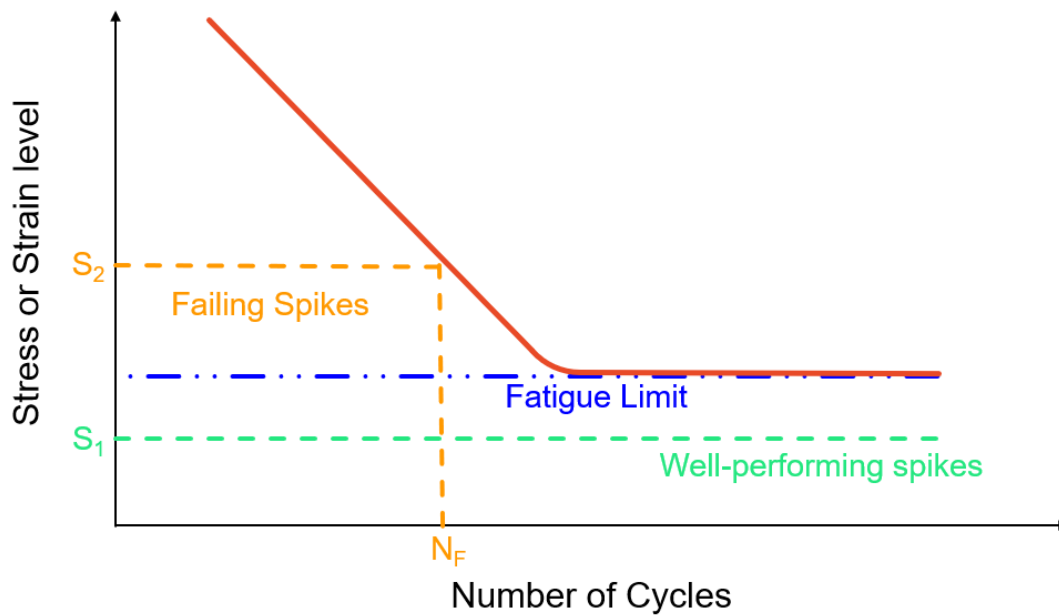
Because the observed spike failures are fatigue failures, one must first understand how and when higher input loads can lead to spike failures. The fatigue life of spikes can be understood with stress versus number of cycles (S-N) curves. The S-N curves shown below represent the fatigue life of a spike, with number of cycles on the spike on the x-axis and stress felt in the spike on the y-axis. The fatigue limit is the stress level below which steel will never fail in fatigue. There are two distinct possibilities for how the failures relate to the fatigue life of spikes. First, it may be that the stress being felt in well-performing spikes is beneath the fatigue limit of steel, whereas the stresses being felt in the failing spikes is above the fatigue limit ([Figure 50](#)). The second possible case is that all spikes are at a stress level high enough that they would eventually fail, but the rail life (in number of cycles) falls between those that break and those that do not. The reason the rail life is important is that when rail is replaced, it is standard to replace fasteners and spikes as well (though there may be cases where this is not done in practice, as will be discussed later) ([Figure 51](#)).

Figure 49. Hypothetical relationship between failing spikes and well-performing spikes on the S-N curve

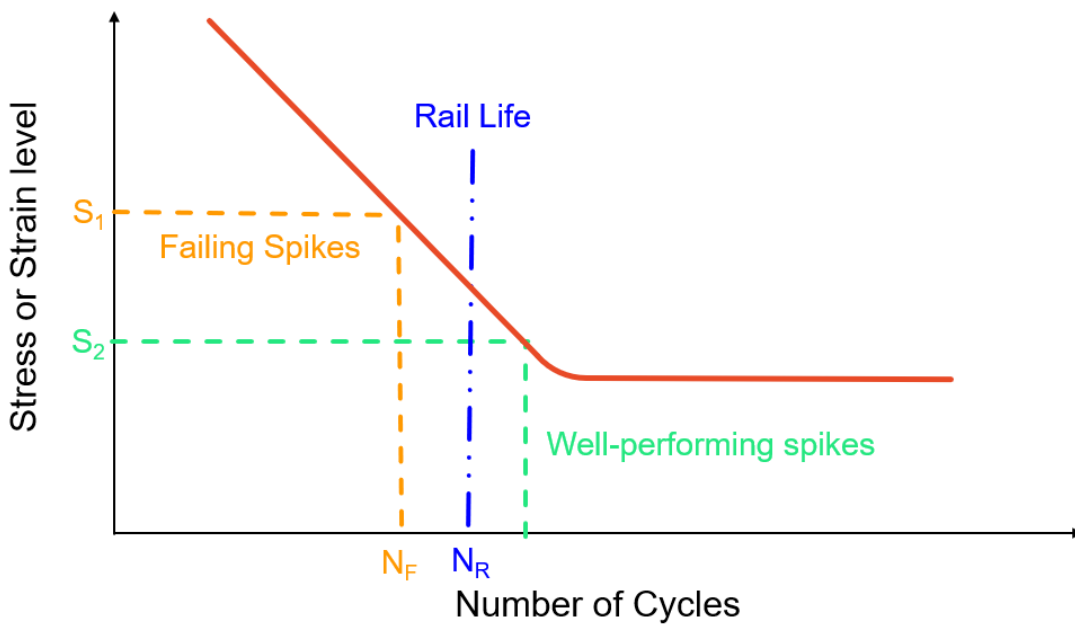
Figure 50. Hypothetical relationship between failing spikes and well performing spikes considering rail/spike replacement on an S-N curve

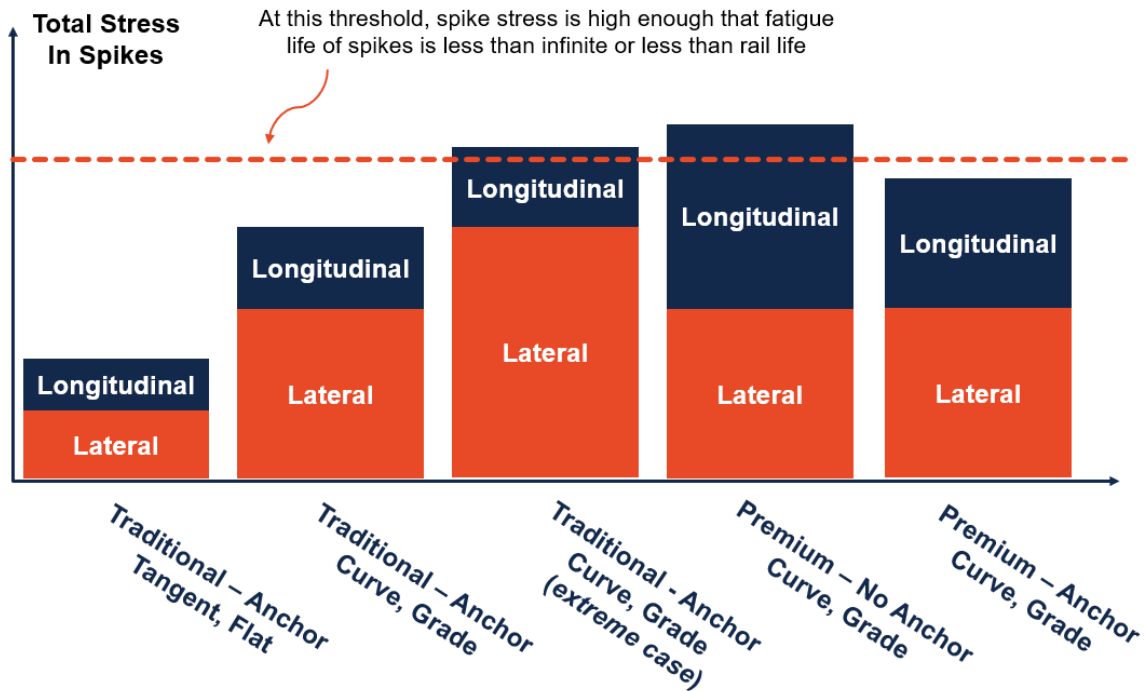
Figure 52 shows a conceptual analysis of how different factors that increase spike stress can lead to broken spikes. The x-axis lists several potential environments for a spike, and the y-axis represents the stress in a spike. The dotted orange line across the top of the graph represents the threshold where spike stress is higher than the fatigue limit of the spike steel, or where the spike stress is high enough that the spike will fail before rail replacement.

Figure 51. Illustrative example of how general factors and premium fastening systems may affect spike stress and the resulting potential for spike failures

In the case of a spike in a traditional fastening system on flat tangent track (far left in Figure 52), this spike may experience some longitudinal forces (for example, from braking or thermal forces) and lateral loads (e.g., from hunting or track irregularities), but they will most likely not be high enough on a regular basis to lead to broken spikes. A spike in a traditional system on a curve and grade will experience higher lateral stresses due to the curving forces of the train and effects of curve breathing with temperature, and it may also experience higher longitudinal forces from traction or braking (though it is expected that the rail anchor takes most of these forces). In an extreme case, these extra forces could be enough to cause spikes to fail.

Premium fasteners may result in higher spike stresses from longitudinal forces due to a lack of rail anchors, as explained in detail in the following sections. It is therefore expected that a spike in a premium fastener will experience higher longitudinal forces as compared with a spike in a traditional system, and that this added force may be sufficient to cause spike failures (fourth case from the left in Figure 52). NS has begun using rail anchors as a mitigation approach to spike failures, and this has been found to result in fewer failures. This case is shown on the far right of Figure 52, where total spike stresses have receded below the threshold for failure.

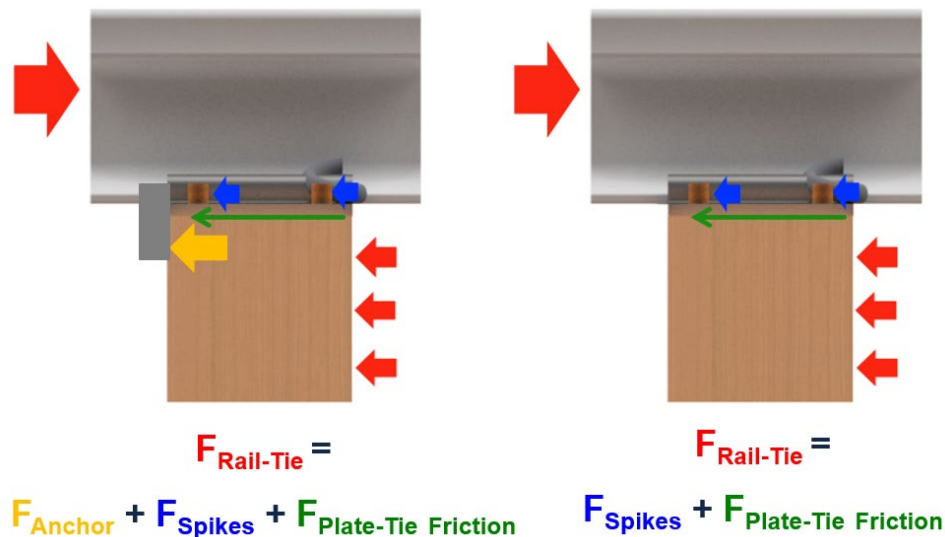
One can imagine the scenario where there is also frozen moisture in the rail seat or tie plate uplift (see Section 7.2.2), reducing or eliminating friction between the plate and tie, forcing all the longitudinal force to move through the spikes. Supporting this theory is one of the findings during the Norfolk Southern field visit, where researchers found that the use of rail anchors with Victor plates reduced the frequency of spike breakage. This situation, shown in Figure 53, is like that of the traditional fastening system in that a rail anchor is present to transfer longitudinal load directly to the crosstie instead of through the spikes. Note that Figure 53 does not show full free-body diagrams. Here the rail and tie plate are considered rigidly connected by the elastic clip. The total longitudinal force being transferred to the crosstie is the same as the sum of the friction, spike, and (if present) anchor reaction forces.

Figure 52. Premium system with and without rail anchors

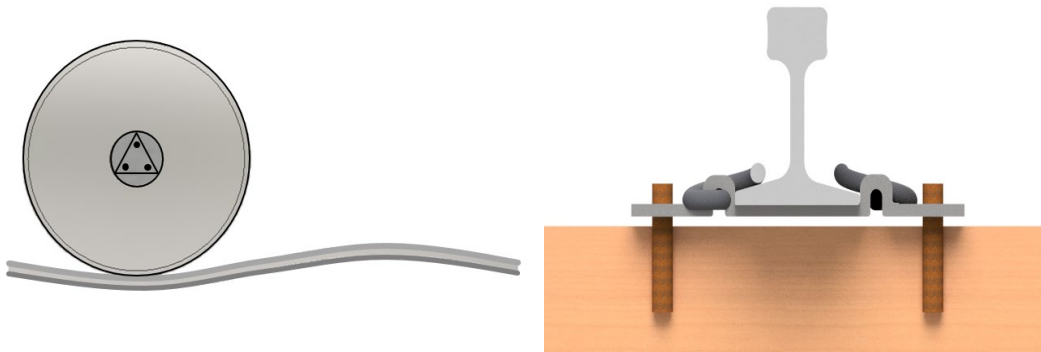
A plate that is lifted off the tie will reduce or eliminate friction between the plate and crosstie, as shown in Figure 54. This in turn will result in a direct force path between the rail and the spikes. It is known that there is a significant amount of longitudinal stress in the rail well ahead of a train or axle loads within a train [17] where this uplift occurs.

Figure 53. Visual depiction showing rail uplift ahead or behind a wheel load and the accompanying plate uplift in a premium fastening system

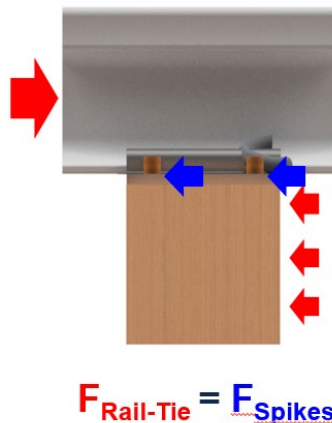
The uplift mechanism may explain the spike hole elongation and/or spike neck wear that has been observed in some premium fasteners. In this scenario, uplifting plates carry longitudinal force, which is transferred to the spikes as shown in Figure 55. As the plate moves up and down, it wears against the spike, leading to spike hole elongation in the plate and/or neck wear on the spike (Figure 56).

Figure 54. Expected effect of rail uplift on longitudinal force path from rail to crosstie

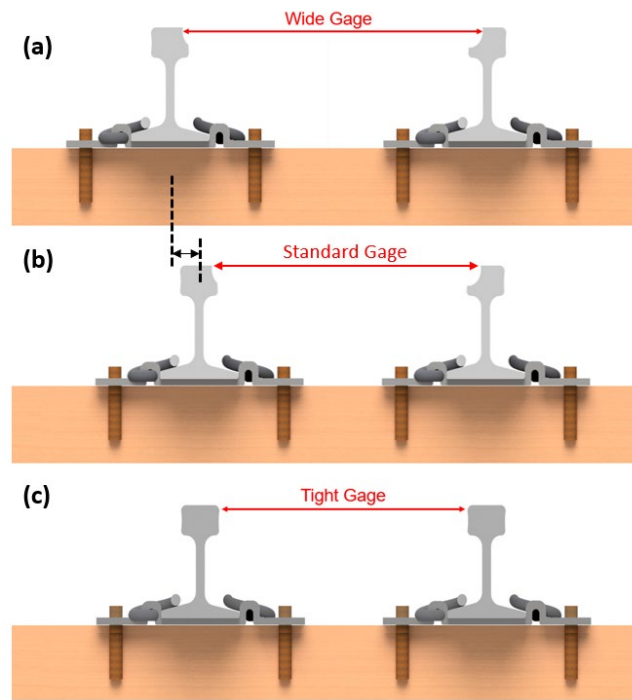
One potential issue with rail replacement alone is illustrated in Figure 57. If rail in a curve gets worn down sufficiently, the wear, in combination with rail and plate movement, may lead to wide gage (Figure 57a). In this case, maintenance may gauge the rails in the curve to keep the track gage within the standard (Figure 57b), bringing it back to standard. If a rail gang then replaces the rail by only removing the clips and laying the new rail the result would be tight gage (Figure 57c). As long the gage is within standards, then this may not be an issue. In this tight-gage scenario the effect would likely be higher lateral forces on the system, and if the spikes are fatiguing, their reliability would decrease. The spikes are in service much longer than they would have otherwise been in the traditional fastening system.

Figure 56. Effect of laying rail over existing premium fasteners

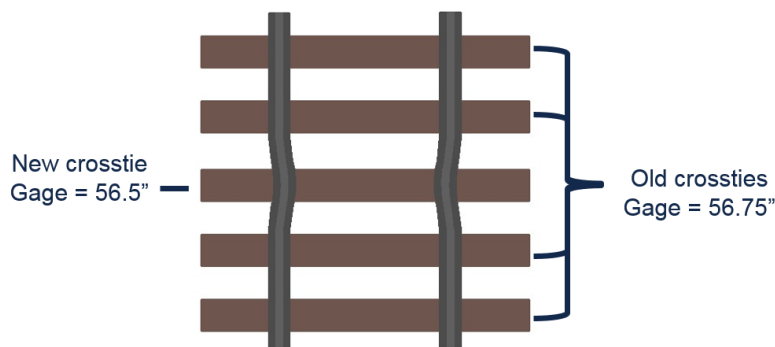
When a new crosstie is installed, spikes and plates are typically removed from the old crosstie to pull it out from under the rail. The new crosstie is then slid under the rail and the rail spiked to the crosstie. When spiking the rail to the new crosstie, the rail should be spiked to “prevailing gauge” (the current gauge of the surrounding track) to prevent the introduction of track irregularities. For example, if the prevailing gauge of a stretch of track is 56.75 inches, the railroad standard is typically to spike to a 56.75-inch gage rather than standard gage (56.5 inches). However, if a spiker operator is not regularly remeasuring the track gauge to be sure he or she is spiking to the current prevailing gauge, then gauge irregularities could be introduced. If the rail is spiked to standard gauge instead of prevailing gauge, the potential result is shown in [Figure 58](#). This creates a track irregularity that could lead to higher lateral dynamic forces into the spikes at these locations as trains pass over. This may help to explain why broken spikes are experienced more frequently in new crossties.

Figure 57. Exaggerated schematic showing a new tie with rails spike to standard gauge while the surrounding track has a prevailing gage of 56.75 inches
