Improving Resilience of Transportation Infrastructure to Hurricane Damage

NCDOT Project 2021-08
FHWA/NC/2021-08
September 2023

B. Shane Underwood, Ph.D.
Brina Montoya, Ph.D..
Department of Civil, Construction, and
Environmental Engineering
North Carolina State University

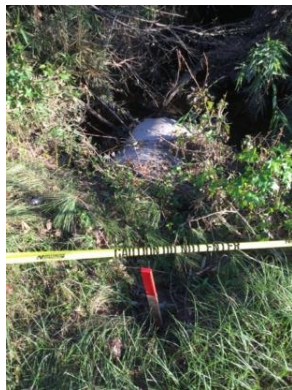
Figure 17. Photos of damage after Hurricane Florence in Site 77-6-F.

This site is located on Townsend Road. It was damaged only after Hurricane Florence and similar to the previous sites described, the compiled information on this site is summarized in Table 8. The damage photos after Hurricane Florence are shown in Figure 17 and the current photos are shown in Figure 18. As shown in Figure 17 the official description of damage is quoted below.

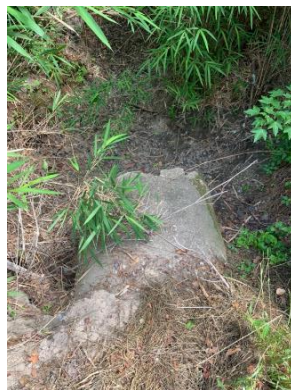
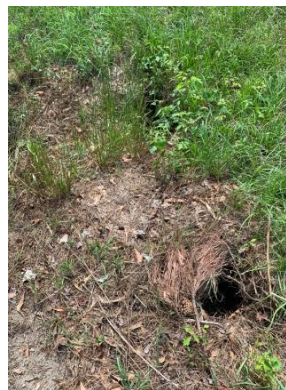
Figure 18. Current photos of Site 77-6-F.

As shown in Figure 18, it seems that the pipe was not fixed and looks the same as it was after Florence. Last part is disjointed in the inlet side and scours holes can be seen on the shoulder near the second joint.

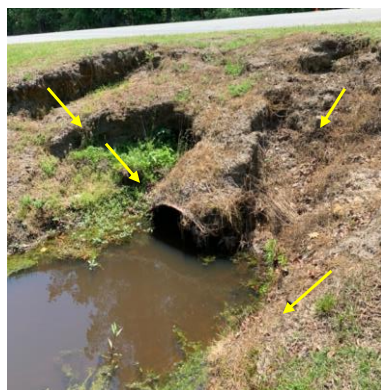
Figure 26. Current photos of Site 77-4-M.

This site is located on Mt. Moriah Church Road, and it was damaged only after Hurricane Matthew. The compiled information for this site is presented in Table 12. The photos of damage on the inlet side after Hurricane Matthew are shown in Figure 25 and photos of the current condition also on the inlet side are shown in Figure 26. In this site, evidence of erosion can be seen around the pipe and on the shoulder even though it was not flagged as damaged after Florence (as highlighted by yellow arrows in Figure 25 and Figure 26). Evidence of continued erosion was observed in at least nine sites among sites visited in Robeson County. In most cases, the sites were only reported as damaged after Matthew (as was the case with the site shown here), but that was not a consistent pattern, some cases were damaged only after Florence and some cases were damaged after both events. Among the nine sites, in six sites the evidence of erosion is seen on the inlet side and in one site on both inlet and outlet site.

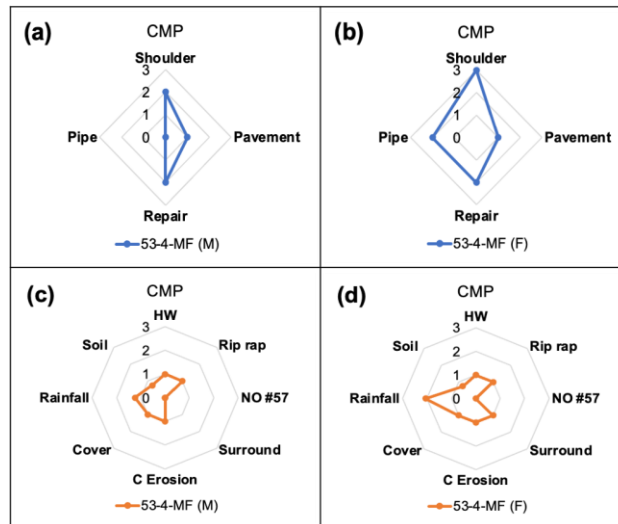
Figure 39. Radar plots of Site 53-4-MF for: (a) damage levels after Matthew, (b) damage levels after Florence, (c) vulnerability scores after Matthew, and (d) vulnerability scores after Florence.

In the initial investigation of radar plots for CMP pipes, the plots were categorized based on the visual pattern. Then within each shape category, radar plots of scores and damage levels were compared to explore correlations. Figure 39 and Figure 40 are presented here as examples. Figure 39 shows the radar plots for Site 53-4-MF as one of the categories. The radar plots of damage levels were previously discussed in this report. As showed in Figure 39(c) and (d), the radar plots of score components for Matthew and Florence are the same except rainfall intensity and

surrounding features (in this case flood plain) is worse in Florence, so the higher damage level in Florence can partly be explained by this factor.

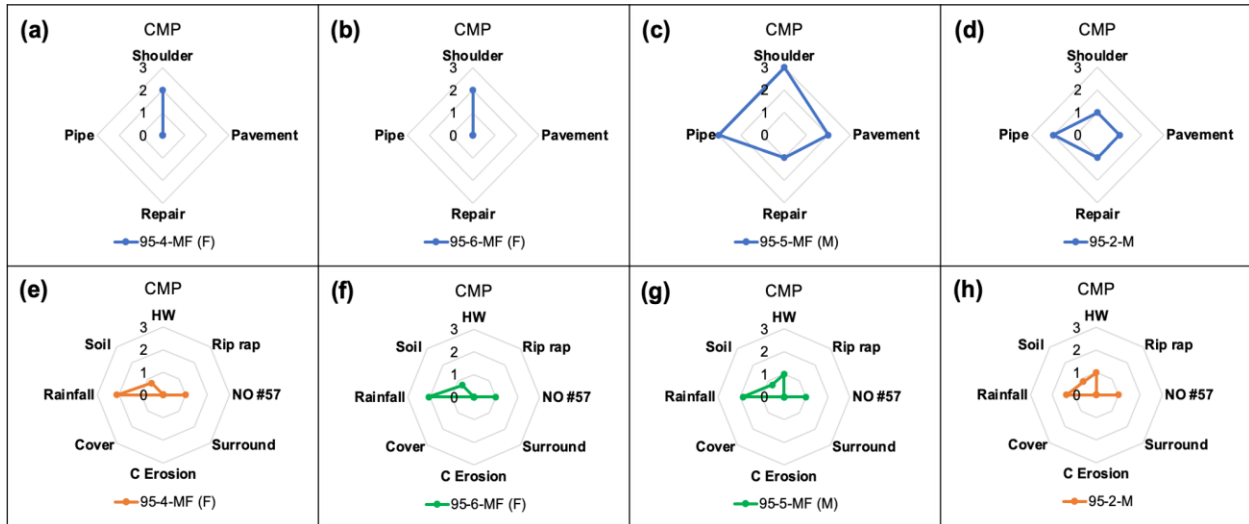
Figure 40 shows the radar plots for Sites 95-4-MF, 95-6-MF, 95-5-MF, and 95-2-M and shows a second category of vulnerability behaviors. Comparing the plots of Sites 95-4-MF and 95-6-MF, Figure 40(a), (b), (e), and (f), with Sites 95-5-MF and 95-2-M, Figure 40(c), (d), (g), and (h), it can be seen that the level of damage is significantly different between these two groups. These differences are present even though their vulnerability score plots are almost similar except for the headwall component. The former group, Figure 40(a), (b), (e), and (f), have headwall, but the latter group does not have headwall, Figure 40(c), (d), (g), and (h), so the higher level of damage in the latter group can be partly explained. Also, it is noted that the color of the graphs in Figure 40(f) and (g) (green) indicates that in these cases the HW/D with respect to the 25-year design event is less than 1.2. The orange color in Figure 40(e) and (h) indicates that the HW/D is higher than 1.2. However, this parameter does not provide further insight on the correlation patterns, therefore, further investigation is needed in exploring the correlations between vulnerability score and damage level component.

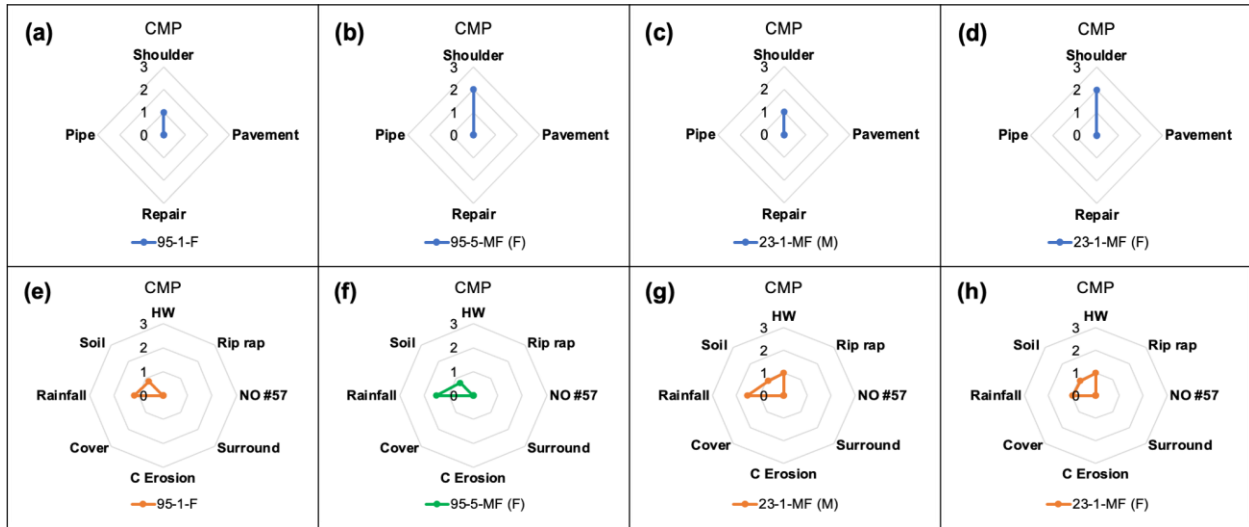
Figure 41(a – h) shows the radar plots for Site 95-1-MF, 95-5-MF, and 23-1-MF to show a third category of the vulnerability radar plots. In this particular case, a combination of the following factors contributed to the absence of damage to the pavement and pipe, requiring only minor repairs:

- Presence of rip rap and No. 57 Stone, along with sufficient cover (due to lack of data during the events, the cover is qualitatively evaluated based on damage photos): These measures provided adequate protection against erosion and mitigated the potential for damage.
- Absence of surrounding features (i.e., swamp, beaver dam, and wide floodplain) and channel erosion: The lack of nearby vulnerability and strong flow causing the erosion of channel minimized the risk of impact on the pavement and pipe.

- Low intensity of rainfall and less erodible soil type: The rainfall during the event was of low intensity, coupled with the presence of less vulnerable soil, further reducing the likelihood of damage.

In this context, the influence of the lack of headwall, Figure 41(g) and (h), and HW/D ratio (low in case on Figure 41(f) and high in cases of Figure 41(e), (g), and (h)) was overshadowed by the combined effect of these other factors.

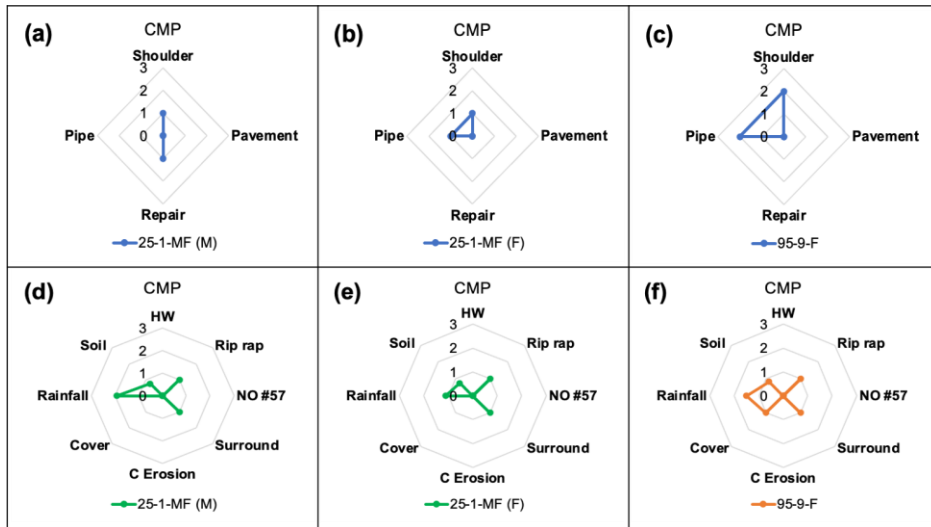
Figure 42. Radar plots of damage level components for: (a) Site 25-1-MF after Matthew, (b) Site 25-1-MF after Florence, (c) Site 95-9-F after Florence, and radar plots of vulnerability scores for (d) Site 25-1-MF after Matthew, (e) Site 25-1-MF after Florence, and (f) Site 95-9-F after Florence.

Figure 42(a – f) shows the radar plots for Site 25-1-MF and 95-9-F as another category of vulnerability radar plots. In this case, a combination of the following factors contributed to the absence of damage to the pavement and the need for only minor repairs:

- Use of No. 57 Stone and headwall: The utilization of No. 57 Stone and a headwall provided sufficient protection and stability for the infrastructure, preventing significant damage.
- Absence of channel erosion: When no channel erosion is observed it implies that the storm flow was not strong. Due to the lack of strong flow, the pavement and infrastructure remained intact, avoiding any significant damage.
- Less erodible soil type and low rainfall intensity: The soil's less erodible nature and the low intensity of rainfall reduced the risk of damage to the pavement.

However, it is worth noting that the presence of surrounding features and the absence of rip rap had adverse effects including requiring minor repairs, Figure 42(a), or damaging the pipe, Figure 42(b) and (c). Comparatively, Site 95-9-F, Figure 42(c), exhibited more significant damage to the pipe and shoulder due to insufficient cover and a high HW/D ratio when compared to Site 25-1-MF after both Matthew and Florence, Figure 42(a) and (b).

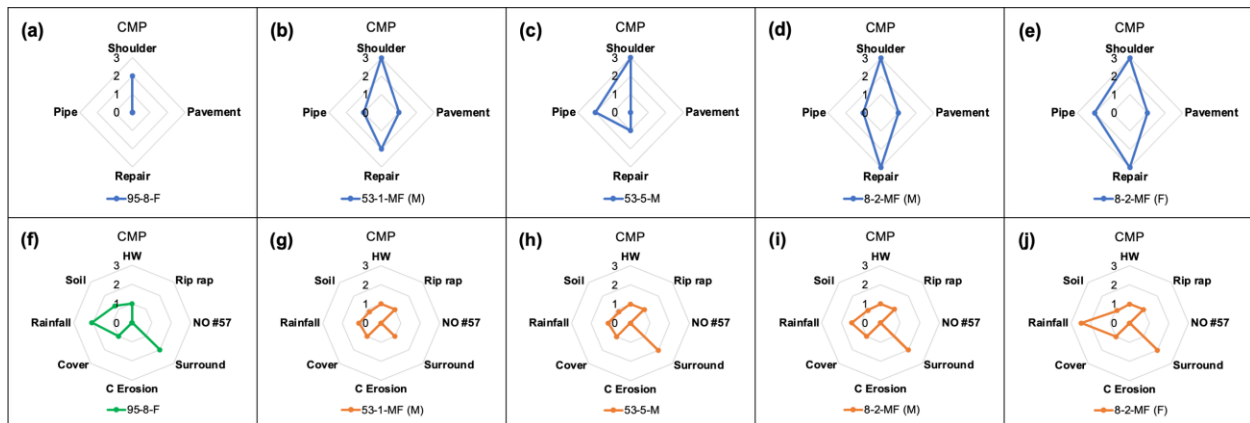
Figure 43 (a – j) shows the radar plots for Site 95-8-F, 53-1-MF, 53-5-M, and 8-2-MF as another category of vulnerability radar plots. In this case, a combination of factors contributed to damage to all components resulting in a diamond shape in radar plot and particularly extreme damage to the shoulder. The factors involved in this case are as follows:

- Absence of headwall, rip rap, and cover: The lack protective measures such as headwall, rip rap, and cover left the site vulnerable, leading to substantial damage to shoulder and pipe. It also required moderate to heavy repair.

- Presence of surrounding features (i.e., swamp, beaver dam, and wide floodplain) and high intensity rainfall: The presence of surrounding features and occurrence of high-intensity rainfall heightened the risk of damage to all components at these sites.
- Use of No. 57 Stone: The utilization of No. 57 Stone provided protection and stability for the pavement.
- Absence of channel erosion: The absence of channel erosion indicates the absence of a strong flow, which played a role in preventing damage.

It should be noted that low HW/D value, which suggests sufficient design helped prevent damage to pipe and pavement, Figure 43(f). However, the combination of factors mentioned above still had a significant impact on shoulder, resulting in considerable damage, Figure 43(f).

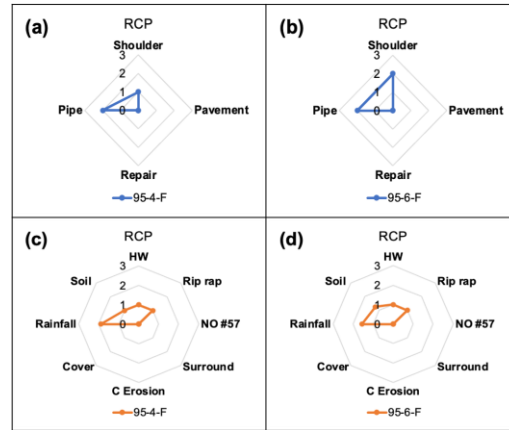
Figure 44. Radar plots of damage level components for: (a) Site 95-4-F after Florence, (b) Site 95-6-F after Florence, and radar plots of vulnerability scores for (c) Site 95-4-F after Florence, and (d) Site 95-6-F after Florence.

Similarly, the radar plots for RCP pipes were evaluated and the plots were categorized based on the visual pattern. Then within each shape category radar plots of scores and damage levels were compared to explore correlations. Figure 44 (a – d) shows the radar plots for Site 95-4-F and 95-6-F as one category of vulnerability radar plots. In this case, a combination of factors contributed to damage to pipe and shoulder resulting in a triangle shape in radar plot. The factors involved in this case are as follows:

- Absence of headwall and rip rap: The lack protective measures such as headwall and rip rap left the site vulnerable, leading to substantial damage to shoulder and pipe.

- Moderate intensity of rainfall and erodible soil type: The rainfall during the event was of moderate intensity, coupled with the presence of vulnerable soil, further increasing the likelihood of damage to pipe and shoulder. More specifically, in Site 95-6-F, Figure 44(d), the soil is more vulnerable than that of Site 95-4-F, Figure 44(c), the damage to the shoulder

is higher in Site 95-6-F, Figure 44(b), even though the rainfall is less intense in Site 95-4-F.

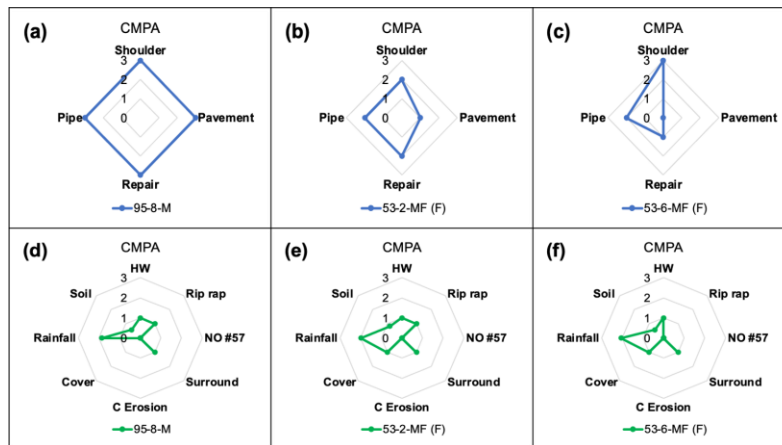
Figure 45. Radar plots of damage level components for: (a) Site 95-8-M after Matthew, (b) Site 53-2-MF after Florence, (c) Site 53-6-MF after Florence, and radar plots of vulnerability scores for (d) Site 95-8-M after Matthew, (e) Site 53-2-MF after Florence, and (f) Site 53-6-MF after Florence.

Similarly, the radar plots for CMPA pipes were evaluated and the plots were categorized based on the visual pattern. Then within each shape category radar plots of scores and damage levels were compared to explore correlations. Figure 45 (a – f) shows the radar plots for Site 95-8-M, 95-2-MF, and 95-6-MF as one category of vulnerability radar plots. In this case, a combination of factors contributed to damage to all components.

- 1- Absence of headwall: The lack protective measures such as headwall left the site vulnerable, leading to substantial damage to shoulder, pipe, and pavement.
- 2- Presence of surrounding features (i.e., swamp, beaver dam, and wide floodplain): The presence of surrounding features heightened the risk of damage to all components at these sites.

- 3- Moderate intensity of rainfall and erodible soil type: The rainfall during the event was of moderate intensity, coupled with the presence of vulnerable soil, further increasing the likelihood of damage to pipe and shoulder.

It should be noted that presence of sufficient cover in Site 95-2-MF and 95-6-MF provided protection for the components and the level of damage for these sites is less than that of Site 95-8-M. Comparing Site 95-2-MF and 95-6-MF, it can be seen that use of rip rap provided additional protection and pavement was not damaged in Site 95-6-MF despite of Site 95-2-MF.

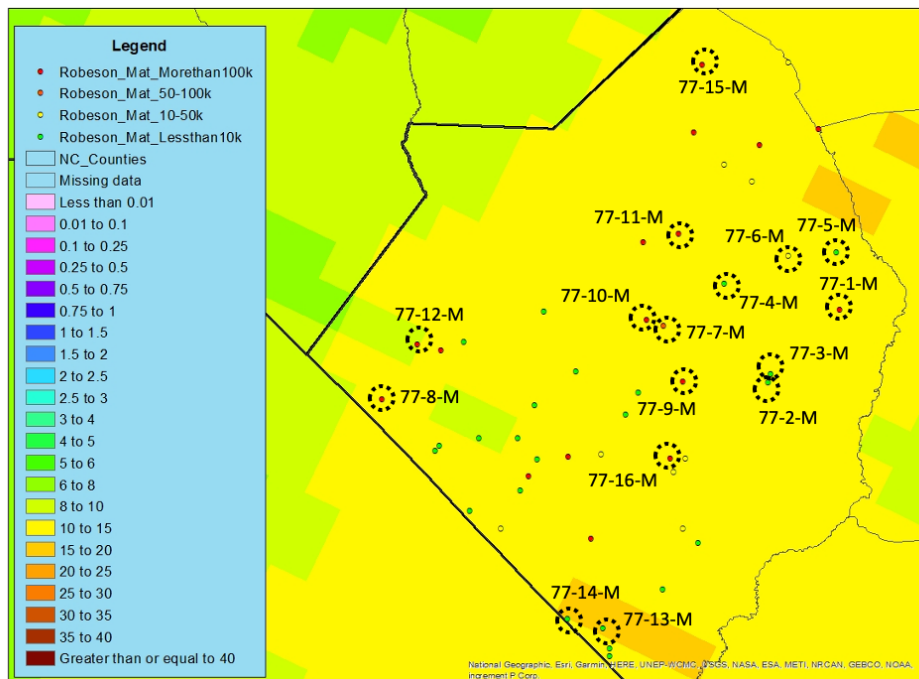
Figure B.7. Damaged locations after Hurricane Matthew overlaid on Hurricane Matthew precipitation map.

The case studies presented in Figure B.7, and Figure B.8 that were only damaged after Matthew are interesting to investigate in comparison with each other as well as stand-alone cases because they help explain some specific situations.

- Case 77-1-M required high-cost category repairs after Matthew, and it was not damaged after Florence (with high level of precipitation) which might be considered as a successful repair.

- Cases 77-2-M and 77-3-M required low-cost category repairs after Matthew, and they were not damaged after Florence (with high precipitation).
 - Comparing case 77-1-M, 77-2-M and 77-3-M might answer the following question: “why both locations were not damaged after Florence considering they were under similar conditions in terms of precipitation intensity?”

- Cases 77-4-M and 77-5-M required low-cost category repairs after Matthew, and they were not damaged after Florence.
- Case 77-6-M and 77-7-M required moderate-cost category repairs after Matthew, and it was not damaged after Florence.

- Cases 77-8-M, 77-9-M, 77-10-M, and 77-11-M required moderate-cost category repairs after Matthew, and they were not damaged after Florence.
 - Comparing cases 77-4-M and 77-5-M – 77-8-M, 77-9-M, 77-10-M, and 77-11-M might explain why these cases that were under the same level of precipitations and received different types of repairs, performed successfully after Florence.

- Case 77-12-M required high-cost category repairs after Matthew, and it was not damaged after Florence.
 - Comparing cases 77-8-M, 77-9-M, 77-10-M, and 77-11-M and 77-12-M might explain the following statement: Case (7) was under lower precipitation in Matthew comparing to case (6), but it was decided to do the same level of repairs on both locations and both locations performed successfully after Florence.

- Cases 77-13-M and 77-14-M was under relatively high precipitation after Matthew, and it only needed low-cost category repairs. What was the specification of this successful design that after Matthew only low-cost category repairs were required and it was not damaged at all after Florence?

- Cases 77-15-M and 77-16-M represent cases that under the same level of precipitation in Matthew and Florence it was not damaged after Florence, but it was damaged after Matthew, and it required high-cost category repairs. What is the reason? What changed between two events?

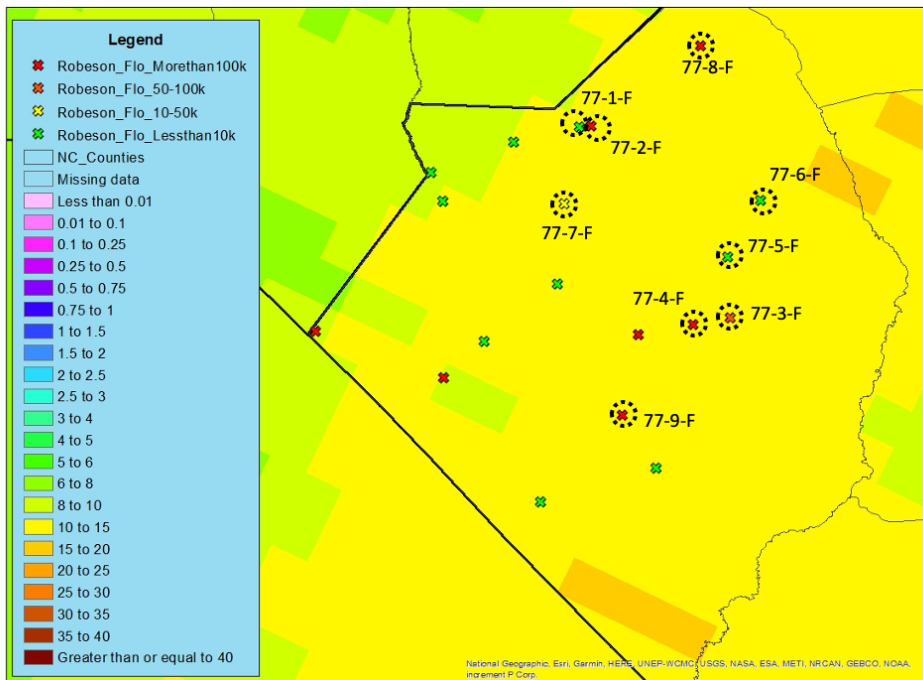
Figure B.9. Damaged locations after Hurricane Florence overlaid on Hurricane Matthew precipitation map.

The case studies presented in Figure B.9, and Figure B.10 that were only damaged after Matthew are interesting to investigate in comparison with each other as well as stand-alone cases because they help explain some specific situations.

- Comparing cases 77-1-F and 77-2-F show cases that were not damaged under the same levels of precipitation after Matthew, but they were damaged after Florence under similar level of precipitation (both in Matthew and Florence) and different type of repairs were required (low-cost and high-cost category repairs).

- Comparing cases 77-3-F and 77-4-F show cases that were not damaged under same level of precipitation after Matthew, but they were damaged after Florence under similar level of precipitation and different type of repairs were required (moderate-cost and high-cost category repairs)

- Cases 77-5-F and 77-6-F represent cases that were not damaged after Matthew under considerable level of precipitation, and after a relatively high precipitation in Florence only low-cost category repair was required. What was the design that performed so successfully?

- Case 77-7-F represents a case that under the same level of precipitation in Matthew and Florence it was not damaged after Matthew, but it was damaged after Florence, and it required moderate-cost category repairs. What is the reason? What changed between two events?

- Cases 77-8-F and 77-9-F represent cases that under the same level of precipitation in Matthew and Florence it was not damaged after Matthew, but it was damaged after Florence, and it required high-cost category repairs. What is the reason? What changed between two events?

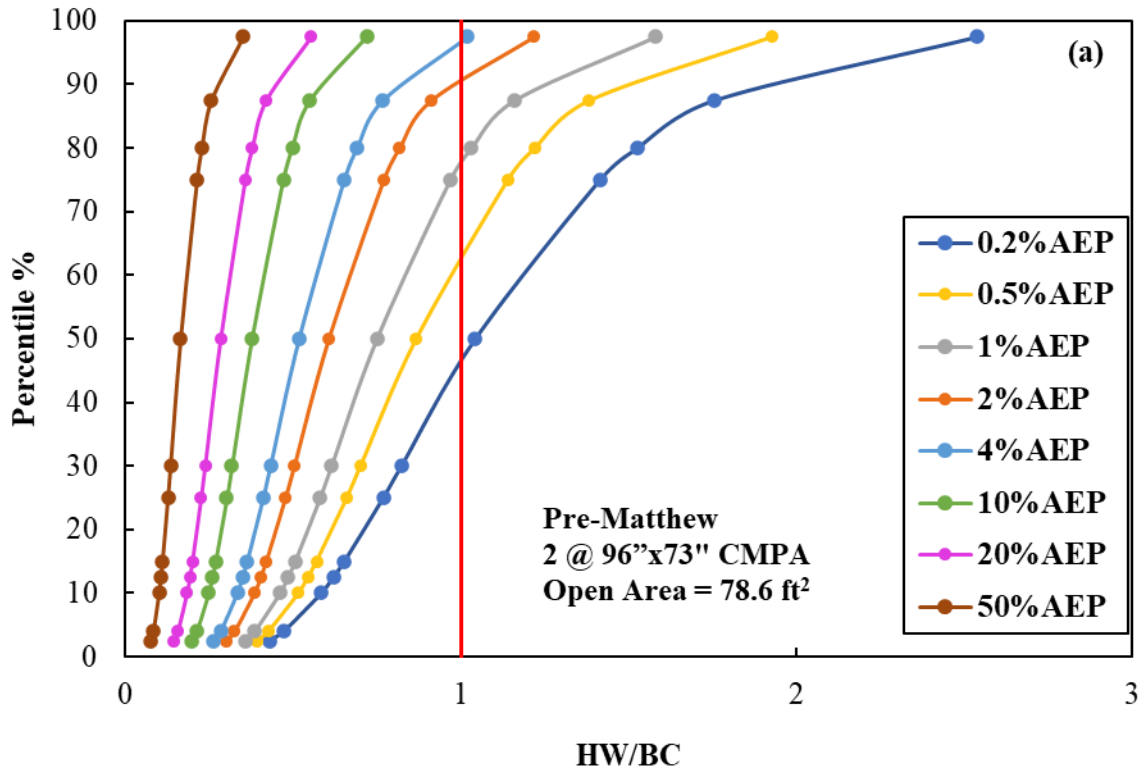
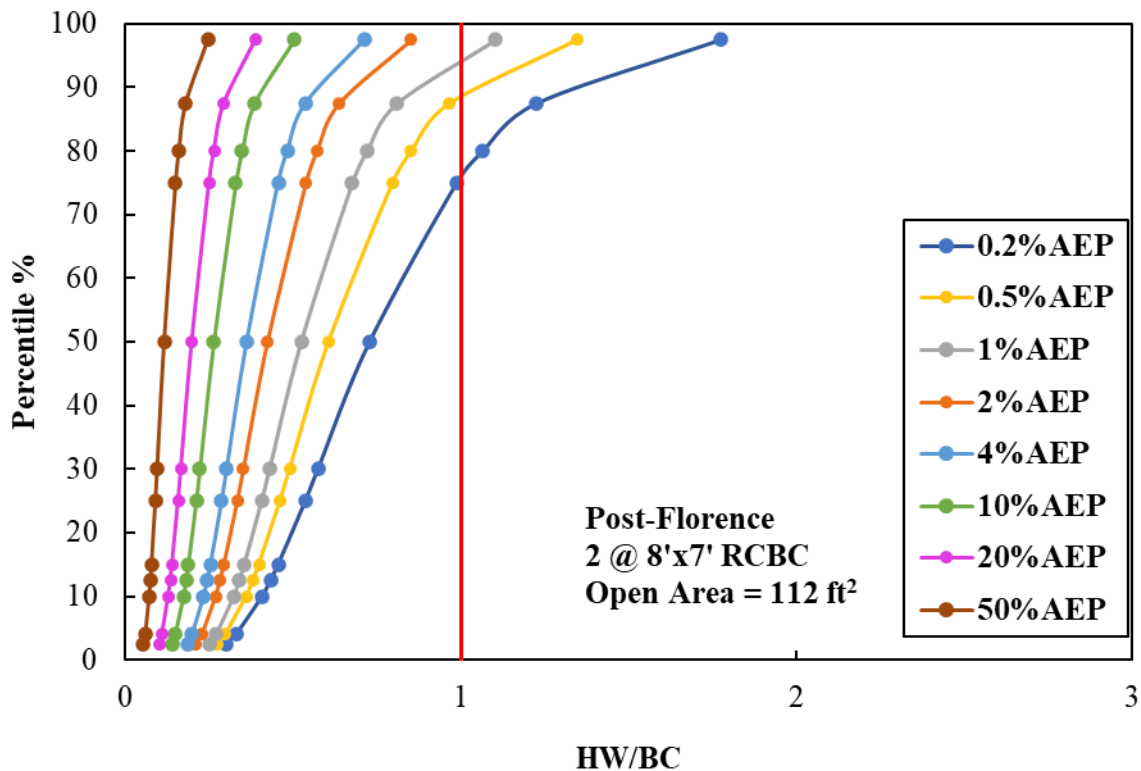
Figure D.5. Probabilistic analysis of overtopping flow values across percentiles for Site 95-9-MF: (a) pre-Matthew structure and (b) post-Matthew structure.

- Cases 95-9-MF-M, 95-8-MF-M, and 42-3-M initially had low probabilities of overtopping prior to Hurricane Matthew. However, hydraulic analysis results depicted in Figure D.5, Figure D.6 and Figure D.7 indicated that including headwalls and upsizing culverts improved performance during the design event. Notably, actual culvert damage, documented in hydro reports, revealed complete washouts in these cases. Conversely, Case 42-3-M, which downsized culvert size (Figure D.7 (b)), exhibited increased post-Hurricane Matthew overtopping probability. This variance in hydraulic headwater values and actual performance challenges conventional overtopping criteria.
