## Minnesota Drive Ramps Micro Surfacing Experimental Feature

January 2024

**Publication Number:** FHWA-AK-RD-4000(181), HFHWY00123

13. ABSTRACT (Maximum 200 words)  During the 2020 construction season, the Alaska DOT&PF Central Region installed its first application of micro surfacing at 17 locations on Minnesota Drive ramps in the city of Anchorage. This treatment offers the potential to be a more economical solution to the typical mill and fill hot mix asphalt (HMA) treatment used to address rutted roads.  Micro surfacing has not been used on roads in Central Region due to poor historical Prall testing (ATM 420) that is used to simulate studded tire wear. A new formulation of micro surfacing was evaluated in 2016 with significantly improved performance on the Prall test. This formulation uses fine aggregate and a high residual binder content with a PG64-40 modified asphalt binder and between 6%-8% SBS polymer. This is a very high percentages of both binder and polymer for a micro surfacing treatment.  There were difficulties encountered during construction with break and set times that made the micro surfacing prone to flushing and deformation rutting immediately after constr

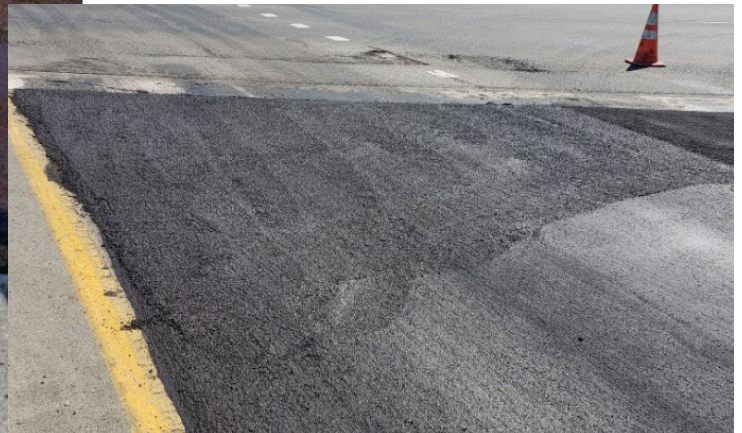
*Photo 3 - Hand Worked Area on Ramp 6*

It takes approximately 90 seconds for the materials to be mixed, travel through the Macropaver unit and enter the spreader box through the diverter. The crew hand works the micro surfacing using a squeegee at locations it is hard for the equipment to access, as well as removes drag marks and other surface imperfections (shown in Photo 2). Photo 3 shows an example of an area that was hand worked at the intersection of Ramp 6 and International Airport Road.

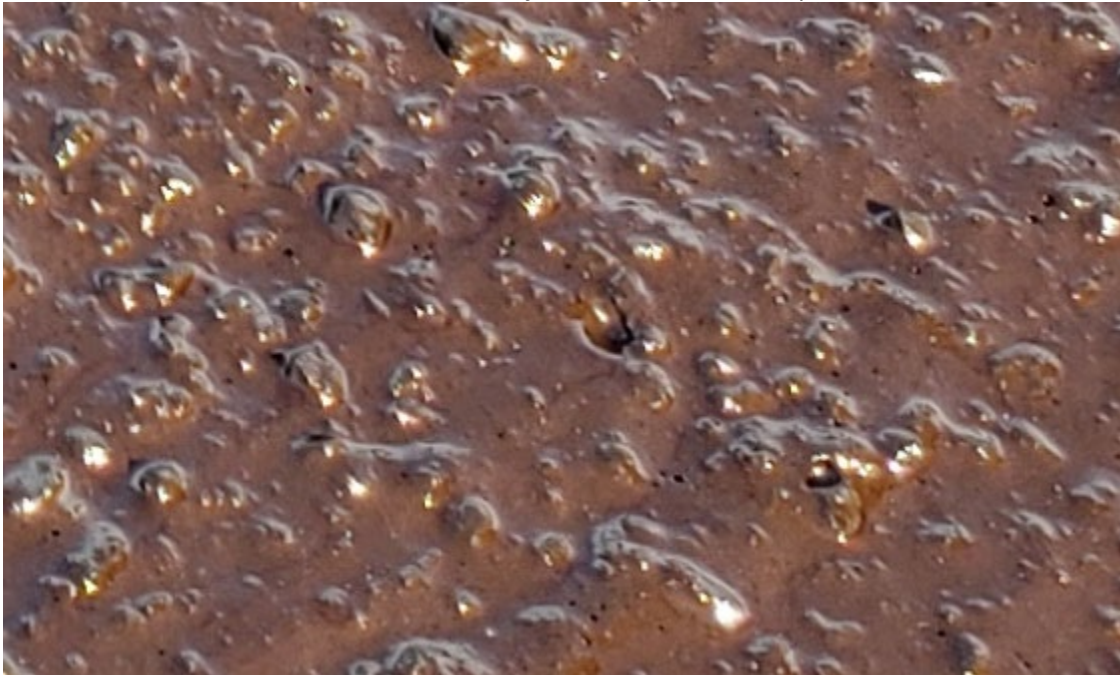
*Photo 5 - Bubbles from Slurry on Test Strip*

After the micro surfacing was placed on the test strip, small holes/bubbles were observed on the surface which were not seen with the previous formulation using lime. This indicates water is escaping the system as it sets and, while difficult to see, can be observed in the photo below.

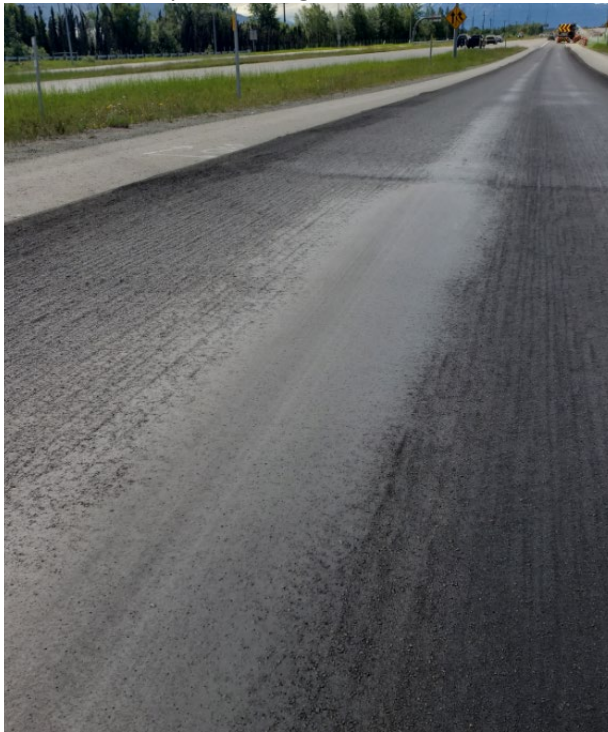
*Photo 6 - Ramp 1 Flushing Distress*

Comment was received from construction that Ramps 1 and 2 were not performing well. On Ramp 1 (photo below on the left) flushing was observed over most of the wheel paths on the ramp. While no deformation or rutting in the wheel paths was visible, it appeared that the coarse aggregate had been depressed and the fines were flushed to the surface. On Ramp 2 (photo below on the right) the center left hand turn lane had severe flushing and deformation/shoving of the micro surfacing material.

Construction had noted Ramps 1 and 2 were being used on a haul route for borrow material being transported to Anchorage International Airport for construction work. On Ramp 2 the damage occurred directly in front of a signalized intersection within a few days of application. It is likely the trucks coming to a stop and then accelerating into the turn onto International Airport Road that caused significant damage on the fresh micro surfacing, including flushing and material pickup.

It was observed the trucks returning to the pit from Anchorage International Airport used Ramp 1 onto Minnesota and then took Ramp 10 onto Raspberry and likely caused flushing damage to the recently placed micro surfacing on both of those ramps.

In August 2020 the observed flushing distresses were considered to be severe enough to perform friction testing on five of the seven ramps, which validated the observed loss of friction. The micro surfacing on those ramps was removed by HMA mill and fill in September 2020.

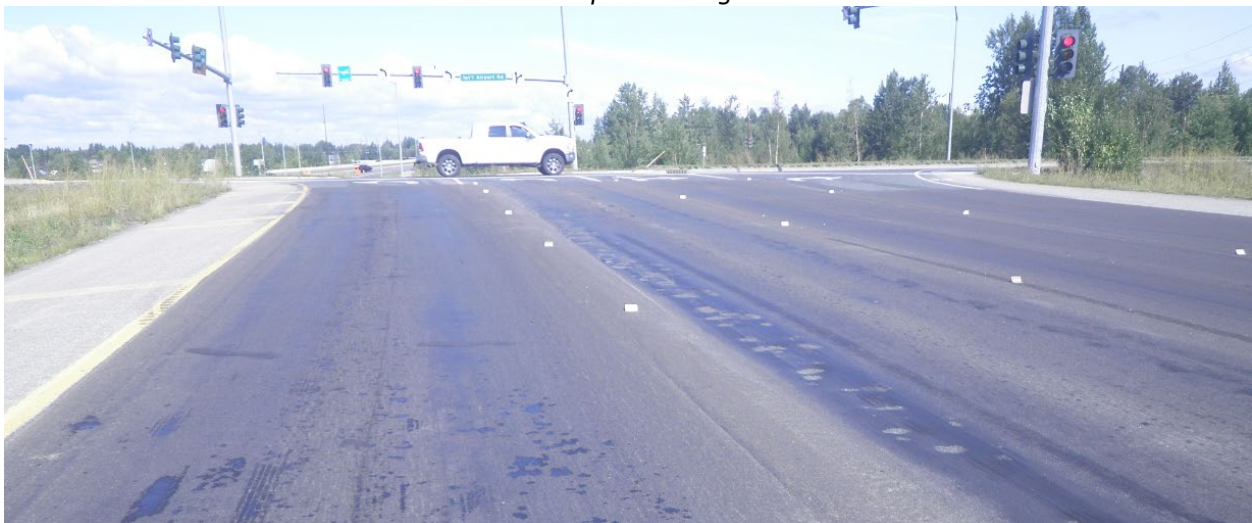
*Photo 8 - Ramp 2 Flushing Distress*

Photo 8 is from August 13<sup>th</sup> where severe flushing and shoving occurred at the signalized intersection on Ramp 2. The resulting surface was not sticky, and tracking was not observed at any locations, but there was a loss of friction and the fines were visible at the surface.

Ramps 1, 2 and 10 were a part of the haul route for QAP hauling borrow material to the airport. Ramp 5 was the ramp with the second highest AADT, being the exit ramp for traffic travelling from downtown Anchorage to the Anchorage International Airport, and experiences heavy traffic loading. Ramps were opened to traffic approximately three to four hours after the micro surfacing was placed, and with the formulation being slow set, the heavy loads likely damaged the surface after application.

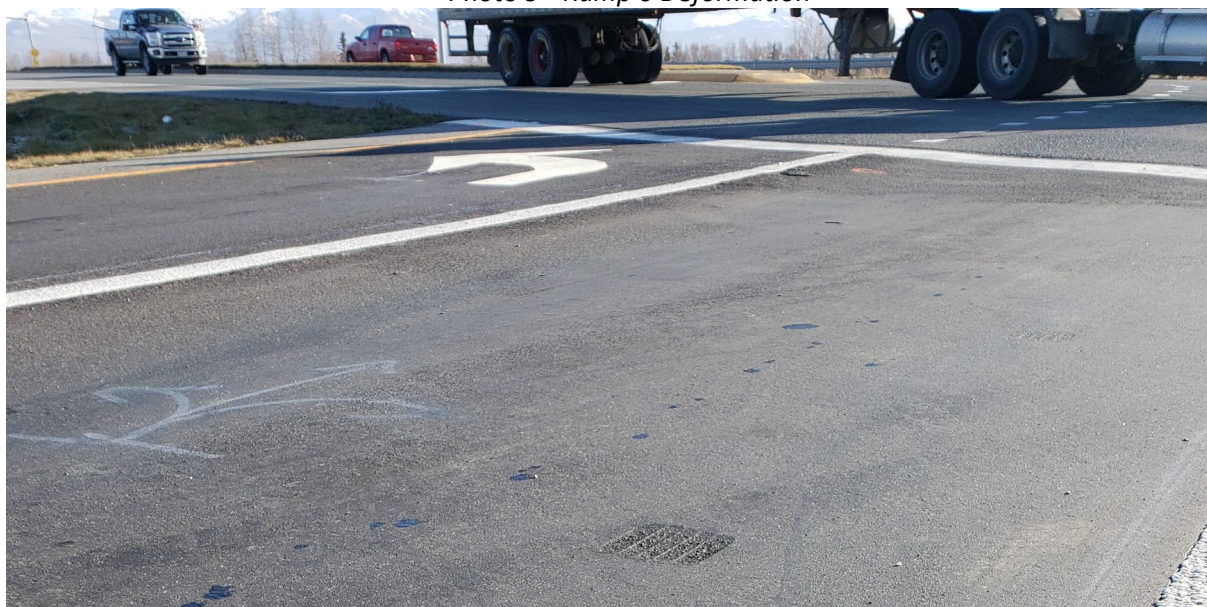
*Photo 9 - Ramp 6 Deformation*

In October of 2020, prior to the first snowfall, the ramps remained in good condition, although it was noted that hand worked areas did look rough and there was deformation observed on Ramp 6 and flushing was present on Ramp 11 (noted in orange in Table 3). Ramp 6 was one of two ramps with stoplights, the other being Ramp 2, which was removed by mill and fill in September of 2020. The deformation on Ramp 6 was likely from static loading of the trucks as the deformation occurred at the stoplight (see Photo 9). Rut depth data collected at Ramp 6 in 2021 and 2023 did not show a significant increase in rutting between those years.

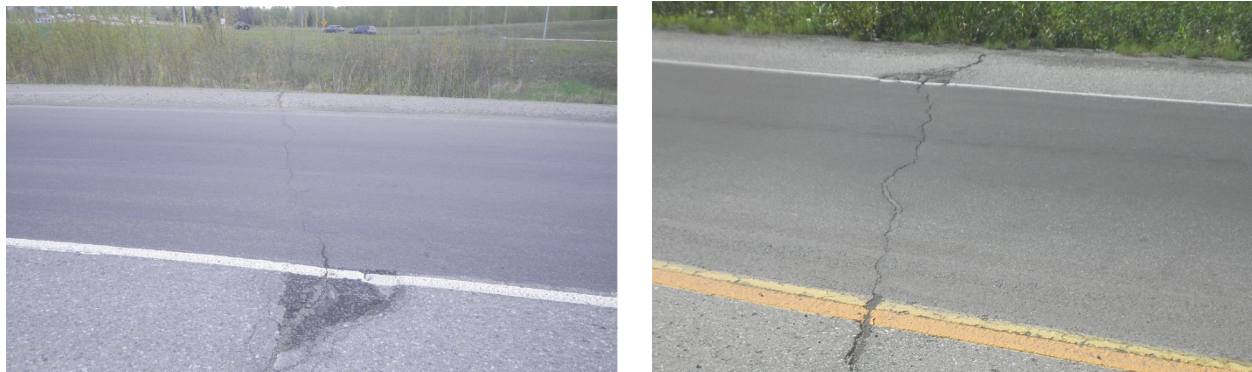
*Photo 11 - Ramp 7 – General Transverse Cracking Conditions 2021 (left) and 2022 (right)*

Photo 11 shows the condition on Ramp 7, the International Airport Cloverleaf, in May of 2021 (left) and September 2022 (right). It displays the typical condition on ramps where there is damage at transverse cracking. While the transverse crack is still smaller than it was previously, as indicated by the shoulder condition, the crack spalled over the winter between 2021 and 2022. Spalling has continued to increase. See photos in the appendix for cracking conditions.

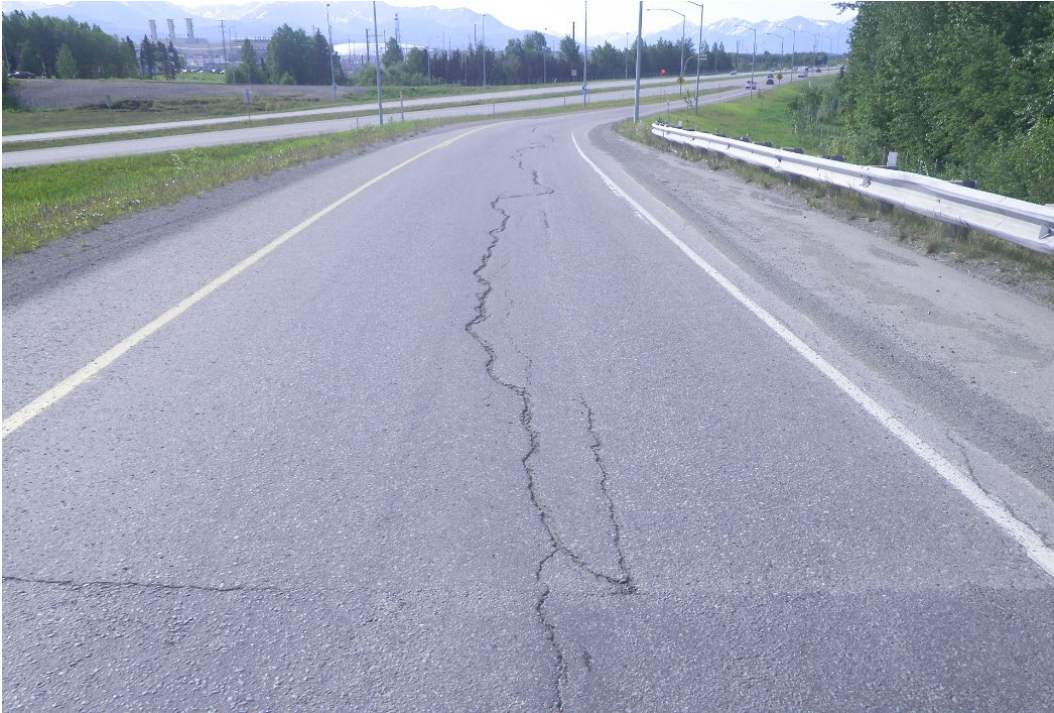
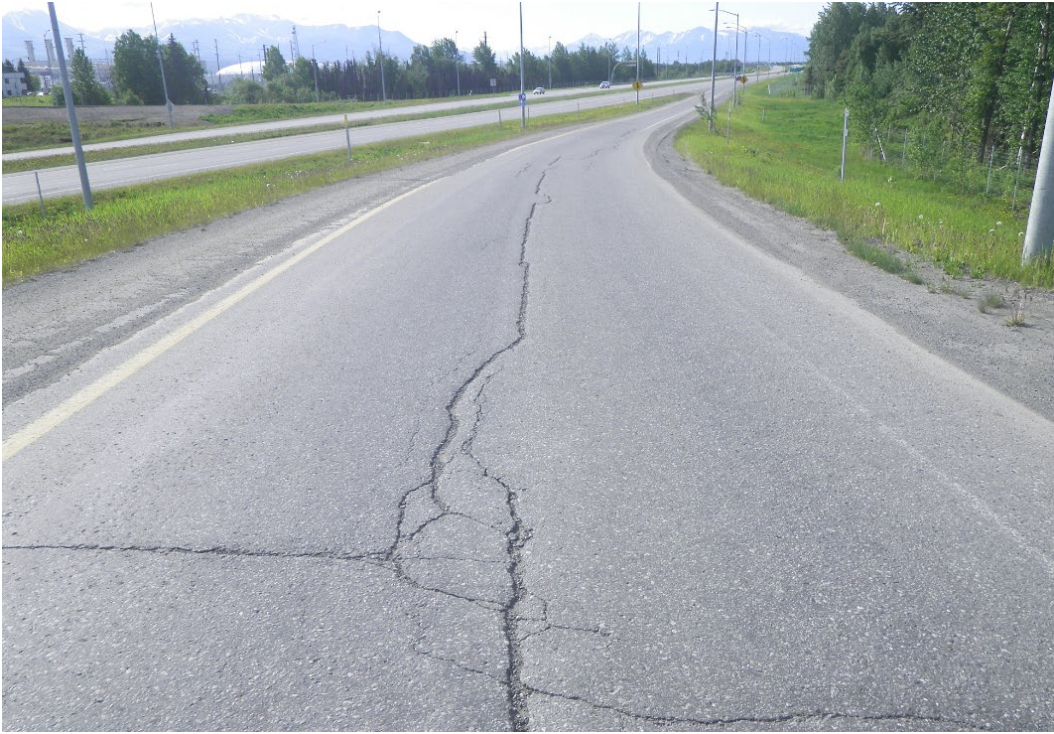
Ramp contained significant longitudinal cracking as well as moderate to high rut depths. This ramp was removed by mill/fill in 2020 due to flushing.

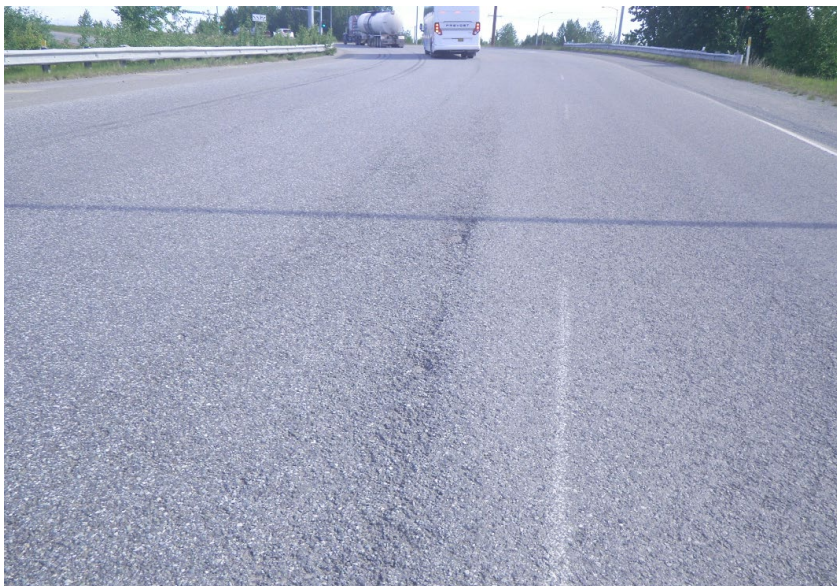
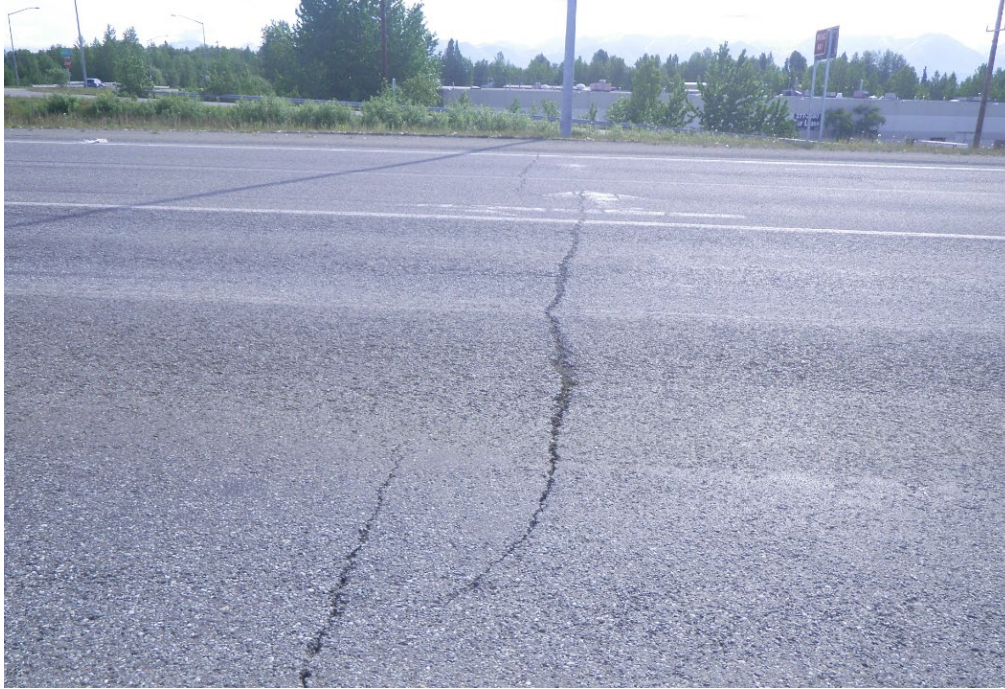
Ramp had moderate rut depths at the intersection with International Airport Road, and moderate raveling and isolated high severity transverse cracking.

This ramp was removed by mill/fill in 2020 outside of the right-hand turn lane.

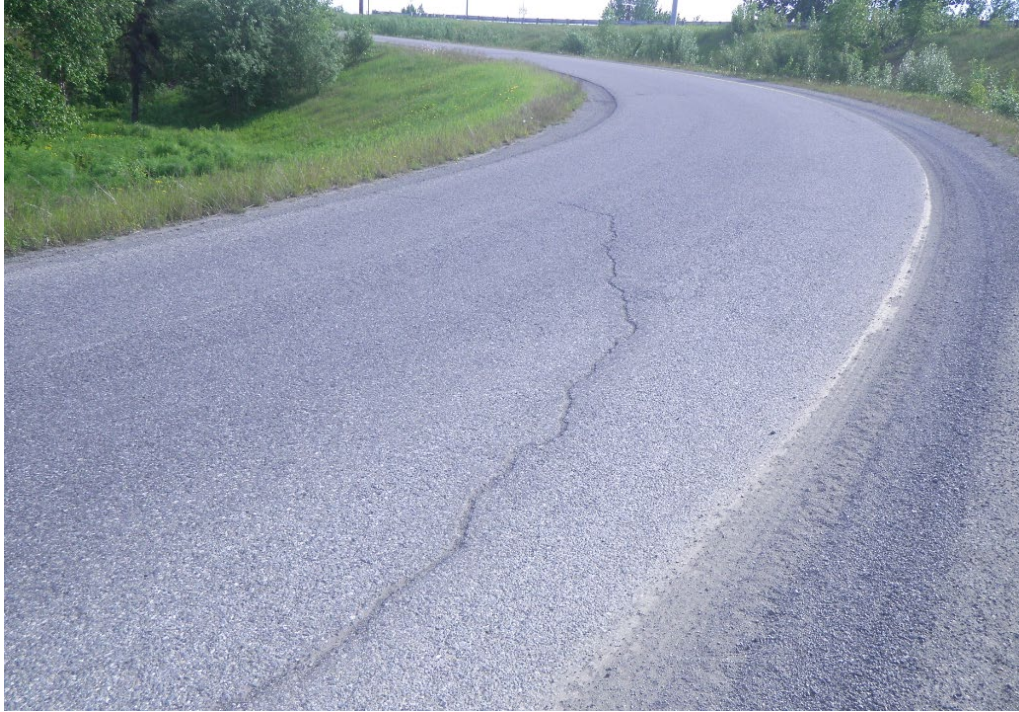
This ramp is a cloverleaf with minimal rutting, minor raveling and isolated moderate severity cracking.

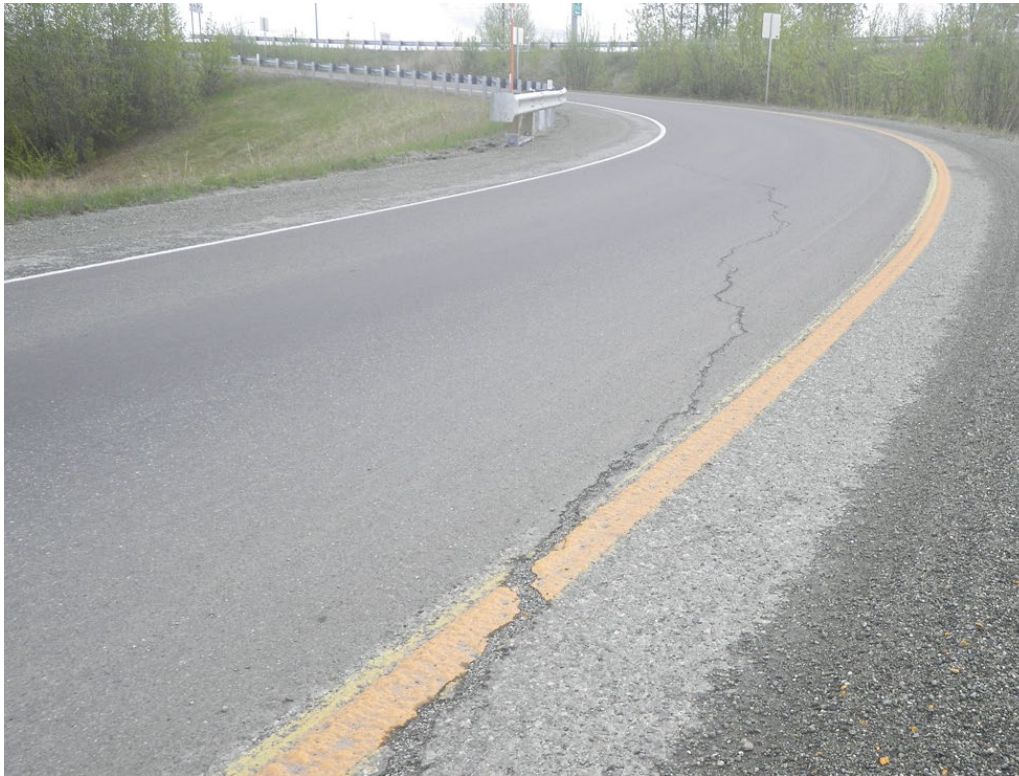
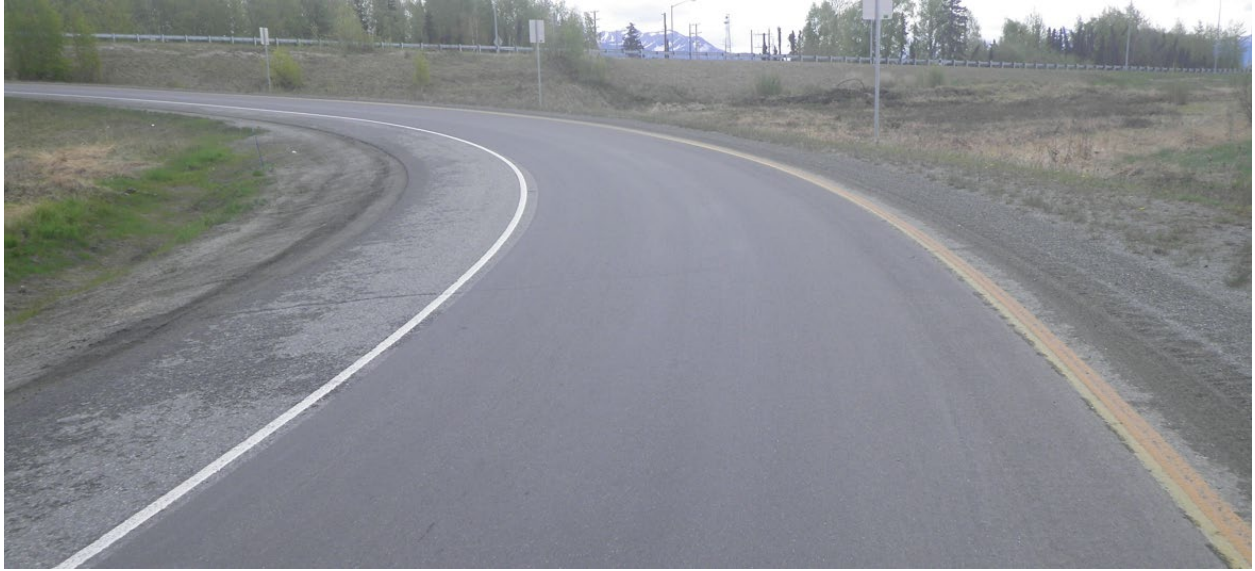
**Year 1 Monitoring Photos**

The ramp remained in good condition although cracks on the ramp did reflect through the micro and plows have worn through the microsurfacing at the crown of the road.

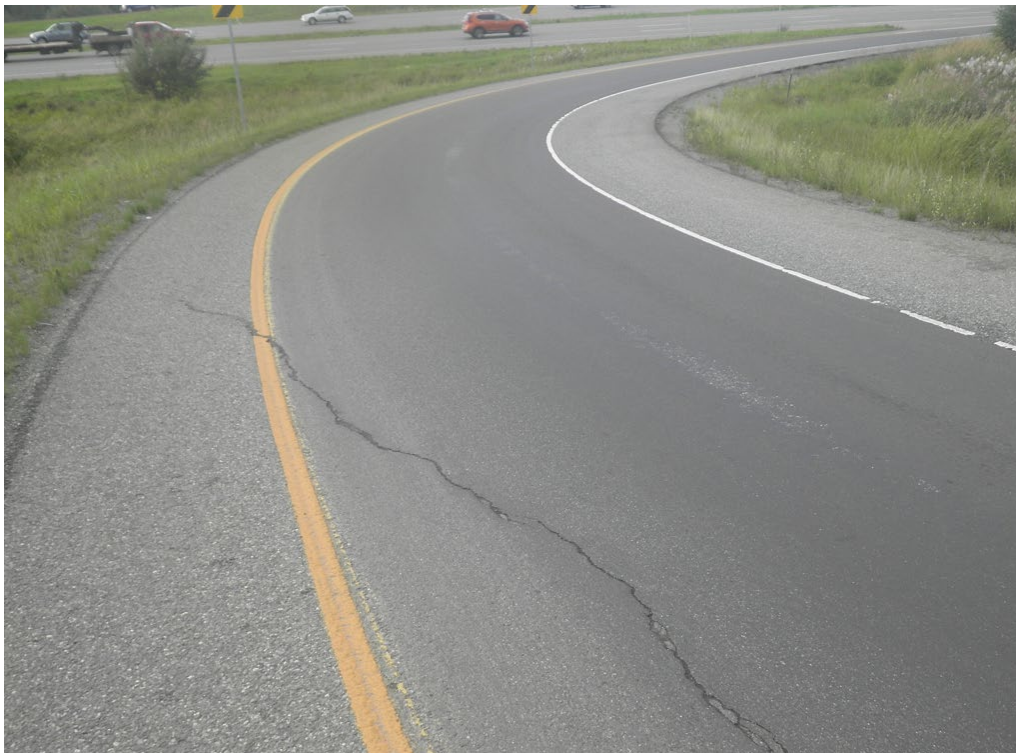
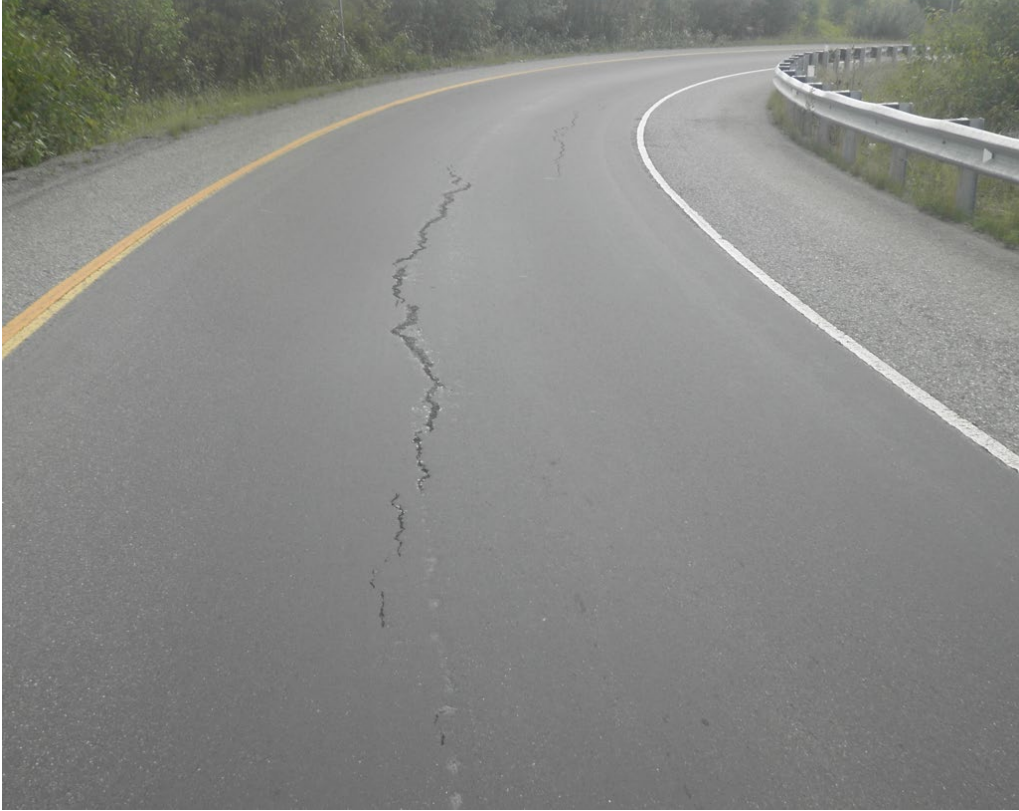
### **Year 2 Monitoring Photos**

There is increased severity in reflective cracking and plow damage along the centerline.

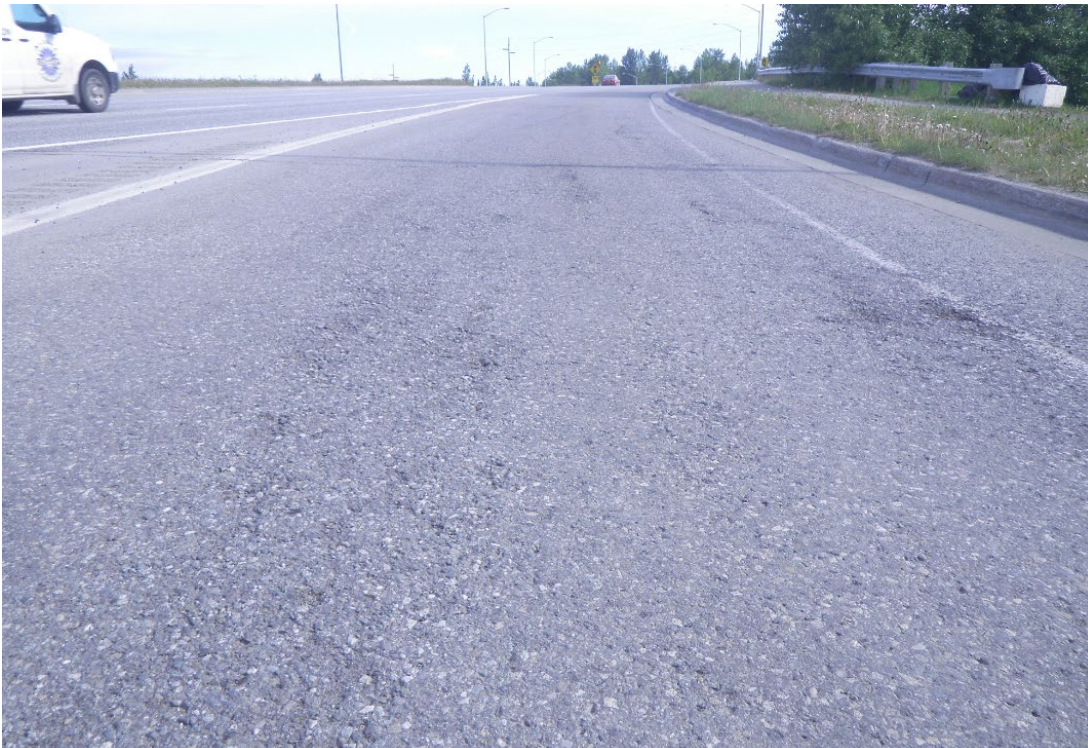
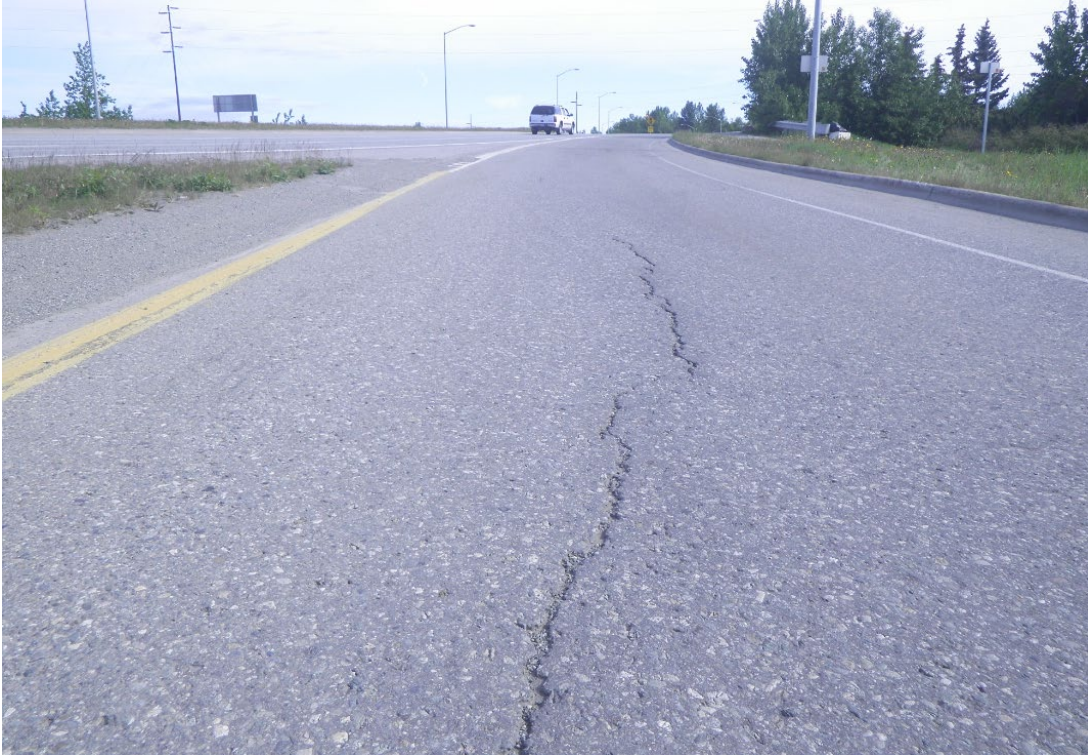
Microsurfacing was applied over a small portion of this ramp to cover an area of raveling and cracking.

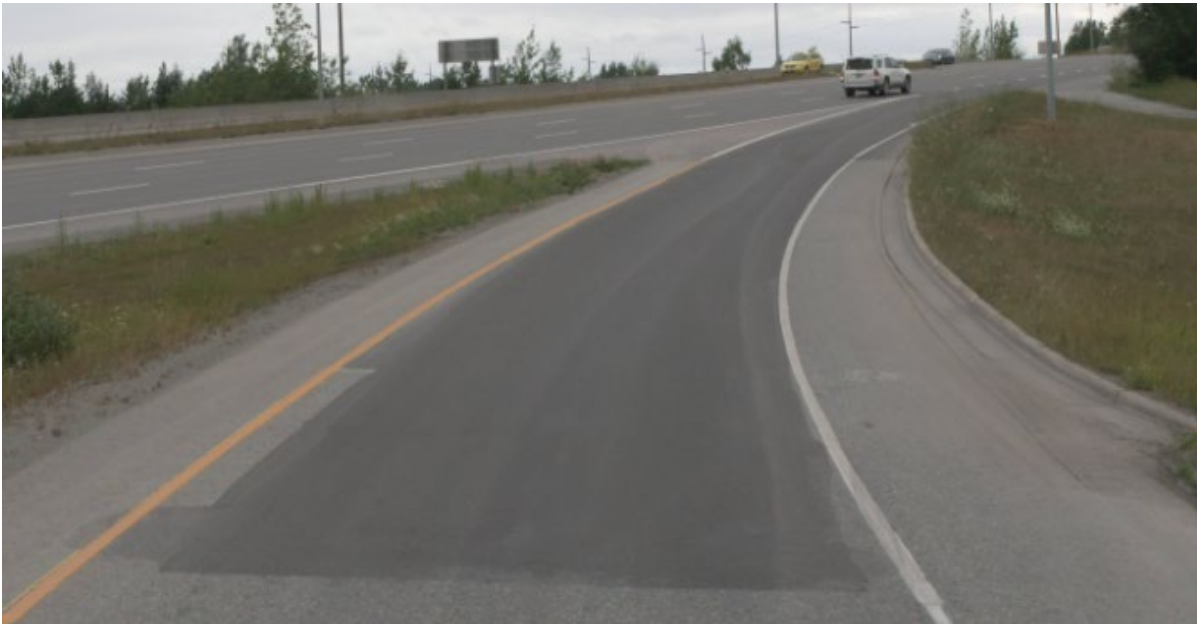
**Year 1 Monitoring Photo**

The microsurfacing still remains in good condition with slight plow damage and reflective cracking.

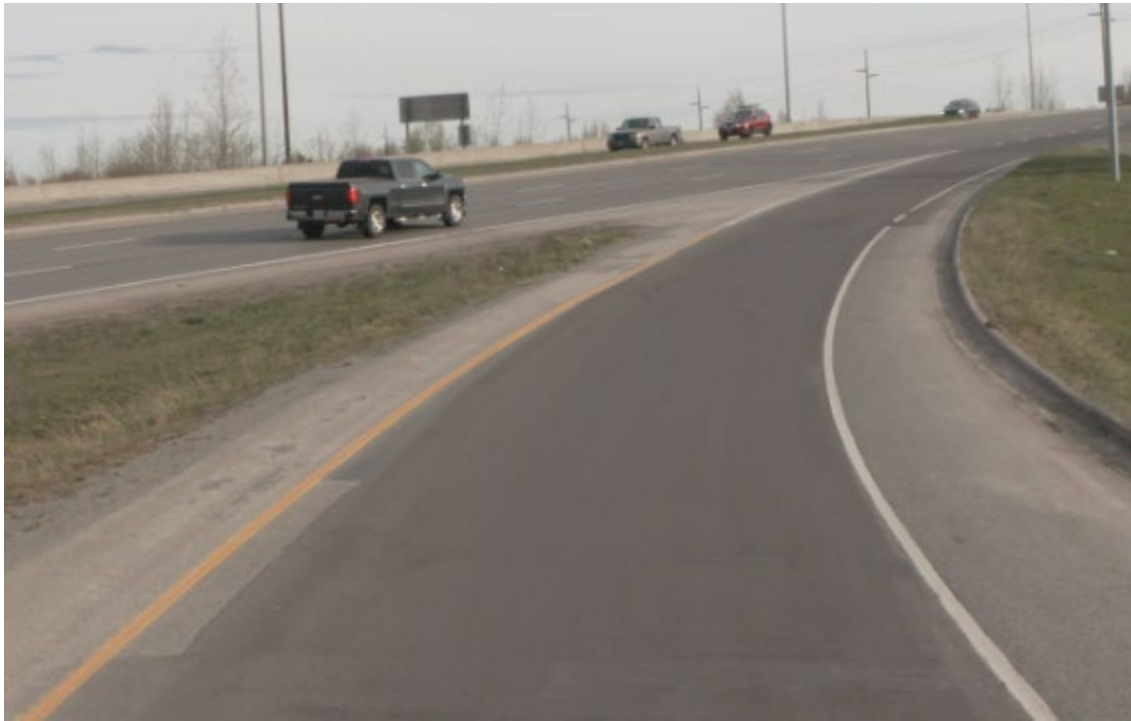
**Year 2 Monitoring Photo**

There is a slight increase in plow damage, but it remains in similar condition to the prior year.

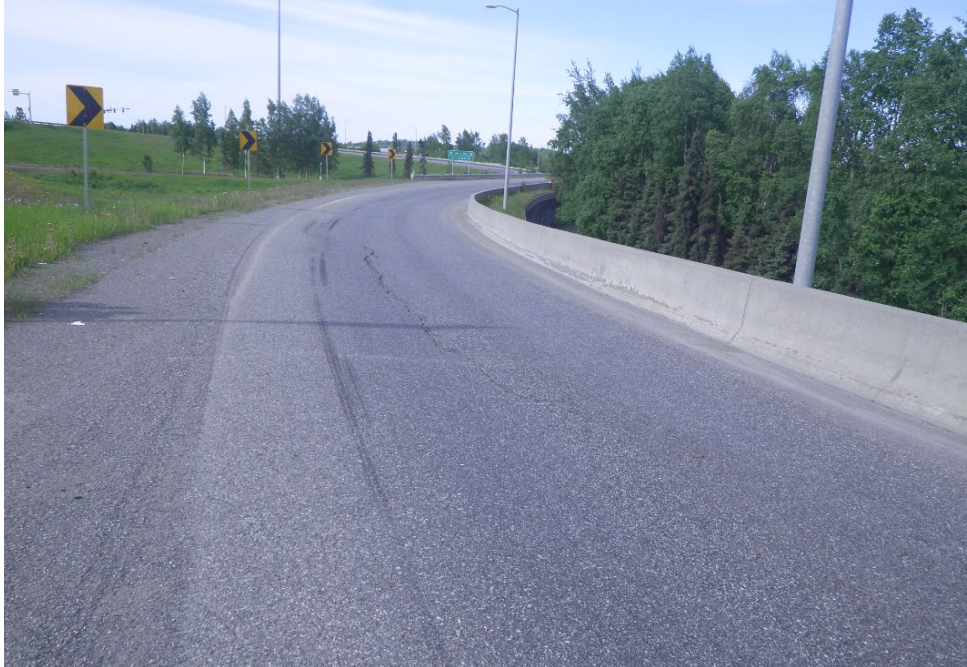
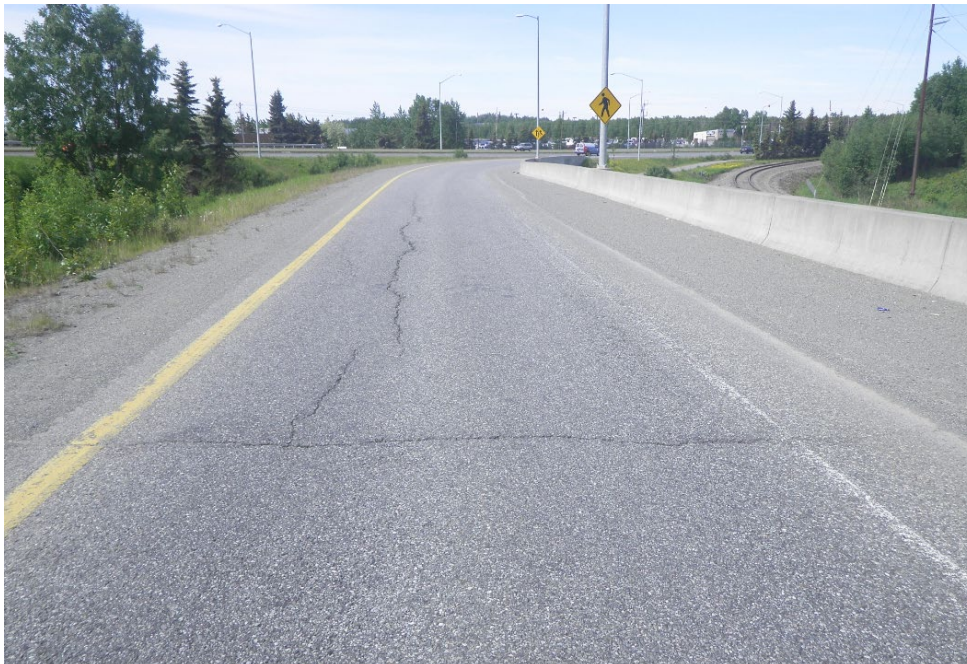
The initial part of this ramp had high severity longitudinal cracking. The worst of this was fixed as part of the earthquake repair portion of the project and did not receive microsurfacing. The rest of the cracking received crackseal and hot mix tamped in place. The later part of the ramp had moderate severity transverse and longitudinal cracking and minor raveling.

This ramp was removed by mill/fill in 2020.

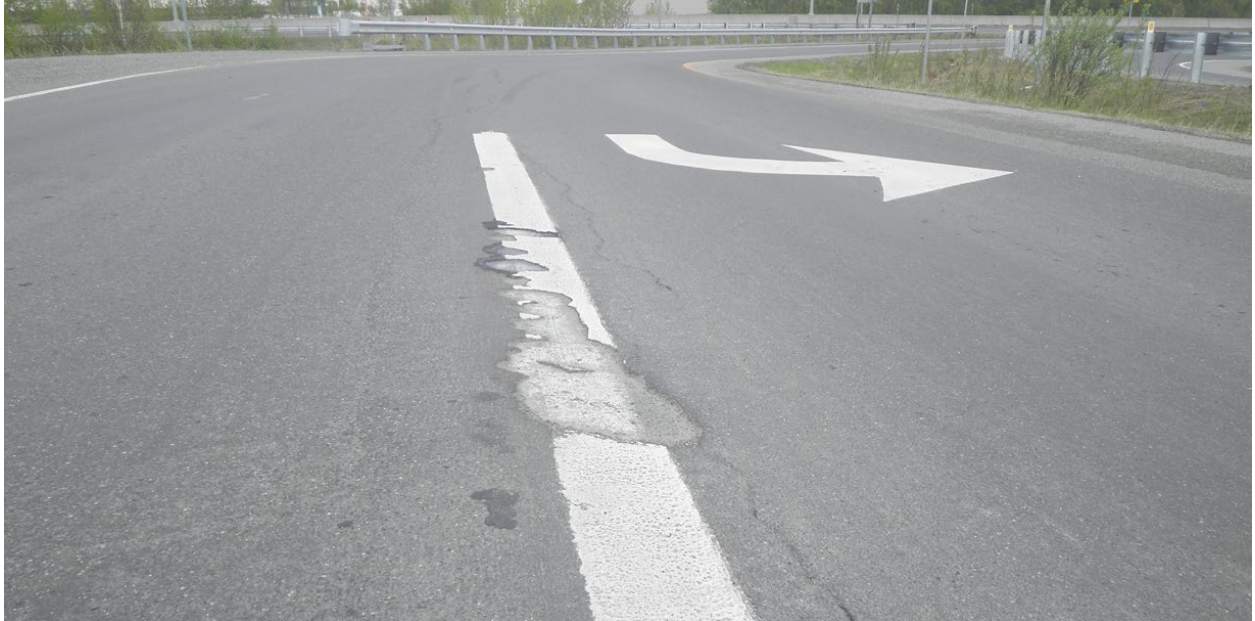
### Year 1 Monitoring Photos

During year 1 of monitoring the cracks reflected through the microsurfacing, plow damage was present on the striping at the center of the lane and rutting from deformation was noted at the signalized intersection.

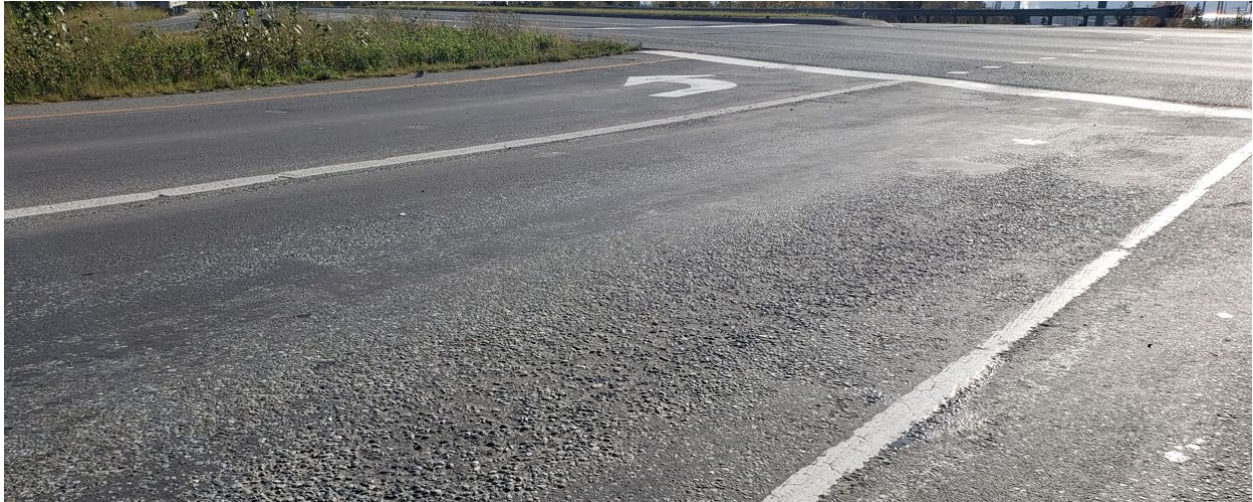
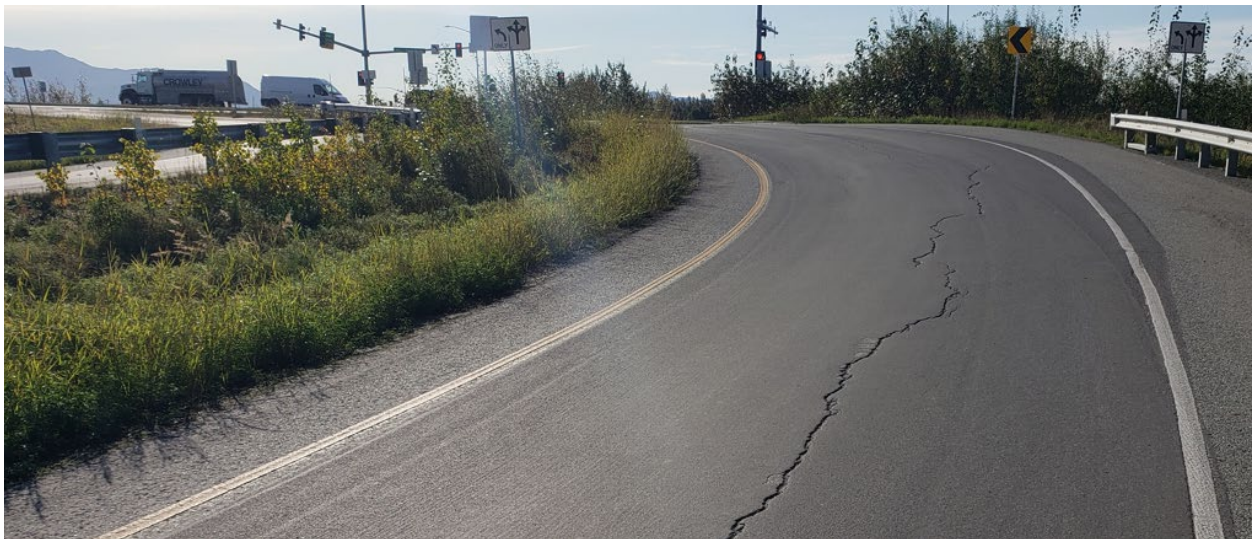
### Year 3 Monitoring Photos

The right lane had a significant increase in raveling and bare pavement is visible throughout a portion of the lane. Cracks have reflected and there is some plow damage and slight spalling.

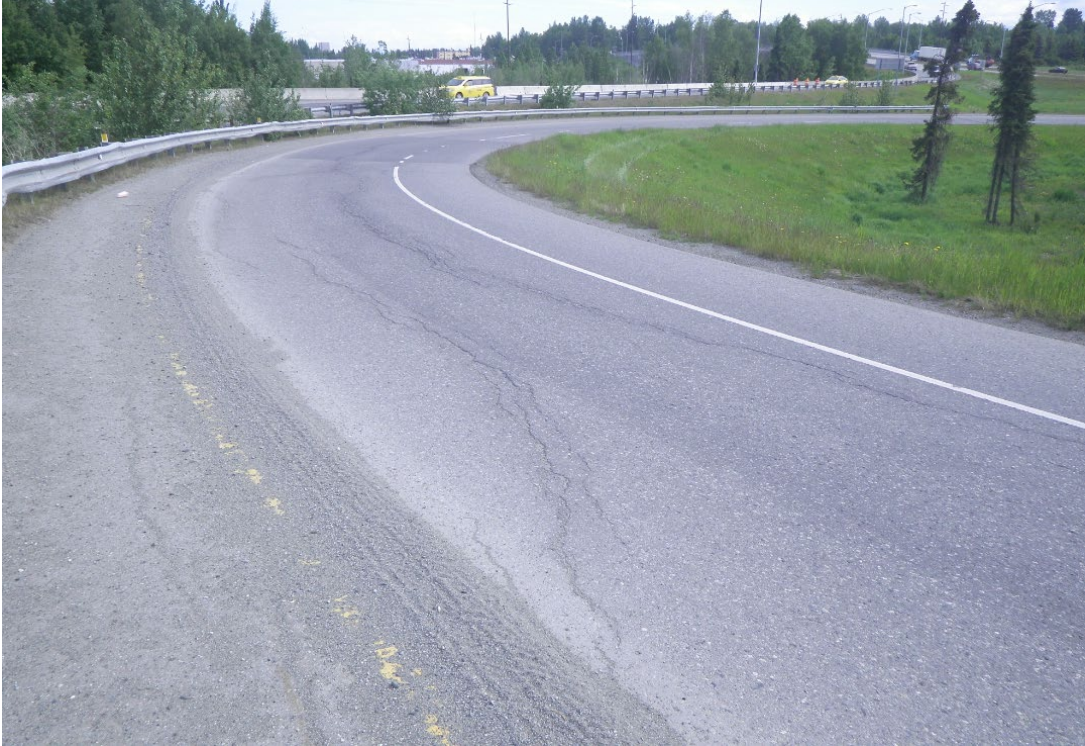
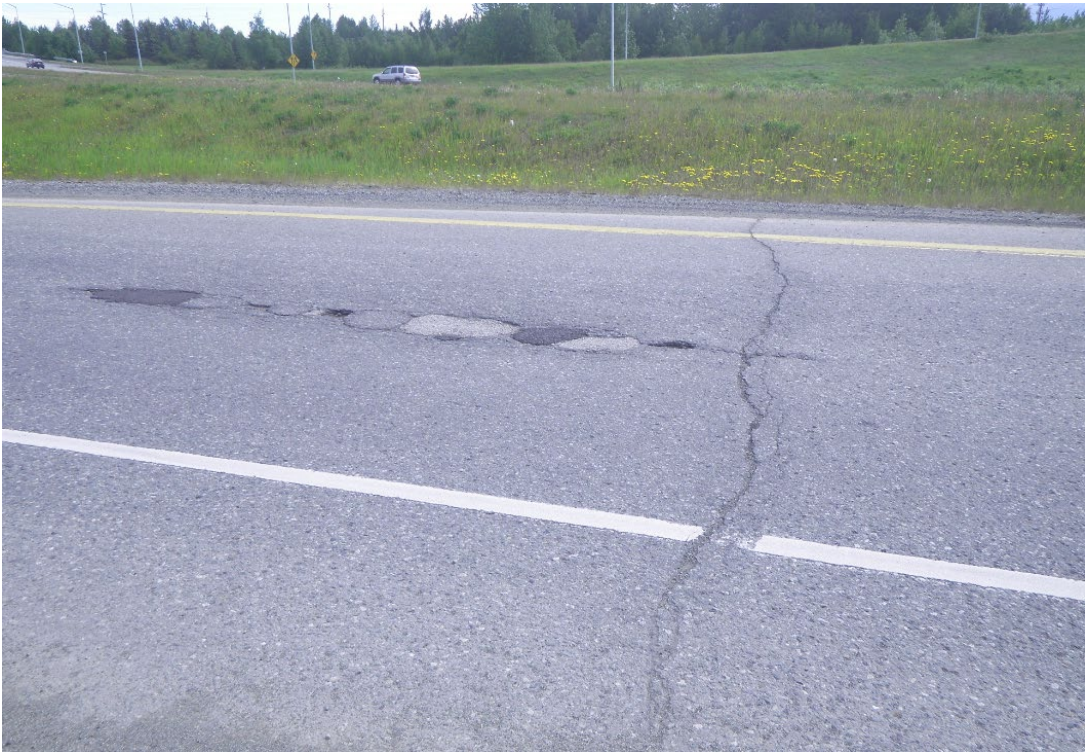
There were low rut depths, but high severity longitudinal cracking was present in the middle of the ramp that may have been related to embankment movement as well as underlying frost susceptible soils. At the base of the ramp there was transverse cracking with potholing.

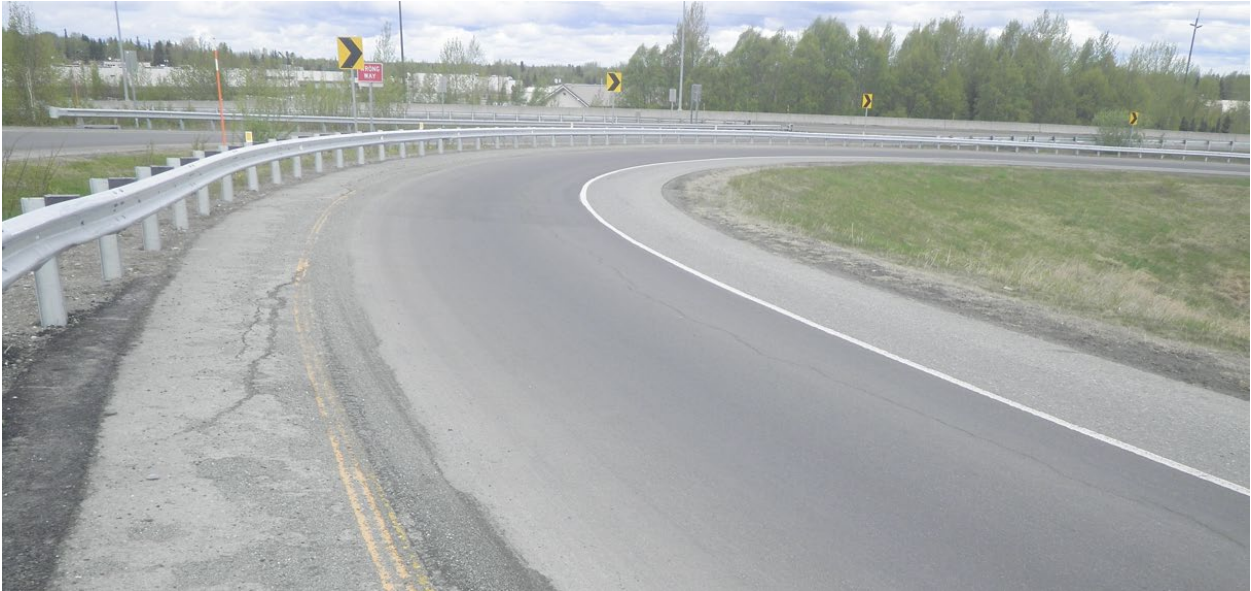
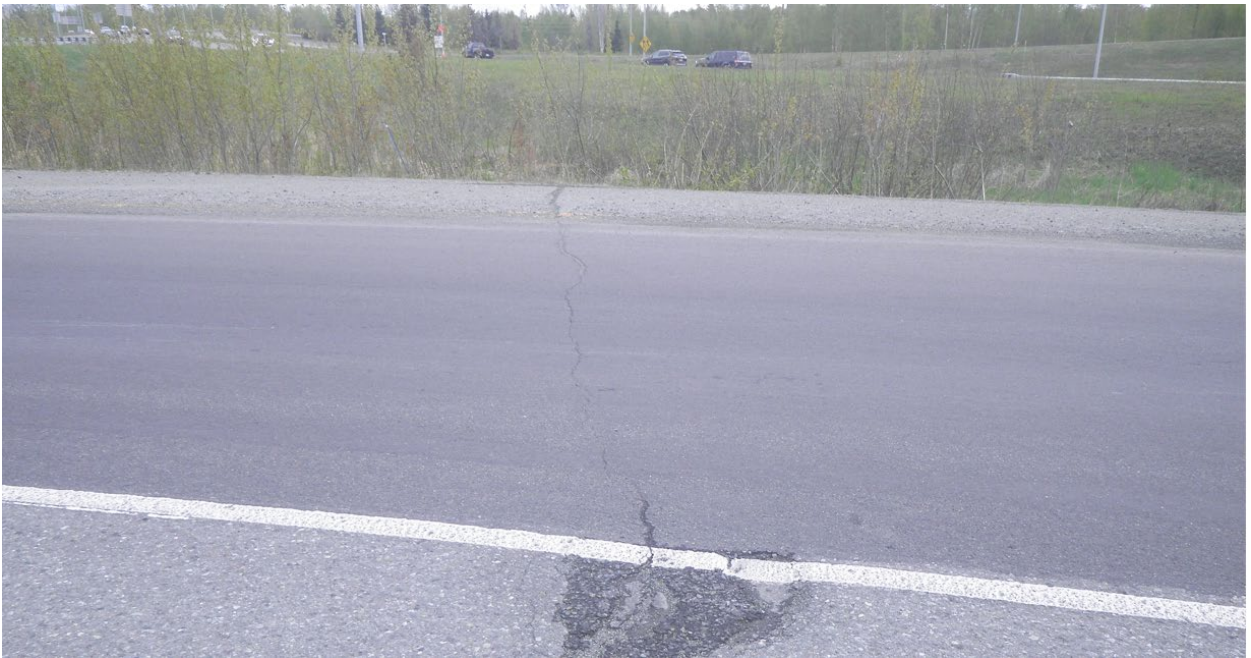
## Year 1 Monitoring Photos

Cracks reflected through the microsurfacing but remained in low severity on this ramp, which is in good condition overall.

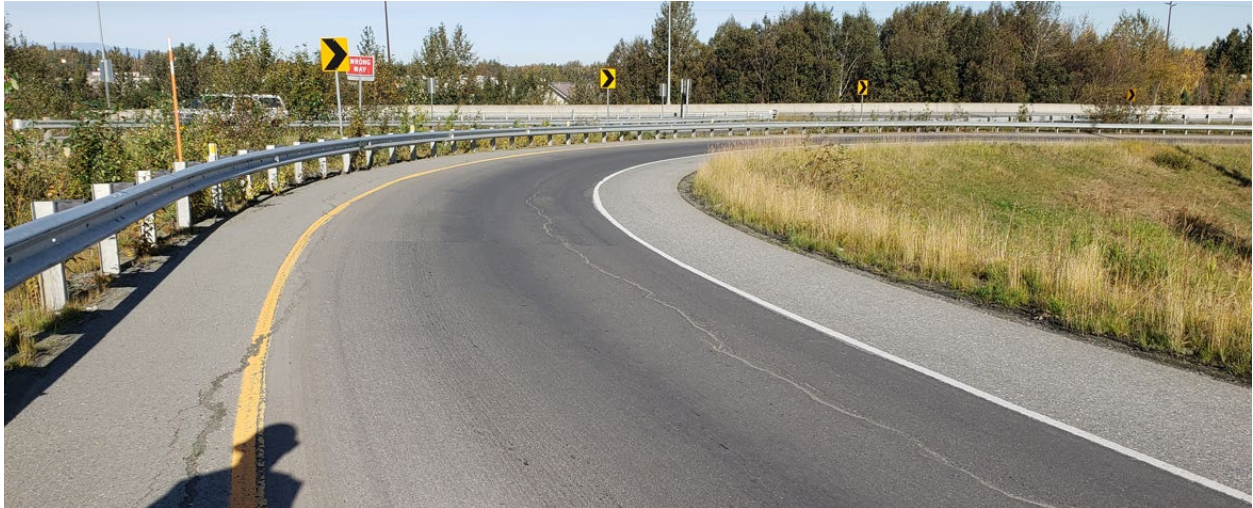
### Year 3 Monitoring Photos

Cracks have continued to widen but are still largely of lessened severity. There is some plow damage along cracks, but the ramp remains in good condition.
