## Minnesota Drive Ramps Micro Surfacing Experimental Feature

January 2024

**Publication Number:** FHWA-AK-RD-4000(181), HFHWY00123

13. ABSTRACT (Maximum 200 words)  During the 2020 construction season, the Alaska DOT&PF Central Region installed its first application of micro surfacing at 17 locations on Minnesota Drive ramps in the city of Anchorage. This treatment offers the potential to be a more economical solution to the typical mill and fill hot mix asphalt (HMA) treatment used to address rutted roads.  Micro surfacing has not been used on roads in Central Region due to poor historical Prall testing (ATM 420) that is used to simulate studded tire wear. A new formulation of micro surfacing was evaluated in 2016 with significantly improved performance on the Prall test. This formulation uses fine aggregate and a high residual binder content with a PG64-40 modified asphalt binder and between 6%-8% SBS polymer. This is a very high percentages of both binder and polymer for a micro surfacing treatment.  There were difficulties encountered during construction with break and set times that made the micro surfacing prone to flushing and deformation rutting immediately after constr

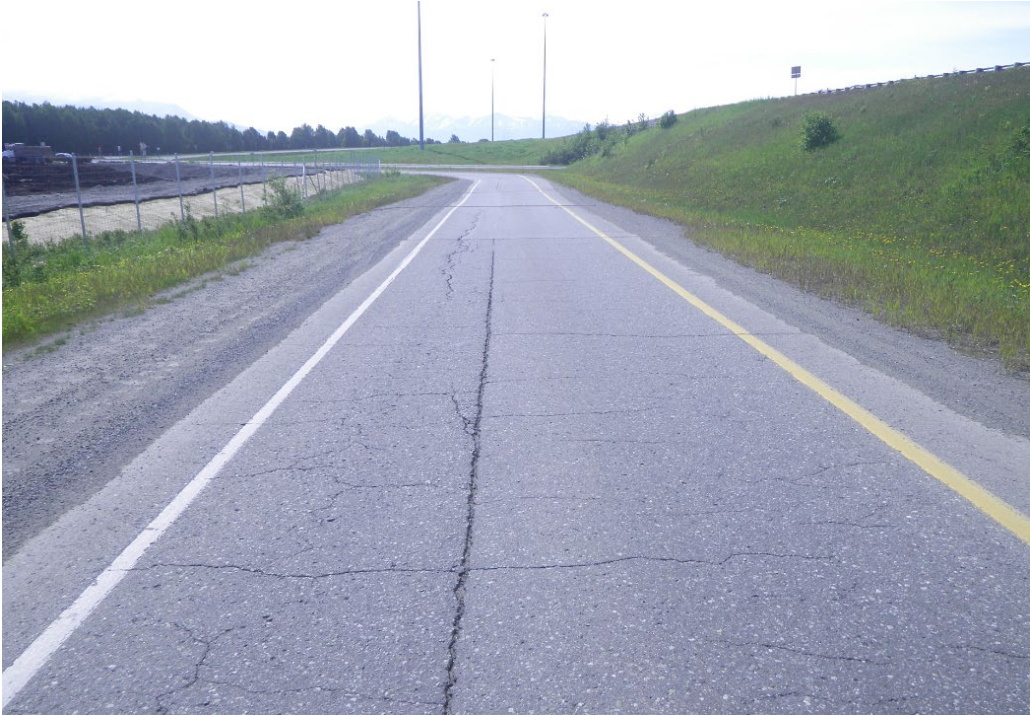
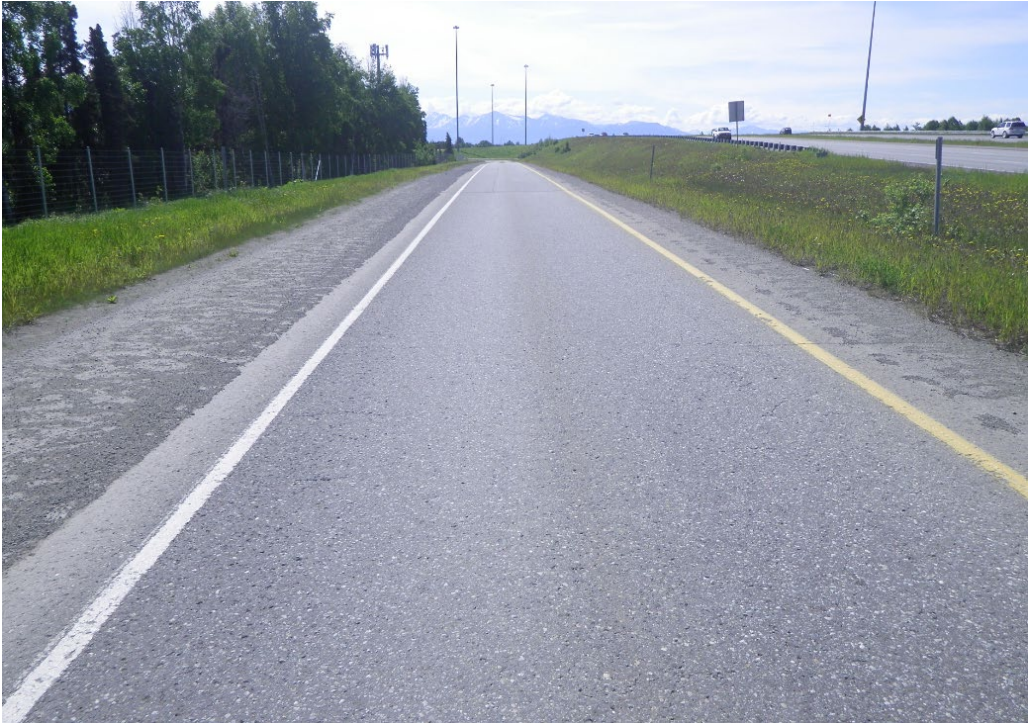
**Pre-construction Photos**

At the beginning of this ramp there was high severity center crack with fatigue cracking forming in the right wheelpath. The conditions improved at the International Airport sign, although faint wheelpath cracking was beginning to form in areas.

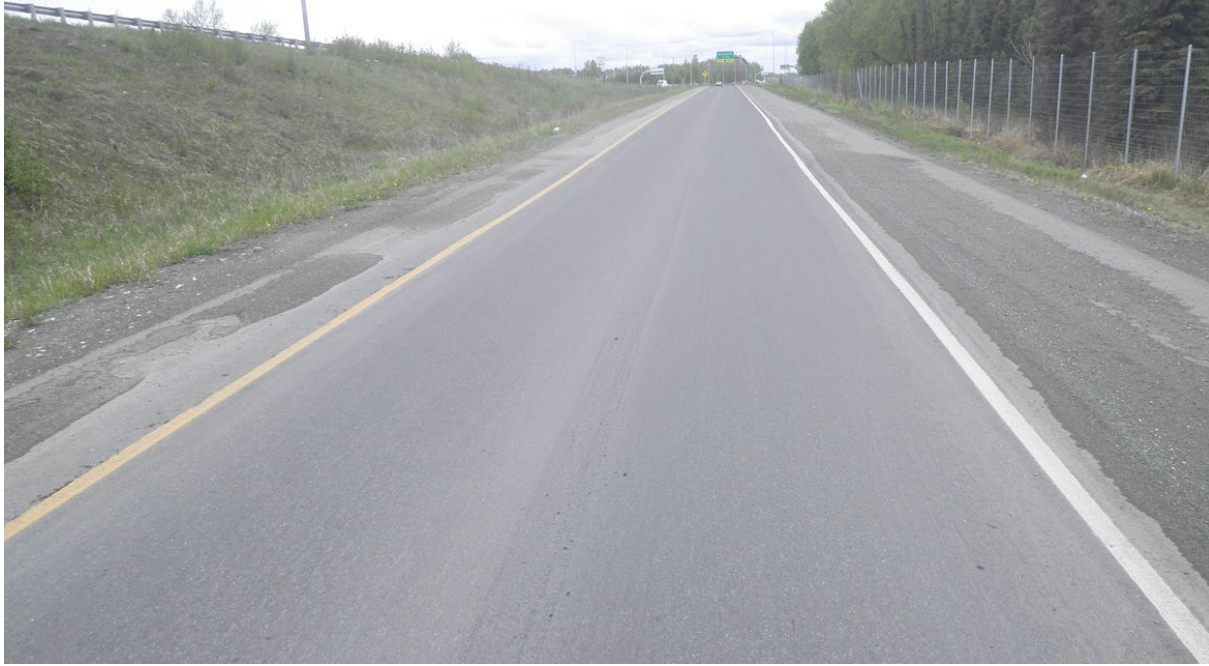
### Year 1 Monitoring Photos

The block cracking and fatigue cracking reflected through the microsurfacing, but the largest cracks to reflect and experience damage were the transverse cracks on the ramp. The ramp remains in moderate condition.

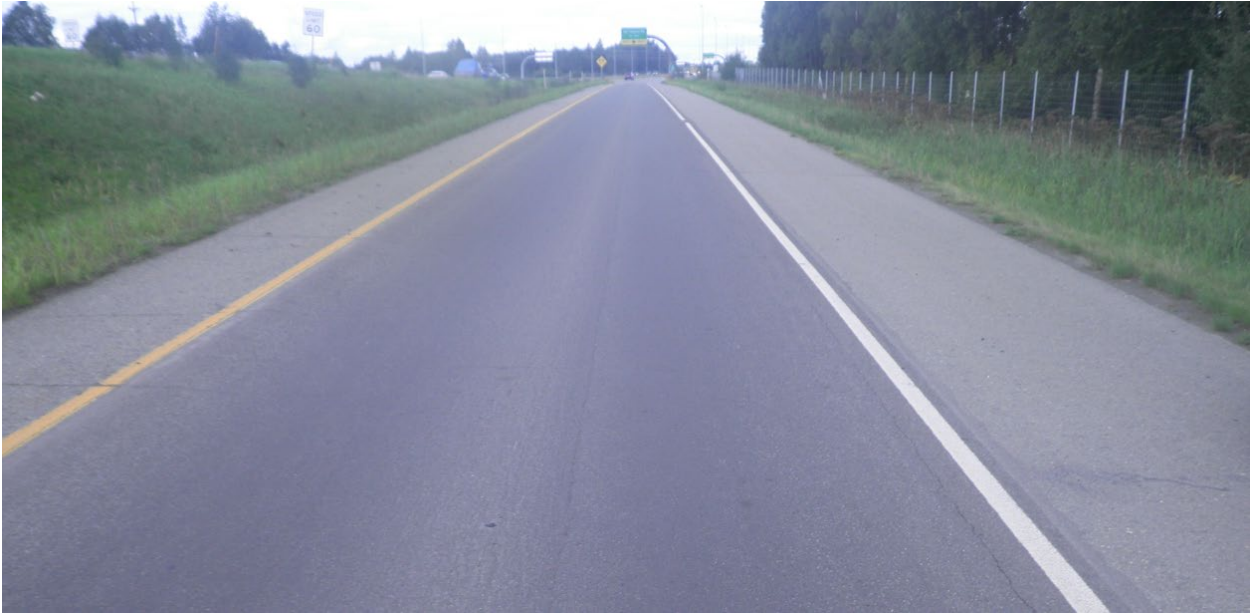
## Year 2 Monitoring Photos

The quantity of reflecting cracking has increased from 2021 to 2022 and the ramp has deformation rutting that occurred post construction, but did not significantly increase in depth from 2021 to 2022.

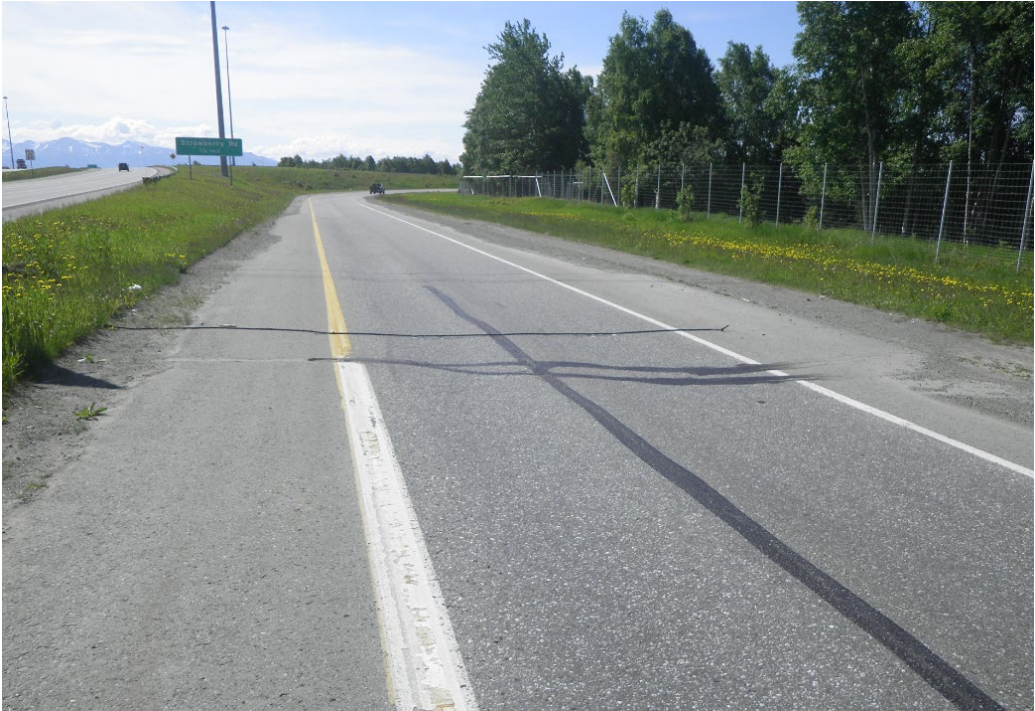
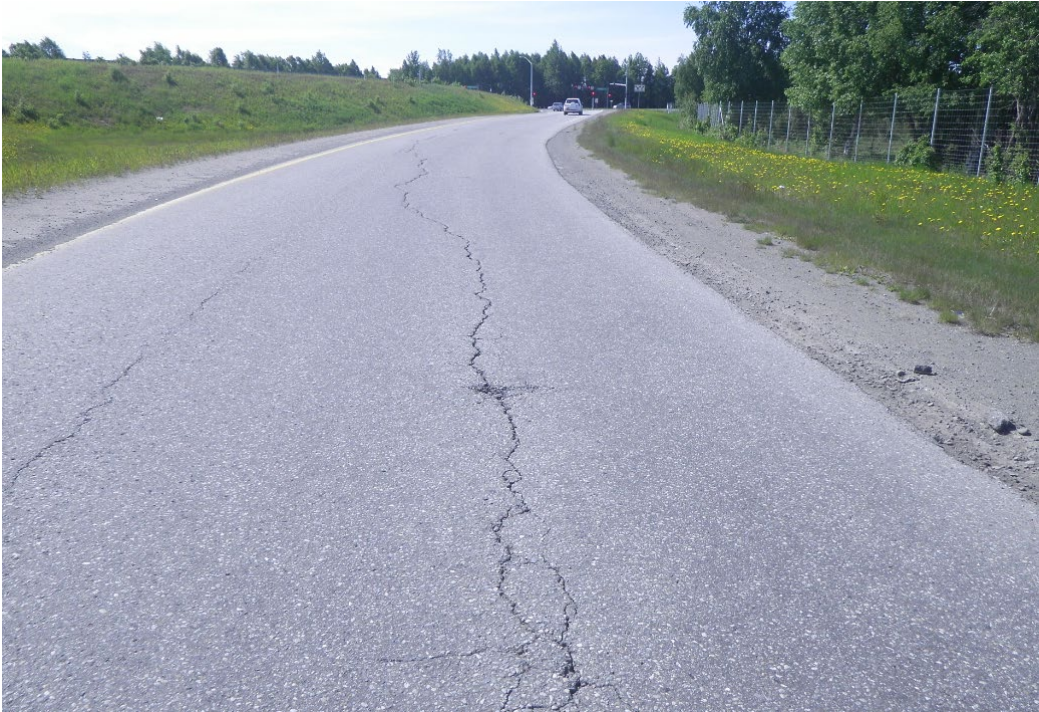
**Pre-construction Photos**

The beginning of this ramp had high rut depths that received hot mix for rut fill prior to the micorsurfacing application. Farther down the ramp there was moderate to high severity longitudinal and transverse cracking with less severe rut depths. This ramp was removed by mill/fill in 2020.

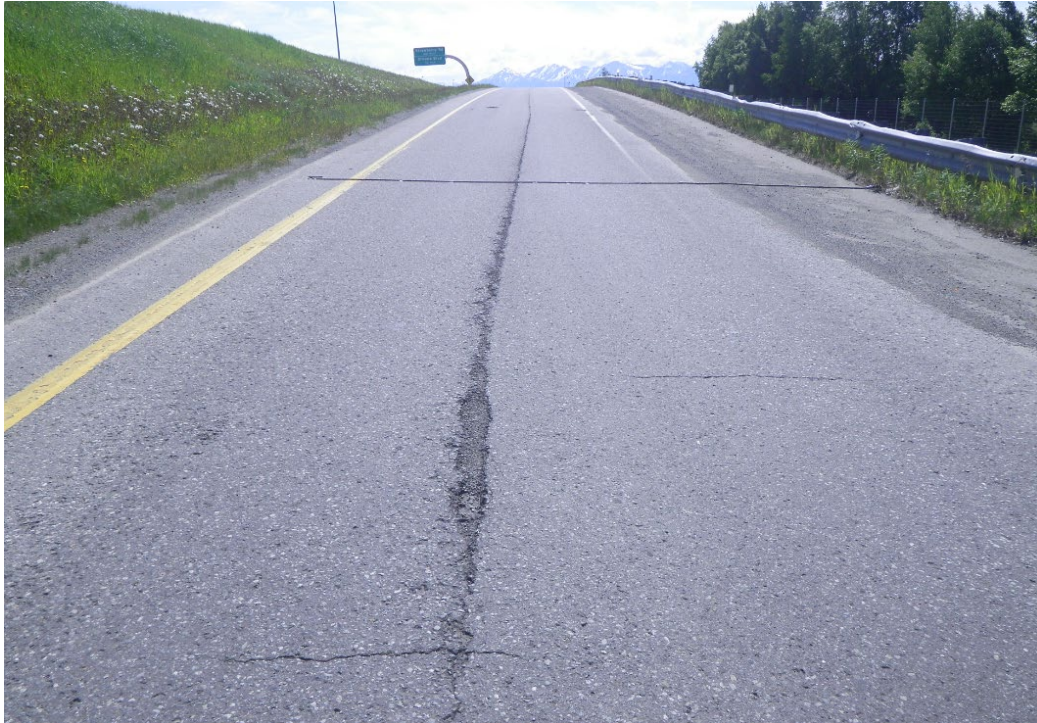
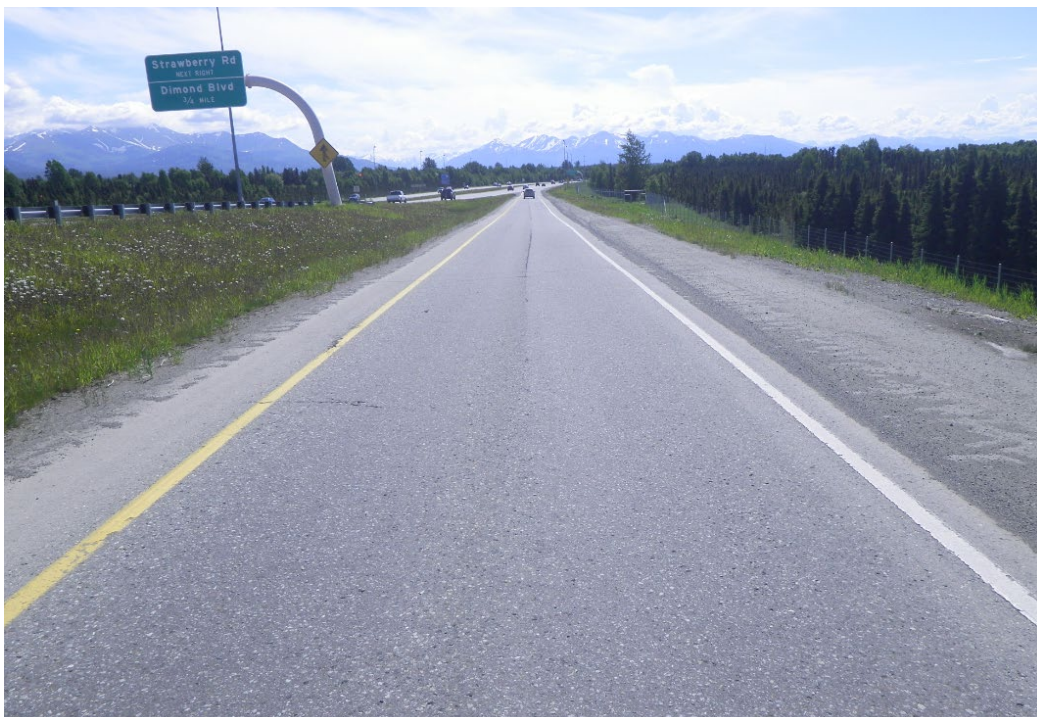
### Pre-construction Photos

The primary distress on this ramp was a longitudinal joint crack and intermittent transverse cracks with associated potholes. The rut depths were minor with the exception of the southern end where traffic accelerates to begin merging with Minnesota where it neared  $\frac{1}{2}$ " on average.

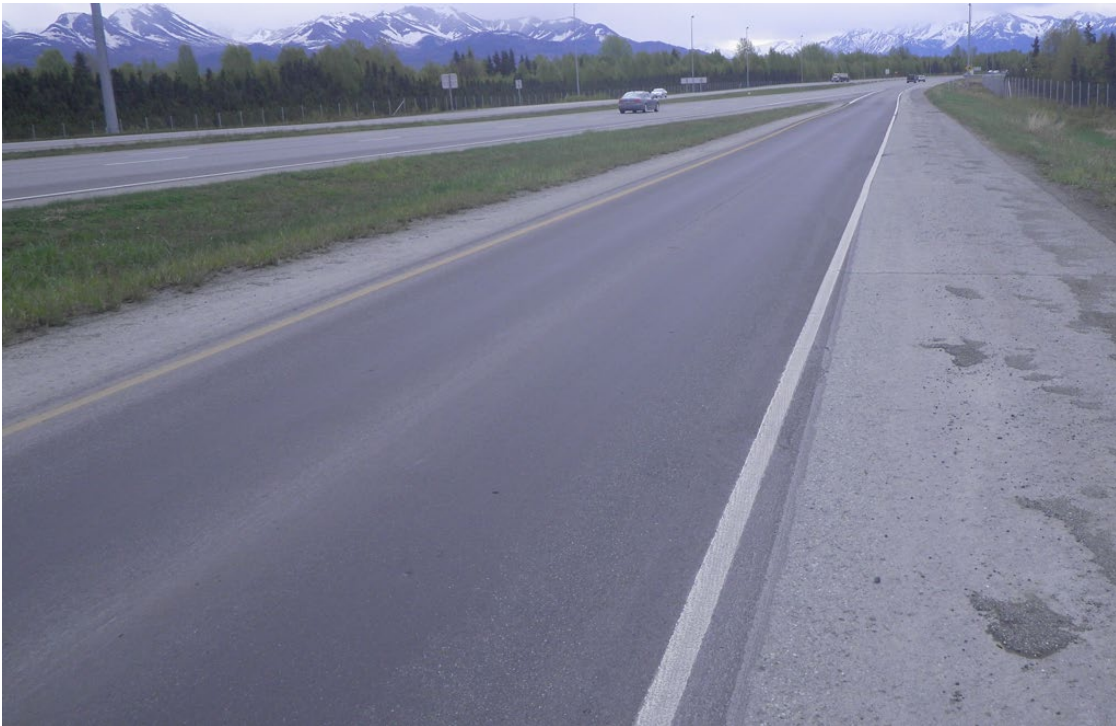
### Year 1 Monitoring Photos

There was moderate flushing present on this ramp in the curve at Raspberry and near the end of the ramp. There was also damage along the centerline joint from plows.

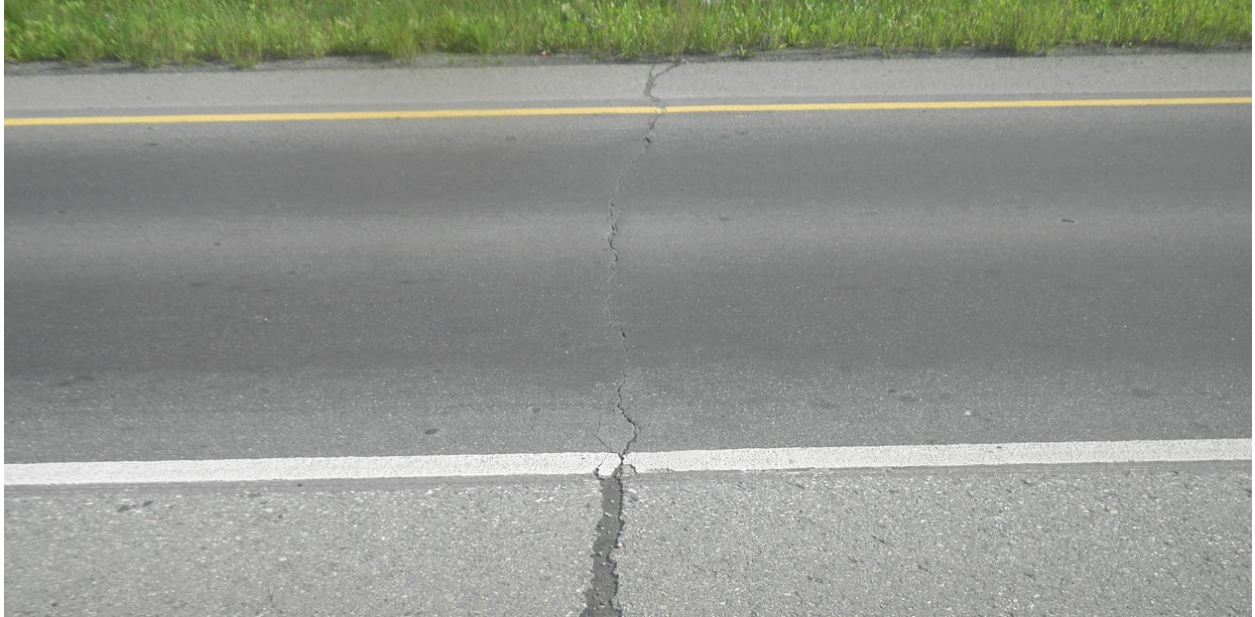
## Year 2 Monitoring Photos

There is significant flushing on this ramp, especially at the beginning of the ramp in the curve and at the end where the deepest ruts were. The reflective transverse cracks are still significantly less severe than they were originally, but the joint raveling along the centerline is opening up since 2021.

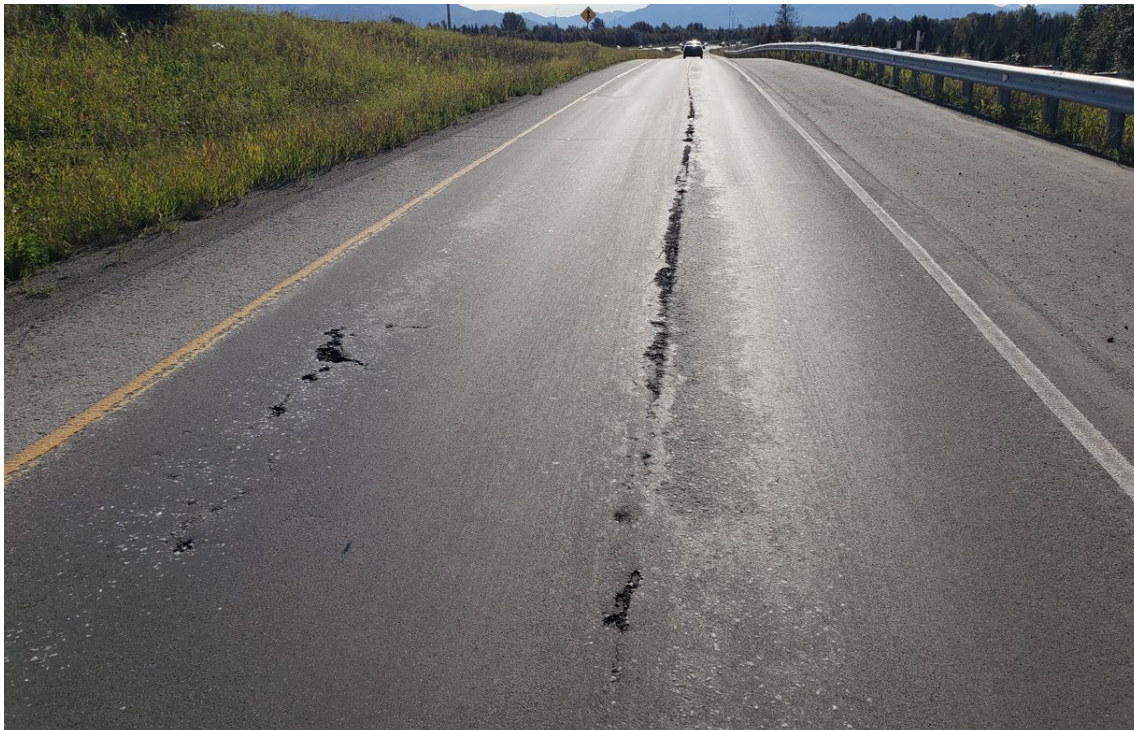
### Year 3 Monitoring Photos

There is significant plow and studded tire damage in the initial curve and going up the hill. It drops to moderate wear for the rest of the ramp where some of the underlying HMA is visible. The high severity joint crack reflected through and has begun to severely spall.

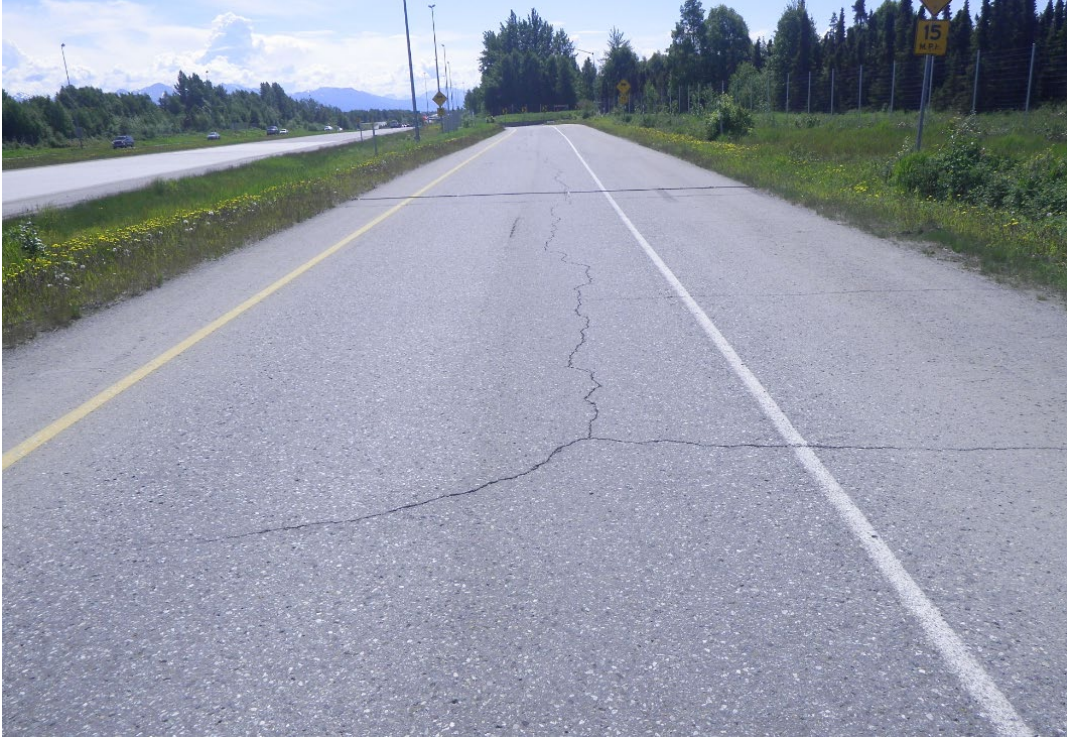
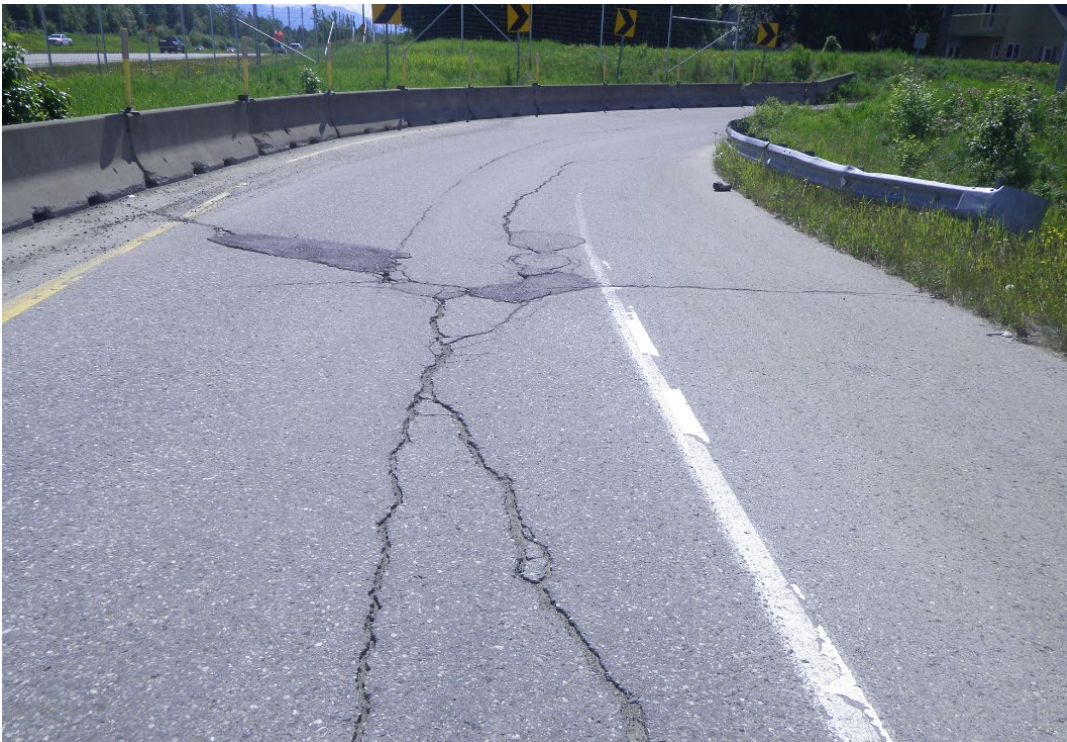
### Pre-construction Photos

There were low rut depths on this ramp, but it did have high severity longitudinal cracking, transverse cracking and potholing that worsen towards the end of the ramp.

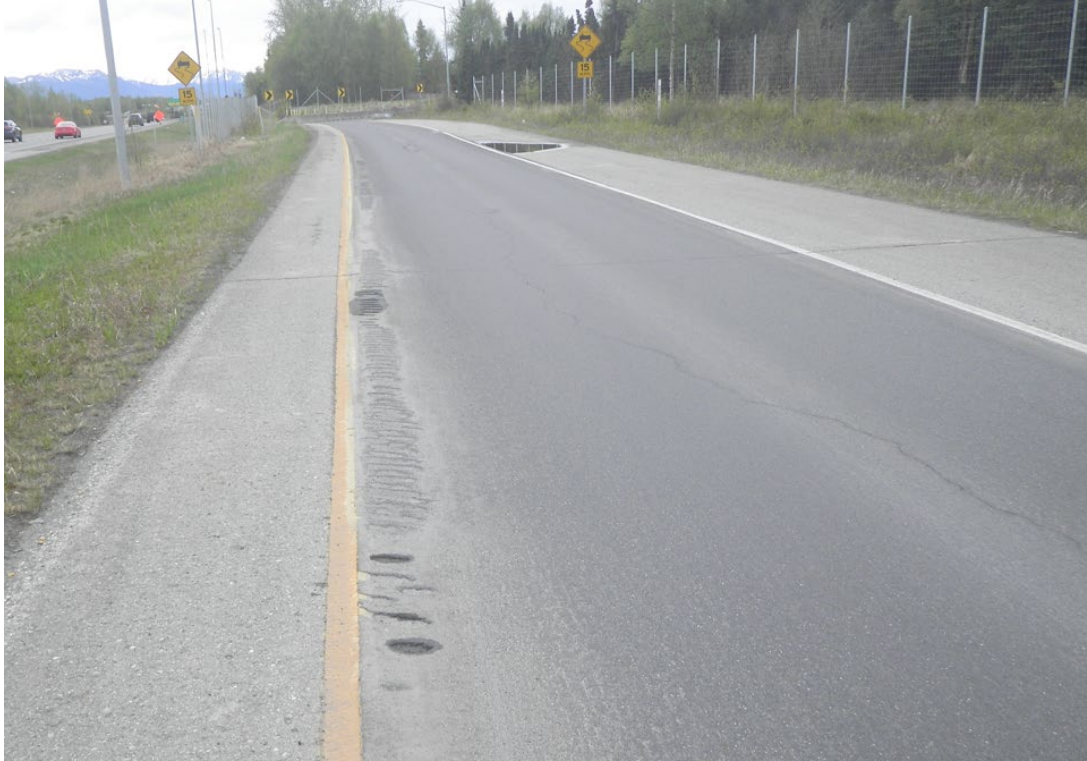
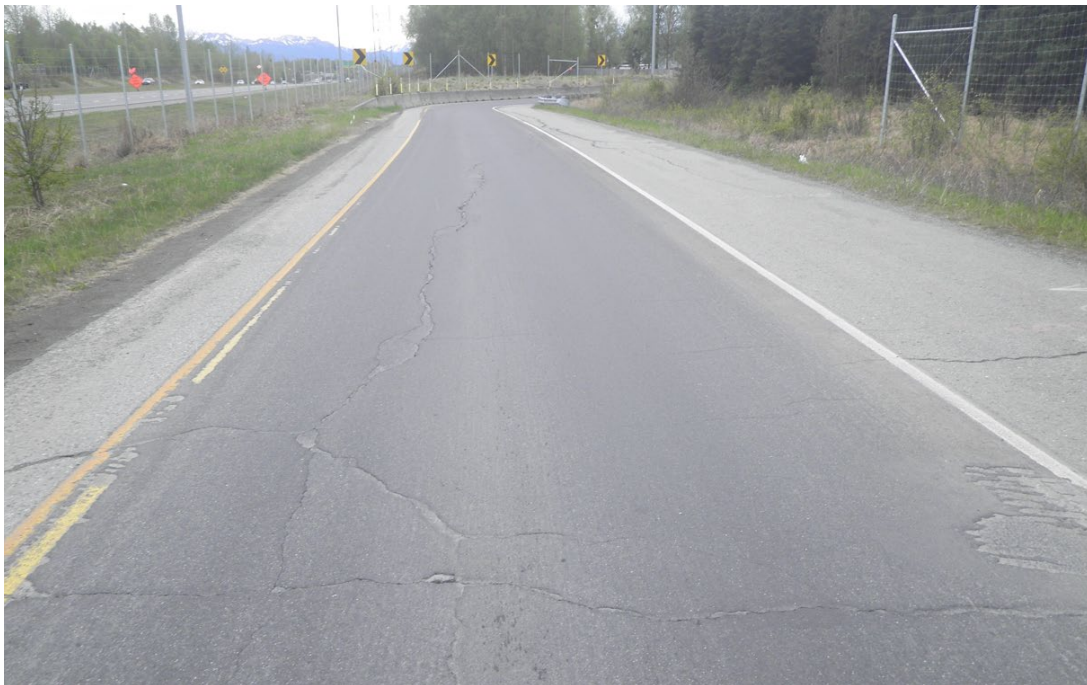
## Year 1 Monitoring Photos

This ramp is in poor condition from plow damage along the centerline and edges of the ramp. The damage was noted after a night of freezing rain when there was likely a large amount of down pressure put on the snowplow to remove ice.

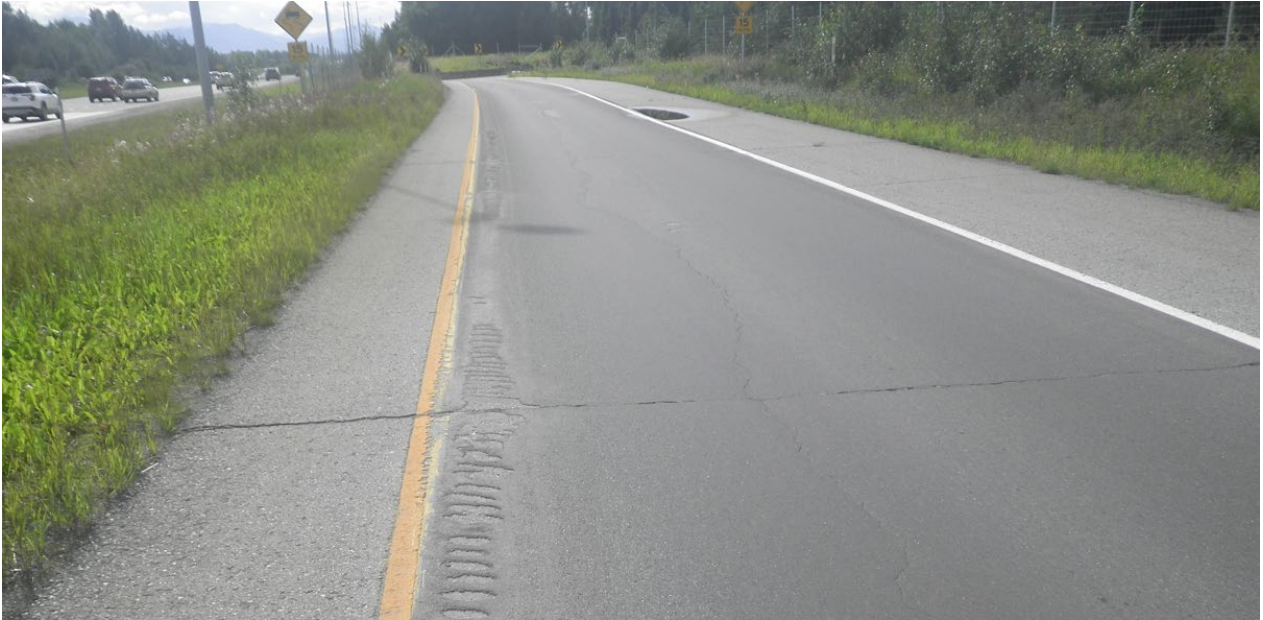
## Year 2 Monitoring Photos

The ramp remains in poor condition with an increased amount of surfacing worn off the center of the road from plows.

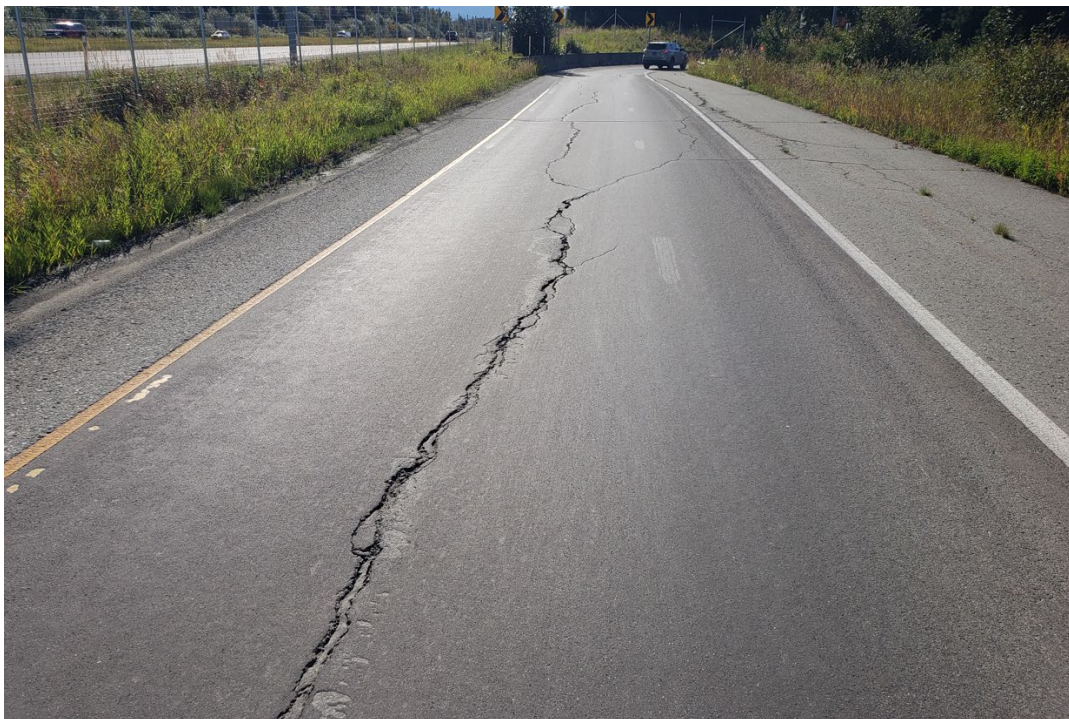
### Year 3 Monitoring Photos

The ramp remains in similar condition to the prior year with significant plow damage and reflective cracking.

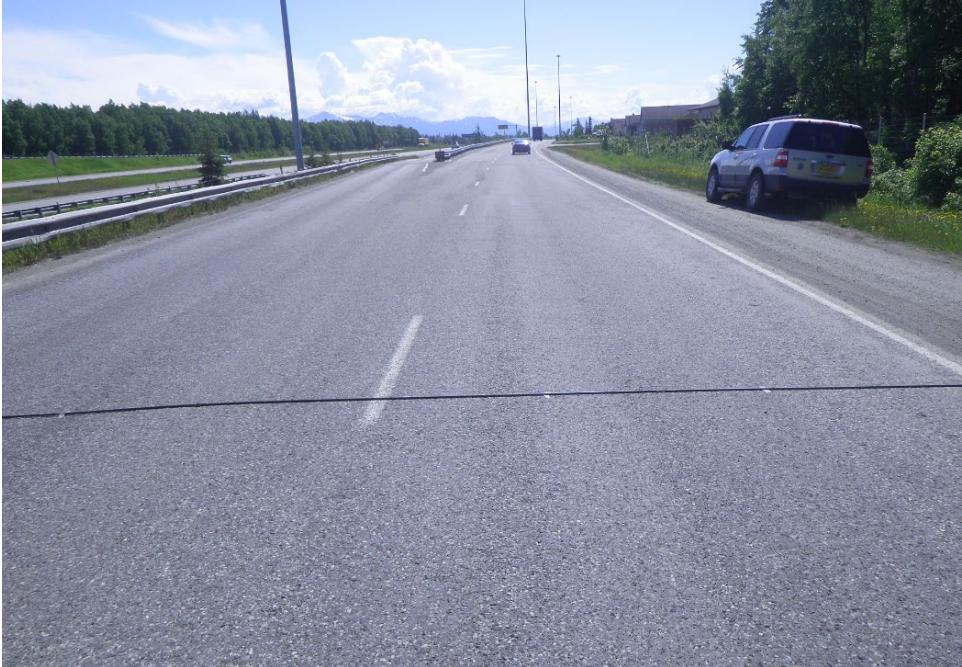
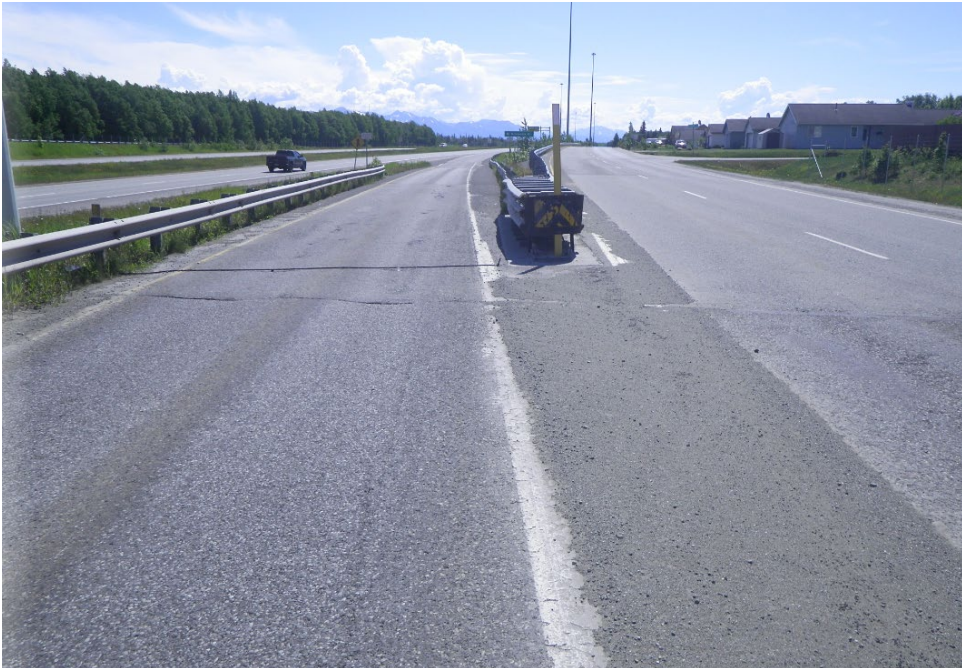
**Pre-construction Photos**

There were moderate rut depths on the left portion of the ramp that accelerates and merges onto Minnesota, which received pre-level prior to the micro surfacing application. The rest of the ramp was in good condition with ruts less than half an inch and low severity raveling.

The portion of the ramp that received pre-level was removed and replaced with a mill/fill due to observed flushing in 2020. The micro surfacing remains on the rest of the ramp.

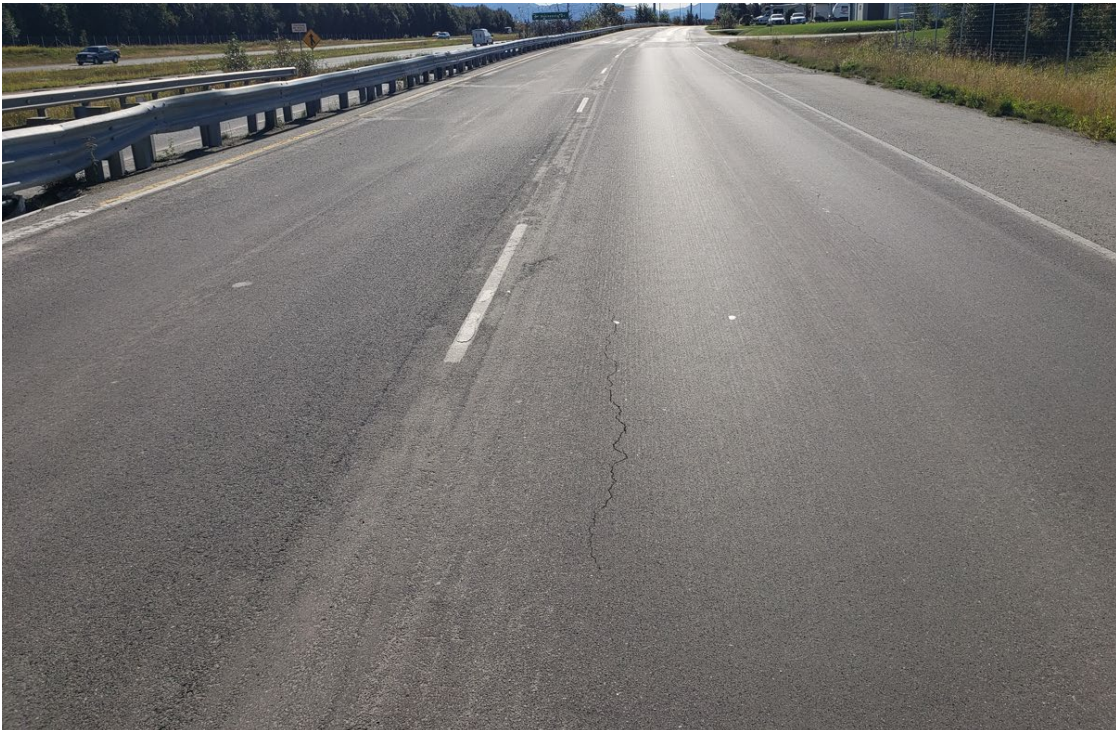
### Year 3 Monitoring Photos

Outside of some isolated wear at the start of the ramp and one moderate severity transverse crack the ramp remains in good condition.

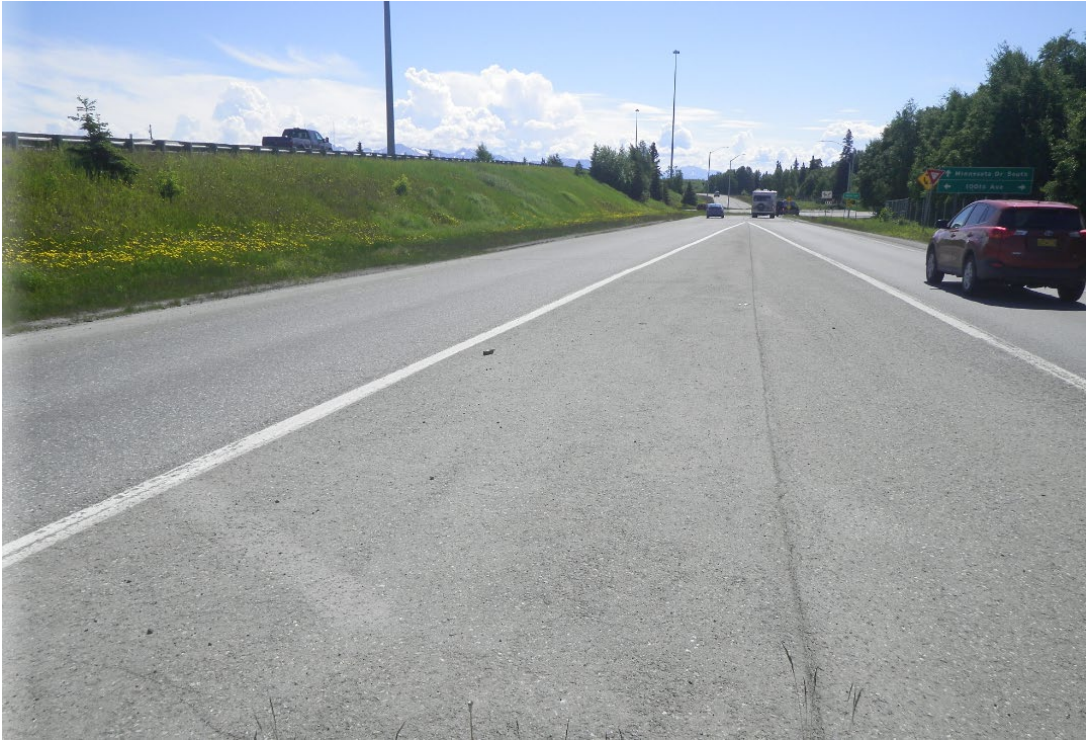
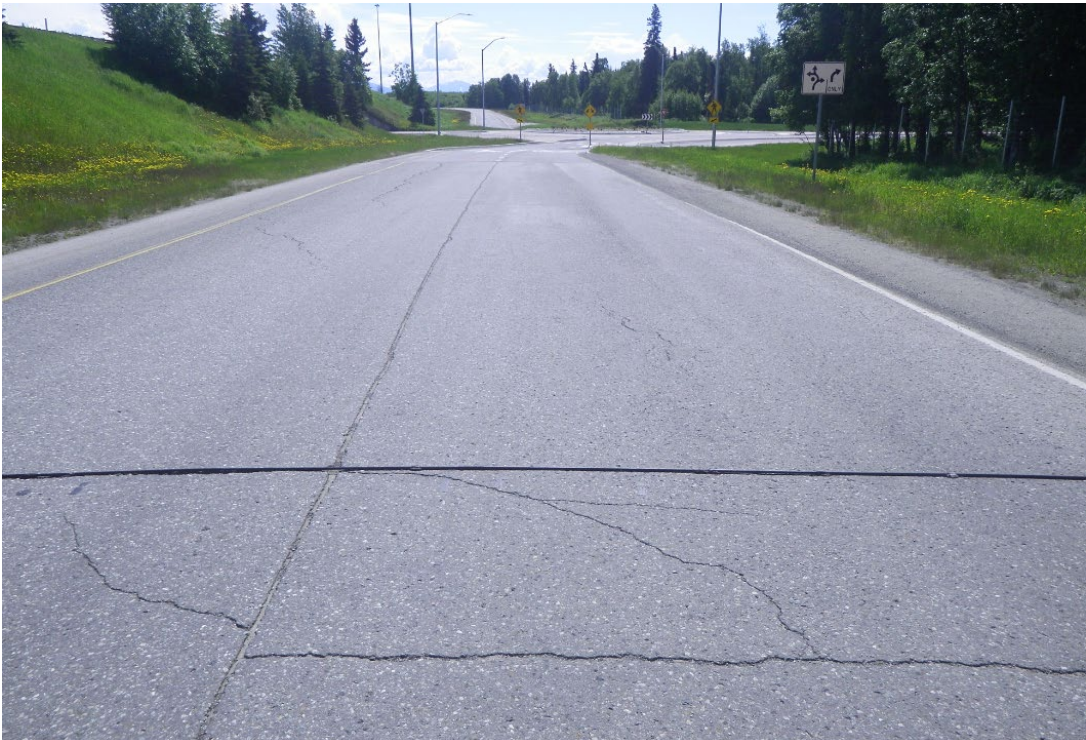
**Pre-construction Photos**

The ramp had isolated potholes, low rut depths but higher severity longitudinal and transverse cracking near 100<sup>th</sup> Avenue.

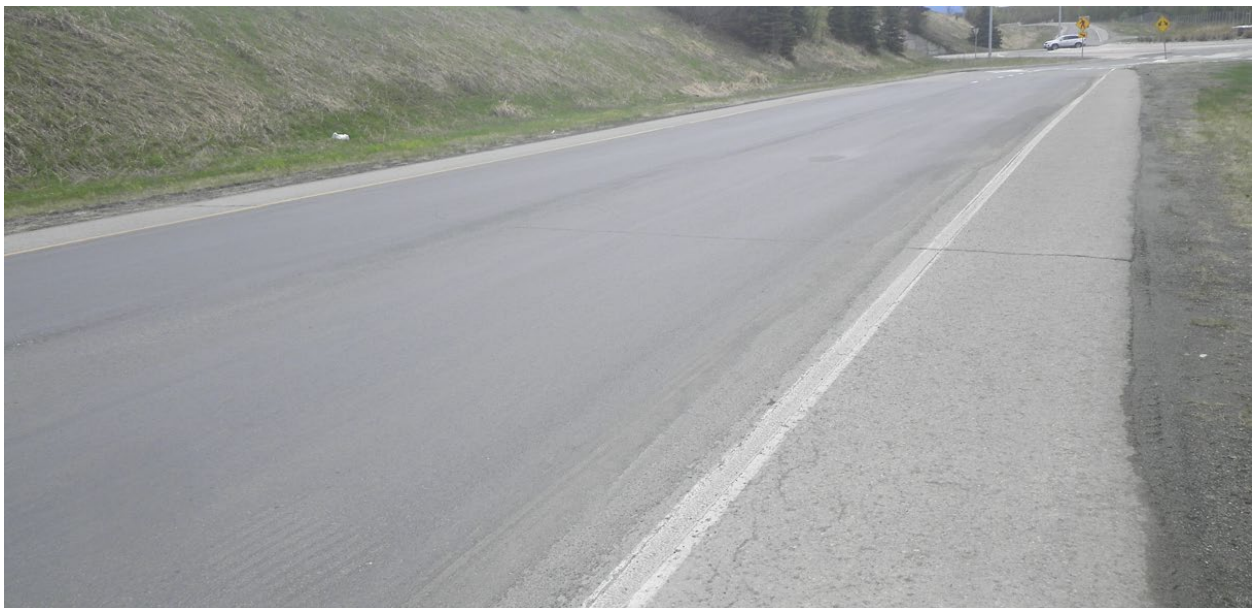
### Year 1 Monitoring Photos

The ramp has some plow damage along the left-hand side and centerline of the off ramp and transverse cracks reflected through the microsurfacing. The ramp remains in moderate to good condition.

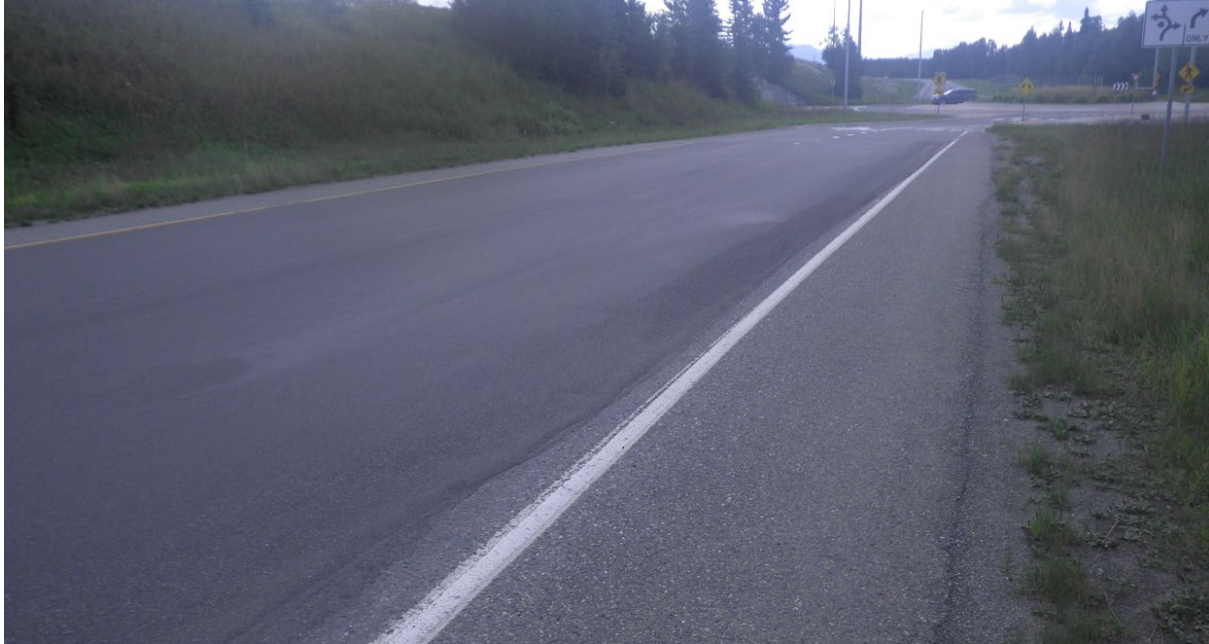
### Year 2 Monitoring Photos

The ramp remains in moderate condition with some isolated plow damage and reflective cracking.

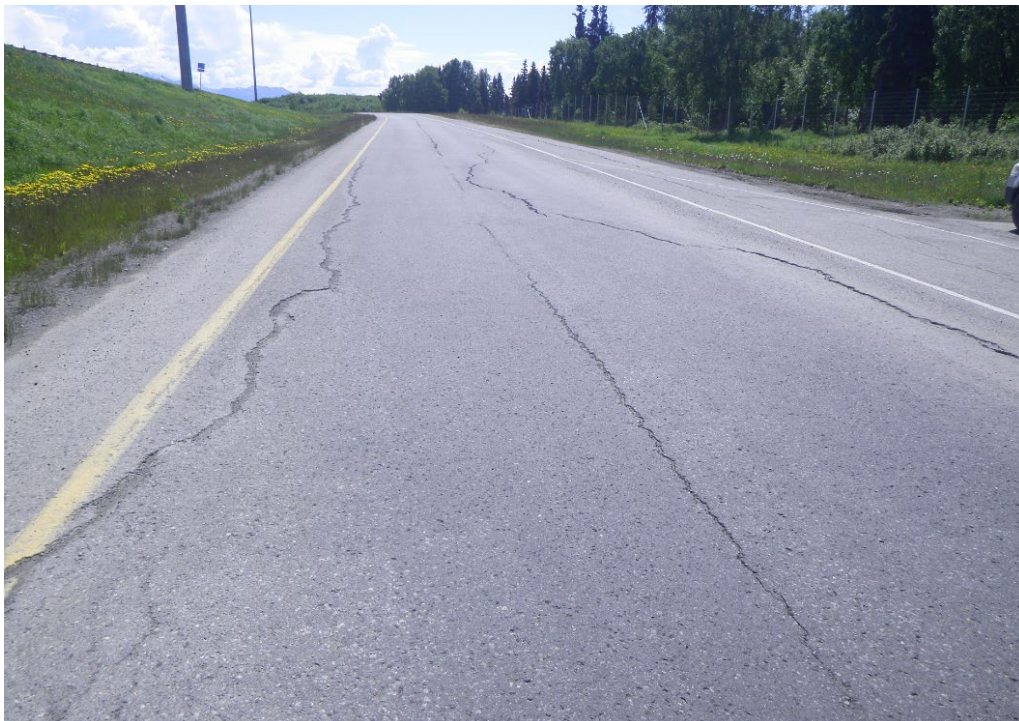
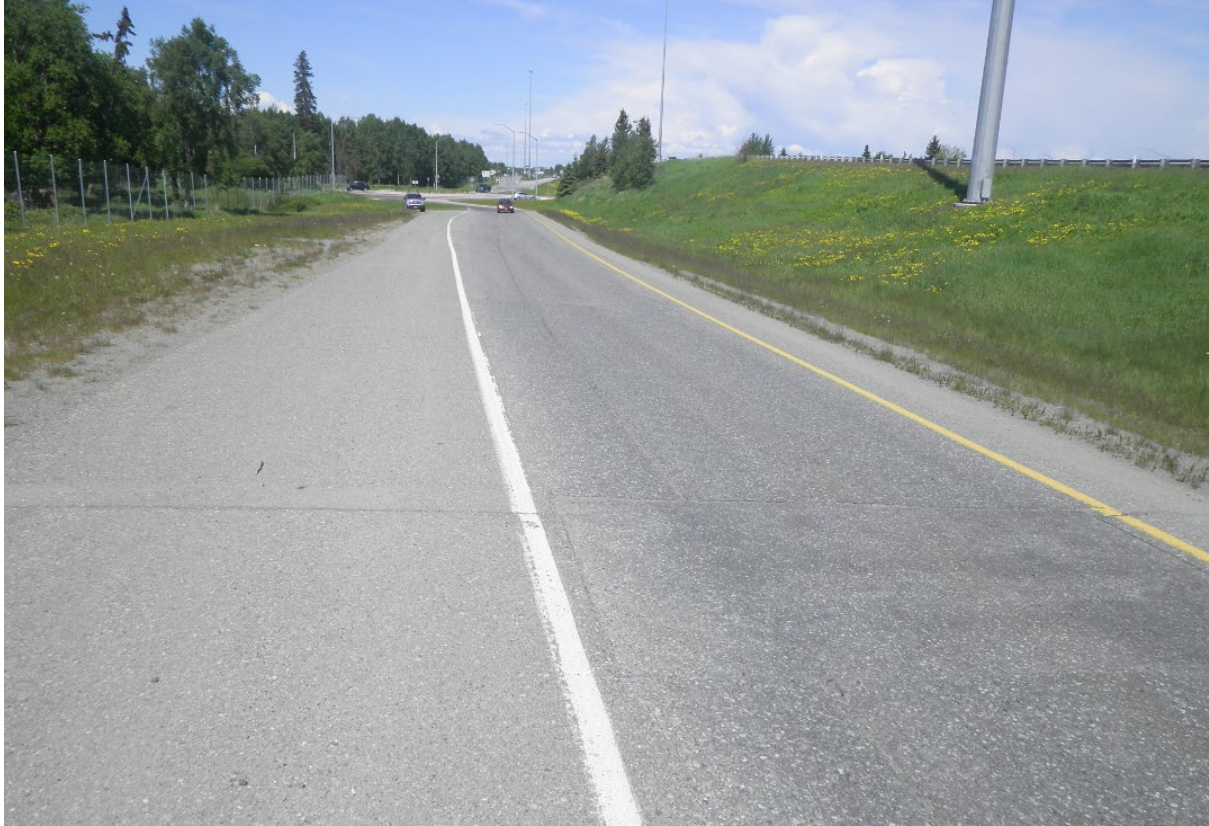
#### **Pre-construction Photos**

There was high severity longitudinal cracking and joint cracking near 100<sup>th</sup> Avenue that improved farther down the ramp.

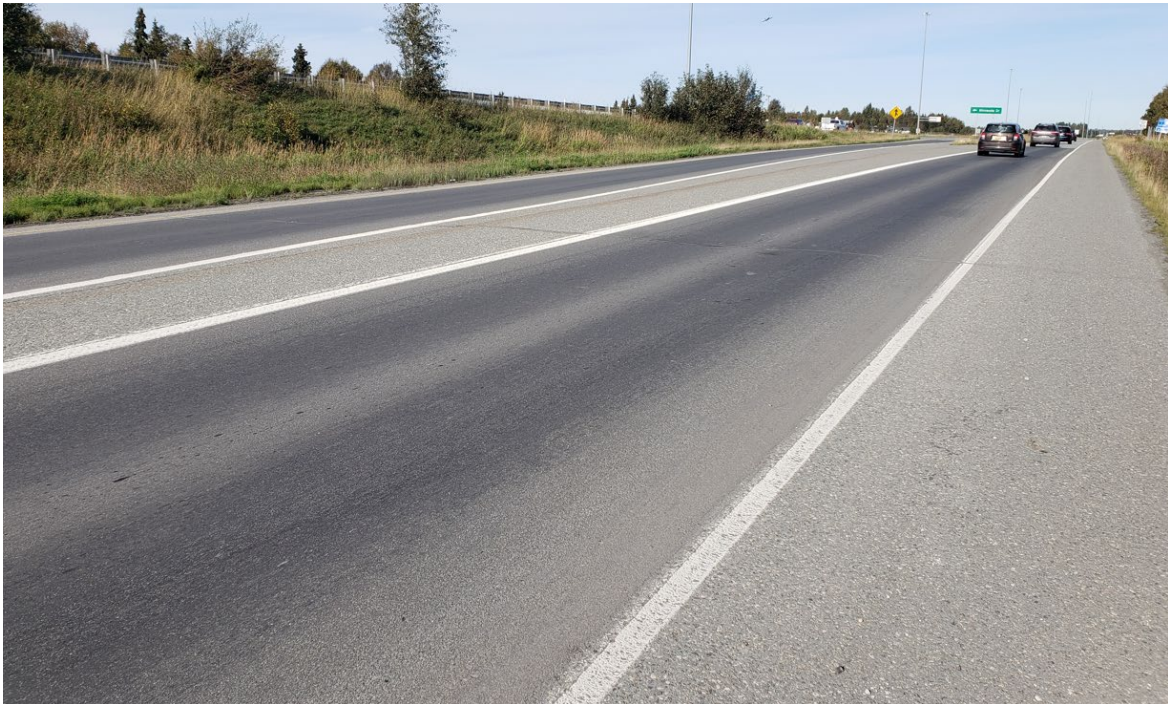
### Year 3 Monitoring Photos

The severe transverse crack has continued to see increase in wear and there is slight spalling around transverse cracks. There is also some isolated plow damage farther down the ramp.

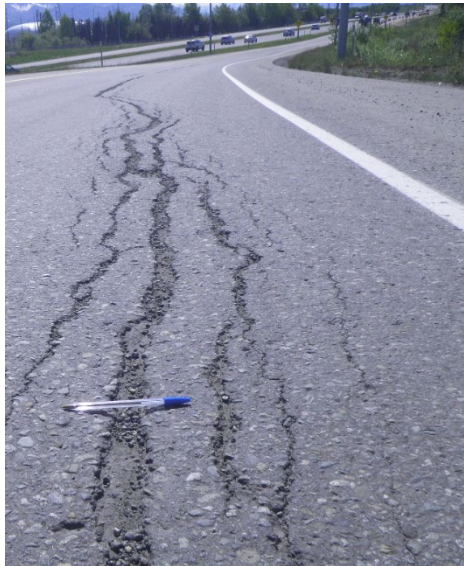
*Ramp 1 Prior to Surface Preparation*

The primary distress is high severity longitudinal cracking down the center and right of the lane starting near International Airport Road. There is low raveling, and studded tire wear that deepens near the bottom of the ramp near Minnesota, which received rut fill using hot mix. At the end of the guardrail, pattern cracking has formed around the cracks. The cracks are near 1.5” at the widest and received crackseal and HMA to fill. The photo on the left is prior to surface preparation, and the right is after, with the larger crack being filled with both crackseal and hot mix.
