## Minnesota Drive Ramps Micro Surfacing Experimental Feature

January 2024

**Publication Number:** FHWA-AK-RD-4000(181), HFHWY00123

13. ABSTRACT (Maximum 200 words)  During the 2020 construction season, the Alaska DOT&PF Central Region installed its first application of micro surfacing at 17 locations on Minnesota Drive ramps in the city of Anchorage. This treatment offers the potential to be a more economical solution to the typical mill and fill hot mix asphalt (HMA) treatment used to address rutted roads.  Micro surfacing has not been used on roads in Central Region due to poor historical Prall testing (ATM 420) that is used to simulate studded tire wear. A new formulation of micro surfacing was evaluated in 2016 with significantly improved performance on the Prall test. This formulation uses fine aggregate and a high residual binder content with a PG64-40 modified asphalt binder and between 6%-8% SBS polymer. This is a very high percentages of both binder and polymer for a micro surfacing treatment.  There were difficulties encountered during construction with break and set times that made the micro surfacing prone to flushing and deformation rutting immediately after constr

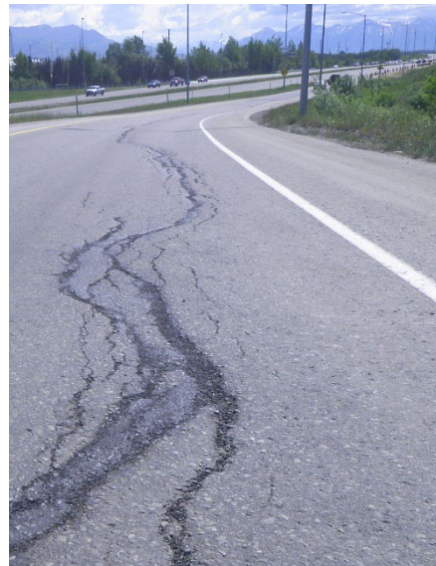
*Ramp 1 After Surface Preparation*

The primary distress is high severity longitudinal cracking down the center and right of the lane starting near International Airport Road. There is low raveling, and studded tire wear that deepens near the bottom of the ramp near Minnesota, which received rut fill using hot mix. At the end of the guardrail, pattern cracking has formed around the cracks. The cracks are near 1.5” at the widest and received crackseal and HMA to fill. The photo on the left is prior to surface preparation, and the right is after, with the larger crack being filled with both crackseal and hot mix.

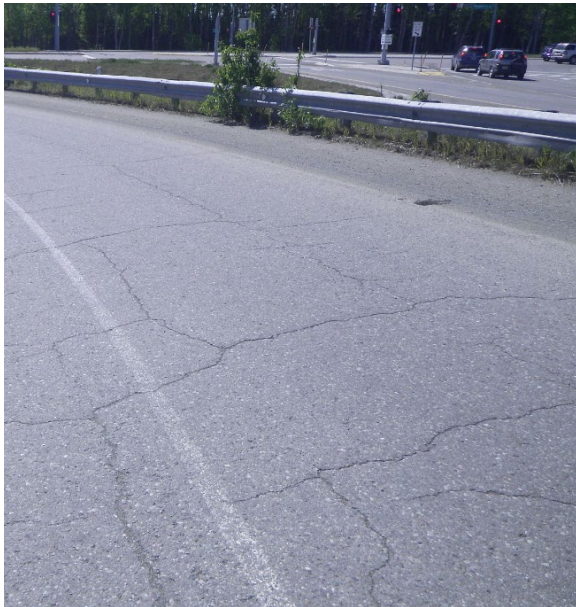
*Photo 1 - Ramp 8 General Condition*

This cloverleaf ramp has block cracks of moderate severity for nearly the entire length along with a wide joint crack. Fatigue based cracking is beginning to appear in the wheel paths in addition to the block cracking. See photo below to the left that shows the general ramp condition.

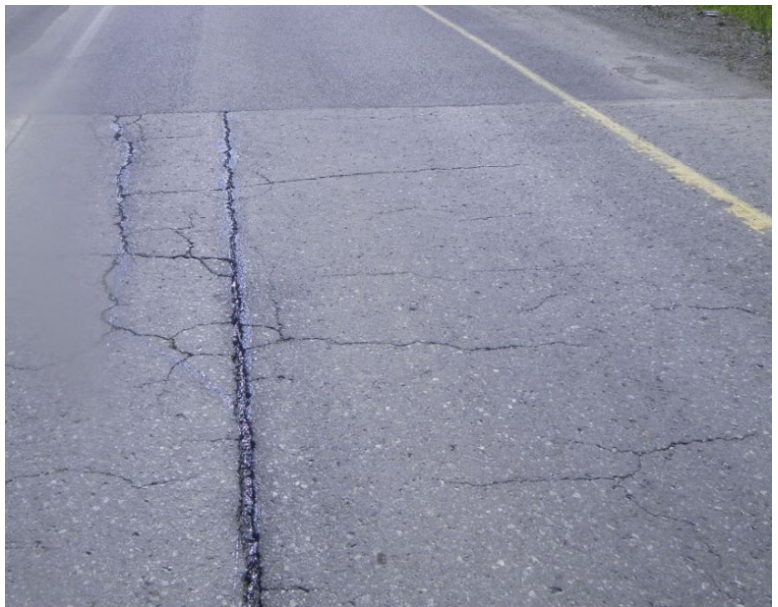
*Photo 2 - Ramp 9 General Condition*

A longitudinal joint crack is present for the majority of the ramp, along with block cracking that has developed into alligator cracking in the right wheel-path that extends to near the end of the ramp at the International Airport sign. From then on, faint block cracking is beginning to develop along with moderate severity transverse cracks. See the photo above and to the right.

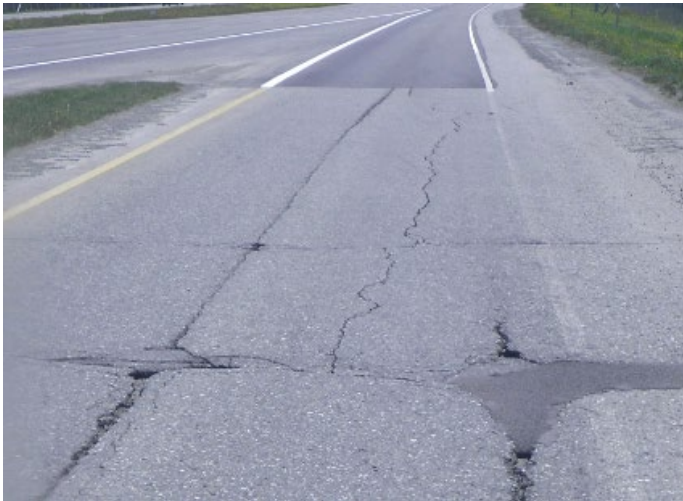
*Photo 3 - Ramp 11 Prior to Surface Preparation*

The predominant distresses are low to moderate severity thermal cracking and a low-density joint that is raveling and losing aggregate. Potholes have been forming at the transverse cracks, with two major potholes approximately 50' from the end of the micro surfacing near Minnesota. There is intermittent longitudinal cracking on the ramp. See the photo below and to the left.

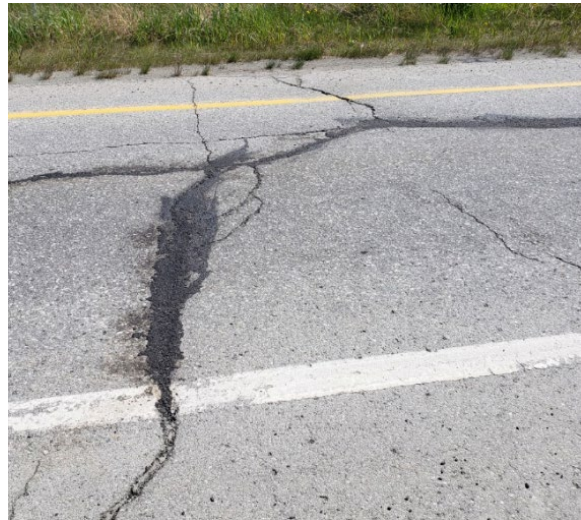
*Photo 4 - Ramp 12 - Cracks after Surface Preparation*

There is high severity longitudinal cracking and potholing beginning approximately halfway down the ramp. Transverse cracking varies between low to high severity throughout the ramp. See the above right photo.

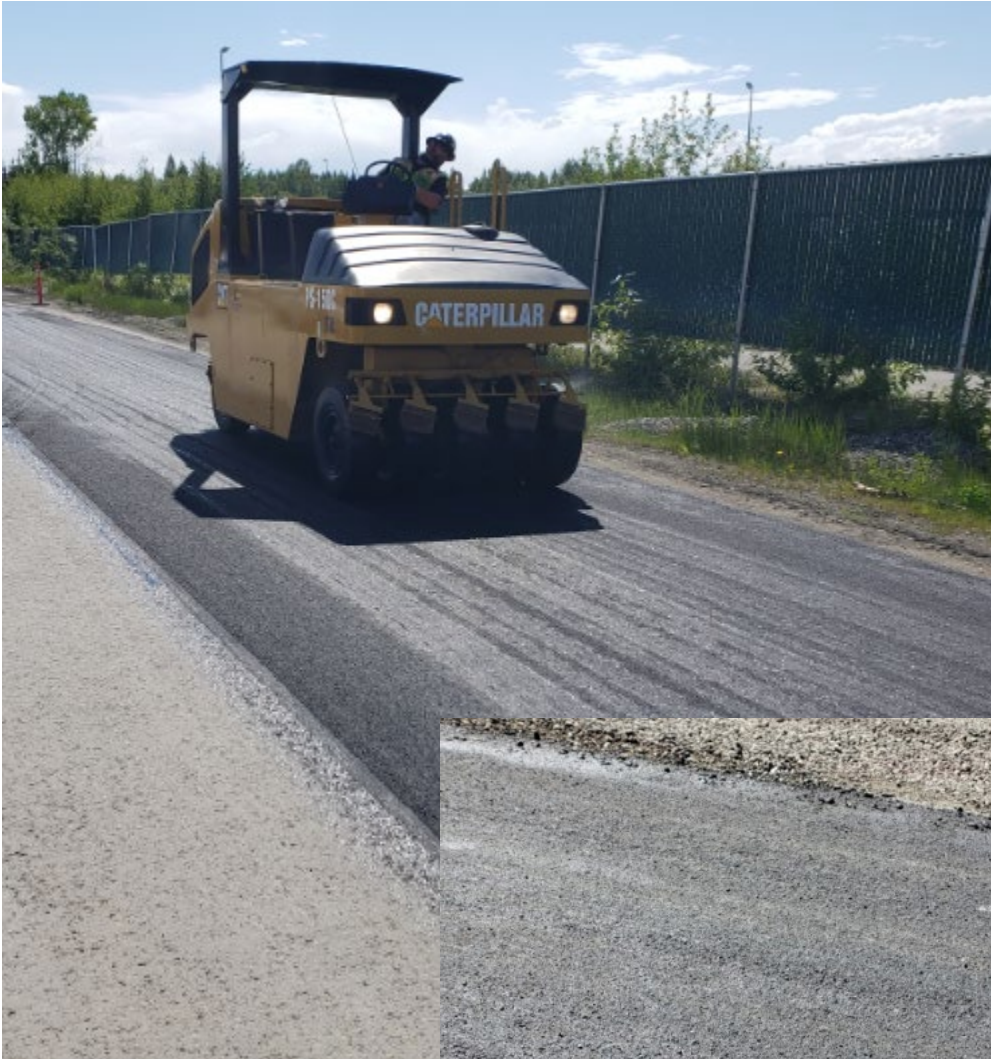
The pneumatic roller mechanically forcing the water out of the system to improve the set time. The water is visible/shiny on the surface after the roller passes over.

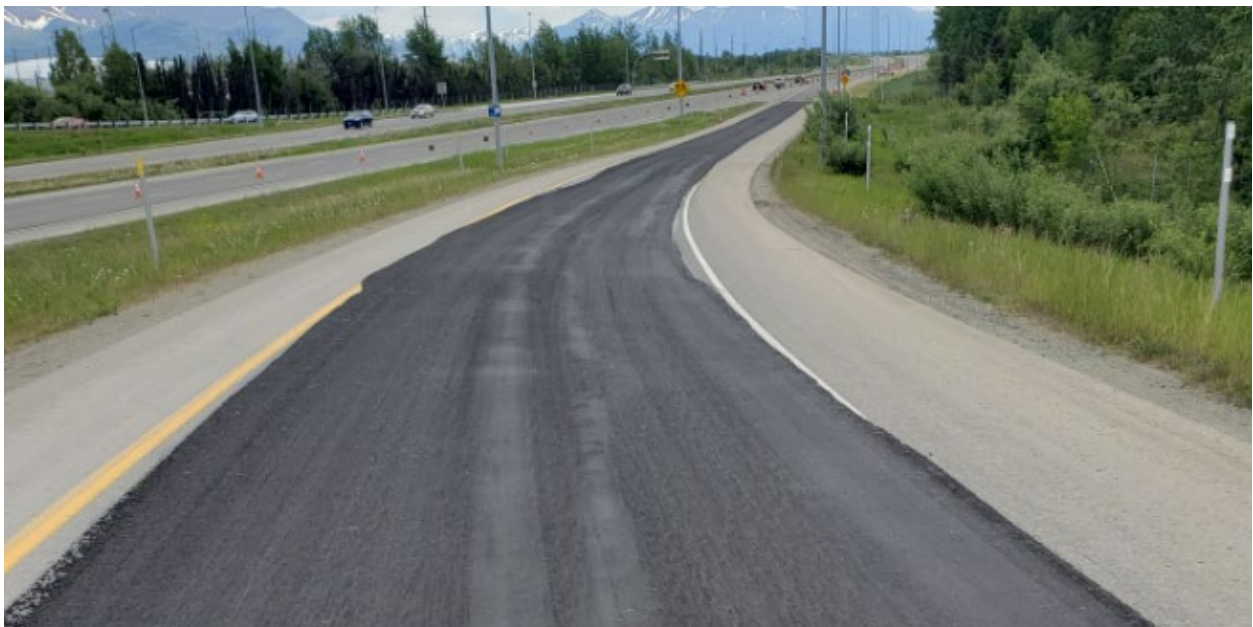
Scratch course on Ramp 1 after rolling. Production was halted after rolling this ramp and placing scratch course on Ramps 5 and 6 due to the set time issues and the time it took to get the pneumatic roller on these ramps.

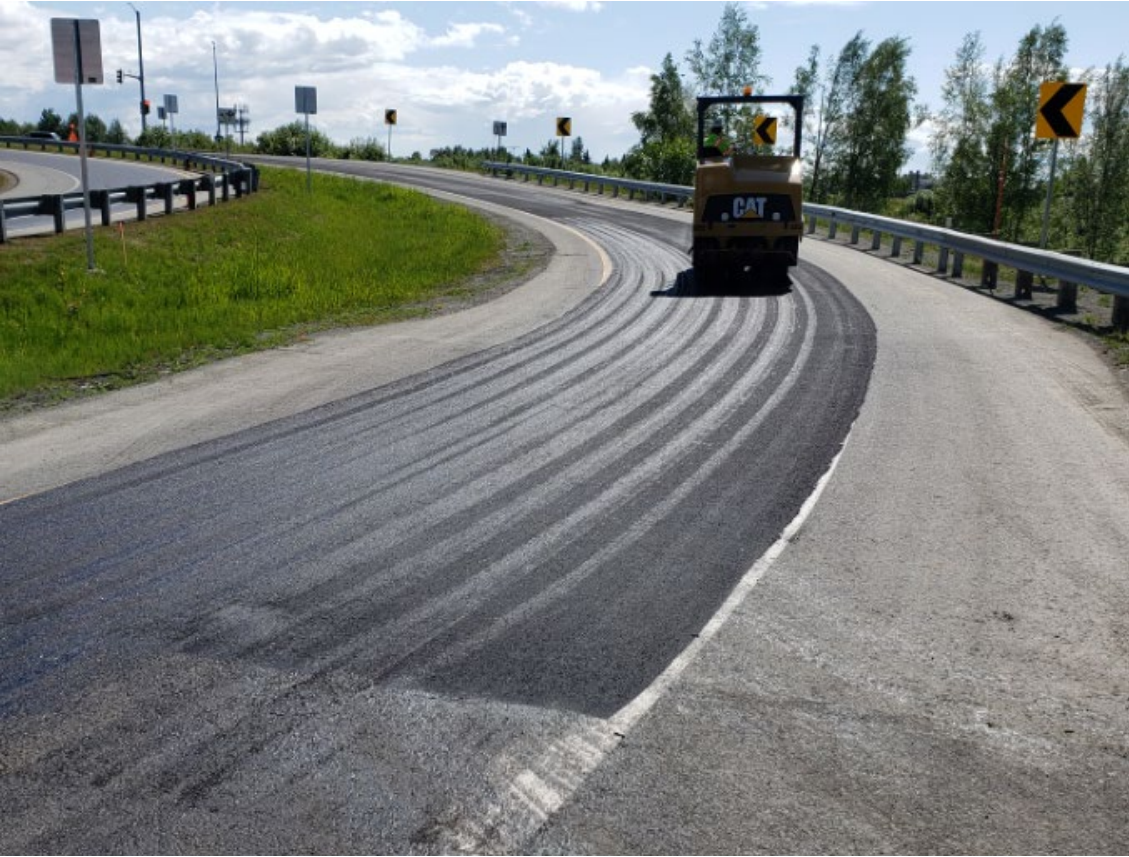
A pneumatic roller finishing a portion of Ramp 6 that was unable to be completed on the first day of production due to the crude source changing for the emulsion. The ramps were able to be rolled and opened to traffic in between 1.5 -2 hours instead of the 4 hours it was taking the first day of production.

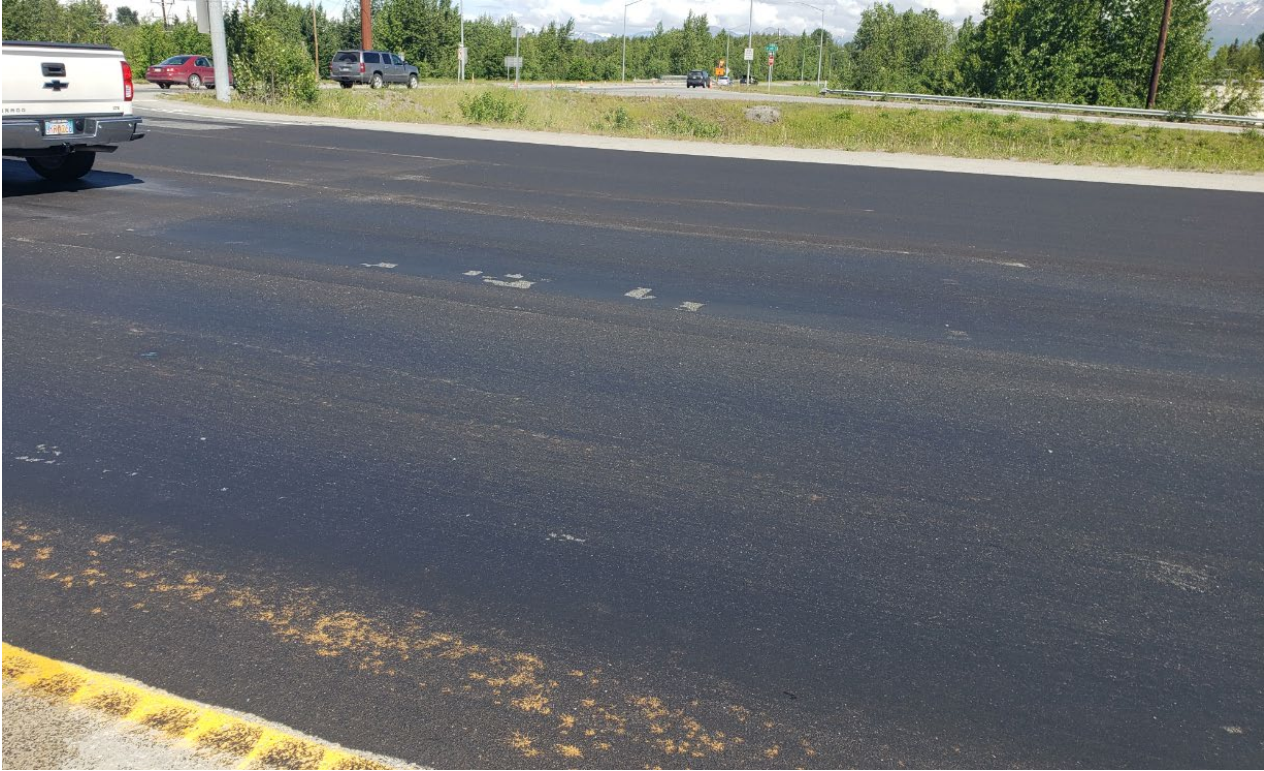
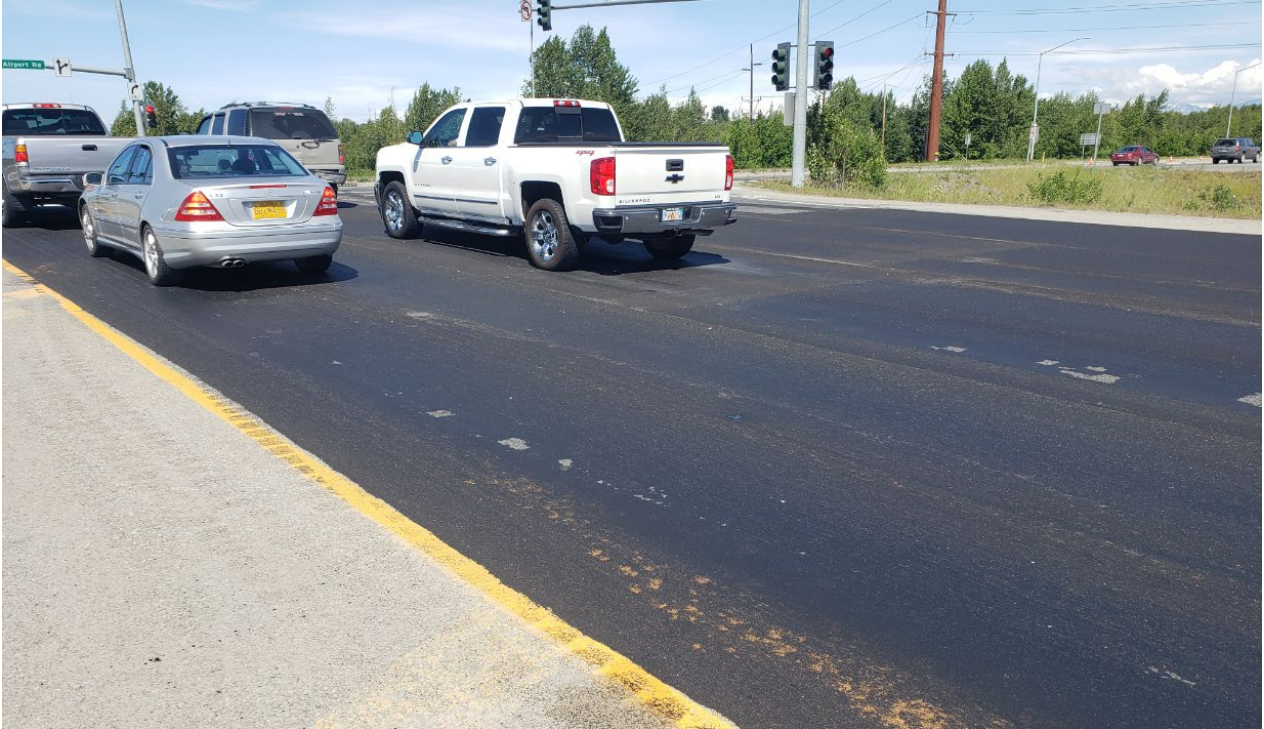
There was some pickup by traffic on the scratch course on Ramp 2 on the fourth day of production. This is at the signalized intersection that the major pickup and deformation occurred on the surface course.

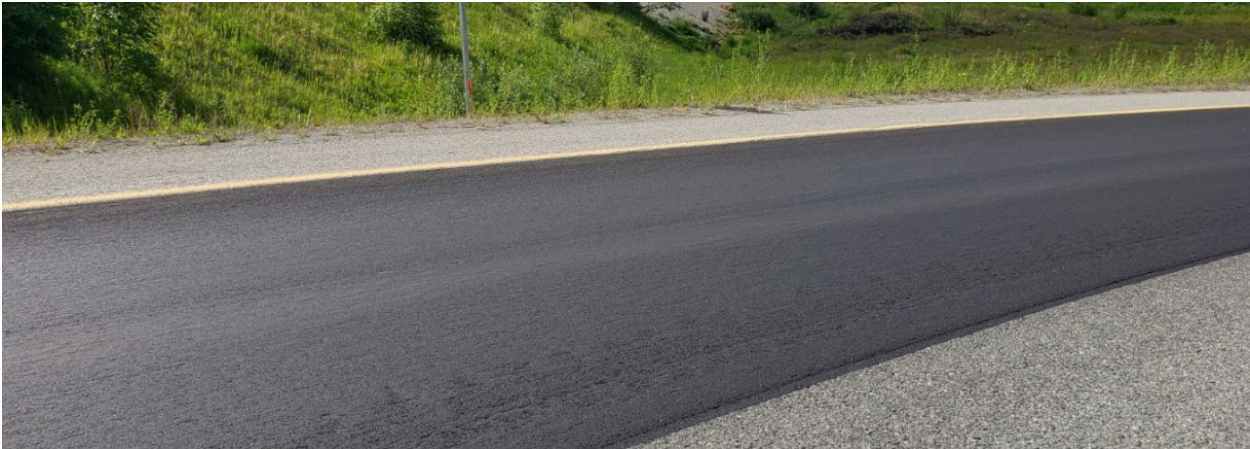
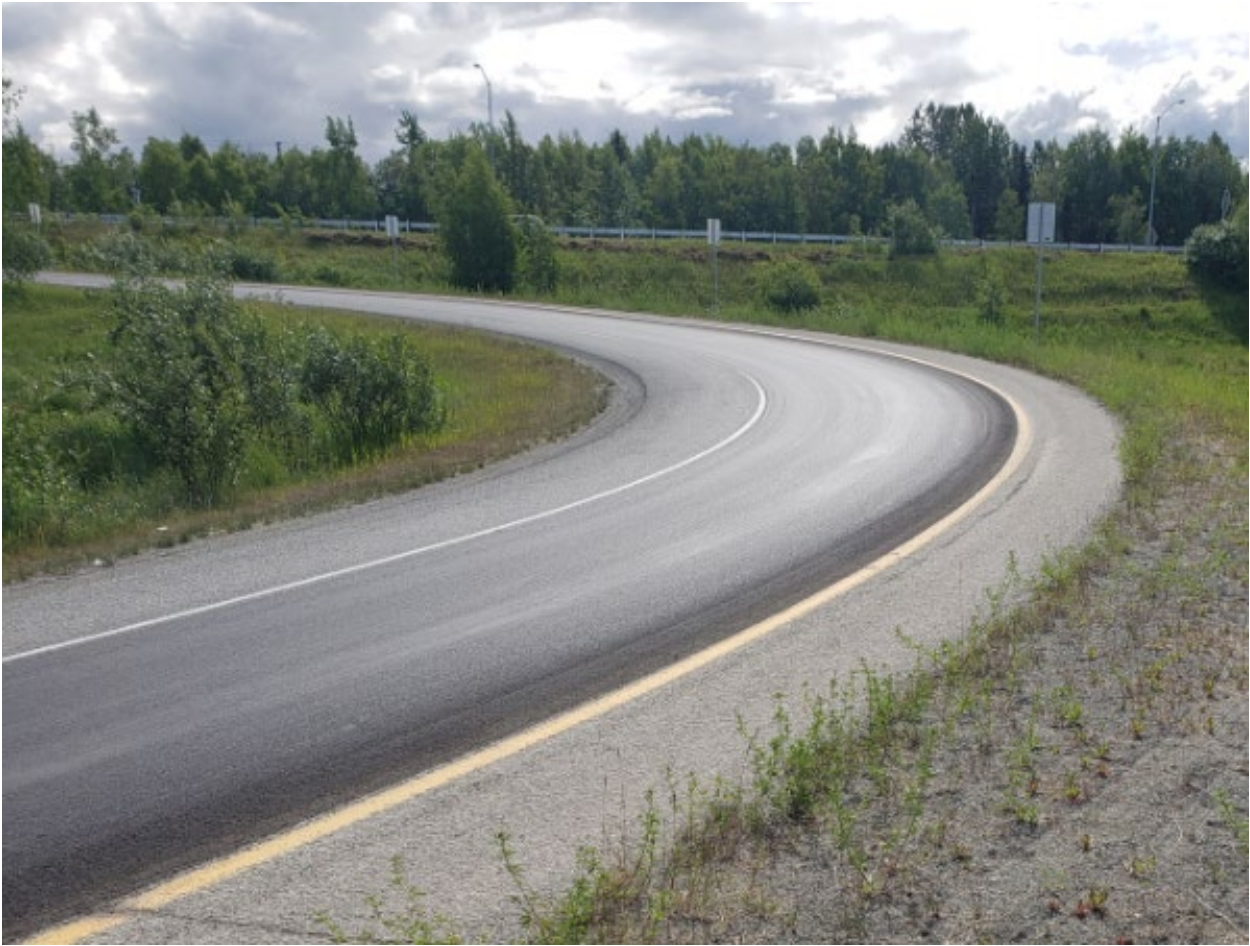
Ramp 3 was reviewed while out looking at Ramps 1 and 2 and no flushing, bleeding or other distresses were present on the ramp. This is the same location that was hand worked in the previous photos.

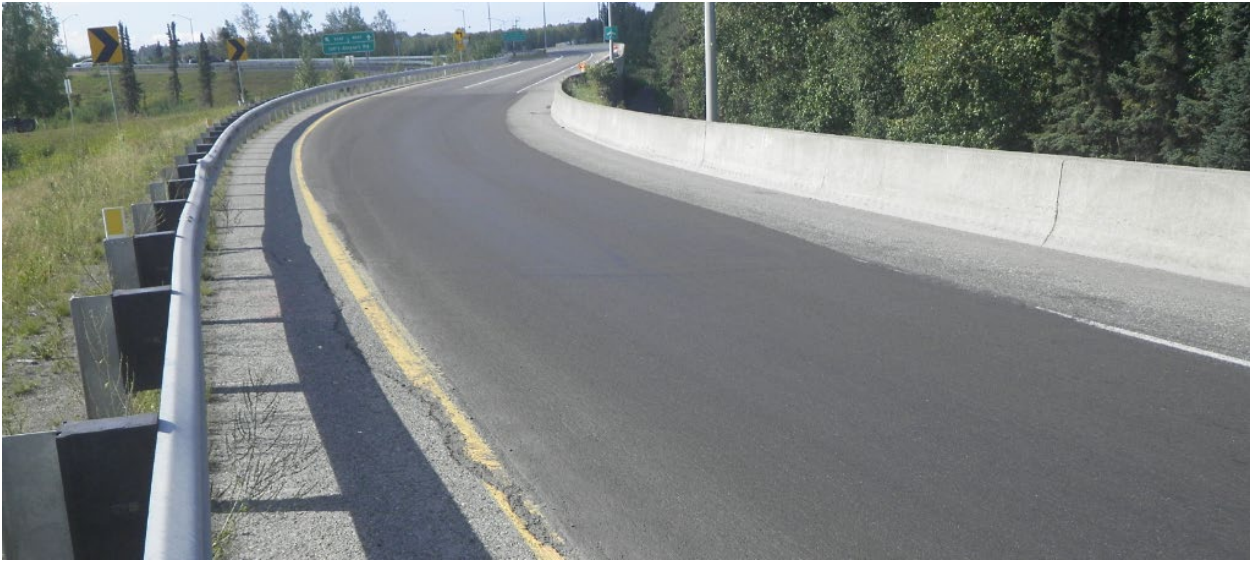
Ramp 5 had some minor flushing on the portion closest to Minnesota shown in the first photo below that was placed over moderate to major severity longitudinal cracks.

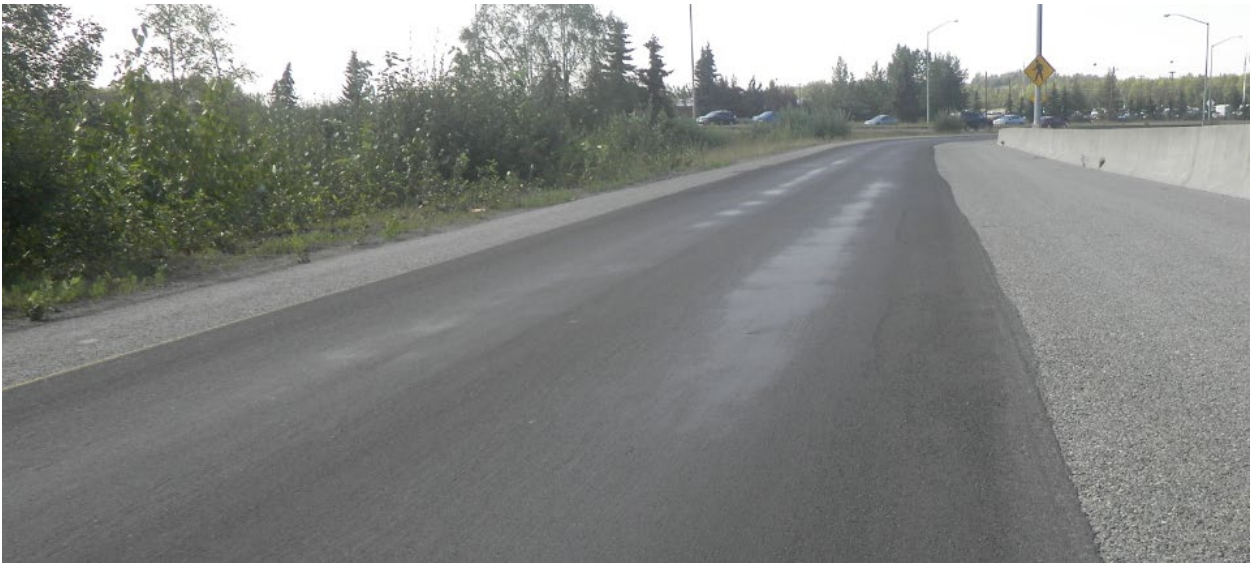
More severe flushing was visible in the area closer to merging onto International.

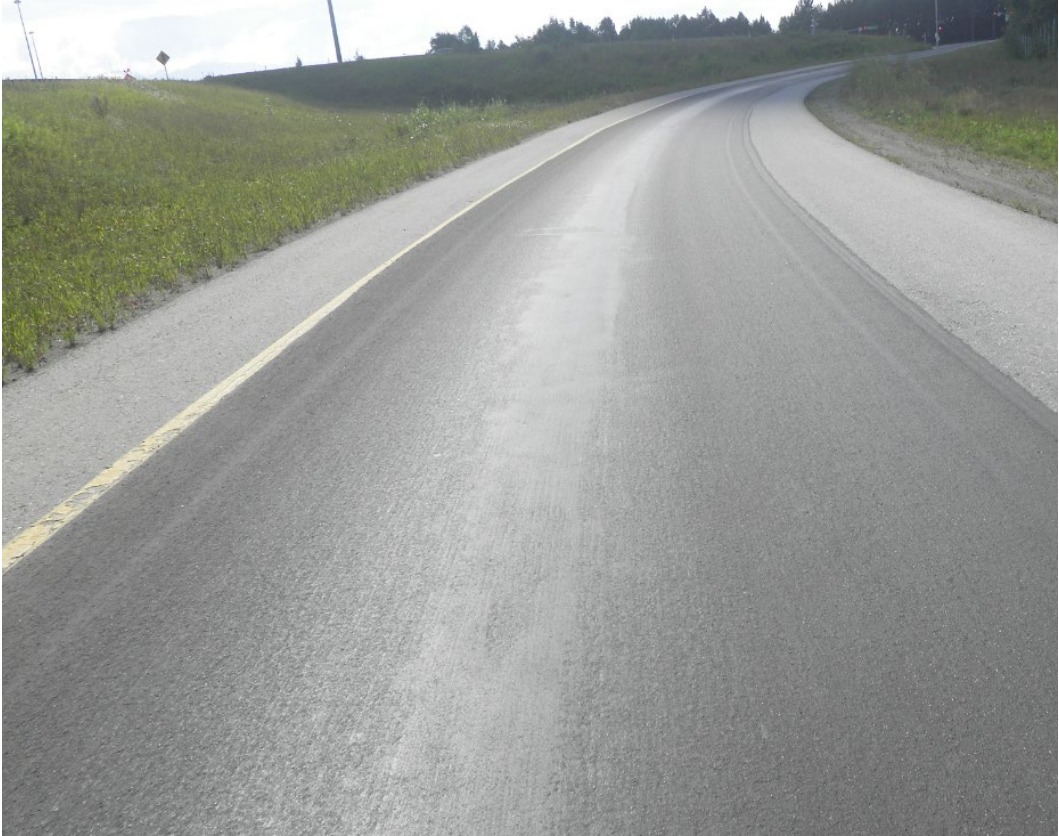
Ramp 10 had been noted to be a part of a haul route, as Ramps 1 and 2 were, so it was investigated as well. There was minimal flushing over the initial part of the ramp that received rut fill.

This turned into more severe flushing after the rut-filled area going into the curve.

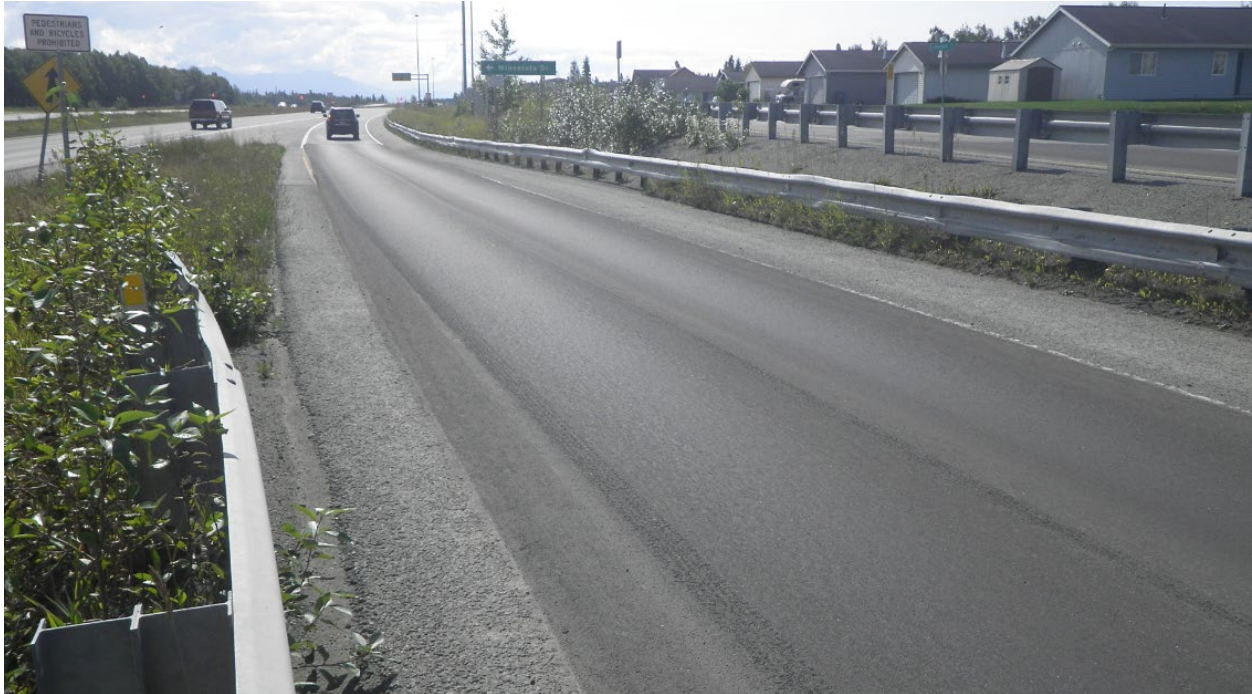
Ramp 13 had the least visible flushing and was placed over a rut filled area, but given the distresses on the other ramps and the shininess visible on the surface it was determined to pursue removal while out performing other milling operations.

Ramp Number	Distressed Micro	Non-Distressed Micro	Hot Mix
1	0.31	0.54	0.54
2	0.28	0.45	0.47
5	0.28	0.47	0.48
10	0.35	0.53	0.55
13	0.45	0.52	0.57
Average:	0.33	0.50	0.52
