Report No. UT-24.05

REPAIR OR STRENGTHENING OF BRIDGE DECKS WITH PARTIAL-DEPTH PRECAST DECK PANELS

Utah Department of Transportation
Research & Innovation Division

**Final Report
January 2024**

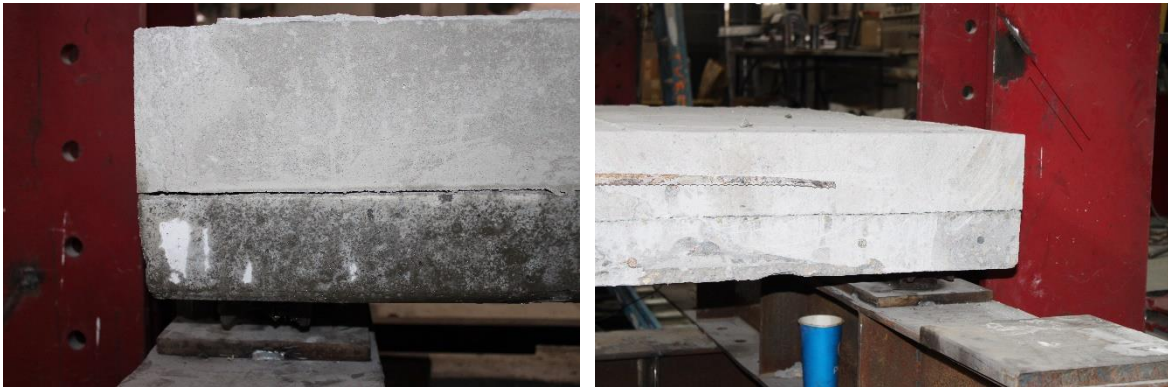
To generate a baseline for comparison, a delaminated panel without any retrofit was tested as the control according to the parameters outlined in *Chapter 3*. **Fig. 5.1** shows the initial delamination of the control panel at the northwest and southwest corners respectively, prior to initiating the loading sequence. This initial delamination was created by applying vegetable oil before casting the cast-in-place concrete, as explained in *Chapter 2*. It is important to note that all measurements made using the LVDTs do not include this initial delamination.

Figure 5.1 Unmodified deck panel prior to starting testing with delamination shown. Southwest; left, Northwest; right.

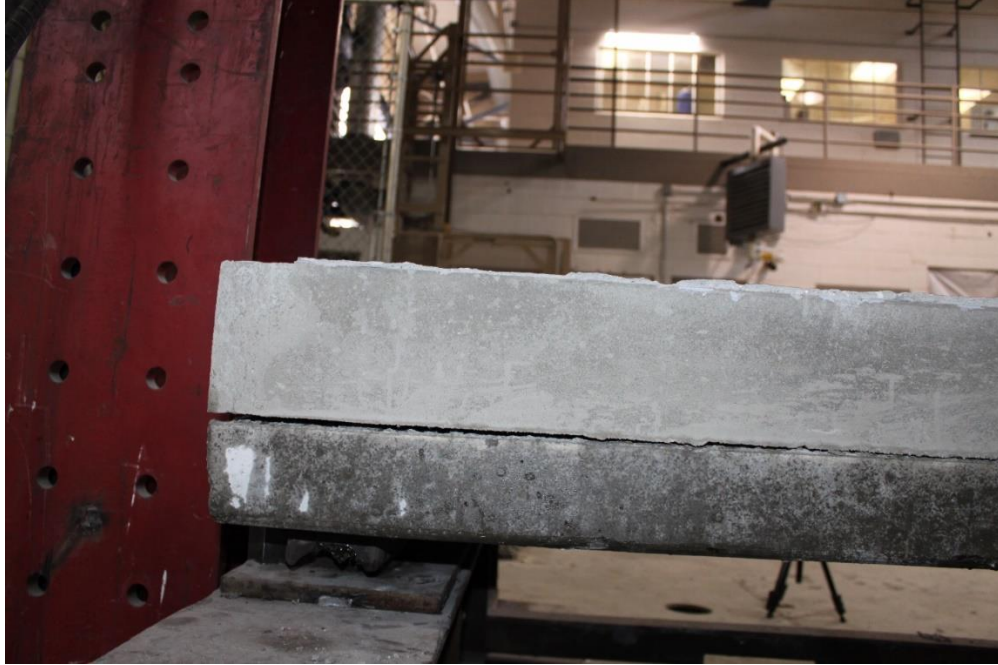
The unmodified deck panel behaved in a manner consistent with a non-composite specimen. The precast and CIP sections of the panel visually appeared to be acting independently of one another. At the end of the sixth displacement cycle (1.2 in.), the delamination became immediately visible. **Fig. 5.2** captured the separation of the two panels at the southwest corner after the 1.2-in. displacement cycle. The delamination continued to grow as anticipated; **Fig. 5.3** shows the panel at 2.4 in. of displacement with the anticipated debonding behavior.

Figure 5.3 Delamination at northwest corner of control specimen at 2.4 in. of displacement.

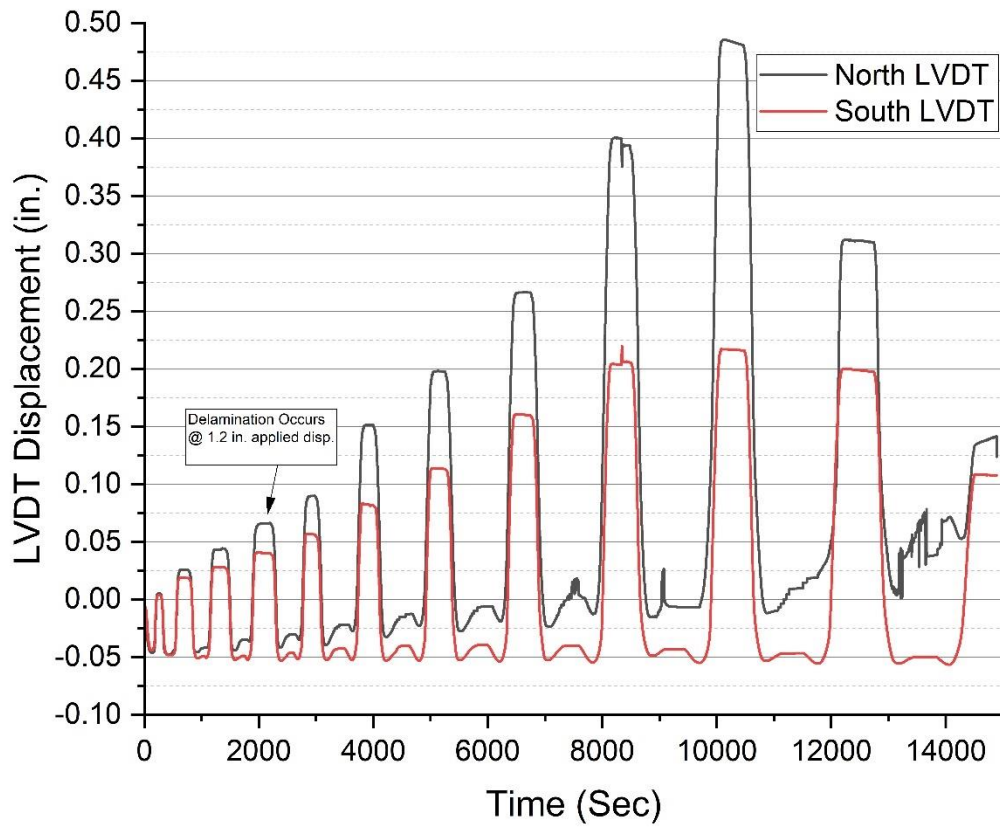
The most critical information captured from each test cycle is shown in **Fig. 5.4**. This graph displays the specimen displacement at the north and south extremes as recorded by the

LVDTs. It is evident in this graph that as the applied displacement increases, the panel is unable to fully recover, and the gap continues to grow. Not only does the delamination increase the deflection, but the deflection becomes permanent, and the specimen's strength is ultimately compromised. The hysteresis curves of the entire loading protocol have been included along with the point of delamination in **Fig. 5.5**. This figure shows in a red circle the point where delamination became visible (1.2 in.).

The LVDT plot in **Fig. 5.4** indicates that internal delamination started at an applied displacement of 0.5 in. due to the reduction in stiffness at that point in time. It is also at this point that small cracks began forming on the underside of the precast panel.

Figure 5.4 Test specimen with no retrofit (control) LVDT displacement at north and south.

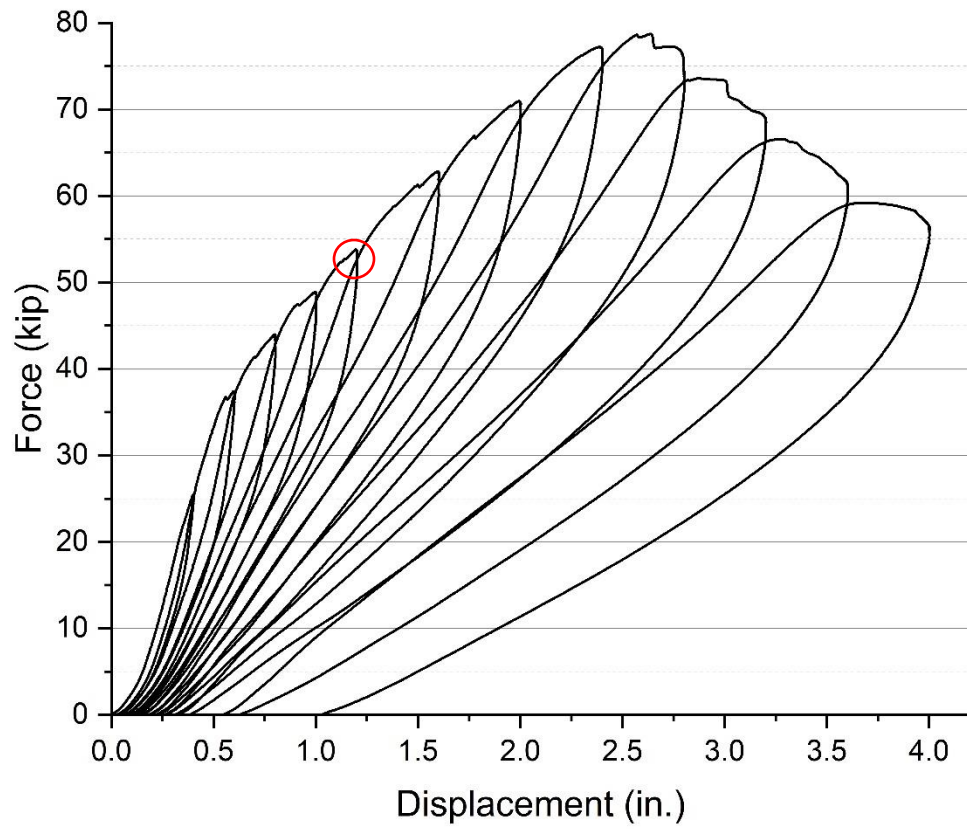
Figure 5.5 Test specimen with no retrofit (control) hysteresis with point of visible delamination circled in red.

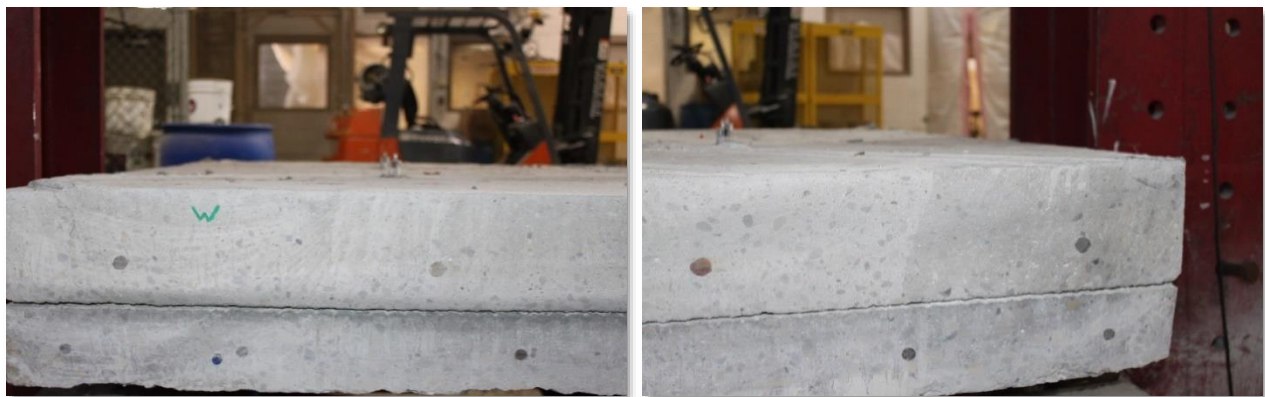
The deck panel with the epoxy injection retrofit resisted the displacement imposed by the hydraulic actuator until the epoxy bond between the precast section and CIP section of the panel failed. The initial delamination at the north and south extremes is shown in **Fig. 5.6**. The epoxy retrofit demonstrated perfectly composite behavior for the first cycle of 0.4 in. Once the epoxy bond had failed, the panel behaved almost identically to the panel without any retrofit from *Section 5.1*. Bond failure occurred at only the north side of the panel while the south end remained completely bonded; this type of failure created a large displacement in the north LVDT as shown in **Fig. 5.7**. The panel with epoxy bond was able to endure a maximum load of 63 kip before delamination, indicated in the hysteresis curves of **Fig. 5.8**. The precast and CIP sections of the panel continued to separate after the epoxy failure. **Fig. 5.9** demonstrates just how much the panel was able to separate; the gap measured almost 0.5 in. when the applied displacement was 4.0 in. During the test it was observed that the CIP section of the panel was deflecting laterally as shown in **Fig. 5.10**; this behavior was anticipated but the displacement was large.

Figure 5.6 Epoxy retrofit initial delamination at northwest; left, southwest; right.

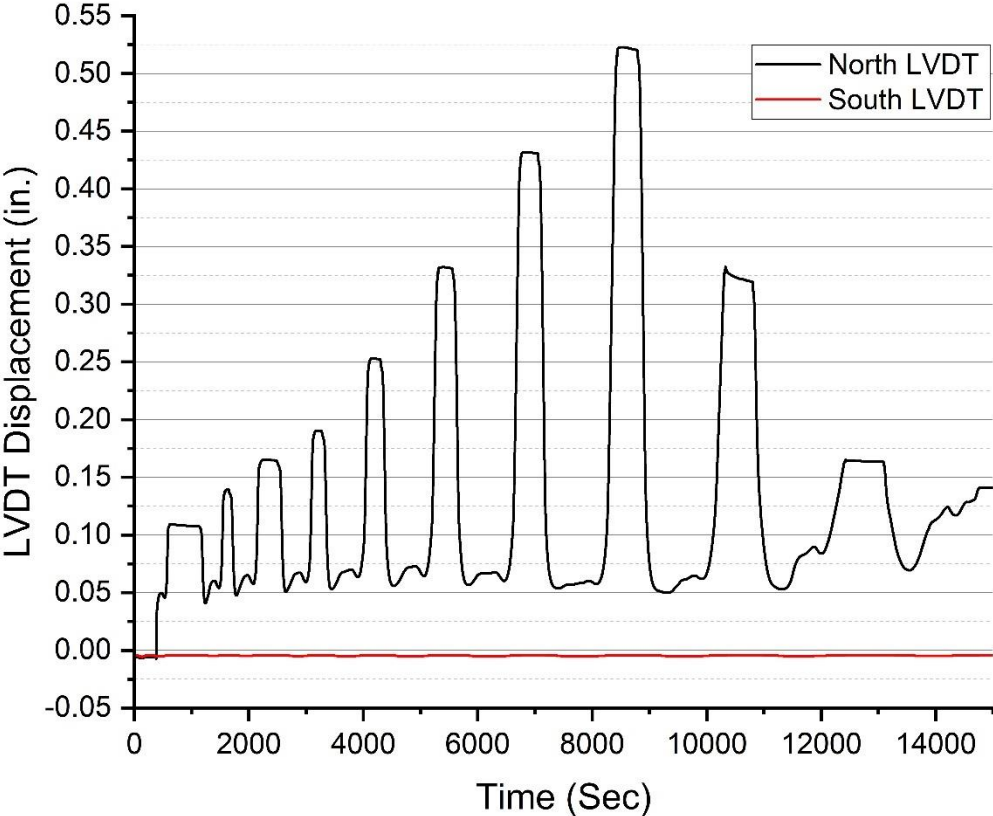
With an approximate stiffness of 150 kip/in., the epoxy retrofit shows improvement over the unmodified panel's stiffness value of 63.3 kip/in. This information combined with the

displacements recorded at the north and south extremes in **Fig. 5.7** indicates that the retrofit is successful until bond failure.

Figure 5.7 Epoxy retrofit panel LVDT displacement at north and south.

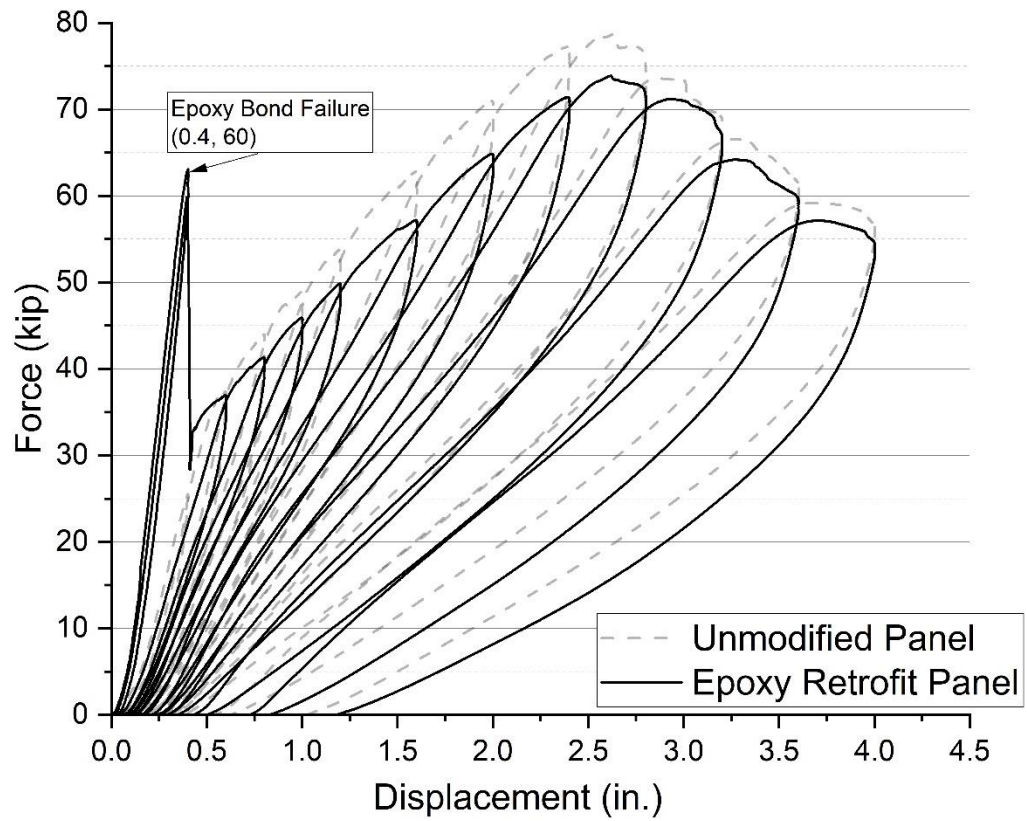
Figure 5.8 Epoxy retrofit panel hysteresis compared to the unmodified panel.

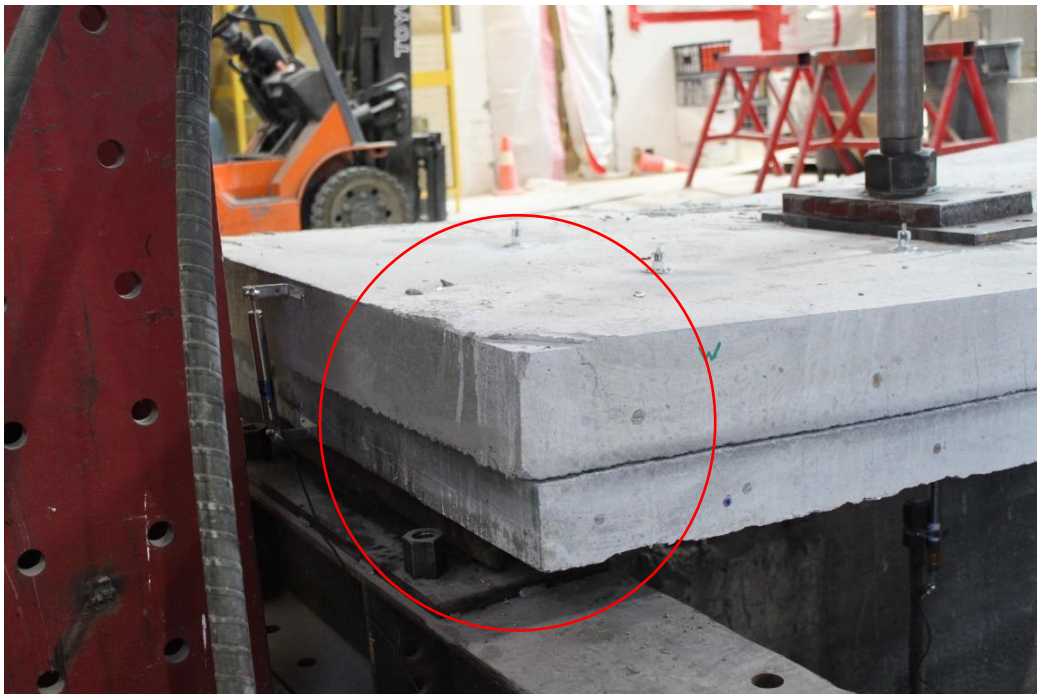
*Figure 5.10 Lateral movement of epoxy retrofit deck panel at applied displacement of 4.0 in.
(Location: northwest)*

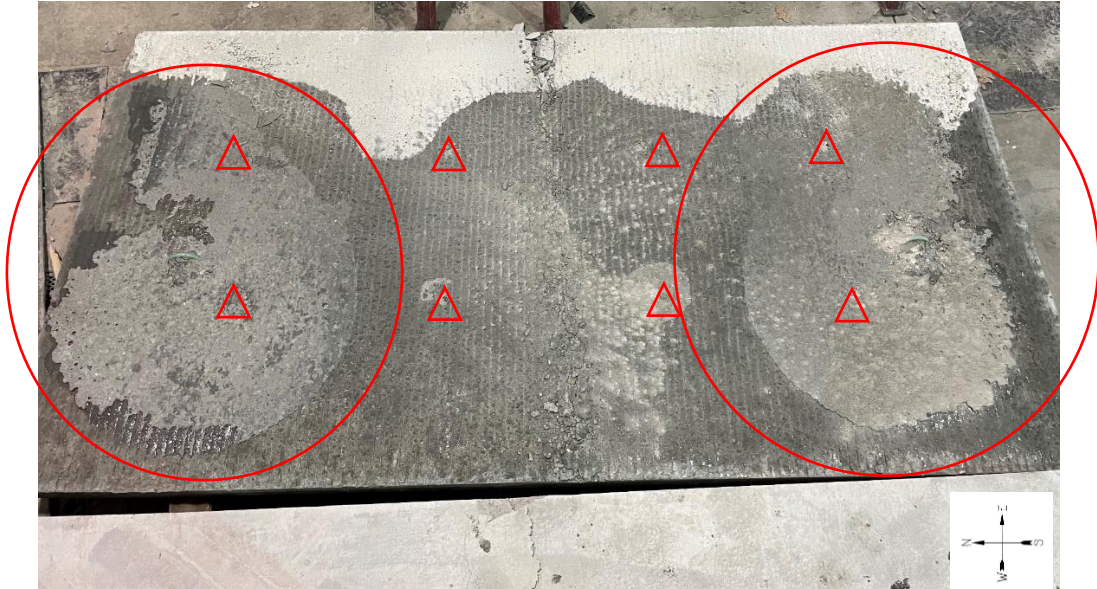
Once the test had been stopped, the precast and CIP panels were removed and separated to verify the dispersion of the epoxy between the panel sections. **Fig. 5.11** shows that the epoxy had been able to fill the void between the two panels at each extreme; the figure also highlights the difficulty in injecting the epoxy in areas that do not have complete interlayer delamination.

Figure 5.11 Distribution of epoxy after testing on the precast panel surface in plan view; triangles indicate location of epoxy injection sites.

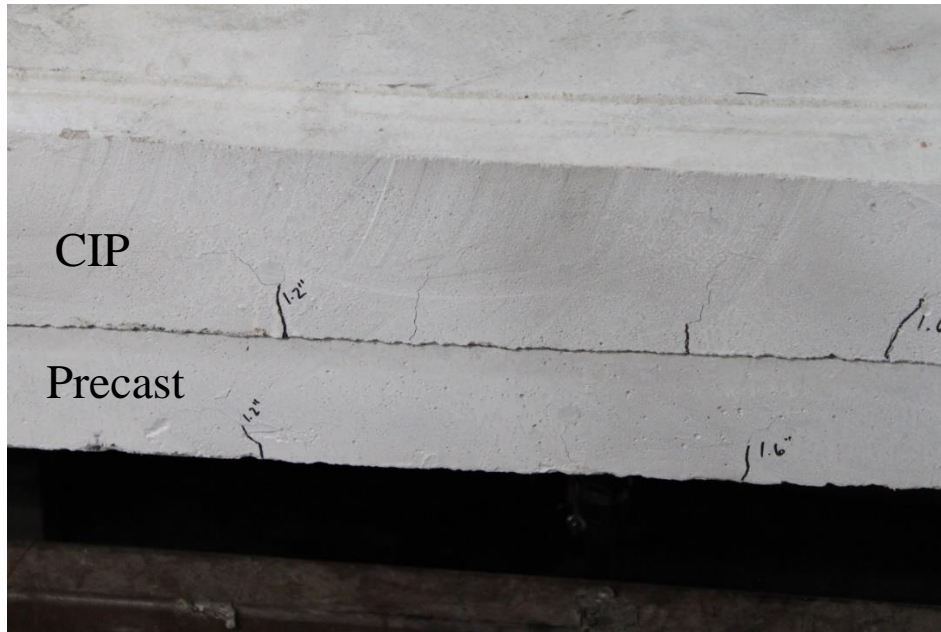
The deck panel with the proprietary mechanical shear anchors had severe delamination prior to testing as shown in **Fig. 5.12**. In fact, the CIP section and precast section of the panel were entirely separate, which is a very extreme condition. The deck panel began to show evidence of cracking along the midspan at an applied displacement of 1.6 in., as shown in **Fig. 5.13**, but the delamination was restrained by the anchors and did not become critical.

*Figure 5.13 Shear anchor retrofit deck panel cracking after applied displacement of 1.6 in.
(Location: east, mid-span)*

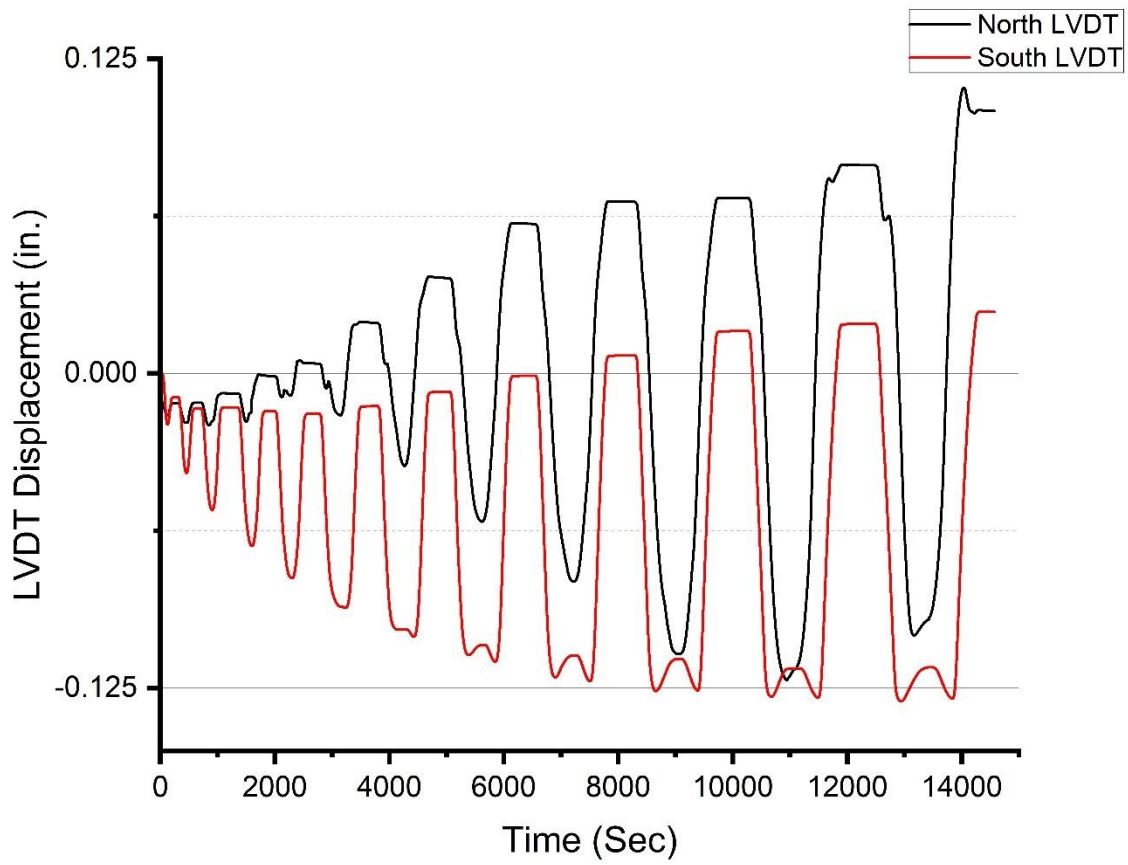
Throughout the experiment, the deck panel retrofitted with shear anchors was able to keep interlayer delamination restrained within a tolerable range as indicated in **Fig. 5.15**. Another indicator of the shear anchor retrofit performance is deflection measured at midspan. **Fig. 5.16** shows that the panel was able to maintain its stiffness at large displacements, indicating that the

Figure 5.15 Shear anchor retrofit deck panel LVDT displacement at north and south.

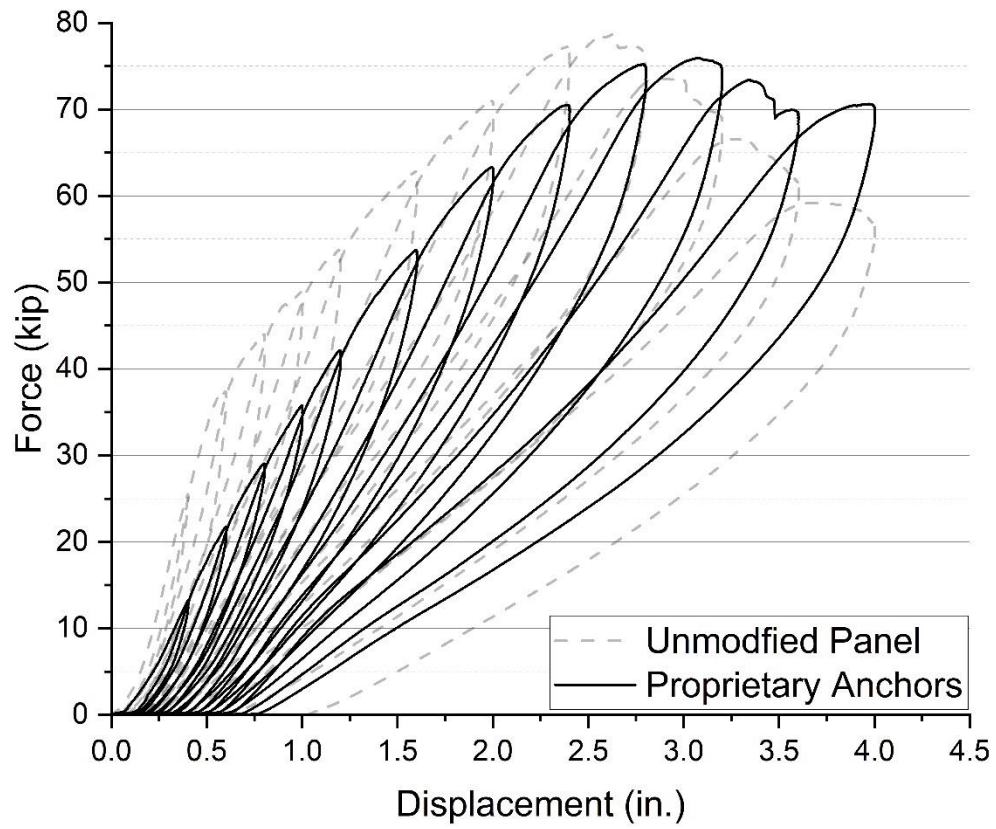
The hysteresis curves indicate that the panel retrofitted with proprietary anchors was not the strongest panel tested but it was the best at resisting delamination. This panel was also the most compromised prior to testing, and it is believed that its ability to resist the applied load was reduced in part due to premature cracking.

Figure 5.16 Shear anchor deck panel hysteresis.

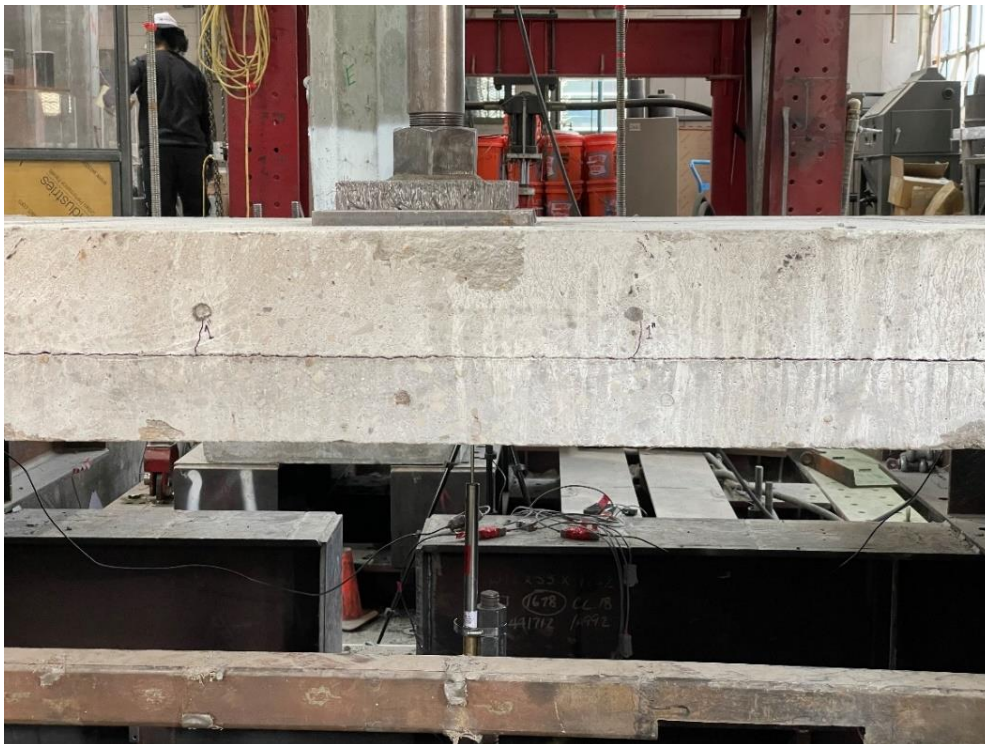
The deck panel specimen retrofitted with CFRP strips had an initial delamination of approximately 0.25 in., as shown in **Fig. 5.17**. At an applied 1.0-in. vertical displacement, the deck panel showed similar cracks to the control panel along the face of the CIP section of concrete, as shown in **Fig. 5.18**. At a 2.0-in. applied displacement, flexural cracks became visible in the precast panel as seen in **Fig. 5.19**. The test panel performed similarly to the unmodified specimen until a displacement of 1.2 in. At that point, tension in the CFRP strips had become large enough to resist further deflection at midspan. However, the additional strength provided by the CFRP was not sufficient to eliminate delamination. The CFRP strips did not fracture but, as **Fig. 5.20** shows, the CFRP strips debonded from the precast panel. **Fig. 5.21** shows that the north and south LVDTs were recording significantly different displacements, indicating delamination is occurring. Even with the additional flexural benefits provided by the CFRP strips, the specimen could not resist delamination in the presence of the increased horizontal shear forces.

Figure 5.18 CFRP retrofit deck panel cracks at 1.0-in. displacement. (Location: east, mid-span)
