**Report No. UT-24.06**

# **CULVERT/STORM DRAIN EVALUATION TECHNOLOGIES**

Utah Department of Transportation  
Research & Innovation Division

**Final Report  
April 2024**

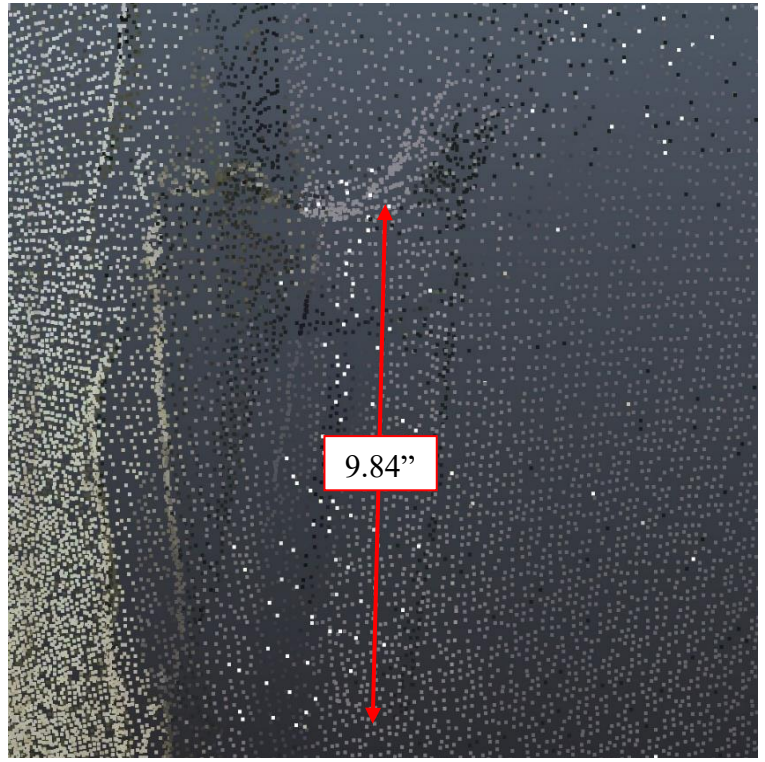
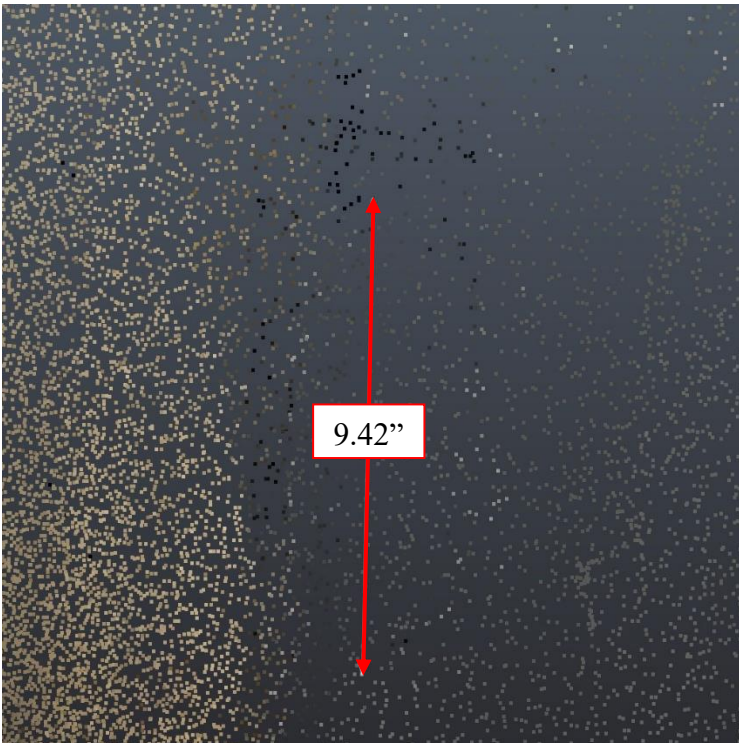
**Figure 4.2.1 – Cracking in Lisa Falls Polypropylene Pipe**

The research focused on what size of cracks could be evaluated with the aid of LiDAR-generated 3D models. Figure 4.2.1 shows an example of a crack in the Lisa Falls Polypropylene pipe. This pipe was chosen as it was found that smaller cracks were not identifiable with current mobile LiDAR technologies.

It needs to be noted that the minimum rating measurement for concrete culverts was a defect threshold of fractures greater than 0.05 inches. None of the point clouds were dense enough to be able to capture a fracture of this width. From the figures it can be seen how difficult it was to identify this extremely large crack through point clouds only. In fact, identifying the crack required changing the orientation of the point cloud for a specific area until the crack became somewhat visible. Without a photo and location as a base condition, this crack would not have been measurable through LiDAR. It can also be seen that very few points in the point cloud fall within cavity of the crack. This shows that if crack widths in the 0.5-inch range are not measurable, that the UDOT threshold of 0.05 inches is not currently measurable.

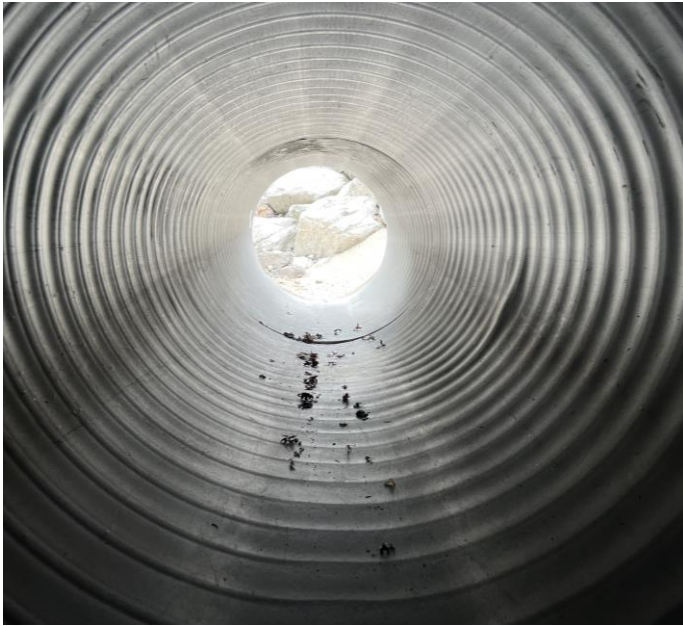
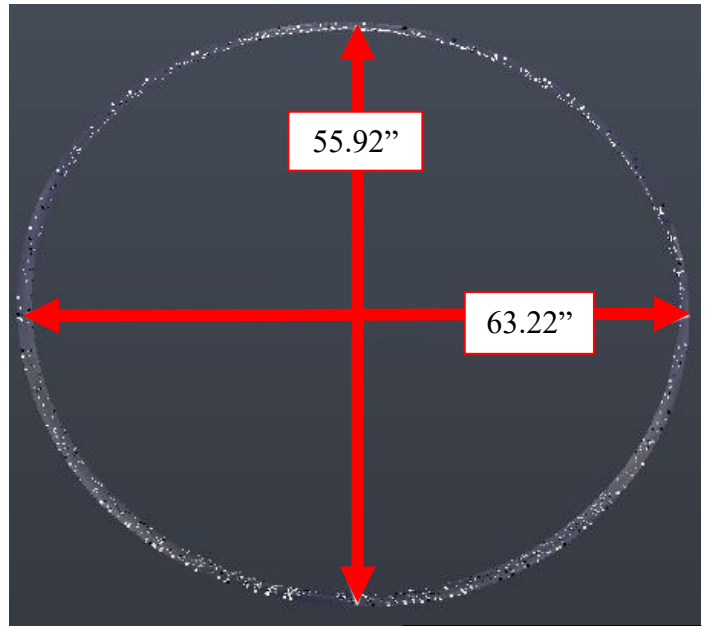
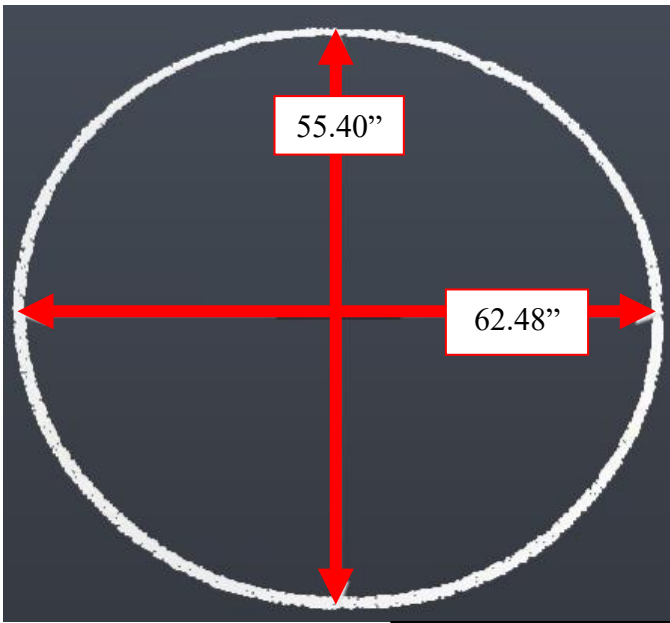
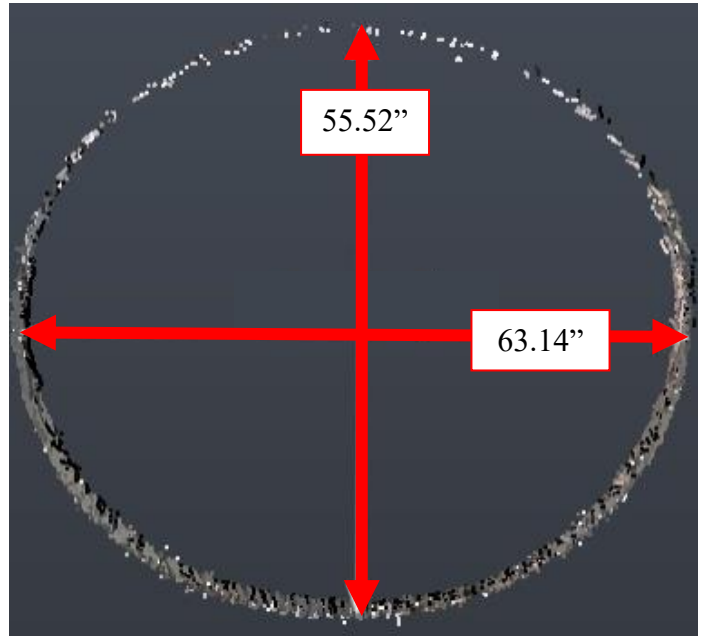
This test case focused on the Lisa Falls pipe as it was the only test pipe where deflection could be measured. In thermoplastic pipe, the flexibility of the pipe will typically yield vertical and horizontal deflections. Typically, the vertical reduction in diameter will be compensated by a similar horizontal deflection. The strength of the pipe comes from proper soil compaction around the pipe. Proper soil compaction allows this deflection to occur, but not to exceed established limits. The UDOT ranking criteria starts scrutinizing deflections greater than 5%. Figure 4.4.1 shows deflections taken at the same place in the Lisa Falls Culvert.

Vertical: -7.3%  
Horizontal: +5.1%

Vertical: -7.7%  
Horizontal: +4.1%

Vertical: -8.1%  
Horizontal: +5.2%

It needs to be noted that the minimum rating measurement for deflection was 5%, with variations in rating occurring between 5% and 10% deflection. The results show that the deflections measurements of each technology are within reasonable tolerances and that this data would be useful for determining the shape/deflection of flexible pipes. This also shows that the Pocket LiDAR, while being the least costly alternative, is accurate enough to utilize.

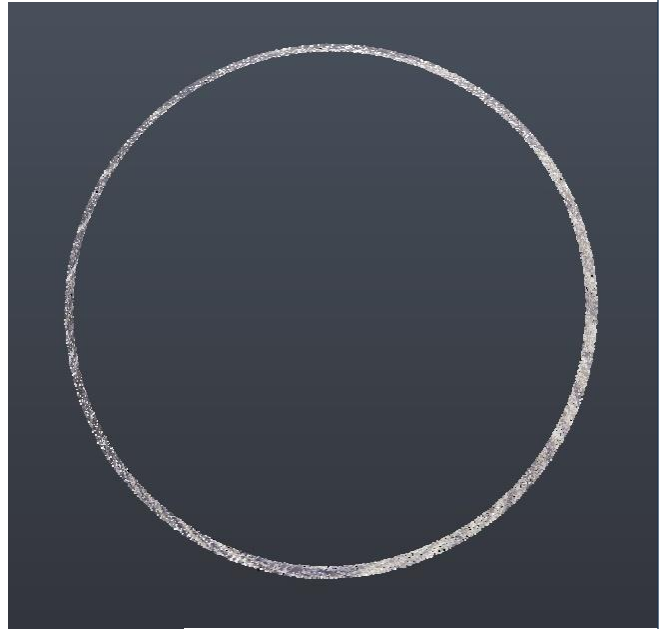
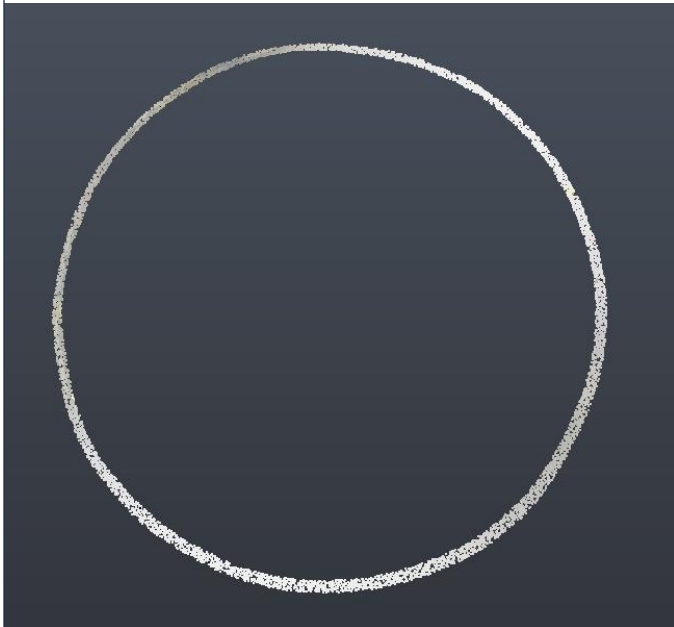
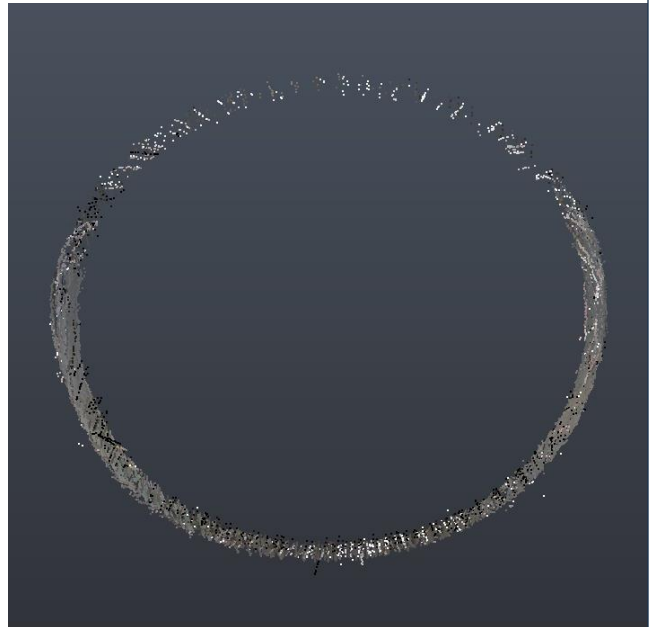
**Figure 4.5.1 – Sections of Lisa Falls Pipe with Localized Buckling**

Localized Buckling or Rippling occurs when high stresses occur in plastic pipe walls. This section will review whether LiDAR can detect this small defect. Figure 4.5.1 shows a photo that illustrates the localized buckling and the sectioned point clouds for the different technologies at this location.

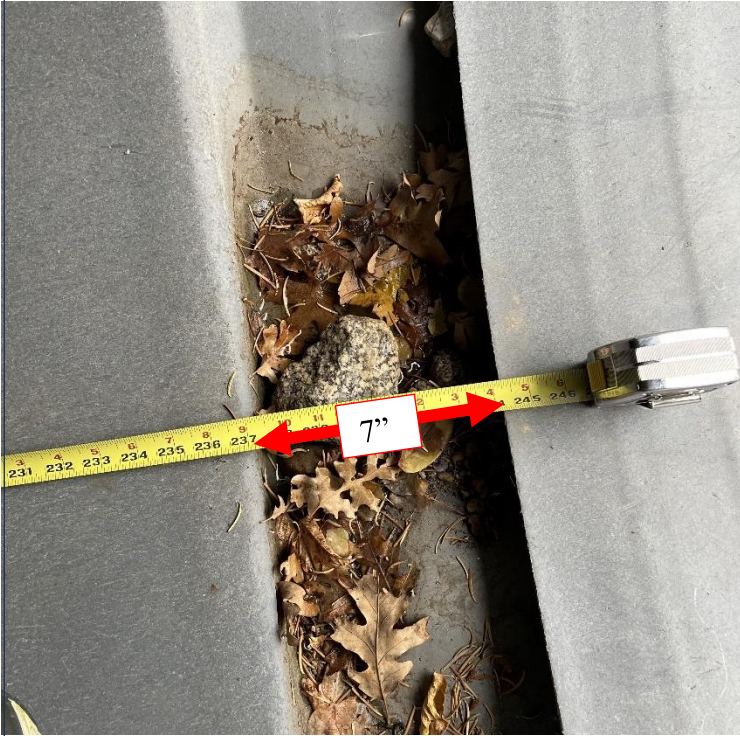
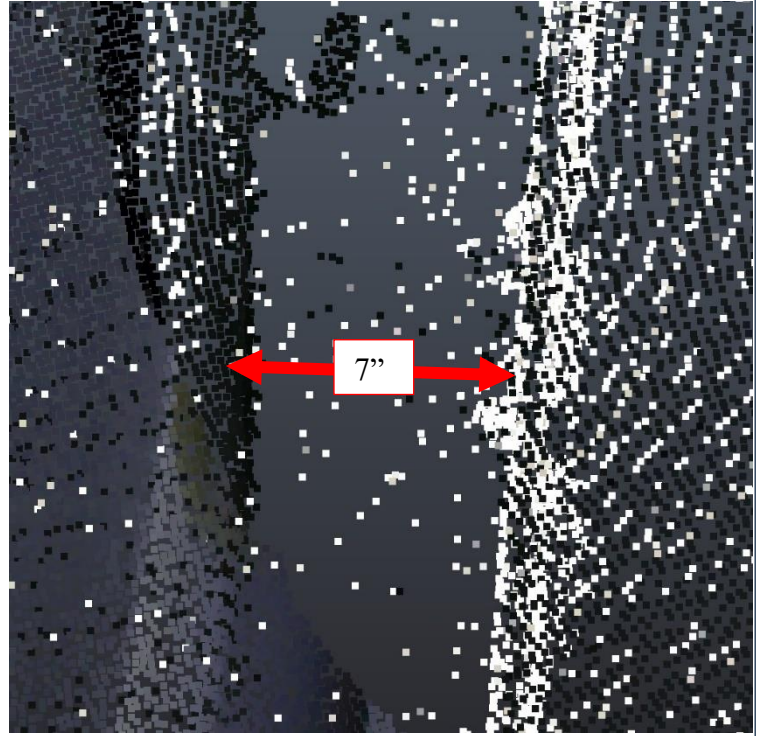
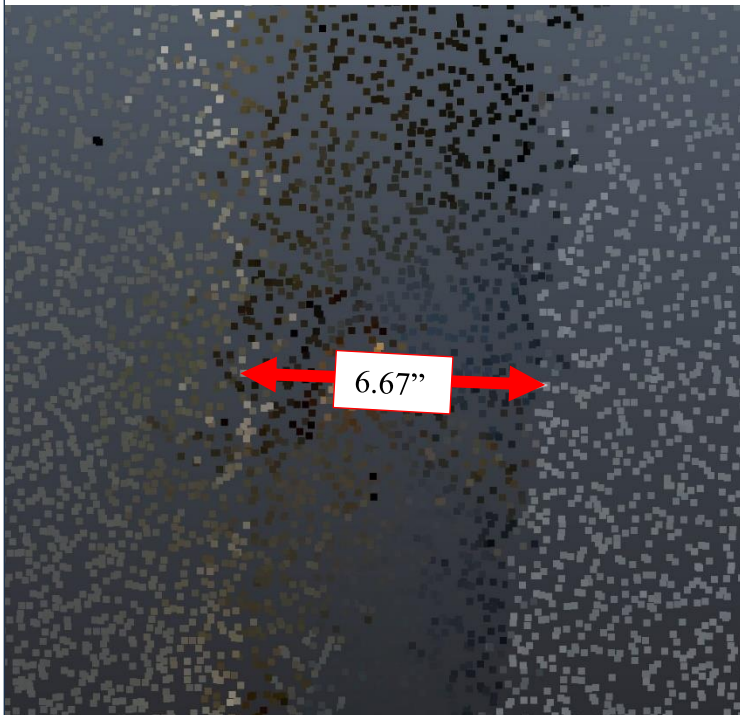
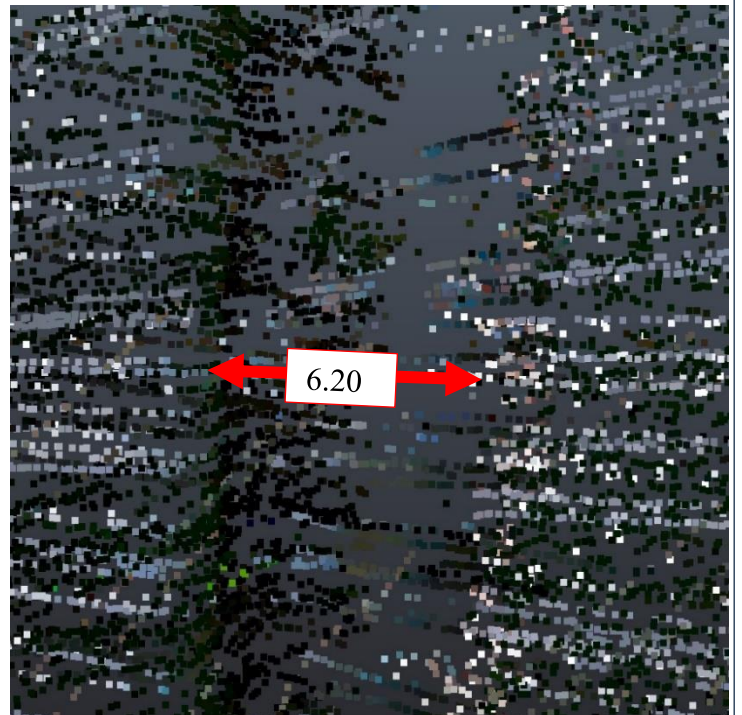
**Figure 4.8.1 – Joint Gaps in Lisa Falls Polypropylene Pipe**

Joint Gap requirements are based on pipe wall thickness, the smallest measure being 1 wall thickness. Therefore, the minimum thresholds for a 24-inch diameter pipe, the smallest UDOT Standard, were 3 inches for concrete pipe<sup>19</sup>, 2 inches for HDPE dual wall pipe<sup>20</sup> and ½ inch for a Corrugated Metal Pipe<sup>21</sup>. Therefore, this research should focus on whether LiDAR is accurately able to measure the smallest joint gap, which would be ½ inch. As it was difficult to find and measure smaller joint gaps, the following 7” gap was measured for accuracy.

Figure 4.8.1 shows the pipes were measured within the following accuracies, with the photo measurement as the base. Table 4.8.1 shows the measurement accuracies as compared to the photo with scale:

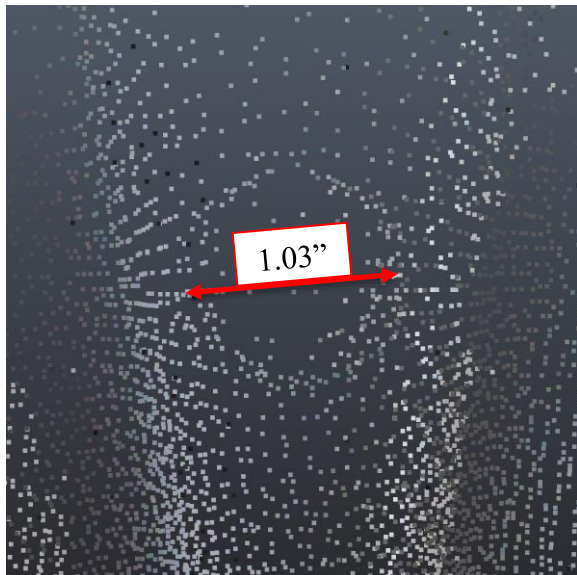
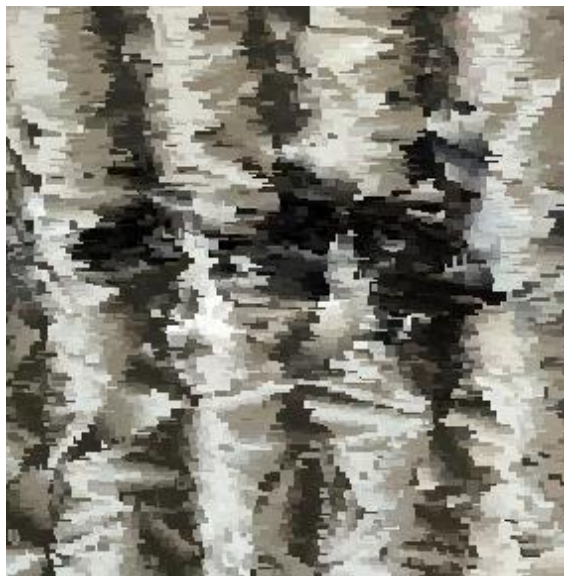
**Figure 4.9.1 – Bolt Measurements at Herriman Midas Creek Culvert**

The threshold for the Bolts defect is a missing bolt. Measurements are not critical for this, so it might be better accomplished by a traditional video camera with AI learning for missing bolt detection. At the same time, bolts in the Corrugated Metal Plate Arch were a good test of the LiDAR capabilities as these approximately 1-inch bolts would be thought to be readily recognizable in a scan. Figure 4.9.1 shows a bolt in the Herriman Midas Creek 32' x 16' Corrugated Metal Plate Arch. This bolt was scanned with the RTC360 in both high and medium resolution, Pocket LiDAR and the BLK2GO. Pocket LiDAR was not measurable due to the width of this culvert being near the end of the range of the Pocket LiDAR laser. Table 4.9.1 shows the results of the bolt measurements with the RTC360 High Resolution as the control.

Figure 4.9.1 is illustrative of several issues that are important to the study. Using the RTC360 on high resolution is not typical as the file size makes it extremely difficult to use these files. While processing speed and data management should improve over time, high resolution is currently an option for only small sections. The data also shows how the BLK2GO scanner has a resolution that is less than the RTC360 medium resolution. This is one of the reasons that the BLK2GO had difficulty resolving small measurements, it simply does not have enough resolution.
