Evaluating Arkansas Weathering Steel Bridge Performance

Yessenia Gonzalez E.I.
Ernie Heymsfield Ph.D., P.E.

University of Arkansas - Fayetteville
Department of Civil Engineering

Final Report

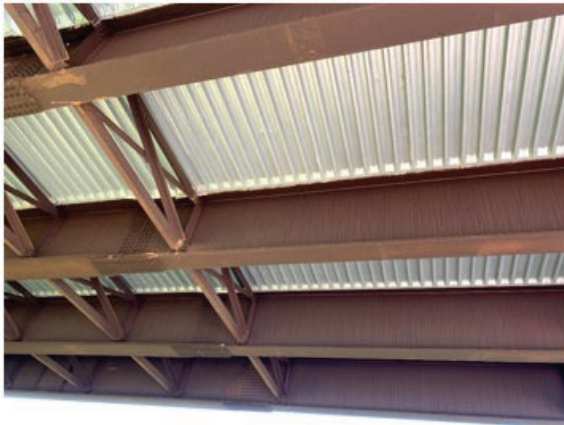
(a) ARDOT Bridge A6284: CS 1

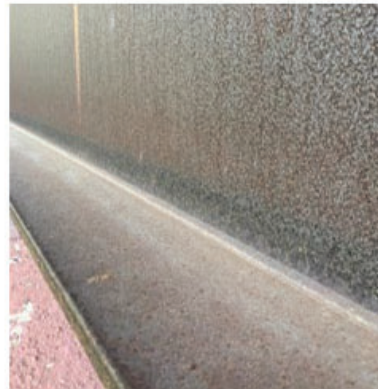
(b) ARDOT Bridge B6503: CS 2

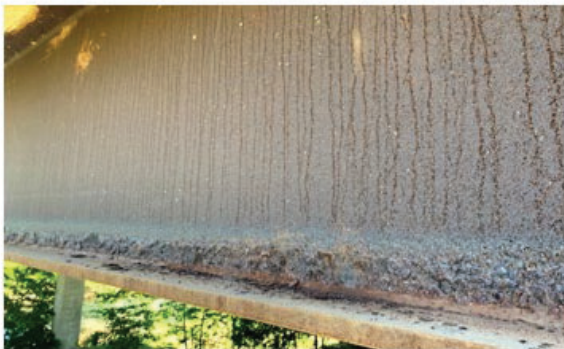
(c) ARDOT Bridge B6507 with an 1/8" pit: CS 3

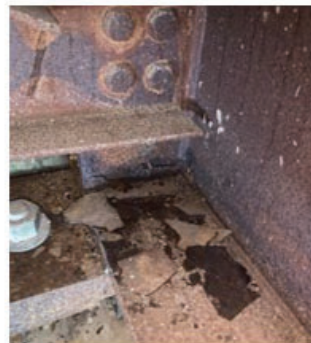
As the patina develops a yellow-orange color oxide layer forms on the weathering steel. Subsequently, the patina takes on a light brown color. As the patina further develops, it transitions to a chocolate brown, purple-brown color. In contrast, a non-protective oxide film layer will blacken. Current guidelines for evaluating oxide film layer conditions at UWS bridges focus on the oxide film's texture and color. A fine-grained, chocolate-brown to purple-brown, tightly adhered, stable rust layer indicates good patina performance (AASHTO, 2019). In contrast, thick, loose rust flakes in the patina are symptomatic of high chloride concentrations (Crampton et al. 2013). The NBIS are used by bridge inspectors to appropriate a consistent oxide film CS number (1-4) (FHWA 1989a). Each CS identifies the oxide film degradation that the UWS member is experiencing (AASHTO 2019). CS 1 corresponds to "Good." CS 2, 3, and 4 correspond to "Fair", "Poor", and "Severe", respectively. **Figure 20** provides examples for each condition state. Typically, UWS girder corrosion occurs at the top of the bottom girder flange where water ponds and poulitice collect. A CS 3 girder web and web stains from dripping water are shown in **Figure 20 (c)**. CS 4 is shown in **Figure 20 (d)** at the bridge bearing. Bridge bearings at the abutment are common locations of CS 4 since the bridge deck expansion joint at the abutment allows draining water mixed with anti-icing chemicals access to the steel superstructure.

(d) Abutment bridge girder joint: CS 4

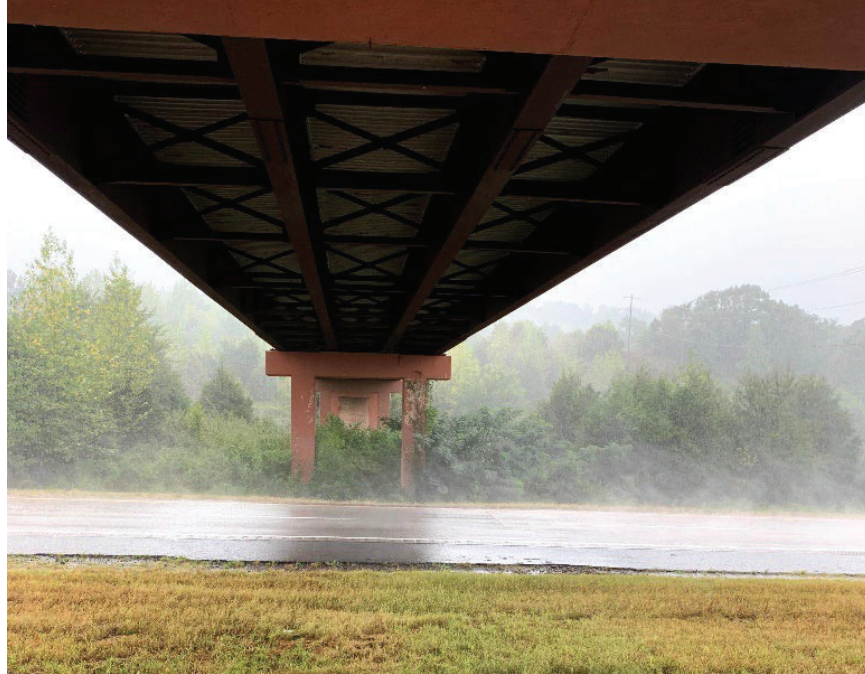
Figure 25. Overpass Where Vehicular Traffic Safety Management is Warranted

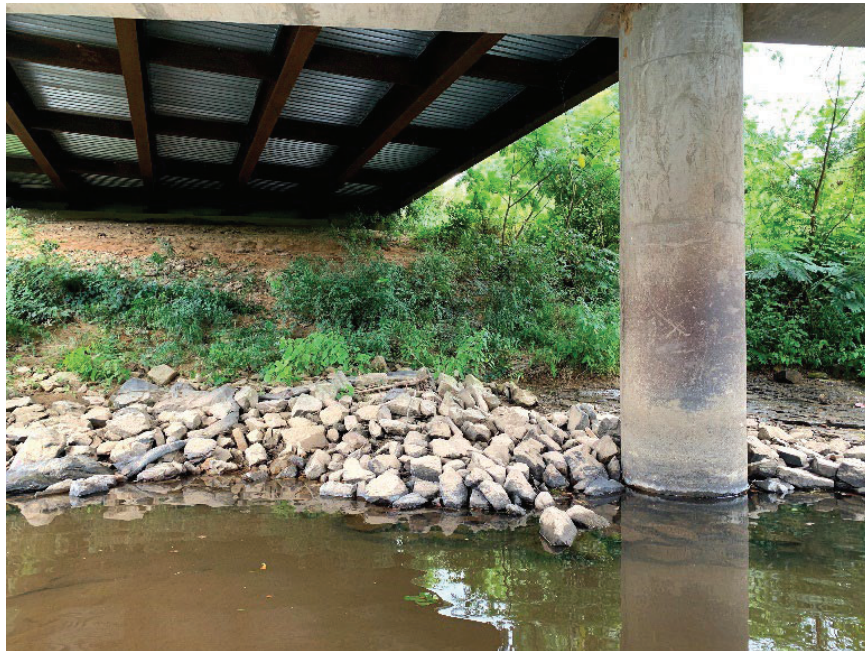
Figure 26. Exposed Fabric Bed near Pier Columns

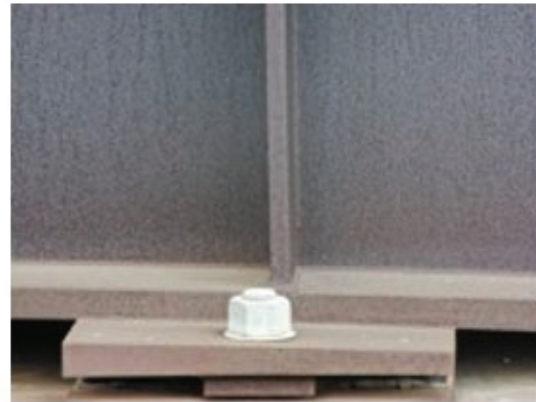
(b) Close-up of girder bearing at bridge pier cap using zoom from UA location in (a)

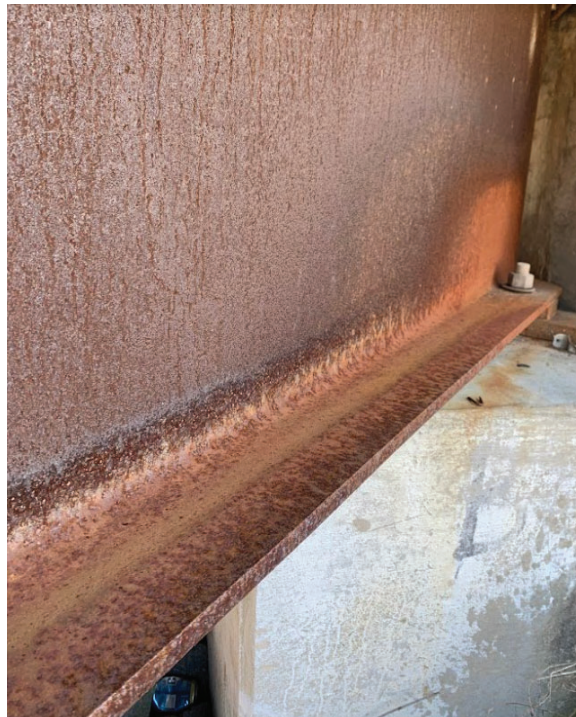
Figure 41. Bridge 02312: CS 1 and CS 2 on the Outside Web and Flange

Afterward, the bridge deck was inspected from below to verify if the issues above it correlated with compromised girder conditions below it. For four of the six bridges, CS 1 and CS 2 were present at most bents and within the spans; CS 4 was identified at limited locations. Bridge 06609 in Woodson displayed CS 4 at only Bent 5, Bay 1, but displayed CS 1 and CS 2 at the remaining bays and bents. This correlated well with the damaged expansion joint right above the deteriorated section. Some contributing factors to corrosion include the bridge slope and surrounding water. Bridge 06609 displayed similarities to the other bridges that were inspected during this March inspection tour. When the girders and bays were analyzed, it was noted that the bridge girders were primarily experiencing CS 2 oxide film degradation and that severe CS 3 and CS 4 were limited to small girder sections, as shown in **Figure 40**, **Figure 41**, and **Figure 42**.

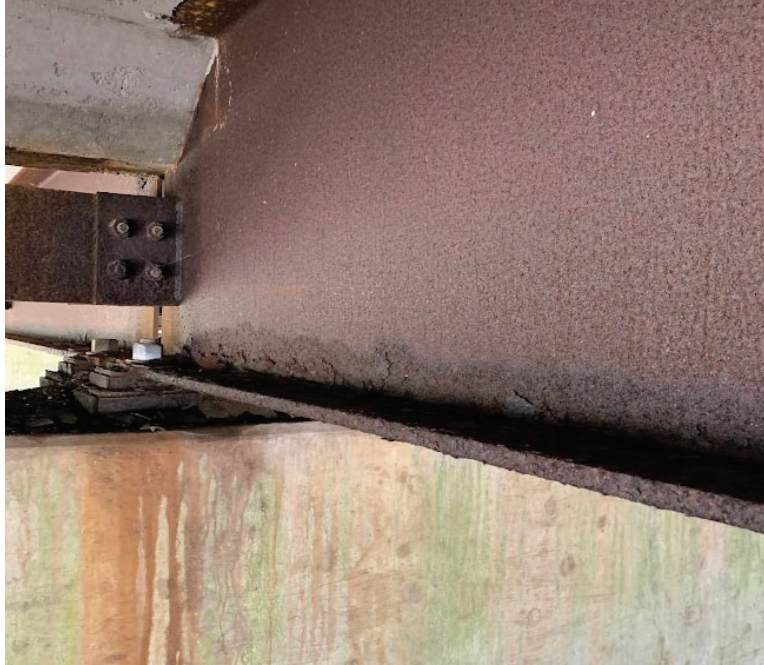
Figure 47. Bridge 06319: CS 3 and CS 4 on Interior Girder

Bridge 06319, located in Hunt, AR, is a multi-simple span bridge representative of the bridges inspected in June. **Figure 46** through **Figure 48** show the oxide film condition at multiple locations typically found to experience oxide film degradation.

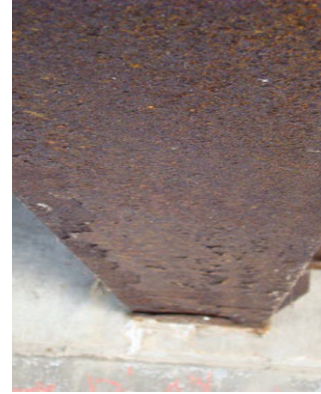
(b) Bottom of Bottom Flange

The bridge is designed using integral abutments. Therefore, each girder extends beyond the abutment surface and is enveloped by concrete to prevent lateral and longitudinal movement. Oxide film degradation was limited to Girder 3 at Bent 1 (east abutment). Efflorescence staining was noted at the girder-abutment interface, **Figure 51 (a)**. Oxide film degradation at the girder extended along the top and bottom of the bottom flange, **Figure 51 (b)**.

Figure 51. Oxide Film Degradation at Girder 3, Bent 1

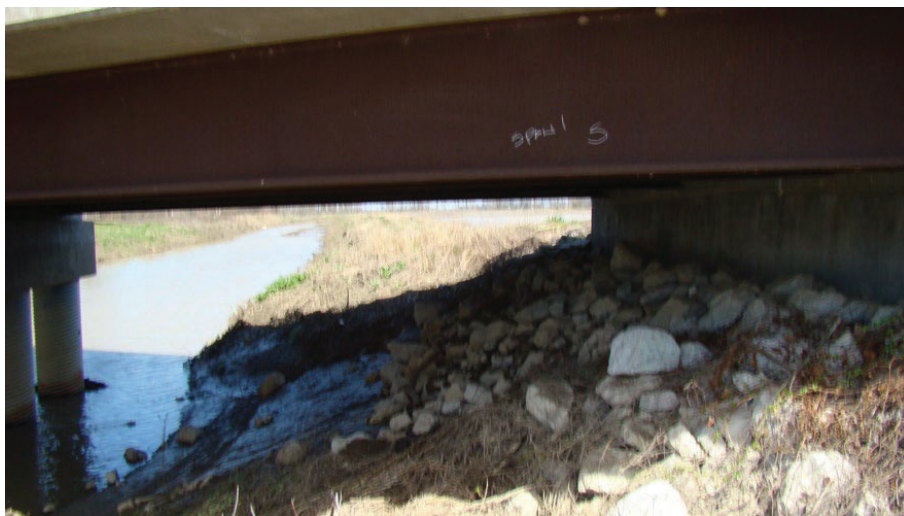
Figure 52. Bridge 07225 Viewing East Abutment from Southside of Bridge

The area adjacent to the bridge was muddy when the TRC2103 research team inspected Bridge 07225, **Figure 52**. In addition, the clearance between the ground and the girder base was minimal. Riprap was especially large underneath Bent 1, Girder 3. These conditions suggest that the river rises to a level that causes the water to splash or contact the girder during rainy seasons. A marsh exists northeast of the bridge in proximity. During heavy rainfalls, this marsh likely overflows into the river along the bridge's east abutment, thus resulting in additional wet conditions for the east abutment girders. Although water seeping through the concrete integral abutment causes efflorescence and water contact with the girder, the nominal clearance between the river and girders is more likely to be the cause of the oxide film degradation.

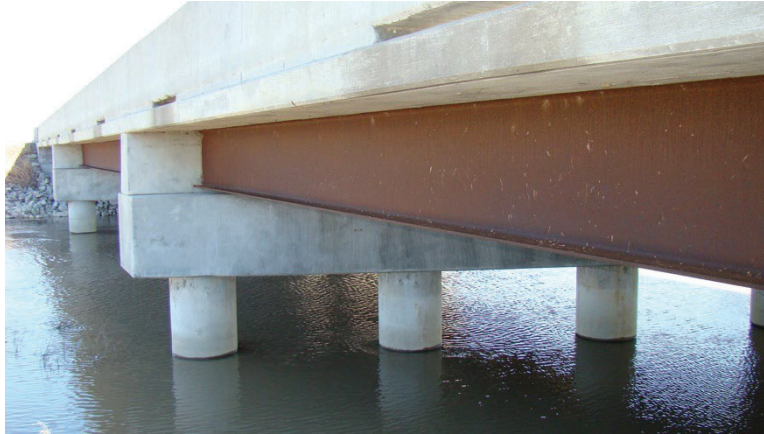
Figure 53. Bridge 07335, North Side of Bridge Looking East

Bridge 07355 consists of five three-span continuous girders. Each girder is a W27x114. The bridge is designed using integral abutments. Oxide film degradation was limited to Girder 3 and Girder 4 at Bent 4 (west abutment), **Figure 53**.

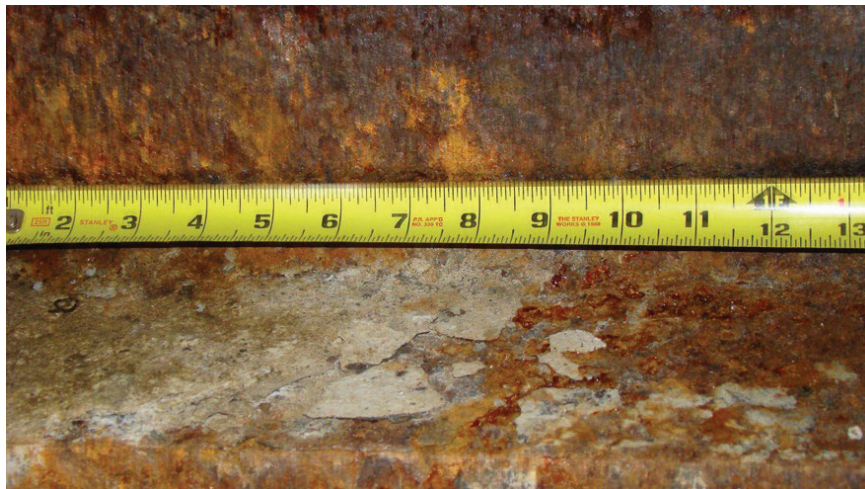
Figure 54. Bridge 07335, Girder 4, Bent 4

Severe oxide film degradation at a CS 4 level was noted at Girder 4, Bent 4, **Figure 54**.

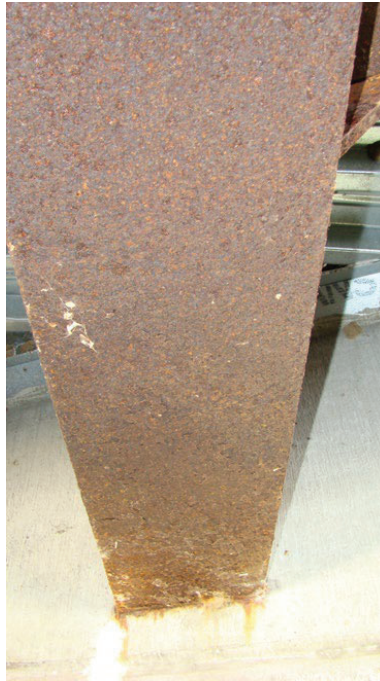
Figure 55. Bridge 07335, Bent 4, Girder 4, Bottom of Girder Flange

Oxide film degradation extends along the bottom flange, **Figure 55**, and efflorescence was identified at the abutment-girder interface, **Figure 56**.

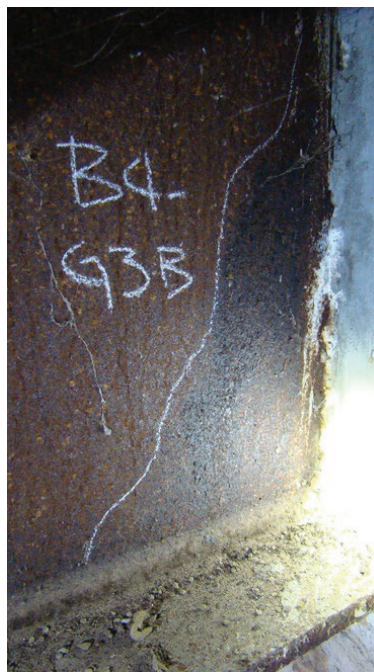
Figure 58. Bridge 07335, Bent 4, Girder 3

Figure 58 shows the north side of Girder 3 at Bent 4. The figure shows efflorescence at the girder web-abutment interface and oxide film degradation on the girder web adjacent to the abutment face.

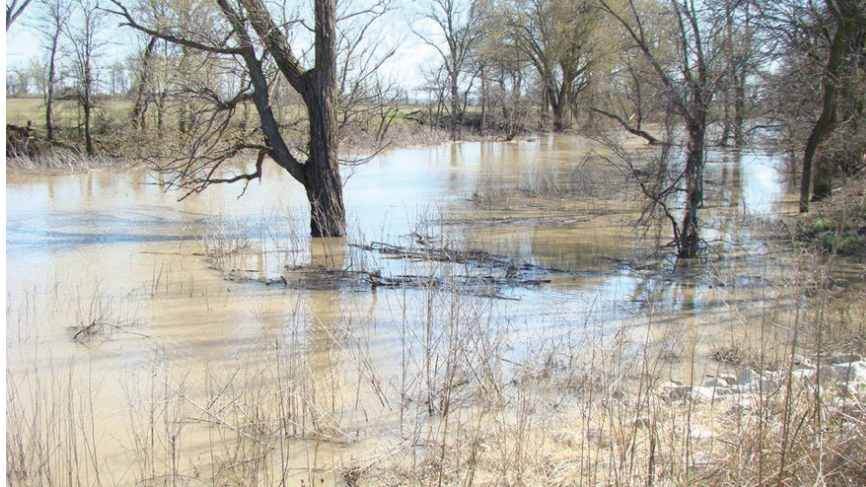
Figure 59. Bridge 07335, View of River Looking South from Bridge

Figure 59 shows the height of the river at the time of the inspection. Having trees that are found partly underwater implies that the river experiences significant level changes. The level and extensiveness of the oxide film degradation in the abutment area were most likely due to inadequate clearance between the river surface and bridge superstructure rather than the bridge’s seismic design.

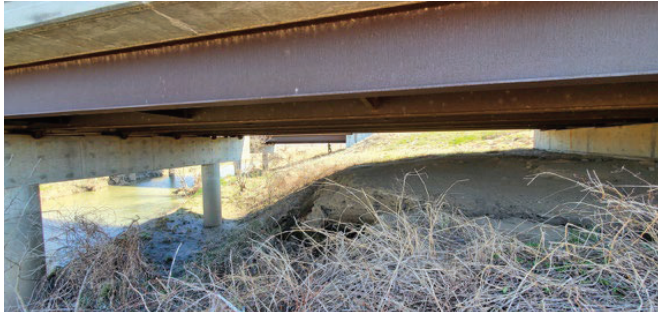
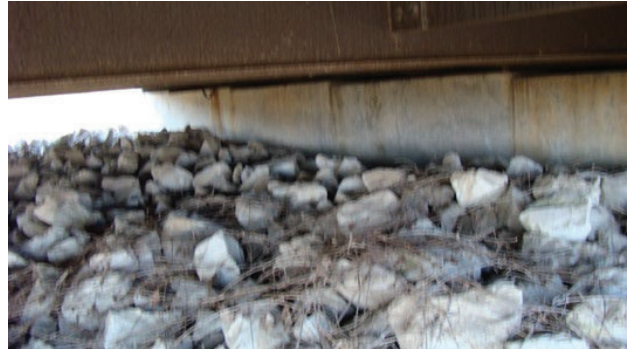
Figure 64. Minimal Clearance Between Bridge Superstructure and Ground Surface

The muddy embankment conditions at these bridge sites also suggest that the river rises to high levels. The embankments provide minimal clearance between the superstructure base and the ground surface to allow for proper water flow. In addition, the embankments were layered at the north abutment with riprap that decreased the clearance, **Figure 64**.

(a) Bridge A6401 at South Abutment

(b) Bridge B6401 at North Abutment

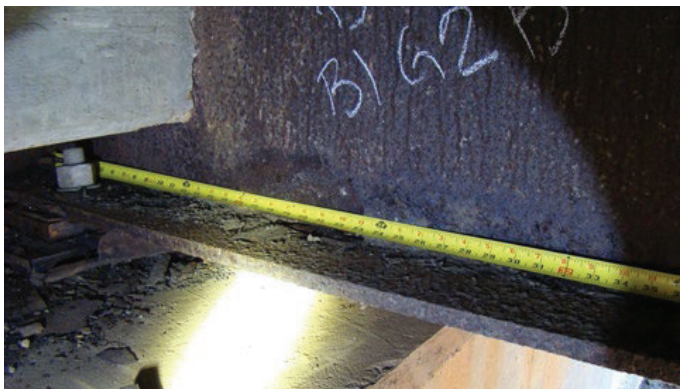
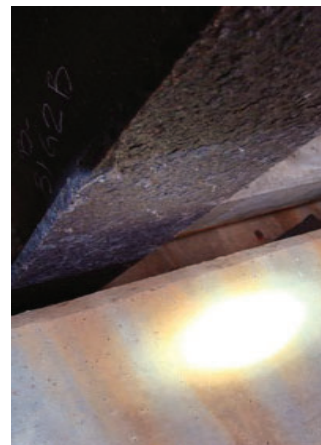
Figure 65. Oxide Film Degradation at B6401, Bent 1, Girder 2 East Side

Oxide film degradation was noted at both bridges but was limited to the abutments. While A6401 oxide film degradation was limited to two girders at the north abutment, the degradation at B6401 was more extensive, including the north and south abutments. The locations of the oxide film degradation at the bottom of the bottom flange, the amount of collected debris at the abutments, and the length of girder experiencing corrosive area, **Figure 65**, suggest that the corrosion was due to the high water level attained during rainy conditions. In addition, the minimal ground to girder clearance and the detail used at the abutments significantly limit airflow in these areas, which is warranted to prevent oxide film degradation.

(a) Web-Flange Interface

(b) Bottom of Bottom Flange

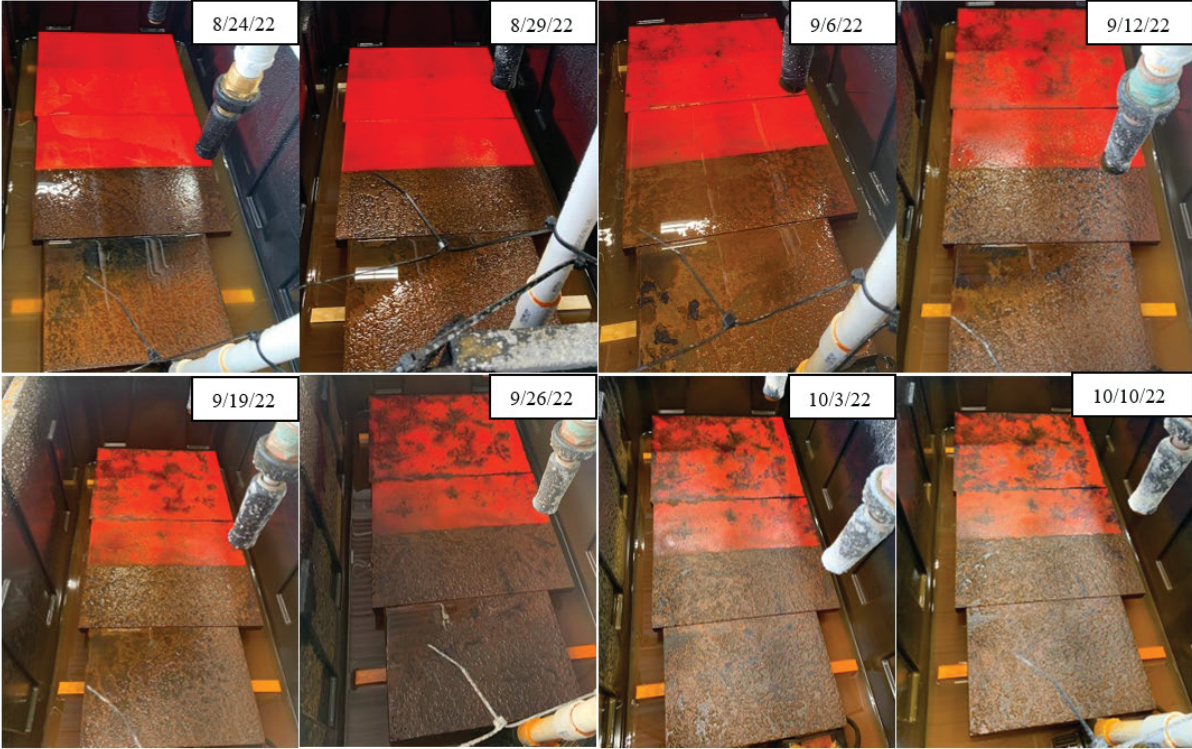
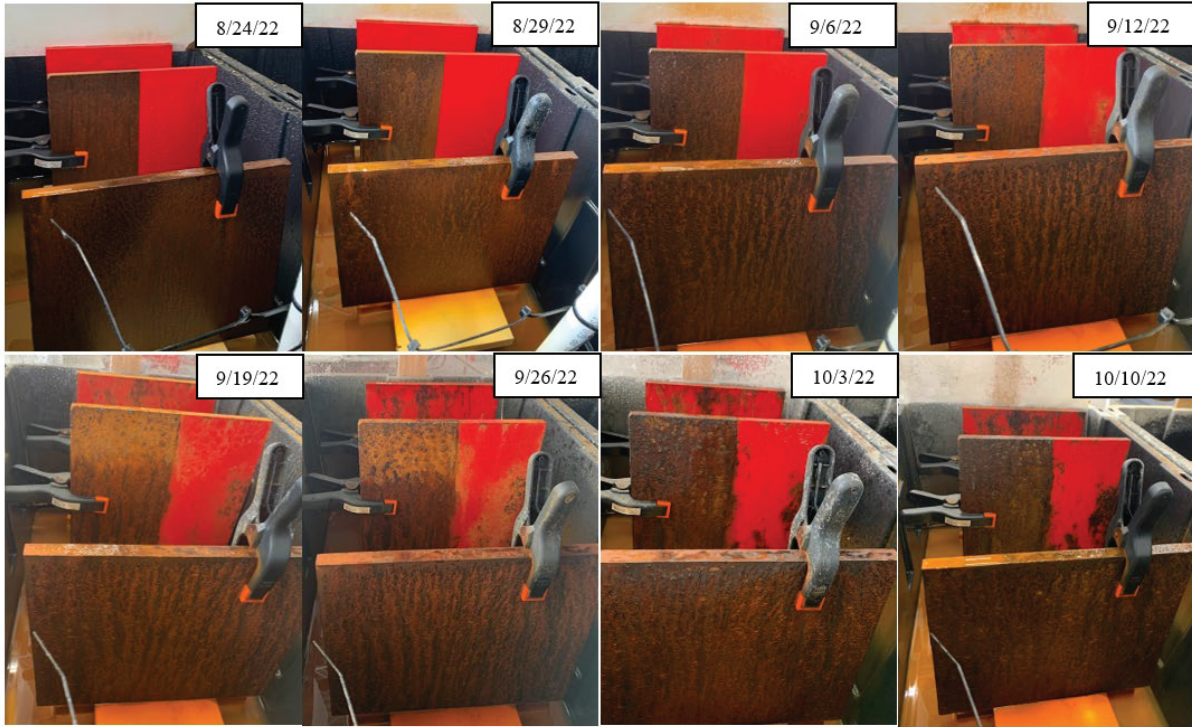
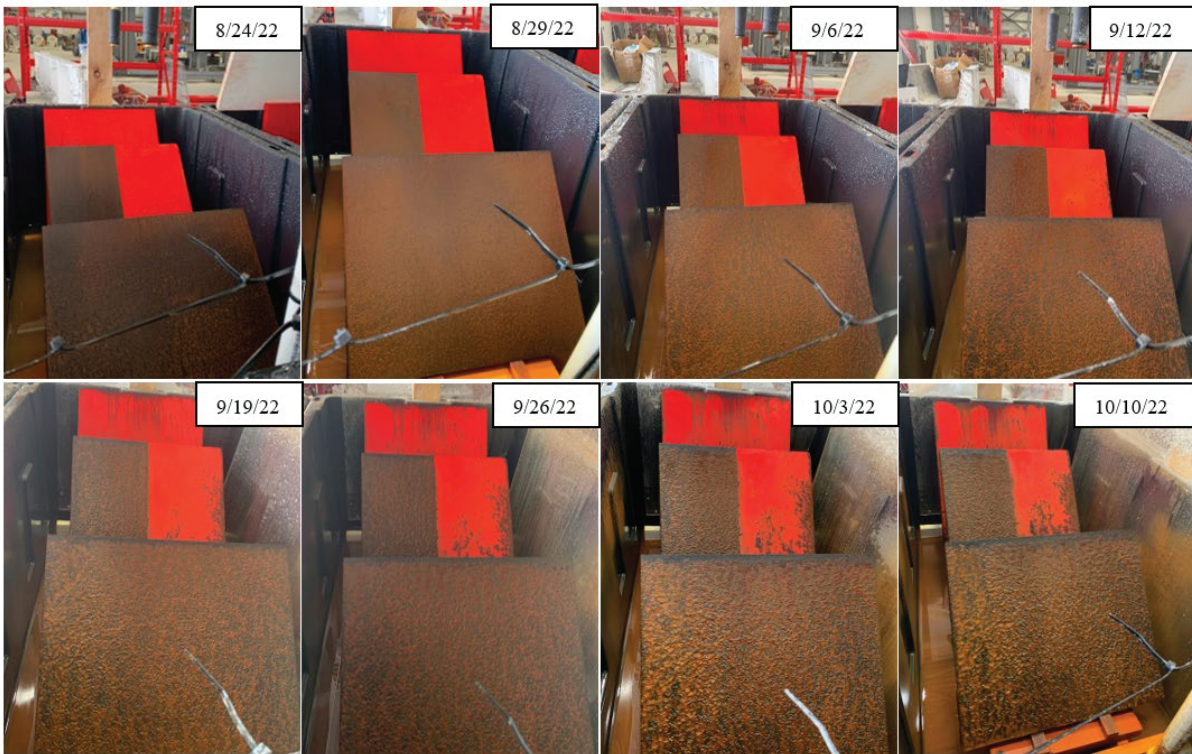
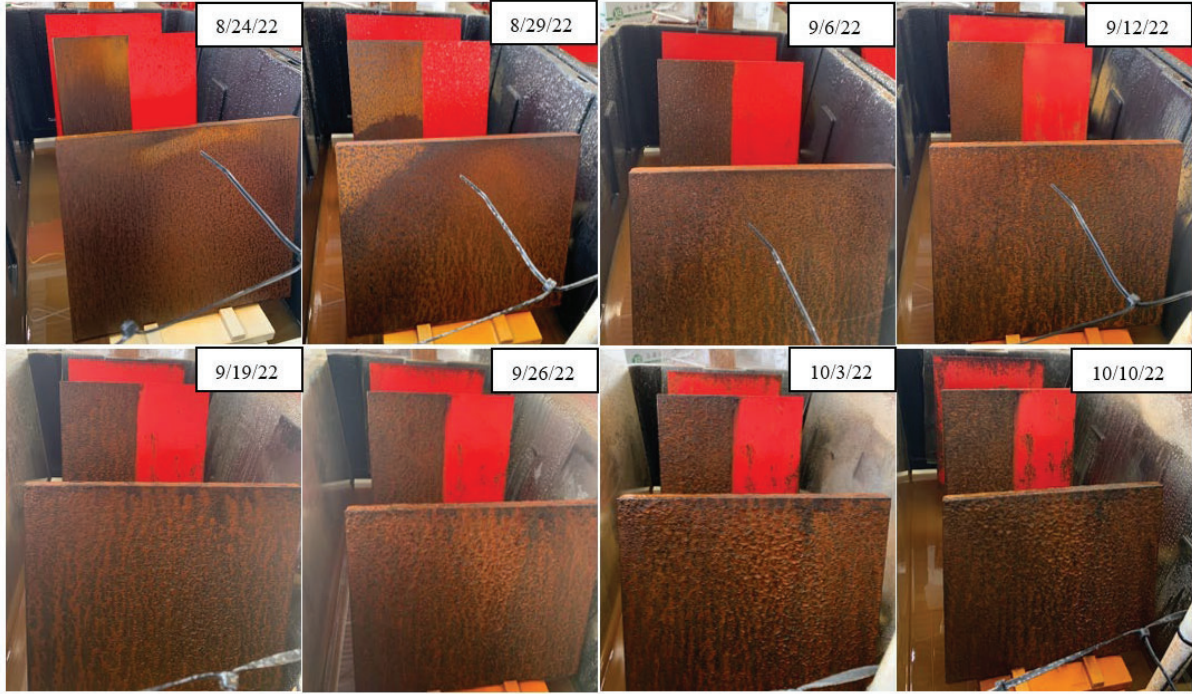
The surface corrosion progress was recorded over the eight-week test period in a series of photos to show the oxide film degradation progression and evaluate the benefits of a paint coating, **Figure 71** to **Figure 74**. As might be expected, providing a paint barrier between the chloride solution and steel surface delayed the onset of surface corrosion. In the experiments, the painted steel surfaces had delayed corrosion compared to the bare steel surfaces; with partially painted steel experiencing a delay that fell between the bare-steel and fully painted specimens.

Orientation angle also affected the rate of corrosion, with the horizontal plates (oriented at 0° relative to the horizontal) showing the most accelerated corrosion out of the four different angles considered. At the end of the eight-week test period, degradation of the coating material was also most apparent on the horizontal (0° orientation) plates compared with the other orientations. Comparing the bare

horizontal plate with the bare vertical plate demonstrates the significance of the bridge girder component orientation (flange vs. web).
