**bridge deck  
drains** final report

AUGUST 1982

1. Report No. FHWA/CA/SD-81/15		2. Government Accession No.		3. Recipient's Catalog No. <b>P88 3 203570</b>	
4. Title and Subtitle Bridge Deck Drains				5. Report Date August 1981

16. Abstract  This report evaluates the drainage on some 25 viaduct type structures. The maintenance problems are discussed and methods of reducing the plugging of the drains are suggested.  Recommendations are made for design specifications to significantly reduce future maintenance costs from drain plugging.

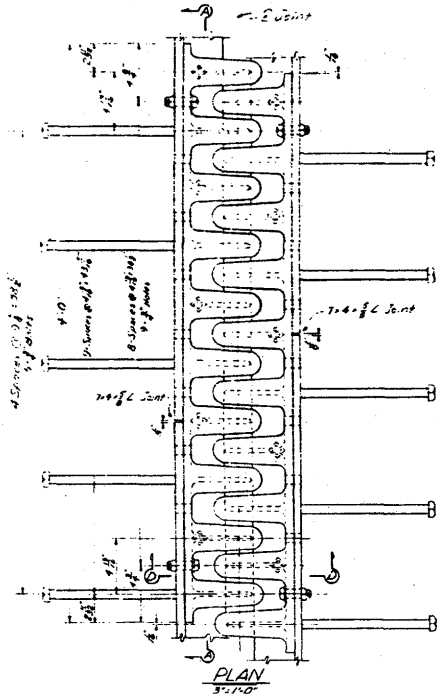
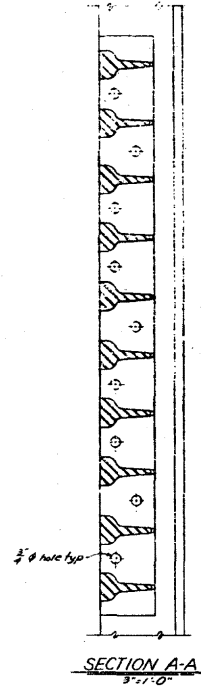
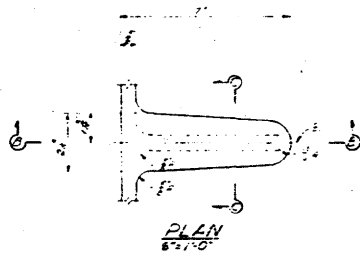
FINGER DETAILS

The expansion joint drains on this structure had a unique problem. The expansion fingertype joint provided for 6-3/4 inches of total movement and to capture the runoff into the joint a horizontal piece of neoprene was loosely attached to both sides across the opening. The "sag" in the neoprene collected then dropped the runoff into a 18" x 24" x 1'-6" deep catch basin located just inside the exterior girder and the runoff was carried horizontally in a 6" Ø pipe to a vertical elbow with a cleanout where the pipe dropped vertically into the cap then column, of a concrete pier. Three inches of the upper drain pipe fit into a 8" reducer at the top of the pier cap. See details on Pages A-3 and A-4.

1. Almost immediately the 1/16" neoprene sheet would flex upward under some vehicles with an audible popping. This was apparently due to air turbulence behind large vehicles.
2. At least one sheet had a construction hole in it and leaked immediately.
3. The neoprene sheet was attached between the finger unit castings and the cast in angles where it apparently acted as a compressible rubber washer which caused the attachment high strength bolts to loosen under traffic time and time again. It also may have lead to significant stress

variations in the high strength bolts which eventually caused fracturing of some bolts.

4. The high strength bolts were not suitable for the stress flexing situation caused by the neoprene "washer" and some finger section bolts broke under traffic. In one case, all 9 HS bolts broke within the first year and the deck had to be chipped out to remove the broken bolt ends.

7. The continued flexing of the neoprene under truck traffic caused wear where the neoprene flapped against the concrete edges of the joint and this soon made holes in the material.

9. Within two years, the 5-foot lengths of neoprene left at the gutterlines cracked and split and became ineffective. The 11-foot to 14-foot sections at the gutterlines were repaired by replacing the split 1/16" neoprene with new 1/8" neoprene.

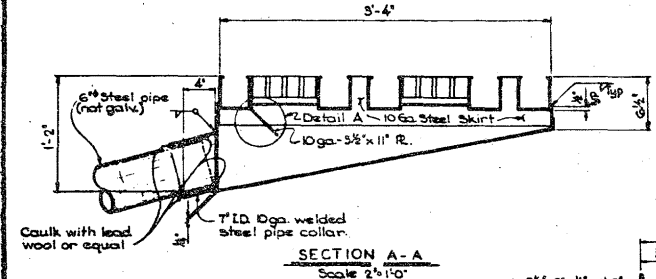
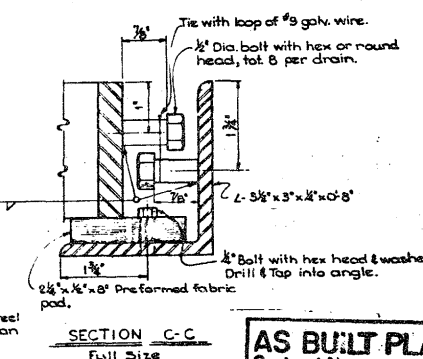
B-1

1. The annual cost of cleaning some 1728 drains in the Sacramento Area in 1975 was \$8.08 each.
2. The "fixed" baffle plates on Fort Sutter Viaduct cause more plugs than they cure (See Detail on Page B-1). The sticks which often cause plugs at the pipe inlet cannot be reached by hand. The four drains where the baffle plates were cut out can be cleared easily and do not plug much more often than those with the plates.

The maintenance crews agree that the baffle plates cause more plugging problems than they solve and should be removed.

11. Maintenance foremen are very opposed to "Y" connections because it makes clearing drain lines far more difficult. They would like a separate line from each drain to the ground.
12. In Sacramento plugging is often caused by rice hulls and wood chips which are mixed with dirt and sand. Grain truck spills which result in wheat growing out of a box with extensive matted roots are not uncommon.
13. If new flushing systems are installed the valves should be on the deck so the "flushing" action can be observed and the situation of a spray rebounding into traffic can be avoided.
14. There was unanimous agreement that all welded in baffle plates should be removed as they interfere too much with drain cleaning.
