Report No. FHWA-RD-79-62

DEBRIS PROBLEMS IN THE RIVER ENVIRONMENT

March 1979
Final Report

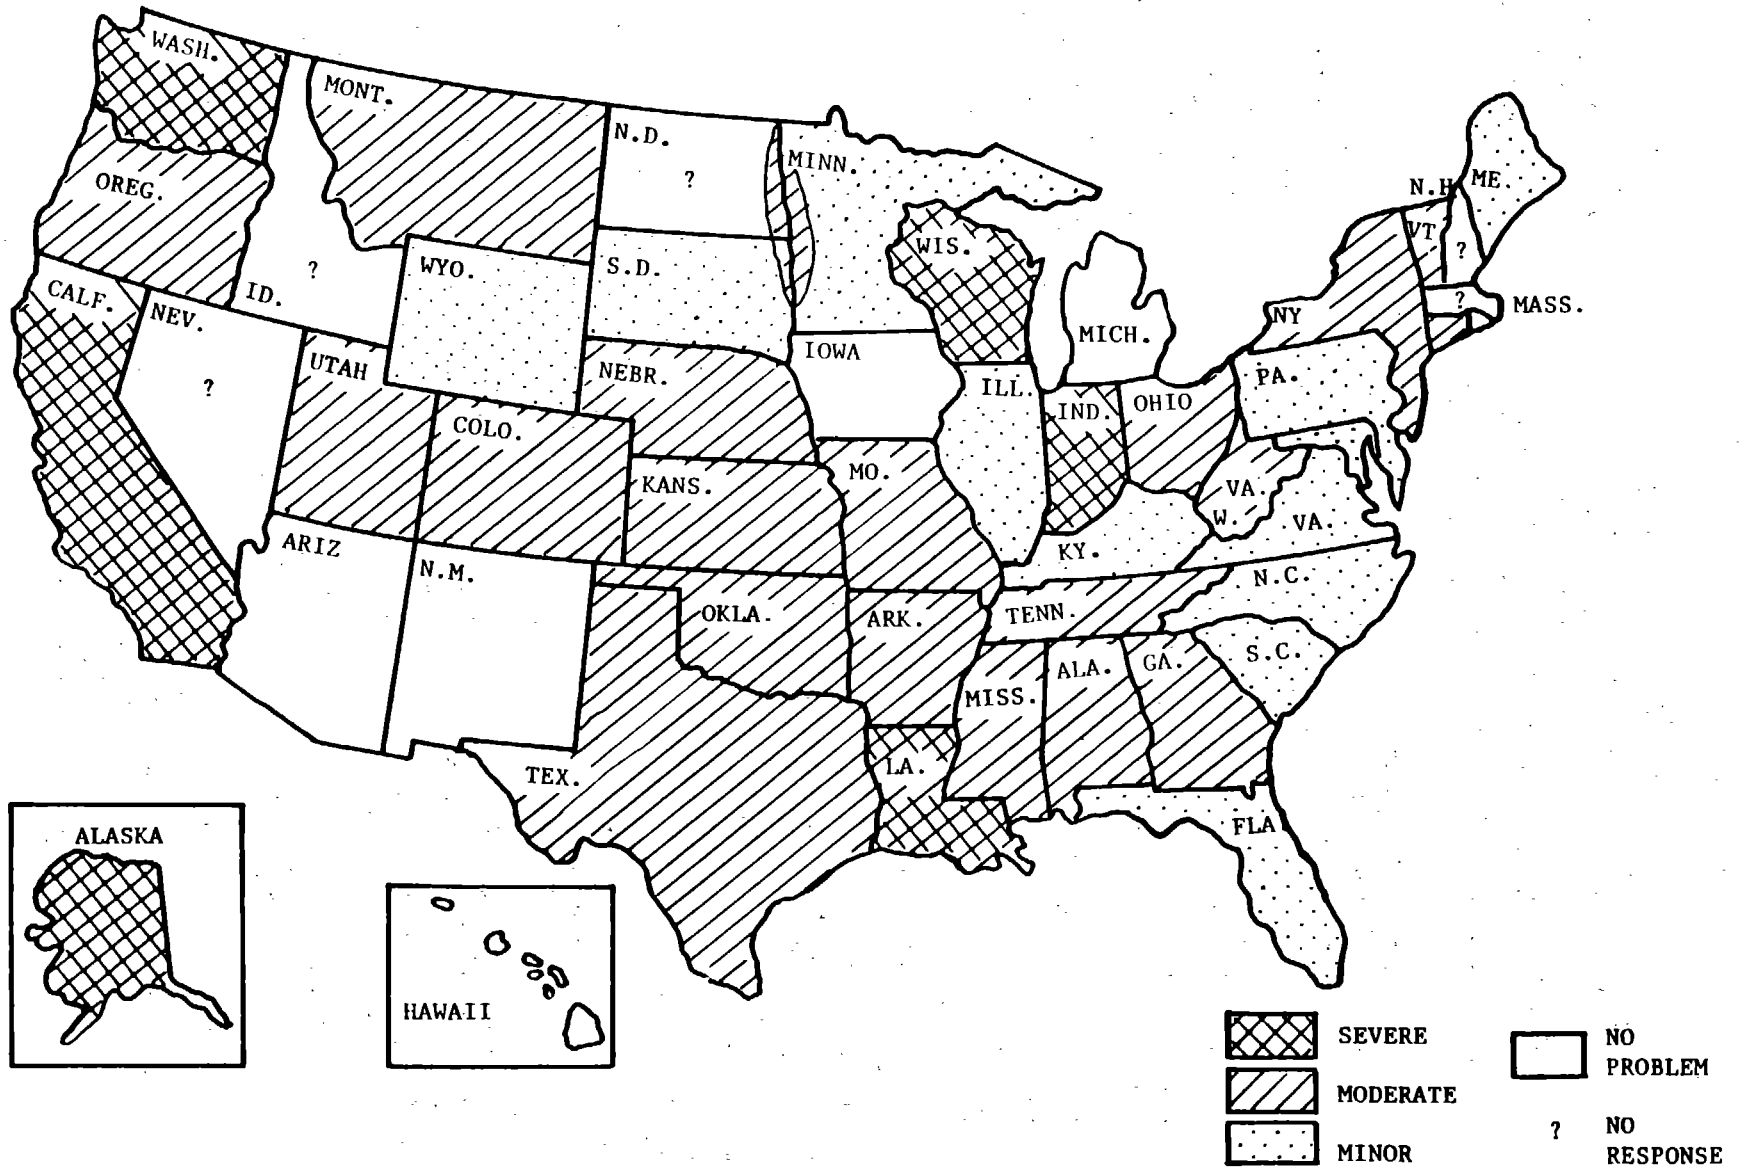
FIGURE 4 DEGREE OF DEBRIS PROBLEMS IN THE RIVER ENVIRONMENT

It is apparent that floating debris poses a problem of varying degree and dimension: four states recognized it as serious while 25 states classified it as of moderate magnitude. In Figure 4, the geographic distribution of debris problems is shown, indicating that the Pacific Northwest and the upper and lower Mississippi River Valley experience serious debris problems.

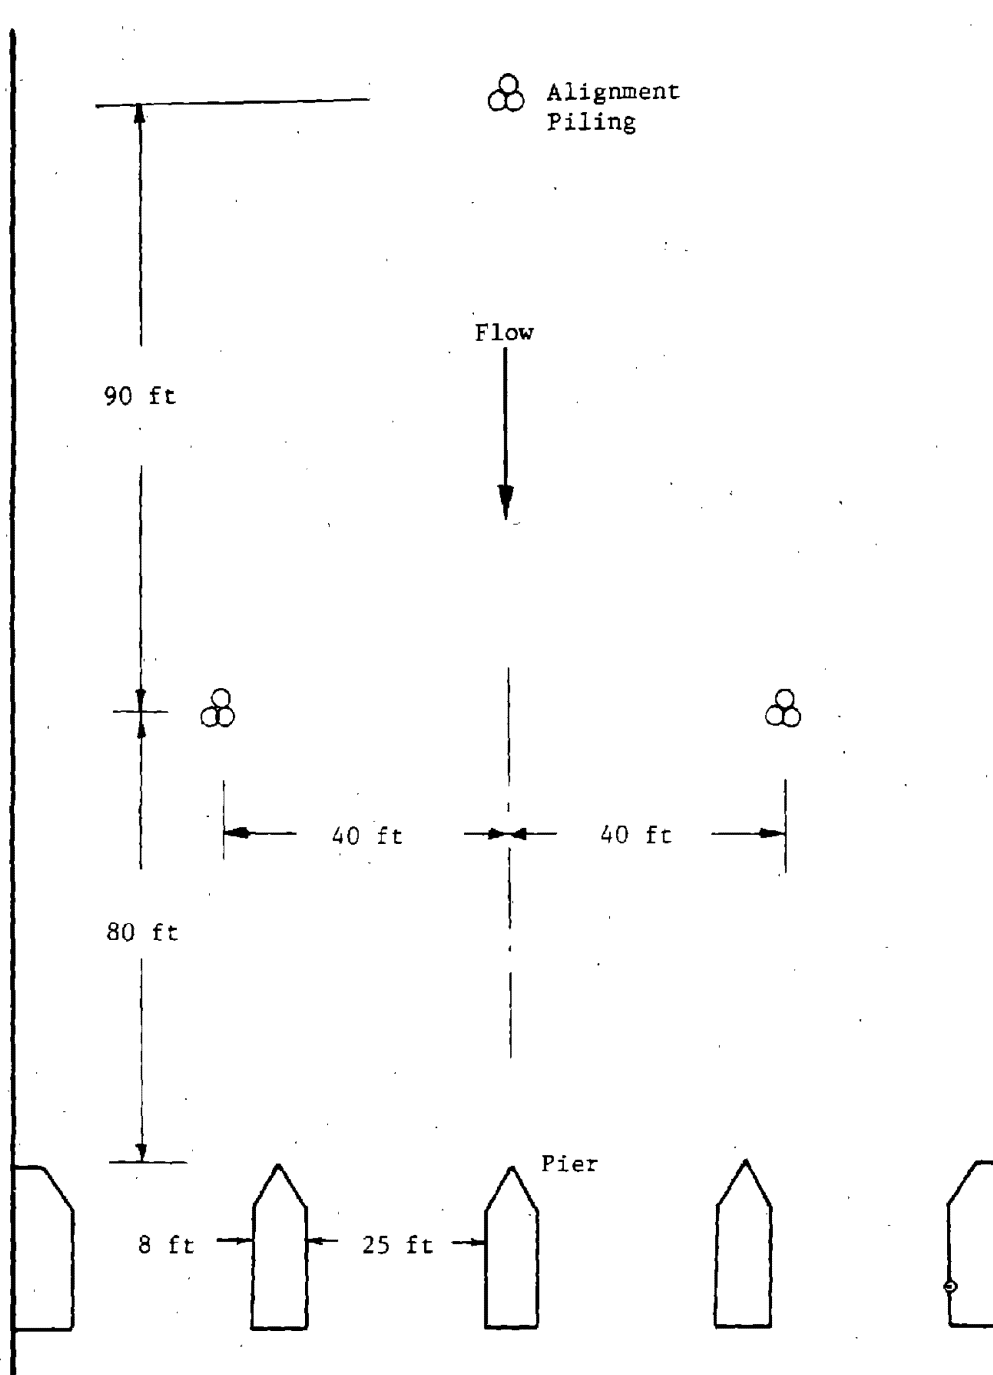
Figure 8 Debris Deflector at the Chena River Flood Control Intake Structure, Alaska.

Debris deflectors are placed upstream of piers to divert and guide debris through bridge openings. The U.S. Army Corps of Engineers used this scheme to solve debris problems at the Chena River Flood Control Dam in Alaska. A group of three pilings were placed well in front of the piers as shown in Figure 8 to align logs coming downstream with axes parallel to the flow. The logs were to pass through the openings without incident. After successful laboratory tests in straight flumes, tests were conducted in a model alluvial channel [19]. Unfortunately, the tests were inconclusive because a change in the channel configuration forced the flow to concentrate on one side of the channel, and two of the pilings were no longer in the flow of the channel. In many cases the model logs were aligned with the flow and passed through the structure. However, in some instances, the model logs would form jams around the pilings.

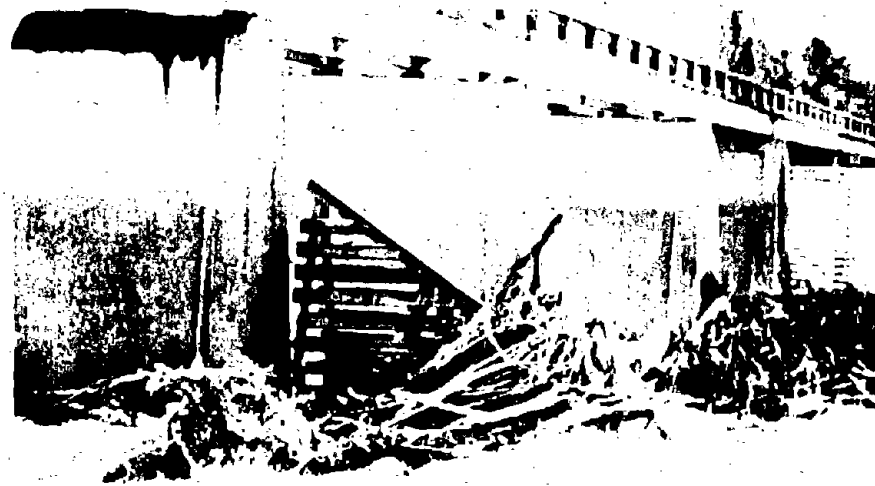
Figure 9. Debris Deflector on a Bridge Across the Homochitto River, Mississippi.

For a bridge over the Homochitto River in Mississippi, a debris deflector, as shown in Figure 9, was placed directly in front of each pier. Approaching debris was to ride up onto the deflector before reaching the pier. As it is pushed by the flow and slides up the ridge of the deflector, it should then be pushed aside and be returned into the main flow downstream. Although this mechanism was claimed by some engineers to function as anticipated, more observations and research are needed to support this claim. This deflector, like the one recommended by the U.S. Army Corps of Engineers, is highly directional: its effectiveness is largely controlled by the direction of stream flow. With a change in flow direction, the deflector could fail to work and in some cases actually worsen the situation.
