**NCHRP REPORT 350 ASSESSMENT OF
EXISTING ROADSIDE SAFETY HARDWARE**

Contract No. DTFH61-97-C-00039
Project No. 404211-F

Sponsored by
U.S. Department of Transportation
Federal Highway Administration

November 2000

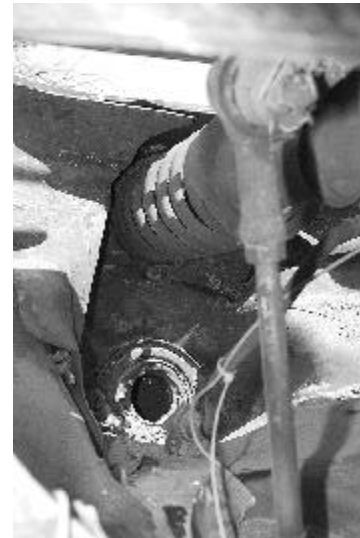
Figure 17. Vehicle after test 404211-6.

The vehicle sustained little damage from impact with the terminal. Structural damage included a deformed lower control arm and strut tower and a torn upper right strut mount. Minor damage occurred to the front bumper. The front right rim was bent and the tire deflated. After the vehicle exited the test site (traversed the sloped ditch and traveled beyond the right of way) the vehicle yawed clockwise and rolled onto its left side. Photographs of the vehicle after the test are shown in figure 17; however, most of the damage occurred during the rollover. No measurable deformation occurred to the front of the vehicle from impact with the terminal. No deformation or intrusion of the occupant compartment occurred prior to the rollover. Exterior crush and occupant compartment measurements are shown in appendix B, tables 29 and 30.

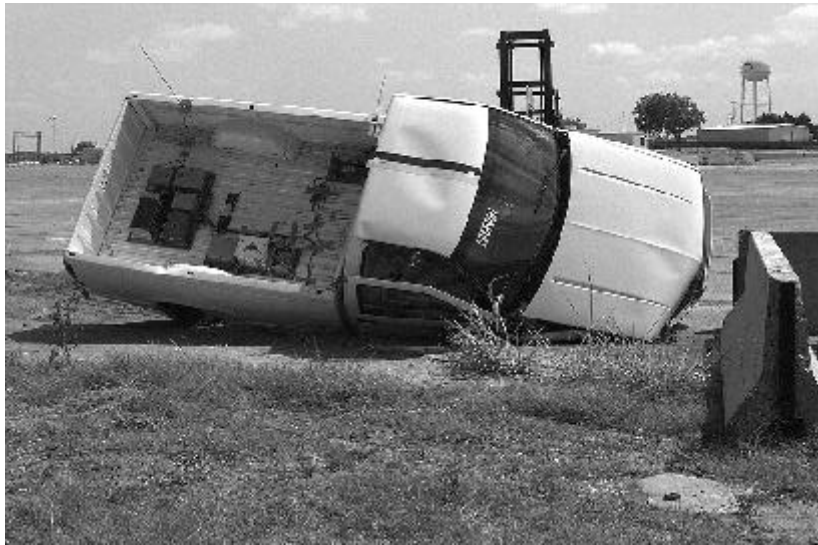
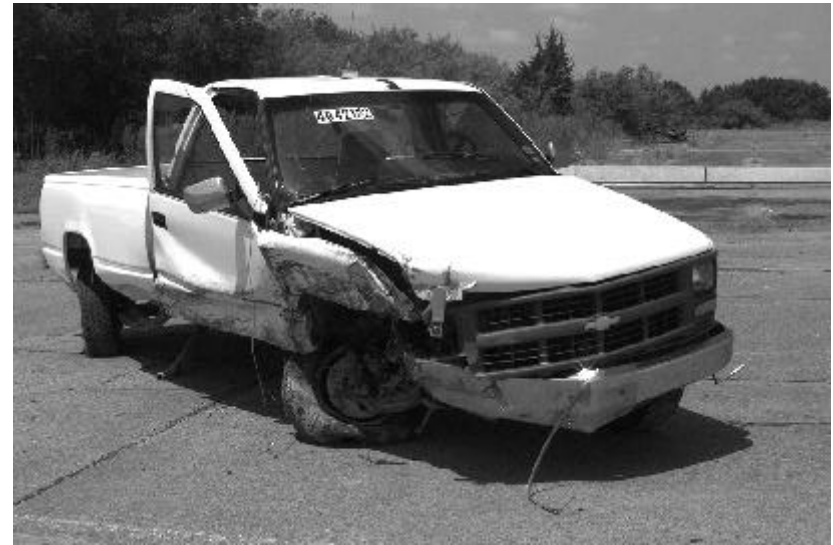
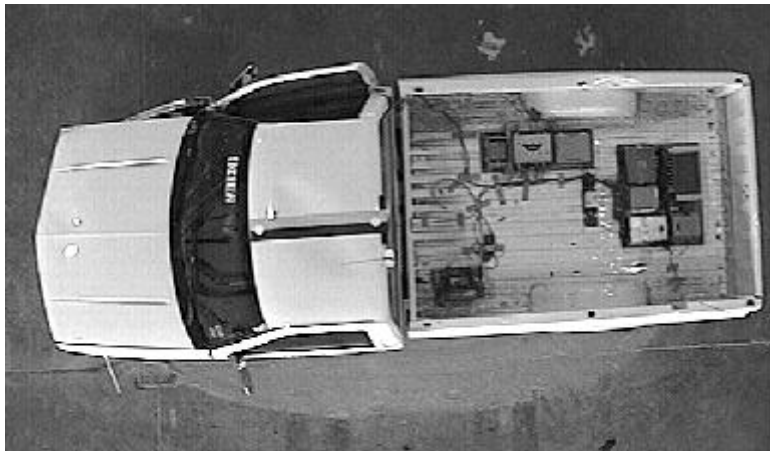
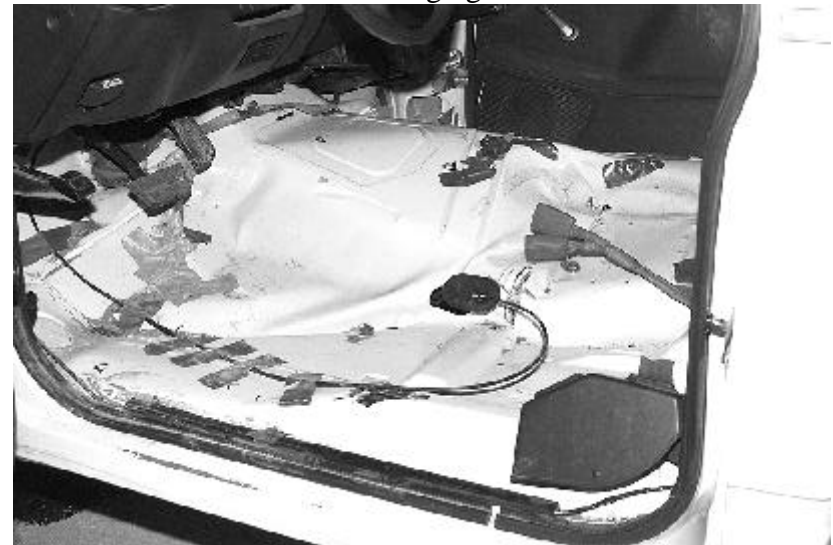
Figure 23. Vehicle after test 404211-2.

The vehicle sustained substantial damage as shown in figure 23. Structural damage included the right front spindle, rod ends, stabilizer bar, front cross member, upper and lower A-arms, right side floor pan, firewall, and frame. The right rear axle springs, U-bolts, and right A-pillar sustained damage. The right front and rear tire and wheel were crushed. Both right side quarter panels were damaged and the right door had a 355-mm gap at the top. The fan, radiator, grill, hood, and bumper were deformed. The left front quarter panel was damaged and the left door was jammed. The windshield was shattered. A 20-mm buckle was noted on the passenger's side of the cab and the cab shifted out 70 mm on the driver's side. Maximum exterior crush to the vehicle was 540 mm at the top of the front bumper and 530 mm at the wheel well. Occupant compartment deformation was 40 mm in the floor to instrument panel area and 97 mm in the firewall area. Details can be found in appendix B, tables 31 and 32.

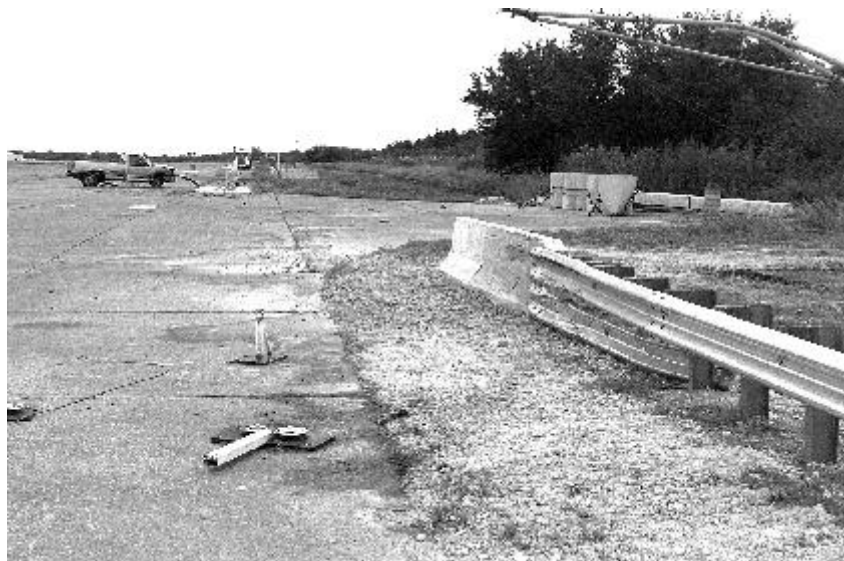
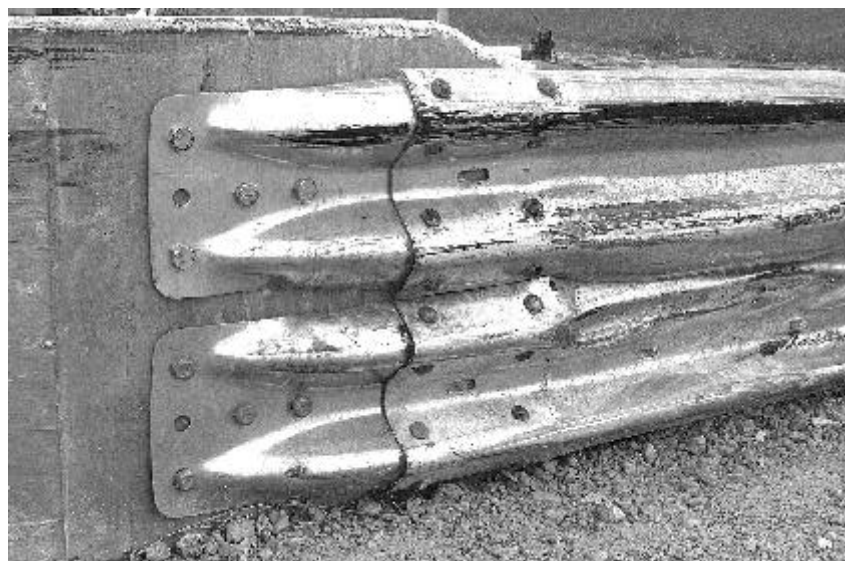
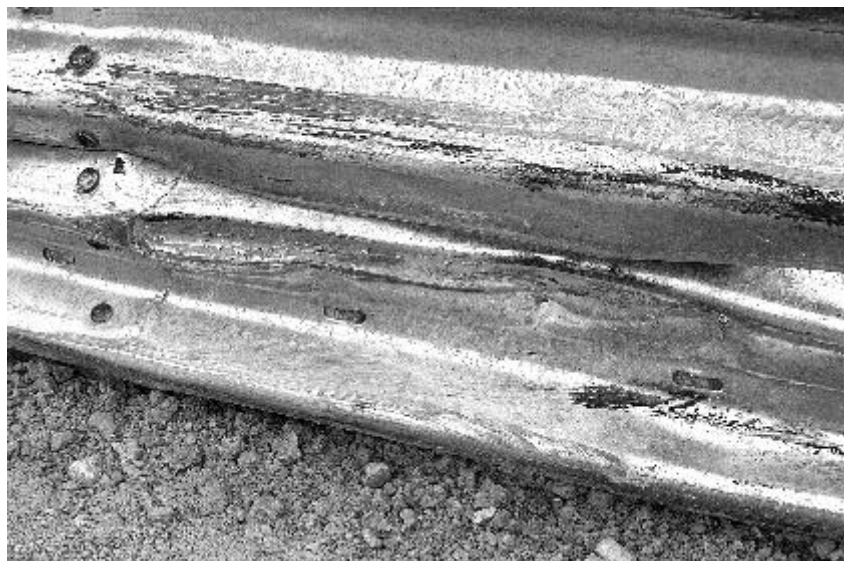
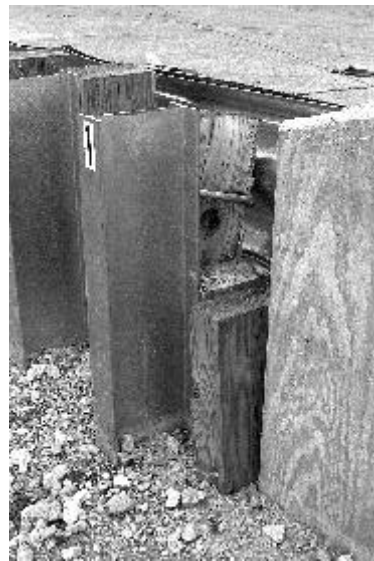
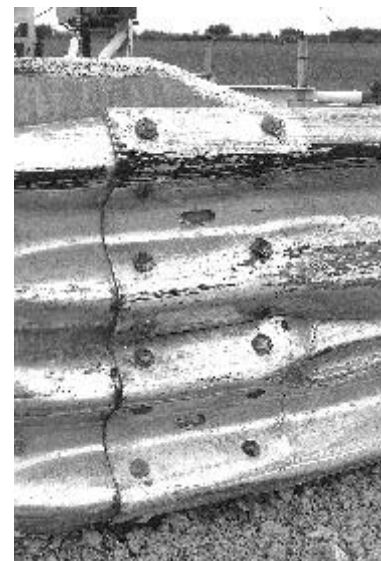
Figure 27. Installation after test 404211-12.

Minimal damage was sustained by the transition as shown in figure 27. The top blockout at post 1 was split and the W-beam and rub rail were deformed. Maximum deformation of the W-beam rail element was 25 mm and the rub rail sustained a maximum deformation of 15 mm. The edge of the parapet wall was chipped. Total length of contact of the vehicle with the transition was 3.84 m.

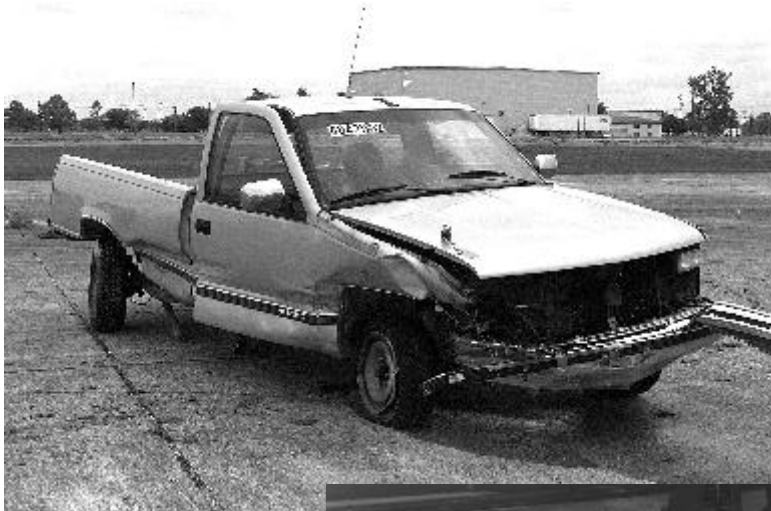
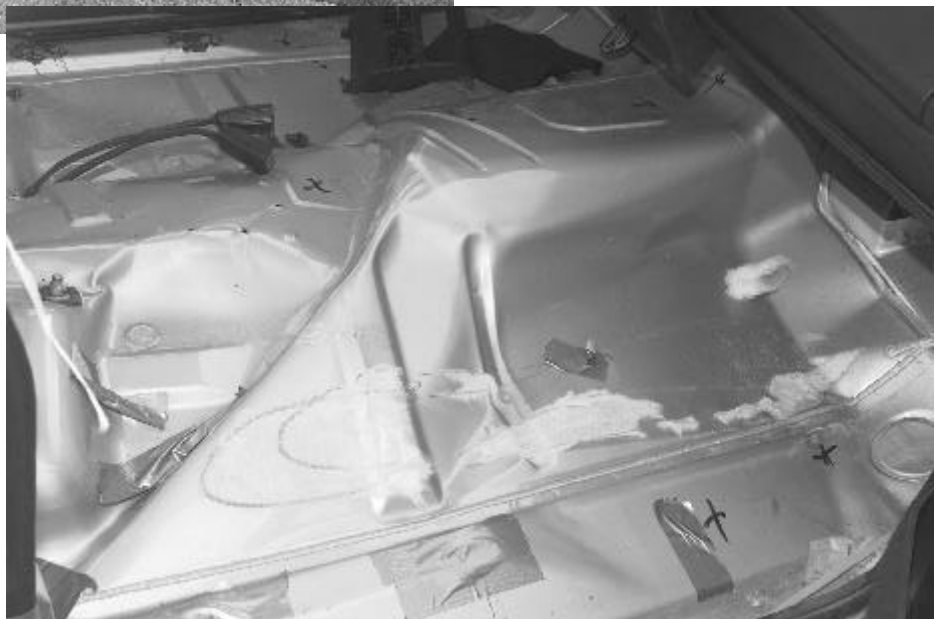
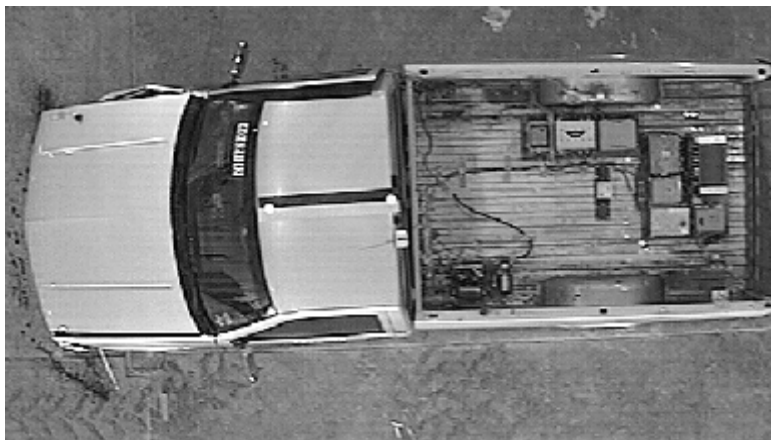
Figure 28. Vehicle after test 404211-12.

The vehicle sustained structural damage to the right side frame rail, right front upper and lower A-arms, and floor pan. The drive shaft was separated, the right rear U-bolts broke at the axle and the shock pulled out. As shown in figure 28, the front bumper, grill, radiator, fan, right front tire and rim, right front quarter panel, right door, right rear quarter panel, rear bumper, and right rear tire and rim were damaged. The windshield was shattered and the cab was pushed rearward into the bed. The front end of the vehicle was shifted to the left 140 mm. Maximum exterior crush to the vehicle was 500 mm at the right corner at bumper height. Maximum occupant compartment deformation was 80 mm in the lateral direction near the occupant's feet. Exterior vehicle crush and occupant compartment measurements are shown in appendix B, tables 33 and 34.

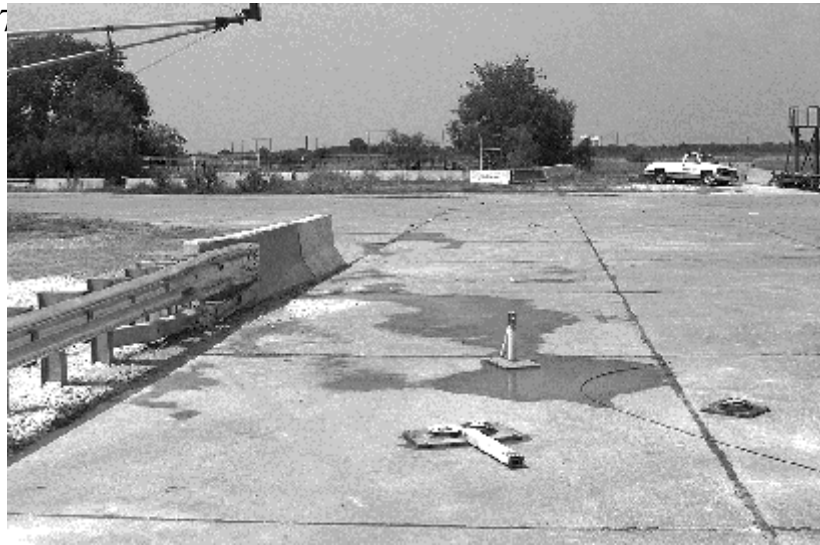
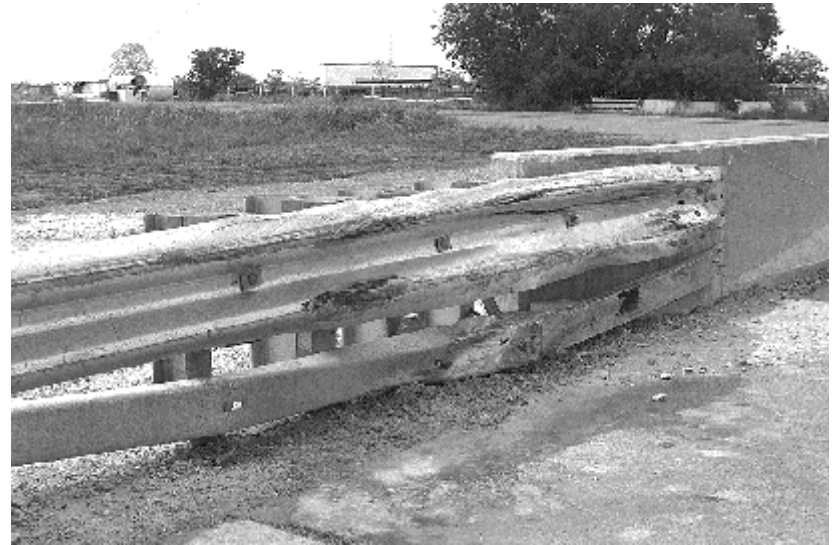
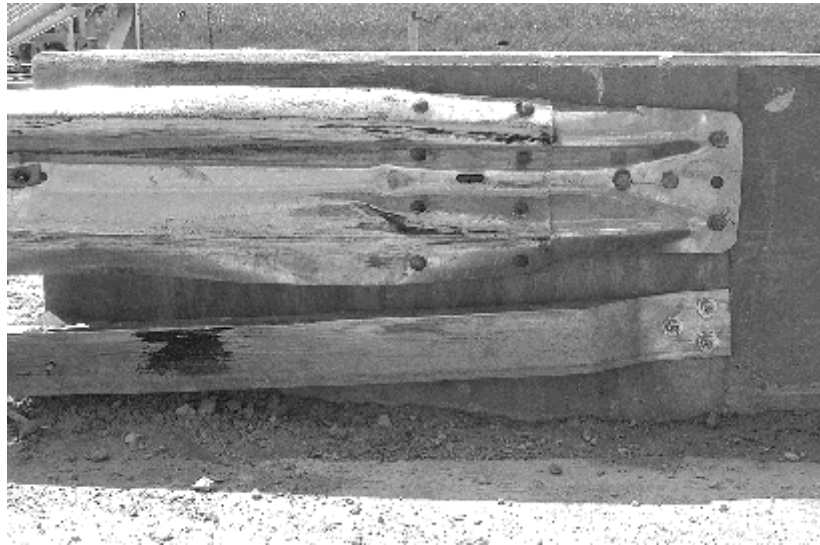
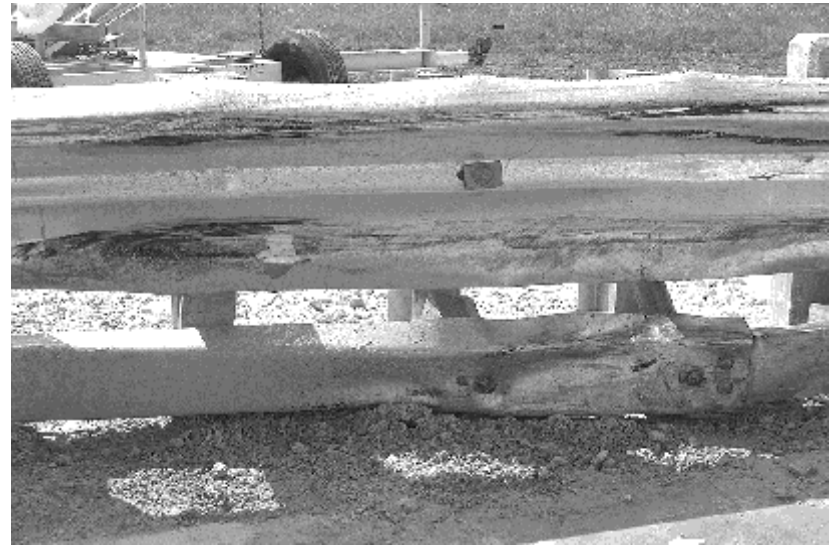
Figure 33. Installation after test 404211-4.

The vertical flared back transition received moderate damage as shown in figure 33. Deformation to the upper and lower W-beams extended from post 5 through post 1. The bolt was out of posts 1 and 2 at the bottom blockout. Also at post 2, the rub rail was deformed outward. At

post 3, the rub rail was twisted. The spacing between the metal pipe and blockout and the concrete parapet was 45 mm before the test and after the test the pipe was leaning against the parapet and the spacing was 15 mm. The concrete parapet was pushed back 25 mm. Total length of contact of the vehicle with the transition and concrete parapet was 3.91 m.

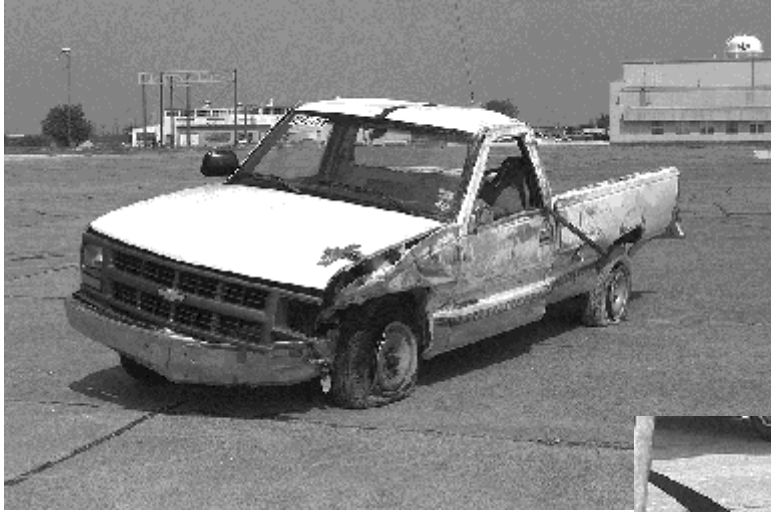
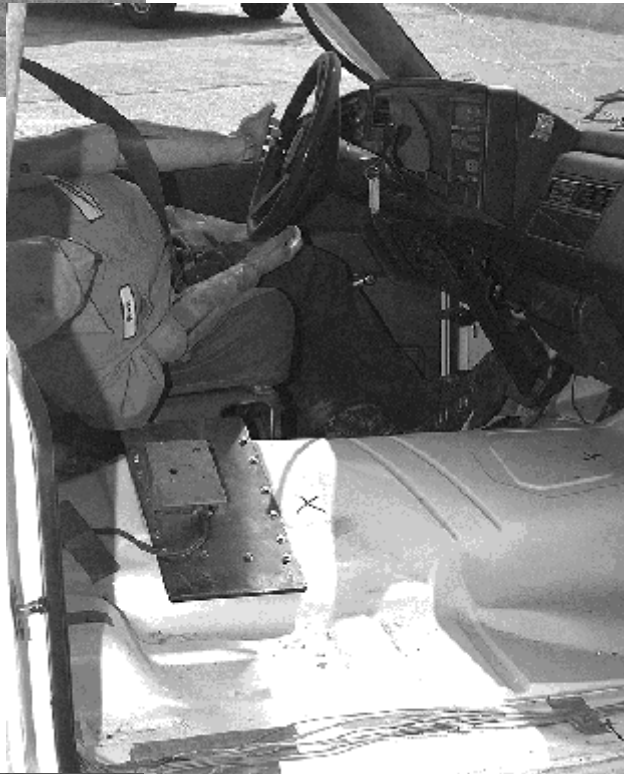
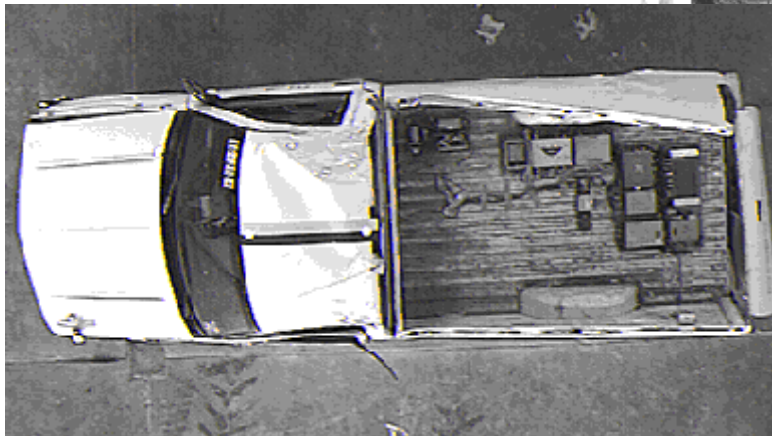
Figure 34. Vehicle after test 404211-4.

The vehicle sustained substantial damage as shown in figure 34. The upper and lower A-arms and frame rail were all severely damaged. Both left-side quarter panels were damaged and the left door had a gap (not measurable). The right door, front and rear rims, and the rear quarter panel sustained damage. Also damaged were the rear bumper and tailgate. The front bumper, grill, hood, radiator, fan, and cab were deformed. The windshield and the right, left, and rear glasses were shattered. Maximum exterior crush to the vehicle was 530 mm at the front bumper and 410 mm above the front bumper. Maximum deformation of the occupant compartment was 75 mm in the center floor pan area and 27 mm in the firewall area. Details can be found in appendix B, tables 35 and 36.

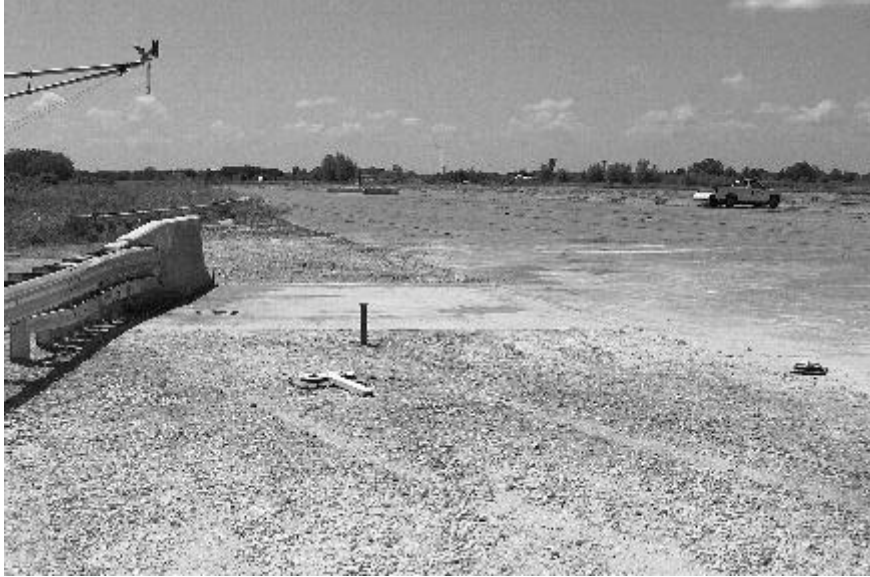
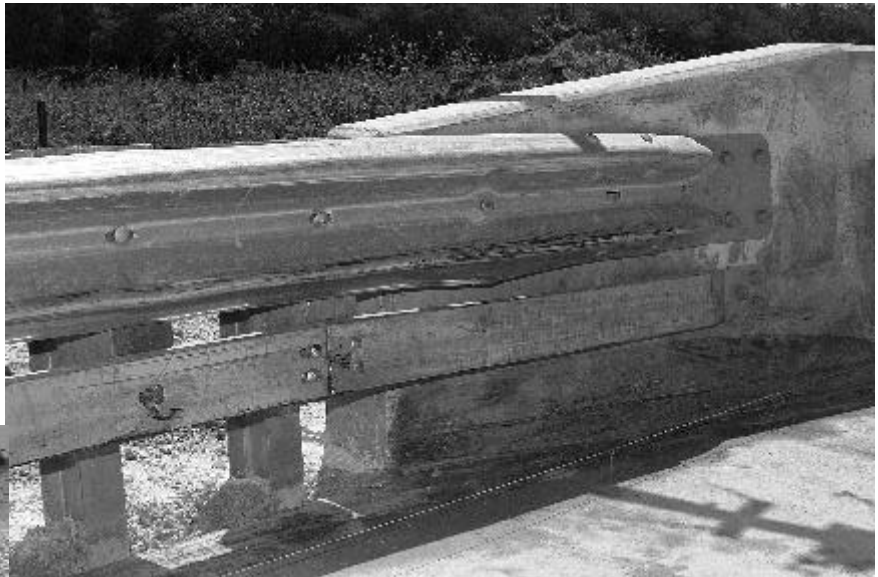
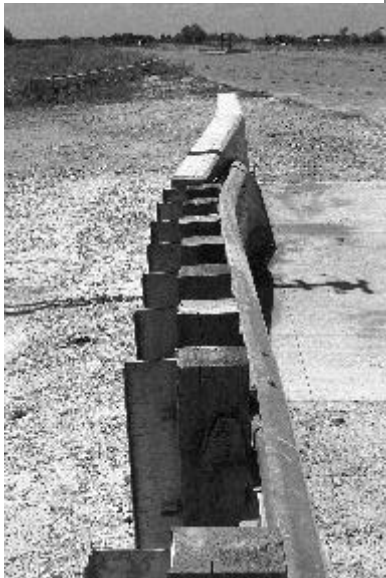
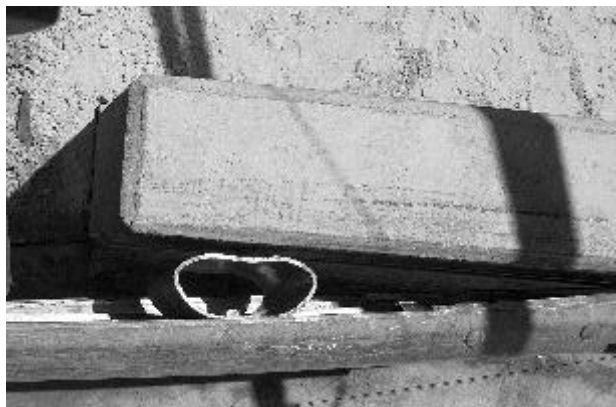
Figure 39. Installation after test 404211-3.

The Pennsylvania transition sustained minimal damage as shown in figure 39. Tire marks were on the face of the W-beam rail element and rub rail and both were deformed. The bolt on the rub rail at post 2 was bent and the bolt was pulled out of the rub rail at post 4. The spacer tube was crushed 28 mm. The space between the spacer tube and the concrete parapet was reduced 5 mm. No movement was noted in the end terminal. Maximum dynamic deflection of the W-beam rail element was 177 mm. Maximum permanent rail deformation of the W-beam rail element was 110 mm at post 1 and the rub rail was deformed 98 mm at post 2. The length of contact of the vehicle with the transition was 3.9 m. No apparent cracking was observed in the concrete parapet or slab.

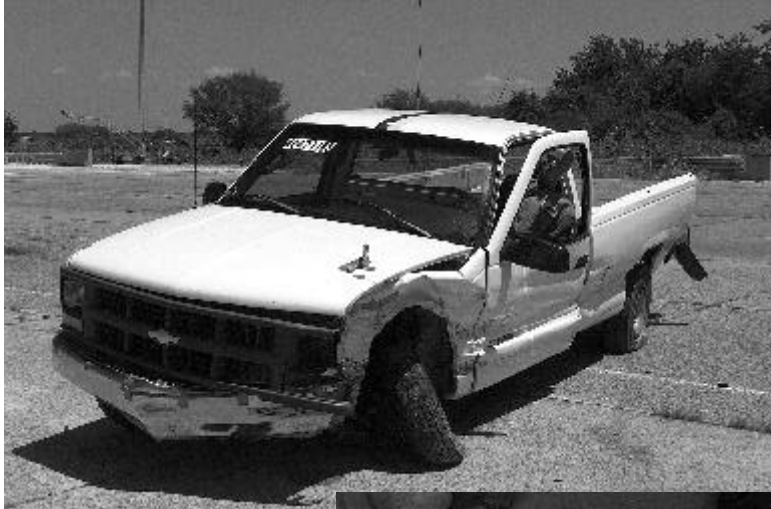
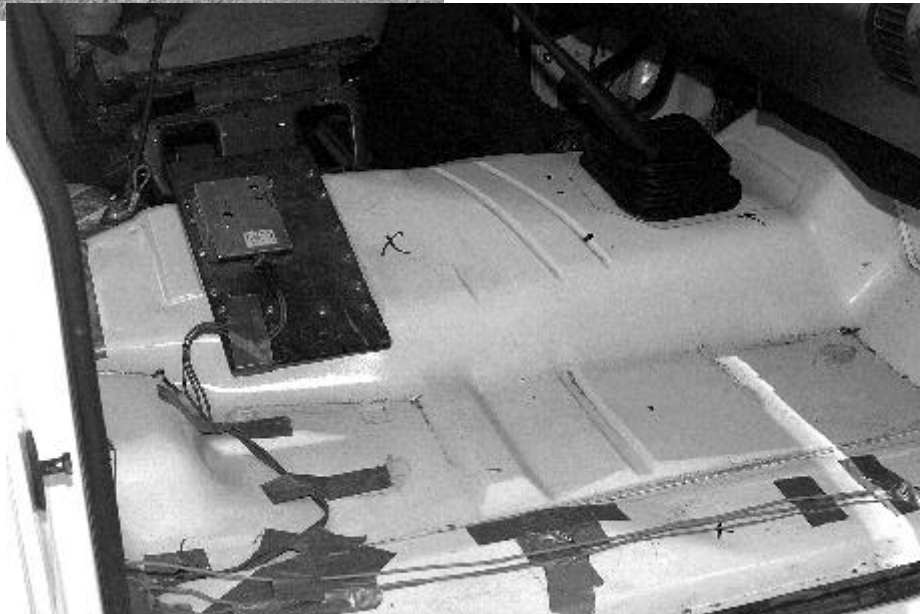
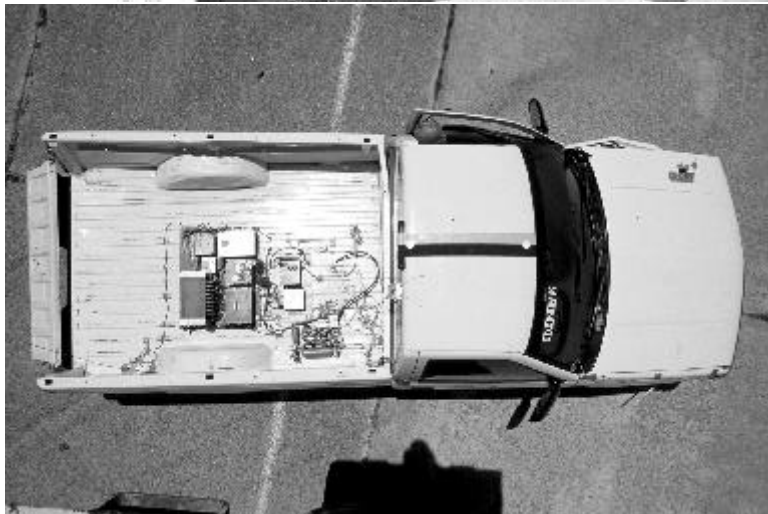
Figure 40. Vehicle after test 404211-3.

The vehicle sustained damage to the left front as shown in figure 40. Structural damage included the left front of the frame, left upper and lower A-arms, left tie rod end, stabilizer bar, floor pan and firewall. Also damaged were the front bumper, grill, fan, radiator, left front and rear quarter panels, left door and window, left front and rear tires and wheel rims. The windshield sustained stress cracks. Maximum exterior crush of the vehicle was 440 mm at the left front corner at bumper height. The maximum deformation of the occupant compartment was 117 mm in the center of the floor pan area. Exterior vehicle crush and occupant compartment measurements are shown in appendix B, tables 37 and 38.

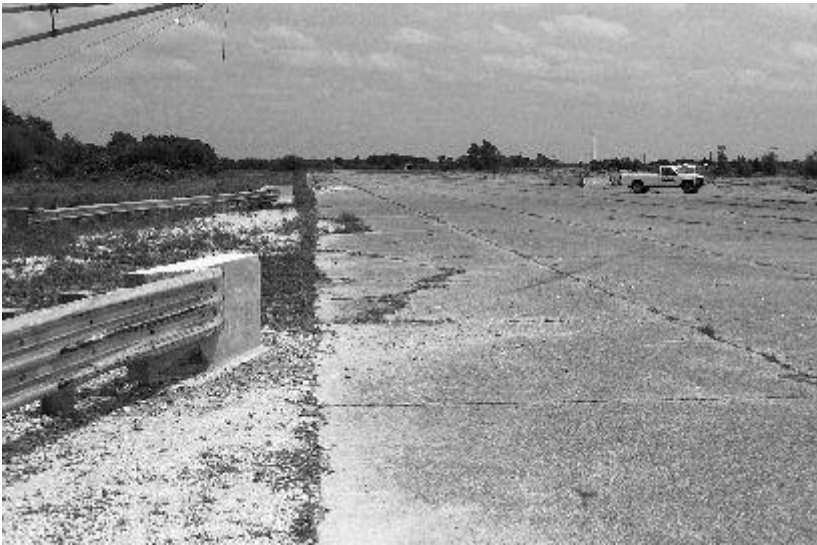
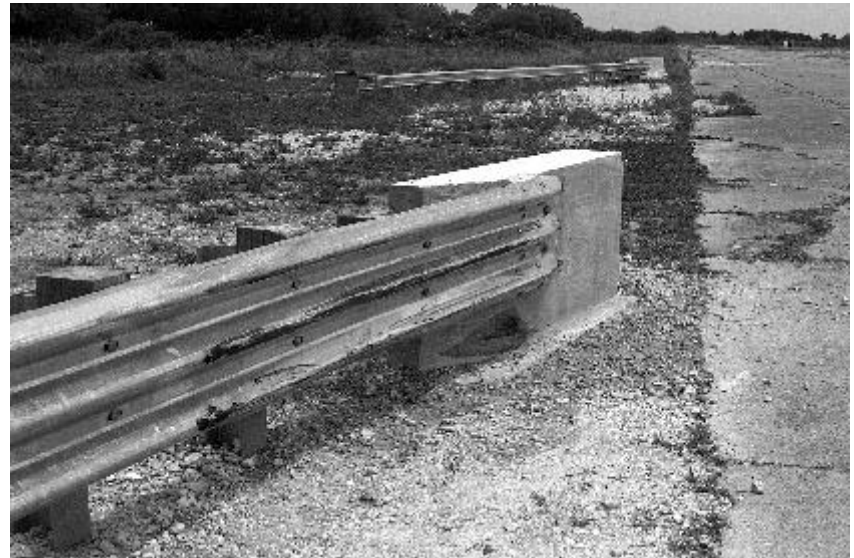
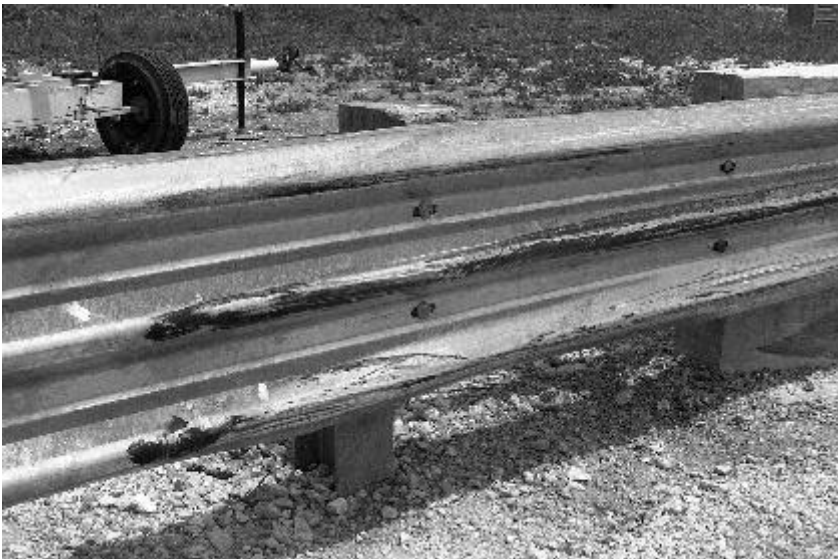
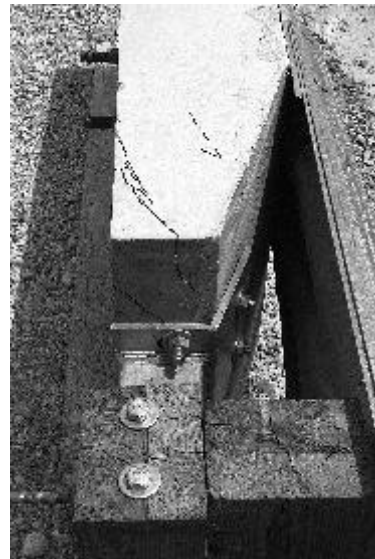
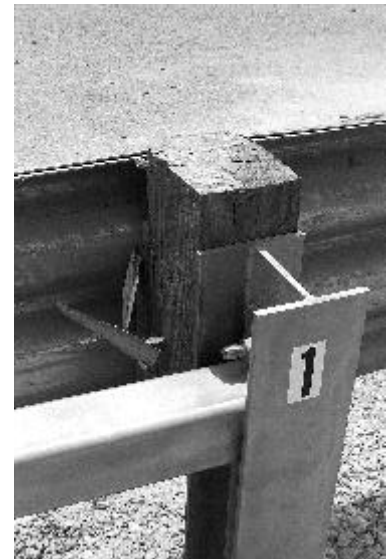
Figure 45. Installation after test 404211-7.

The Nebraska thrie beam transition sustained minimal damage as shown in figure 45. No movement was noted in the end terminal. Posts 4 and 5 were disturbed, post 3 moved rearward 4 mm, and post 2 was pushed rearward 20 mm. The corner of the blockout at post 1 was missing and the post was pushed back 15 mm. The pipe spacer between the parapet and rail element was crushed 25 mm and the parapet base was disturbed 2 mm. Tire marks were on the flare of the parapet and cracks in the end of the parapet radiated from the bolts connecting the thrie beam. Length of contact of the vehicle with the transition was 3.07 m. Maximum dynamic deflection of the rail element during the test was 82 mm and maximum permanent deformation was 24 mm, both occurring at post 2.

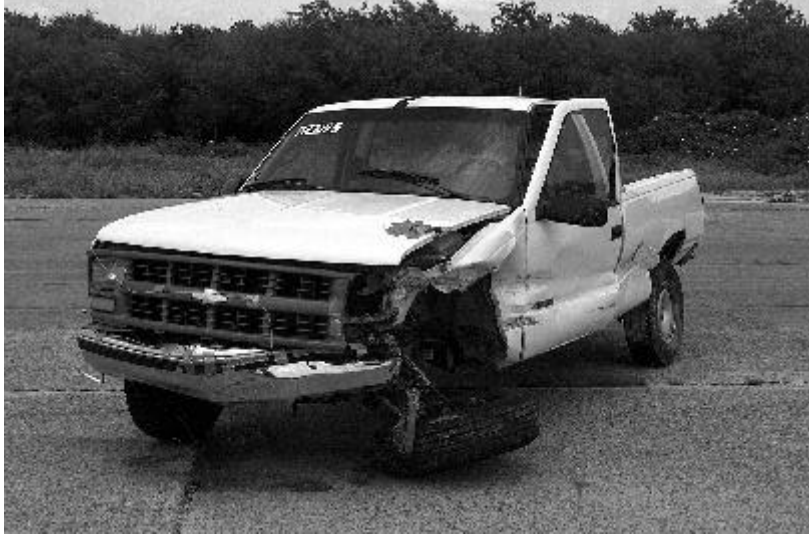
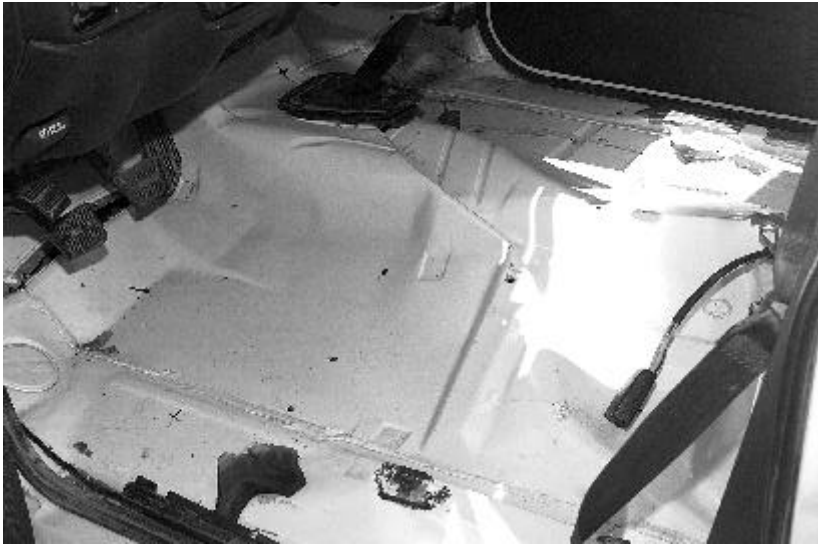
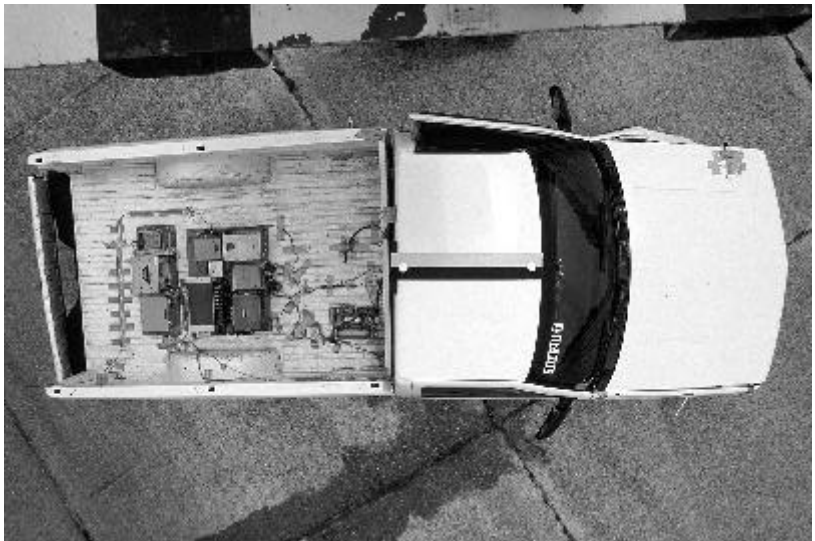
Figure 46. Vehicle after test 404211-7.

Moderate damage was imparted to the 2000P vehicle as shown in figure 46. The following vehicle components received structural damage: the frame at the left front, steering arm, stabilizer bar, left side rod ends, left upper and lower A-arms, and left front spindle, rotor and tire. Also damaged were the front bumper, fan, radiator, left front quarter-panel, left door, left side of the bed, and the left rear rim. The floor pan and firewall were deformed and the seam where the floor pan and firewall connect were separated. Maximum exterior crush to the left front corner was 400 mm. Maximum interior deformation was 129 mm at the left side floor pan area. Exterior vehicle crush and occupant compartment measurements are shown in appendix B, tables 39 and 40.

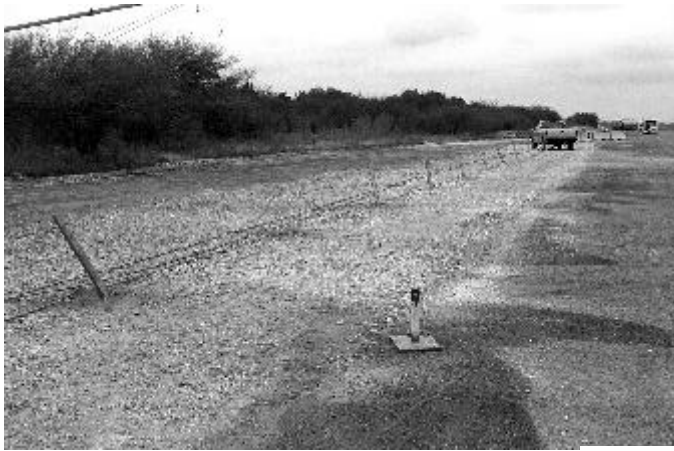
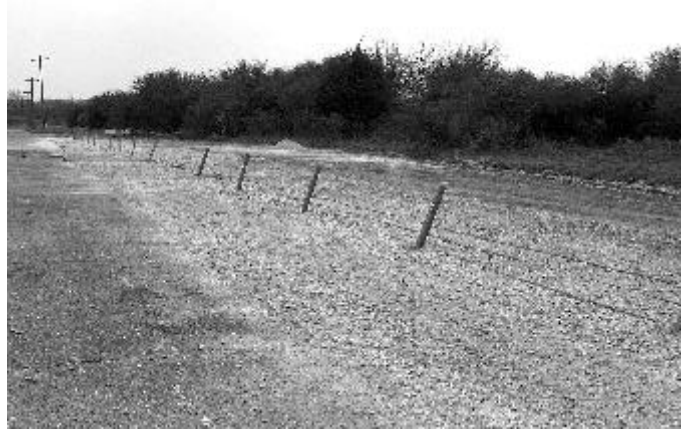
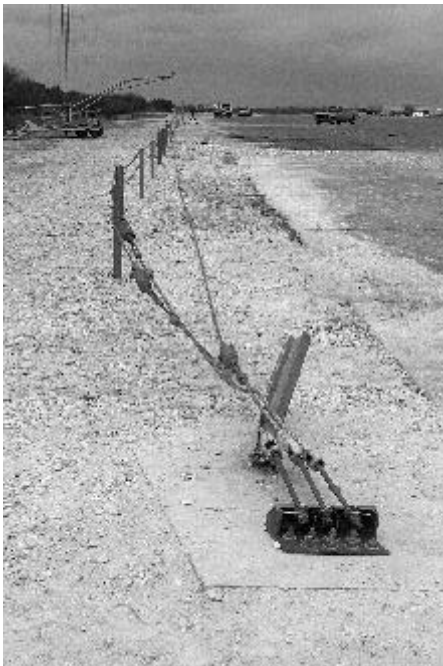
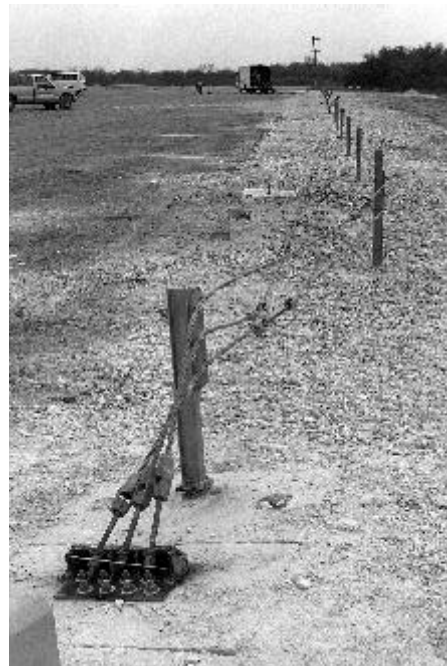
Figure 58. Installation after test 404211-8.

Other than damage to the posts, damage to the Washington 3-strand cable barrier was minimal as shown in figure 58. The upstream anchor had minor stress cracks radiating from the anchor bolts in the concrete footing. Post 1 moved 670 mm longitudinally downstream. Posts 2 through 9 were disturbed and posts 10 through 15 were displaced 25 mm, 13 mm, 40 mm, 45 mm, 15 mm, and 40 mm, respectively. Posts 11 through 17 were rotated and post 12 was torn on the flange above the soil plate. The downstream anchor moved 5 mm longitudinally upstream. The cables were slack throughout the length of the installation. Maximum dynamic deflection during the test was 3.4 m.

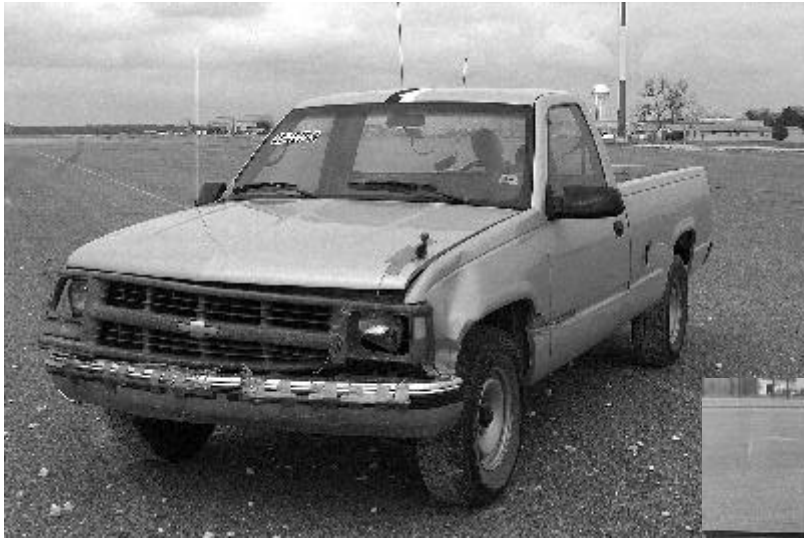
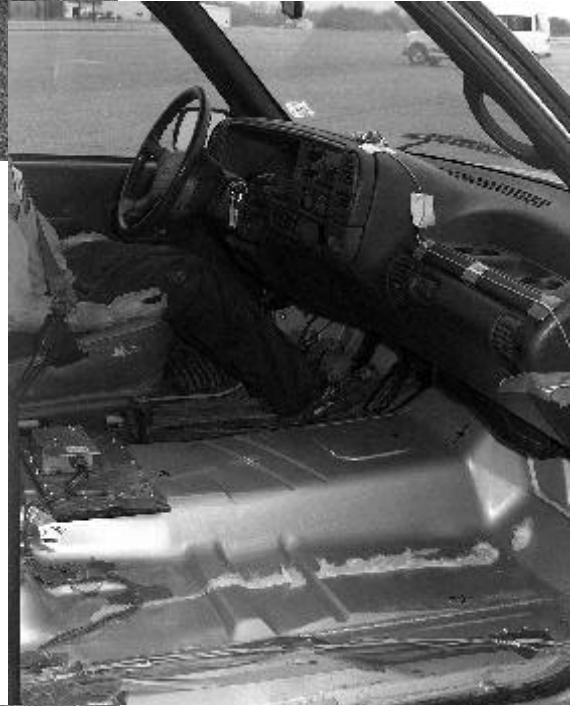
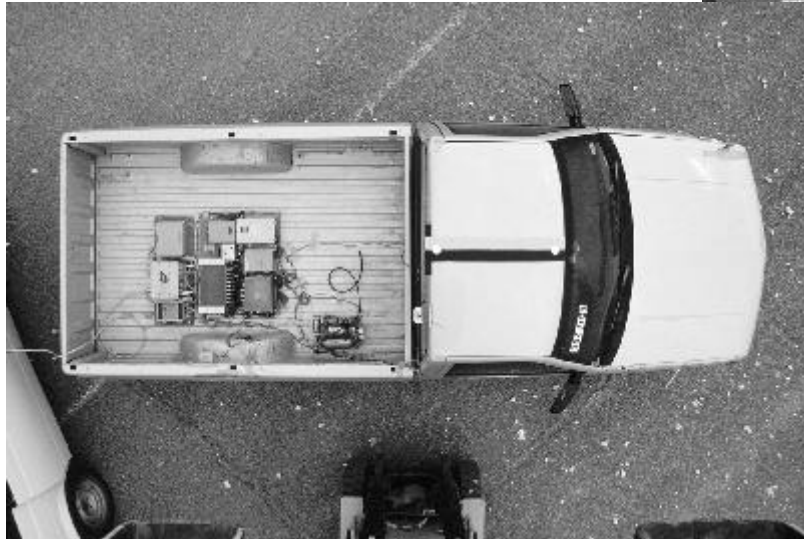
Figure 59. Vehicle after test 404211-8.

The vehicle sustained minor damage as shown in figure 59. There were scuff marks on the left front and rear quarter panels and left door. In addition, the left front and rear tires were cosmetically damaged. Maximum exterior crush to the vehicle was 320 mm above the front bumper at the left front corner. No deformation or intrusion into the occupant compartment occurred from the impact with the cable barrier. Exterior vehicle crush and occupant compartment measurements are shown in appendix B, tables 43 and 44.

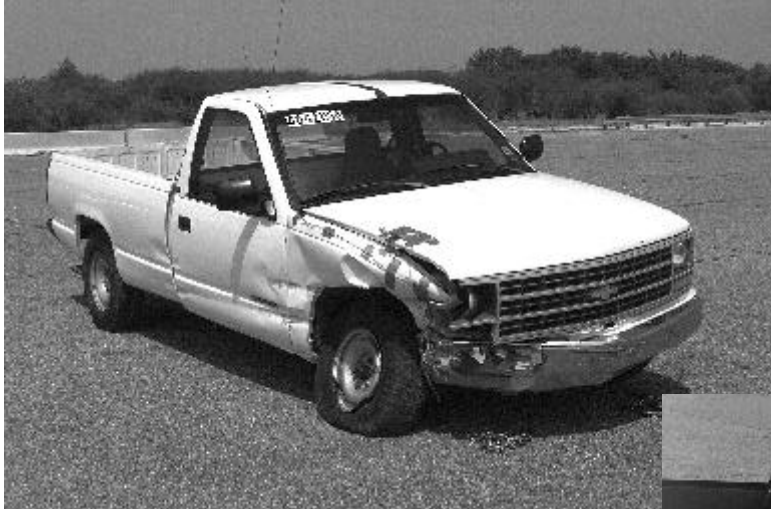
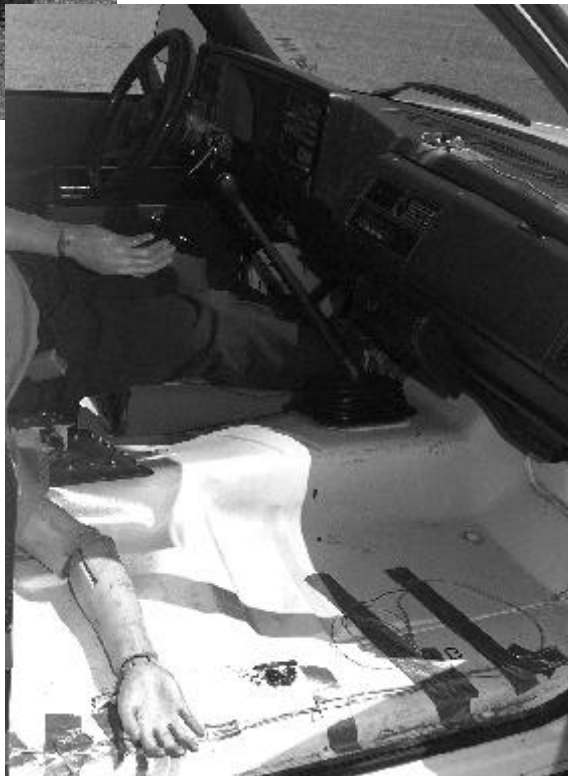
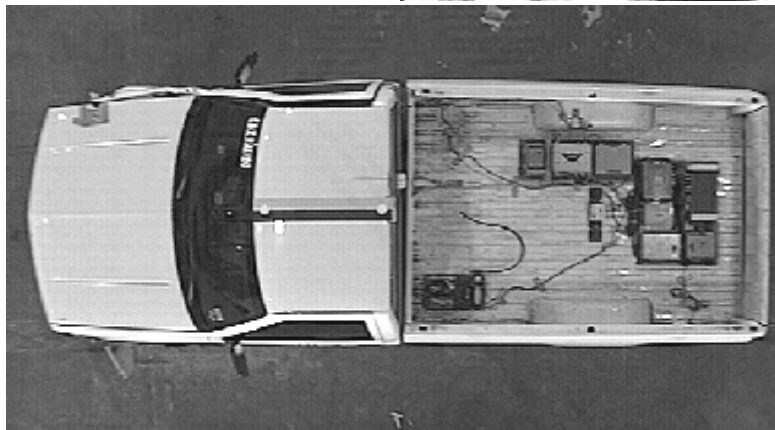
Figure 65. Vehicle after test 404211-10.

Damage to the 2000P vehicle was also minimal, as shown in figure 65. Structural damage was imparted to the right side rod ends, right upper and lower A-arms, the stabilizer bar and the right front frame. Also damaged were the front bumper, grill, fan, radiator, right front quarter panel, right front tire and rim, and the right door was jammed. Maximum exterior crush to the vehicle was 280 mm at the front right corner at bumper height. Maximum occupant compartment deformation was 75 mm in the center floor pan area. Exterior vehicle crush and occupant compartment measurements are shown in appendix B, tables 45 and 46.

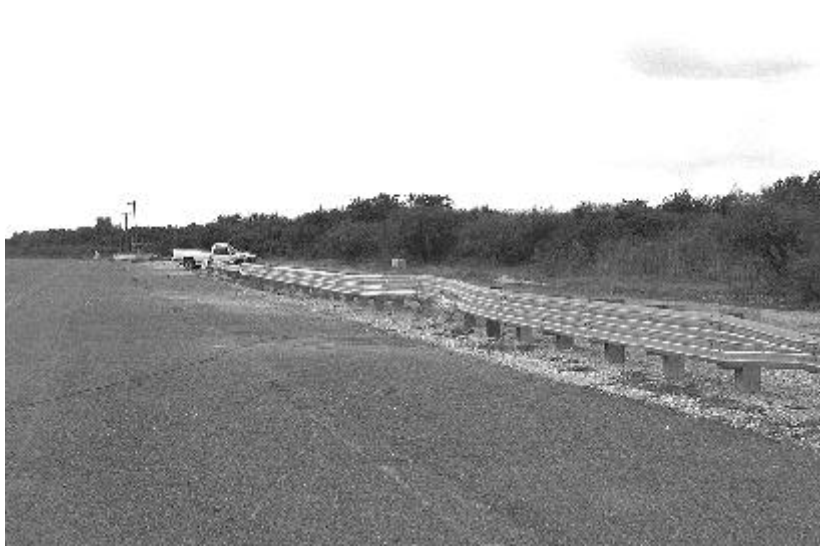
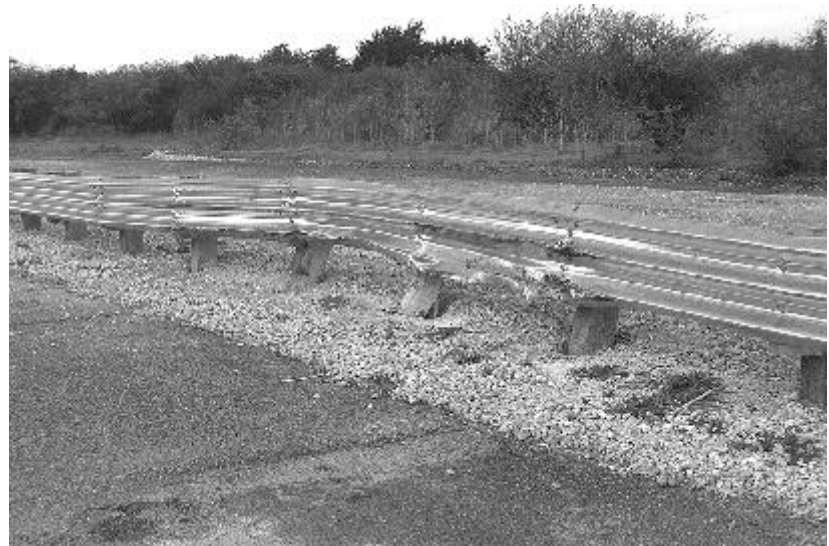
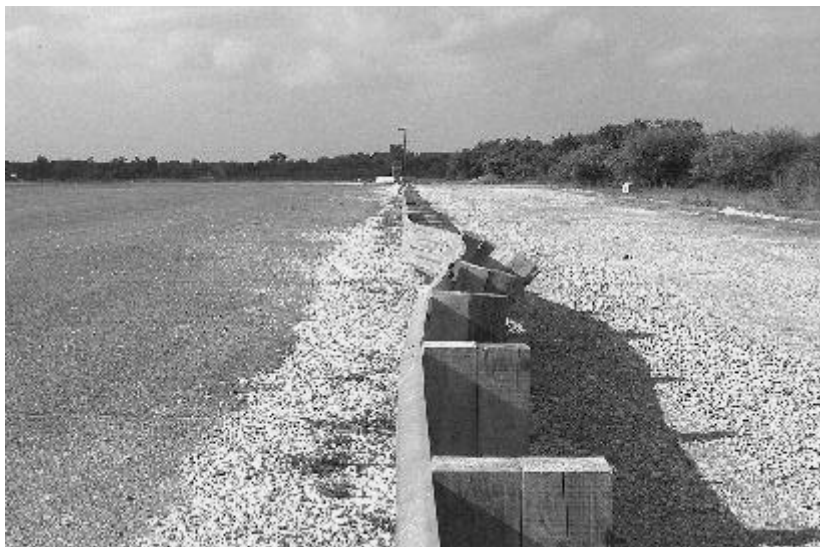
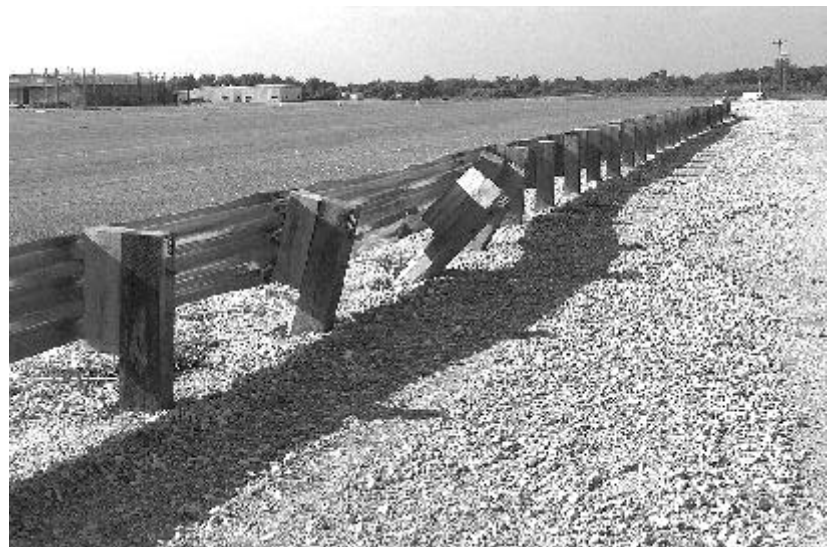
Figure 70. Installation after test 404211-11.

Damage to the strong wood post thrie beam guardrail is shown in figure 70. Post 17 fractured just below ground level and post 18 split along the longitudinal axis. The bolts pulled out of the rail element at posts 17 and 18. The ET-2000 end terminal on the downstream end was disturbed as were posts 6 through 14. Posts 15 through 20 were pushed back with a maximum displacement of 110 mm at post 16. Maximum dynamic deflection of the guardrail was 676 mm and the maximum permanent deformation was 390 mm between posts 16 and 17. Total length of contact during the initial impact was 6.3 m. The vehicle contacted the installation again at post 40 and rode off the end (post 43).
