**NCHRP REPORT 350 ASSESSMENT OF
EXISTING ROADSIDE SAFETY HARDWARE**

Contract No. DTFH61-97-C-00039
Project No. 404211-F

Sponsored by
U.S. Department of Transportation
Federal Highway Administration

November 2000

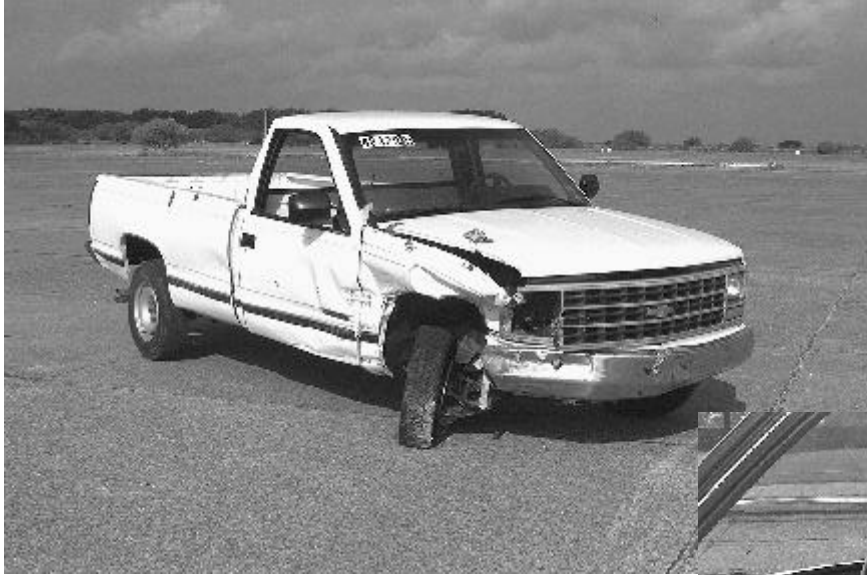
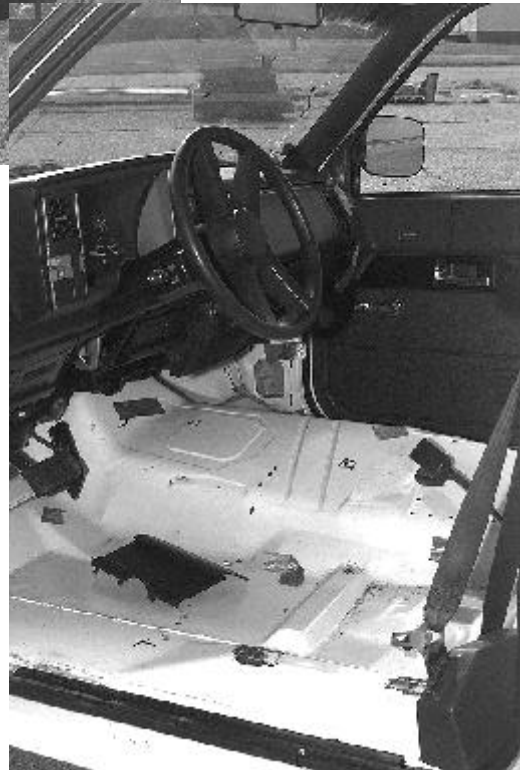
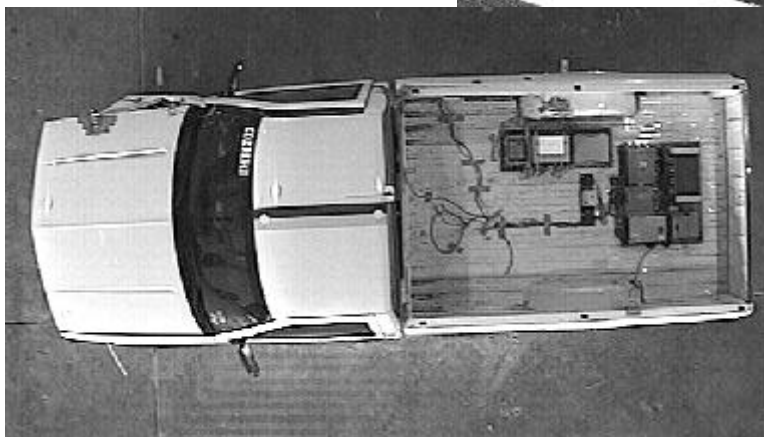
Figure 71. Vehicle after test 404211-11.

The bumper, hood, grill, fan, radiator, right front tire and wheel, right door, right front and rear quarter panels, and left door were damaged and the windshield was shattered as shown in figure 71. Structural damage included the right upper and lower A-arms, right spindle and rod ends, stabilizer bar, right front frame, firewall, and floor pan. Maximum exterior crush to the vehicle was 470 mm at the right front corner of the bumper. Maximum occupant compartment deformation was 30 mm in the center floor pan area under the instrument panel. Exterior crush measurements and occupant compartment measurements are shown in appendix B, tables 47 and 48.

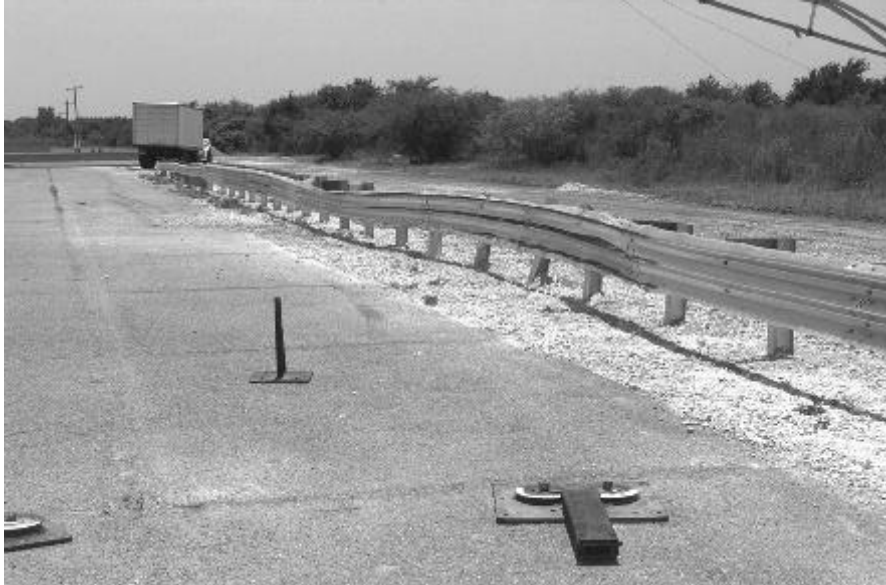
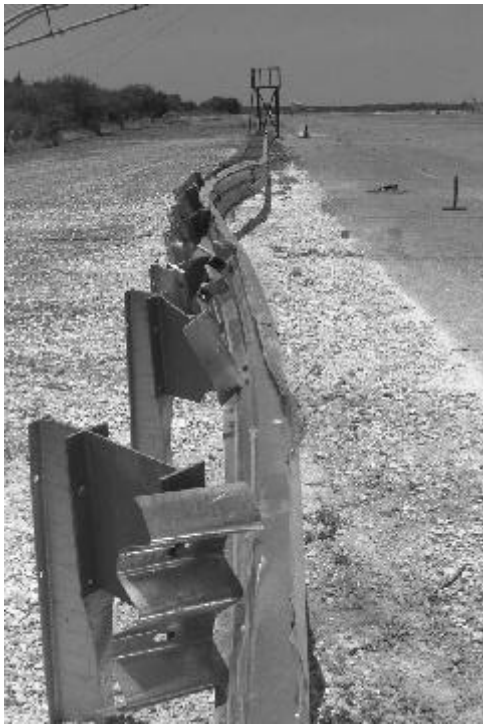
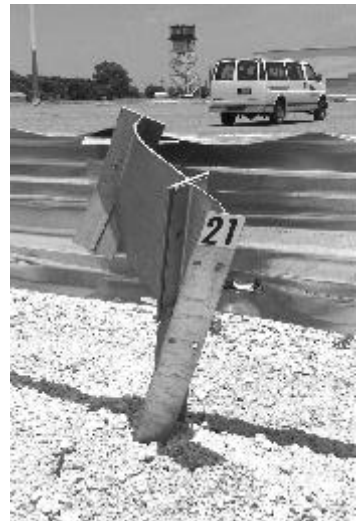
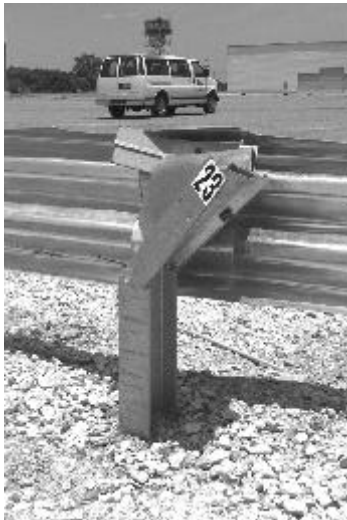
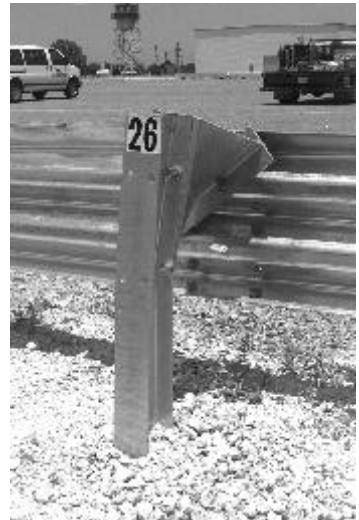
Figure 76. Installation after test 404211-5.

Damage to the modified thrie beam guardrail is shown in figure 76. Posts 19 through 26 were deformed and the blockouts on those posts were significantly deformed. The blockouts on posts 17, 18, and 27 were slightly deformed. The guardrail bolts pulled through the thrie beam at posts 20, 23, 24, and 25. Tire marks were on the face of posts 20 and 21. Length of contact during the initial collision was 16.0 m. For 2.8 m of that distance, the truck rode on top of the thrie beam. The second contact occurred between posts 27 and 28 and continued to just past post 30. The third contact occurred between posts 37 and 38 and the vehicle rode off the end, taking the ET-2000 head off the end. Maximum dynamic deflection during the test was 0.71 m and maximum permanent deformation was 0.51 m, both occurring near post 21.

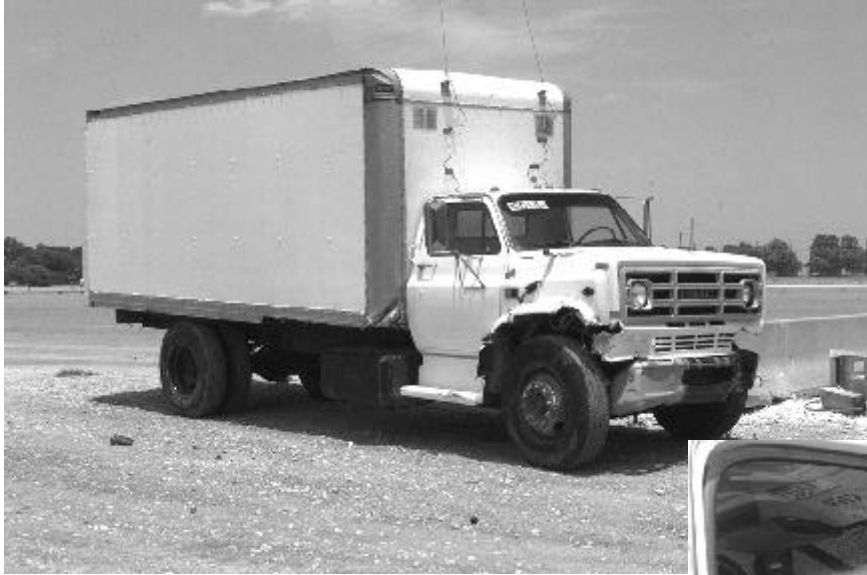
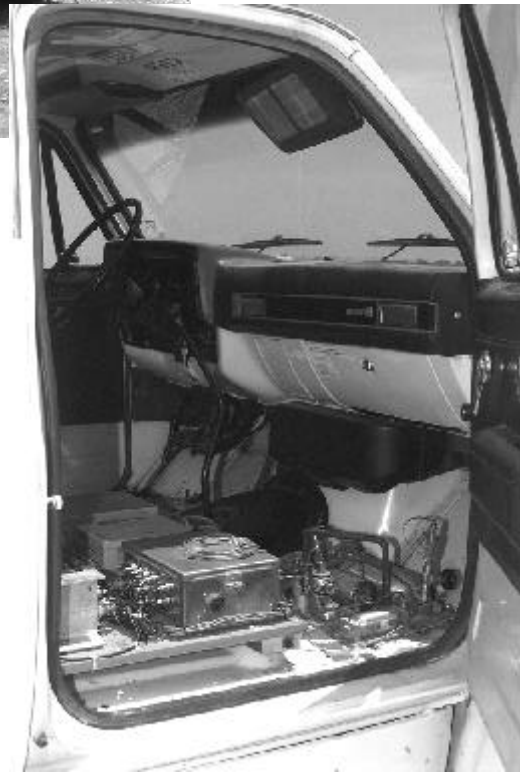
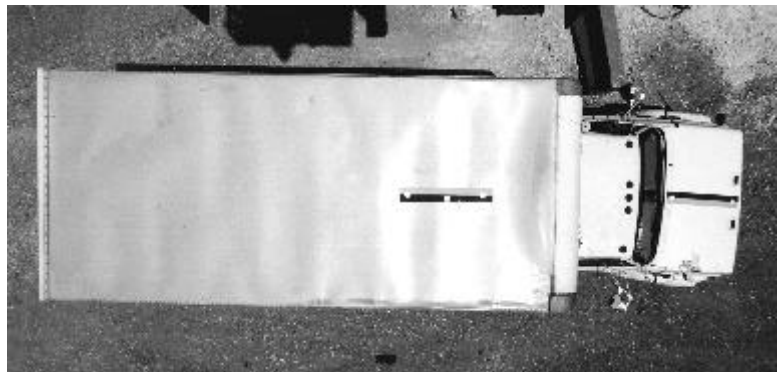
Figure 77. Vehicle after test 404211-5.

Minimal damage was sustained by the vehicle as shown in figure 77. Structural damage was received by the front axle and right front wheel. The lower right front corner of the cargo box received a dent as well as the right side fuel tank. The bumper and supports, hood, right front quarter panel, grill, and right door step were damaged. The right door was jammed and the right outside tire received gouges. Maximum exterior vehicle crush was 140 mm at the right front corner of the bumper.

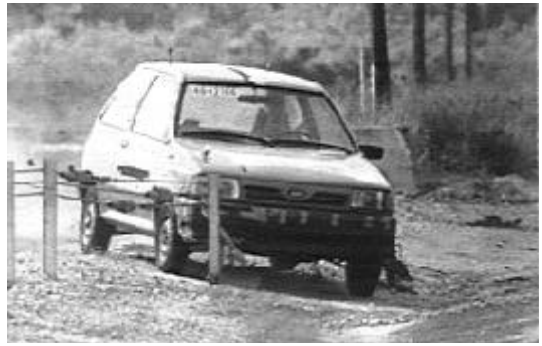
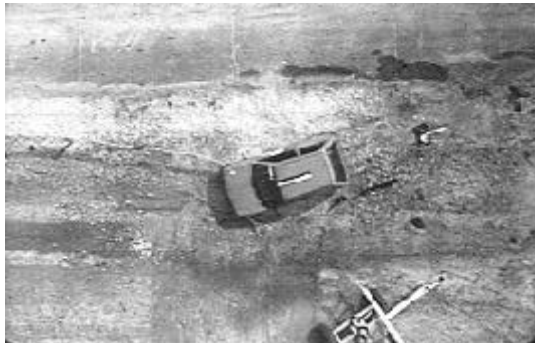
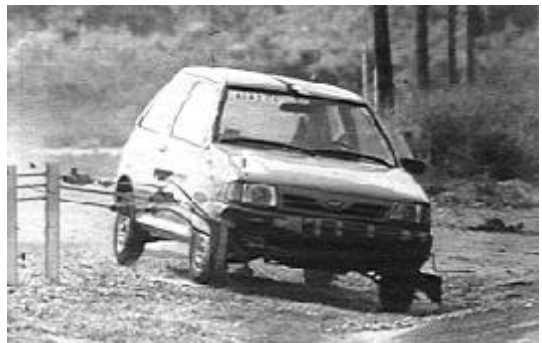
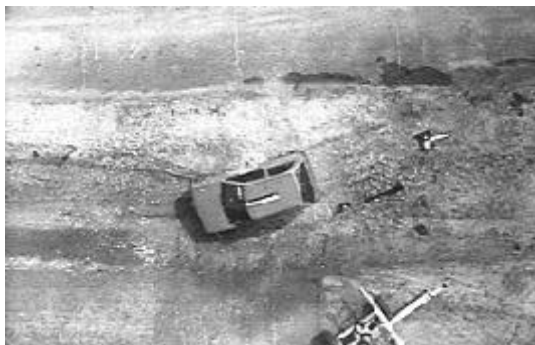
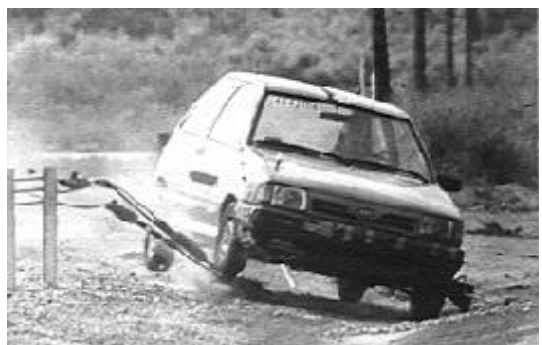
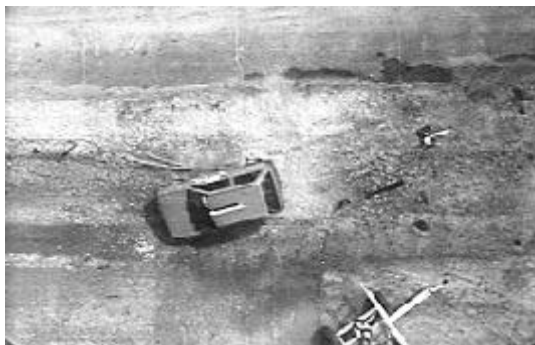
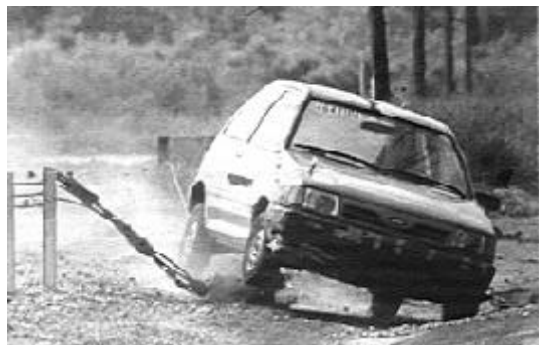
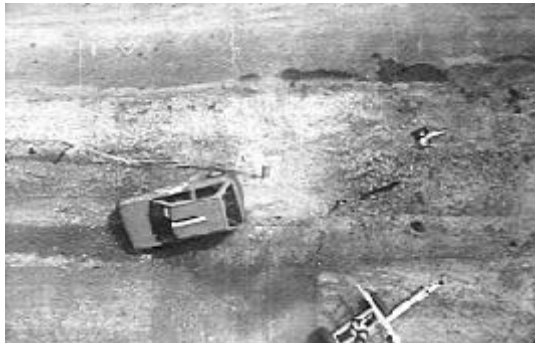
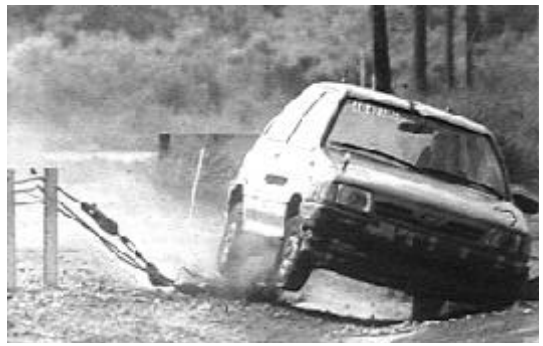
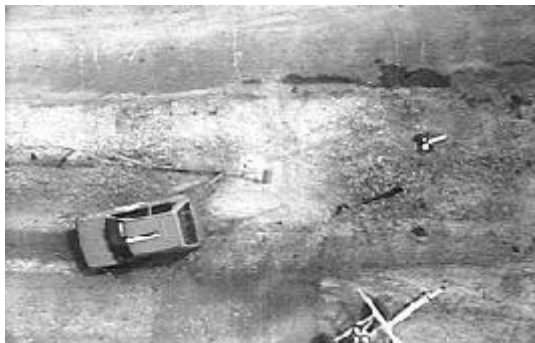
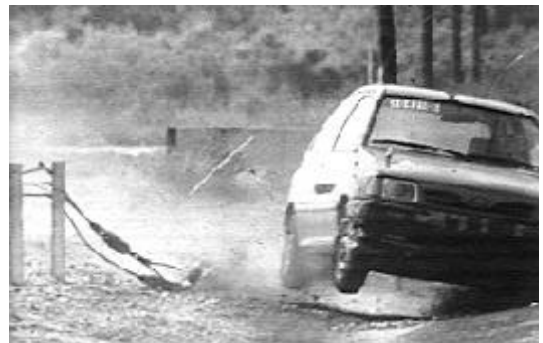
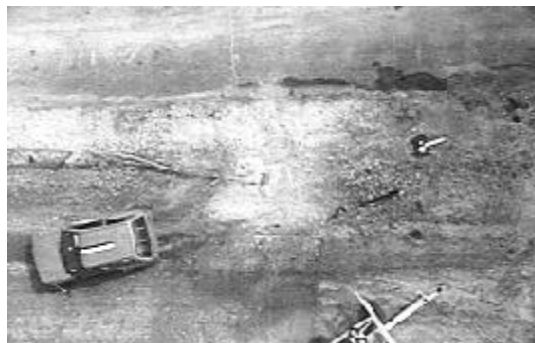
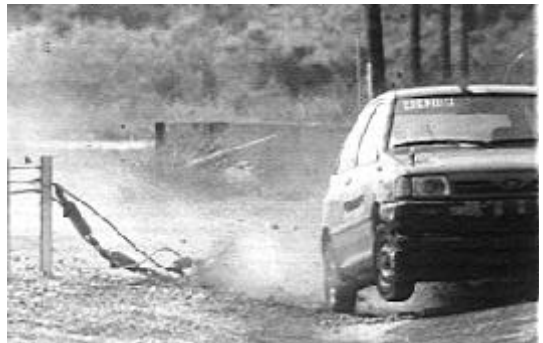
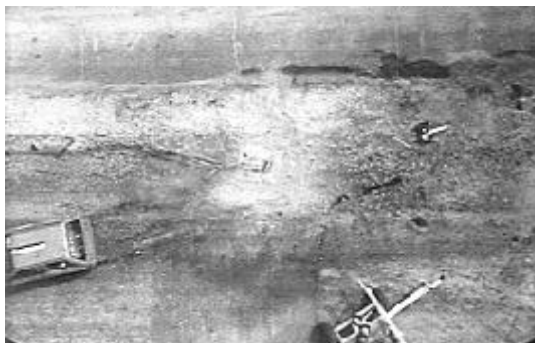
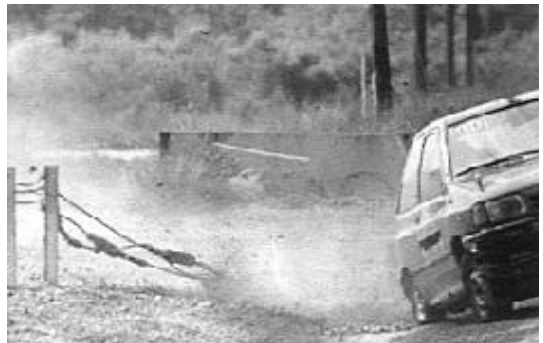
Figure 96. Sequential photographs for test 404211-6 (overhead and frontal views).

The vehicle, traveling at 99.3 km/h, impacted the New York terminal at 14.7 degrees. Initial contact with the terminal was such that the right front corner of the bumper of the vehicle impacted the cables in the downward-sloping portion of the anchor. Approximately 0.013 s after impact, the vehicle bumper contacted the end post (post 1), which activated at the slip base. The front right tire contacted the post at 0.036 s and knocked the post to the ground. The right rear wheel lost contact with the ground at 0.059 s and the right front at 0.085 s. The vehicle lost contact with the terminal at 0.115 s while traveling at a speed of 94.4 km/h and an exit angle behind the terminal of 15.7 degrees. The vehicle continued to travel down the slope of the ditch and the right side wheels touched ground again at 0.236 s and 0.305 s as the vehicle reached the field side of the ditch. The vehicle then traversed up the slope and traveled out of what would be the right of way and into private property. Brakes on the vehicle were not applied. As the vehicle entered the brushy area beyond the right of way, it yawed clockwise and rolled onto its left side for reasons not related to the performance of the guardrail (the vehicle impacted a large bush). The vehicle came to rest 42.5 m down from impact and 25.0 m behind the installation. Sequential photographs of the test period are shown in appendix C, figures 96 and 97.

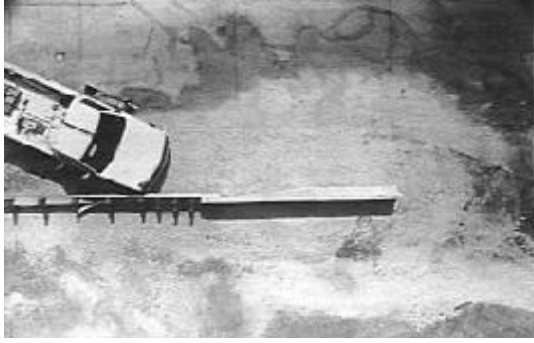
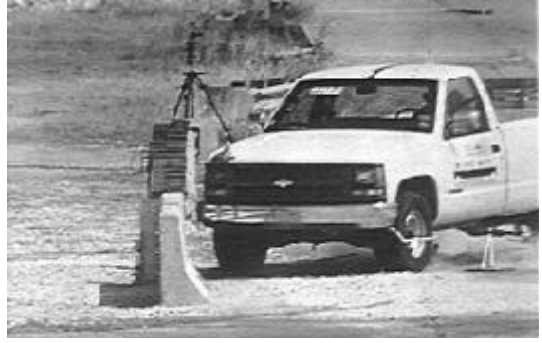
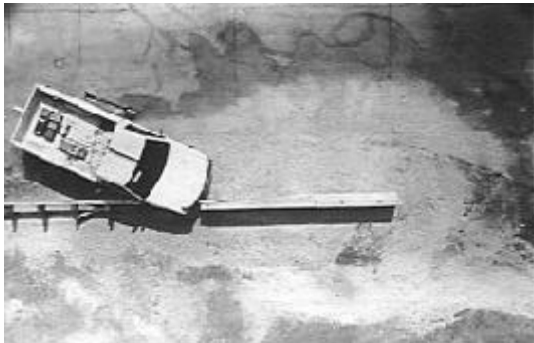
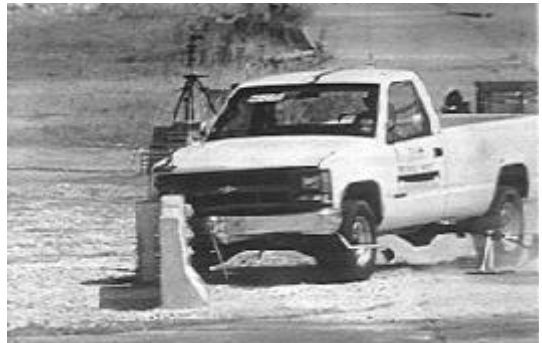
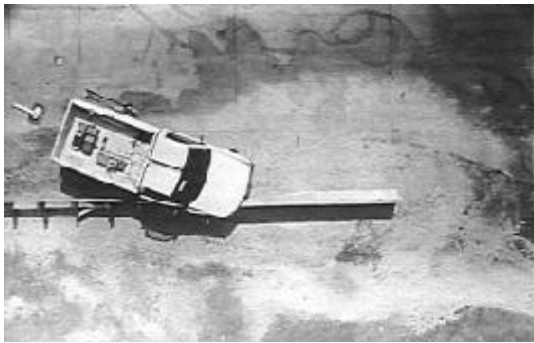
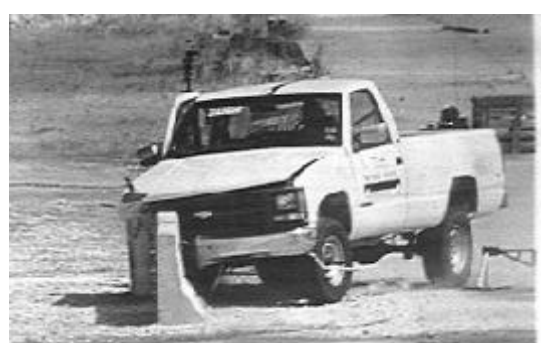
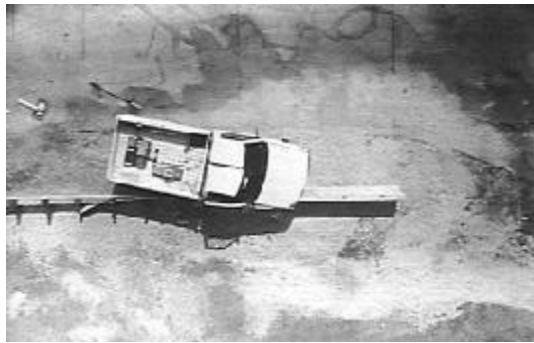
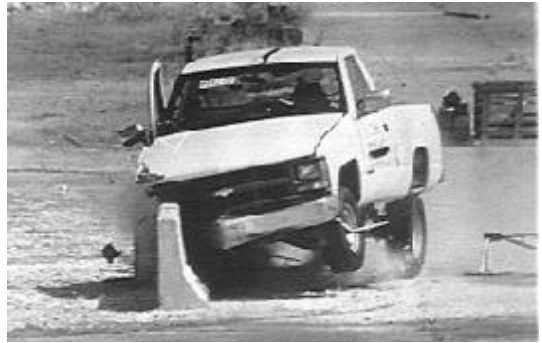
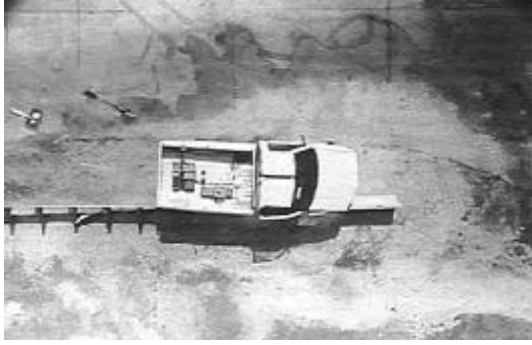
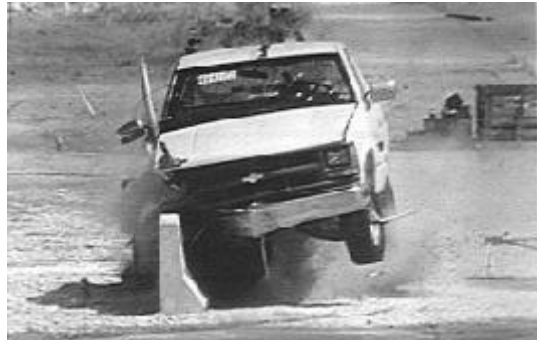
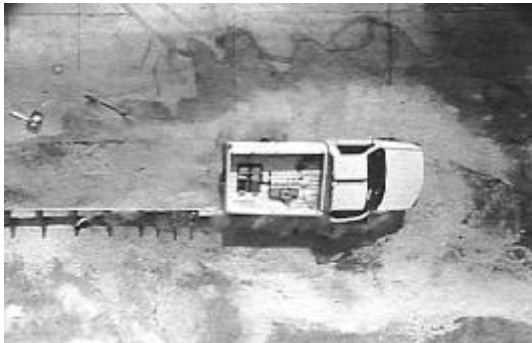
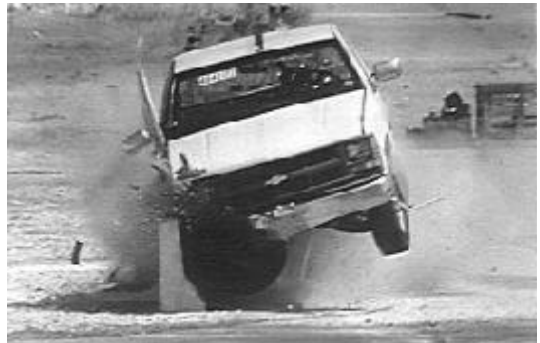
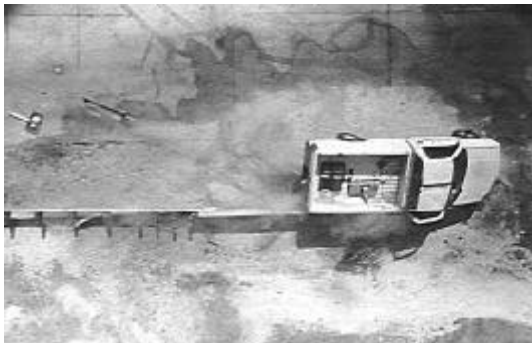
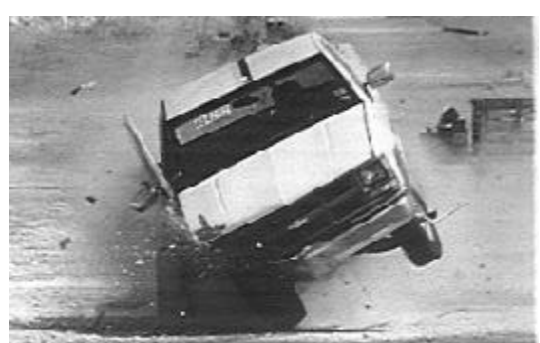
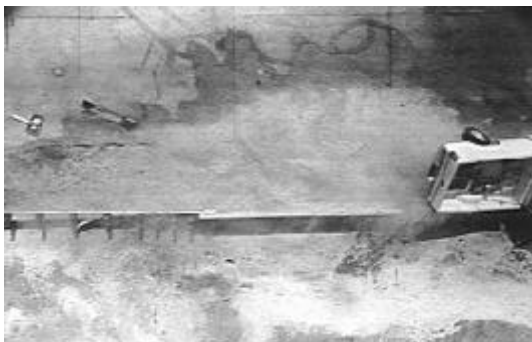
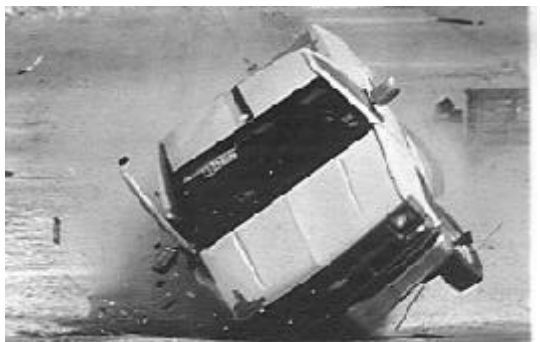
Figure 98. Sequential photographs for test 404211-2 (overhead and frontal views).

The vehicle, traveling at 97.5 km/h, impacted the vertical wall transition 1.5 m from the end of the bridge parapet at a 25.5-degree angle. Shortly after impact, posts 3 and 4 moved followed by movement at post 2 and then 1. At 0.047 s redirection of the vehicle occurred. The concrete wall moved at 0.051 s. The top of the passenger's side door separated from the cab of the vehicle at 0.073 s, and the windshield cracked at 0.076 s. At 0.110 s the left front tire lost contact with the ground. The rear right and left tires lost contact with the ground at 0.163 and 0.187 s, respectively. The right rear tire contacted the rail at 0.207 s, and the right front tire lost contact with the ground. At 0.240 s the right rear tire snagged on the rail and at 0.261 s the tire blew out. At 0.272 s the vehicle began to roll clockwise. The vehicle, traveling at 66.5 km/h, was parallel to the installation at 0.289 s. The right front tire contacted the ground at 0.467 s. The vehicle lost contact with the transition at 0.625 s, and was traveling at 52.5 km/h and an exit angle of 7.3 degrees. As the vehicle exited the transition, the vehicle continued to roll clockwise and touched down on its right front corner. Brakes on the vehicle were not applied. The truck slid to a stop on its right side 44.2 m down from impact point and 3.0 m toward traffic lanes. Sequential photographs of the test period are shown in appendix C, figures 98 and 99.

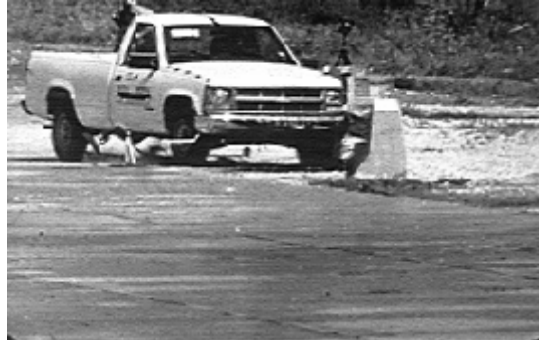
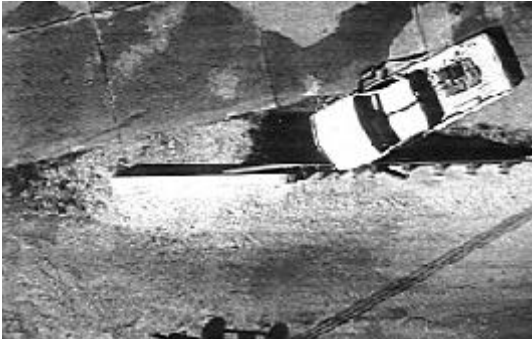
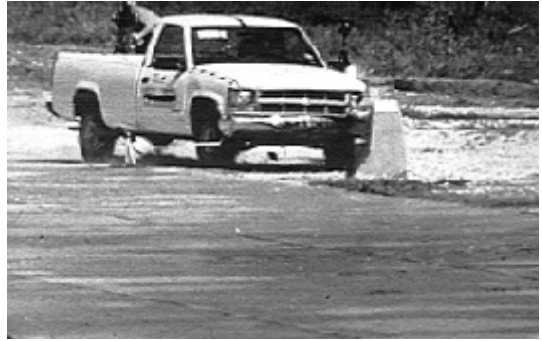
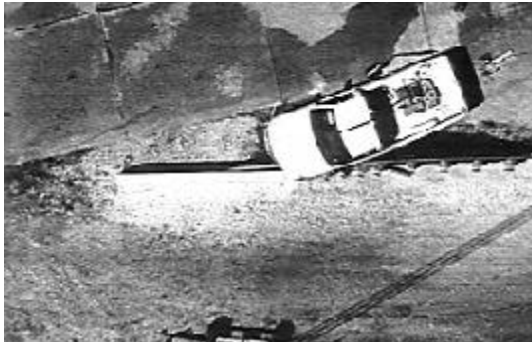
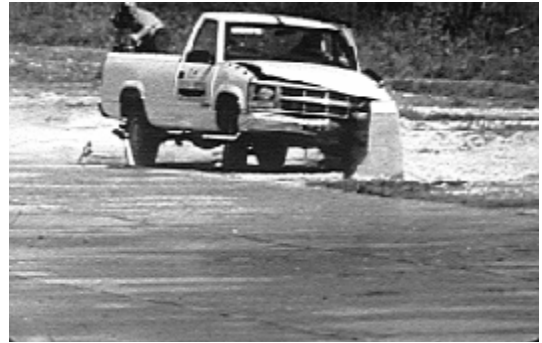
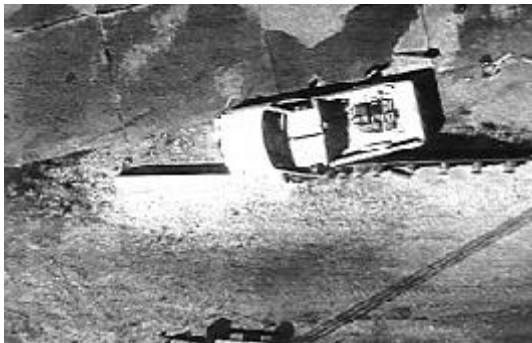
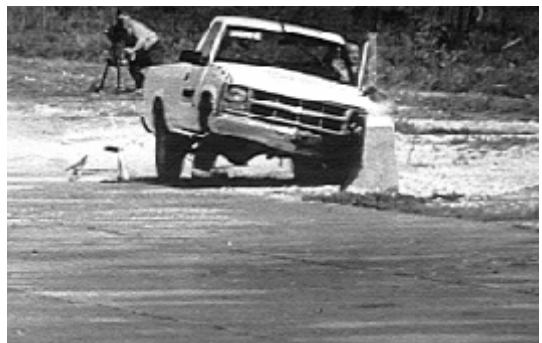
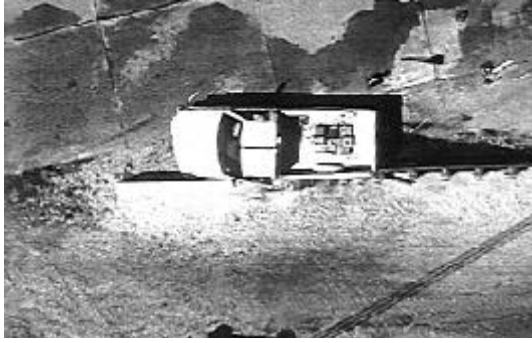
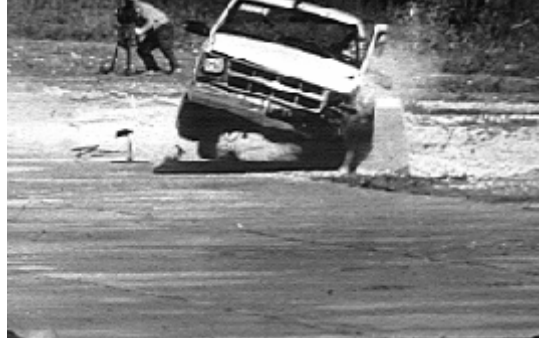
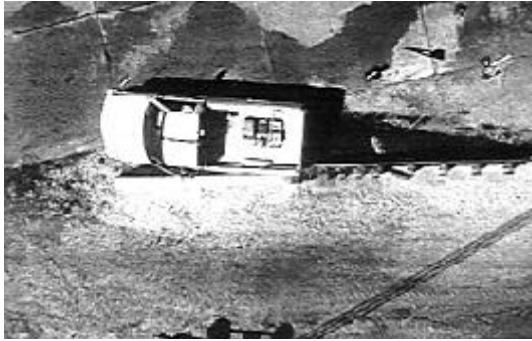
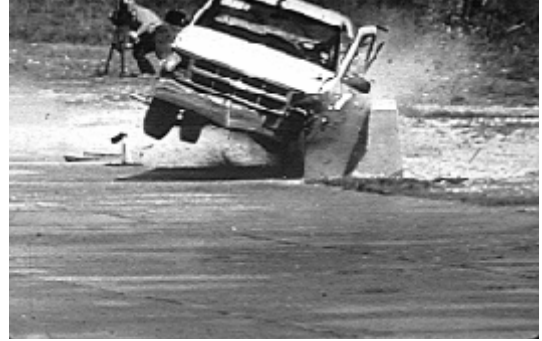
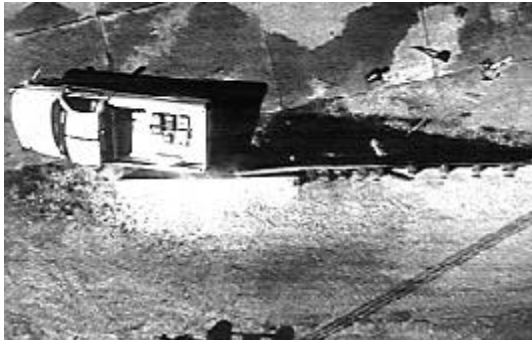
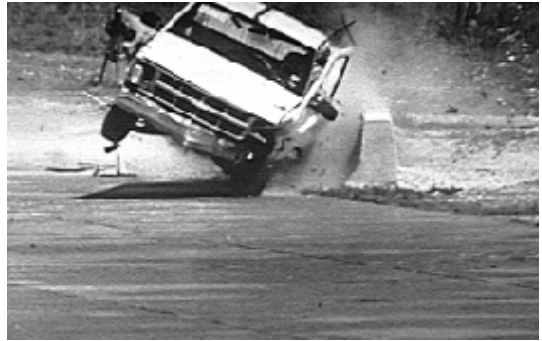
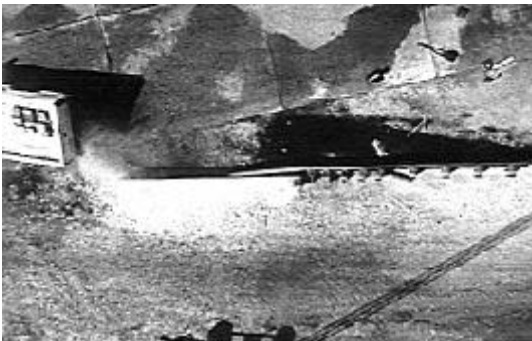
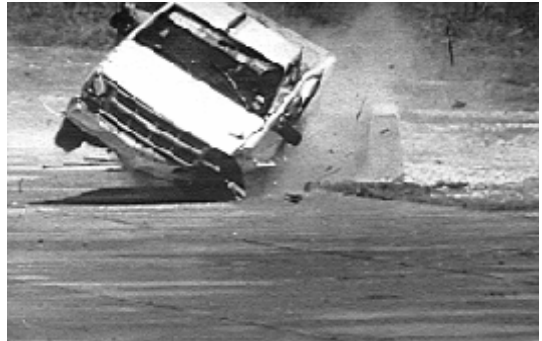
Figure 108. Sequential photographs for test 404211-9 (overhead and frontal views).

The 2000P pickup truck, traveling at 100.8 km/h, impacted the Connecticut transition 1.96 m from the end of the concrete parapet at a 25.6-degree angle. Shortly after impact, the left front tire contacted the rubrail. The left and right front wheels steered away from the rail element at 0.029 s and the vehicle began to redirect at 0.051 s. The dummy contacted the driver's side window, and the window glass shattered at 0.099 s. By 0.106 s, the right front tire lost contact with the ground, and by 0.175 s, the rear left side of the vehicle contacted the rail element. At 0.186 s, the vehicle was traveling parallel with the transition at a speed of 80.3 km/h, and at 0.187 s, the right rear tire lost contact with the ground. The left rear tire lost contact with the ground at 0.285 s. The vehicle lost contact with the transition at 0.299 s, and was traveling at a speed of 77.0 km/h and an exit angle of 3.7 degrees. The left rear, right front, and right rear tires returned to the ground surface at 0.858 s, 0.920 s, and 0.933 s, respectively. Brakes on the vehicle were applied at 1.55 s, the vehicle yawed clockwise and subsequently came to rest 61.7 m down from impact and 27.4 m laterally from the traffic face of the rail. Sequential photographs of the test period are shown in appendix C, figures 108 and 109.
