Solutions to Mitigate Dowel/ Tie-Bar Propagated Cracking - Phase 1

Shreenath Rao, Principal Investigator
Applied Research Associates, Inc.

April 2024

Final Report NRRRA202402

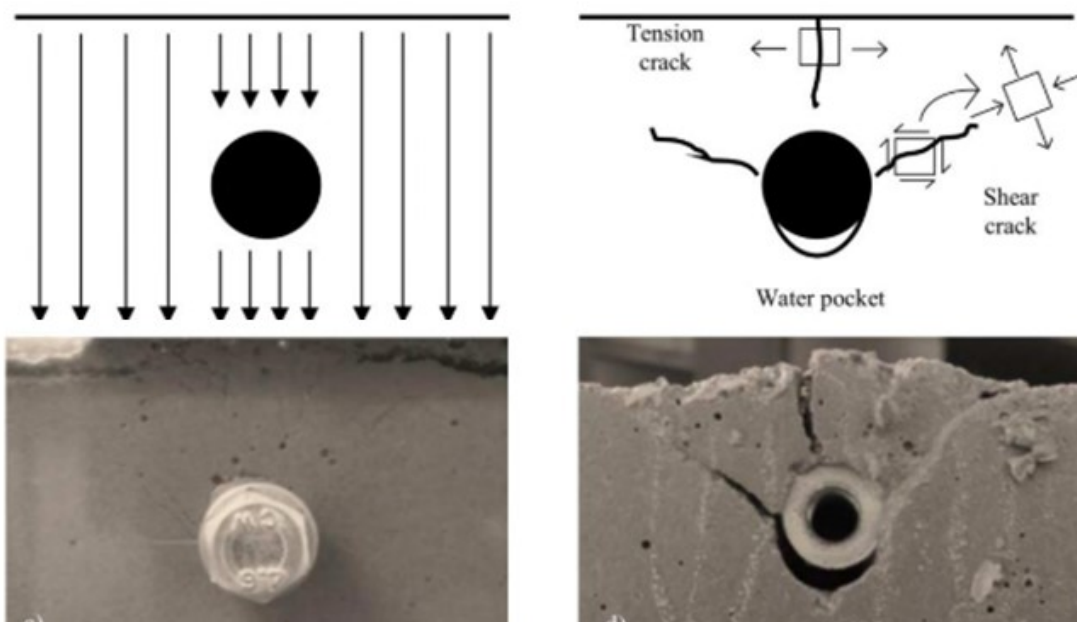
Combrink and Boshoff (2014) conducted laboratory tests to investigate the formation of plastic settlement cracks, the influence of cover depth, and the spacing of the reinforcement bars on the cracks' behavior. They found that vertical cracks started from the surface of the concrete and then propagate downward above the bar, as shown in Figure 3.6. Shear stress caused the crack to initiate at an angle of about 42 degrees on both edges of the rebar. These shear cracks formed from the bottom upward and were not visible from the surface. They concluded that vertical and angle cracks resulted because of the difference in settlement between the solid particles and reinforcement bar and that the vertical cracks appeared before angled cracks. Settlement cracks increased as the cover depth and bar spacing decreased.

Figure 3.6 Illustrations and Photos. Settlement cracks caused by a reinforcement steel bar (Combrink and Boshoff 2014).

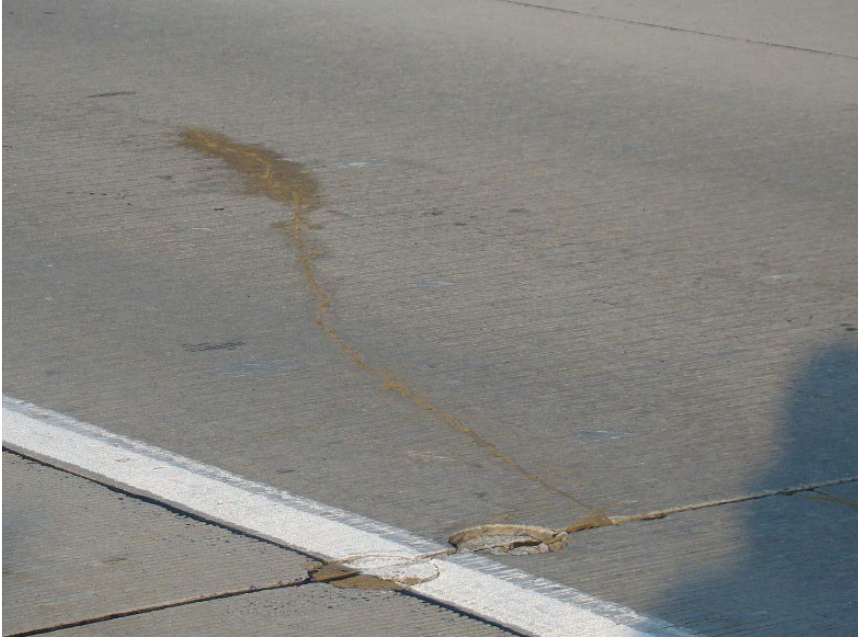
If the newer concrete (lane or shoulder) is of similar strength to that of the older concrete lane, a shear fracture initiates at the transverse joint of the older concrete, often directly over the dowel bar. Dowel bars reduce the effective thickness at that location, creating a plane of weakness as seen in Figure 3.12. This type of cracking may be mitigated by (Harrington et al. 2018):

Figure 3.12 Photo. Longitudinal shear restraint crack of dowel initiating over dowels at two locations on opposite sides of the joint (Harrington et al. 2018).

- Paving adjacent lanes when all existing lane joints are uniformly activated and of similar narrow width (e.g., paving in warmer weather).
- Plunge-cutting new pavement transverse joints to provide a width that is similar to that of the existing pavement joints (to eliminate restraint of existing pavement joint closure in warmer weather).
- Using no more tie bars than necessary and providing as much distance between the joint and the first tie bar on either side as possible. The use of isolation or bond-breaking material along the joint between the tie bars may also be effective in reducing stress concentrations along the joint.

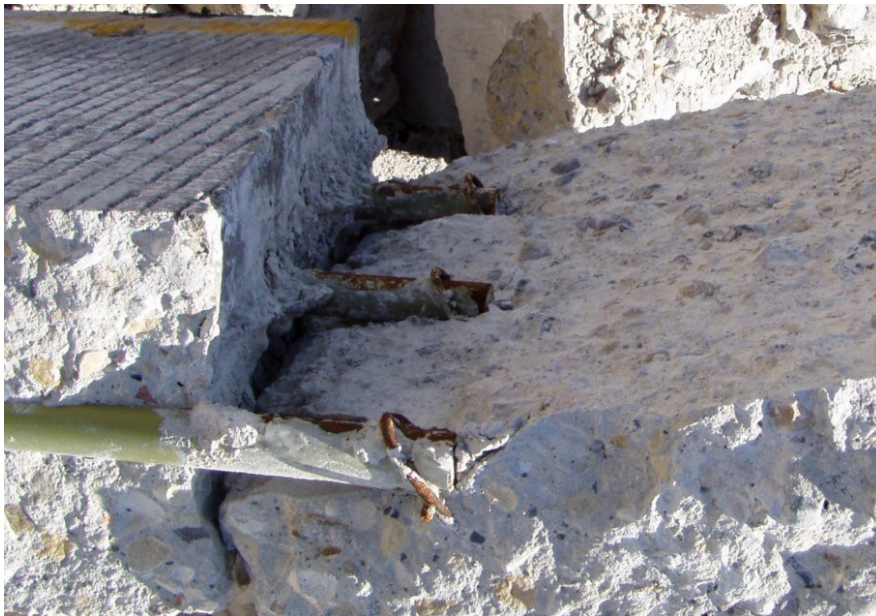
The effect of curling and warping restrained due to dowel bars were also assessed since they have a significant impact on the occurrence of delamination, corner cracks, and mid-panel cracks. Stresses caused by environmental loads due to temperature and/or moisture changes can detrimentally impact the occurrence of delamination cracks from the restrained movement of slab edges and corners as shown in Figure 4.3. The upward curling or warping and the weight of the slab along with various restraint factors such as dowel bars result in high concentration stresses around dowel bars and high tensile stresses at the top of the slabs. The higher the upward curling, the higher the stresses around the dowel bars and at the top of the slab. The combination of heavy traffic along with curling/warping effects can accelerate the propagation of horizontal crack that initiated at the weakened plane in the slab (Rasmussen et al. 2007).

Figure 4.1 Photo. Corner crack showing delamination at dowel depth level and the difference conditions of dowel bars (Rasmussen et al. 2007).

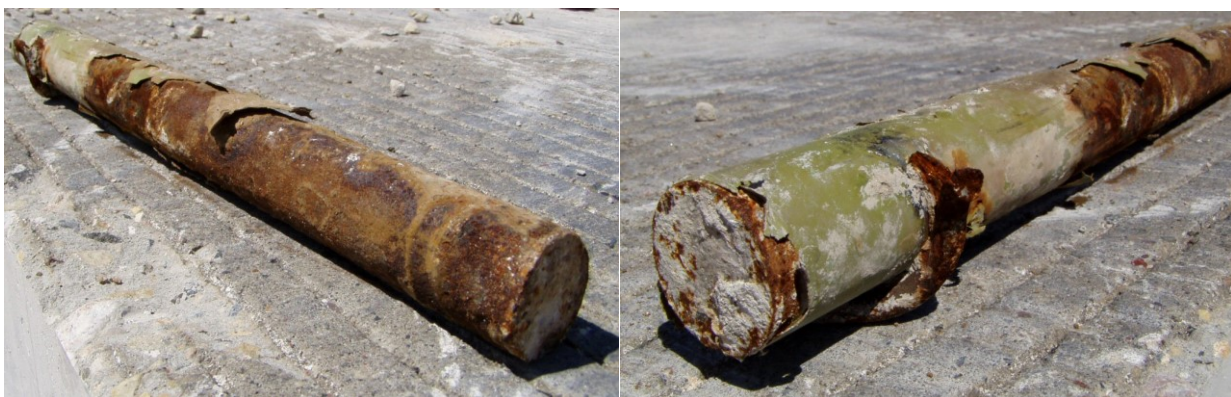
Figure 4.2 Photo. Dowel bar conditions showing ineffectiveness of epoxy coating and abrasion (Rasmussen et al. 2007).

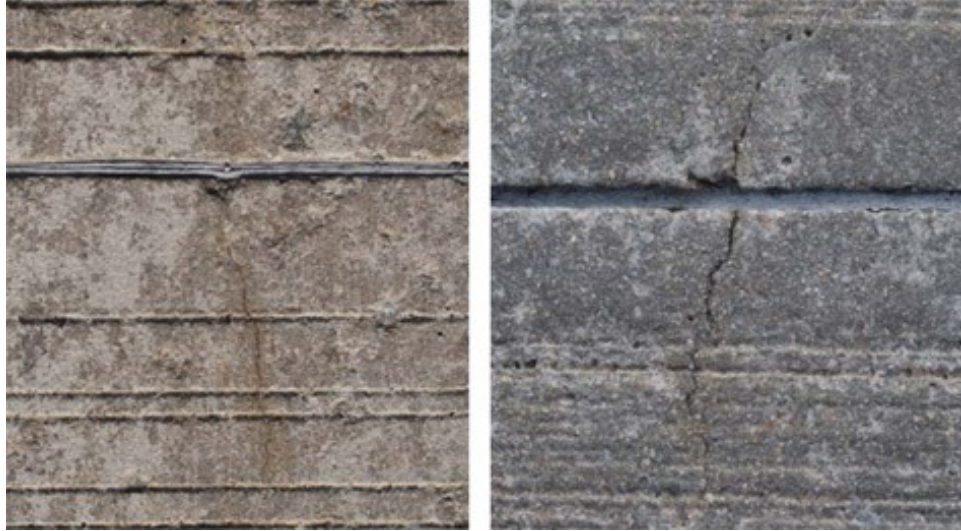
Longitudinal cracking at transverse joints caused by dowel bars in jointed concrete pavements in Korea was investigated by Seo and Kim (2012). Field observation and numerical analyses were conducted to ascertain the causes of the longitudinal crack. They observed that longitudinal cracks developed before the pavement was open to traffic. Longitudinal cracks occurred at transverse joints at one side or both sides of the slab as shown in Figure 4.4. Several longitudinal cracks were observed at the joint and the distances between adjacent cracks were consistent. Some longitudinal cracks at the joint were combined with severe spalling. In general, longitudinal cracks were observed near the central area of the slab at the transverse joint.

Figure 4.4 Photo. Longitudinal cracks at joint (Seo and Kim 2012).

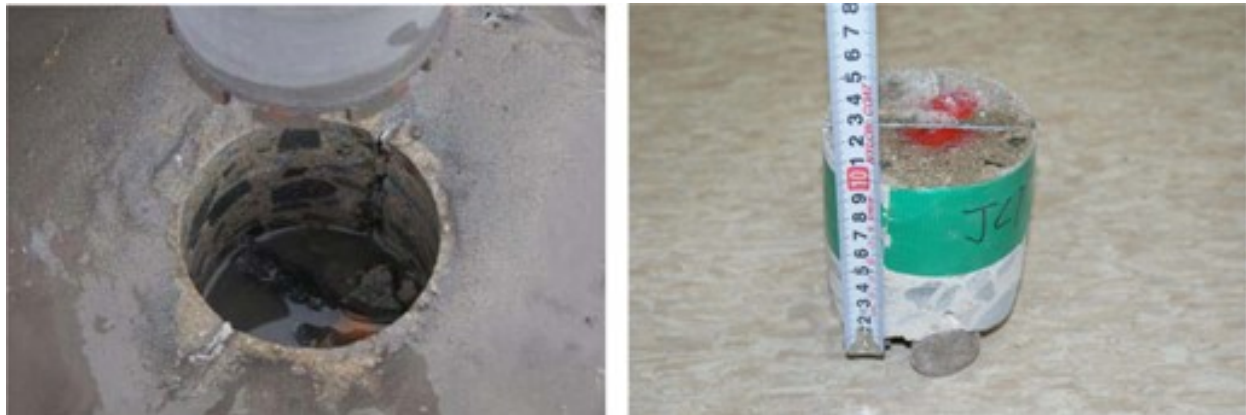
Concrete cores were taken at the longitudinal crack and MIT scanning was performed to better understand the development of such cracking. A longitudinal crack was exhibited over the dowel bar and the dowel bar was observed to be above the mid-depth as shown in Figure 4.5. A few cores showed horizontal delamination at the dowel bar depth. Concrete cores indicated that the longitudinal cracks did not propagate through aggregates particles, which implied that the cracks occurred during the early age of concrete. The primary factor that caused the occurrence of the longitudinal cracks was attributed to environmental load resulting from temperature and moisture variations across the pavement depth.

Figure 4.5 Photo. Core taken from longitudinal crack location (Seo and Kim 2012).

- To mitigate longitudinal cracking at the joint, dowel bars should be installed at the mid-depth of the slab and care must be taken when installing dowel bars to prevent vertical translation and provide adequate cover.

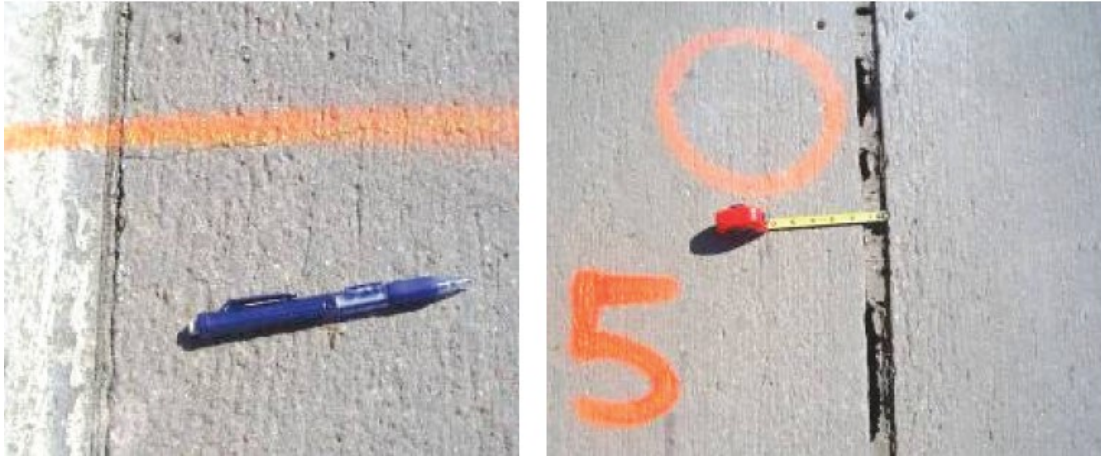
The field investigations were not conclusive regarding the role of tying too many lanes together on pavement distress. Longitudinal cracking was observed on pavements with varying tied widths starting from as low as 24 feet, establishing it as a form of distress that needs to be addressed in design. Figure 4.7 shows an example of a low severity crack above a tie bar, typical of a majority of joints at a Colorado site. Also shown is Test Joint B with a 1.25-inch joint opening and detached sealant. The cause of the crack above a tie bar was not investigated. The pavement section consisted of a 9.5-inch JPCP, a 7- to 10-inch asphalt treated base, and a 10-inch silty sand subbase. The pavement lane width was 12 feet, and the slab length was 15 feet. MIT scanning was performed to determine the tie bar alignment. Tests showed that the mean depth to the tie bars was 3.1 inches in the control joints, shallower than the mid-thickness depth of 4.75 inches. The load transfer efficiency and joint movement data as a function of temperature from this site were evaluated.

Figure 4.7 Photo. Control Joint A (left) with low-severity crack above a tie bar and Test Joint B (right) open 1.25 in, showing the detached sealant at the Colorado testing site.

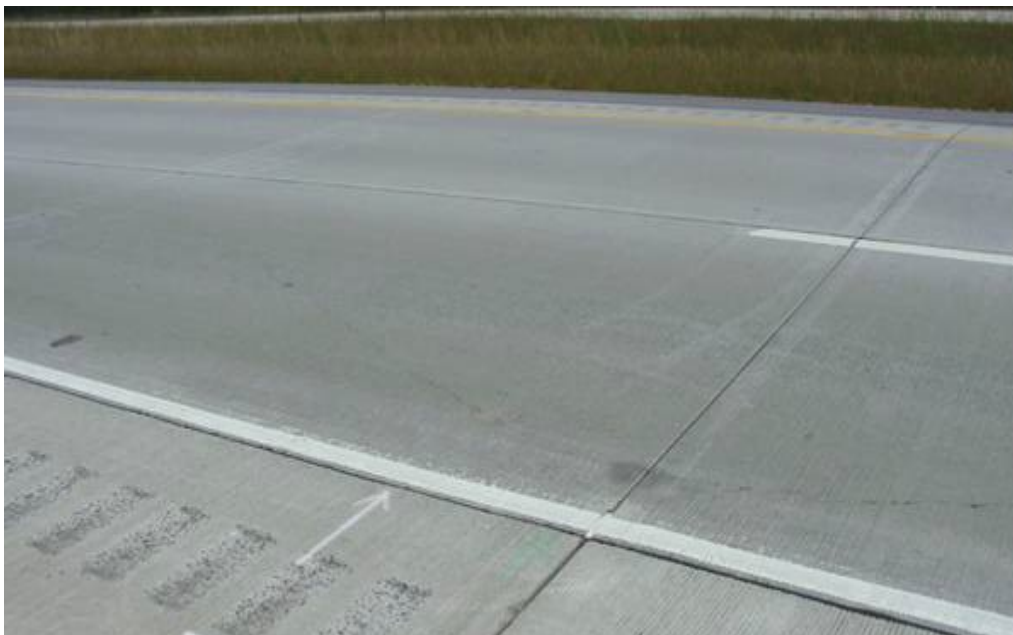
Figure 4.11 Photo. Characteristic pattern of edge-restraint cracking.

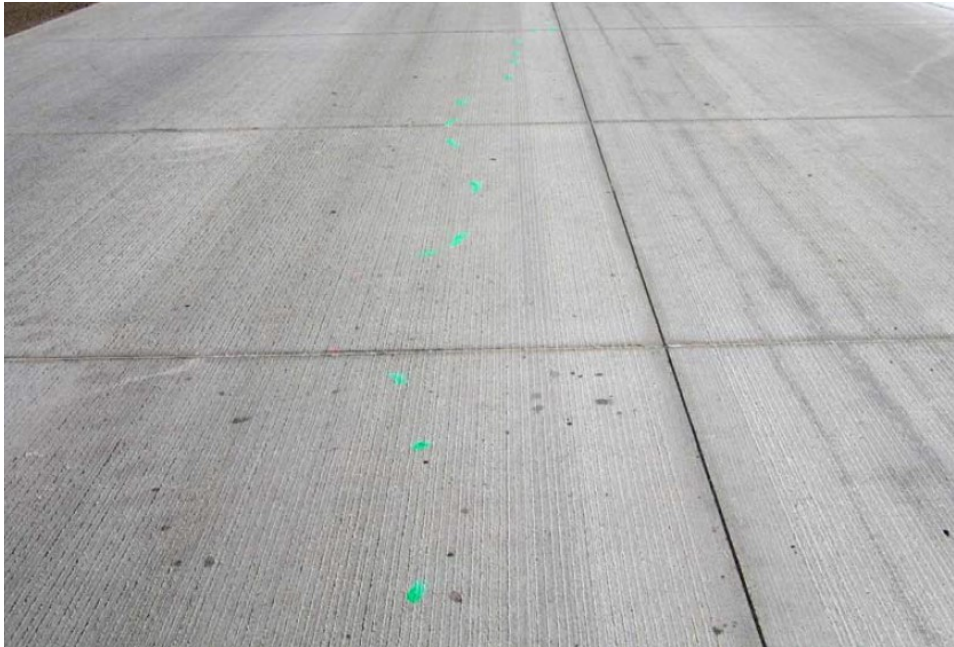
The North Dakota project demonstrated the potential risk of base-restraint cracking due to the use of a highly permeable stabilized base. The penetration of fresh concrete into the base not only has the effect of bonding the PCC surface to the base to restrain the movement of the PCC surface, the incidence also effectively increases the slab thickness, leaving the possibility of the saw-cut depth being inadequate.

Figure 4.12 Photo. Early age longitudinal cracking on I-94 in North Dakota.

Tyson et al. recommended using either an asphalt layer or geotextile as a separator layer to prevent bonding between concrete slab and cement treated permeable base.

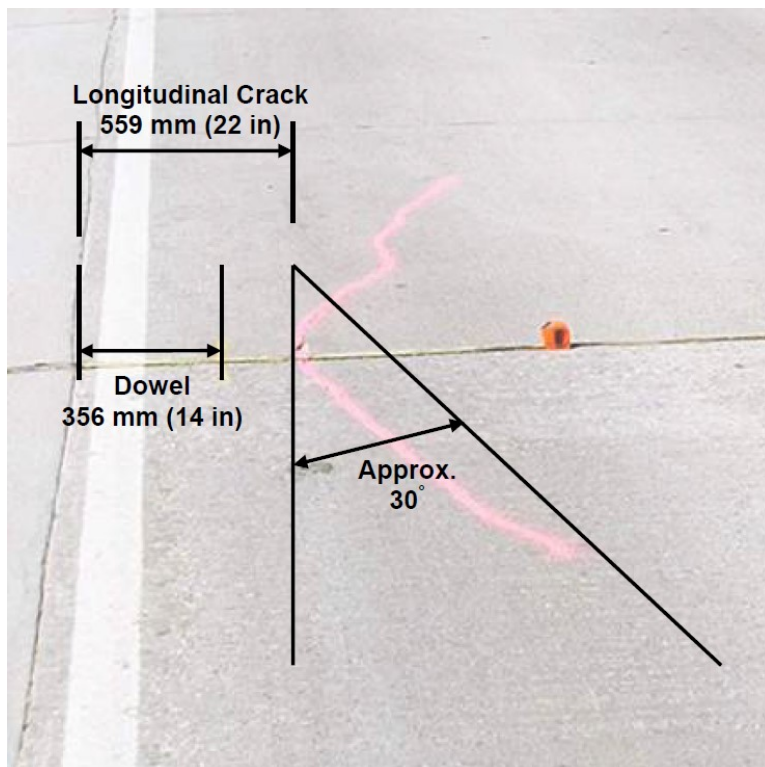
The cracking that occurred on I-35 in Oklahoma in 2005 is an example of edge-restraint cracking. The pavement was constructed as an overlay over the existing asphalt concrete pavement. The overlay is 10.5-inch thick, and the transverse joints were sawed at 15-foot spacing. The mainline pavement consisting of two 12-foot lanes tied at the center was placed first. Later, 10-foot outside and 4-foot inside tied concrete shoulders were added. The cracking initiated at the transverse joints and propagated diagonally inward at approximately 30-degree angle, as shown in Figure 4.13.

The Oklahoma DOT investigations into the cause of cracking identified the edge-restraint as the most probable cause of the cracking. The analysis results showed that a temperature difference of 20 to 30 °F between the temperatures at the time of paving of the mainline and tied concrete shoulders would have been sufficient to initiate cracking in the mainline, if the shoulders were placed at the lower temperature. As a result, Oklahoma DOT placed the following restrictions on the paving temperatures:

Figure 4.13 Photo. Longitudinal cracking on I-35 in Oklahoma.

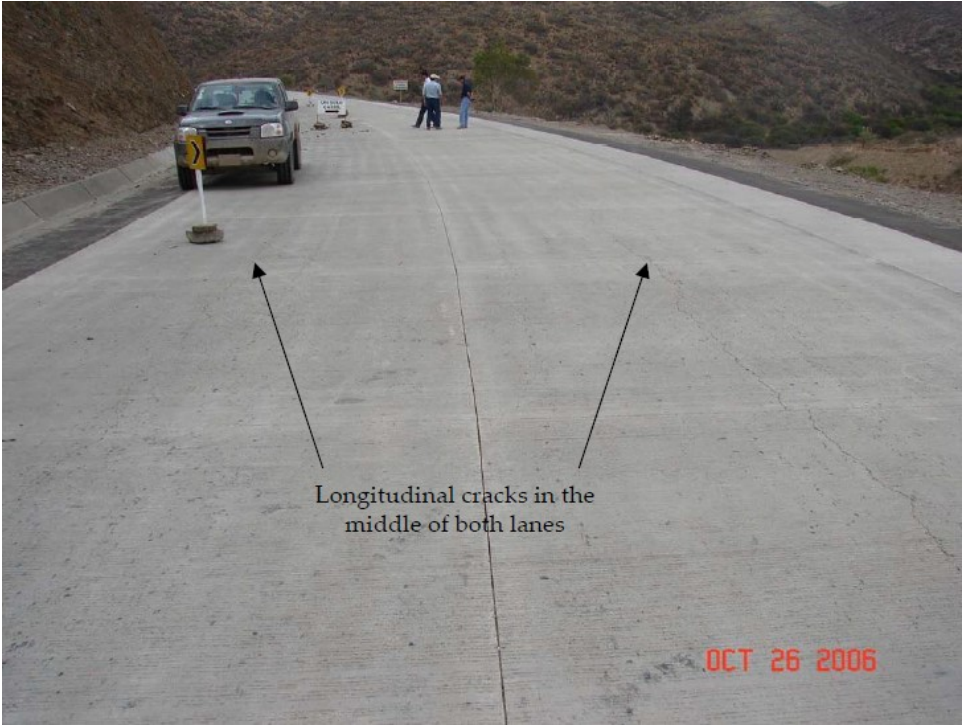
approximately in the middle of each lane in each direction as shown in Figure 4.14. Premature longitudinal cracks were mostly top-down as shown in Figure 4.15 and do not cross the longitudinal joint. It was noted that the longitudinal cracks occurred above the dowel bars. The longitudinal joints were observed to have formed properly.

Figure 4.14 Photo. Cracking pattern when both lanes were placed together.

- Cracking was observed in the center of the traffic lanes regardless of whether they were placed together or separately. When two lanes were placed together the longitudinal joint was sawed at least 1/3 of the thickness as soon as possible to avoid spalling of the joint. The depth was verified by coring.

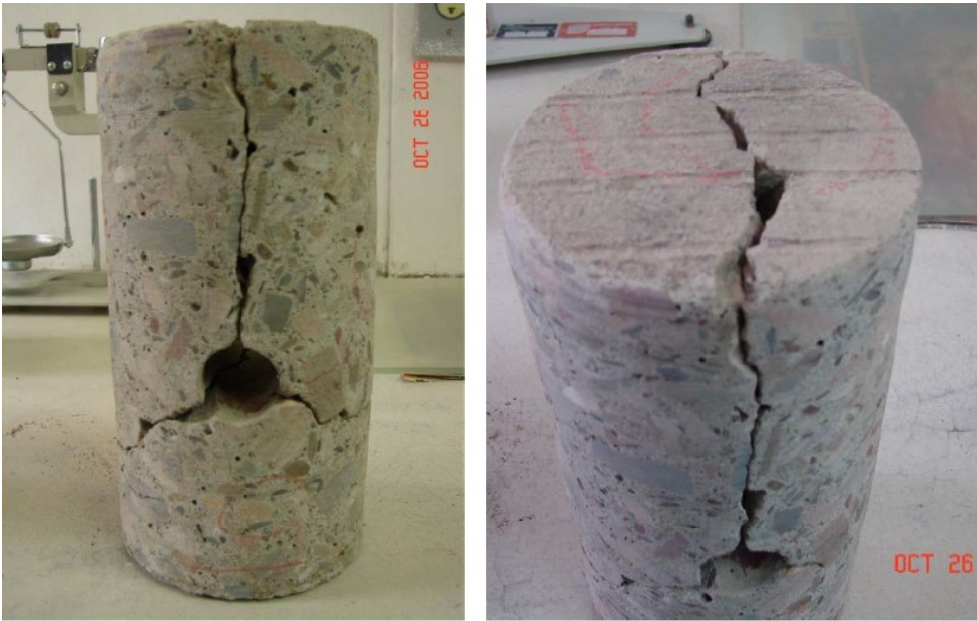
Figure 4.15 Photo. Typical cracking mode: top down.

- Coring showed that these longitudinal cracks initiated at the top of the slab and propagated downward through the slab.
- Measurement of upward curling of the slabs throughout the project indicated a very large curling (e.g., 0.2 to 0.6 inches).

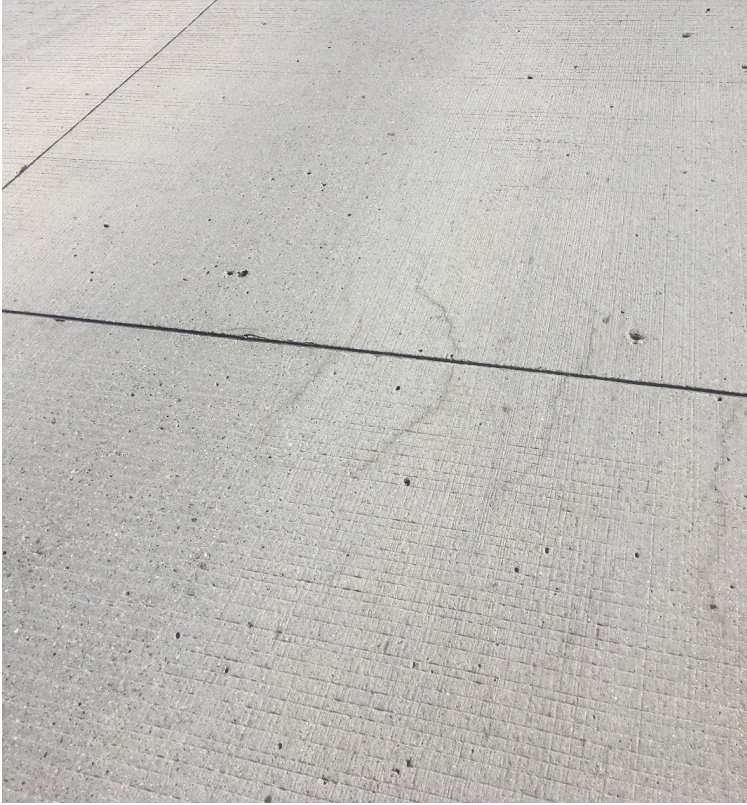
Senn K. (2018) conducted a field survey to evaluate the performance of the SPS-2 of the LTPP test sections in Arizona, Colorado, Washington, Iowa, Kansas, and North Dakota. During the site visit, recommendations of pavement preservation treatments were provided for some sections. Cracks over dowel bars were observed in Kansas and North Dakota. It was noted that several sections in Kansas exhibited small longitudinal cracks along transverse joints. These cracks were mostly observed on the 8-inch-thick 900-psi flexural strength sections and aligned over the dowel bars. Also, longitudinal cracks over dowel bars were observed on many test sections in North Dakota that occurred shortly after construction as shown in Figure 4.16. Senn states that “map cracking was commonly present on the 900 psi test sections...” suggesting that the higher flexural strength of the concrete may have had a role in the observed cracking. However, Senn also states that detailed investigations into the reasons for the noted observations have not yet been completed.

Figure 4.16 Photo. Crack over dowel bars in SPS-2 in North Dakota.

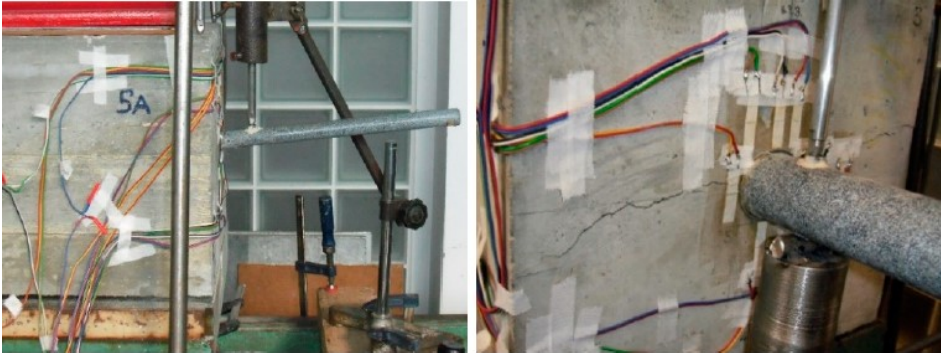
force of 2.3 kips while the beam with a dowel bar diameter of 1.5 inches was damaged (horizontal crack as shown in Figure 38) when the applied force reached 11.25 kips. As the dowel bar diameter increased, tensile stresses in the vicinity of the dowel bar decreased.

Figure 5.5 Photo. Normal stresses obtained from strain gauges; (left) beam under loading, (right) horizontal crack through the concrete beam around dowel (Zuzulova et al. 2020).

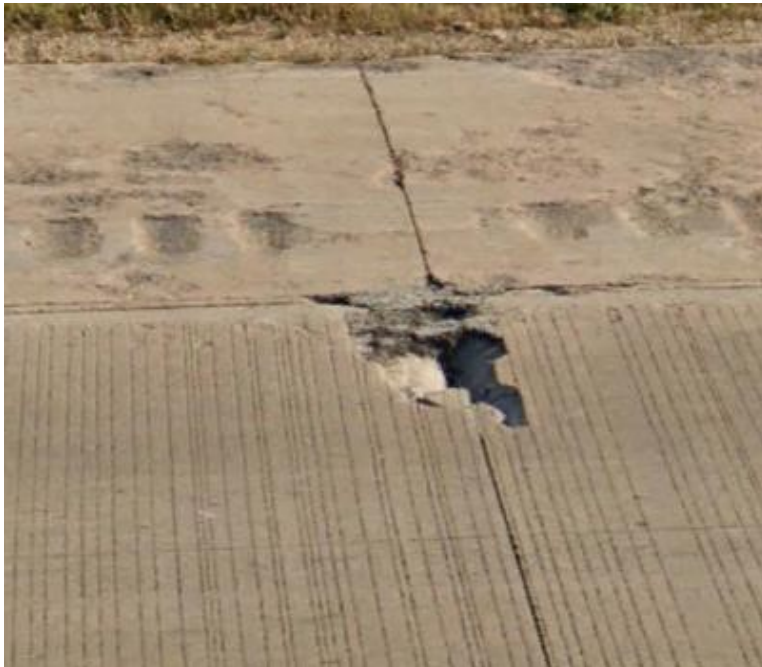
I-39 NB in Dane County, Wisconsin was constructed about 14 years ago at the time of the field survey. For a relatively new concrete pavement, this roadway exhibits significant number of large spalls. Examples of these large spalls, some that have been partially or fully repaired with hot mix asphalt (HMA) patches are shown in Figure 7.1 through Figure 7.3. The pavement also exhibited transverse cracking roughly two to three feet from the transverse joint as shown in Figure 7.4.

Figure 7.1 Photo. Corner break observed on I-39 NB in Dane County, Wisconsin.

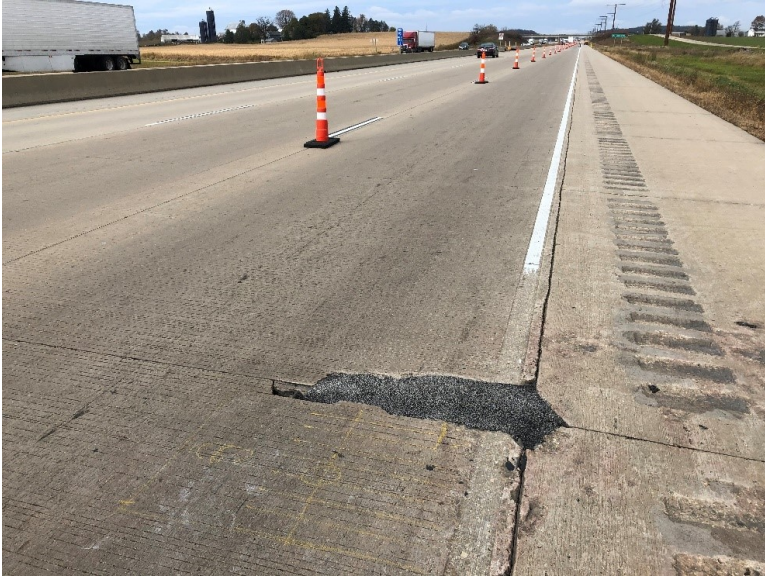
Figure 7.2 Photo. Small corner break fully patched with asphalt observed on I-39 NB in Dane County, Wisconsin.

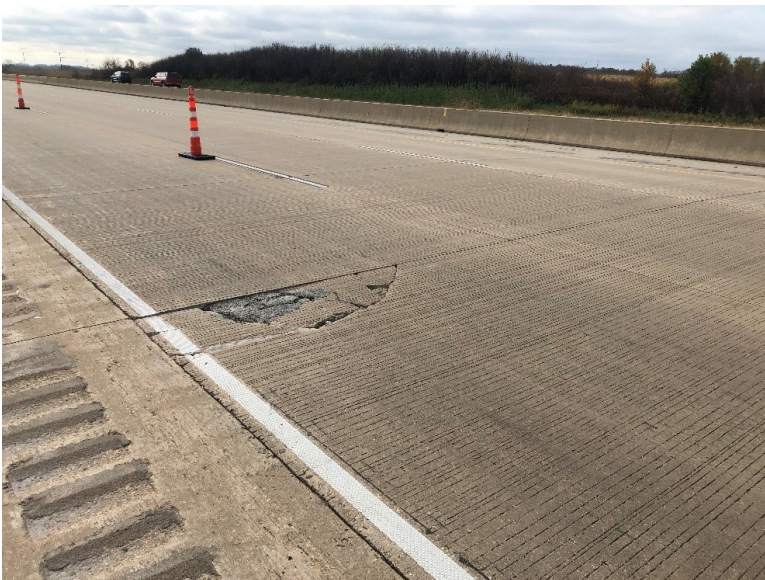
Figure 7.3 Photo. Large corner break partially patched with asphalt observed on I-39 NB in Dane County, Wisconsin.

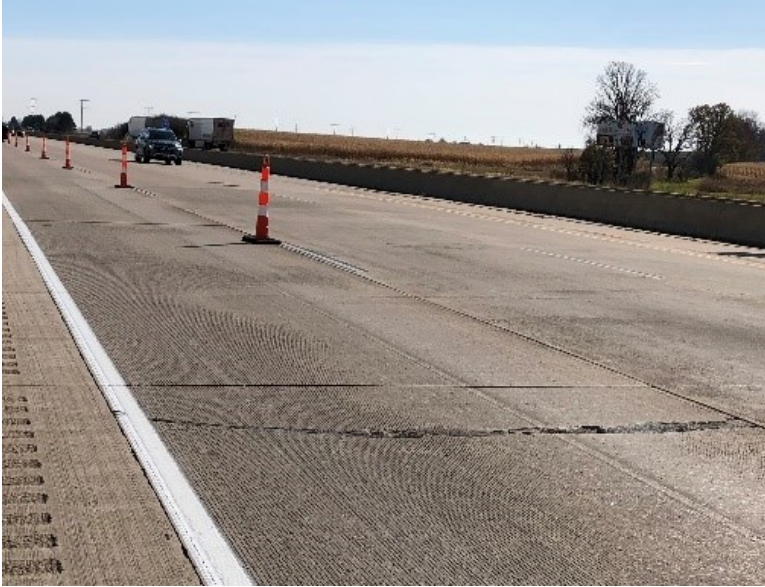
Figure 7.4 Photo. Full length transverse crack about two to three feet from transverse joint observed on I-39 NB in Dane County, Wisconsin.

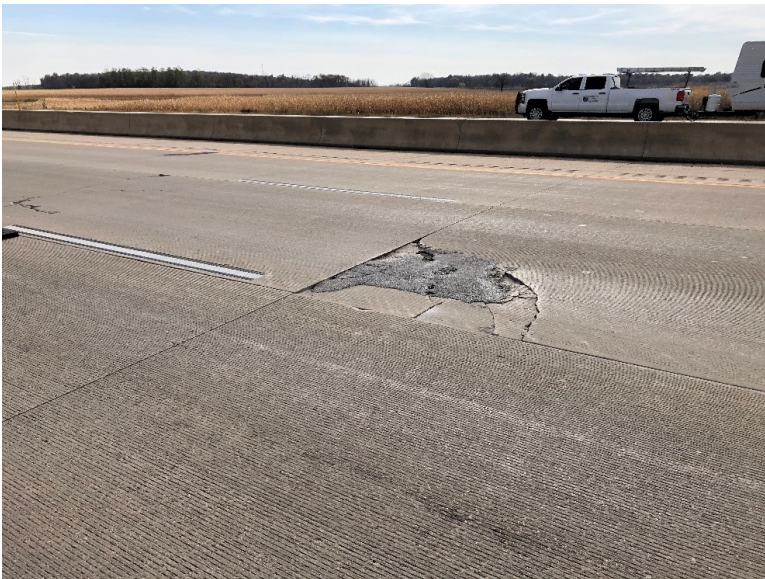
I-39 NB in Columbia County, WI, is a relatively new pavement constructed in 2009 (11 years in service at the time of field data collection). Despite this short service life, this roadway exhibits high levels of pavement distress similar to that observed in Dane County (Figure 7.5 through Figure 7.9).

Figure 7.5 Photo. A large spall partially filled with asphalt observed on I-39 NB in Columbia County, Wisconsin.

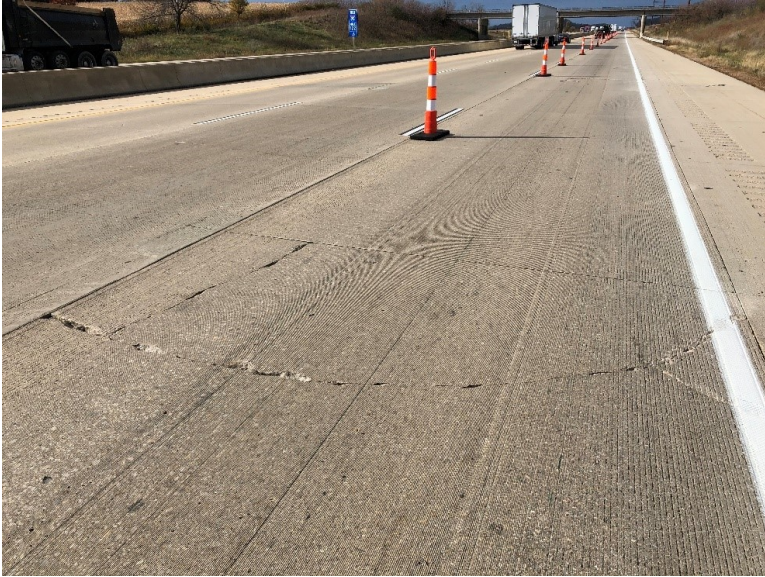
Figure 7.6 Photo. A meandering transverse crack with a partial length longitudinal crack observed on I-39 NB in Columbia County, Wisconsin.

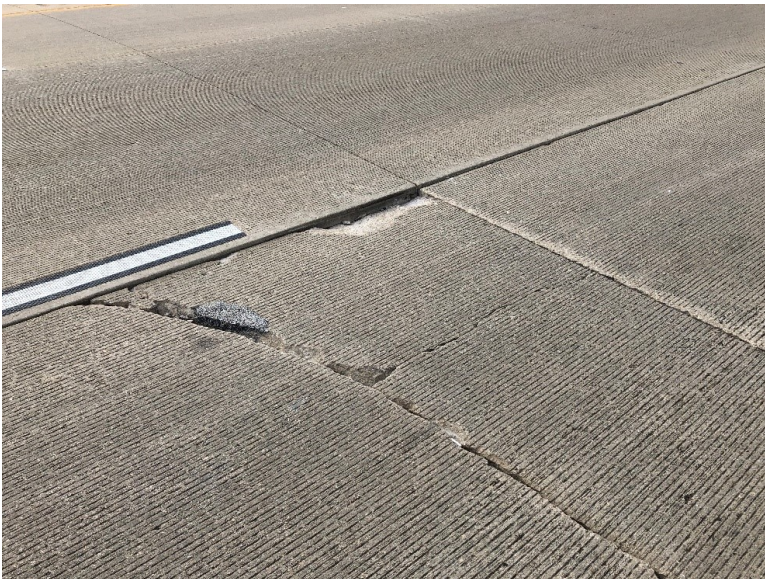
Figure 7.7 Photo. Full length transverse crack with a partial length longitudinal crack observed on I-39 NB in Columbia County, Wisconsin.

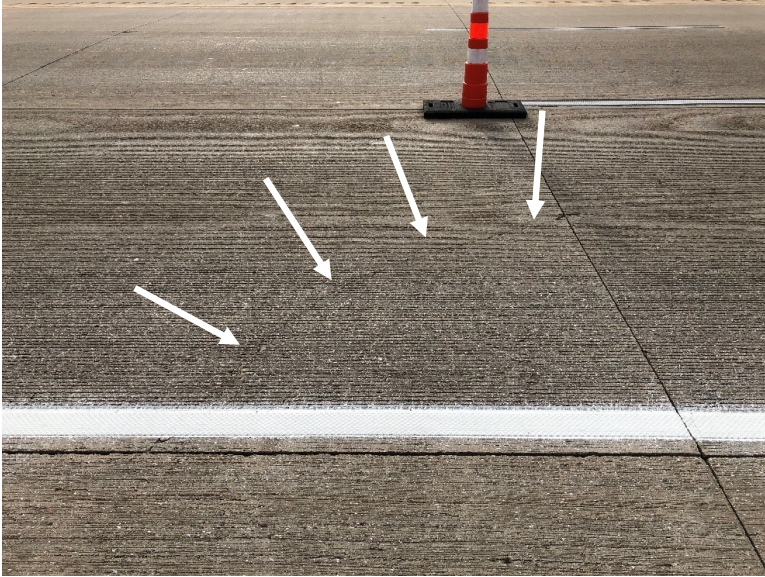
Figure 7.8 Photo. Corner break observed on I-39 NB in Columbia County, Wisconsin.

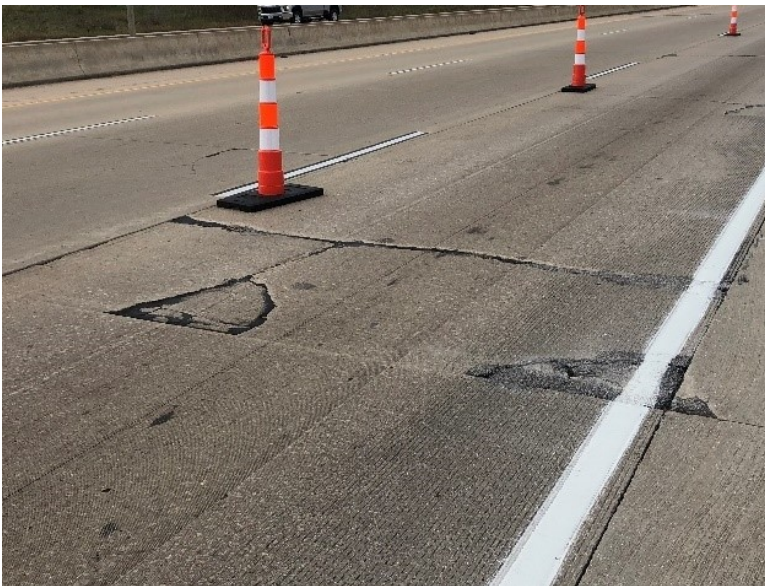
Figure 7.9 Photo. Full length transverse crack with a partial length longitudinal crack and compound spalls observed on I-39 NB in Columbia County, Wisconsin.

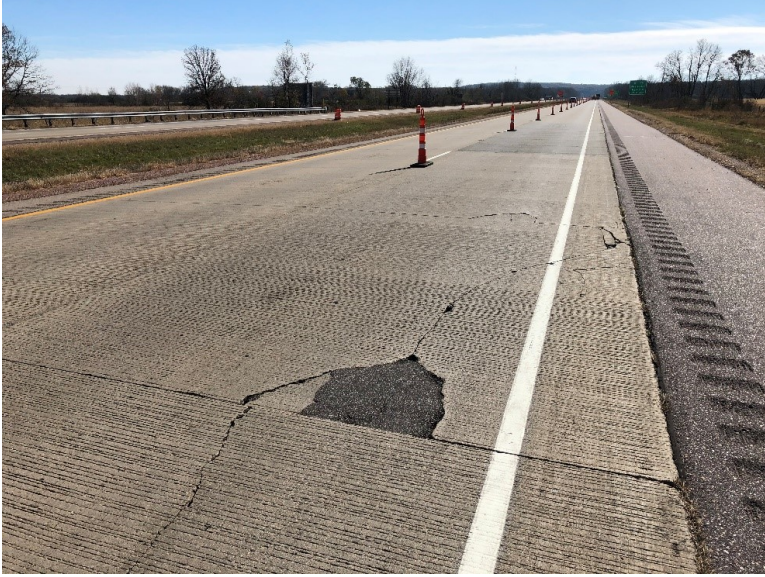
Figure 7.10 Photo. Large spall partially filled with asphalt along with meandering longitudinal crack observed on I-39 SB in Columbia County, Wisconsin.

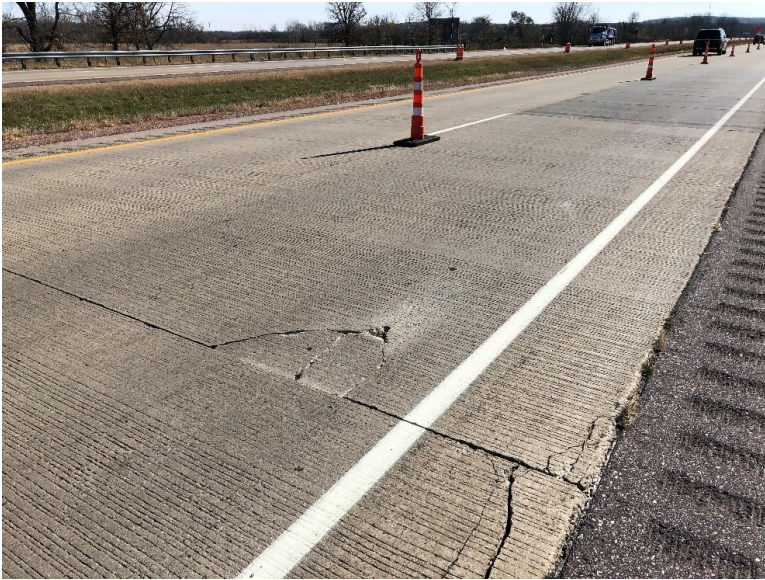
Figure 7.11 Photo. Large unrepaired spall observed on I-39 SB in Columbia County, Wisconsin.

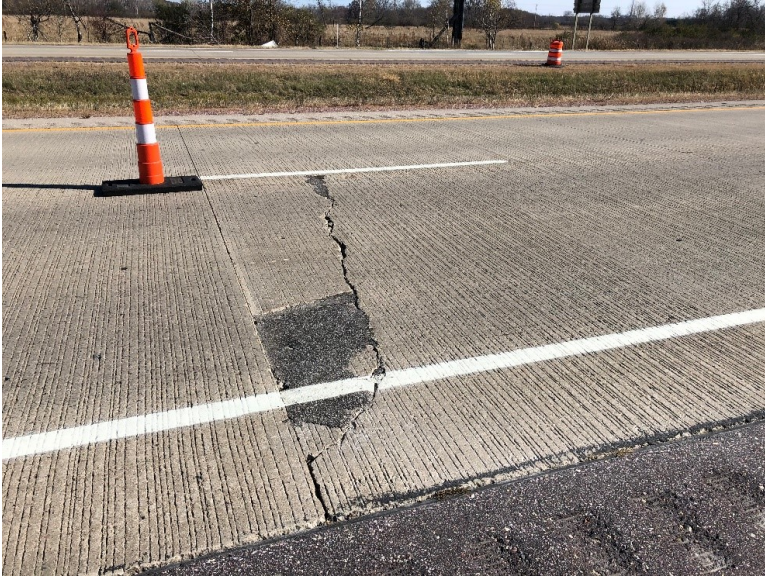
Figure 7.12 Photo. Large spall partially filled with asphalt along with meandering transverse crack observed on I-39 SB in Columbia County, Wisconsin.

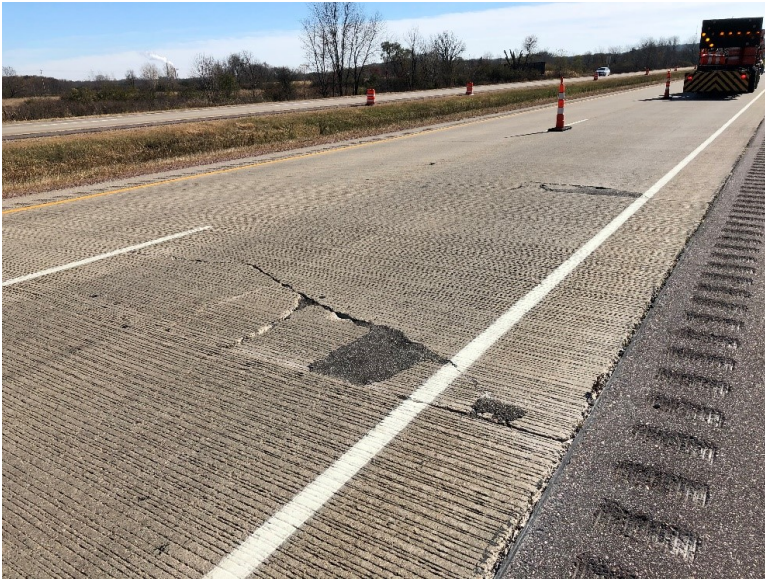
Figure 7.13 Photo. Transverse crack near joint along with associated multiple partial longitudinal cracks and spalling (some filled with asphalt) observed on I-39 SB in Columbia County, Wisconsin.

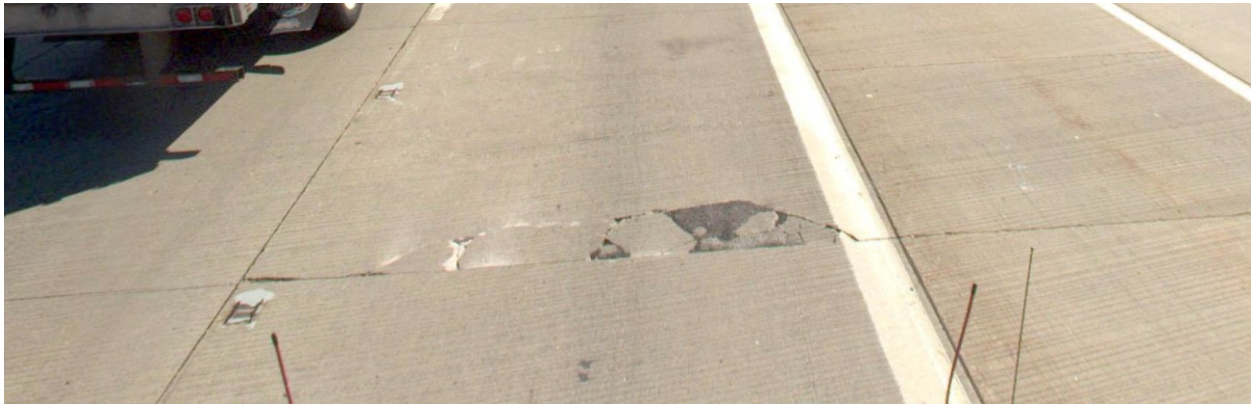
Figure 7.15 Photo. Advanced joint deterioration with patching material on I-94 at the Illinois Tollway.

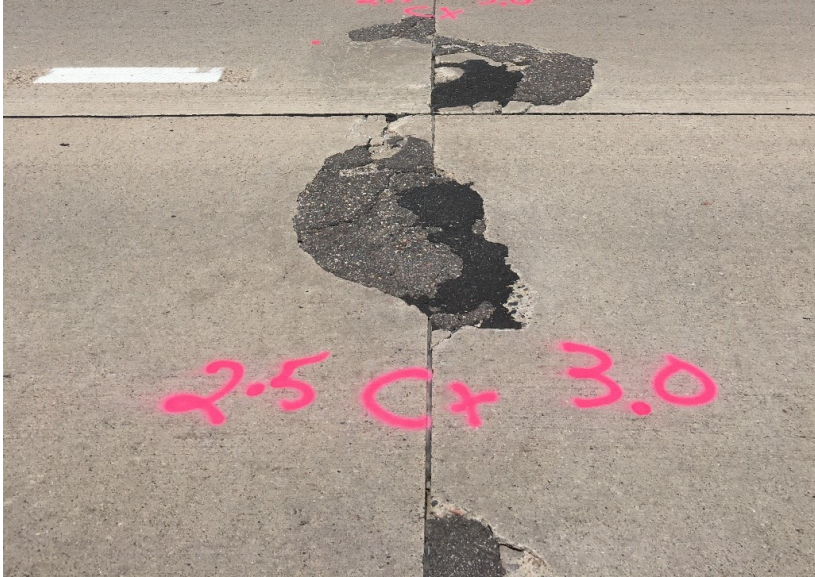
Figure 7.16 Photo. Advanced large joint spalls with asphalt patches on TH 610 in Hennepin County, MN.

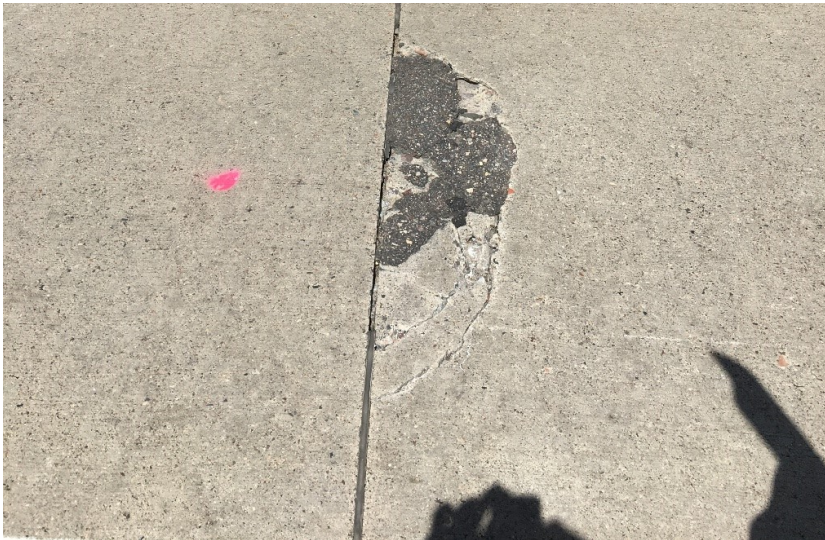
Figure 7.17 Photo. Joint deterioration with asphalt patch on TH 610 in Hennepin County, MN.

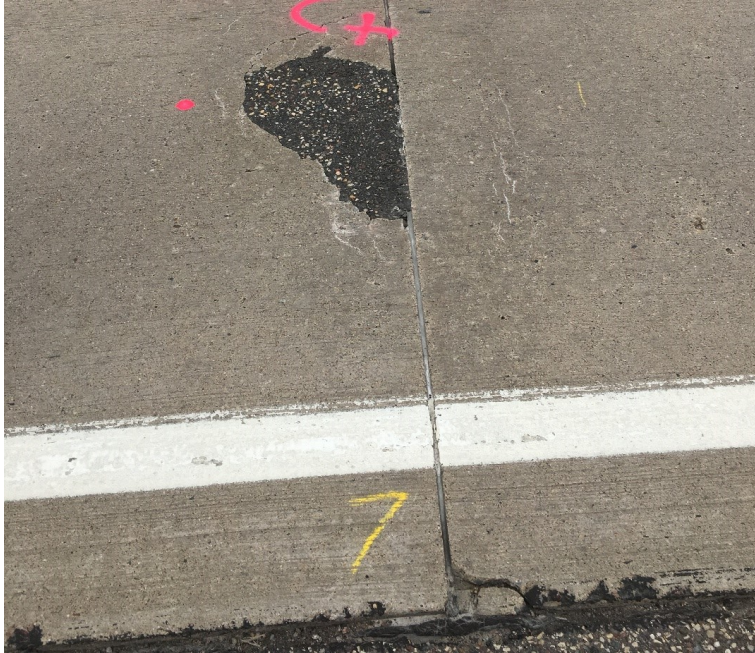
Figure 7.18 Photo. Joint spalling with asphalt patch and evidence of new cracks that could potentially lead to additional spalling on TH 610 in Hennepin County, MN.

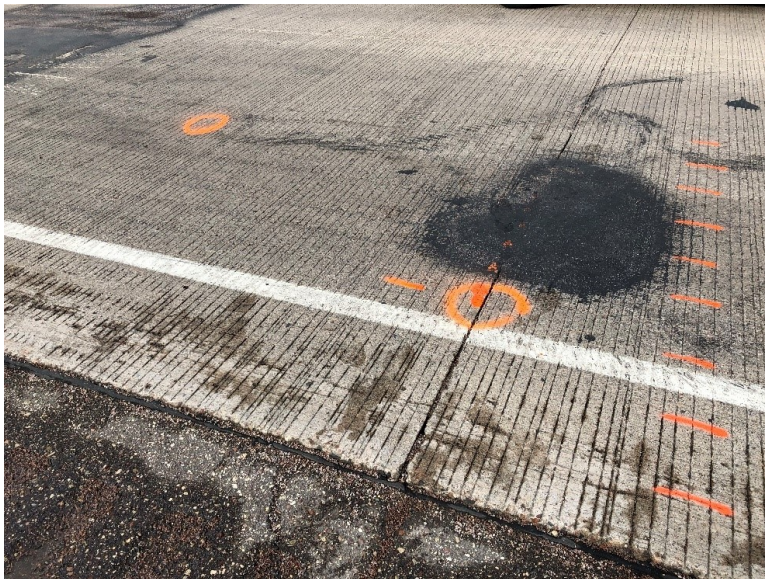
Figure 7.19 Photo. Large spall with asphalt patch and on US 53 in Eau Claire County, WI.

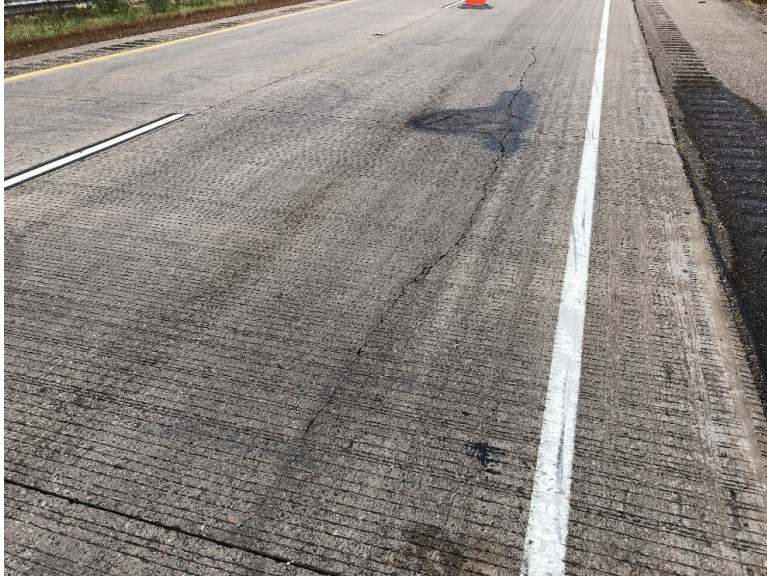
Figure 7.20 Photo. Joint spalling with asphalt patch along with longitudinal crack on US 53 in Eau Claire County, WI.

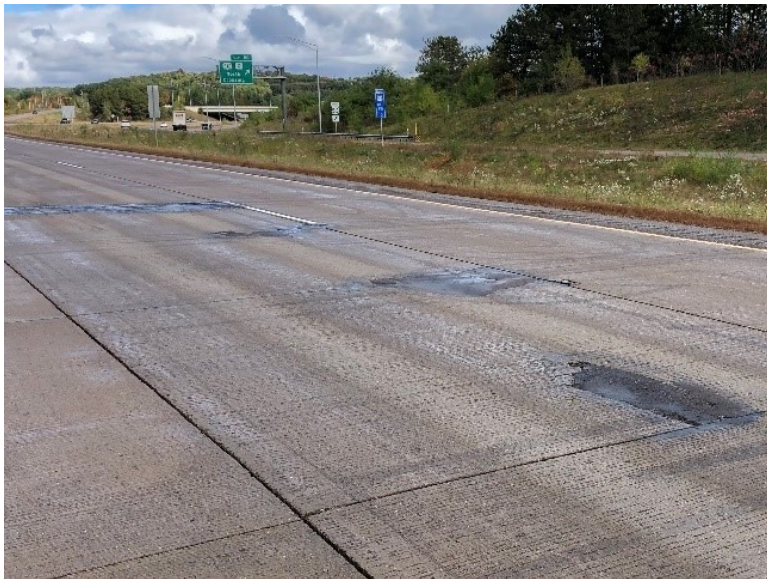
Figure 7.21 Photo. Several consecutive joints with spalling filled with asphalt patches on US 53 in Eau Claire County, WI.

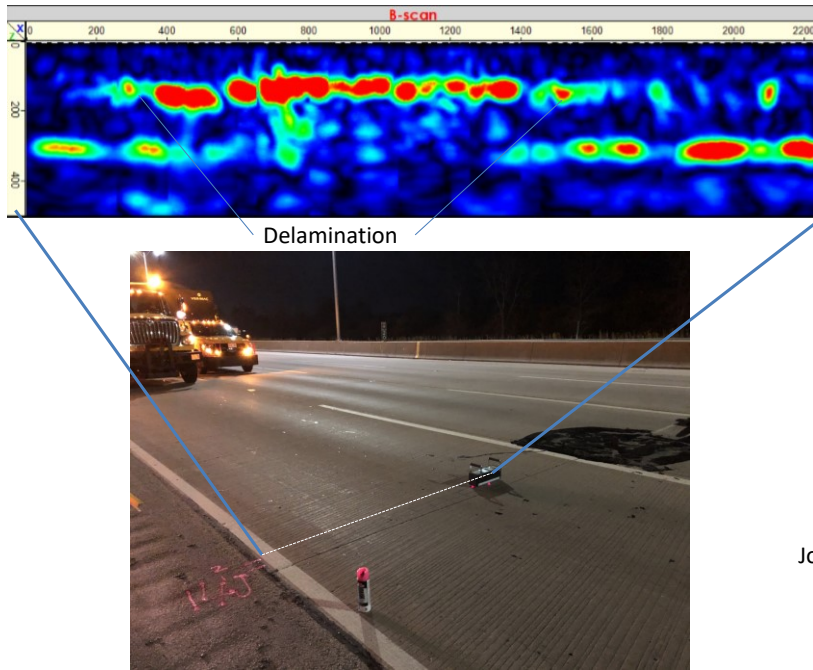
Joint # 14

Another joint (Joint #14) shows no visible distresses at the surface of the concrete. However, the MIRA scan shows significant horizontal delamination cracks at the depth of the dowel bars. The cracking in Joint #14 is more advanced transversely than the cracking in Joint #3. As in the case of Joint #3, these cracks can be expected to progress over time until they turn up and result in one or more spalls of the concrete at the approach side of the transverse joint. The 2D and 3D MIRA scans for Joint #14 are shown in Figure 9.2 and Figure 9.3.

Figure 9.2 Photo and Contour Plot. 2D MIRA scan showing delamination crack initiating at dowel bar level for Joint #14 on I-94 at the Illinois Tollway.

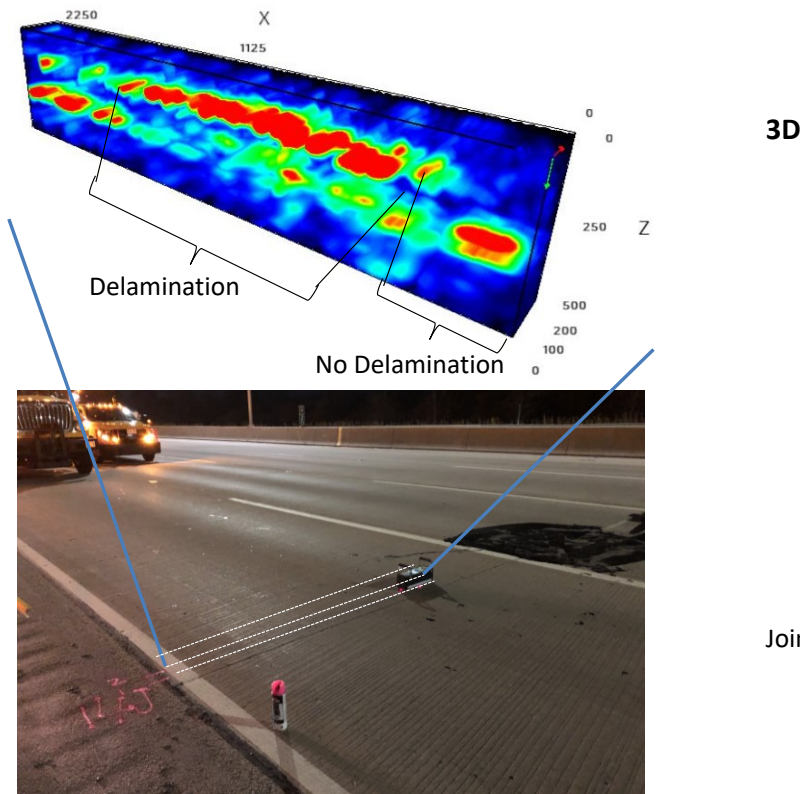
Joint # 14

Figure 9.3 Photo and Contour Plot. 3D MIRA scan showing delamination crack initiating at dowel bar level for Joint #14 on I-94 at the Illinois Tollway.

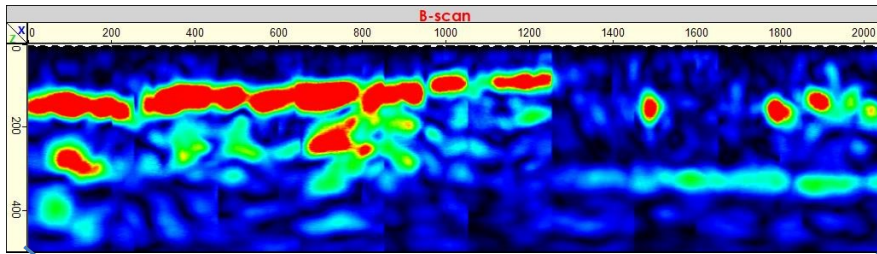
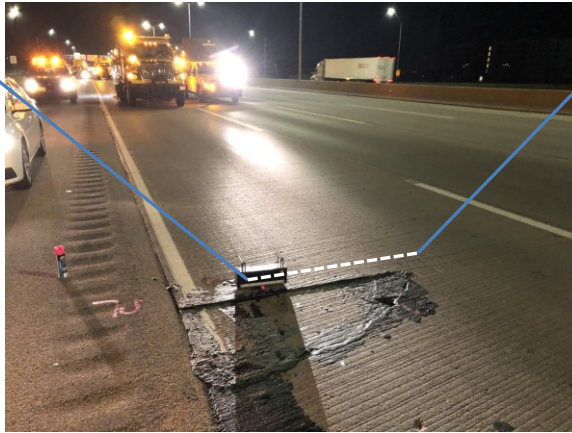
Joint # 7

Figure 9.9 Photo and Contour Plot. 2D MIRA scan showing delamination crack initiating at dowel bar level for approach side of Joint #7 on I-94 at the Illinois Tollway.
