Solutions to Mitigate Dowel/ Tie-Bar Propagated Cracking - Phase 1

Shreenath Rao, Principal Investigator
Applied Research Associates, Inc.

April 2024

Final Report NRRRA202402

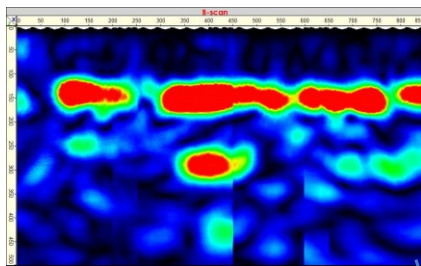
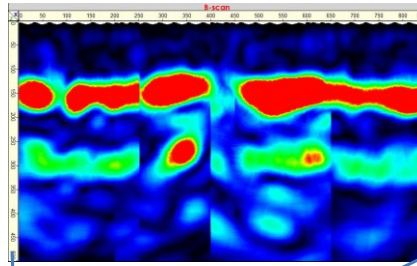
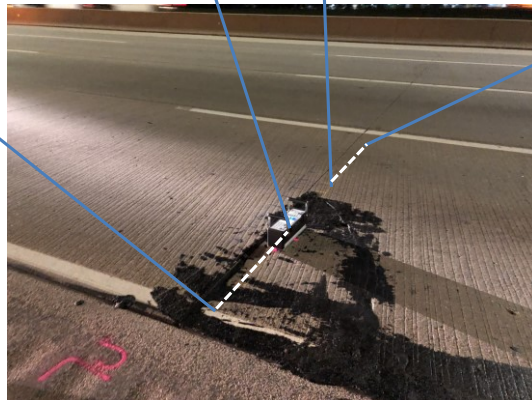
Joint # 7

Figure 9.10 Photo and Contour Plot. 2D MIRA scan showing delamination crack initiating at dowel bar level for leave side of Joint #7 on I-94 at the Illinois Tollway.

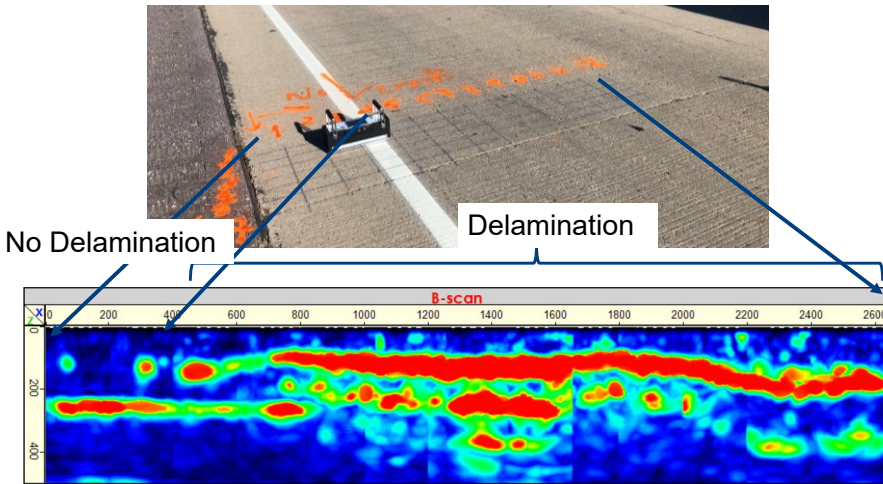
The delamination observed in the MIRA scans in Wisconsin and Minnesota (Figure 9.13 through Figure 9.17) beneath the pavement surface, even when there were no visible distresses, was consistent with those observed at the Illinois Tollway.

Figure 9.13 Photo and Contour Plot. 2D MIRA scan showing delamination crack initiating at dowel bar level on I-39 SB in Columbia County, Wisconsin.

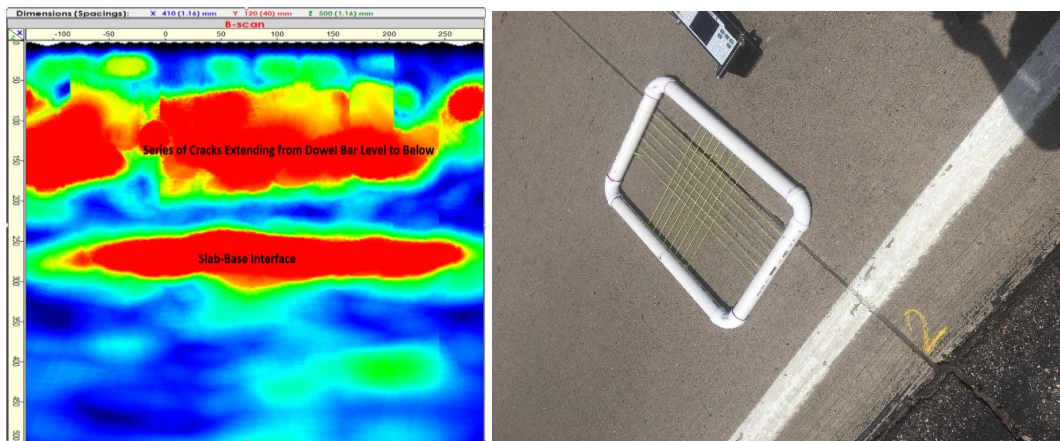
Figure 9.14 Photo and Contour Plot. MIRA scan near intact joint showing delamination cracking beneath the surface on TH 610 in Hennepin County, MN.

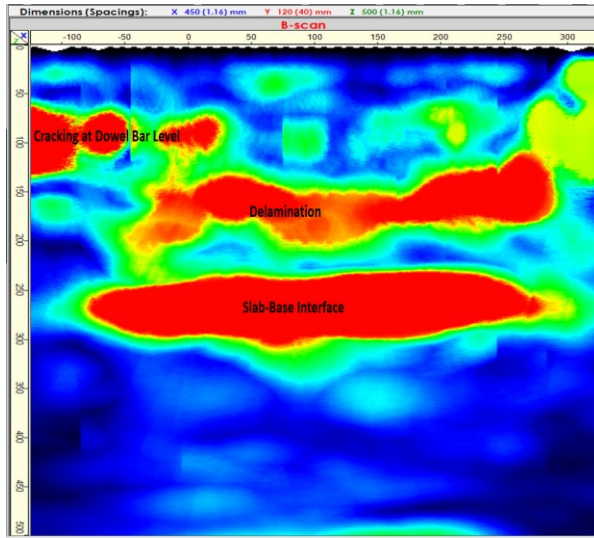
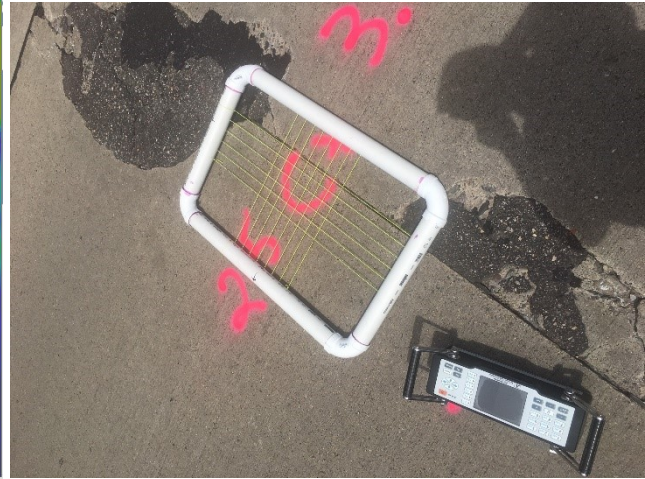
Figure 9.15 Photo and Contour Plot. MIRA scan near spalled joint showing delamination cracking beneath the surface on TH 610 in Hennepin County, MN.

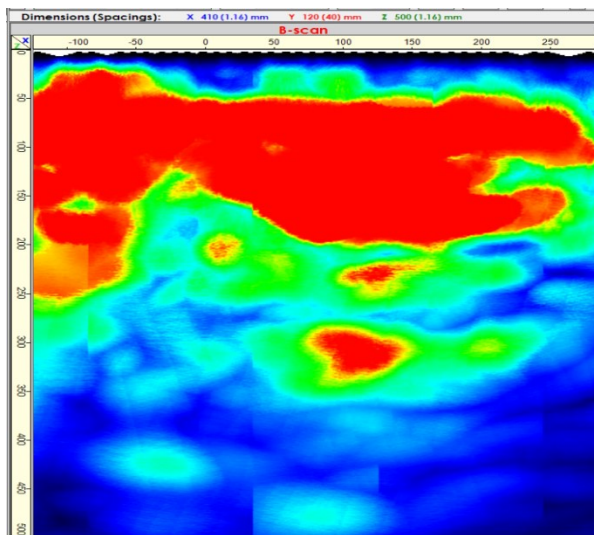
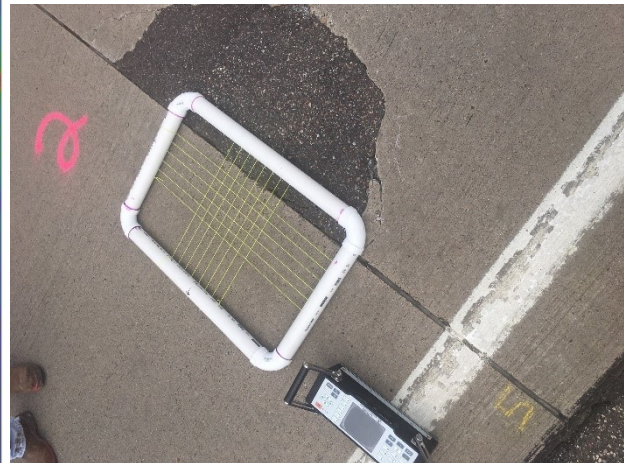
Figure 9.16 Photo and Contour Plot. MIRA scan near spalled joint showing strong delamination cracking signal on TH 610 in Hennepin County, MN.

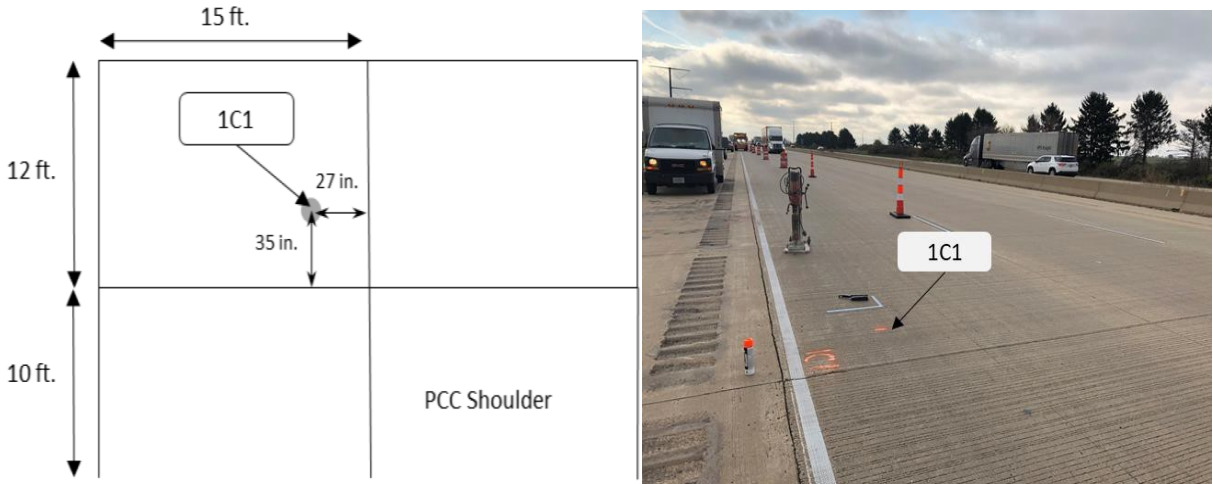
Several cores were taken from panels where slab and joint showed distresses and also from the panels where slab and joint had no visible distresses observed at the surface. Figure 10.1 shows the core location and Figure 10.2 shows the approach side of the core and leave side of the same core. Figure 10.3 shows the cross section of the core at the crack. The coring provides evidence that the delamination crack has extended to at least 27 inches from the joint even though no distresses are visible at the surface.

Figure 10.1 Photo and Illustration. Location of core on I-39 NB in Dane County, Wisconsin, where no visible distresses were observed at the surface.

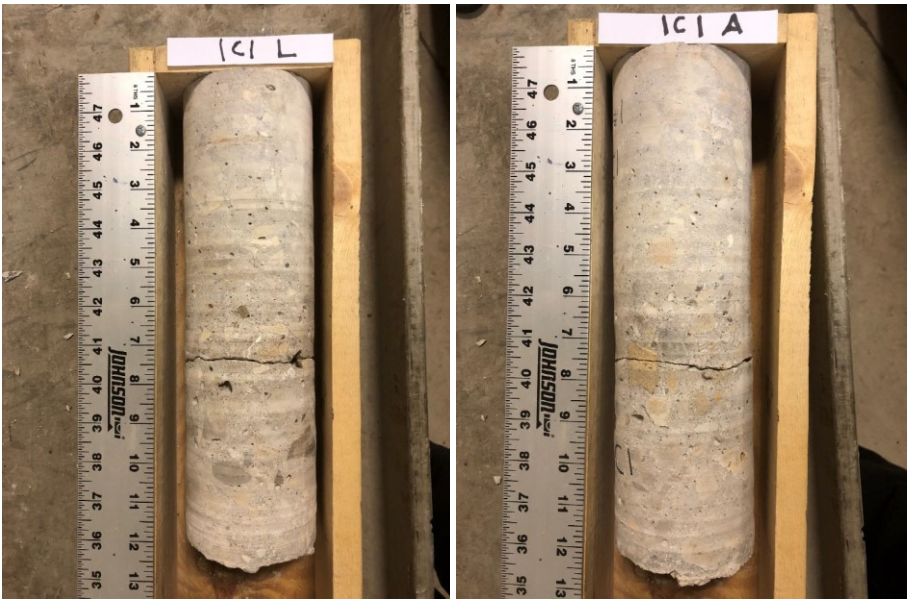
Figure 10.2 Photo. Leave side of 1C1 core (left) and approach side of 1C1 core (right) from I-39 NB in Dane County, Wisconsin.

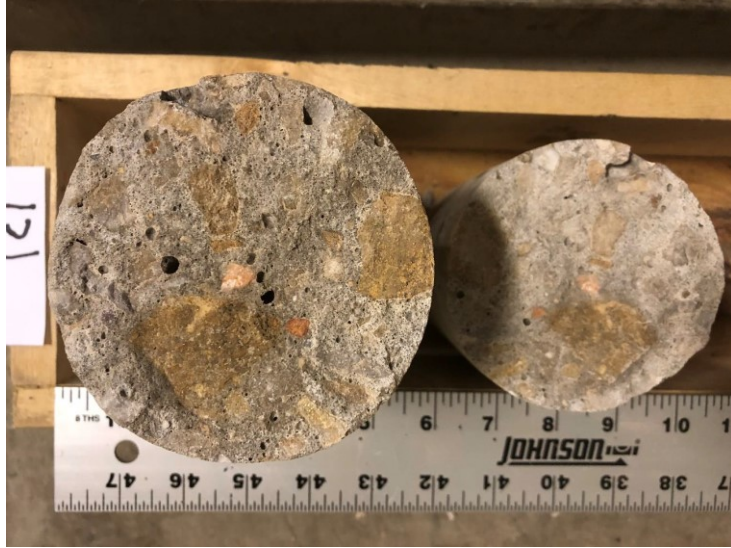
Figure 10.3 Photo. Cross section of 1C1 core from I-39 NB in Dane County, Wisconsin.

Figure 10.3 shows that the crack propagated through the aggregate, suggesting that at this location, the crack propagated only after the concrete had gained sufficient strength (comparable to that of the aggregate). If the concrete strength was significantly lower than the aggregate when the crack tip approached the aggregate, the crack would have propagated around the aggregate rather than through the aggregate.

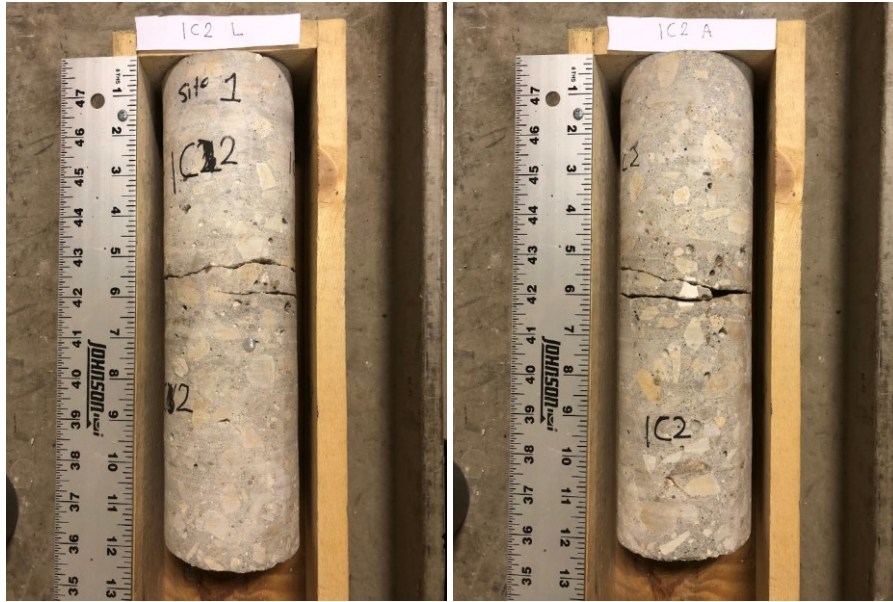
A second core was taken near a spot with significant spalling (Figure 10.4). Figure 10.5 shows the approach side of the core and leave side of the same core. The coring provides evidence that the delamination crack has extends the full length of the transverse joint even though only part of the joint has spalled to date. Figure 10.6 shows the cross section of the core at the crack. The figure also shows the concrete cracking through some of the aggregate indicating the crack propagated to this point after the concrete had gained significant strength.

Figure 10.5 Photo. Leave side of 1C2 core (left) and approach side of 1C2 core (right) from I-39 NB in Dane County, Wisconsin.

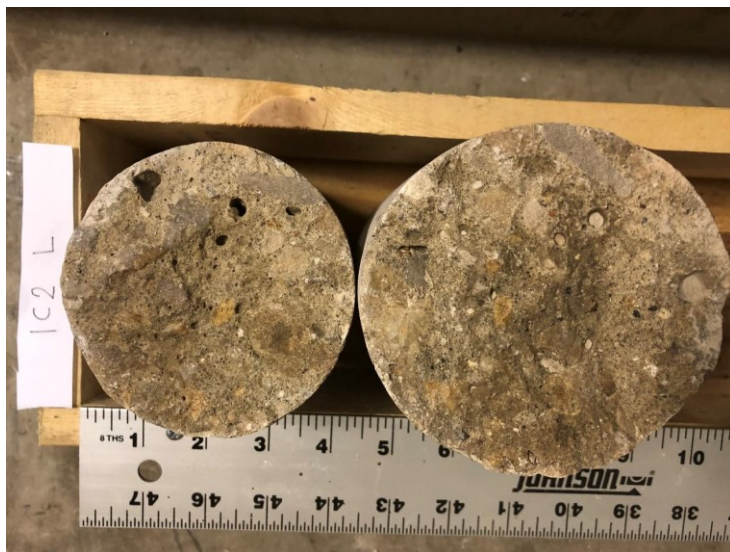
Figure 10.6 Photo. Cross section of 1C2 core from I-39 NB in Dane County, Wisconsin.

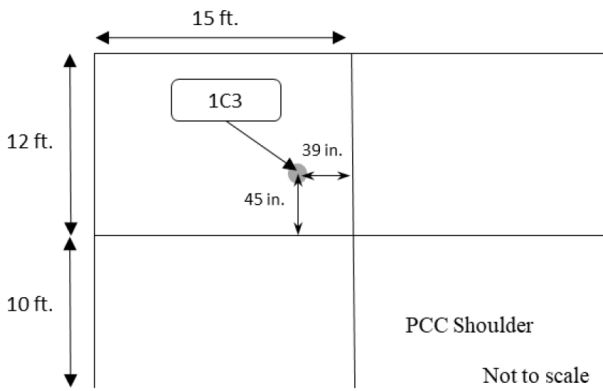
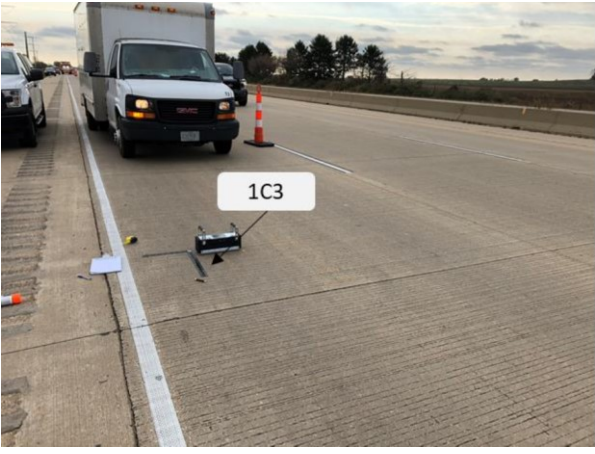
Figure 10.7 through Figure 10.9 show coring results from another joint with no visual distresses observed at the surface of the slab. The core taken 39 inches from the transverse joint exhibits delamination cracking suggesting the extent to which the delamination crack extends from the transverse joint. As in the case of core 1C1, Figure 10.9 shows that the crack propagated through the aggregates in the concrete.

Figure 10.7 Photo and Illustration. Location of core on I-39 NB in Dane County, Wisconsin, with no distresses observed at the surface.

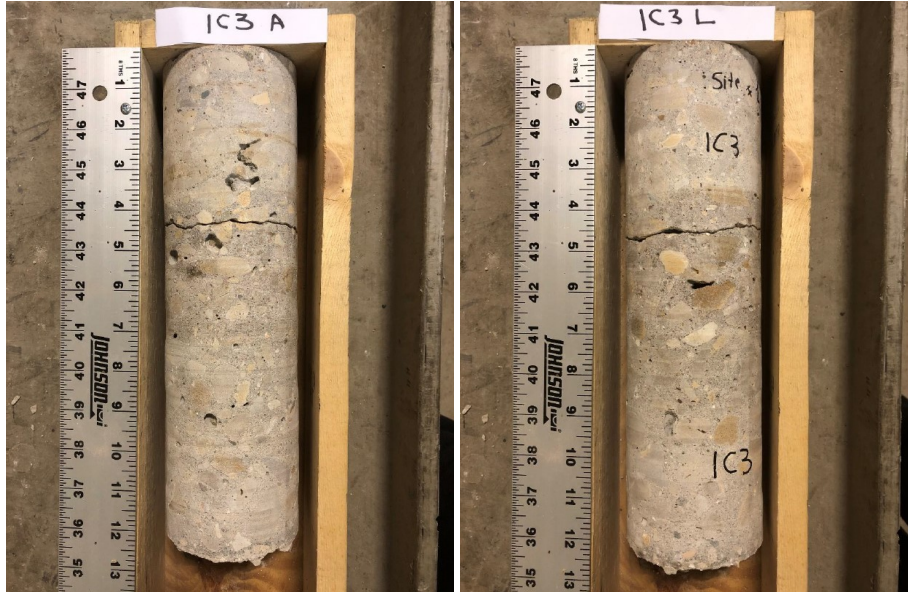
Figure 10.8 Photo. Approach side of 1C3 core (left) and leave side of 1C3 core (right) from I-39 NB in Dane County, Wisconsin.

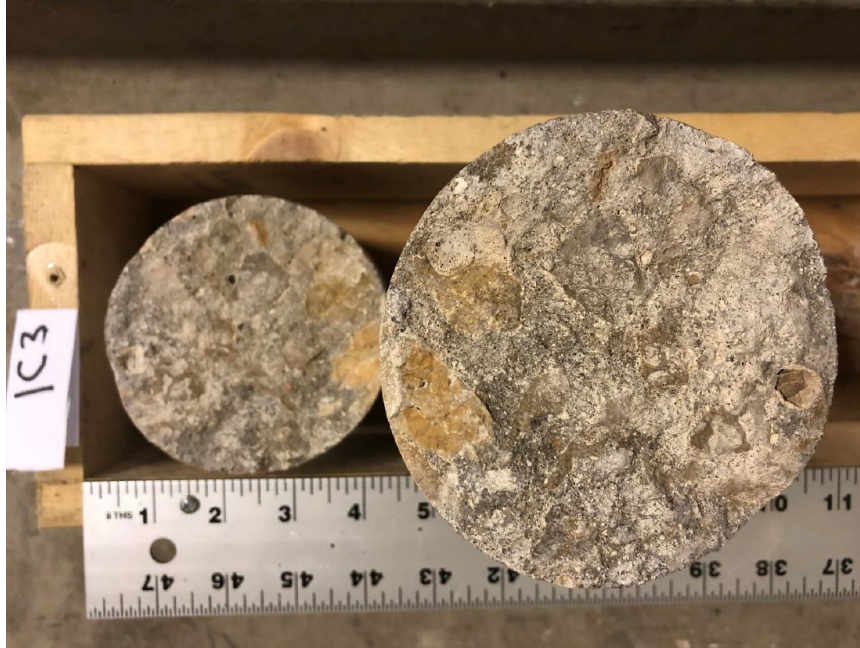
Figure 10.9 Photo. Cross section of 1C3 core from I-39 NB in Dane County, Wisconsin.

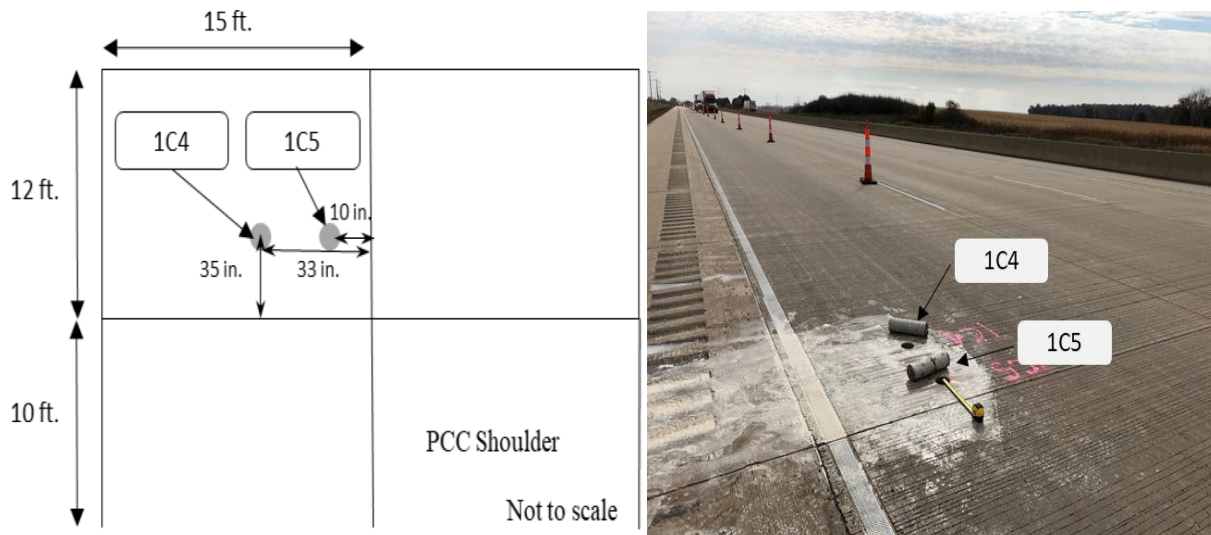
Two cores were taken from two spots of a slab where slab and joint did not show any signs of distresses (Figure 10.10 through Figure 10.13). In this case, the core taken 10 inches from the transverse joint had delamination cracking whereas the core taken further away from the transverse joint (33 inches) showed no delamination cracking (Figure 10.11). This is an indication that the cracking starts from joints and then propagates further away from the joint. As in the case of the other delamination crack cores, Figure 10.13 shows the 1C5 core had the delamination crack through the aggregate rather than around the aggregate.

Figure 10.10 Photo and Illustration. Location of two cores on I-39 NB in Dane County, Wisconsin, with no distresses observed at the surface.

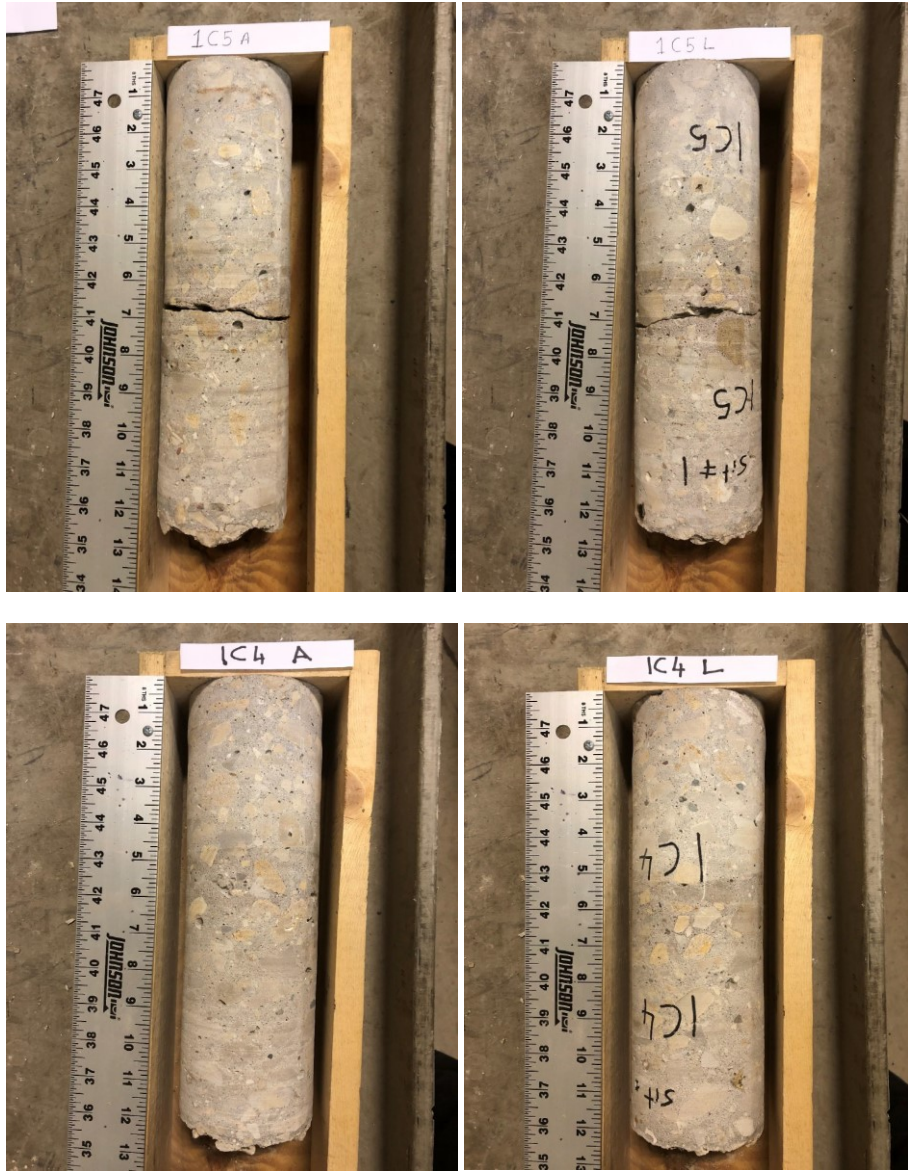
Figure 10.11 Photo. Approach side of 1C5 core (top left), leave side of 1C5 core (top right), approach side of 1C4 core (bottom left) and leave side of 1C4 core (bottom right) from I-39 NB in Dane County, Wisconsin.

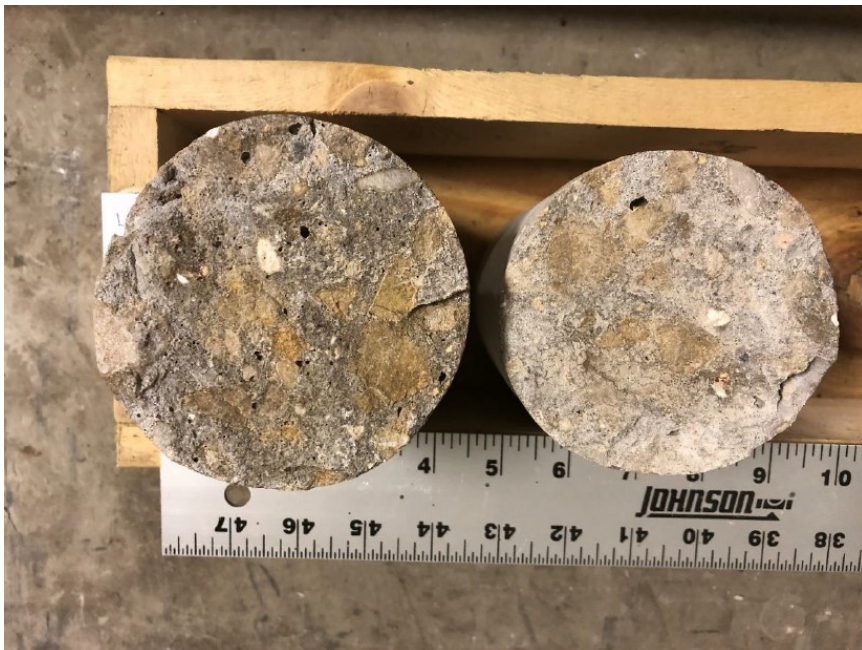
Figure 10.13 Photo. Cross section of 1C5 core from I-39 NB in Dane County, Wisconsin.

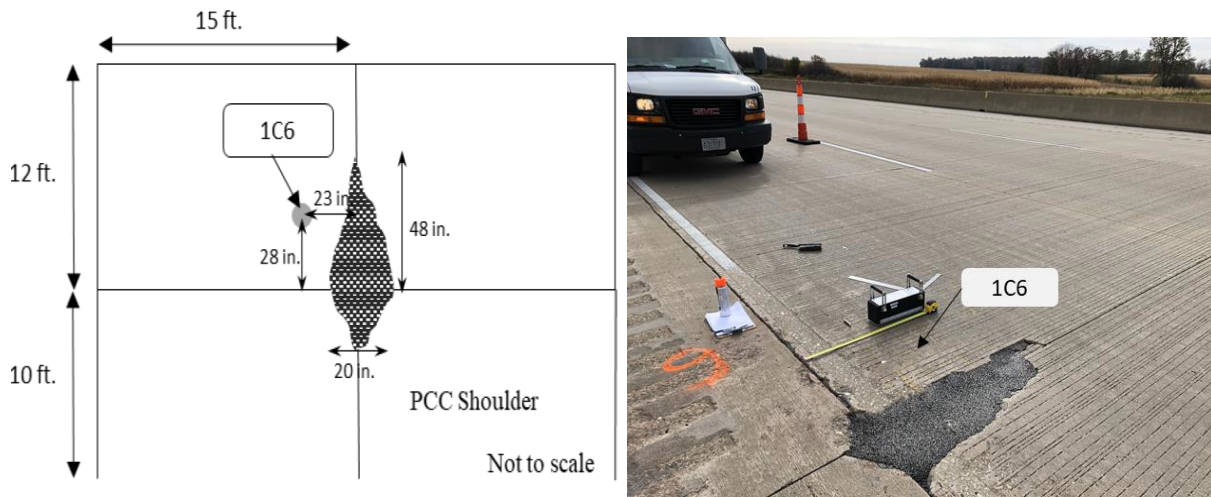
Another core was taken from a spot where slab and joint showed spalling that had previously been patched with HMA (Figure 10.14). Horizontal delamination crack was observed on this core taken outside the patch area (Figure 10.15). This suggests that although some of the delamination crack

Figure 10.14 Photo and Illustration. Location of core on I-39 NB in Dane County, Wisconsin, near a patched spall.

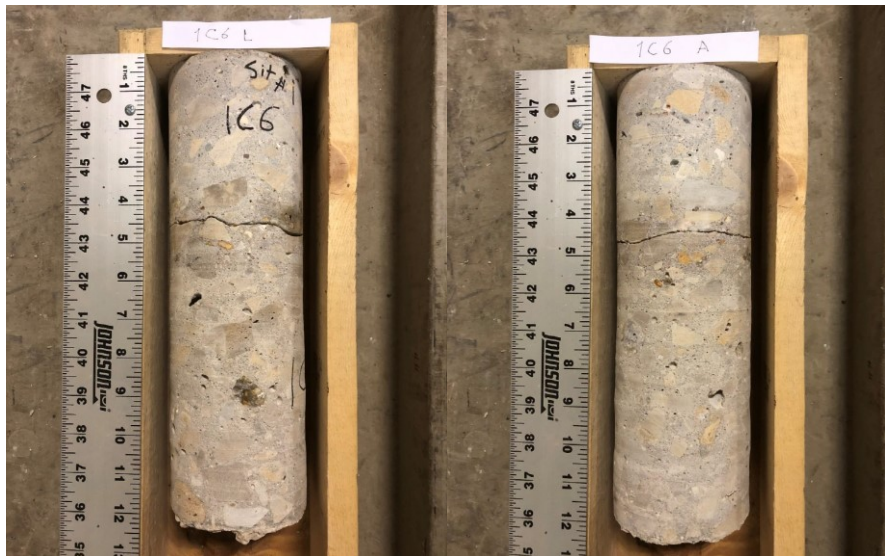
progressed upwards resulting in spalling of the concrete (which was patched by WisDOT), there is additional delamination cracking within the concrete and could result in further spalling near the existing patched spall, thus compounding the spall. Figure 10.16 shows the delamination crack through the aggregates.

Figure 10.15 Photo. Approach side of 1C6 core (left) and leave side of 1C6 core (right) from I-39 NB in Dane County, WI.

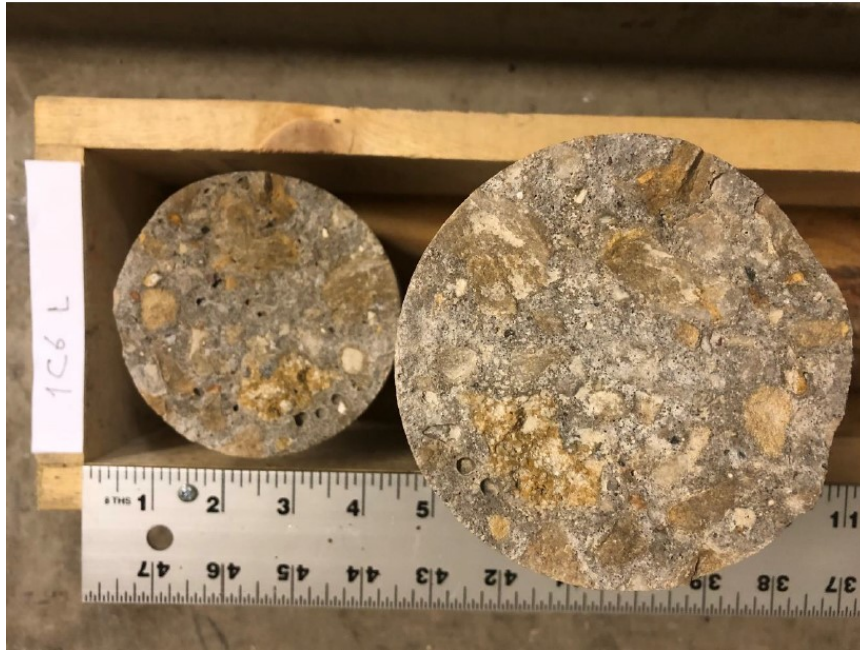
Figure 10.16 Photo. Cross section of 1C6 core from I-39 NB in Dane County, WI.

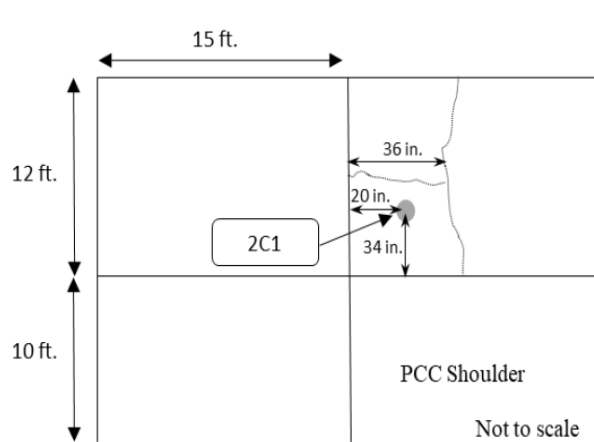
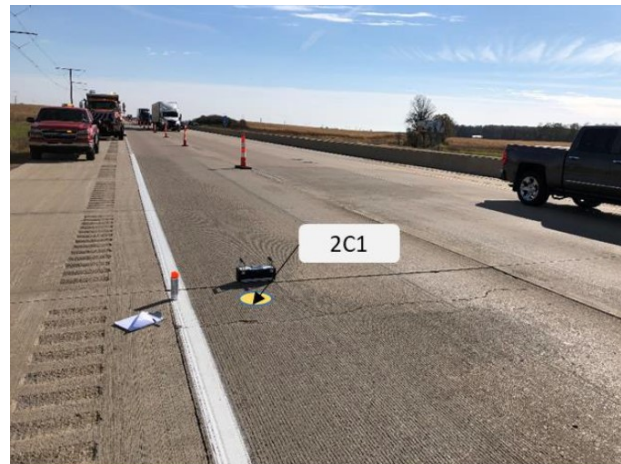
Figure 10.17 Photo and Illustration. Location of core on I-39 NB in Columbia County, Wisconsin, near a full-length transverse crack and a partial length longitudinal crack.

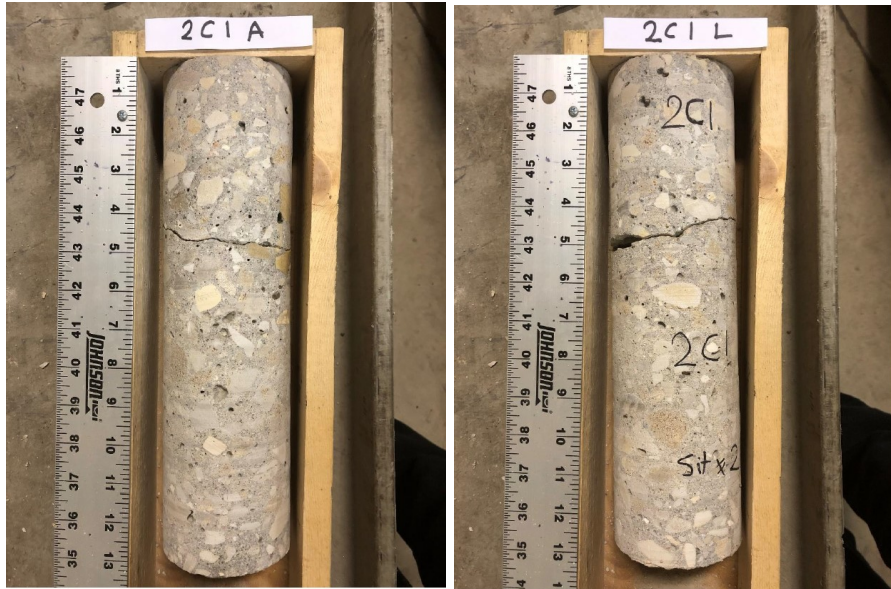
Figure 10.18 Photo. Approach side of 2C1 core (left) and leave side of 2C1 core (right) from I-39 NB in Columbia County, WI.

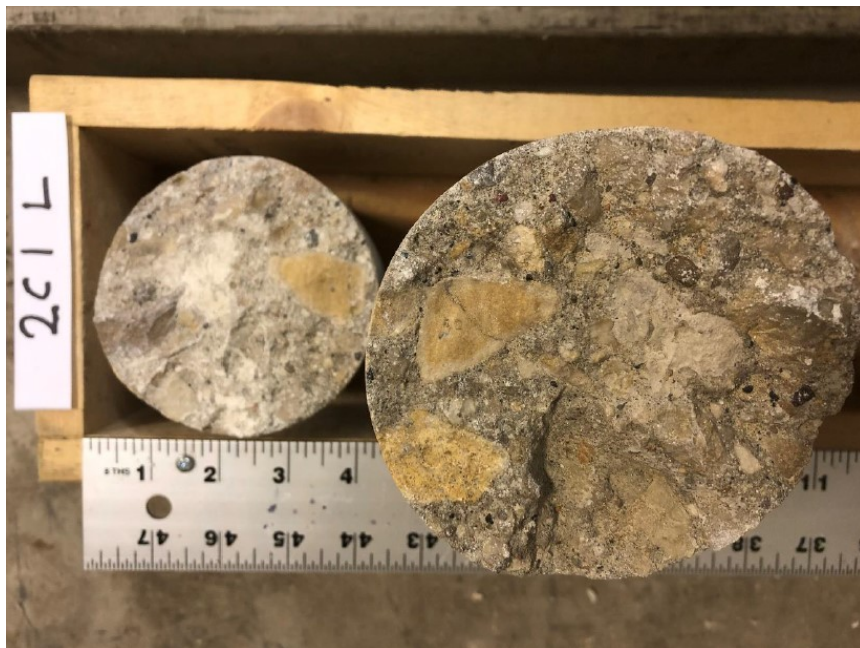
Figure 10.19 Photo. Cross section of 2C1 core from I-39 NB in Columbia County, WI.

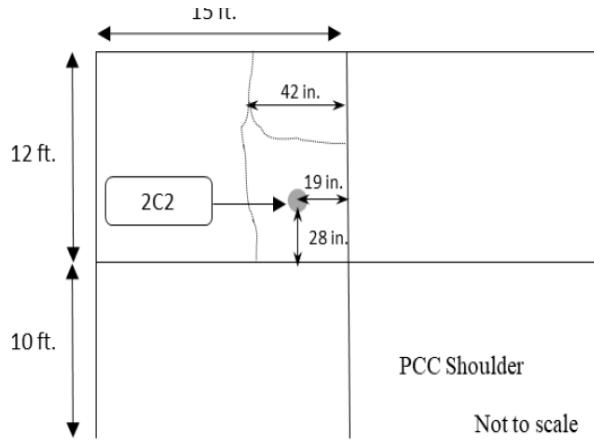
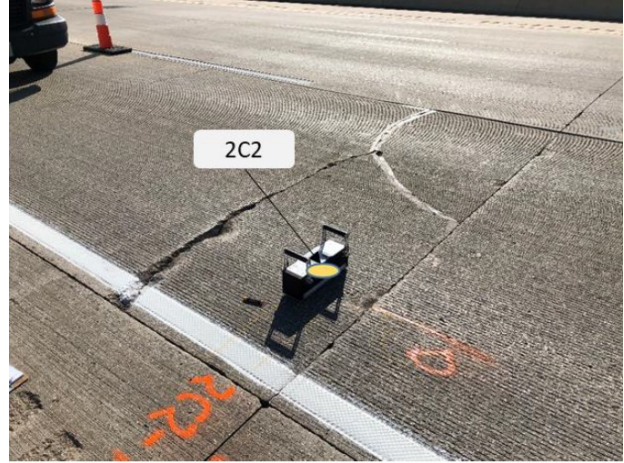
Figure 10.20 Photo and Illustration. Location of core on I-39 NB in Columbia County, Wisconsin, near a cracked slab exhibiting a transverse crack and a corner break.

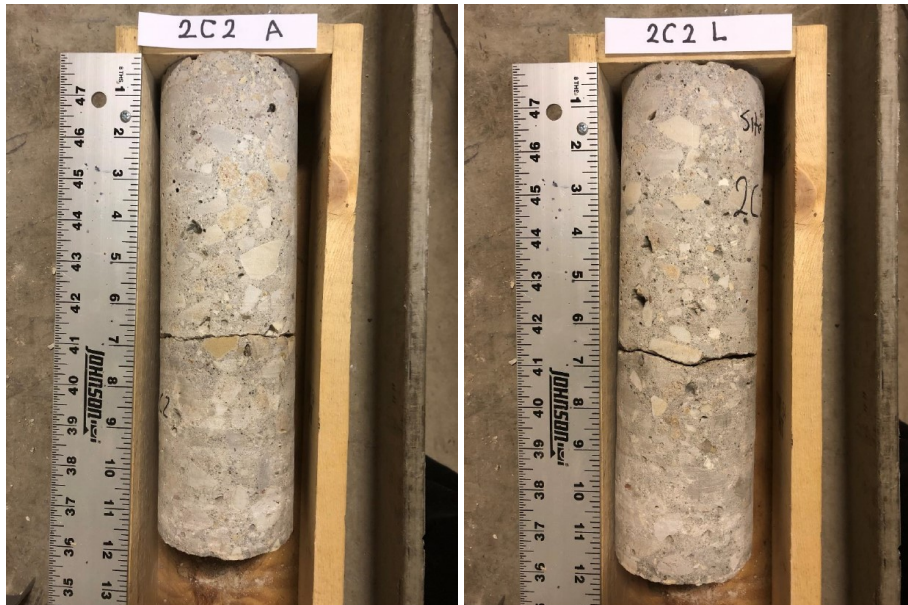
Figure 10.21 Photo. Approach side of 2C2 core (left) and leave side of 2C2 core (right) from I-39 NB in Columbia County, WI.

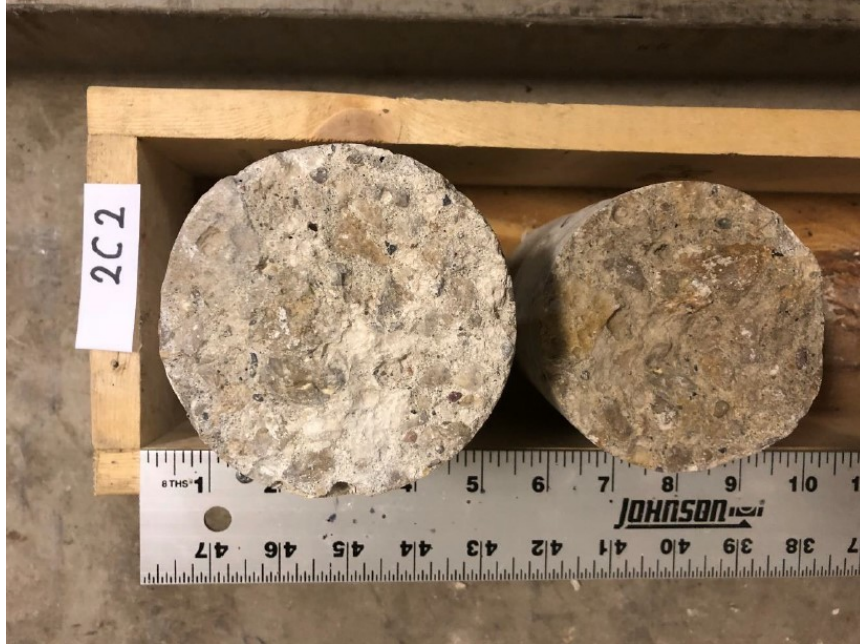
Figure 10.22 Photo. Cross section of 2C2 core from I-39 NB in Columbia County, WI.

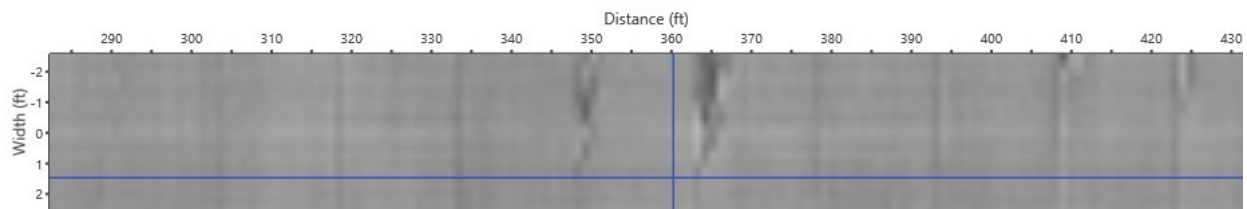
The first analysis completed was a review of the high-speed runs to determine if the deteriorated joints could be identified from the side scan GPR data. The deterioration could be seen from the top-down scanning as shown in Figure 11.2, but this result does not provide any additional insight into the deterioration. The top-down view only mimics a visual survey as can be completed during digital surveys. An example of the side scan GPR signal is presented in Figure 11.3. The side scan shows the individual joints from the long run scanning, but the good and bad joints are indistinguishable. Joints 17A and 18A are present in Figure 11.3, but without prompting on their location through DMI or GPS, the good and bad joints cannot be determined.

Figure 11.2 GPR Image. Top-down view of the long run scan at the location of joints 17A and 18A.

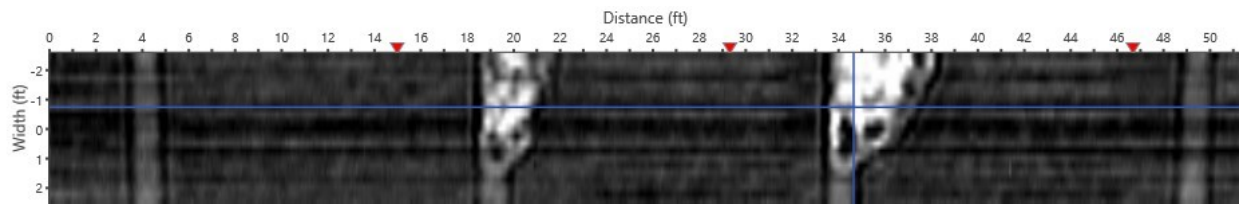
Figure 11.4 is a top-down image of joints 17A and 18A, with the joints at 19.2 and 34.4 feet respectively in the image. The other joints in the image are performing as expected and show no deterioration. In the image we can see the extent of the surface deterioration for 17A and 18A, some of the most significant in the eastbound direction. These same joints can be found in Figure 11.5, the side scan view of the 18A scan. The deterioration, highlighted in the squares, shows that the deterioration has progressed to the bottom of the concrete slabs, and into the asphalt support layer. The dashed line indicates the bottom of the concrete, while the dotted and dashed line indicates the bottom of the asphalt layer. These joints would be expected to have little to no load transfer, and potentially significant pumping, as all support has likely been lost. The good joints are barely visible in the image, highlighted with triangles, indicating the layers of concrete and asphalt are still homogeneous, and providing the structural support expected of the pavement section.

Figure 11.4 GPR Image. Top down image of GPR scan of joint 18A that includes 17A and two non-deteriorated joints.

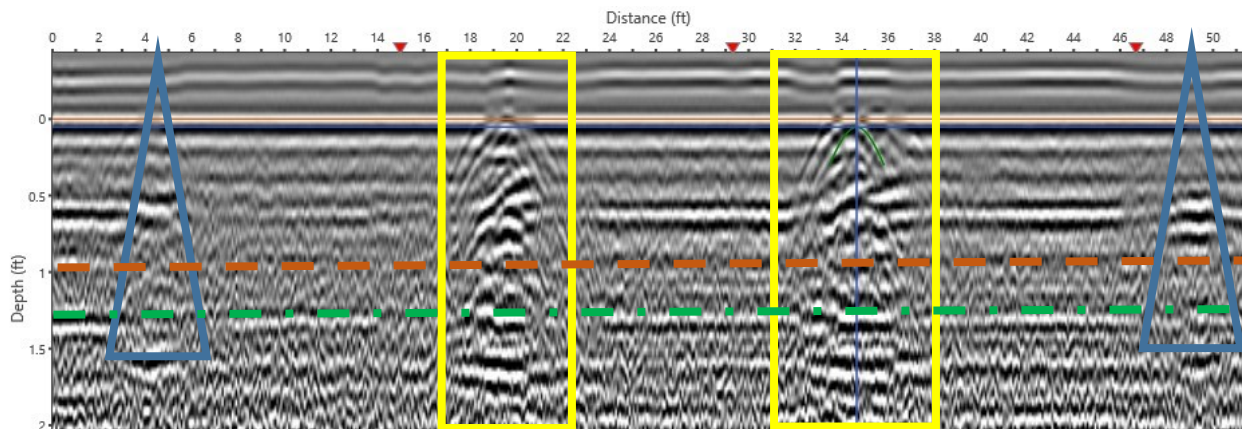
Figure 11.5 GPR Image. Side scan image of GPR scan of joint 18A that includes 17A and two non-deteriorated joints.

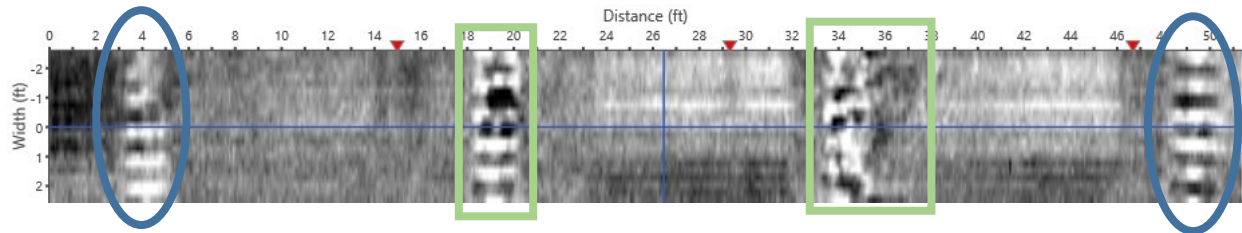
Another interesting level to explore as part of the joint investigation is the level of the dowel bars. Given the surface deterioration appears to extend to the ends of the dowel bars on the surface of the slab, the GPR investigation included a look at the dowels themselves. Figure 11.6 is the top-down view from the level of the dowels, instead of the top of the pavement presented in Figure 11.4. The individual dowel bars of the good joints, highlighted in ovals, can be observed, with some details observable. However, at

the location of the bad joints, highlighted in the rectangles, the individual dowel bars cannot be distinguished, indicating the deterioration is significant enough to no longer consider them effective. While the two presented joints are the most significant cases of deterioration around the dowel bars for the eastbound direction, all the joints scanned with some level of deterioration show that the deterioration extends at least to the level of the dowels. The majority of low to medium severity deteriorated joints do not show concrete deterioration past the level of the dowels.

Figure 11.6 GPR Image. Dowel level view of joint location 18A, including 17A and two good joints.

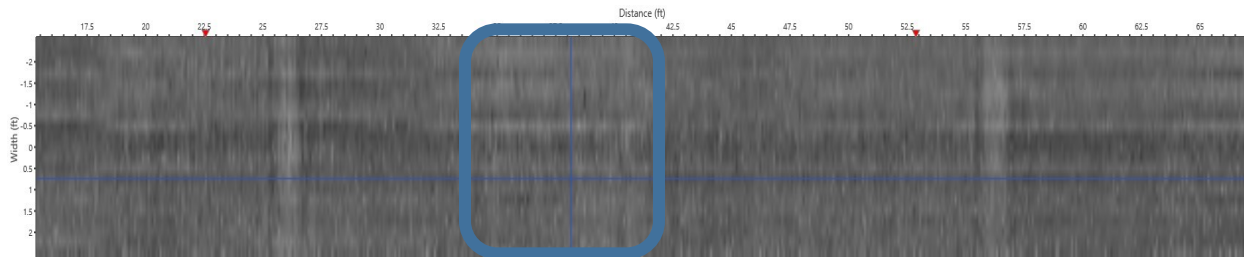
The final location type scanned in the eastbound direction was over one of the prior full depth repair locations. The goal was to determine the effectiveness of the repair in returning the joint to an acceptable condition. Figure 11.7 is a top-down view of the location of the scanned repair. The repair is located at the vertical line location and appears to blend seamlessly into the surrounding concrete. This result is to be expected as the GPR relies on changes in material types to provide reflections, and the repair appears to be an integral part of the existing pavement structure. The side scan view of the repair, Figure 11.8, does not show any deterioration remaining at the repair location. These results indicate that the type of repair performed on the joints that have deteriorated previously, should be effective in returning the pavement to a reasonable condition.

Figure 11.7 GPR Image. Top-down look at the location of a pavement full-depth repair.

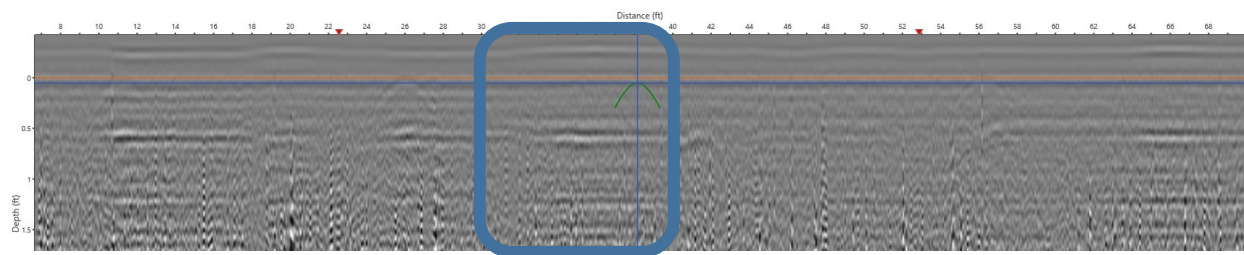
Figure 11.8 GPR Image. Side view of full-depth repair location in the right wheelpath with repair highlighted by the rectangle.

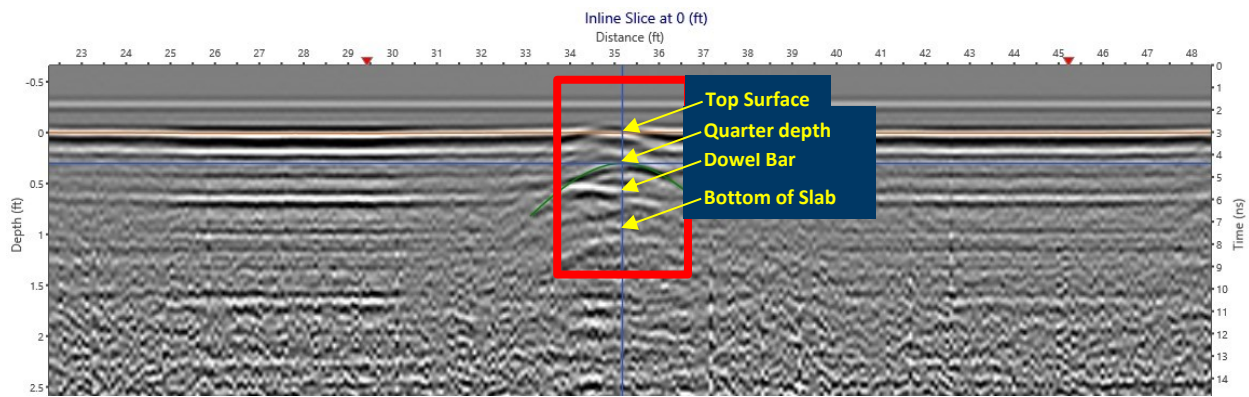
Several individual locations were also selected in the westbound direction. Joint 1A was located in Lane 4 and was the first joint scanned in the westbound direction. Joint 1A had noticeable deterioration near the edge of the joint but is greatest in the right wheel path. Figure 11.9 shows the GPR side scan image of joint 1A in the right wheel path. The horizontal slice shows that the distress extended to the level of the dowel bars. Figure 11.10 is a top-down view of the joint at a level three inches below the surface of the pavement that shows how the deterioration progresses beyond the surface of the pavement. Figure 11.11 is the top-down view of the joint at the level of the dowel bar, showing how the deterioration continues into the depth of the slab, but reducing in severity. Figure 11.12 is the top-down view of the joint at a depth of 9.5 inches, just above the bottom of the concrete, where the deterioration is less than the level of the dowel bar. The overall condition of the joint gives indications that the joint spalling is likely initiating from the dowel bar and progresses upwards.

Figure 11.9 GPR Image. GPR side scan image of joint 1A showing the levels of the deteriorated joint including the dowel bar and the bottom of the slab.

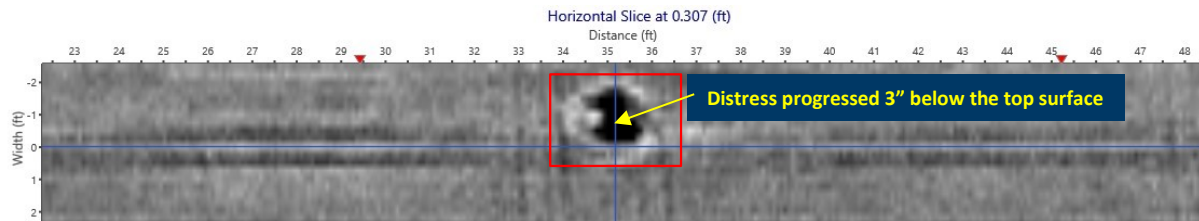
Figure 11.10 GPR Image. Location of deterioration at joint 1A, 3-inch below the top surface.

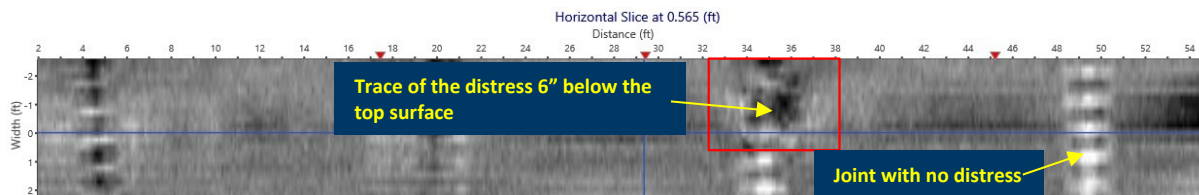
Figure 11.11 GPR Image. Location of deterioration at joint 1A, 6-inch below the top surface.

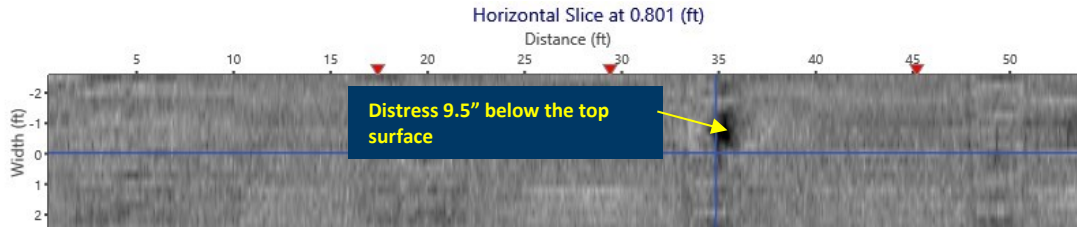
Figure 11.12 GPR Image. Location of distress at joint 1A-RWP, 9.5-inch below the top surface.

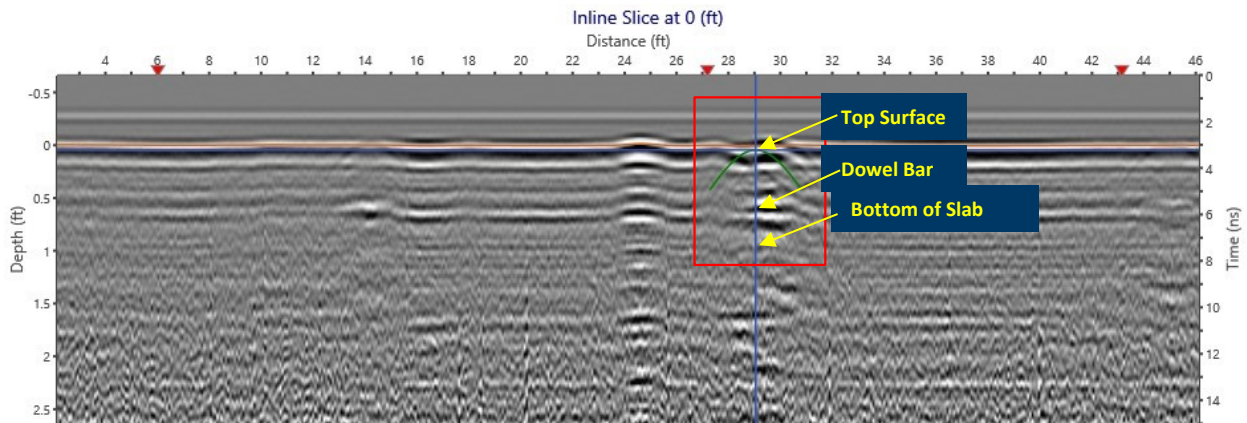
Joint 3A has not deteriorated to same degree as Joint 1A, or the two joints discussed in the eastbound direction. Figure 11.13 is the side scan view of Joint 3A, where the deterioration appears less than in Joint 1A. Figure 11.14 and Figure 11.15 represent the GPR scan images of Joint 3A at different depths from top surface. Although the distress is obvious in the top surface (Figure 11.14), it is not as obvious at depth 8.6-inch (Figure 11.15).

Figure 11.13 GPR Image. Side scan view of Joint 3A.

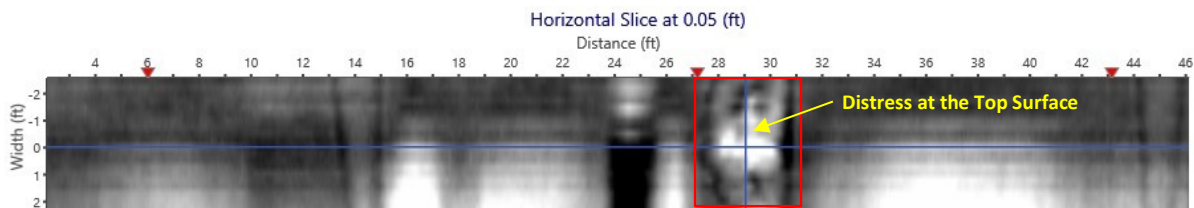
Figure 11.14 GPR Image. Location of distress at joint 3A, at the top surface.

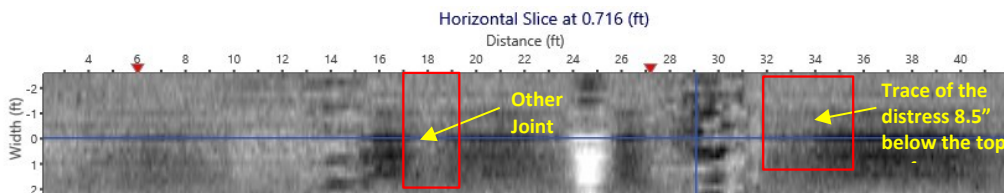
Figure 11.15 GPR Image. Location of distress at joint 3A, 8.5-inch below the top surface.

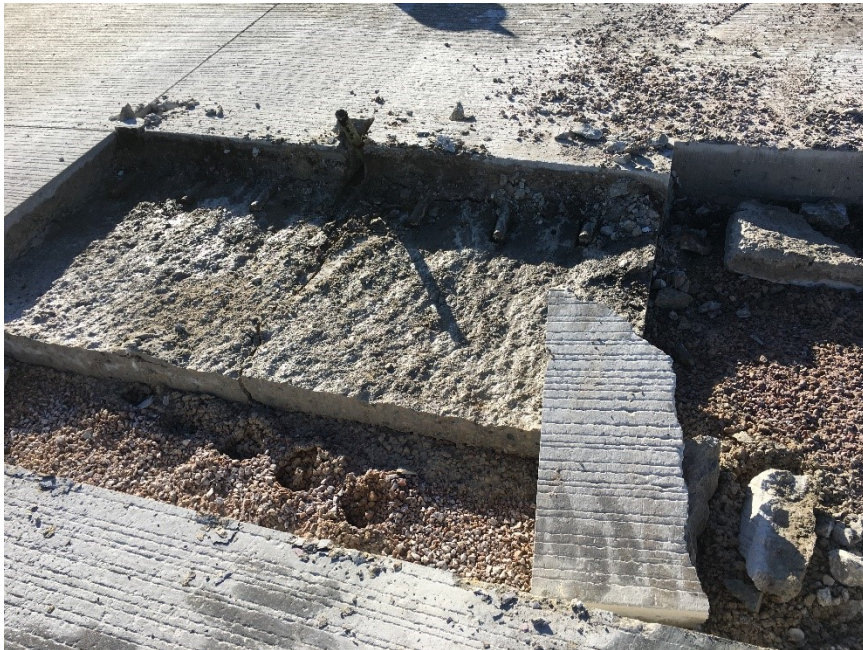
Figure 13.3 Contour Plots. Trench showing delamination cracked concrete from undocumented site in Wisconsin.

The results of the trenching operations conducted by MnDOT and WisDOT are consistent with the results from coring, MIRA scans, and GPR testing. The delamination cracks are at the depth of the dowel bars and extend rather uniformly through significant transverse length of the concrete slab. The uniformity of the crack (i.e., the crack is fairly horizontal and extends through multiple dowel bars) suggests that the delamination action is caused by the combined action of multiple dowel bars (acting in sync) rather than that of one or two dowel bars. At the very least it likely indicates a horizontal zone of weakness for the crack tip to propagate.
