Solutions to Mitigate Dowel/ Tie-Bar Propagated Cracking - Phase 1

Shreenath Rao, Principal Investigator
Applied Research Associates, Inc.

April 2024

Final Report NRRRA202402

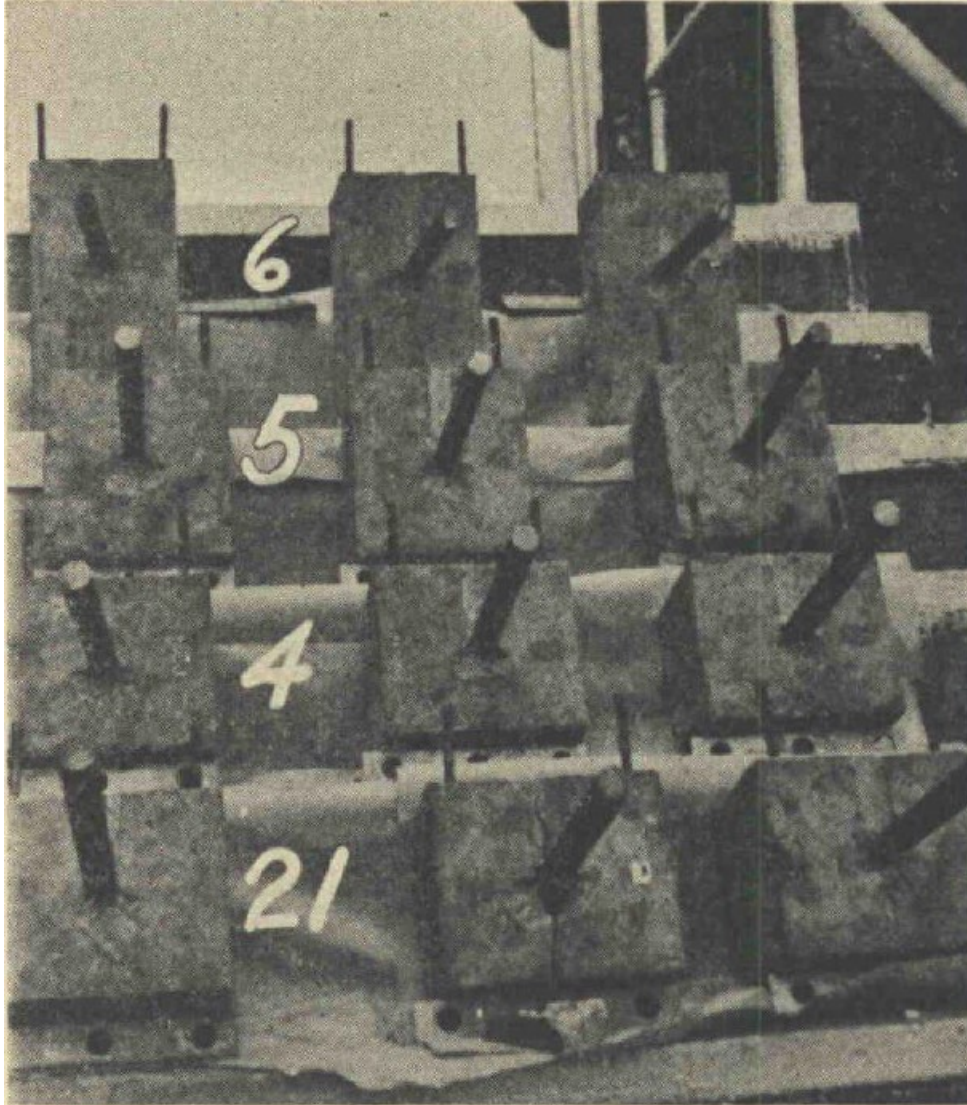
It is relevant to note that the phenomenon of microcracking around concrete dowel bars is not new. As early as 1938, Friberg, who conducted laboratory tests on single dowel bars encased in concrete and loaded to failure noted “the initial visible distress of the concrete comes a considerable time before the ultimate load is reached. The initial warning almost always consisted of a small spalling underneath the dowel, first noticeable as a fan-shaped crack from 0.5 inch to 1.5 inch away from the dowel. In the deeper specimens, the first evidence would be a very small, horizontal crack, extending from the dowel toward each side, merging into a fan-shaped failure as the load increased.” (Figure 15.3).

Figure 15.3 Photo. Specimens from laboratory testing of dowel bars showing typical failures around dowel bars (Friberg 1938).
