Federal Railroad Administration

Automated Weld Repair of Manganese Frogs for Extended Service Life

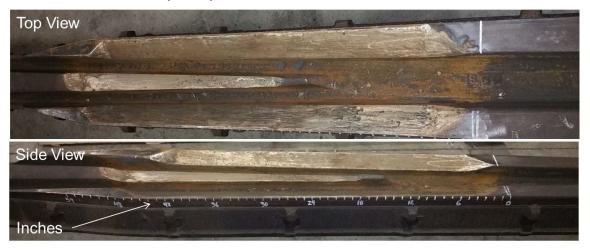
EWI prepared both the wings and the point using the same methodology as in Phase 1. The surfaces were initially carbon-arc-gouged to remove the bulk of the material (Figure 14). An electric grinder made the final dimensions and smoothed out the surfaces. In the future, this operation could be carried out with robotic automation, using grinders that would keep the grind profiles more consistent as well as reduce any safety concerns with the manual work.

Figure 14. Frog surface prepared

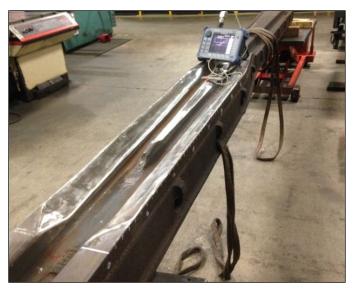
eddy current testing as an alternative for detecting surface cracks (Figure 15). The eddy current setup consisted of a Nortec model 600 portable eddy current instrument with a Hocking NDT model 800P01 cross-point 100-KHz probe. A piece of AISI 4340 steel was used to calibrate the system. The calibration sample contained three electrical discharge machined (EDM) notches to simulate surface cracks. The notches were 0.2-, 0.5-, and 1.0-mm deep. An image of the eddy current equipment and calibration sample is in Figure 16. An image of the eddy current response for each EDM notch is in Figure 17. Following calibration, the entire excavated and ground area was manually scanned using the eddy current cross-point probe. No cracks were detected during this inspection.

Figure 15. Prepared frog with eddy current equipment

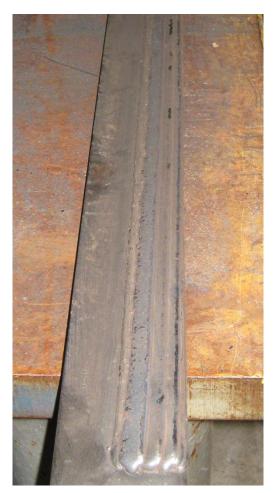
There was excessive spatter within the nozzle observed during the point welding process (Figure 20). EWI had some concerns about the weld spatter negatively impacting the weld characteristics and quality, especially considering that the wing repairs would be significantly longer passes. To evaluate the effect of spatter on weld quality, EWI executed a test weld on a carbon steel base plate, welding three beads across and three layers high over a 47-inch length (Figure 21). The entire length was subjected to radiographic testing that revealed zero pores and no lack of fusion. The spatter was not affecting the weld quality.

Figure 21. Spatter collection test beads

Excessive spatter may be a negative factor in a production-type automated welding process. Frequent nozzle cleaning would be necessary, thus reducing the productivity of the system. Considering this, EWI made a few changes to the process to minimize spatter collection. The first change was the nozzle material. The GMAW torch nozzle was a standard brass shroud. This is typically sufficient for most applications. However, copper shroud nozzles are also available and typically used for more heavy-duty applications. Copper has high thermal conductivity and spatter does not collect as easily on this surface. The second change was to the contact tip and nozzle diameter. The setup used a recessed contact tip position which increases the chance of spatter collection (Figure 22). EWI changed the setup to use an extended-contact tip position and a largerdiameter nozzle (Figure 22, Figure 23).

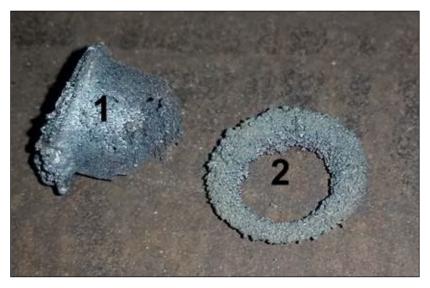
EWI ran additional tests to verify the changes resulted in less spatter collection. The tests showed the changes produced a significantly less spatter collection within the nozzle. Figure 24 shows the difference in spatter collection once these changes were implemented, where a "1" represents the spatter with the previous setup, and a "2" represents the spatter with the changes implemented.

Figure 24. Spatter collection comparison

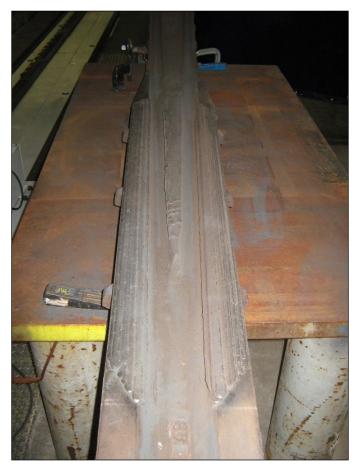
Proceeding with the weld repair, EWI repaired the lower wing first (Figure 25). A total of eight layers were required to build up the wing (Figure 26). Layers 1–6 were deposited in the same direction. Once the end of Layer 6 was reached, the weld deposit was approximately 0.125 inch below the work-hardened surface. Layers 7 and 8 were then welded from the opposite direction and started on top of the work-hardened base material surface. The upper wing was repaired in the same manner as the lower wing. The final repair is shown in Figure 27.

Figure 27. Both wings and point repaired

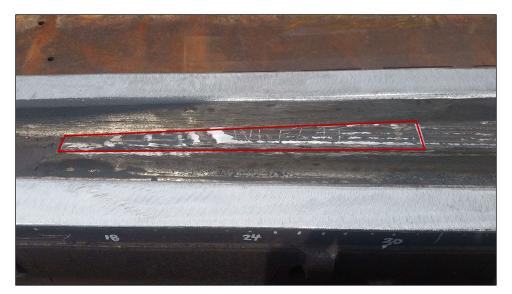
Both wings were ground to final dimensions and part of the point was finished. However, during final grinding, the point appeared to be slightly lower than the 0.1875-inch requirement (Figure 29). During initial layout of the repair, the point exhibited the correct height, but the additional thickness of repair on the wings was not taken into consideration. To bring the point back to the correct height, CSX recommended that EWI add additional weld material in the area shown in Figure 30, which extended 14 inches back from the point. EWI deposited eight layers of weld material in this area to bring up the height (Figure 31).

Figure 30. Area on point needing additional deposit

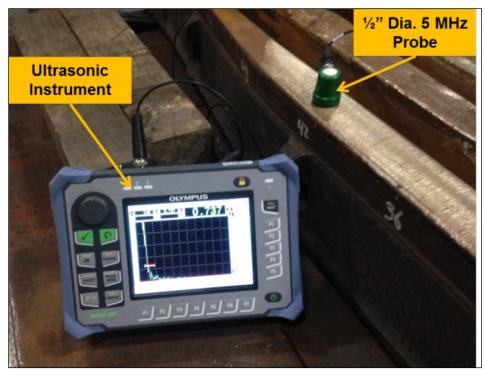
EWI completed post-grind dye penetrant (PT) and ultrasonic (UT) inspections. The UT setup consisted of an Olympus Epoch model 650 portable ultrasonic instrument and two, 0-degree, longitudinal wave probes. Two scans were performed on the repaired area to detect discontinuities in the weld deposit layers and interface. For the first scan, a 5-MHz, 0.25-inch-diameter delay line probe was used to detect discontinuities up to 0.5 inch deep. For the second scan, a 5-MHz, 0.5-inch-diameter probe was used to detect discontinuities up to 1.5 inches deep. EWI used a NAVSHIPS carbon steel calibration block with 0.046875-inch-diameter, side-drilled holes for calibration. An image of the UT equipment is in Figure 35. No discontinuity indications were detected during the inspections.

Figure 35. Ultrasonic equipment used for the inspection

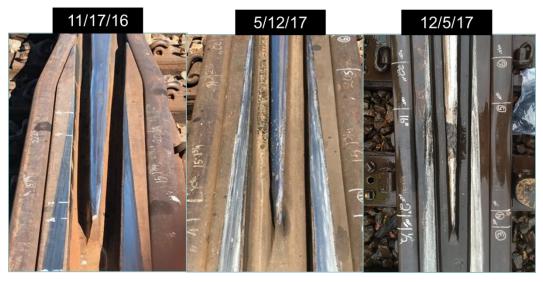
Detailed profile measurement data is provided in Table 20 and images of the frog at installation, midpoint, and end of test are shown in Figure 38. CSX and EWI estimated the frog's service load reached 63 MGT over its 13-month service life – roughly 125 percent of the life of an average first-time repair on a frog, as reported by field personnel. Per CSX, the frogs installed at Decatur Junction often required more frequent weld repairs than average, sometimes once per month. CSX qualified the frog's wear as minor, aside from the breakout near the point tip (described below). Only minimal grinding was needed to remove plastic metal flow from the point and wings. The final profile measurements show a maximum wear of 0.3125 inch at an isolated location. The average wear was 0.125 inch over the wings and point. The wear criteria for weld repair is 0.375 inch.

Figure 38. Frog profile over the revenue service life

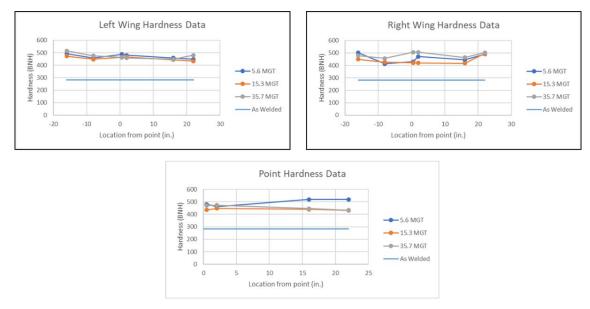
measured the hardness at the same points along the frog where the profile measurements were made. Measurements were taken on both wings and the point at the locations shown in Figure 40. A traverse of 10 to 12 individual hardness measurements were taken across the running surface at each location. The individual hardness traverses were statistically analyzed by the Proceq tester. The mean value for each measurement location and set is shown graphically in Figure 41. The repaired area quickly work-hardened. To gage the rate of work hardening, EWI collected measurements from the repaired area, but outside the running surface. These areas had an average as-welded hardness of 283 Brinell (BNH). Hardness measurements taken at the running surface after a little more than 5 MGT had an average of 464 BNH, confirming a rapid work-hardening in the repaired areas.

Figure 41. Hardness measurements in repair areas of the CSX frog

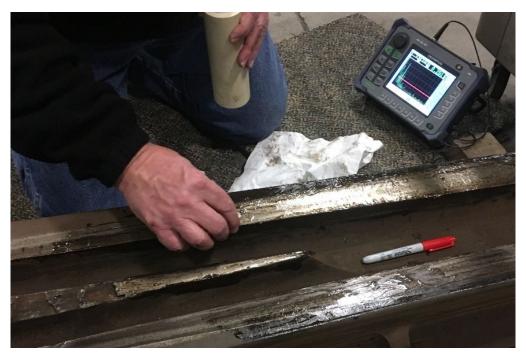
Figure 44. UT inspection with a single crystal probe

The UT inspection found 19 notable crack indications at various depths from the running surface. All UT crack indications were located within the running surfaces. Welding repair areas outside the running service (no wheel contact) had no indications. The depth of the indications from the running surface ranged from 0.125 inch to 0.650 inch. The indications were isolated, and there were no clusters of indications. The longest indication was roughly 2 inches in length. EWI mapped the locations (Figure 45) and documented their depths and positions relative to the frog point (Table 21).

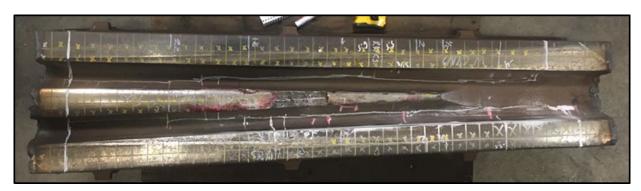
After PT was complete, EWI cut the frog into sections with an oxyfuel torch near the ends of the repair for ease of handling. A grid area (approximately 1×1-inch) was drawn over the repair area (Figure 47). A technician acquired four hardness measurements in each box and the results were statistically analyzed by the Proceq tester. The mean values were plotted on graphs for comparison to hardness measurements taken while the frog was installed at Decatur and to the frog repaired during Phase 1 (Figure 48). The hardness data plots focus on the left wing and point since there was no repair on the right frog wing Phase 1. EWI gathered hardness data from the CSX frog's right wing and is comparable the left wing. The hardness levels for the CSX and Phase 1 (labelled "TTCI" in figure) frogs were very close in value. Both were in the desirable range for AMS inservice material. The Phase 1 frog was welded with commercially available FCAW wire, while the CSX frog was welded with a custom metal-cored wire based on the FCAW wire. The parity between the hardness results indicates the new metal-cored electrode and GMAW-P process did not reduce the hardenability of the weld material. The hardness measurement taken near the tip of the

point (~0 in.) after 63 MGT on the CSX frog was notably lower than the other readings taken at that location. This was likely due to subsurface cracking in that area. The Proceq hardness tester uses a rebound-style probe to measure hardness. This style of test requires the material to have a minimum level of stiffness; the measurement system will produce erroneous results when the test area is flexible. Subsurface cracks, discussed later in this section, will reduce the local stiffness of the assembly.

Figure 47. CSX frog with hardness grid layout

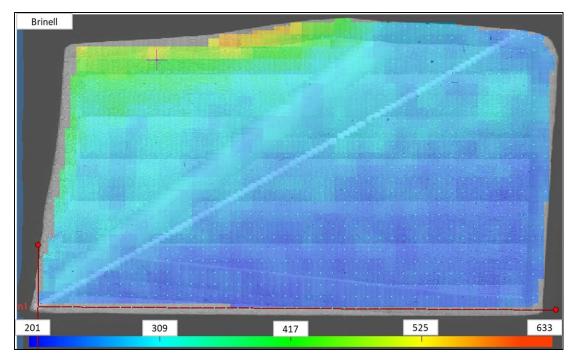
Figure 50. Left wing cross-section with hardness map

The cross-sections for both wings were taken from the running surface (wheel contact area) in the frog transition zone where the wheel load is partially carried by the point. The full width of the wing was excised down to approximately 1.5 inches below the running surface (Figure 50 and Figure 51). EWI completed hardness mapping with an automatic micro-harness system using a 500g load. Indents were made 0.057 inch apart.

These maps clearly show the depth of hardening that occurred due to the wheel loads. The section of wing taken from the left side had an average hardness near the running surface of 543 BNH (Figure 50) – similar to the hardness measured at the surface (Figure 48). Hardness in the as-welded areas of the build averaged 296 BNH. New premium frogs are explosion depth-hardened on their running surfaces to approximately 352 BNH, and the hardened depth extends approximately 0.5 inch below the running surface. On the left wing section of the CSX frog, hardness decreased to 352 BNH at the depth of 0.35 inch. The right wing section had an average hardness near the running surface of 515 BNH (Figure 51). The as-welded area had an average hardness of 260 BNH. The depth to reach 352 BNH from the running surface on this wing was 0.29 inch.

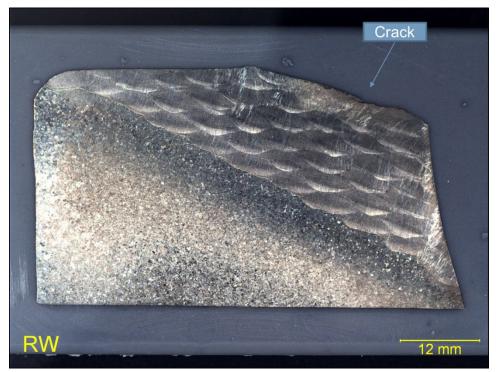
Figure 59. Right wing cross-section

EWI also examined the cross-sections taken from the wings and found no indications of microstructural issues. Both wing cross-sections had clear areas of strain bands where the deformation was highest (Figure 58 and Figure 59). On the right wing a crack was visible on the running surface. This location corresponded with the breakout area on the point. When the wheel fell into the breakout, it landed on the wing, which is a likely cause for this crack.

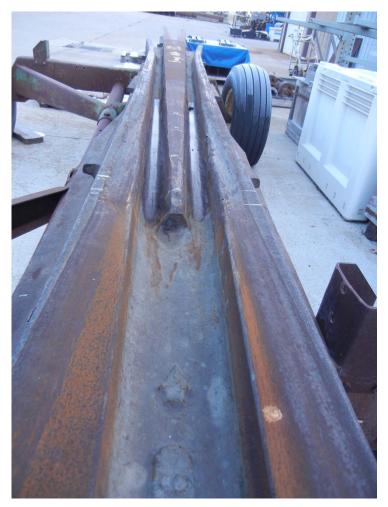
Figure 65. #20 WMB frog as delivered to EWI

The NS #20 WBM frog was part of an experimental lot provided by Nortrak to NS in 2013 and had a heavy point (wider than standard) and conformal wings (designed to carry wheel loads over a greater area). NS removed the frog from service in Kentucky after 366 MGT over more than 4 years. During that time, NS weld-repaired the frog in the field 14 times (Figure 67). The frog was destined for scrap but was instead re-directed to this automated weld repair program.

The NS frog was significantly more worn than the Phase 1 or CSX frogs. Approximately 1 inch of material removal was required to prepare the frog for the weld repair process. Per NS, some of the damage to the wings of the frog was caused by a height mismatch between the wings and point. For the train wheel to smoothly transition from the wing to point, or vice versa, both must be at the same height where the load is transferred. According to NS, some frogs with this conformal wing design have had wings roughly 0.25 inch above the point. This mismatch resulted in the wheel

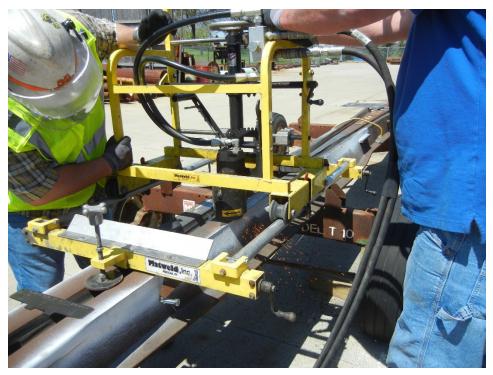
Figure 69. Mechanized grinding system to lower frog wings

The WBM frog provided to EWI was not the only frog that suffered from excessive damage due to wing height mismatch in NS service. To address this issue, NS engaged a program to grind the wings of all affected frogs in the system. EWI and NS agreed that completing this grinding process before the automated weld repair was essential to achieving the correct final wing heights after repair. NS sent a crew to grind the frog in EWI's laydown area (Figure 69), which included a mechanized and manual grinding process.

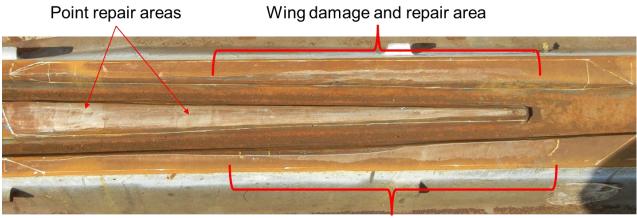
Figure 70. Field repair areas pop out visibly due to light rust formation

After NS completed grinding, EWI laid out the repair area in a fashion similar to the previous frogs. One unexpected effect of grinding the wing and point surfaces was it allowed the easy identification of prior field repair locations. A light coat of rust formed on the freshly ground surfaces, causing the field repairs to pop out due to less rust forming in these areas. This is due to the filler material used for field repairs which contains a small amount of chromium that the base frog material does not, making the weld-repaired areas more corrosion resistant (Figure 70). With the field repairs visible, EWI chose to extend the total repair area to roughly 54 inches to remove as many field repairs as possible.

Wing damage and repair area

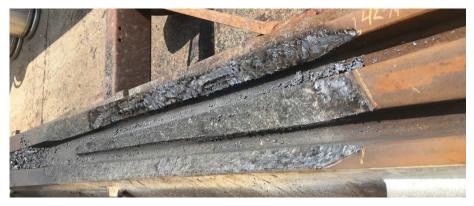
Figure 78. WBM frog after gouging repair area

EWI manually carbon-arc-gouged the worn frogs to remove the bulk of the material (Figure 78). After gouging, a crack was found in the point near the end of the repair (Figure 79).

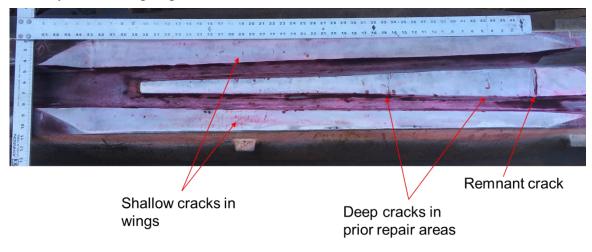
Figure 80. Repair area in WBM frog after penetrant test

EWI ground a groove on the point to remove the crack found after grinding. An electric grinder was used to achieve the final dimensions and to smooth the surfaces. To inspect the ground repair area a PT was performed (Figure 80), revealing deep cracks in the point that were areas subject to prior filed repairs. Shallow cracks were also found in the wings, many of which would be consumed by the weld repair penetration.

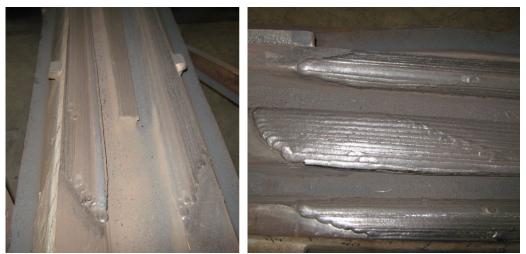
Figure 88. Fully welded frog repair joint

The weld repair used roughly 90 lbs of filler material to build up the wings and point. In total, nearly 500 beads were needed to create the 8 layers each for the wings and 11 layers for the point (Figure 88). EWI monitored inter-pass temperatures closely, with an average temperature at 154°F and a max of 220°F. Due to the distortion created from weld shrinkage, the frog would move; these movements required monitoring and shifting the weld paths. These position checks and position shifts led to longer pauses between beads than expected and influenced the inter-pass temperatures.

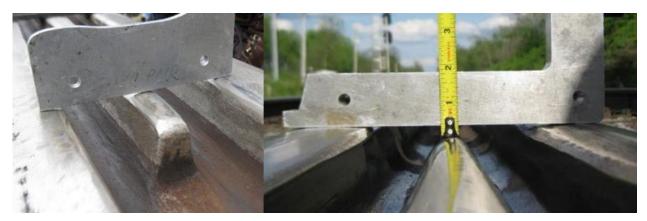
Figure 92. Point before (left) and after (right) taper was ground to the proper profile

NS technicians completed additional point grinding after the frog arrived at a preinstallation yard near Danville, Kentucky. A profile gauge inspection performed by the welding crew in Danville showed the end of the point was at the same height relative to the wings. In the first 10 inches, the point was to taper from 0.3125 inch below the wings to even with the wings (Figure 92). The welding crew in Danville used an electric grinder to modify the point profile to the proper taper.

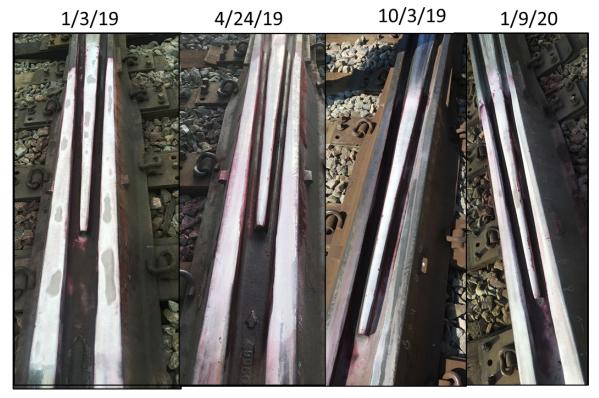
Figure 95. Frog PT

In addition to profile measurements and visual inspections during the visits, EWI inspected with PT four times (Figure 95). PT was not performed during the final visit due to the need for weld repairs. Crack indications were found on the running surface of the point during each of the last three inspections. Most areas of surface spalling and surface cracks grew between the second and third visit (October 2019 to January 2020). There were no indications of cracking that required repair during the final PT. The wings had no crack indications aside from isolated pores.

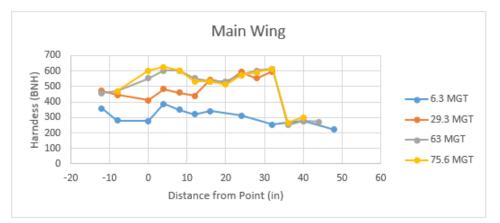
Figure 97. Hardness measurements: NS frog, main wing

The Proceq tester statistically analyzed the individual hardness measurements. The mean value for each measurement location and set is shown graphically in Figure 97, Figure 98, and Figure . Measurements were also taken on the automated weld repair outside the running surface. These areas had an average as-welded hardness of 250 BNH.

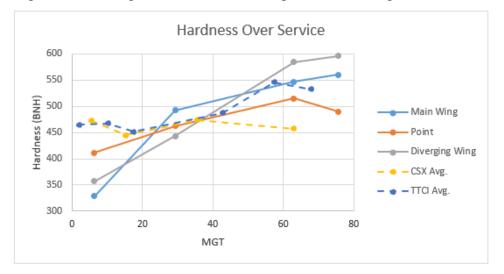
Figure 98. Comparison of work hardening rates

Hardness values taken at the running surface did not reach a stable, work-hardened state as quickly as the previous frogs (Figure 98). (Note: Phase 1 frog labelled TTCI in figure.) Once the hardness level of the automated weld repair reached a stable work hardened range, it averaged around 20 BNH points higher than the highest level measured in previous test frog.
