TECHBRIEF

Corrosion-Induced Major Tendon Failures in Post-Tension (PT) Concrete Bridges

FHWA Publication No.: FHWA-HRT-24-148

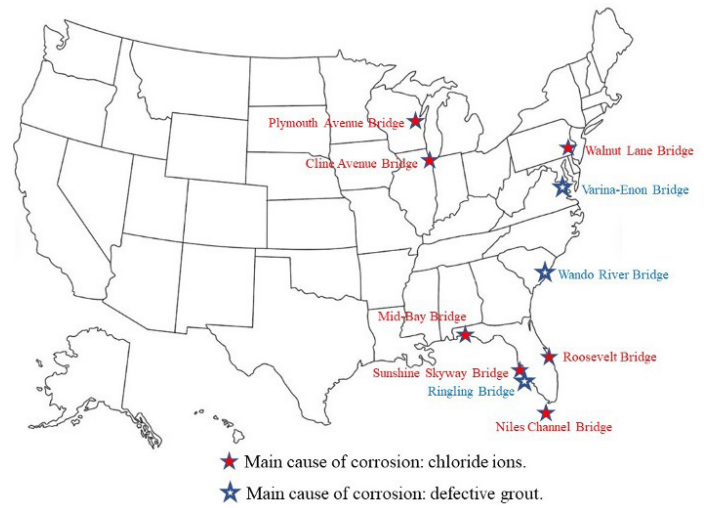
Figure 1. Illustration. Bridge locations on the U.S. map, modified by the authors.

Between 1990 and 2020, 6 States—Pennsylvania, Florida, Virginia, Minnesota, Indiana, and South Carolina—experienced tendon failures in a total of 10 major PT bridges. Figure 1 shows the approximate locations of the affected bridges and their main causes. Also, table 1 summarizes the bridge characteristics and key corrosion-related information.
