Mitigation of Corrosion in Continuously Reinforced Concrete Pavement

Study SD2009-05

Final Report

Prepared by
Allen L. Jones and Nadim I. Wehbe
South Dakota State University
Department of Civil and Environmental Engineering

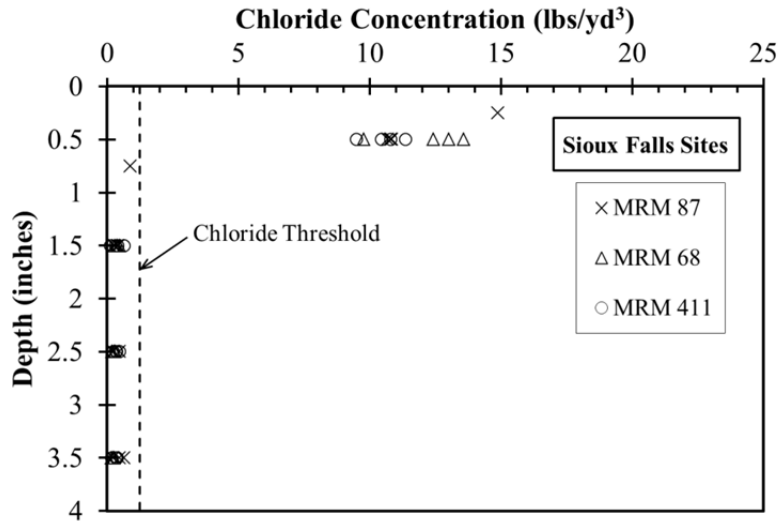
Figure 6-2: Chloride concentration versus depth in dust samples collected near Sioux Falls

Table 6-1 and Figure 6-2 show that the chloride ion concentration is typically above the threshold within the top one inch of the concrete. From depths of greater than 1 inch to 3.5 inches, the chloride concentrations are all below the threshold. The maximum chloride concentration obtained at 3.5 inches was 0.64 lbs./yd³, which is approximately half of the chloride threshold.

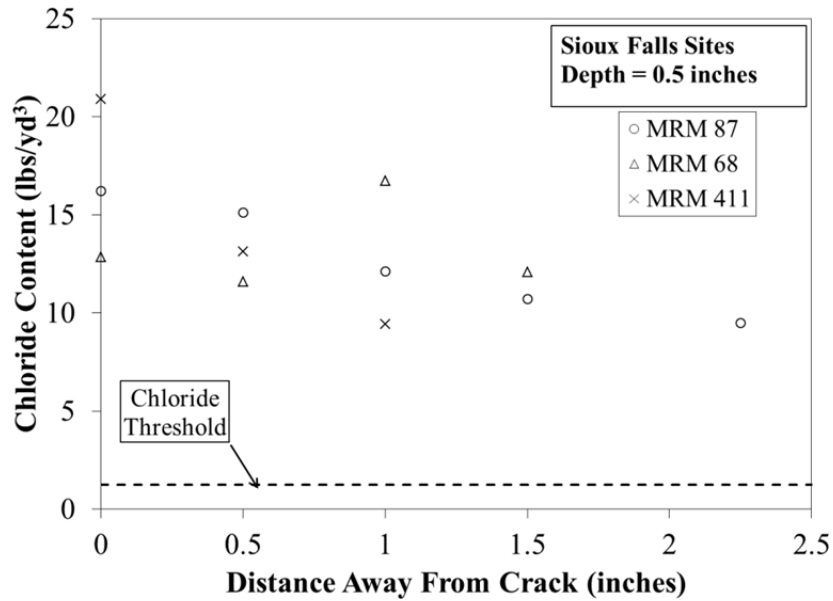
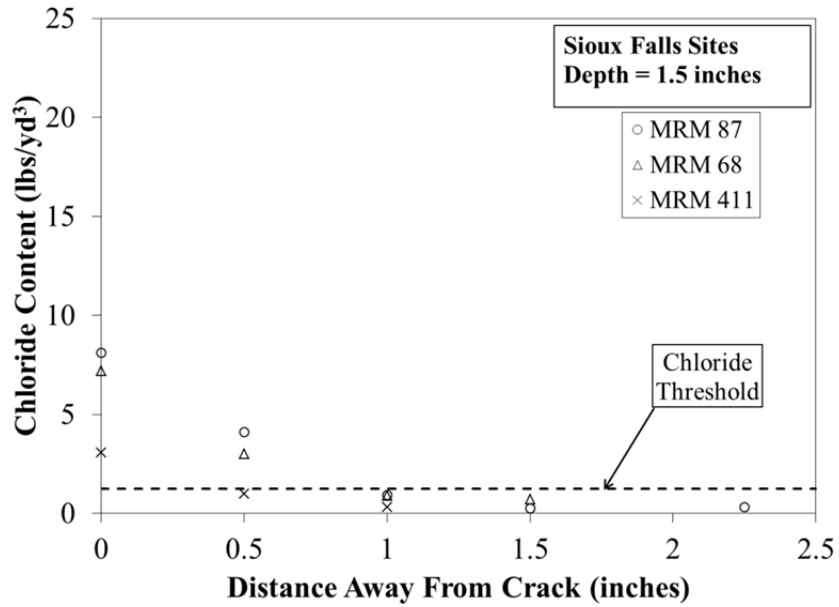
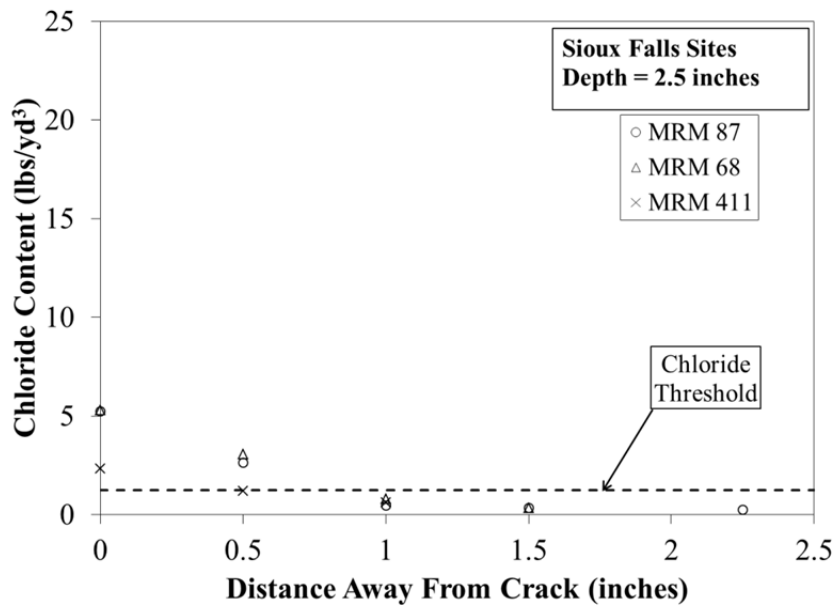
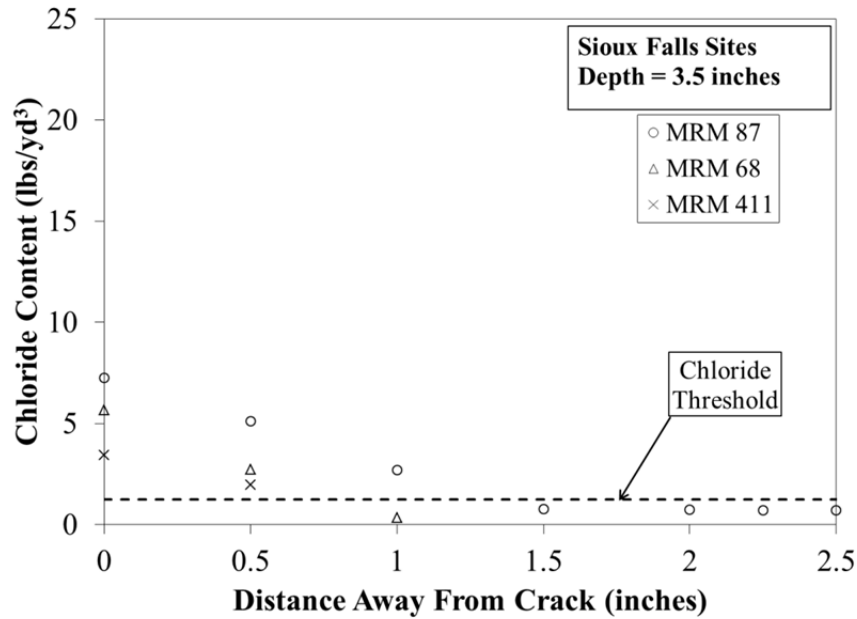
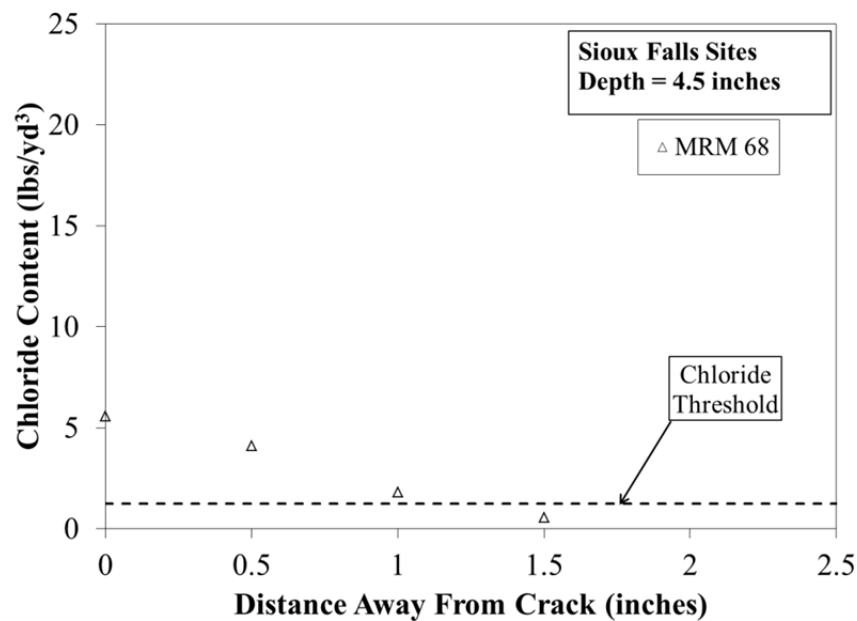
The data presented in the previous figures shows that the chloride concentrations are above the threshold within the top vertical inch of the pavement. Also, chloride concentrations are above the threshold within the first lateral half inch of a crack location. This is true even at depths of 3.5 and 4.5 inches.

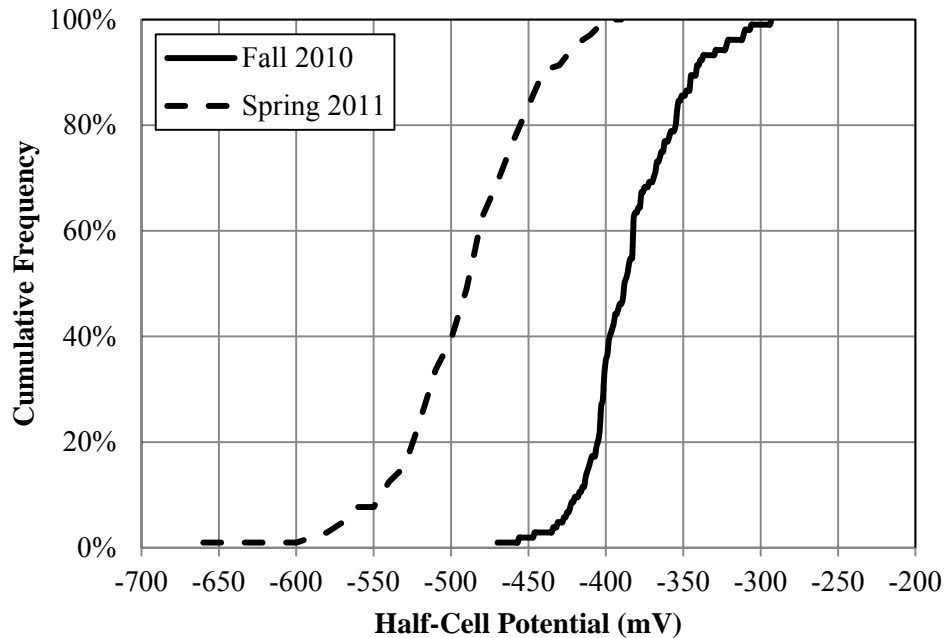
Figure 6-8: MRM 87 half-cell cumulative frequency distribution

Potential Measurement Range	Indication	Percent of Data Points in Range	
		Fall 2010	Spring 2011
> -200 mV	90% probability that no reinforcing steel is corroding	0.0%	0.0%
Between -200 mV and -350 mV	Corrosion activity is uncertain	14.4%	0.0%
< -350 mV	Greater than 90% probability steel is corroding	85.6%	100.0%

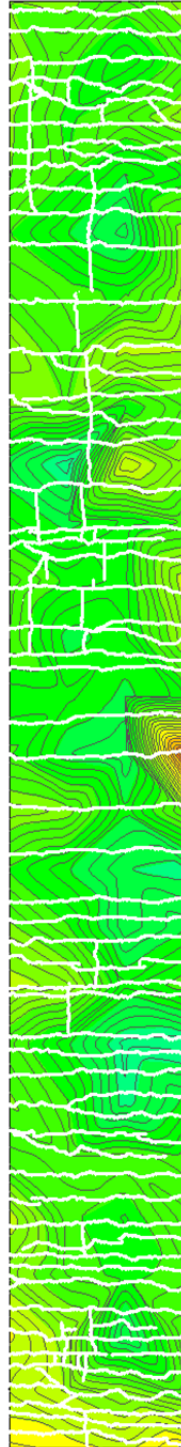
Figure 6-9: MRM 87 equipotential contour map

Equipotential contour maps were constructed using the half-cell data. The equipotential contour map for the spring measurements at MRM 87 is presented in Figure 6-9 along with its corresponding legend. Equipotential contour maps of both sets of half-cell potential measurements are presented in Appendix B.

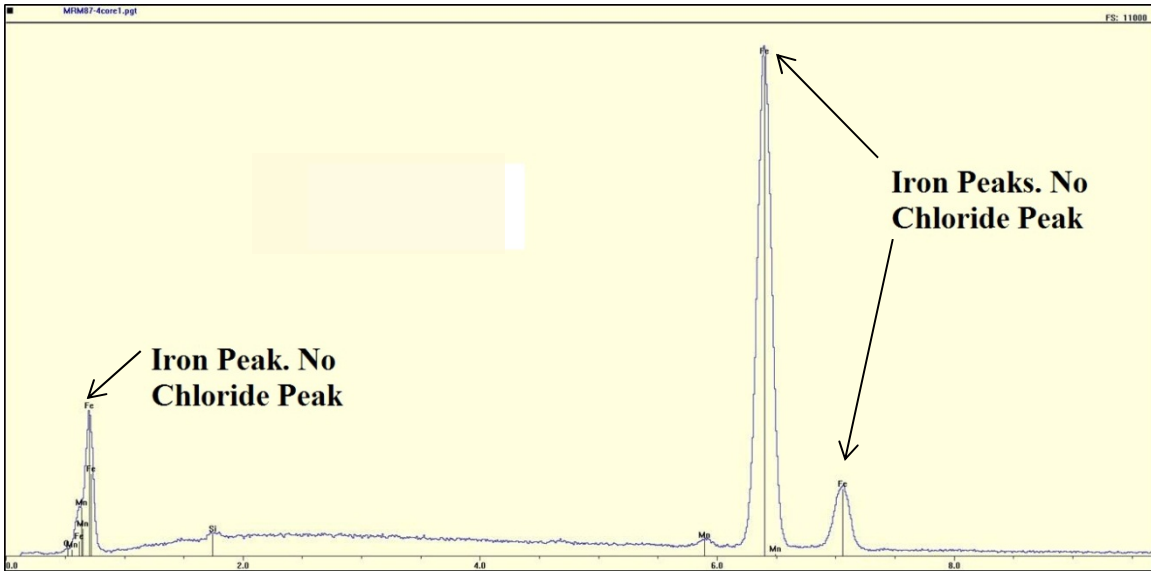
The reinforcement in an uncracked concrete core from site MRM 87 was also analyzed to determine if corrosion was present in the reinforcement away from pavement cracks. The core was labeled MRM 87-4. A photograph of the polished section of reinforcement from this core is shown in Figure 6-12. The photograph shows that there are no signs of corrosion in the reinforcement. As with cracked core MRM 87-3, the intact core exhibited a thin oxidized layer around the entire perimeter of the steel bar. This layer was analyzed using SEM, and the results showed no signs of chlorine or corrosion. Figure 6-13 shows the energy dispersive spectrum of the sample. Only iron peaks are present.

Figure 6-13: Energy dispersive spectrum of reinforcement sample - no chlorine present

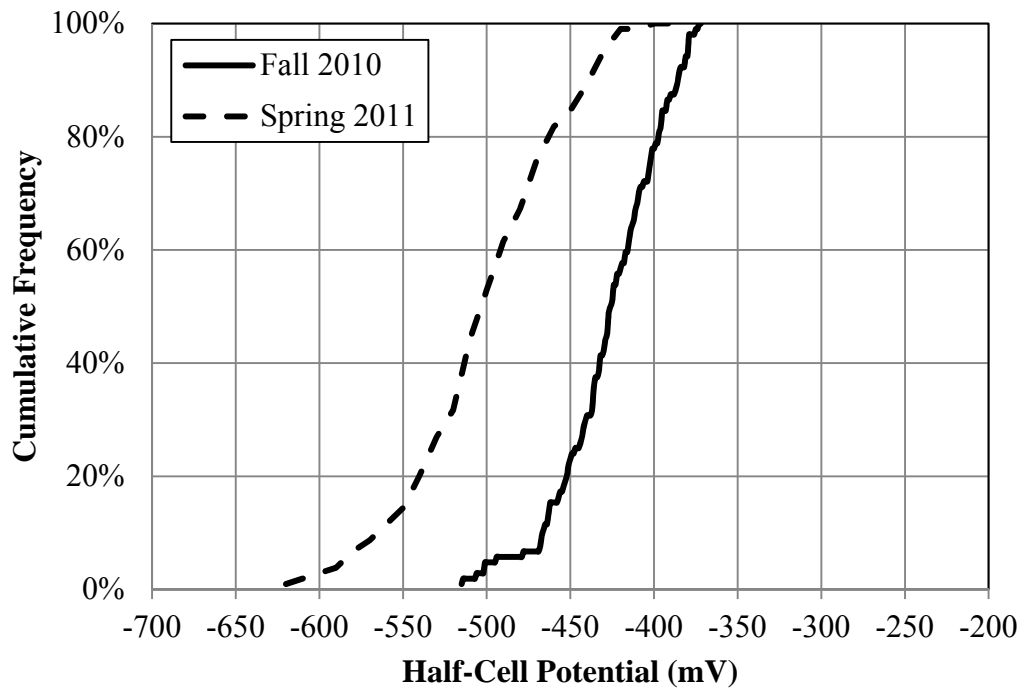
Figure 6-14: MRM 68 half-cell cumulative frequency distributions

Figure 6-14 presents the cumulative frequency distribution for half-cell potential at this site and Table 6-6 presents a summary of the data points that fall within certain ranges of corrosion probability. The figure and the table show that all of the measurements obtained at this site indicate high probability of corrosion according to ASTM C876. Equipotential contour maps of both sets of half-cell potential measurements are presented in Appendix B.

Potential Measurement Range	Indication	Percent of Data Points in Range	
		Fall 2010	Spring 2011
> -200 mV	90% probability that no reinforcing steel is corroding	0.0%	0.0%
Between -200 mV and -350 mV	Corrosion activity is uncertain	0.0%	0.0%
< -350 mV	Greater than 90% probability steel is corroding	100.0%	100.0%

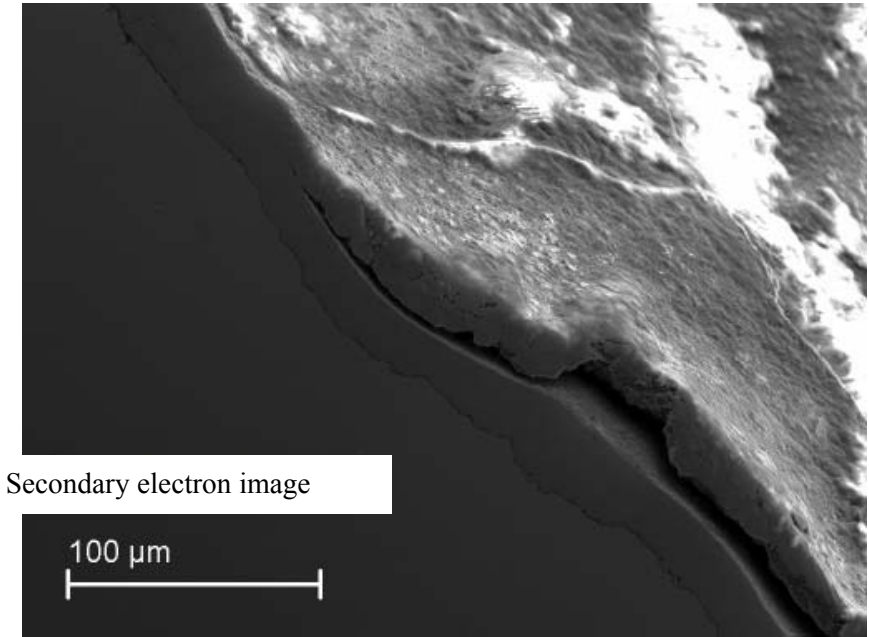
SEM, a thin oxidized layer (30-50 μm) was detected, consistent with that which was observed in core MRM 87-3. A backscattered electron image of a portion of the reinforcement is shown in Figure 6-16. There did not appear to be corrosion, even though there was local delamination evident along the reinforcement which could potentially allow the intrusion of chlorides.

Figure 6-16: Local delamination along reinforcement

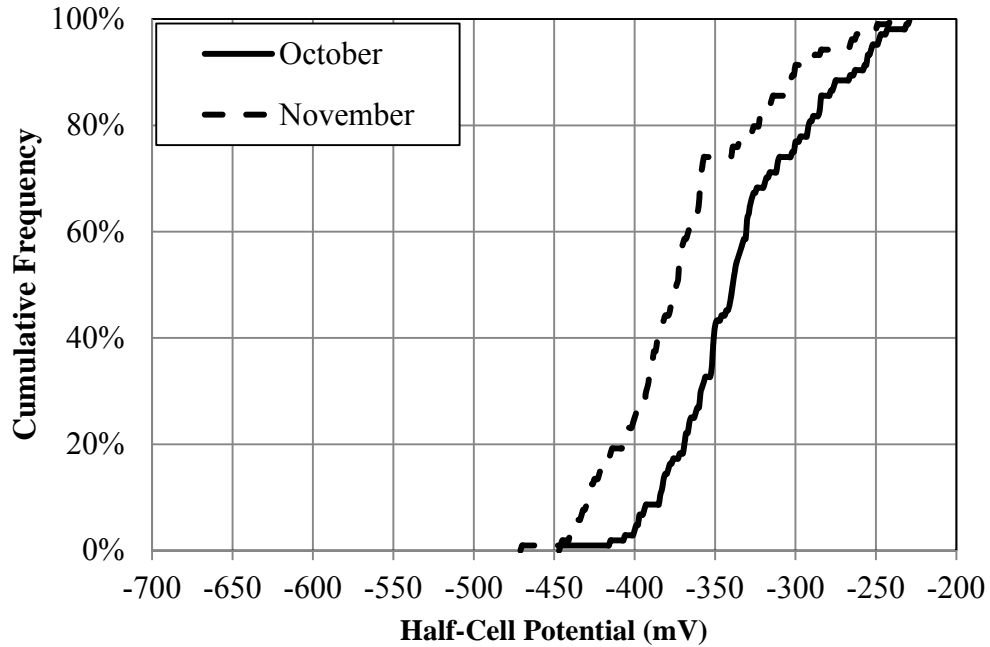
Figure 6-17: MRM 411 Half-cell potential cumulative frequency distribution during fall 2010

The initial and follow-up half-cell potential measurements obtained on October 14 and November 3, 2010, respectively, were compared to determine if there was a drift in the measurements. In general, the half-cell follow-up measurements were more negative than, but within 10 percent of, the initial measurements. The distributions from the two sets of measurements are presented in Figure 6-17.

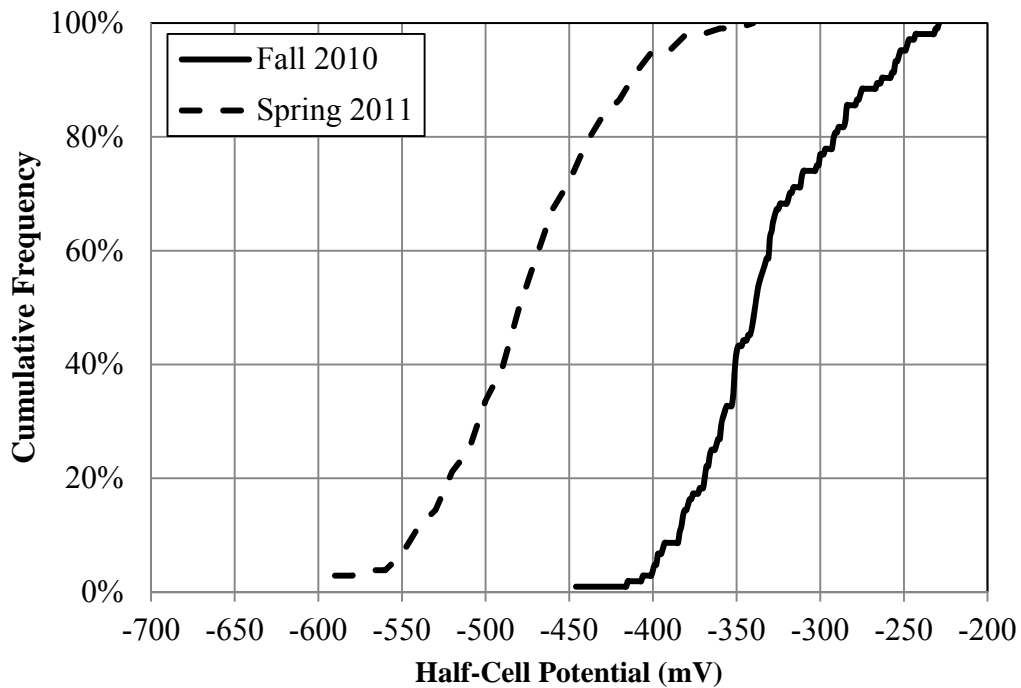
Figure 6-18: MRM 411 half-cell potential cumulative frequency distribution

Figure 6-18 presents the cumulative frequency distribution for half-cell potential before and after one winter maintenance cycle. Table 6-8 presents a summary of the data points that fall within certain ranges of corrosion probability. Equipotential contour maps of both sets of half-cell potential measurements are presented in Appendix B.

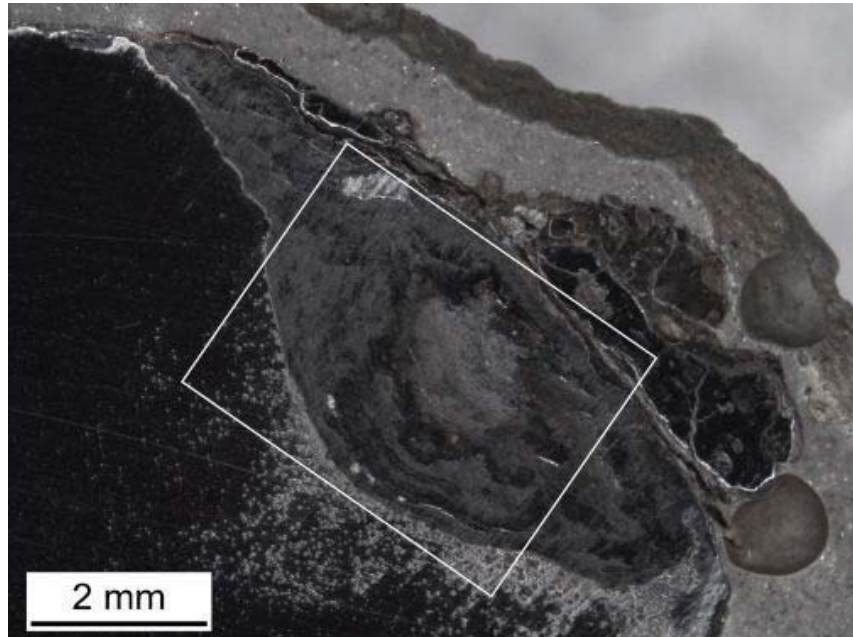
The corroded area towards the top of Figure 6-19 was determined to be either minimal corrosion or surficial rusting based on energy dispersive analysis. There were also other areas along the exterior of the steel bar that were found to exhibit surficial rusting but not corrosion. Elemental mapping showed that the area on the right side of the reinforcement was corroded and the surrounding concrete contained

Figure 6-20: Corroded area enlarged

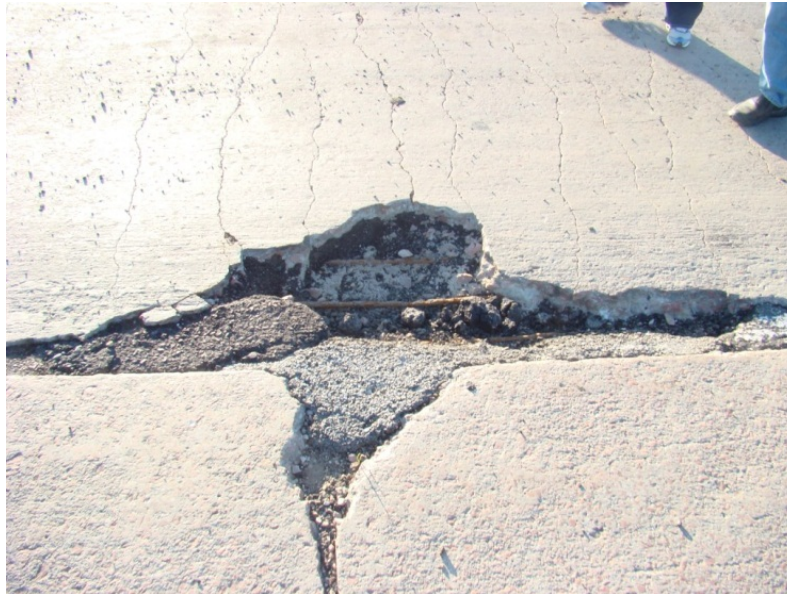
completed on July 1, 2010. Visual inspection revealed that several sections of pavement had been previously patched at this site. Most of these patches were filled with asphalt, while some were filled with concrete. The reinforcement steel in some of the patched locations showed signs of corrosion, as shown in Figure 6-22. It was uncertain if the corrosion in patched sections similar to that shown in Figure 6-22 was due to deicing salts, open exposure to precipitation, or a combination of both. However, within a patch, localized corrosion resulting in a noticeably reduced cross-sectional area of reinforcement was present, which could indicate that deicing salts or water intrusion played a role in the corrosion process. Localized corrosion was also observed on steel reinforcement from CRCP that had already been demolished by the time the research team had arrived at the site as shown in Figure 6-23.

Figure 6-22: Patched pavement with exposed reinforcing steel

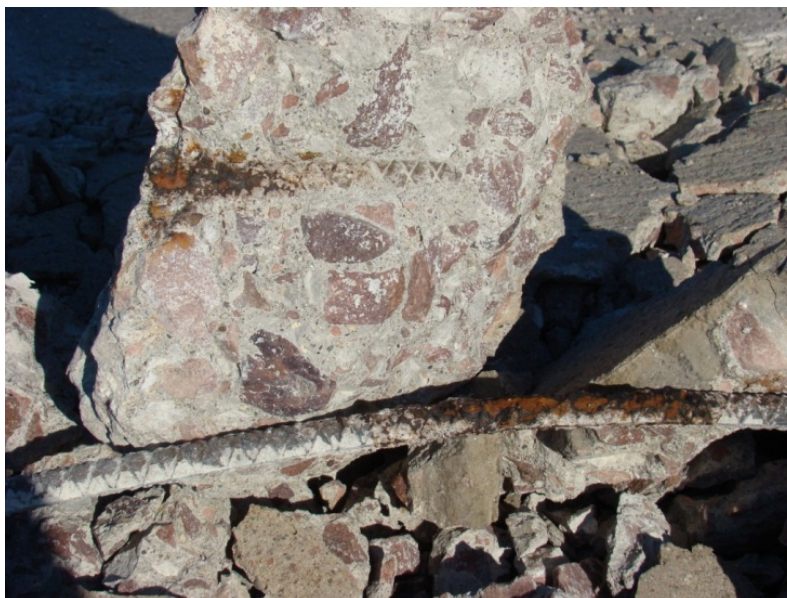
Figure 6-23: Localized corrosion found in the concrete rubble that was eventually removed

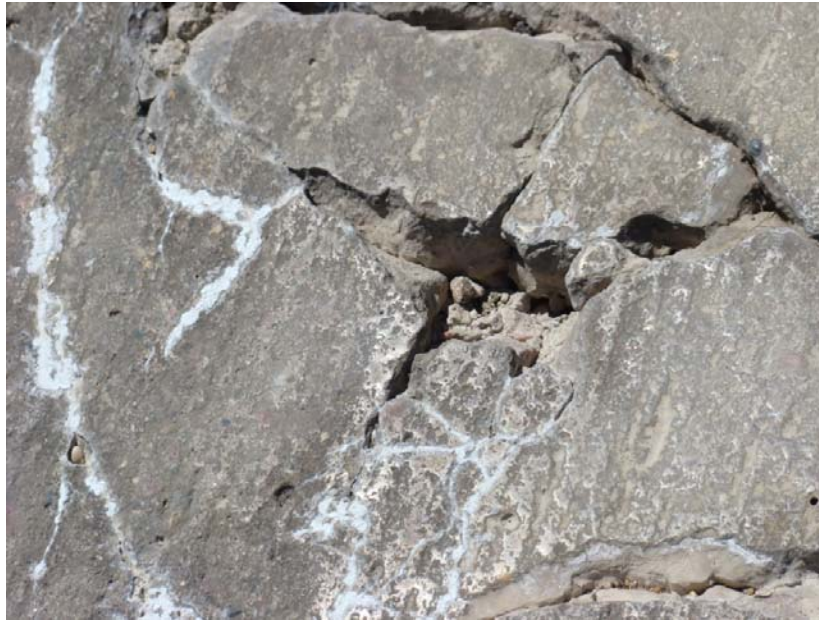
Prior to inspection, ground penetrating radar was used to locate the longitudinal and transverse reinforcement bars embedded in the intact pavement. The ground penetrating radar instrument was provided and operated by SDDOT personnel. Transverse cracking was observed to have occurred directly above the transverse reinforcement bars throughout the site. The measured depth of the concrete cover over the reinforcing steel was inconsistent and ranged from less than 3 inches to 4 inches. Also, it was noted that some locations with a considerable amount of spalling did not show visible signs of corrosion. An example of one such location is presented in Figure 6-24. This indicates that corrosion may not necessarily have caused this type of pavement distress.

Figure 6-24: Spalled area with no signs of corrosion

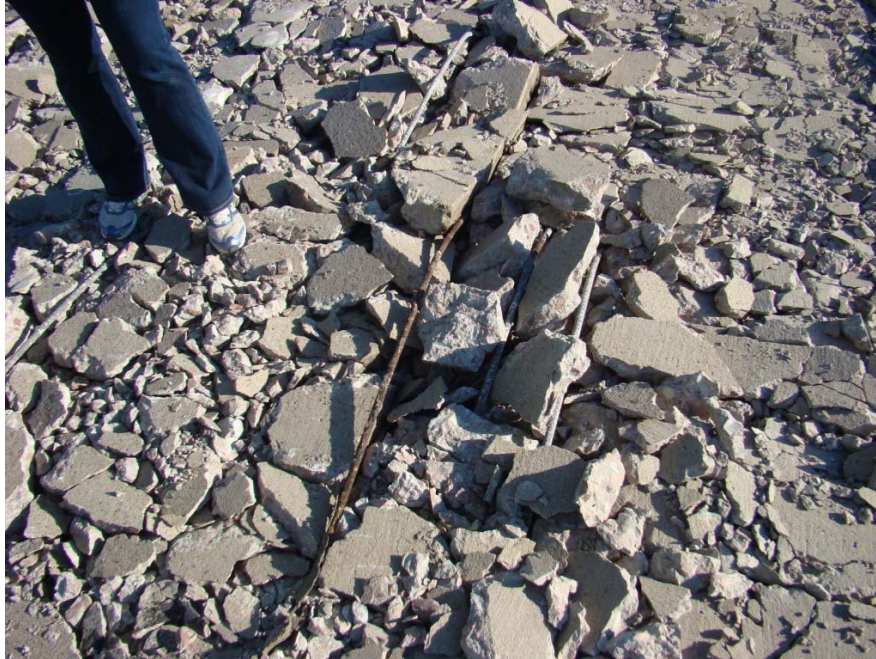
The research team observed a longitudinal reinforcing bar that was severely corroded throughout its length as shown in Figure 6-25. This bar had been placed below the longitudinal center joint in the pavement section.

Figure 6-25: Corroded longitudinal reinforcing bar

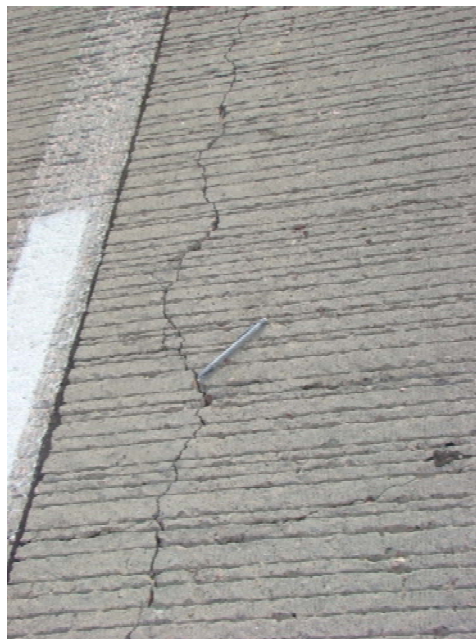
showed several signs of distress, including longitudinal cracking, transverse cracking, and spalling. Figure 6-26 shows transverse cracking and spalling close to a newly repaired section of CRCP. Figure 6-27 shows a wide longitudinal crack next to the longitudinal joint in the pavement.

Figure 6-27: Longitudinal cracking on I-90

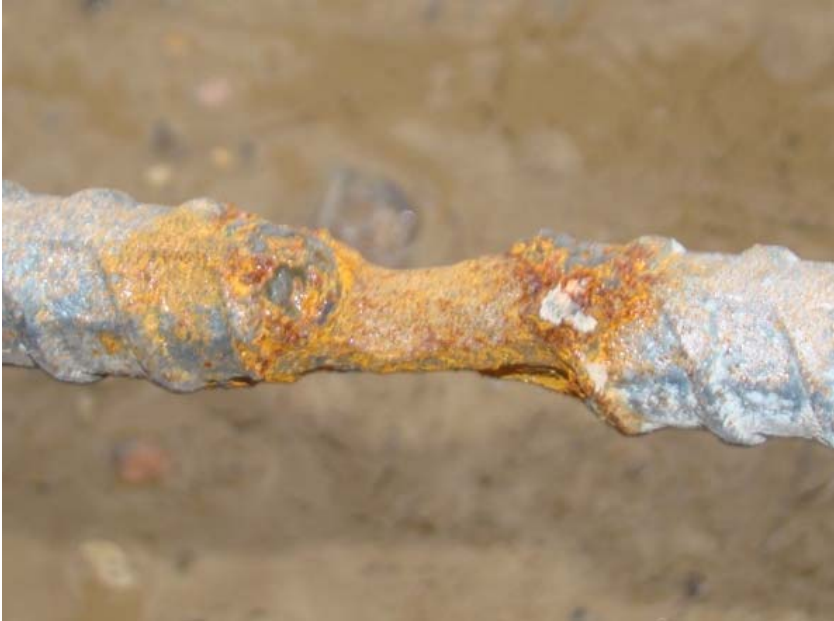
In addition to the surface distress, noticeable loss of cross-section in the steel reinforcement was present at several locations within the sections that were cut for repair. At some locations, nearly half of the

cross-section had deteriorated as shown in Figure 6-28. Furthermore, most of the corrosion occurred at the intersections of the longitudinal bars with the transverse cracks. Figure 6-29 shows corrosion marks in exposed longitudinal bars. The red marks at the edge of the concrete cut in the photo represent crack locations. The corrosion marks in the successive bars can be seen to have occurred along the crack.

Figure 6-28: Severe loss of cross-sectional area

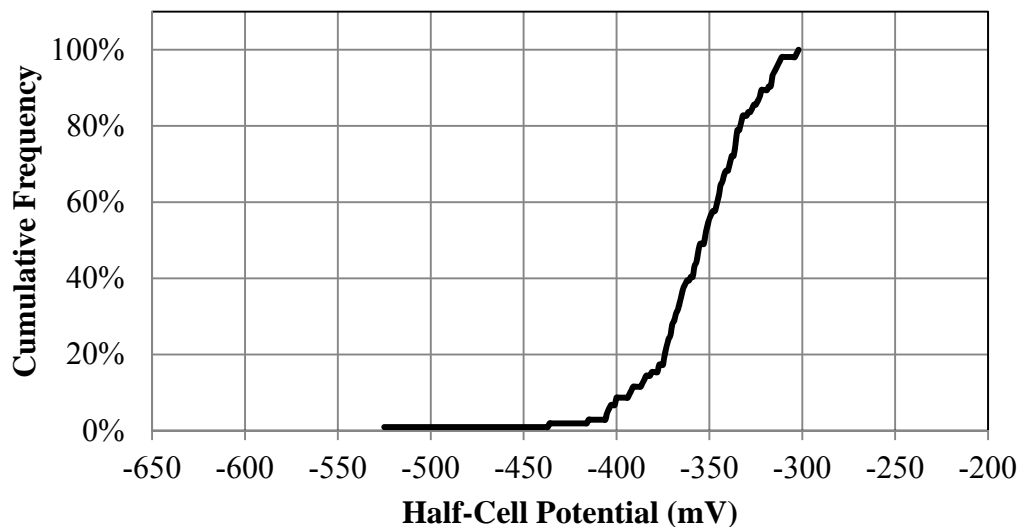
Figure 6-30: MRM 33 half-cell cumulative frequency distribution

The results of the half-cell measurements were between a minimum of -525 mV and a maximum of -302 MV, with an average of -356 mV and standard deviation of 46.5 mV. The distribution of the half-cell measurements is presented in Figure 6-30. The equipotential contour maps are presented in Appendix B. The probability of corrosion activity based on the measured data, as suggested by ASTM C876, is presented in Table 6-10.

Potential Measurement Range	Indication according to ASTM C-876	Percent of Data Points in Range
> -200 mV	90% probability that no reinforcing steel is corroding	0.0%
Between -200 mV and -350 mV	Corrosion activity is uncertain	46.2%
< -350 mV	Greater than 90% probability steel is corroding	53.8%

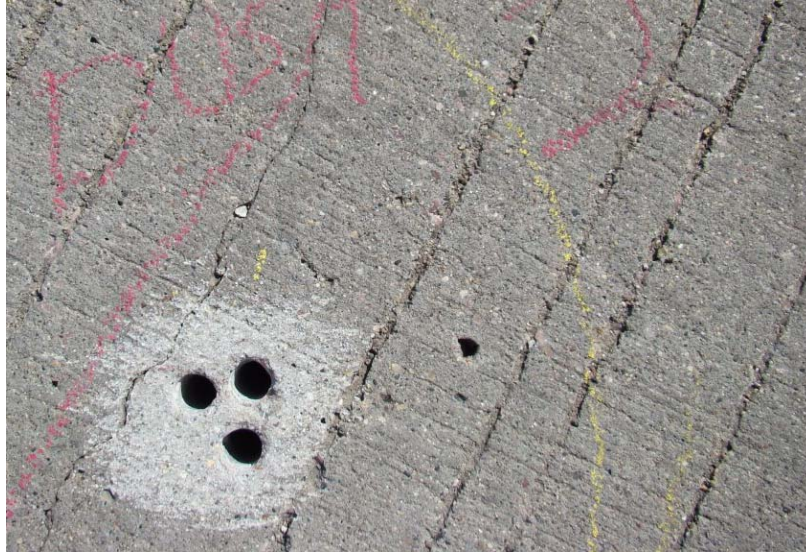
Figure 6-31: Dust sample 2 at MRM 33

Dust samples were obtained at the locations with the most elevated (most negative) measurements, unless the traffic on the passing lane imposed a safety concern for collecting a dust sample. The location of dust samples one and two had half-cell measurements of -436 mV and -525 mV, respectively. Cracks were observed within inches of both dust samples as shown in Figure 6-31.

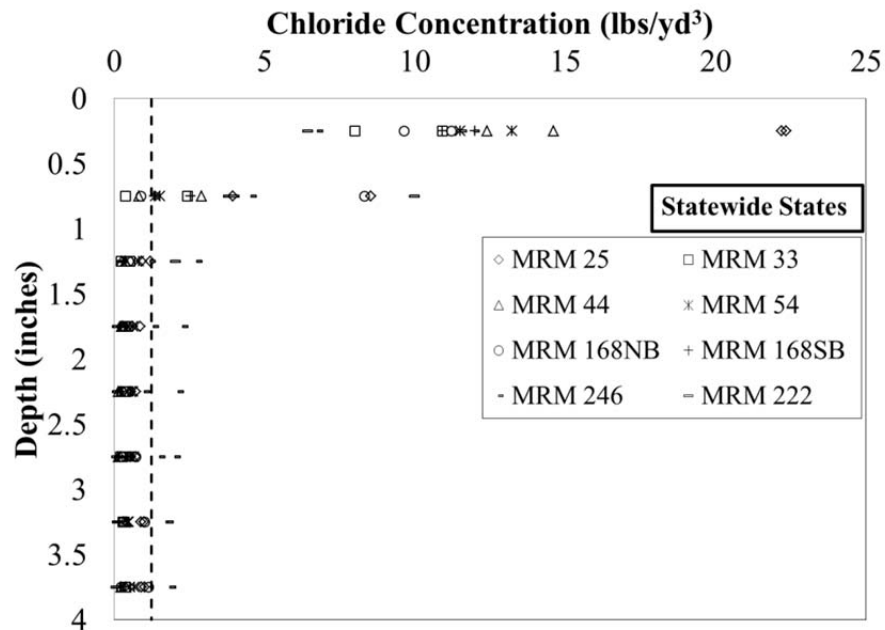
Figure 6-32: Vertical chloride distribution for statewide CRCP evaluation

The results from the chloride analysis of the dust samples for all sites evaluated during the statewide CRCP evaluation are presented in Table 6-11 and Figure 6-32. The data shows that the chloride values are generally above the threshold within the top 1 inch of the pavement surface. The chloride levels are generally below the threshold at depths below 1 inch in the pavement. However, there are some cases in which the chloride ion concentration is above the threshold at a pavement depth of 3.75 inches. The reason for this will be discussed in Chapter 5. Individual vertical chloride profiles from this site are presented Appendix C.

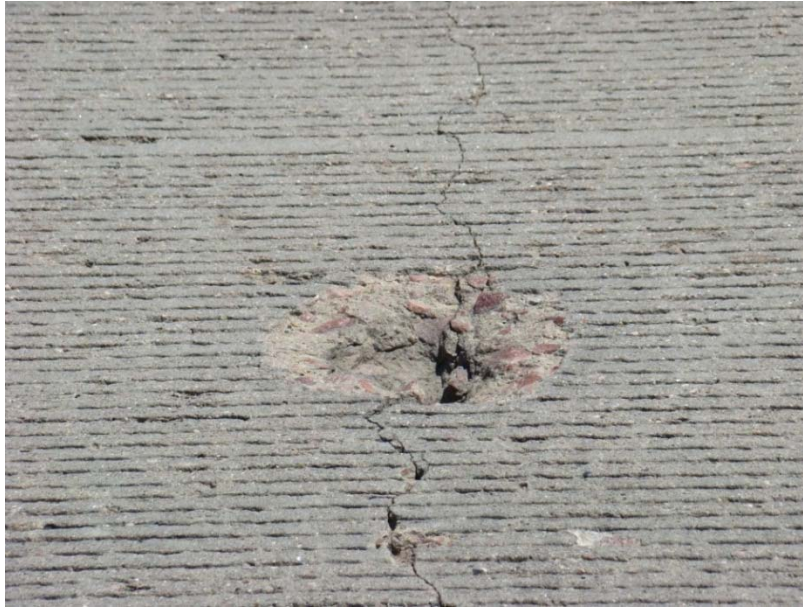
Evaluation of site MRM 44 occurred on July 20th, 2011. The crack density was 0.453 foot/square foot. Transverse, Y-cracking, and pop-outs were observed. The transverse cracks were spaced every one to four feet. No longitudinal cracking was identified within the 100 foot section. Spalling was observed in the passing lane, but not in the lane which was surveyed (see Figure 6-33). The depth to the reinforcement was measured as 3.5 inches with a hand-held tape measure.

Figure 6-33: Spalling observed in passing lane at MRM 44

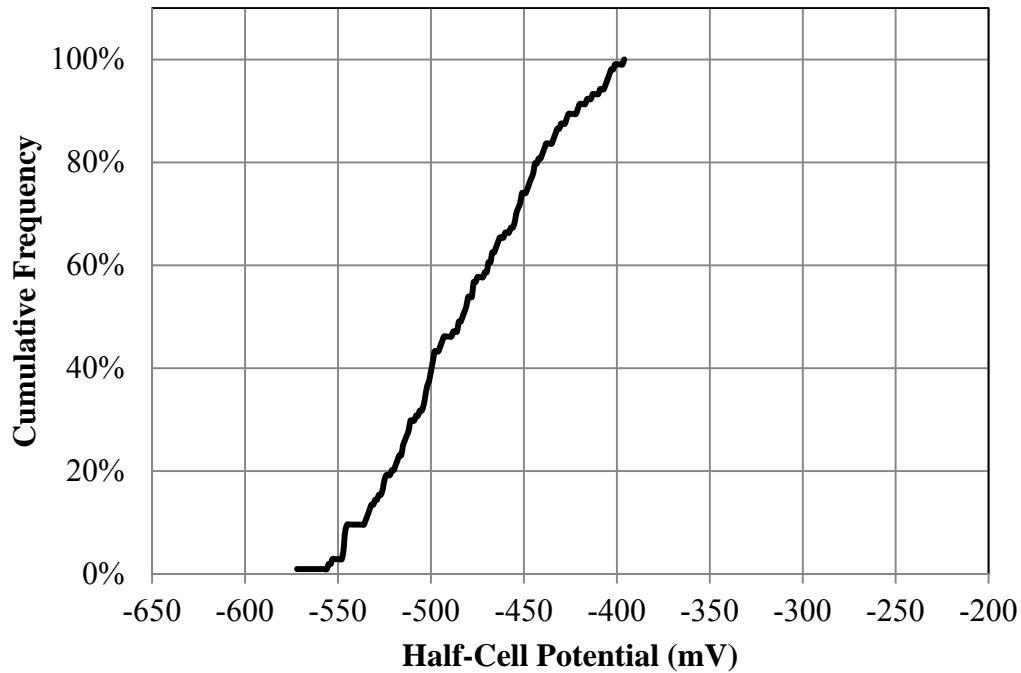
Figure 6-34: MRM 44 half-cell cumulative frequency distribution

The results of the half-cell measurements were between a minimum of -572 mV and a maximum of -396 mV, with an average of -481 mV and standard deviation of 63.4 mV. The distribution of the half-cell measurements is presented in Figure 6-34. The equipotential contour maps are presented in Appendix B. The probability of corrosion activity based on the measured data, as suggested by ASTM C876, is presented in Table 6-12.

Potential Measurement Range	Indication according to ASTM C-876	Percent of Data Points in Range
> -200 mV	90% probability that no reinforcing steel is corroding	0.0%
Between -200 mV and -350 mV	Corrosion activity is uncertain	0%
< -350 mV	Greater than 90% probability steel is corroding	100%

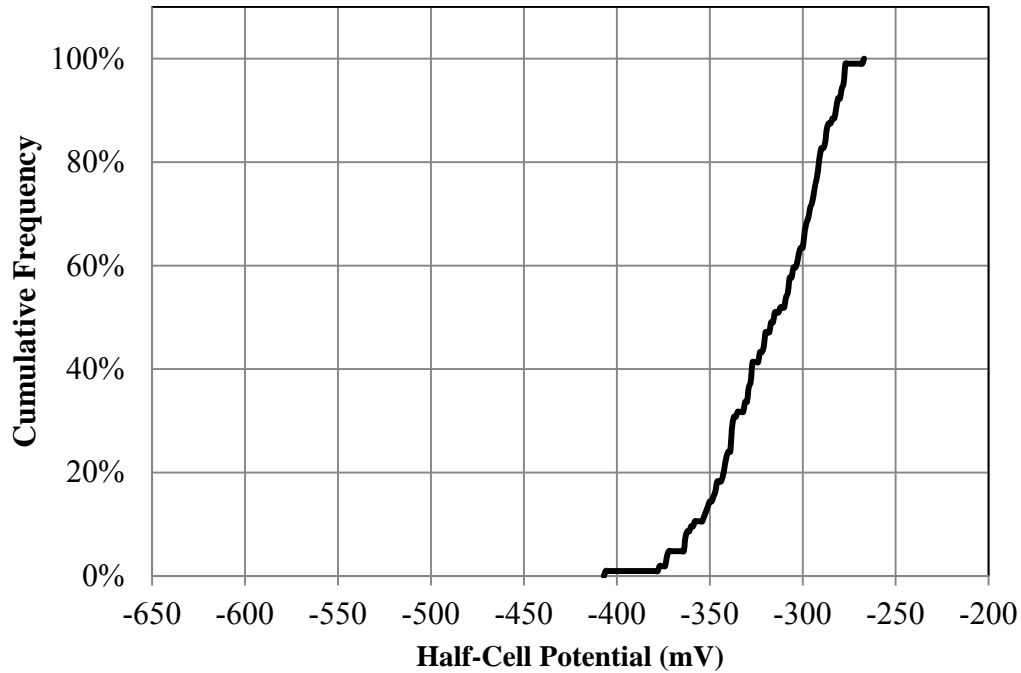
Figure 6-35: MRM 25 half-cell cumulative frequency distribution

The results of the half-cell measurements were between a minimum of -407 mV and a maximum of -268 mV, with an average of -318 mV and standard deviation of 42.2 mV. The distribution of the half-cell measurements is presented in Figure 6-35. The equipotential contour maps are presented in Appendix B. The probability of corrosion activity based on the measured data, as suggested by ASTM C876, is presented in Table 6-13.

Potential Measurement Range	Indication according to ASTM C-876	Percent of Data Points in Range
> -200 mV	90% probability that no reinforcing steel is corroding	0.0%
Between -200 mV and -350 mV	Corrosion activity is uncertain	85.6%
< -350 mV	Greater than 90% probability steel is corroding	14.4%

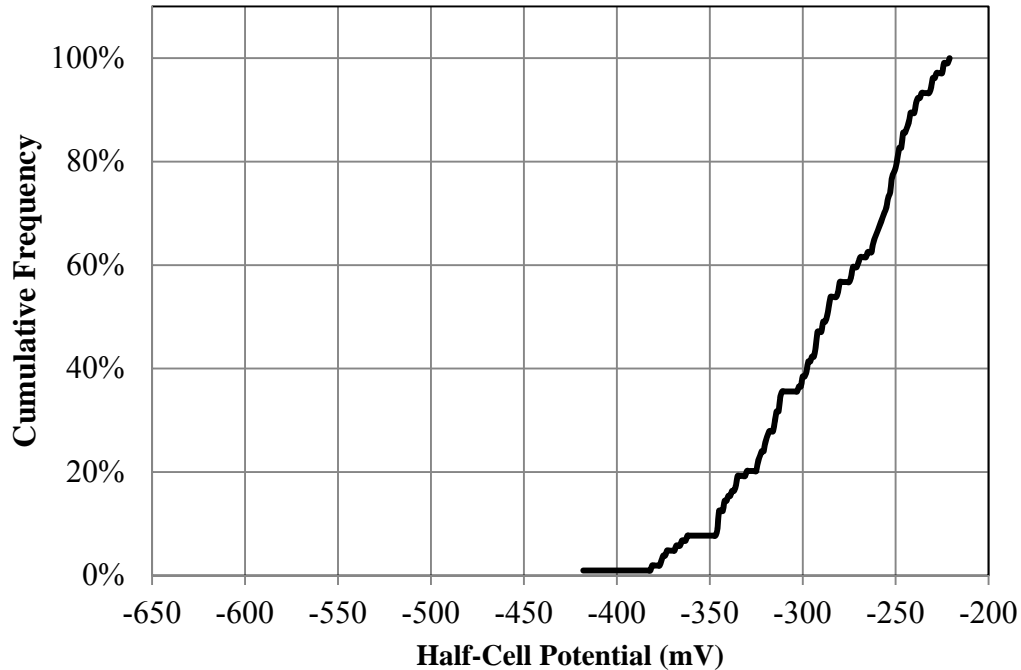
Figure 6-36: MRM 54 half-cell cumulative frequency distribution

The results of the half-cell measurements were between a minimum of -418 mV and a maximum of -221 mV, with an average of -290 mV and standard deviation of 51.5 mV. The distribution of the half-cell measurements is presented in Figure 6-36. The equipotential contour maps are presented in Appendix B. The probability of corrosion activity based on the measured data, as suggested by ASTM C876, is presented in Table 6-14.

Potential Measurement Range	Indication according to ASTM C-876	Percent of Data Points in Range
> -200 mV	90% probability that no reinforcing steel is corroding	0.0%
Between -200 mV and -350 mV	Corrosion activity is uncertain	92.3%
< -350 mV	Greater than 90% probability steel is corroding	7.7%

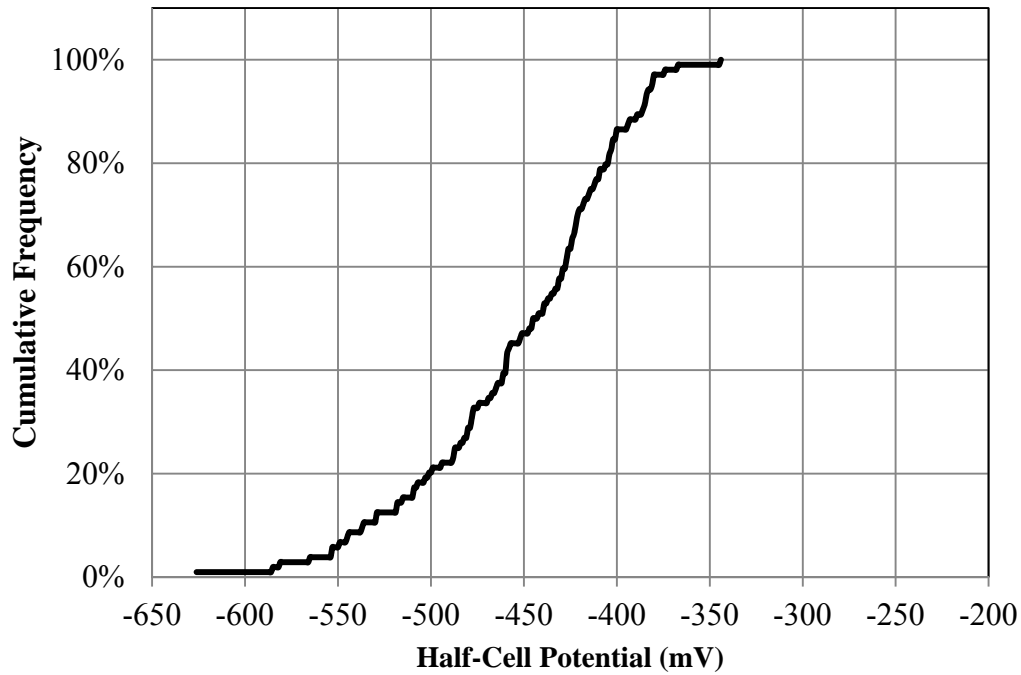
Figure 6-38: MRM 222 half-cell cumulative frequency distribution

The results of the half-cell measurements were between a minimum of -626 mV and a maximum of -344 mV, with an average of -453 mV and standard deviation of 70.4 mV. The distribution of the half-cell measurements is presented in Figure 6-38. The equipotential contour maps are presented in Appendix B. The probability of corrosion activity based on the measured data, as suggested by ASTM C876, is presented in Table 4-16.

Potential Measurement Range	Indication according to ASTM C-876	Percent of Data Points in Range
> -200 mV	90% probability that no reinforcing steel is corroding	0.0%
Between -200 mV and -350 mV	Corrosion activity is uncertain	1.0%
< -350 mV	Greater than 90% probability steel is corroding	99.0%

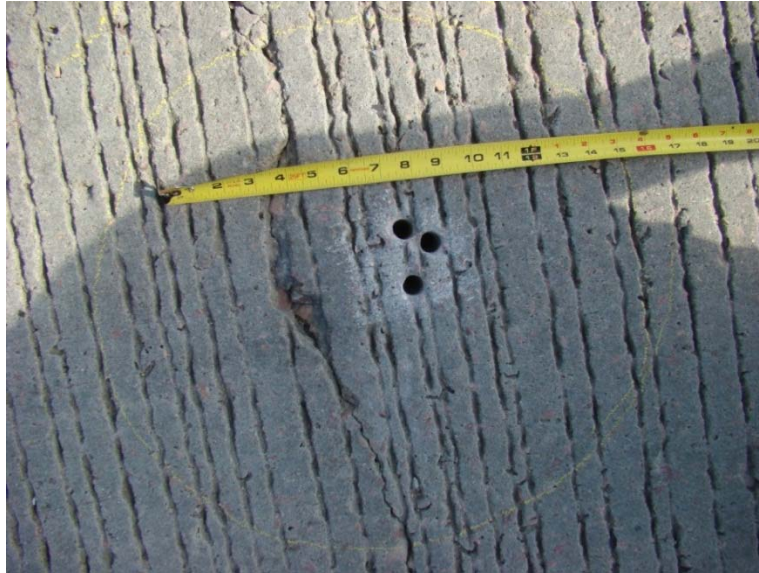
The location of dust samples one and two had half-cell measurements of -626 mV and -585 mV, respectively. Dust sample one was obtained within three inches of a wide crack (see Figure 6-39), and dust sample two was obtained within eight inches of a crack. Results from the chloride testing are presented in Figure 6-32 and Table 6-11. Individual vertical chloride profiles from this site are presented Appendix C.

Figure 6-39: Dust sample one at MRM 222

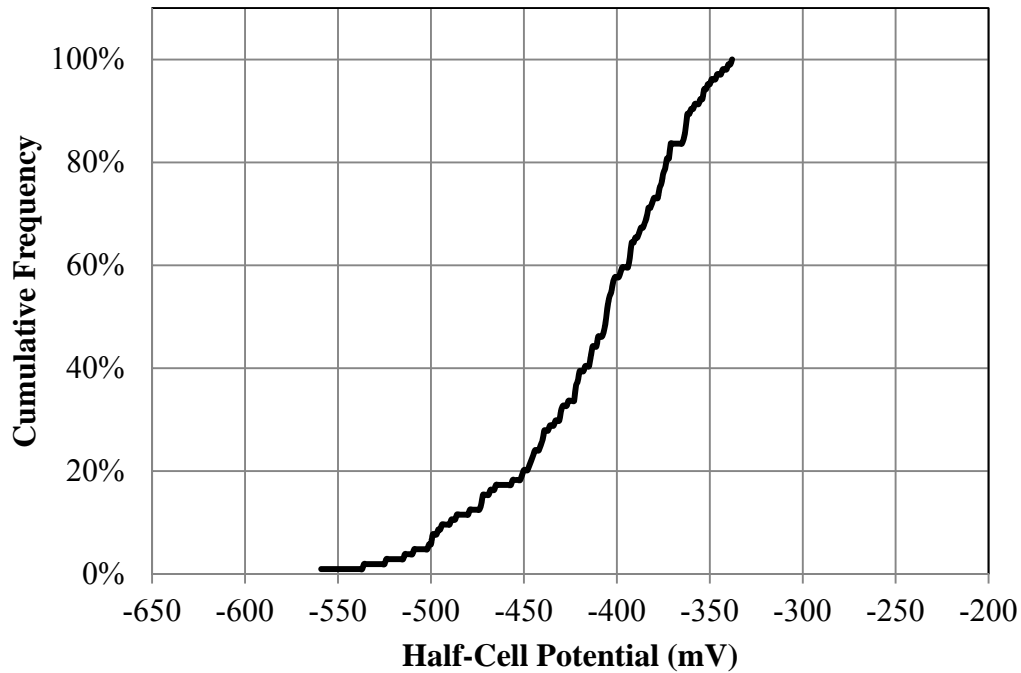
Figure 6-40: MRM 246 half-cell cumulative frequency distribution

The results of the half-cell measurements were between a minimum of -559 mV and a maximum of -338 mV, with an average of -414 mV and standard deviation of 62.6 mV. The distribution of the half-cell measurements is presented in Figure 6-40. The equipotential contour maps are presented in Appendix B. The probability of corrosion activity based on the measured data, as suggested by ASTM C876, is presented in Table 6-16.

Potential Measurement Range	Indication according to ASTM C-876	Percent of Data Points in Range
> -200 mV	90% probability that no reinforcing steel is corroding	0.0%
Between -200 mV and -350 mV	Corrosion activity is uncertain	4.8%
< -350 mV	Greater than 90% probability steel is corroding	95.2%

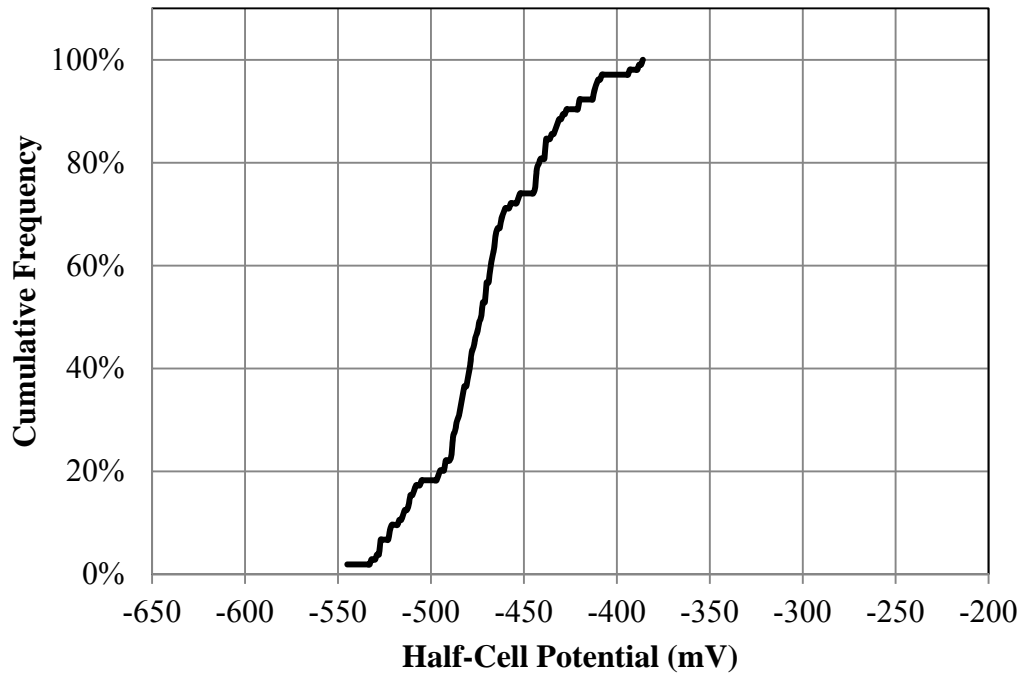
Figure 6-41: MRM 168NB half-cell cumulative frequency distribution

The results of the half-cell measurements were between a minimum of -545 mV and a maximum of -386 mV, with an average of -471 mV and standard deviation of 57.2 mV. The distribution of the half-cell

Potential Measurement Range	Indication according to ASTM C-876	Percent of Data Points in Range
> -200 mV	90% probability that no reinforcing steel is corroding	0.0%
Between -200 mV and -350 mV	Corrosion activity is uncertain	0%
< -350 mV	Greater than 90% probability steel is corroding	100%

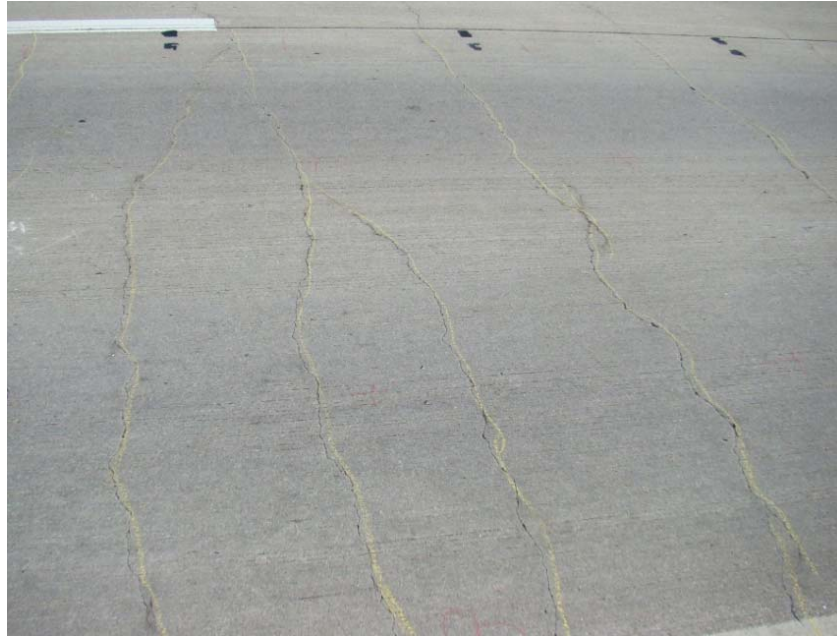
Evaluation of site MRM 168 southbound (SB) occurred on August 1st, 2011. The crack density was calculated to be 0.322 foot/square foot. Transverse and Y-cracking was observed (see Figure 6-42). The transverse cracks were spaced from less than one foot to five feet apart. No longitudinal cracking was

Figure 6-42: Cracking observed at MRM 168SB

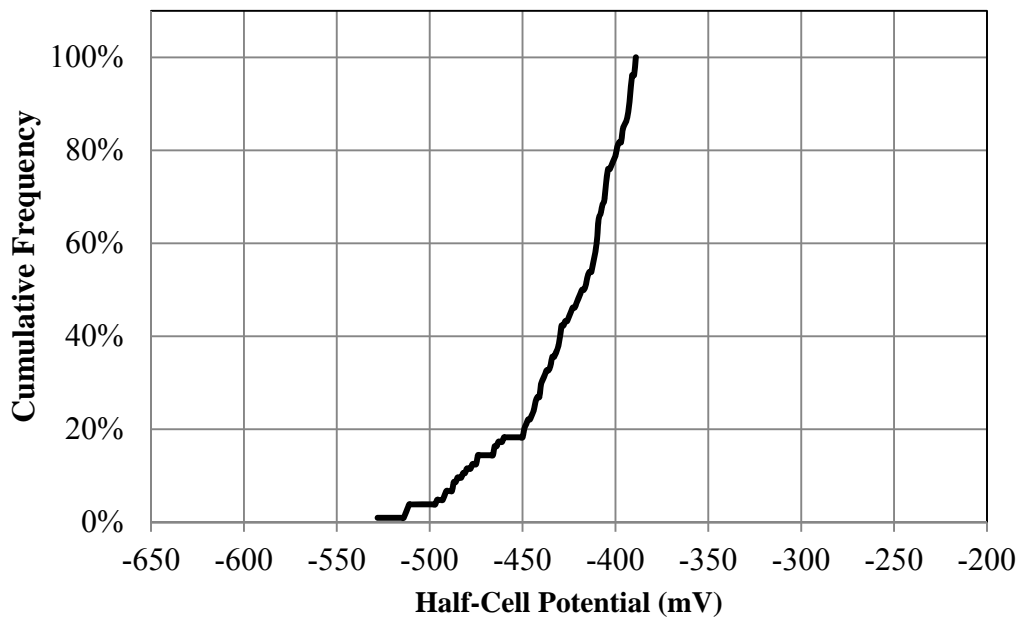
Figure 6-43: MRM 168SB half-cell cumulative frequency distribution

The results of the half-cell measurements were between a minimum of -529 mV and a maximum of -390 mV, with an average of -428 mV and standard deviation of 53.4 mV. The distribution of the half-cell measurements is presented in Figure 6-43. The equipotential contour maps are presented in Appendix B. The probability of corrosion activity based on the measured data, as suggested by ASTM C876, is presented in Table 6-18.

Potential Measurement Range	Indication according to ASTM C-876	Percent of Data Points in Range
> -200 mV	90% probability that no reinforcing steel is corroding	0.0%
Between -200 mV and -350 mV	Corrosion activity is uncertain	0%
< -350 mV	Greater than 90% probability steel is corroding	100%
