Mitigation of Corrosion in Continuously Reinforced Concrete Pavement

Study SD2009-05

Final Report

Prepared by
Allen L. Jones and Nadim I. Wehbe
South Dakota State University
Department of Civil and Environmental Engineering

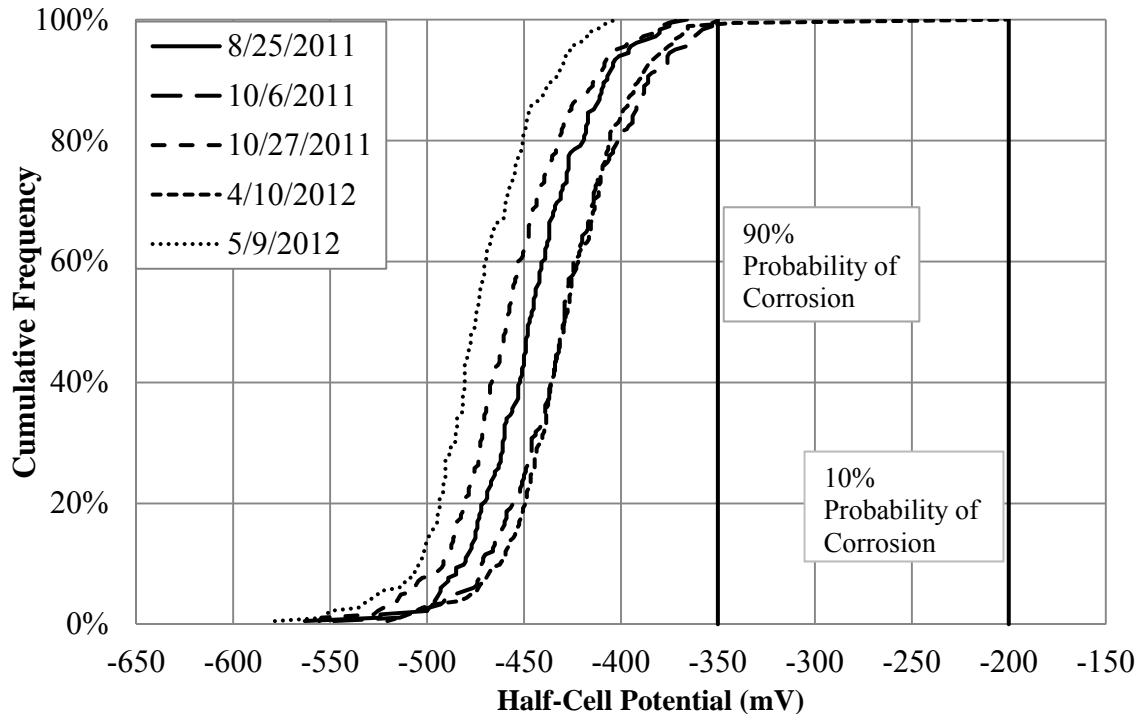
Figure 6-44: Cumulative frequency distribution for MCI-2018

Date	Mean (mV)	Standard Deviation (mV)	Minimum (mV)	Maximum (mV)
8/25/2011	-445.8	30.2	-563	-366
10/6/2011	-428.8	33.9	-548	-349
10/27/2011	-456.7	32.3	-556	-370
4/10/2012	-427.1	34.0	-507	-188
5/9/2012	-473.4	28.8	-570	-394

The average of each product section and the control section remained in the greater than 90 percent chance of corrosion range according to ASTM C876-09. Also, the majority of the points in each section remained in the high probability of corrosion range as shown by the cumulative distribution graphs in Figure 6-44 and Figure 6-49 through Figure 6-54, as well as the half-cell potential contour maps presented in Appendix E.

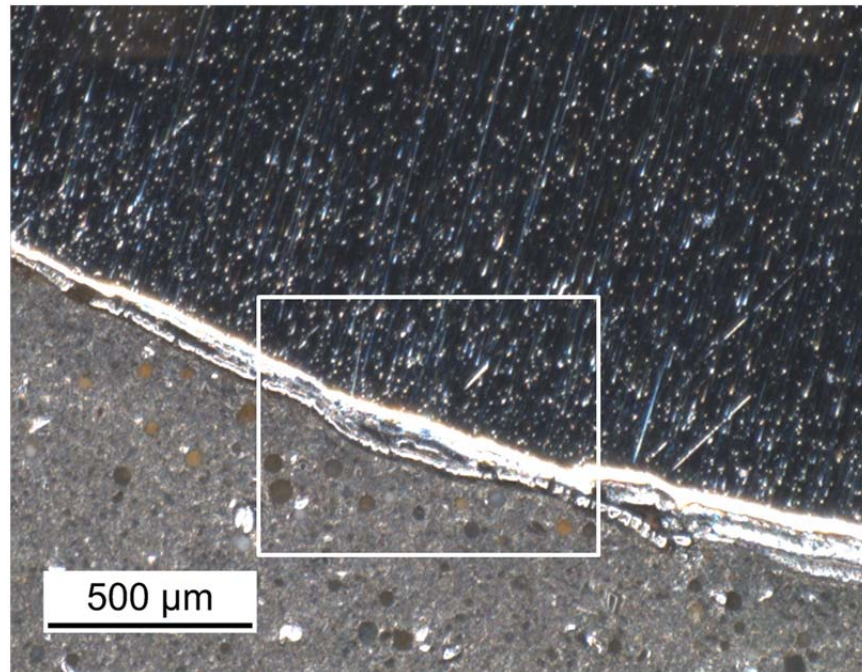
Figure 6-60: Optical image for Ferrogard 903 and Protectosil CIT

Figure 6-60 through Figure 6-64 show the results of the SEM testing. Figure 6-60 is an optical image showing the thin ring of corrosion around the exterior of the reinforcement. The white rectangle shown in Figure 6-60 is the area that was further analyzed to produce the BSE image and elemental maps of oxygen (O), iron (Fe), and chloride (Cl) shown in Figure 6-61. The areas with concentrations of both iron (red) and oxygen (green) are the corroded areas. The thin layer of corrosion is clearly seen in the BSE image and shows up as brighter red than the rest of the corrosion on the iron element map. No significant concentrations of chlorides were detected in the chlorine element map as shown in Figure 6-61. Figure 6-62 and Figure 6-63 show similar results from another area of the reinforcement from Specimen 3. However, some small concentrations of chlorides are seen near the edges of the pitting corrosion shown in Figure 6-63. No X-ray spectrum graph was produced for Specimen 3.

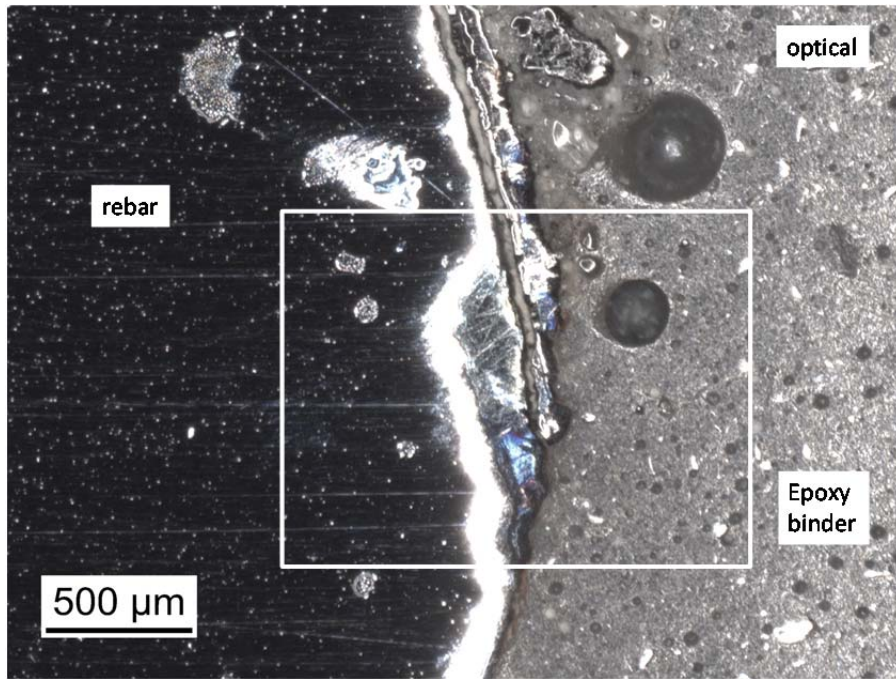
Figure 6-67: Optical image for Protectosil CIT

Figure 6-67 through Figure 6-69 show the results for the SEM testing. Figure 6-67 is an optical image showing the thin ring of corrosion around the exterior of the reinforcement. The white rectangle shown in

Figure 6-67 is the area that was further analyzed to produce the BSE image and the elemental maps of oxygen, iron, and chloride shown in Figure 6-68. There was a thin layer of corrosion products around the entire reinforcement. A small concentration of chlorides can be seen near the edges of the pitting corrosion shown in Figure 6-68. Figure 6-69 shows the X-ray spectrum graph for Specimen 5 and the approximate element concentrations found at the indicated location of the reinforcement.

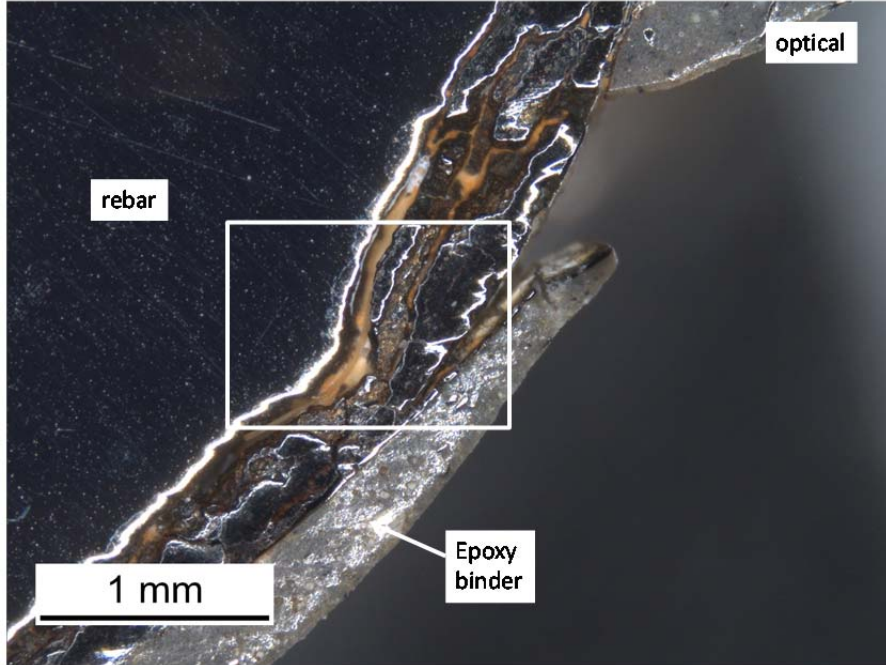
Figure 6-73: Optical image for Ferrogard 903

Figure 6-73 through Figure 6-75 show the results for the SEM testing of Specimen 7. Figure 6-73 is an optical image showing localized corrosion. The white rectangle shown in Figure 6-73 is the area that was further analyzed to produce the BSE image and the elemental maps of oxygen, iron, and chloride shown in Figure 6-74. There was a thin layer of corrosion products around the entire reinforcement and some localized, pitting corrosion. A small concentration of chlorides can be seen near the edges of the pitting corrosion shown in Figure 6-74. Figure 6-75 shows the X-ray spectrum graph for Specimen 7 and the approximate element concentrations found at the indicated location of the reinforcement.

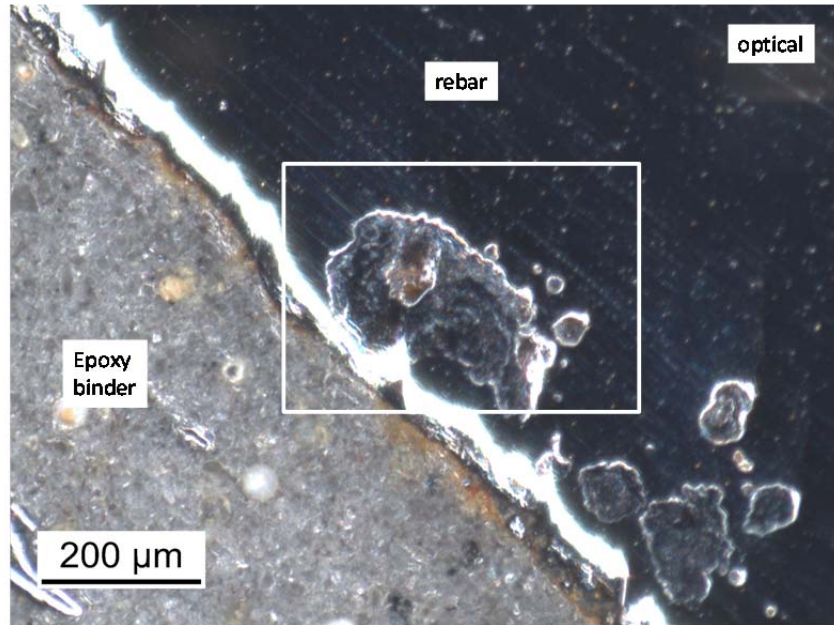
Figure 6-83: Optical image of wet, cracked control specimen

Figure 6-83 through Figure 6-85 show the results for the SEM testing of Specimen 15. Figure 6-83 shows an optical image showing pitting corrosion. The white rectangle shown in Figure 6-83 is the area that was further analyzed to produce the BSE image and the elemental maps of oxygen, iron, and chloride shown in Figure 6-84. There was a thin layer of corrosion products around the entire reinforcement and some localized, pitting corrosion. A concentration of chlorides can be seen within the pitting corrosion shown

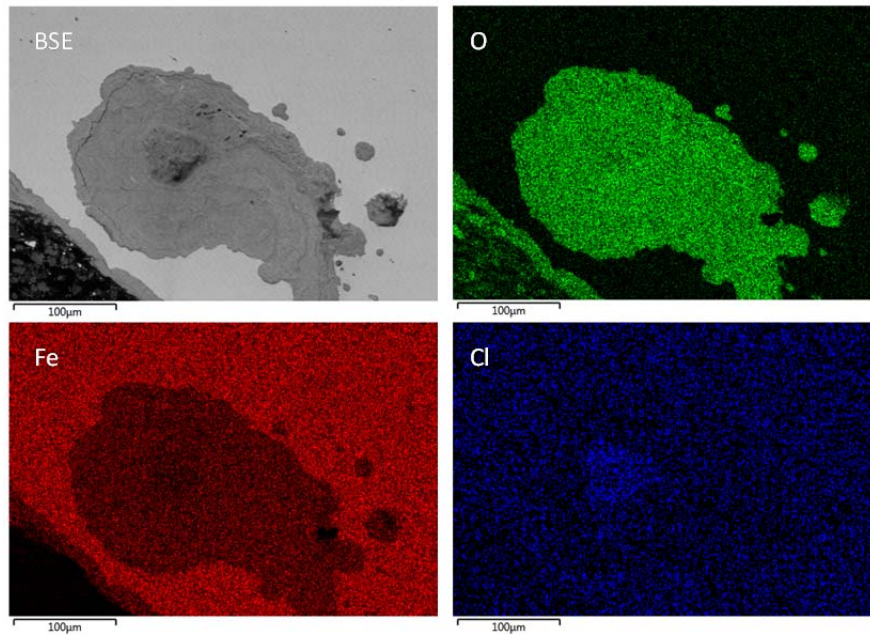
Figure 6-84: BSE and element maps for wet, cracked control specimen

in Figure 6-84. Figure 6-85 shows the X-ray spectrum graph for Specimen 15 and the approximate element concentrations found at the indicated location of the reinforcement.

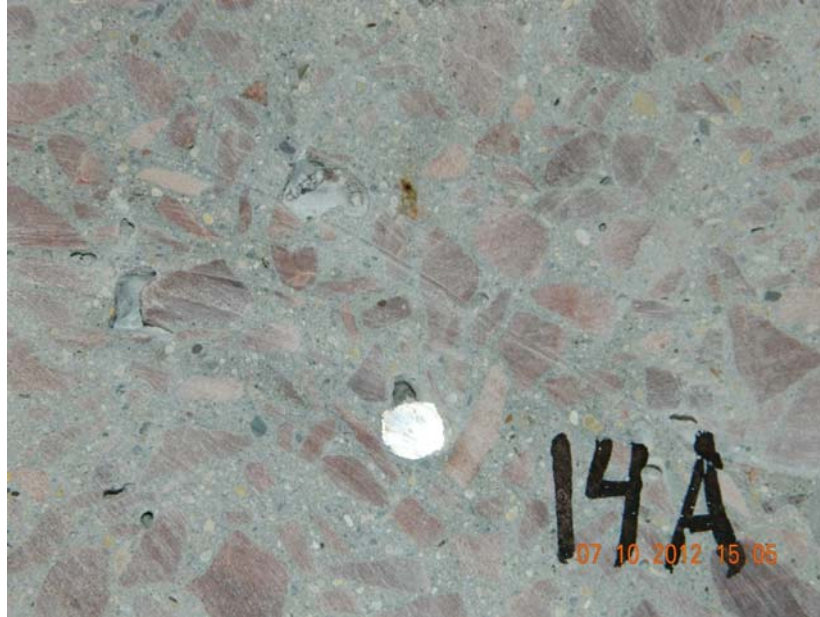
Figure 6-86: Saw cut along the crack of dry, cracked control specimen showing the reinforcement

The specimen was cut in half along the simulated crack and the reinforcement from one of the halves was completely removed from the concrete. Figure 6-86 and Figure 6-87 show the reinforcement for Specimen 14. No corrosion was visible along the saw cut face, however the part of the reinforcement that was removed from the concrete did show slight surface oxidation (Figure 6-87). Also, no corrosion products were observed at the wire connection.

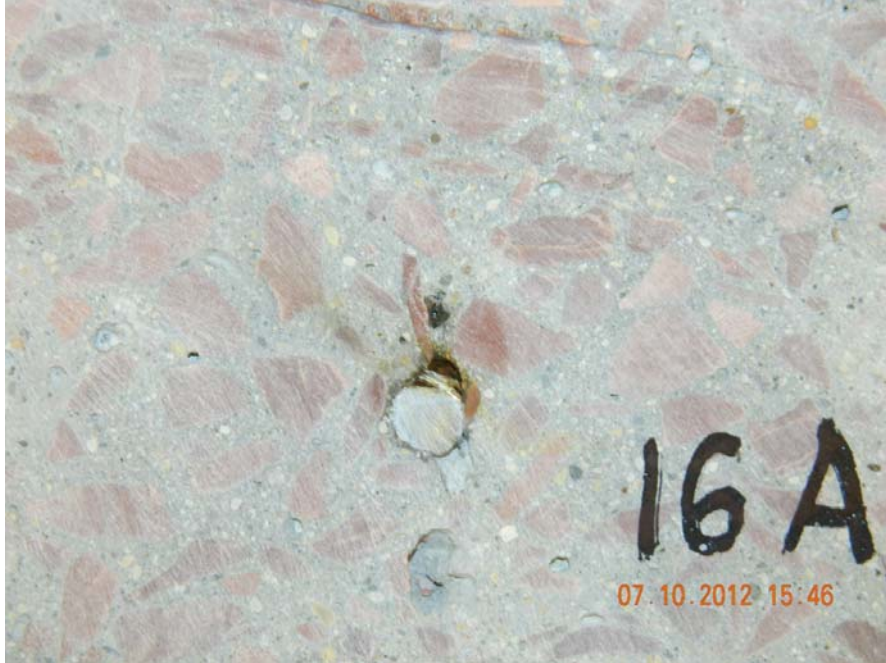
Figure 6-88: Saw Cut along the simulated crack of Specimen 16

The reinforcement removed from Specimen 16 is shown in Figure 6-88 and Figure 6-89. Some staining of the concrete caused by corrosion was visible along the saw cut face, and an area of staining approximately one and a half inches long had formed near the crack as shown in Figure 6-89. This corrosion appears to have begun to deteriorate the ribs in the reinforcement, but the overall cross section loss of the bar was still negligible. A thin layer of corrosion products formed around the reinforcement near the wire connection, but there was no observable loss of material that would affect half-cell potential measurements.

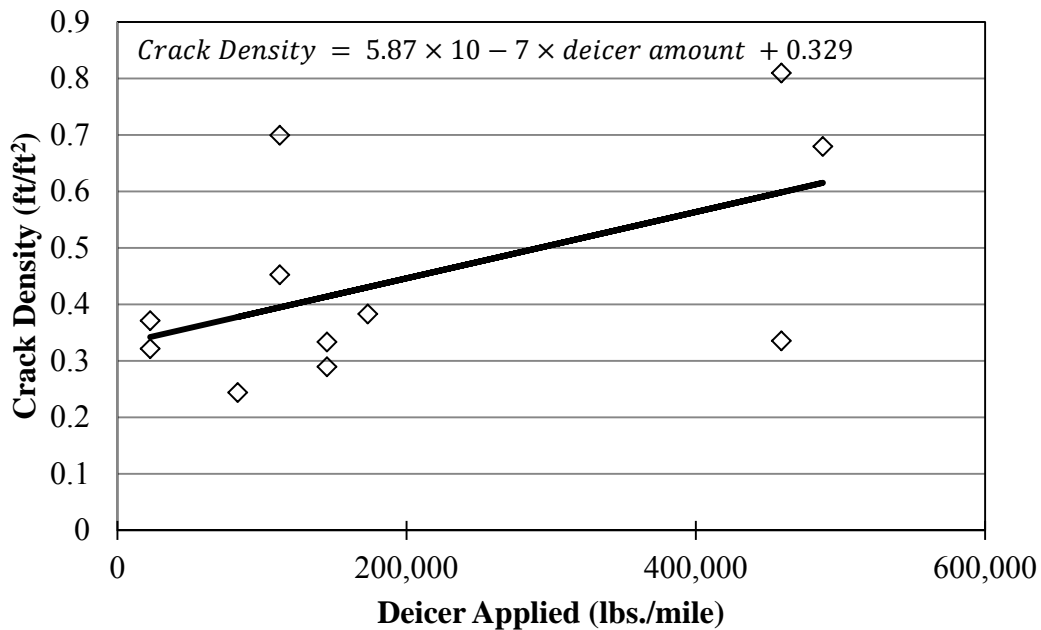
The p-values were significant at the 0.10 significance level for the 3 relationships evaluated. The crack density increased significantly with an increase in deicer amount and age. The SCI decreased significantly with an increase in deicer amount. However, the coefficients of variation were below 0.50 in all cases. Therefore, the linear trends do not explain the variability in the data effectively. Figure 7-10 through Figure 7-12 present the data and model estimates.

Figure 7-10: Crack density versus deicer applied for all sites surveyed

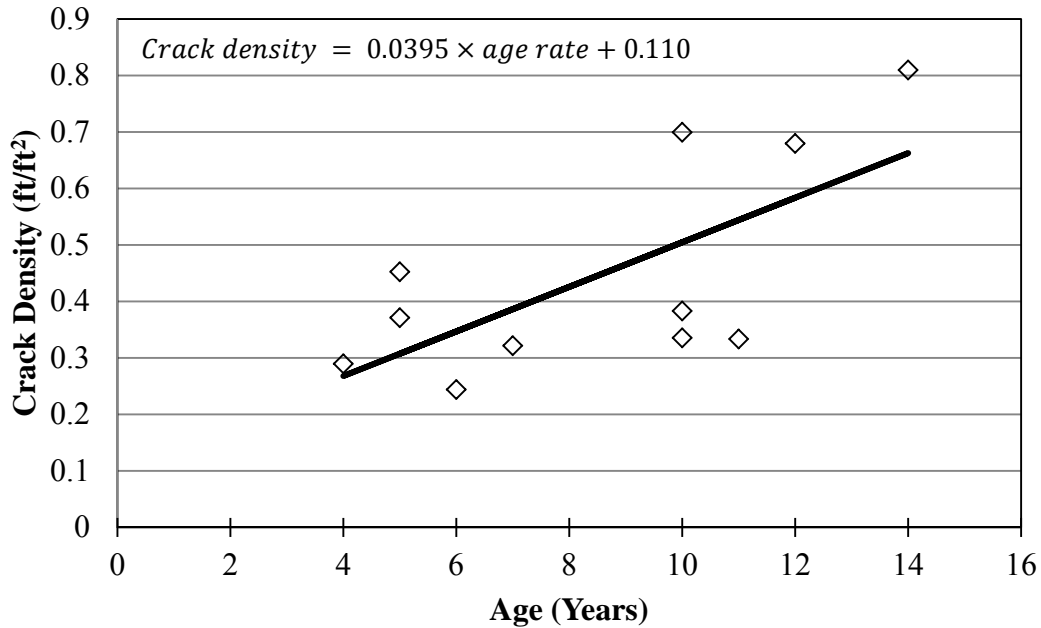
Figure 7-11: Crack density versus age of all sites surveyed

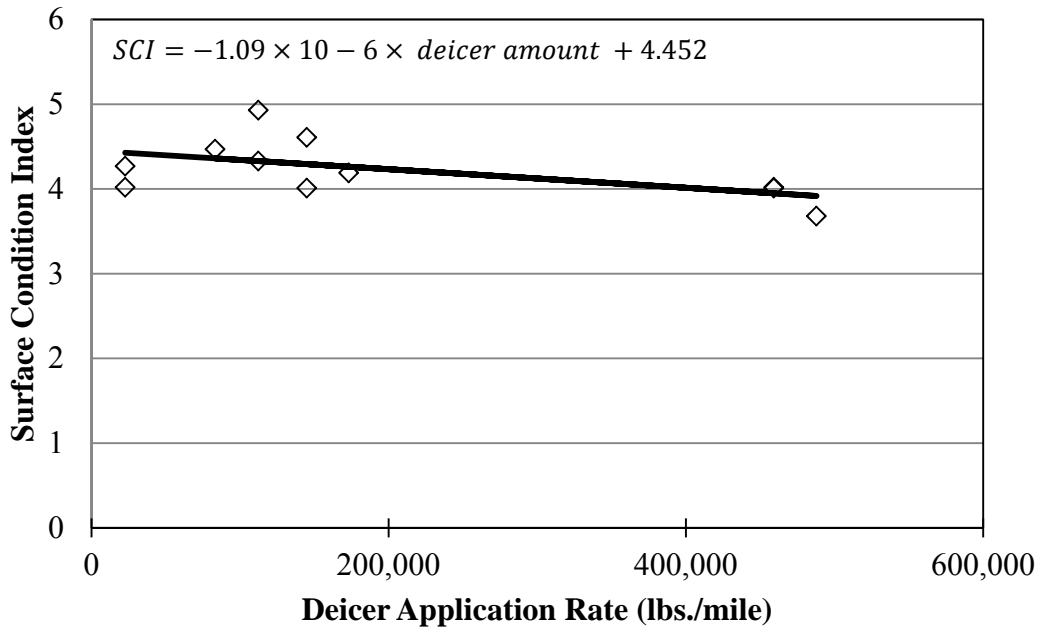
Figure 7-12: Surface condition index versus deicer application rate (all sites)

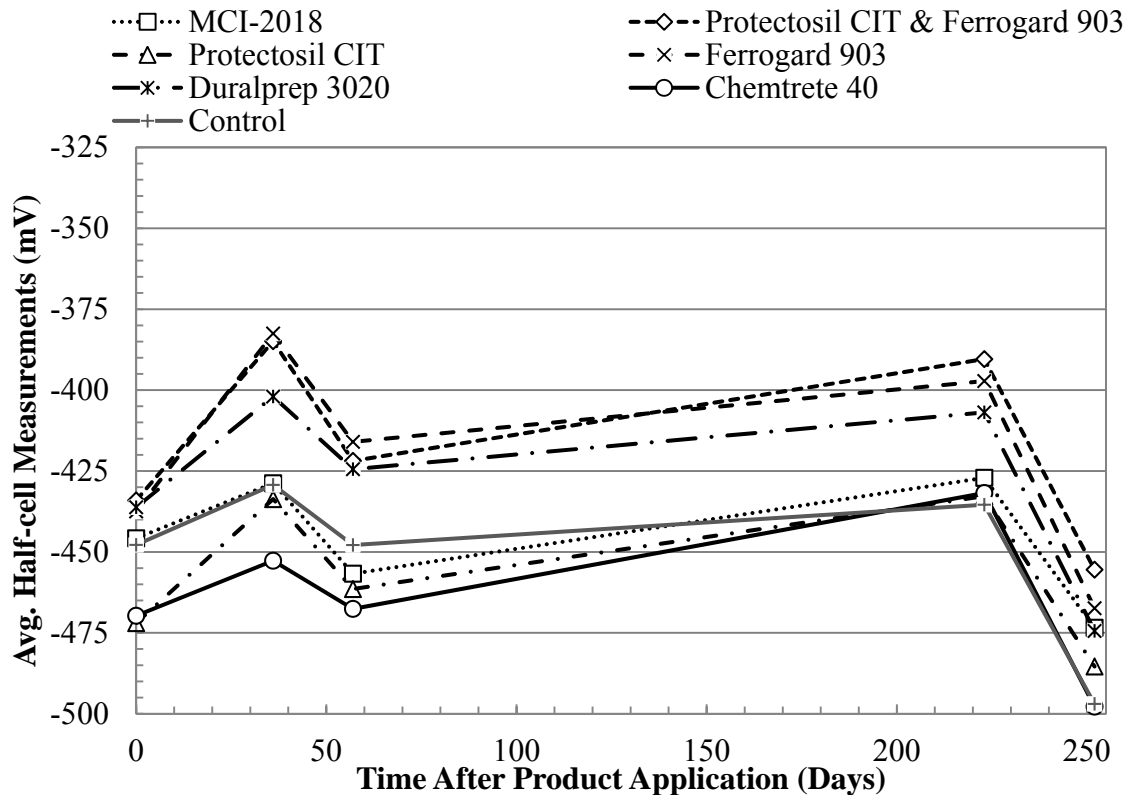
Figure 7-13: Average half-cell measurements for each section vs. time

Figure 7-13, Figure 7-14, and Figure 7-16 show that average half-cell potential in the field tends to fluctuate up and down as a group. The control section also fluctuated in a similar manner as the product test sections, which shows that this fluctuation is not likely a primary effect of the corrosion mitigation products. According to Assouli, et al. (2008) and Elsener (2001 and 2003) these differences that occur throughout a section are due to differences in the environment such as the percent of moisture in the concrete, changes in temperature, or changes in chloride content. However, the temperature effect on the half-cell potential measurements was accounted for using the temperature correction coefficient from ASTM C876-09. The temperature coefficient of a copper-copper sulfate reference electrode is approximately 0.5 mV more negative per degree Fahrenheit for temperatures ranging from 32 to 120 degrees Fahrenheit (ASTM 2009). By using this coefficient, the bias caused by the differences in temperature was eliminated.

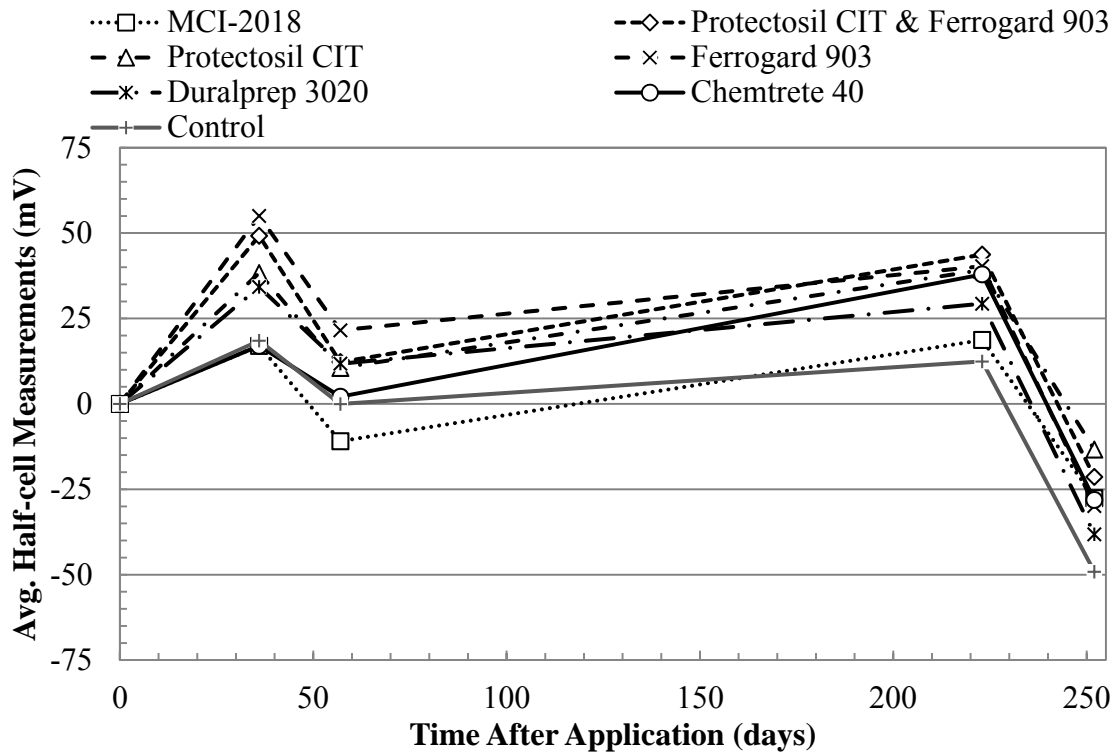
Figure 7-14: Relative change in half-cell measurements vs. time

the last measurement obtained at the test site (May 9, 2012), the rainfall amounts were 0.3 inches on May 4, 2012, 0.02 inches on May 5, 2012, and 0.74 inches on May 6, 2012 (NOAA 2012). The weather was also cloudy and cool throughout the week prior to obtaining measurements which also potentially reduced the amount of evaporation which occurred after the rain. This rainfall likely resulted in increased moisture content in the concrete. The concrete also still appeared to be slightly damp along the cracks when the measurements were obtained. Because of the likely increased moisture content, the average half-cell potentials shifted to more negative values prior to the May 9, 2012 measurements than any of the previous measurements as shown in Figure 7-14. In comparison, no rain events occurred during the weeks prior to other field measurements.

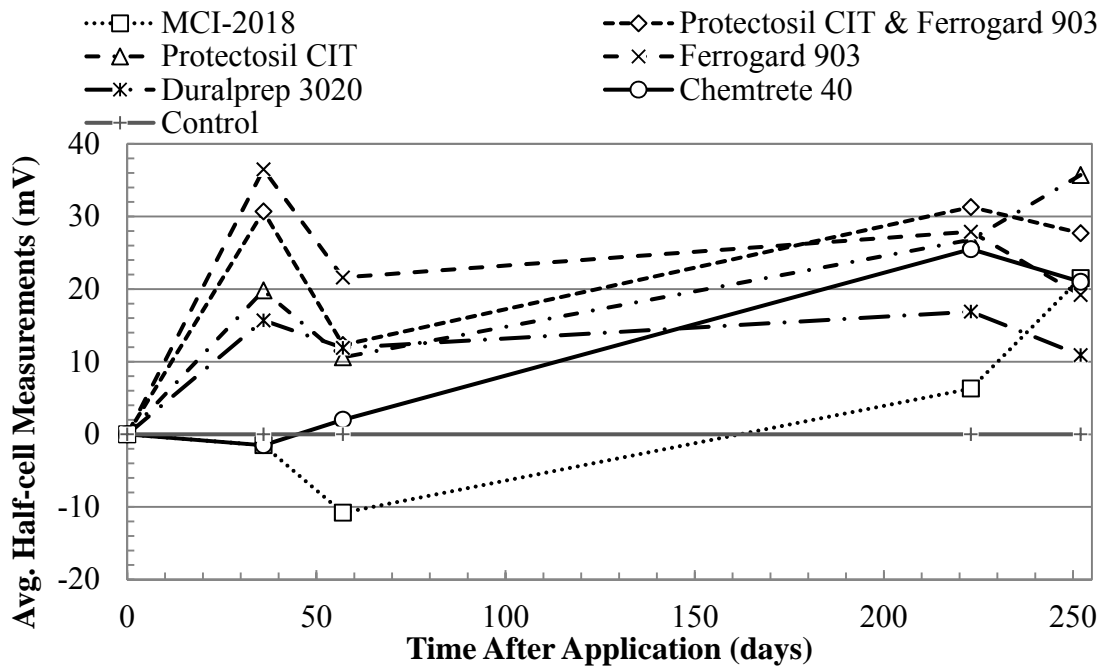
Figure 7-15: Relative change in half-cell measurements vs. time, normalized to control section

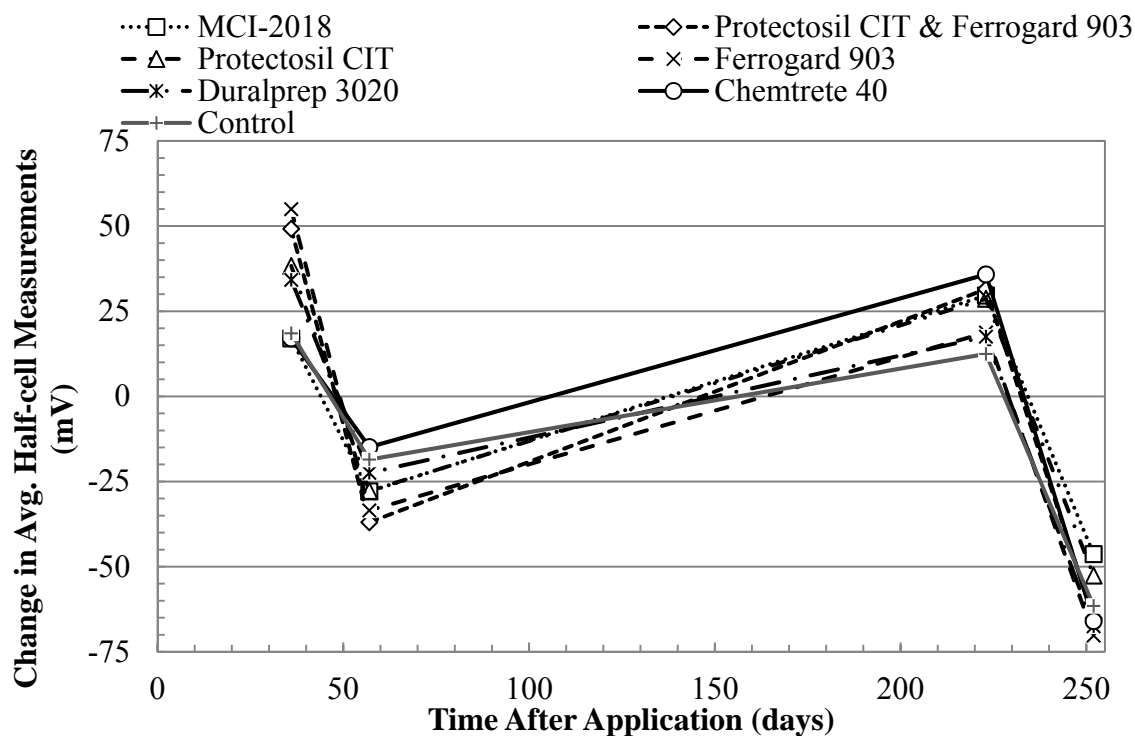
Figure 7-16: Relative change in half-cell measurements for each measurement event vs. time

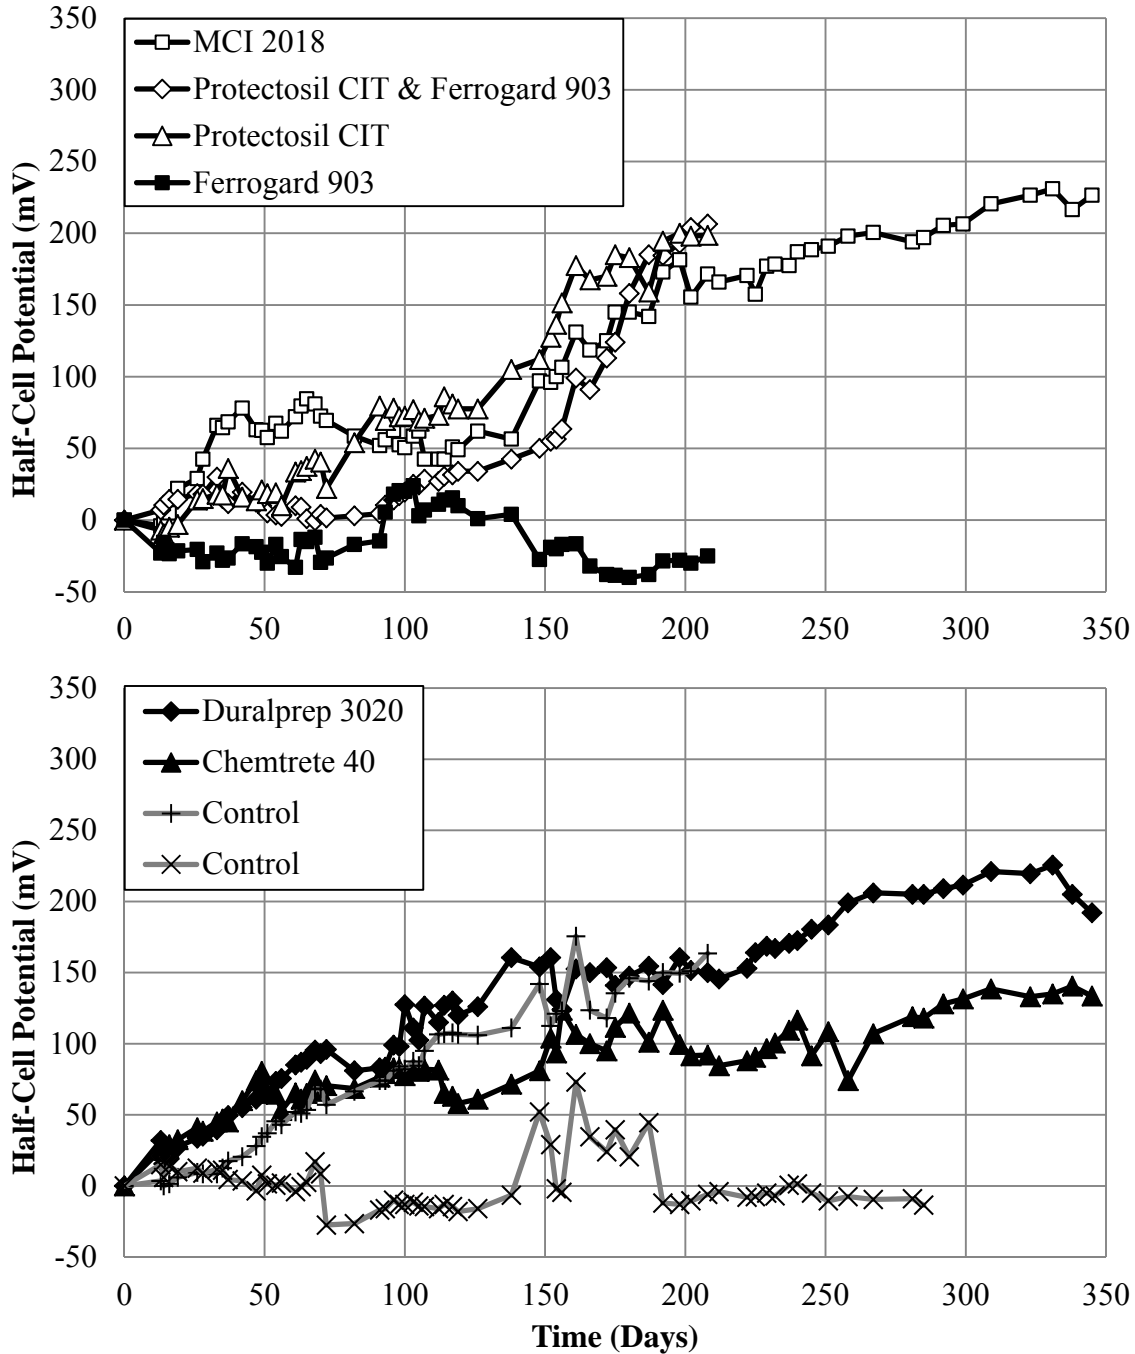
Figure 7-19 shows the change in half-cell potential for each wet, cracked specimen from the time the products were initially applied. It has been split into two plots for ease of viewing. As shown in Figure 7-19, the Protectosil CIT & Ferrogard 903 and the Protectosil CIT specimens had the largest half-cell potential increases of any of the cracked, wet specimens. Therefore these specimens were chosen to be further analyzed with SEM and chloride ion concentration analysis. The Ferrogard 903 and one of the Control specimens were also further analyzed with SEM and chloride ion concentration analysis.

Figure 7-19: Wet specimens – change in half-cell potential after initial product application

A potential alternative method to analyze the laboratory specimens would be to compare the magnitude of the increase in half-cell potential of the product specimens to the increase in half-cell potential of the corresponding control specimen over the same period of time as shown in Figure 7-19 and Figure 7-20. This method may not account for any changes in concrete properties caused by the application of the products. However, changes should occur relatively quickly after product application which would lead to a significant change in half-cell potential shortly after application, and this change in half-cell potential would be expected to occur in both the cracked and uncracked specimens. None of the uncracked specimens showed any noticeable changes in half-cell potential after product application, therefore the effect corrosion inhibitors have on the half-cell potential measurement was thought to be considerably less than the effect that the change in corrosion rate would have on half-cell potential measurement.

of corrosion. However, for the wet, cracked, control specimens, one control specimen had a half-cell potential change of approximately +150 mV over the first 200 days after the initial product application date, and over the same time period, the other wet, cracked control specimen had a change in half-cell potential of approximately -10 mV as shown in Figure 7-19. These show that even between two identical specimens that were exposed to the same conditions, the half-cell potential can greatly vary. Also, the change in half-cell potential for the more positive control specimen was within 50 mV of the two product specimens with the highest increase in half-cell potential, as seen in Figure 7-20. This likely means that mitigation products did not perform more effectively than the controls.

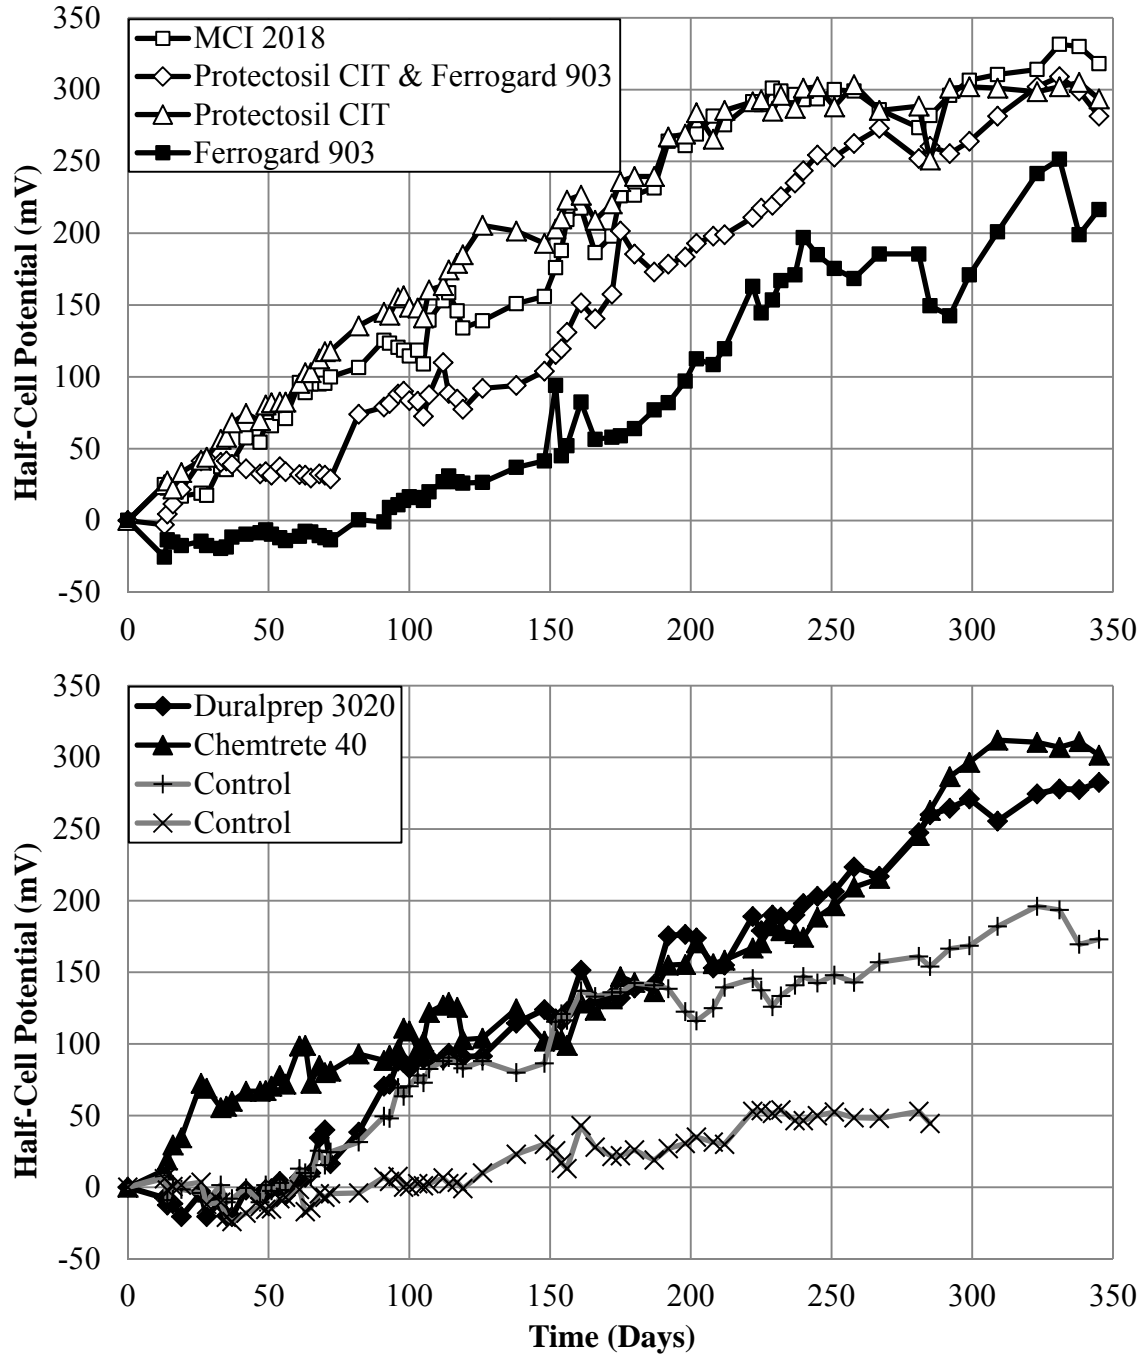
Figure 7-20 shows the change in half-cell potential for each dry, cracked specimen from the time that the products were initially applied. It has been split into two plots for ease of viewing. As shown in Figure 7-20, the MCI-2018 specimen had the largest increase on half-cell potential of the cracked, dry specimens.

Figure 7-20: dry Specimens – change in half-cell potential after initial product application

The specimens with MCI-2018, Protectosil CIT & Ferrogard 903, Protectosil CIT, Duralprep 3020, and Chemtrete 40 had changes in half-cell potential that were more than 100 mV or 57 percent greater than the control specimen with the most positive relative change in half-cell potential. This indicates that for the dry, cracked specimen case, some of the products were at least partially effective in increasing the half-cell potentials which can be correlated to the probability of corrosion; however, because this comparison is using half-cell potentials, no reduction in corrosion rates or increased life expectancy can be directly calculated.

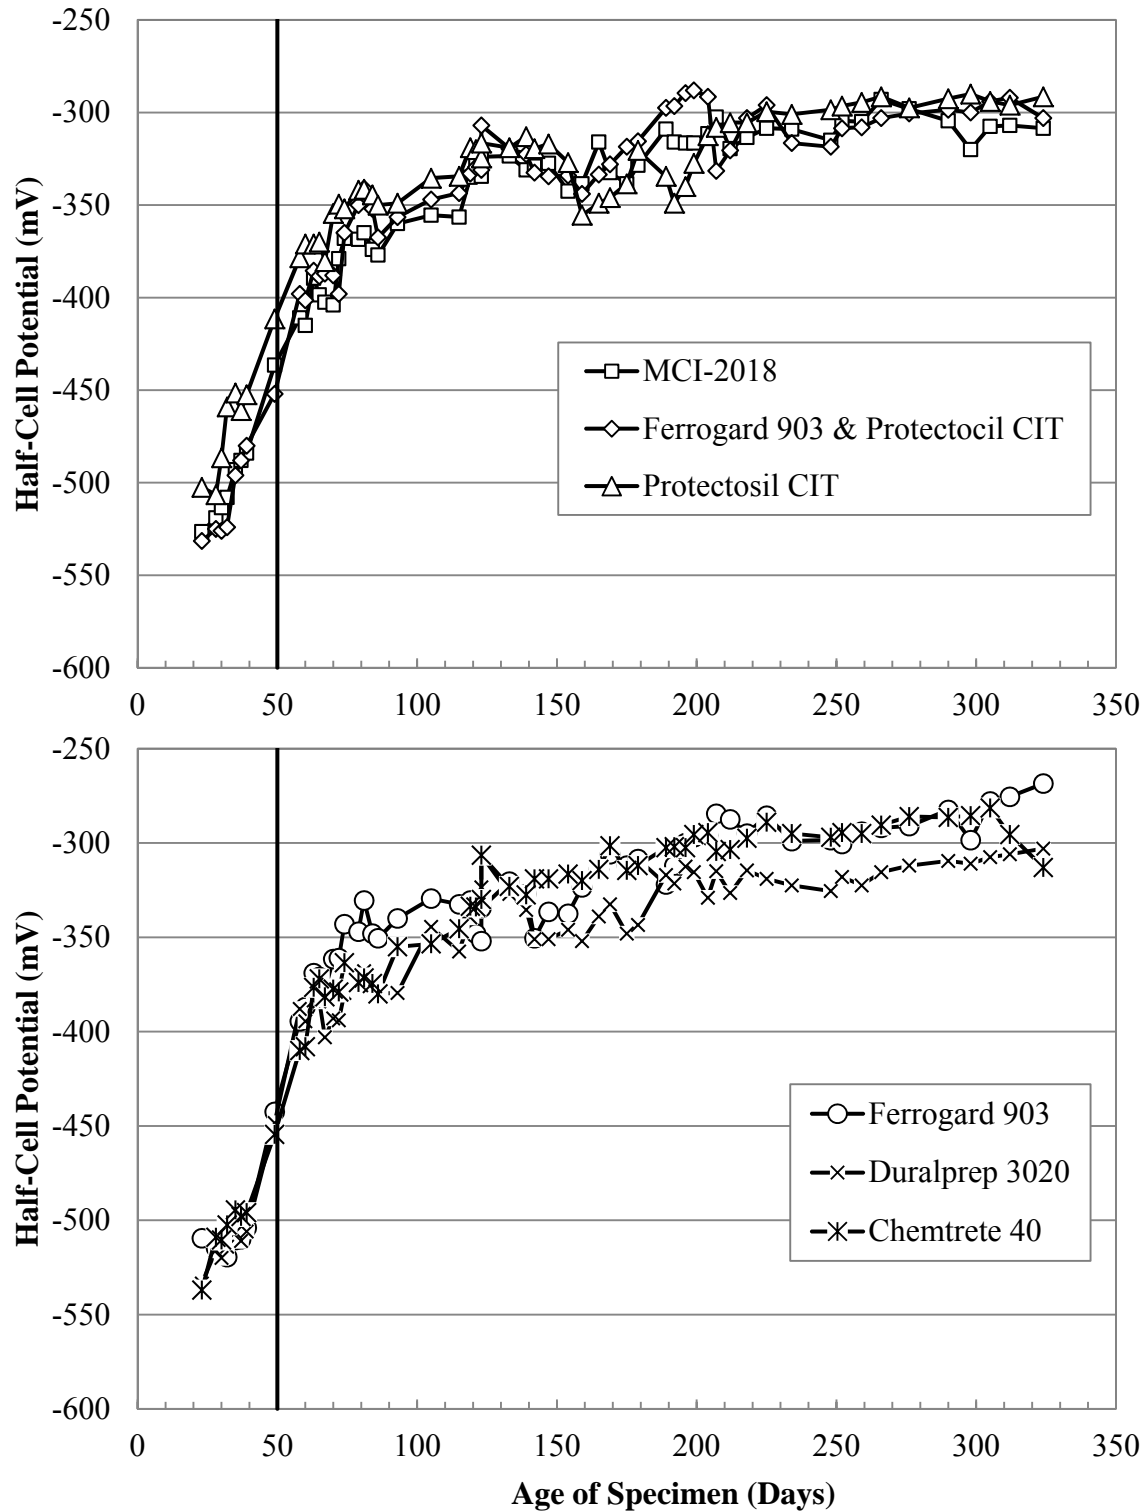
Figure 7-21 shows the half-cell potentials of the uncracked specimens when salt was added to the mix. It has also been split into two plots for ease of viewing. Figure 7-22 shows the half-cell potentials of the uncracked specimens when no salt was added to the mix and no products applied.

Figure 7-21: Half-cell potential of uncracked specimens with salt in mix

The cracked, dry, control specimens also exhibited a large difference in half-cell potentials throughout the testing period as shown in Figure 7-21. For the dry, cracked specimens after 345 days, the half-cell potentials for all of the specimens with products applied, except for Ferrogard 903, experienced shifts of +275 to +325 mV. In comparison, Ferrogard 903 shifted approximately +220 mV, and the control specimens shifted approximately +175 mV and +50 mV.

The uncracked specimens with salt in the mix had half-cell potentials within 50 mV of each other throughout the entire study. These specimens also did not exhibit any changes in the half-cell potential trend after the corrosion inhibitors were applied even though the half-cell potentials were very negative. This indicates a high probability of corrosion when the products were applied. The half-cell potentials of these specimens stabilized approximately 200 days after they were cast, at -300 mV with a range of ± 25 mV as shown in Figure 7-22. In comparison, the uncracked control specimens with no salt in the mix, half-cell potentials gradually shifted in positive direction, from -38.5mV and -26.5mV at 200 days after casting to 40 mV and 66.5 mV at 370 days after casting respectively. This comparison shows that corroding pavements with high chloride contents can exhibit up to 300 mV more negative half-cell potentials than intact, non-corroding pavements with no chlorides in it.

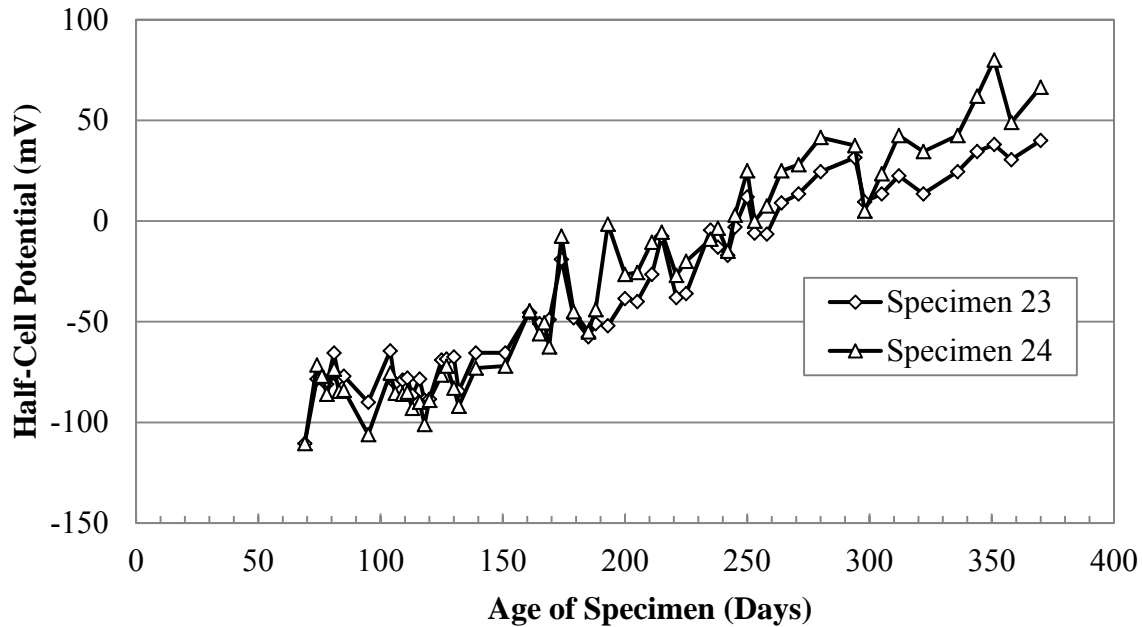
Figure 7-22: Half-cell potential of uncracked control specimens

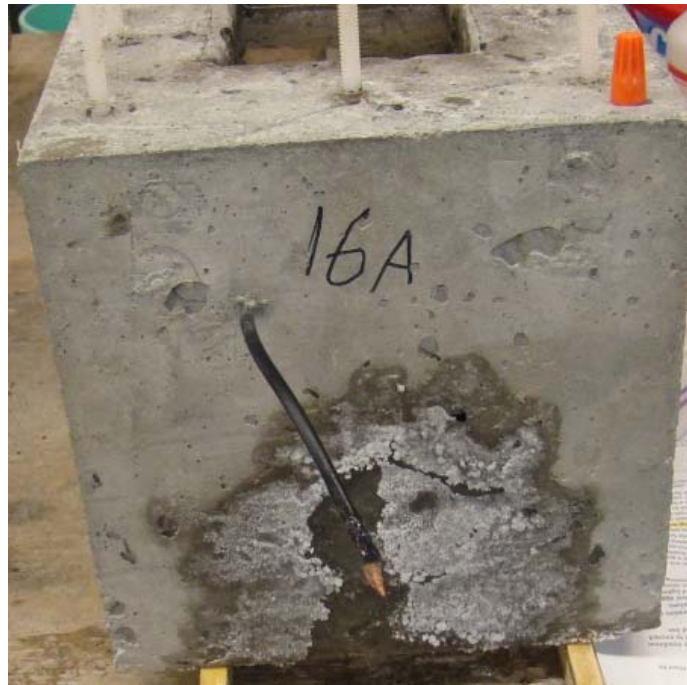
The chloride ion analysis away from the simulated crack showed that the top inch, measured from the bottom of the chloride well, had chloride ion concentrations up to 21 lbs/yd³ which is much greater than

the chloride threshold. The chloride ion concentrations only decreased slightly away from the crack at the top one inch in the specimens. The chloride concentrations from depths of one inch to three and three-fourths inches were either slightly above or below the chloride threshold at one half inch and farther away from the crack. This shows that chloride ions did not penetrate into the intact portion of the concrete. However, the layer which contained the reinforcement had chloride ion concentrations above the threshold up to two inches away from the crack in three of the four specimens tested. The chloride solution traveled along the reinforcement, which could possibly be caused by incomplete consolidation of the concrete around the reinforcement. During chloride ponding, this was evident by salt crystals that formed around the concrete patches that were placed over the reinforcement after the specimens were cast. This is shown in Figure 7-23.

Figure 7-23: Salt crystals from the chloride solution migrating through the concrete.
