SD2004-02-F

Corrosion Monitoring of Hot Springs VSL Mechanically Stabilized Earth Wall

**Study SD2004-02
Final Report**

November 2005

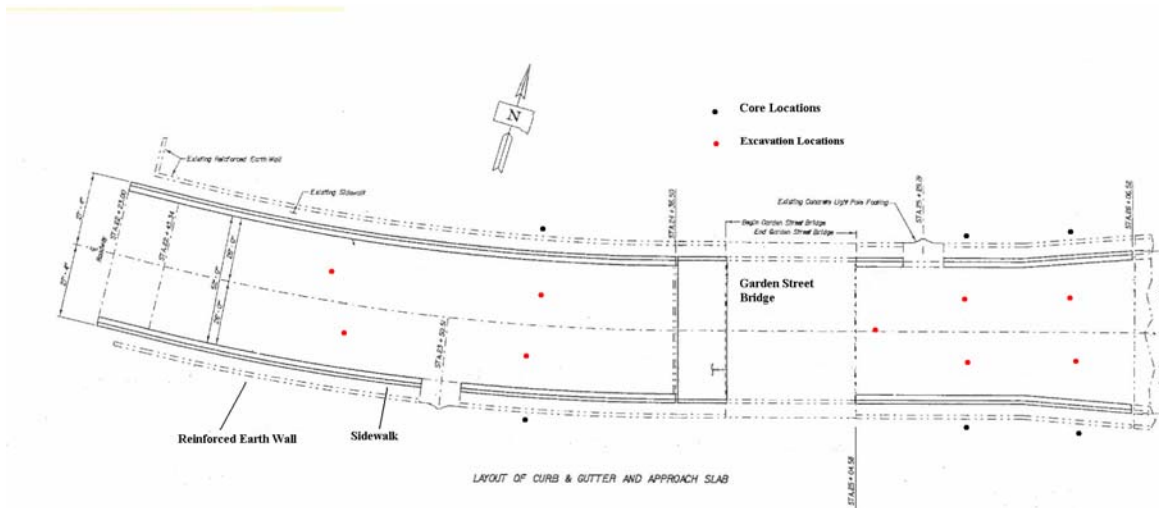
Figure 2 Excavation and core locations

The plans for project NH0018(117)39 called for exposing and evaluating the condition of the mesh at 9 sites throughout the wall after concrete pavement slabs were removed. Areas investigated included the west abutment of the Garden Street bridge, directly beneath some of the most severe longitudinal cracking and the lower elevations at the east end of the structure. Excavation and core locations are listed in Table 1 and shown in Figure 2. Because of the unknown character of the mesh condition, the plans called for up to five

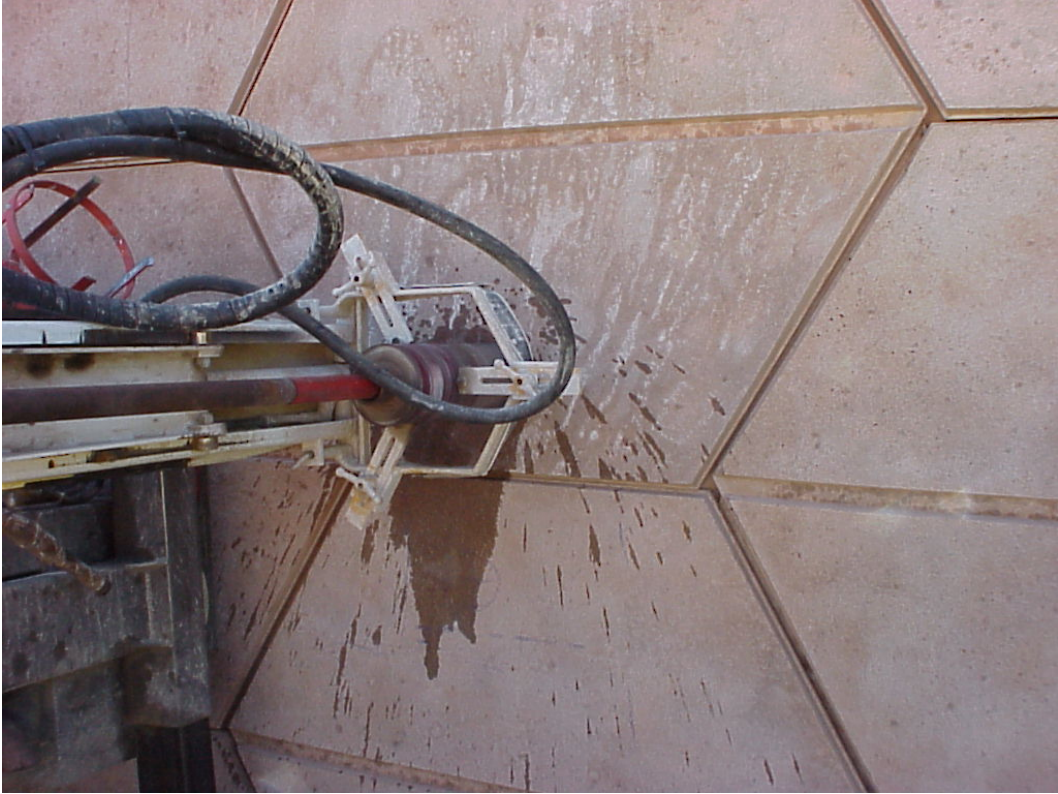
Figure 12 Coring operation at wall base

Six inch cores were cut from the wall (Figure 12) at accessible locations corresponding to the areas where mesh had been exposed above. The primary purpose of the cores was to inspect the condition of the mesh in the critical zone where it connected to the concrete panels and to determine how badly the poor consolidation and settlement had affected its integrity. The inspection of the first layer of reinforcement mesh indicated that there was little need to instrument the wall and monitor corrosion. In every case where a core was drilled, the area behind the concrete was generally part of a network of voids with relatively large chunks of granular backfill (many in excess of 6") providing the framework for the voids. The mesh was also uniformly bent downward, in many cases at angles approaching 45°. No evidence of any significant corrosion was forthcoming at any of the six core locations as illustrated in Figure 13. The beginning of a typical bend in the mesh just off the wall face is shown in Figure 14.
