# **SD2005-11: Evaluation of Crack-Free Bridge Decks**

## **FINAL REPORT**

June 2011

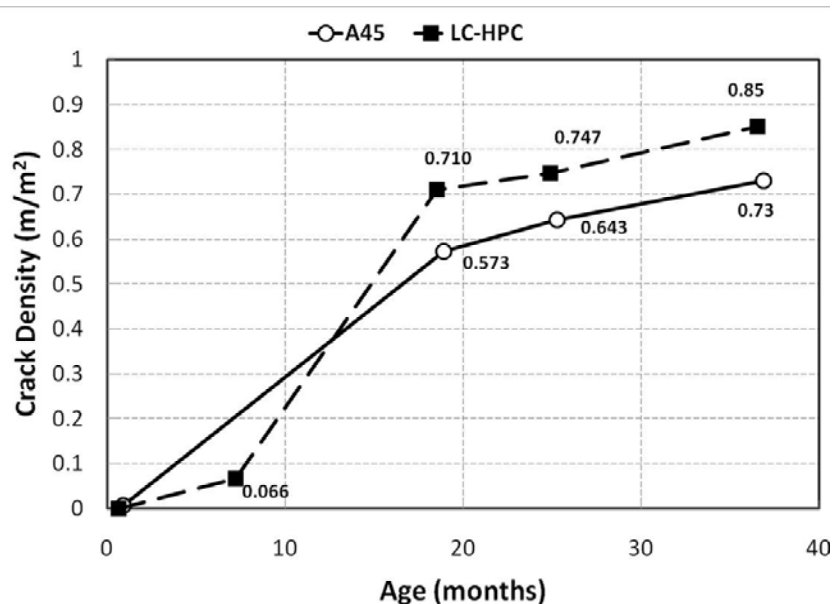
**Fig. 1.1** Summary of Crack Densities for Pennington County Bridges

Fig. 1.1 shows the comparison of crack densities for the two types of bridge decks in Pennington County. The crack density of A45 bridge deck after three years of service was found to be  $0.73 \text{ m/m}^2$  while the crack density of LC-HPC bridge deck after three years of service was found to be  $0.85 \text{ m/m}^2$ . These crack densities reveal that the current SD-DOT A45 concrete deck performed better than the proposed LC-HPC bridge deck in Pennington County.

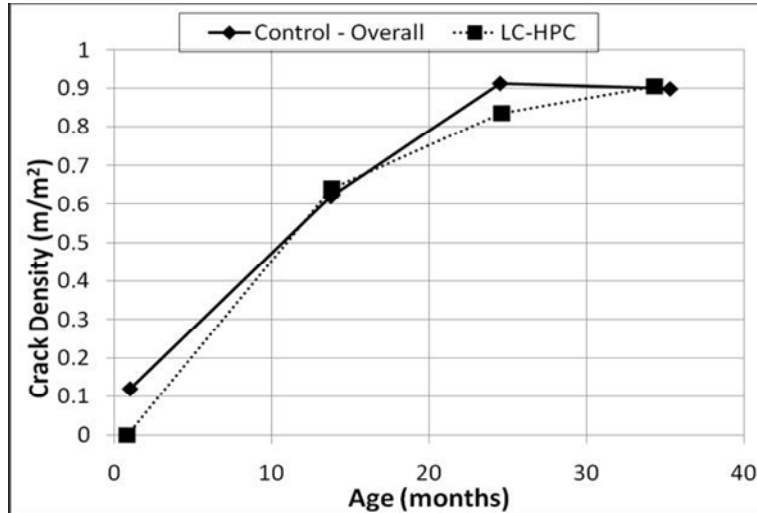
**Fig. 1.2** Summary of Crack Densities for Brule County Bridges

Comparison of crack densities for the two types of bridge decks in Brule County is shown in Fig. 1.2. The figure shows that the crack density of A45 bridge deck after three years of service was practically the same as the crack density of LC-HPC bridge deck after about three years of service.

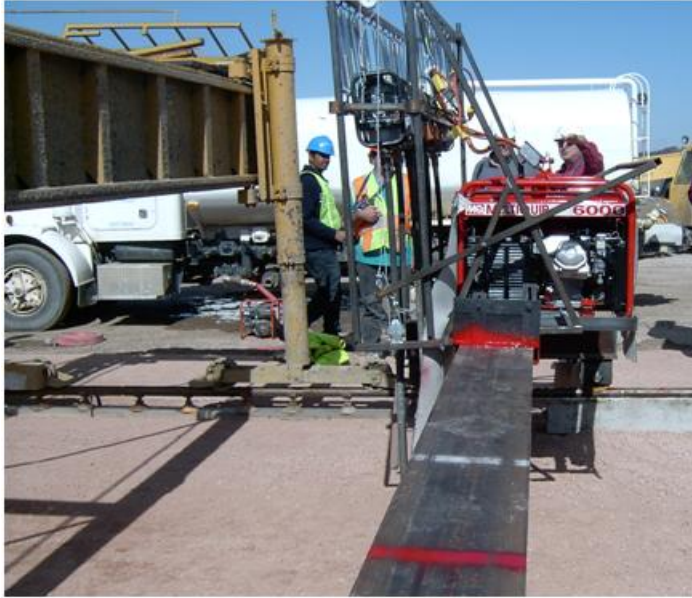
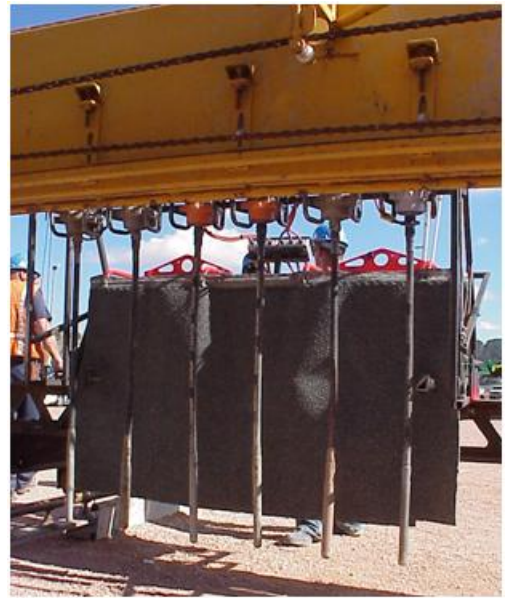
**Fig. 8.1** Vibrator Setup

Vibrator setup (see Fig. 8.1) worked well. Vibration time needed to be increased for proper consolidation. A backup for possible breakdown of the system needs to be in place. Delays in pumping concrete interfered with consolidation.

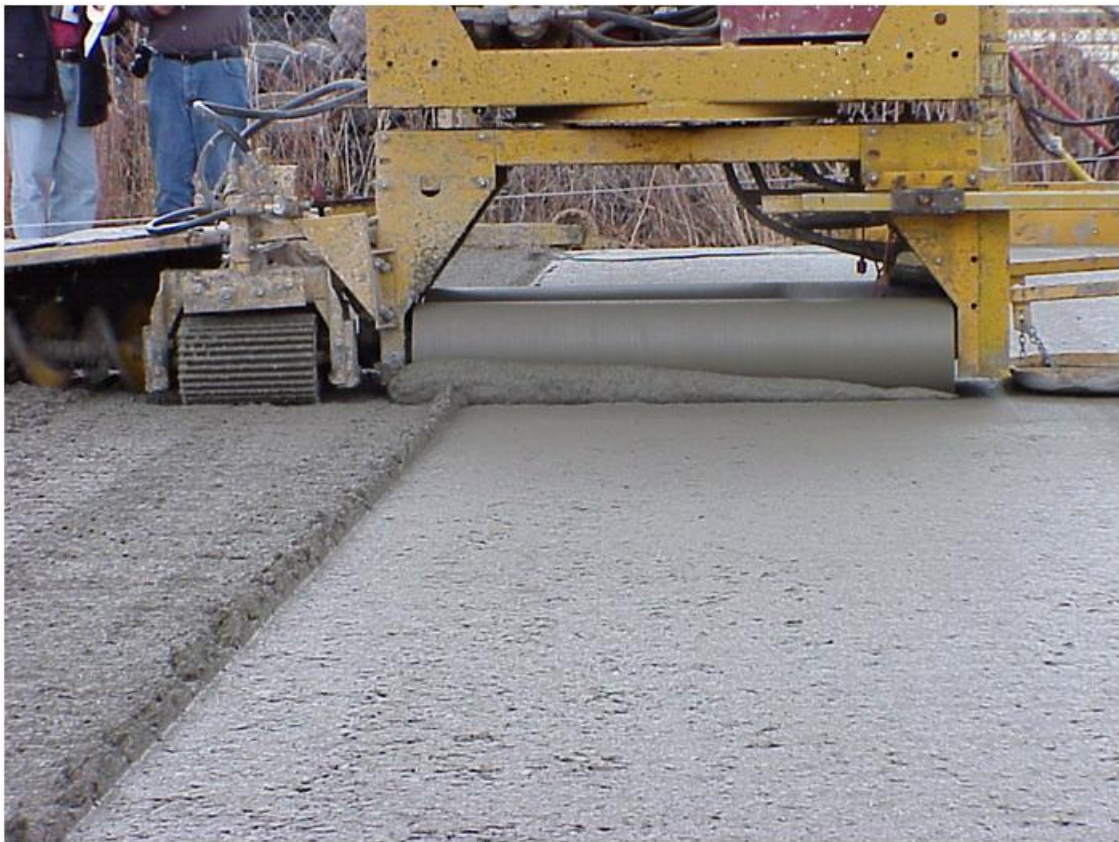
All eight observers were dissatisfied with finishing (Figs. 8.2 and 8.3). While hand finish was kept to a minimum, the placement rate and concrete (was stiff initially) affected the finish. In the later half of pour, the finish got better than the first half. However, fines were removed excessively from the concrete and pushed aside by the finishing machine rollers (Fig. 8.2).

**Fig. 8.2** Fines from Concrete Being Excessively Removed by the Roller

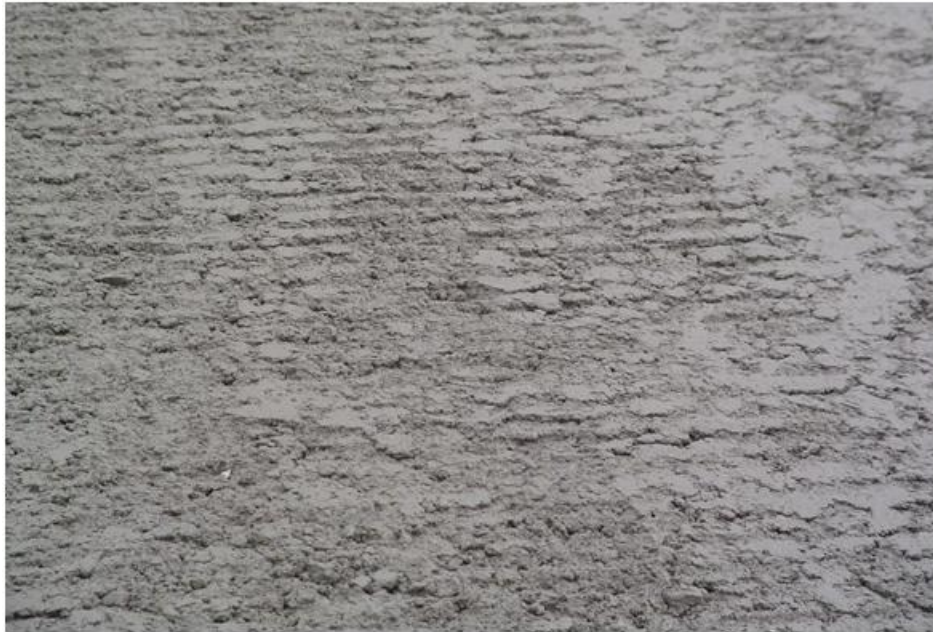
**Fig. 8.3** Poor Finish of Concrete

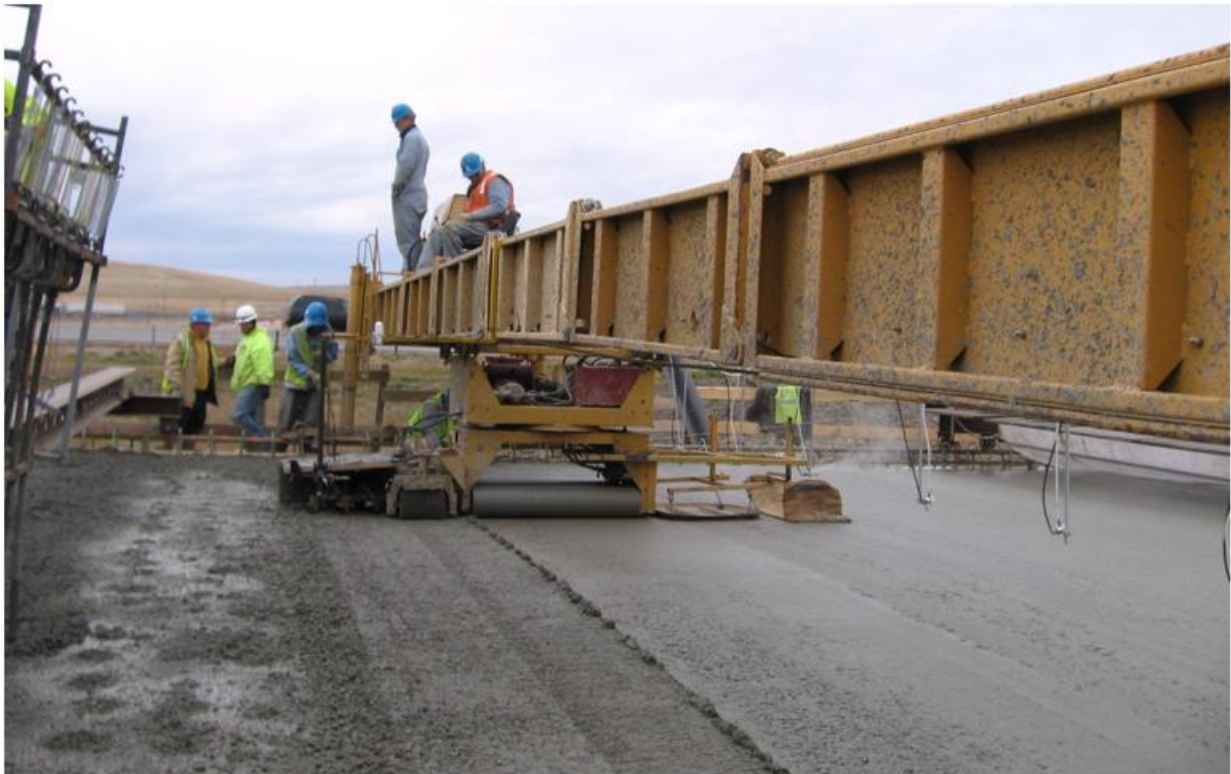
The drag pan behind the finish machine was not attached correctly at the beginning of the pour, and the finish was poor as a result. Contractor made adjustments and finishing was much better after making the adjustment (Figs. 8.13 and 8.14).

**Fig. 8.13** Concrete Finishing with Two Rollers

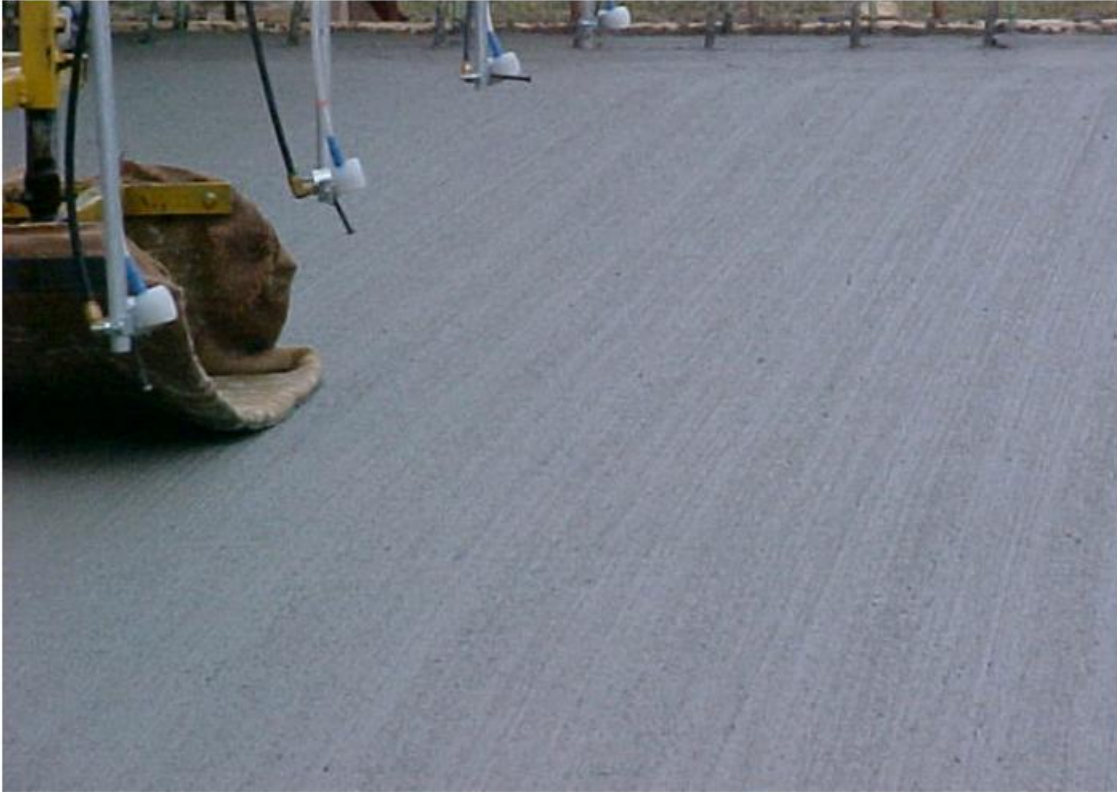
**Fig. 8.14** Finish Achieved

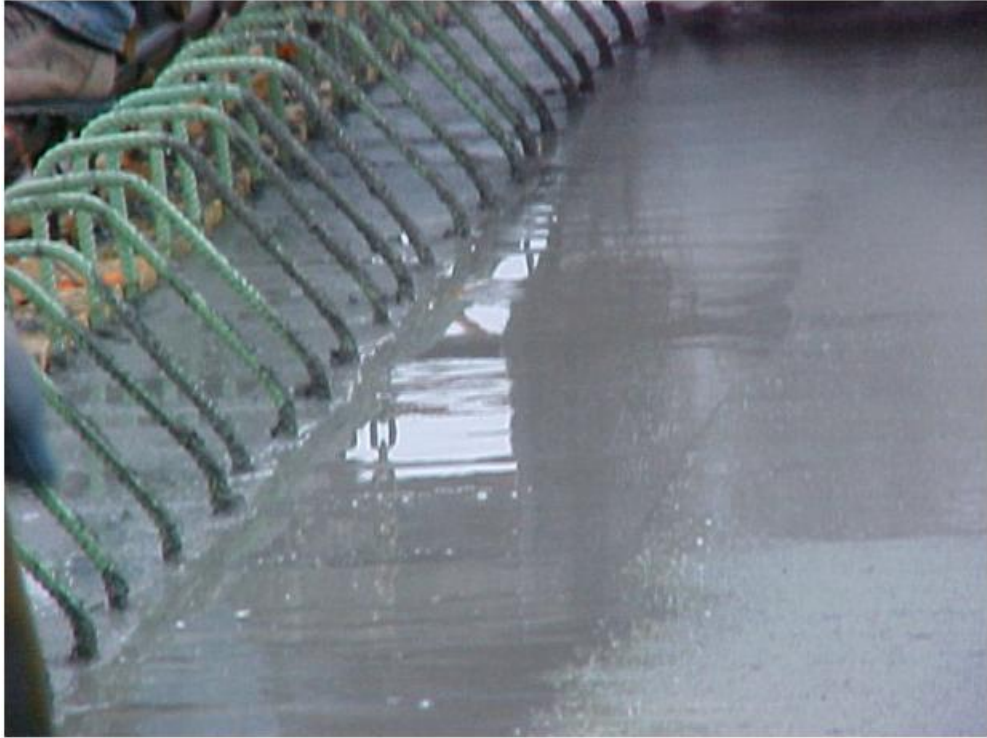
No excessive fog spray was required prior to the application of curing materials. No fogging was required close to concrete surface to finish concrete (Fig. 8.15). There were some minor problems with water from curing blankets and fogging running into the curb lines in the areas (Fig. 8.16) where some hand finishing was required. Some of this water may have been worked into the surface and may result in some scaling.

**Fig. 8.16** Puddles of Water from Excessive Fogging in Some Patches

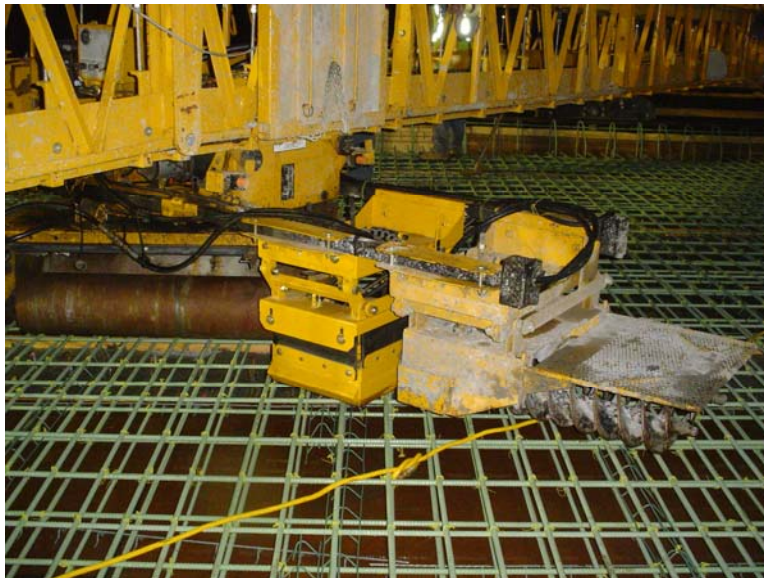
The concrete finishing machine bridge was placed along the bridge deck skew. The axis of the rotating finishing drums was set parallel to the longitudinal axis of the bridge deck, but the augur was skewed relative to the drums. Although the finishing machine had two rotating drums, only one drum was used to finish the concrete surface. Figure 8.18 shows the rotating drums with the skewed augur.

**Fig. 8.18** Rotating Drums and Skewed Augur on the Finishing Machine

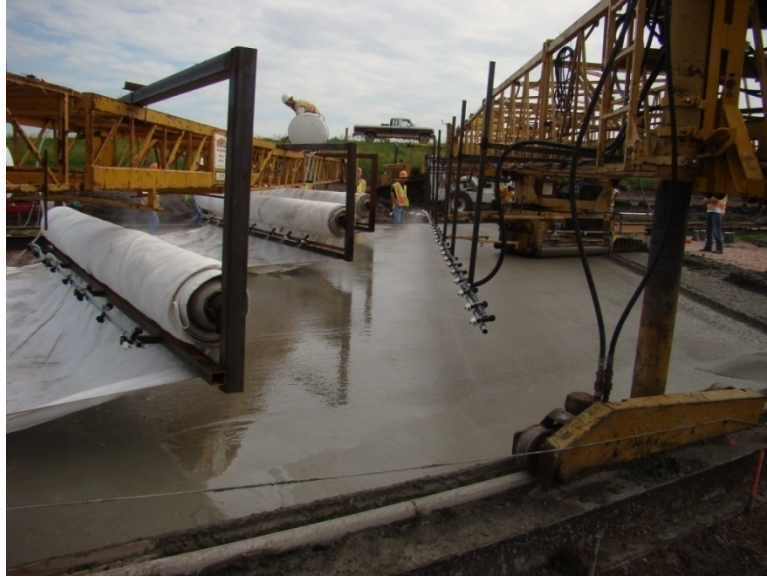
- Placement of curing blanket was about 2 hours after strike-off and excessive water was being placed on the blanket.

The curing blankets set up and fogging/finishing can be seen in Figure 8.23. The excessive water can be seen on the concrete surface. It can also be seen that the blankets did not reach the edge of the test slab.

**Fig. 8.23** Curing Blankets and Concrete Finish for Test Slab I

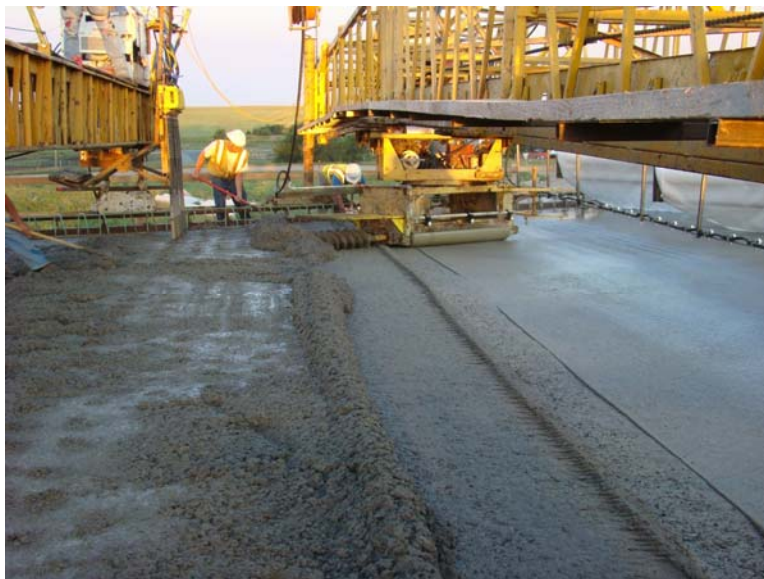
The concrete was deposited by means of a conveyor belt. Figure 8.24 shows the conveyor belt set up on the bridge deck. At the beginning of the concrete pour, the concrete quantity that was deposited on the deck was in excess of what is required to provide the required deck thickness. Figure 8.25 shows the

excess concrete. This caused some progress delay as the construction crew had to move the excess concrete. As the work progressed, the rate of concrete placement improved and reached an average of 35 ft of deck length per hour.

**Fig. 8.25** Excess Concrete Deposit at the LC-HPC Deck in Brule County

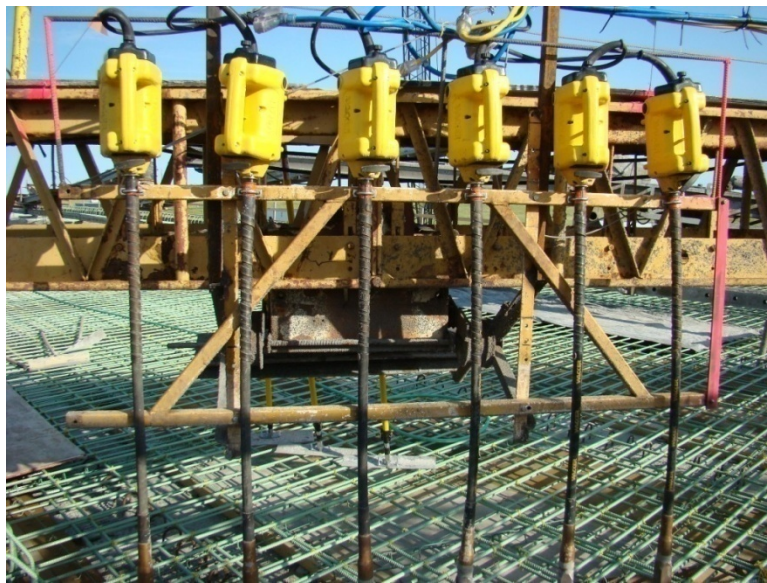
Six vibrators mounted on a steel bridge allowed for transverse and longitudinal movement and vertical insertion of the vibrator set all at once. Set up allowed for the vibrator gang to be moved parallel to the skew and advanced 1' along the bridge length. Due to operator error, the vibrator set up was not always moved 6' across the bridge and several spots were vibrated twice. It was also observed that the vibrators should have been moved across the deck a little quicker. The concrete gang vibrator set up is shown in Figure 8.26.

**Fig. 8.26** Gang Vibrator Set Up for the LC-HPC Deck in Brule County

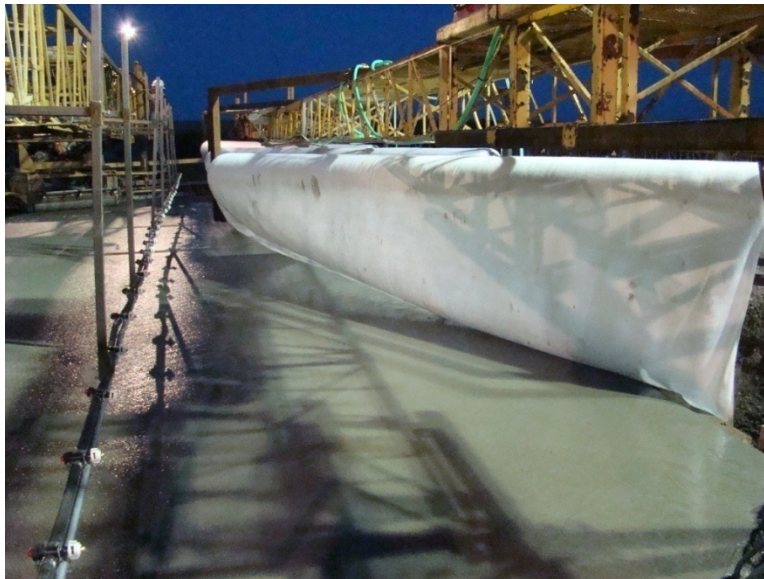
**Fig. 8.27** Concrete Fogger Set Up for the LC-HPC Deck in Brule County

Figure 8.27 shows the fogging system that was used to provide moisture to the finished surface. It was observed that the fogging nozzles provided a fine water spray rather than mist. This resulted in some pooling water on the surface of the deck. The contractor tried to minimize the water pooling by controlling the on/off operation of the fogging system.

- Excessive fogging did occur and there were some leaks in the lines.
- The entire process could have been sped up if the depth of concrete placement was more consistent. .
- Curing materials need to be applied sooner and not be soaked to prevent puddling of water.
- LC-HPC placement and finishing is manageable when the weather conditions are favorable and sufficient advance preparations are made. For successful placement, the contractor and concrete supplier must be familiar with the behavior of the fresh mix and the weather must be favorable.

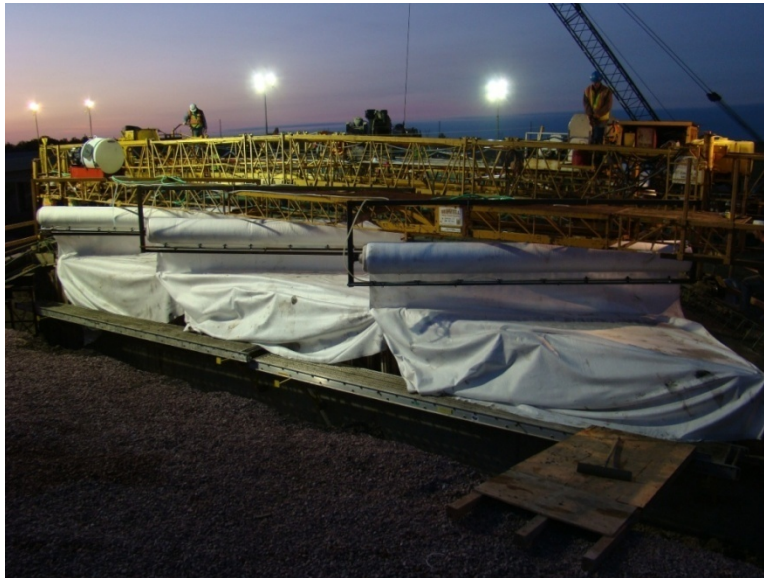
**Fig. 8.28** Curing Blankets on the LC-HPC Deck in Brule County

A soaker hose was used to wet the curing blanket after it was placed on the finished concrete surface. However, it was observed that excess water was applied to the curing blanket causing the water to run and collect on the sides of the slab. Figure 8.28 shows the soaked curing blankets being placed on the deck.

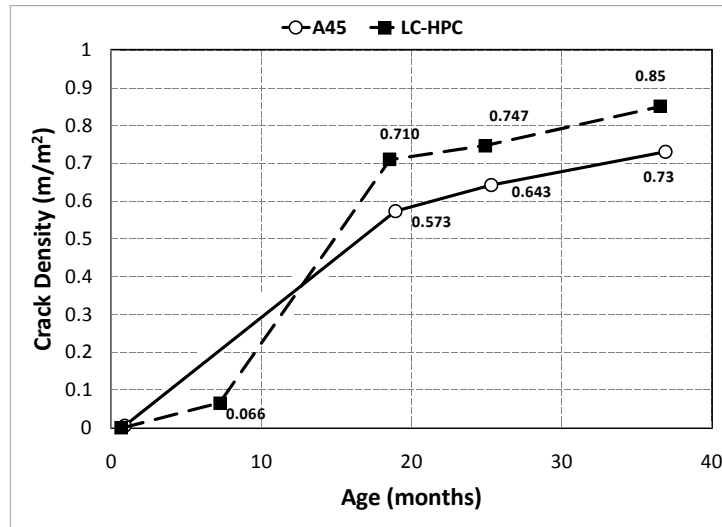
**Fig. 9.1** Comparison of Crack Densities of A45 Bridge Deck and LC-HPC Bridge Deck

The crack densities determined for the two bridge decks (A45 and LC-HPC) that are located in Pennington County are compared in Fig. 9.1. The two curves shown the figure demonstrate that the control deck using A45 concrete has a smaller crack density than that of LC-HPC bridge deck.

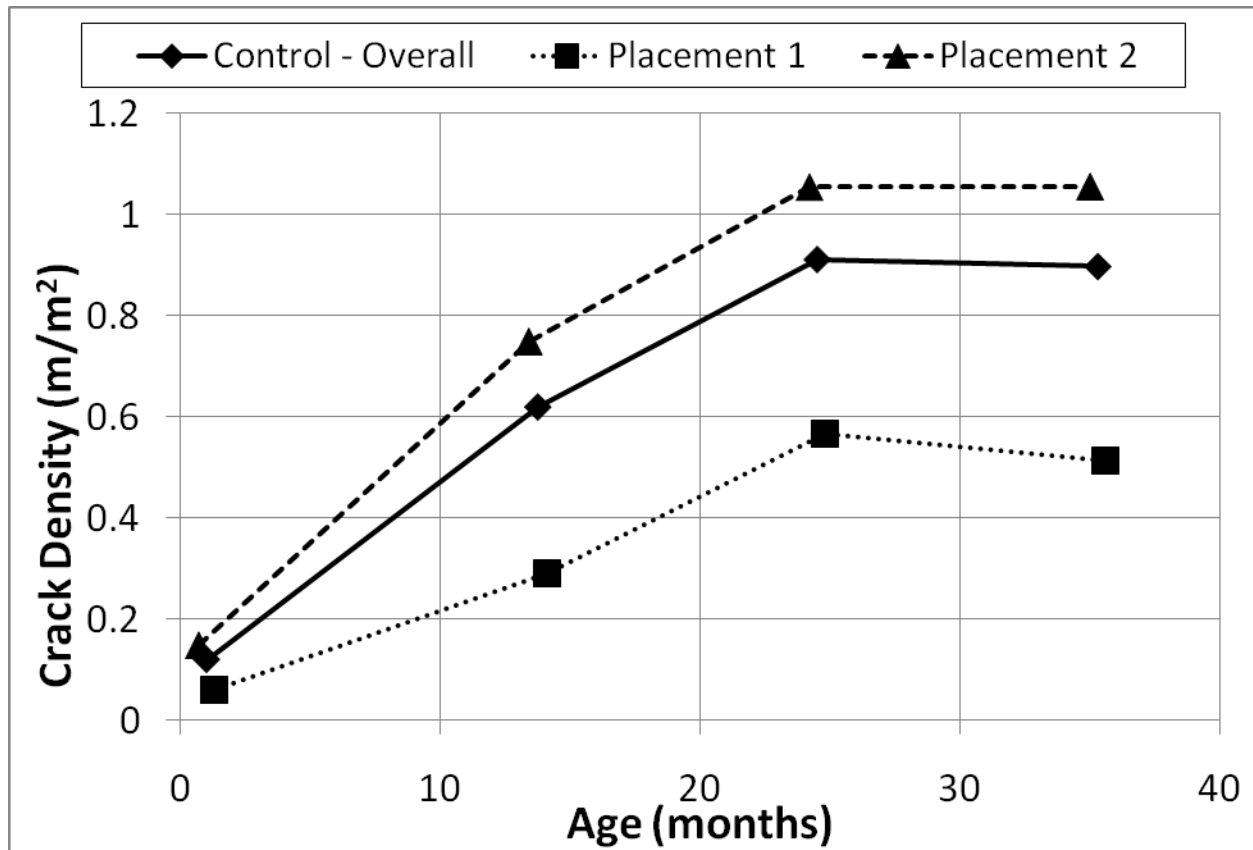
**Fig. 9.20** Control Deck Crack Density vs. Time

The 3 year crack densities for placements 1 and 2 were approximately the same as the 2 year crack densities. The trends in cracking versus time can be seen in Fig. 9.20.

Both placements 1 and 2 experienced increased cracking with age in the first 2 years. It should be noted that the DOT applied crack sealant to existing cracks between years 2 and 3. While the crack sealant may have prevented the cracks from extending, it also made crack surveying difficult and cracks were not captured in the surveys. This could also explain the small drop in crack density for overall and placement 1 from year 2 to 3.

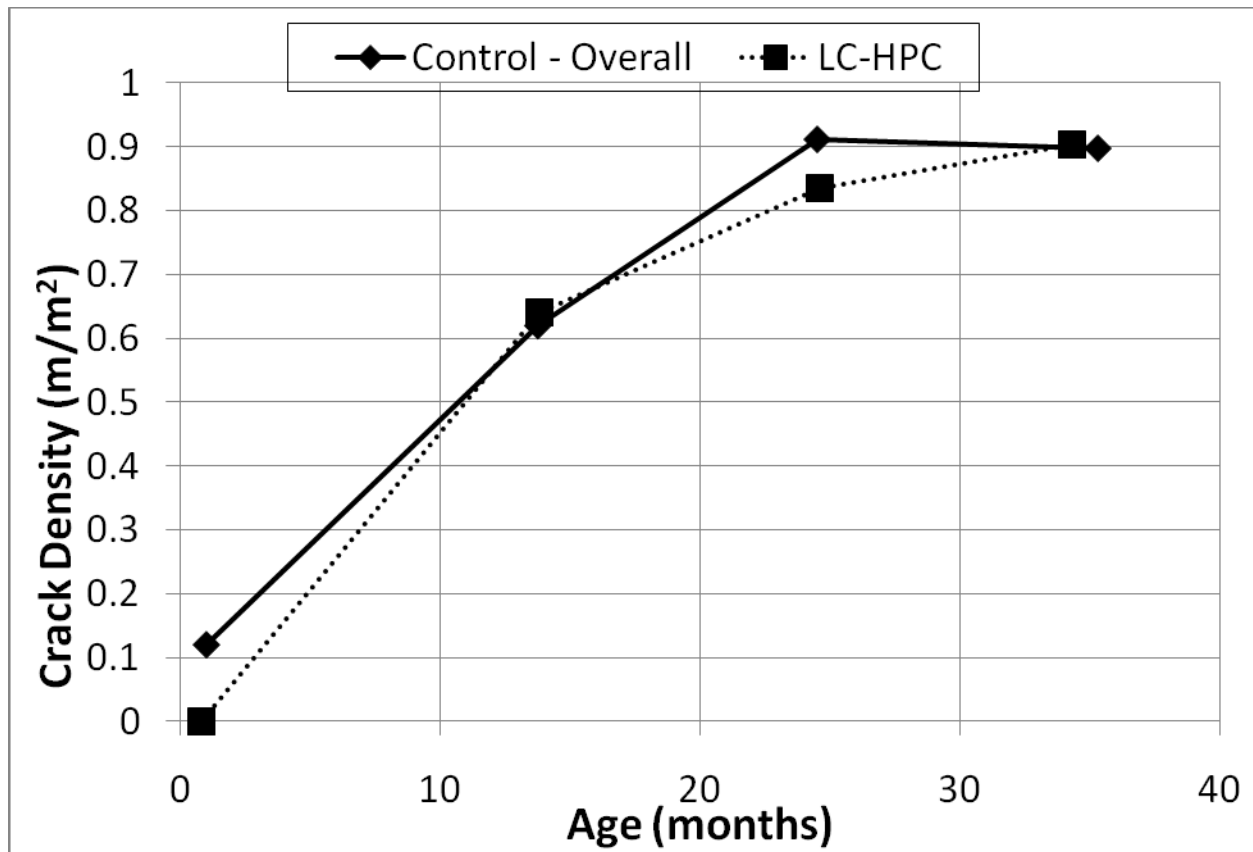
**Fig. 9.24** LC-HPC Deck Crack Density vs. Time

The LC-HPC bridge deck cracking performance was similar to the cracking performance of the control deck. The LC-HPC deck should have experienced less cracking but after 3 years, the bridge decks experienced the same amount of cracking. The University of Kansas suggests the fogging system used during placement had an effect on the bridge deck performance. During placement, the deck surface was moistened using a fogger at the finish roller and a fogging bridge between the finish and curing bridge. The foggers at both locations provided a fine water spray rather than a mist. This may have increased the w/c ratio at the top of the deck, raising it past specifications for LC-HPC. The increased w/c ratio led to more cracking and decreased the performance of the LC-HPC bridge deck.

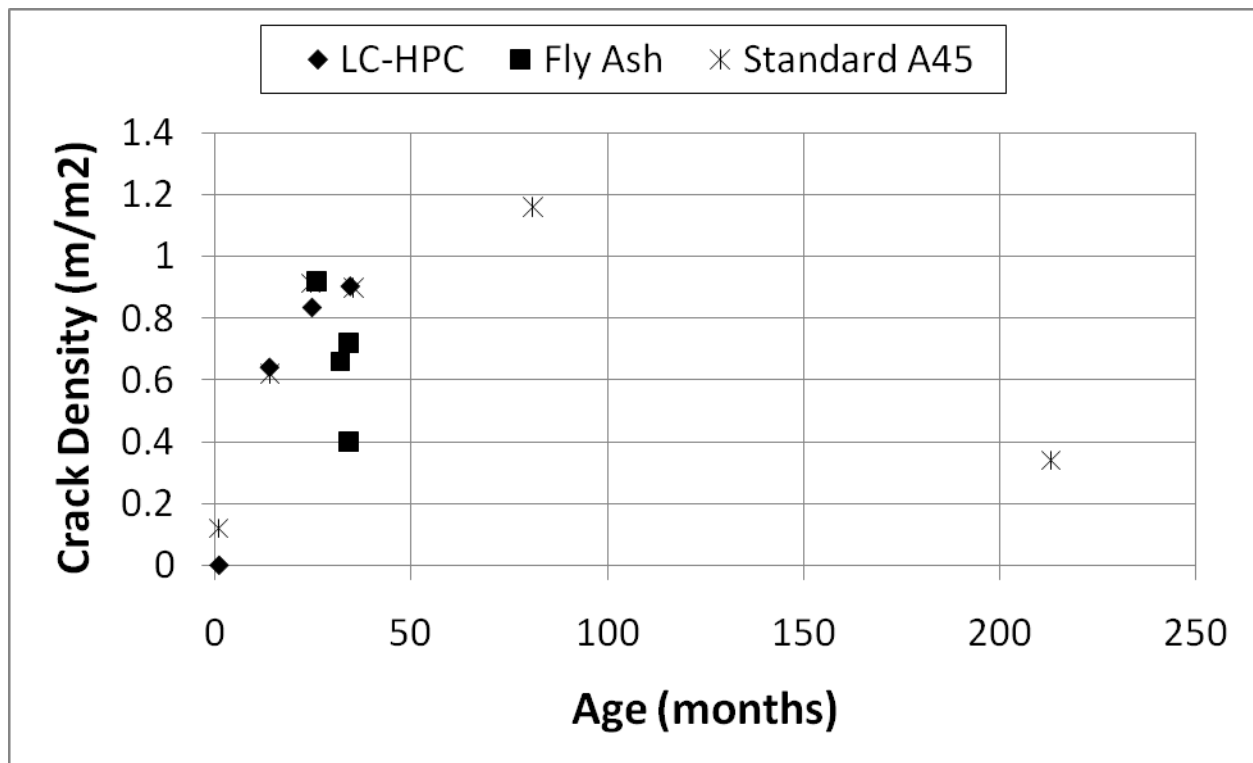
**Fig. 10.1** Bridge Deck Crack Densities vs. Time

The results of the crack survey are summarized in Table 10.1 and Fig. 10.1. From the limited data, it was hard to draw conclusions regarding the effects of time on deck cracking. Only the control bridge decks (standard A45 mix) and LC-HPC bridge decks from this project were surveyed more than once. Therefore, there is no direct comparison available for the remaining bridges in this research. Literature shows cracking increases with time and that was seen in the control deck and LC-HPC deck (Schmitt and Darwin, 1995). The other bridges in this study should be surveyed at a later date to determine any age related trends. Of the pairs of bridges with similar decks, it was observed that the older bridge had significantly less cracking. Since deck materials and bridge support types were nearly the same, the difference in crack densities may be the result of different placement conditions and other factors that are unknown and unavailable at this time. Literature states that the temperature high to low variation

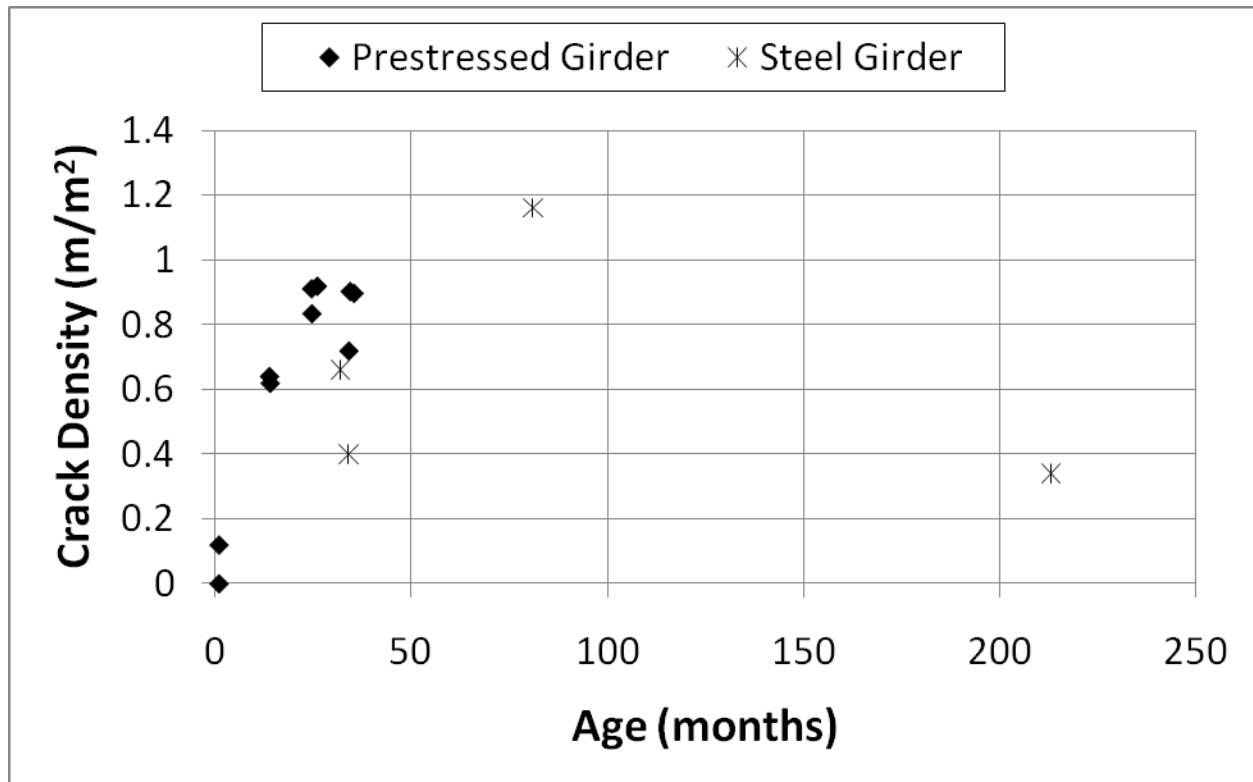
**Fig. 10.2** Prestressed and Steel Girder Bridge Deck Crack Densities vs. Time

Figure 10.2 compares the crack densities between prestressed girder and steel girder bridges. Typically the prestressed girder bridges had more cracking than steel girder bridges. The data is limited, but in this study there were two prestressed bridges and two steel girder bridges around the 30 month age. The prestressed bridge had a deck with flyash and the steel girder bridge had a flyash and optimized aggregate deck. The prestressed bridges had significantly more cracking. French et al. (1999) suggested the opposite of this trend. The study concluded that the main cause of bridge deck cracking was the differential shrinkage between the concrete deck and steel girder. The optimized aggregate of the steel girder bridge may have reduced the cracking as the literature suggests (Schmitt and Darwin 1999).

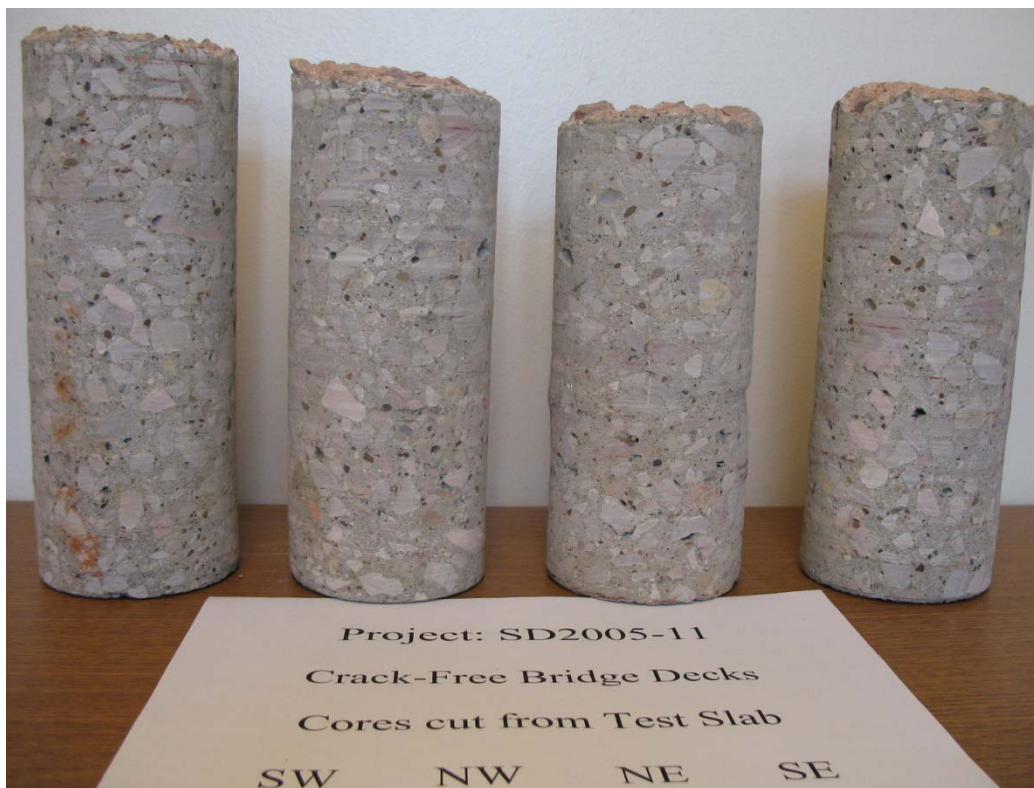
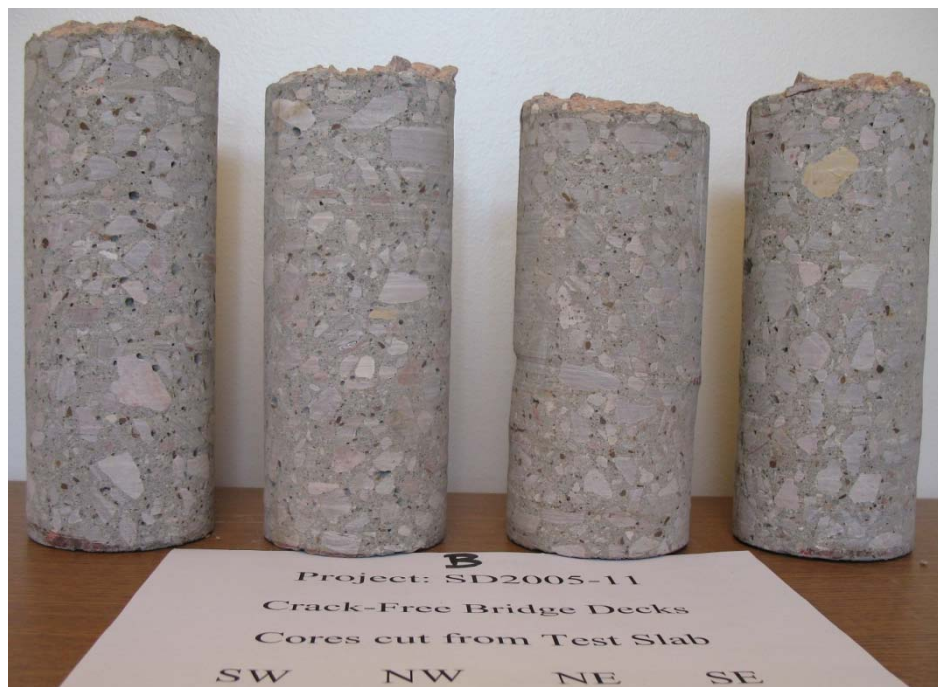
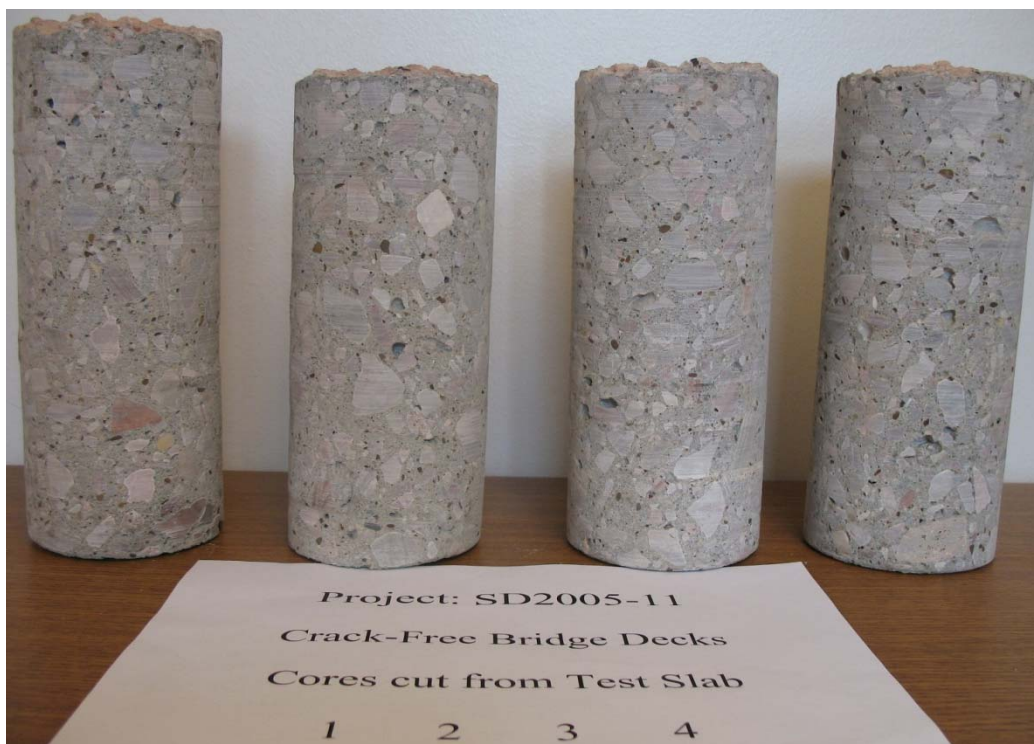
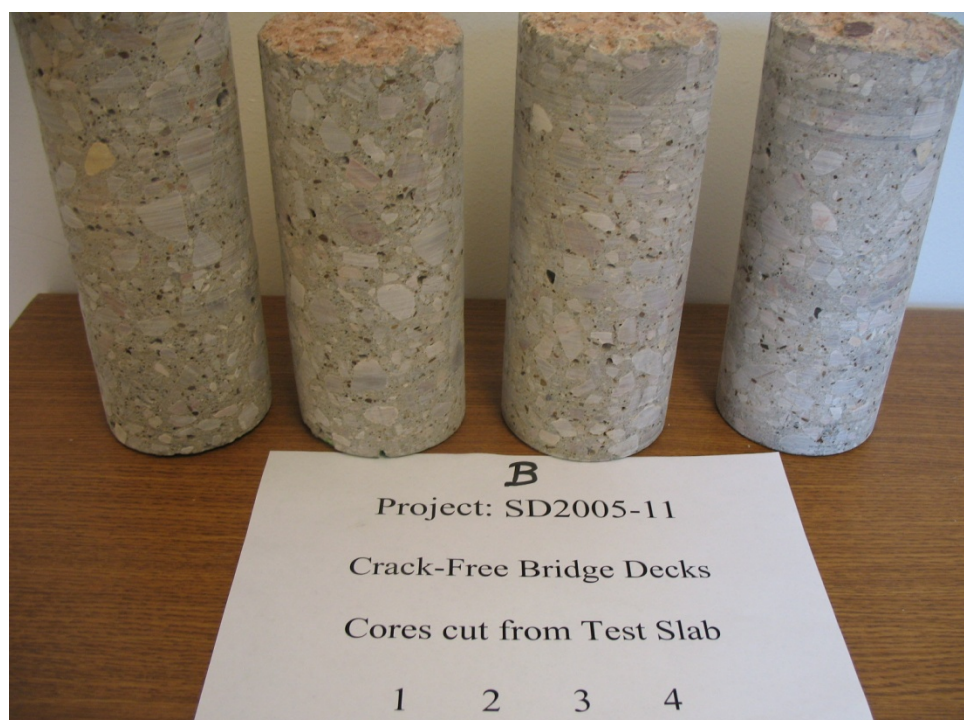
The pictures of the cores cut from test slab are shown in Figs. 12.3 to 12.6. The cores cut from A45 concrete bridge (west bound) are shown in Figs. 12.7 and 12.8. The cores cut from the LC-HPC bridge (east bound) are shown in Figs. 12.9 and 12.10. Physical inspection of the cores generally showed that there were more or less the same amounts of air voids on the surfaces of the cores for the three sets of cores cut from the three types of concretes (test slab, A45 bridge deck and LC-HPC bridge deck). The consolidation of concrete appeared to be the same or marginally different, if any. The paste content also seemed to be more or less same in all the concrete cores. There appeared to be very good bond between the aggregate particles and the cement paste. All the aggregate particles seemed to be fully coated with cement paste.

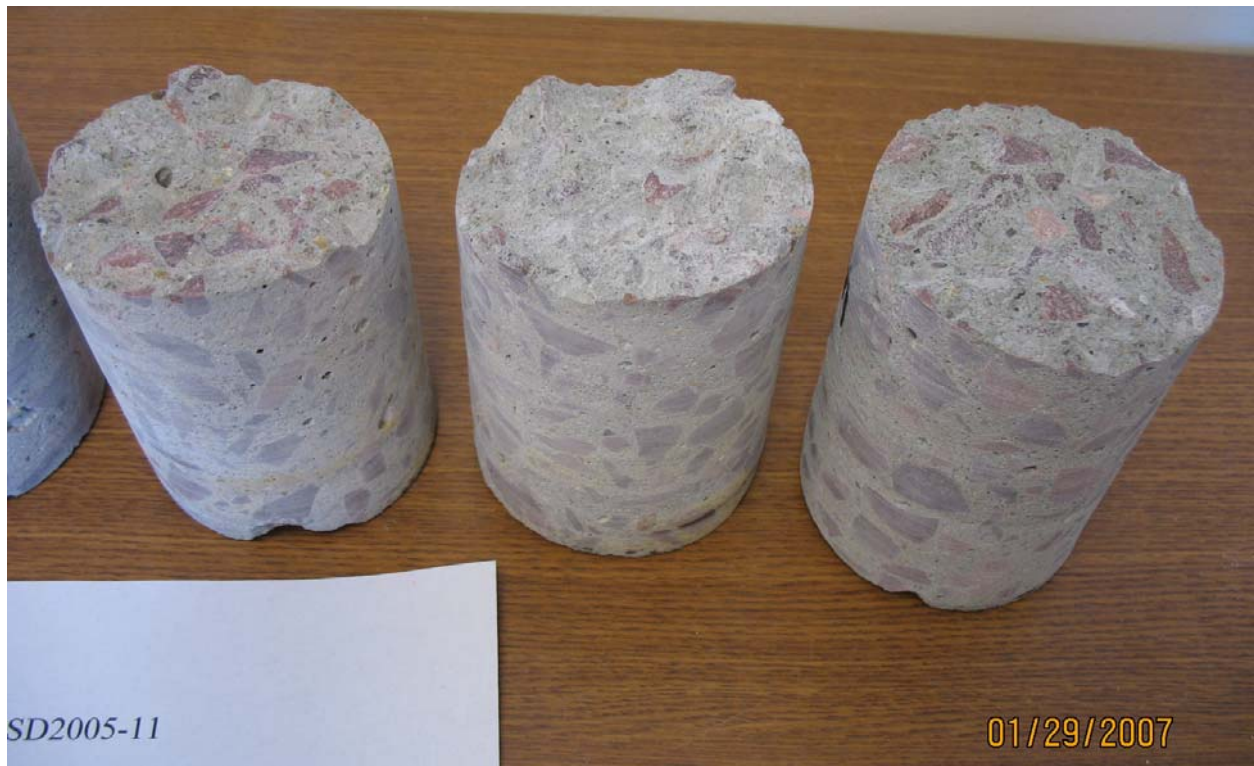
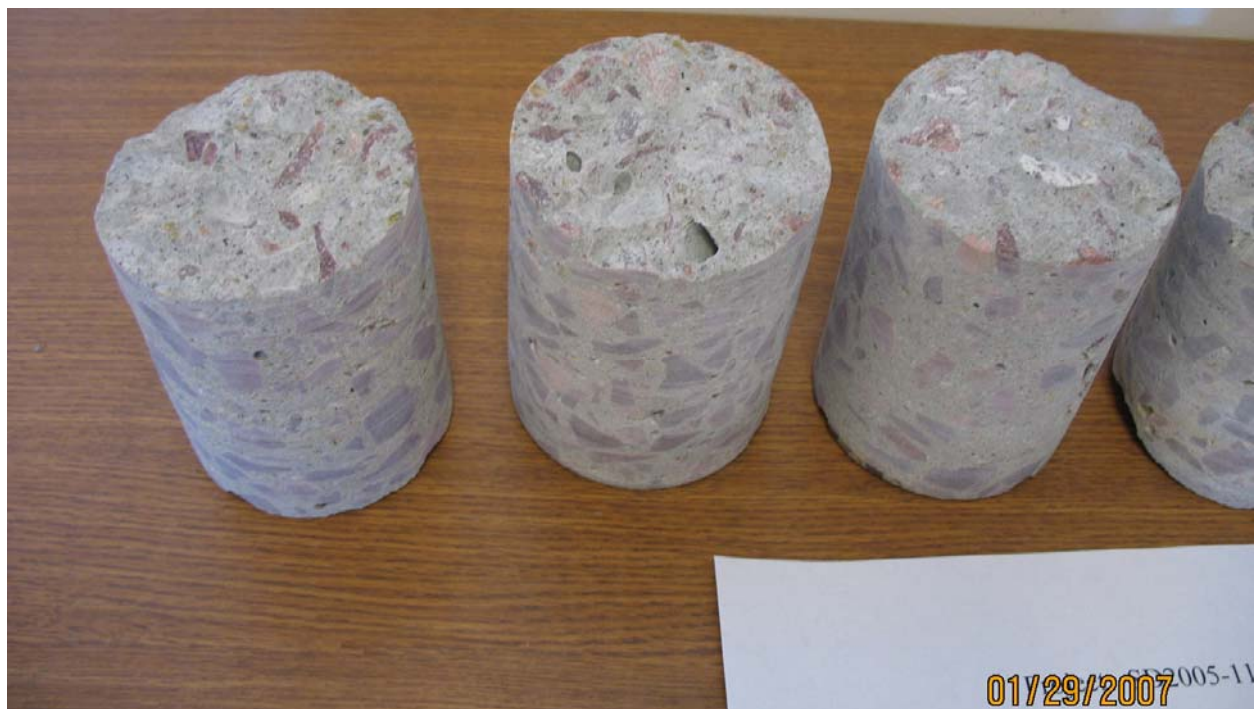
Fig. 12.11 and Fig. 12.12 shows three cores each cut from Brule County bridges. Physical inspection of the concrete cores cut from the test slabs, A45 concrete deck and LC-HPC deck showed no discernable difference between the microstructure of the cores. Air voids, aggregate content, and distribution, and an estimate of density, absorption and void content were determined from a petrographic analysis conducted at SDSMT. The quartzite cores (Brule County) tend to have slightly greater air void content and slightly greater total aggregate content than the limestone cores (Pennington County). The concrete consolidation for all the bridge decks was very good. The average coarse aggregate content in the cores was found to be about 40% on the slices cut and examined. The volume of permeable voids for these concretes ranged from 10.6 to 12.5%. Complete details of petrographic evaluation of the eight concrete cores are given in the following section.
