Final Report
Project Number 930-866R

EVALUATION OF REMEDIATION STRATEGIES FOR SHRINK-SWELL CLAYS IN WESTERN ALABAMA

The Alabama Department of Transportation

JUNE 2024

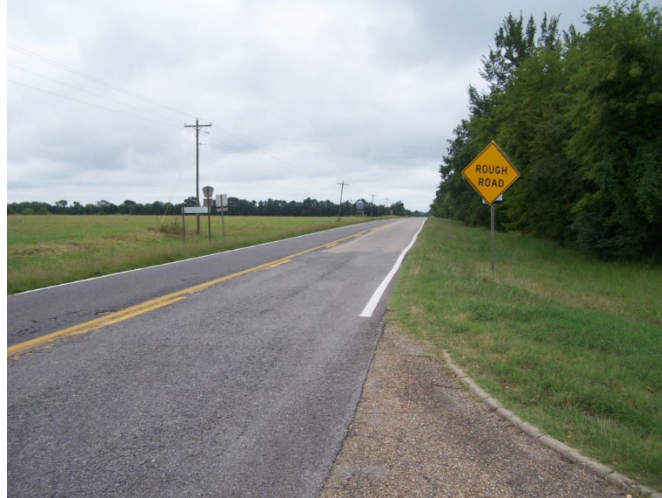
Figure 3 shows a Google Map superimposed over an inset of Alabama from Figure 2 (Patrick and Snethen 1976). The portion of AL 5 of interest, point A, falls in a zone of medium expansive clay. During a site visit in July of 2013 with ALDOT Tuscaloosa Area (formerly Division 5) and Materials and Tests Bureau Personnel, severe pavement distress was observed in the form of cracking and an uneven undulating surface. Heavy rain fell at the time and there was dangerous amounts of standing water encountered, resulting in hydroplaning. The distress is evident in Figure 4. After walking a local section then driving the length of the project, an initial hypothesis was made that drainage, or lack thereof, coupled with the character of the clays underneath the roadways, is the root cause of the distress. Of note, often the most severe distress was where there were agricultural ponds along the roadway. A secondary issue could be the pore water chemistry effects due to agricultural runoff and seepage in the area.

Figure 4. Recent photograph of AL 5 facing south depicting the condition of the roadway.

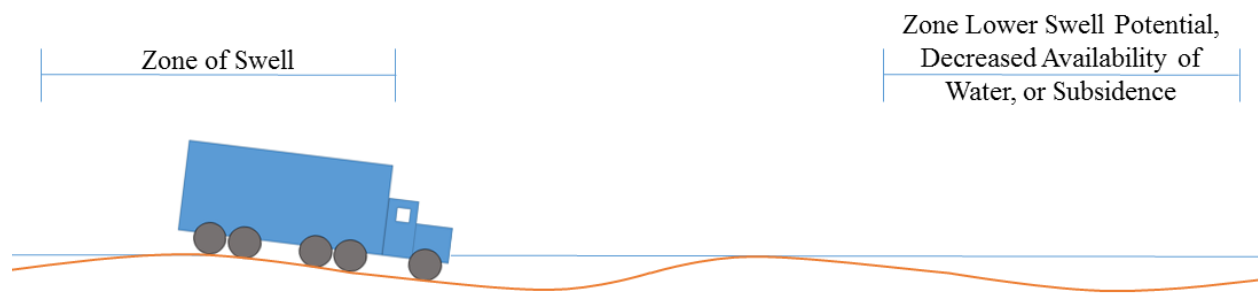
Figure 52: Illustration of Differential Heave (Not to Scale)

The first 2.4 miles of the project is generally characterized by heave. For the purposes of this investigation differential heave is a general term used to describe sections of roadway that may experience different amounts of heave (or subsidence) do to varying swell potentials or availability of water. As a result, motorists may experience a rolling (over long sections) or bumpy (over short sections) ride. Figure 52 illustrates this concept as observed by the authors.

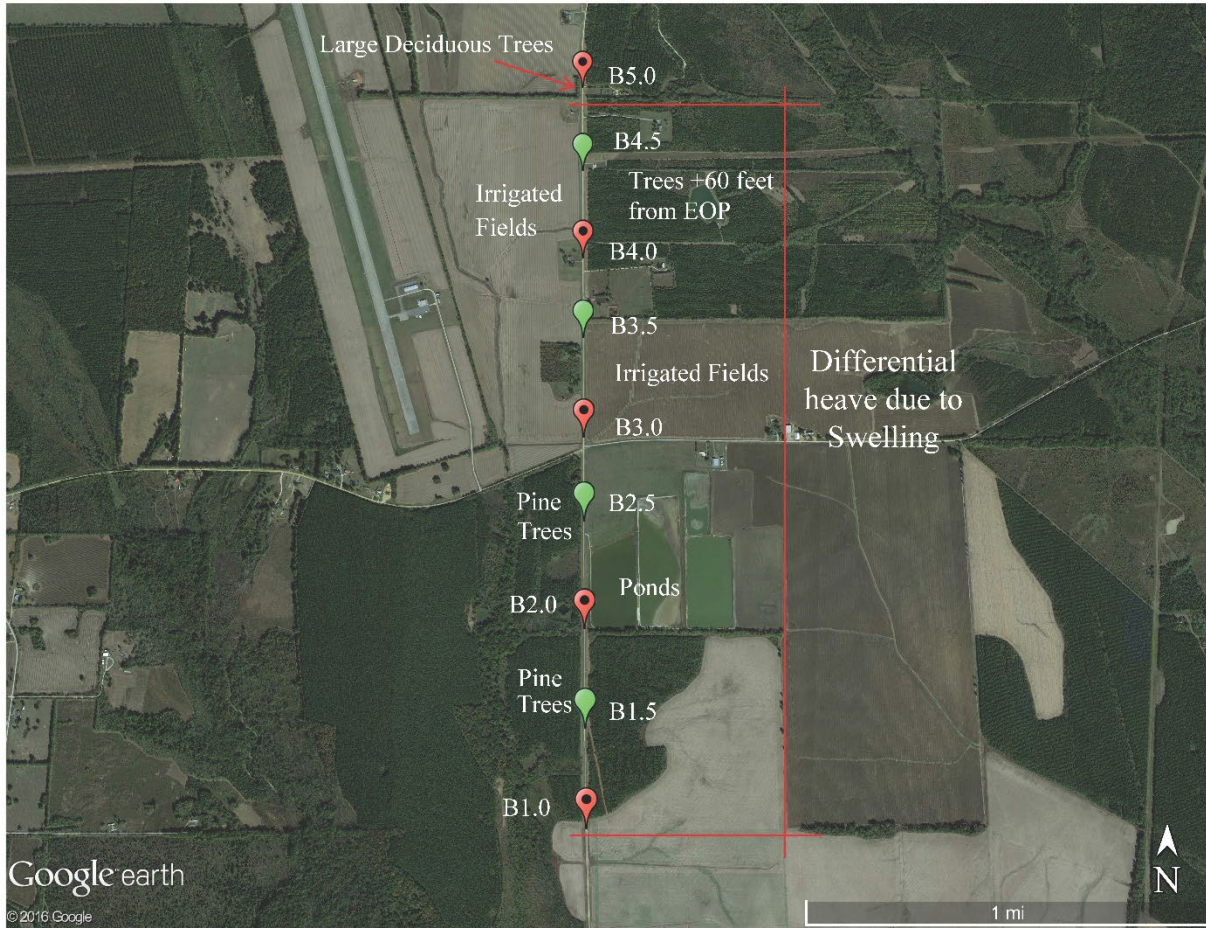
Figure 53: Google Earth Image of AL 5 from Borings B1.0 to B5.0 (after Google Earth 2014)

Figure 53 is a Google Earth image of the highway and surroundings from Boring B1.0, MP 50.85, to boring B5.0, MP52.85. The area of interest stops just short of the large deciduous trees in the image, approximately MP 50.75. It is suggested that the moisture fluctuation in this zone is significantly less varied than the rest of the project for several reasons.

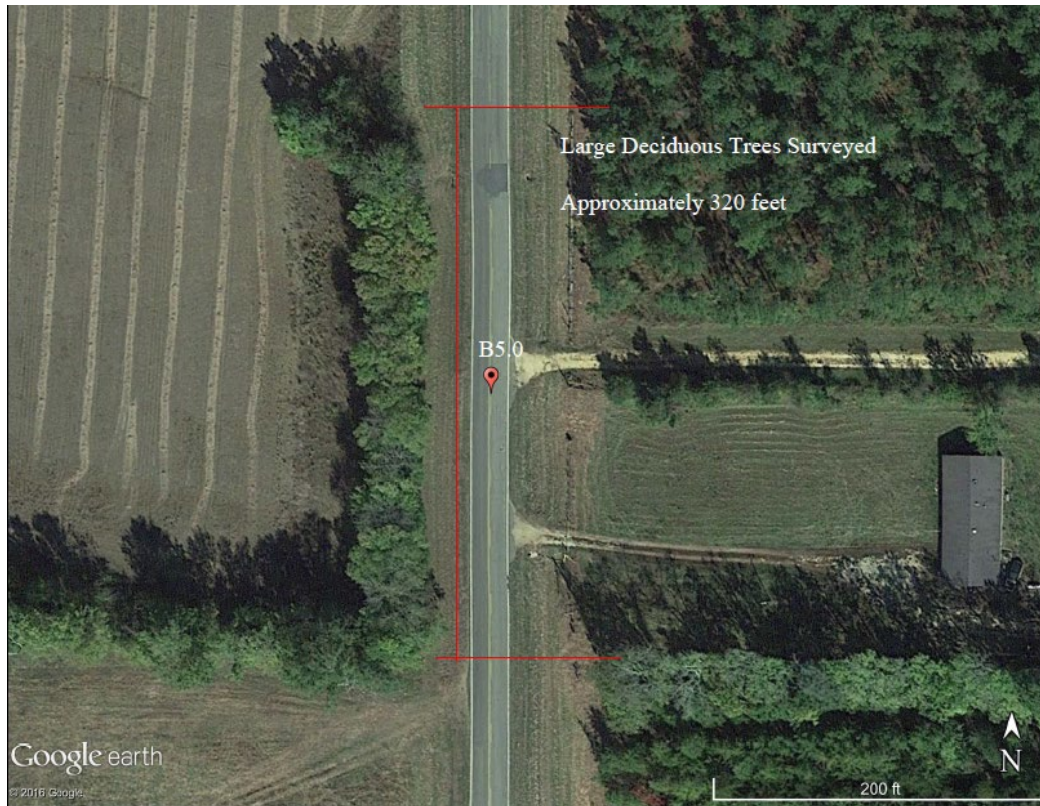
Figure 56: Google Earth Image of AL 5 near Boring B5.0 (Google Earth 2014)

Starting at MP 52.82, in the area of boring B5.0 on the west side of the southbound lane, a stretch of large deciduous trees runs along the Right of Way (ROW) for approximately 320 feet. The author observed longitudinal shrinkage cracks, distressed or failing slopes, and rutting in this portion of the southbound lane. Figure 56 shows the location of boring B5.0 and the surrounding area. This line of trees predominately consists of Sugarberry Trees, a member of the Elm Family, which has high water demands and large root mats (Biddle 2001).

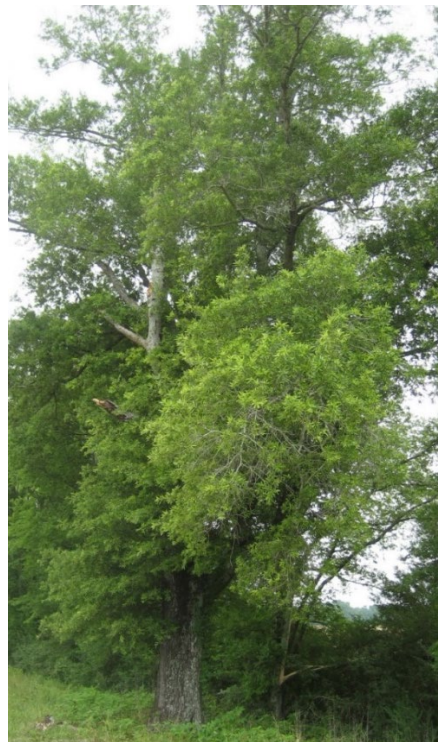
Figure 57: Willow Oak, Diameter 41.1 inches (Photo Taken 09/13/16)

The largest tree surveyed at this location was a 41.1-inch diameter willow oak, Figure 57. Oak trees have among the highest water demand and largest root systems (Biddle 2001). The willow oak was located 64.7 feet off the edge of pavement, but due to its large diameter may still be able to influence water contents under the pavement.

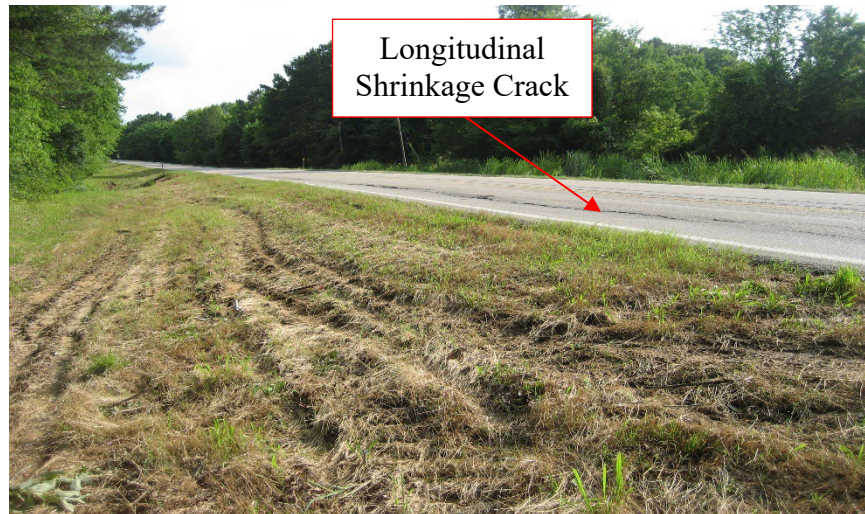
This relationship has been described graphically in Figure 15, as the matric suction and net normal stress increase, the volumetric change of the solid and water phases will decrease. Figure 59 depicts the longitudinal shrinkage crack (Zornberg and Gupta 2009), failing shoulder slope, and ditch near boring location B5.0. The basin of the ditch was very moist at the time the photograph was taken due to recent rainfall.

Figure 59: Longitudinal Crack due to Shrink Swell near Boring 5.0 MP 52.85 (Photo Taken 06/02/15)

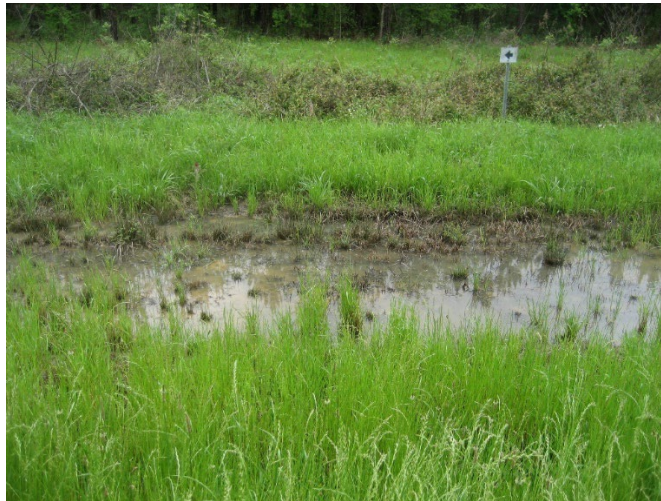
Standing water was observed in the ditches along the right of way on many occasions throughout 2015 and 2016. Figure 60 and Figure 61 depict two such areas observed in April 2015 and July 2015. The presence of standing water off the shoulders of the roadway provides a reservoir for desiccated soils to draw water from. Recharging of the shoulder slope lead to reduction of shear strength and potential slope failure. Most of the site has at least a 4:1 slope on either side of the roadway, allowing storm water to pool in the low lying areas. The presence of standing water alongside the roadway also promotes root growth in the direction of the roadway itself, and tree roots will grow in the direction of water sources and produce the densest root system at these locations Biddle (2001).

Figure 60: Standing Water Observed in Ditch (Photo Taken 4/14/2015)

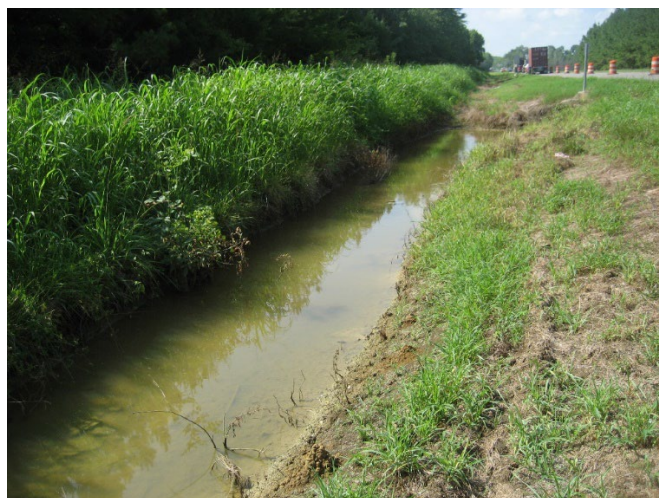
Figure 61: Standing Water Observed between Borings 1.0 and 1.5 (Photo Taken 7/10/15)

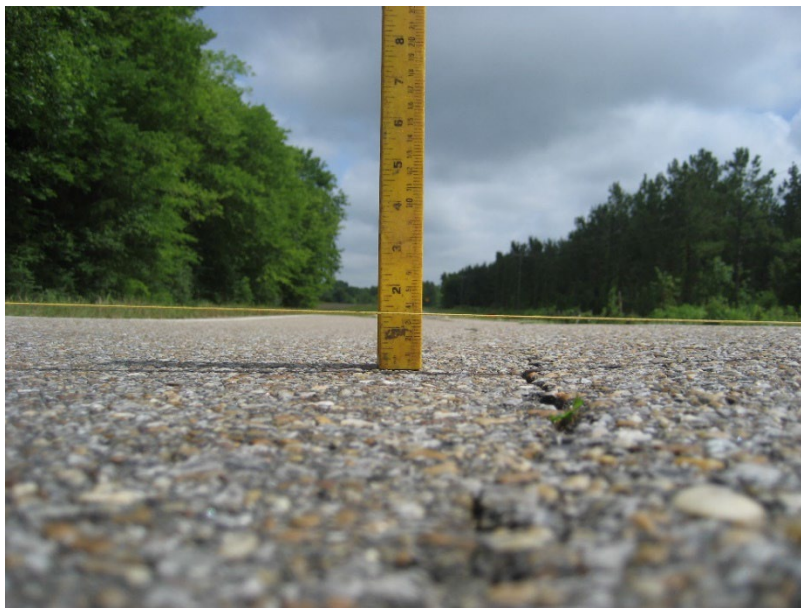
Pavement rutting was observed at many locations throughout the site. At MP 52.85, $1\frac{3}{8}$ inches of rutting was observed between EOP and the longitudinal shrinkage crack. Pavement rutting results from permanent vertical strain in the asphalt and subgrade layer over a period of many load repetitions. Deformations occurring within the asphalt may be due to problems with the mix design or compaction during placement. Subgrade rutting occurs as the subgrade soils below each wheel path are consolidated by repeated traffic loads. As the subgrade begins to deform the asphalt layers mirror the deformations so that the ruts translate to the pavement surface. Rutting in the asphalt layers can be repaired by milling and overlaying the surface but subgrade rutting indicates much deeper problems. As shown in the boring logs, AL 5 pavements were built directly on top of expansive clays. In a few locations it appeared that a fat clay/sand mixture may have been placed as a base course. The boring logs in the appendix show specific locations. The increase in sand can potentially reduce the swell potential of soils and increase the shear strength of that layer. However, the majority of the site lacks the sand/clay mixture. It has been established that as expansive soils saturate they lose shear strength. The increase in water content and loss of shear strength will promote subgrade rutting.

Figure 62: Observed Rutting Near Boring 5.0 MP 52.85 (Rut Depth $1\frac{3}{8}$ inch) (Photo Taken 09/13/16)

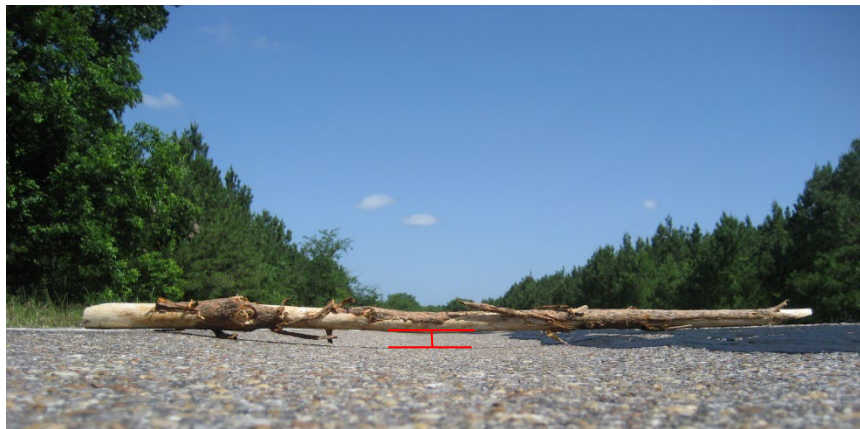
Figure 62 through Figure 64, depict two different locations with sufficiently deep ruts to cause safety hazards on site.

Figure 64: Observed Rutting (Photo Taken 09/14/16)

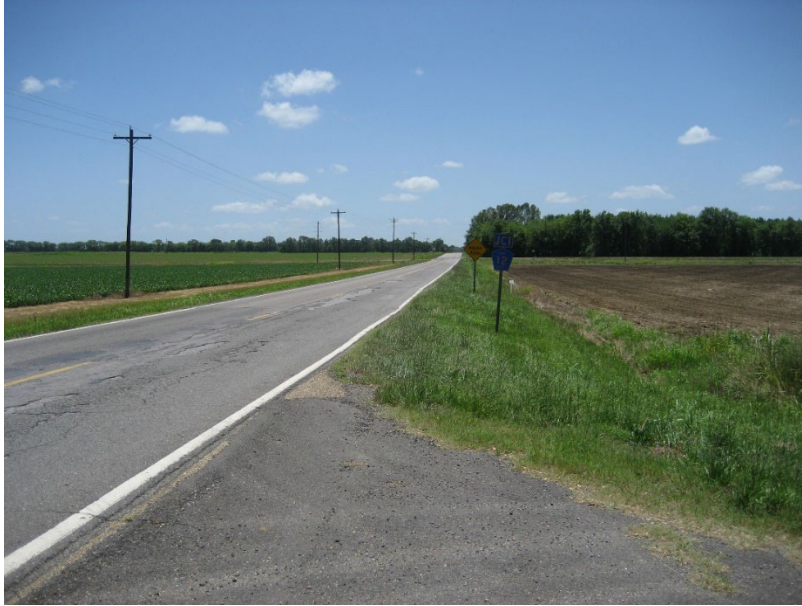
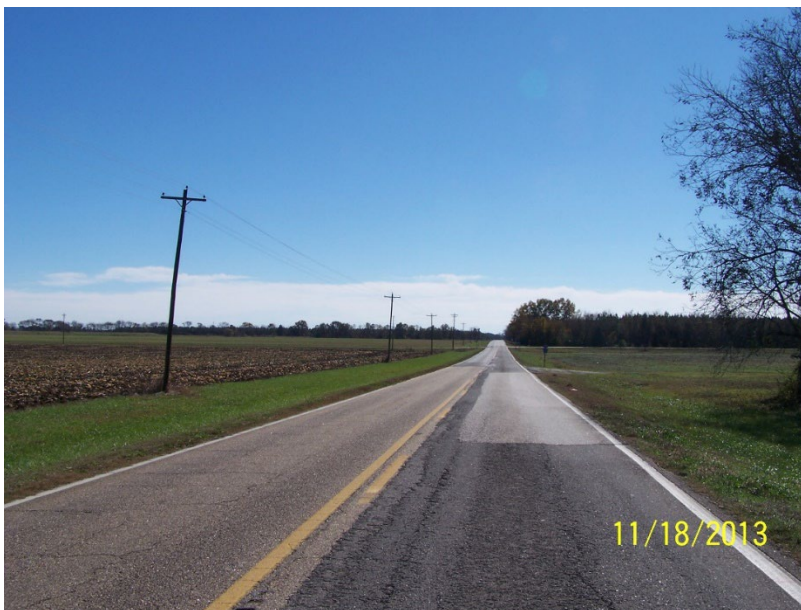
- Asphalt Raveling with pieces of surface layer removed, Figure 69 and Figure 70
- Rutting and longitudinal cracking not observed
- Standing water in ditches
- Ponded water at 4x4 double barrel culvert with algae growth

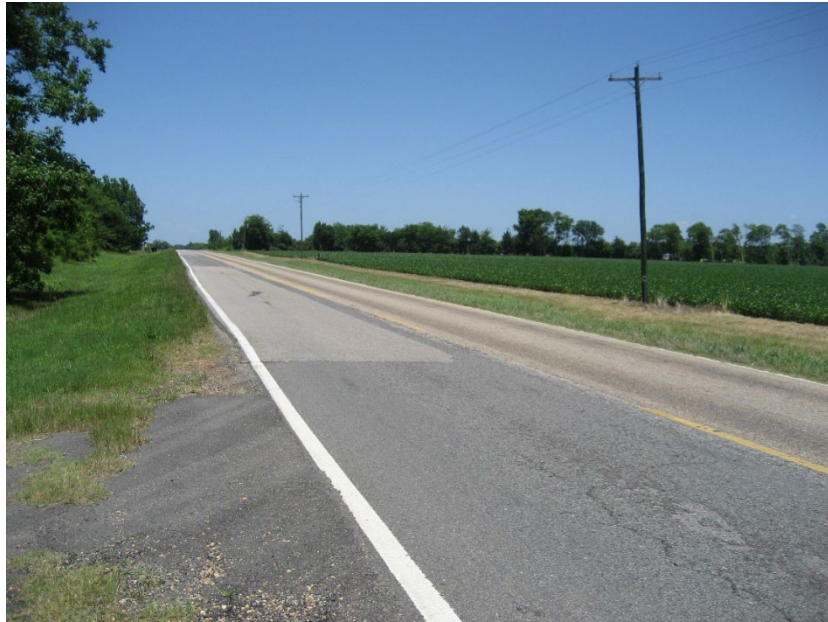
- Large deciduous trees present beyond right of way, Figure 71
- Observed Longitudinal Shrinkage Crack, Figure 72
- Observed Rutting and subsidence of pavement section, Figure 71 and Figure 73

- Irrigated fields planted in row crops beyond right of way, Figure 71
- Observed significant lateral and longitudinal cracking but not a clearly defined longitudinal shrinkage crack

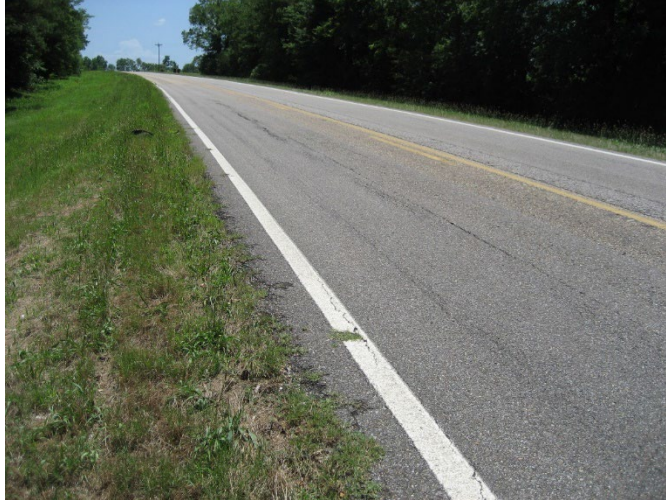
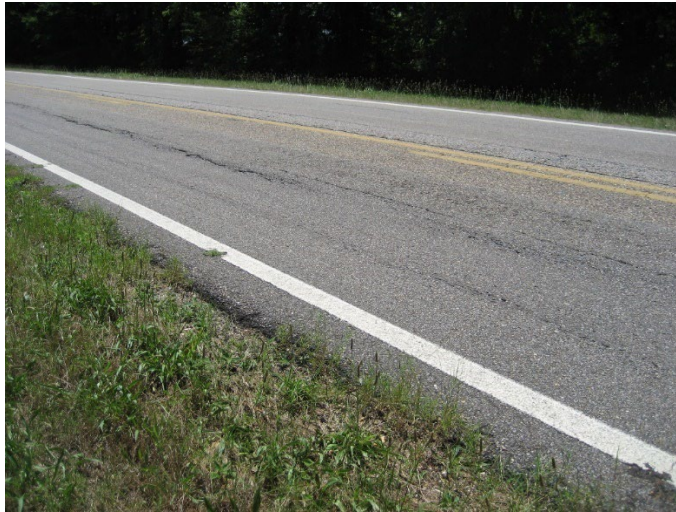
- Mixed deciduous and evergreen trees beyond right of way, Figure 74 and Figure 75
- Observed rutting & cracking, Figure 75 and Figure 76
- Observed slope stability problems

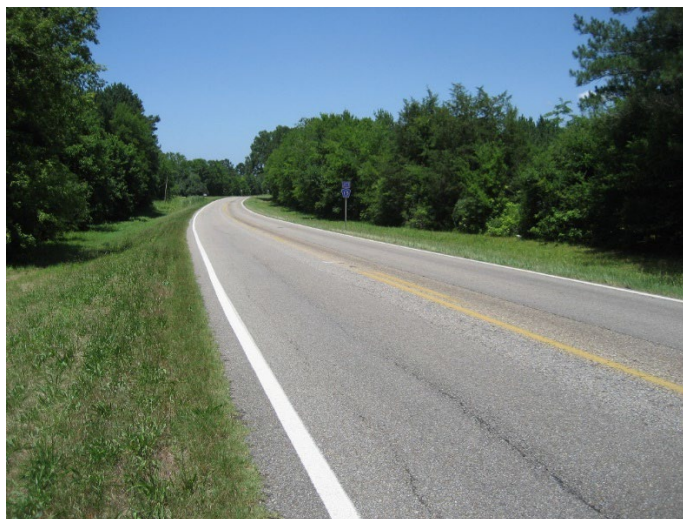
- Predominately pine trees with a few deciduous trees beyond right of way
- Observed rutting & cracking, Figure 77

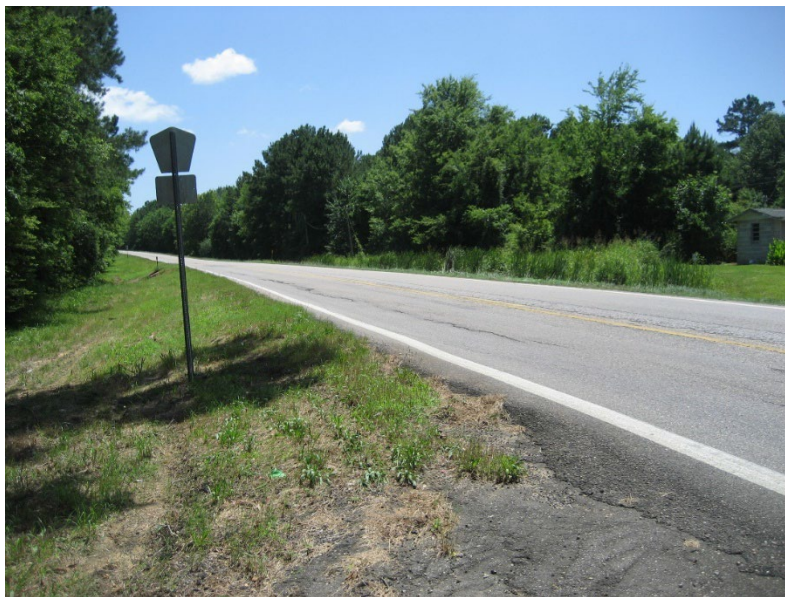
- Mixed deciduous and evergreen trees beyond the right of way, Figure 78
- Observed rutting and pavement subsidence, Figure 78
- Observed longitudinal shrinkage cracking, Figure 78
- Observed slope stability problems
- A 4x4 single barrel culvert located at creek bed, Figure 79
- Slope subsidence toward creek bed, Figure 79

- Marsh with standing water and cattail reeds beyond the right of way, Figure 78
- Community center located at the intersection of CR 15 and AL 5, Figure 78
- Southbound lane was previously patched obscuring any pavement observations

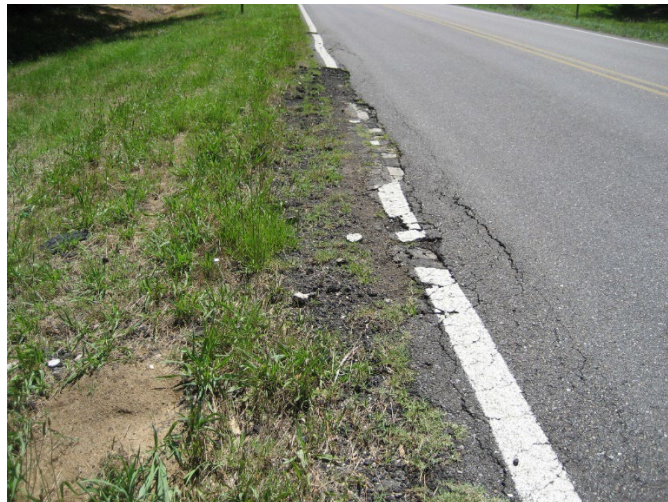
- Localized pavement damage, raveling at edge of pavement, Figure 80
- Pavement leveled both lanes obscuring pavement damage observations, Figure 80
- Mixed deciduous and evergreen trees beyond right of way on both sides of roadway
- Observed grass growing through cracks at pavement edge, Figure 80
- Shallow shoulder slopes
- Desiccated soils with tension cracking in shoulders

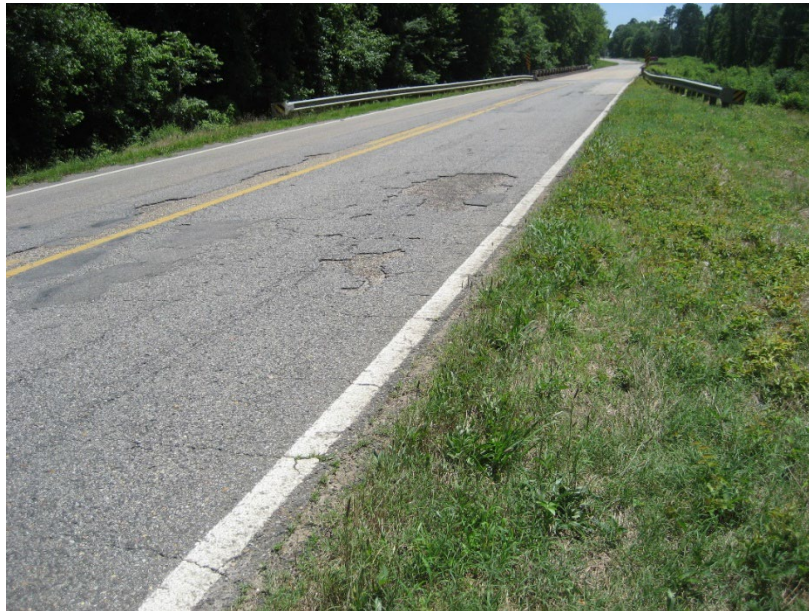
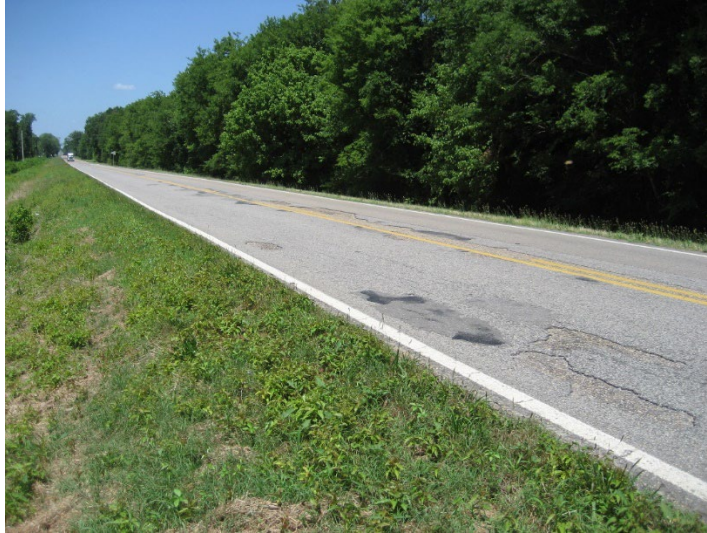
- Localized pavement raveling at discreet locations with patching, Figure 81 and Figure 82
- No rutting or cracking observed
- Steep shoulder slopes, Figure 82

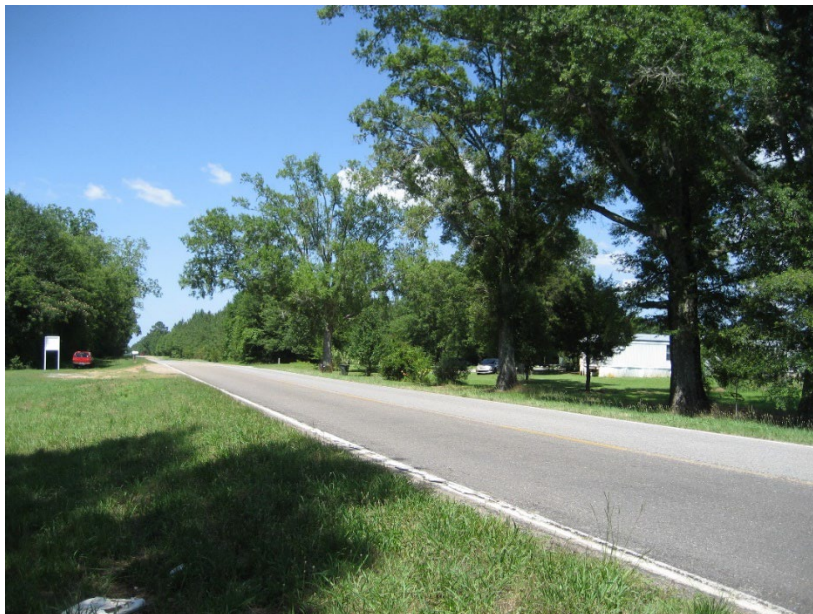
- Four large willow oak trees observed beyond right of way with dripline extending across centerline of roadway, Figure 83
- Leveled both lanes obscuring pavement damage observations, Figure 83

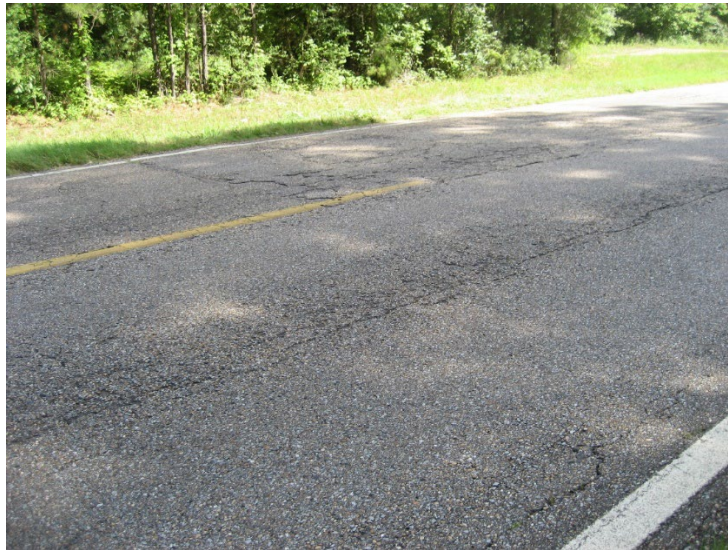
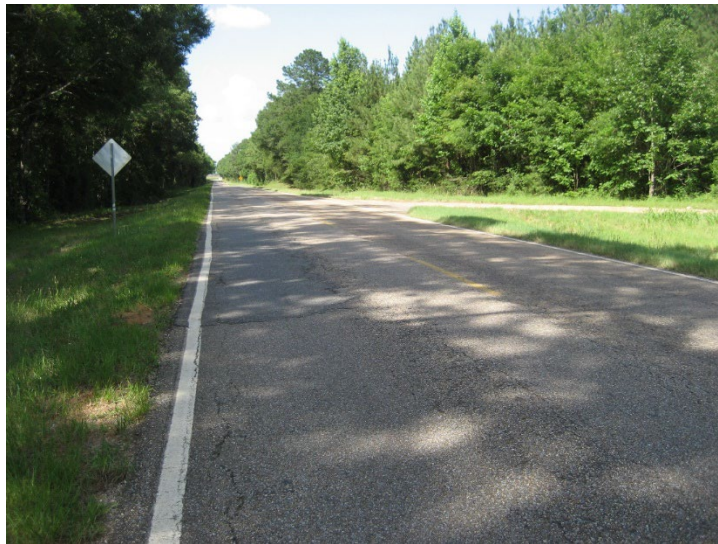
- Observed mild rutting, fatigue cracking and longitudinal shrinkage cracking, Figure 84 and Figure 85
- Patching at various locations, Figure 85
- Mixed deciduous and evergreen trees beyond the right of way, Figure 85 through Figure 87

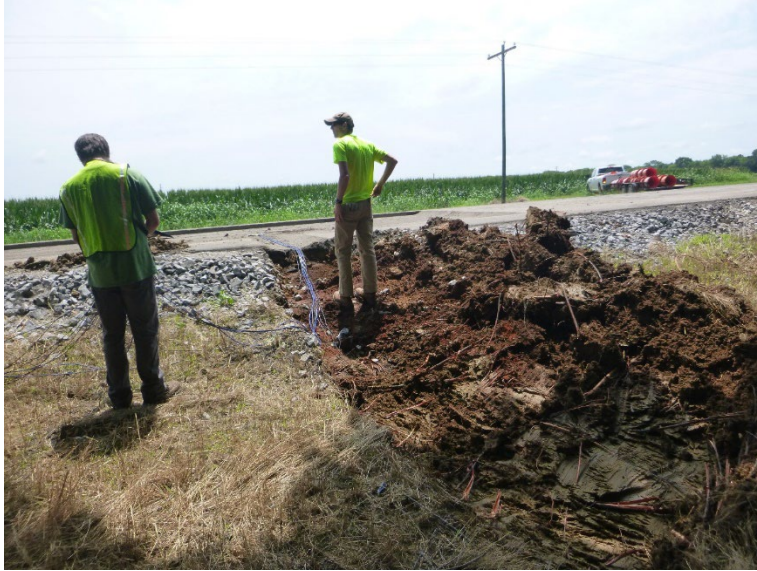
During the course of the tree survey and soil sampling, tree roots were encountered growing toward the roadway as shown in Figure 88 through Figure 90.

Figure 88: Tree Roots Observed During Installation of Sensors (Photo Taken 06/28/16)

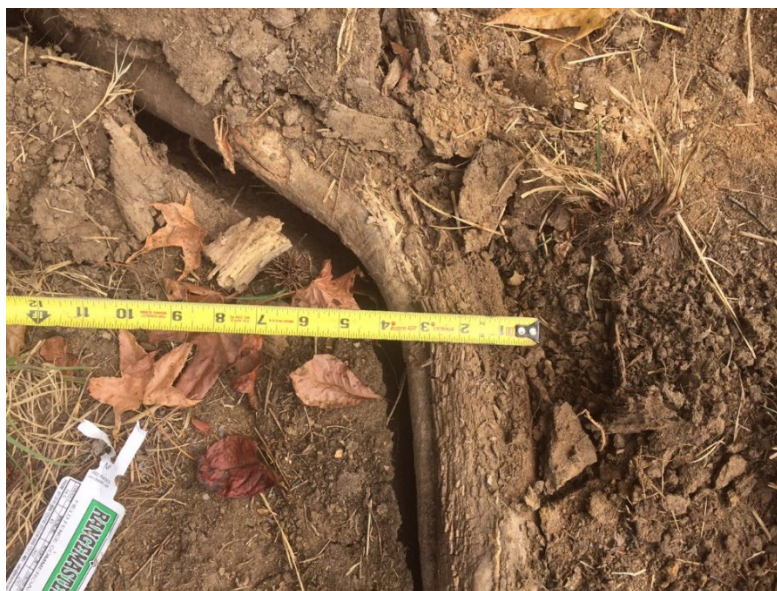
Figure 89 depicts a 4-inch diameter structural root approximately 15 feet from the roadway that was uncovered during silt fence installation. Structural roots provide a foundation for the tree and anchor it in the ground against heavy winds and rain. While the structural roots only have limited participation in the collection and redistribution of water, a network of fine feeder roots are likely to be connected to or in the vicinity of the structural root system.

Figure 89: Tree Root (4" Diameter) Approximately 15' from Edge of Pavement

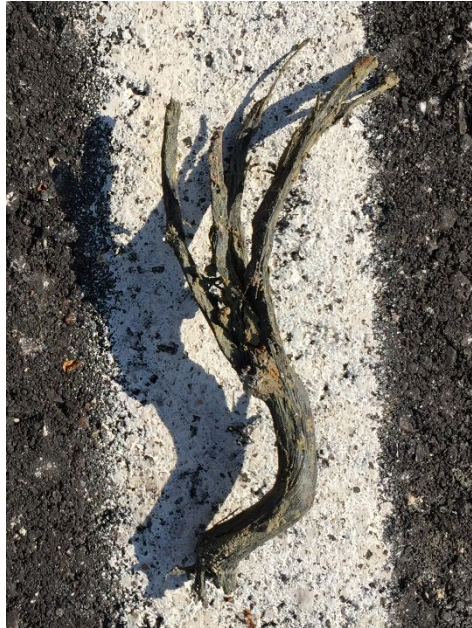
The root shown in Figure 90 was discovered in the bore hole at B4.5 during sampling. The bore hole was located in the center of the northbound lane. At this time there are not any trees near the boring location; however, its presence does indicate that it is possible for tree root systems to extend underneath the pavement. The root was approximately a half inch in diameter.

Figure 90: Tree Root Extracted from Boring Hole 4.5 (Photo Taken 5/23/16)

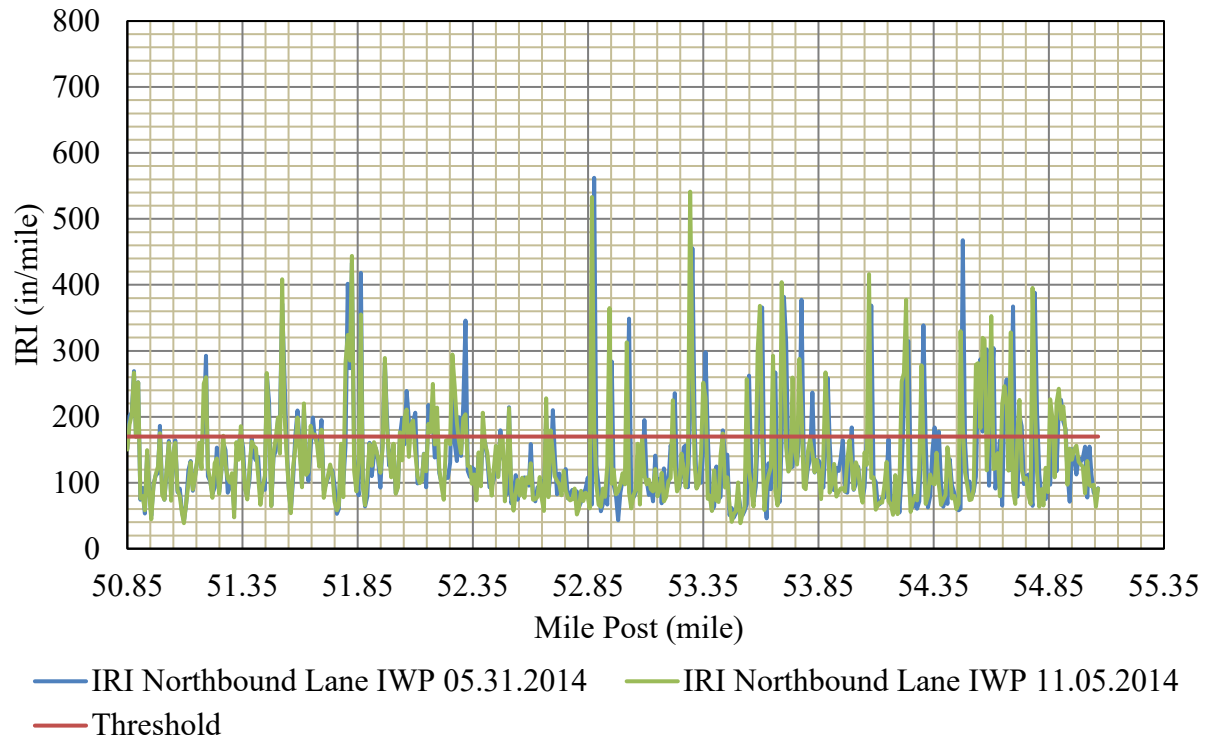
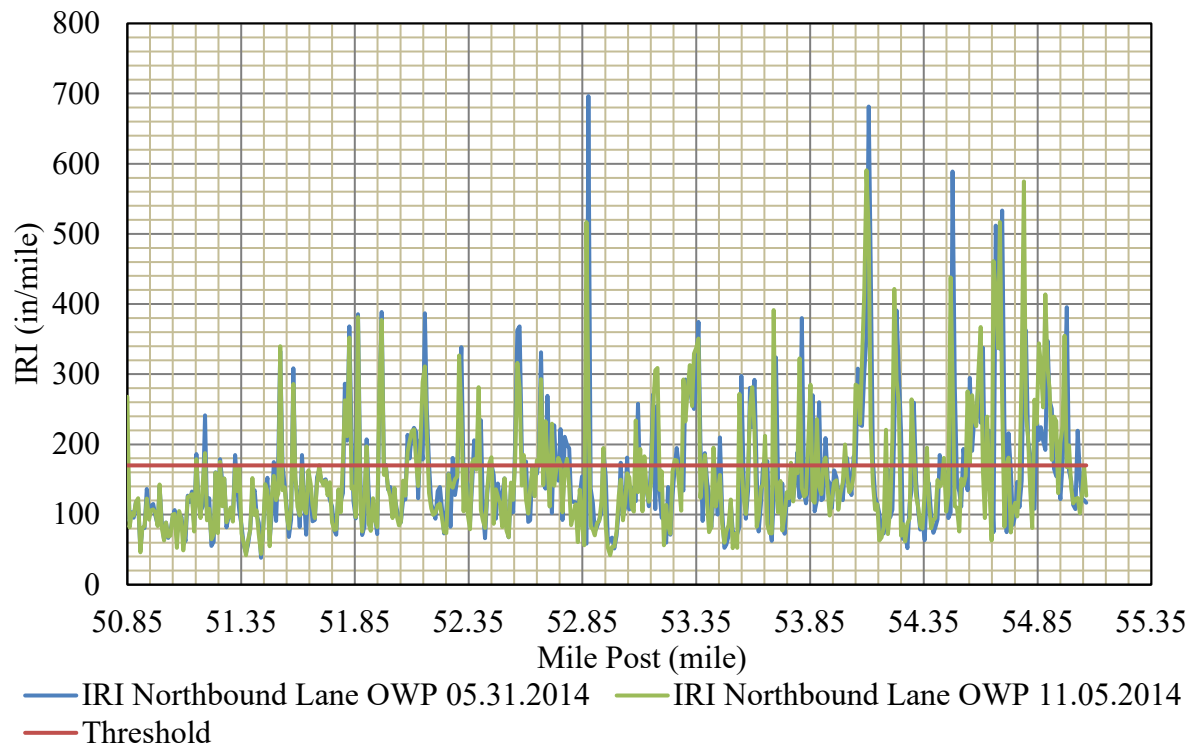
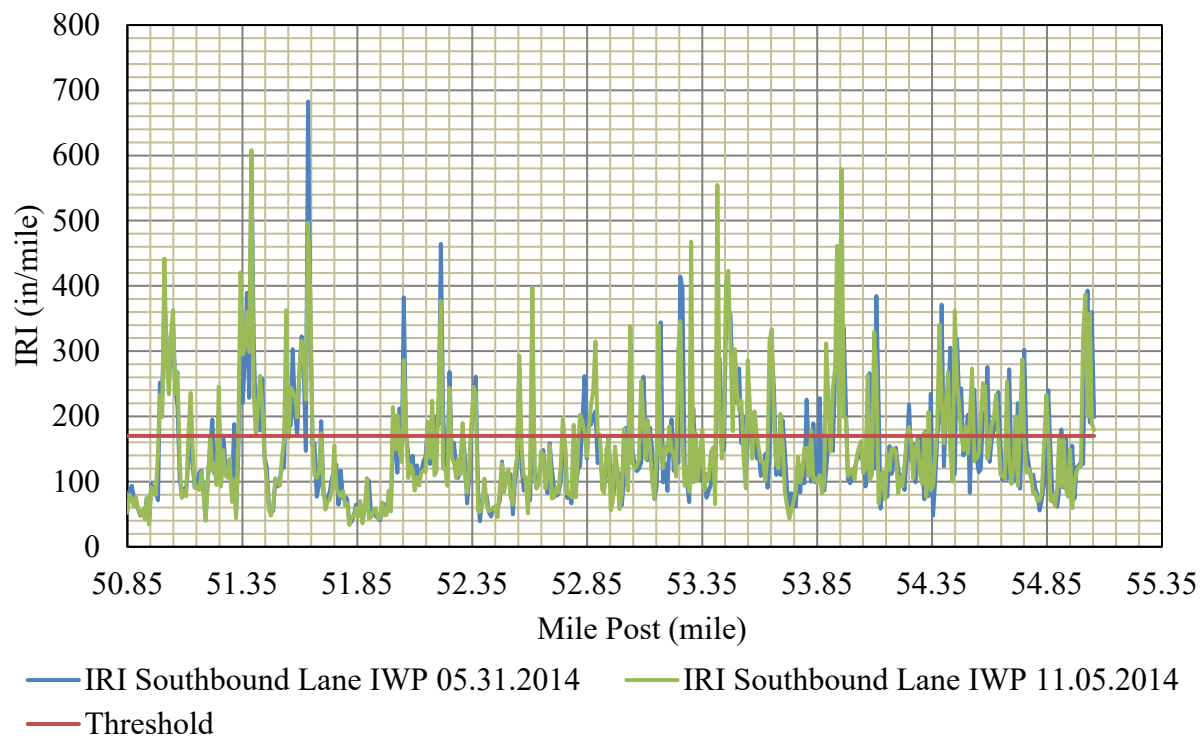
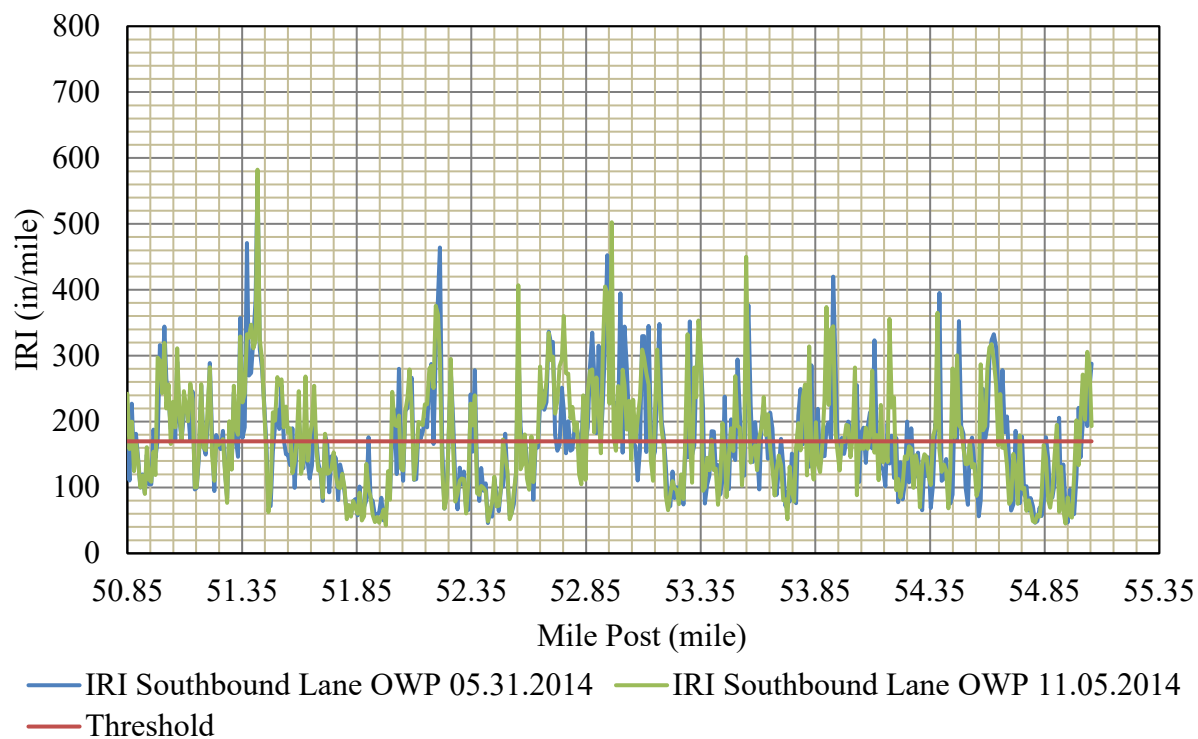
IRI values for AL 5 were determined using the National Center for Asphalt Technology (NCAT) ARAN inertial profiler on May 30, 2014 and November 11, 2014 to provide pre-construction baseline information. On each date four IRI profiles were developed, one per wheel path, between MP 50.8 and 54.3. Figure 93 through Figure 96 show the calculated IRI values versus distance along project where the origin corresponds to MP 50.8 for each plot. The FHWA threshold for unacceptable pavement surfaces, 170 in/mile, is also shown on the plots as a reference. Based on the IRI data, the pre-construction pavement surface is severely damaged. The majority of the surface exceeds acceptable threshold limits set by the FHWA.

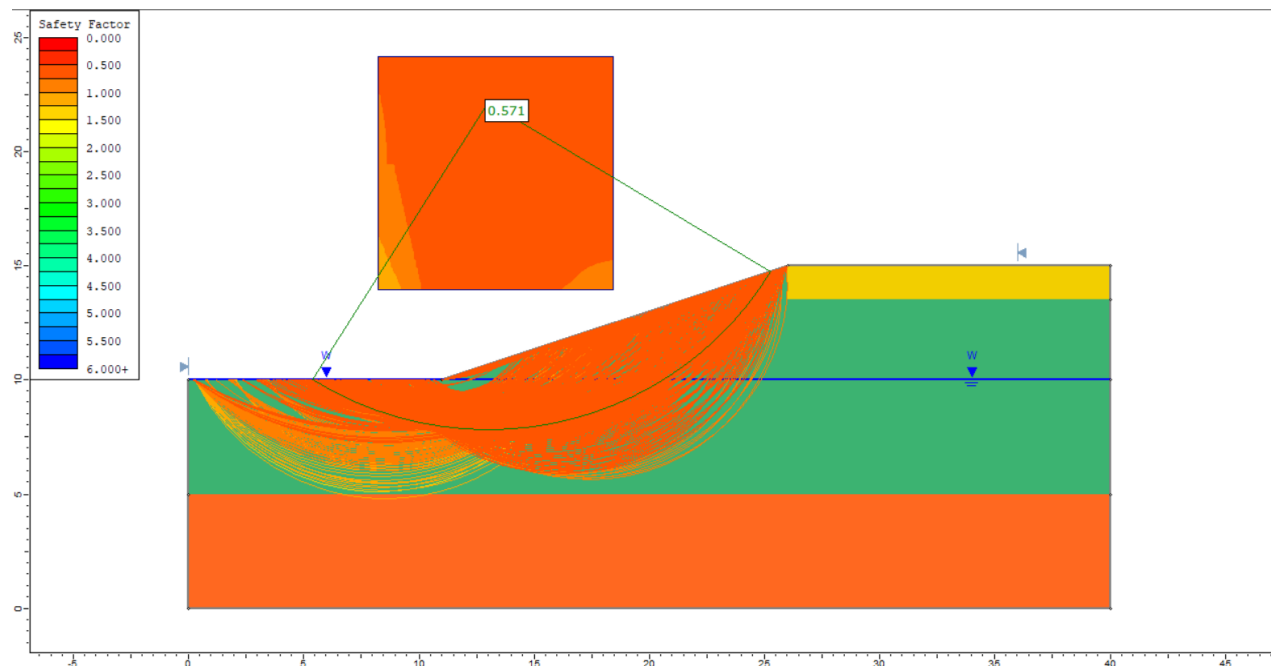
Figure 103: Minimum Failure Surfaces for B1.5 using Residual Strength Values

residual shear strength envelope in the software determined by the ring shear testing. Figure 103 shows the output of the analysis when the software is run. The minimum factor of safety for the residual strength values for the sand blanket test section is 0.571; therefore, the embankment is very unstable and would be expected to have slope stability problems. The software was used for each scenario for each test section and the results from the slope stability analyses are shown in Table 18.

As shown in Table 18, all of the slopes were stable after construction was completed with factor of safety values as high as 3.34. However, as time has passed, the factor of safety has decreased until failure of the slope or embankment was met. At the time of failure, the factor of

safeties are very close to 1. After failure, the strength value of the material was decreasing and caused the factor of safety to decrease. Using the residual strength values results in factor of safeties around 0.5; therefore, all the slopes would likely experience stability issues if the residual strength of the material was reached. These slope failures could be an explanation of the cracks seen in the pavement and the pavement distress in the travel lanes. The analyses have shown relatively deep circular failures which has been observed on the embankments along AL 5.
