Final Report
Project Number 930-866R

EVALUATION OF REMEDIATION STRATEGIES FOR SHRINK-SWELL CLAYS IN WESTERN ALABAMA

The Alabama Department of Transportation

JUNE 2024

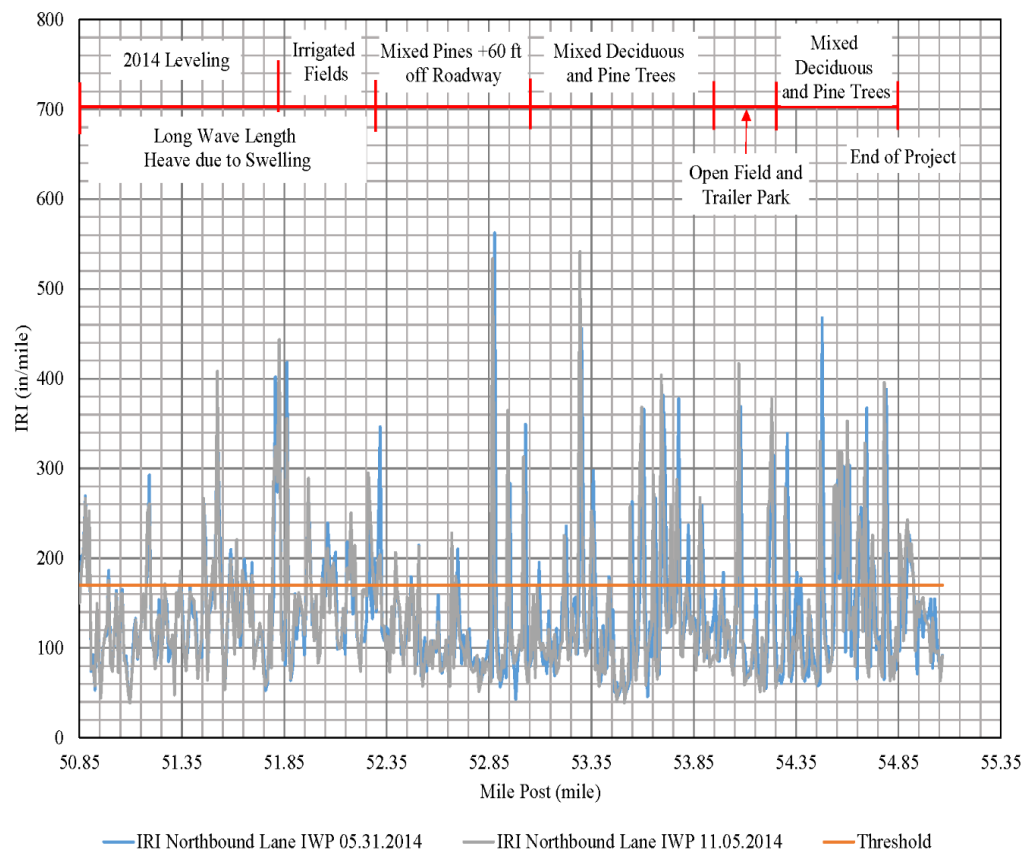
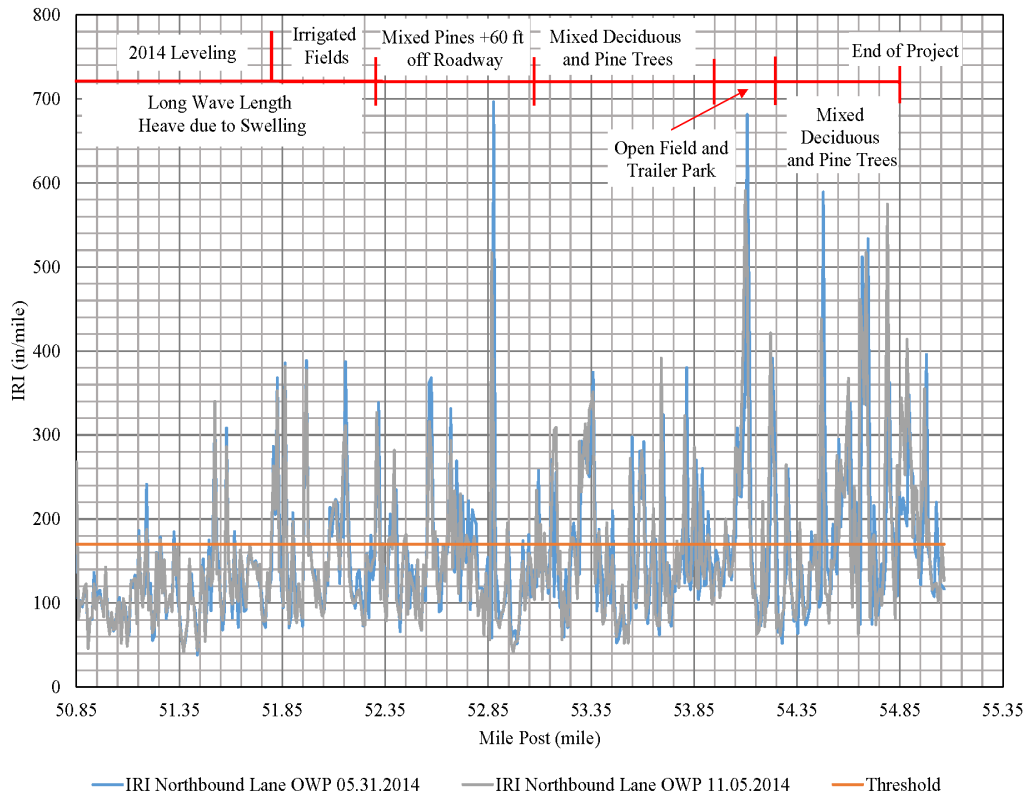
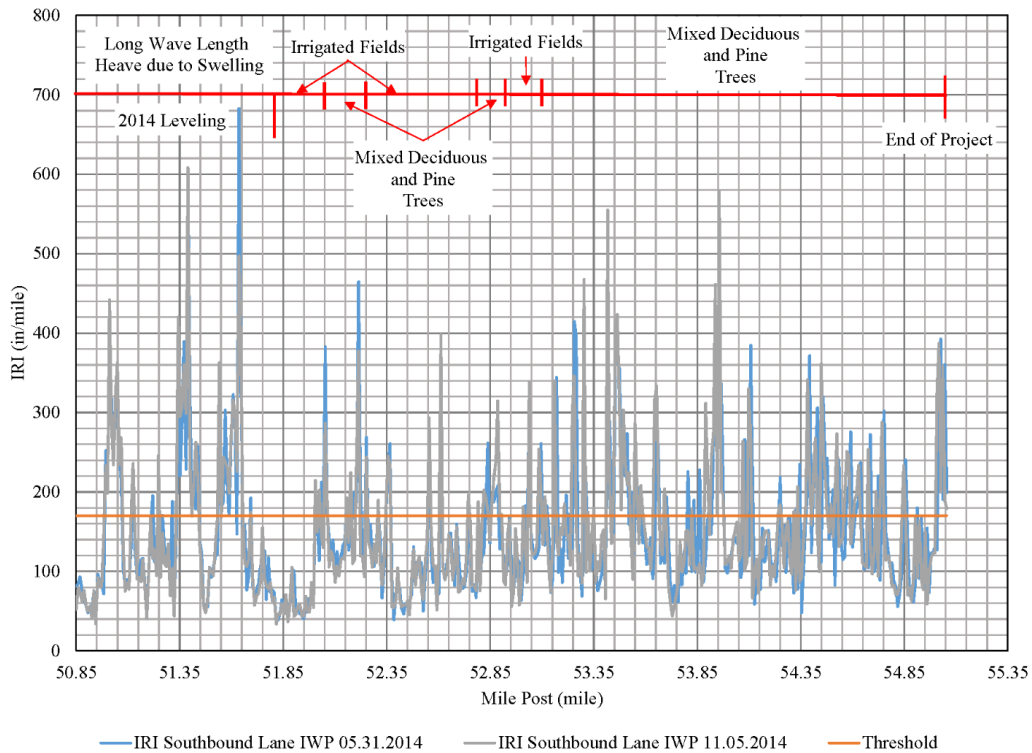
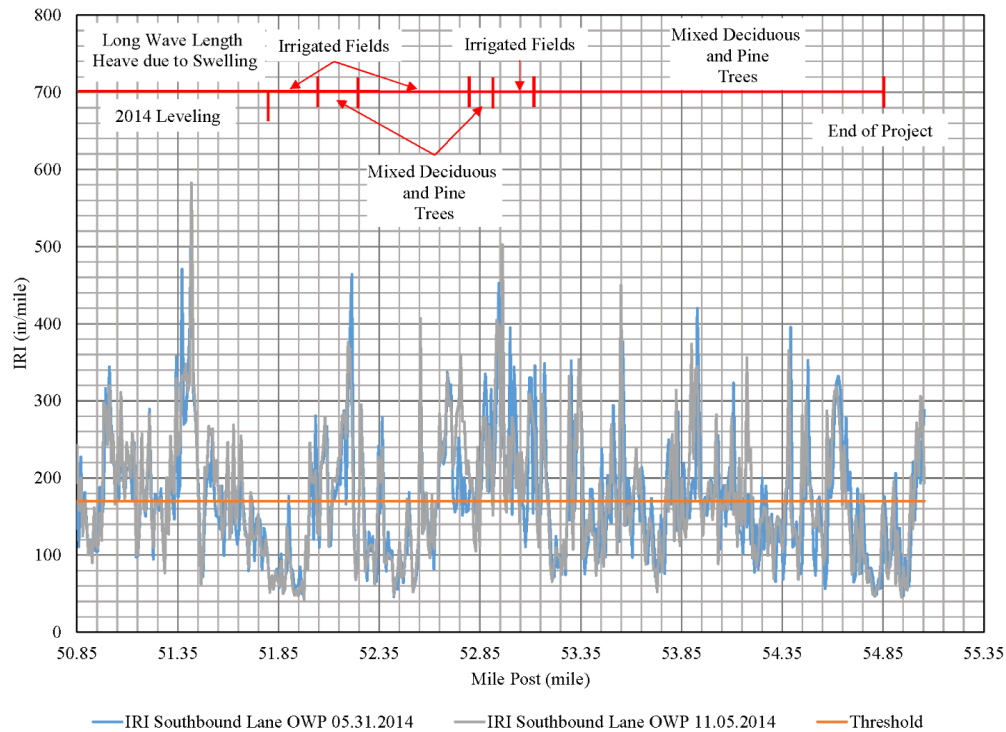
The observational, photographic and IRI surveys all point to a highly damaged roadway surface. The tree survey validates the presence, size and type of trees capable of influencing the shrink/swell cycle of subgrade soils underneath the roadway. The laboratory results also confirm the soils capacity for volumetric change and the generation of high swell pressures. Clays with very low residual strength were present in all sections. The following figures and discussion will bring the results from the different activities together according to location. Figure 104 through Figure 107 show the IRI surveys from 2014 with commentary on general site conditions overlain and corresponding to the mile post locations indicated in the survey. In theory the outside wheel path should be more susceptible to shrink swell damage than the inside wheel path because the outside edges of the pavement will be more susceptible to precipitation infiltration than the inside wheel path. Similarly, areas with large deciduous trees should show more damage than areas without. While the IRI data is suggestive of these trends, it must be recognized that before the IRI surveys were performed the roadway had been patched or leveled at various locations throughout the site and the IRI surveys do not provide an indication of damage type. However, it is clearly

established that the roadway was severely damaged before the start of project and outside the range of acceptable FHWA thresholds.

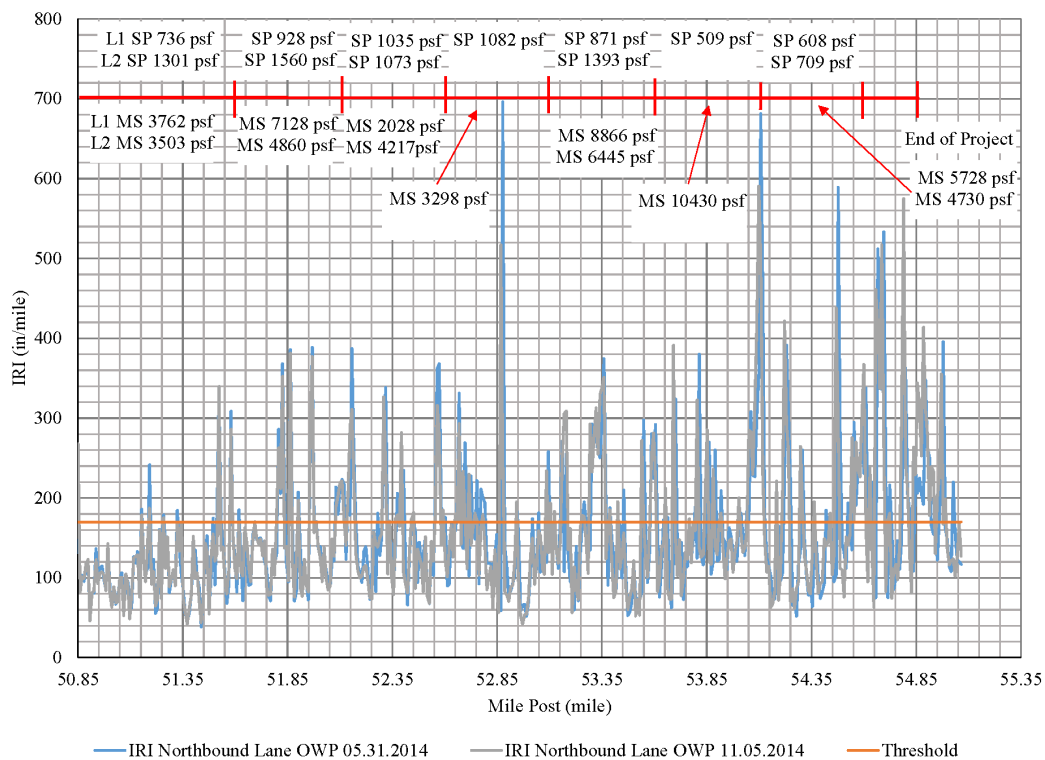
Figure 108: Northbound, Outside Wheel Path IRI Surveys Overlain with Swell Pressures and Matric Suction

Figure 108 shows the IRI surveys overlain with the experimentally determined swell pressures and the calculated matric suction values from the trimmed swell samples. The swell pressures and matric suction correspond to a specific water content. In general, the swell and matric suction values do not correspond to specific damage observations in the IRI data or visually. However, the figure does validate that the entire site is affected by expansive clays.

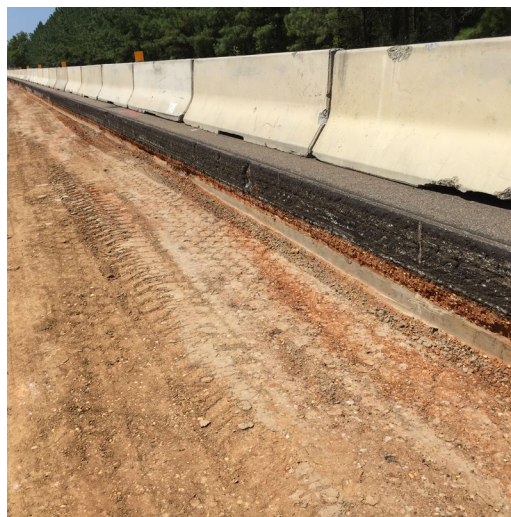
Figure 111: Excavation for Sand Blanket Showing Thick Pavement Over Minimal Compacted Base

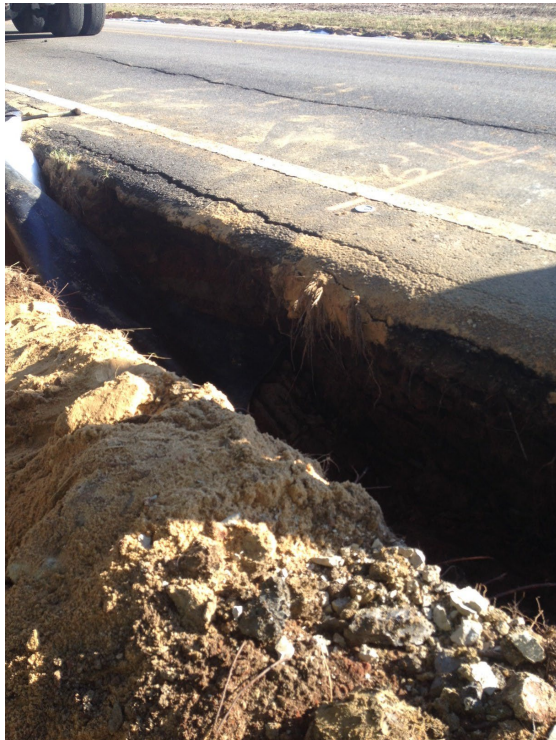
The design for the AL 5 test section included two depths for the barriers six feet and 10 feet. However, due to cave-ins during construction, the ten foot barrier section was eliminated, thus the entire section was constructed with six foot barriers. Plans for the vertical barriers are shown in Figure 116. Selected photographs from vertical moisture barrier construction are included as Figure 117 through Figure 121.

Figure 118: Vertical Moisture Barrier Cave-In

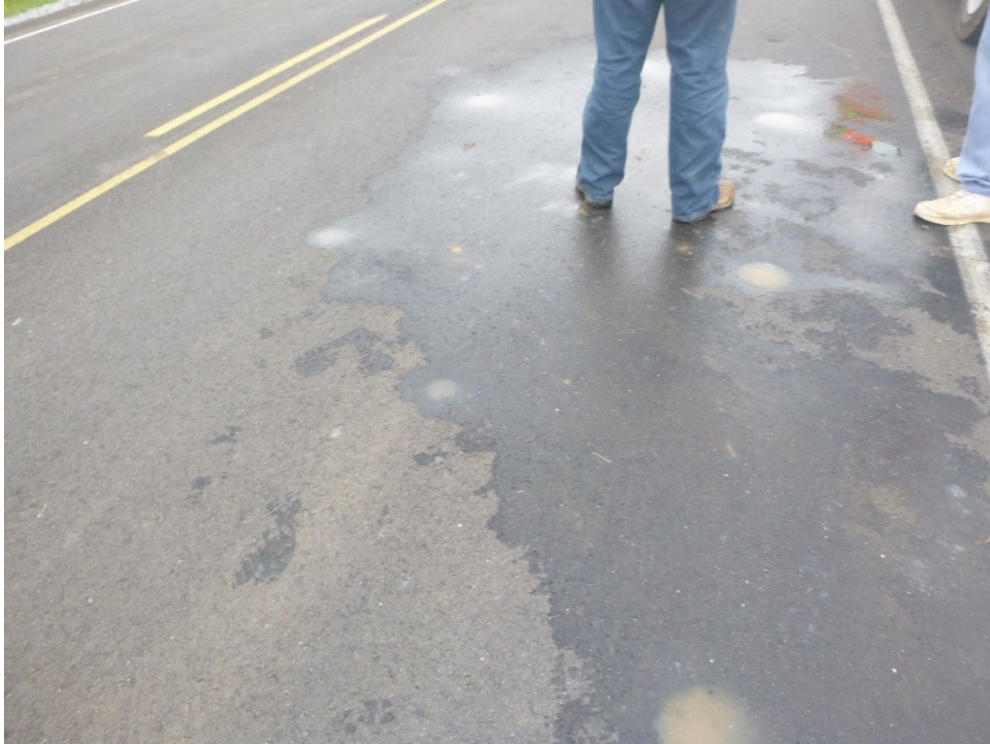
Figure 128: Lime Columns Reflecting to Pavement Surface

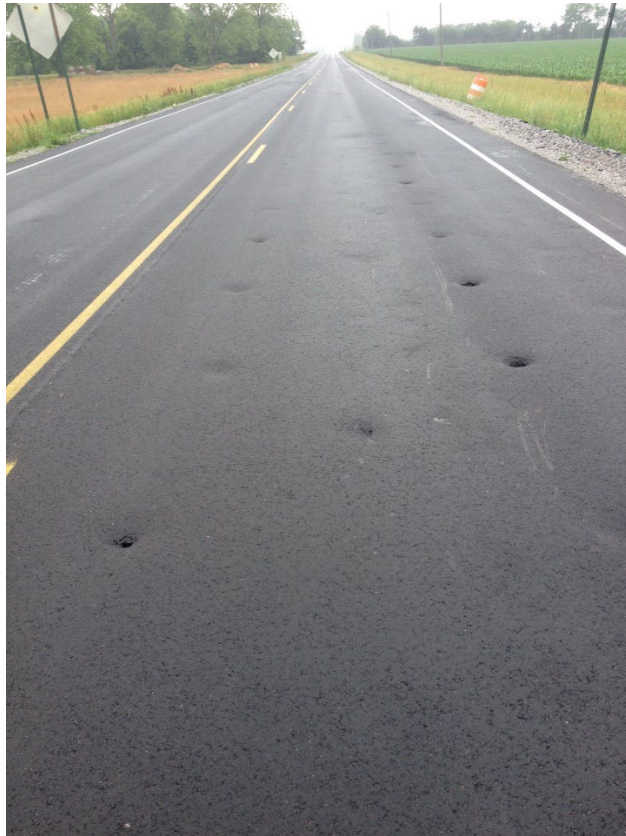
Figure 129: Lime Columns Reflected Through Binder Course and Holding Water

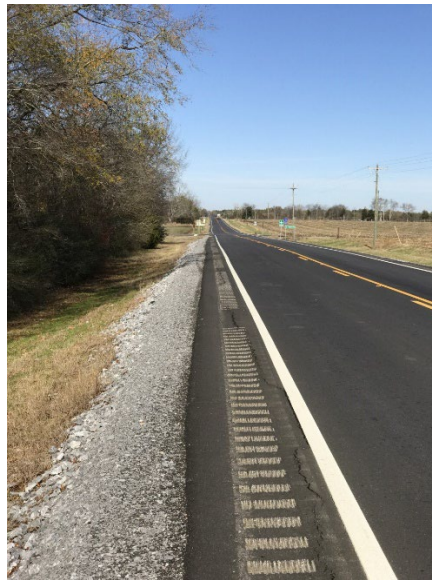
Figure 197: Longitudinal crack in Vertical Barrier section

During this site visit, the cracks in the safety widening of the vertical barrier sections were evident as in Figure 197. These were likely due to the folding over of the membrane barrier. Distresses were noted off project on both AL 5 in Perry County and US 80 in Dallas County. This is depicted in Figure 198 and Figure 199, respectively.

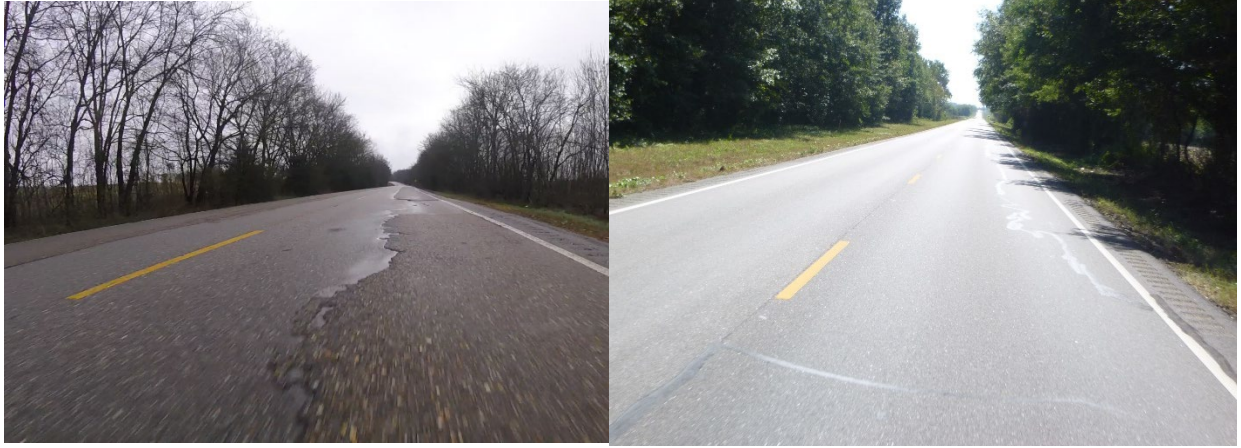
Figure 200: Tree related distress on AL in Dallas County

AL 5 between US 80 and the Dallas County line appeared severely distressed. Significant patching work was visible in areas where non-pine species trees encroach the roadway. This distress, shown in Figure 200, continued to be the case all along the section of AL 5 that extends to Safford. There was a section near Safford where the shoulders were paved out about 8 feet. It is interesting to note that while there was damage in areas where trees encroach, the damage was confined to the paved shoulder area. An area where trees encroach on the paved shoulders is shown in Figure 201.

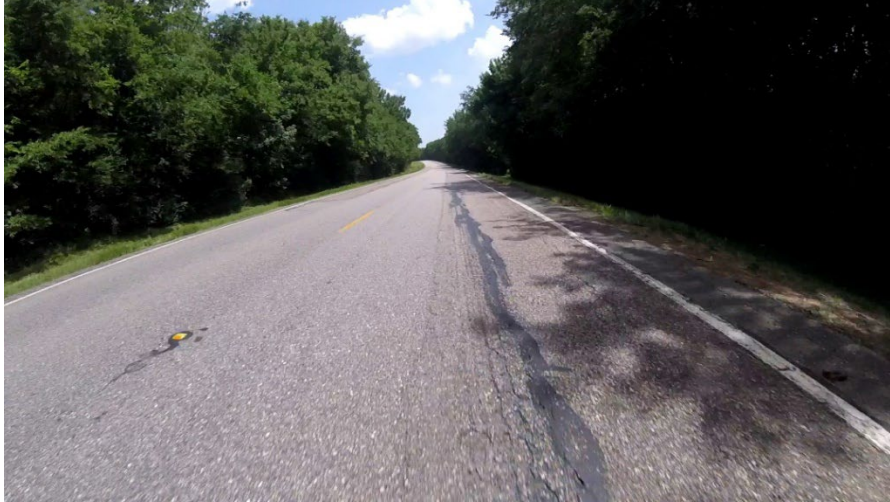
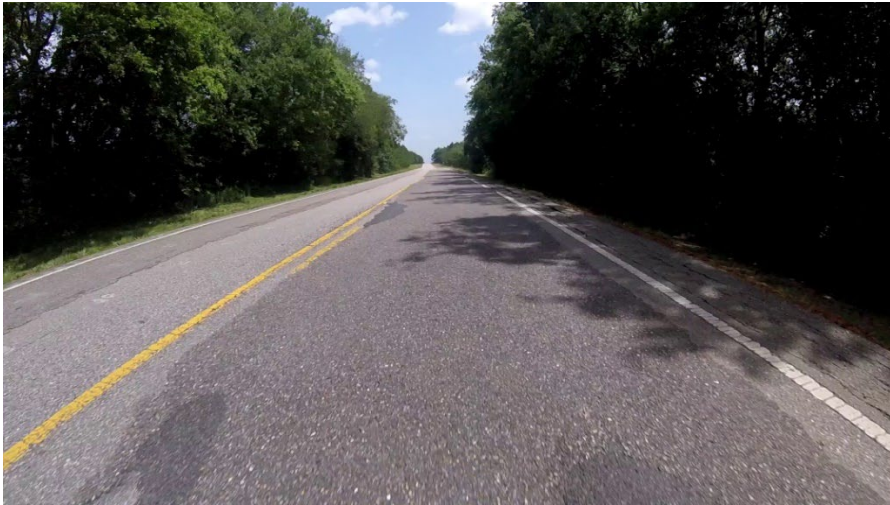
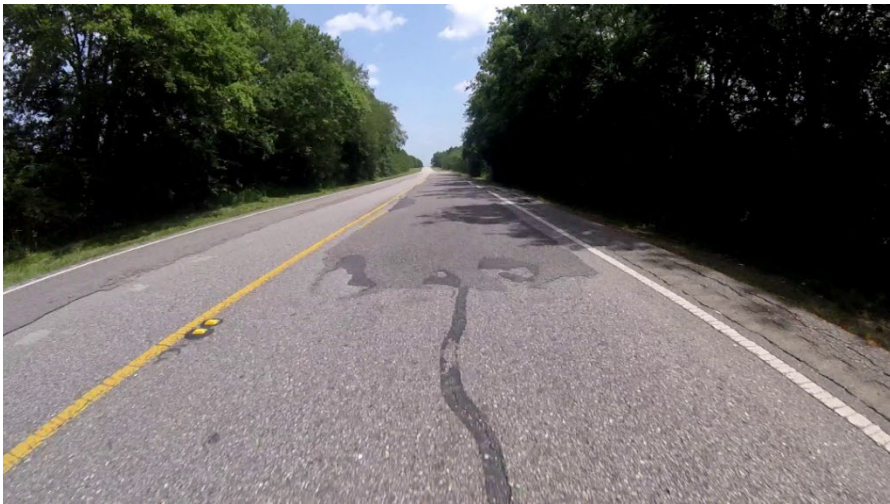
Figure 202: Observed Pavement Distress on AL 5 in Dallas County

During this site visit, the condition of the AL 5 test sections and surrounding roads was documented by video and continued shooting video between the Dallas/Perry County line and US 80. There was evidence of continued distress in the unimproved section in Dallas County. There were significant new patches and the ride is extremely rough. There appeared to still be a strong correlation between the presence of deciduous trees and the distress. This distress is clear in the photos included in Figure 202.

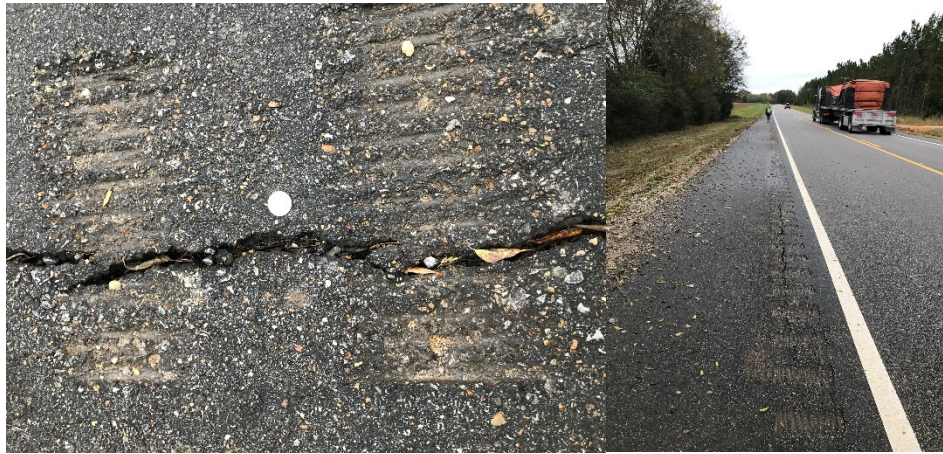
In November of 2018, the research team visited the site to maintain the dataloggers and also collect photographs. Distress was visibly noted in the paved shoulders, the lime columns and vertical barriers sections. Further, the stretch of AL 5 between the south boundary of the project and US 80 was in particularly poor condition. Figure 203 through Figure 206 that follow document the observations.

Figure 203: Cracking in the paved shoulders section

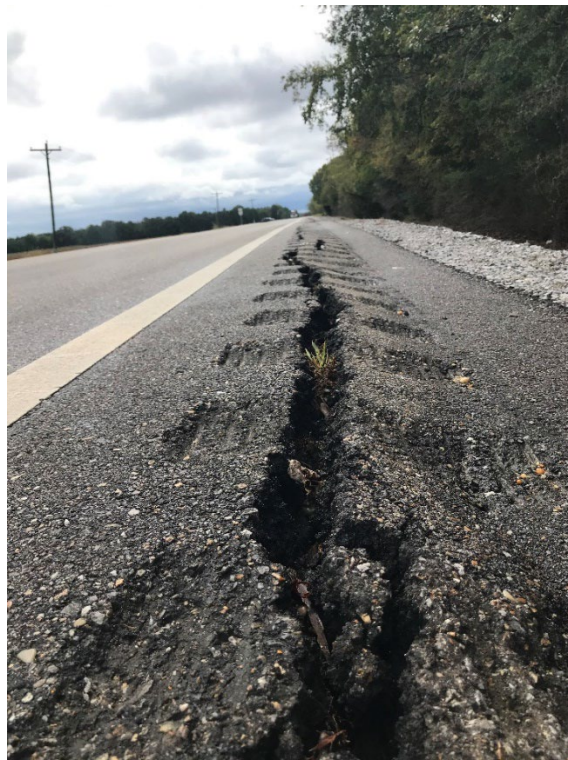
Figure 207: Vertical Barriers Crack

The research team visited AL 5 on October 16, 2019. Nearly two months had passed without rain, and qualitative impacts at the site were noted. The cracking in the southbound safety widening of the vertical barriers section had worsened. It appears that wide track farming equipment caused the existing crack to widen and settle, as depicted in Figure 207. Distress was

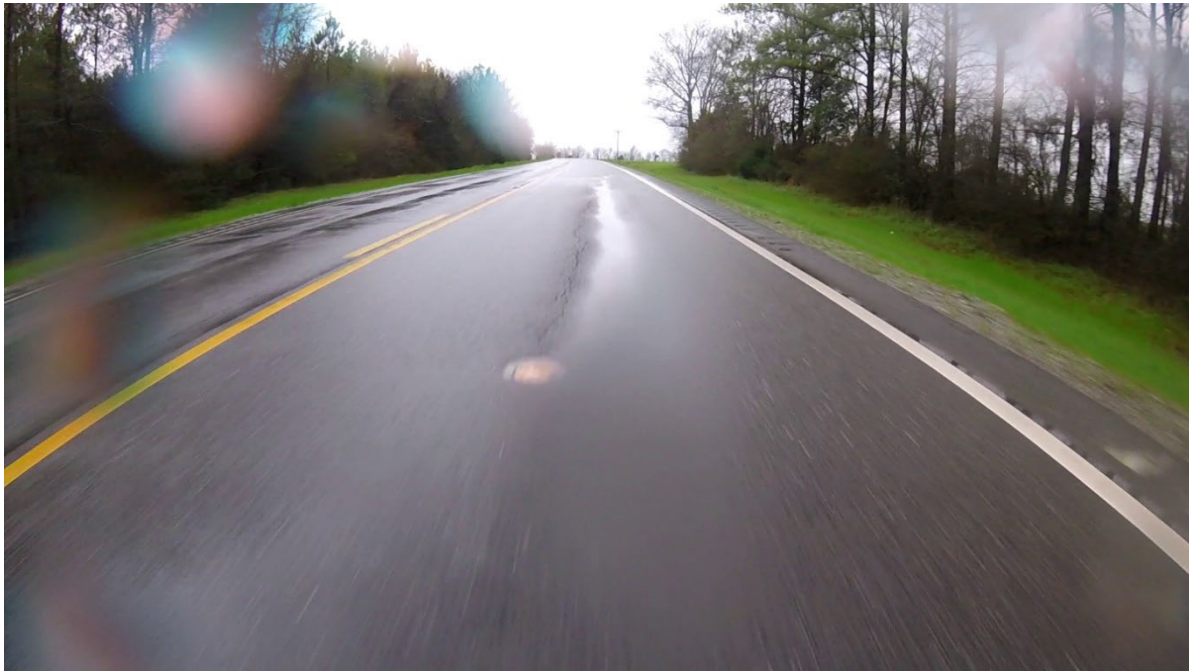
Figure 209: Edge Drains Section

The PI visited AL 5 on February 20, 2020. Distress was evident visually in most sections. There was cracking in the wearing surface and several instances of pavement shoving, likely from the truck traffic. For comparison, visual inspection of the portion of AL 5 from the Dallas County Line to Safford, AL showed severe distress in many stretches in that area, especially attributed to the presence of trees and also along built-up sections. Figure 207 through Figure 215 are still photos from a GOPRO inspection during the February 20 visit.

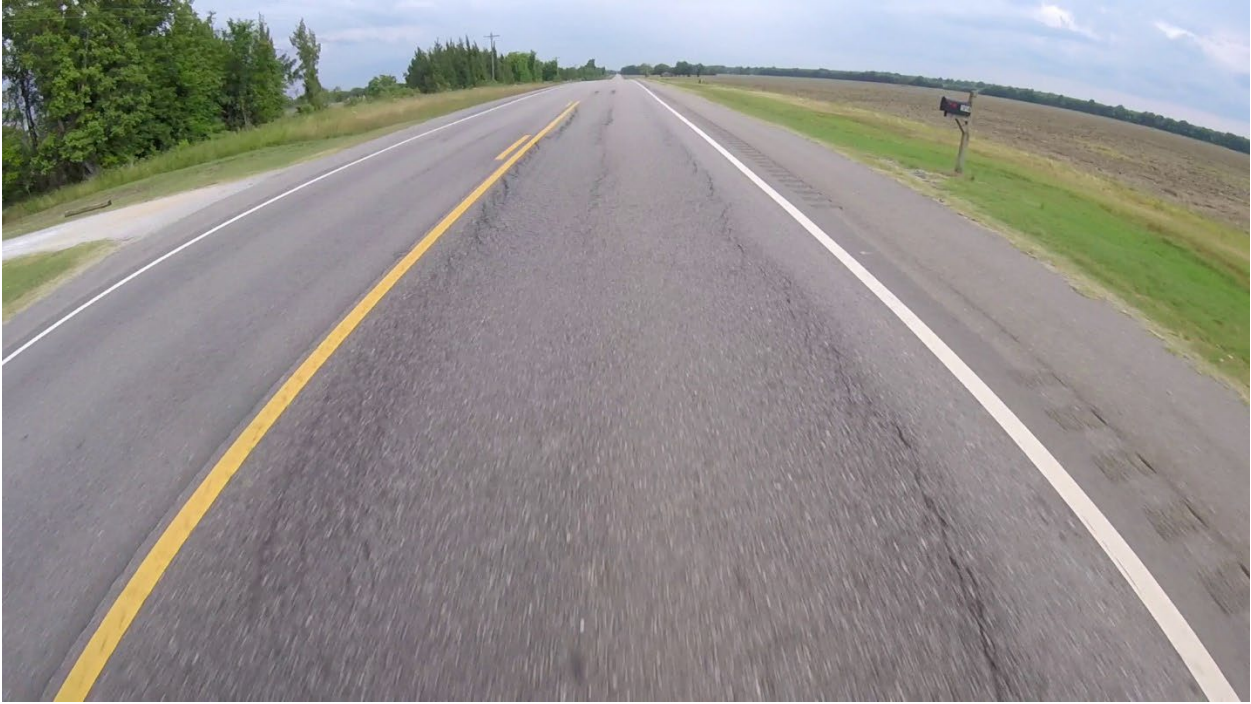
During a site visit in May 2020, multiple shoving type failures were observed. There was also cracking along the safety widening of several sections. This cracking may be due to wide farm vehicles with wheels that ride along the safety widening and edge of pavement. The ride of AL 5 from the Dallas County Line to US 80 is still much rougher than the project test sections. There has been recent leveling and patching, especially along sections where broad leaf trees encroach the roadway. Figure 207 through Figure 221 are still photos from a GOPRO inspection during the May 21, 2020 visit.

Figure 219: Shoving in Paved Shoulder Section
