U.S. Department  
of Transportation

**National Highway  
Traffic Safety  
Administration**

DOT HS 813 644

# **A Teardown Study of Flood-Damaged Electric Vehicles**

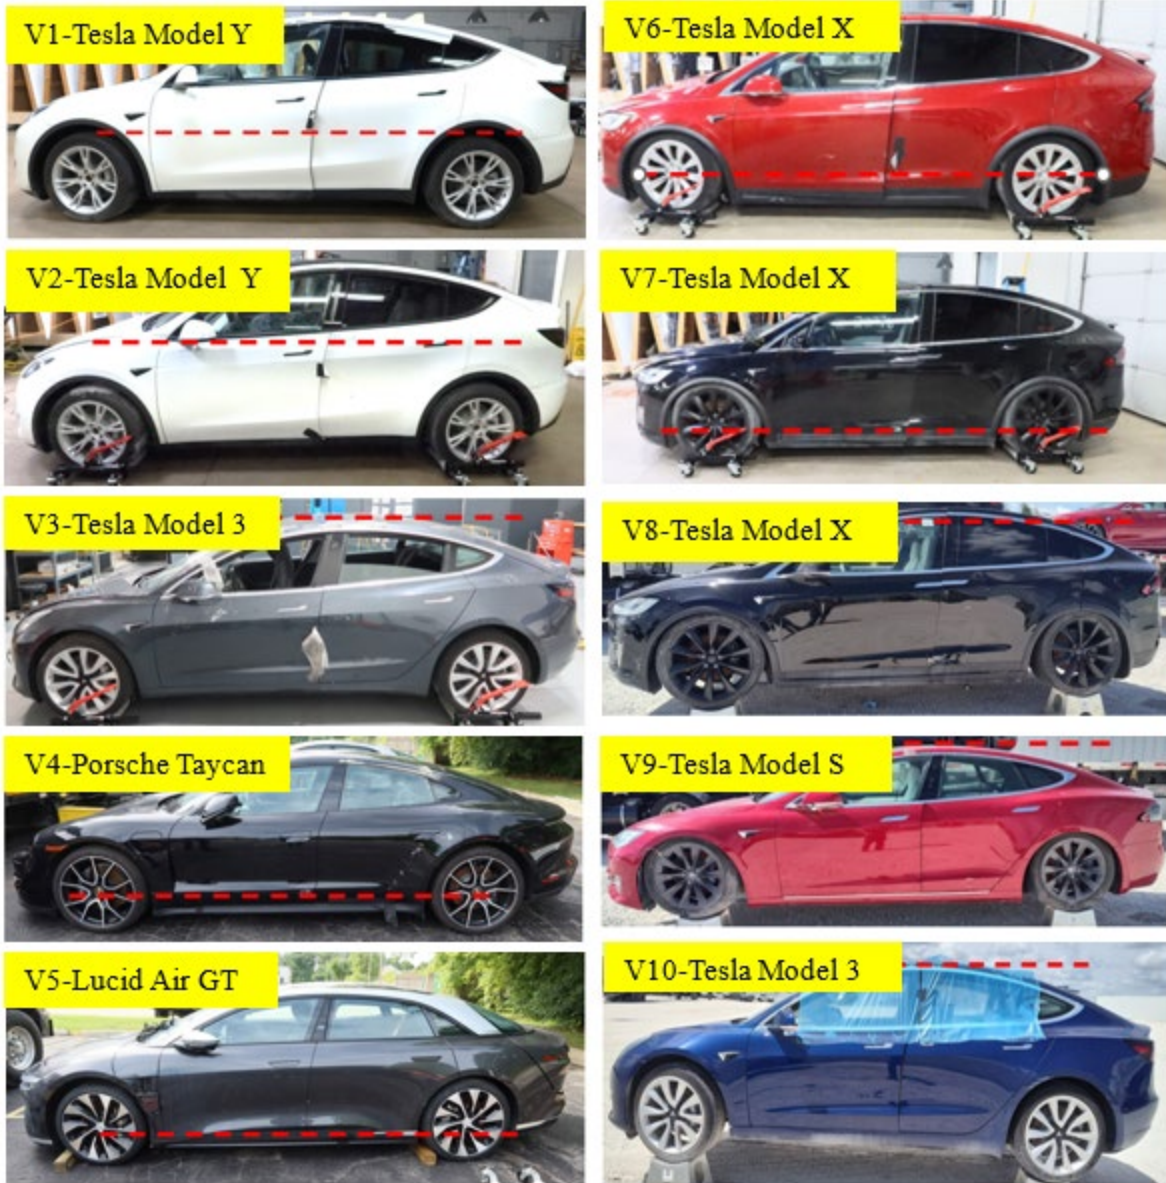
Figure 1. Ten flood-damaged EVs, showing the approximate flood-line represented by the dashed line

The submersion status of the LV battery varied based on the flood-line indicated in Figure 1. Some LV batteries were fully submerged, some partially, and others remained unaffected by the saltwater. For detailed information about the location, chemistry, and submersion status of the 12-volt batteries, please refer to Table 3.

Pack Design 3 consisted of a 2022 Lucid Air Grand Touring EV, designated as V5. The level of flooding experienced by this vehicle, as determined by the flood-line, was established at the height of the rocker panels at the bottom of the doors, as illustrated in Figure 1. This was corroborated by the evidence of water intrusion into the cabin underneath the second-row seats. Physical inspection of the EV interior and exterior revealed minimal debris or evidence of water, with the only notable indication of ingress being the significant corrosion on the primary 12-volt battery under the second-row seats. Other key observations are listed below.

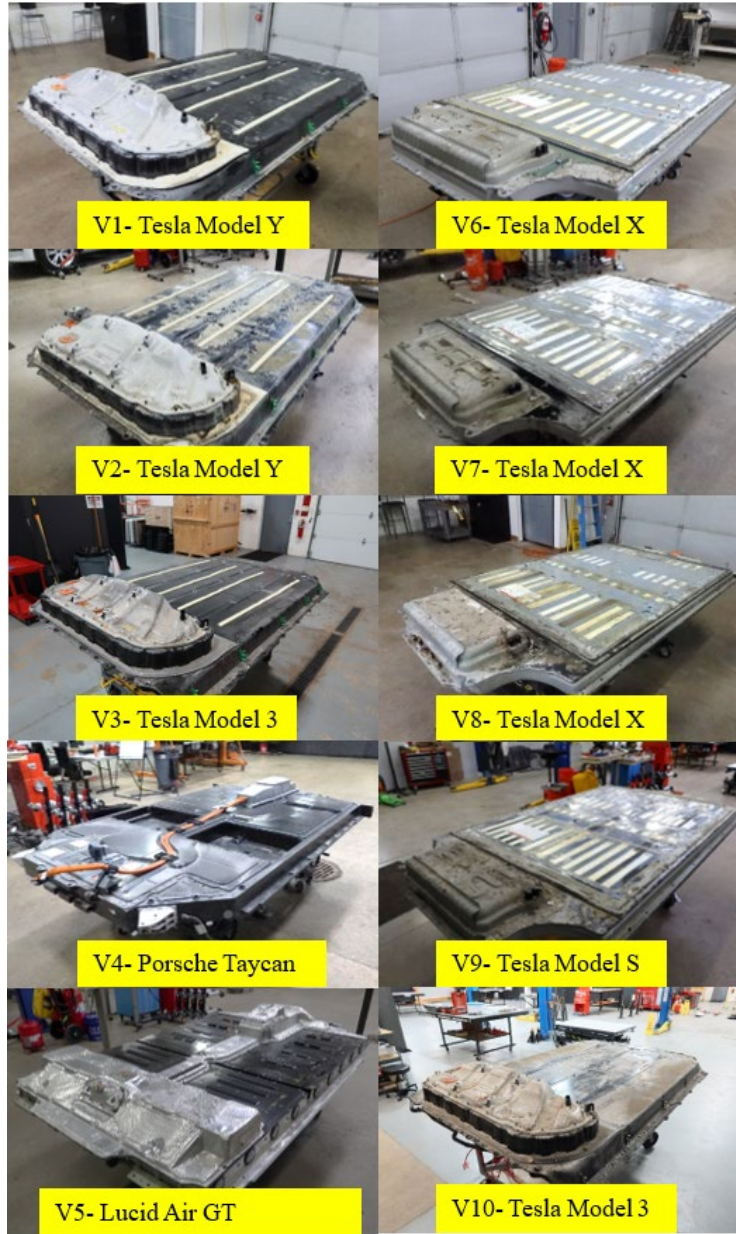
Figure 6. Top view of the packs after being removed from the EVs

Figure 6 shows the top view of the packs after their removal from the EVs. A visual examination of the exterior of the packs showed some similarities in their design and overall architecture. For instance, irrespective of model year, Tesla Models 3 and Y shared a similar pack design/architecture. On the other hand, the Tesla Models S and X shared a different pack design/architecture. Porsche and Lucid had additional distinctions in their respective pack designs/architectures as well. Hence, the packs were grouped into four categories, as shown in Table 2. Different pack design attributes and distinctions are covered in the respective pack design discussions in Key Observations. Respective teardown video links are included in Table A-1 in Appendix A.

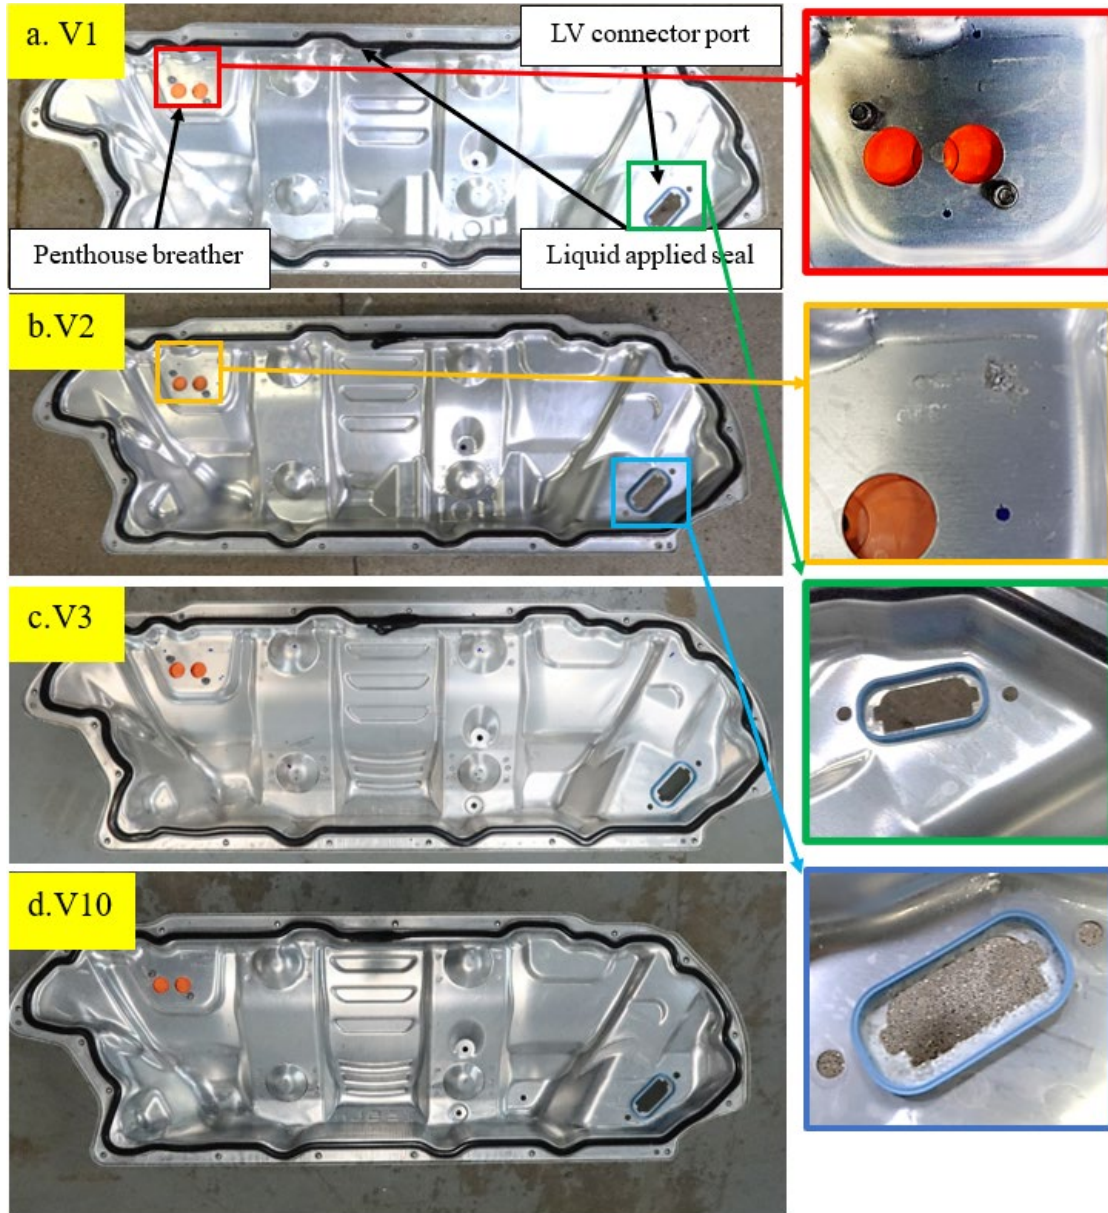
Figure 23. Undersides of the penthouse covers for Pack Design 1

The underside of the penthouse lid cover in EVs V1 and V2 displayed dried residue of a liquid, which suggested either condensation or some degree of water ingress into the area, as observed in Figure 23(a–b). In the case of V1, these areas were mostly concentrated around the penthouse breather vent and the LV communication connector, as illustrated in Figure 23(a). Notably, there was no visible evidence of water ingress or corrosion, so it is plausible the marks observed on the underside of the penthouse lid in V1 were due to condensation, rather than actual water penetration.

In the case of V2, more noticeable watermarks were evident on the underside of the lid. An approximately 1 cm area near the LV communication connector silicone seal showed signs of corrosion, as indicated in Figure 23(b). This suggests that some level of water ingress was likely. However, EVs V3 and V10 did not display any signs of dried residue of a liquid in the underside areas of the penthouse cover, as illustrated in Figure 23(c) and Figure 23(d), respectively.

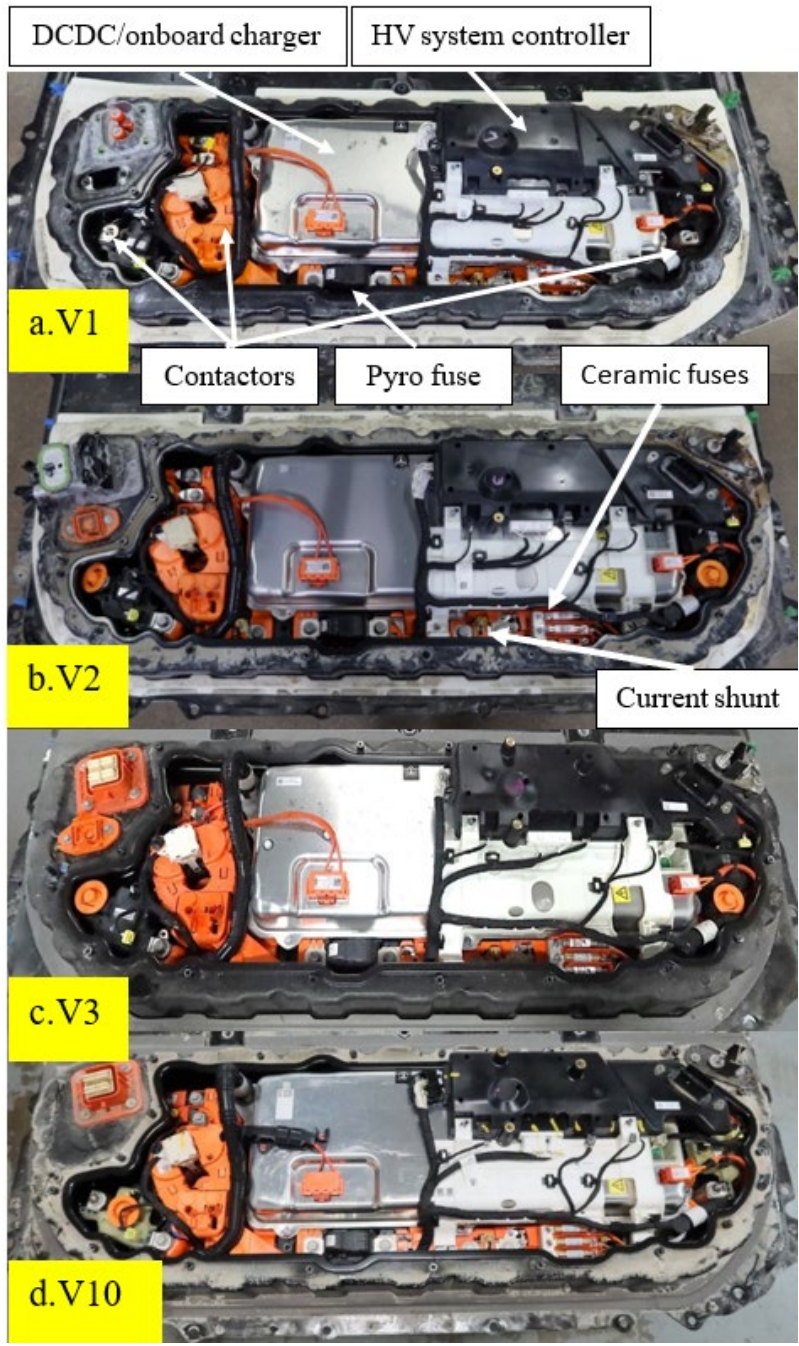
Figure 24. Top view of the penthouse after removing the lid

Figure 24(a–b) shows the inside of the penthouse with the key components identified. During the preparation stage of HV battery removal, there was no voltage measured at the external HV connectors or charge port for all the EVs in this group, which verified the contactors were in an open state and functioning as expected. Upon inspection of the interior of the penthouse for EVs V1, V2, and V10, no signs of water ingress were observed, and no damage to the contactors was noted; therefore, removal and further analysis of the contactors was deemed unnecessary. The

ceramic and pyrotechnic fuses within the penthouse of these three EVs remain intact, suggesting the HV battery pack did not experience an overvoltage or overcurrent event prior to teardown. Continuity of the squib in the pyrotechnic fuse was verified with a digital multimeter. The current shunt was intact and showed no signs of corrosion or damage.

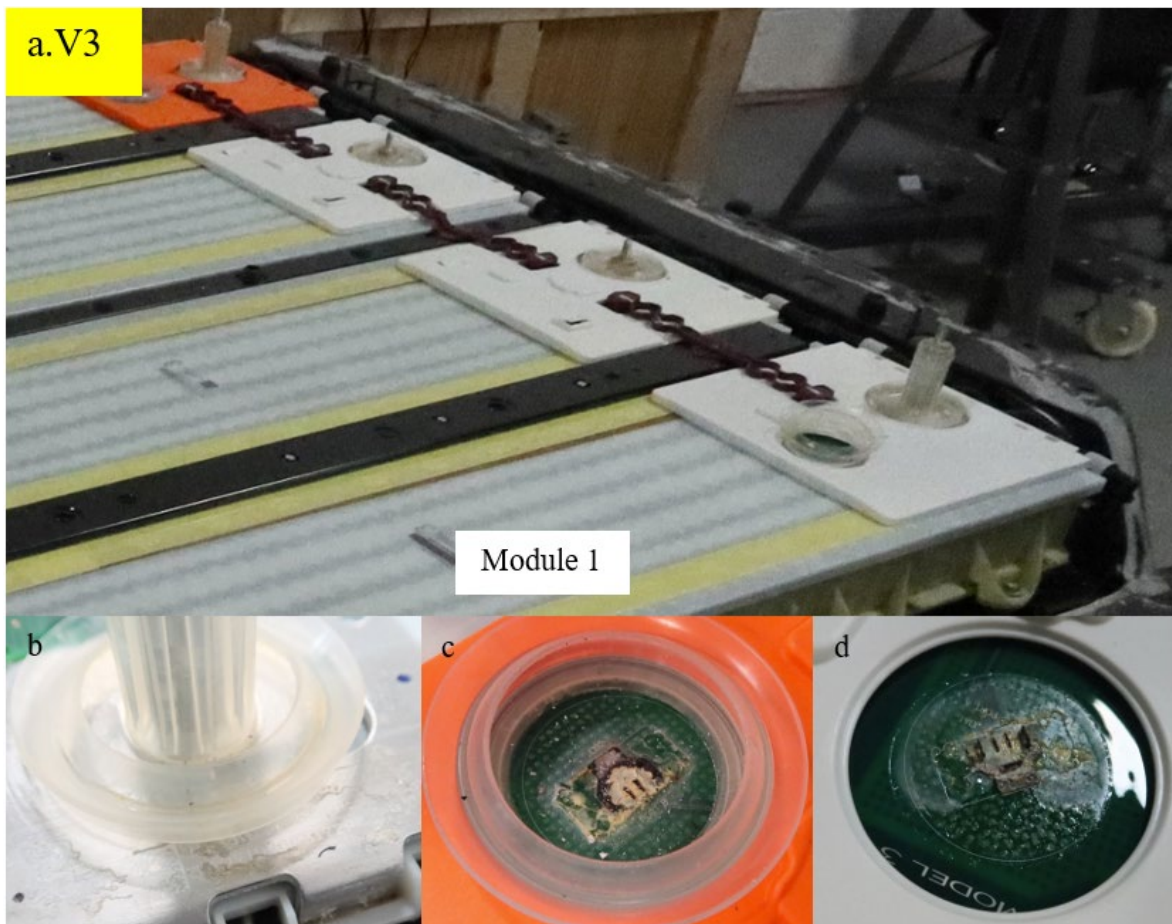
*Figure 26. Penthouse interface seals of vehicle V3*

Figure 26 shows that the areas at the tops of the battery modules interfacing with the penthouse and the electronics within feature circular gaskets for sealing between the penthouse and the module space. Corrosion and contamination observed on the surfaces of these sealed areas, which were exposed to the penthouse space of vehicle V3, as indicated in Figure 26, are most likely due to the water ingress revealed in Figure 25. Moreover, one of the gaskets appears to have failed, with some surface corrosion noted around the terminal bus plate of Module 1, as observed in Figure 26(c–d). It is very possible the exposure and corrosion on the BMS printed circuit-board assemblies have incurred some form of damage that would negatively affect their function.

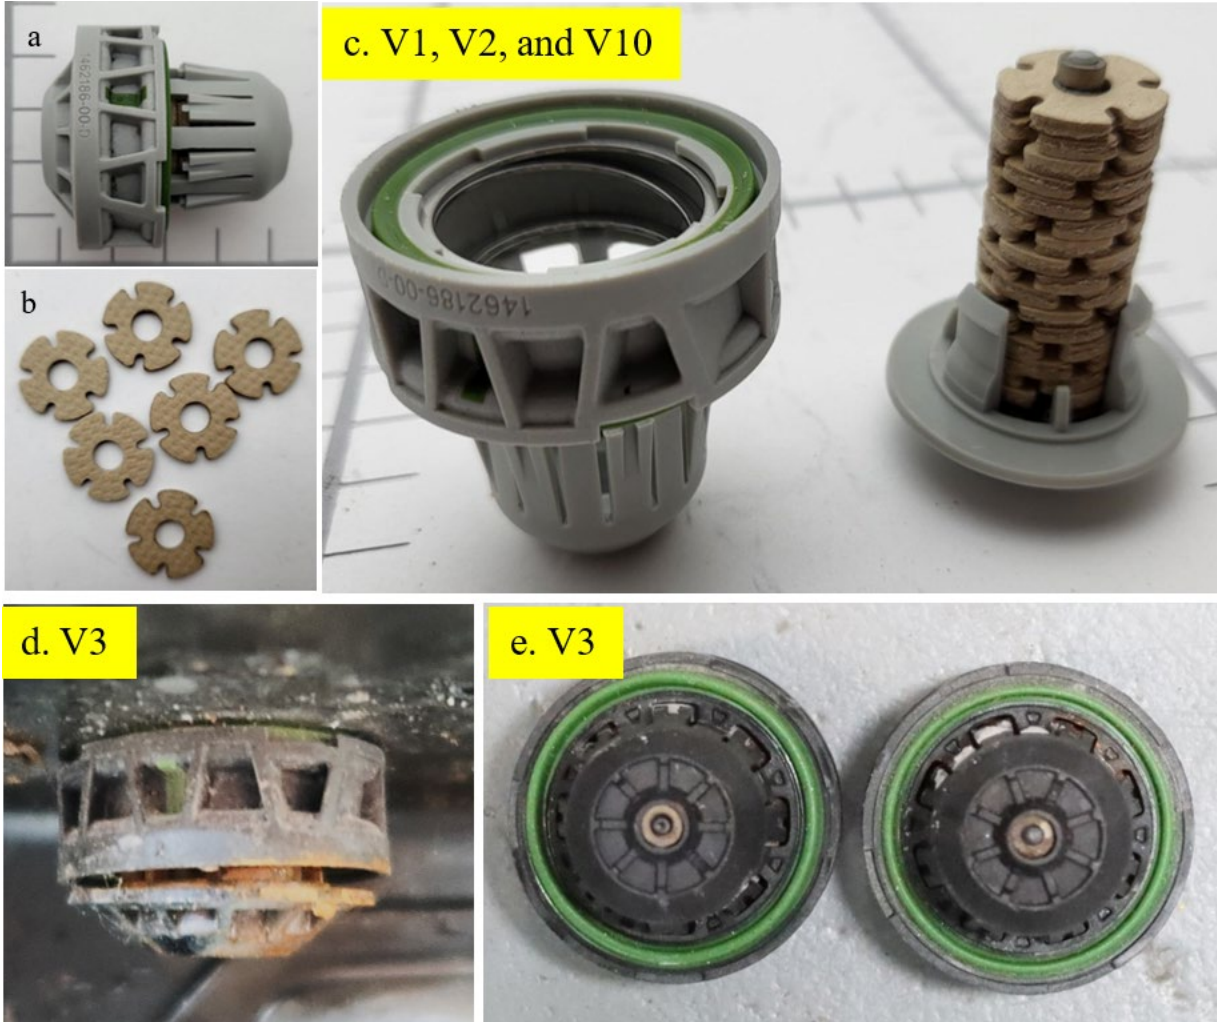
Figure 27. Penthouse moisture vents of Pack Design 1

Two moisture-activated vents, or “flood ports” in Tesla nomenclature, are located on the rear-right and rear-left sides of the battery packs in Pack Design 1, mounting through the bottom of the tray into the interior of the penthouse compartment. In these vents, cellulose-based wafers are stacked around a central shaft held closed by a spring that expands in the presence of moisture, thus compressing the spring and opening the vent. In general, the exterior portion of this moisture vent showed signs of debris from the submersion of the EVs in Pack Design 1. For the V1, V2, and V10 EVs, the sealed, interior portion of the vent appeared to be clean, suggesting

the seal prevented intrusion into the pack, as indicated in Figure 27(a–c). For V3, both vents were observed to have been activated and stuck open, as shown in Figure 27(d–e). Additionally, the O-rings of the vents appeared to be intact and uncompromised. While it is difficult to determine whether these vents failed in some way and allowed water intrusion into the penthouse space or they merely operated as intended and only opened due to exposure to water within the penthouse from another source, they would present a point of ingress if at least one of the two are either flawed or activated due to exposure to water from the outside of the pack. Note that the Tesla service manual implies there is a first and second design of this port, along with a retrofit procedure.

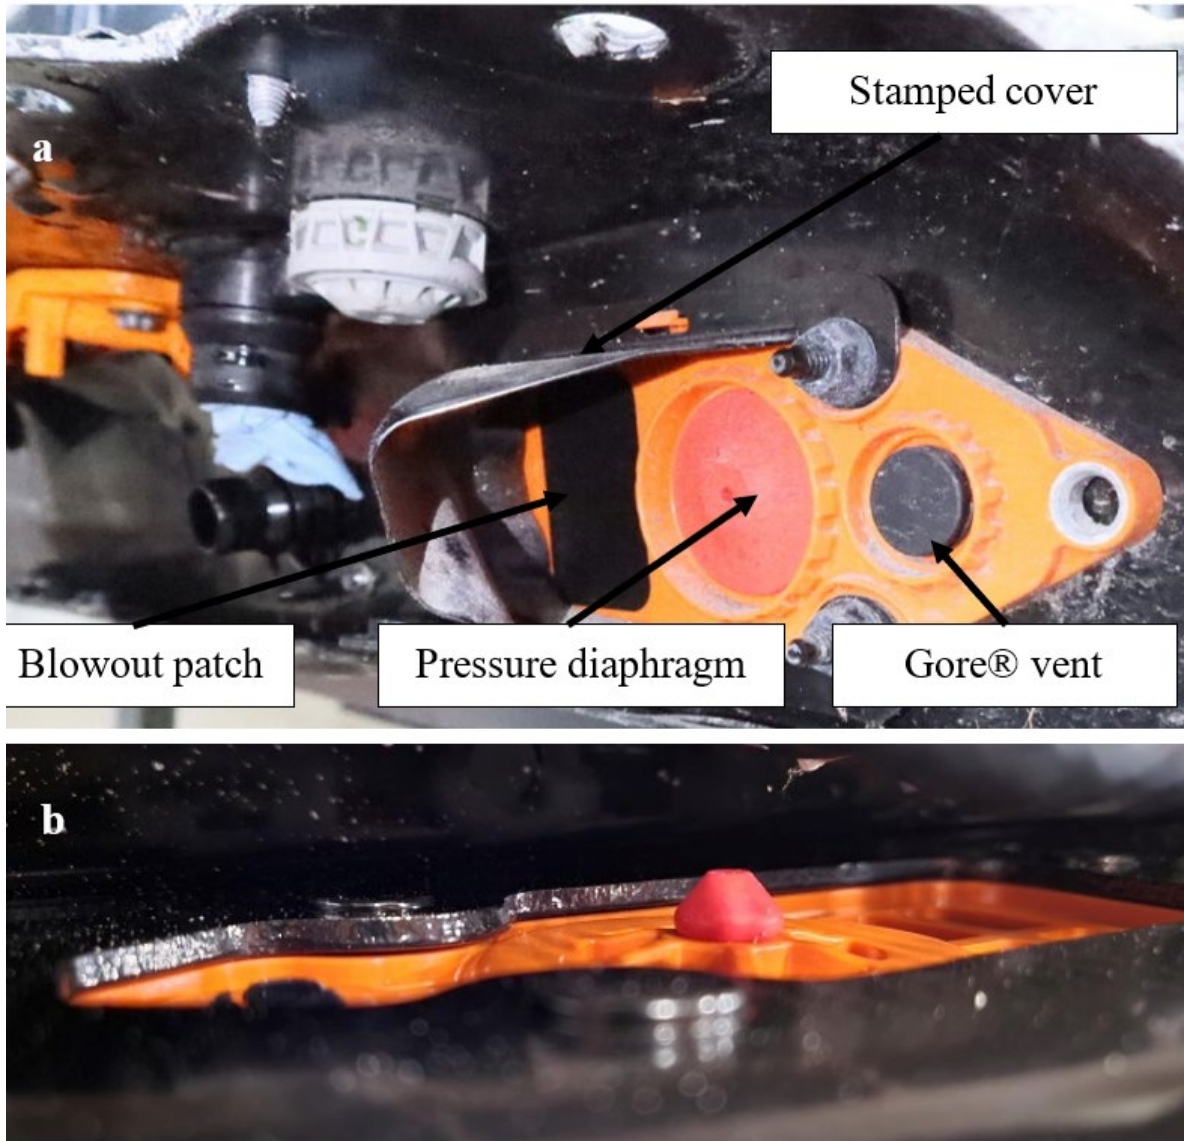
Pack Design 1, which is common to Tesla Models Y and 3, featured two vent assemblies attached to the rear-left and rear-right sides of the main battery pack via threaded fasteners with a seal against the pack tray, as shown in Figure 28. As identified in Figure 28(a), each side employed a Gore vent, a pressure diaphragm, and a pressure-blowout patch. Ventilation was directed outward on either side with a stamped cover over the top of the vents. An examination

of the exterior and interior of the vent assemblies for all EVs in this design group showed no sign of seal failure or water ingress through any component of the vent assembly. Two fasteners appeared to have been removed from each vent assembly as a running change, likely to reduce cost, but there was no evidence that seal efficacy was compromised as a result.

*Figure 28. Battery pack vent assembly of Pack Design 1: (a) vent assembly exterior, and (b) vent assembly interior*

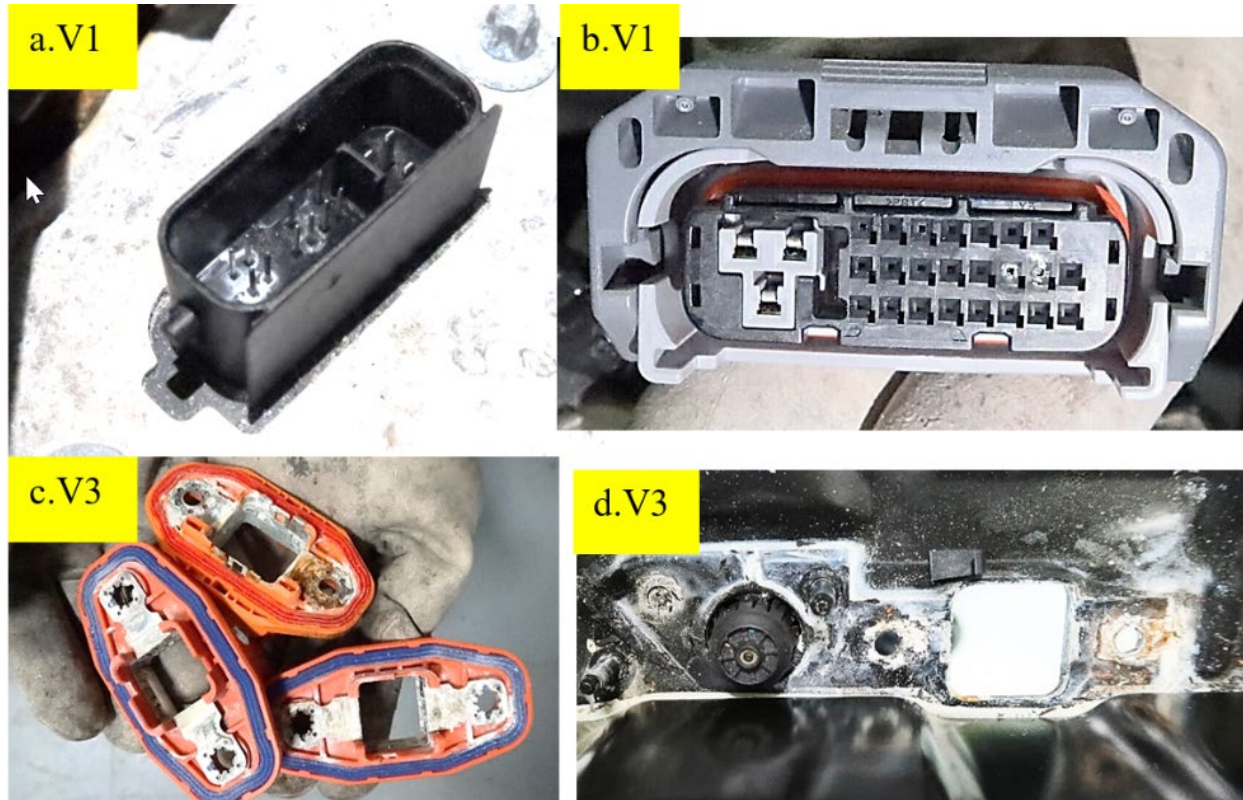
The HV battery penthouse compartment featured an LV communication connector port close to the DC-DC converter of the LV terminals, as shown in Figure 29(a). The male connector on the penthouse, as observed in Figure 29(a), mated to a female connector on one of the vehicle's LV harnesses, as observed in Figure 29(b), to communicate battery-diagnostic information. A single seal was present on the interior of the female connector, as shown in Figure 29(b). Figure 29(a) shows the interior, sealed area of the LV communication connector on the penthouse of V1 that

exhibited what appeared to be the dried residue of water intrusion and remnants of light corrosion or contamination surrounding the bases of several pins. Similar corrosion was discovered on the corresponding terminals of the EV wire harness, as shown in Figure 29(b). No melting was observed on the connector terminals or pins—only powdery white sediment appeared to be present. Although no apparent issues with communication were observed, increased levels of corrosion could eventually affect EV operation due to potentially impaired EV to battery communication. This issue was not observed in EVs V2, V3, and V10.

Figure 29. (a–b) LV communication connector of V1. (c–d) HV connector of V3

In the case of Vehicle V3, a significant degree of corrosion was evident on the HV connectors located in the electronics penthouse, as depicted in Figure 29(c–d). Additionally, the internal surface of the pack, where these connectors are mounted, exhibited substantial contamination, as shown in Figure 29(d). These observations suggest the HV connectors in Vehicle V3 may have served as a potential entry point for water, allowing for water intrusion into the vehicle.

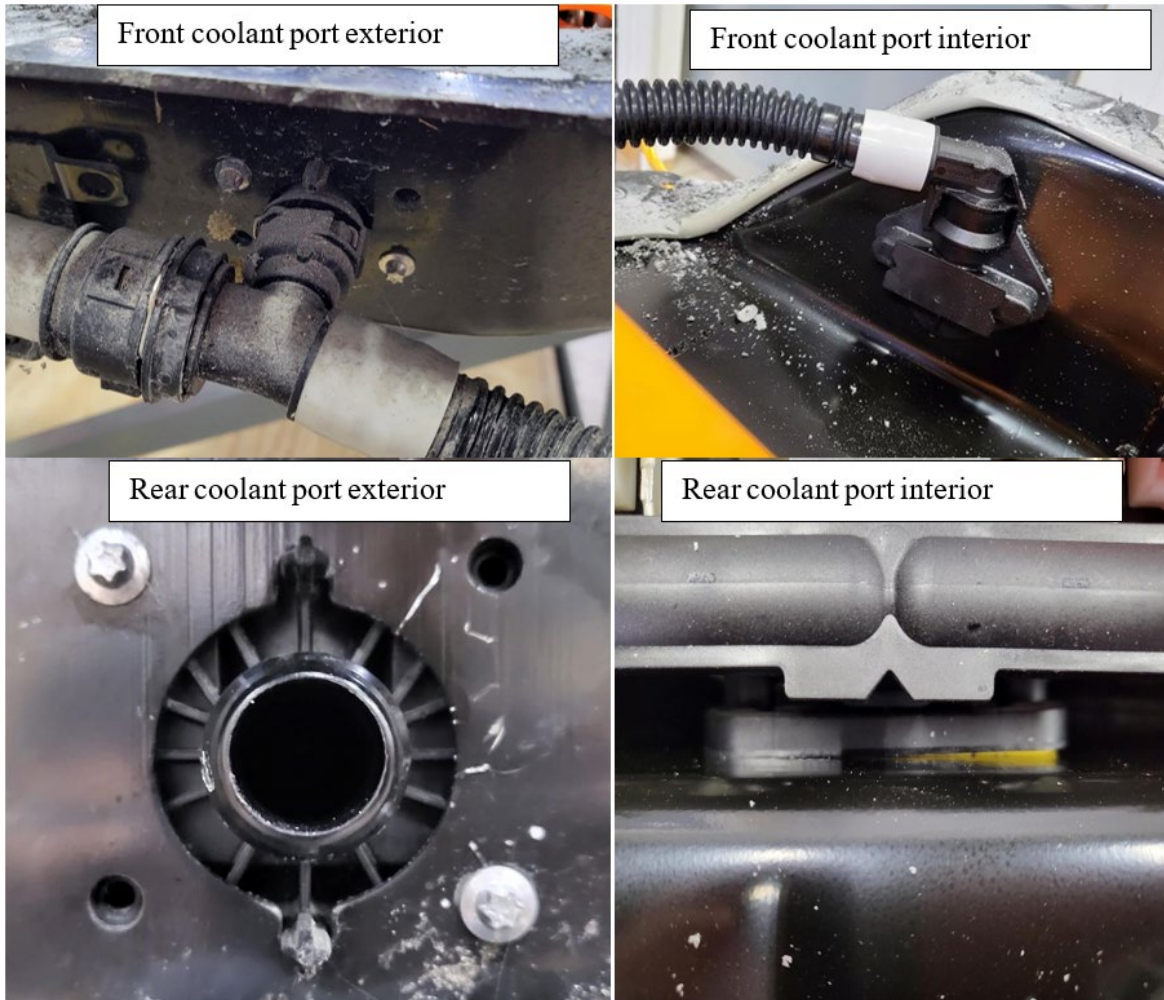
Tesla Models Y and 3, grouped into Pack Design 1, featured four coolant ports—two at the front and two at the rear—for the supply and return of the ethylene-glycol coolant to thermally manage the battery pack, as shown in Figure 31. Each coolant port was attached with threaded fasteners and seals against the interior face of the pack tray. An examination of the exterior and interior of the coolant ports showed no sign of seal failure or water ingress for any of the EVs in Pack Design 1. Two fasteners appeared to have been removed from each coolant port as a

running change, likely to reduce cost, but there was no evidence that seal efficacy was compromised as a result.

Figure 31. Representation (V1) coolant port of Pack Design 1

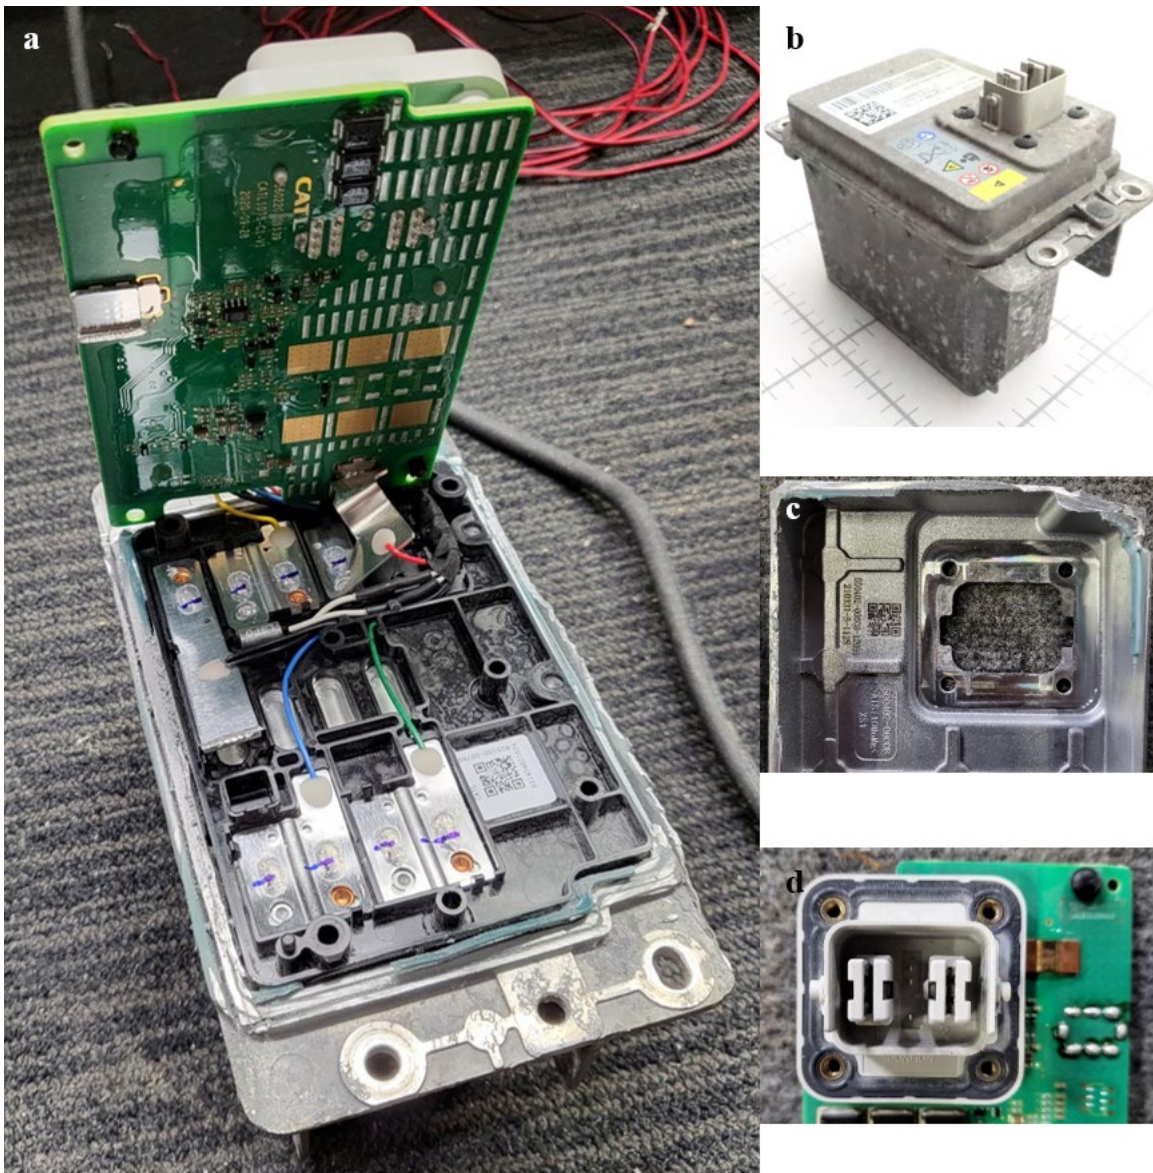
The 12-volt battery for this pack design was located under the wiper cowl. Vehicle V1 had a LiB while the other EVs had conventional lead-acid batteries to supply LV power. As shown in Figure 32, the V1 Li-ion battery was at least partially submerged, as evidenced by the corrosion present on the surface of the cast-aluminum housing. The voltage reading from the main external terminals at the time of removal was 0.026 V. A control board was located under the cast-aluminum lid covering the four prismatic Li-ion cells within the battery. The prismatic cell voltages measured 0.612, 0.407, 0.277, and 0.409 V, or 1.7 V total.

Such an LV reading indicates this LiB reached a state of over-discharge, likely through the submersion of the LV terminals on the HV battery pack penthouse. Given the low state of charge, it is highly unlikely this battery could be safely recharged or used again, but it does not appear to have failed in a catastrophic manner nor does it appear to be responsible for any damage to its neighboring components. The 12-volt battery interior did not display signs of water ingress, as shown in Figure 32, suggesting that, despite submersion, the connector seal was

uncompromised. The switching components on the PCBA and the disparity in the voltages measured at the external terminals and directly from the cells suggest the 12-volt battery possesses the capability to open the circuit between the main external connector and the prismatic cells within the housing, which would theoretically allow the battery to self-protect against a short-circuit or abuse conditions.

Figure 32. Dissection of LV battery of Vehicle VI

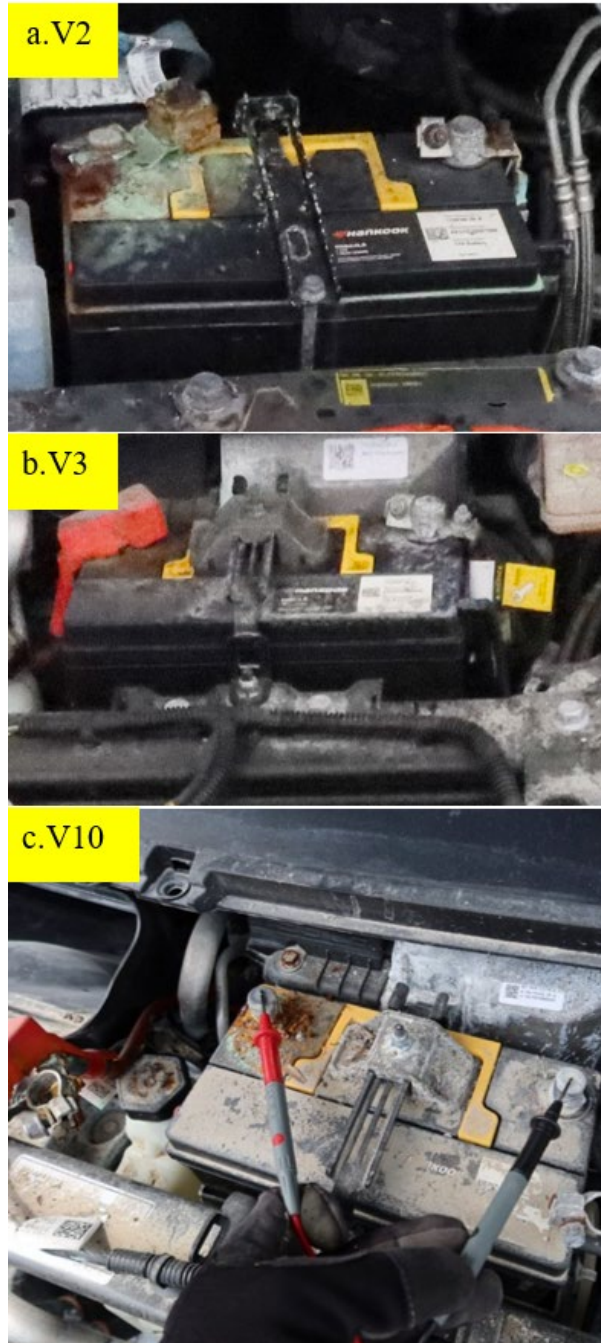
Snapshots of the 12-volt lead-acid batteries are presented in Figure 33, which provides evidence (marks, debris, sediment, etc.) of full submersion. The terminals of all these batteries showed heavy corrosion. These LV batteries measured ( $\sim 0.05$  V) as severely drained but did not appear to have failed in a catastrophic manner or to be responsible for any damage to neighboring components.

*Figure 33. LV battery of V2, V3, and V10*

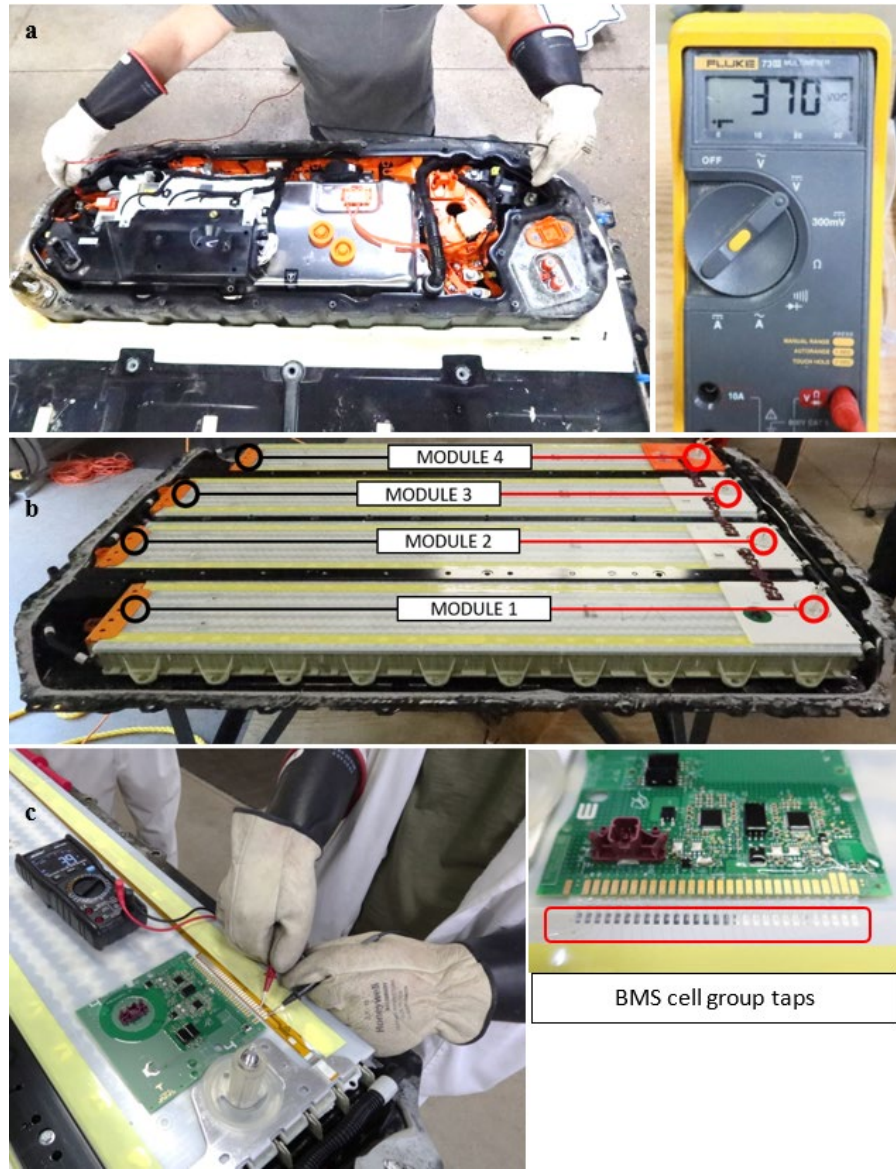
Pack-level voltage measurement was taken from the main positive and negative terminals inside the penthouse immediately following penthouse cover removal, as shown in Figure 34(a). The main battery compartment of Pack Design 1 contained four battery modules, as identified in Figure 34(b). Module-level voltage measurements were taken at the positive and negative terminals of each module. Modules 1 and 4 consisted of 23 cell groups each while Modules 2

and 3 contained 25 cell groups each. The voltage measurement of those cell groups were taken through the BMS cell group taps indicated in Figure 34(c).

*Figure 34. Inside of battery pack and measurement strategy: (a) pack voltage measurement through penthouse terminals, (b) module arrangement within a pack, and (c) cell group voltage measurement through BMS taps*

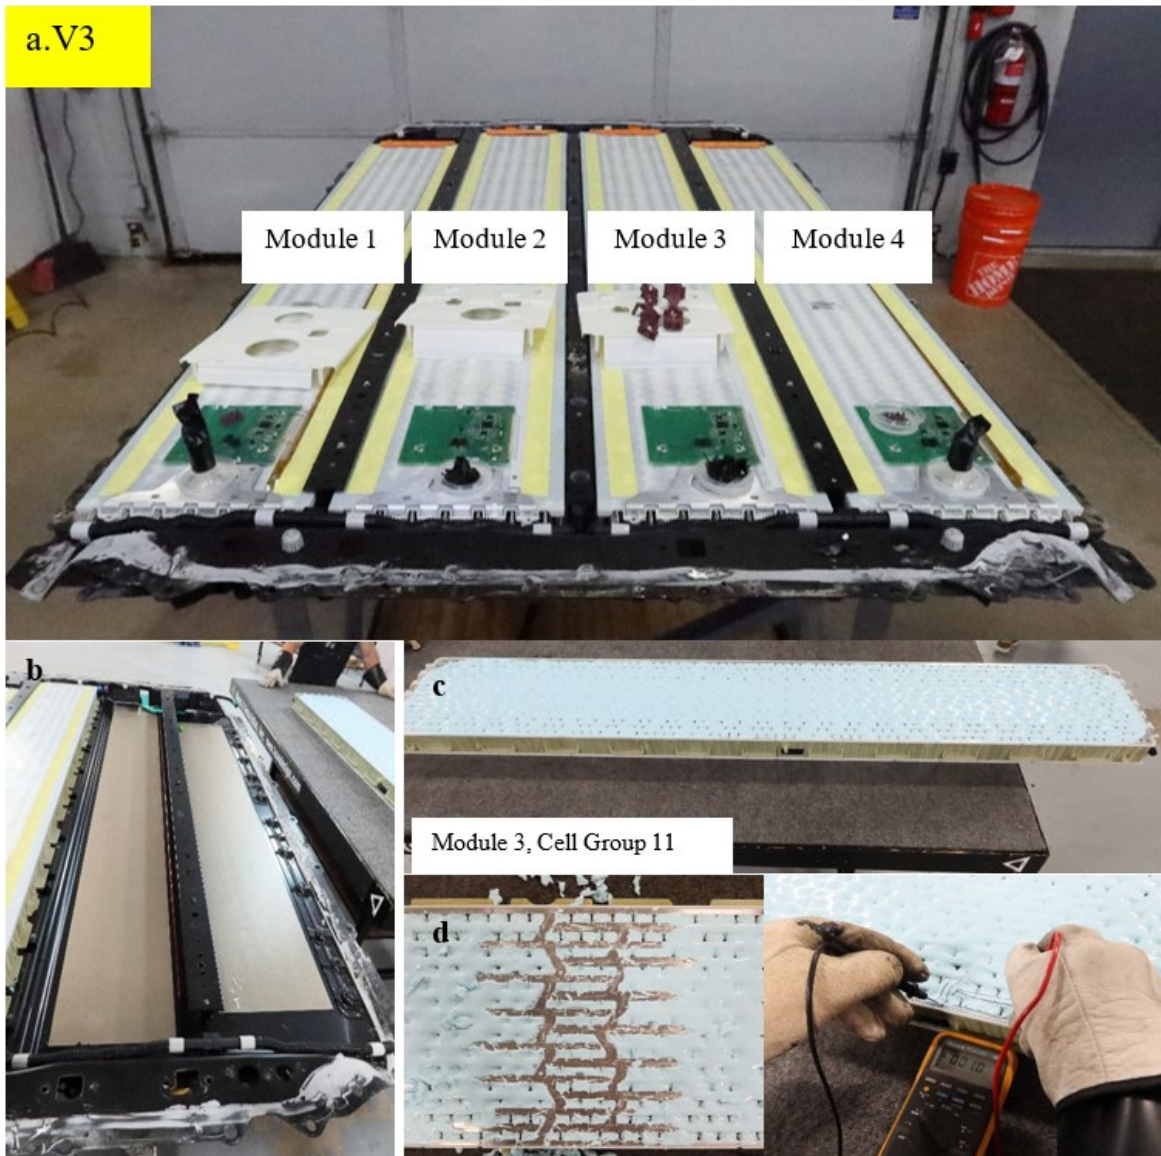
Figure 35. Vehicle V3 battery pack:

Table 4 presents the measured pack, module, and cell group voltages. In general, the pack retains HV even after more than 10 months of storage. Figure 35(a) shows a representative open battery with the modules identified. Except for V3, the maximum cell group voltage variation remained within 14 mV. Module 3 of V3, as shown in Figure 35(b–d), measured 3 V lower than the identical Module 2. Cell group voltage testing revealed Cell Group 11 within Module 3 of V3 measured 1.06 V (i.e., severely over-discharged) vs. the average cell group voltage of 3.91 V. Module 3 was removed to inspect the floor area directly underneath, as observed in Figure 35(b–c). The floor of this module space revealed neither any sign of water intrusion nor sign of

damage, as shown in Figure 35(b). The over-discharged Cell Group 11 was consequently located, and the surrounding materials removed. No evidence of any physical damage was found, as shown in Figure 35(c). The absence of any evidence of water-induced damage indicates probable manufacturing- or age-related issues within Cell Group 11 resulting in higher self-discharge during the extended period of storage following the flood event in the absence of charging.

(a) open battery pack showing the four modules, (b) the battery pack after removing Module 3 and 4, (c) Module 3 isolated, and (d) Module 3, Cell Group 11. Module 3 compartment has no ingress evidence. Bond-wire encapsulation was removed from Module 3 for bond-wire and current collector inspection after LV reading on Cell Group 11

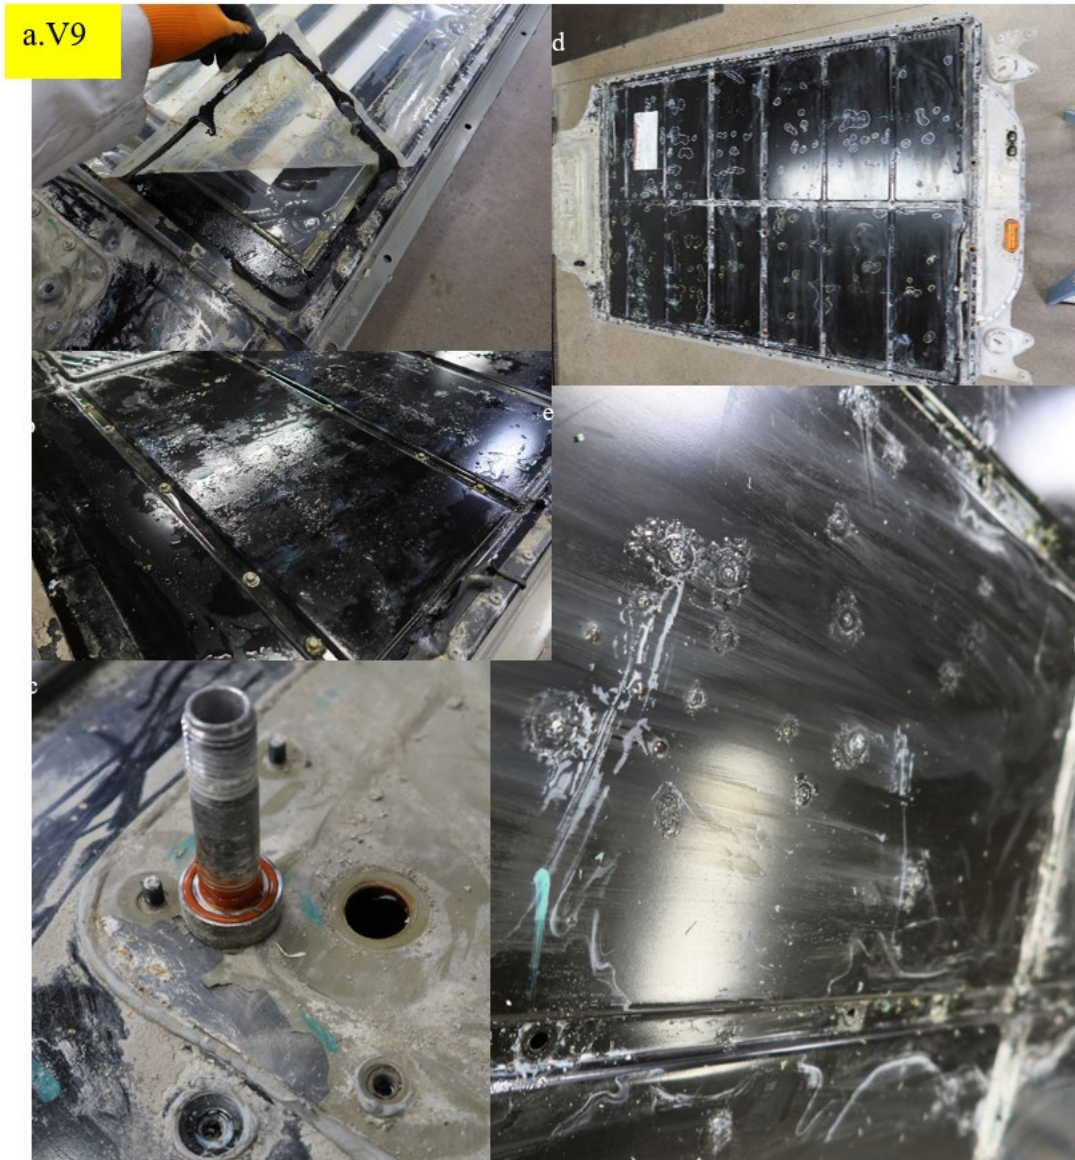
Figure 38. V9 battery pack after removal from the vehicle:

In general, all pack exteriors in this group were covered in sediment and debris, indicating full submersion. For Vehicle V6, the plastic sheet was able to retain its integrity. However, the plastic cover in the remaining EVs (e.g., V7 to V9) failed to retain their integrity, as shown in Figure 36–Figure 38. Standing water was evident on the pack exterior, both on top of and underneath the plastic lid cover. Adhesive beads were penetrated by water, allowing water across the barrier. The lid did employ an environmental coating to minimize degradation from corrosion. However, a multitude of areas with corrosion or failed environmental coatings are noted across the entirety of the lid exterior, as evidenced by “bubbling” of the lid coating, and most likely caused by the trapped water compromising the coating. This corrosion also extended to several fasteners exhibiting a rusty appearance.

Despite the numerous exterior areas showing corrosion, the interior-facing underside of the lid exhibited no signs of corrosion, contamination, or damage, and the pack interior likewise had no evidence of such, as shown in Figure 36 to Figure 38. It is possible the corrosion could compromise the sealing around the fasteners and/or the lid material itself and allow water and contaminant intrusion into the pack interior in the future, but this would conceivably take a long time.

(a) V9 battery pack exterior showing failed plastic cover, (b) water underneath plastic cover, (c) corrosion in the fastener area, (d) marked corroded areas on the exterior of the lid, and (e) salt residues at the exterior of the lid. The underside of the lid was observed to be corrosion free.

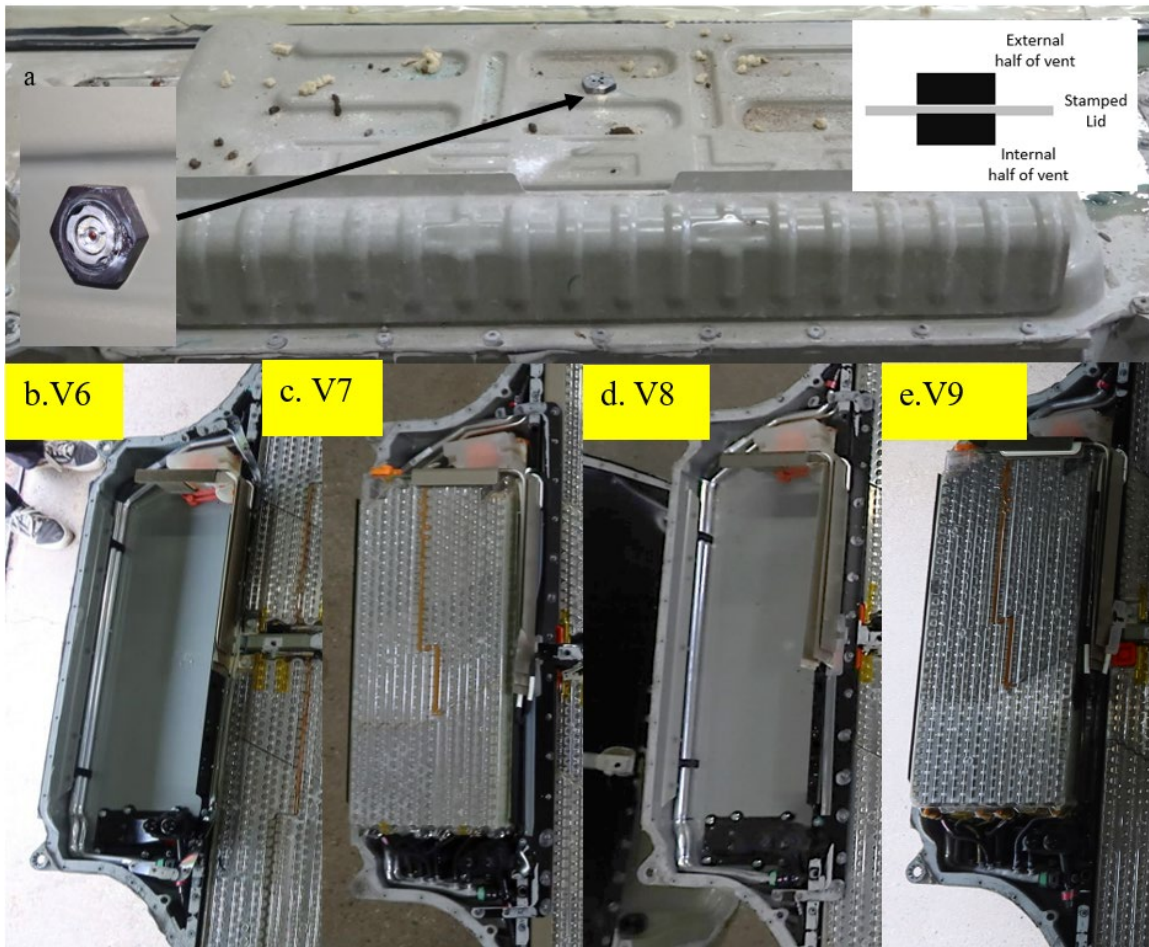
As discussed earlier, the HV battery for this pack design had a raised penthouse section, as observed in Figure 39(a). For this pack design and in an extended-range model, this section of the pack housed extra battery modules, as shown in Figure 39(b–e). A mechanical breather vent sat on the lid in the center of the penthouse of V6, V8, and V9, as shown in Figure 39(b–c, and e). Vehicle V7 did not have a breather vent. This mechanical breather vent is a two-part assembly with an injection-molded nut fastening to the vent body from inside the pack to secure it to a lid, as observed in Figure 39 (a and inset). The penthouse of V6 and V8 were empty, as they housed standard range 75 kWh battery packs. Vehicles V7 and V9 consisted of extended-

range 100 kWh battery packs and contained two extra battery modules in the raised, penthouse section, as shown in Figure 39.

Figure 39. (a) Penthouse breather vent located at the center of lid, and (b), (c), (d) and (e) top view of the penthouse enclosure upon removing the lid. Vehicle V7 did not have a breather vent.
