U.S. Department  
of Transportation

**National Highway  
Traffic Safety  
Administration**

DOT HS 813 644

# **A Teardown Study of Flood-Damaged Electric Vehicles**

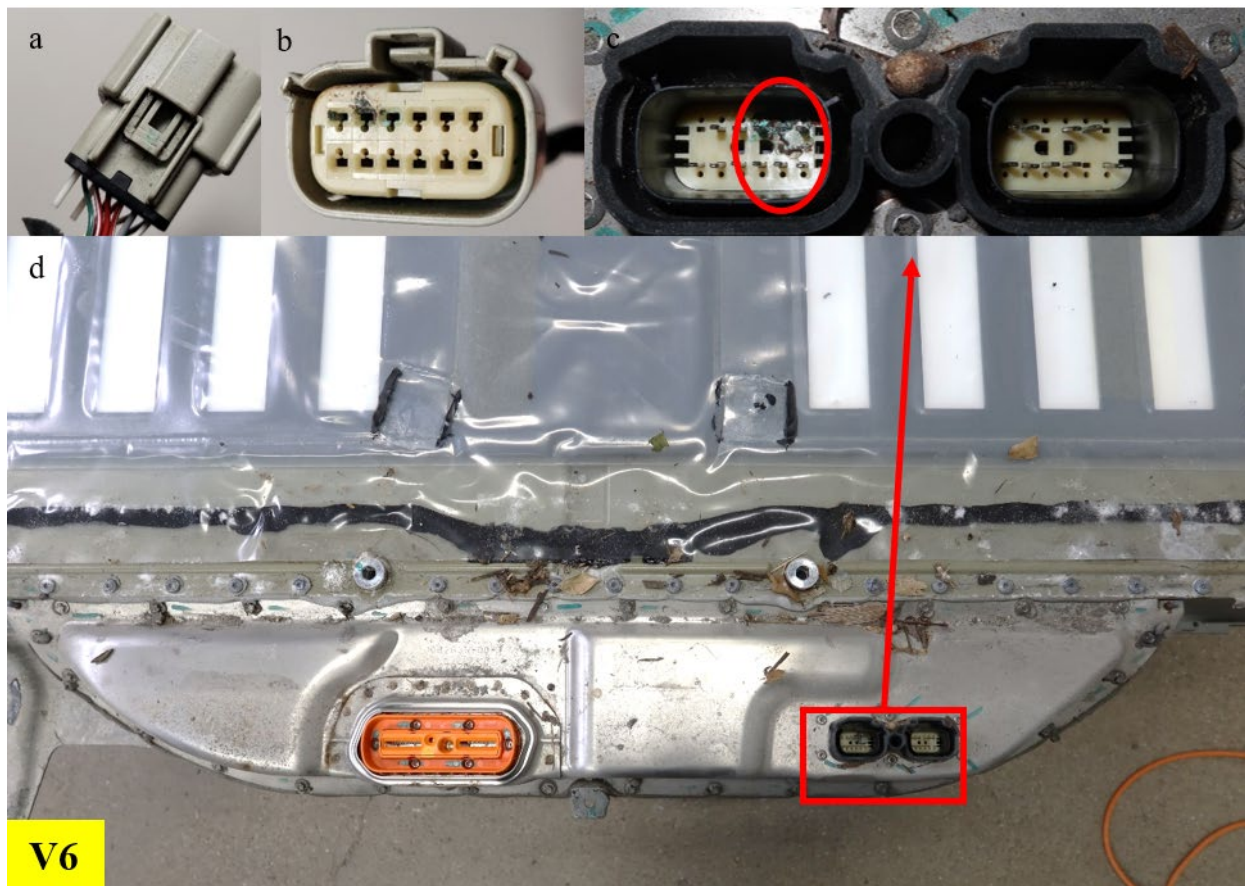
The HV battery featured two LV connectors for communication with the rest of the vehicle, as shown in Figure 50. Each connector had a seal against the lid in addition to seals within the connector housings themselves. The body-side female connector employed a snap-fit feature that would normally lock the mating connector in place if used as an in-line connection in a conventional wire harness. Given that the HV battery is designed to drop vertically from the EV without having to manually disengage coolant or electrical connections, this snap-fit feature is effectively unused in this application. The snap-fit feature serves as positive assurance that a connection has been made and will also ensure the seal around the terminals achieves sufficient compression.

Upon examination of the LV connectors after dropping the pack, significant corrosion was noted around several pins, in addition to one of the pins having been broken off in the corresponding female body-side connector, as observed in Figure 50. CAN communication was still possible, even with the observed damage. The lack of a snap-fit mechanism to ensure proper installation depth for the LV connector is likely the mechanism by which the water was able to enter the connector and cause the observed corrosion on the pins and terminals. The compression of the LV connector seal depends on the installation of the entire HV battery pack. This failure mode was not observed in the remaining EVs in this design group.

Figure 50. Image showing LV connector of Pack Design 2 (or V6)

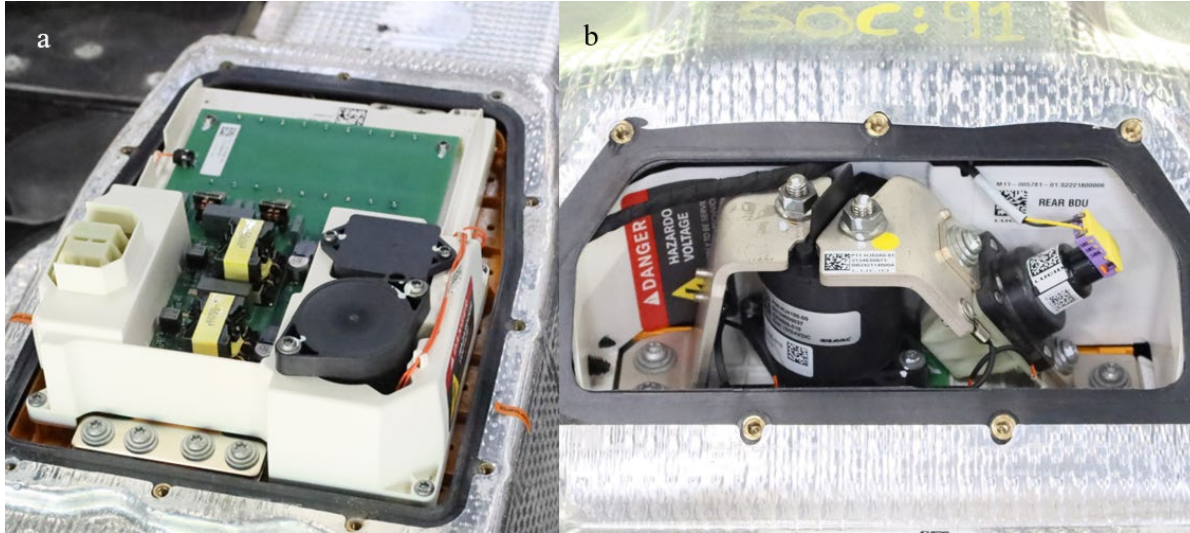
Despite the water submersion and the water marks and corrosion observed on some of the aluminum components of the tray within the tray structure, none of the internal electronics (e.g., contactors, pyrofuses, etc.), busbars, or battery modules showed any trace of water or visible damage, nor did they exhibit any unusual results during inspection and testing, as indicated in Figure 54.

*Figure 54. PDU of Pack Design 3: (a) front PDU and (b) rear PDU*

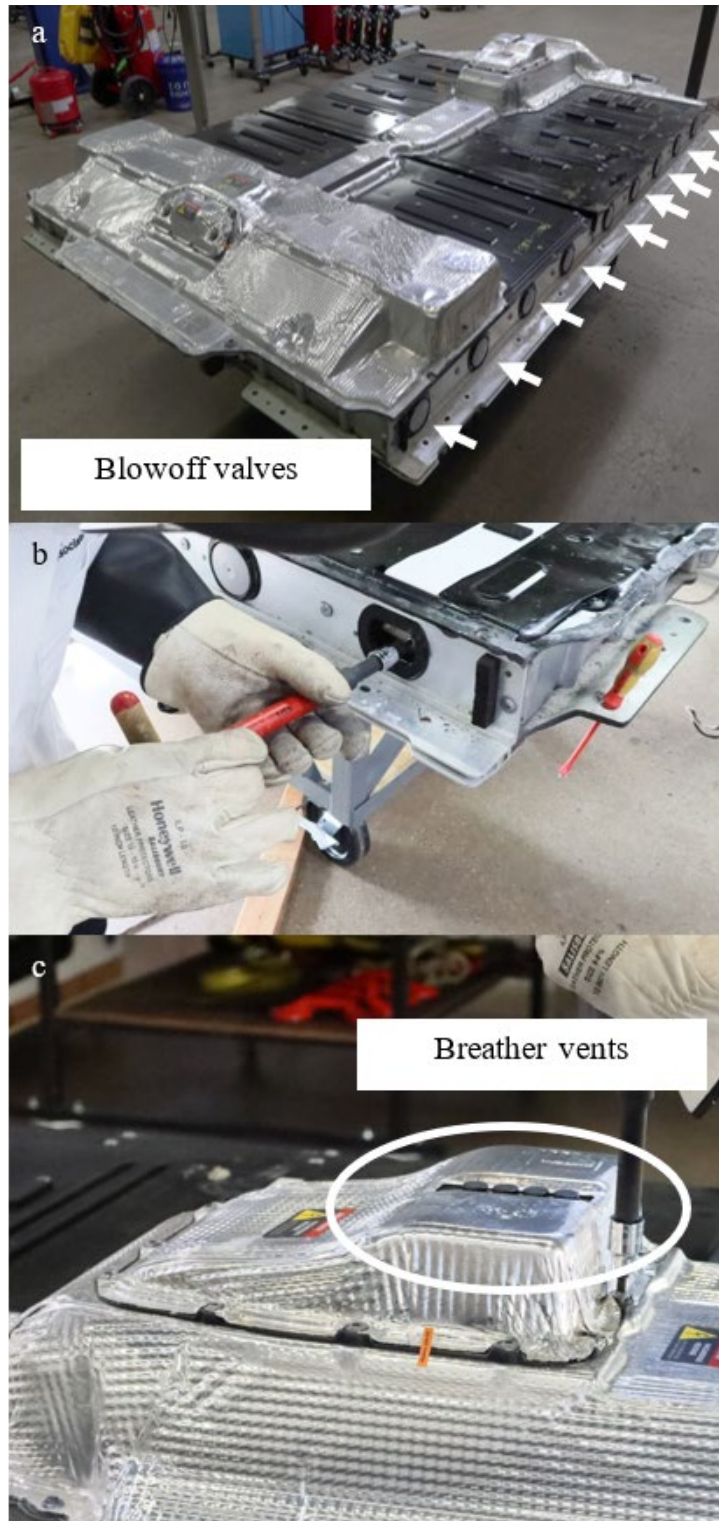
For this pack design, the side sill diaphragm-type pressure vents provided access to the busbar fasteners on the modules, as shown in Figure 55. These pressure vents consisted of an injection-molded base attached to the side sill extrusions via a liquid-applied adhesive and flexible diaphragm pressed into the base. None of the 18 pressure vents lost integrity due to water submersion. The breather vents on top of the PDU, as shown in Figure 55(c), also retained integrity against water submersion.

Figure 55. Lucid Air Grand Touring battery pack venting mechanisms: (a) 18 blowoff valves, (b) access of module busbars through the vents, and (c) breather vents

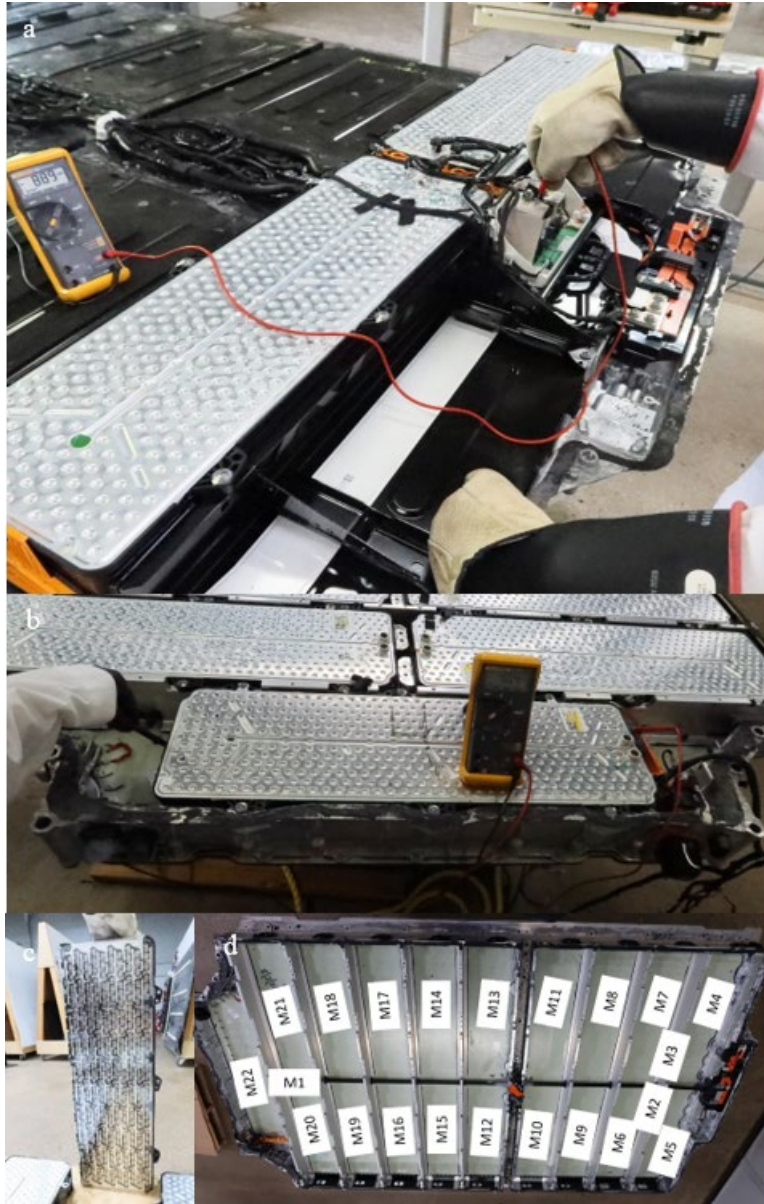
Figure 58 shows the pack and module voltage being measured. Pack voltage was measured to be 889 V, seemingly congruent with markings on the pack exterior that denoted 91 percent state-of-charge, as observed in Figure 58(a). Module-level voltages were consistent without any significant variation, as observed in Table 6, indicating that none of the modules had shorted out or otherwise been damaged by water ingress.

Figure 58. Pack and module voltage measurement of Lucid Air Grand Touring vehicle: (a) Pack-level voltage measurement, (b) module-level voltage measurement, (c) current collector (underside) of battery module, and (d) labeled modules

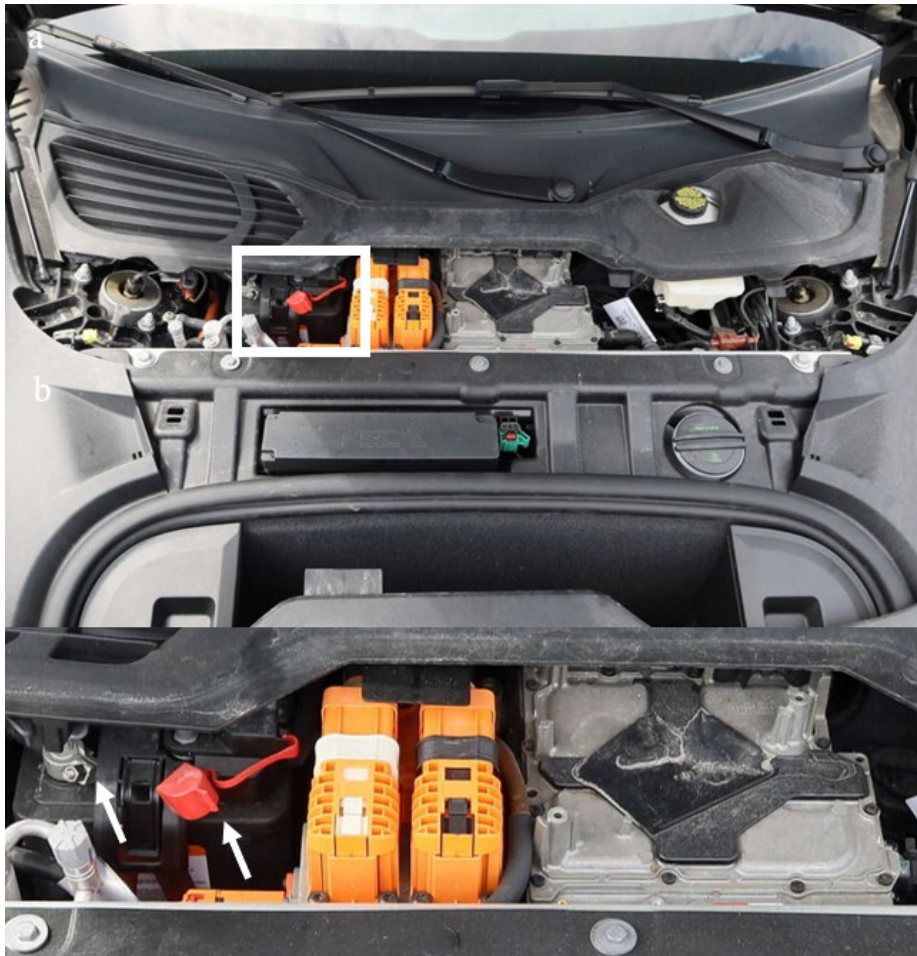
The Porsche Taycan 12-volt battery was located at the front-right of the EV under a trim panel. The charge port and HV battery cables were located next to the 12-volt battery, where they were connected to the HV power distribution modules, such as the DC-DC converter and OBC. Given the location of the 12-volt battery and the low height of the flood-line, the 12-volt terminals displayed no observable corrosion, as shown in Figure 59.

Figure 59. (a) 12-volt battery location and (b) 12-volt battery terminals, showing no corrosion

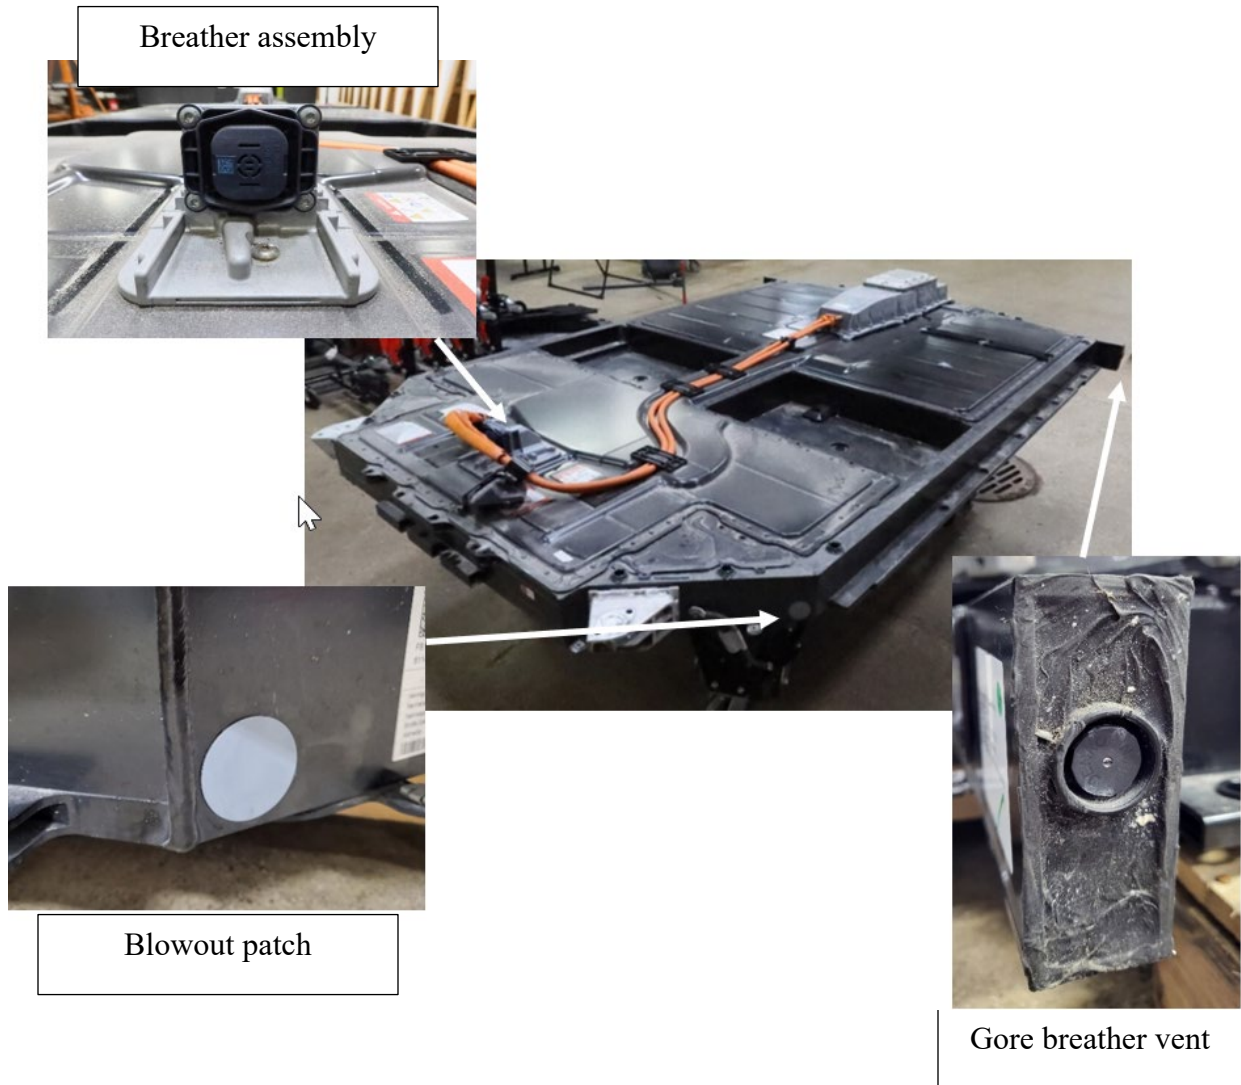
The Porsche Taycan employed a series of breather vents and what appeared to be blowout patches on the battery pack exterior, as shown in Figure 61. Gore breather vents were installed to the ends of the tray extrusions located at the front-right and front-left sides of the pack. Circular adhesive-backed patches were located at the rear-right and rear-left of the pack, which presumably act as pressure-blowout valves when gases are directed through the cells of the extruded walls of the tray. At the top rear of the pack was a large breather assembly, which housed a membrane within a cast-aluminum and injection-molded housing attached to the lid via threaded fasteners with an injection-molded seal.

The seal integrity of the large breather assembly at the top rear of the pack was not found to be compromised, and no signs of ingress were noted on the underside of the lid in this area. The breather vents at the front of the pack and the (presumed) blowout patches at the rear were installed to the extruded sections that form the perimeter of the pack tray. The interiors of the extruded sections were used as a path for off-gassing and are not directly exposed to the module area inside the pack. No evidence suggested that either the blowout patches or breather vents were compromised and allowed water ingress.

*Figure 61. Porsche Taycan pack-venting strategy*

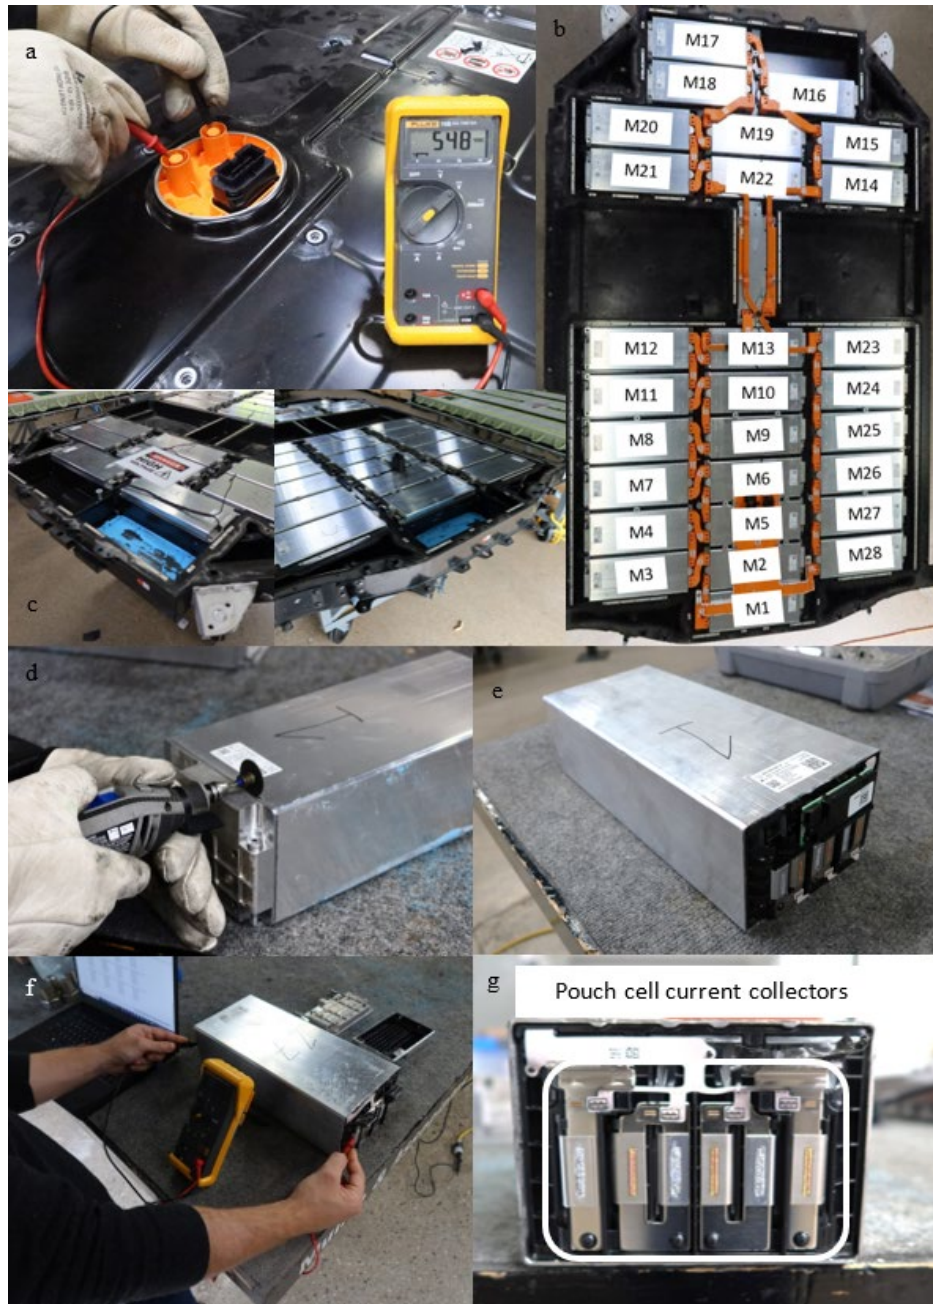
After the lid was removed, voltage checks were conducted to ensure everything fell within the expected and normal ranges. Next, the internals were inspected. No signs of corrosion or contamination were observed within the battery pack interior, as shown in Figure 62. Pack-level voltage was measured following the removal of the penthouse module. Two additional modules were taken out for further disassembly to obtain the cell group voltages. Module-level voltage measurements were taken upon the removal of the lid, prior to the removal of the busbars. Modules 1 and 17 were chosen due to their locations at the opposite ends of the pack, as indicated in Figure 62. Cell group voltages were obtained from the current collectors inside the module. The cells were arranged in a 2p6s configuration; therefore, six cell groups were measured per module.

*Figure 62. Porsche Taycan battery pack external and internal views with measurements being completed*

During an inspection of the pack interior, no contamination or corrosion was discovered within. The mid-pack fuse was found to be unbroken. No damage to any modules was observed. The module-level voltage delta was measured at 0.09 V between the highest and lowest measurements, as shown in Table 7. No damage was observed within the HV battery pack interior to suggest that water ingress occurred at any point. The pack voltage corresponded to an SOC of ~5 percent, which indicates either that the SOC of the pack was at that level during the time of flooding, or it experienced a higher rate of self-discharge relative to other packs evaluated in this study.

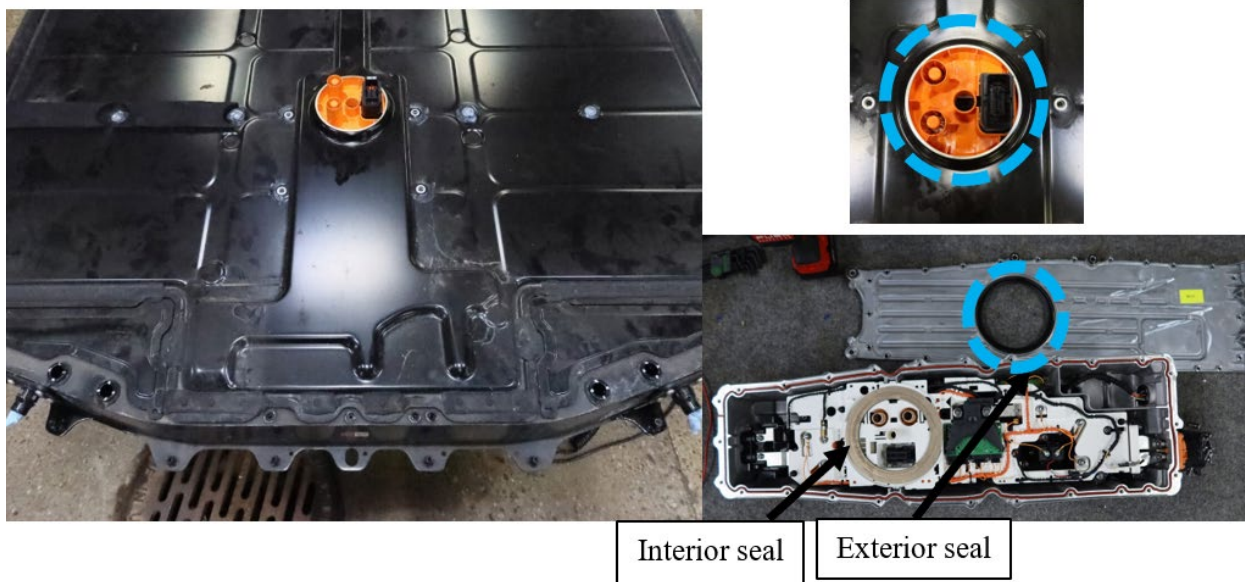
Figure 63. Image showing the location of the main battery terminals underneath the penthouse.

The Porsche Taycan houses all power distribution components inside the penthouse module/PDU. The PDU interfaces with the main positive and negative terminals protruding from the battery pack lid when installed, as observed in Figure 63. The PDU base featured a circular seal that sits between the battery pack lid and the PDU, which encapsulated the main battery terminals.

The PDU seal around the main battery terminals showed no signs of ingress; however, the flood-line noted on the EV exterior indicated the likelihood the seal was only partially submerged. The integrity of this seal is critical to the safety of the pack, given that, even at this vehicle’s 5 percent SOC, there was still a 548-volt potential across these two terminals. Should any water ingress have occurred, a short between these terminals would have been possible.
