Final Report: Submitted to
State of Florida
Department of Transportation

Submitted by the
Texas A&M Transportation Institute

Green Bike Lane Evaluation for Florida Pavements

Final Report

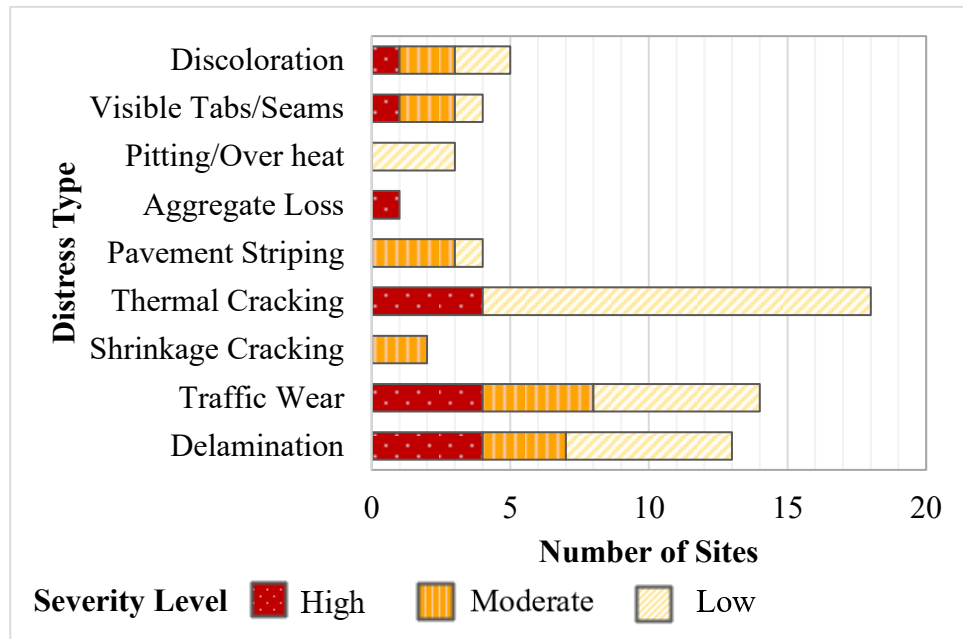
Figure 3-2. Number of GCPM Installations versus Distress Type.

A summary of distresses observed for each site is shown in Table 3-2. Severity is marked as low (L), moderate (M), or high (H). An overall qualitative rating of ‘good,’ ‘fair,’ or ‘poor’ was also made. In general, the researchers found that thermal cracking, delamination, and wear were the three most common distresses in Florida’s bike lanes (Figure 3-2).

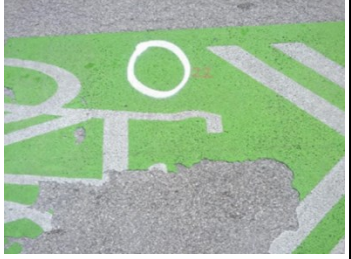
<p><u>Wear</u></p> <p>Wearing and skid marks were observed in areas exposed to traffic. This problem could be seen on GCPMs next to parallel parking and on turns.</p>

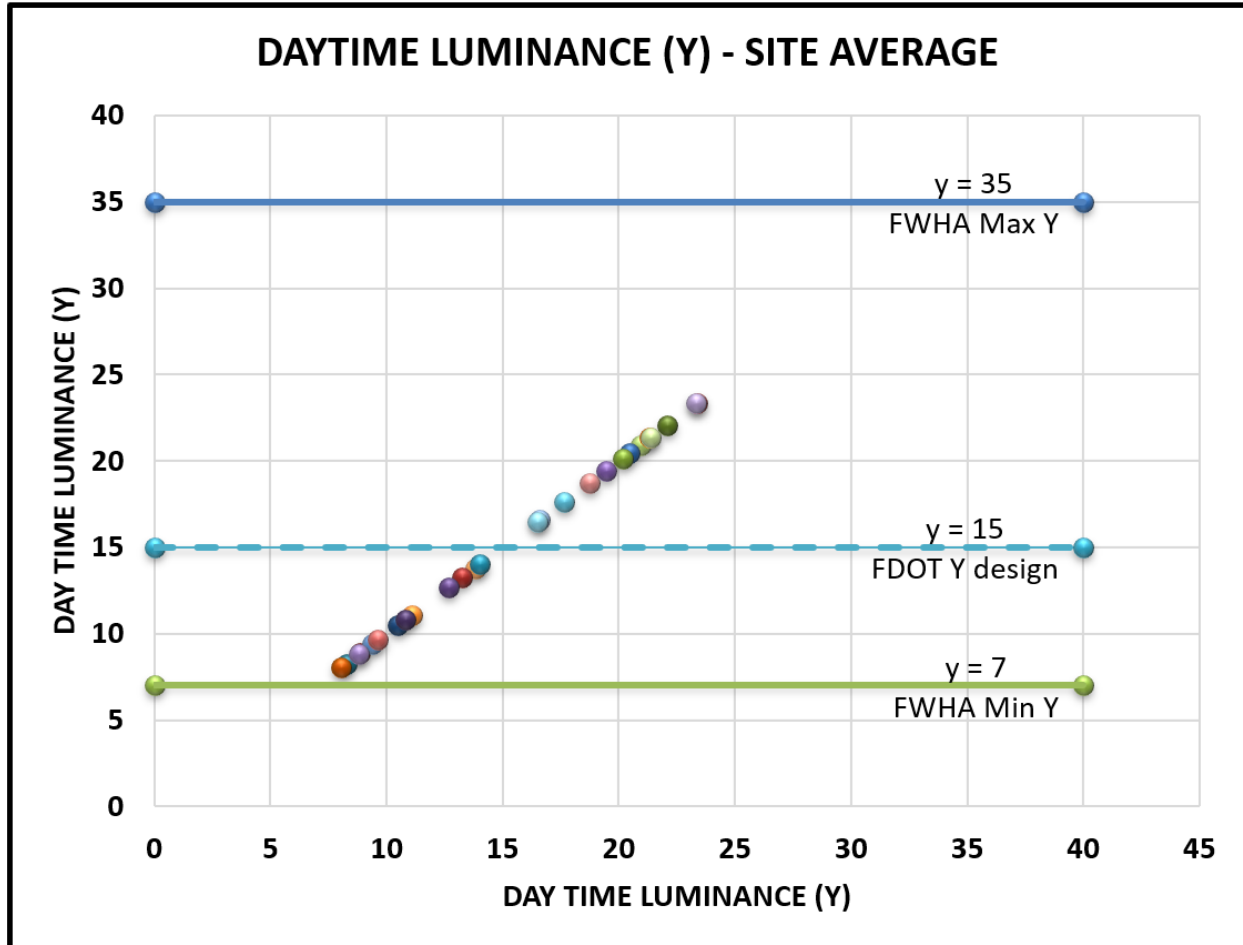
Figure 3-6. Daytime Luminance (Y) Field Test Results.

Furthermore, the research team measured the luminance (Y) of the GCPMs. The average luminance of different sites is shown in Figure 3-6. All areas passed the Y criterion (between 7 and 35). To be precise, all sites 'Y' lies between 7 and 25, and over 50 percent of the site's Y values are above 15.

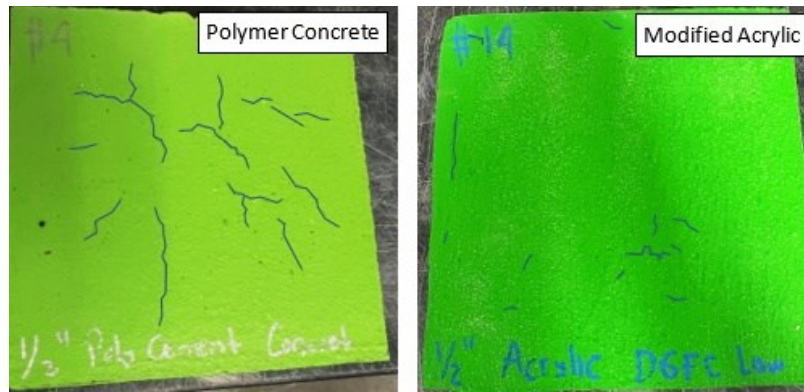
Figure 4-18 shows examples of the slabs after freeze and thaw conditioning. The full cracking results are in Table 4-13. The research team observed that one concrete slab treated with 0.5-inch MMA had thermal-induced cracking. The only other signs of distress were from the sample preparation. The polymer-cement slab on concrete had shrinkage cracking on the surface. This treatment on this sample, notably, had a higher water content because of mixture segregation. The thick modified-acrylic samples also had shrinkage cracks on the surface (Figure 4-19). The cracks were induced by curing the water-based treatment quickly with a heat gun.

Figure 4-19. Shrinkage Cracking after Surface Preparation (Cracks Enhanced).

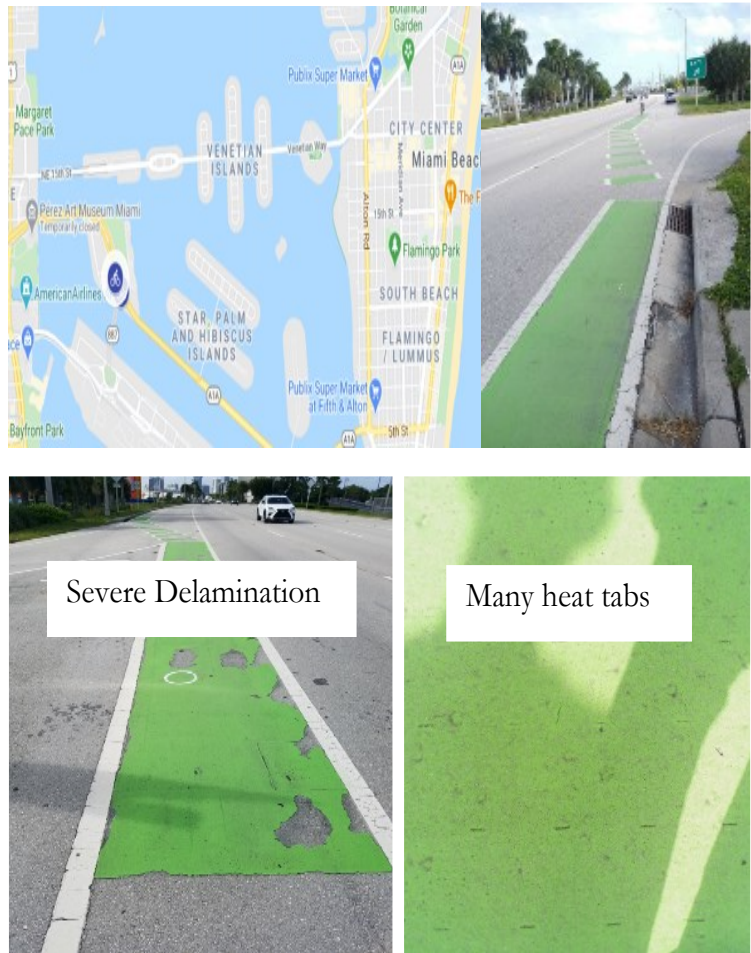
Figure A-7. Site 28 and 29-Location and Distresses.

The site was constructed in 2015 on a DGFC substrate. The substrate was built during the same period. The bike lane is in District 6, Dade County.
- Observation
 - Overall poor condition.
 - Severe delamination was observed on both sites 28 and 29.
 - Many heat tabs issues, probably due to poor construction.

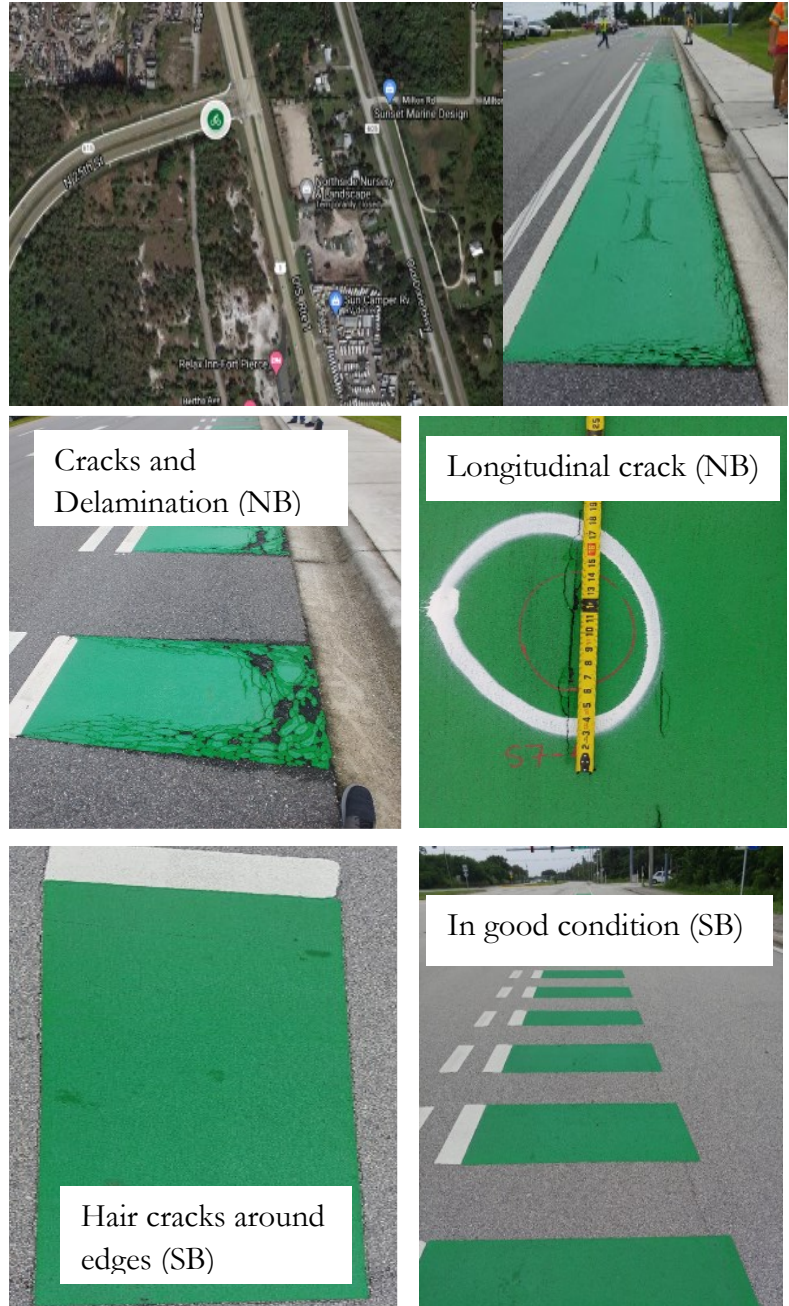
Site 7

- Construction and Materials
 - The epoxy-acrylic treated lane and its substrate (DGFC) were three years old during the survey. Both were built in October 2017. The bike lane is on SR 615 from St. Lucie Blvd to SR-5, in district 4, St. Lucie County.
- Observation
 - The northbound (NB) bike lane, located adjacent to the gutters, was in poor condition.
 - The southbound (SB) lane, constructed off-gutters, is in relatively good condition.
 - Significant cracking on shoulder lanes (Figure A-13).
 - Epoxy-acrylic peeling off with HMA.
 - Skips edges badly cracked.
 - Longitudinal cracks were observed at the center turning box lane.
 - Since the damages are mainly on the gutter's proximity, less compacted substrates and perhaps water infiltration could be the primary sources of the problems.

Figure A-13. Site 7-Location and Distresses.

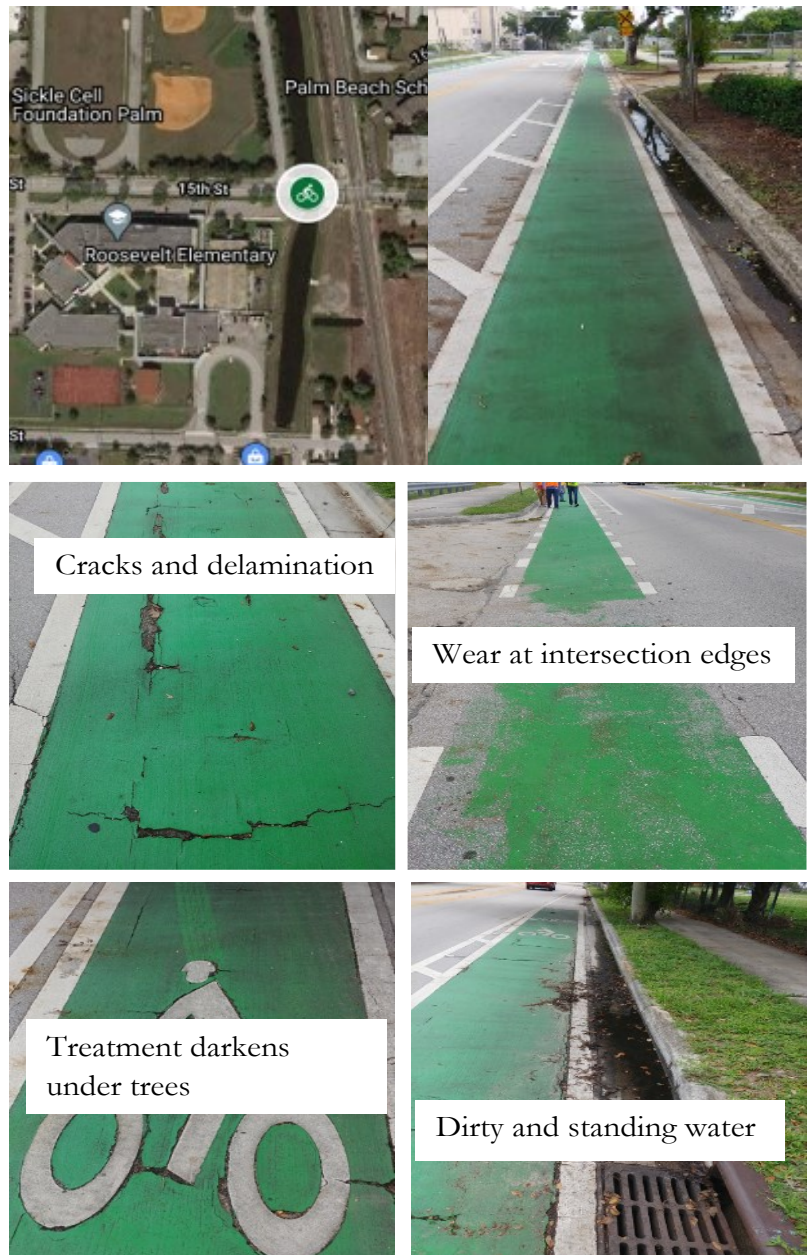
Site 17

- Construction and Materials
 - This epoxy-acrylic treated lane on a DGFC substrate was two years old during the survey. The Epoxy-acrylic treated surface was built in November 2018. Meanwhile, the substrate was estimated to be slightly older. The lane is on 15th St from Australian Ave to Dixie Hwy, in District 4, Palm Beach.
- Observation
 - West of the railroad—poor condition. East of the railroad—fair condition (Figure A-15).
 - The epoxy-acrylic treatment is badly cracked and delaminated with chunks of HMA. The distresses are more pronounced in the westbound direction.
 - The epoxy-acrylic treatment has badly worn out at the intersection .
 - Areas, under trees and along the gutters, are darkened. Some areas seemed to have been underwater.

Figure A-15. Site 17-Location and Distresses.

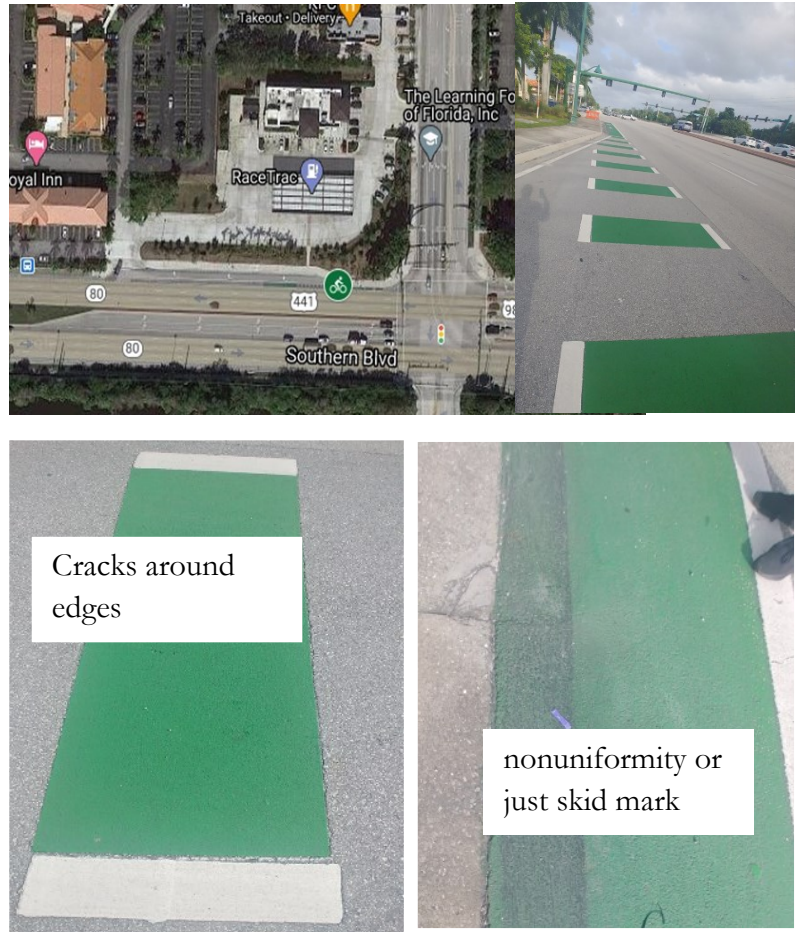
Site 34

- Construction and Materials
 - The substrate (DGFC) and the epoxy-acrylic treatment were relatively new during the survey period. The green bike lane is on SR80 at Royal Palm Beach Blvd, in District 4, Palm Beach.
- Observation
 - Overall in good condition.
 - Some cracks around the edges of the epoxy-acrylic treatment (Figure A-17).
 - Slight application nonuniformity. Maybe skid mark.

Figure A-17. Site 34-Location and Distresses.

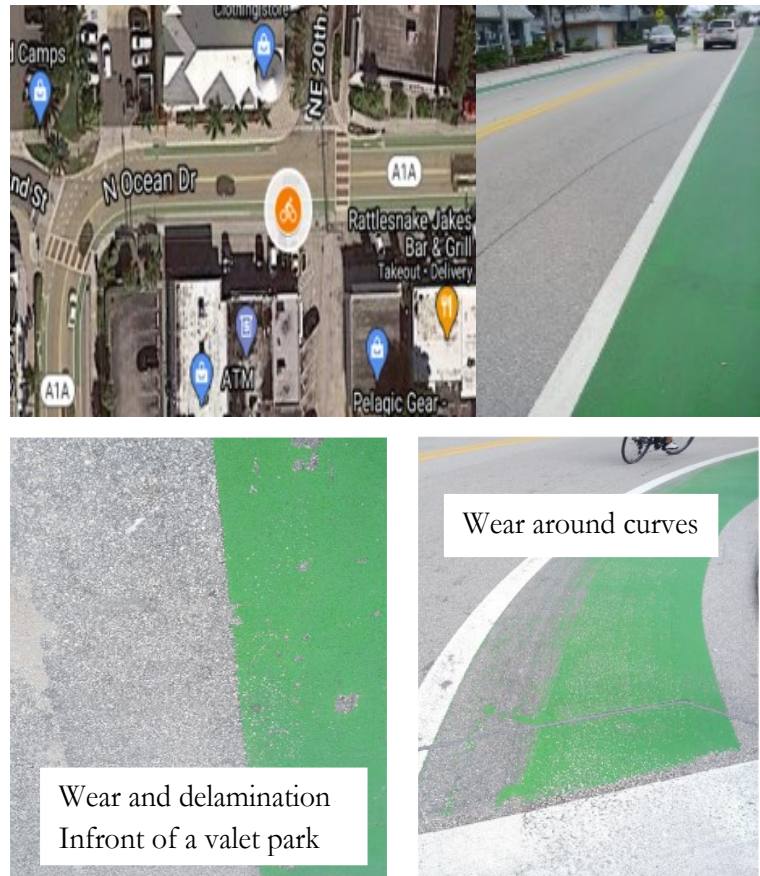
Site 21

- Construction and Materials
 - This is an Epoxy-acrylic treated bike lane laid on DGFC substrate in November 2016. The substrate is about two years older than the Epoxy-acrylic treatment. When the survey was conducted, the epoxy-acrylic treatment was about four years old. The green bike lane is on N. Ocean Dr. from NE 2nd St to Ne 2nd St. (Road Bends), in District 4, Broward County.
- Observation (Figure A-20)
 - In general, the lane is in relatively good condition.
 - The team observed wear around the corner due to traffic encroaching.
 - Wear in front of a valet parking.
 - A few localized cracks and delamination.

Figure A 20. Site 21-Location and Distresses

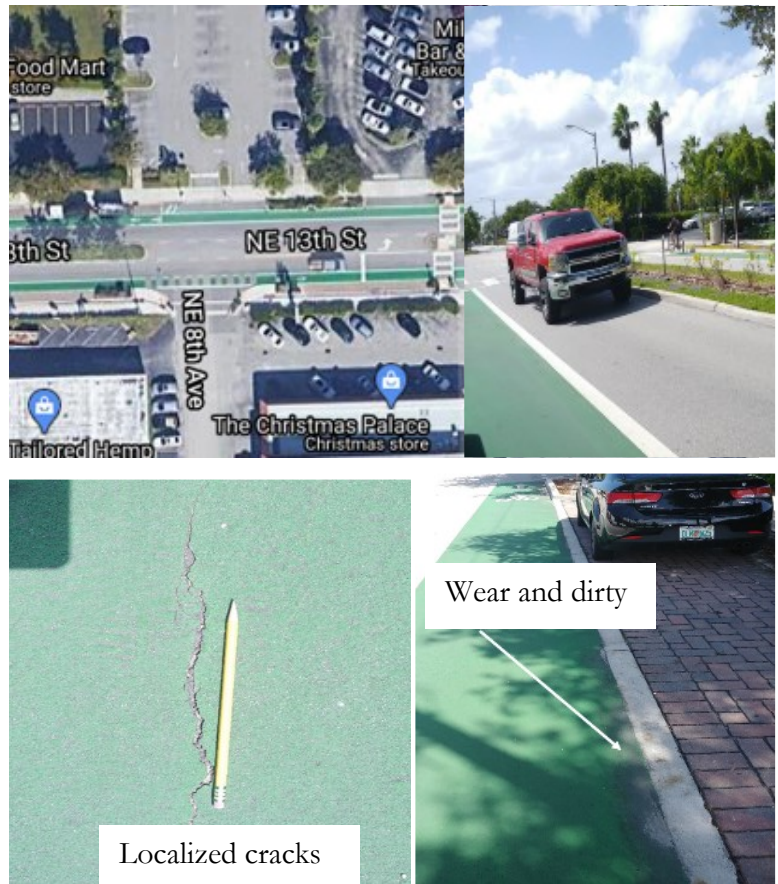
Site 56

- Construction and Materials
 - This is 205 years old epoxy-acrylic treated green bike constructed in April 2018 on a DGFC substrate. The lane was built at the same time as sites 23 and 55. However, it is in excellent condition compared to the other two lanes. The green bike lane is on NE 13th Street from NE 4th Ave to NE 9th Ave, in District 4, Broward County.
- Observation (Figure A-22)
 - The survey observed a few localized cracks.
 - Wear and dirt under tree shades and roadside parking.
 - The lanes are in good condition.

Figure A-22. Site 56-Location and Distresses.

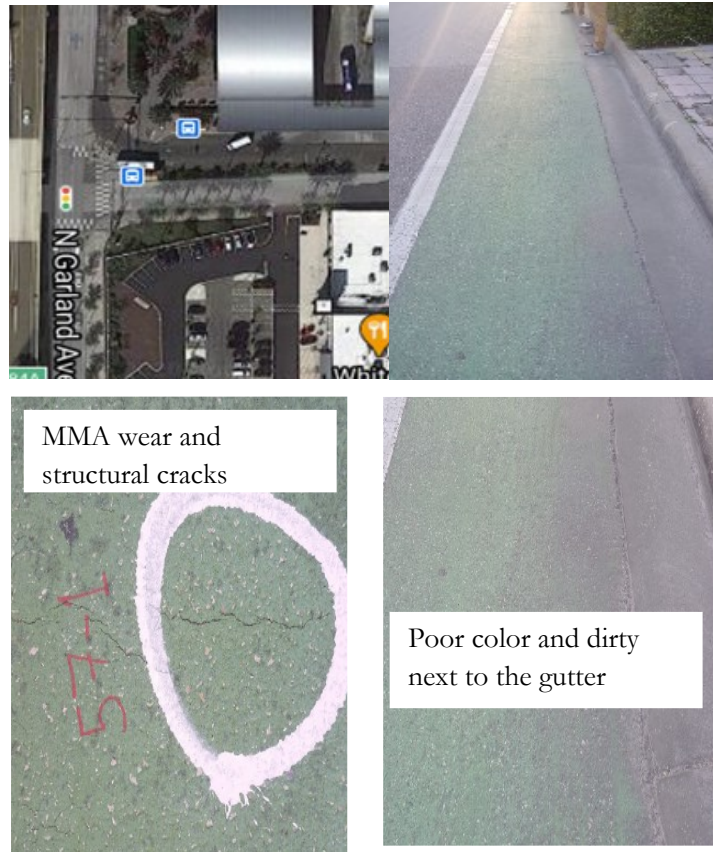
Site 57

- Construction and Materials
 - As is for sites 27 and 58, this bike lane is also treated with MMA product. The bike lane is on E Livingston Street from I-4 to Magnolia Ave, in District 5, Orange County. The age of the MMA and a DGFC substrate are currently not known to the researchers.
- Observation (Figure A-27)
 - Wearing on the MMA.
 - Structural cracks.
 - Fading color and dirty next to gutters.
 - The rate of deterioration (wearing and cracks) is less than the MMA observed on sites 58 and 27. It looked like the MMA on-site 57 was reapplied.
 - In general, the site is in poor condition.

Figure A-27. Site 57-Location and Distresses.

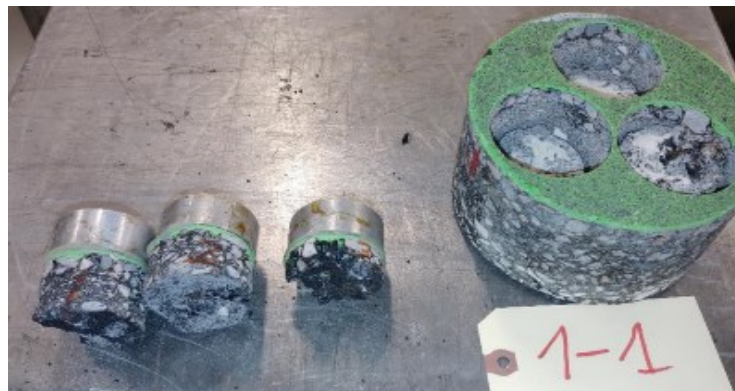
Figure B-2. Pull-Off Test for Specimen 1-1.

The research team determined that the failure mechanism for this thermoplastic-treated specimen was 100% substrate failure (Figure B-2). However, the achieved Pull off strength (64.8 psi) was relatively very low (<<150 psi). At this failure mechanism and low strength, deciding on the thermoplastic-to-substrate bond is challenging. Therefore, an additional surface pull-off test on a shallow-cut specimen is needed.

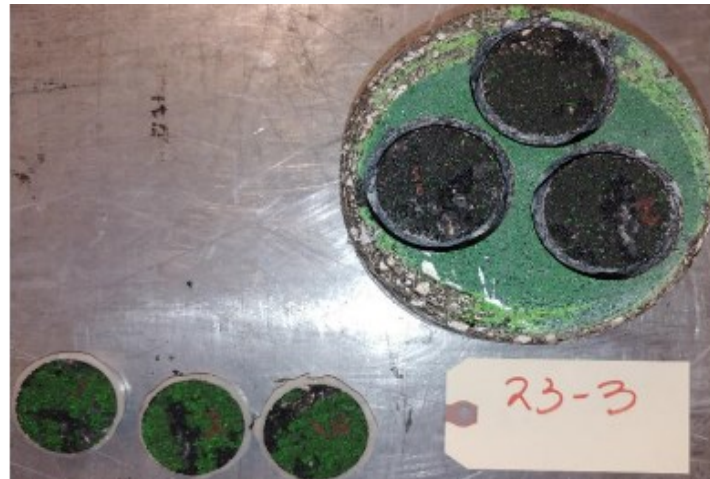
Figure B-3. Pull-Off Test for Specimen 23-3.

The research team determined that the failure mechanism for this specimen was a clean delamination/debond of epoxy from the Substrate (Figure B-3). The average pull-off strength was 155.7 psi (>150). The Epoxy treatment meets the minimum bond strength.

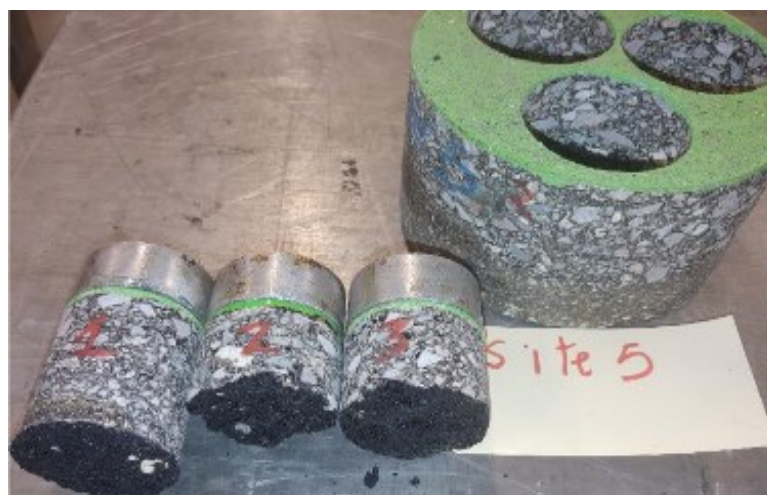
Figure B-4. Pull-Off Test for Specimen 5-1.

The research team determined that the failure mechanism for this specimen was 100% substrate failure (Figure B-4). The average pull-off strength (253.1 psi) was relatively high (<<150 psi). The thermoplastic bond did not fail, implying that the thermoplastic-substrate bond is strong (>253.1 psi).

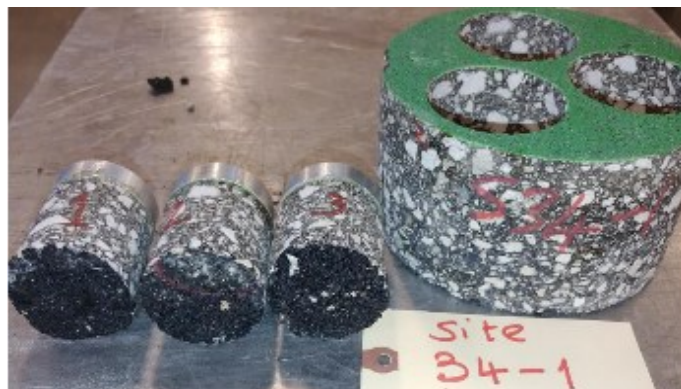
Figure B-6. Pull-Off Test for Specimen 34-1.

The research team determined that the failure mechanism for this specimen was 100% substrate failure (HMA to HMA bond). Maybe due to the ingress of water, the bond was already partially de-bonded. The average strength (113 psi) was relatively low (<150 psi) (Figure B-6). The failure mechanism and low strength imply that an additional surface pull-off test is needed (with a shallow cut). At the current state, the thermoplastic to substrate bond strength is inconclusive.

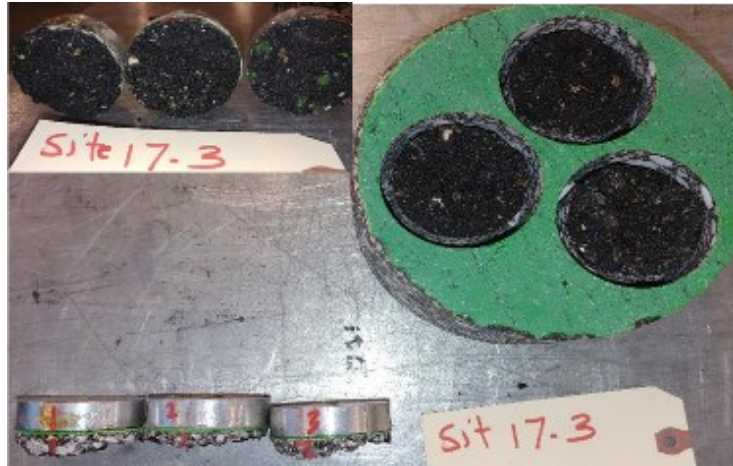
Figure B-7. Pull-Off Test for Specimen 17-3.

This is an Epoxy-treated-DGFC specimen. The research team determined that the failure mechanism for this specimen was 100% near-surface substrate failure or partial delamination (Figure B-7). The average pull-off strength was 155.6 psi. Since the average strength is above 150 psi, the Epoxy-substrate bond strength is good.

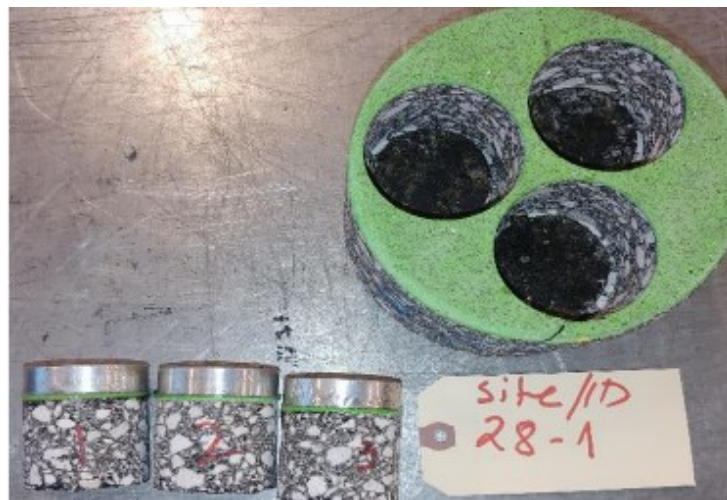
Figure B-8. Pull-Off Test for Specimen 28-1.

The research team determined that the failure mechanism for this specimen was 100% substrate failure (HMA to HMA bond) (Figure B-8). The average strength at failure (87.4 psi) was relatively very low (<150 psi). Because of the failure mechanism and low strength, an additional surface pull-off test is needed (on a sample with a shallow groove). At the current state, the thermoplastic-substrate bond strength is inconclusive.

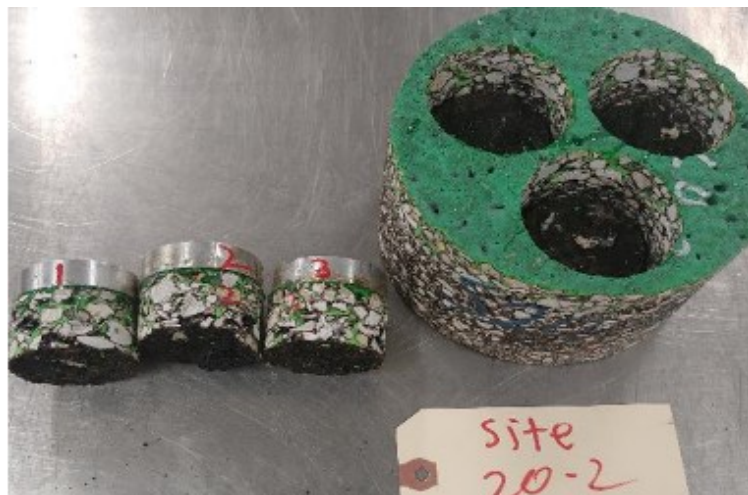
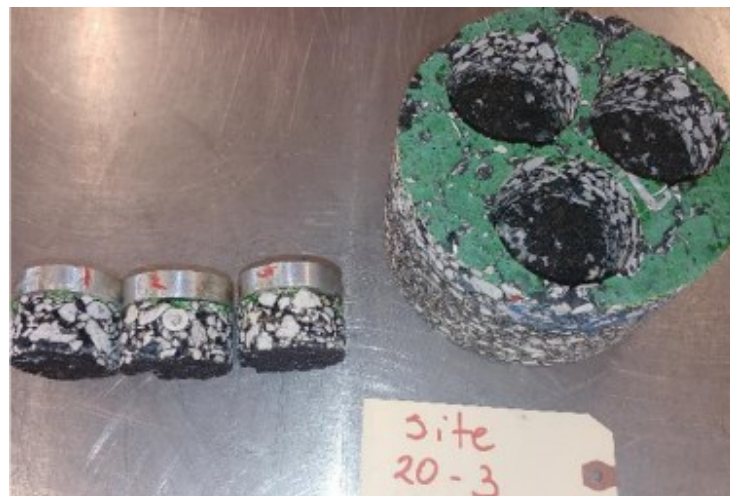
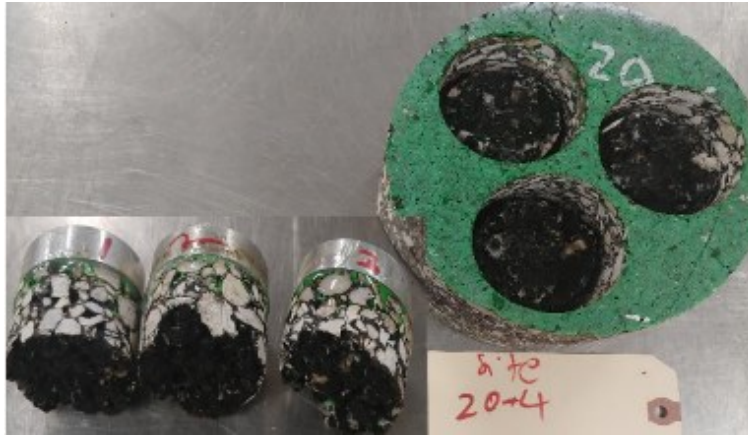
Figure B-9, Figure B-10 and Figure B-11 show cores number 2, 3, and 4, respectively, collected from site 20. The cores are Epoxy-treated-OGFC. Cores 2 and 4 show that the epoxy penetrated the substrate voids. Meanwhile, there was no penetration in Core 3 (maybe due to different application methods, e.g., squeegee vs. spray). Moreover, core-3 was severely cracked, and almost no effort was needed to break up the sample under the pull-off test (weaker substrate?). In general, the cores from section 20 offered very low resistance force ($\ll 150$ psi) to pull off test force (Table B1). The research determined that the failure mechanism for this specimen was 100% OGFC failure. Additional tests on a shallowly grooved sample may be needed to assess Epoxy-substrate bond strength separately.

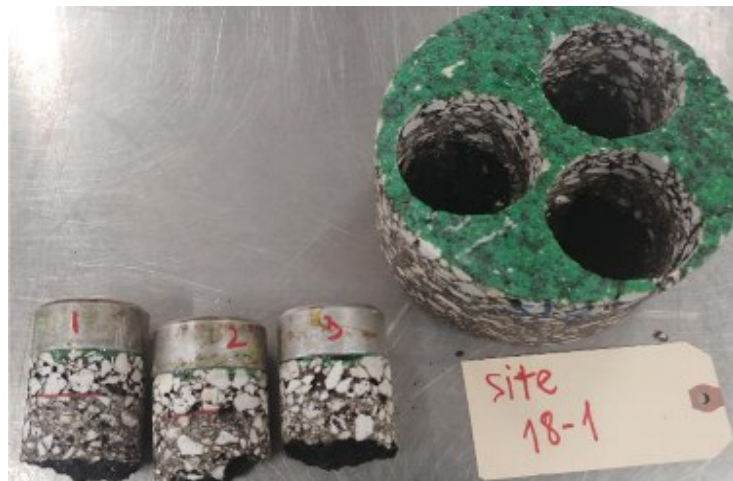
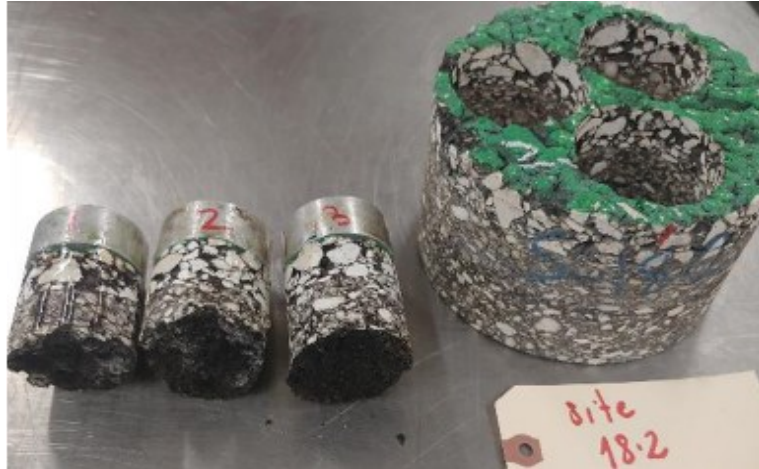
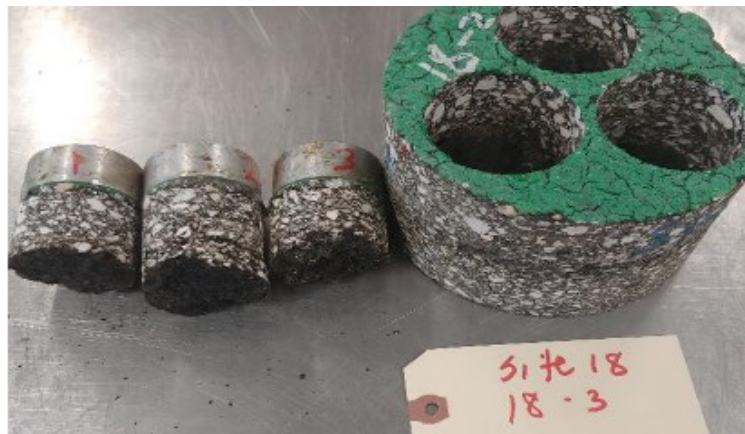
Figure B-12, Figure B-13 and Figure B-14 show cores number 1, 2, and 3, respectively, collected from site 18. Cores 1 and 2 are Epoxy-treated-OGFC, whereas Coore-3 is Epoxy-treated-DGFC. During the pull-off test, the research team observed that the failures for all three cores were 100% substrate and the strength at failure was below 150 psi. Therefore, the research team determined that the Epoxy-substrate bond strength is inconclusive based on the failure mechanism and low strength. Future tests will include shallowly grooved specimens to specify GCPM bond strength separately.

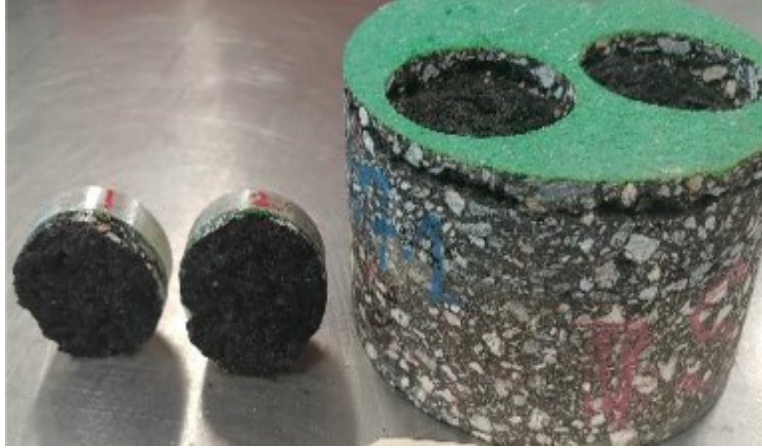
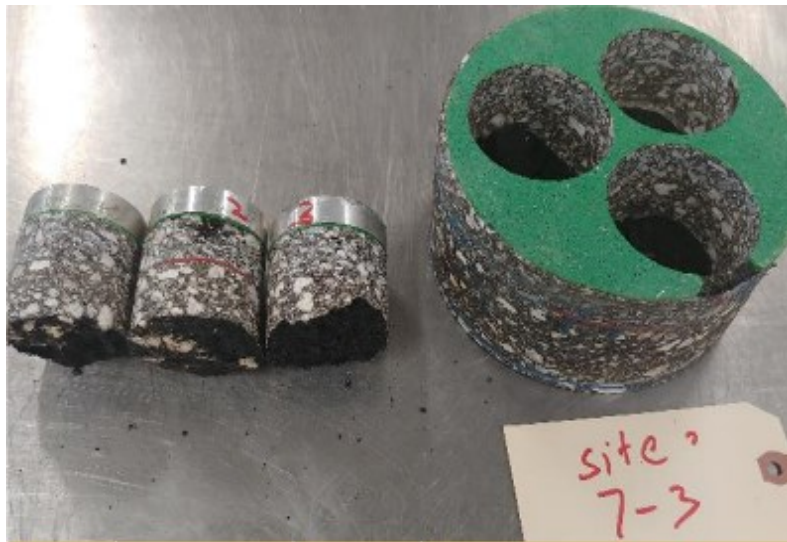
Figure B-15 and Figure B-16 show cores 1 and 3 collected from site 7. All cores are Epoxy-treated-DGFC. Core-1 was extracted from the surface of a cracked shoulder (Site 7NB). At the same time, core-3 was pulled from an excellent location next to the turning lane. Laboratory investigation shows that core-1 has an existing horizontal fissure under the surface. Therefore, no effort was needed to pull off the layer. The failure was 100% substrate failure. Similarly, core-3, which was extracted from the bike lane next to a turning lane (good location), yielded high pull-off strength (204.6 psi > 150psi).

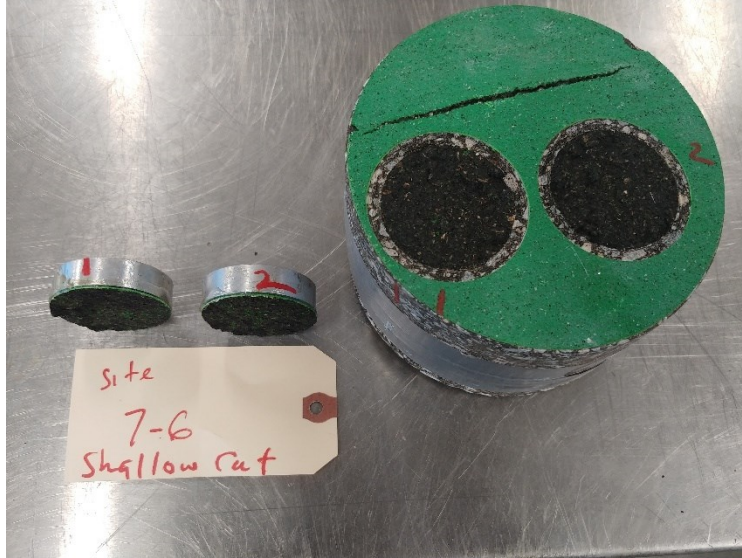
Figure B-18. Pull-Off Test for Specimen 7-6.

The specimen is an Epoxy-treated-DGFC core. Based on the pull-off test, the average strength of the epoxy DGFC bond was 280.85psi. It passed the minimum cut-off value (150 psi).

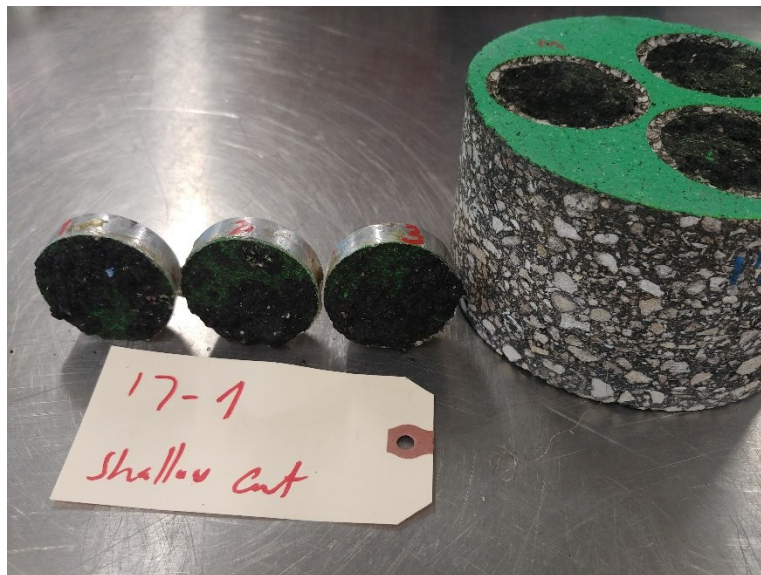
Figure B-19. Pull-Off Test for Specimen 17-1.

Site 17 – Core 1: Epoxy Treatment Age: 2 years; DGFC Substrate Age: Slightly older

The forced delamination was also demonstrated on Site 17 cores. Figure B-19 shows core-1 collected from site 17. The specimen is an Epoxy-treated-DGFC core. Based on the pull-off test, the average strength of the epoxy to DGFC bond was 197.4 psi. It passed the minimum cut-off value (150 psi).
