Test Report No. 440863-03-1

**MASH TEST 4-12 EVALUATION OF A LUMINAIRE POLE BEHIND
SINGLE SLOPE TRAFFIC RAIL**

Texas Department of Transportation

TEXAS A&M TRANSPORTATION INSTITUTE PROVING GROUND

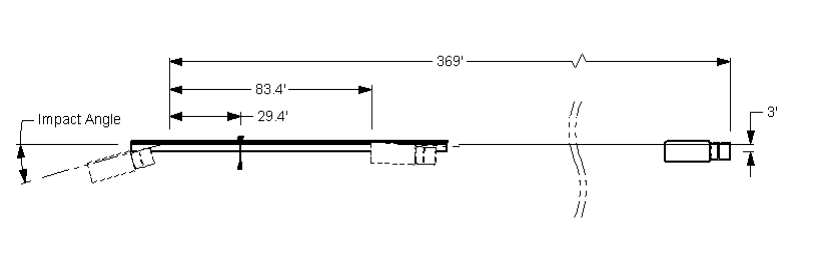
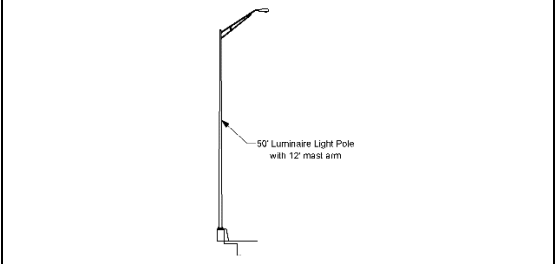
Figure 5.11. Summary of Results for MASH Test 4-12 on Luminaire Pole behind Single Slope Traffic Rail.

TEST ARTICLE DEFLECTIONS							
	Barrier Dynamic (inches)		0					
	Barrier Permanent (inches)		0					
	Working Width / Height (inches)		57.86 / 123.18					
VEHICLE DAMAGE								
VDS		11LFQ7						
CDC		01FLWH3						
Max. Ext. Deformation (inches)		14						
Max Occupant Compartment Deformation		7 on left front side of floor pan, in location of seam separation						
OCCUPANT RISK VALUES								
Long. OIV (ft/s)	6.4	Long. Ridedown (g)	4.5	Max 50-ms Long. (g)	-1.8	Max Roll (deg)	33.0	
Lat. OIV (ft/s)	10.5	Lat. Ridedown (g)	5.5	Max 50-ms Lat. (g)	4.2	Max Pitch (deg)	7.2	
THIV (m/s)	3.9	ASI	0.5	Max 50-ms Vert. (g)	-3.2	Max Yaw (deg)	17.9
