FISH PASSAGE ENGINEERING PROJECT

Site Analysis Final Report

SITE ANALYSIS FINAL REPORT

Humboldt State University
Michael Love & Associates, Inc.

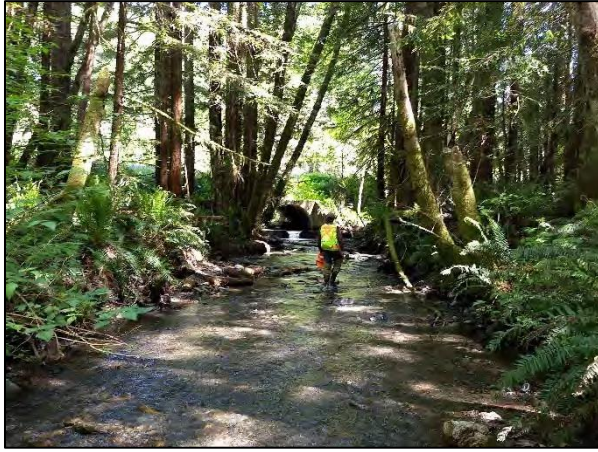
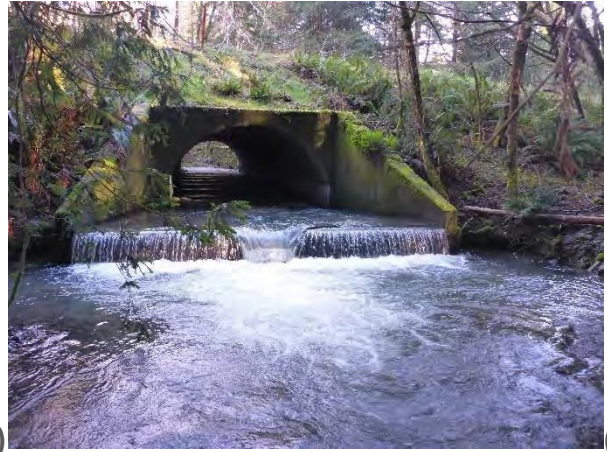
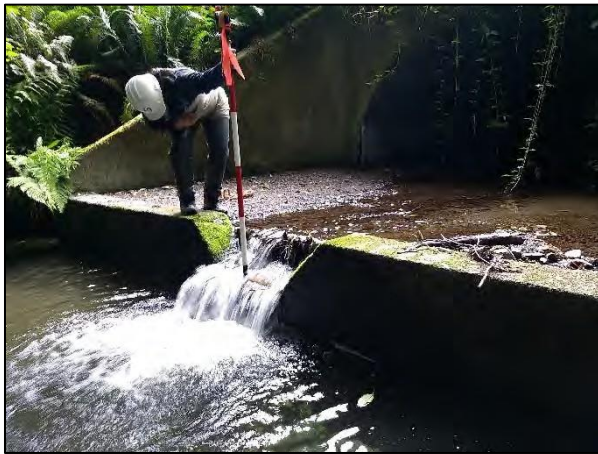
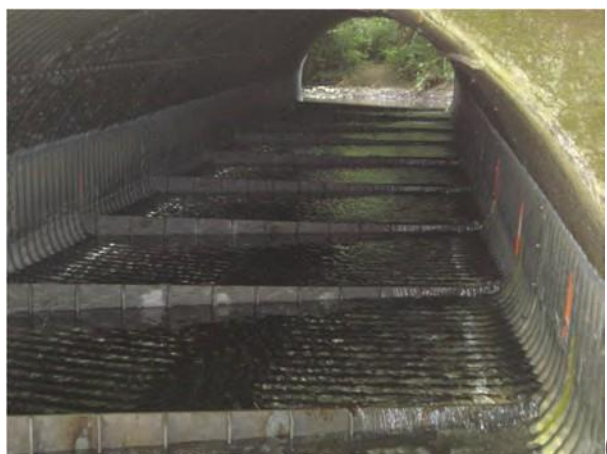
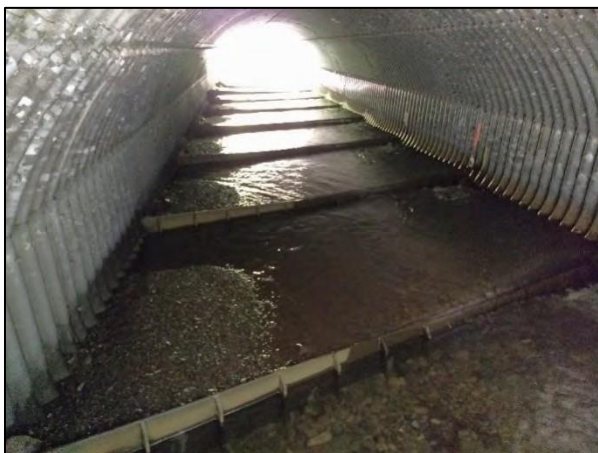
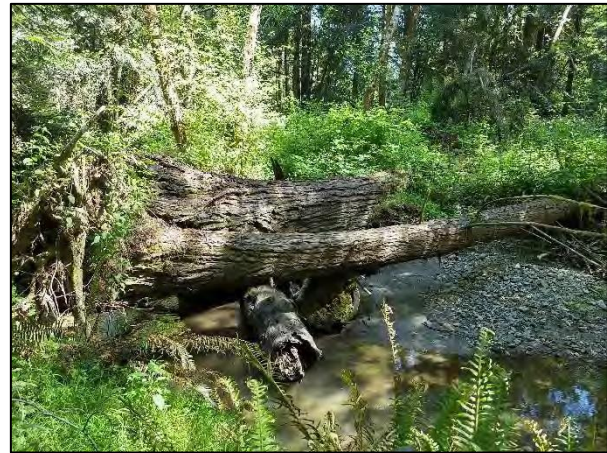
HSU visited the site during low-flow conditions on May 9, 2019 and August 6, 2020. Visually, the baffles appeared to provide suitable passage conditions and had retained gravel substrate throughout most of the culvert (Figure 1-1e). During the second visit a small piece of wood was lodged across the weir notch at the outlet and appeared to make the weir impassable by juvenile salmonids at this low flow (Figure 1-1c). Recent debris racking was noted on top of the inlet wingwalls, indicating that recent high flows resulted in a headwater level that was only a couple feet below the culvert soffit.

FIGURE 1-1. PEACOCK CREEK AT (A) CHANNEL DOWNSTREAM OF SR197, THE CULVERT OUTLET APRON (B) AT HIGH FLOWS AND (C) WITH WOOD PLUGGING NOTCH, (D) REPLACEMENT BAFFLES IN CULVERT IMMEDIATELY AFTER CONSTRUCTION AND AFTER SEDIMENT ACCUMULATION, AND (F) THE WOOD JAM ACROSS THE CHANNEL IMMEDIATELY UPSTREAM OF THE CULVERT INLET.

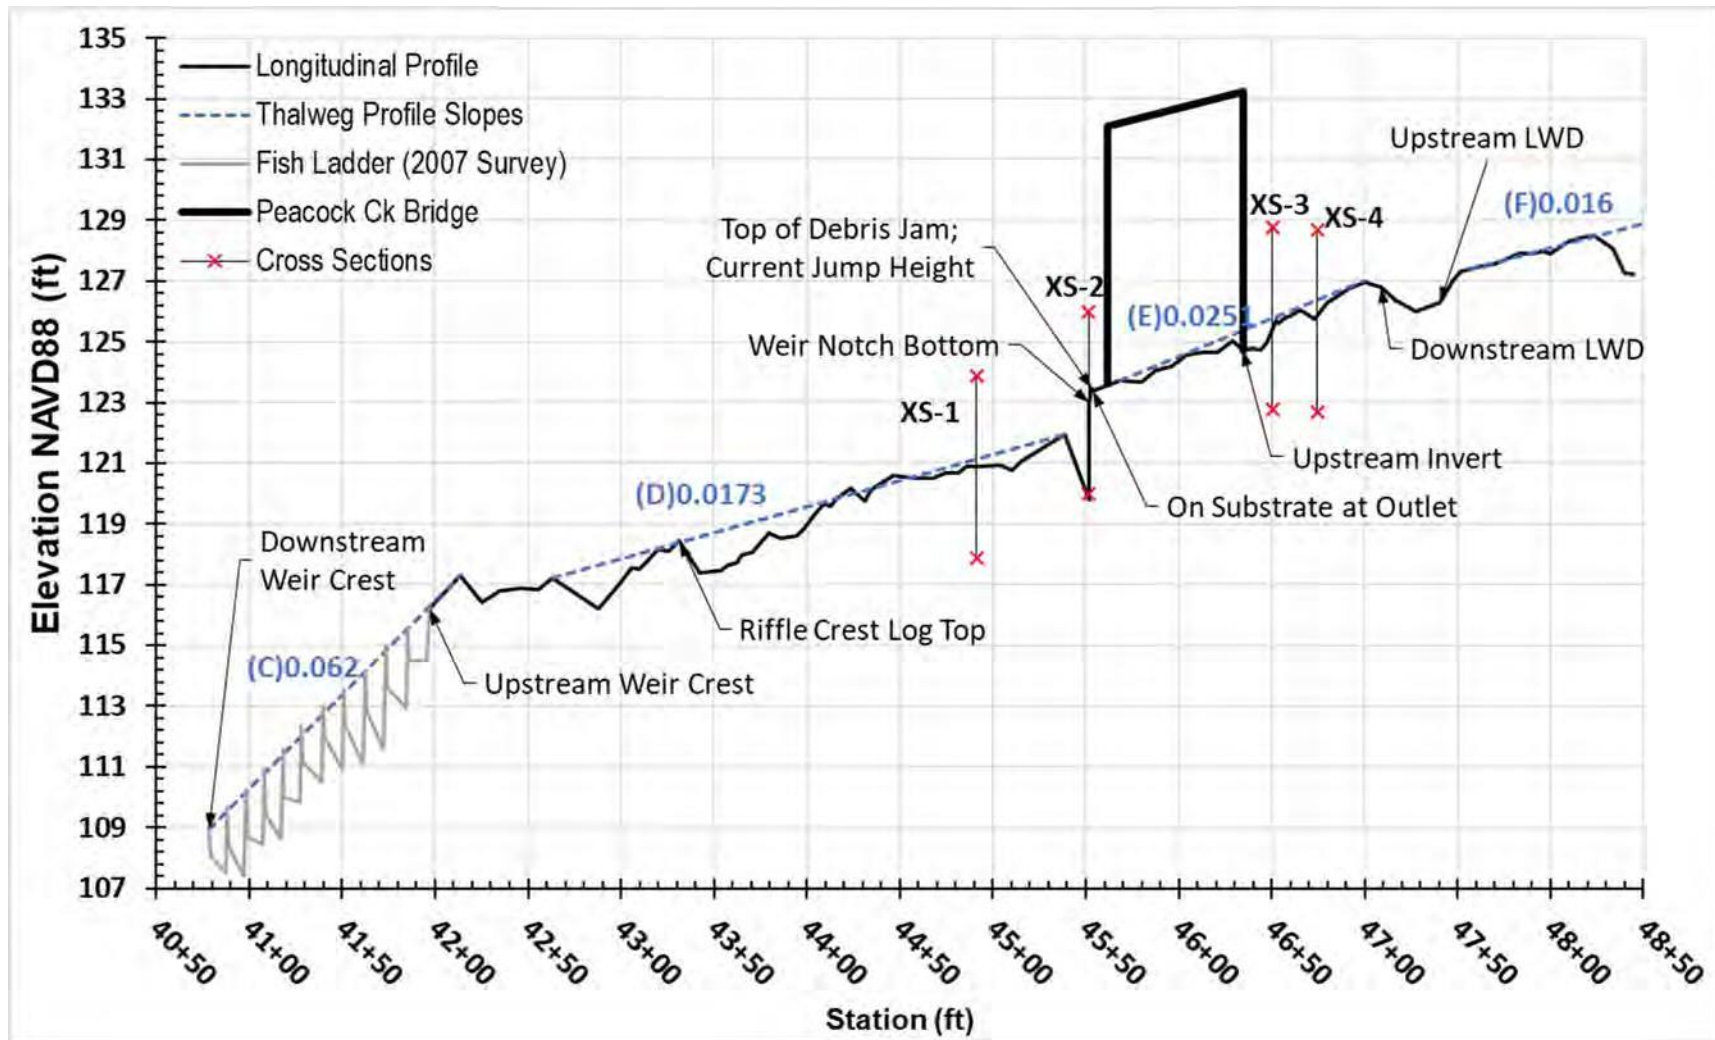
The drop over the outlet weir appears to have increased by 0.5 feet since 2013. Without continuous monitoring, the cause of this change is difficult to identify. The stream section between the outlet weir and the fishway at the Tan Oak Road crossing approximately 400 feet downstream appears stable and elevations are controlled by these two structures. The observed adjustment is most likely due to local wood or bedload repositioning. The increased

drop may influence overall fish passage performance so periodic monitoring of fish passage flow conditions is recommended.

FIGURE 1-4. 2019 SURVEYED THALWEG PROFILE ALONG CHANNEL CENTERLINE ALIGNMENT, WITH DEFINED SLOPE SEGMENTS. LOCATION AND IDENTIFICATION OF CHANNEL CROSS SECTIONS DENOTED.

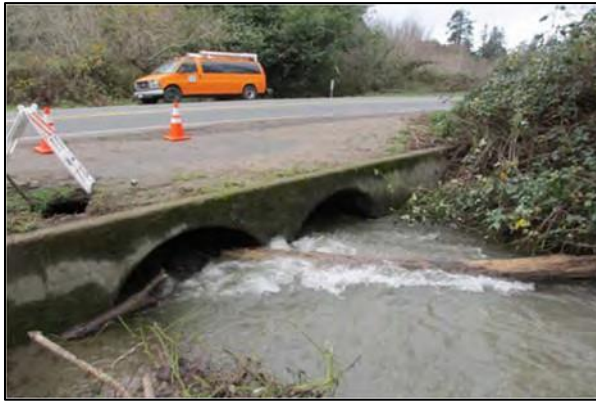
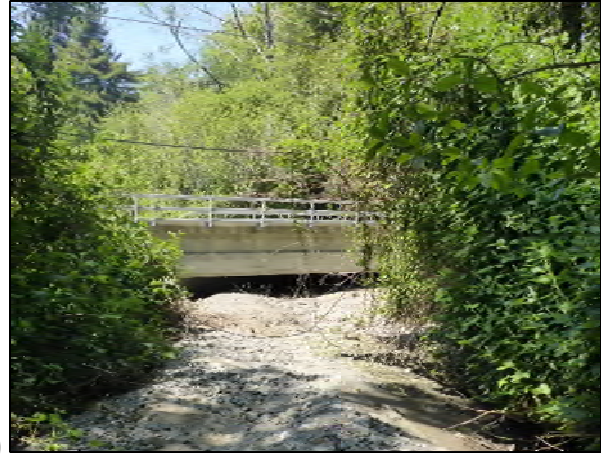
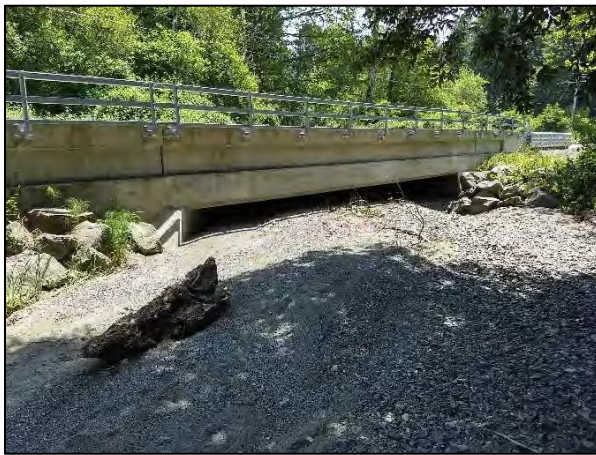
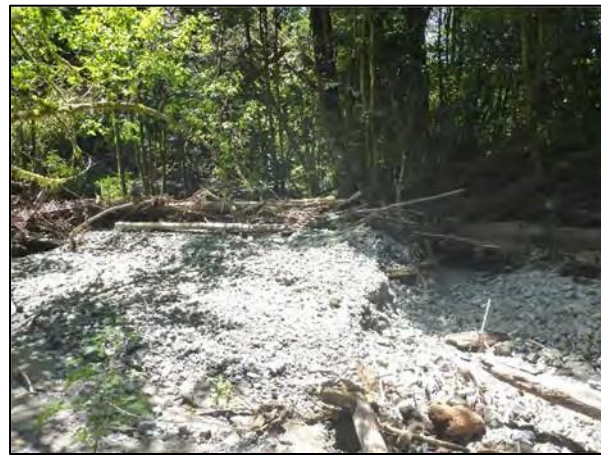
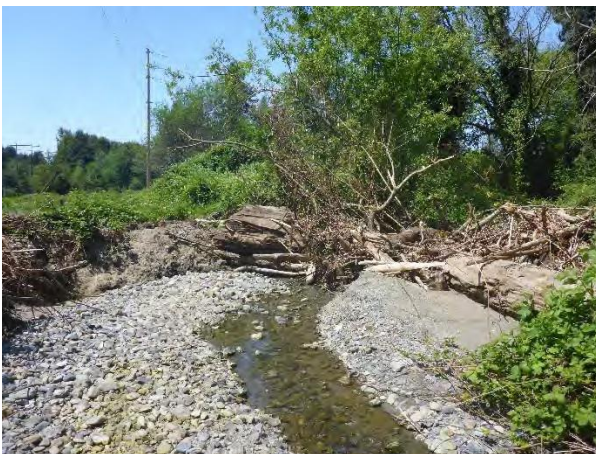
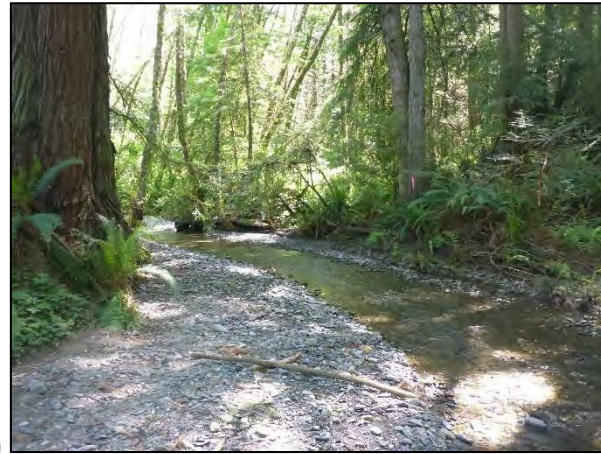
The crossing site appeared to have experienced substantial aggradation since construction, leaving a minimal opening height under the bridge for conveyance of streamflows (Figure 2-1). Additionally, the thickness of the bridge deck and the low-profile of the roadway appeared to place the soffit of the bridge below the channel's bankfull height.

Downstream of the crossing the stream flows through a dense riparian forest before entering the Smith River. Approximately 350 feet downstream of the crossing a large and complex debris jam was identified that formed an approximately 4-foot drop in the channel profile (Figure 2-1d). The jam appeared to be associated in part with backwatering from the nearby Smith River. Downstream of the jam the channel split into multiple branches as it flowed towards the river located approximately 600 feet downstream. Upstream of the jam the channel appeared highly aggraded, with the base of riparian trees buried in recently deposited gravels.

FIGURE 2-1. SULTAN CREEK (A) ORIGINAL CROSSING INLET AT HIGH FLOW AND CURRENT (B) UPSTREAM AND (C) DOWNSTREAM BRIDGE FACE, (D) DOWNSTREAM AND (E) UPSTREAM CHANNEL AGGRADATION AND DEBRIS JAMS, AND (F) THE SELECTED REFERENCE REACH, WHICH IS ALSO AGGRADING.

A large flow event had occurred prior to the first site visit in 2019. Walking upstream of the channel revealed a large debris jam near station 12+50 (Figure 2-1e) which had pushed flow overbank onto an adjacent roadway owned by Green Diamond Resource Company. Debris lines showed that the floodwaters were conveyed down this road and onto State Route 197. Other locations of overbank flows leaving the channel were observed. The channel upstream of this debris jam appeared aggraded.

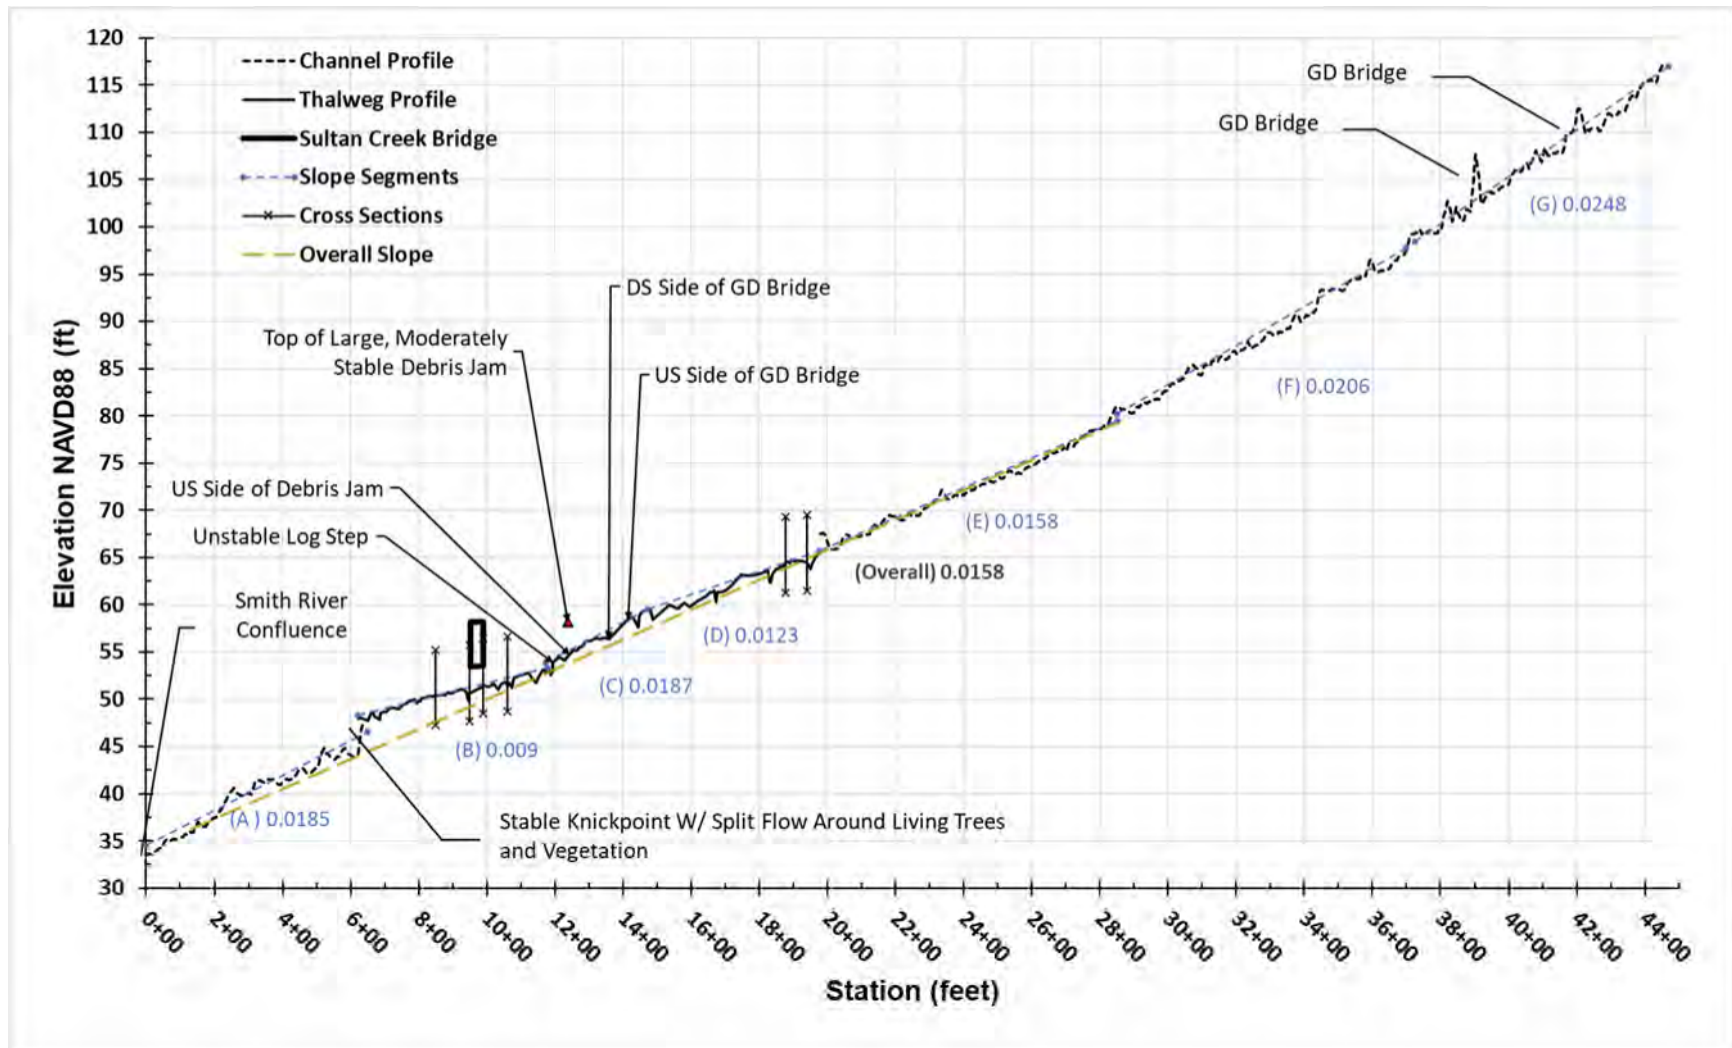
A combined survey and LiDAR DEM generated profile is provided in Figure 2-4 along with defined channel slope segments. The observed debris jam downstream of the crossing near Station 6+50 and resulting nearly 5-foot step in the profile is clearly visible in the LiDAR DEM. The top of the jam is about 15 feet above the low-flow elevation of the river, which places it within the river backwater influenced during high flows. The profile suggests aggradation extends more than 1,500 feet upstream of this jam. Ignoring the aggraded channel segments, the overall slope of the channel appears to be 1.5% extending from near the river confluence to approximately 2,800 feet upstream. However, the aggradation has reduced the channel slope through the crossing to approximately 0.9%.

FIGURE 2-4. CHANNEL PROFILE THROUGH PROJECT REACH GENERATED FROM COMBINED LiDAR DEM AND GROUND SURVEY POINTS, WITH CHANNEL SLOPE SEGMENTS DEFINED.

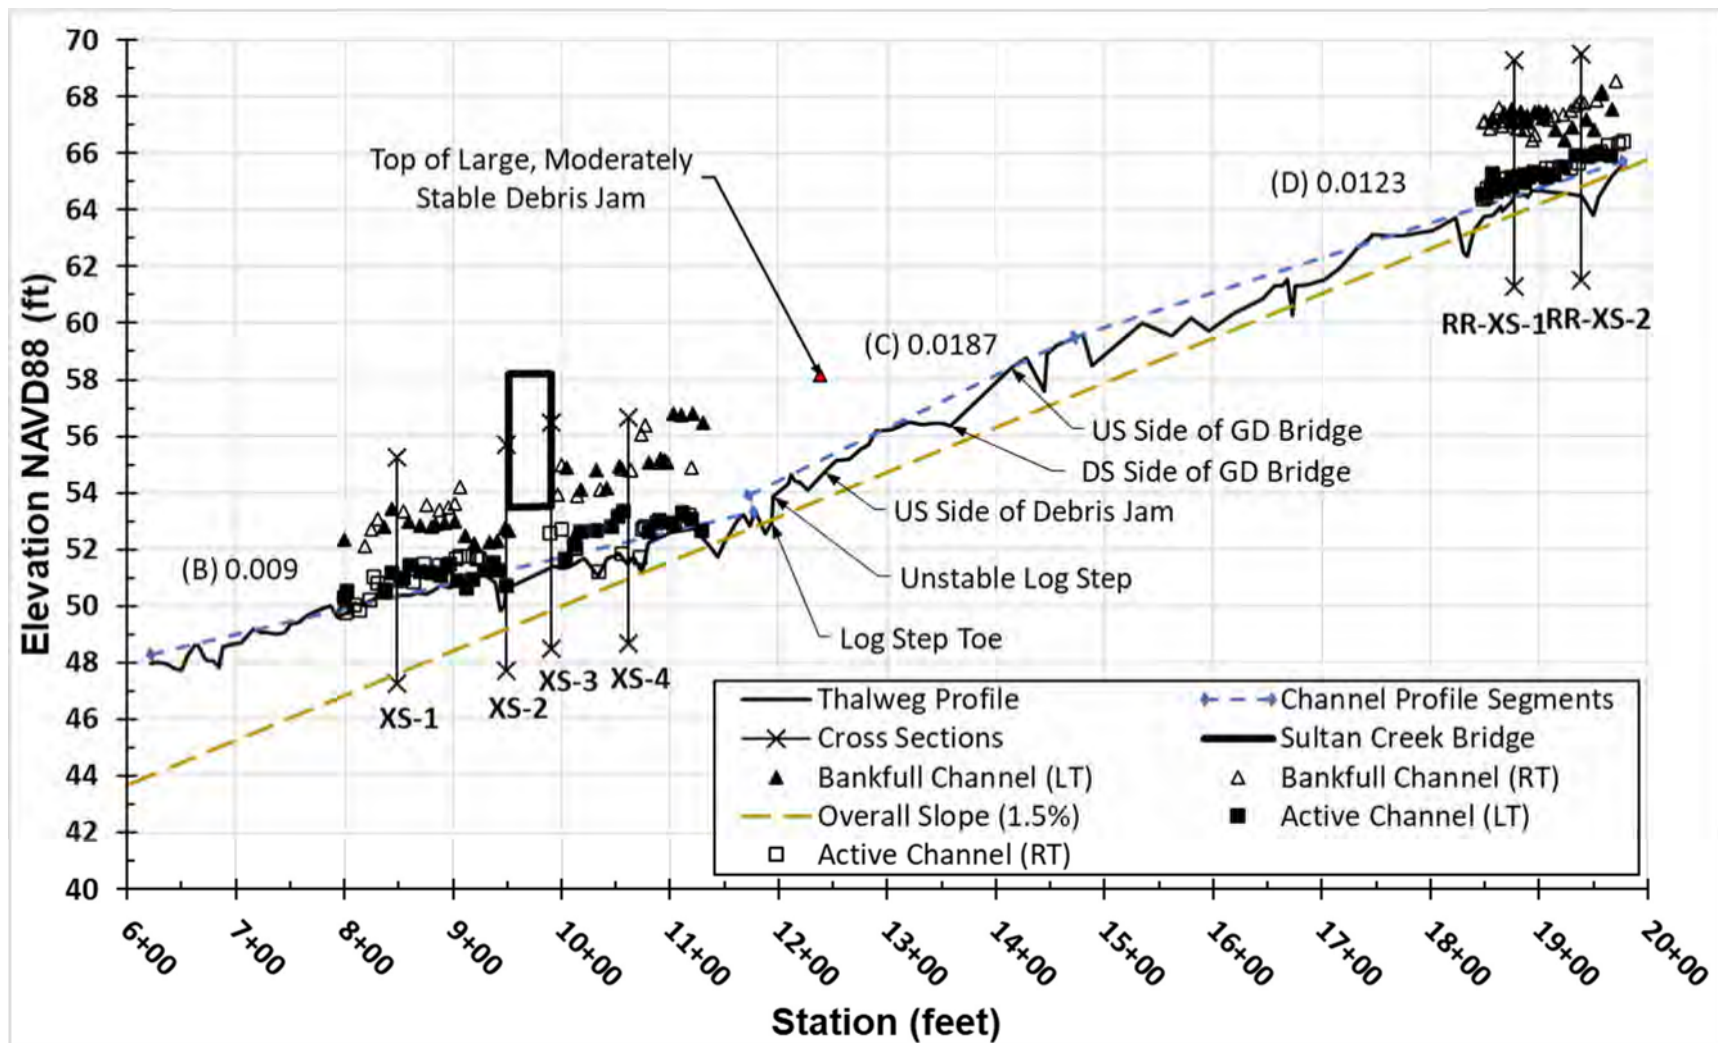
The surveyed profile (Figure 2-5) reveals that aggradation at the bridge crossing resulting from the downstream debris jam may be as much as 2 feet. Based on the project design plans, it appears the constructed channel under the bridge was built close to the elevation of the overall profile, and the downstream debris jam formed subsequent to the design and installation of the new bridge.

FIGURE 2-5. 2019 SURVEYED THALWEG PROFILE ALONG CHANNEL CENTERLINE ALIGNMENT, WITH DEFINED SLOPE SEGMENTS. LOCATION AND IDENTIFICATION OF CHANNEL CROSS SECTIONS DENOTED.

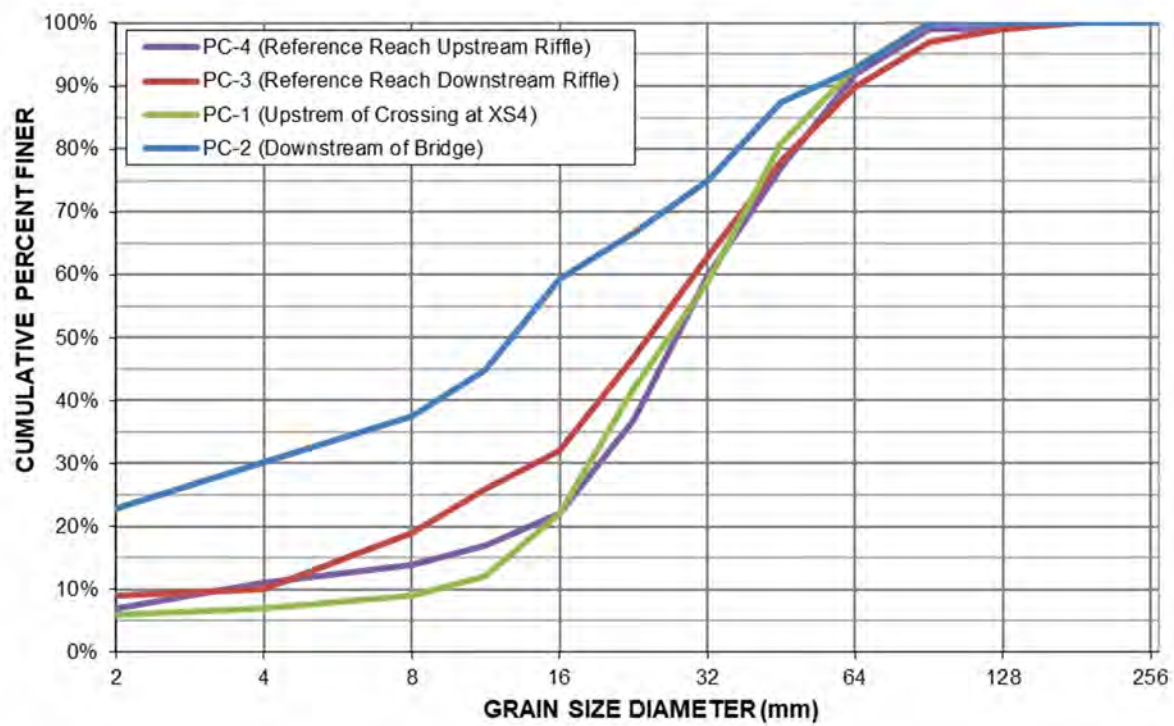
Pebble counts of the streambed material (Figure 2-7) revealed the bed material downstream of the bridge is much finer than immediately upstream and within the upstream reference reach. This may be in part due to decreasing stream power associated with the decreasing channel slope and loss of flow confinement, causing the bed material to become finer downstream of the bridge.

FIGURE 2-7. SURFACE STREAMBED GRADATION MEASURED USING PEBBLE COUNTS.

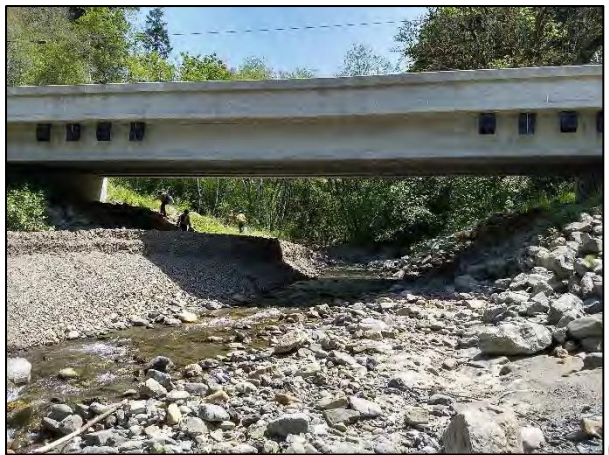
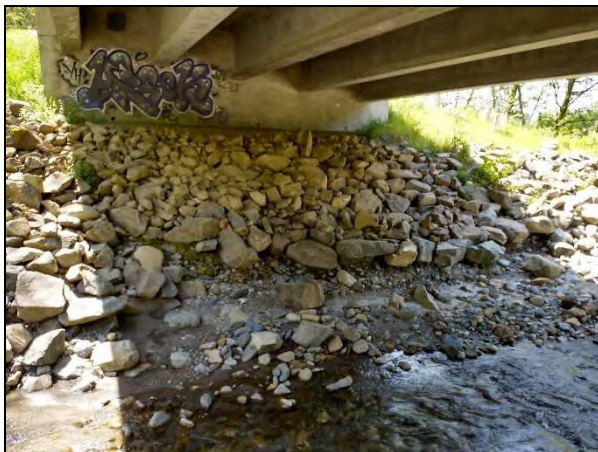
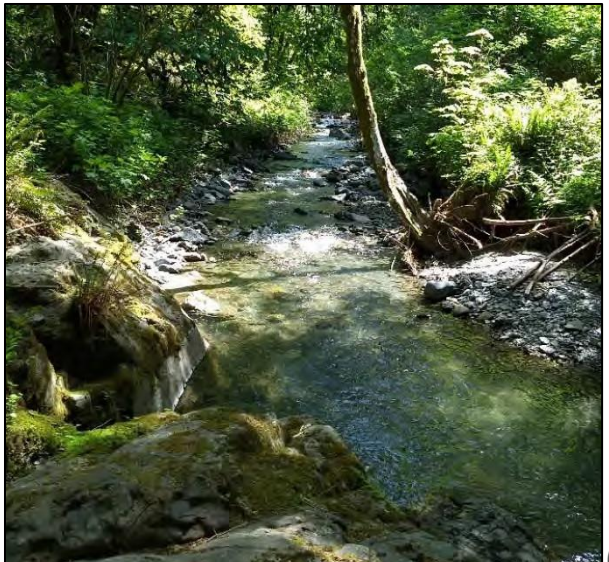
FIGURE 3-2. LITTLE MILL CREEK (A) BRIDGE LOOKING DOWNSTREAM, (B) STEEP CHANNEL SECTION FLOWING INTO SMITH RIVER DOWNSTREAM OF BRIDGE, (C) BRIDGE LOOKING DOWNSTREAM (D) LOOKING UPSTREAM AT CHANNEL AND DEPOSITIONAL BAR UNDER BRIDGE, (E) CLOSE UP OF SCOURED RSP TOE UNDER BRIDGE, AND (F) LOOKING UPSTREAM AT THE REFERENCE REACH.

The overall channel design slope through the bridge opening was relatively close to the current slope of 2.7%. However, the channel design cross section was narrower than the channel widths measured in the reference reach and other locations upstream of the project. High flow events reshaped the constructed channel, widening the channel and eliminating all of the rock weirs. With this, the channel also adjusted vertically downward, undermining the shallow RSP toe along the left side of the channel.

Given the dynamic nature of the channel, allowing the stream to be vertically and laterally unconstrained between the two RSP embankments will allow for natural stream processes. An analysis of the channel's longitudinal profile and natural vertical adjustment potential (VAP) through the project reach as part of the design process would have assisted in identifying the range of channel elevations that may occur over the service life of the bridge crossing and could have ensured that the RSP toe was placed below the low VAP elevation to avoid undermining and loss of RSP protection along these banks.

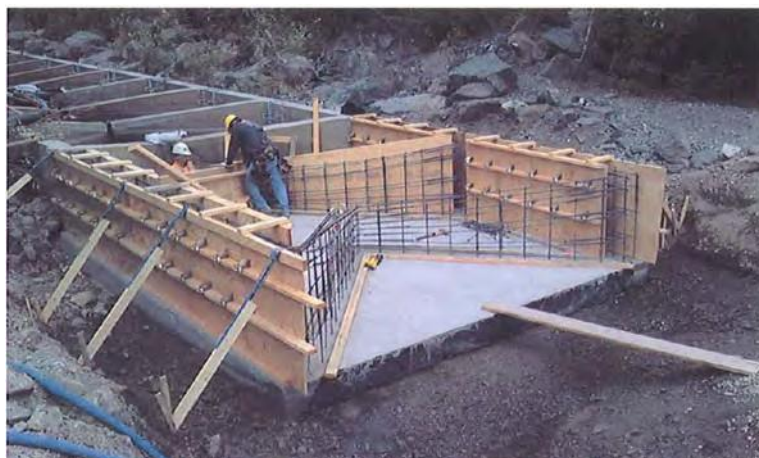
The Hall Creek as-built plans describe the concrete fishway as 108-foot long with a 15-foot interior width and 12 weirs. The two downstream-most weirs were added the year after initial construction due to an excessive drop at the fishway entrance (downstream end) (Figure 4-2). The weir crests were designed to have an 8-inch drop between adjacent weirs and the overall elevation drop from the most upstream to downstream weir crest is 7.4 feet. The weirs are skewed 45 degrees to the flow, creating a V-shape. The resulting crest length is approximately 29 ft and slope down at a 4H:1V slope from the fishway wall to their center apex. The top elevation of the fishway wall and the weir crests are coincident at the weirs' outer edges; thus, there is no freeboard available at flows that fully submerge the weirs. HEC-RAS 1D analysis summarized in Appendix E of the Hall Creek Mad River Fish Passage Mitigation Report (Hurlburt, 2013) shows that for simulated flows of 55 cfs and greater the flow width exceeds the 15-foot fishway width. Fifty-five cfs is the resident salmonid high fish passage flow and $Q_{2\text{-year}}$ is reported as 374 cfs. Along both sides of the fishway, the banks are constructed primarily of 1-ton RSP reused from the previous outlet conditions. Live willow and cottonwood cuttings were installed into the RSP.

During the design process for fishways and other types of grade control it is important to evaluate the stability of the downstream tie-in elevation. The Mad River main channel in this reach is unconfined and experiences frequent lateral migration as revealed when reviewing historical photos. For example, in 2003 the main river channel was directly adjacent to the SR 299 Hall Creek bridge, and the next year it was more than 400 feet away from the bridge. These shifts in the main channel will change the tie-in elevation at the downstream end of the fishway. This must be considered during the design process through review of historical aerial photographs and geomorphic interpretation to establish the lowest fishway tie-in elevation that may occur. This may have been the reasons additional weirs had to be added to the downstream end of this fishway a year after initial construction.

FIGURE 4-2. DOWNSTREAM FISHWAY EXTENSION UNDER CONSTRUCTION IN AUGUST, 2013.

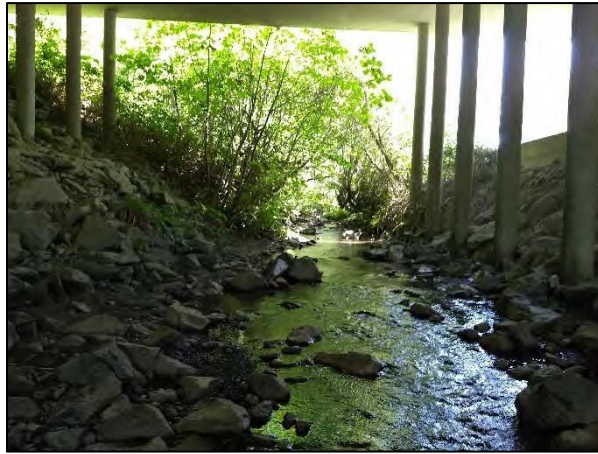
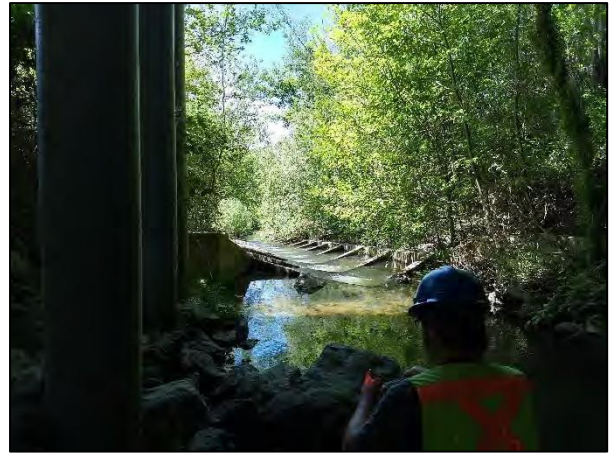
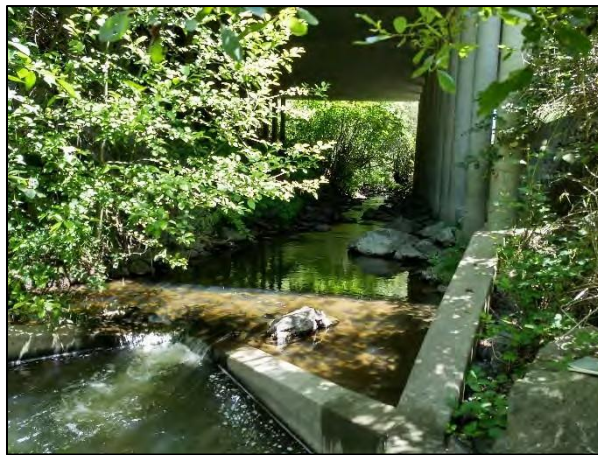
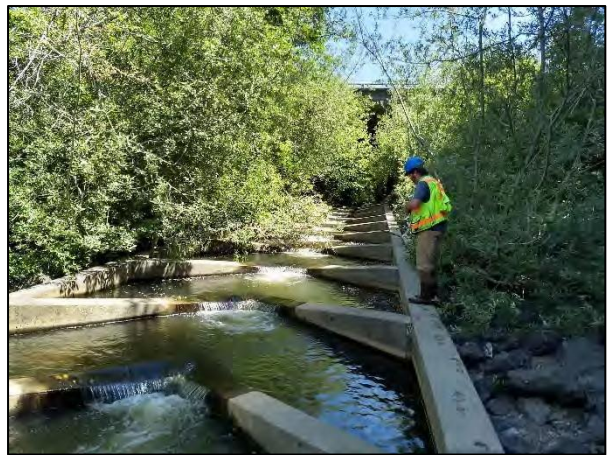
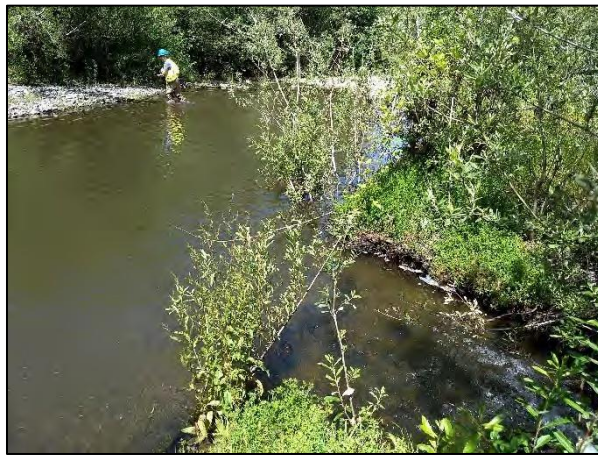
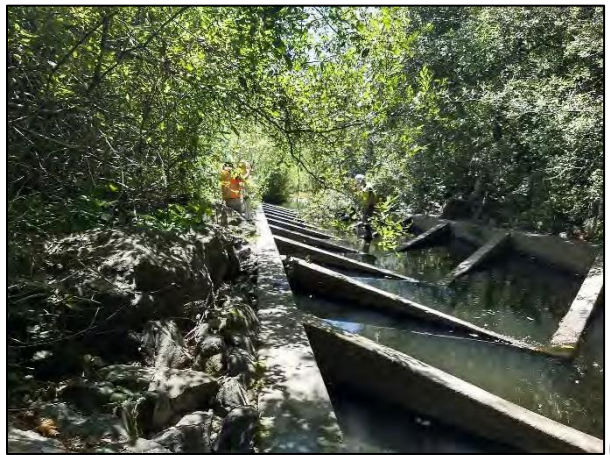
HSU visited the crossing in June 2020 for preliminary assessment and completed a site survey on July 12, 2020. Photos taken during the field site visits are provided in Figure 4-3. During the preliminary assessment visit, Hall Creek was well connected to a side channel of the Mad River (Figure 4-3e) but this pool's outlet riffle was close to drying up and disconnecting from the Mad

Channel and fishway cross sections were surveyed (Figure 4-7) and measurements of channel width were made upstream of the fishway (Table 4-1). The channel upstream of the bridge and fishway is slightly narrower than the more exposed, armored channel under the bridge (Figure 4-3a).

The fishway conditions match the design and appears to be functioning as intended to provide passage. The fishway interior width matches the active channel width. Thus, the active channel filling flow likely corresponds to the flow that just fully submerge the weirs which is consistent with the HEC-RAS analysis of the fishway summarized above (Section 4.1.1). As noted, the fishway side wall elevations are coincident with the weir heights so higher flows are not contained within the fishway. The adult high fish passage flow was reported as 133 cfs and the top width of flow in the fishway was predicted by HEC-RAS as 20 to 23 feet. Under these conditions, the fishway could act as a passage corridor through a wider flow channel but fish passage under these conditions should be confirmed. Additionally, there is some concern of stranding of fish on the RSP outside of the fishway at these flows. Typical fishway design criteria include containing the fish passage flows within the fishway and providing a minimum of 2 feet of freeboard to prevent fish from leaping out of the fishway.

FIGURE 4-3. HALL CREEK (A) UPSTREAM CHANNEL LOOKING UPSTREAM AT THE TRANSITION FROM THE ARMORED TO NATURAL CHANNEL, (B) LOOKING DOWNSTREAM AT THE FISHWAY (C) LOOKING UPSTREAM AT THE FISHWAY ENTRANCE (D) LOOKING UPSTREAM FROM WEIR 11, (E) CONFLUENCE OF HALL CK AND THE MAD RIVER SIDE CHANNEL ON JUNE 9, 2020, AND (F) LOOKING DOWNSTREAM ALONG FISHWAY AND ARMORED BANKS. PHOTOS TAKEN JUNE 2020 BY M. LOVE AND M. LANG.

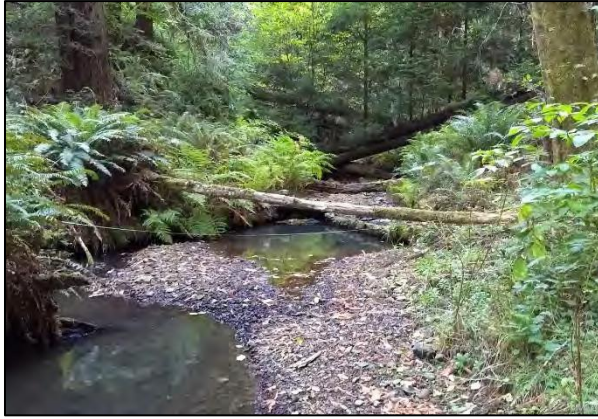
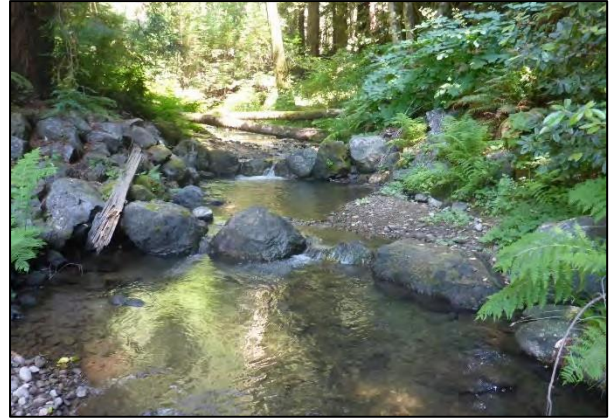
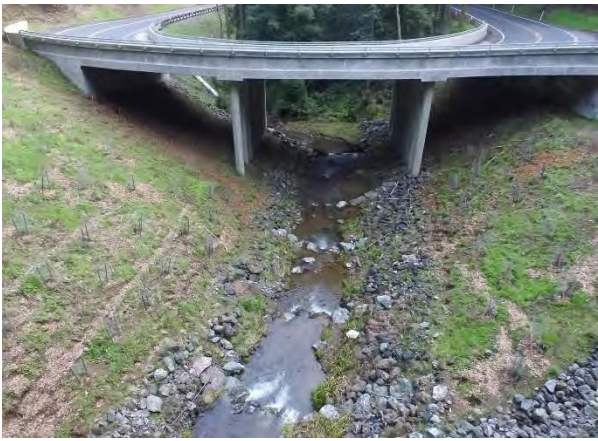
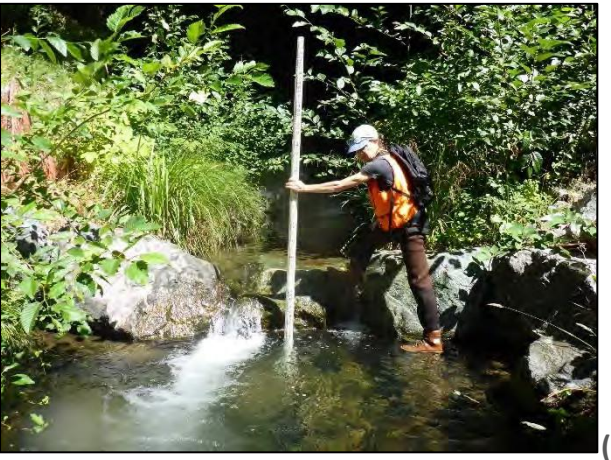
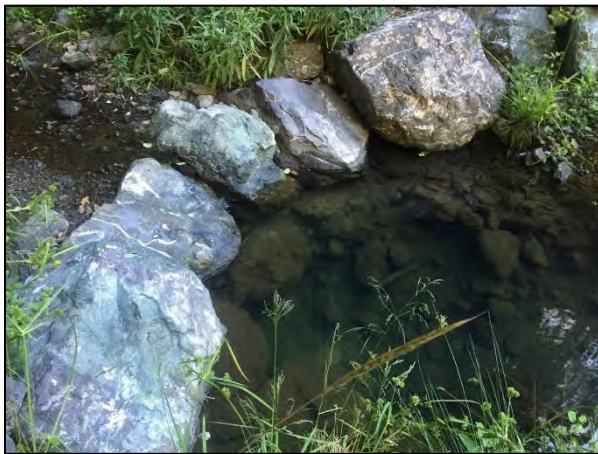
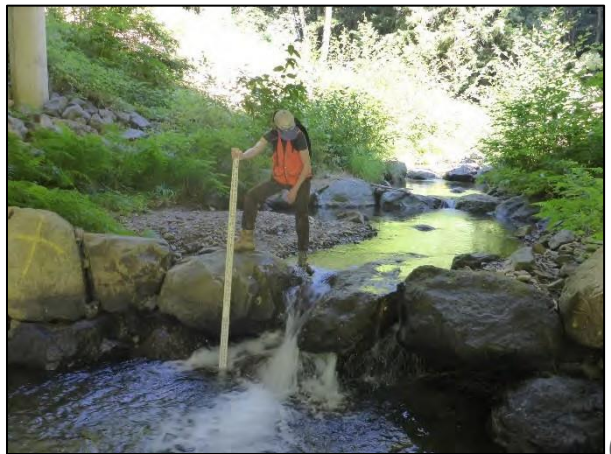
HSU visited the crossing in July 2019 and surveyed the site in October 2020. Alder trees had revegetated much of the project reach, except under the bridge (Figure 5-1d). The channel spanning log that controlled the channel bed elevation at the downstream end of the project (Figure 5-2) had shifted and the channel bed appeared to have incised immediately upstream of its location as a result. The downstream most boulder weir had failed, likely due to the increased drop following shifting of the downstream log control, thus creating a drop of greater

than 2.5 feet over the second weir at low flows (Figure 5-1f). Boulders from the failed weir were pushed downstream. Remanent roots/wood buried in the channel near the failed weir location appeared to help maintain the local channel bed elevation and prevent a larger drop from forming over the second weir. However, the footer rocks of the second weir were undermined and this weir looked at risk of failing.

The channel and weir widths under the bridge appeared much wider than the weirs further upstream, and over-widened compare to channel reaches outside the project area. Weirs upstream of the bridge looked stable and provided a diversity of flow paths over their crests at low flow. However, some of the pools between weirs were scoured deep enough to expose the bottom of the upstream weir's footer rocks, raising concerns regarding long-term stability of these weirs (Figure 5-1e). Based on field notes during construction, these locations of excess scour appear to correspond to locations where the channel had been realigned and the parent material in the constructed channel was road fill.

The upstream most weir appears to be maintaining the upstream channel elevation and preventing any headcutting/incisions from the project (Figure 5-1a and b).

FIGURE 5-1. DUNN CREEK (A) UPSTREAM REFERENCE REACH, (B) TWO UPSTREAM-MOST WEIRS, (C) OVERALL PROJECT SHORTLY AFTER CONSTRUCTION, (D) TYPICAL WEIR UPSTREAM OF BRIDGE, (E) EXCESS POOL SCOUR BELOW U-SHAPED WEIR, AND (F) EXCESSIVE DROP OVER WEIR 2 AFTER DOWNSTREAM-MOST WEIR FAILURE.

The means of failure for Weir 1 was scour and undermining of the footer rocks that serve as the foundation for the weir. Deep scour pools that exposed the bottom of the footer rocks were observed at two other upstream weirs, currently placing them at risk of failure. Some of these deep scour pools appear to coincide with where the channel was realigned into exposed fine-grain fill material rather than native streambed material. The best means for reducing risk of

The project relied on 11 boulder weirs to maintain the upstream channel grade for the service life of the bridge crossing, which is likely 70+ years. However, boulder weirs are highly susceptible to cascade failures; if one weir fails all of the upstream weirs are at a high risk of failure. Design of in-channel incision control structures could better match the bridge lifespan.

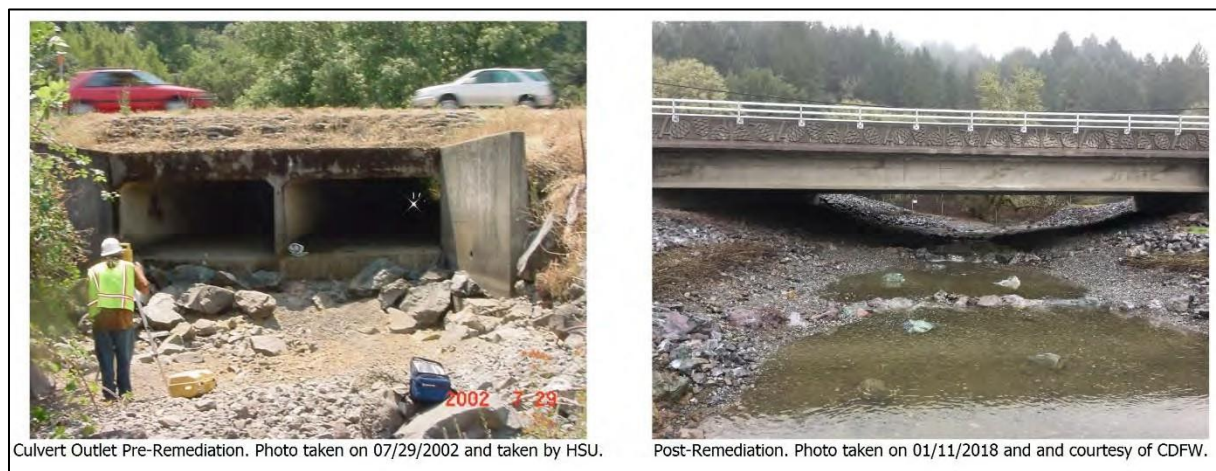
The Upp Creek crossing on the original section of US 101 (now a frontage road), immediately north of Willits, California in Mendocino County was replaced in 2017 (Figure 6-1). Prior to replacement, the crossing consisted of a 71-foot long double bay box culvert (Figure 6-1), with each bay being 10-feet wide by 5-feet tall. The culvert had a slope of 4.4% and a water surface drop at the outlet of 1.0 feet.

The culvert was replaced with a 75.5-foot full-span bridge and a series of 13 boulder weirs. RSP was designed to extend to above the design flood event. The design channel bed under the bridge was approximately 3.3 feet lower than the pre-project culvert outlet invert.

FIGURE 6-1. PRE AND POST PROJECT LOOKING UPSTREAM AT CROSSING.

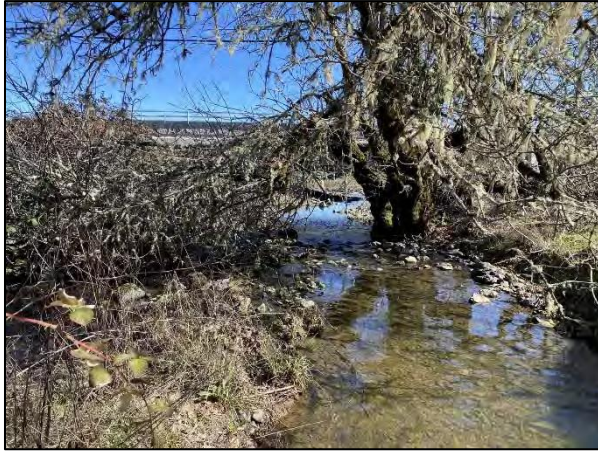
(A)

HSU visited the site in September 2019 and conducted the channel survey in February 2021. The primary observation was that the width of the constructed channel was substantially wider than the channel upstream and downstream of the project (Figure 6-2a verses b). In portions of the project reach sediment had deposited on the inside of the bend in the channel, forming a bar that was helping to confine lower flows and maintain water depth (Figure 6-2d).

The channel downstream of the project appeared highly disturbed (Figure 6-2e and f). Further downstream the channel had been routed to flow under bridges associated with the new US 101 Willits Bypass and on- and off-ramps. Upstream of the project the channel was also relatively disturbed and geomorphically unstable, but had a floodplain and limited riparian vegetation present (Figure 6-2a).

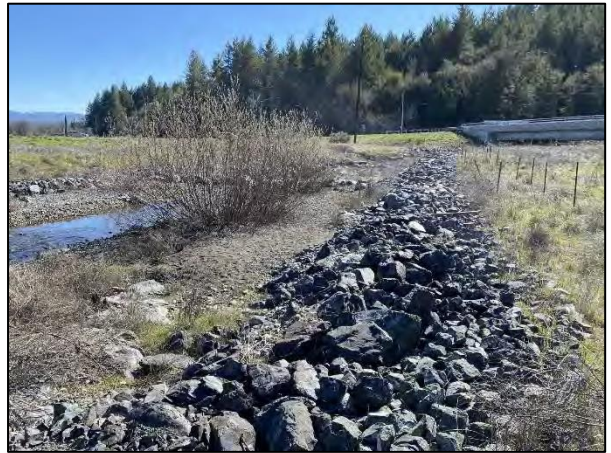
(D)

The upstream-most boulder weir had failed. It was originally constructed as a straight weir, and the mobilized rock from the weir that was deposited in the downstream channel appeared relatively small in size. Also of note was the large amount of rock used to form the streambanks downstream of the bridge crossing and the lack of successful revegetation within this bank rock (Figure 6-2d).

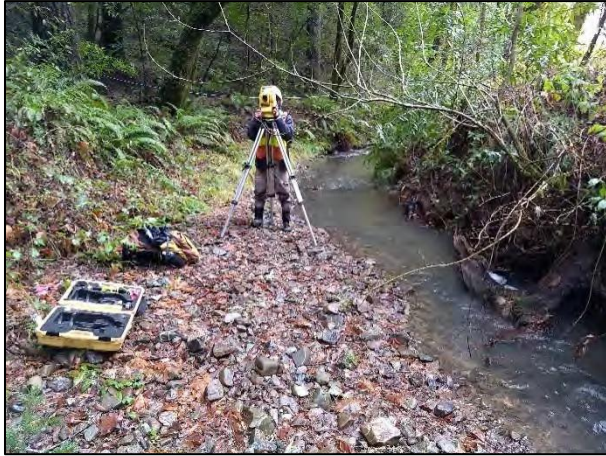
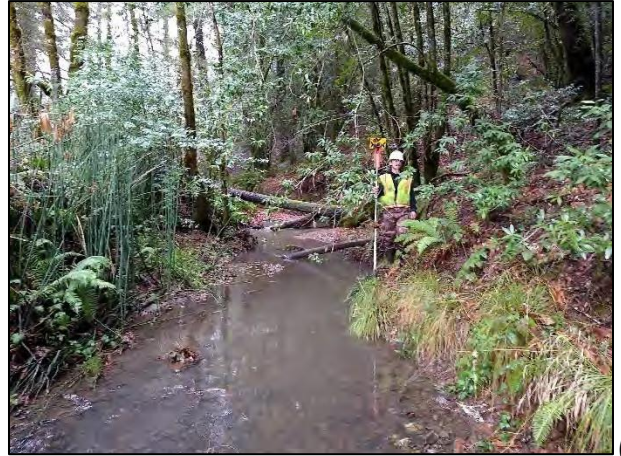
A reference reach was selected upstream of the project reach. This reference reach was gravel-bedded with riffles and pools. Wood and roots provided bed and bank controls. Water was flowing throughout this reach during both site visits and juvenile salmonids were observed within the pools. The channel banks were relatively steep, and an established riparian forest provided ample shade over the channel (Figure 7-1).

FIGURE 7-1. NF RYAN CREEK (A AND B) REFERENCE REACH, (C) WEIR AT UPSTREAM END OF PROJECT, CROSSING (E) INLET AND (E) OUTLET, AND (F) DOWNSTREAM OF CROSSING. PHOTOS A, B, C, D AND F TAKEN JAN 14, 2020; PHOTO E TAKEN SEPT 12, 2019.

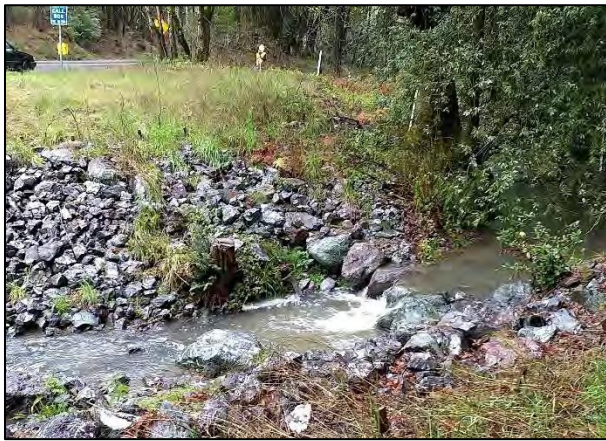
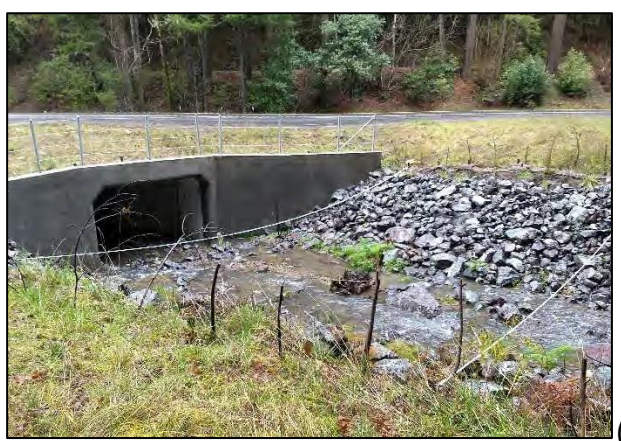
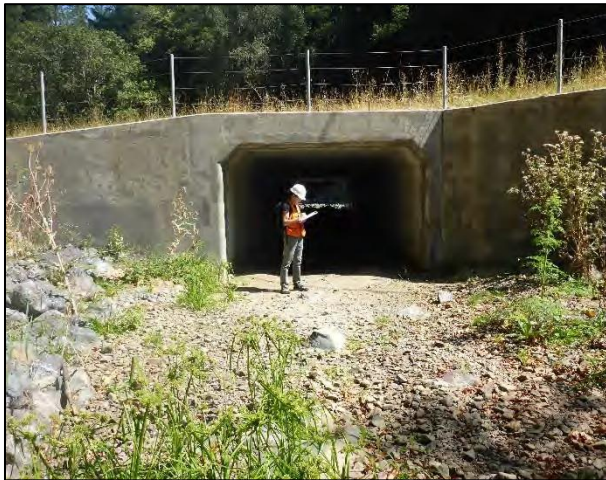
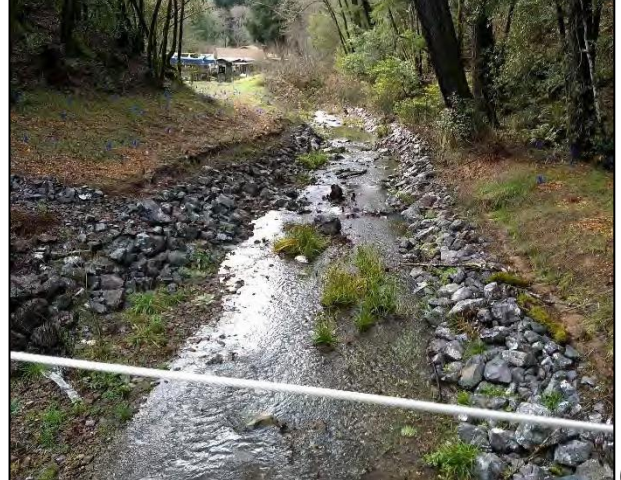
HSU visited the site to evaluate and survey the current crossing and channel conditions on September 12, 2019 and January 14, 2020. Photographs from these visits are provided in Figure 7-1. Figure 7-2 shows pictures of the site pre-construction and just after construction in 2018. The weir closest to the culvert inlet was not visible but a jumble of large rock was present. The upstream-most rock weir had a 1.5-foot drop, and the bottom of the footer rocks were exposed, suggesting that its stability was compromised. On the September 12, 2019 visit surface flow was continuous upstream of the project but was observed going subsurface at the left corner of the culvert inlet, apparently due to higher porosity of the streambed material at this location. The flow remained subsurface through the culvert and resurfaced at select locations to form isolated pools in the downstream project reach. Downstream of the project the surface flow reemerged.

The streambed within the crossing appears to have aggraded to some degree since construction. The disrupter boulders are nearly buried rather than protruding above the streambed; as such, the channel bed within the crossing is plain-bedded and relatively featureless. These changes are evident in comparing pictures showing the inlet opening and the culvert bed in Figure 7-1 and Figure 7-2.
