FISH PASSAGE ENGINEERING PROJECT

Site Analysis Final Report

SITE ANALYSIS FINAL REPORT

Humboldt State University
Michael Love & Associates, Inc.

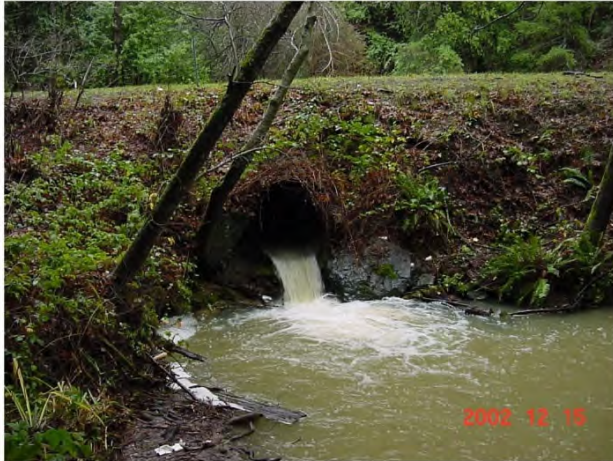
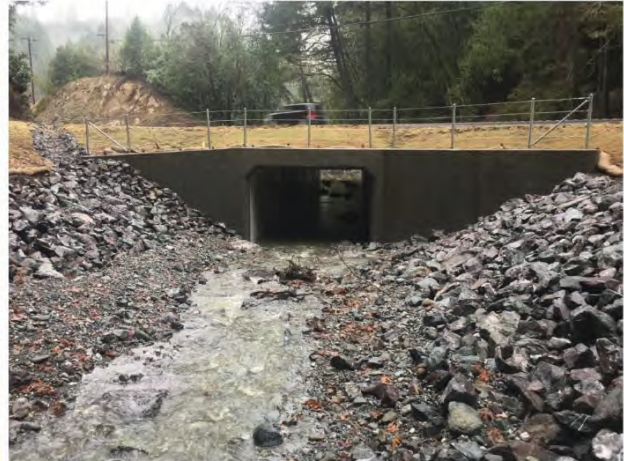
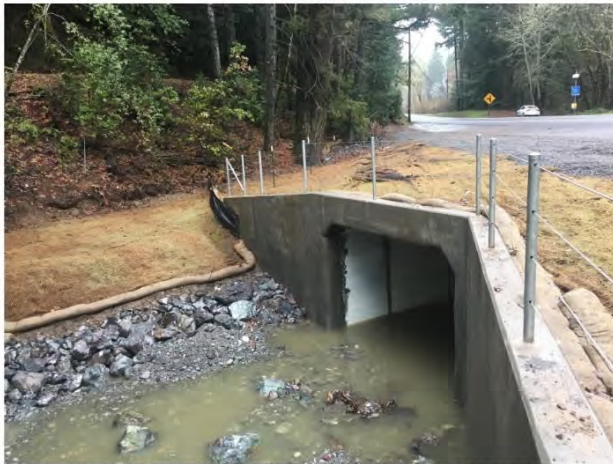
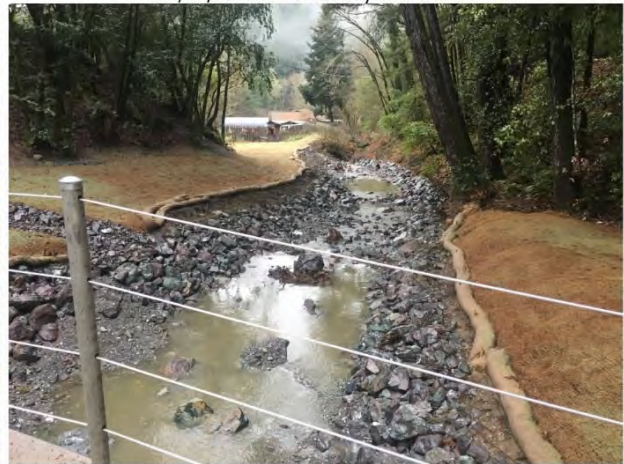
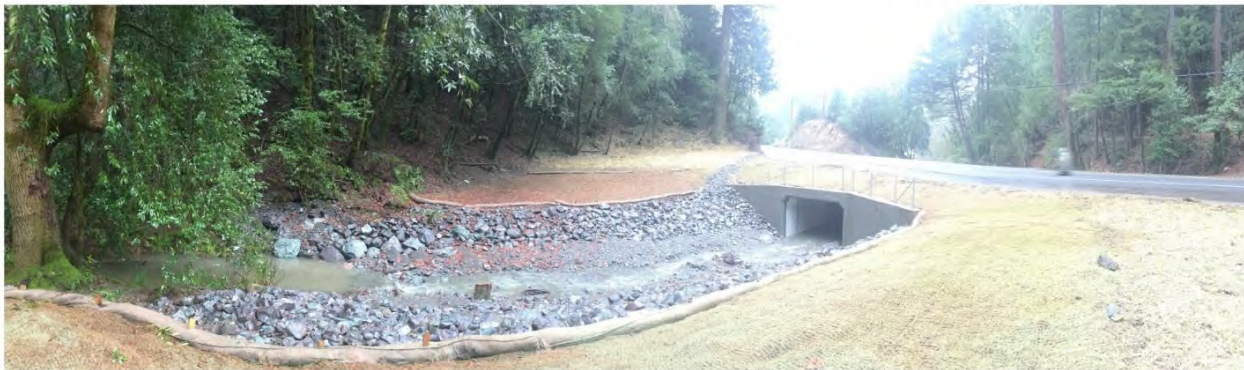
The streambed within the crossing appears to have aggraded to some degree since construction. The disrupter boulders are nearly buried rather than protruding above the streambed; as such, the channel bed within the crossing is plain-bedded and relatively featureless. These changes are evident in comparing pictures showing the inlet opening and the culvert bed in Figure 7-1 and Figure 7-2.

FIGURE 7-2. NF RYAN CREEK PRE- AND POST-CONSTRUCTION PHOTOS PROVIDED BY M. MOLNAR, CALTRANS.

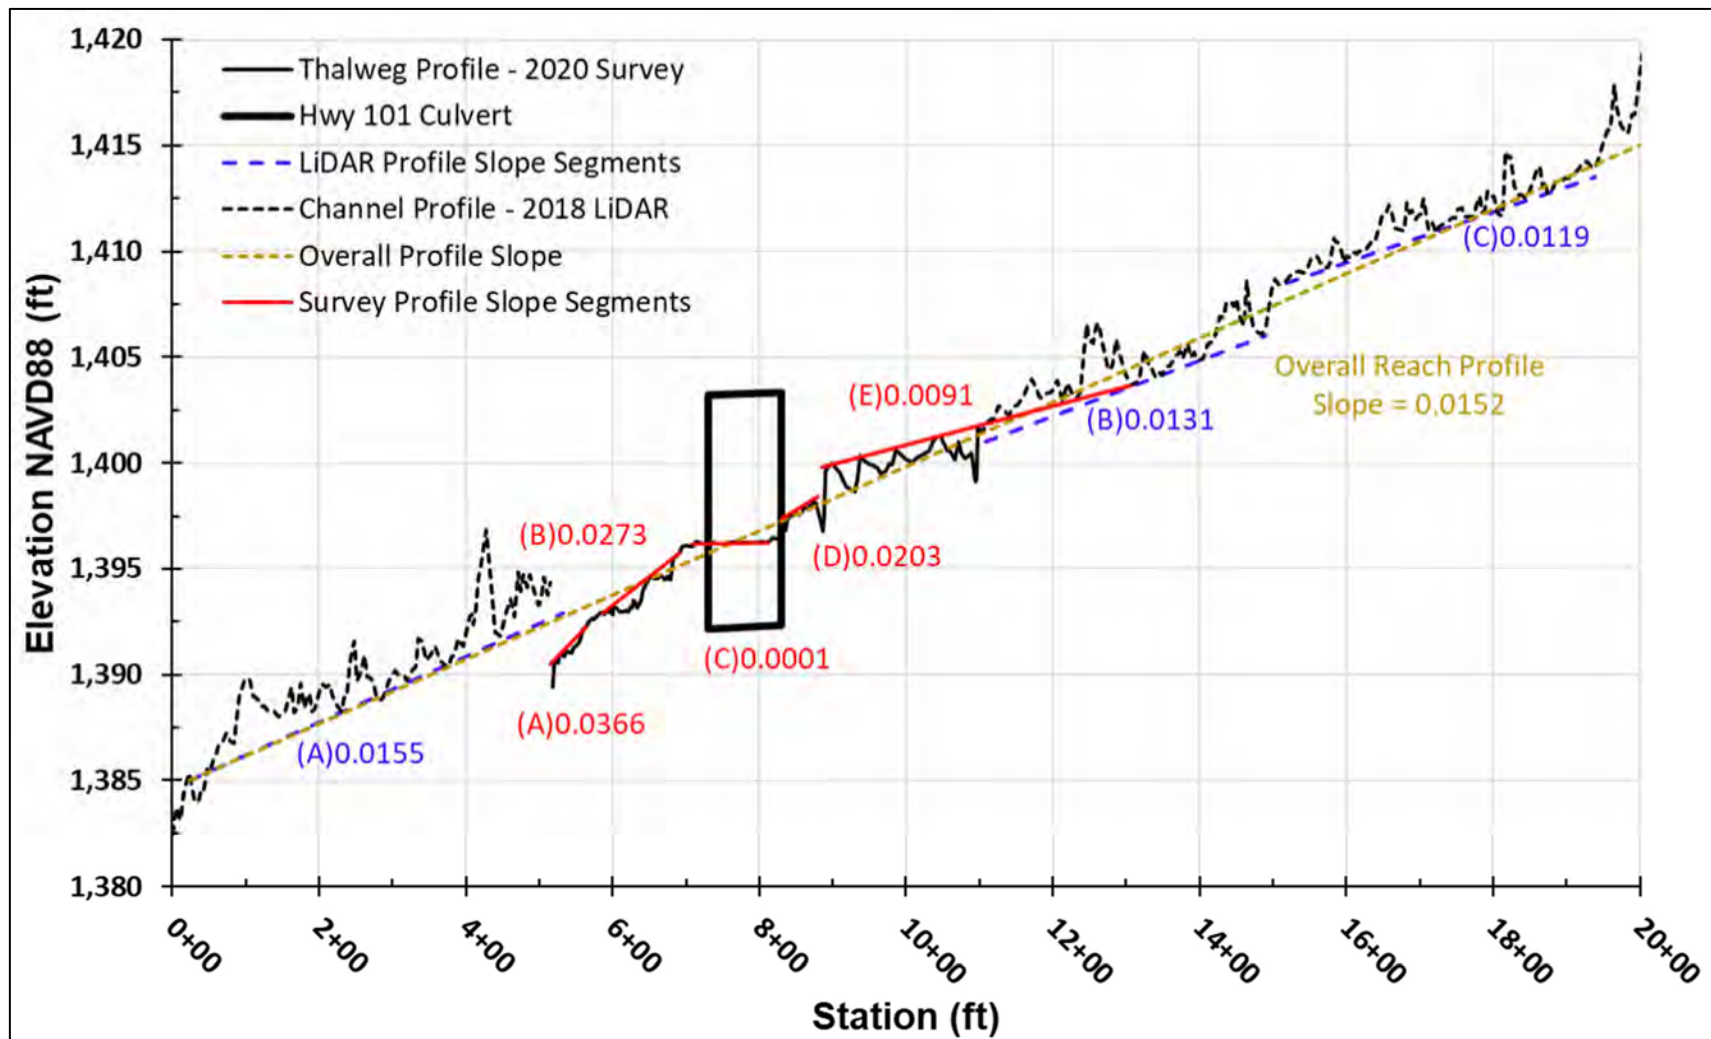
The channel profile from the LiDAR and site survey was broken into slope segments (Figure 7-5 and Figure 7-6). The reference reach slope was relatively constant at 0.9%, while the slopes within the project reaches varied from nearly flat through the culvert to 3.7% in a portion of the downstream project reach.

The combined surveyed and LiDAR channel profile (Figure 7-5) suggests the upstream most rock weir is potentially retaining stored sediment deposited upstream of the pre-project undersized culvert. The slope segments throughout the project deviate substantially from the upstream channel slopes, and the upstream-most rock weir creates a distinct discontinuity in the stream profile that may create a partial barrier for upstream fish movement.

FIGURE 7-5. CHANNEL PROFILE THROUGH PROJECT REACH GENERATED FROM COMBINED LiDAR DEM AND GROUND SURVEY POINTS, WITH CHANNEL SLOPE SEGMENTS DEFINED. AN OVERALL REACH SLOPE OF 0.0152 IS SUPER ONTO THE PROFILE.

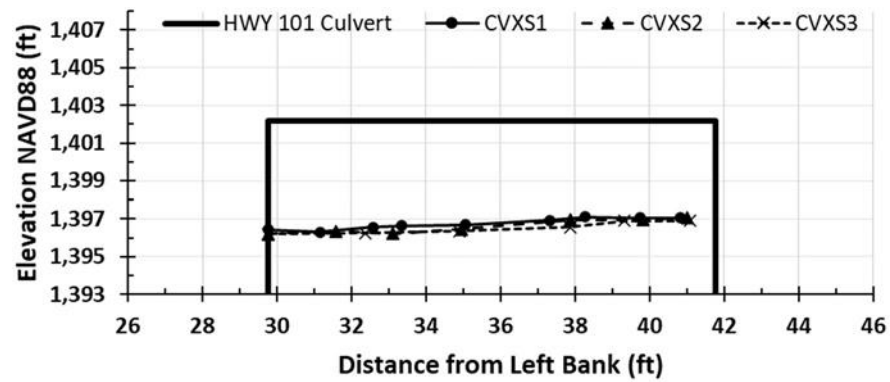
The channel cross section within the culvert has a nearly flat channel bed, as seen in Figure 7-7. The cross sections at the riffle crests in the reference reach (Figure 7-8(a) and(b)) have more

FIGURE 7-7. CROSS-SECTIONAL SURVEYS OF THE CHANNEL BED WITHIN THE 12 FOOT SPAN CULVERT.

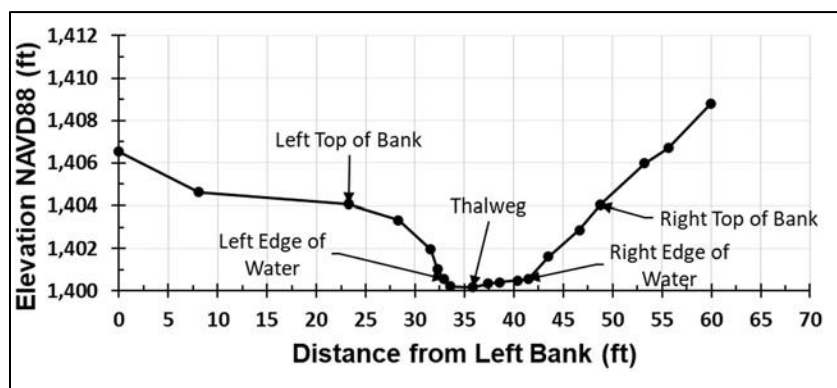
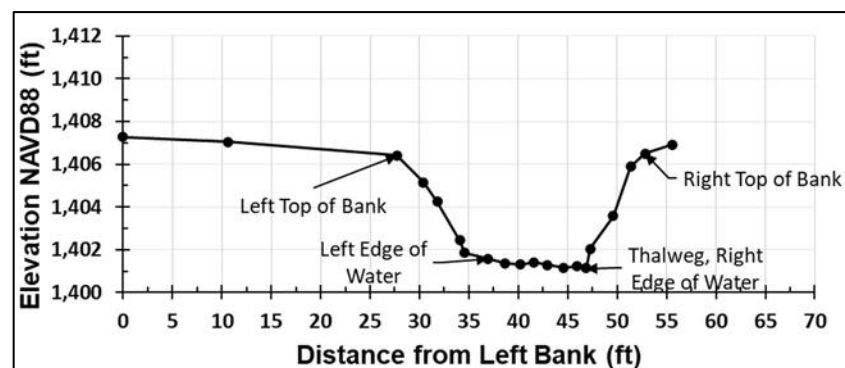
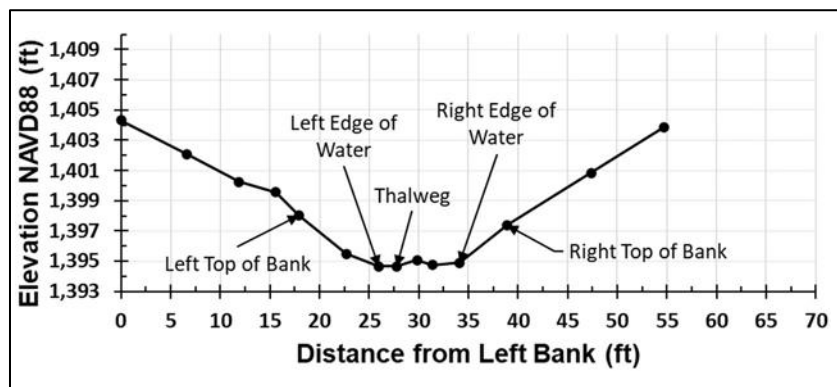
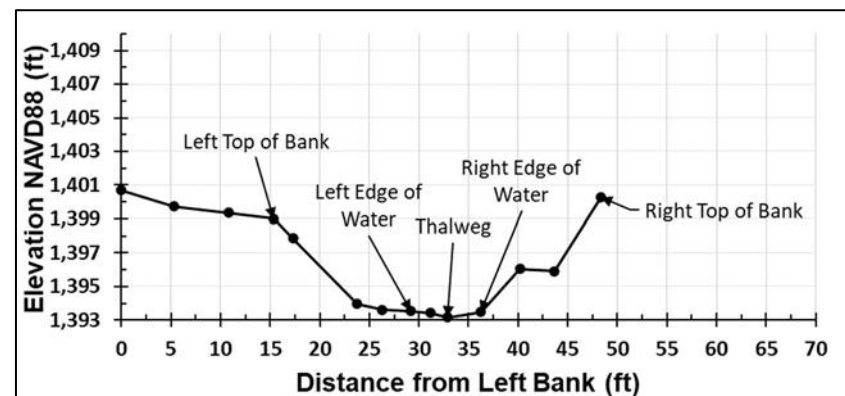
FIGURE 7-8. CHANNEL CROSS SECTIONS FOR THE REFERENCE REACH AT (A) RR1 AND (B) RR3 AND DOWNSTREAM PROJECT REACH AT (C) DS2 AND (D) DS4.

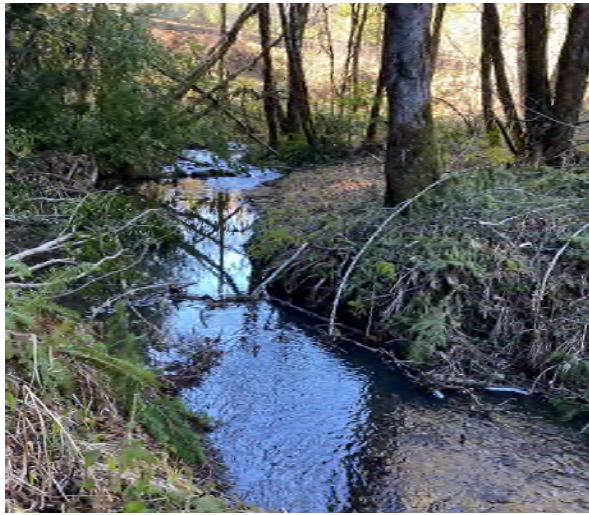
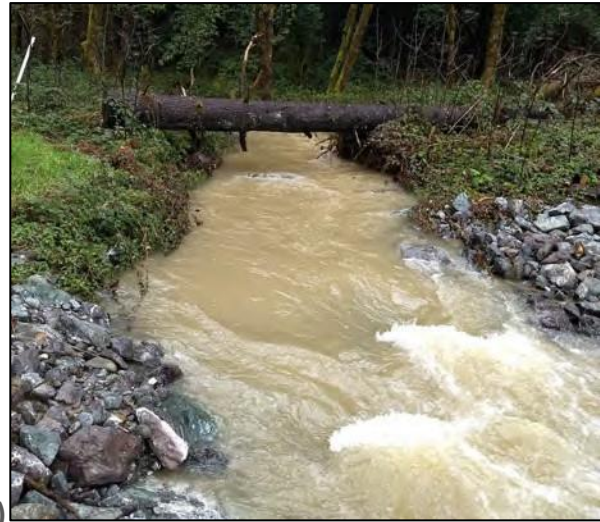
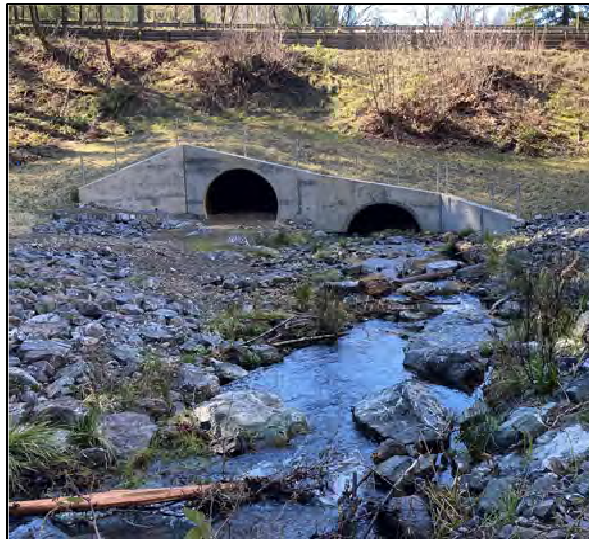
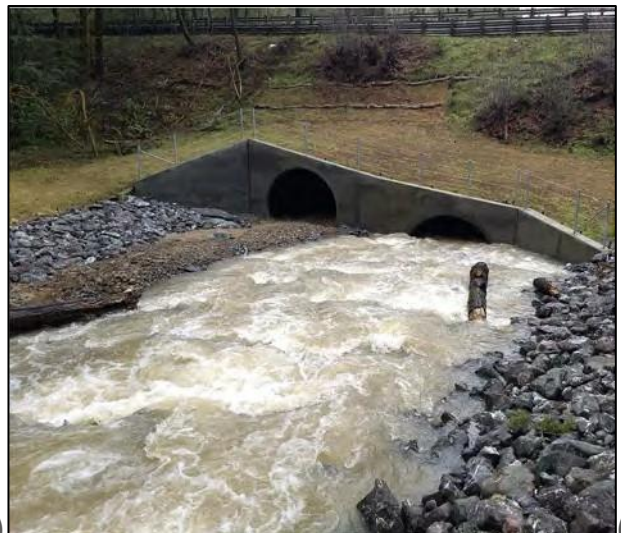
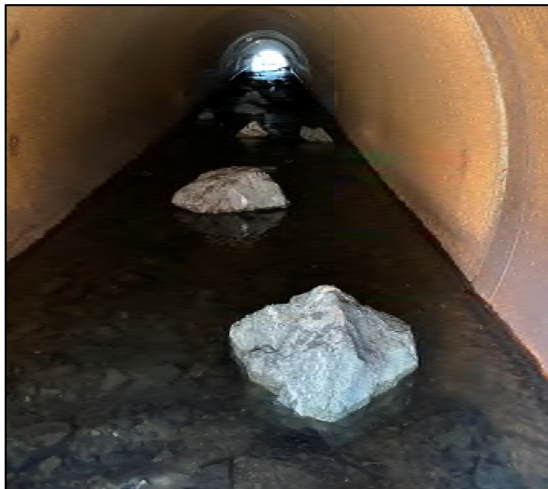
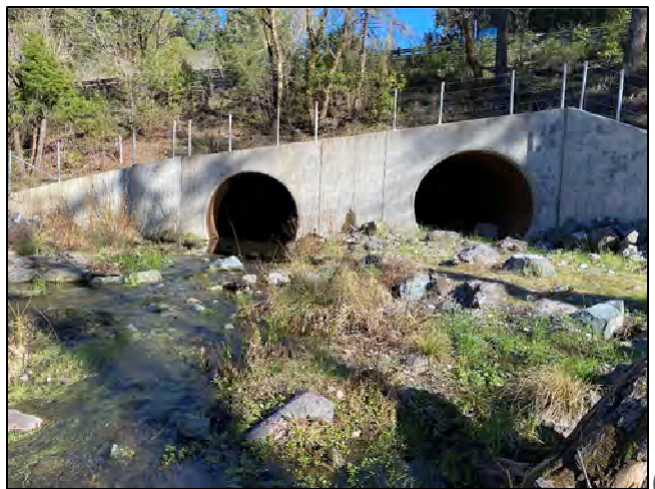
In areas without grade control substrate resembles the reference reach streambed material. The pebble counts even showed the gradation of the streambed material inside the low-flow culvert generally matched the reference reach streambed. The grade control makes the channel morphology dissimilar to the natural channel, with very steep channel segments.

FIGURE 8-1. SF RYAN CREEK (A) REFERENCE REACH, (B) UPSTREAM TRANSITION, (C AND D) INLET AT LOW AND HIGH FLOWS, (E) INSIDE CROSSING, AND (F) DOWNSTREAM OF CROSSING.

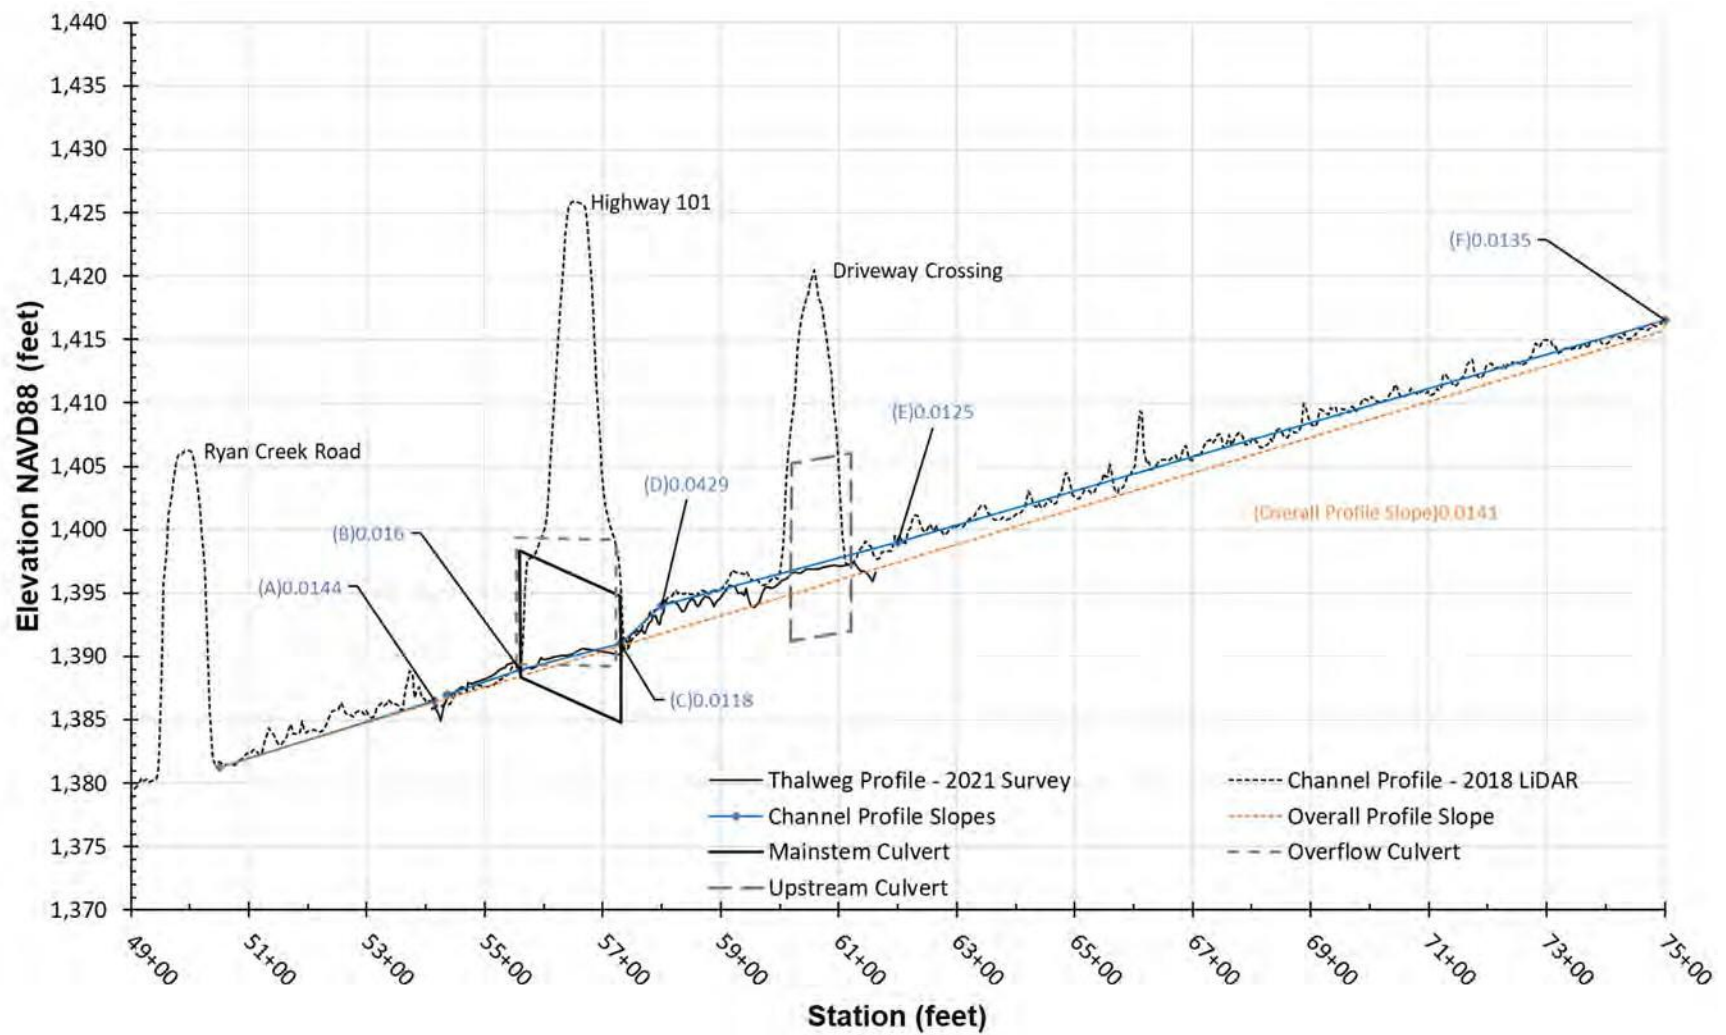
The LiDAR DEM generated channel profile (Figure 8-3) reveals a relatively constant overall slope of approximately 1.4% starting at the confluence with NF Ryan Creek just upstream of Ryan Creek Road and extending over 2,500 feet upstream. Breaking the channel profile into slope segments reveals the primary deviation from the overall slope occurs between the Highway 101 culvert and the next upstream private driveway culvert. This reach is lower gradient and above the overall profile, suggesting local aggradation caused by frequent backwatering from the previous undersized culvert crossing at Highway 101. No discrete knickpoints are noted on the LiDAR DEM profile

FIGURE 8-3. CHANNEL PROFILE THROUGH PROJECT REACH GENERATED FROM COMBINED LIDAR DEM AND GROUND SURVEY POINTS, WITH CHANNEL SLOPE SEGMENTS DEFINED.

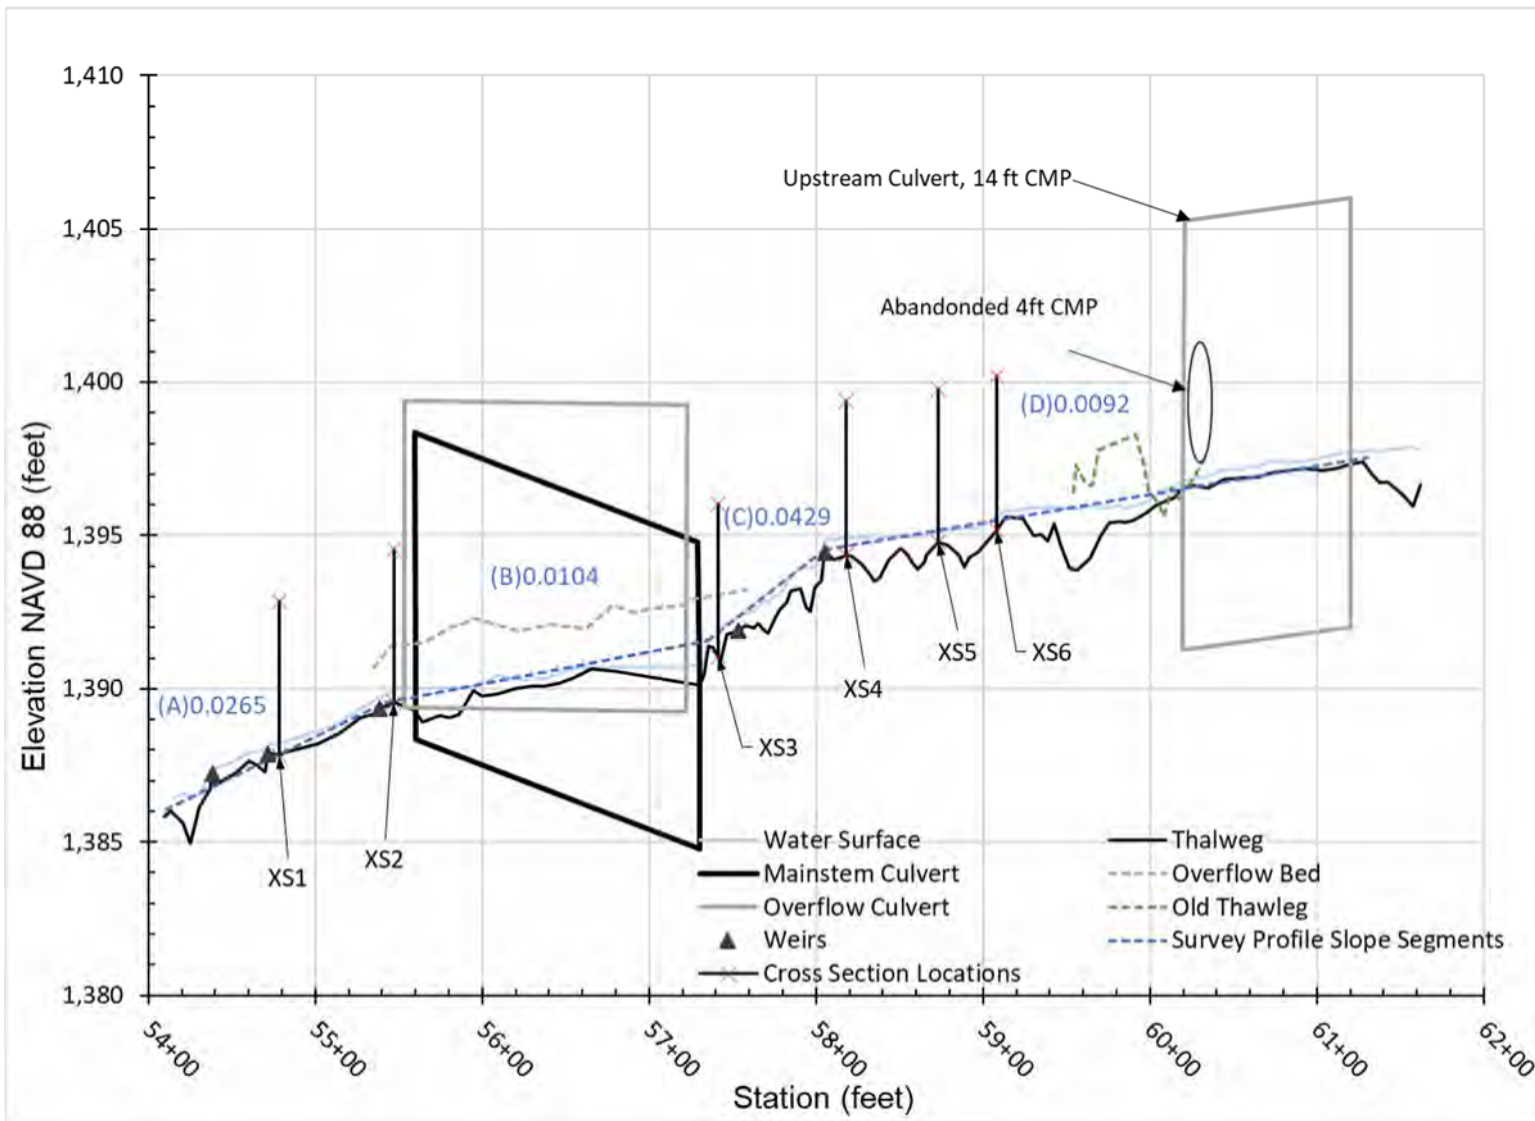
A reference reach was selected immediately upstream of the project for comparison purposes. It has a slope of approximately 0.009 (Figure 8-4). As mentioned previously, this reach appears aggraded due to backwatering from the replaced undersized culvert at Highway 101 that caused upstream sediment deposition. Thus, this section is at a lower slope than the overall profile seen in Figure 8-3.

FIGURE 8-4. 2021 SURVEYED THALWEG PROFILE ALONG CHANNEL CENTERLINE ALIGNMENT, WITH DEFINED SLOPE SEGMENTS AND THE OVERALL PROFILE PLOTTED. LOCATION AND IDENTIFICATION OF CHANNEL CROSS SECTIONS DENOTED.

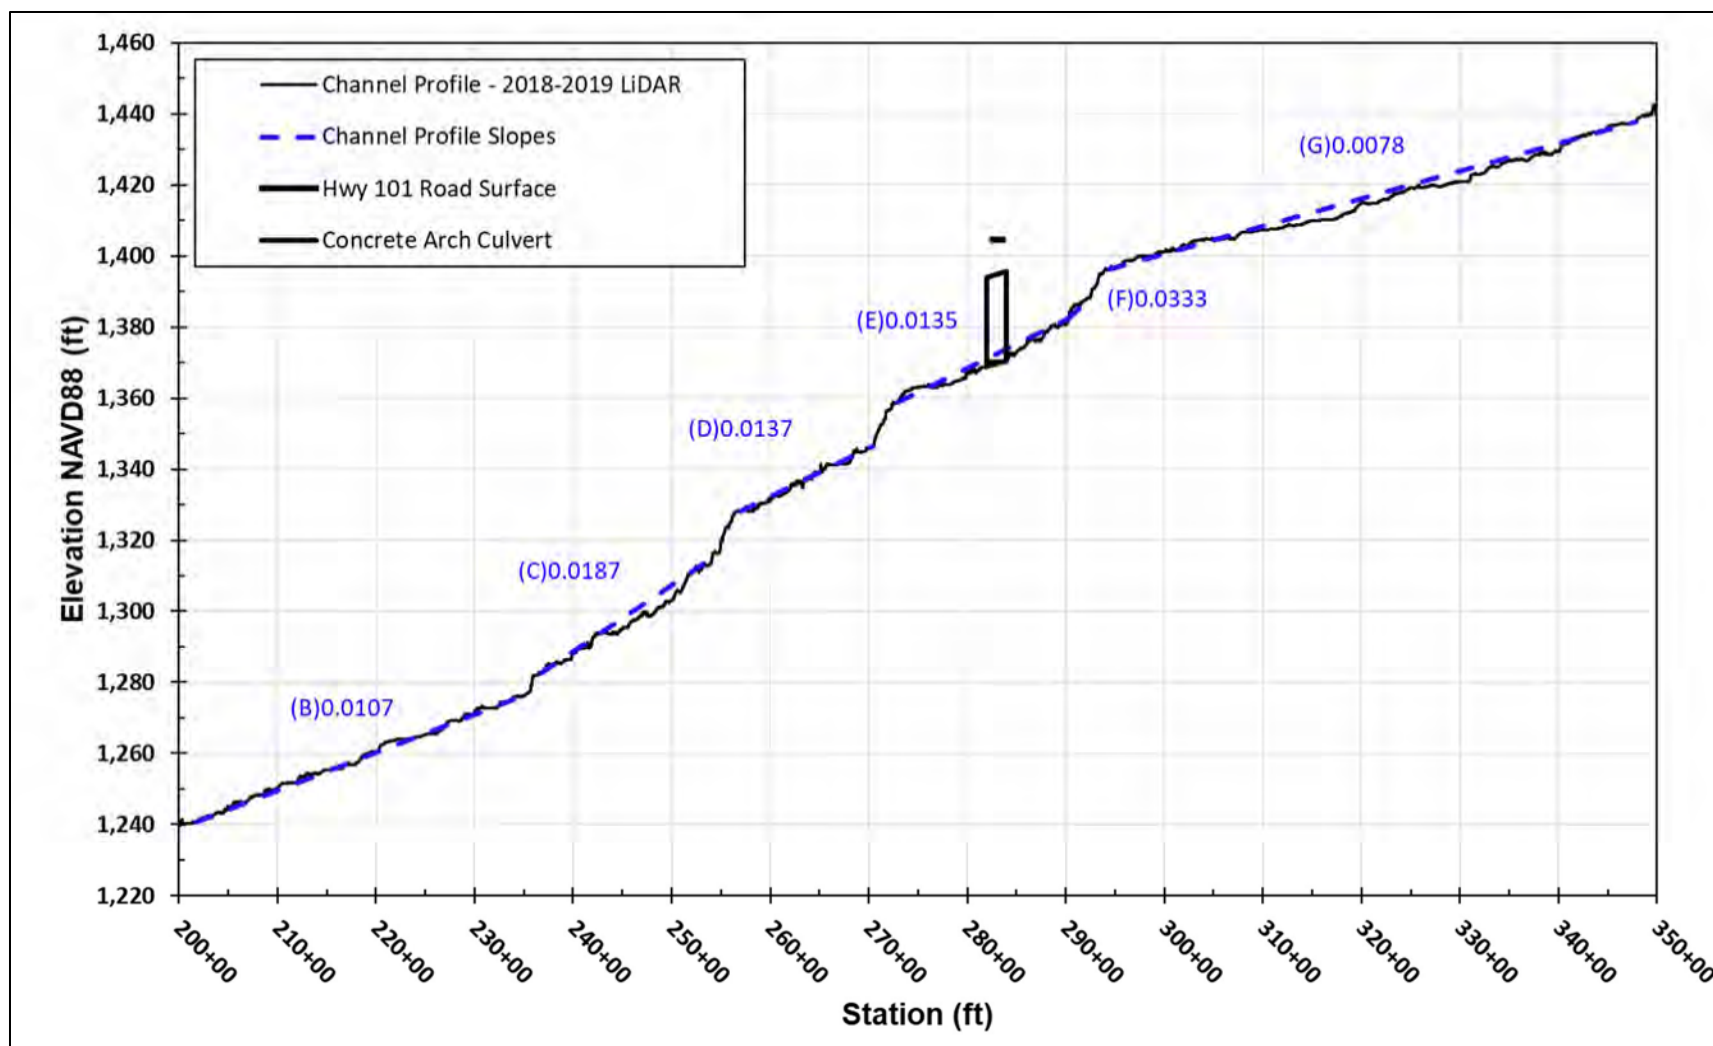
Figure 9-6). The project reach appears to be located a couple hundred feet downstream of a channel slope transition from an average slope of 0.8 percent to a steeper 1.4 percent slope through the project reach. Just upstream of the crossing inlet there is an abrupt slope section of approximately 3.3 percent (segment F,

Figure 9-6). This section of channel is characterized by steps formed by large boulder jams. It could be a result of frequent backwater from the crossing, causing boulders to deposit in the upstream channel, thus forming this knickpoint. However, it could also be a result of large material being input to the stream from an adjacent earthflow given the observed instability of the northern hillslope.

FIGURE 9-6. CHANNEL PROFILE THROUGH PROJECT REACH GENERATED FROM THE LIDAR DEM WITH CHANNEL SLOPE SEGMENTS DEFINED.

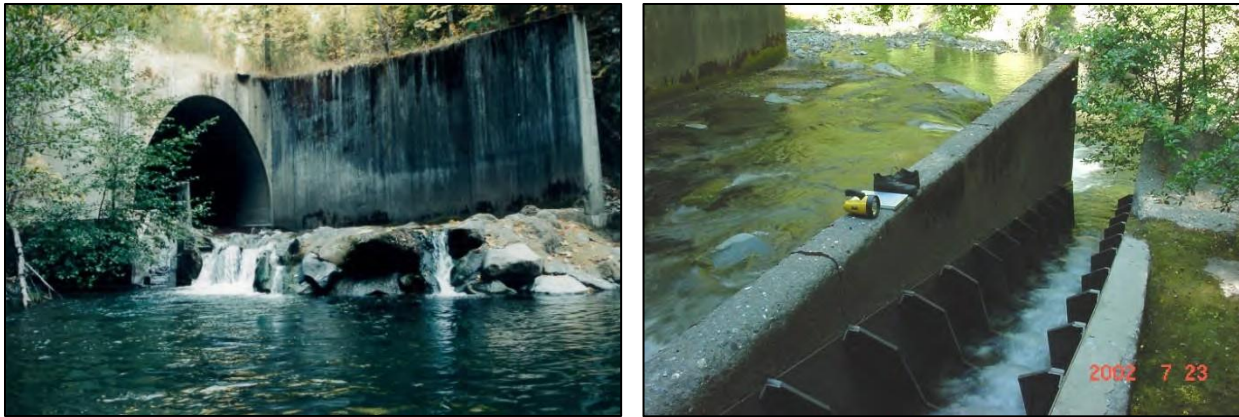
HSU visited the crossing in April and June 2021 for preliminary assessment and review. This site did not have a full field survey due to the project restructuring following COVID19 work and travel restrictions. Figure 10-1 shows the perched grouted rock apron outlet and fish ladder prior to the 2017 modifications. Photos taken during the two field assessment site visits are provided in Figure 10-2. The concrete weirs appear to be functioning well for fish passage, however, the drop heights over adjacent weirs are somewhat variable ranging from 0.5 to 0.8 feet as measured during the June 3, 2021 site visit (Table 10-1). The rock weirs installed downstream of the fishway have failed and the rocks forming the weir portions within the active channel having been displaced downstream (Figure 10-2e). Despite the weir rock displacement, the channel bed elevation controlling the tailwater level at the fishway entrance (downstream end) remains close to the intended design elevation, creating a drop height of 1.25 feet at the most downstream fishway weir compared to the design 1-foot drop. The tailwater control is being maintained by natural streambed substrate and fish passage through this section is not compromised.

FIGURE 10-1. CEDAR CREEK CROSSING OUTLET AND FISH LADDER BEFORE THE 2017 MODIFICATIONS. PHOTO ON LEFT PROVIDED BY M. MOLINAR CALTRANS, PHOTO ON RIGHT BY M. LANG.

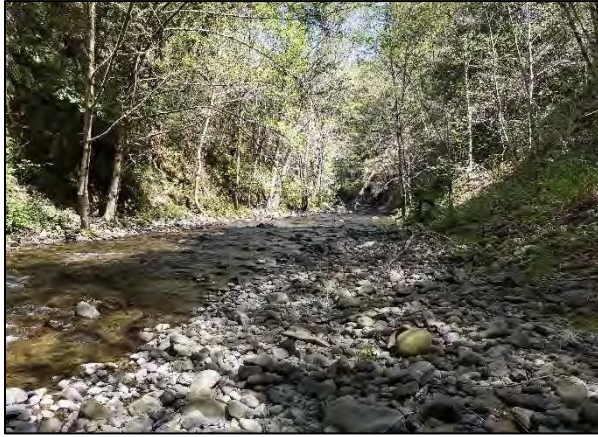
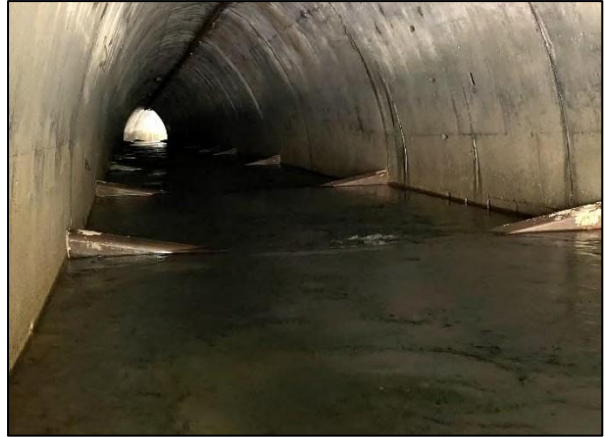
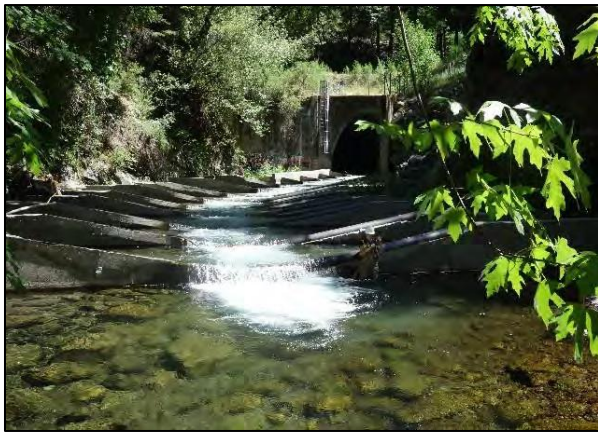
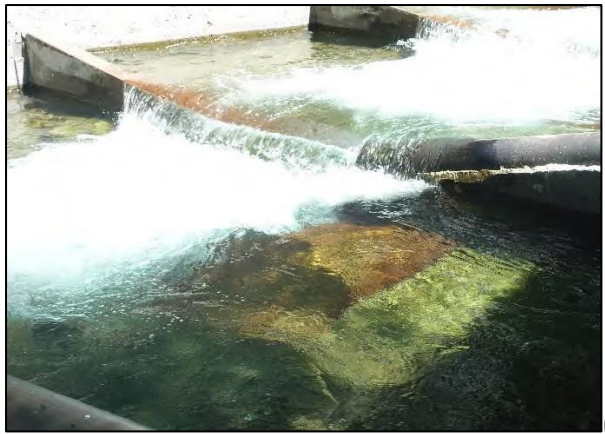
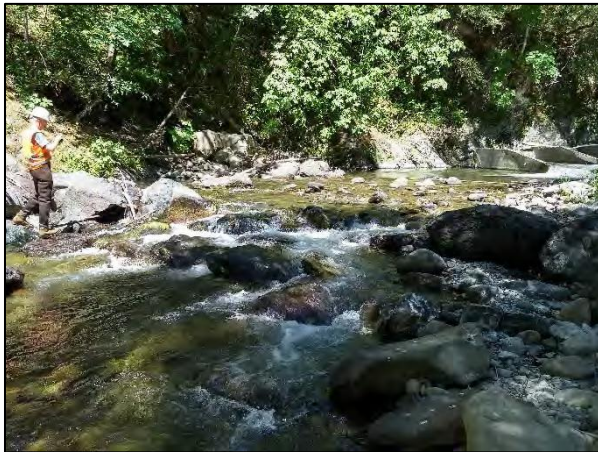
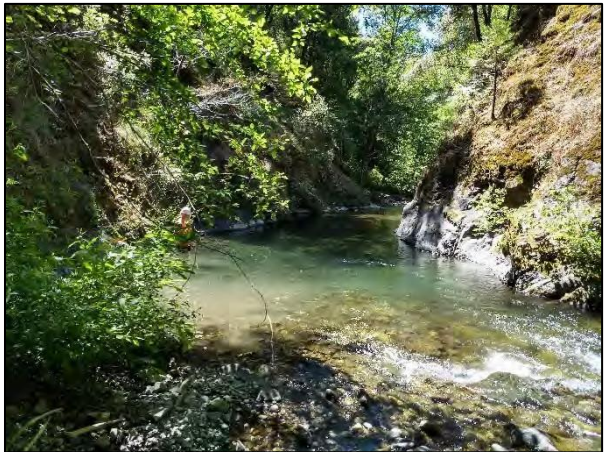
The upstream and downstream channels are both confined in a steeply sloped valley. They have nearly identical active and bankfull channel widths and similar substrate (Figure 10-2A and F). There are bedrock outcrops that form pools and control grade, with the frequency of these features increasing moving downstream from the crossing towards the confluence of Cedar Creek with the South Fork Eel River. In general, the existing culvert crossing width, at 22 feet, is substantially narrower than the active and bankfull channel widths.

The rock weirs installed to maintain grade control and a drop of 1 foot over the fishway entrance have partially failed. However, the existing downstream cobble/gravel tailout is maintaining a low flow drop height of 1.25 feet at the fishway entrance weir. Downstream of this control is a large pool confined by bedrock outcrops on both sides. This pool and confined channel (Figure 10-2f) likely become the control at high flow, backwatering the rock weir location. Under these conditions, deposition of bedload at the low flow tailout would occur

FIGURE 10-2. CEDAR CREEK (A) UPSTREAM CHANNEL, (B) CULVERT BARREL SHOWING INSTALLED WEIRS, (C) OUTLET POOL AND WEIR FISHWAY, (D) CLOSEUP OF THE SQUARE (LEFT) VS. ROUNDED (RIGHT) WEIR CRESTS, (E) LOOKING UPSTREAM AT THE OUTLET POOL TAILOUT AND ROCK WEIR REMNANTS, AND (F) DOWNSTREAM CHANNEL.

such that it should remain stable over the long-term. A site visit and photographs from the culvert outlet at flood flows could confirm these flow conditions.

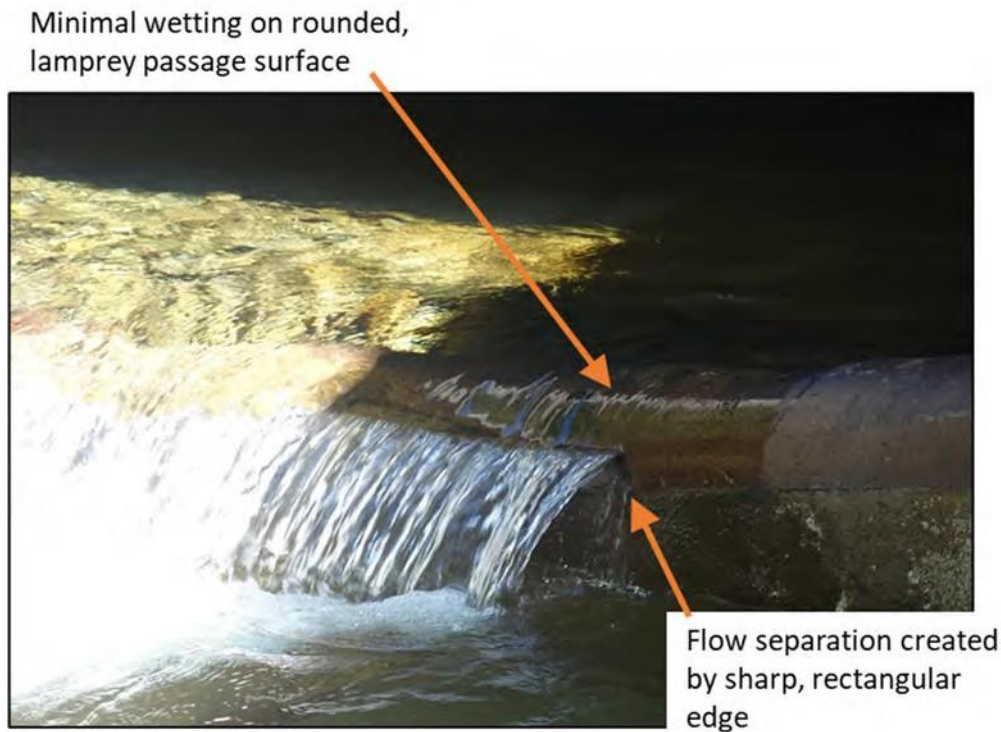
FIGURE 10-5. SOME OF THE OUTLET FISHWAY WEIRS HAVE SHARP EDGES AND PROTRUSIONS THAT MAY NOT BE EFFECTIVELY WETTING THE LAMPREY PASSAGE PORTION OF THE WEIR AND CREATE FLOW SEPARATION THAT COULD HINDER JUVENILE SALMONID PASSAGE. PHOTO TAKEN JUNE 3, 2020 BY M. LANG.

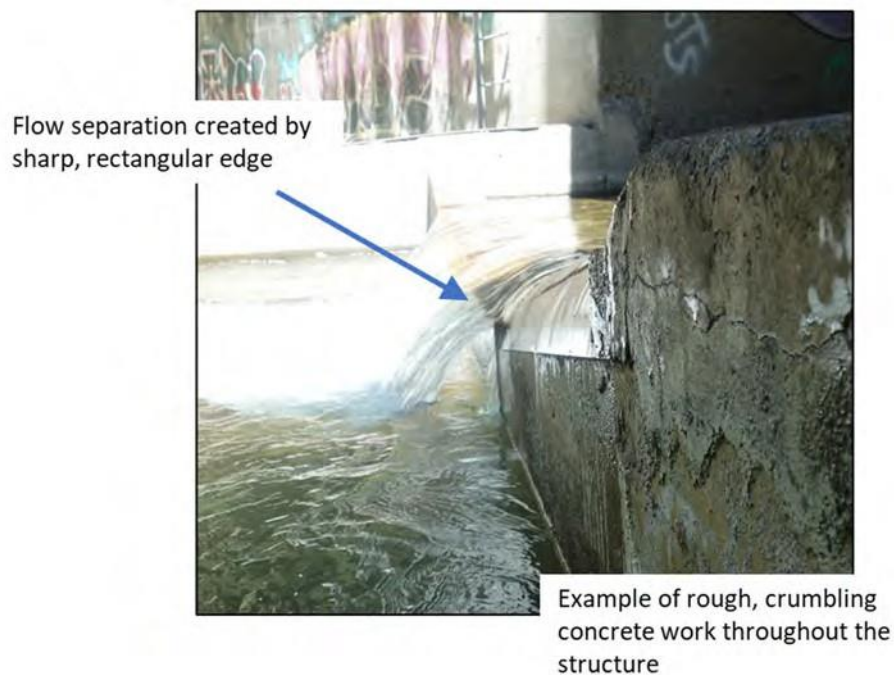
FIGURE 10-6. SIDE VIEW OF FLOW SEPARATION DUE TO A SHARP, RECTANGULAR EDGE ON WEIR 1, THE MOST UPSTREAM WEIR AT THE CULVERT OUTLET. PHOTO TAKEN JUNE 3, 2020 BY M. LANG.

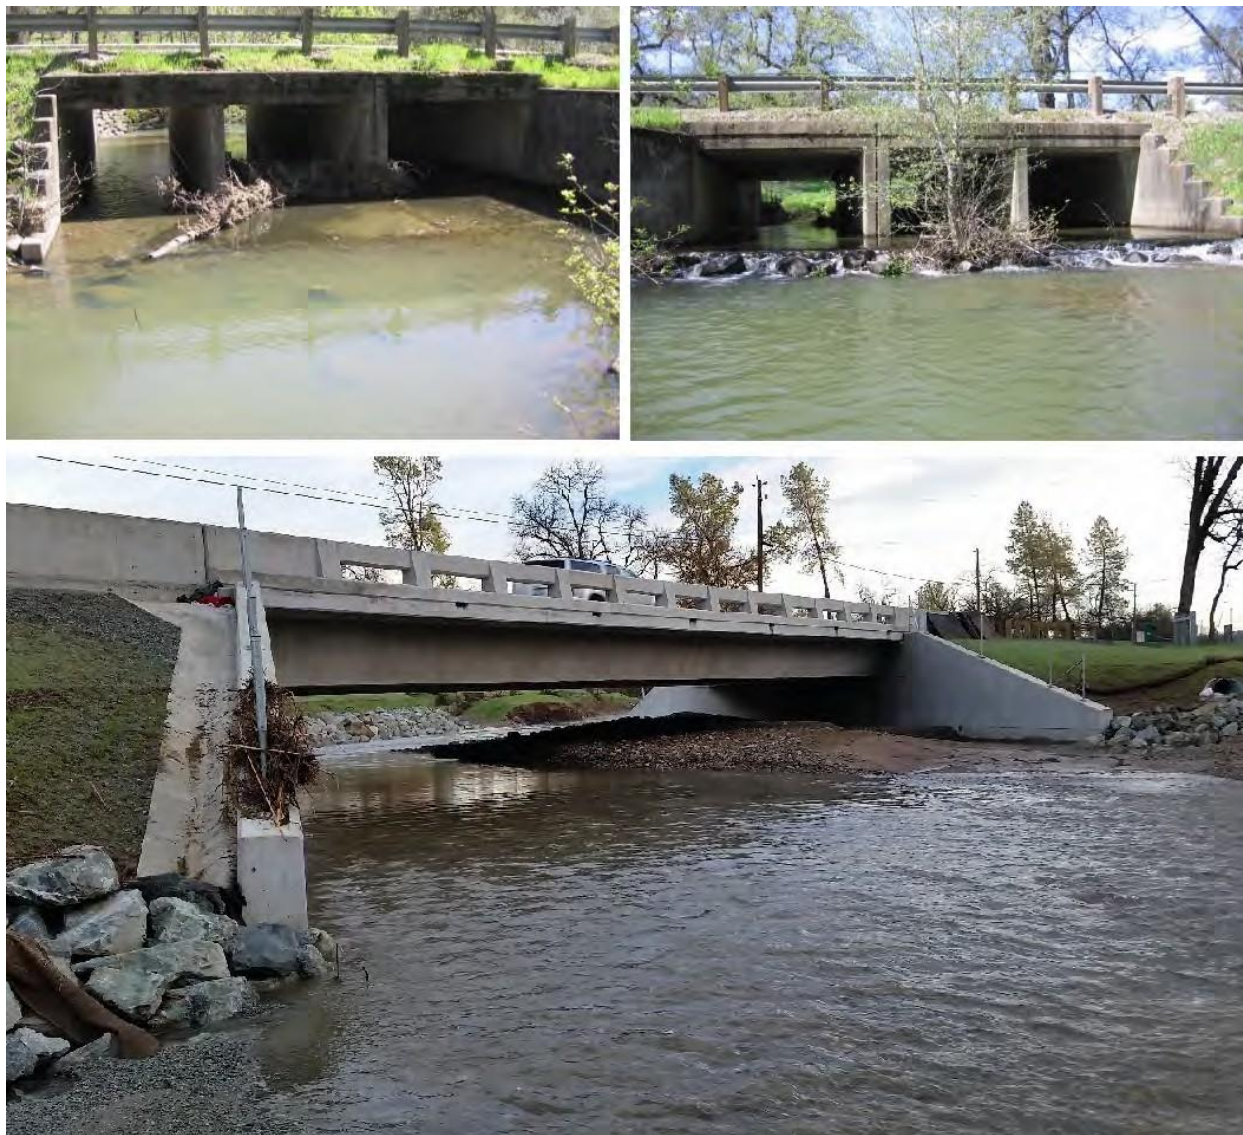
FIGURE 11-1. YANK (LEMM) CREEK CROSSING BEFORE THE BRIDGE CONSTRUCTION (TOP) AND LOOKING DOWNSTREAM AT THE REPLACEMENT BRIDGE IN 2015 (BOTTOM). THE TOP, LEFT PHOTO IS LOOKING DOWNSTREAM AT THE CROSSING AND THE TOP, RIGHT PHOTO IS LOOKING UPSTREAM SHOWING THE PERCHED APRON. NOTE THE HIGH WATER MARK DEBRIS ON THE INLET, LEFT WINGWALL. PHOTOS PROVIDED BY M. MOLINAR, CALTRANS.

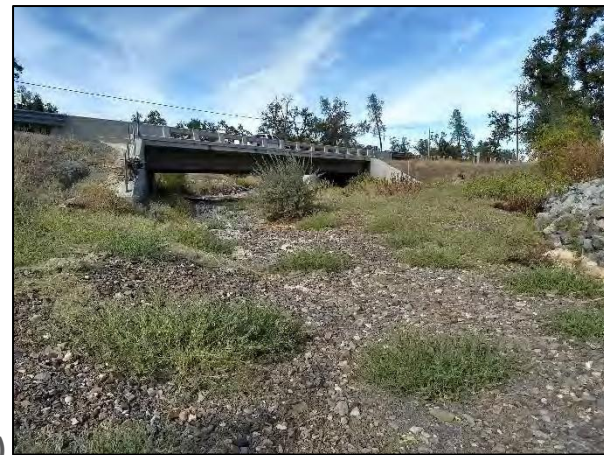
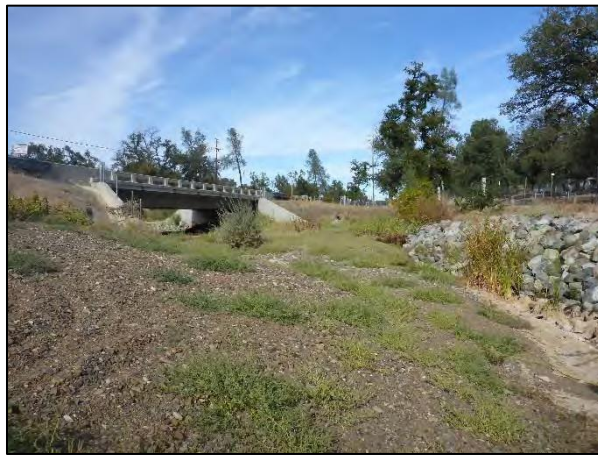
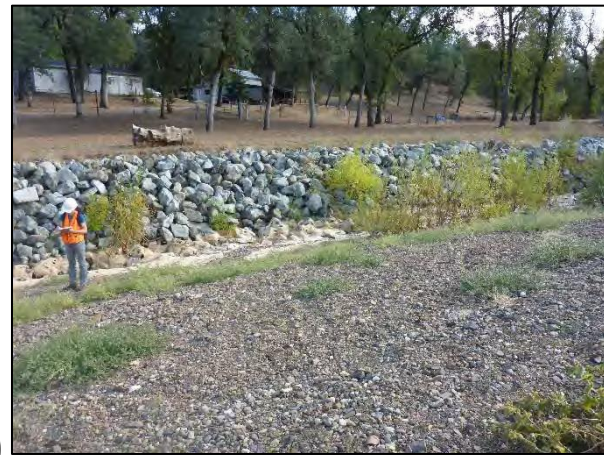
FIGURE 11-2. YANK (LEMM) CREEK (A) UPSTREAM CHANNEL, (B) LOOKING DOWNSTREAM AT THE BRIDGE- NOTE HIGH WATER DEBRIS ON LEFT BANK, (C) CHANNEL UNDER THE BRIDGE SHOWING SKEW FROM LEFT TO RIGHT BANK (D) LOOKING UPSTREAM AT THE BRIDGE — NOTE HIGH WATER DEBRIS ON RIGHT BANK, (E) LOOKING UPSTREAM AT BRIDGE AND 90-DEGREE CHANNEL BEND, AND (F) ARMORED DOWNSTREAM CHANNEL AFTER 90-DEGREE BEND. PHOTOS TAKEN OCT 4, 2019 BY M. LOVE AND M. LANG.

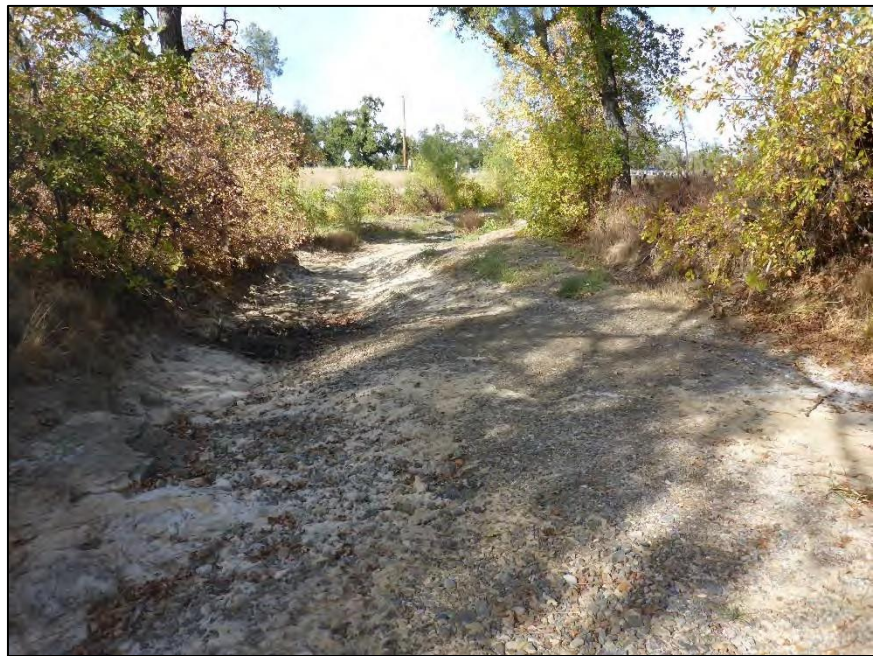
FIGURE 11-5. YANK (LEMM) CREEK (A & B) MORE CONFINED DOWNSTREAM CHANNEL SECTION WITH EXPOSED CLAYSTONE AND BEDROCK CONTROLS. PHOTOS TAKEN OCT 4, 2019 BY M. LOVE AND M. LANG.
