FISH PASSAGE ENGINEERING PROJECT

Site Analysis Final Report

SITE ANALYSIS FINAL REPORT

Humboldt State University
Michael Love & Associates, Inc.

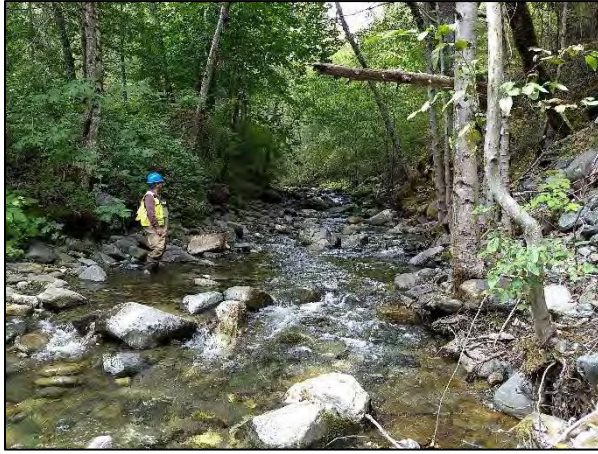
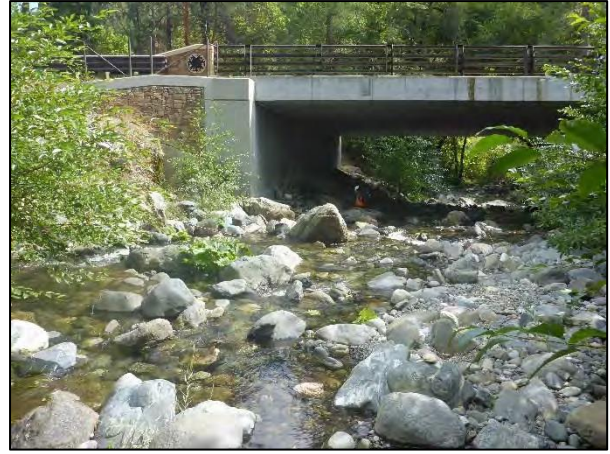
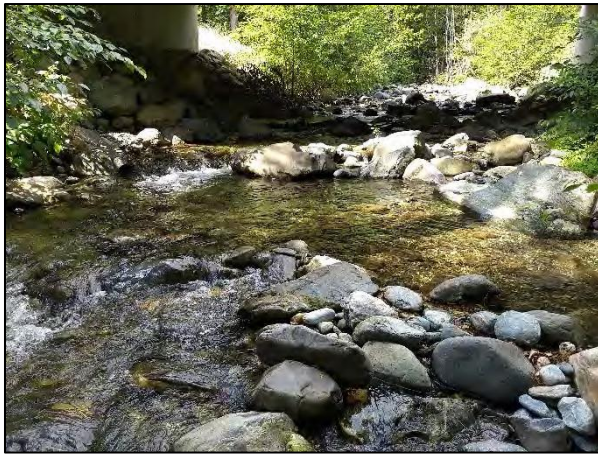
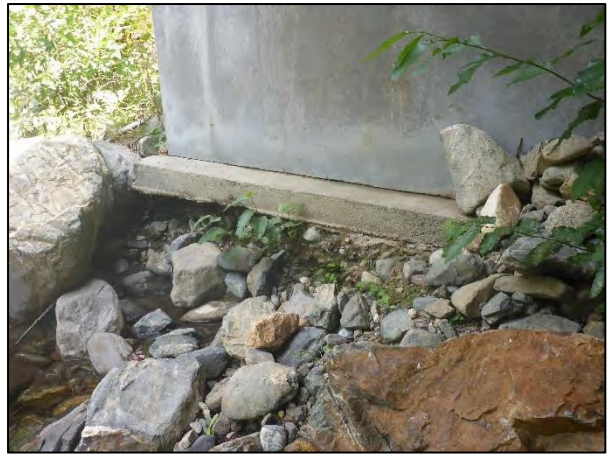
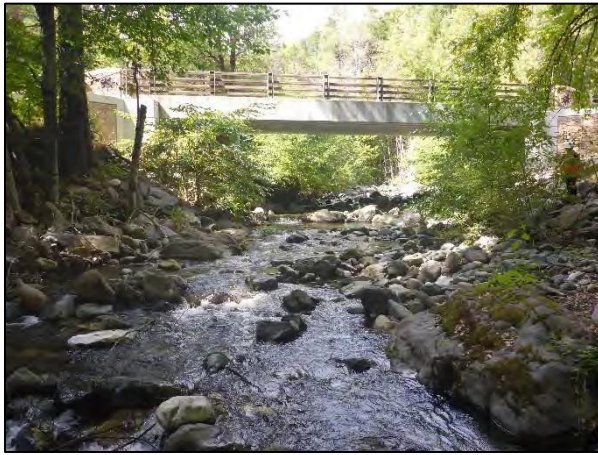
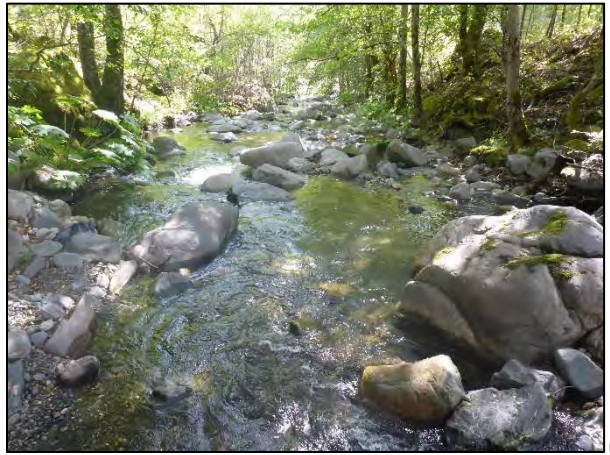
HSU visited the crossing in September 2019 for preliminary assessment and review. This site had a full field survey conducted in March 2021. Photos taken during the 2019 field assessment site visit are provided in Figure 12-3. Overall, the crossing and restored streambed were intact and functioning well. The streambanks constructed along the channel abutments have persisted. They form a bankfull channel that has similar dimensions to the natural channel. The channel bed through the project reach appeared to have similar structure, slope, and hydraulic conditions as the adjacent channel.

The upstream portion of the left abutment footing has scoured and was exposed and undercut for a length of approximately 10 feet (Figure 12-3d and Figure 12-4). The bank material on the left bank just upstream of the bridge was also experiencing some scour. The approaching channel bends to the right, likely resulting in higher velocity on the left bank at the upstream face of the bridge. The approaching channel bend appeared to be more pronounced in the field than shown in the as-built drawings. The extent of scour at the bridge and upstream bank showed no change between the September 2019 initial assessment and the March 2021 survey.

The only observed issue was scour of the bank and placed bank rock along the upstream, left bank. In this region, there was scour along the bank toe and loss of approximately 10 feet of placed rock over the bridge footing (Figure 12-3d and Figure 12-4). This location is the outer bank of a channel bend entering the project reach with bank scour also evident upstream of the project. Thus, it is likely that this bank is exposed to higher velocities that impinge the bank and promote scour. Large RSP was placed in the channel and along the bank during project construction to mitigate potential bank and footing scour but has not completely prevented scour (Figure 12-2a and Figure 12-4). During design development use of a two-dimensional hydraulic model to analyze flow conditions may have highlighted this area as needing larger and/or thicker rock or a change in the grading of the upstream bank and headwall to better protect this area from scour.

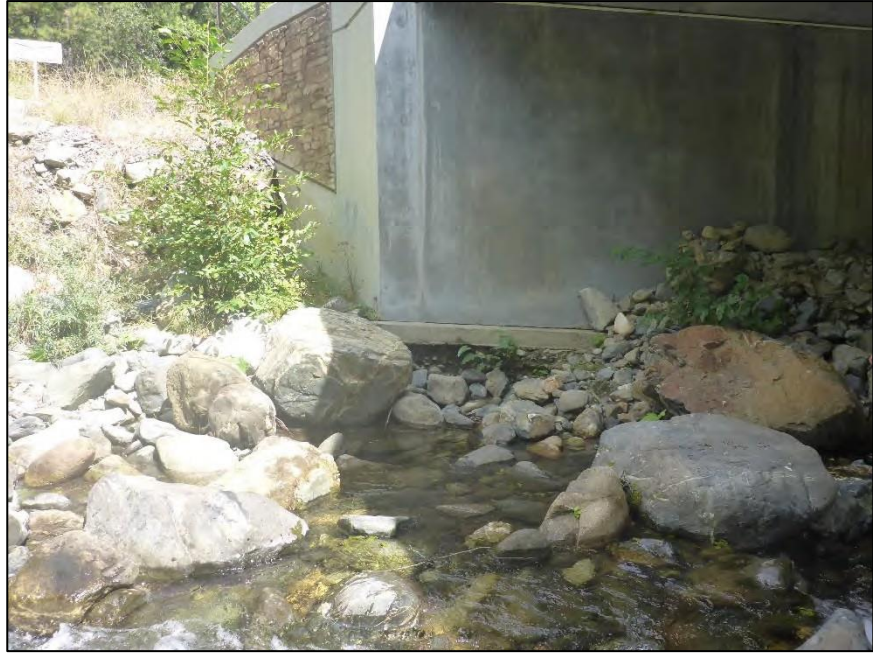
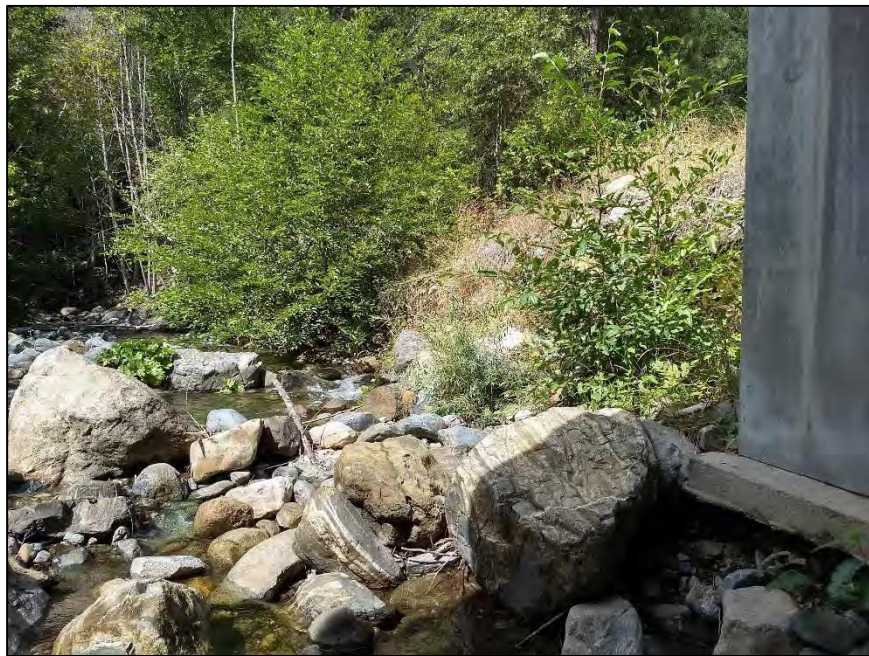
Measured stream channel active and bankfull widths in the project reach are similar to those in the reference reach (Table 12-2). The 51-foot bridge span allows natural channel banks throughout the crossing, with the exception of the upstream scoured section (Figure 12-4).

FIGURE 12-4. UPSTREAM LEFT BANK SCOUR (A) LOOKING DOWNSTREAM AT SCoured BANK BENEATH THE BRIDGE AND (B) LOOKING UPSTREAM AT ROCK POSSIBLY ADDED LATER TO PROTECT THE FOOTING. PHOTO TAKEN SEPT 19, 2019 BY M. LANG.

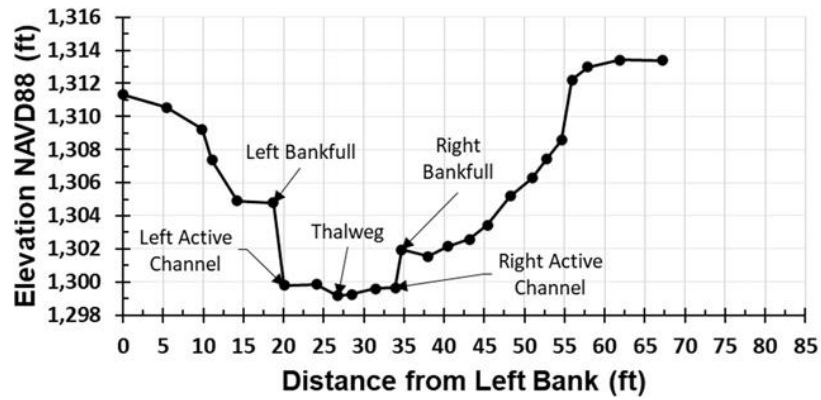
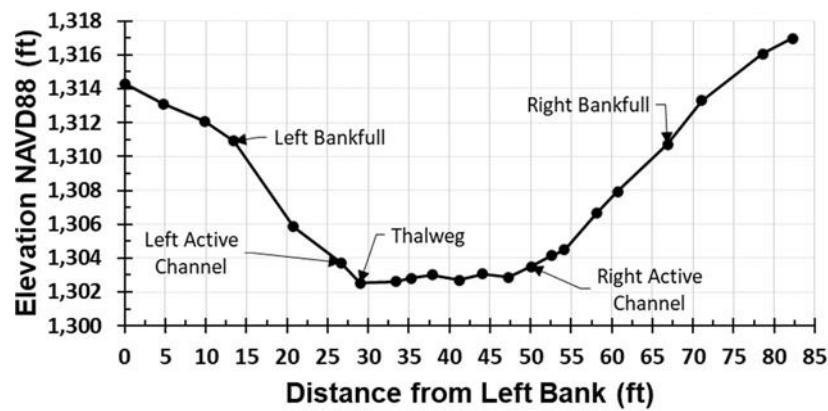
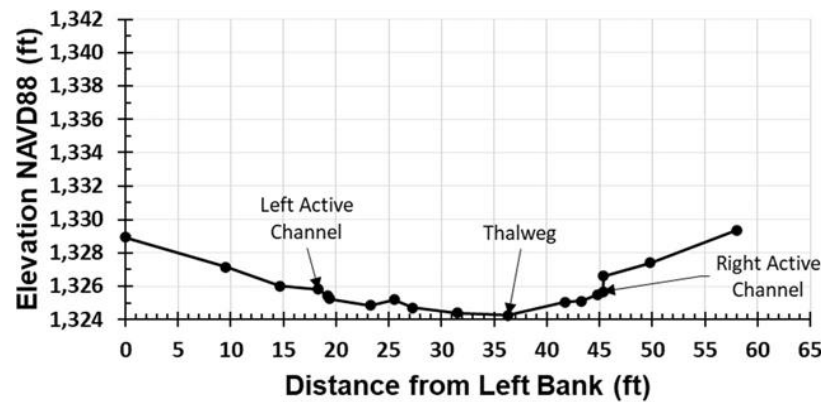
Two cross sections were surveyed in the project reach and one in the upstream reference reach (Figure 12-5). The actively scoured bottom widths (active channel width) and bankfull channel widths were measured (Table 12-2), and key points are noted on the cross sections (Figure 12-5).

In general, the active channel (bottom) and bankfull widths in the project and reference reaches were approximately 23 feet and 27 feet, respectively. The exception are the channel widths just upstream of the bridge. There is some bank scour in the channel bend and just upstream of the bridge that has widened the channel. As noted above, the cross sectional shape of the reference reach (Figure 12-5) does not have as high of banks as the project reach.

FIGURE 12-5. CROSS-SECTIONAL SURVEYS OF THE CHANNEL (A) DOWNSTREAM CHANNEL (XSUS1), (B) AT THE DOWNSTREAM OF THE BRIDGE (XSUS1), AND (C) IN THE UPSTREAM REFERENCE REACH (XSUSREF).

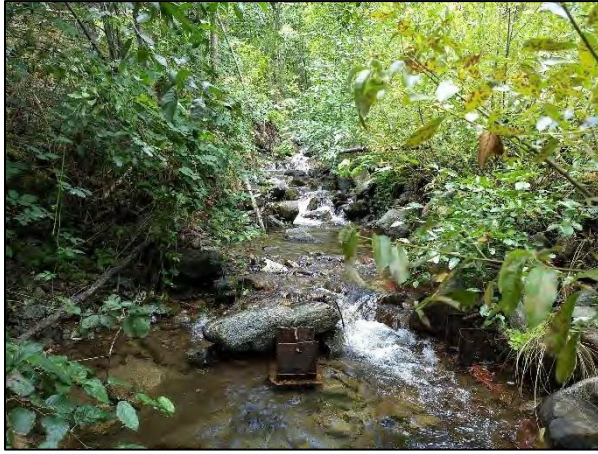
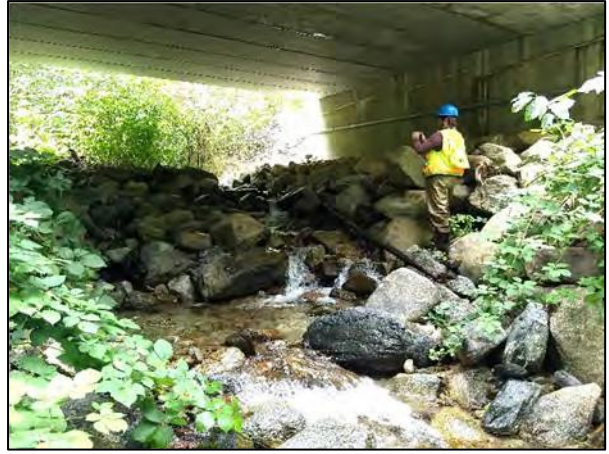
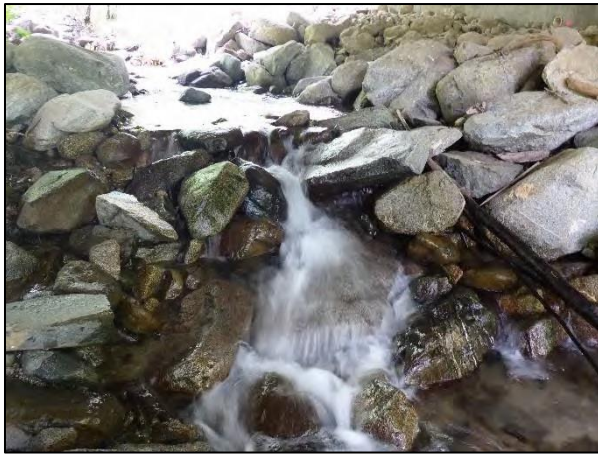
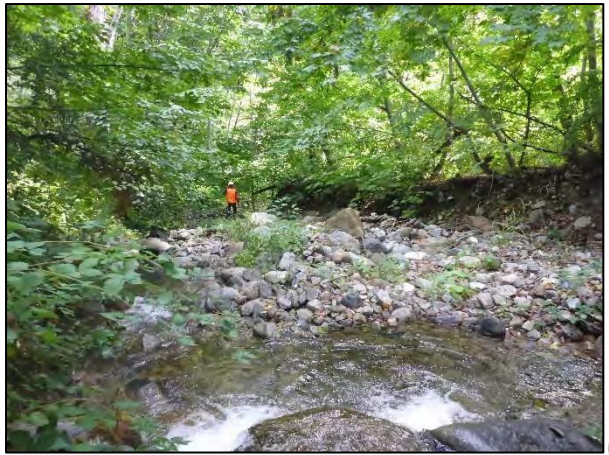
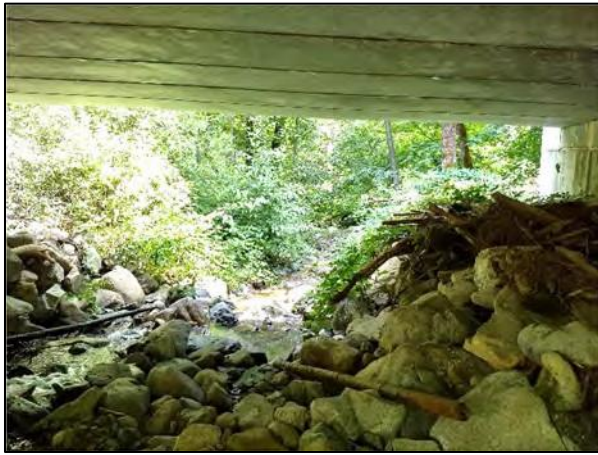
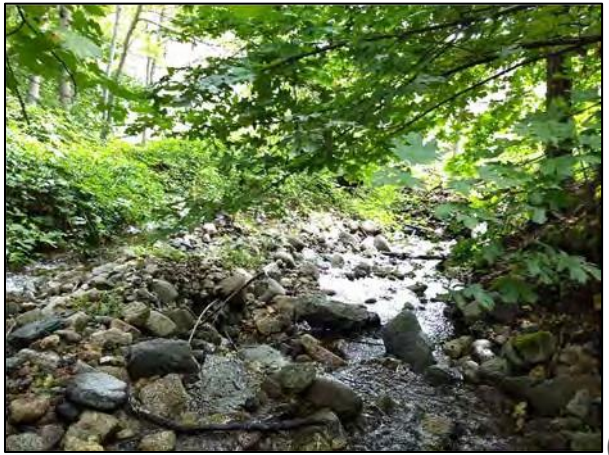
The downstream channel has similar step-pool structure to the upstream channel but all steps are boulder formed and not wood. Approximately halfway between the bridge and the Klamath River confluence, there is a channelized water diversion (see left side of Figure 13-3f). This channel section also experienced backwatering from the Klamath River during one or more recent flood events, resulting in sediment and debris transported by O'Neil Creek depositing in the channel and onto the adjacent banks (Figure 13-4).

Measured stream channel active and bankfull widths are similar in the project reach to those in the adjacent natural channel (Table 13-1). The bridge span is 41 feet and allowing natural channel banks and a terrace to form beneath and through the project (Figure 13-3E).

FIGURE 13-3. O'NEIL CREEK (A) UPSTREAM CHANNEL, (B) LARGE SUBSTRATE UNDER THE BRIDGE WITH LOW FLOW CHANNEL FOLLOWING LEFT BANK, (C) CLOSE UP OF DROP SHOWN IN (B), (D) DOWNSTREAM CHANNEL, (E) LOOKING DOWNSTREAM FROM UNDER BRIDGE, AND (F) DOWNSTREAM CHANNEL THERE IS A HIGHER ELEVATION CHANNEL ON THE LEFT THAT APPEARS TO BE MAINTAINED TO DELIVER A WATER SUPPLY. PHOTOS TAKEN SEPT 19, 2019 BY M. LOVE AND M. LANG.

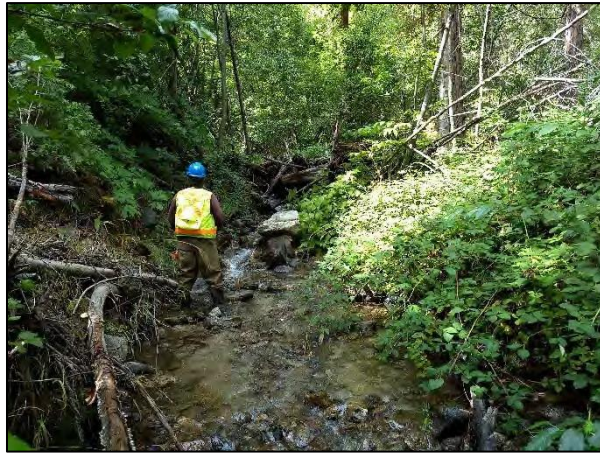
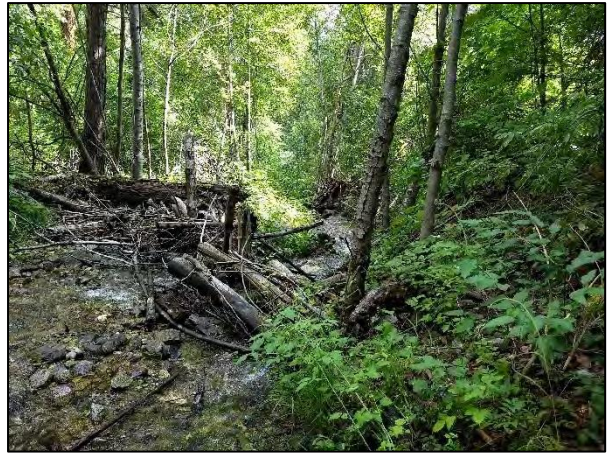
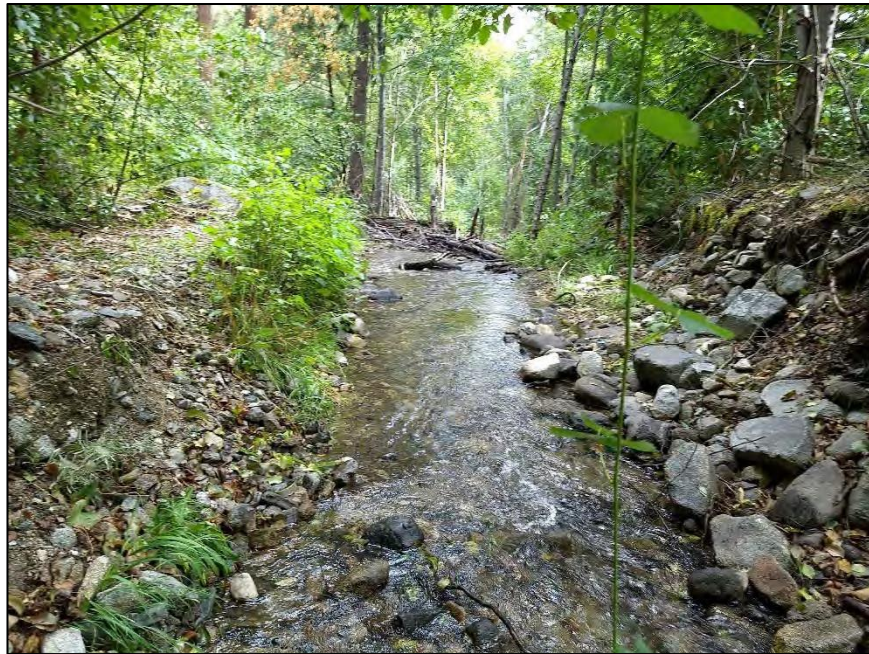
The upstream channel is a step-pool channel formed by boulders and wood, and may be prone to debris flows. There are regular wood debris jams (Figure 13-4) that retain sediment but are likely not permanent. The upstream channel also appears to be incising through sediment deposits or mine tailings (Figure 13-4c).

FIGURE 13-4. UPSTREAM CHANNEL (A) LOOKING UPSTREAM AT LOGJAM ABOVE THE BRIDGE, (B) LOOKING DOWNSTREAM AT CONSECUTIVE LOGJAMS RETAINING SEDIMENT, AND (C) UPSTREAM CHANNEL SEDIMENT DEPOSITS SHOWING EROSION THROUGH SEDIMENT DEPOSITS UPSTREAM OF TEMPORARY LOGJAMS. PHOTO TAKEN SEPT 19, 2019 BY M. LANG.

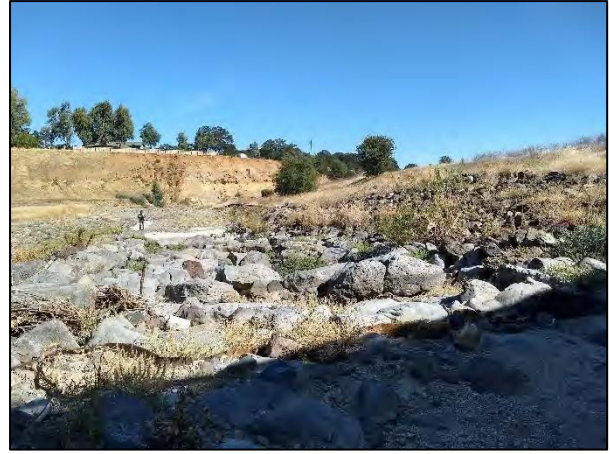
from the high flow, left channel (Figure 14-1c). In addition, material used to fill the voids between the 2-ton rocks forming the weirs was mostly scoured out making the weirs more porous. The remnants of the Backing No. 1 rock (~1-ft diameter) are present within the pools (Figure 14-1b) and do continue to act as roughness elements within the fishway. Despite these changes, the fishway appeared to be able to function as intended but, because of these structural changes, its effective length may be reduced.

FIGURE 14-1. DIBBLE CREEK (A) UPSTREAM CHANNEL LOOKING DOWNSTREAM AT CROSSING (MAIN CHANNEL ON LEFT OF PICTURE), (B) LOOKING DOWNSTREAM AT THE ROCK RAMP (SHEET PILING GRADE CONTROL IN FOREGROUND), (C) LOOKING UPSTREAM AT ROCK RAMP (D) LOOKING DOWNSTREAM AT ROCK RAMP AND CHANNEL, (E) LOOKING UPSTREAM AT CROSSING, AND (F) EXAMPLE OF ARMORED BRIDGE PIERS IN MAIN CHANNEL. PHOTOS TAKEN OCT 2019 BY M. LOVE AND M. LANG.

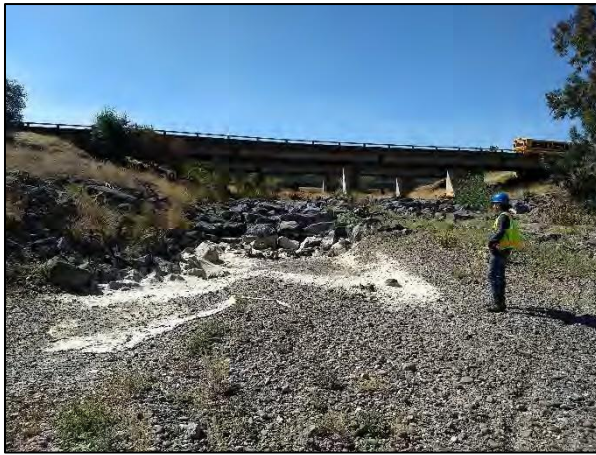
(C)

In 2019, the basic structure of the rock weir fishway and the four rock weirs were essentially intact but some structural elements were missing or displaced. Two primary changes to the site as-built were noted. The first was loss of Backing No. 1 and permeable material used to form the streambed between the rock weirs. The second was that a downstream portion of the lateral berm was missing and appears to have been overtopped and displaced by flow entering

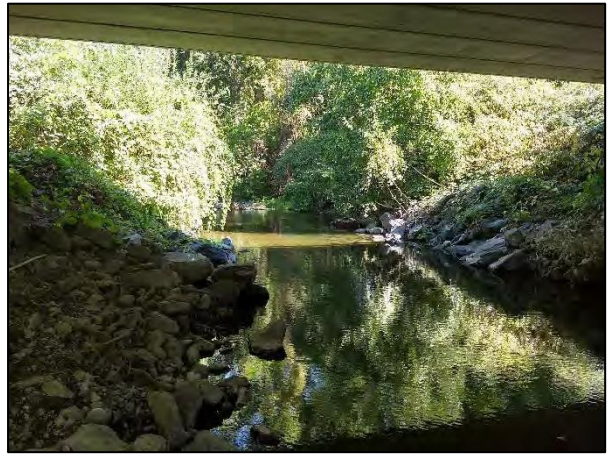
The Craig Creek crossing is functioning as designed and not an impediment to fish passage. The project motivation was primarily mitigation of bridge foundation scour which was addressed with the installation of a wider bridge with deeper abutments. The crossing is within a channel that is highly incised and there appears to be additional scour occurring beneath the bridge as evidenced by mobilization of RSP on the right bank (Figure 15-2b) and undercutting of grouted rock/RSP on the left bank (Figure 15-2c).

FIGURE 15-2. CRAIG CREEK (A) UPSTREAM CHANNEL WITH COARSE SUBSTRATE DEPOSITS LOOKING DOWNSTREAM AT BRIDGE, (B) UPSTREAM CHANNEL LOOKING UPSTREAM FROM BRIDGE, (C) LEFT BANK IS UNDERCUTTING UNDER THE BRIDGE, (D) RIGHT BANK UNDER THE BRIDGE HAS SOME SCOUR, (E) DOWNSTREAM CHANNEL LOOKING UPSTREAM AT BRIDGE, AND (F) DOWNSTREAM CHANNEL IS HIGHLY INCISED. PHOTOS TAKEN OCT 4 19, 2019 BY M. LOVE AND M. LANG.

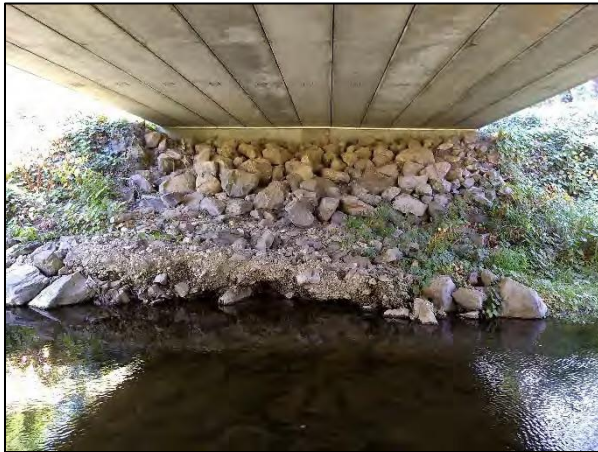
(C)

The channel gradient through the project is low and most of the site is backwatered by shallow riffles or constriction by the bank RSP (Figure 15-2). The RSP on the left bank is undercut by scour and appears to have been previously grouted to mitigate the scour progression (Figure 15-2c). The right bank RSP has also scoured and some of the large rock along the toe has been displaced. This scour is not compromising the bridge structure or adversely affecting fish passage conditions.

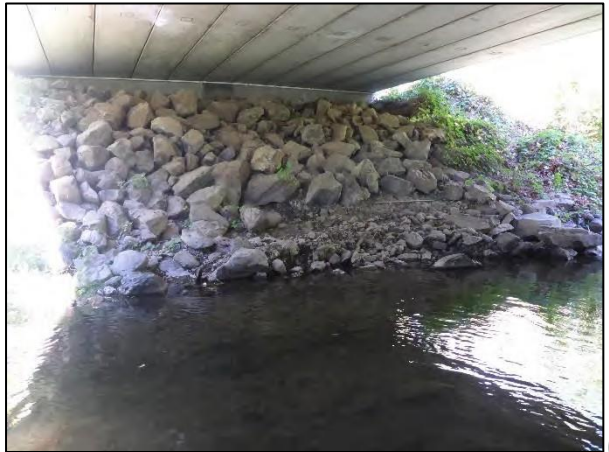
(D)

The channel substrate is a mix of fine silt, sand, and gravel. There are gravel patches and occasional riffles (Figure 15-2A and E). The entire channel through the project reach and beyond is highly incised and this is more prevalent downstream (Figure 15-2D, F). This incision appears to be regional and is consistent with channel scour and degradation observations and estimates used in the project design. Caltrans (2008) estimated the scour potential from combined degradation and local scour at 8 feet at the new bridge foundation and recommended another 6 feet of depth, for a total of 14 feet, for the new bridge abutments.

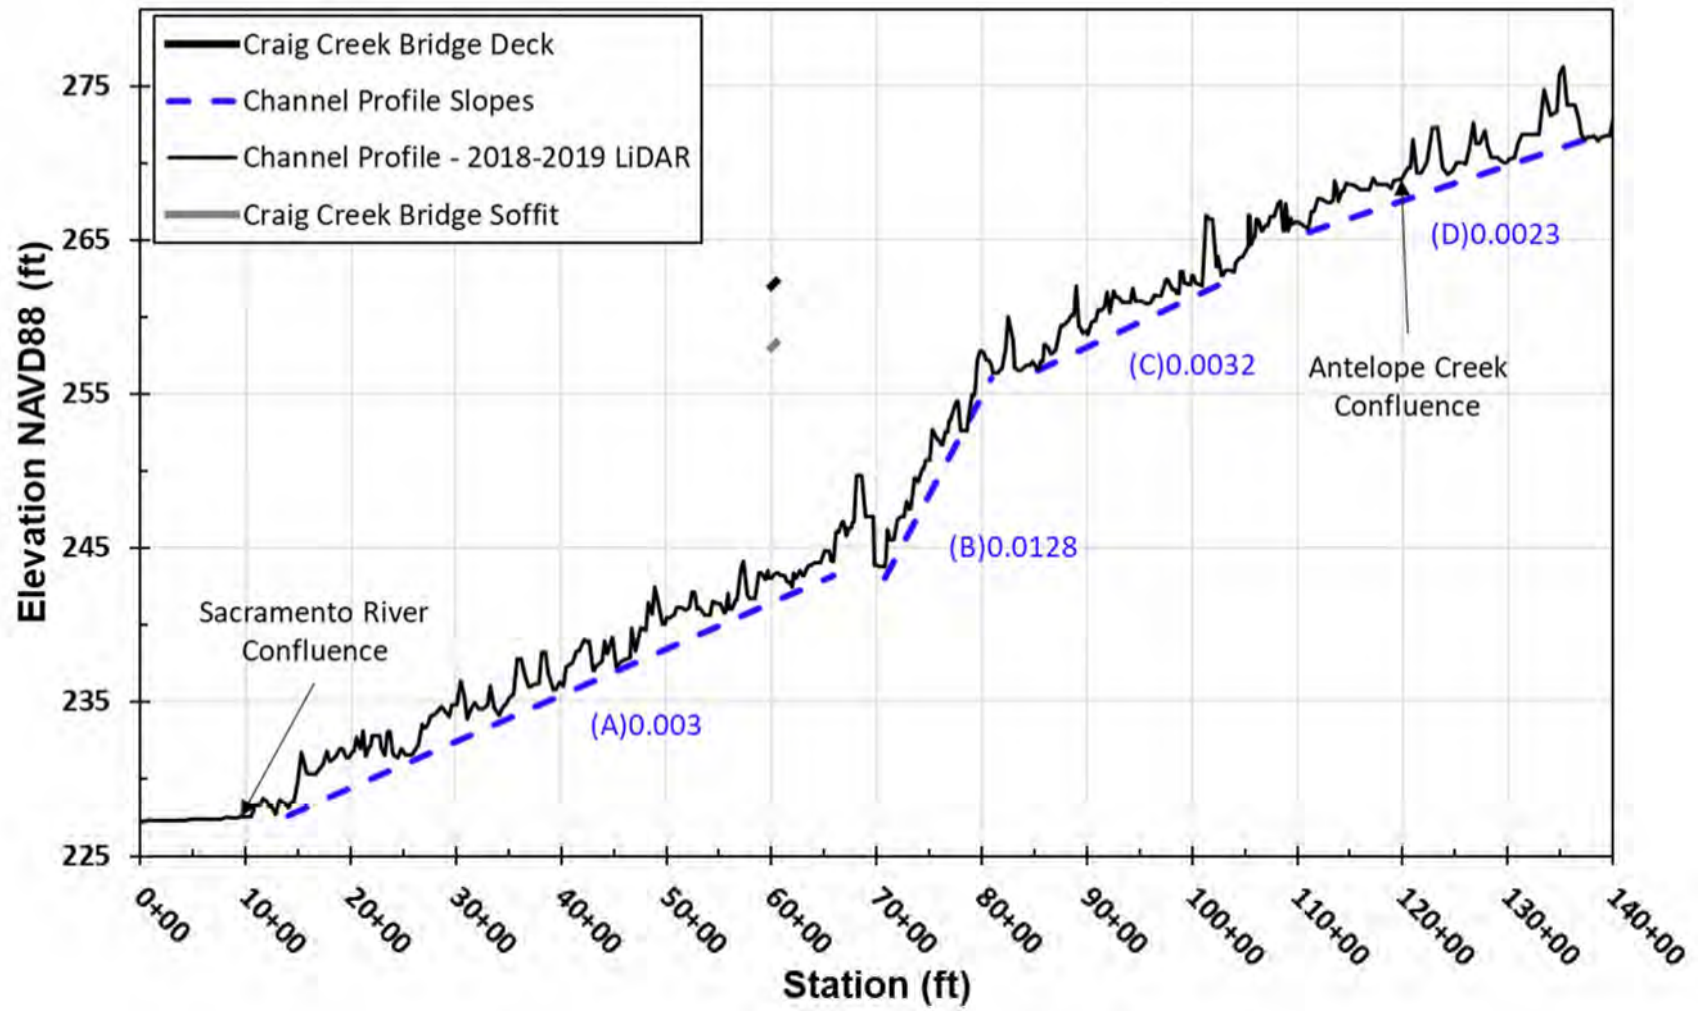
FIGURE 15-4. CHANNEL PROFILE THROUGH PROJECT REACH GENERATED FROM THE LIDAR DEM WITH CHANNEL SLOPE SEGMENTS DEFINED.

The DEM from the 2019 USGS LiDAR was used to generate an extended longitudinal profile through the project site (Figure 15-3 and Figure 15-4). The Craig Creek bridge is about equidistant from the Antelope Creek confluence with Craig Creek and Craig Creek's confluence with the Sacramento River. Throughout most of the channel, the average slope is 0.3 percent. However, approximately 1,000 ft upstream of the bridge there is a steeper channel section approaching 1.3 percent. A review of aerial photographs shows this steeper reach being controlled by exposed bedrock. The channel downstream of the bridge and through the project reach is highly incised. This steeper channel section appears to be the current knickpoint.

The extended longitudinal profile (Figure 15-4) suggests that the majority of the incision and scour potential has migrated upstream of the crossing. However, sediment transport from a migrating headcut, regional influences that might be altering connected channel elevations and water diversions may continue to be an influence on the stream morphology in this reach. The site should be periodically monitored for additional incision, scour and possible influences of the RSP constriction at the crossing creating a depositional zone and higher slope channel segment upstream of the bridge.

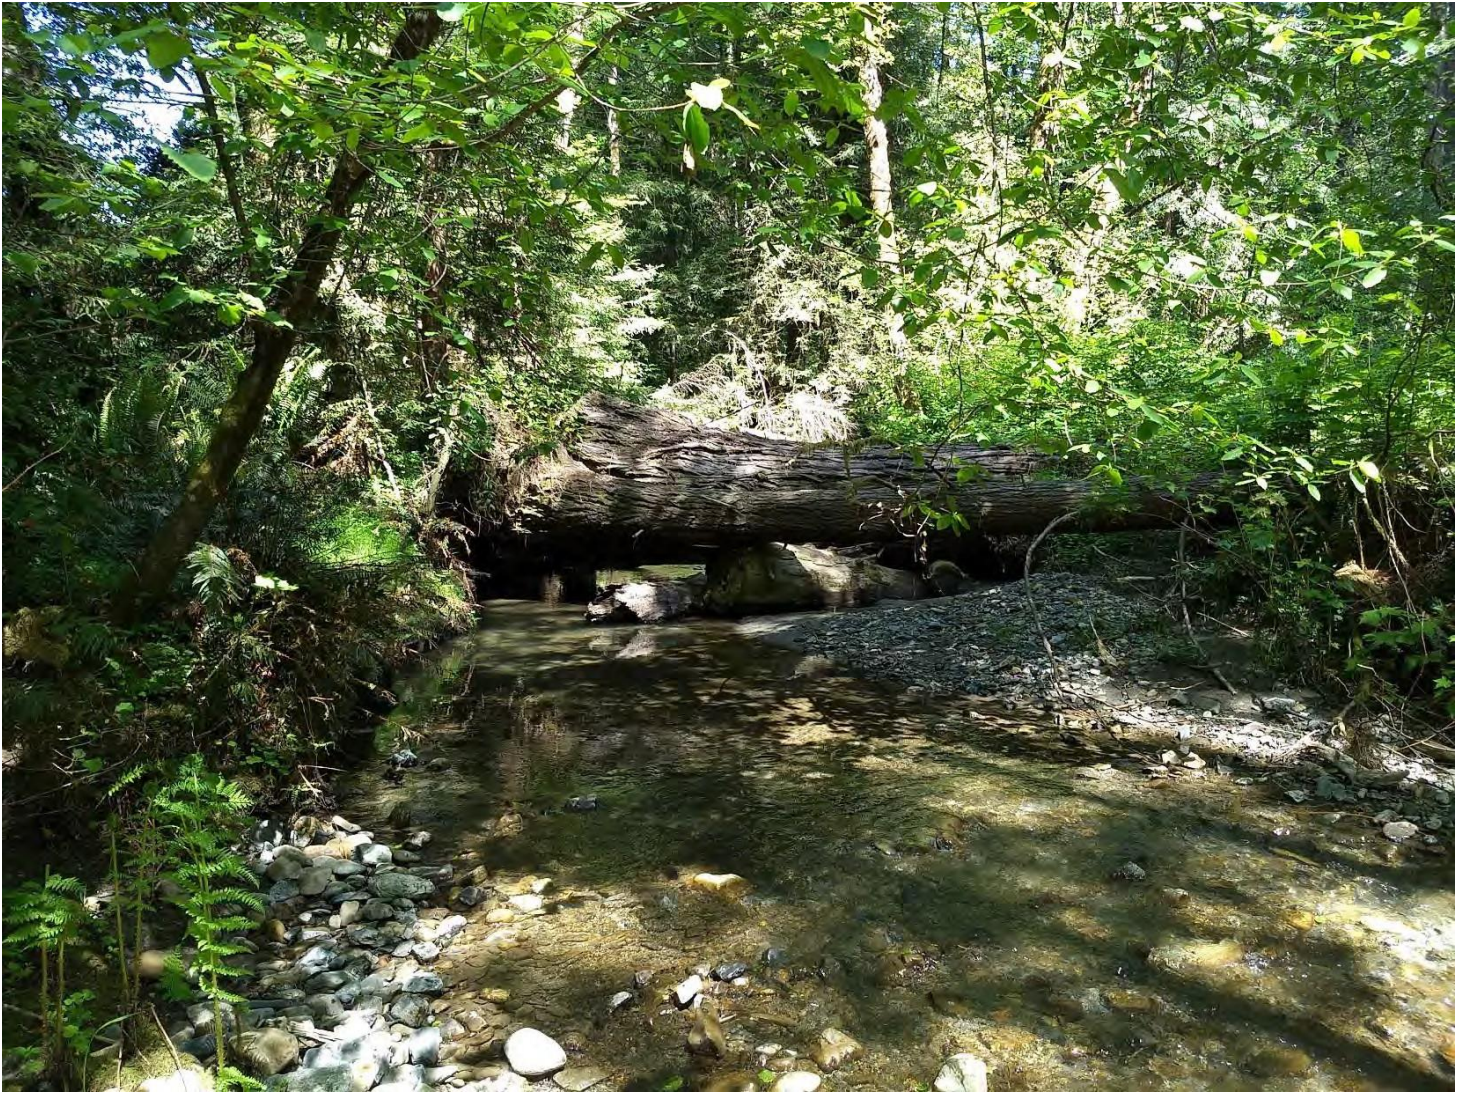
The culvert might have caused the channel to migrate towards the left bank and scour a tree. The tree has now fallen into the channel, backwatering the culvert inlet during high flow events, and is beginning to accumulate some debris. Channel aggradation has occurred upstream of this debris/logjam.

Figure 1. Upstream channel looking upstream to show logs in channel.

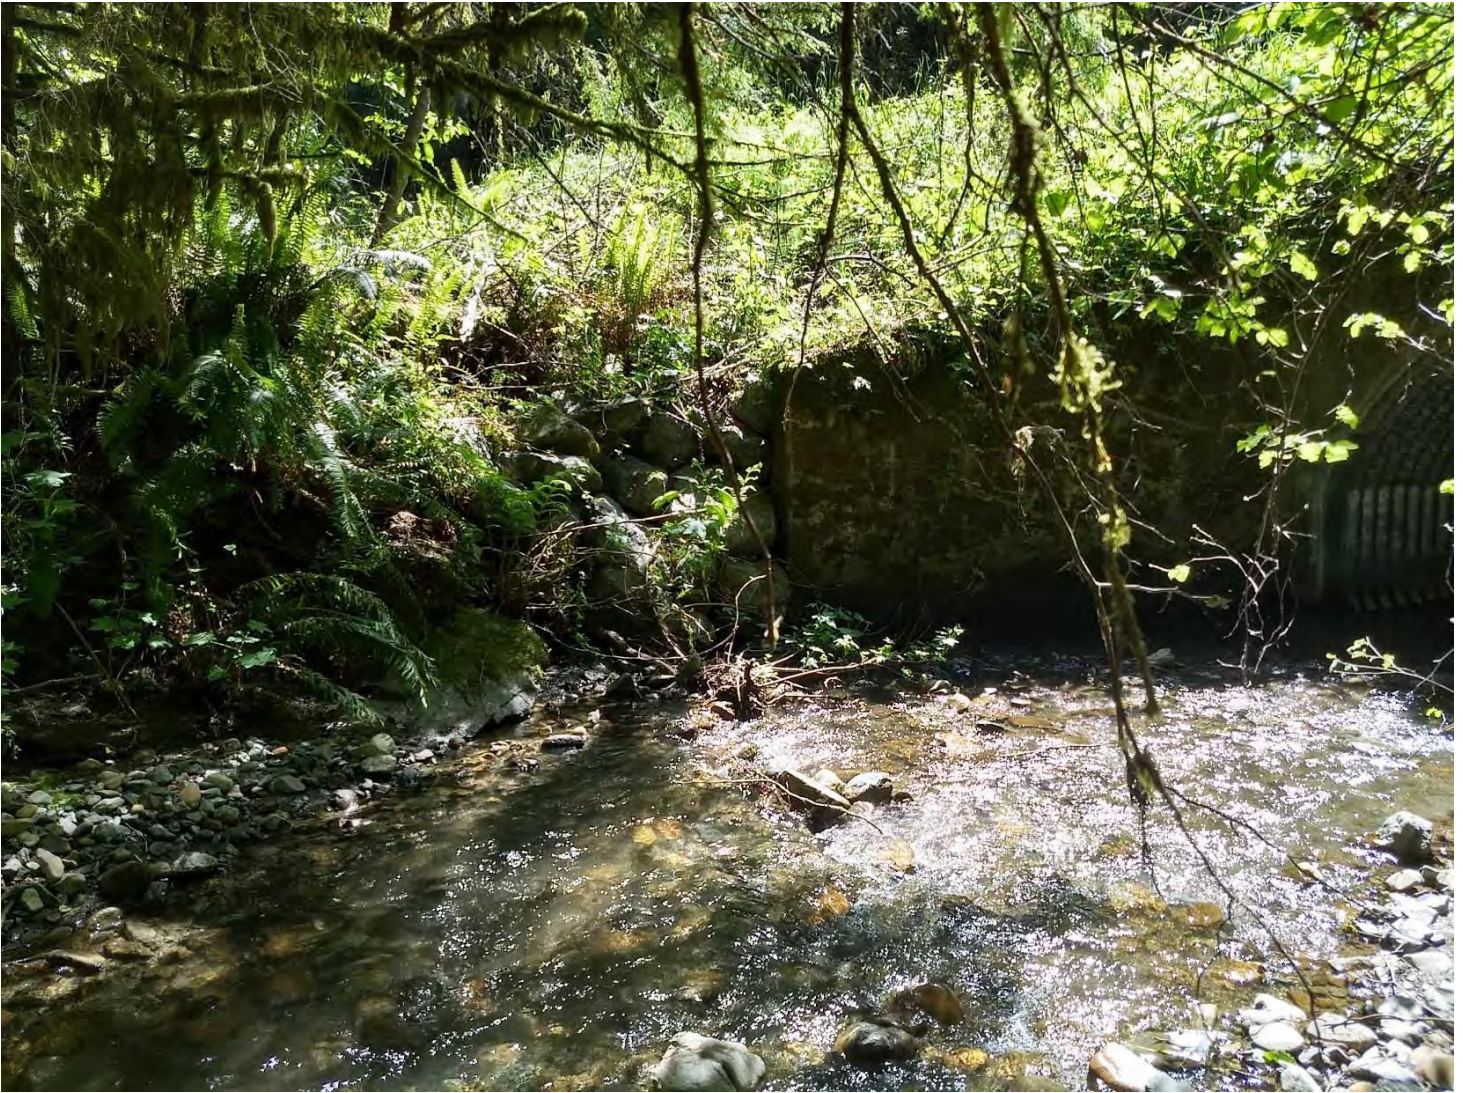
Figure 2. Left inlet wingwall showing some bank erosion from backwatering during high flows.

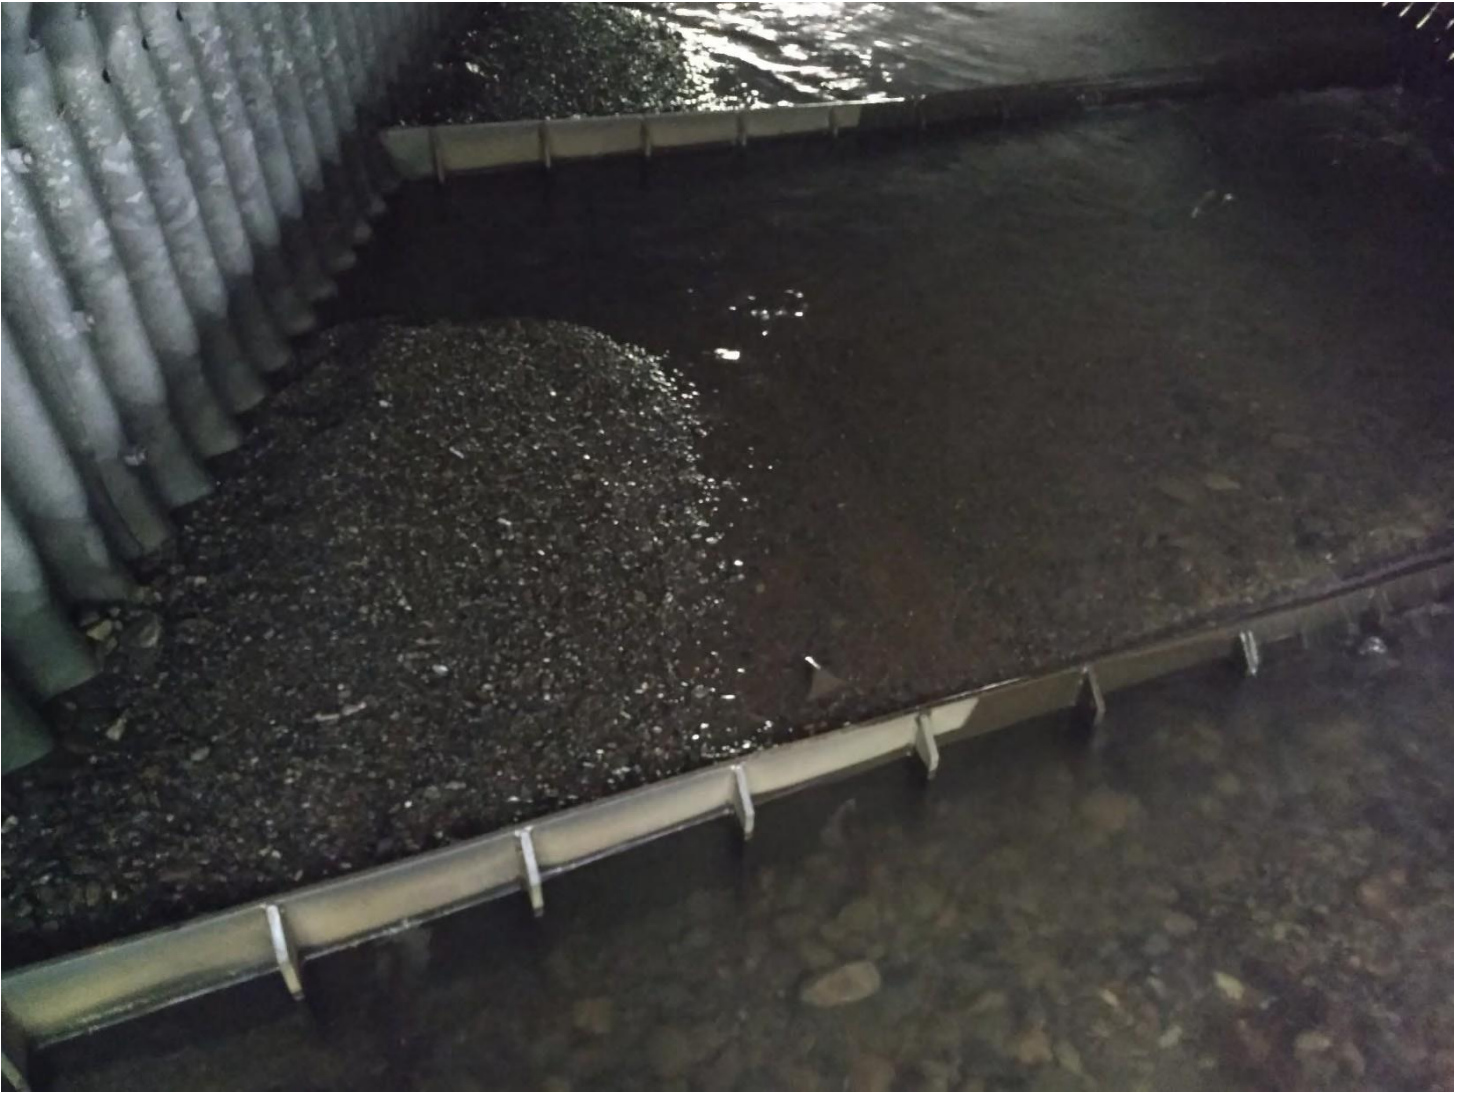
Comments						
Structural condition	Excellent	<u>Good</u>	Fair	Poor	Failed	
Comments						
Is there any visual evidence of damage to the structure?				Yes	<u>No</u>	
if yes, take photos and describe:						
Picture name	Description					
Is there an accumulation of sediment or debris in or upstream of the facility?				<u>Yes</u>	No	
if yes, take photos and describe:		Baffles are trapping some sediment which may increase local velocity and reduce depth but the sediment doesn't appear to be impairing passage hydraulics.				
Picture name	Description					
Figures 3 & 4	Attached Figures 3 and 4 show the culvert baffles and trapped sediment

Figure 4. Sediment accumulation behind most baffles.

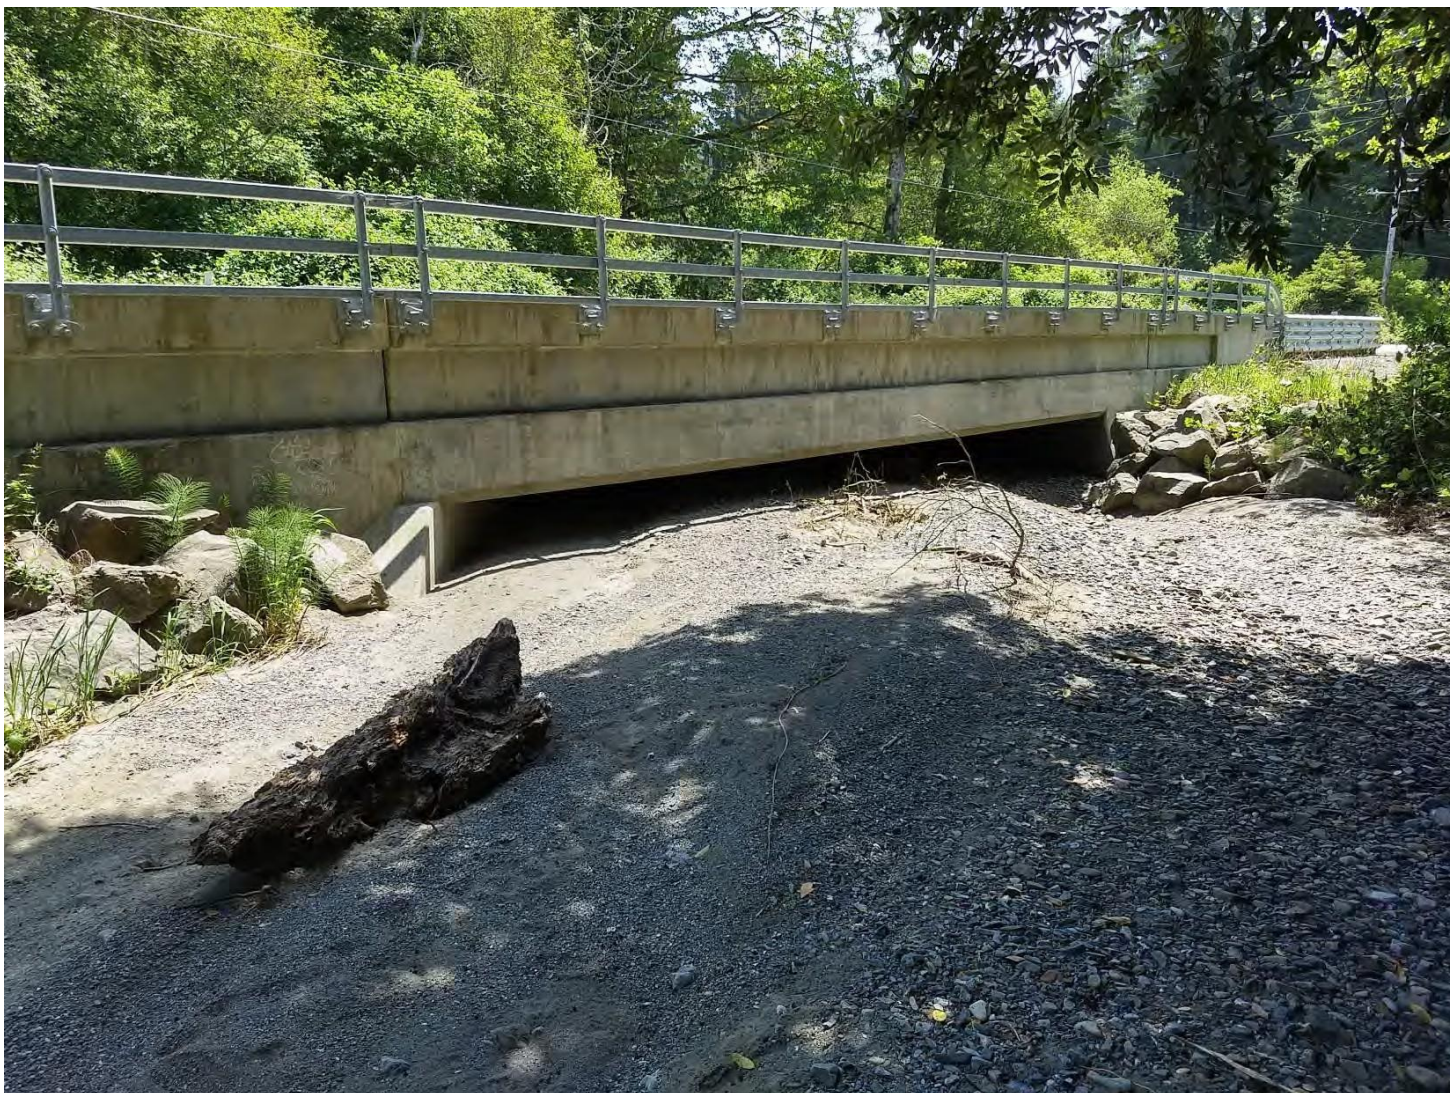
The reduced cross section area is likely affecting fish passage under some conditions.

Figure 1. Sediment accumulation under the Sultan Creek bridge on Del Norte 197, postmile 5.00. View is looking upstream from the downstream channel.

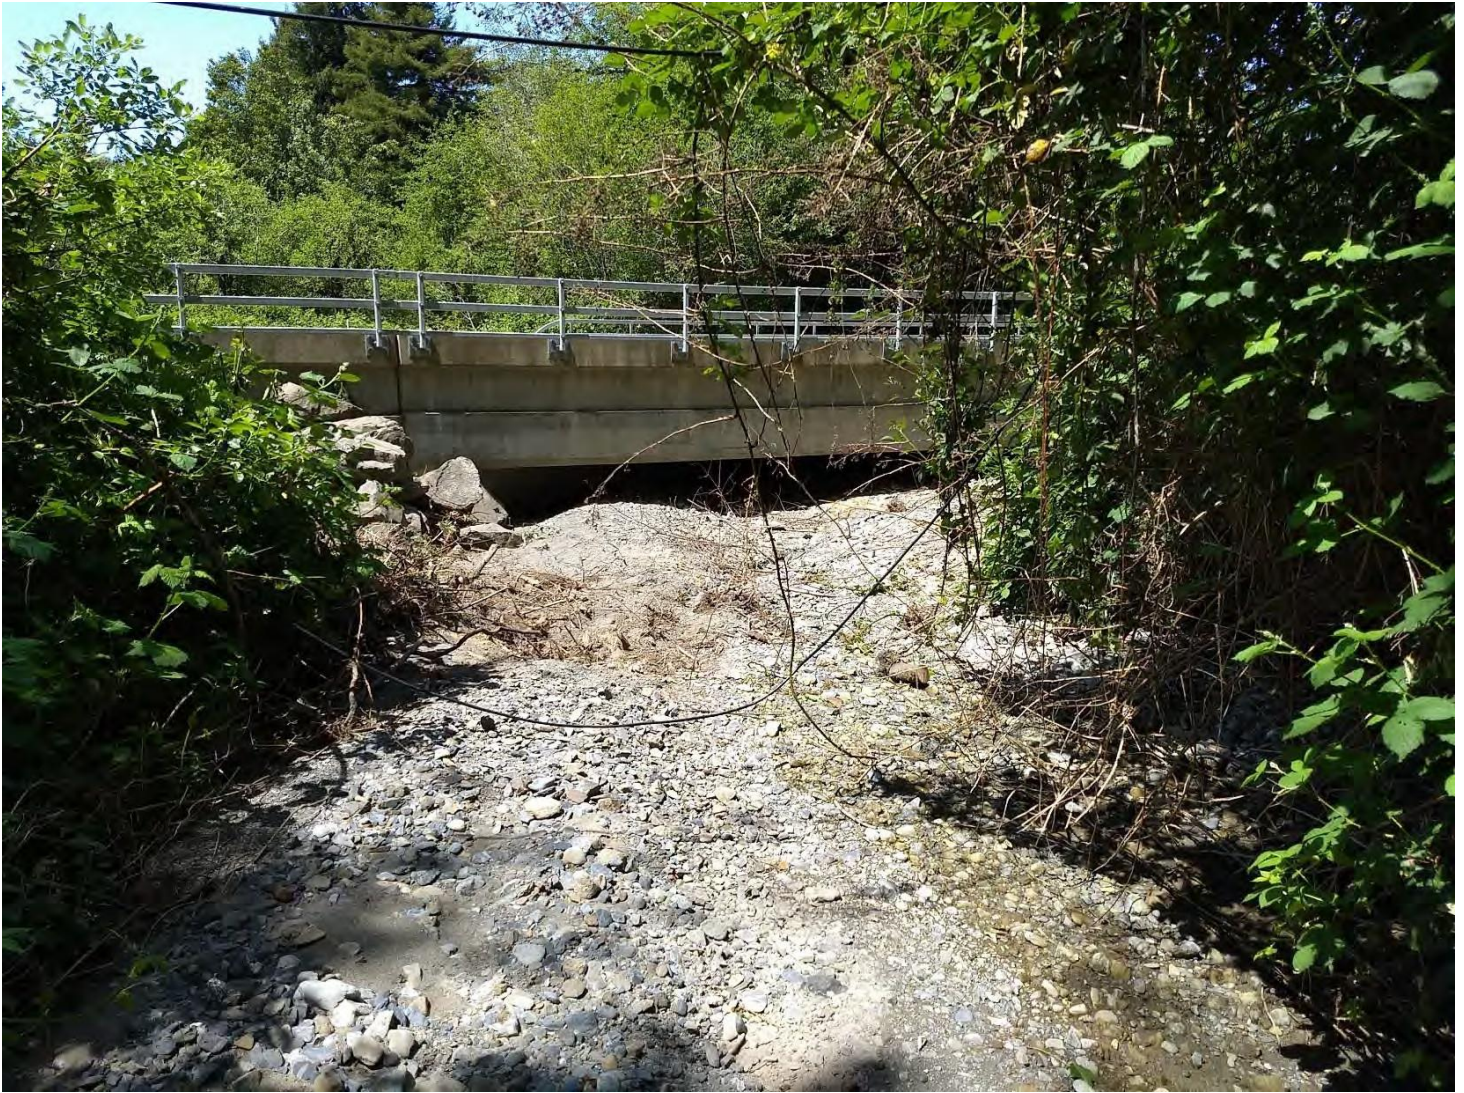
Structural condition	Excellent	Good	Fair	Poor	Failed	
Comments						
Is there any visual evidence of damage to the structure?	Yes	No				
if yes, take photos and describe:						
Picture name	Description					
Is there an accumulation of sediment or debris in or upstream of the facility?	Yes	No				
if yes, take photos and describe:	The crossing site is in a depositional zone with lots of aggradation and debris is accumulated in the channel upstream of the crossing..					
Picture name	Description					
Figure 1	View of accumulated sediment looking upstream from downstream channel.					
Figure 2	View of accumulated sediment looking downstream from upstream channel.

Figure 2. Sediment accumulation under the Sultan Creek bridge on Del Norte 197, postmile 5.00. View is looking downstream from the upstream channel.

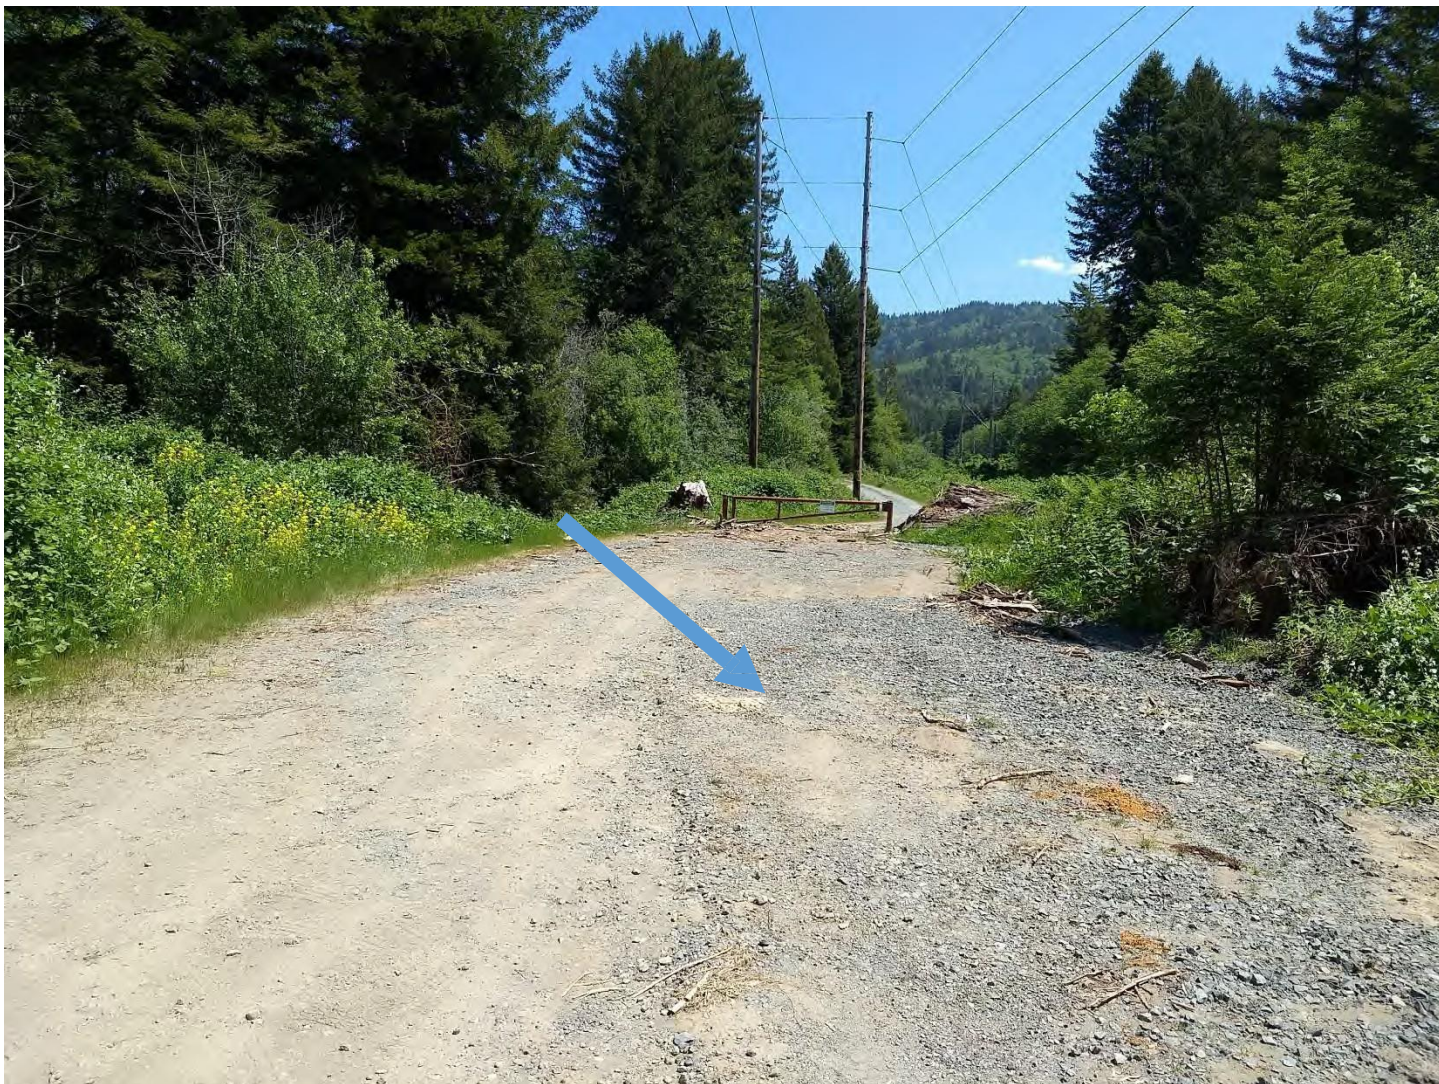
Figure 3. At high flow, water leaves the channel at this location and flows down the Green Diamond access road. There is a debris jam and channel bend at this location in the main channel.
