FISH PASSAGE ENGINEERING PROJECT

Site Analysis Final Report

SITE ANALYSIS FINAL REPORT

Humboldt State University
Michael Love & Associates, Inc.

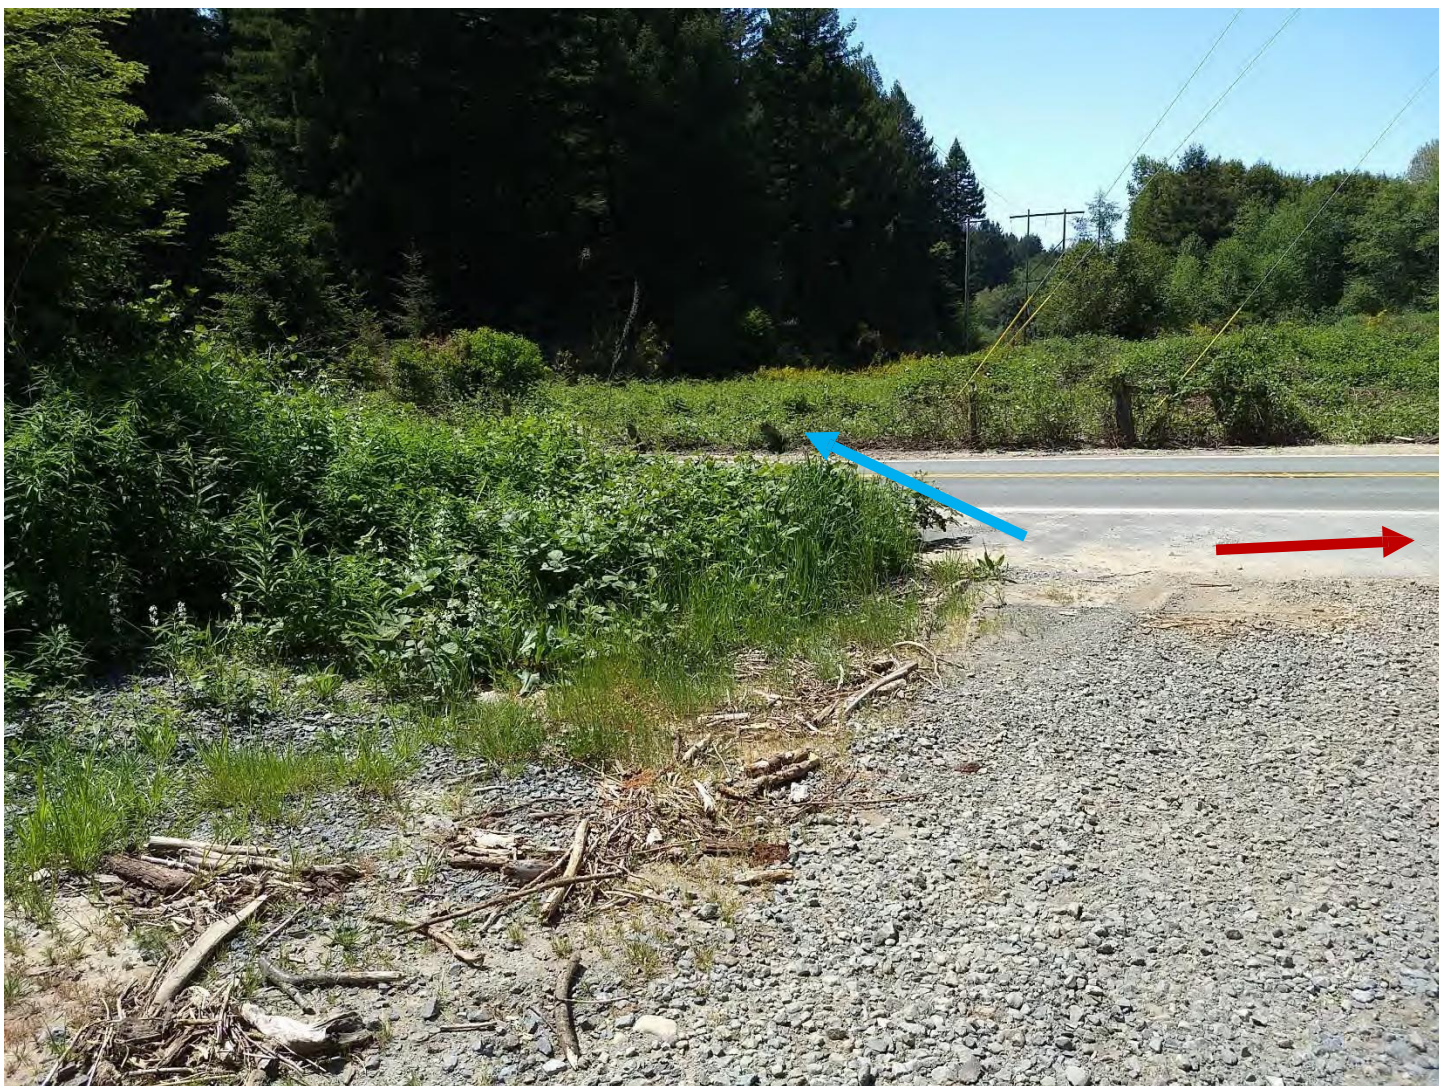
Figure 4. Intersection of Green Diamond access road and DN 197. Water along the road has deposited wood from the channel. Water that leaves the channel flows to the left on DN 197 (blue arrow); Sultan Creek is to the right (red arrow).

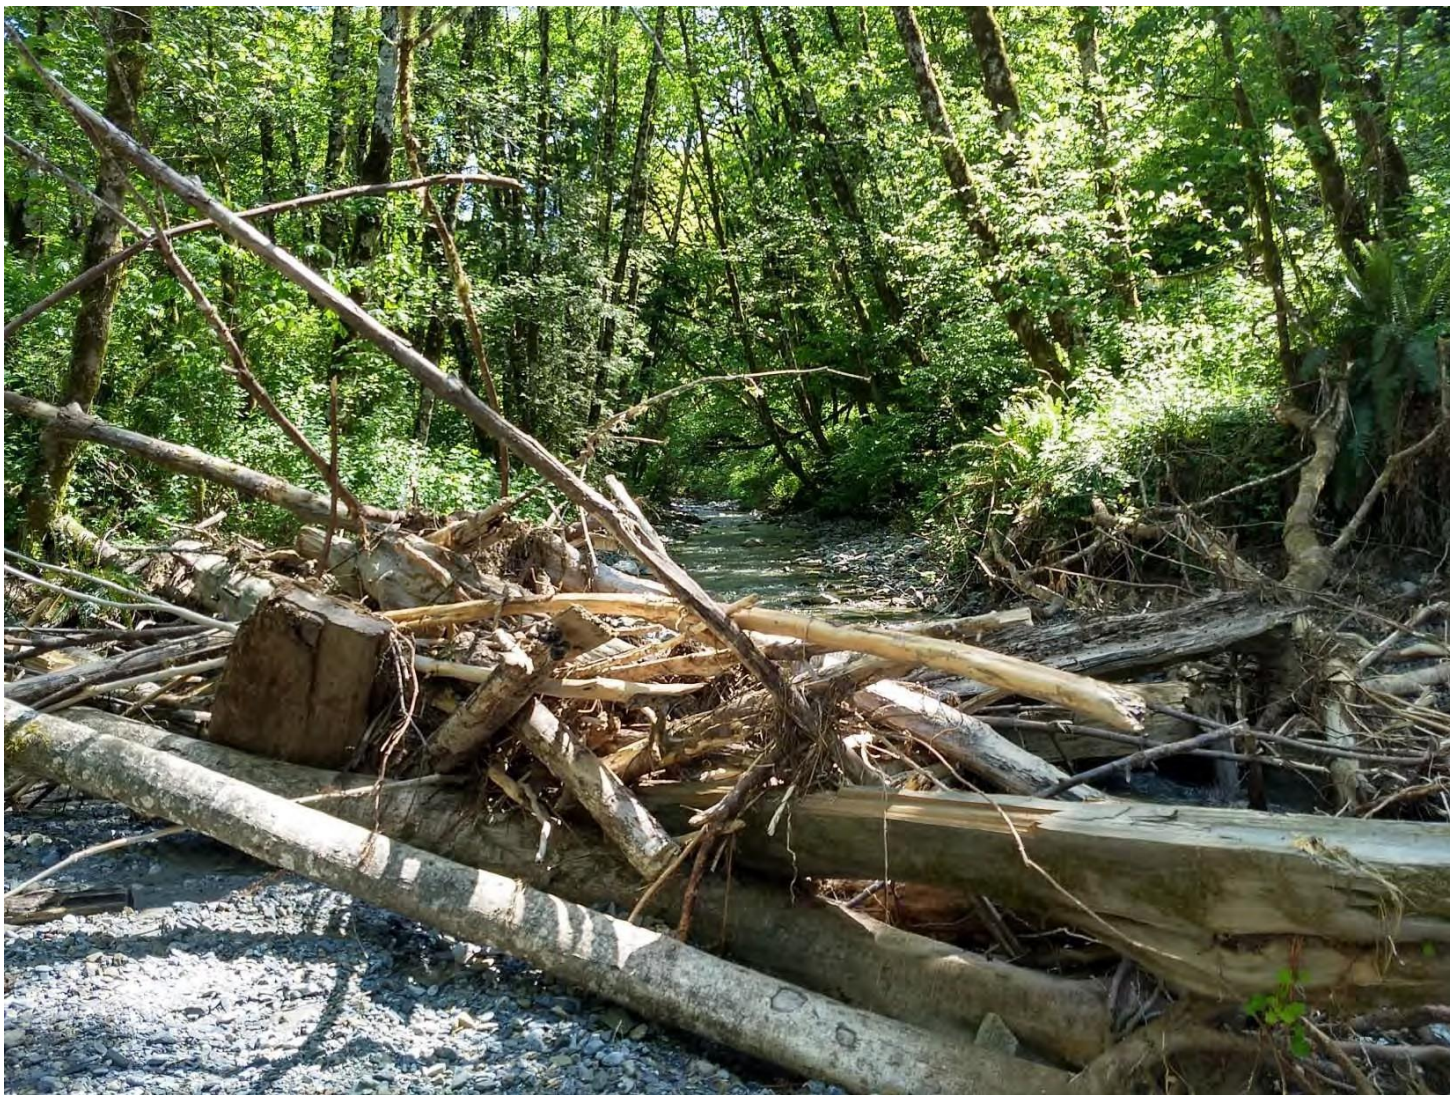
Figure 1. Wood and sediment ~100 m upstream of project site. View is looking US. This deposit would likely not be captured at the crossing.

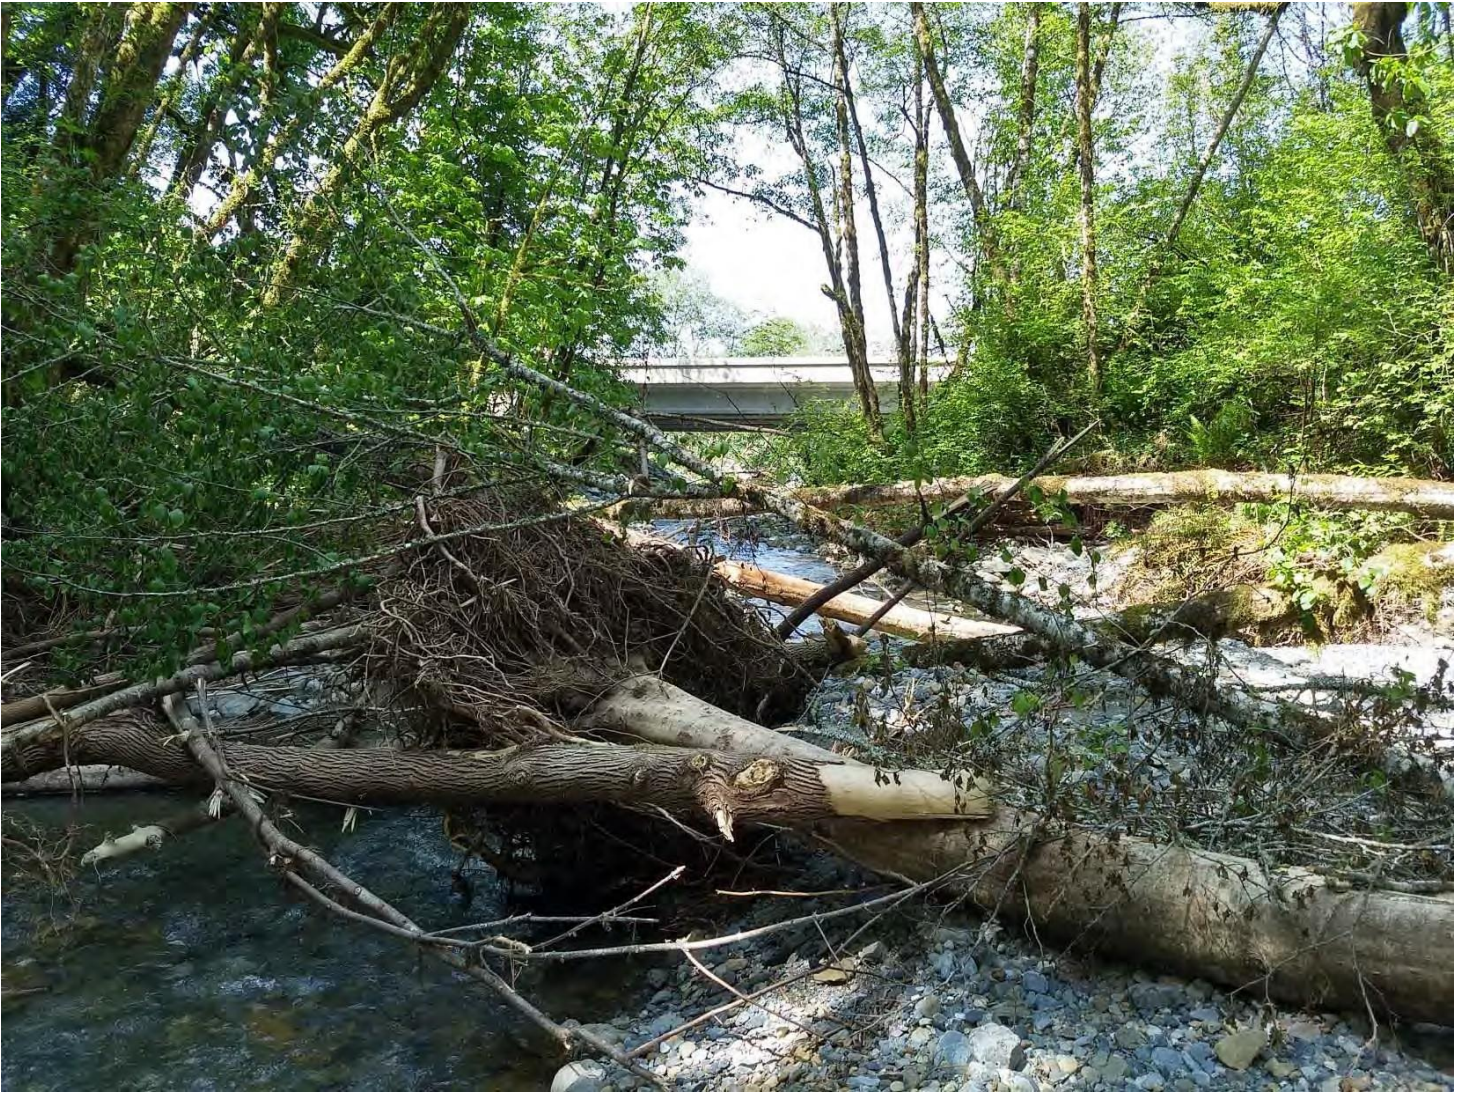
Figure 2. Wood and sediment ~100 m upstream of project site. View is looking DS through project site. This deposit would likely not be captured at the crossing.

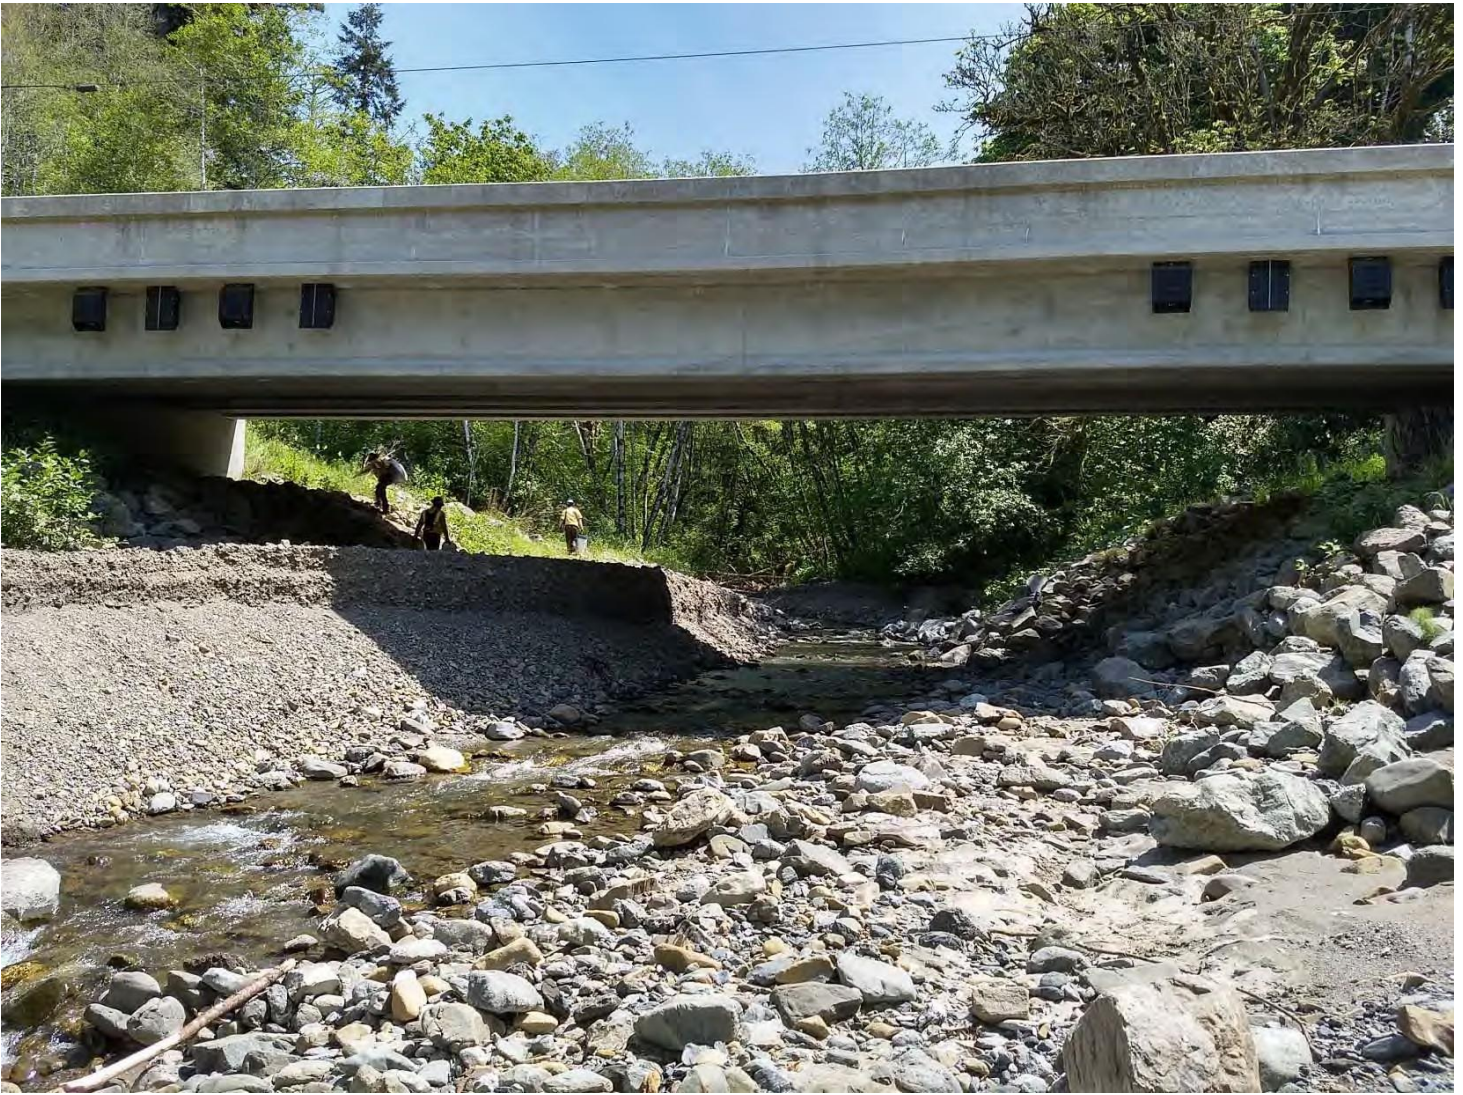
Figure 3. Right bank sediment deposit looking US through project site.

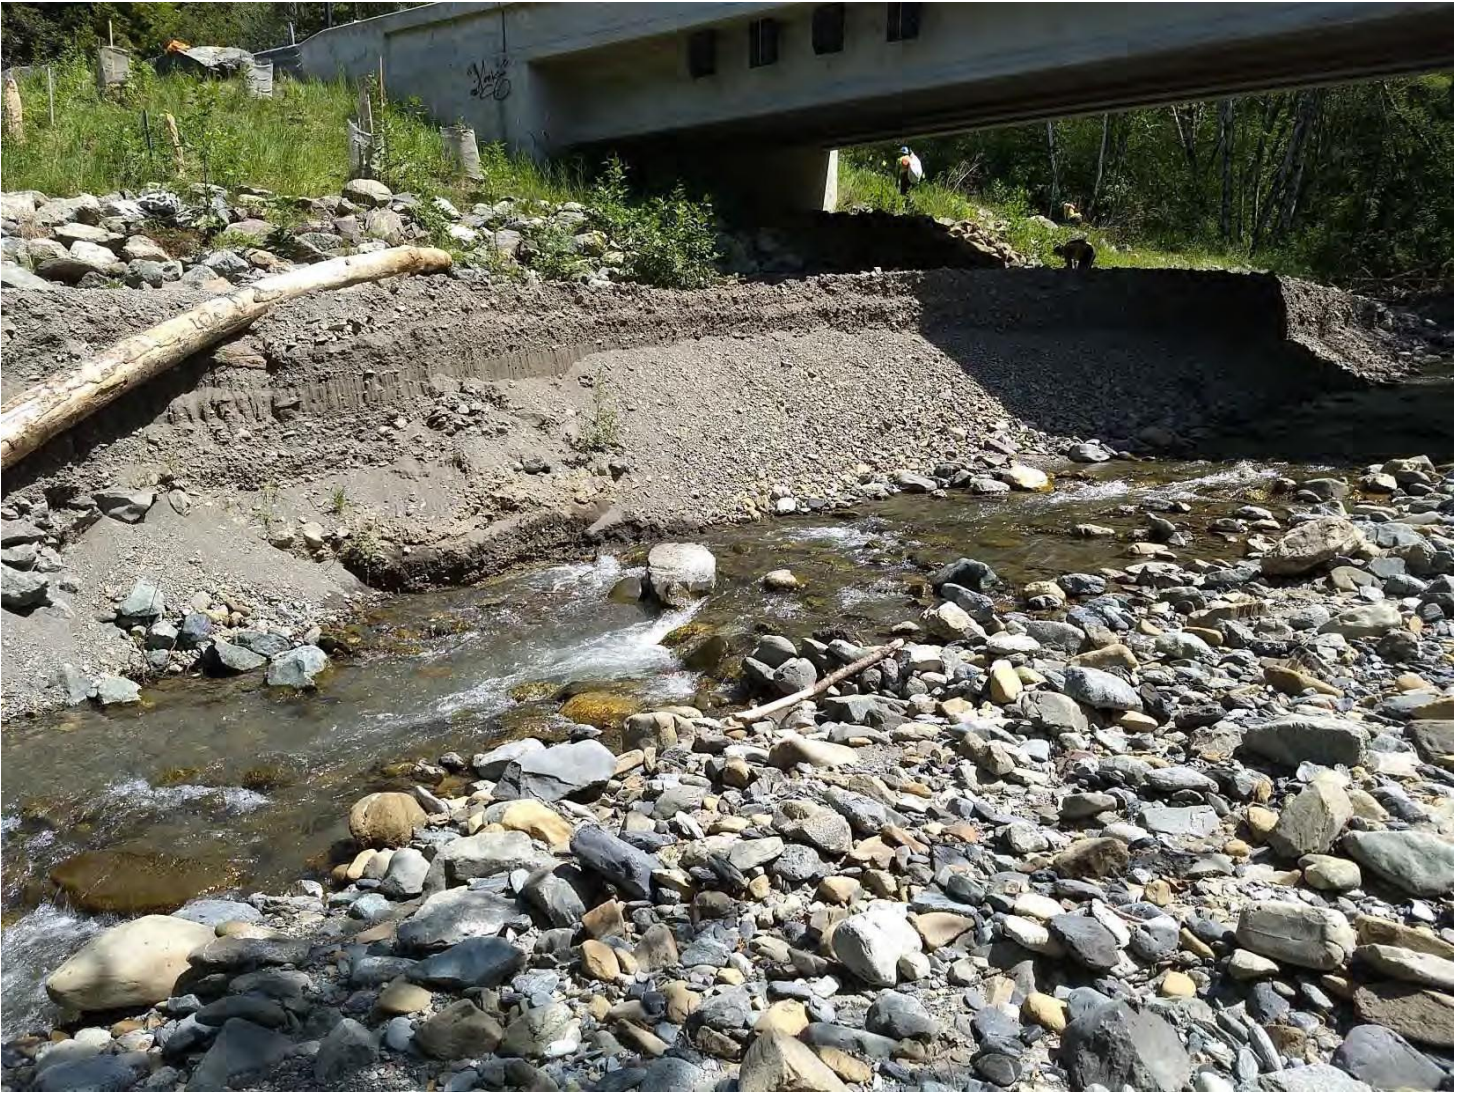
Figure 4. Right bank sediment deposit looking US through project site – closer view.

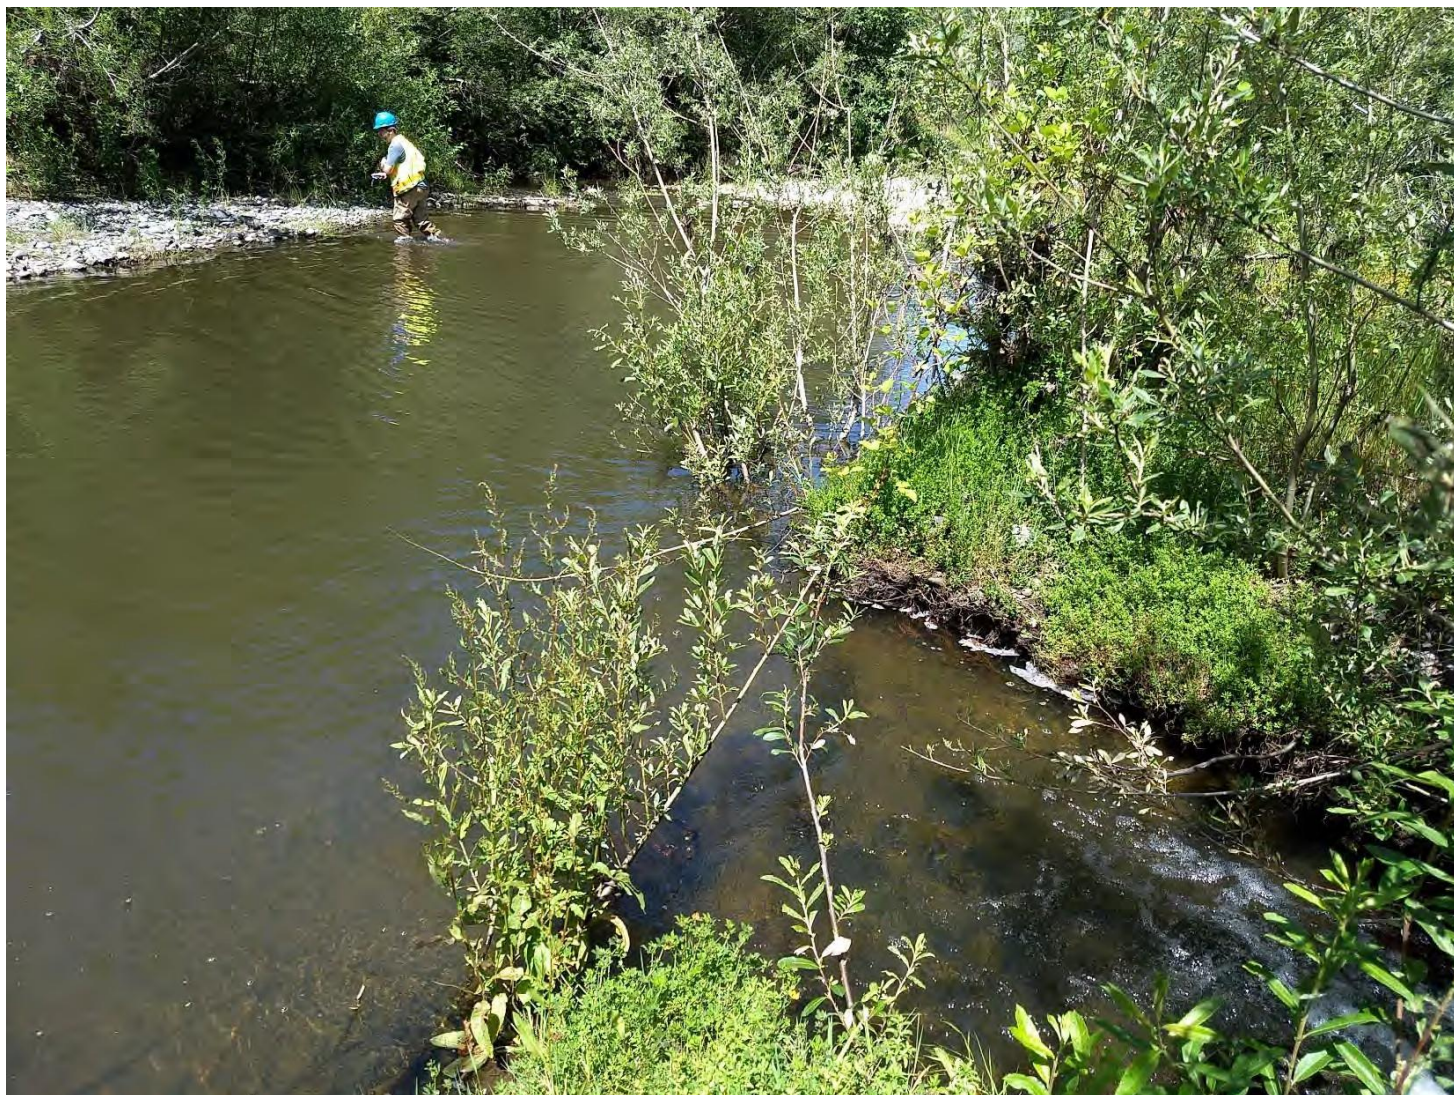
Figure 1. Confluence of Hall Creek with the Mad River. The confluence is currently located in a backwater with the pool elevation control at the downstream riffle crest seen on the upper left of this photograph. The pool dries up and disconnects during most summers. Photo taken by M. Lang June 6, 2020.

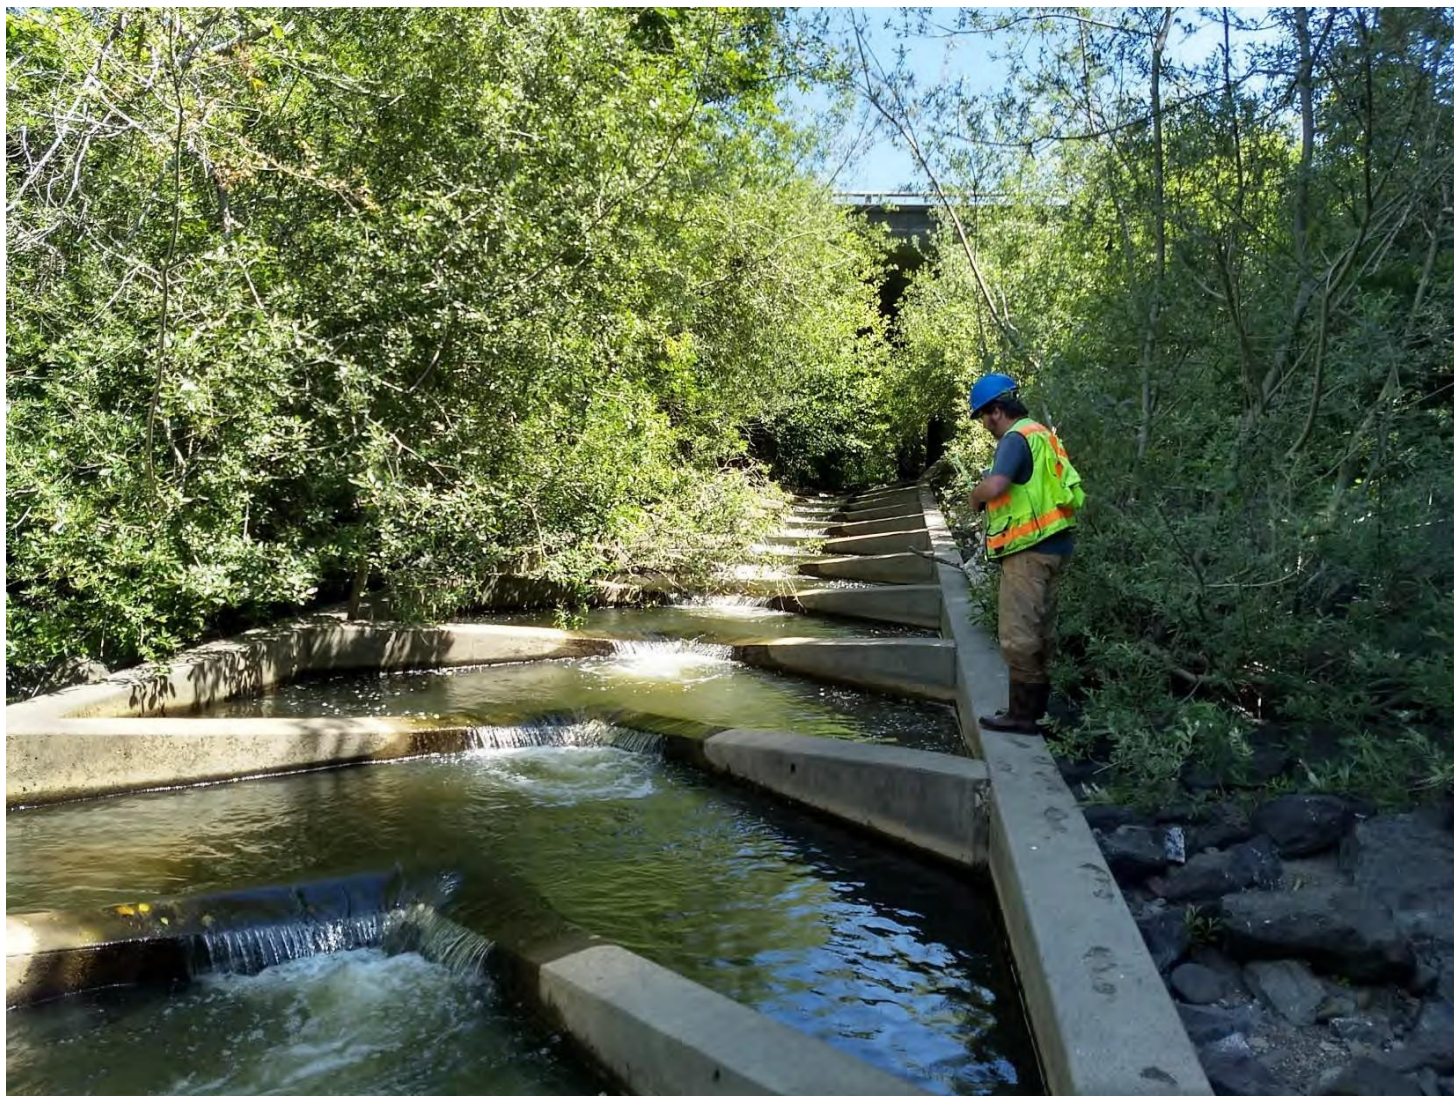
Figure 4. Hall Creek fish ladder looking upstream to the inlet transition under the HUM299 bridge. Photo taken by M. Lang June 6, 2020.

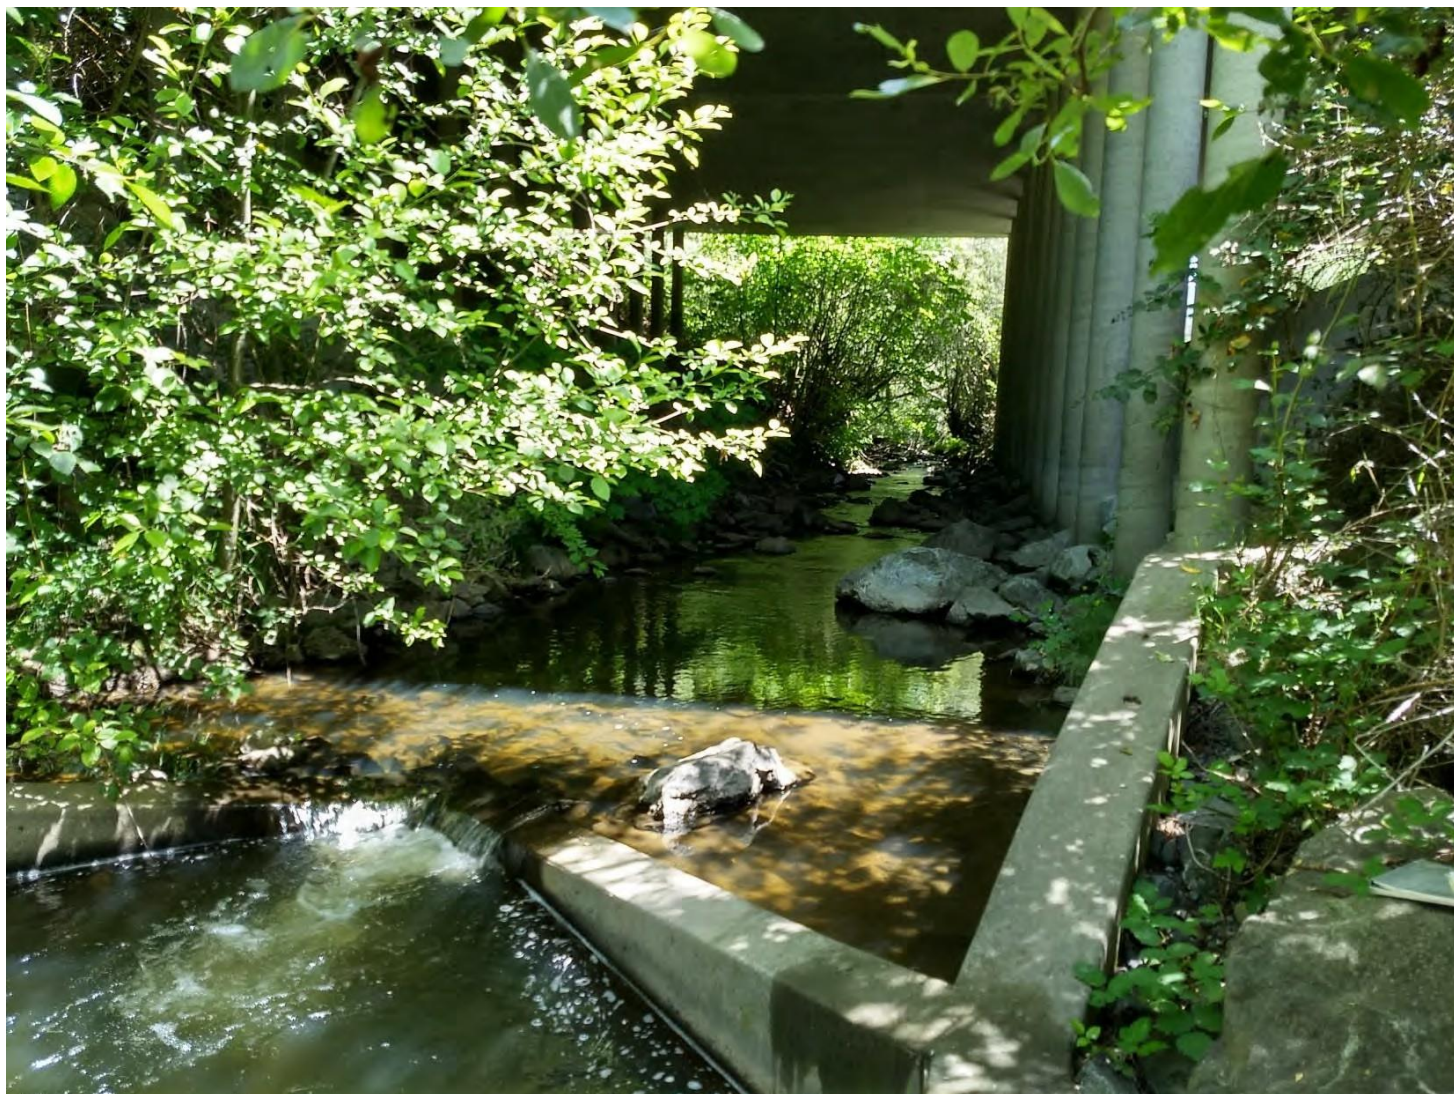
Figure 5. Hall Creek fish ladder looking upstream from the first weir to the natural channel bottom under the HUM 299 bridge. The ladder was installed to maintain the stream bed elevation at this upstream-most weir. Photo taken by M. Lang June 6, 2020.

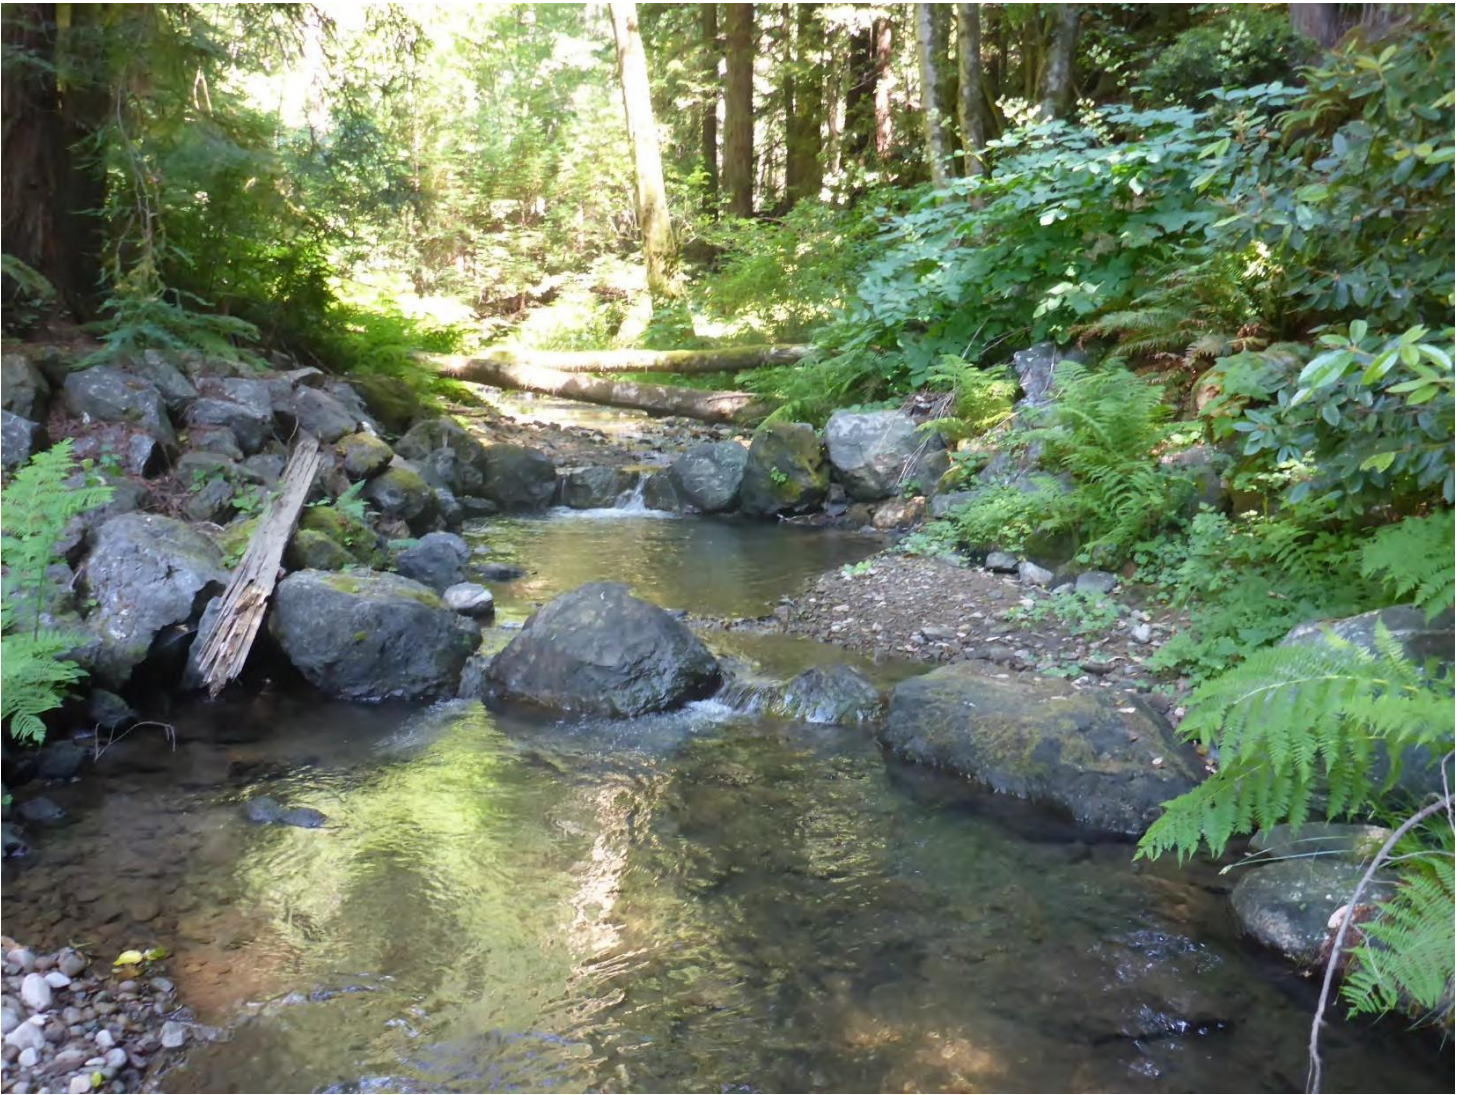
Figure 4. The two most upstream weirs in wider, lower gradient channel region and without the deep plunge pools.
Photo by Michael Love on 7/17/2019.

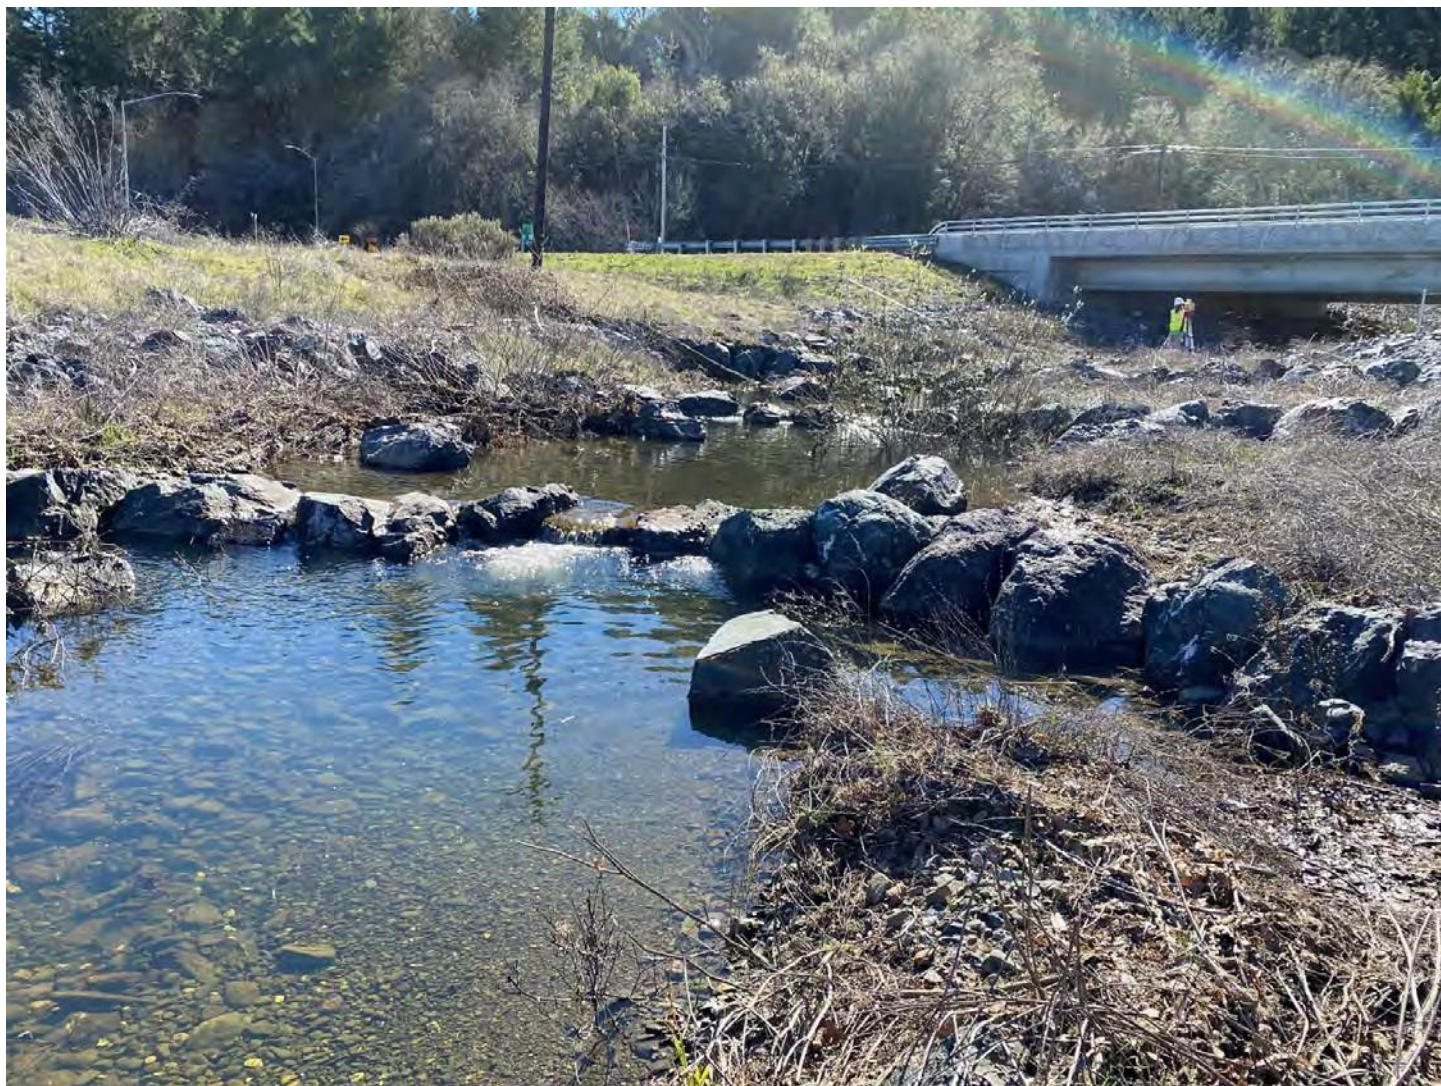
Figure 2. Intact and fully functioning rock weirs viewed from downstream looking upstream at new bridge. Photo by Michael Love on 2/24/2021.

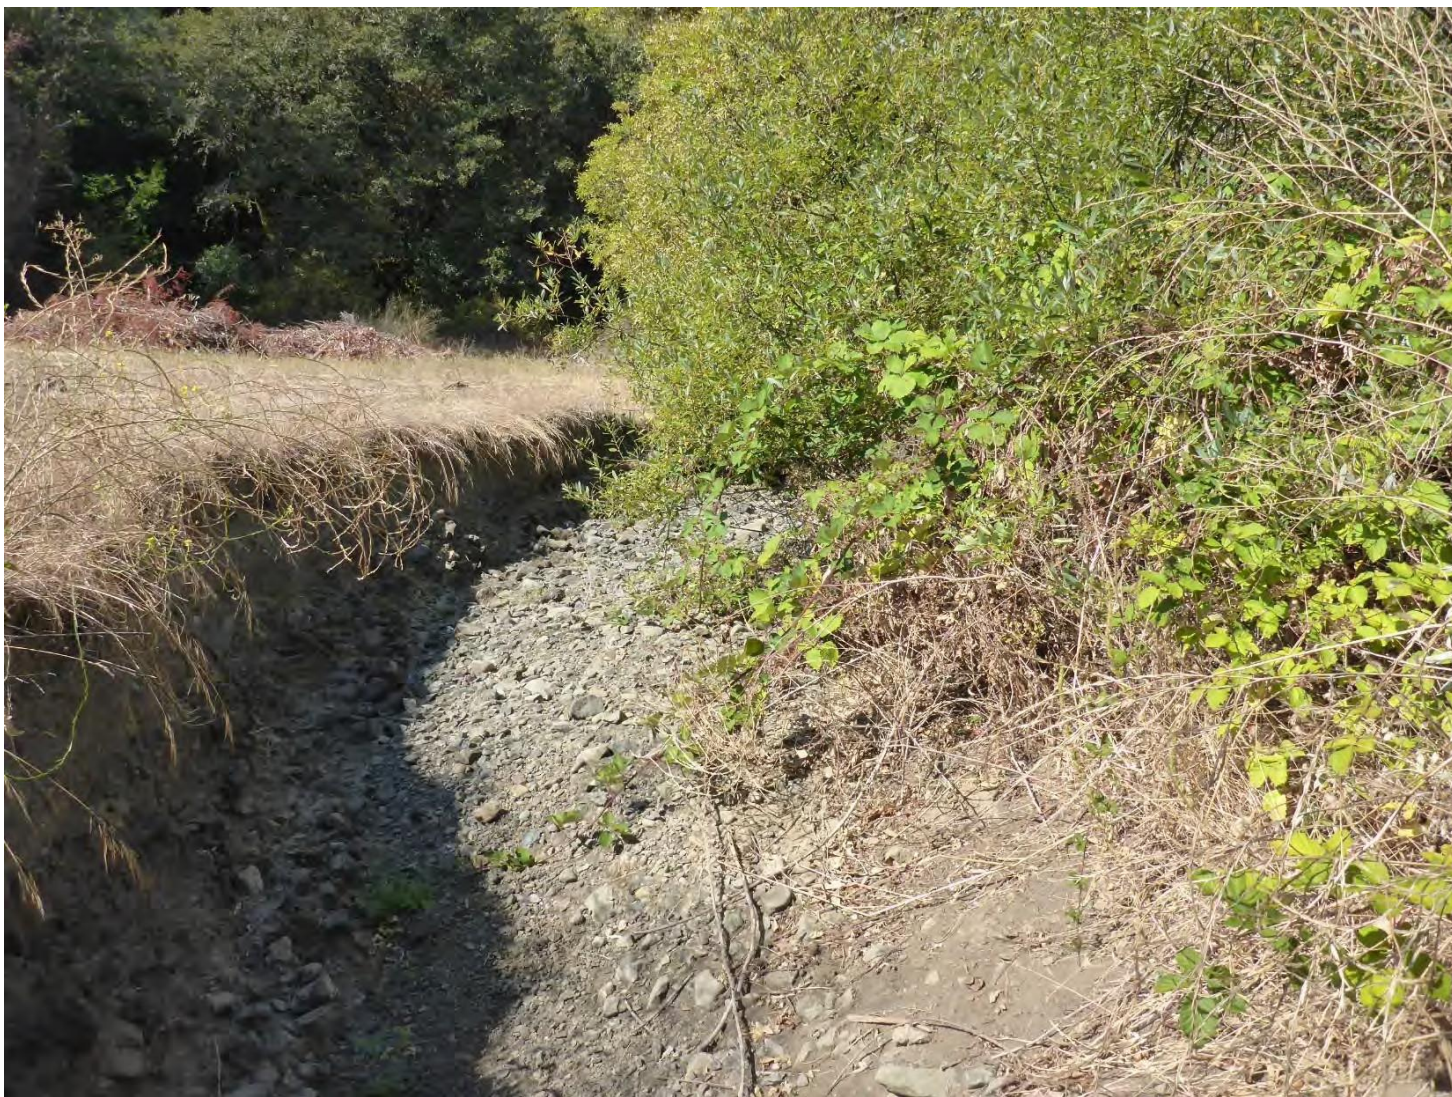
Figure 3. Upstream erosion on right bank, view is looking upstream and new bridge is downstream. Photo by Michael Love on 9/12/2019.

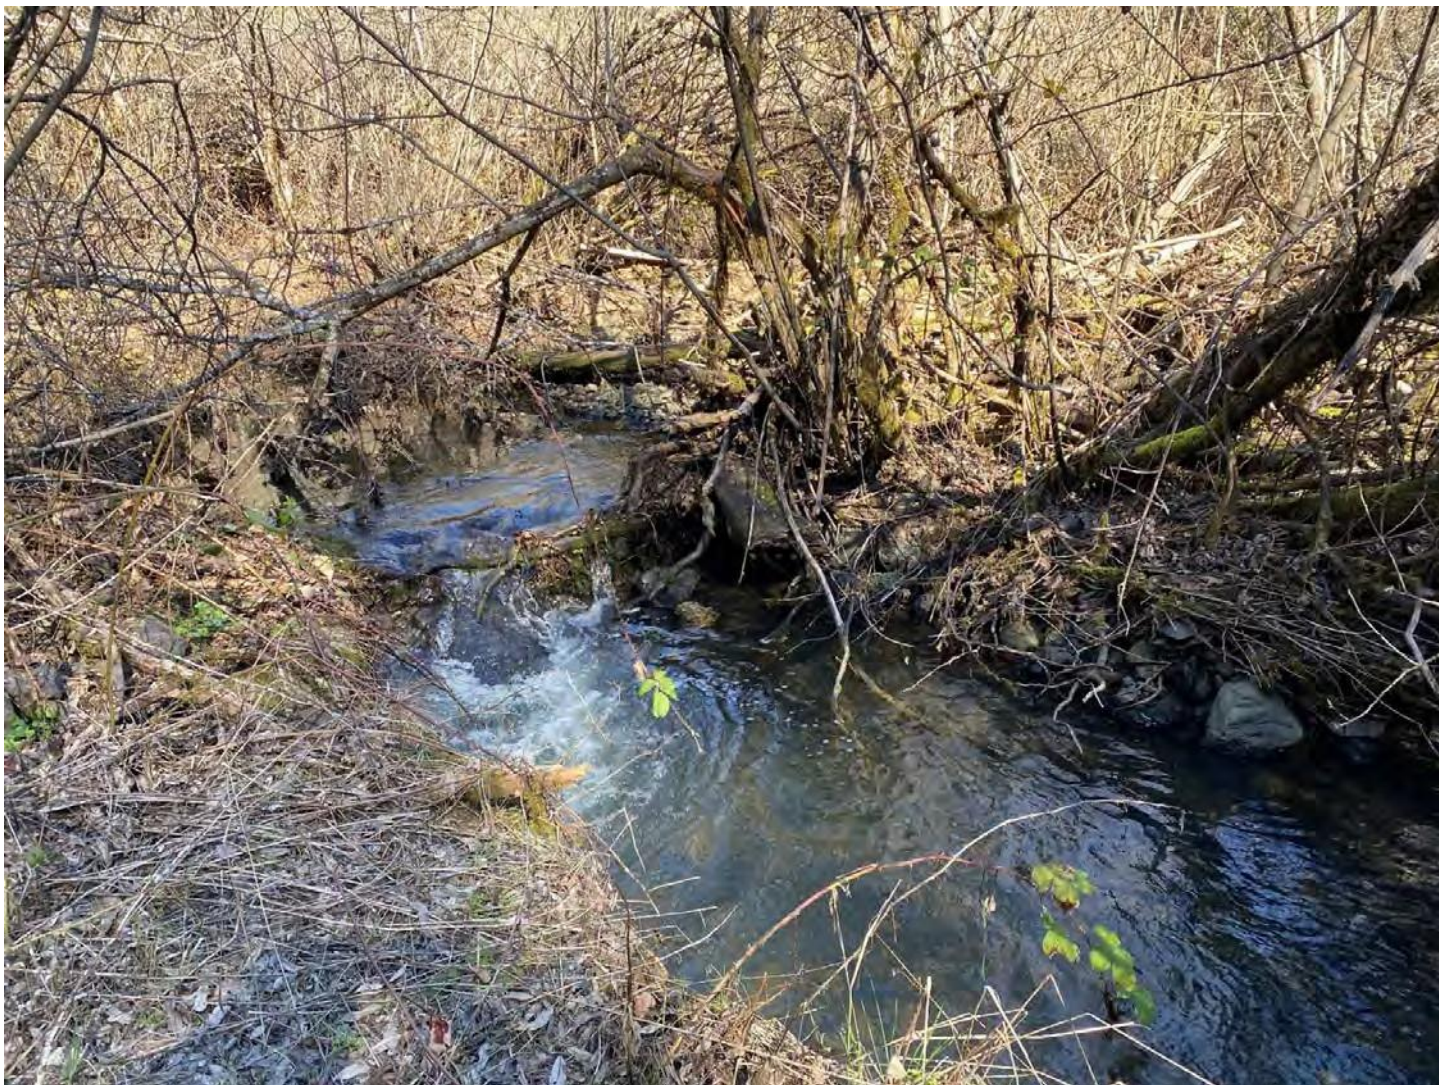
Figure 4. Tree roots stabilizing headcut and bank erosion upstream of the project site. Photo by Michael Love on 2/24/2021.

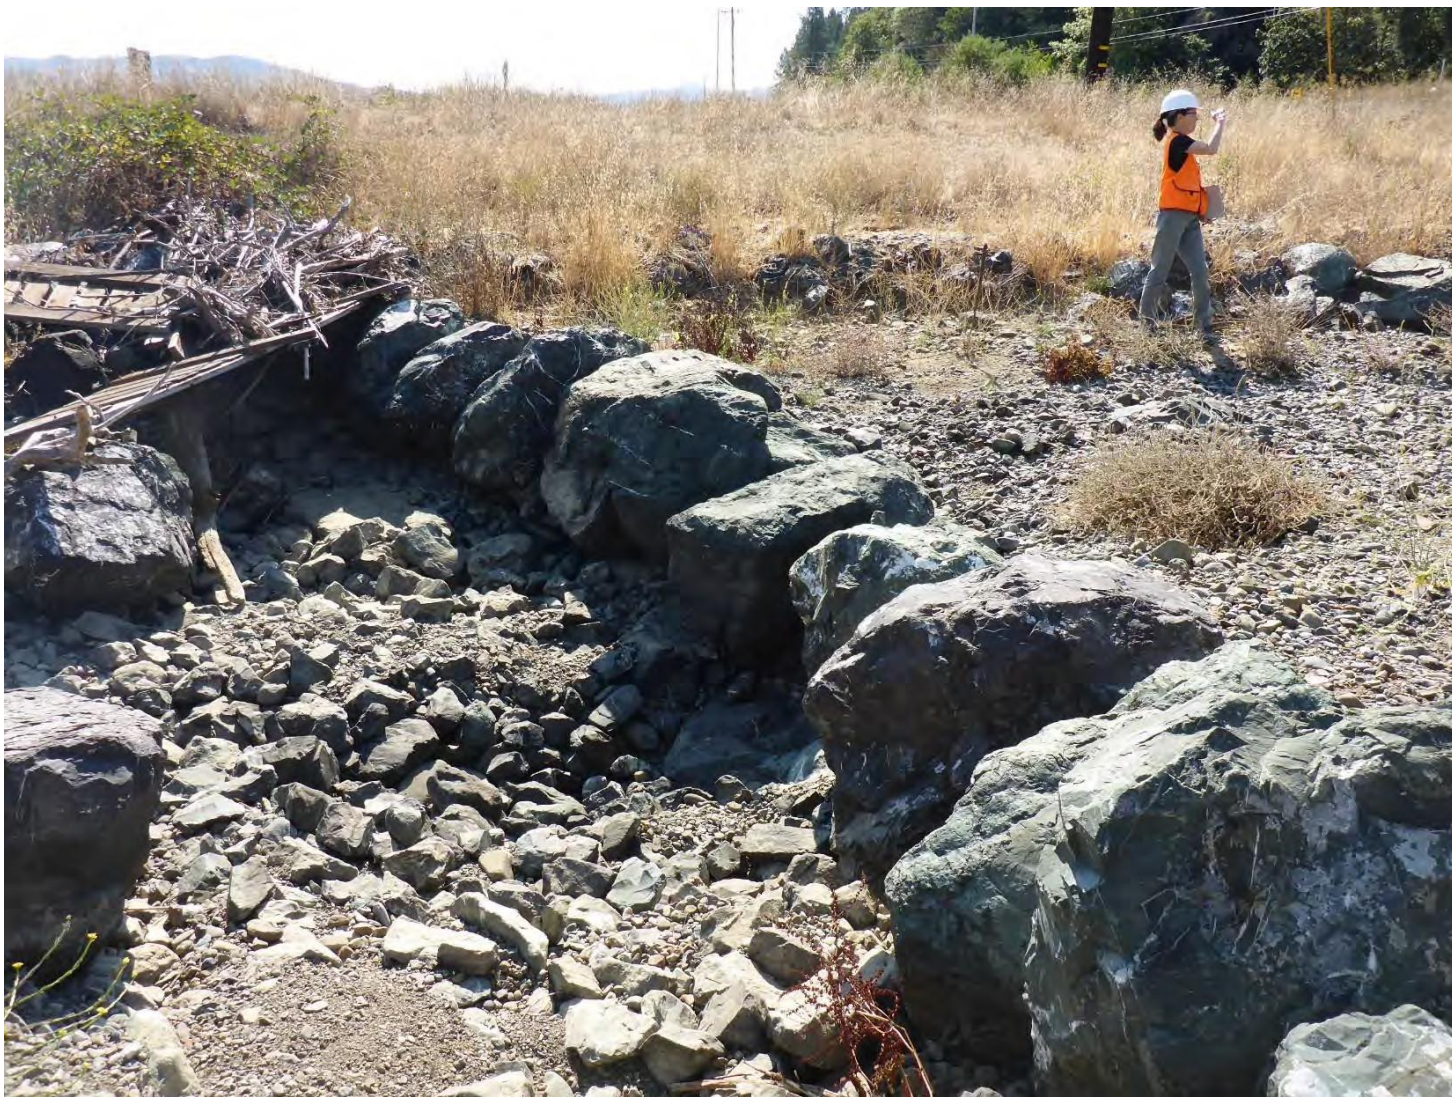
Figure 5. Scour maintained pool downstream of rock weirs. This is the same rock weir shown in Figure 2. Photo by Michael Love on 9/12/2019.

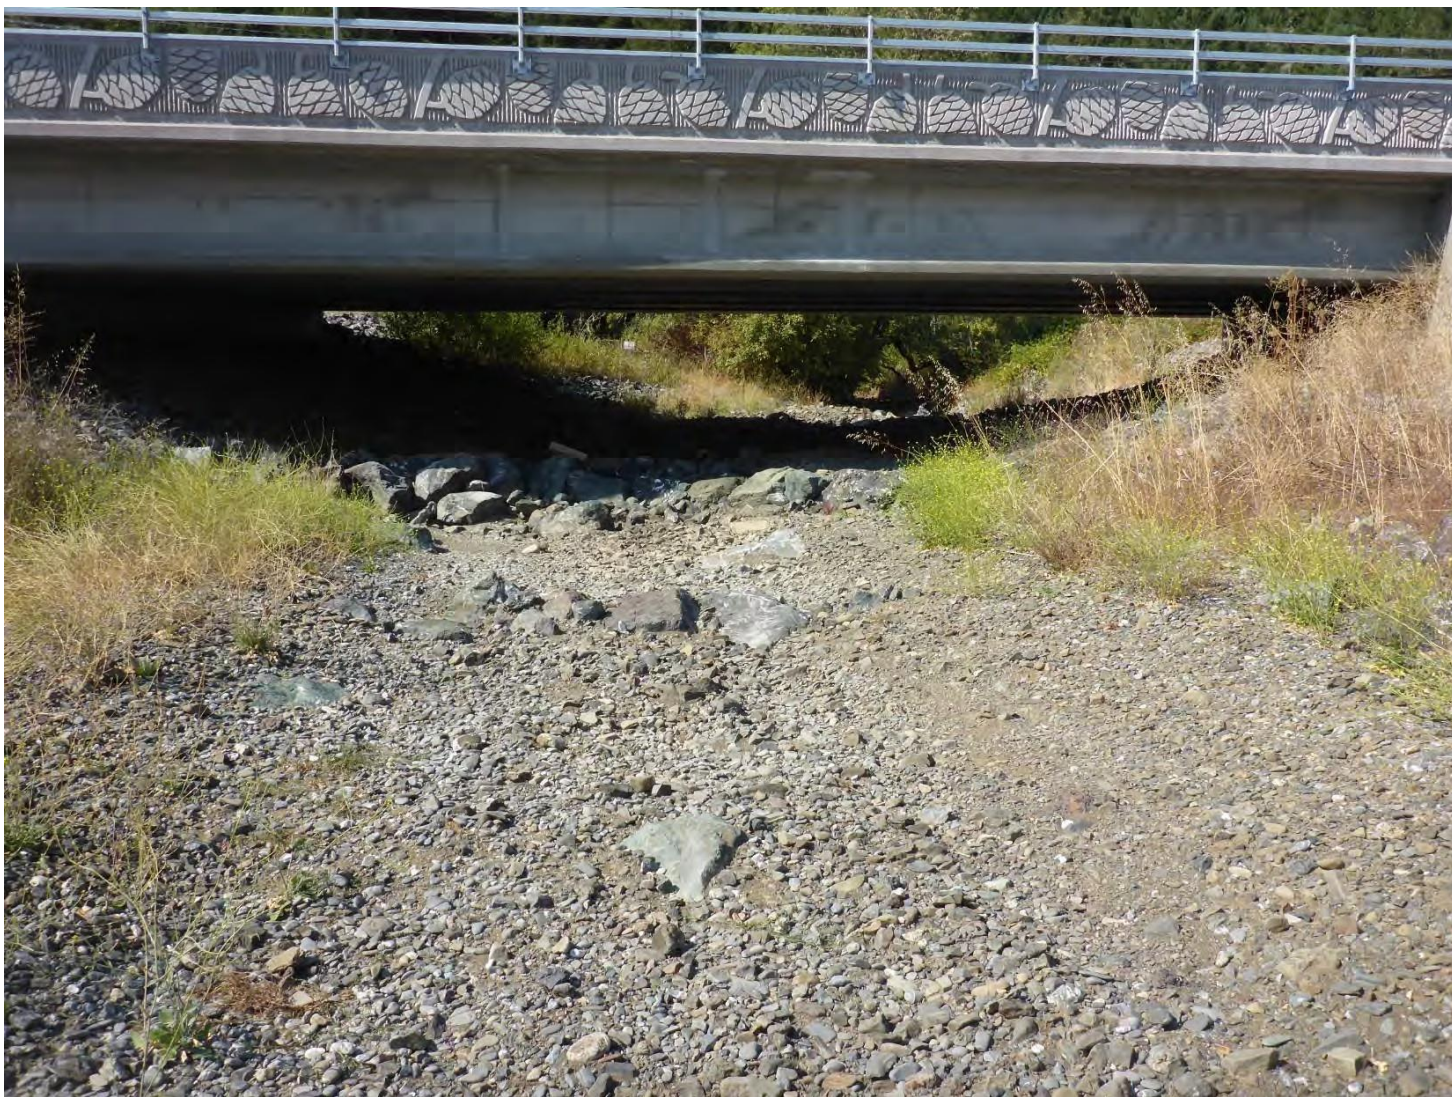
Figure 6. The weir just downstream of the bridge appear to be backwatered and being buried in sediment. Photo by Michael Love on 9/12/2019.
