FISH PASSAGE ENGINEERING PROJECT

Site Analysis Final Report

SITE ANALYSIS FINAL REPORT

Humboldt State University
Michael Love & Associates, Inc.

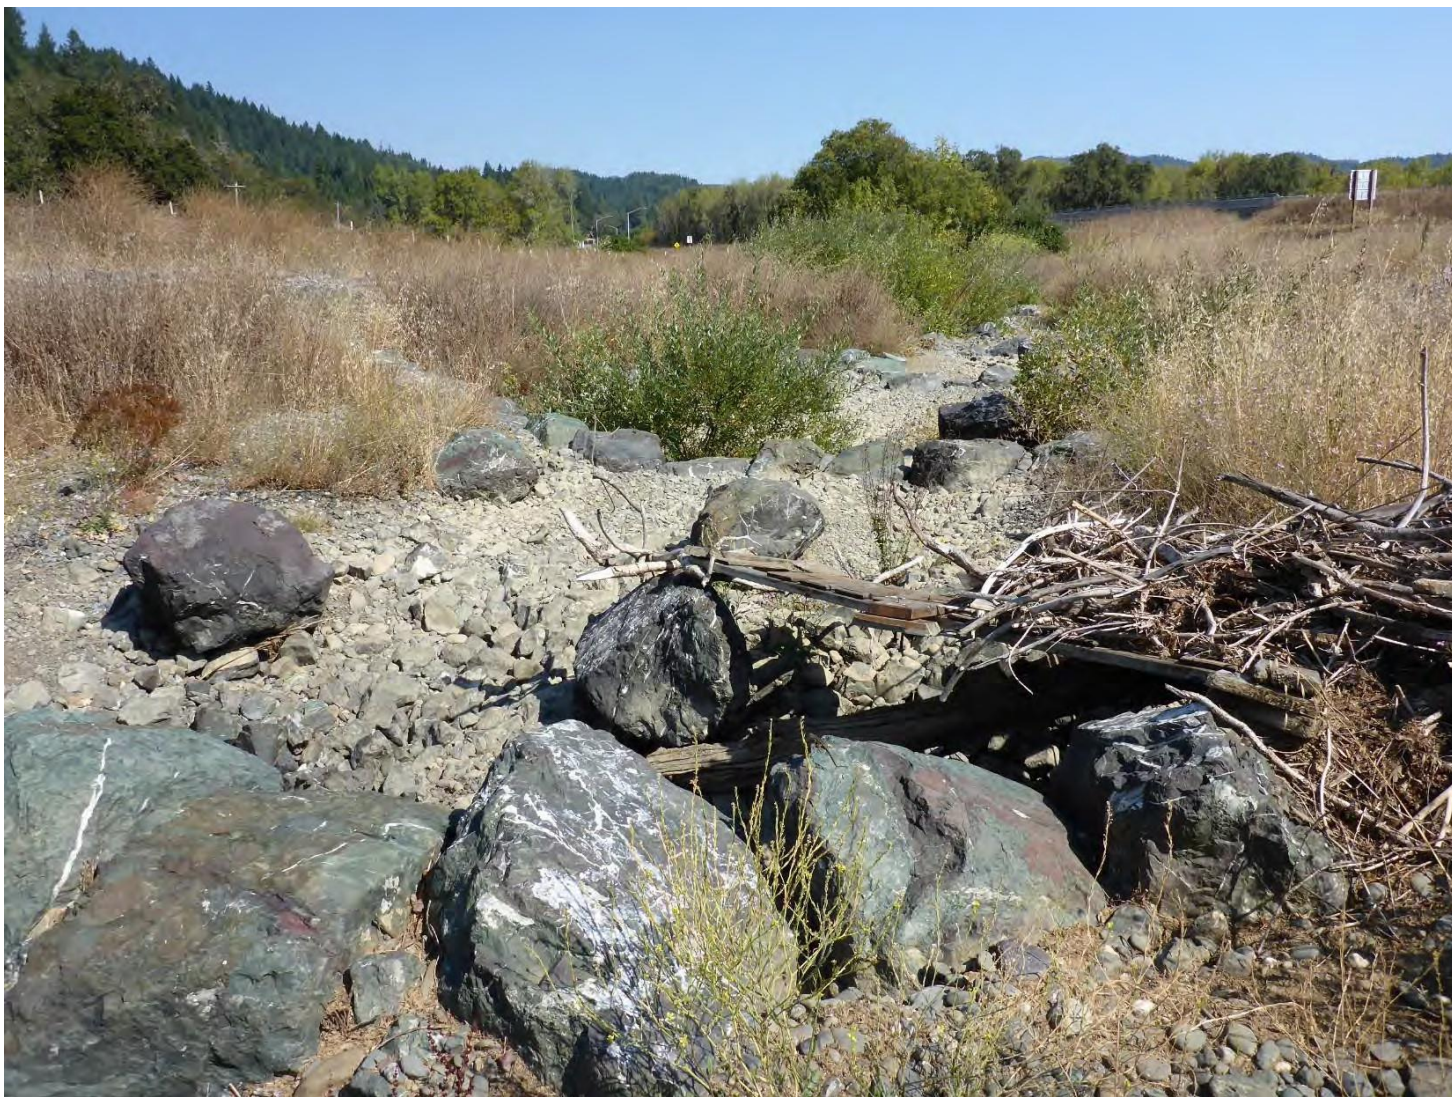
Figure 7. The older channel restoration just downstream of this project site was built at similar channel widths as the new channel under the bridge. This channel is being narrowed by encroaching willows. Photo by Michael Love on 9/12/2019.

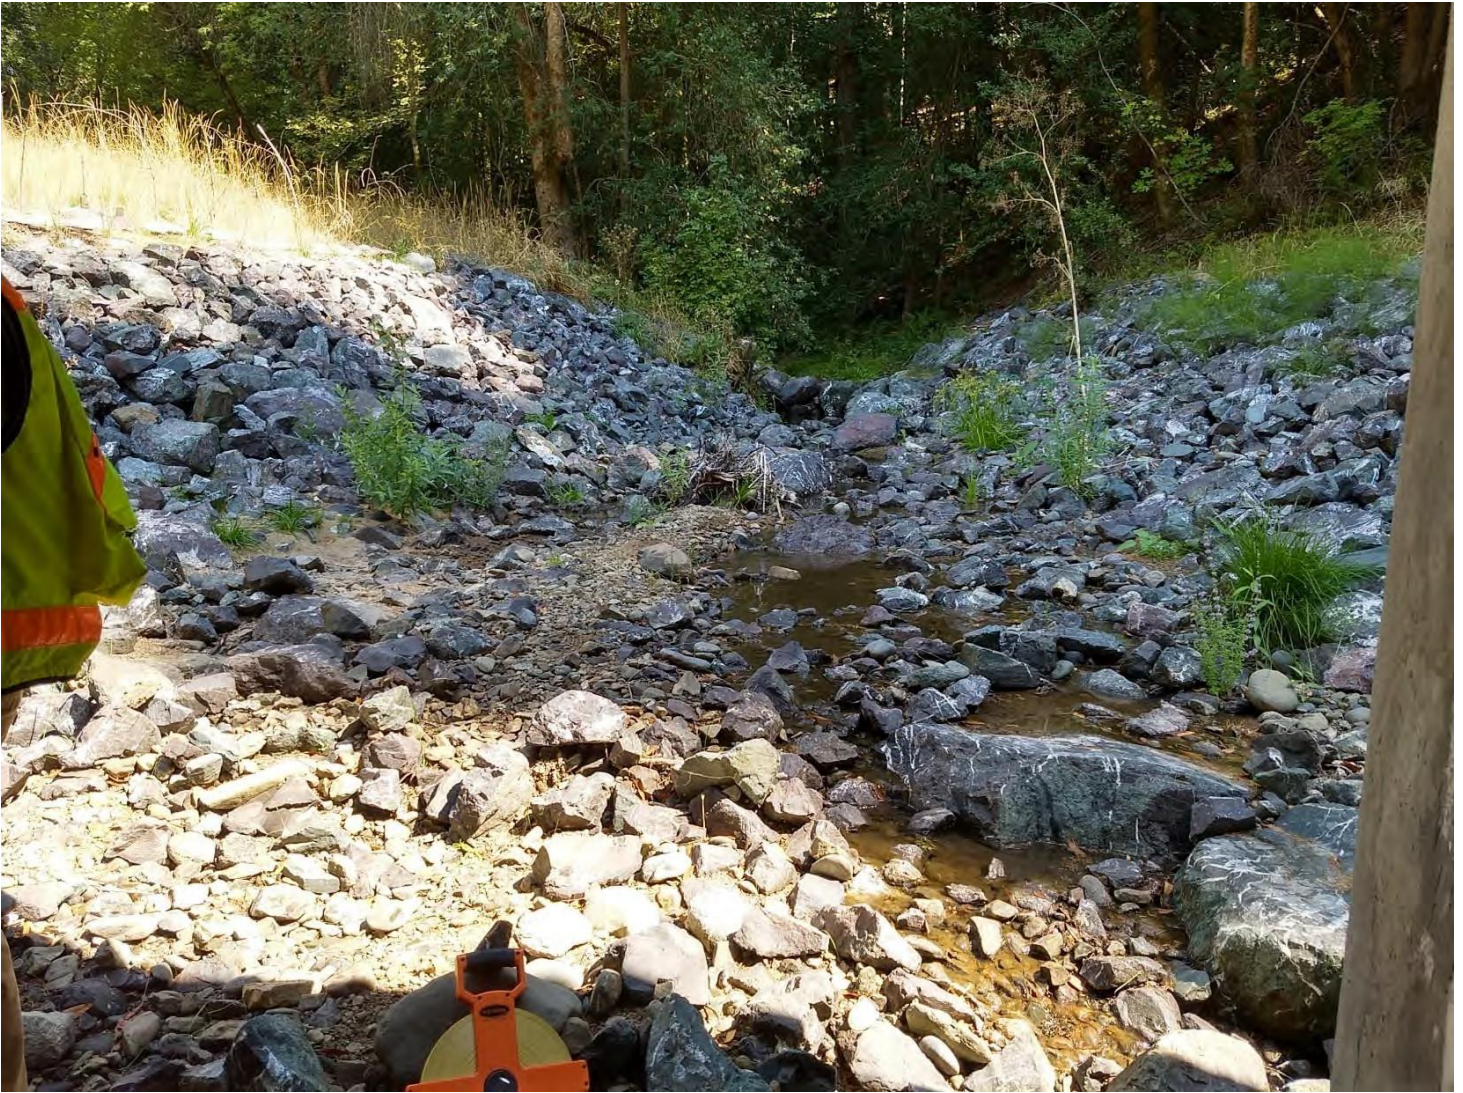
Figure 1. View looking upstream from the North Fork Ryan Creek culvert inlet. The rock weir installed for grade control at the upstream project boundary has a low flow drop of approximately 1.5 feet. Note that flow goes subsurface at the lower right corner of the photo. Photo by Margaret Lang on 9/12/2019.

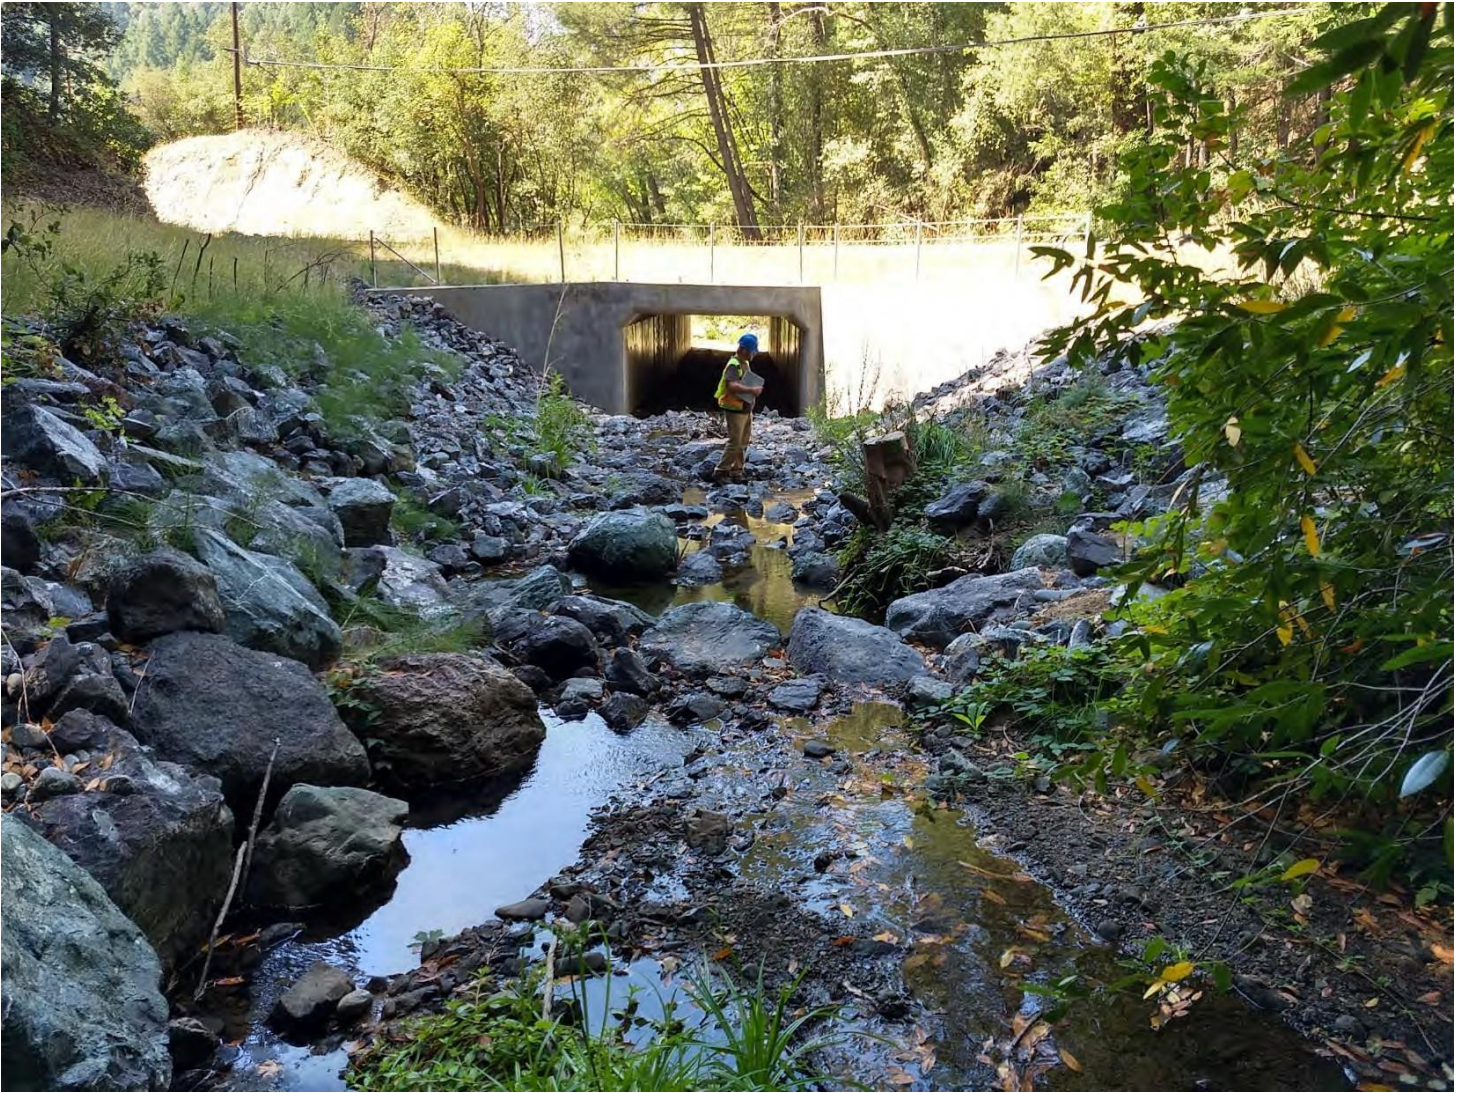
Figure 3. Culvert inlet looking downstream from the upstream project boundary. Stream flow was low but continuous upstream of the culvert during this site visit. Photo by Margaret Lang on 9/12/2019.

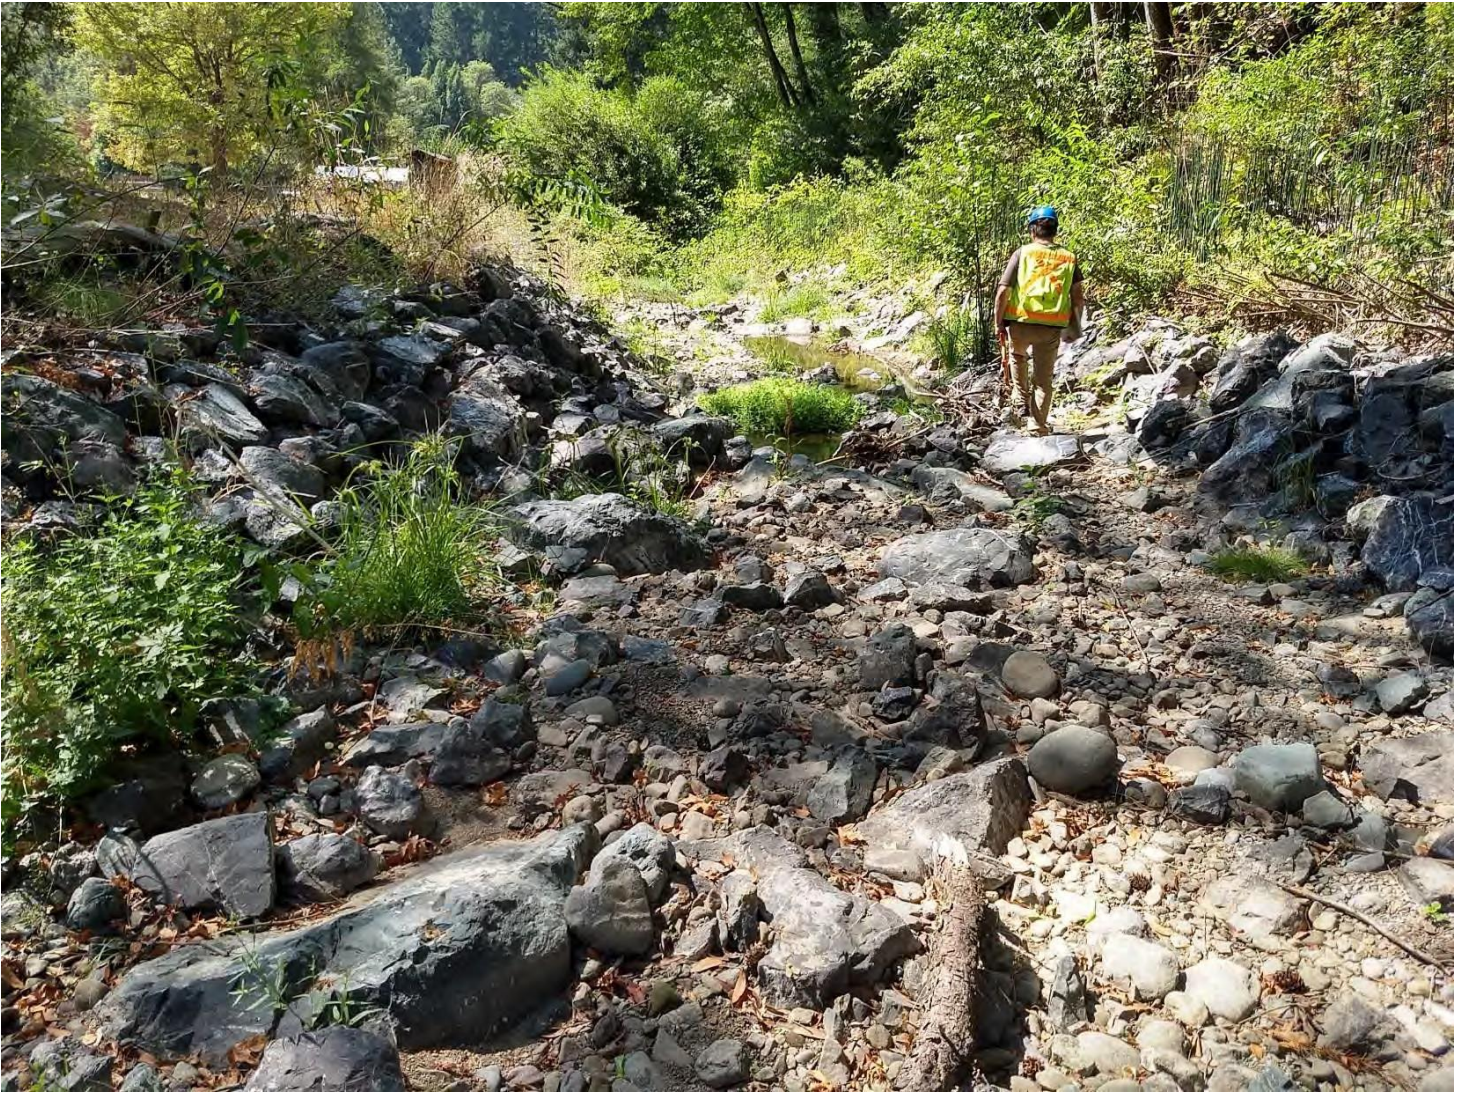
Figure 6. The downstream project channel looking downstream from the culvert outlet. Flow is discontinuous but surfaces behind most of the rock weirs. Photo by Margaret Lang on 9/12/2019.

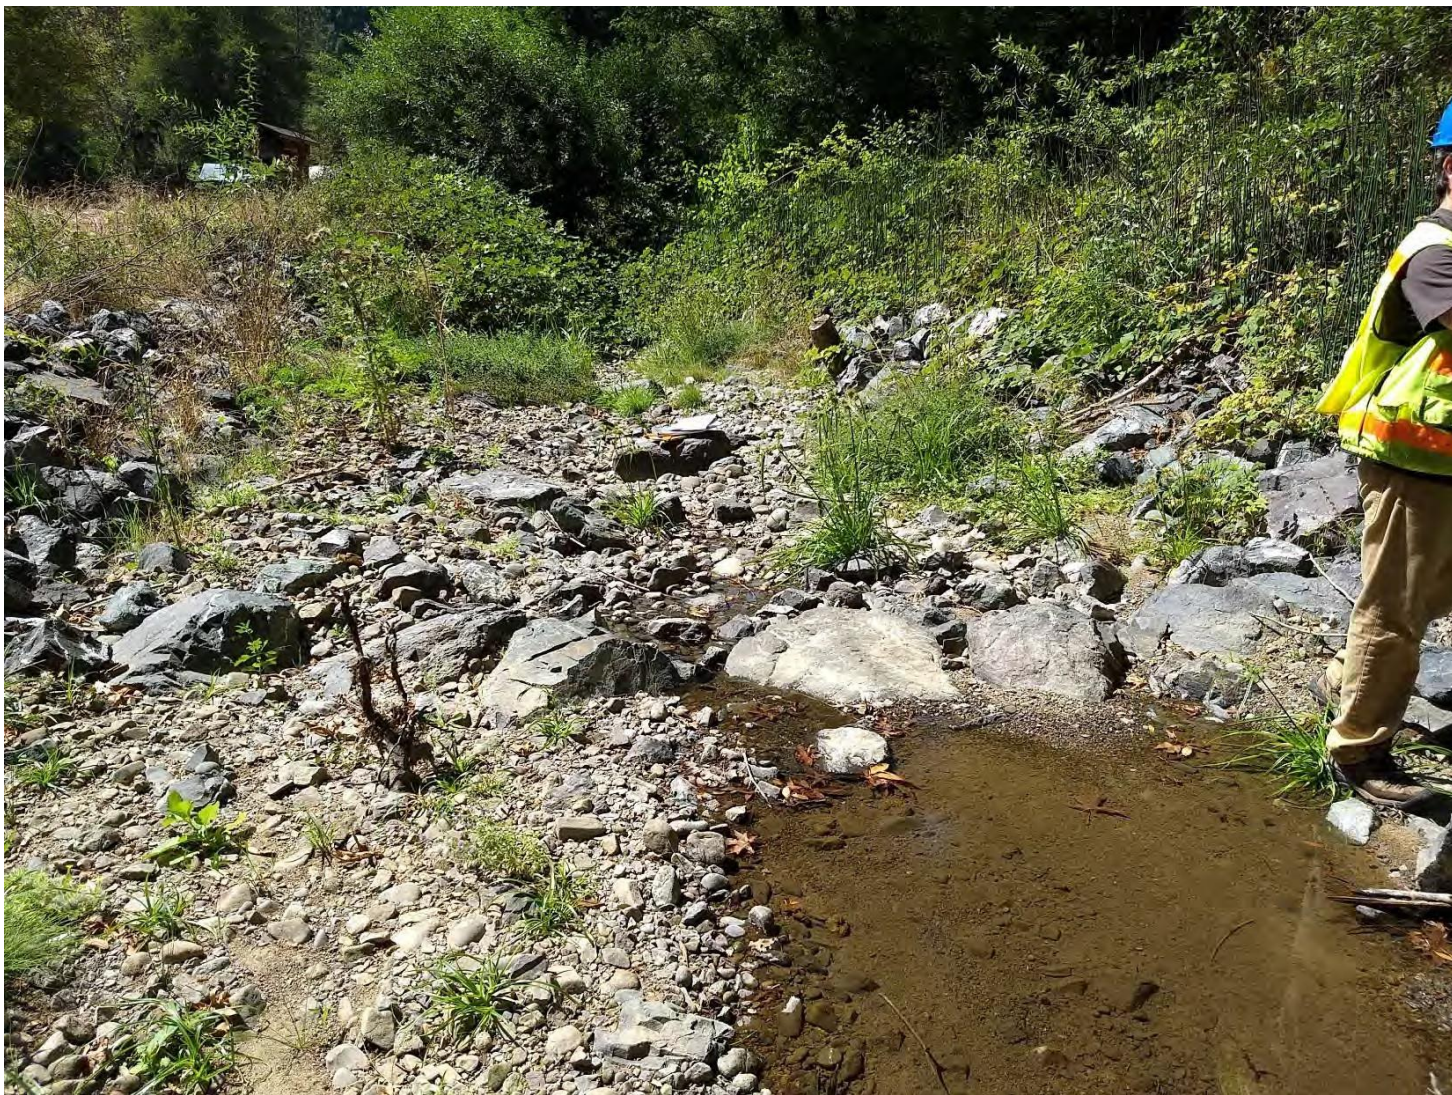
Figure 7. The downstream channel showing some surface flow upstream of the third rock weir. Photo by Margaret Lang on 9/12/2019.

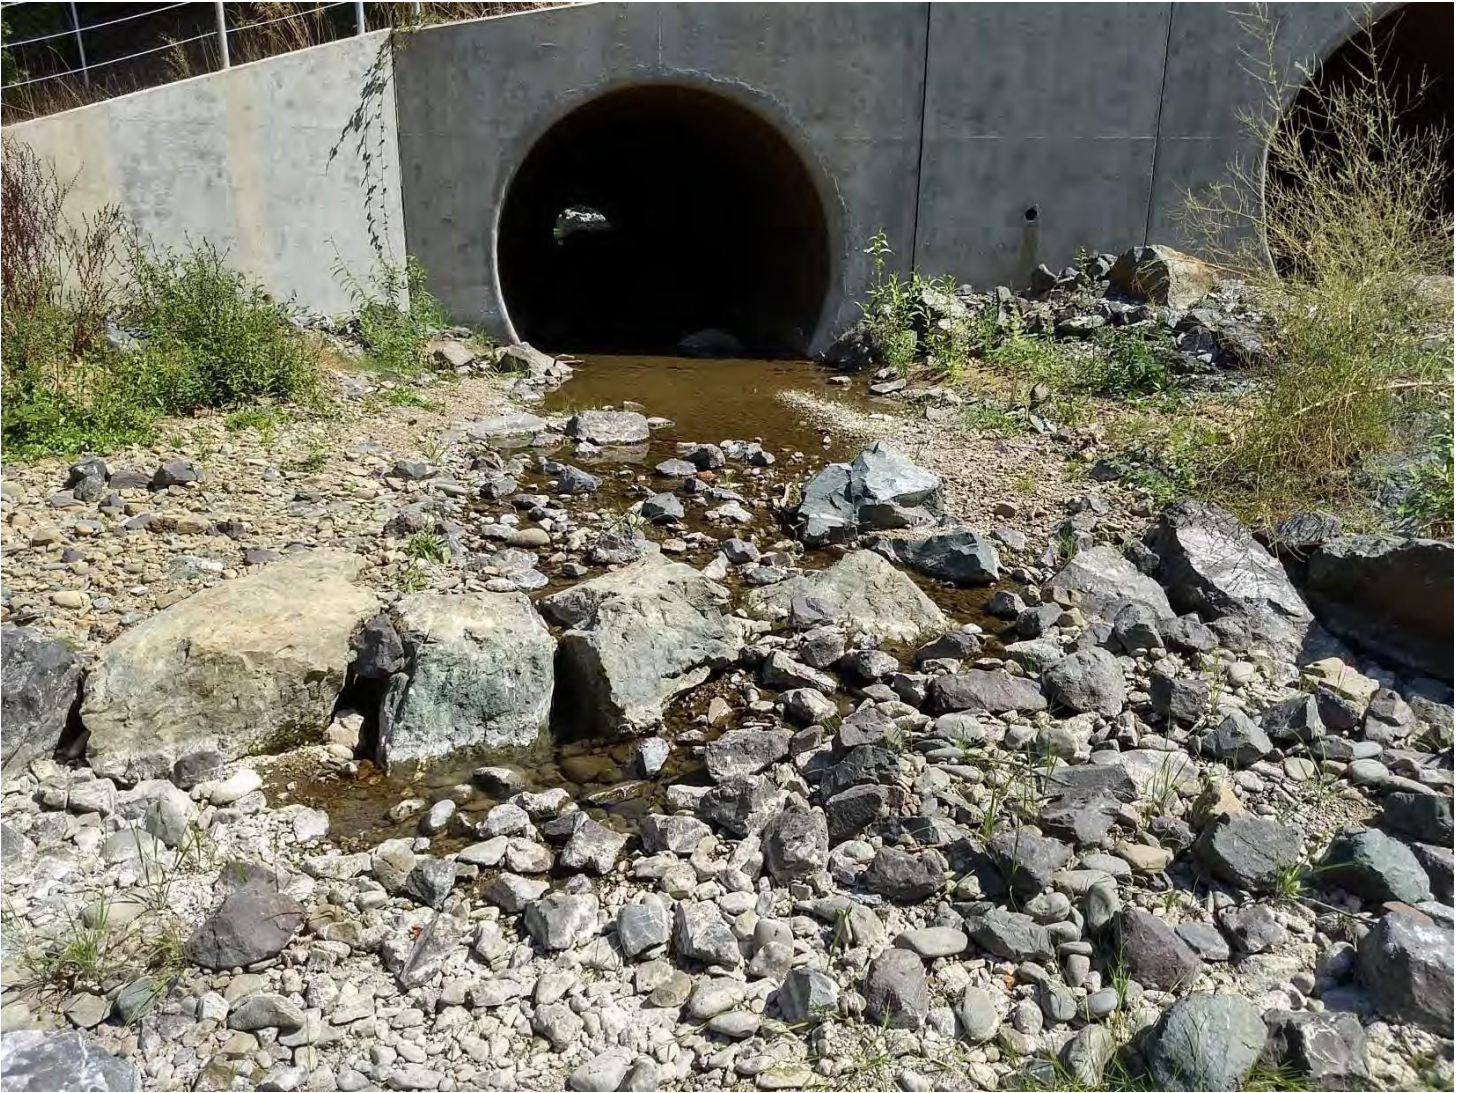
Figure 6. The lower culvert's outlet looking upstream. At low flows, the flow goes subsurface and was discontinuous starting at the first rock weir downstream as seen in the photo's foreground. Photo by Margaret Lang on 9/12/2019.

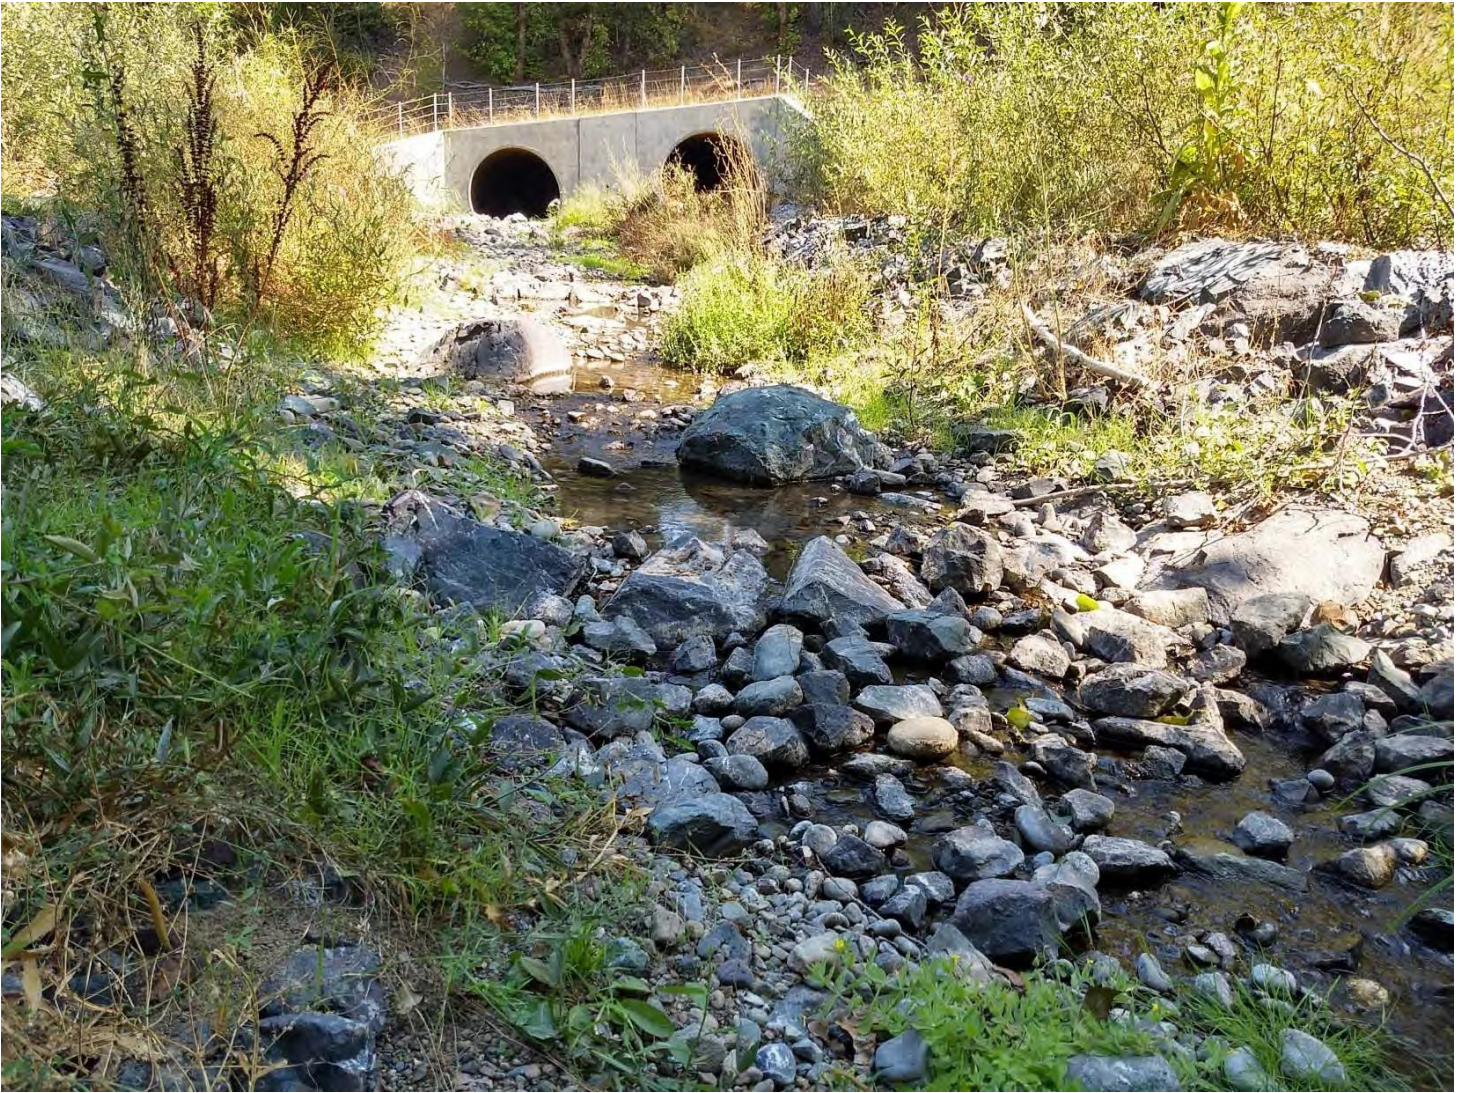
Figure 7. The culverts' outlets looking upstream from the downstream channel. The low flows resurface and become continuous again with the lower sections of the project and were continuous in the downstream channel. Photo by Margaret Lang on 9/12/2019.

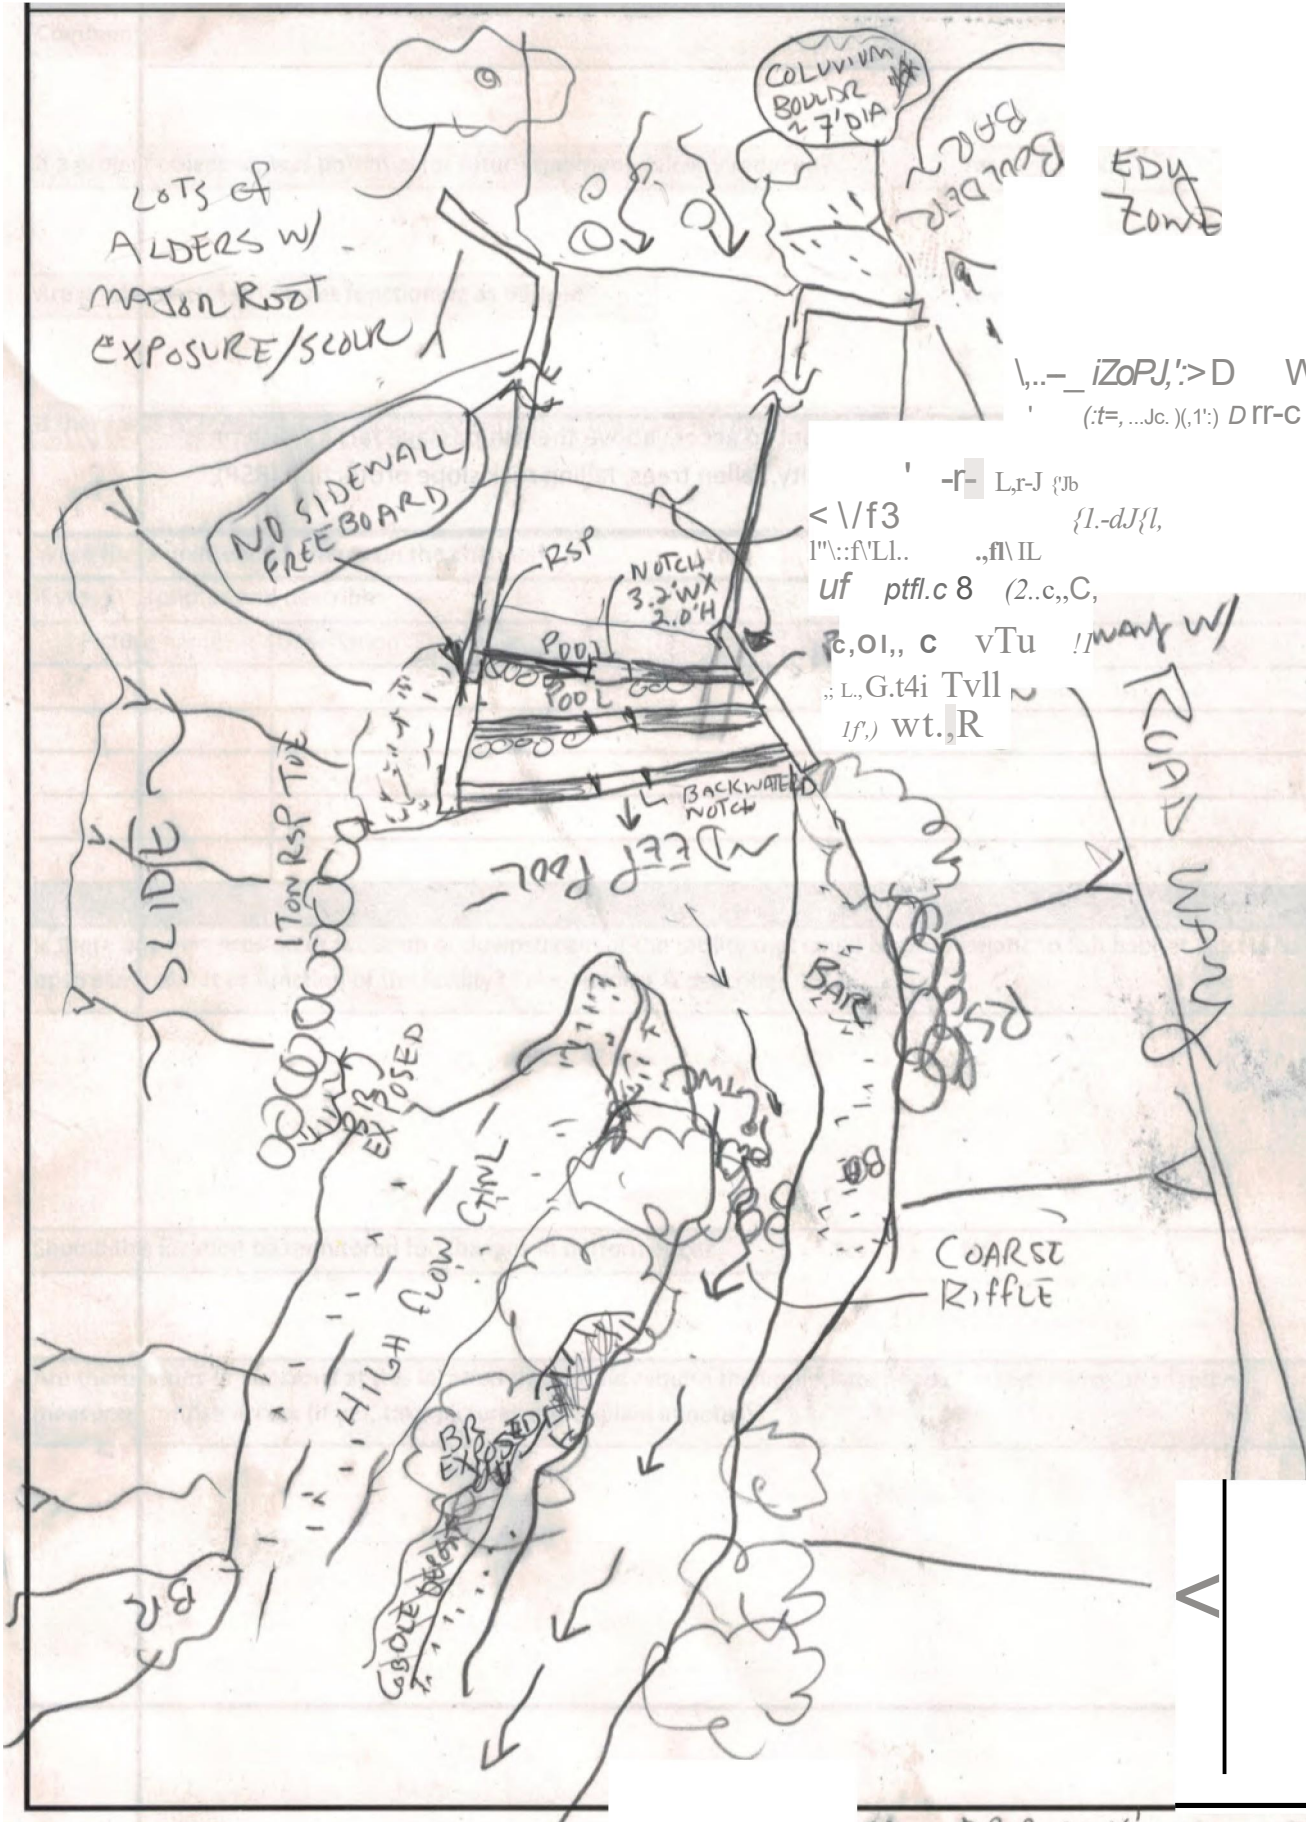
Site Sketch

CAN DROP ~ 1' STILL MEET 6" DROP CRITERIA

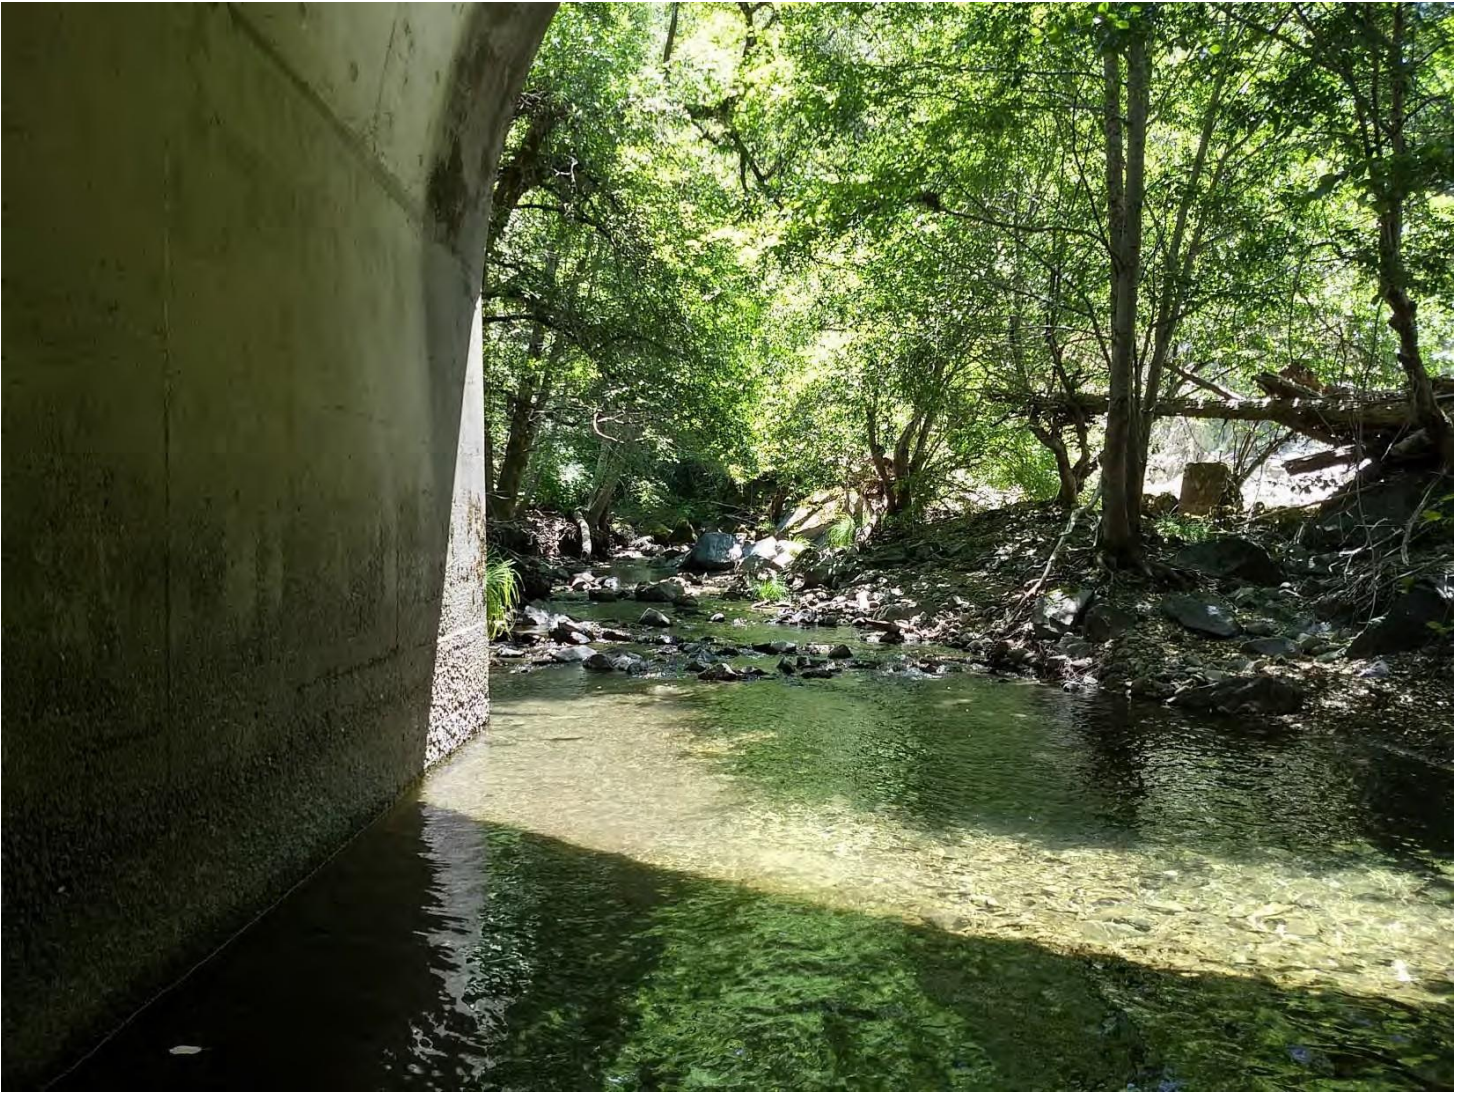
Figure 1. Looking upstream from the culvert inlet. Substrate in the channel is coarser here suggesting that the channel constriction due to a culvert width less than active channel width creates locally higher velocity than the natural channel. Photo M. Lang on July 17, 2019.

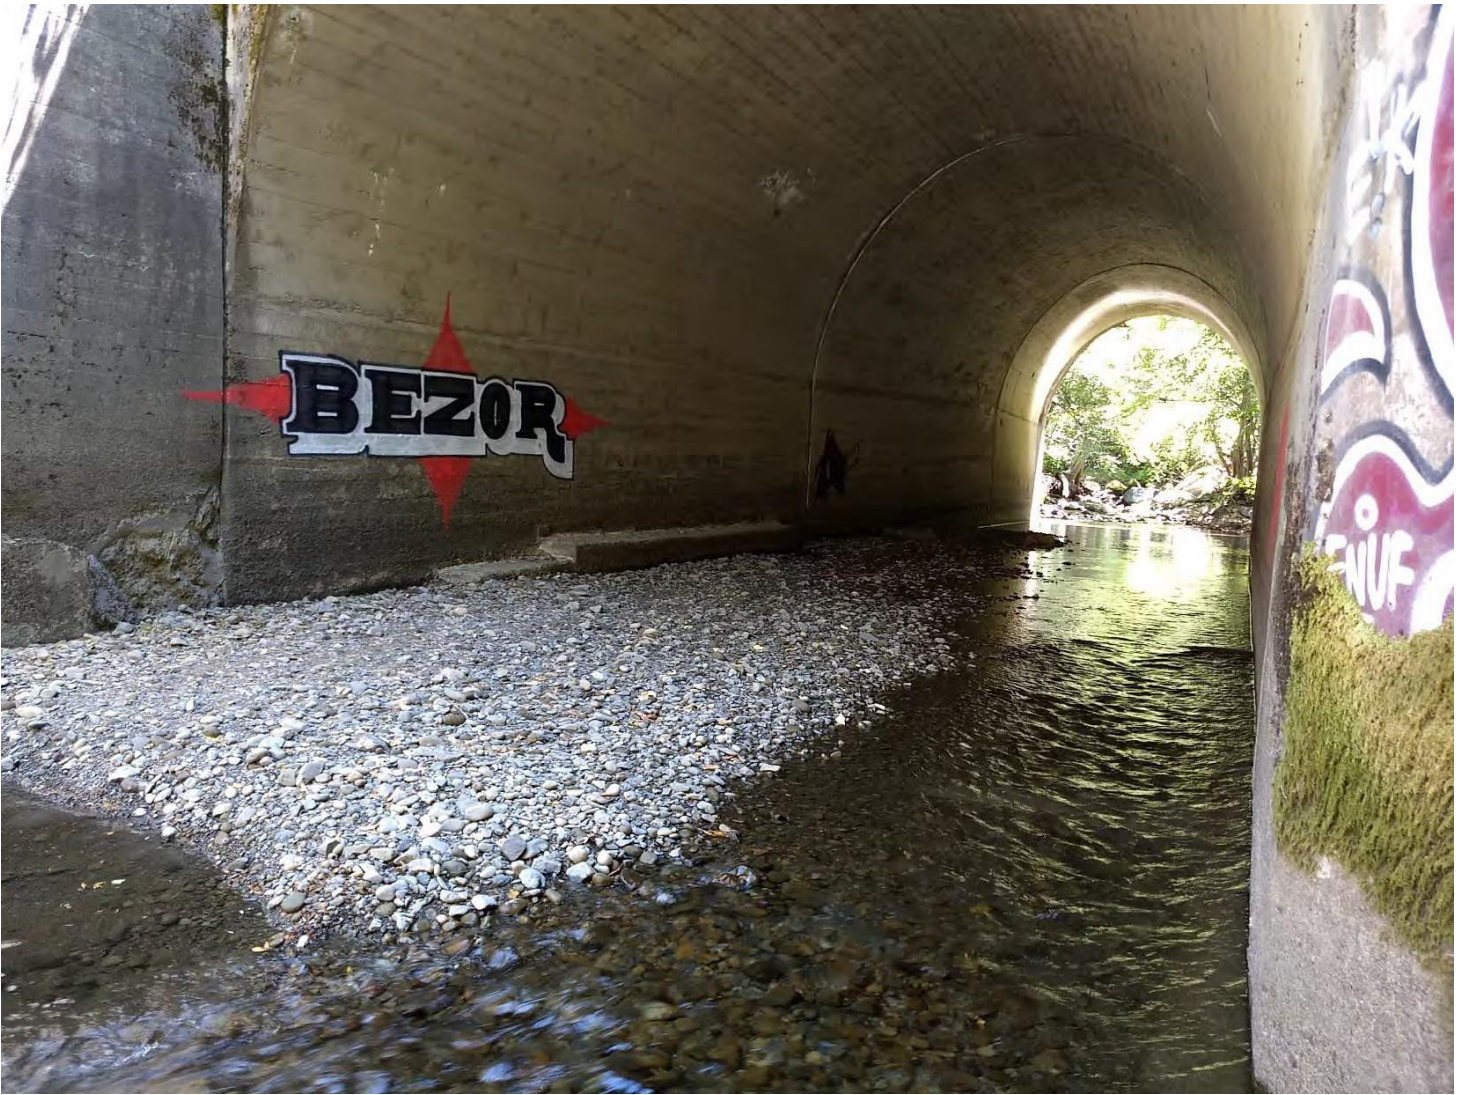
Figure 2. Sediment accumulating to form a natural substrate channel bottom within most of the culvert, view is upstream from the culvert outlet. Photo M. Lang on July 17, 2019.

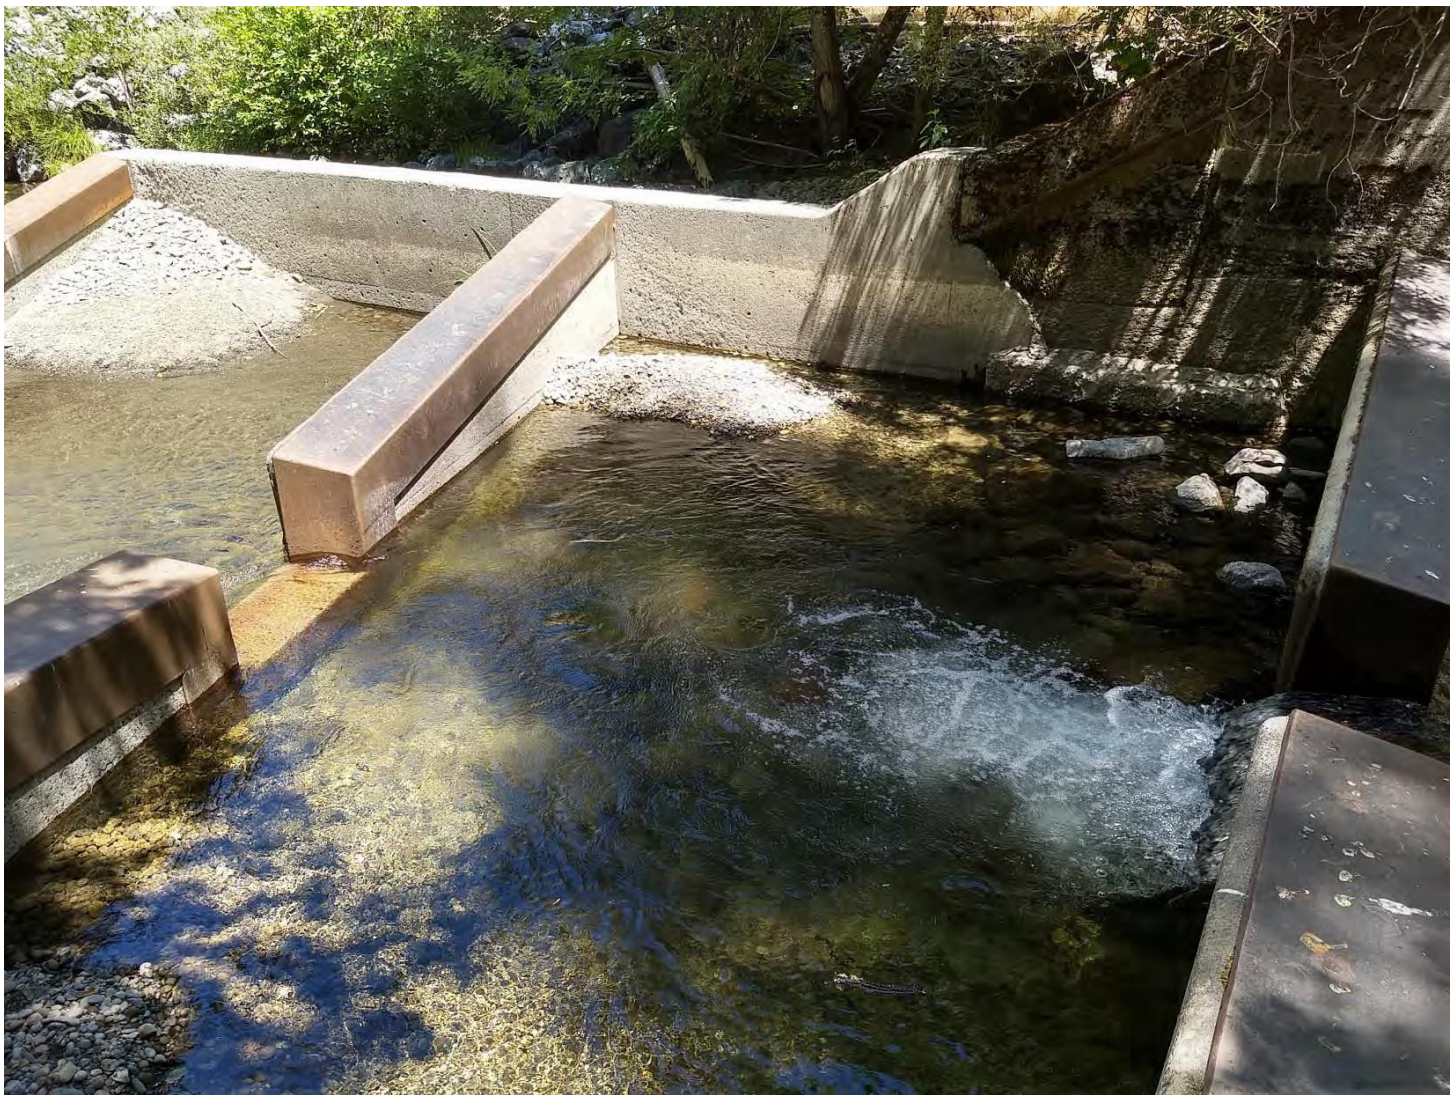
Figure 3. Sediment trapping and pool maintenance in the outlet weirs. Photo M. Lang on July 17, 2019.

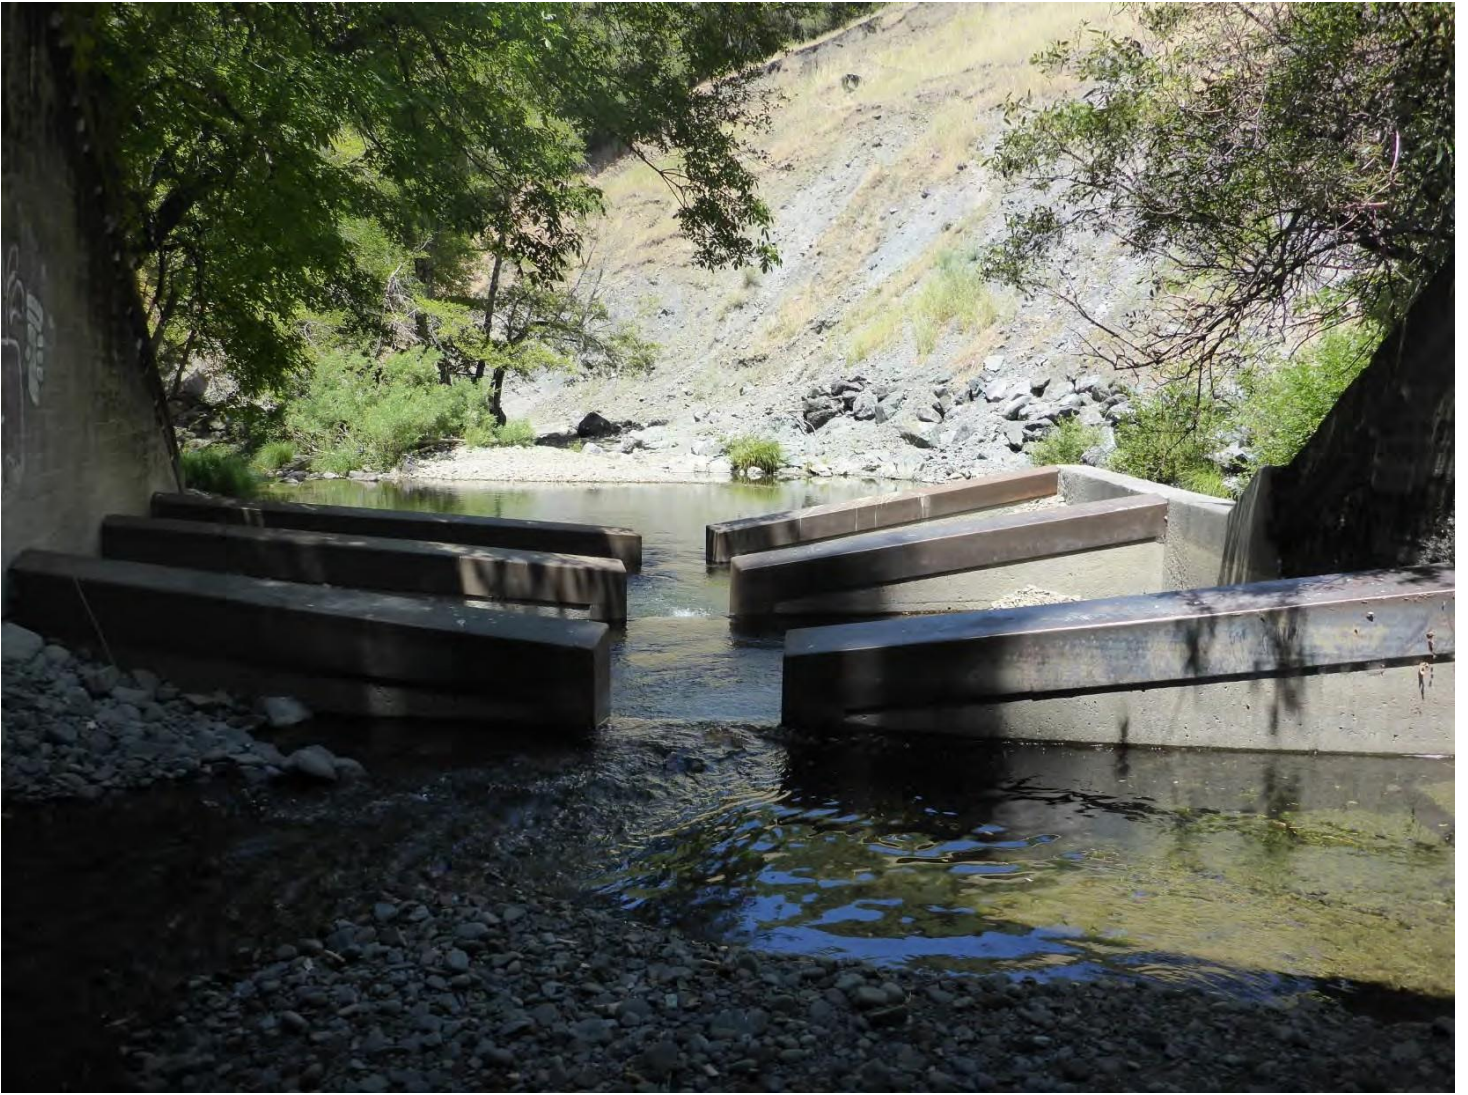
Figure 4. The outlet pool weirs and right channel bank looking downstream from the culvert outlet. The modifications to add the weirs and reorient the outlet flow away from the right bank has reduced the erosion of the right channel bank. Photo M. Love on July 17, 2019.

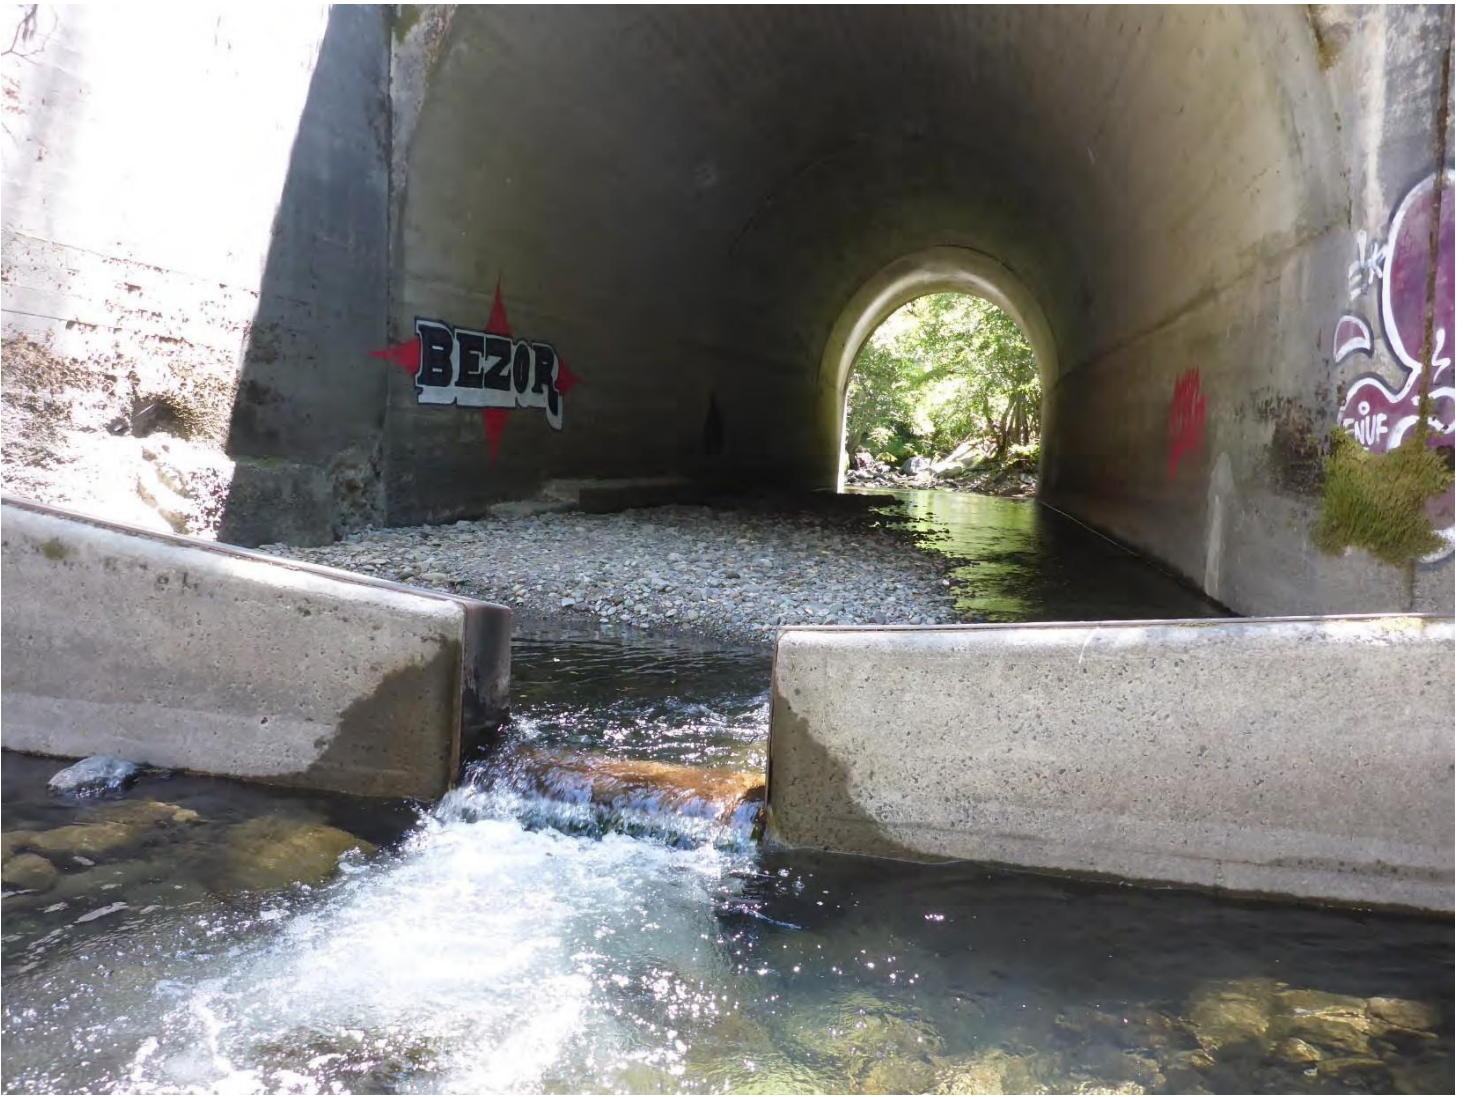
Figure 6. The culvert outlet and most upstream weir notch looking upstream from the from outlet weirs. Photo M. Love on July 17, 2019.
