FISH PASSAGE ENGINEERING PROJECT

Site Analysis Final Report

SITE ANALYSIS FINAL REPORT

Humboldt State University
Michael Love & Associates, Inc.

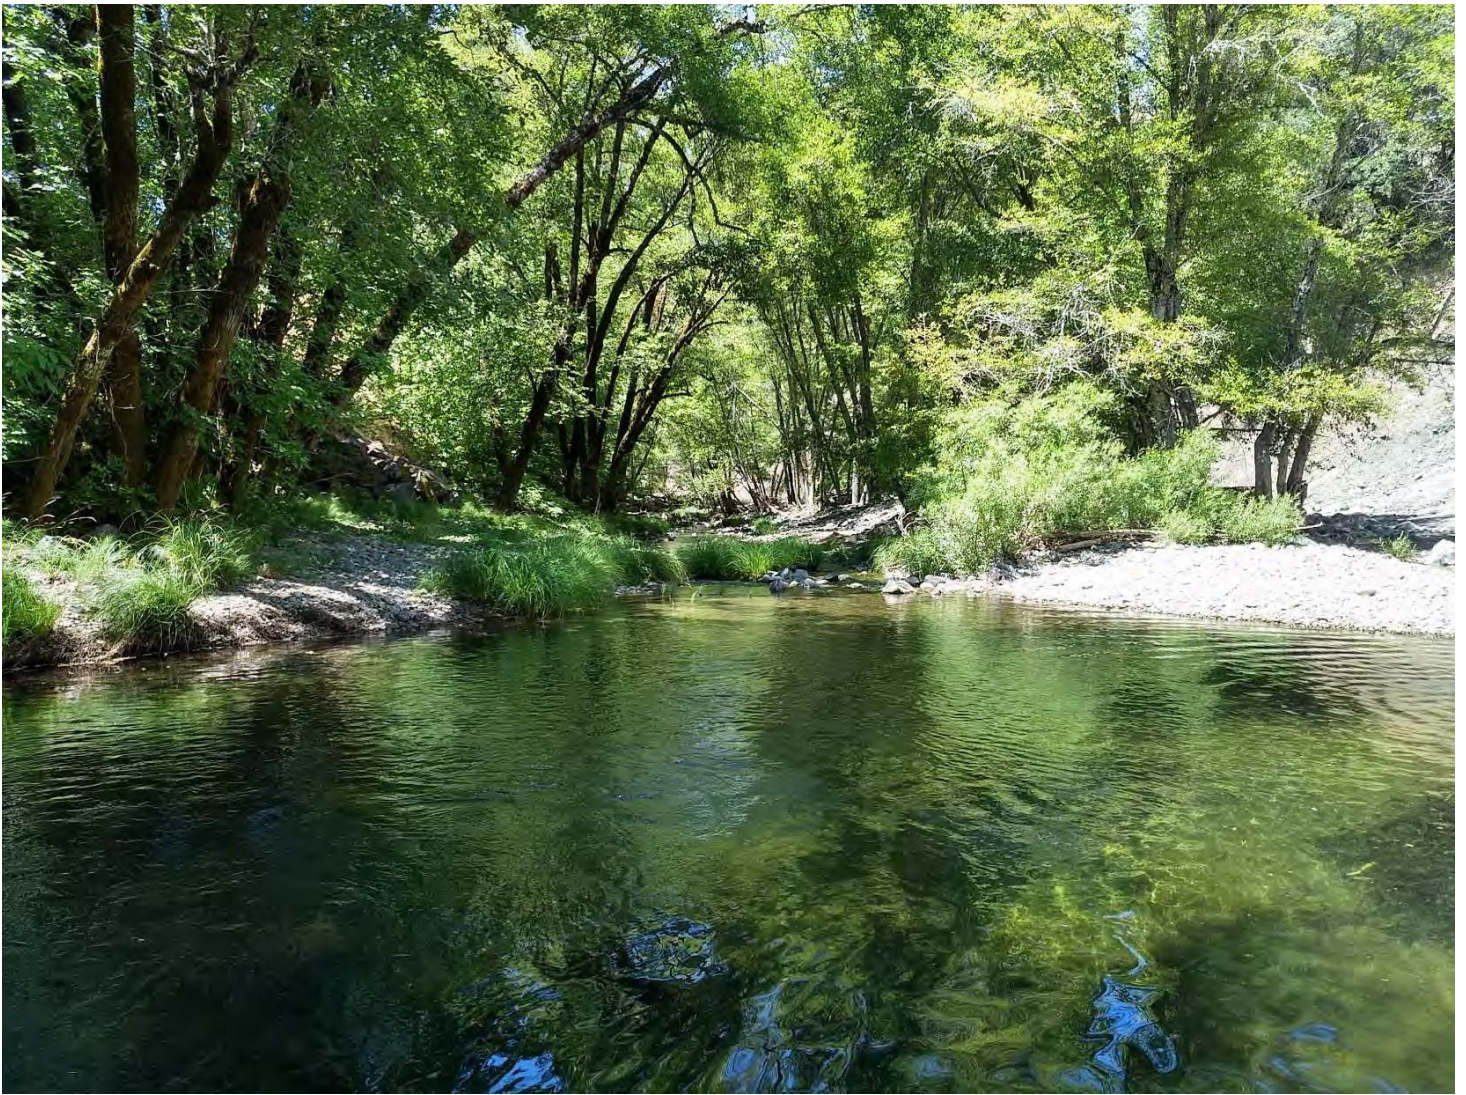
Figure 7. The outlet pool tailwater control looking downstream from the culvert outlet. Photo M. Lang on July 17, 2019.

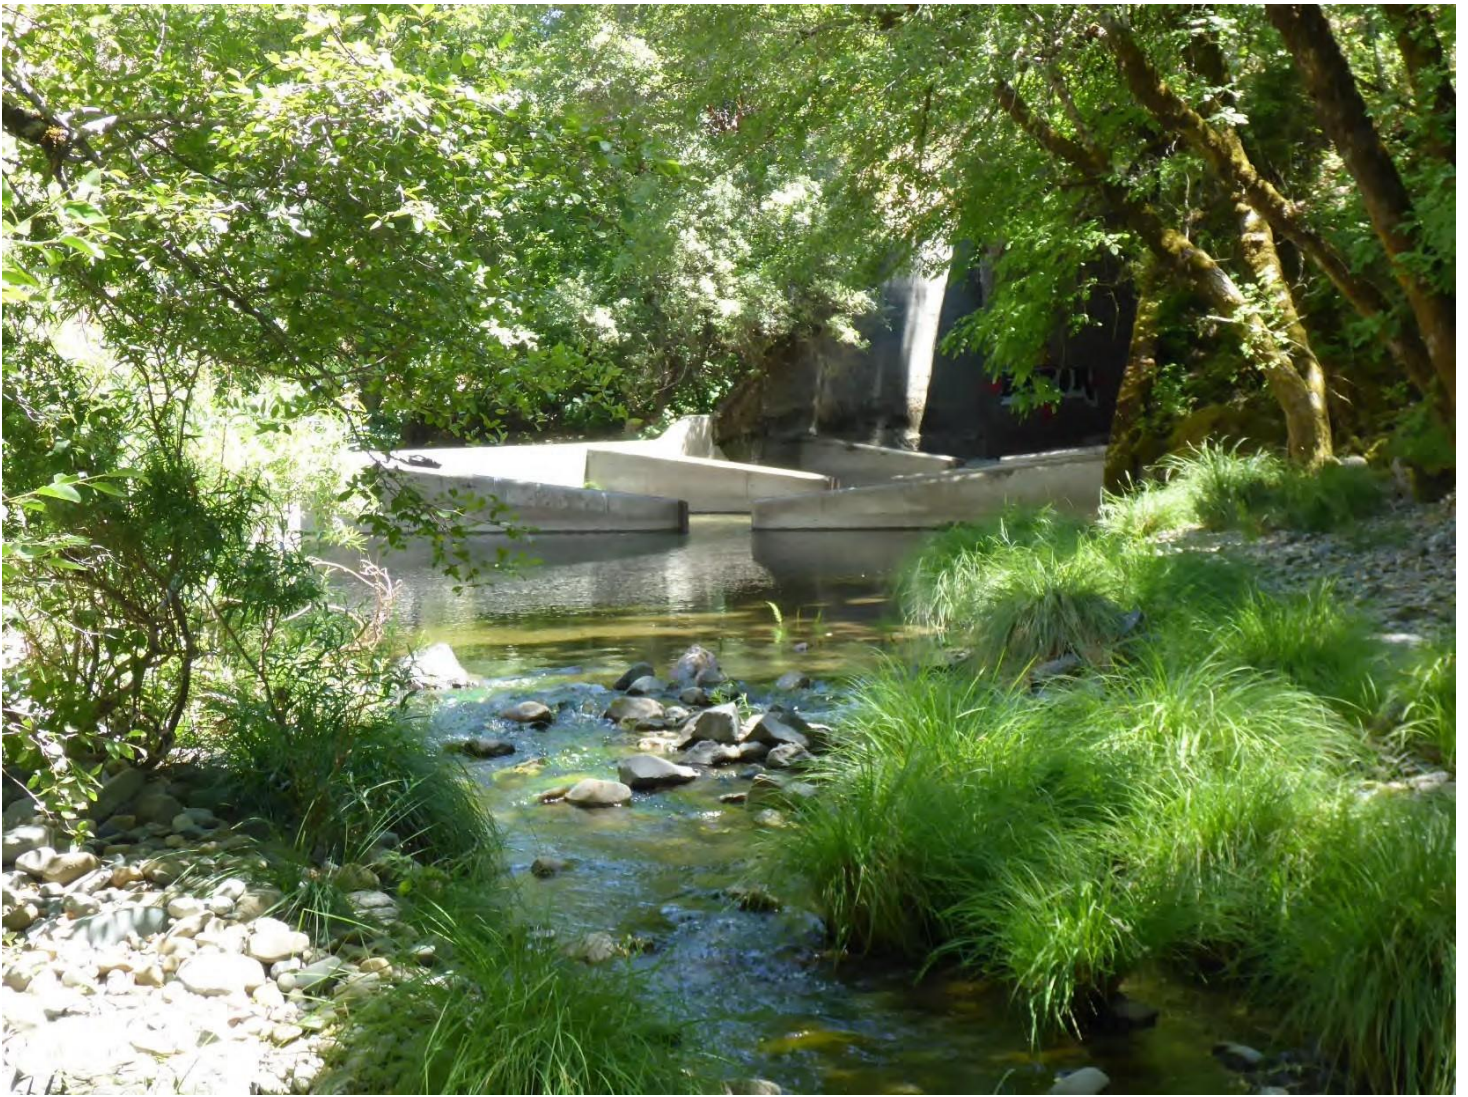
Figure 8. Outlet weirs looking upstream from the outlet pool tailwater control. Photo M. Love on July 17, 2019.

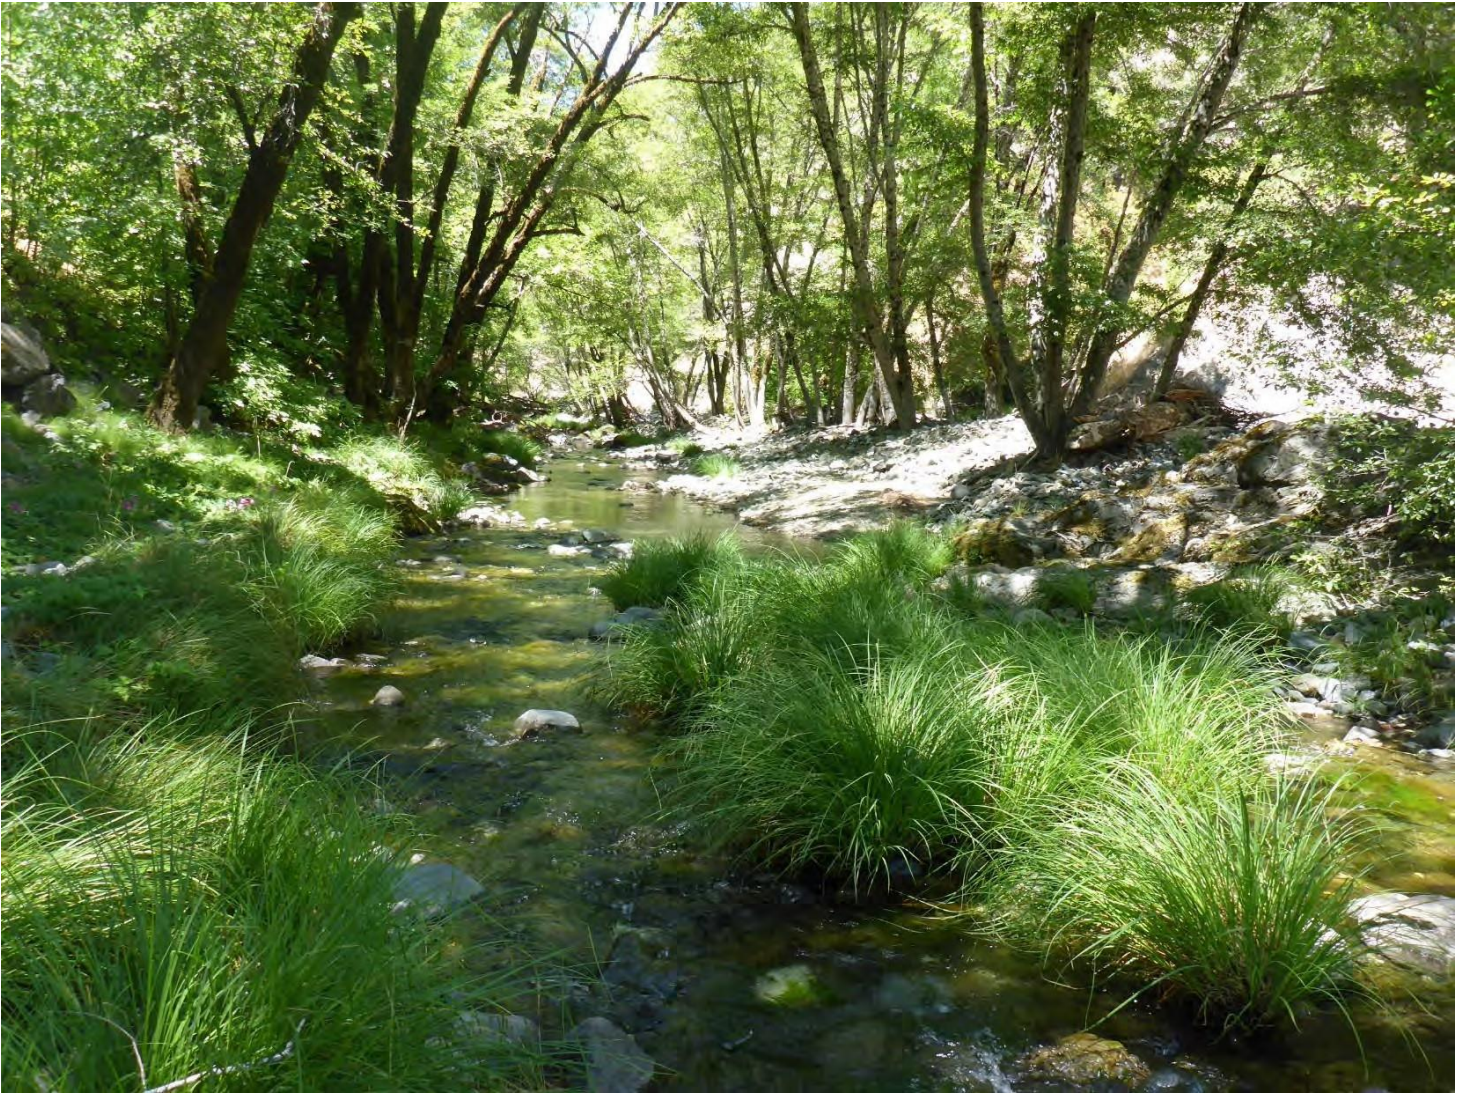
Figure 9. Downstream channel looking downstream from the outlet pool tailwater control. Photo M. Love on July 17, 2019.

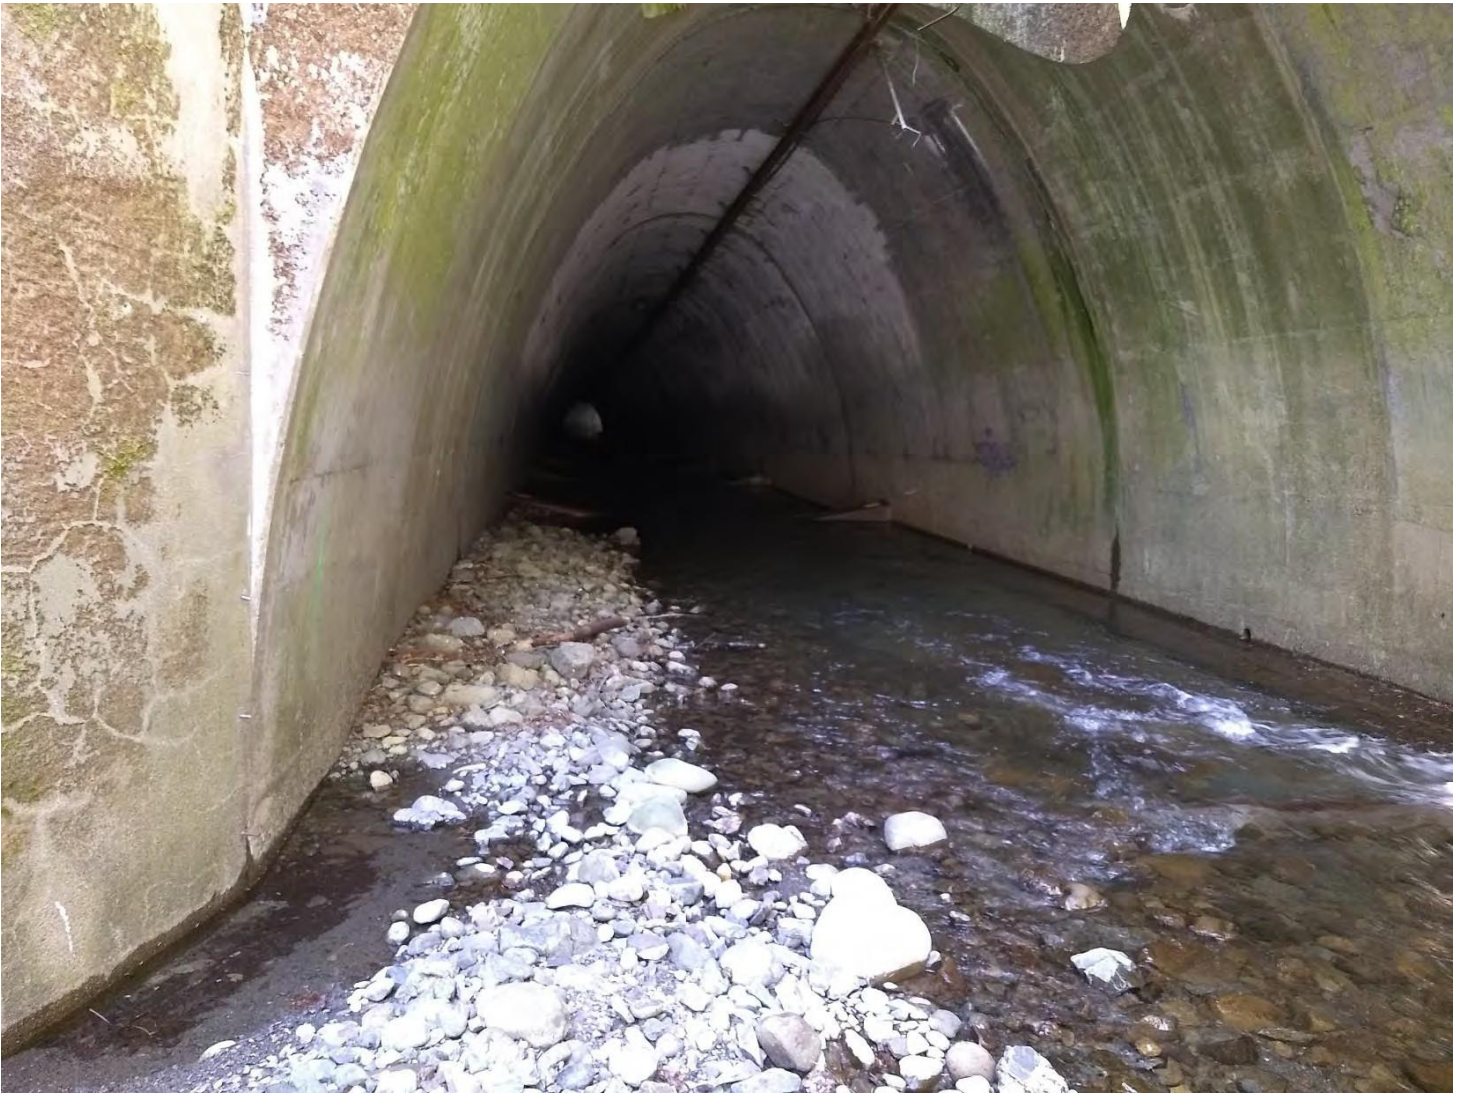
Figure 3. Cedar Creek culvert invert looking downstream from the inlet. The installed weirs are capturing sediment and maintaining a natural streambed near the inlet. Photo taken by M. Lang April 15, 2021.

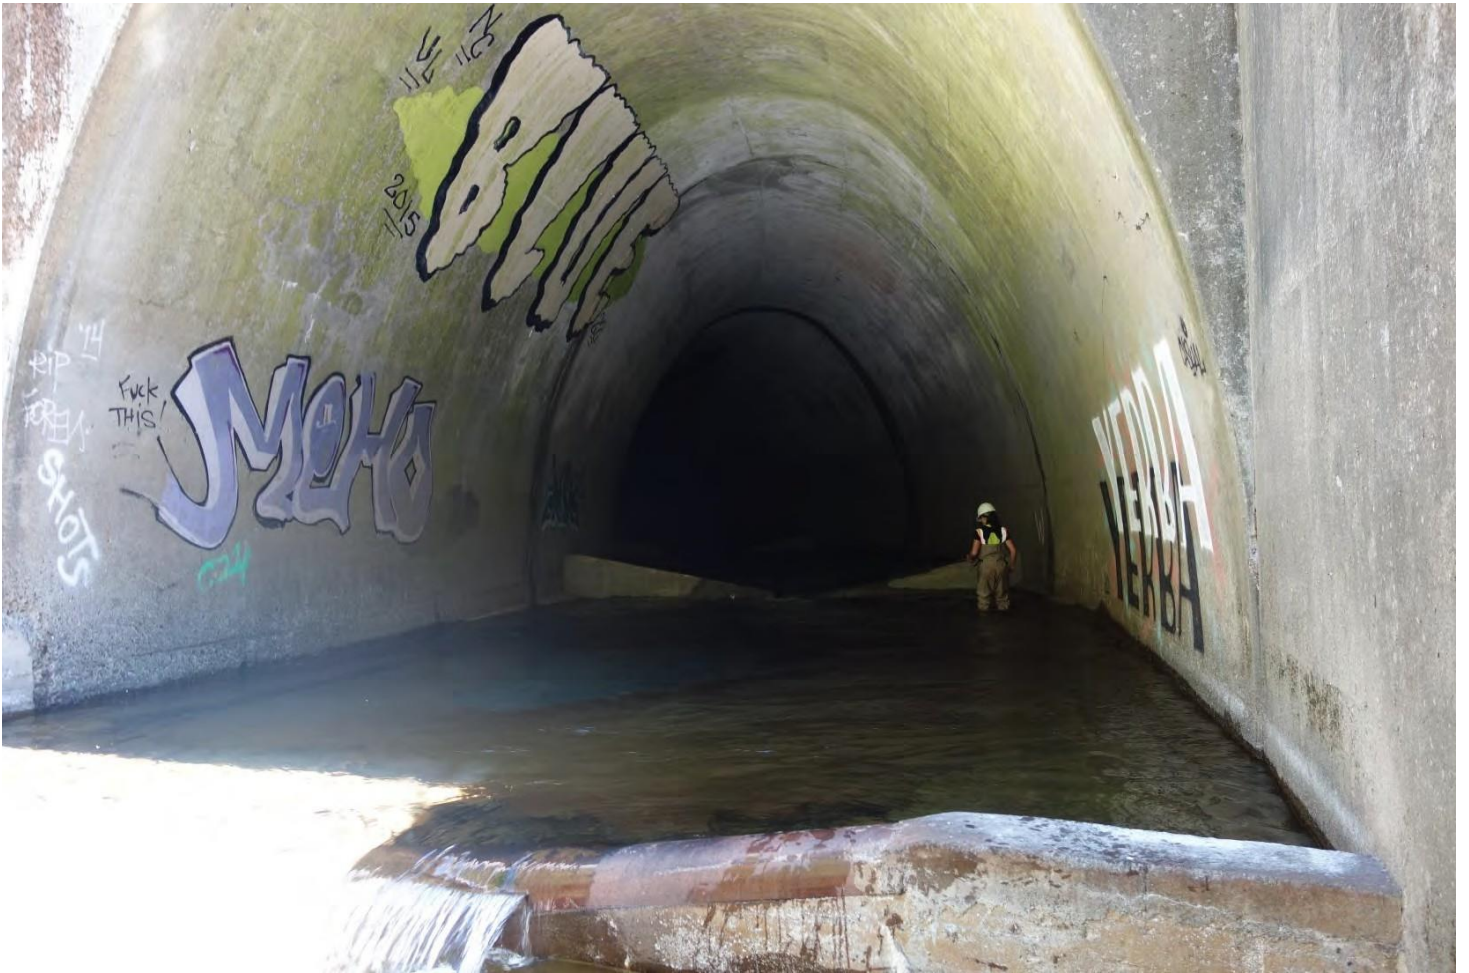
Figure 4. Cedar Creek culvert looking upstream from the outlet. The internal fish weirs are functioning well. Photo taken June 3, 2021.

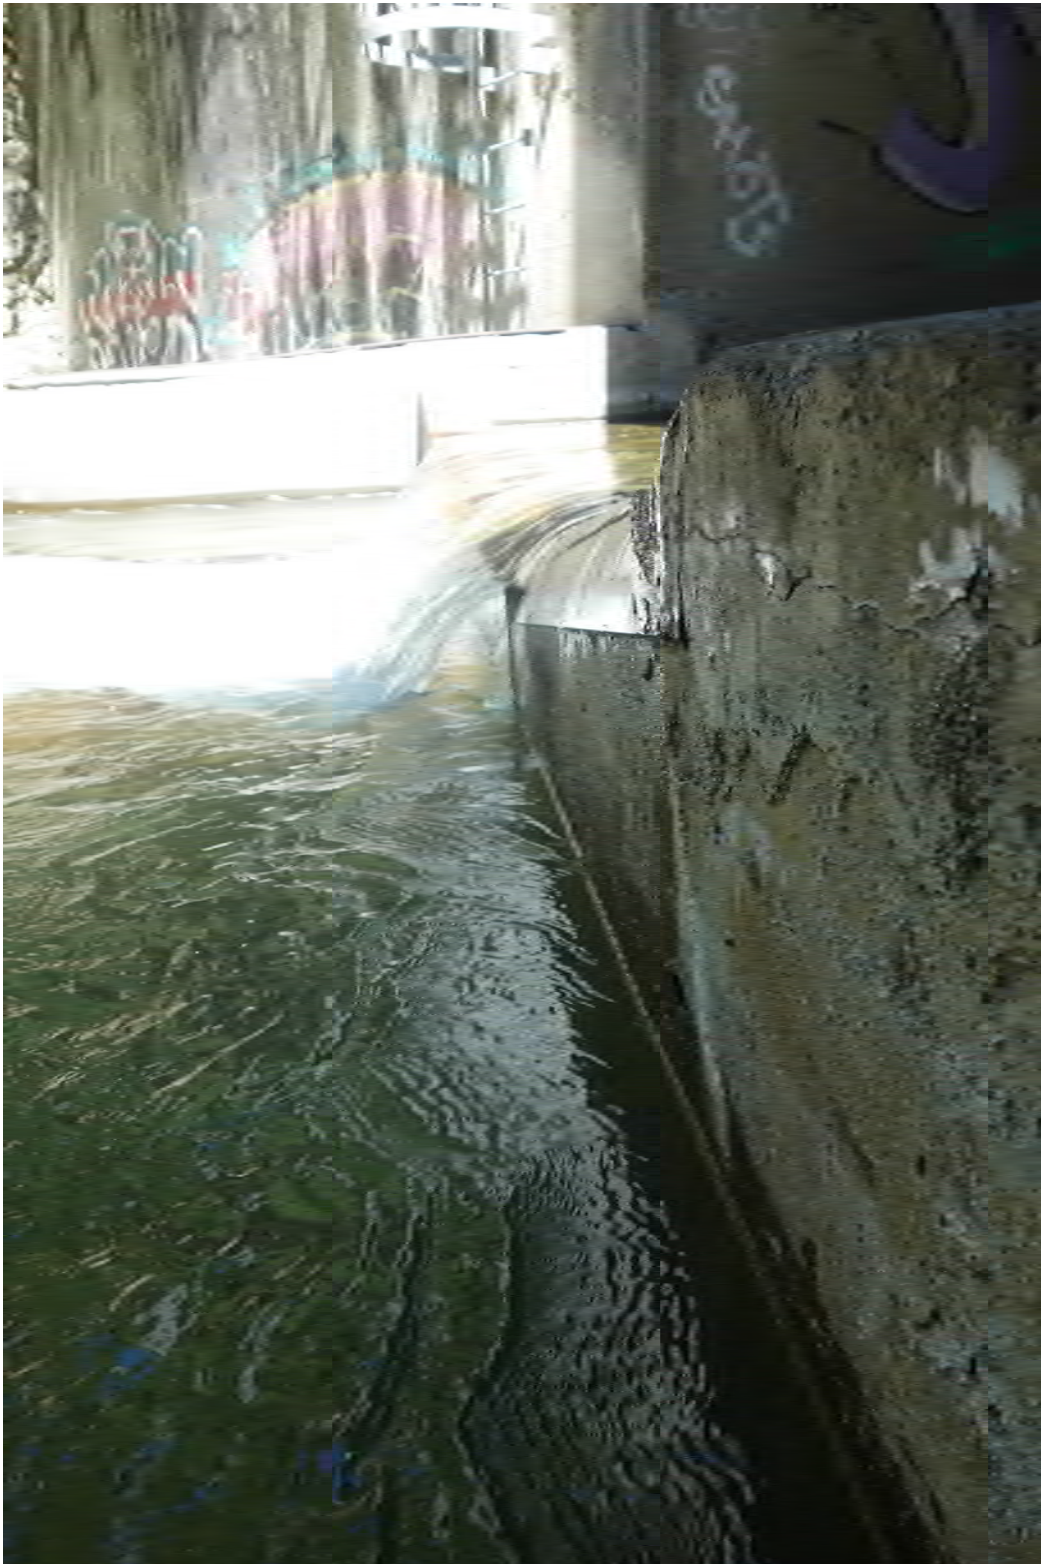
The concrete work used to install the steel tops on the outlet fishway appears to be crumbling or vulnerable to erosion by bedload transport (see Figure 10). Suggest periodic monitoring of these weirs and installing timelapse cameras to document hydraulic conditions in the fishway and inside the culvert at higher fish passage flows.				
Are there issues or concerns at this location that would require the immediate need of maintenance or adaptive measures, for fish access (if yes, take pictures and explain in notes)?				
Possibly. Some sections of the weir tops rounded to provide lamprey passage were dewatered at the flows encountered during assessment (see Figures 8 and 9).

Figure 8. Cedar Creek culvert outlet weir. The concrete at this location has a small edge which was not smoothed out when the steel cover was installed. This edge creates a detached flow that does not wet the rounded section installed to assist lamprey migration. Photo taken June 3, 2021.

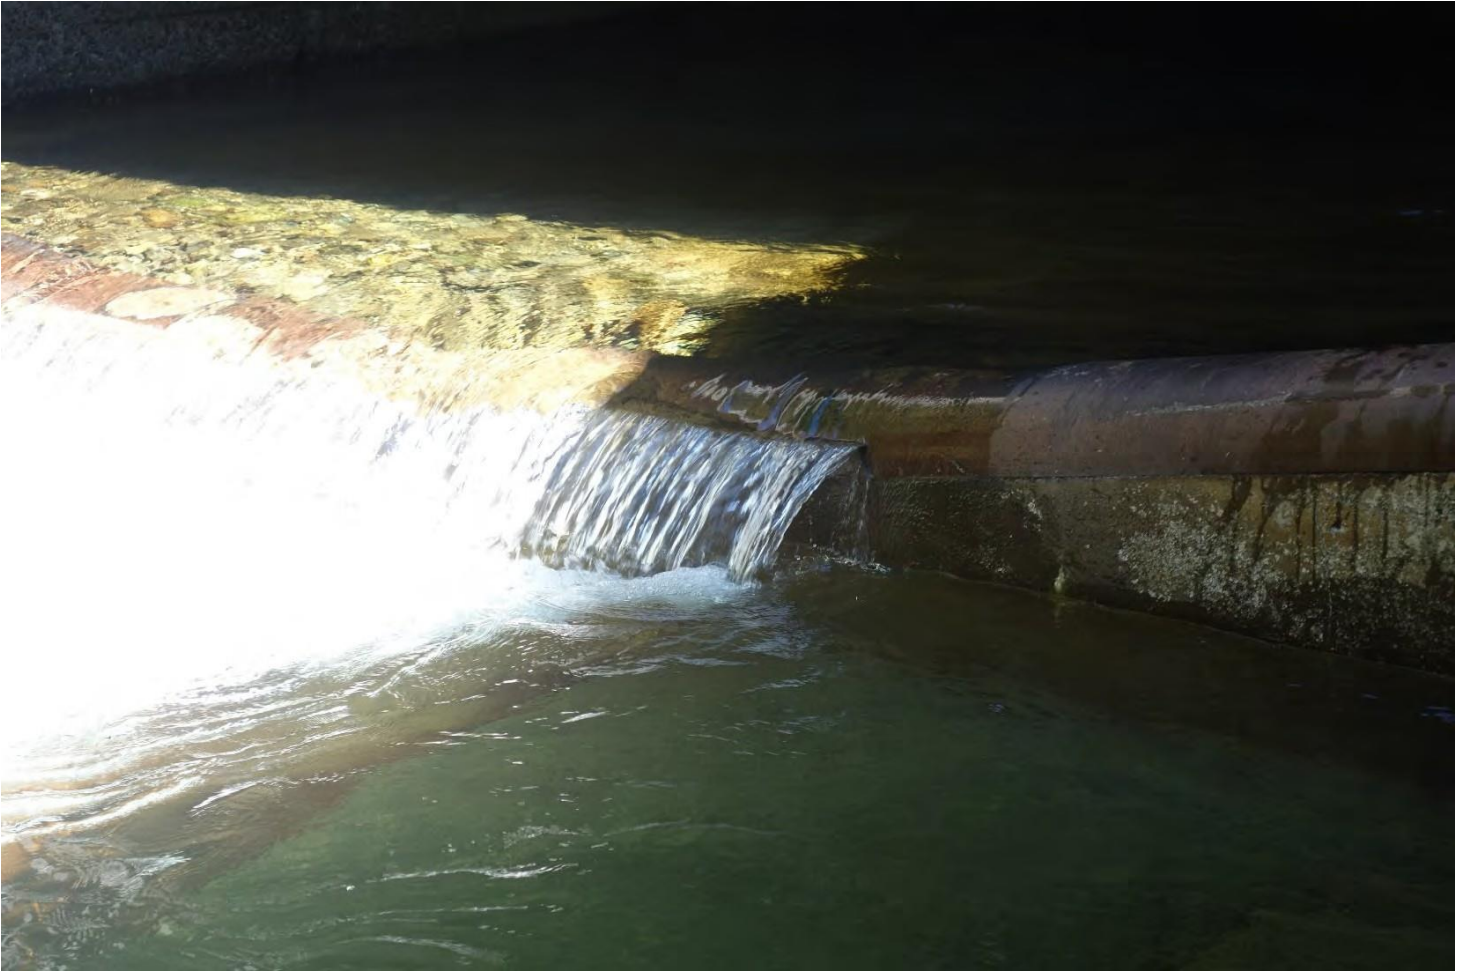
Figure 9. Cedar Creek culvert outlet weir. The concrete at this location has a small edge which was not smoothed out when the steel cover was installed. This edge creates a detached flow that does not wet the rounded section installed to assist lamprey migration. Photo taken June 3, 2021. (alternate view to supplement Figure 8)

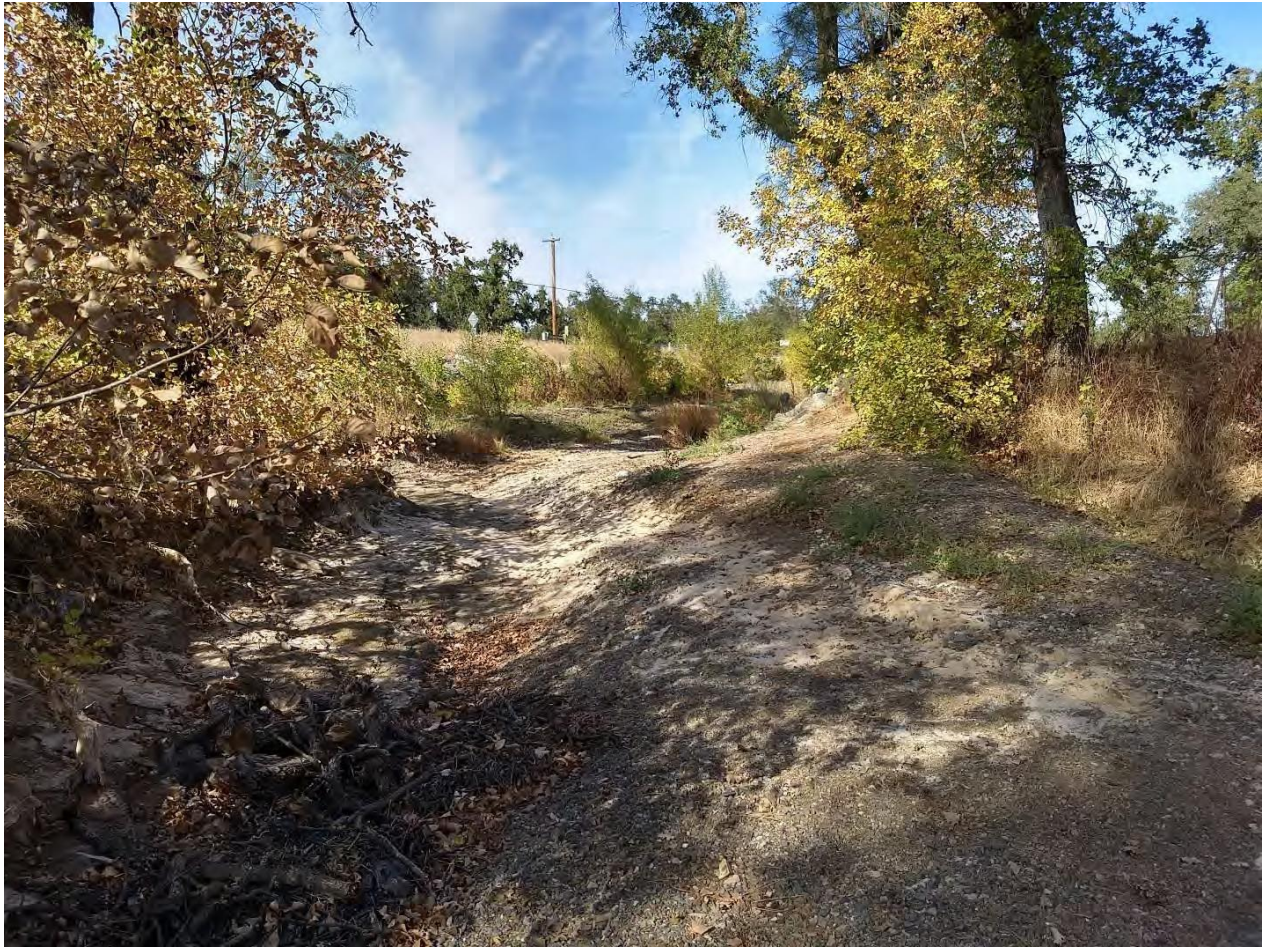
Figure 1. Lemm/Yank Creek Highway 299 bridge looking upstream from the downstream channel. The downstream channel is a mix of claystone bedrock sections and gravel. Photo taken October 4, 2019.

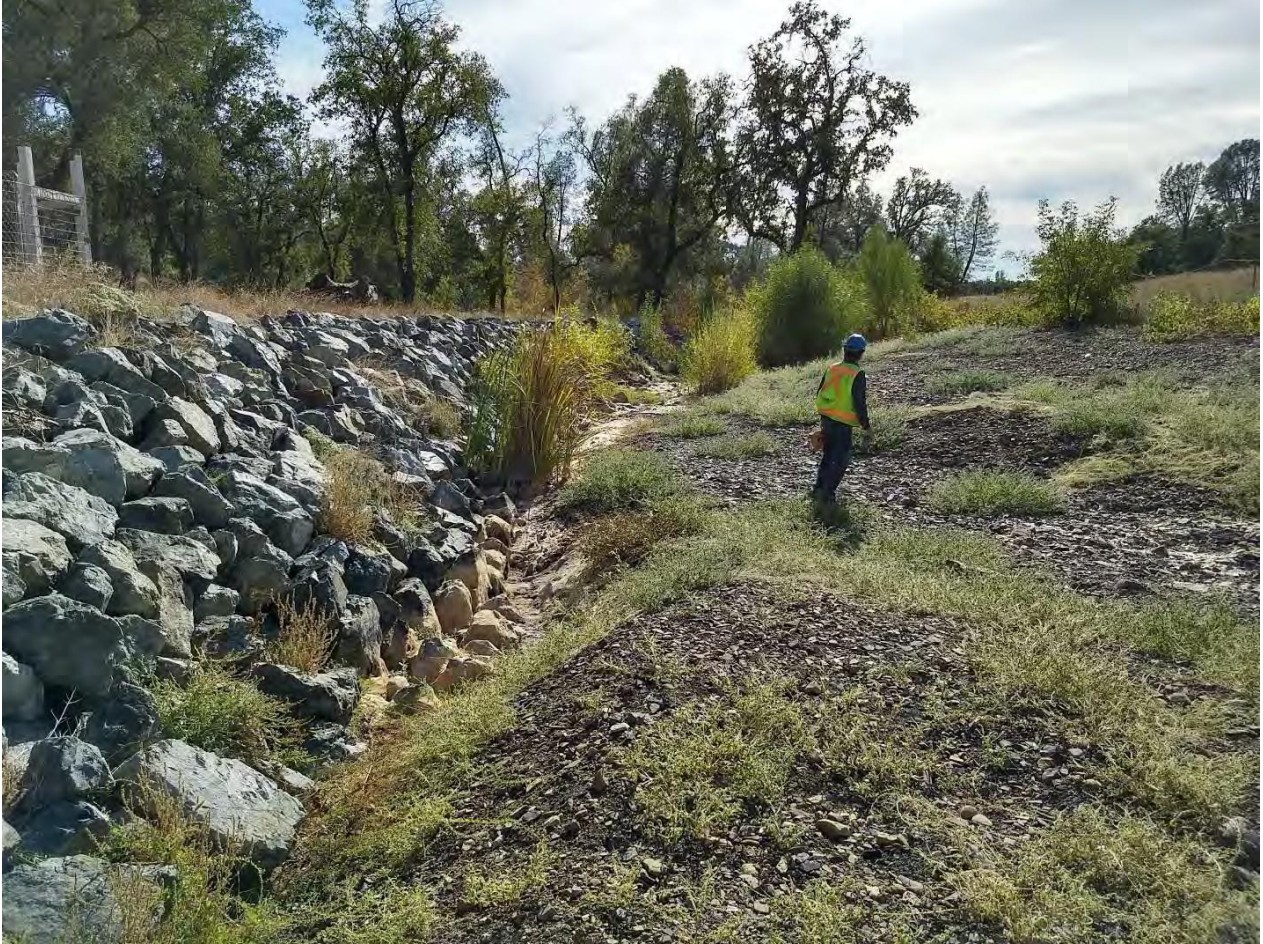
Figure 2. Lemm/Yank Creek Highway 299 bridge looking downstream at the downstream channel just after the bridge. This section makes a sharp right turn along the armored embankment into a narrow, V-shaped channel for approximately 60 feet before the downstream channel widens and transitions to a natural channel shape with a mix of claystone bedrock sections and gravel. Photo taken October 4, 2019.

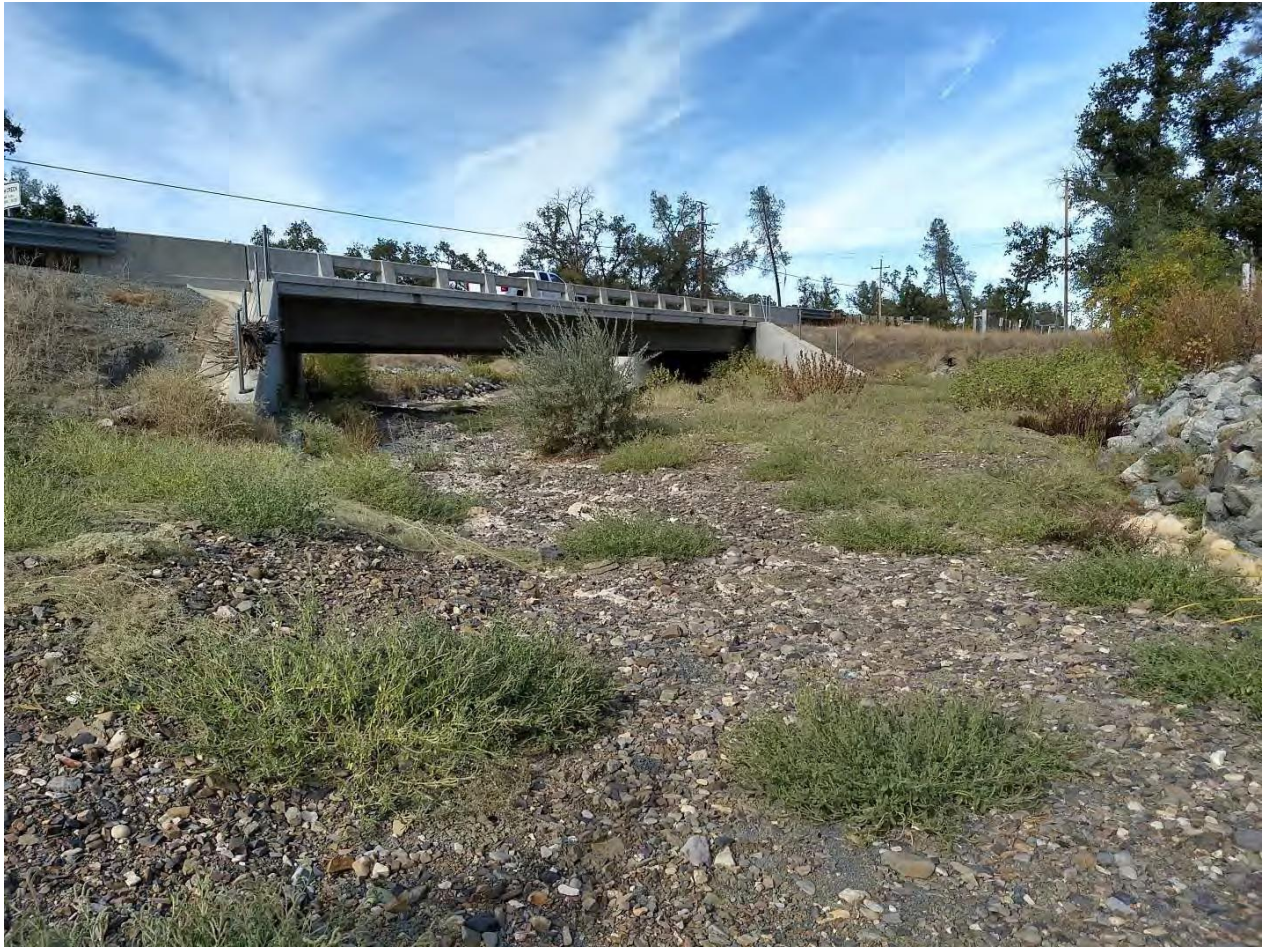
Figure 3. Lemm/Yank Creek Highway 299 bridge looking upstream. The creek channel is aligned with the thalweg along the left wingwall upstream, then crossing through the structure to the right wingwall downstream as shown in this picture. High flow debris was captured on the fence above the right wingwall as shown which matches debris at the same elevation as on the left wingwall fence upstream. Photo taken October 4, 2019.

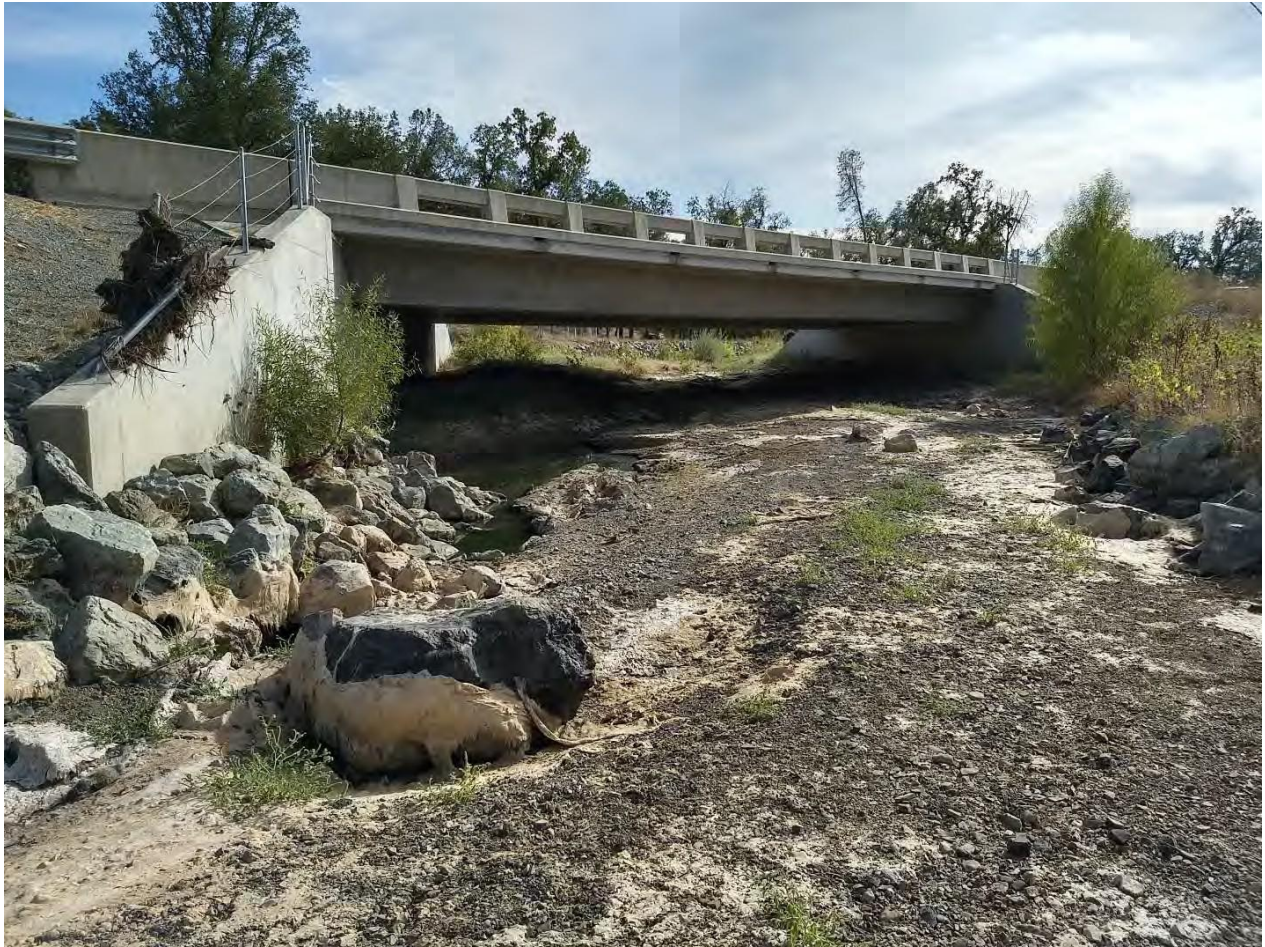
Figure 4. Lemm/Yank Creek Highway 299 bridge looking downstream. The creek channel is aligned with the thalweg along the left wingwall upstream, then crossing through the structure to the right wingwall downstream. High flow debris was captured on the fence above the left wingwall as it poured over the wall creating the scour hole in the foreground. Photo taken October 4, 2019.

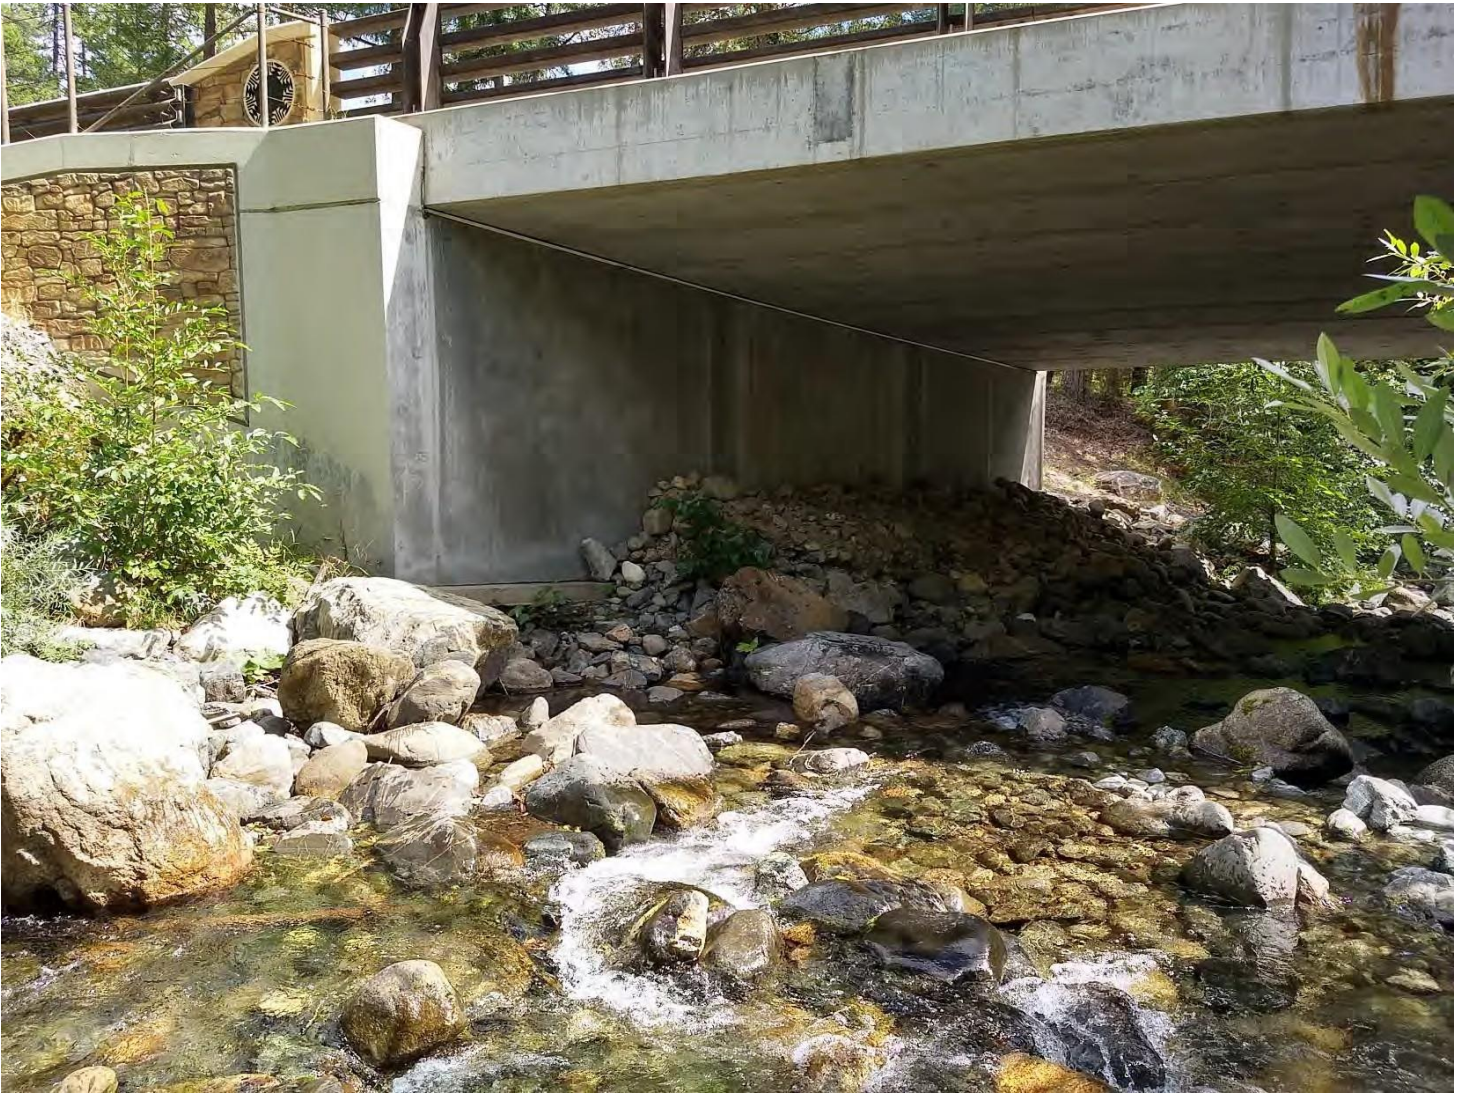
Figure 3. Upstream, left bank of bridge showing scoured bank protection and exposed footing. Photo by M. Lang on 9/19/2019.

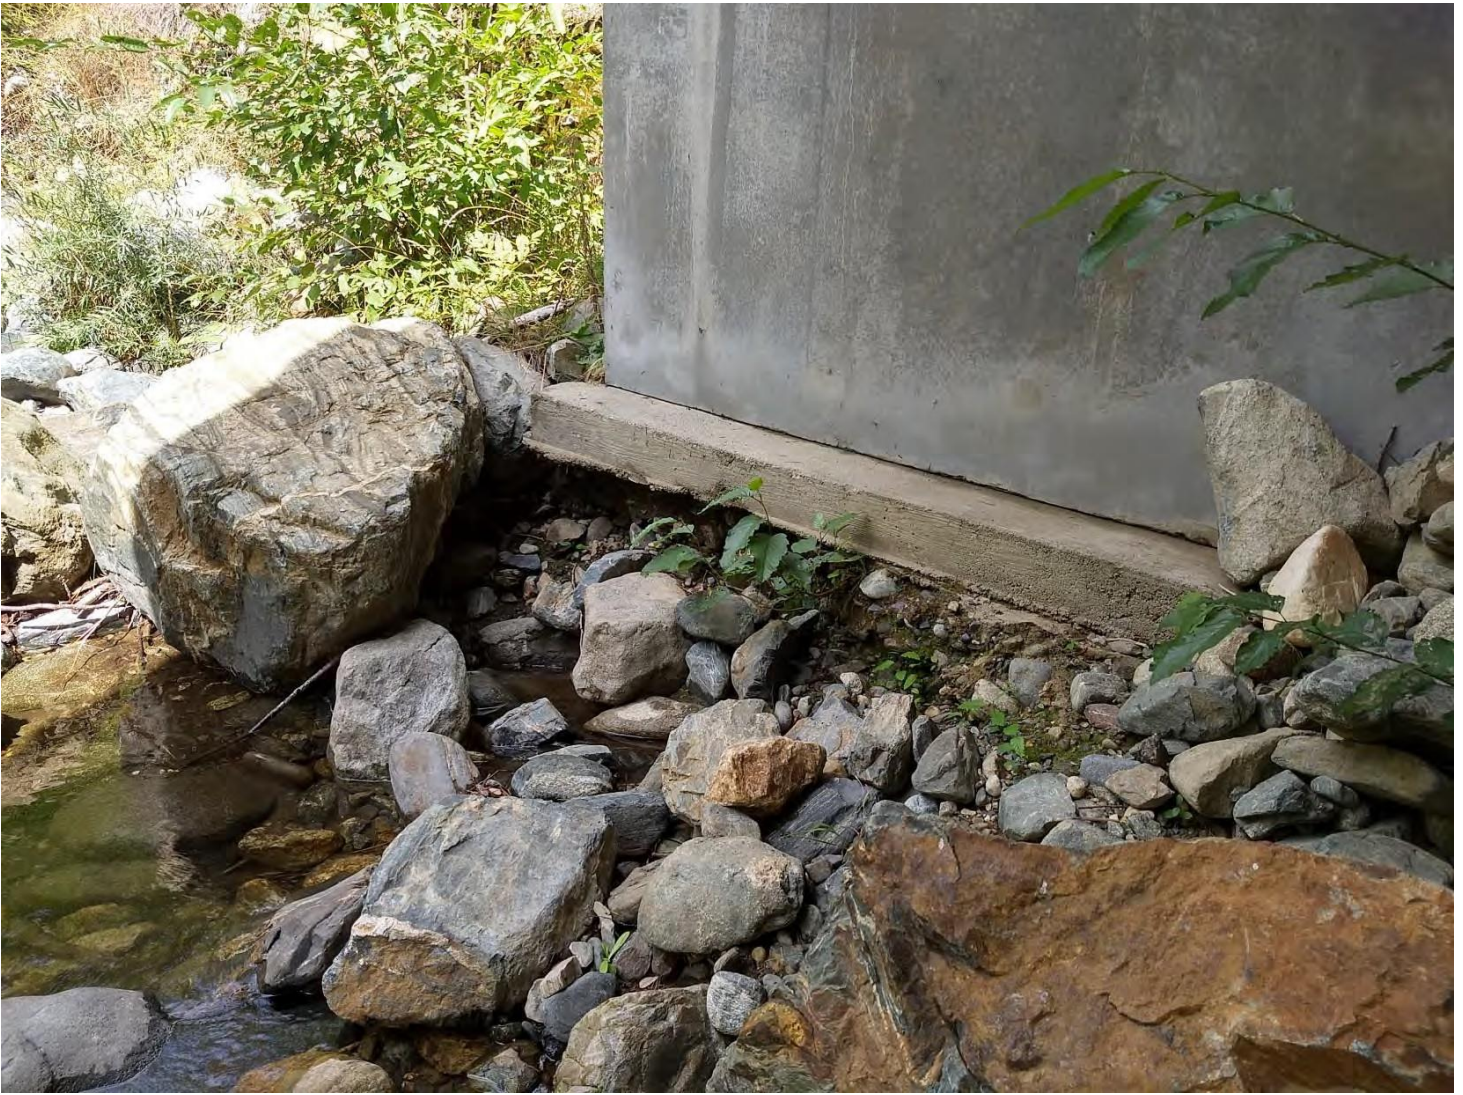
Figure 4. Close-up of upstream, left bank of bridge showing scoured bank protection and exposed footing. Photo by M. Lang on 9/19/2019.

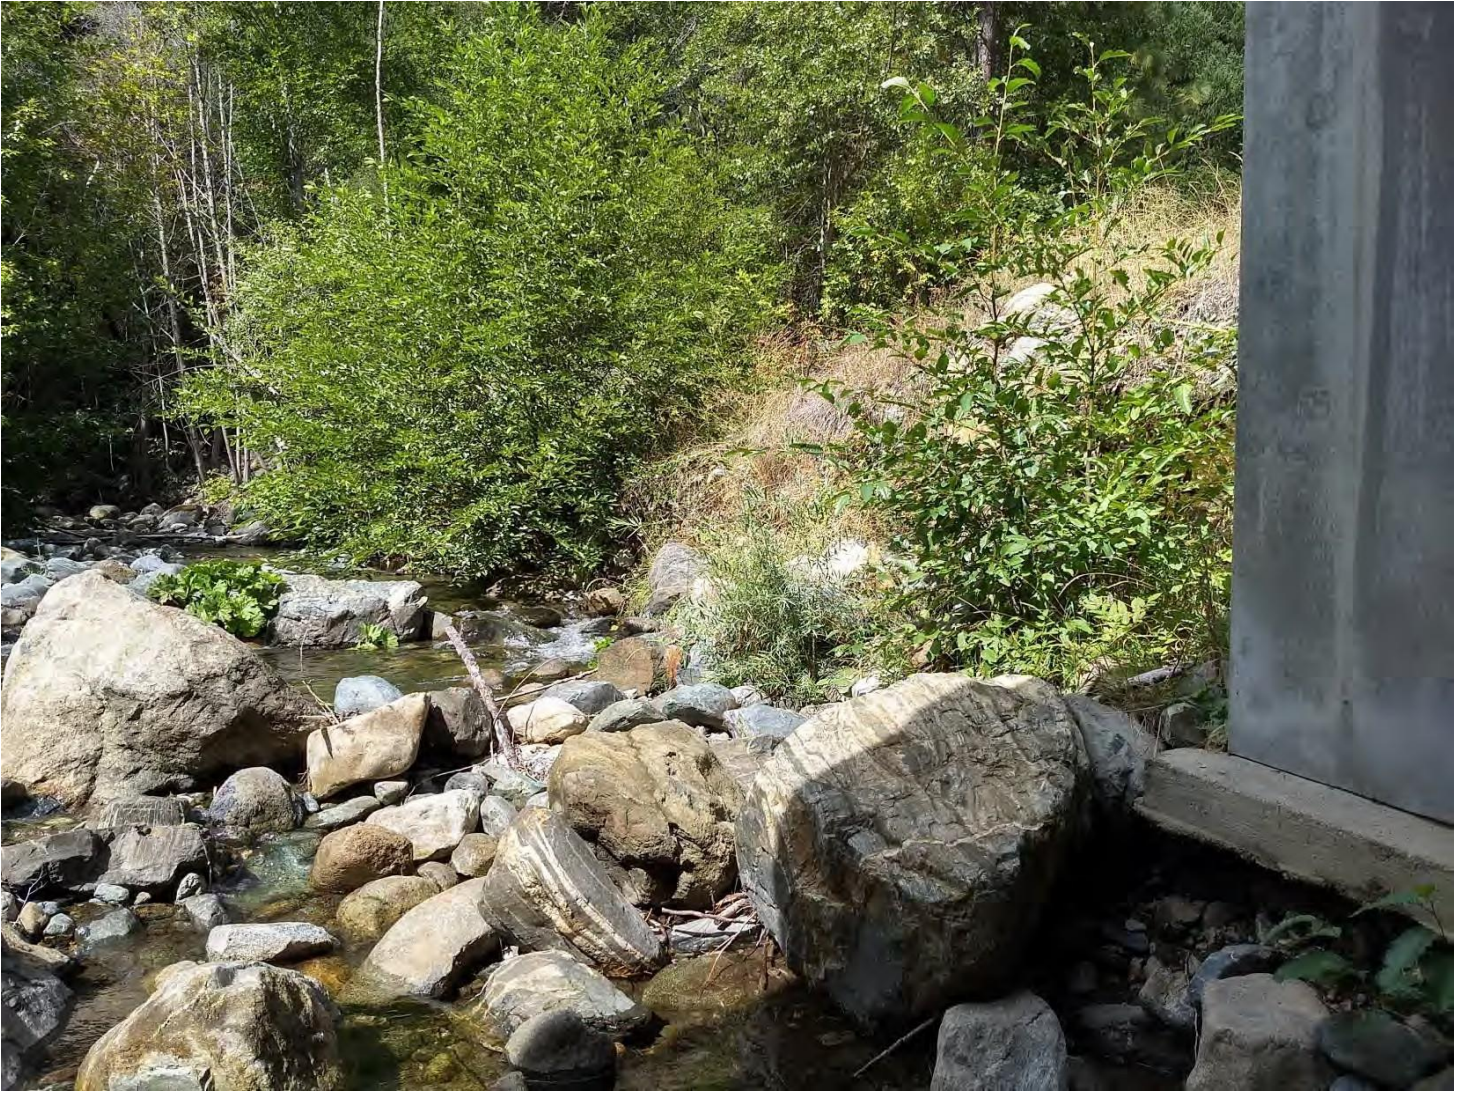
Figure 5. Upstream, left bank and bridge footing showing scoured bank protection and exposed footing. This is an outer channel bend coming into the bridge project site. Photo by M. Lang on 9/19/2019.

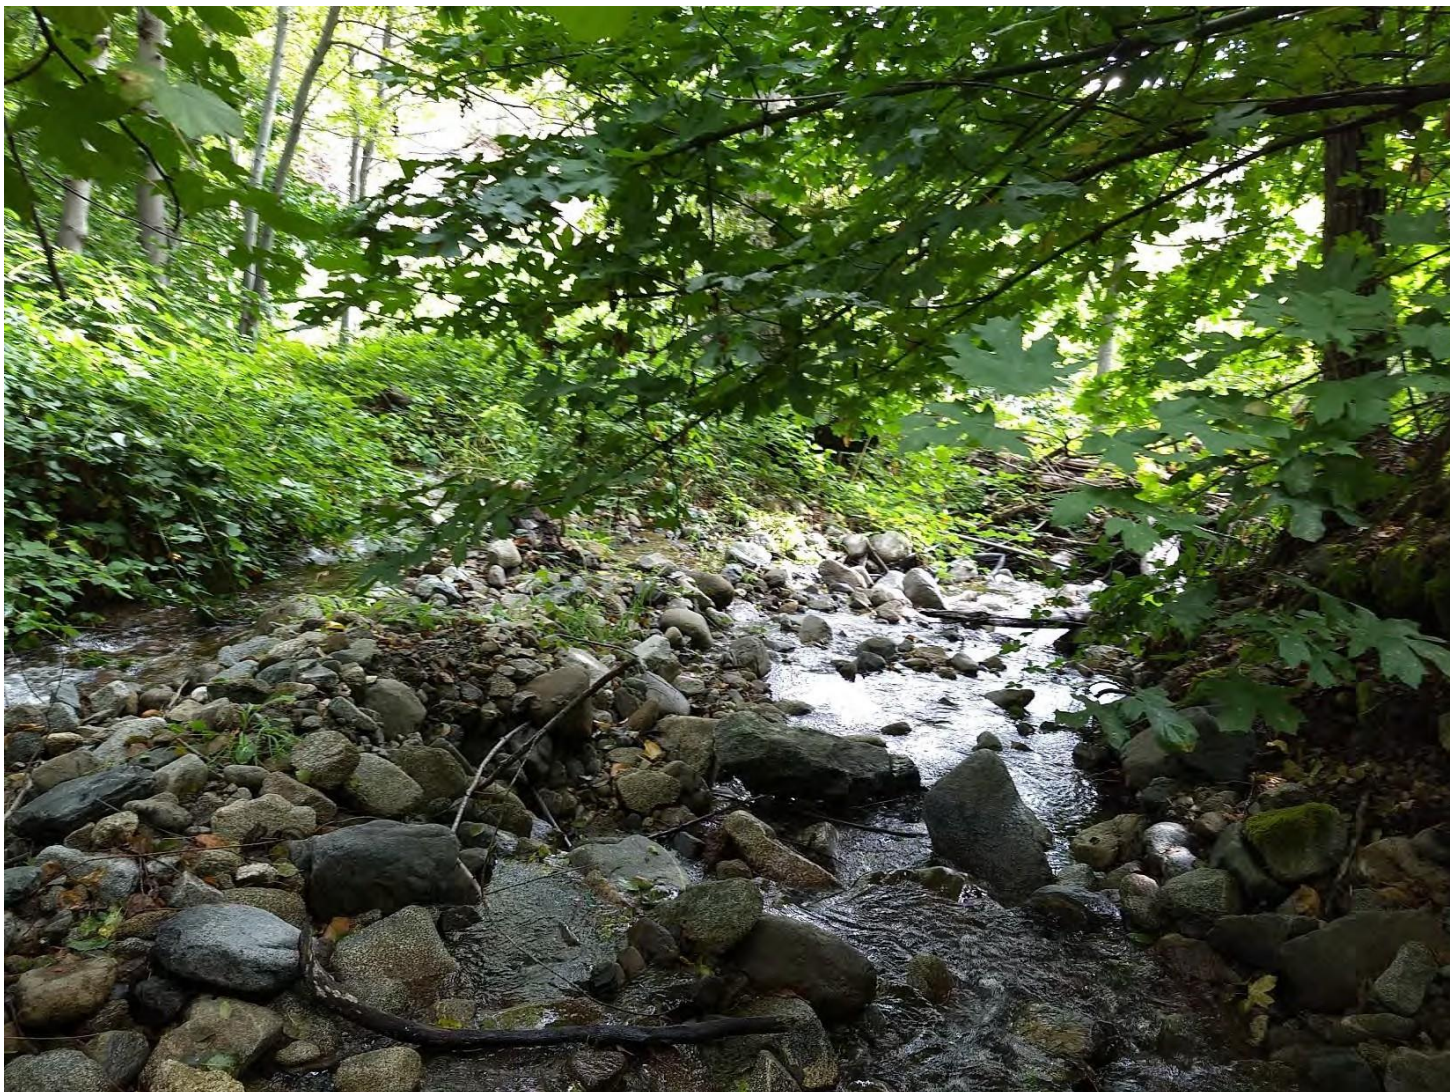
Figure 2. Channel downstream of the bridge looking downstream at the section with backwater deposits. There is a water diversion on the left channel that had been reworked to maintain its flow and elevation. The main channel is on the right. Photo by M. Lang on 9/19/2019.
