FISH PASSAGE ENGINEERING PROJECT

Site Analysis Final Report

SITE ANALYSIS FINAL REPORT

Humboldt State University
Michael Love & Associates, Inc.

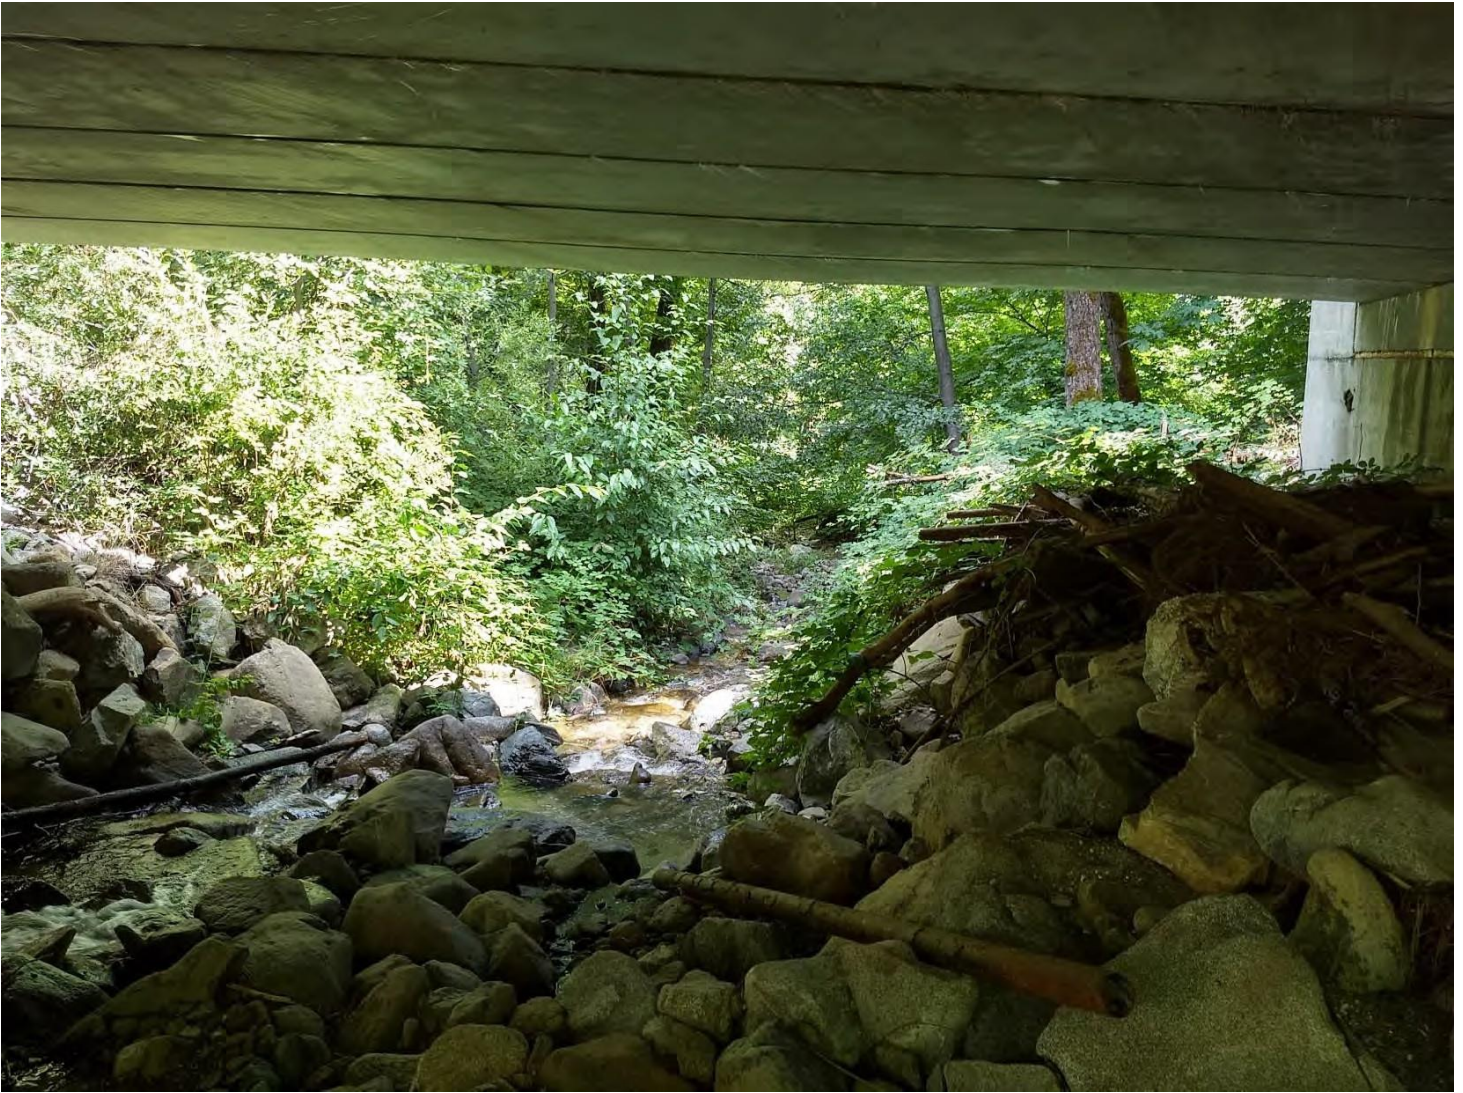
Figure 6. Channel under the bridge showing wood deposited at high flows onto the top of the constructed bank protection. Photo by M. Lang on 9/19/2019.

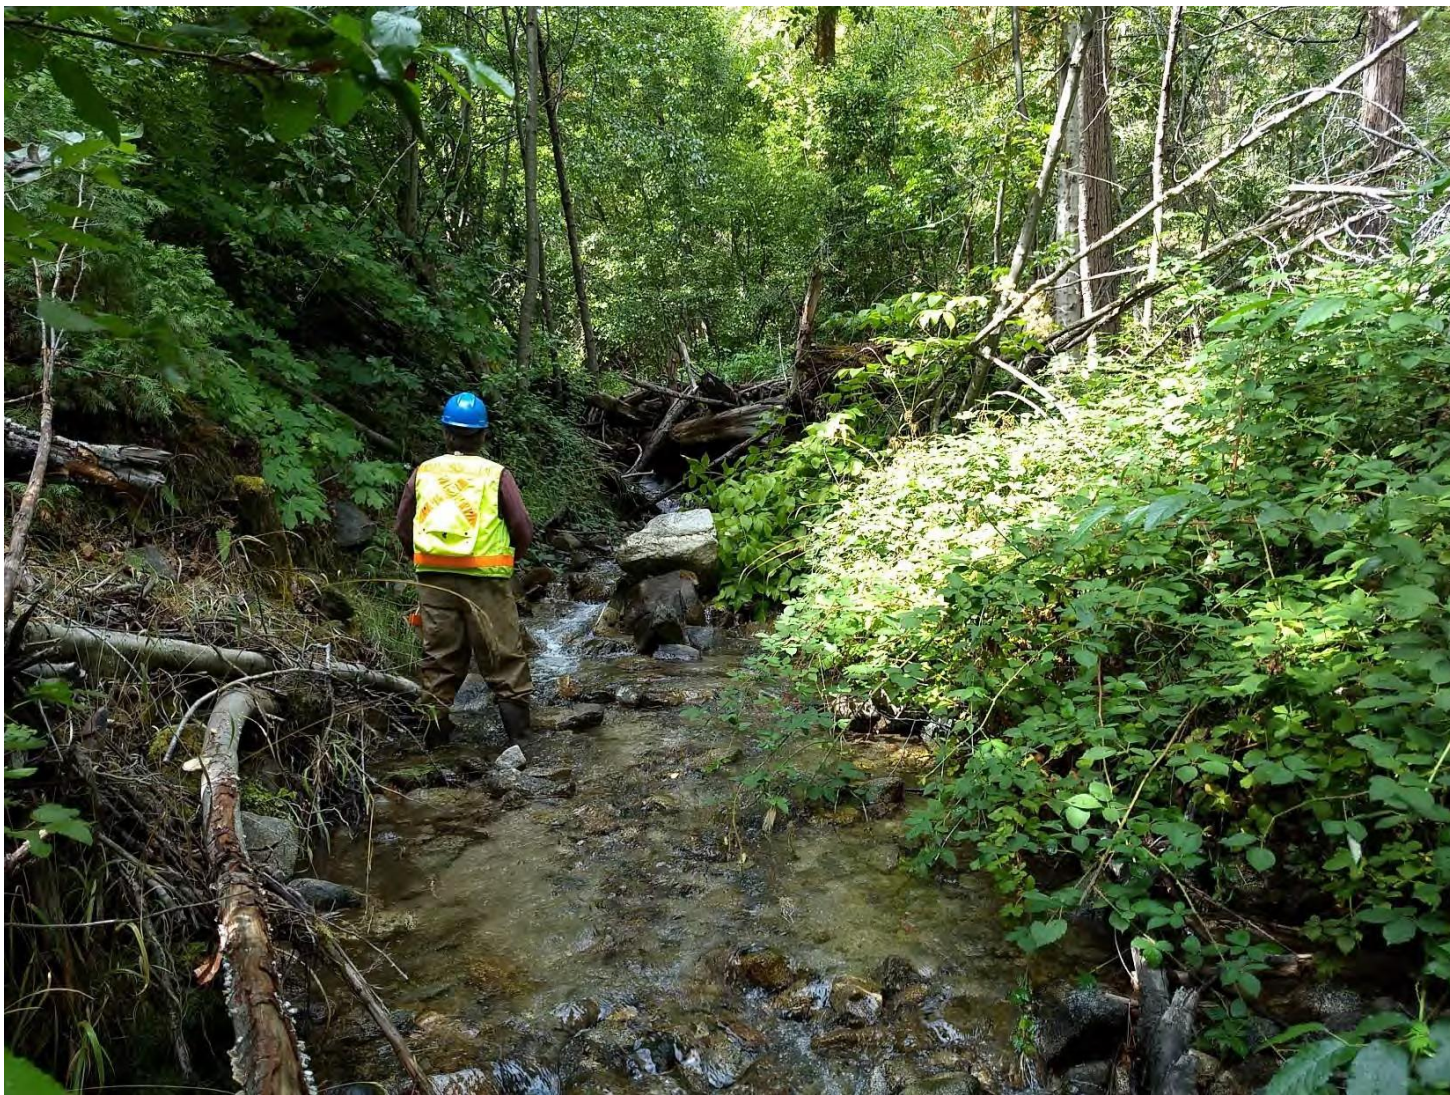
Figure 8. Log jam in upstream channel looking upstream. This wood jam looks like it could mobilize at high flows with a potential to release finer sediment. Photo by M. Lang on 9/19/2019.

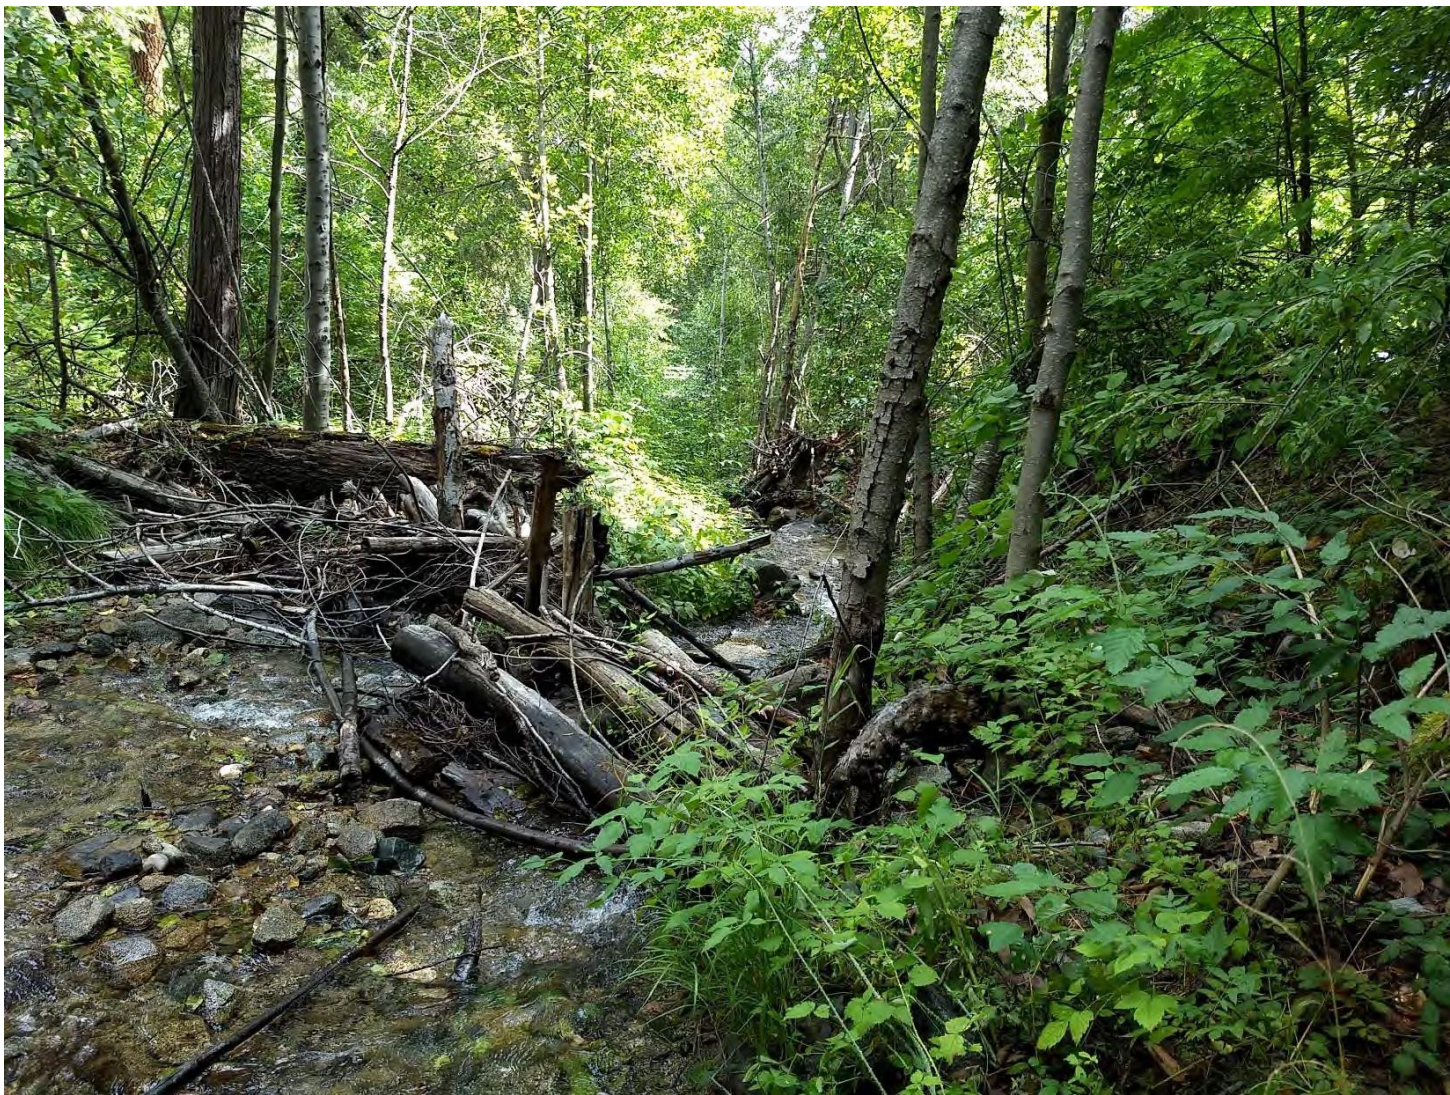
Figure 9. Log jam in upstream channel looking downstream. This wood jam looks like it could mobilize at high flows with a potential to release finer sediment. Photo by M. Lang on 9/19/2019.

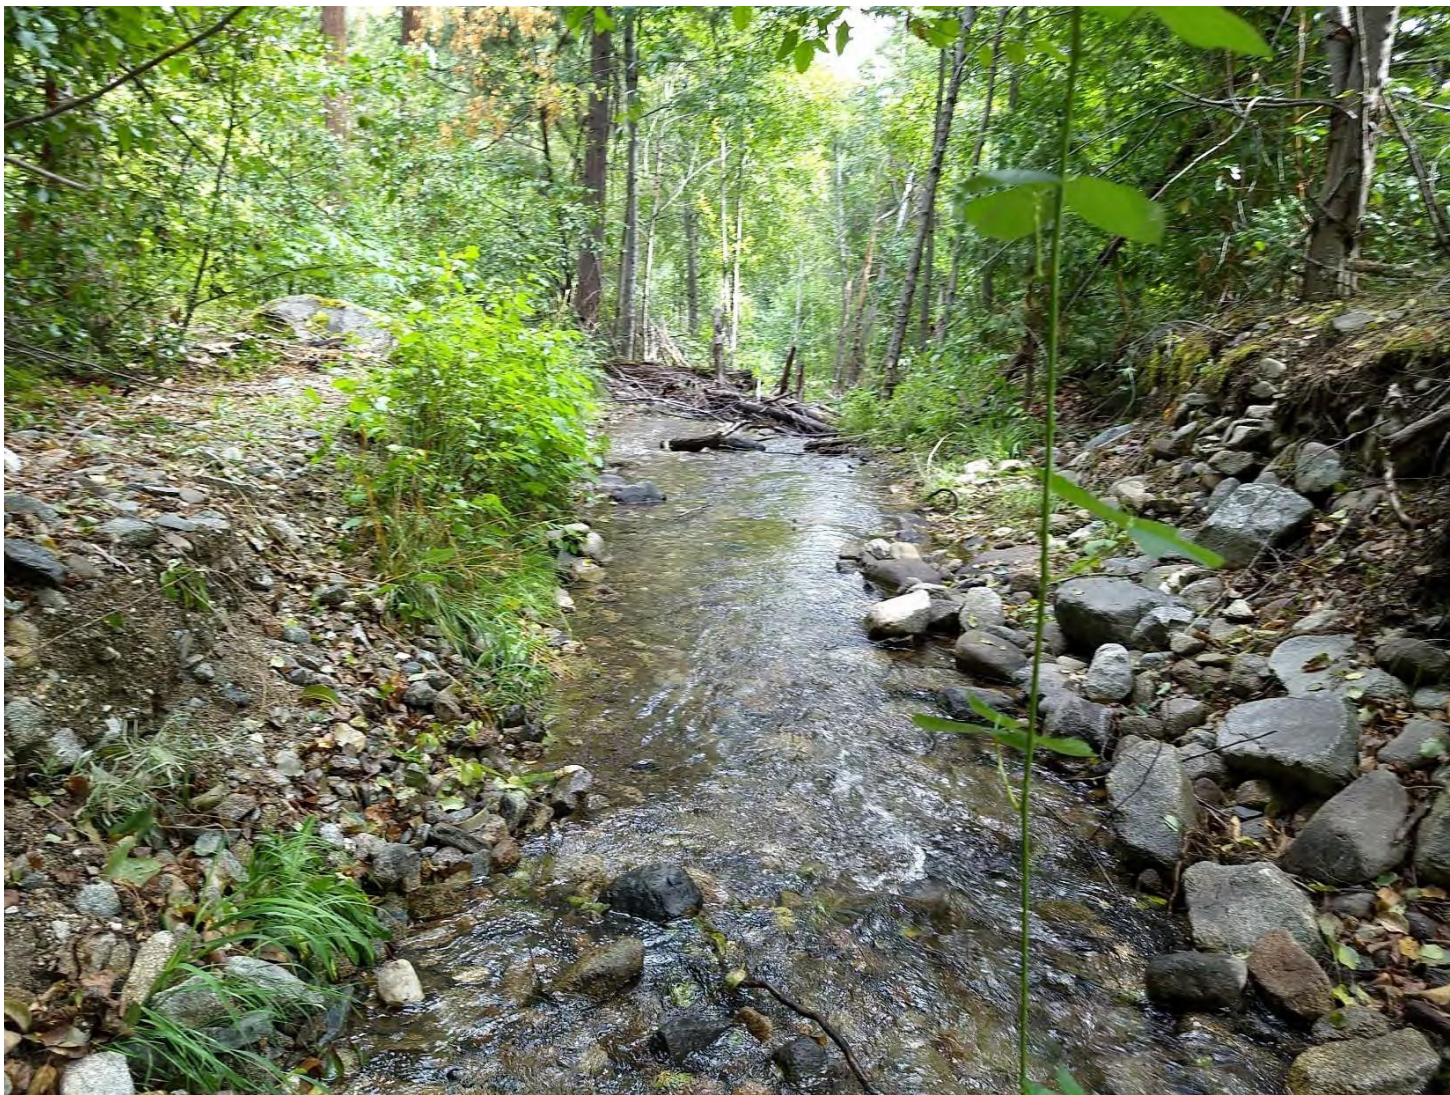
Figure 10. Log jam in upstream channel looking downstream. The sediment in the channel and the banks in this reach are finer than downstream. This channel section looks appears to be a location of periodic deposition. Photo by M. Lang on 9/19/2019.

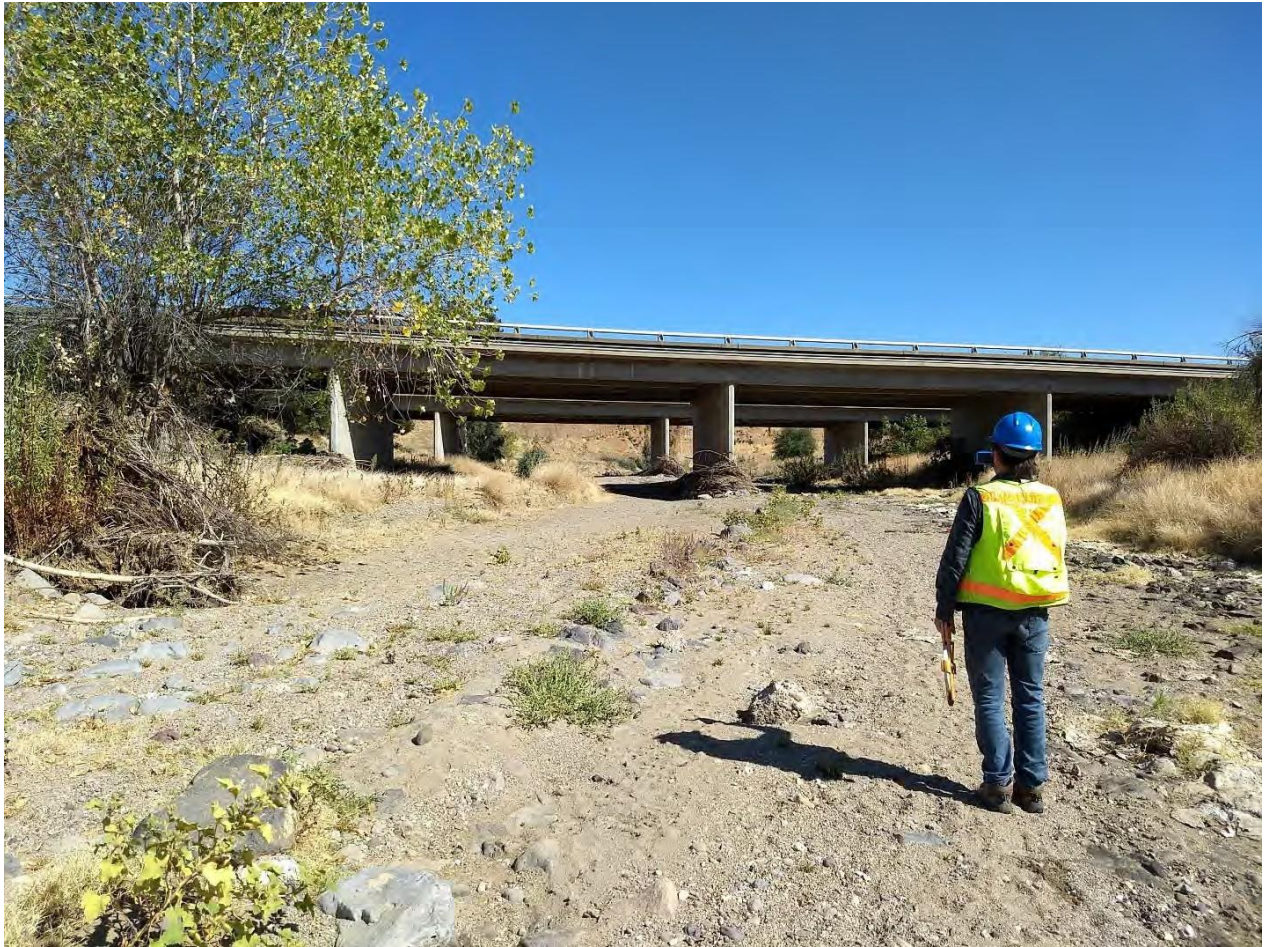
Figure 1. Dibble Creek looking downstream at the Highway 5 bridges. The main channel is on the right as indicated by the lower elevation and coarser substrate. Photo taken October 4, 2019.

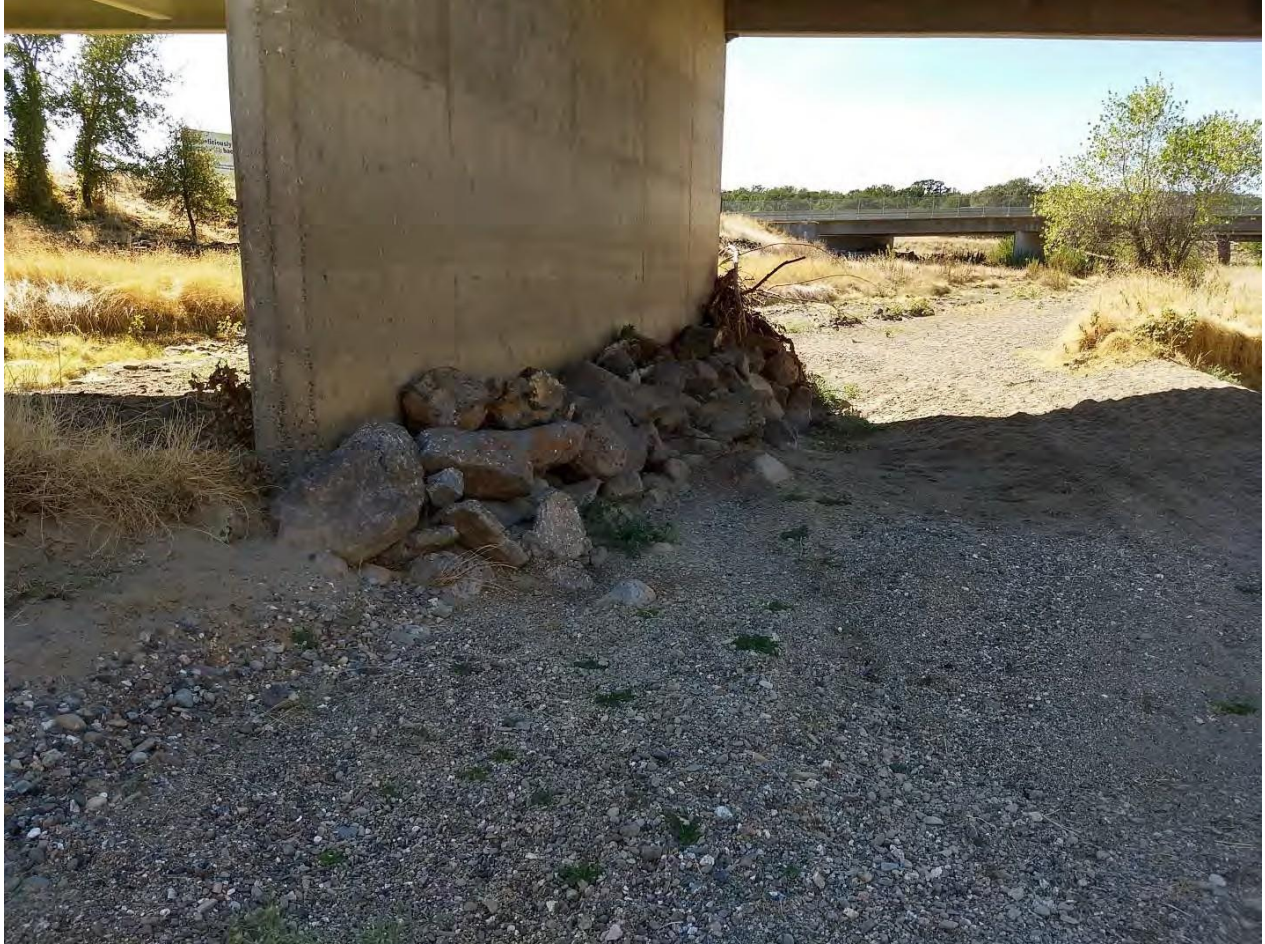
Figure 2. Dibble Creek middle footing of southbound Highway 5 bridge looking upstream at the frontage road bridge. The main channel is on the left of this picture. The left channel has much finer sediment. Photo taken October 4, 2019.

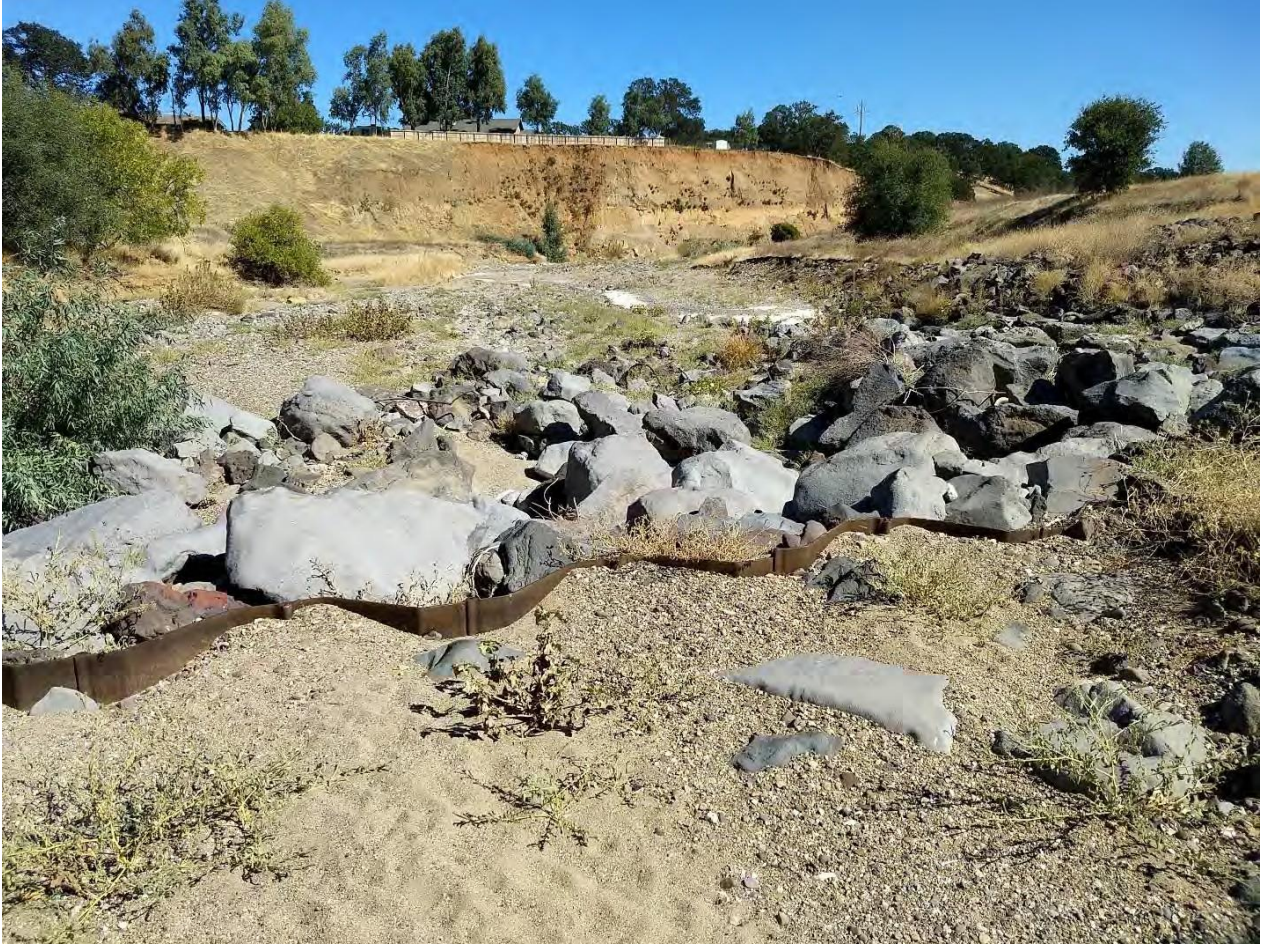
Figure 3. Dibble Creek looking downstream from the bridge left span. The low flow channel is on the right. The high rock weir in the picture forefront controls water elevation in the left channel to guide water to the low flow channel on the right. The sheet piling is just visible upstream of the rocks and is present but at lower creat elevation on both sides of the channel. Photo taken October 4, 2019.

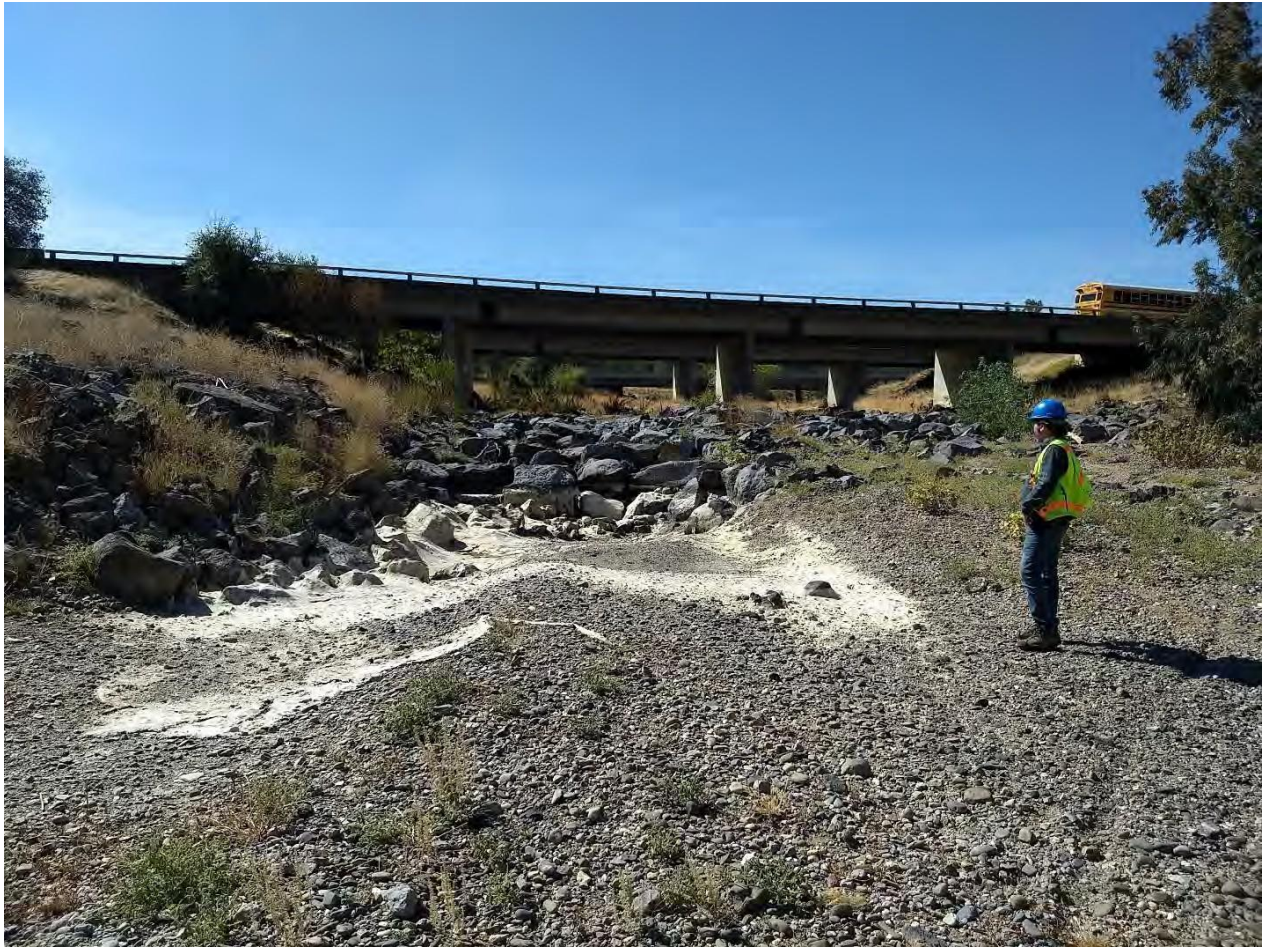
Figure 4. Dibble Creek looking upstream at the Highway 5 bridge from just downstream of the low flow channel. The low flow channel is on the left. Photo taken October 4, 2019.

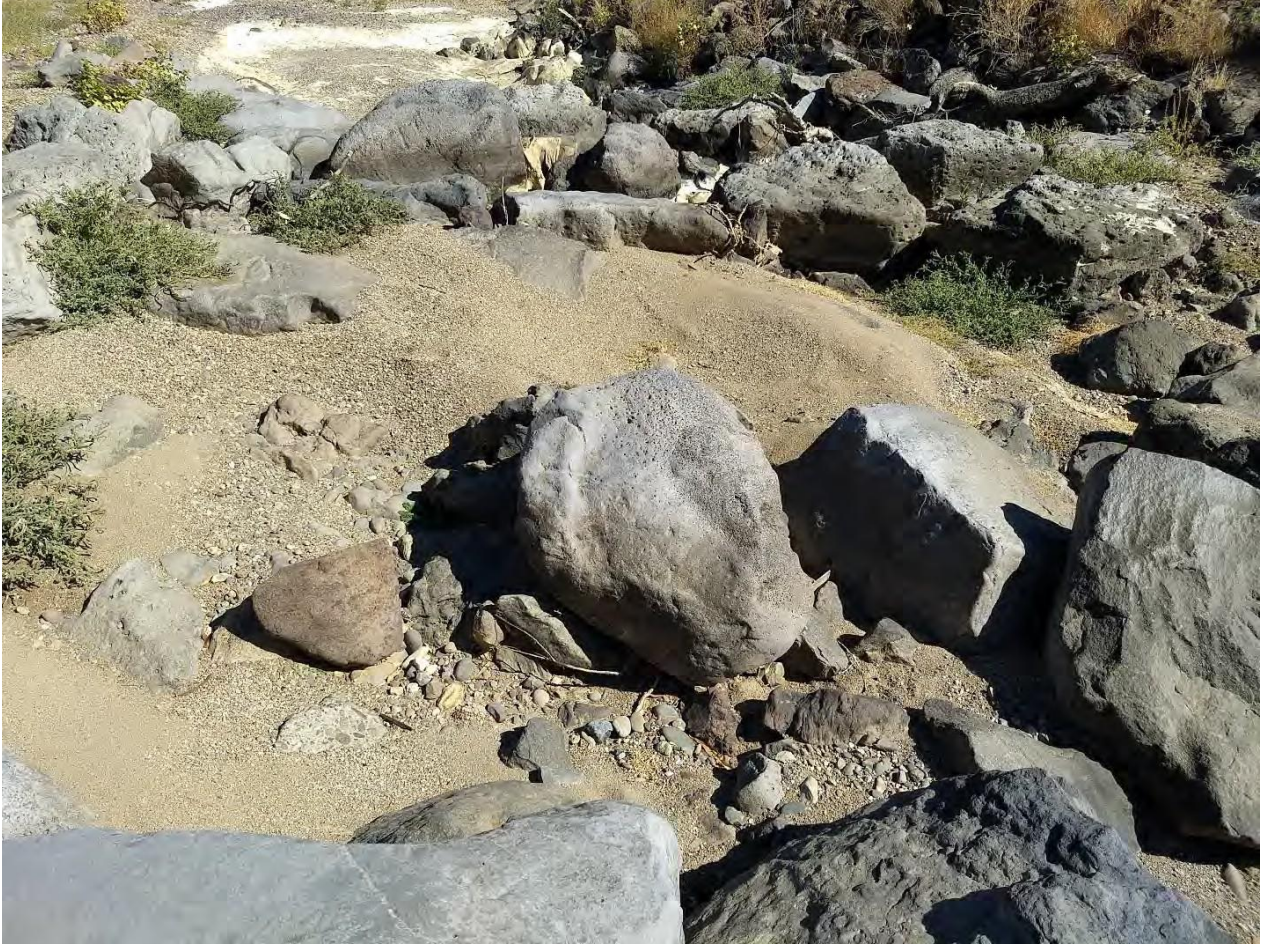
Figure 5. Dibble Creek low flow channel with stored fine sediment. Photo taken October 4, 2019.

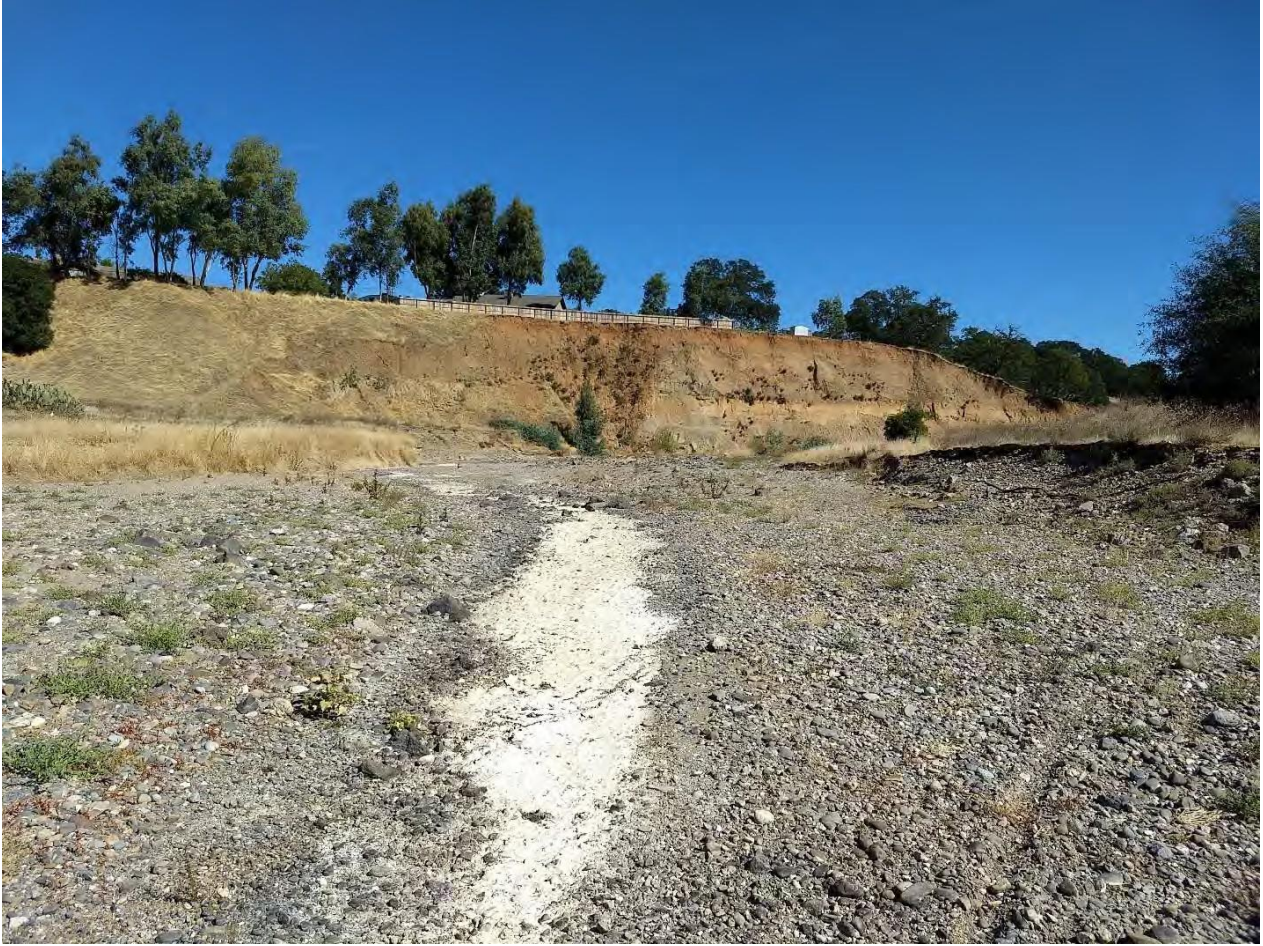
Figure 6. Dibble Creek looking downstream from the Highway 5 bridge Photo taken October 4, 2019.

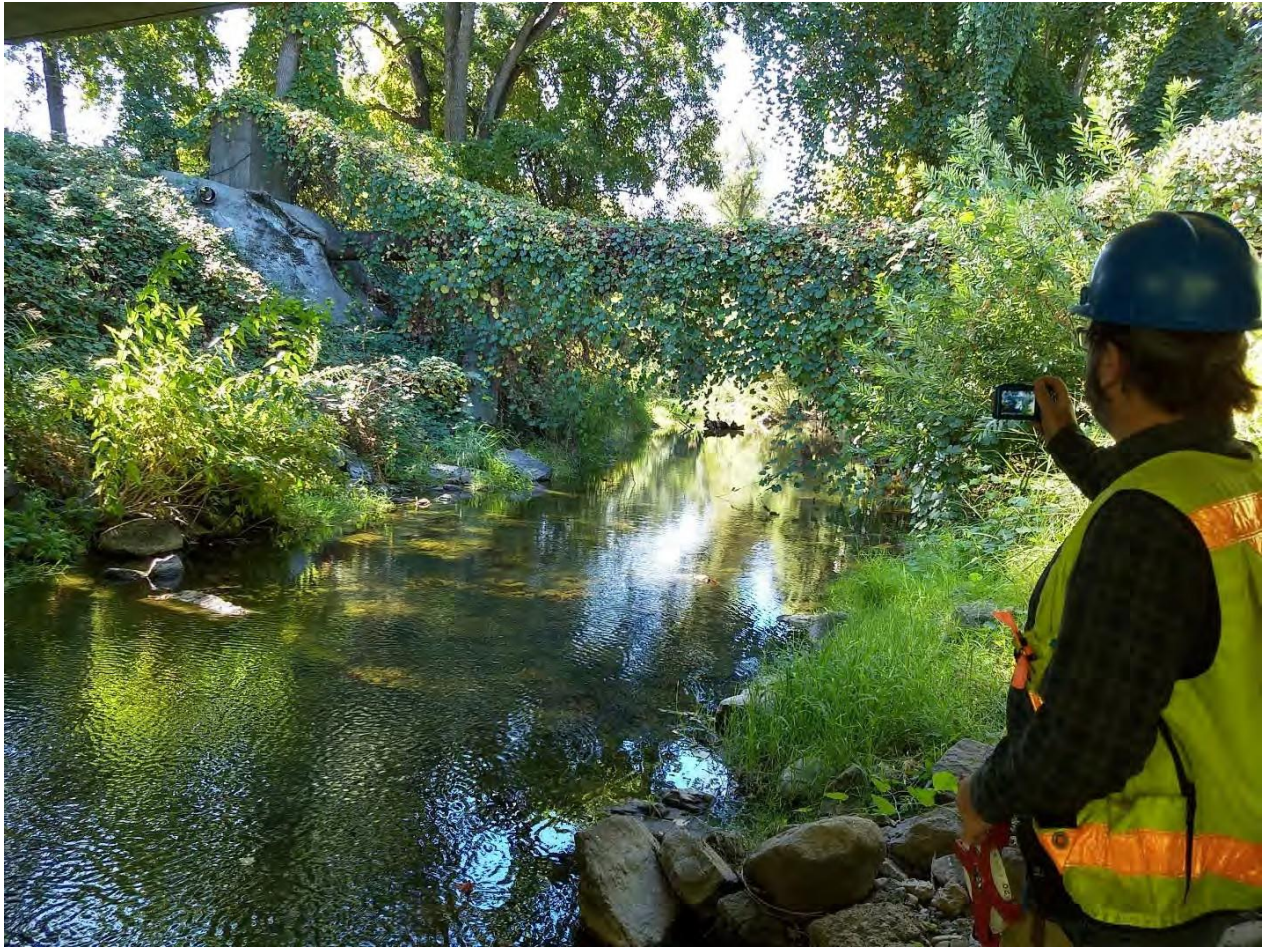
Figure 1. Craig Creek looking upstream from the Highway 99 bridge. Photo taken October 4, 2019.

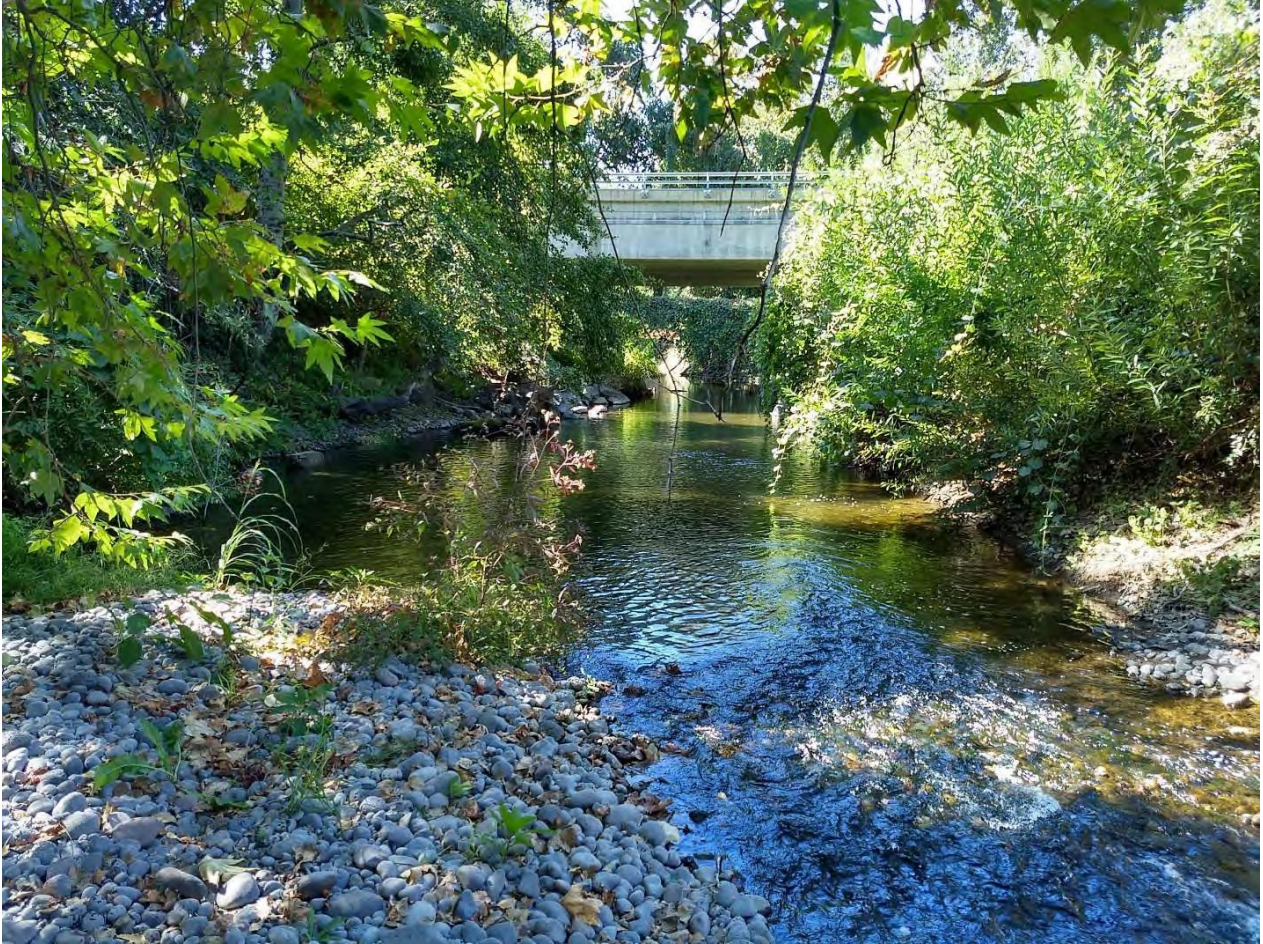
Figure 2. Craig Creek looking upstream at the bridge. The substrate and gravel/cobble bar deposits in this reach provide good channel diversity. Photo taken October 4, 2019.

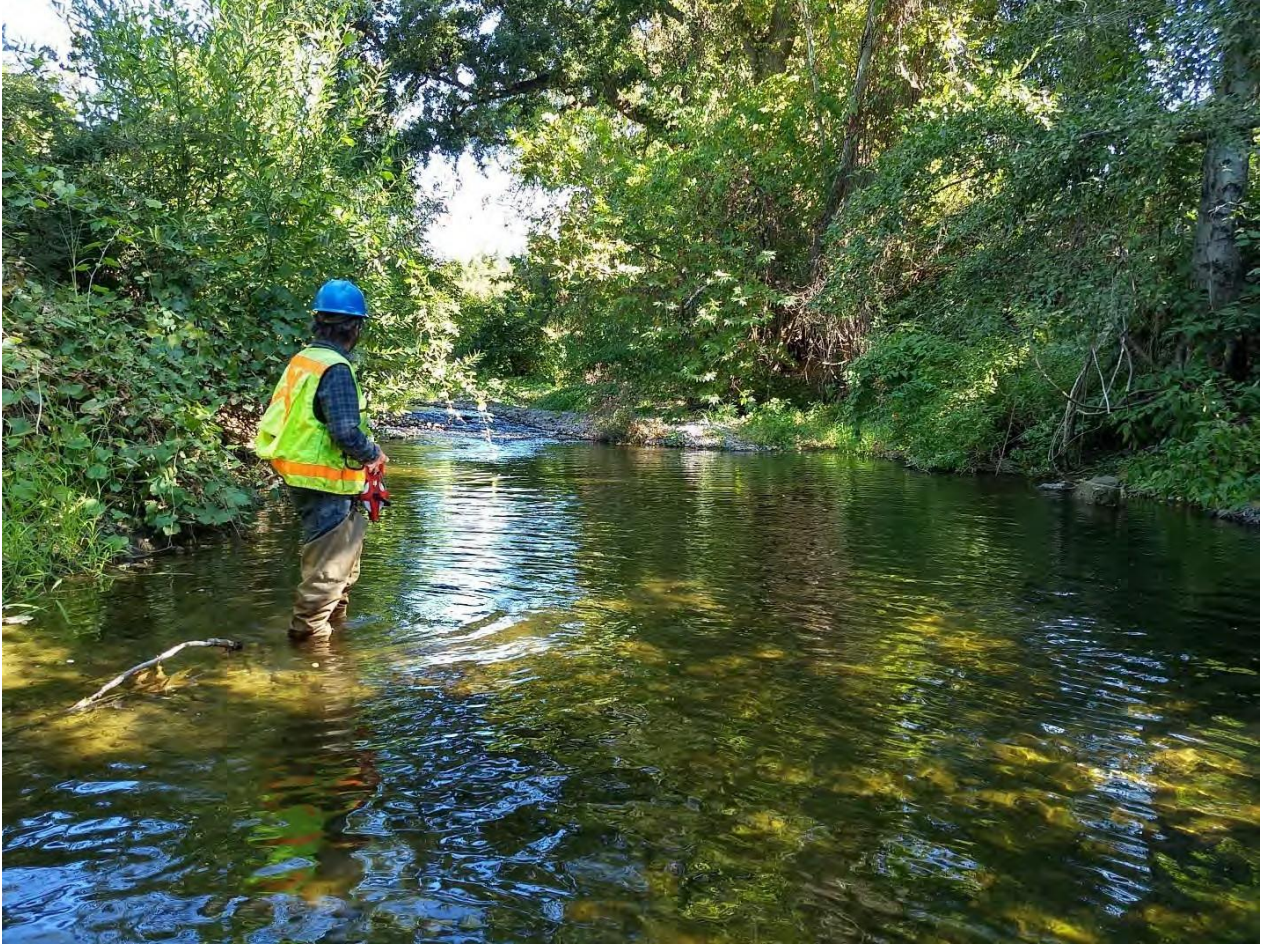
Figure 3. Craig Creek looking downstream from the bridge. Just downstream of the bridge, there are gravel/cobble bar deposits. Photo taken October 4, 2019.

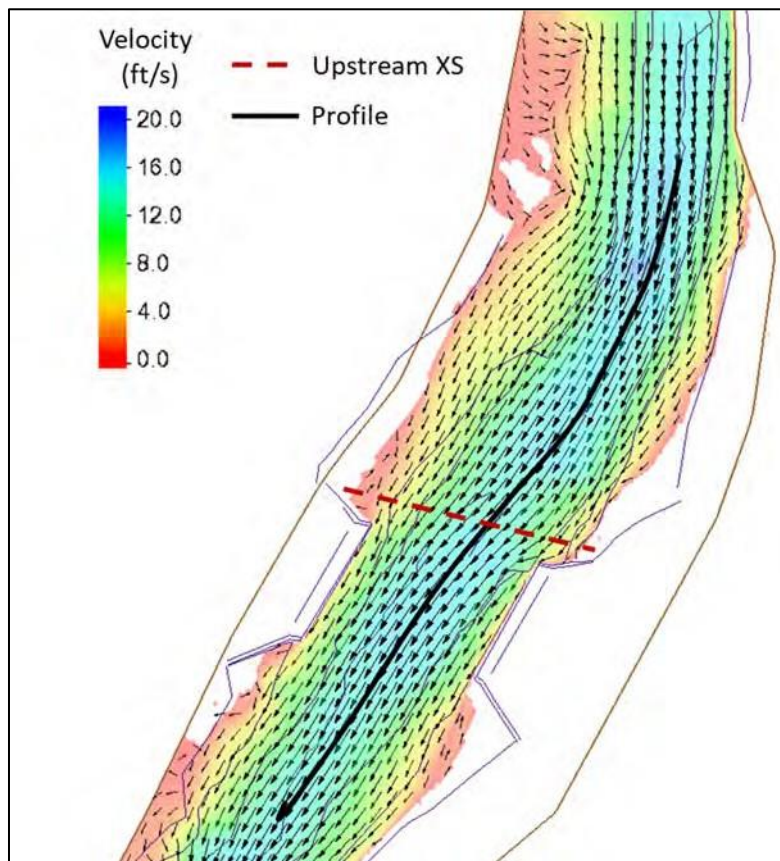
Figure 5 shows the distribution of depth-average velocity extracted from the simulation results along the cross section spanning the channel from right bank to left bank just upstream of the bridge (Figure 3) for the three different simulation flows. For all simulations, higher velocities are predicted along the left bank entering the bridge opening. This is expected because the left bank is an outer bend in the channel and the 2D simulations clearly show its effect on the velocity patterns. At the winter baseflow of 60 cfs (Figure 5a), the two constant n simulations predict velocities approximately 1.5 times higher than the depth-varying n simulations. The simulations defining the large boulders as part of the mesh also predict higher and more concentration of velocities near the left bank as a result of flows being directed around individual boulders near this location. These boulders may have been placed to try to protect the bridge footing but instead are causing local concentration of flows and higher velocities against the bank, exacerbating the observed scour of the bridge footing in this location.

FIGURE 3. LOCATIONS OF VELOCITY CROSS SECTION UPSTREAM OF THE BRIDGE OPENING AND THE PROFILE LINE USED TO COMPARE PREDICTED WATER SURFACE ELEVATION FOR THE MODEL SIMULATIONS. THESE LOCATIONS ARE USED TO COMPARE THE WATER SURFACE ELEVATIONS IN FIGURE 4 AND DEPTH-AVERAGED VELOCITIES IN FIGURE 5.

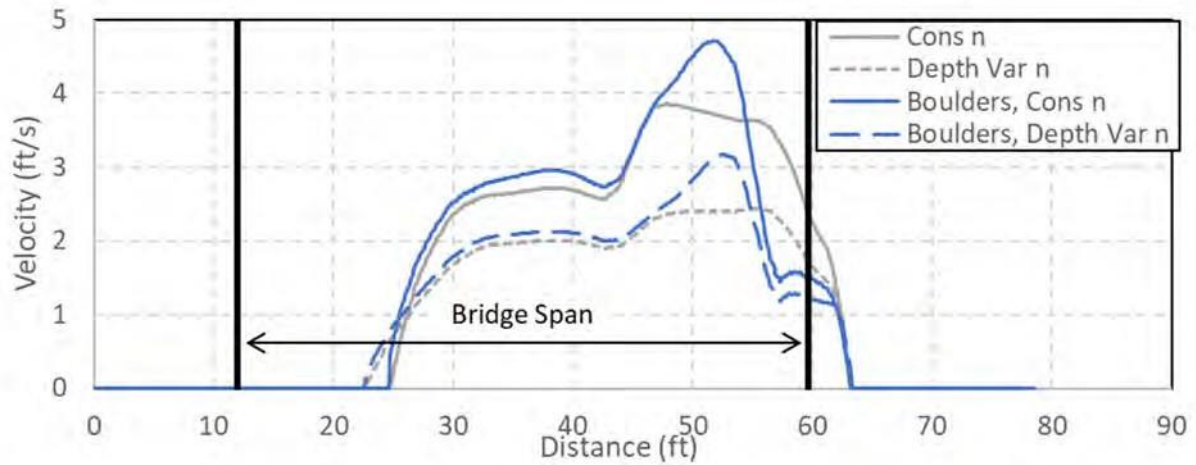
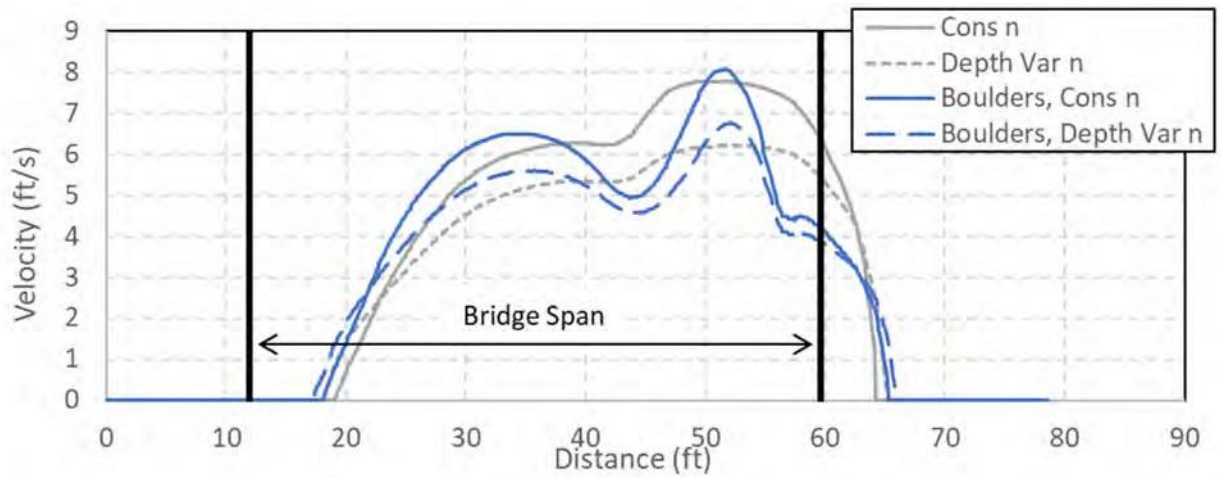
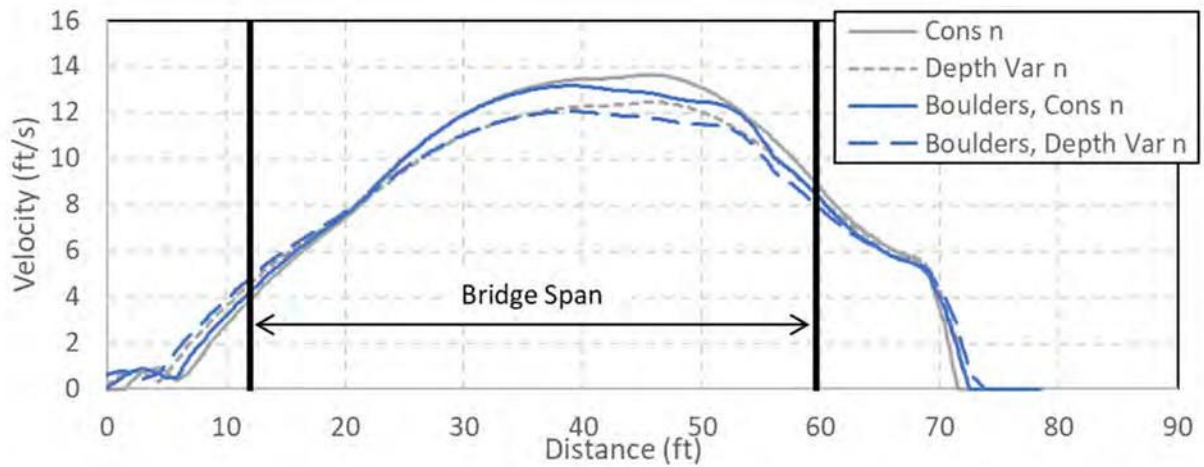
FIGURE 5. DEPTH-AVERAGED VELOCITY ACROSS THE UPSTREAM BRIDGE OPENING (A) 60 CFS WINTER BASE FLOW, (B) 419 CFS 50% OF $Q_{2\text{-YEAR}}$, AND (C) 4,433 CFS $Q_{100\text{-YEAR}}$.

Figure 5b shows a similar velocity pattern estimated for 419 cfs, 50% of $Q_{2\text{-year}}$, a moderate winter storm flow. The difference in velocity magnitude between simulation assumptions is less, ranging from 6.2 to 8.1 ft/s, and the boulder defining mesh simulations show more concentrated, greater velocities near the left bank. At the $Q_{100\text{-year}}$ flow of 4,433 cfs, the difference between simulation assumptions is diminished because the water depths within the channel are almost all large enough that the n values approach the minimum n -values in Figure 1 and become near constant (Figure 5c). At this flow, the boulders are also fully submerged and velocity patterns are no longer influenced by flow around individual boulders. Predicted velocities still show a distinct skew to the left side of the channel and bridge opening where scour has been occurring.

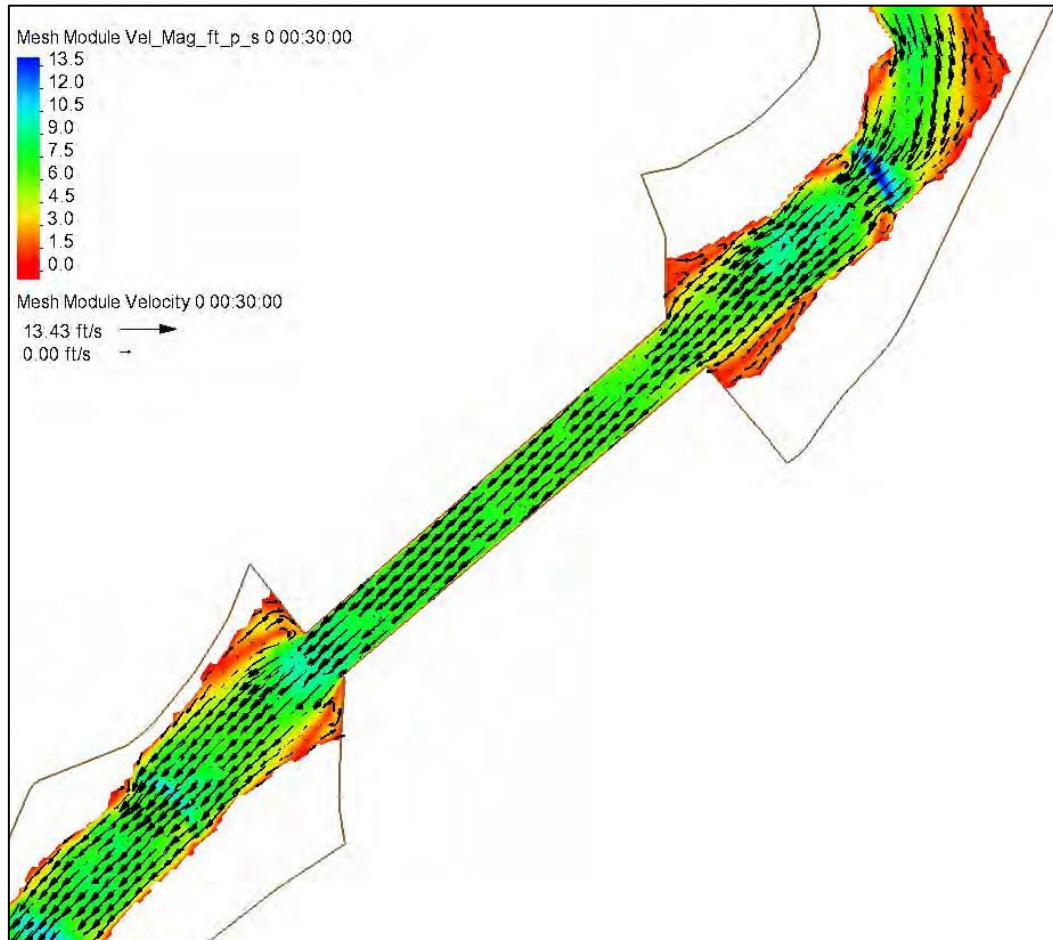
The average velocity across the inlet opening is 5.8 ft/s and eddies are predicted to form on both the right and left banks. Hydraulic conditions predicted at the culvert outlet are similar to the inlet with two pronounced eddies adjacent to the left and right banks. The velocities at the culvert outlet are predicted to be 8.6 ft/s at the right edge of the culvert, 9.6 ft/s in the middle of the outlet opening, and 8.3 ft/s at the left culvert wall. All of these velocities exceed the 6.9 ft/s average velocity predicted at the culvert outlet by the 1D HEC-RAS simulation for this flow rate. Inlet velocities for the 1D results were not available.

FIGURE 7. VELOCITY FOR $Q_{100\text{-YEAR}} = 263$ CFS. MAXIMUM VELOCITY OCCURS OVER THE UPSTREAM ROCK WEIR SHOWN HERE AS A BLUE PATCH IN THE UPSTREAM CHANNEL SECTION.
