# Implementation of Concrete Overlay Evaluation and Design

Research Project 5-6910-01  
Research Report 5-6910-01 R1  
<http://www.techmrt.ttu.edu/reports.php>

1. Report No. FHWA/TX-24/5-6910-01-1	2. Government Accession No.	3. Recipient's Catalog No.	
4. Title and Subtitle Implementation of CRCP Overlay on CPCD		5. Report Date July 2023

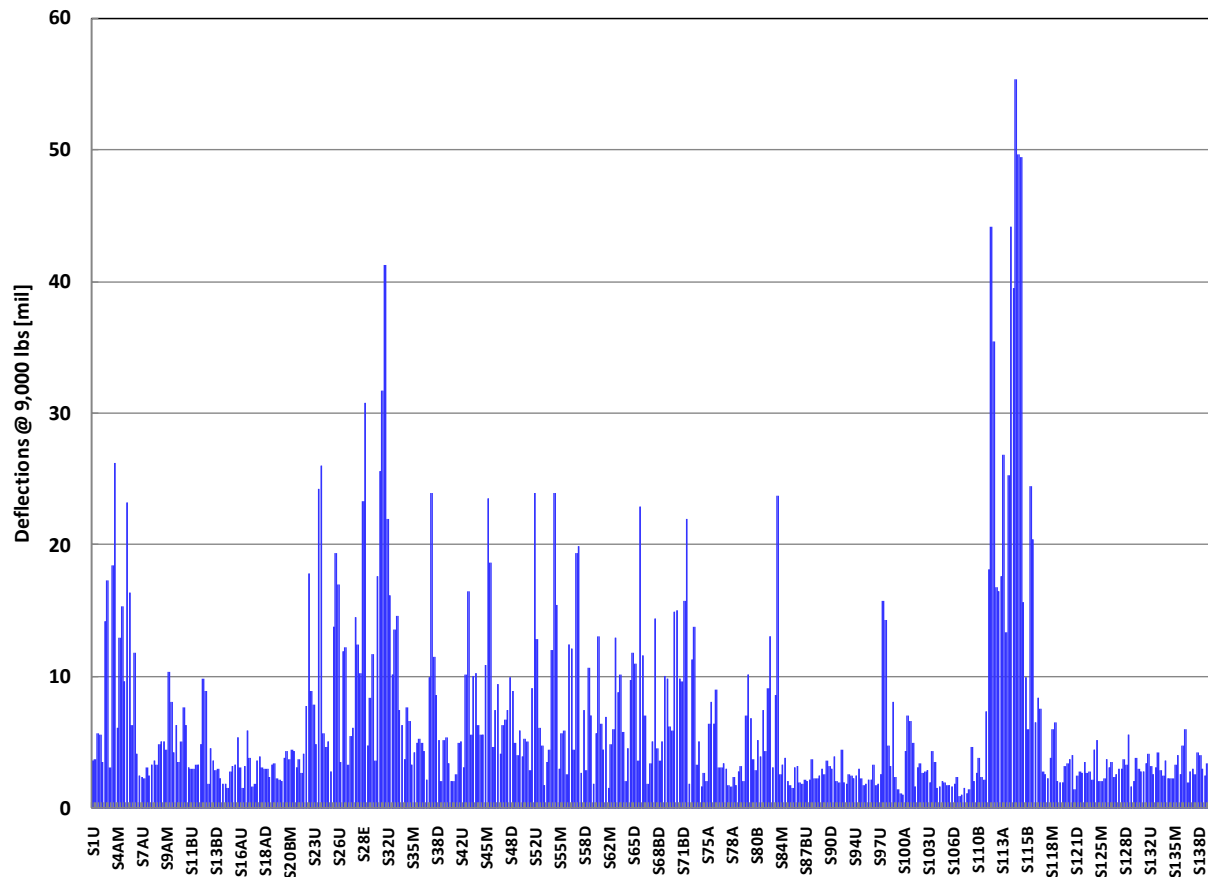
**Figure 2 Deflections measured using FWD machine in US 75 in Sherman**

For the rehabilitation of CPCD in US 75 in Sherman, detailed evaluations of the existing condition of the CPCD were made with FWD. The deflections obtained are shown in [Figure 2](#). It illustrates quite poor structural conditions at some joints and cracks. It is to be noted that in this project, dowels were used at transverse contraction joints, which quite possibly keeps deflections low and load transfer efficiency (LTE) over 70 %. Even though most large deflections were at transverse repair joints and cracks, some were at transverse contraction joints, indicating poor slab support. There were two major issues in this pavement section: one is poor drainage and the other poor materials in the flex base. The PI values of the base materials in this section were quite high, and the combination of high PI and poor drainage (high moisture content) was a primary cause for distress and a poor condition of the CPCD. In CPCD sections in US 75 managed by the Sherman Area Office, this section was in the worst condition, and was selected for the 7-in CRCP BCO. The thought was that, if 7-in CRCP BCO could provide good performance in this section, the same overlay design could be applied to the rest of the CPCD sections managed by the Sherman Area Office. However, large deflections at contraction joints/repair joints/cracks were a major concern for CRCP bonded overlay, especially a potential for reflection cracking. No information was available regarding whether reflection cracking in CRCP might compromise the performance of CRCP overlay. To address this uncertainty concerning a potential problem with reflection cracking, it was decided that 2-ft wide non-woven fabric be placed on transverse contraction joints and repair joints. This decision was based on neither past experience nor theoretical analyses. This decision was solely based on the engineering judgement of the pavement designer. The placement of this fabric is not without potential problems. It will actually cause debonding between old and new concrete, increasing slab deflections and potential distresses. As of the writing of this report, there are 30 repairs done in the outside lane, but none in the inside lane. In other words, the difference in the performance for more than 13 years between inside and outside lanes is significant.

Since the truck traffic is mostly in the outside lane, it could be construed that the truck traffic was the primary cause for the difference. On the other hand, there were a number of issues during the construction of the outside lane, while the inside lane construction went smoothly with no issues. Accordingly, construction quality might explain the difference. Or it could be the combination of both – i.e., truck traffic and construction quality caused a big difference in the performance of inside and outside lanes. The use of fabric does not explain the difference in the performance of the two lanes since fabric was placed in both lanes. However, the performance of the repairs of distresses in the outside lane, which consisted of removing deteriorated concrete in the overlay and non-woven fabric, followed by cleaning the surface of CPCD and placing new concrete, has been excellent, indicating that the use of fabric was not needed to prevent or retard reflection cracking. The tentative conclusion from the US 75 experimental project is that (1) bonded CRCP overlay on CPCD could be a good rehabilitation option, (2) construction quality is an important factor for the good performance of bonded CRCP overlay on CPCD, and (3) the use of non-woven fabric is not needed. Encouraged by the satisfactory performance of this 7-in CRCP bonded overlay on CPCD under heavy truck traffic, the Paris District identified a section of Loop

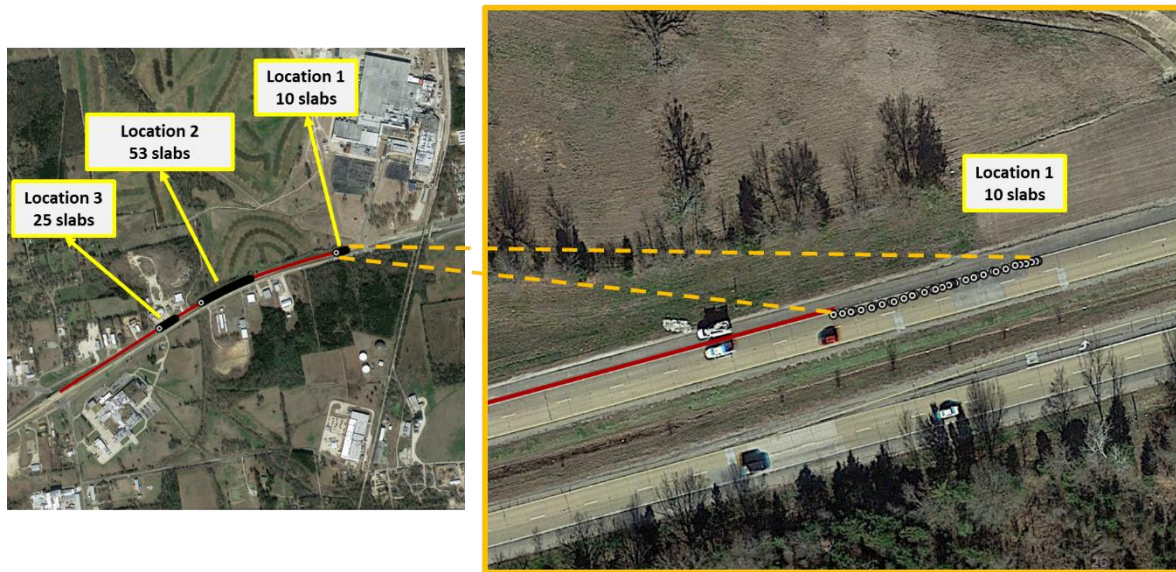
**Figure 10 FWD drops in location 1**

In Location 1 as shown in Figure 10, the deflection of 37 points were measured. Figure 11 shows the measured deflections in Location 1 segment. It is observed that 2 larger deflections are between 2 smaller deflections. The 2 larger deflections are those evaluated at a joint, and the other 2 smaller deflections are at mid-slabs. Most of the mid-slab deflections are about 4 mils, while the joint deflections vary from 4 to 8 mils. The variations at transverse contraction joints or repair joints may be attributed to various conditions of joints – some may be locked, and some may be fully separated. It can be recalled in the specifications that the dowels shall be coated or smooth. This is to prevent bonding of the dowel bar and concrete. However, when the dowel bars are bonded to the concrete at both sides of joints, joint movements are restrained, forcing slabs on both side of the joint behave like a continuous slab (“locked joints”). With this, some joints in Location 1 are potentially locked, resulting deflections comparable to those mid-slabs. Such

behavior suggests potential issues with dowel installation. It was also noticed that the LTE values obtained at those suspected locked joints were relatively high.

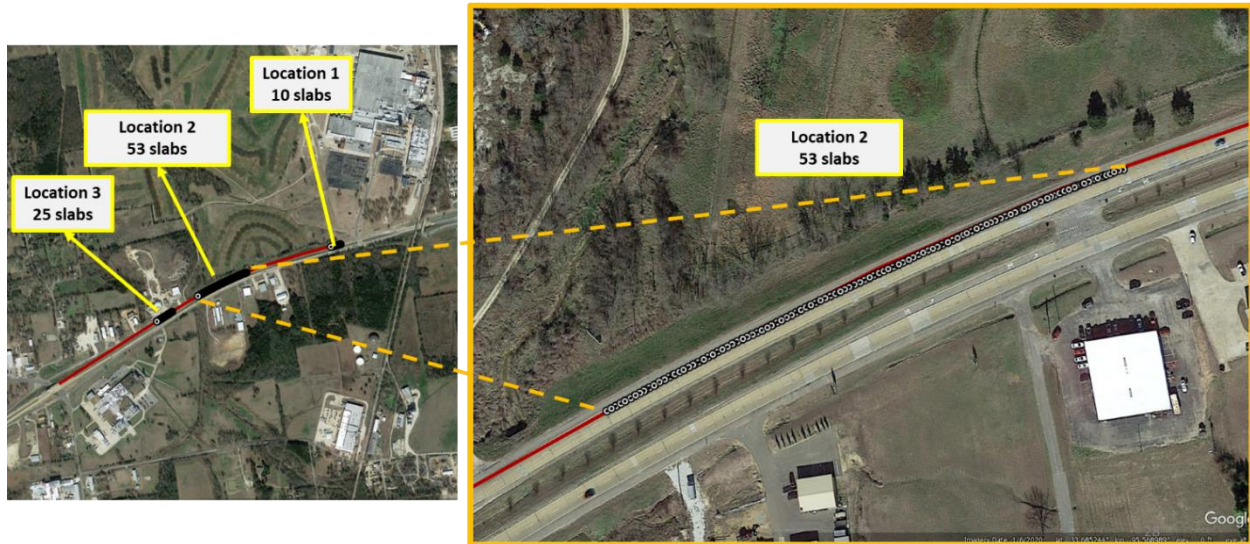
**Figure 12 FWD drops in Location 2**

The Location 2 segment, shown in [Figure 12](#), had a total of 180 points covering 53 slabs. [Figure 13](#) shows the measured deflections across the entire segment. It can be observed that the first 300

feet of the segment have high deflections. The deflection recorded went up to 20 mils. Pavement condition information shows that these areas are repaired slabs, which indicates that the repairs were not done properly. Meanwhile, the deflections mid-slabs recorded after the first 300 feet of the segment were relatively consistent which ranges from 4 to 4.5 mils.

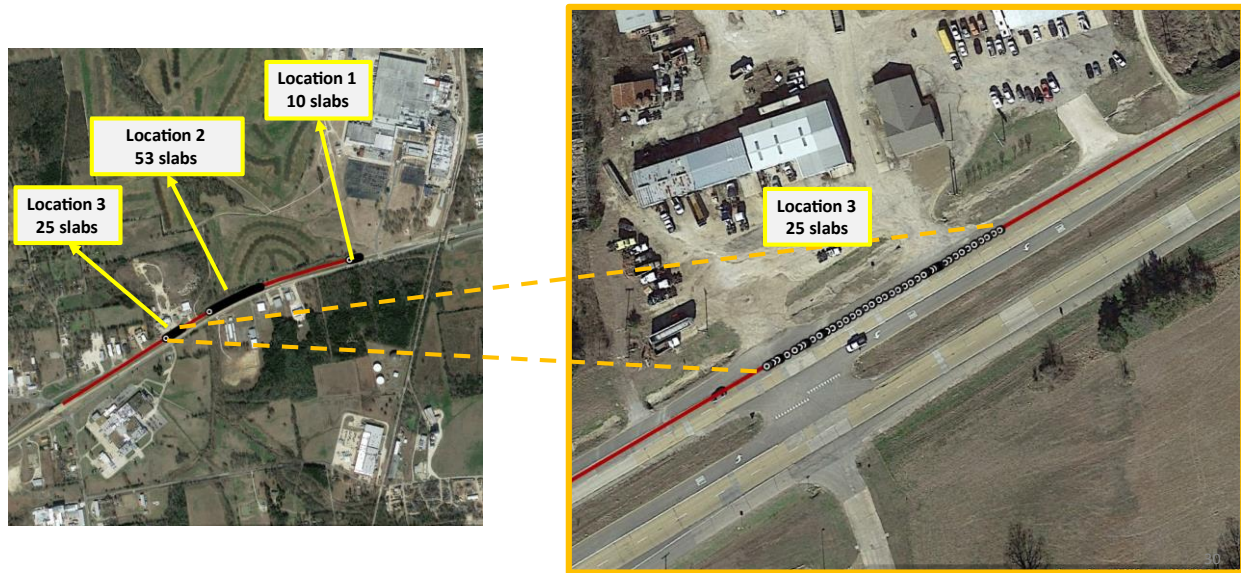
**Figure 14 FWD drops in Location 3**

The Location 3 segment, shown in [Figure 14](#), had a total of 74 points covering 25 slabs. [Figure 15](#) shows the measured deflections in the entire segment. It was also observed that the large deflections were measured on the repaired slabs. The highest deflection in the segment was recorded to be 17.3 mils whereas the lowest deflection was 3.9 mils.

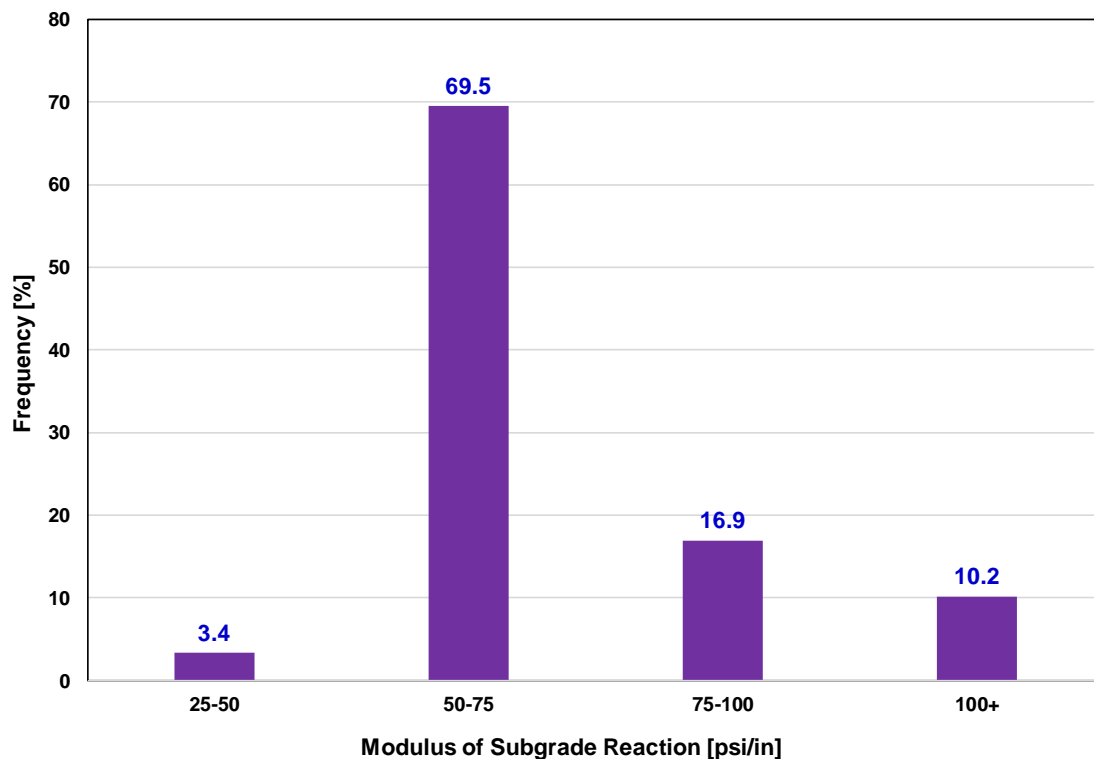
**Figure 16 Modulus of subgrade reaction**

From the FWD data, the modulus of subgrade reaction and LTE were calculated. The average value of LTE was about 83% with standard deviation of 10.6%. Meanwhile, the average value of modulus of subgrade reaction estimated from the AREA method was about 72 psi/in. The distribution of the calculated values is shown in [Figure 16](#).

It can be observed that most of the modulus of subgrade reaction values fall within 50-75 psi/in accounting for 70% of the data points evaluated and about 17% are within the 75-100 psi/in range. A typical value assumed for new CRCP design is 300 psi/in; however, it can be observed that only about 10% of the data points are above 100 psi/in. This indicates that the slab support in this project is inferior to the slab support provided by the current 2 base structures, which justifies the implementation of concrete overlay.

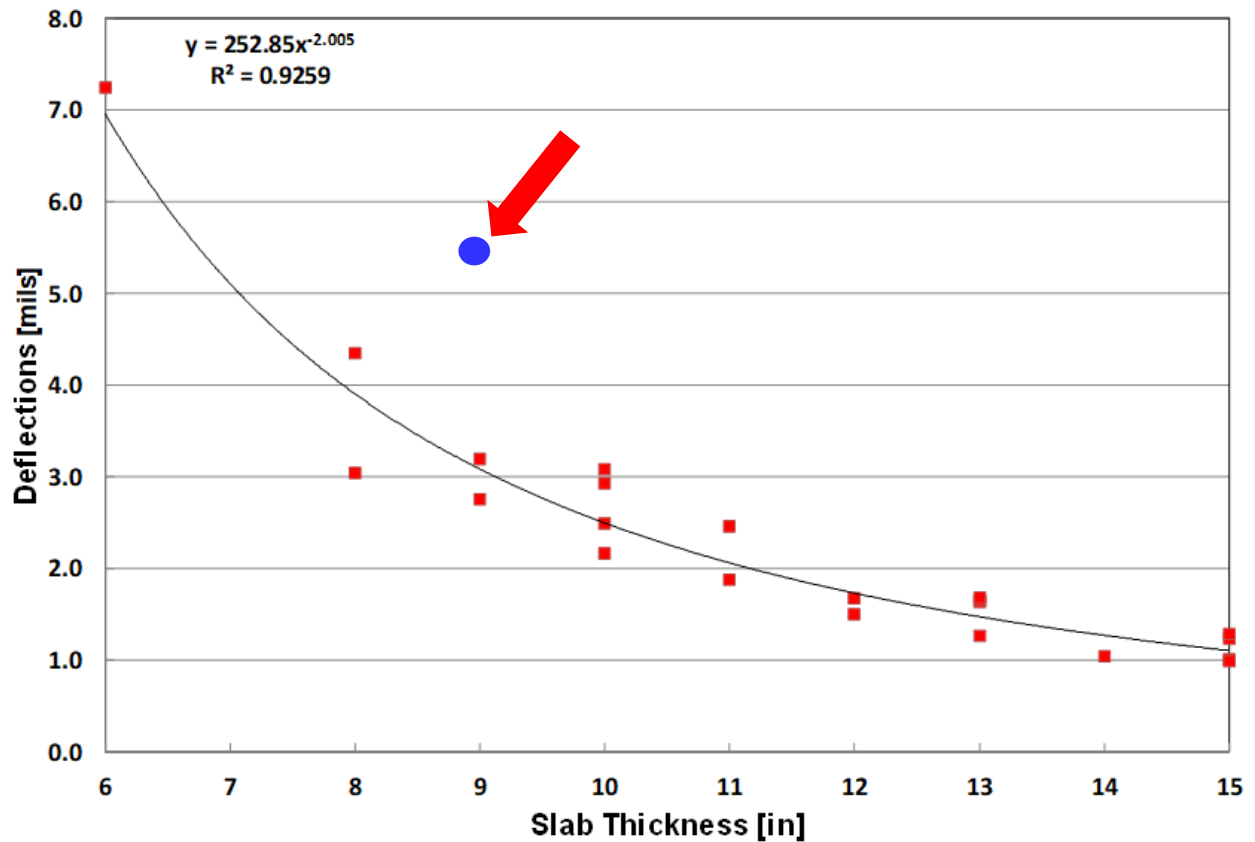
**Figure 17 Relationship between slab thickness and deflections from the database project**

To identify the effects of the lower subgrade support in the measured deflections, the average mid-slab deflection was compared to the statewide average deflections in CRCP obtained from the dataset collected in the previous rigid pavement database projects. It can be seen in [Figure 17](#) that the average mid-slab deflection of this 9-in CPCD section at 5.4 mils, represented in blue

round marker, is higher than the deflection of a typical 9-inch CRCP. The “equivalent” CRCP slab thickness is about 6.5-in. In other words, the structural capacity of the existing CPCD here is, even though the slab is 9-in thick, it is structurally equivalent to 6.5-in CRCP with one of the current 2 base types. Again, this justifies a concrete overlay as a logical rehabilitation option.

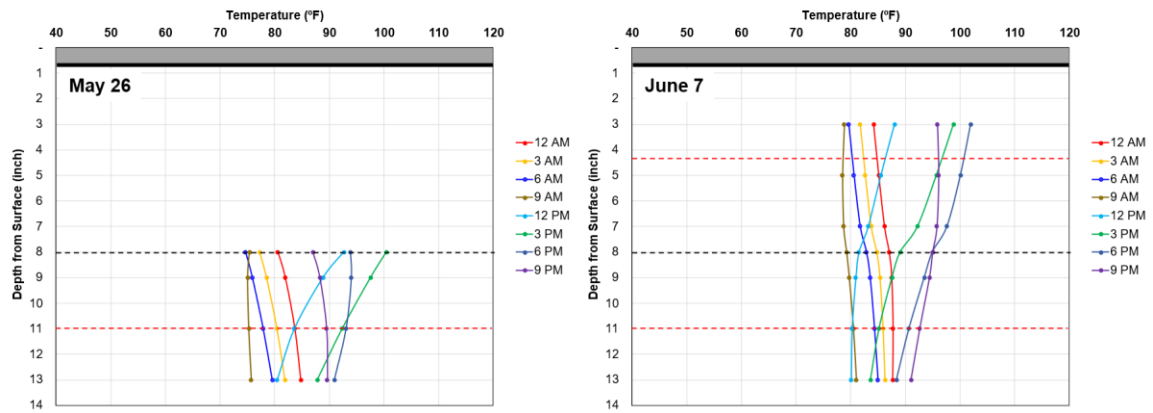
**Figure 54 Temperature variation before and after concrete placement in Section 2**

For Section 2, May 26 and June 7 temperature data satisfied the above 3 requirements and the temperature gradients are shown in [Figure 54](#). It should be noted that Section 2 is located at, before concrete placement, the temperature at 8-inch depth on May 26 is the temperature at the surface of the existing CPCD, while, on June 7, the temperature at 3-inch depth is the temperature at 2.4 inches from the surface of the overlay and the temperature at 8-inch depth is the temperature at the interface between CPCD and CRCP. The range of temperature variation at the surface is relatively similar at around 25 degrees. However, the range of temperature variation at the bottom of the slab after concrete placement has reduced from 15 degrees to 11 degrees. Also, the range of temperature variation at the interface is 15 degrees which is 10 degrees lower (40% reduction) under the same air temperature before the concrete overlay was placed. This reduction of temperature variation on the existing slab is expected according to the concepts of heat transfer.

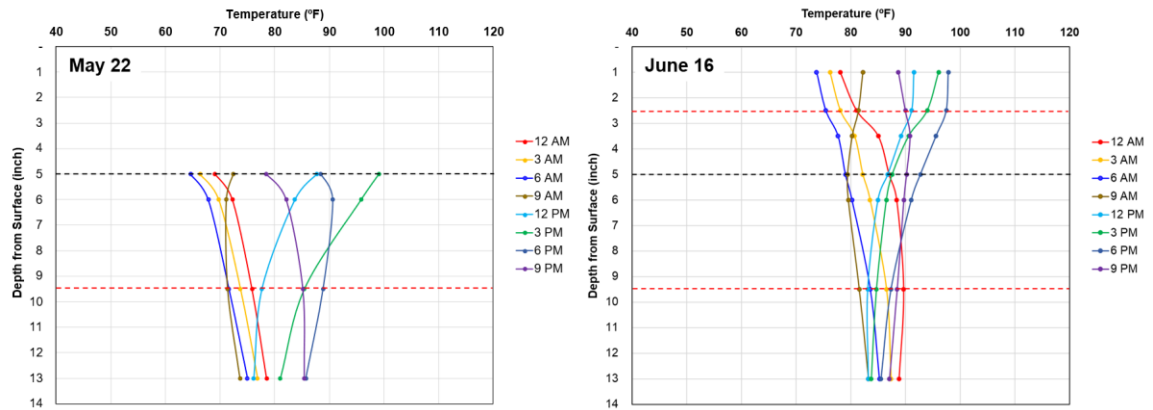
**Figure 55 Temperature variation before and after concrete placement in Section 3**

For Section 3, May 22 and June 16 temperature data are comparable as shown in [Figure 55](#). Before concrete placement, the range of temperature variation on May 22 was 35 degrees at the surface and 11 degrees at the bottom of the existing CPCD. On June 16, after concrete overlay placement, the range of temperature variation was 24 degrees at the surface and 5 degrees at the bottom of the existing CPCD. In addition, the range of temperature variation at the interface was 13 degrees (60% reduction).

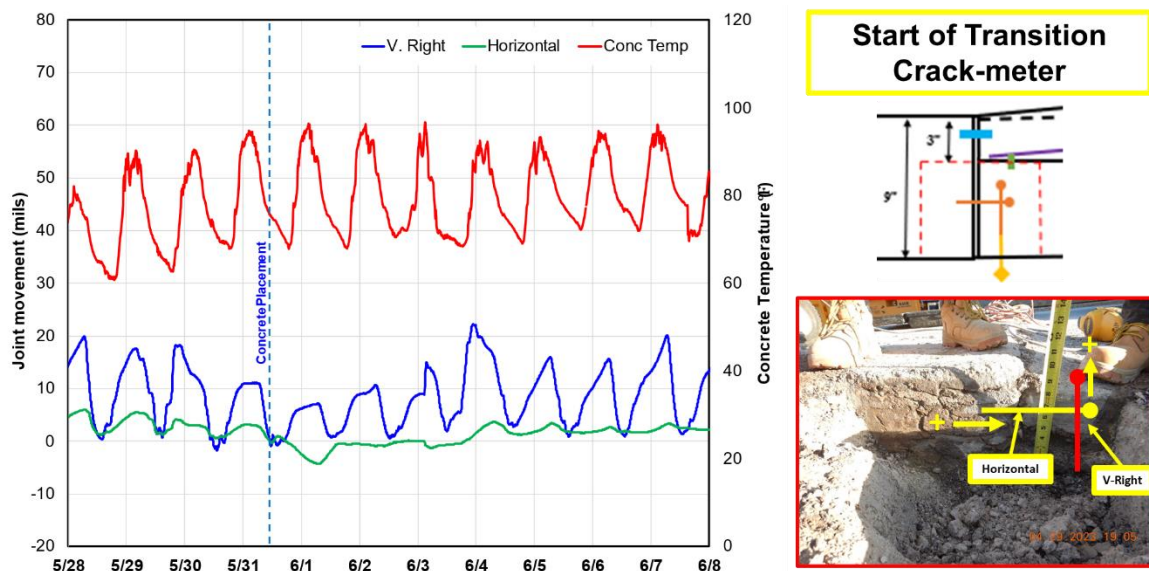
**Figure 56 Crackmeter data analysis at section 1**

The recorded data from Section 1 (start of the transition) is presented in [Figure 56](#). Here, the primary y-axis is joint movement measured in mils. The secondary y-axis provides information on concrete temperature at a depth of 3-inch from the milled section where the horizontal crackmeter is installed. The x-axis provides the date and time it was recorded. It can be observed that there was minimal horizontal movement recorded before and after concrete placement. The same is true with the vertical movement of the slab. There was no significant effect that resulted from the concrete overlay. At this location, the thickness of the overlay was 3 inches, equal to the depth of the milling since this is the beginning of the transition. However, as will be discussed later, the horizontal movements at this joint are quite small. If the dowels were properly installed, they are not supposed to restrain slab movements in the longitudinal direction. The daily joint movement in the longitudinal direction at this joint should be in the range of 9 mils to 14 mils. This range was estimated with the assumption that the subbase friction will reduce the free slab movements by 20 % to 50 %, as well as the thermal coefficient of concrete at 5 microstrains/°F. Prior to the overlay placement, the maximum joint movement was 4 mils, which suggests that dowels restrained concrete movements, and this joint was locked. On the other hand, vertical movements are not small, indicating that locking joints still experience warping movements, even though their magnitudes are much smaller than those at joints with working dowels, which will be discussed later.

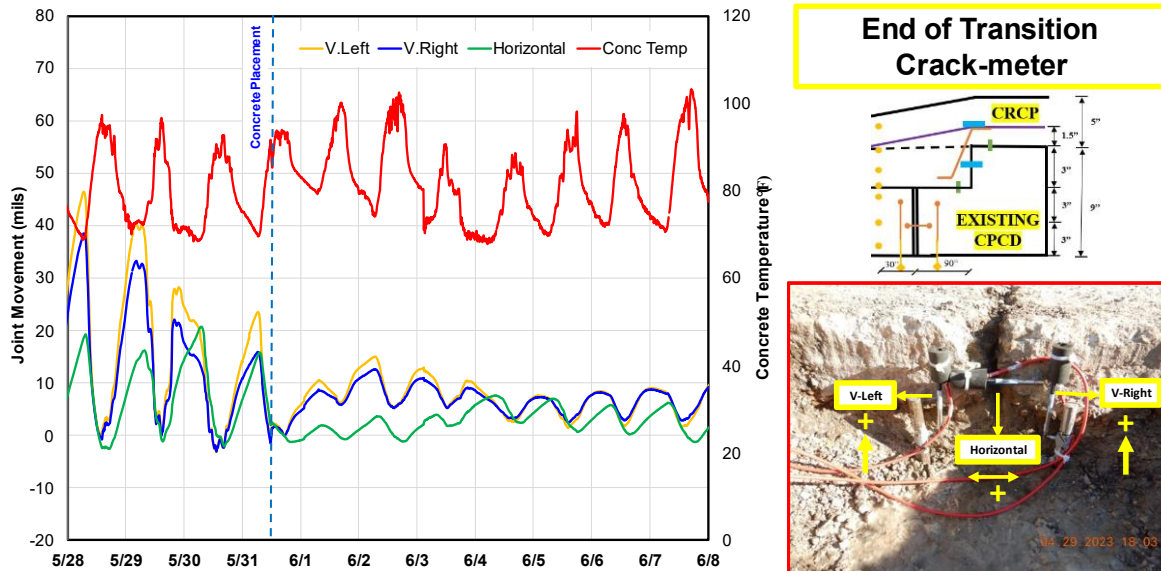
**Figure 57 Crackmeter data analysis at section 2**

As shown in Figure 57, three crackmeters were installed in Section 2. Section 2 is a joint located 120 feet from the start of transition and 7 feet before the end of transition. This section has 6 inches of existing CPCD and 7.7 inches of CRCP overlay thickness above the joint. The horizontal joint movement is measured 3 inches from the milled surface of the existing CPCD, while the vertical joint movements were measured 2 inches from the milled surface of the existing CPCP and 2 inches away from the joint. The positive (increasing) values of the horizontal displacement indicate that the sensor is expanding and thus the joint width is expanding. Meanwhile, the positive (increasing) values of the vertical displacement indicate that the sensor is moving upward, i.e., the slabs are curling up.

It is observed that, compared with the slab movements after the overlay concrete placement, the slab movements before the concrete overlay placement were significantly larger, as much as up to 20 mils for longitudinal movements and 40 mils for vertical movements, while those after the overlay concrete placement were about 8 mils for both movements. Temperature insulation effects and the restraints provided by the longitudinal steel in CRCP overlay on concrete volume changes in the existing CPCD are considered to be responsible for this substantial reduction in slab movements. This manifests the benefits of longitudinal steel in concrete pavement in reducing slab movements from temperature and moisture variations. Compared with the slab movements observed in Section 1, those in this Section are much larger, especially before the placement of overlay concrete. It appears that dowels are not locked in this joint. Another observation is that substantial reduction in vertical movements were recorded in this joint after overlay placement, while not much difference was observed in Section 1. It is recalled that in Section 1, longitudinal steel was not continuous through the joint; rather, it was terminated at the

joint. This indicates the role of longitudinal steel in restraining concrete volume changes. The last observation is a rather small difference between data from 2 gages, which indicates a good quality of gage installation practice.

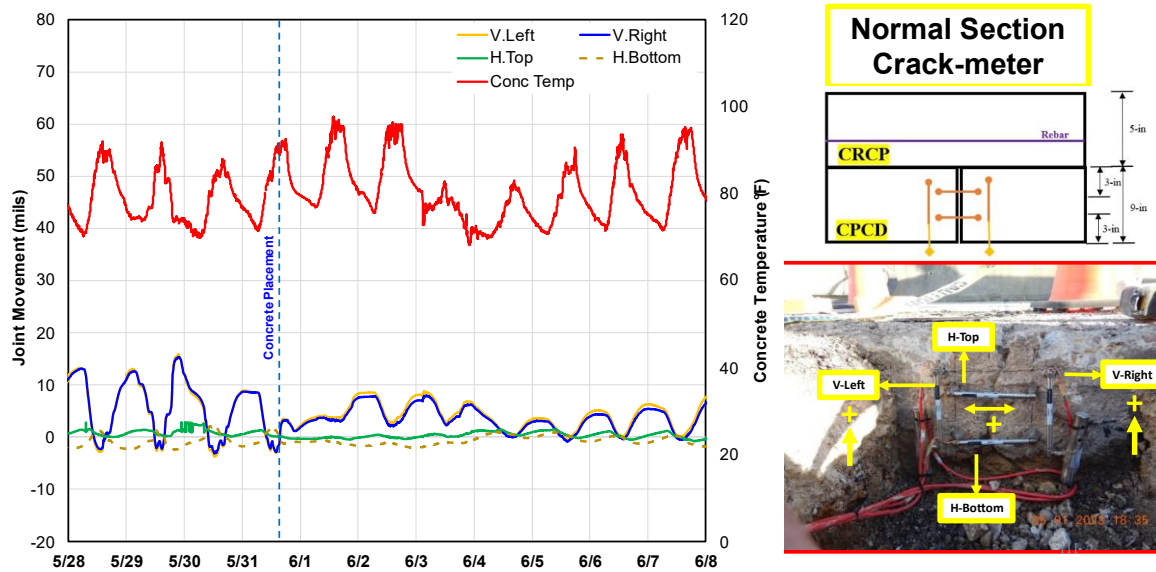
**Figure 58 Crackmeter data analysis at section 3**

Compared to Section 1 and Section 2, this section recorded the least horizontal movements, even smaller than those in Section 1, where the joint was suspected of being locked. It appears that this joint was also locked. The vertical movements prior to overlay concrete placement are comparable to those for Section 1. However, after overlay concrete placement, they were reduced substantially in the beginning, followed by increased vertical slab movements, which could be due to the formation of a transverse crack in CRCP overlay on top of this joint. However, their magnitude is much smaller, about 1/3 of those observed in Section 1, which again manifests the effects of continuous longitudinal steel above this joint. On more observation is that, prior to the overlay concrete placement, vertical movements at this joint were not small, indicating that locked joints restrain longitudinal concrete movements more effectively than vertical movements. In other words, even when the joint is locked, the joint experiences some level of warping and curling, which reduces warping and curling stresses in concrete slabs. This explains

why very few transverse cracks have been observed in CPCD in Texas, even when some joints are locked. Another evidence of warping and curling being allowed in the locked joint is that the longitudinal movements observed in the two gages in Figure 58 shows warping and curling behavior. For example, in the morning of May 29, while the temperature increases, the longitudinal slab movements recorded were contraction in the top gage and expansion at the bottom gage.

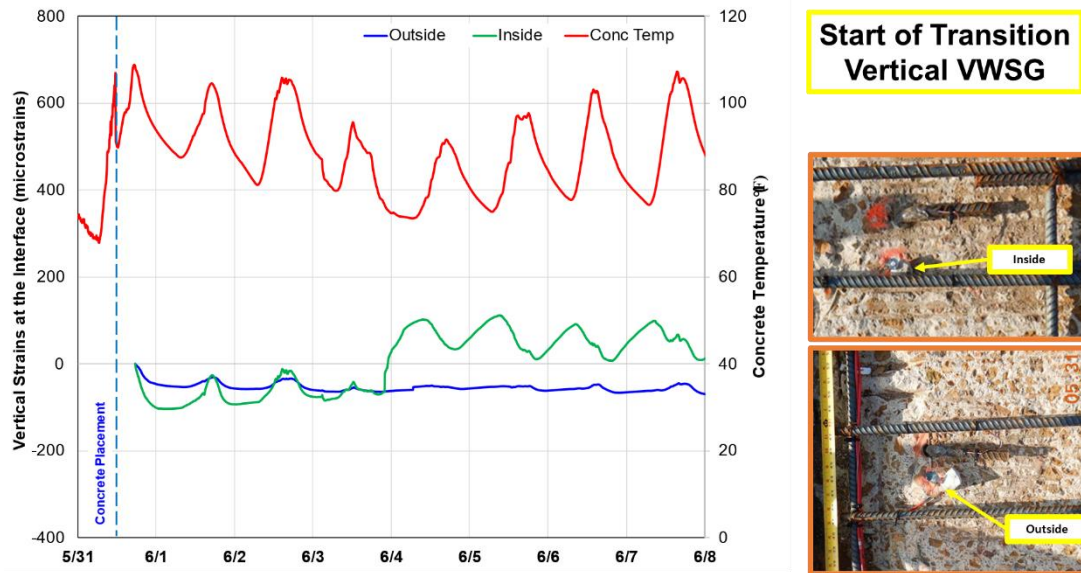
**Figure 59 Vertical VWSG data analysis at section 1**

Figure 59 and Figure 60 show the typical installation of vertical VWSGs and longitudinal VWSGs at Section 1 as well as obtained data, respectively. A total of 4 VWSGs were installed at Section 1 – start of the transition. Two vertical VWSGs were installed at 2 locations (“outside” and “inside”) in the outside lane as discussed in Chapter 3. As can be seen in Figure 59, the data shows that little variations were observed in vertical strains at outside. On the other hand, it is observed that in the morning of June 4, around 150 microstrains of vertical strain were observed inside. The distance between outside and inside is 47 inches, and it appears that there was a large difference in bonding behavior between the concretes in the two locations.

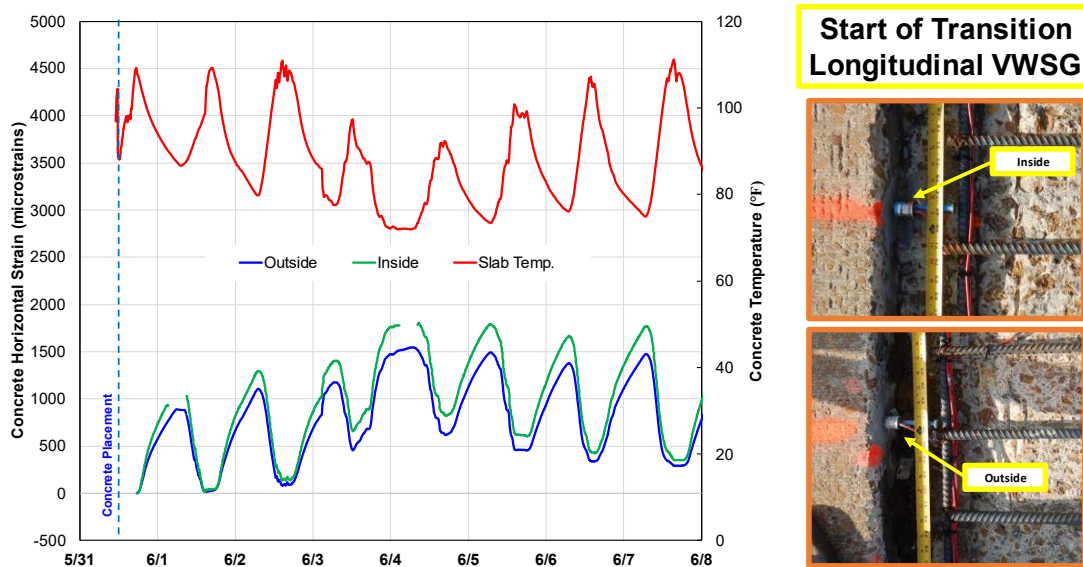
**Figure 60 Longitudinal VWSG data analysis at Section 1**

The longitudinal concrete strains at Section 1, as shown in Figure 60, are already in tension and are undergoing daily cycles – as temperature goes up, the concrete strains move into compression direction, vice versa. . This is a typical behavior expected at transverse construction joints. It is also observed that the magnitude of longitudinal strains at “inside” is larger than that at “outside,” which is consistent with the vertical strain behavior at the interface, where the strains at “inside” were larger than those at “outside.”.

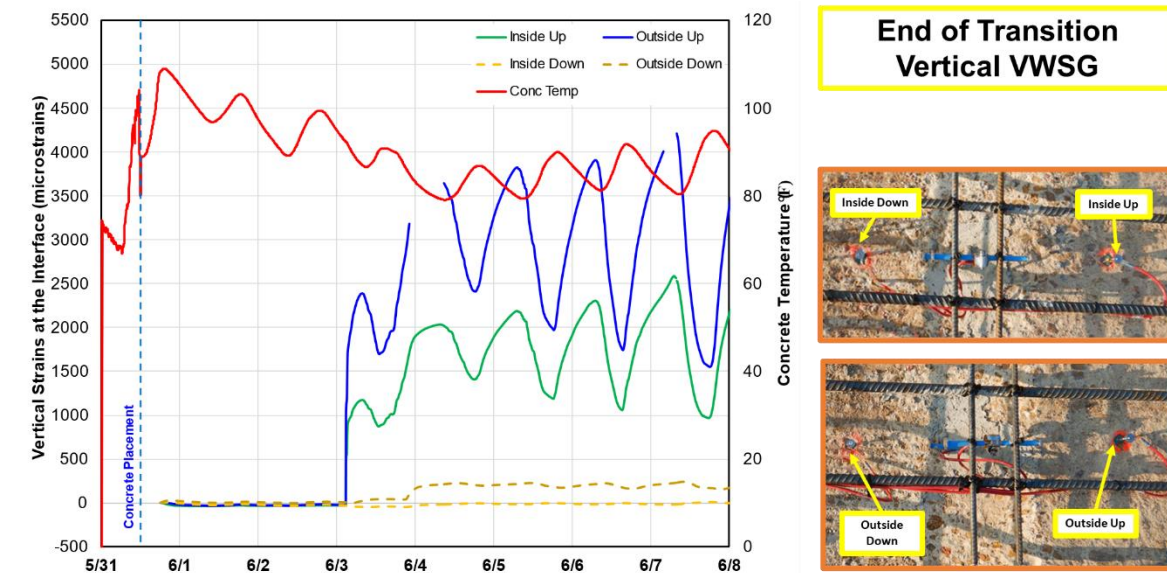
**Figure 61 Vertical VWSG data analysis at section 2**

Figure 61 depicts the standard setup and data analysis for both vertical VWSG and longitudinal VWSG in Section 2. Notably, all four vertical VWSGs registered negligible strain from the concrete placement on May 31, 2023, until June 3. It's worth recalling our earlier discussion in Section 4.1 (Figure 51), where a significant 1-inch rainfall event occurred on June 3, contributing to a sustained reduction in concrete temperature.

The abrupt vertical movement at the overlay interface, potentially triggered by the plummeting slab temperature and other factors, resulted in a rapid increase in vertical strain. At 6 inches after the end of the transition segment, the outer sensor indicated approximately 2500 microstrains, while the inner sensor recorded about 1200 microstrains. These substantial strain values strongly suggest debonding at the interface after the transition segment.

Meanwhile, at 6 inches before the end of the transition segment, vertical strains displayed minimal increases, emphasizing that significant vertical movement at the interface occurred primarily at the area after the transition segment. However, it's noteworthy that the "Outer-Down" sensor exhibited a strain increase of 250 microstrains on June 4, coinciding with a further surge in vertical strains of up to 3500 microstrains at the locations after the transition segment ("Outside-Up" and "Inside-Up" sensors).

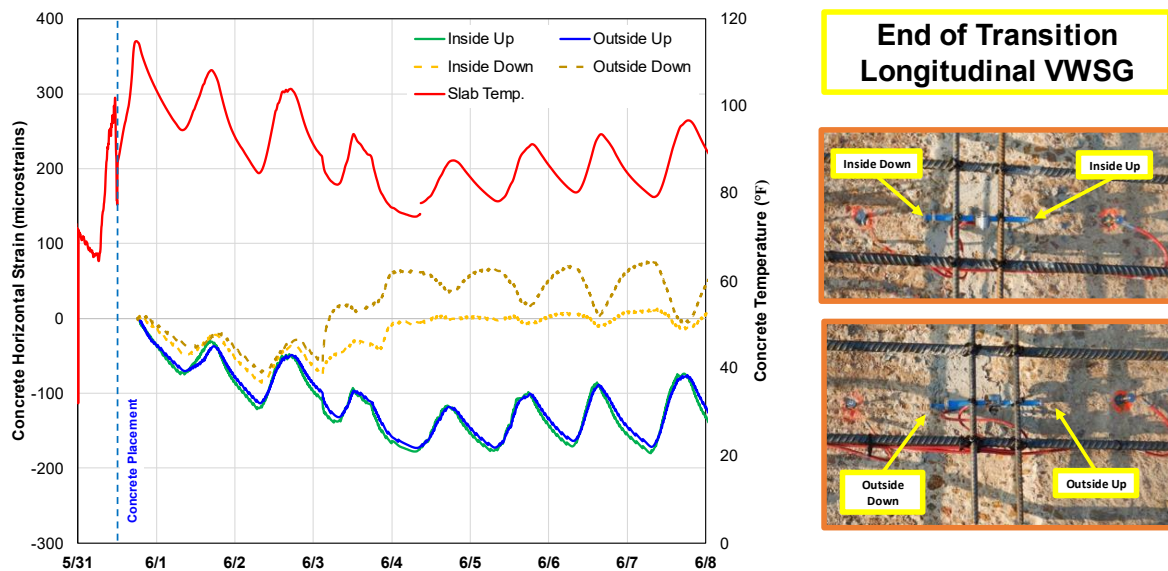
**Figure 63 Longitudinal VWSG data analysis at Section 2**

Figure 63 illustrates the longitudinal concrete strain behaviors at the termination of the transition segment, with two "Up" sensors installed at the mid-depth of the concrete overlay and another two "Down" sensors, where half of their length is embedded in the existing CPCD, and the remaining half in the CRCP overlay, as depicted in Figure 64. This dual-sensor arrangement provides insights into the interface behavior at the transition's conclusion.

From the time of concrete overlay placement until June 3, all four longitudinal VWG sensors recorded compressive strains, characteristic of concrete undergoing the hydration process. However, a notable shift occurred on June 3, simultaneous with the vertical strain surge to 2500 microstrains. The two longitudinal VWG sensors situated at the interface recorded an escalating tensile strain. The outer longitudinal sensor exhibited a higher tensile strain of approximately 80 microstrains compared to the inner longitudinal sensor, which showed about 0 microstrains. While these values do not clearly indicate debonding, they suggest tensile behavior in the interface, likely resulting from debonding beyond the end of the transition segment.

Conversely, the longitudinal sensors at the mid-depth of the overlay continued to record compressive strains, indicating an absence of cracks traversing the sensor locations in the overlay layer. This phenomenon, distinct from observations in US 75 in Sherman, raises the idea of significant drying shrinkage in the concrete overlay as the underlying cause.

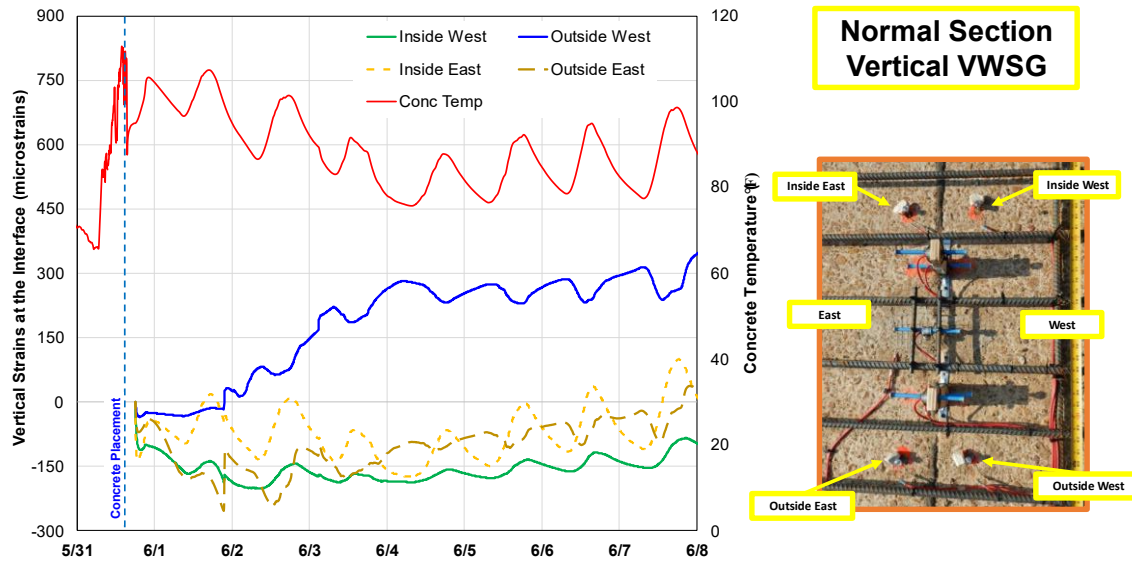
**Figure 65 Vertical VWSG data analysis at Section 3**

Figure 65 and Figure 66 show the installation of vertical and longitudinal VWSGs at Section 3. As shown in Figure 65, except outside west, the 3 other vertical sensors are in compression but are showing trends that it is moving towards the tension side. It is important to note that this section was saw-cut exactly at the location where the sensor was installed. From the data on longitudinal VWSG and vertical VWSG we can see the sensor recorded peak strains on June 2. This means the saw cut which was made right after the concrete placement led to crack propagation. The crack propagated across the slab and the sensors recorded the strains. In the

case of longitudinal VWSG both inside up and outside up followed same pattern and recorded as high as 1000 microstrains. This implies that there was comparatively larger longitudinal movement experienced on the top of CRCP overlay. Similarly, inside down and outside down followed same pattern and recorded strains as high as 750 microstrains. This was compared with the embedded longitudinal VWSG data which is observed in between top and bottom. This points out the fact that there is substantial longitudinal movement going on existing CPCD. In the case of vertical VWSG at the interface, similar inference can be made.

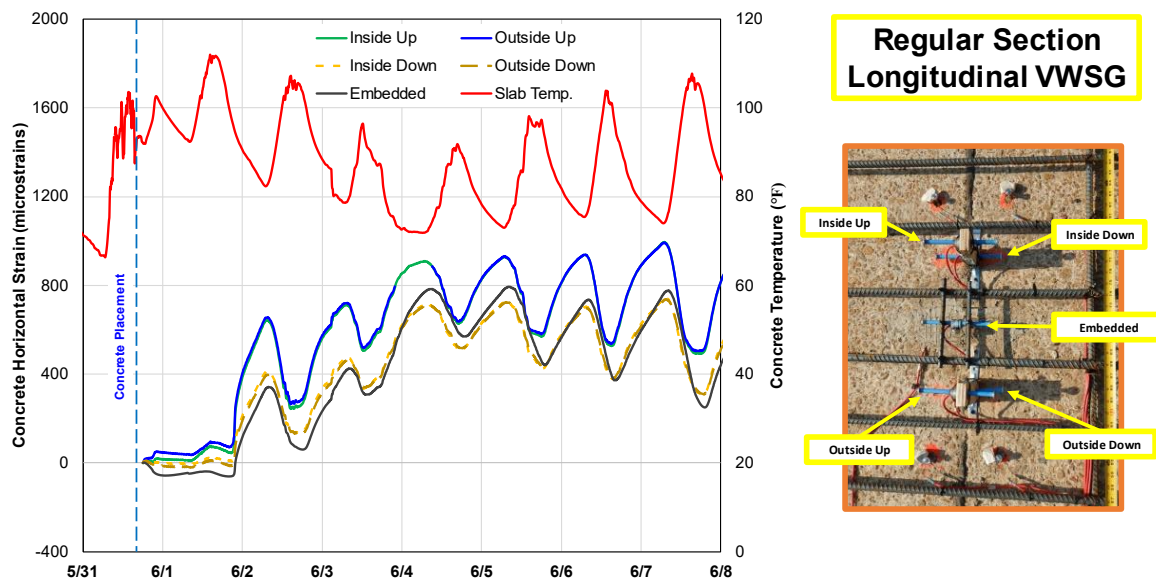
**Figure 66 Longitudinal VWSG data analysis at Section 3**

Figure 66 shows the longitudinal strain behaviors at various depths in the CRCP overlay. It can be observed that the strain near the surface of the overlay (Inside Up and Outside Up) have higher strains compared to the strain behaviors at the bottom of the overlay layer (Inside Down and Outside Down). The difference in strain behaviors at the top and bottom of the CRCP overlay is indicative of the curling and warping behavior that exists in the overlay layer.

Another observation is the strain behavior at the top of the existing CPCD layer (Embedded). The strain magnitudes between the top of the CPCD layer and bottom of the CRCP overlay layer are close but there is a slight difference. It is presumed that when the interface is properly bonded, the strain close to the interface will be similar or very close in magnitude and trends. One may also argue that the locked joint condition which was identified earlier may have influenced the difference in strain behaviors. Nevertheless, this data implies that the interface is not behaving under as a fully bonded condition.

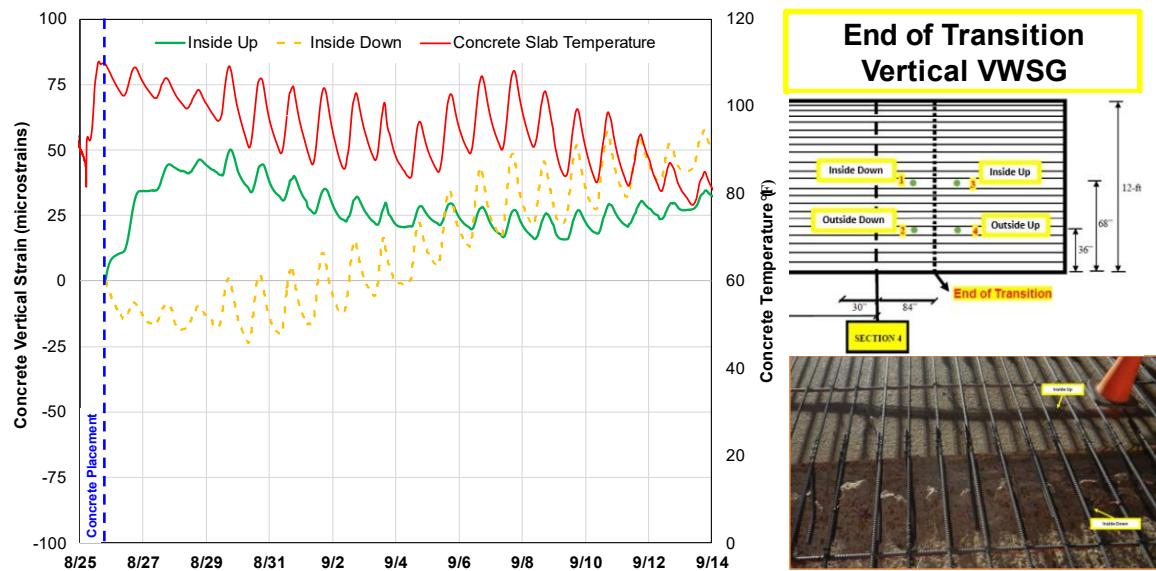
**Figure 67 Vertical VWSG data analysis at Section 4**

Figure 67 illustrates the standard setup and data analysis for the VWSG at Section 4, located at the end of the transition. On August 25, 2023, during the concrete placement, only two of the VWSGs remained functional. Consequently, the data from the other two gauges, which were situated in the outside up and outside down positions, is not included in this report. The VWSGs installed in the 'inside up' and 'inside down' locations exhibited relatively low vertical strains from the outset. The strain values fluctuated between zero microstrains and a range of -25 microstrains to +50 microstrains during the first 21 days following concrete placement. Given the minimal magnitude of these recorded microstrains, it may imply that there was no significant vertical movement at the overlay interface which will indicate that there was no sign of debonding which was observed at the same location on the outside lane. This finding is validated by the absence of cracks in this area.

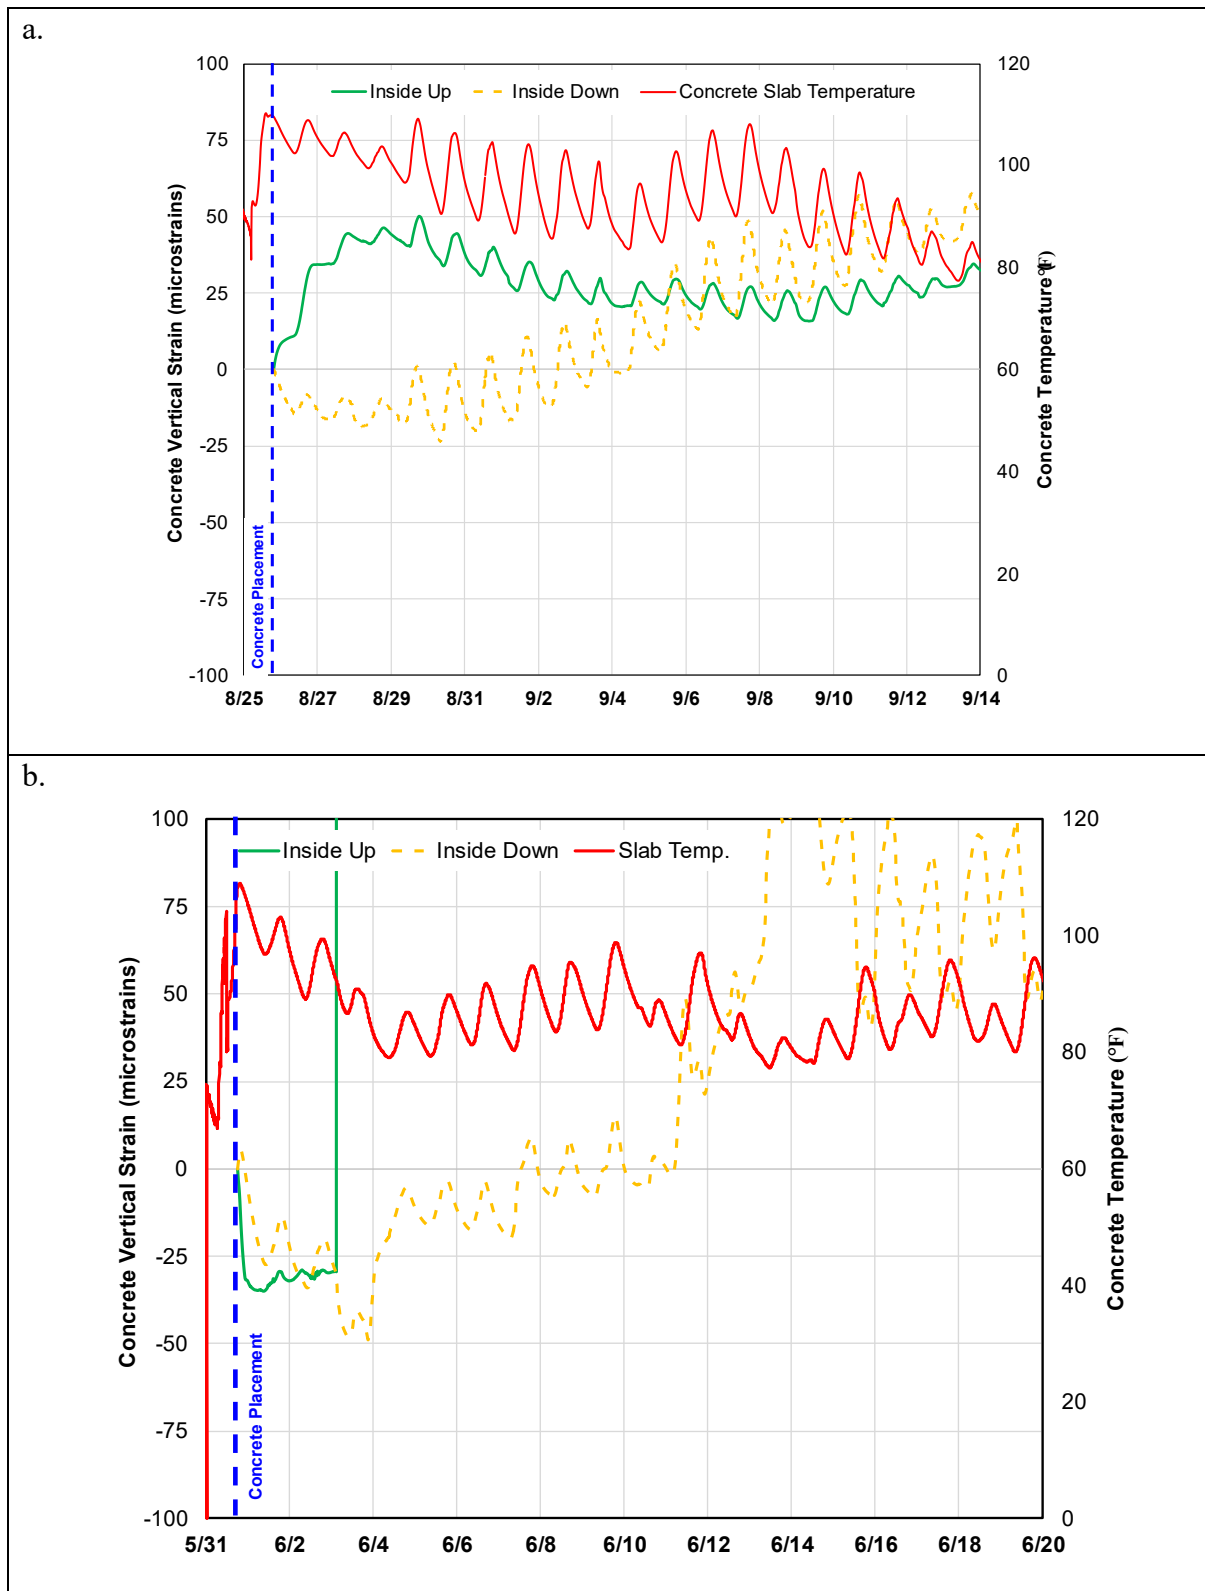
**Figure 68 Comparison of vertical strains in Section 2 and Section 4**

The installation of VWSGs in Section 4 during the construction of the inside lane primarily aimed to detect any discrepancies in the results compared to those observed in Section 2. Since both sections represented the end of a transition, a thorough understanding of their behavior was deemed essential. [Figure 68-\(a\)](#) presents an analysis of Section 2 and [Figure 68-\(b\)](#) Section 4 for the first 21 days following concrete placement. To facilitate a clear comparison, data from only two VWSGs, specifically 'inside up' and 'inside down,' are considered.

The analysis clearly shows that Section 4 exhibited relatively higher deformation compared to Section 2. This difference, as previously discussed in Section 4.4.2, is attributed to the crack observed adjacent to Section 2. Notably, the 'inside down' VWSG readings for both sections demonstrated very similar trends, with an initial recording of -25 microstrain. This comparative analysis leads to an important conclusion: in the absence of cracks, the end of a transition, such as Section 4, is expected to behave in a manner similar to this section.

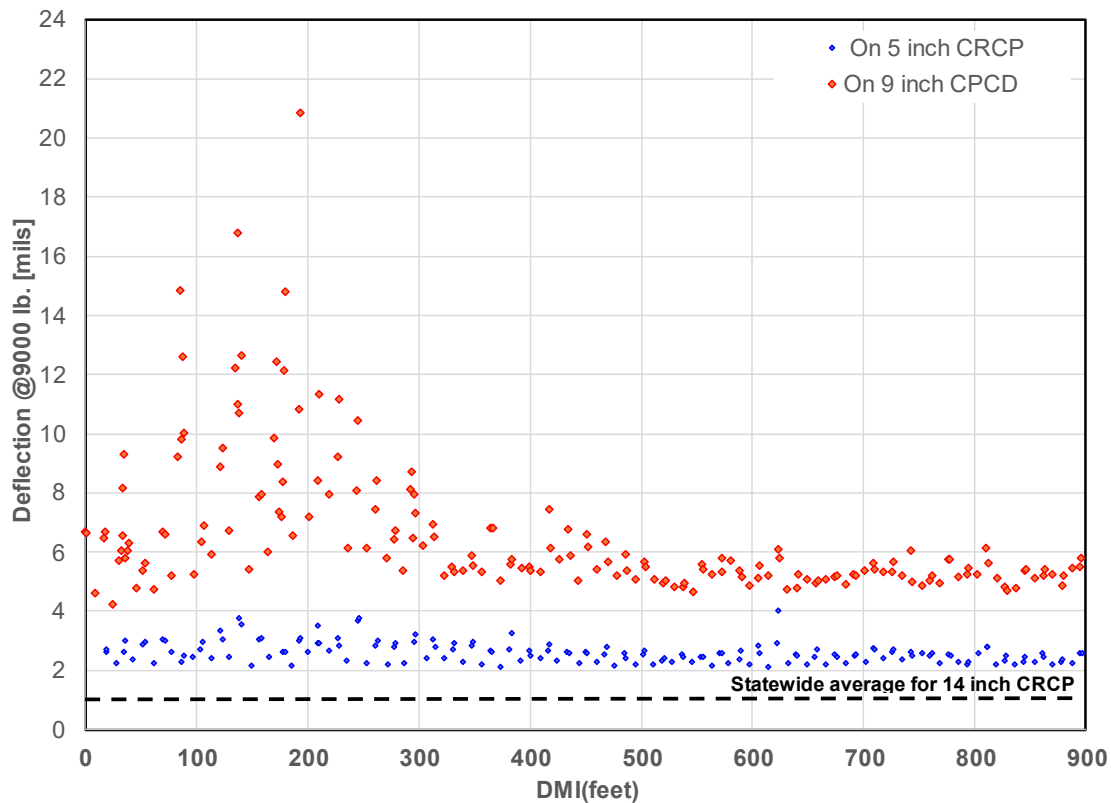
**Figure 69 Comparison of FWD deflection between 9-inch CPCD and after placing 4-inch CRCP in location 2**

Figure 69 shows the FWD deflections on newly overlaid 5-inch CRCP at Location 2. Comparing it with FWD deflections on 9-inch CPCD, FWD results showed improved uniformity even at the locations where there are large deflections recorded on the CPCD. The blue dots, which represent FWD drops on CRCP overlay ranged between 2 mils to 4 mils. It can be observed that, regardless of the variability in deflections on the CPCD layer, the deflections measured on the CRCP overlay are relatively consistent. For instance, if we compare the deflections of the segment between DMI 0 to 300 and between DMI 300 to 900 after the overlay, there is minimal difference in the measured deflections on CRCP overlay, even though there was a large difference in deflections on CPCD between the two segments. This indicates the capability of bonded CRCP overlay on improving the structural condition of CPCD.
