# Implementation of Concrete Overlay Evaluation and Design

Research Project 5-6910-01  
Research Report 5-6910-01 R1  
<http://www.techmrt.ttu.edu/reports.php>

1. Report No. FHWA/TX-24/5-6910-01-1	2. Government Accession No.	3. Recipient's Catalog No.	
4. Title and Subtitle Implementation of CRCP Overlay on CPCD		5. Report Date July 2023

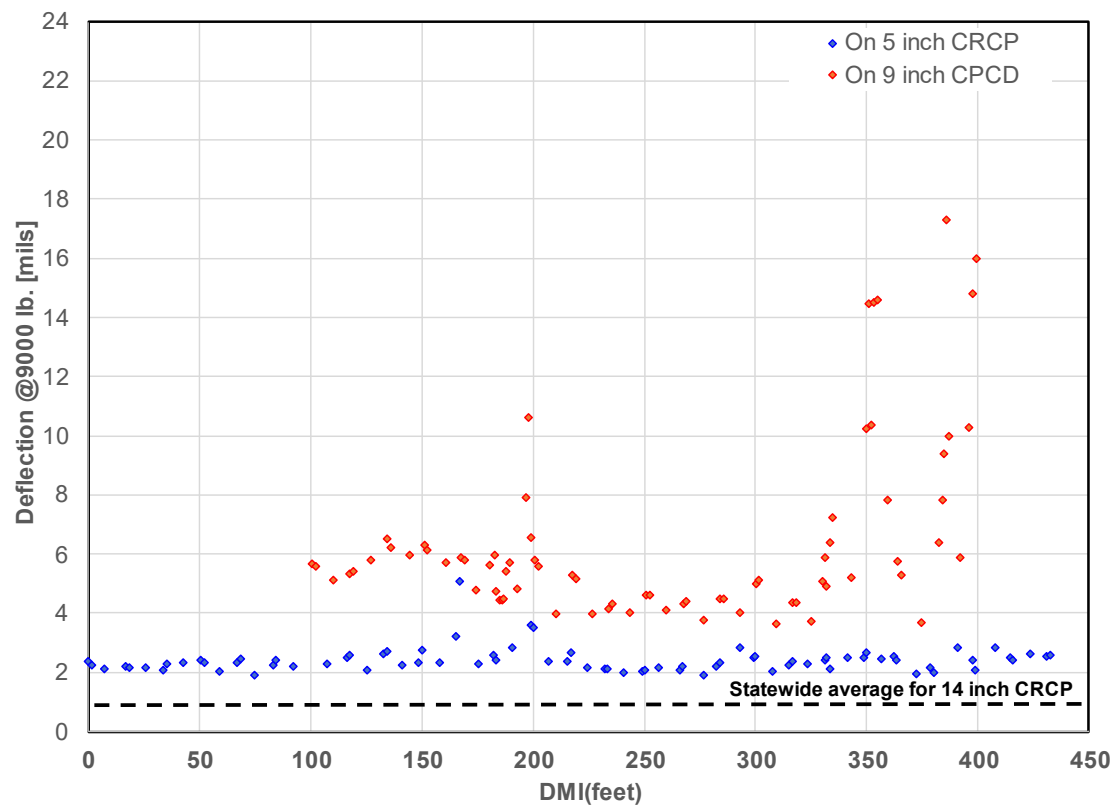
**Figure 70 Comparison of FWD deflection between 9-inch CPCD and after placing 5-inch CRCP in location 3**

Figure 70 shows the FWD deflections on CPCD and 5-inch CRCP at Location 3. As was observed in Location 2, 5-in CRCP overlay reduced not only the deflections themselves, but the variability in slab deflections. This improvement in the deflection characteristics implies better long-term performance of the overlayed CRCP. Although the average deflection on the CRCP overlay is larger than the statewide average of 1.25 mils for a 14-inch CRCP, the reduction in deflection compared to the existing CPCD is notably significant. The significant reduction in deflection by the placement of CRCP overlay was also observed in previous BCO projects in US 281 Wichita Falls and Loop 610 South in Houston.

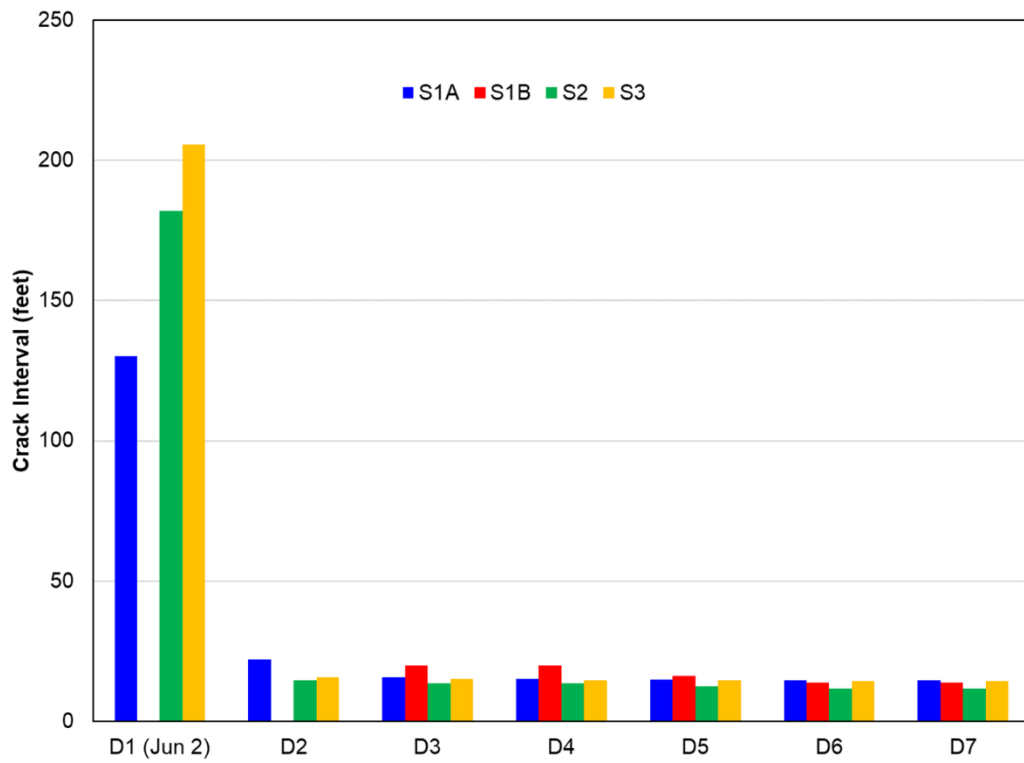
**Figure 72 Crack spacing observed in different Segments**

Figure 72 illustrates average crack spacings during the first week post-placement. On Day 1, it shows limited crack developments in Segments 1A, 2, and 3, resulting in larger crack spacing. For example, the average crack spacing on Day 1 was approximately 135 feet for Segment 1A, 180 feet for Segment 2, and 205 feet for Segment 3. However, by Day 2, significant cracking developed across all segments, reducing the spacing to less than 20 feet. Figure 73 provides a more detailed average crack spacing after Day 2. This increased crack development could be attributed to the temperature drop on June 3rd and continued drying shrinkage of concrete. Over time, the average crack spacing across all segments stabilized, ranging between 12 and 14 feet, regardless of whether the segments were sawcut or not. This observation suggests that saw-cutting does not significantly affect later-age crack development.

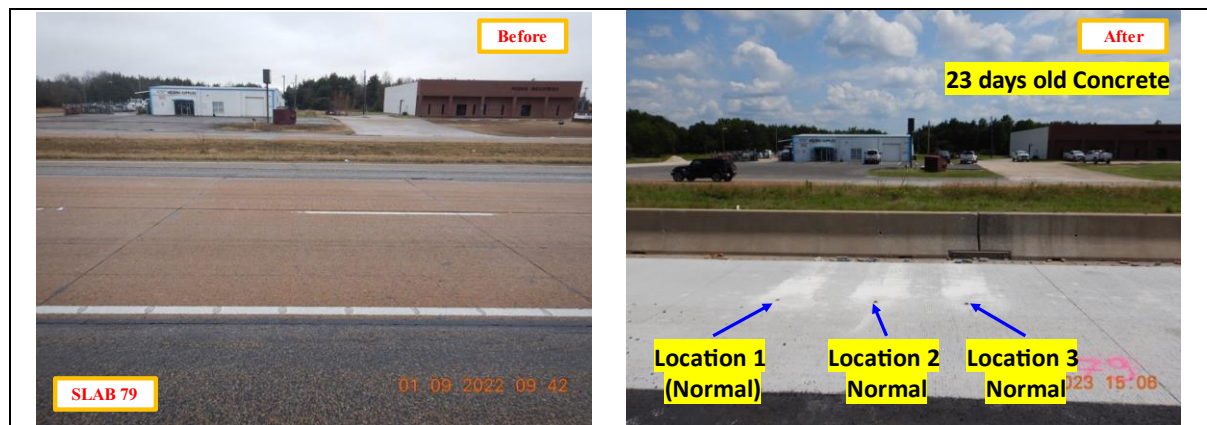
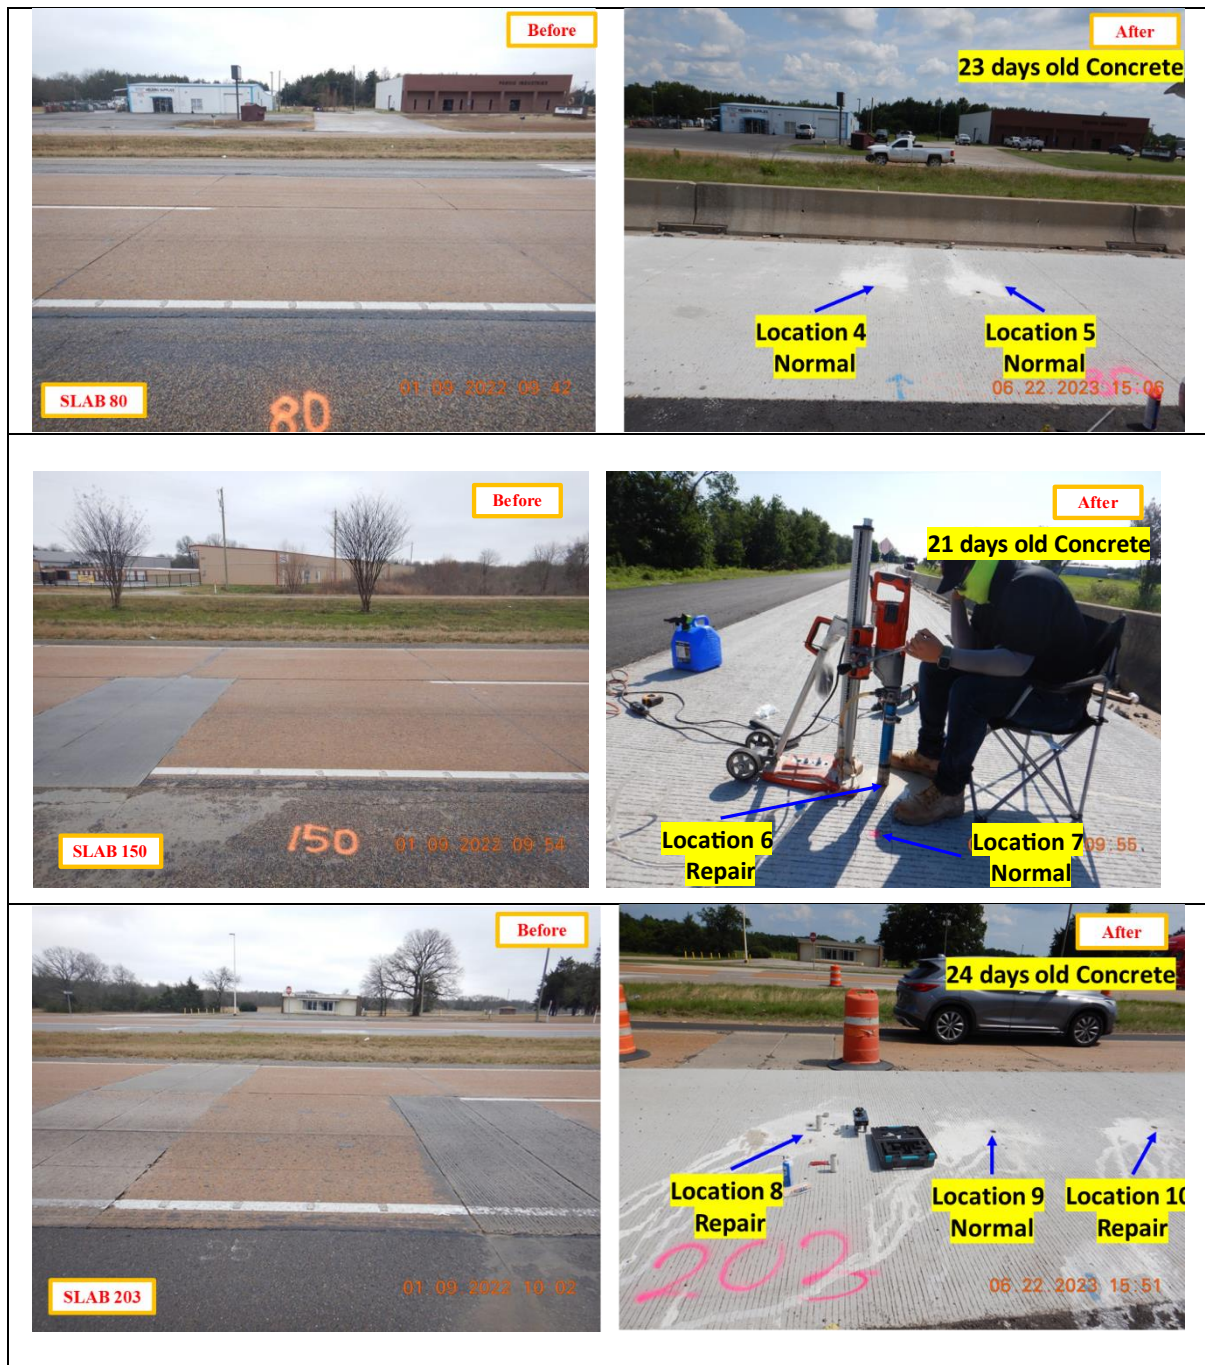
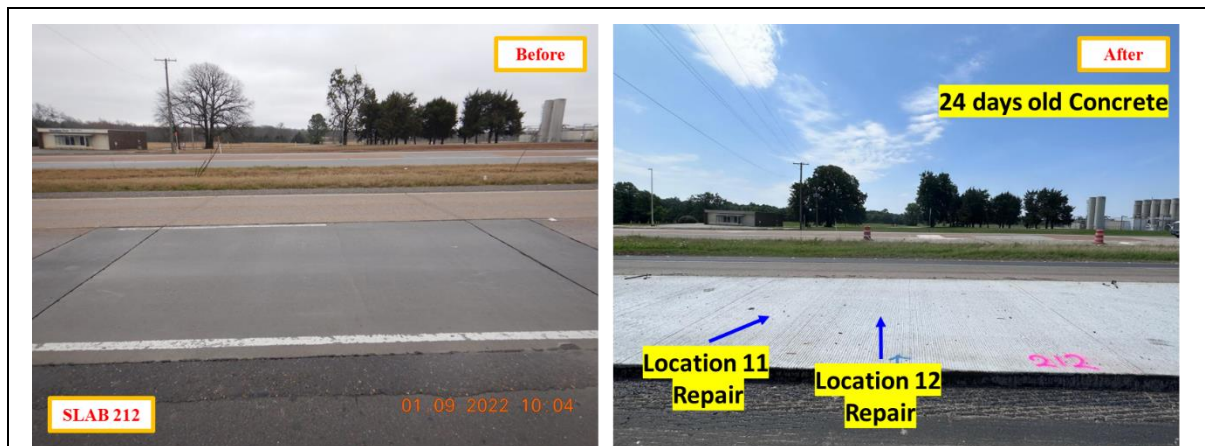
**Figure 74 Coring Location for Bond Test on outside lane**

Table 7 presents a summary of the bond tests conducted on the outside lane. A total of five slabs were identified based on visual survey conducted in November 2019. 12 coring locations were selected in those 5 slabs. Of these, 5 coring locations were on repaired areas, labeled as 'Repair' in the summary. The remaining 7 locations were on existing CPCD without distresses, marked as 'Normal' in the summary. Figure 74 Coring Location for Bond Test on outside lane illustrates the coring locations for each slab, both before and after concrete placement. Notably, all bond

tests resulted in failure, occurring at the interface between the existing CPCD and the new CRCP overlay.

One of the potential reasons for the failure in conducting the bond test is the condition of the existing CPCD. It was observed during coring operation that the concrete in CPCD layer is quite solid, and it took a long time to be able to core the existing concrete even by a quarter of an inch. It might be that the phase of coring for existing CPCD concrete induced bending on the 5-in concrete core, causing debonding at the interface. This needs to be further verified.

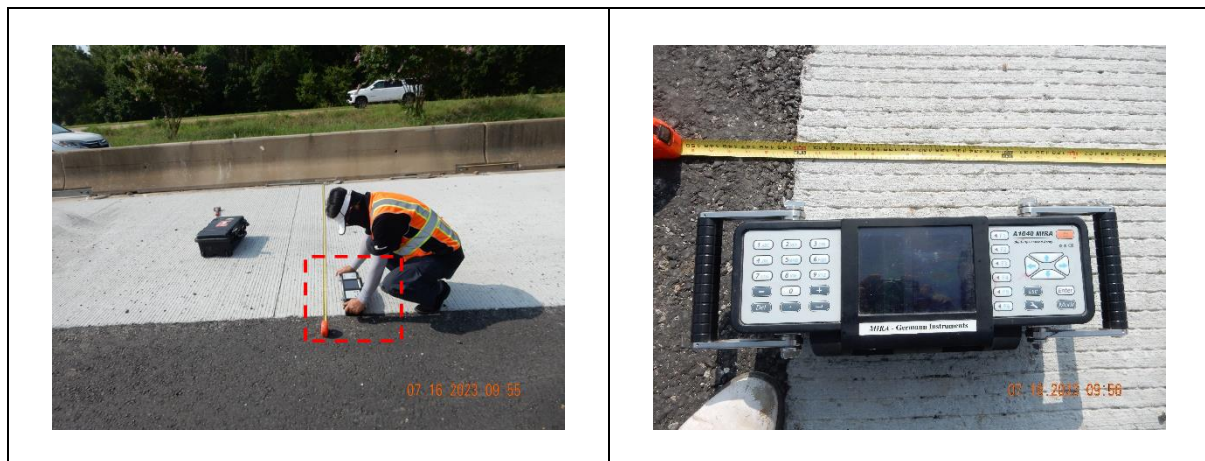
**Figure 75 MIRA scanning performed in a selected slab.**

As discussed earlier, an issue of debonding in the outside lane was identified. To investigate potential debonding, a specific slab section in the outside lane was selected, and MIRA testing was performed. Figure 75 illustrates the MIRA testing on the selected slab.

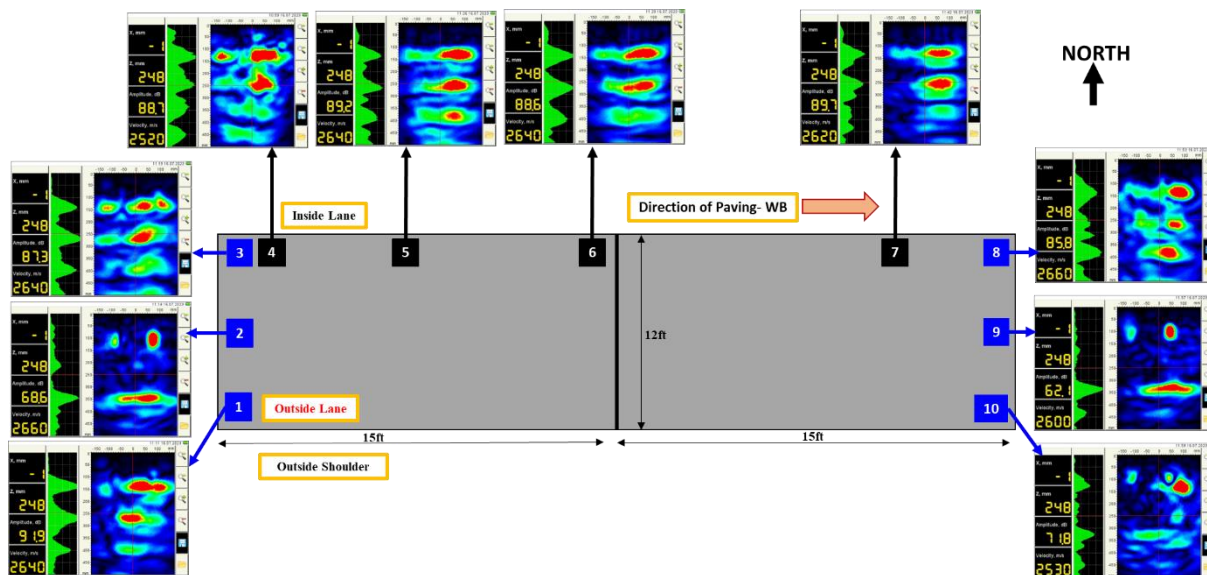
**Figure 76 MIRA image of selected slab on outside lane**

Figure 76 presents the MIRA testing results. The images, specifically numbers 1, 3, 4, 5, 7, and 8, indicate, in general, debonding occurred at slab corners and along the longitudinal edges. However, at the middle of the transverse contraction joints, debonding was not observed.

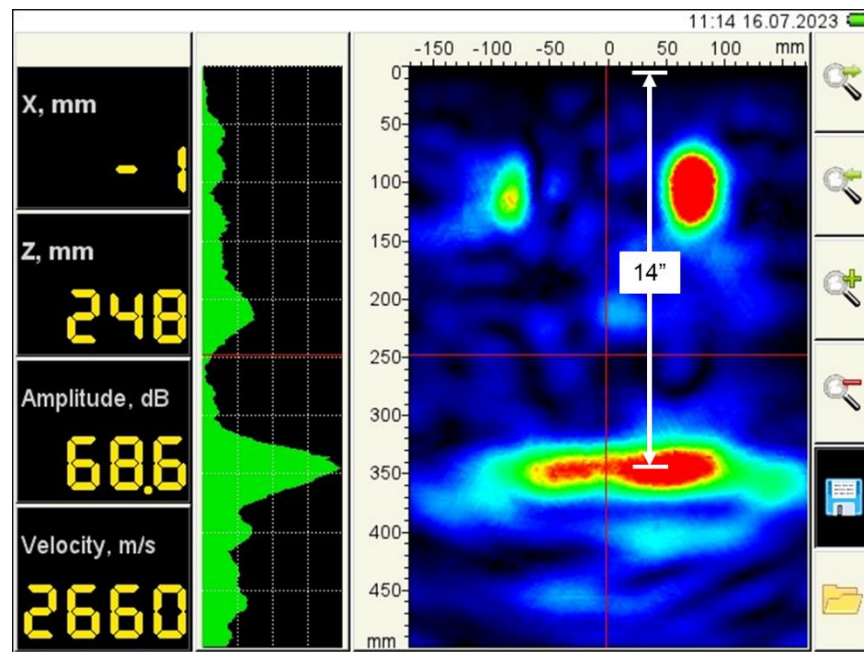
**Figure 77 MIRA image with no debonding**

In MIRA images, areas in blue represent solid concrete with no large voids. On the other hand, red areas represent void or materials quite different from concrete, such as steel. Figure 77 is the image taken at Location 2, showing two longitudinal steels placed at 4-in deep and a total slab thickness of 14-in (350 mm), which is the combined slab thickness of 9-in CPCD and 5-in CRCP. And no void or debonding is observed at the interface (100 mm down from the surface).. This is evident in MIRA images numbered 9 and 10 as well.

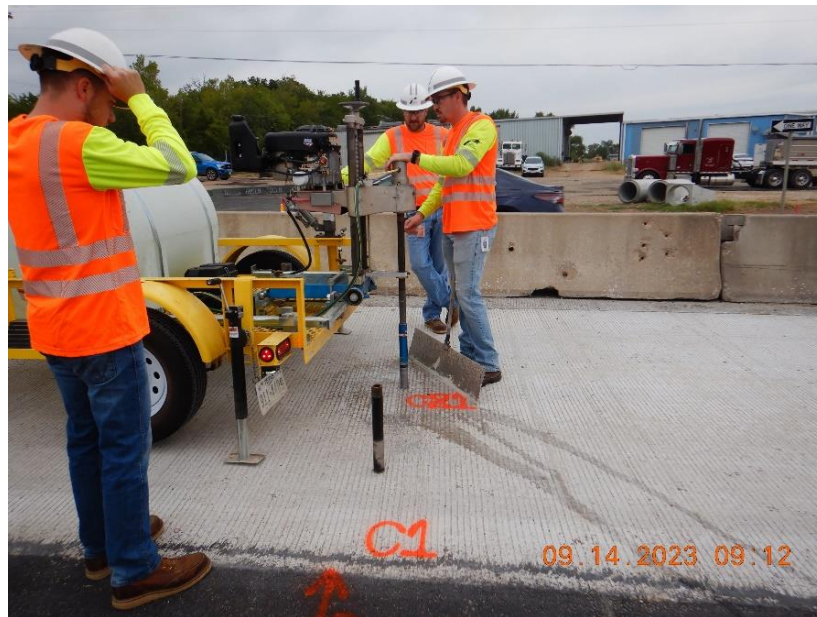
Figure 79 Trailer mounted coring machine used for Inside lane

Based on the experience of bond test conducted in the outside lane, the research team opted for a trailer mounted coring machine to perform the test in the inside lane as shown in [Figure 79](#). The primary objective of this approach was to determine if a trailer-mounted coring machine could minimize eccentricity of the drilling to prevent premature shear failure at the overlay interface or

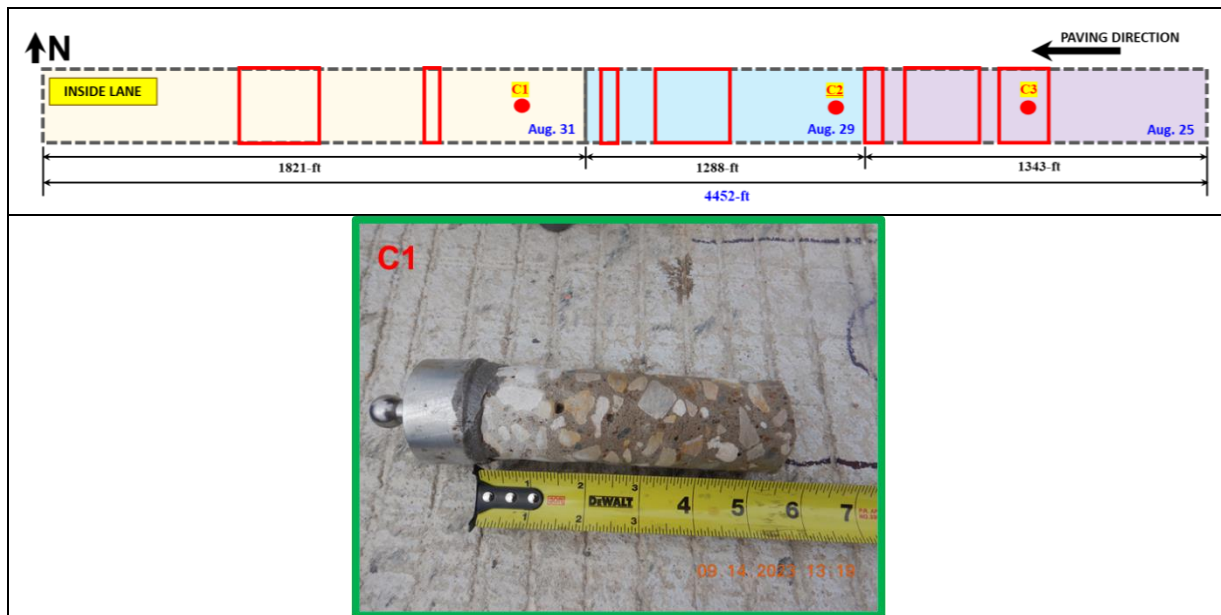
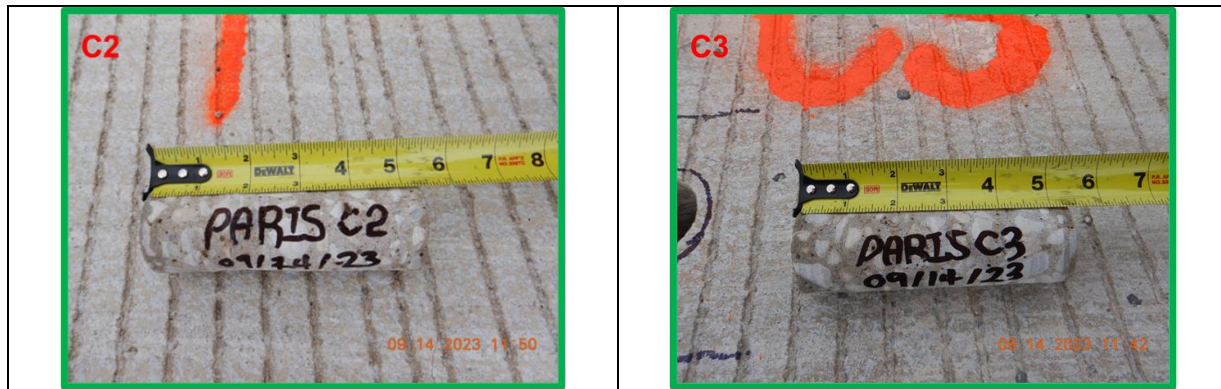
Figure 80 Coring location and bond test for Inside lane

to minimize damage to the concrete interface. To this end, three locations were selected for coring tests, as shown in [Figure 80](#). [Table 9](#) provides a summary of these tests in the inside lane.

Of the three coring locations, locations C2 and C3 encountered failures during the coring operation, while location C1 did not fail. The bond test at coring location C1 revealed a bond strength of 109 psi. Concrete in this location was placed on August 31, 2023, making it relatively new concrete at only 15 days old. In contrast, coring locations 2 and 3, constructed on August 29 and August 25, 2023, respectively were 17 and 21 days old, respectively, yet they failed during the coring operation. This observation led to the hypothesis that the failures were not attributable to shear failure at the interface caused by the coring method.

An alternative explanation for the shear failures at the interface between the existing and overlay slabs could be linked to construction methods, as suggested by the distresses observed in the inside lane. These findings and their correlation with the bond test results in both the inside and outside lanes are further discussed in the following sections.

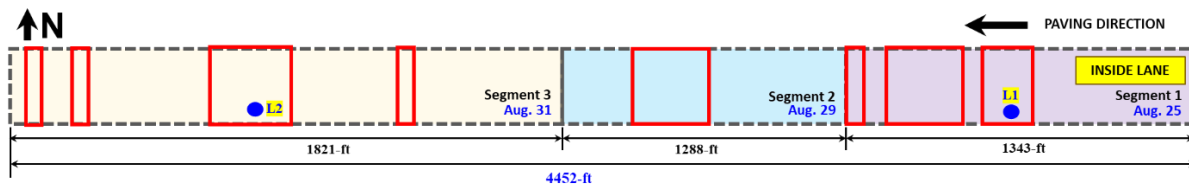
Figure 81 Location of longitudinal crack in inside lane

Upon completion of the inside lane construction, longitudinal cracks were observed. Figure 81 shows the location of a longitudinal crack observed in the field. Table 10 provides a detailed summary of these longitudinal cracks as observed in the field.

Longitudinal cracks were notably aligned directly above the longitudinal steel, indicating that these are settlement cracks. This correlation suggests a direct link to the construction process. During construction, it was noted that the slump of the delivered concrete was higher than the required 4 inches. This observation is supported by the job control testing results as shown in [Table 11](#). This data implies a correlation between higher slump and the occurrence of settlement cracks in the inside lane.
