HEAVES AT TRANSVERSE CRACKS IN ASPHALT CONCRETE PAVEMENT

Study SD92-11
Final Report

Prepared by
Terje Preber and Darla J. Peters
South Dakota School of Mines and Technology
501 E St. Joseph St.
Rapid City, SD 57701

June, 1993

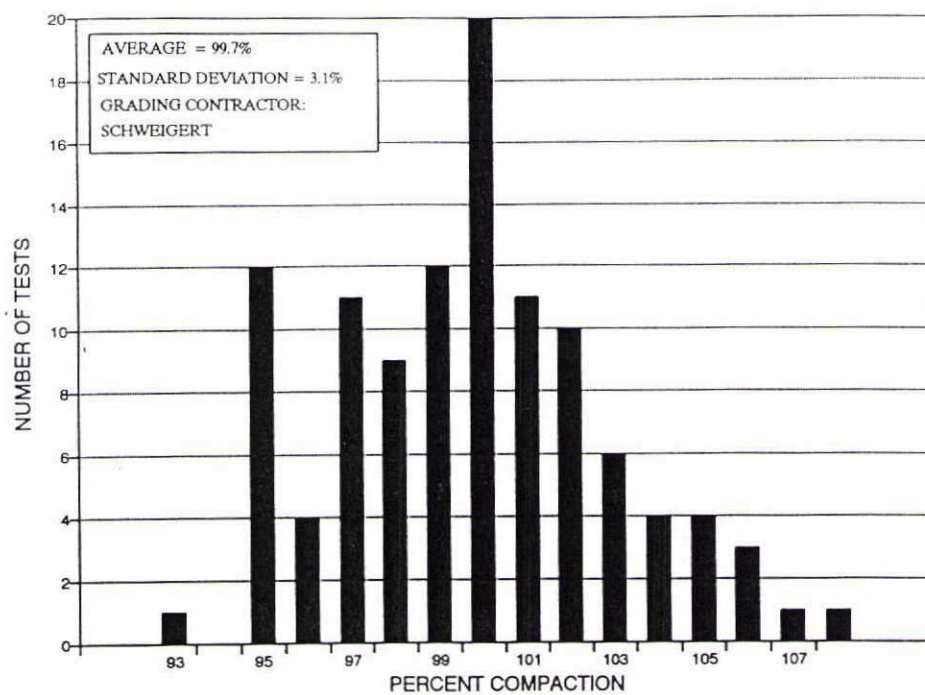
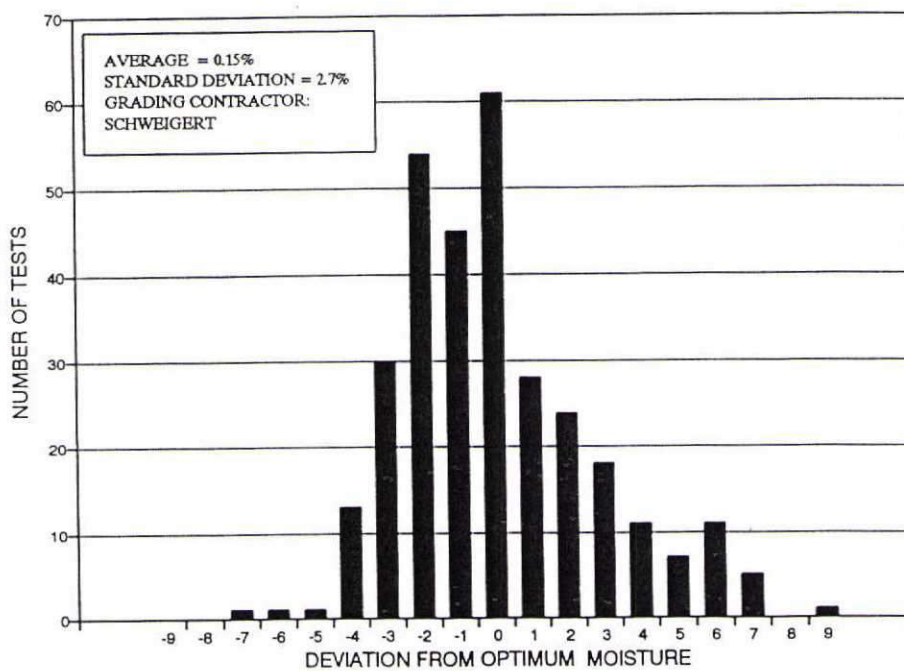
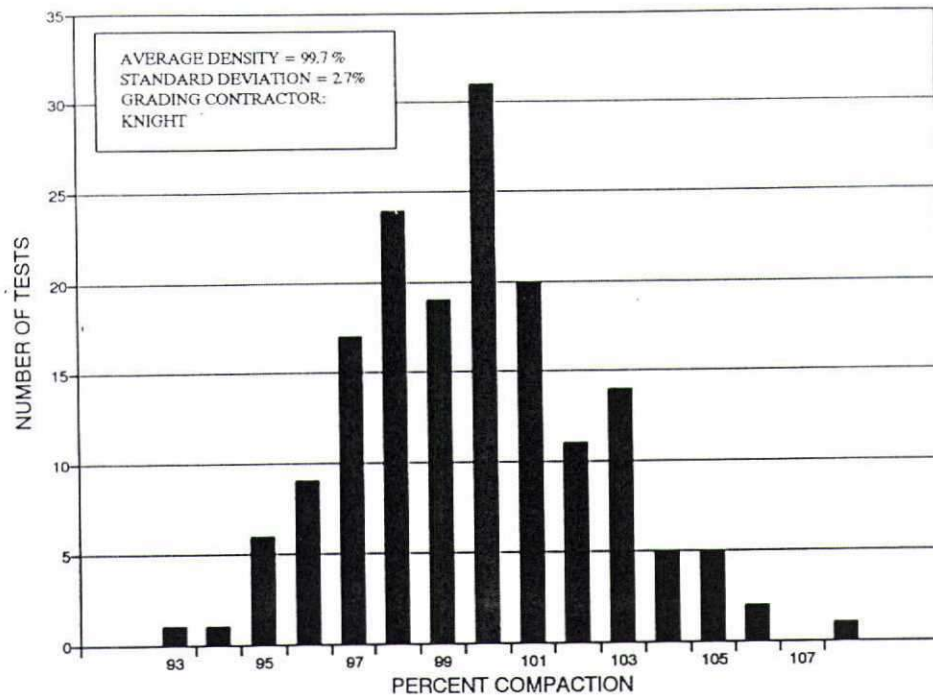
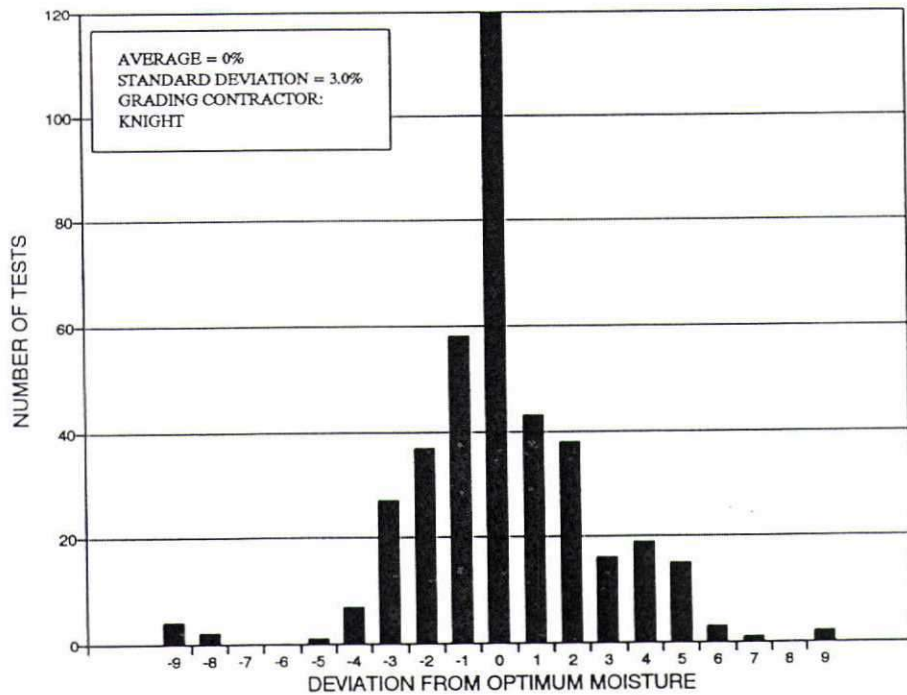
FIGURE IV-1. US212 LAPLANT TO RIVER
DENSITY DISTRIBUTION

The results of the density and moisture test on the subgrade performed during construction are shown in Figures IV-1 through IV-4, and are separated by contractor. No significant difference between the results from the different contractors is evident. The results indicate the moisture content varied from 4 percent dry of optimum to 7 percent wet of optimum. Percent compaction was nearly identical for the contractors, with an average degree of compaction of 99.7 percent. The range in compaction was from 95 to 107 percent.

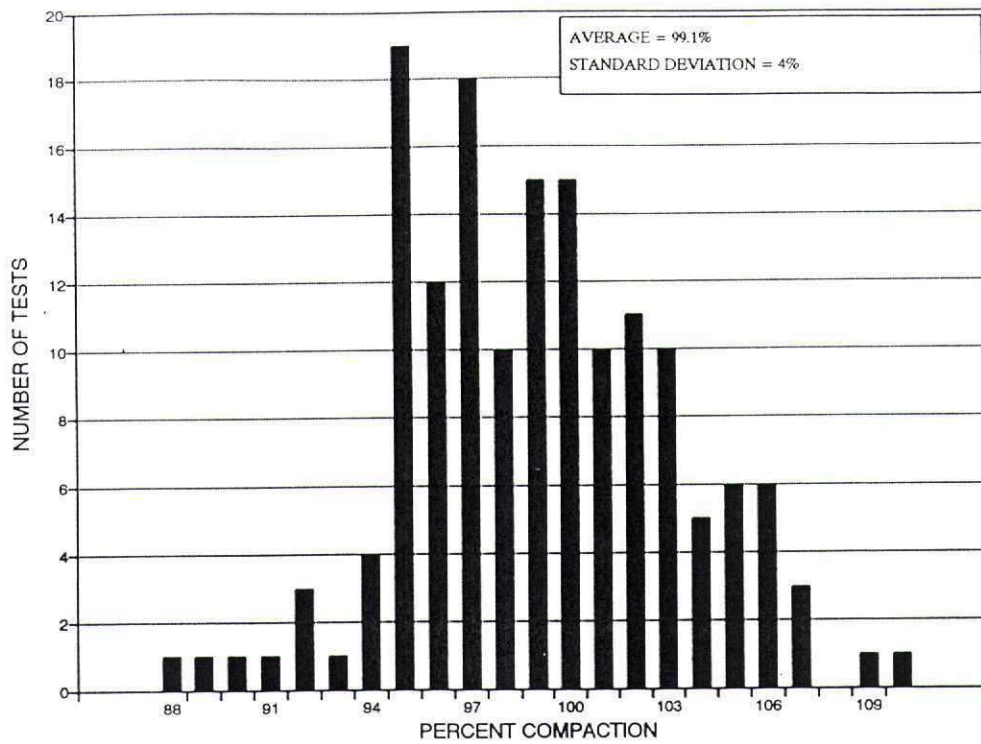
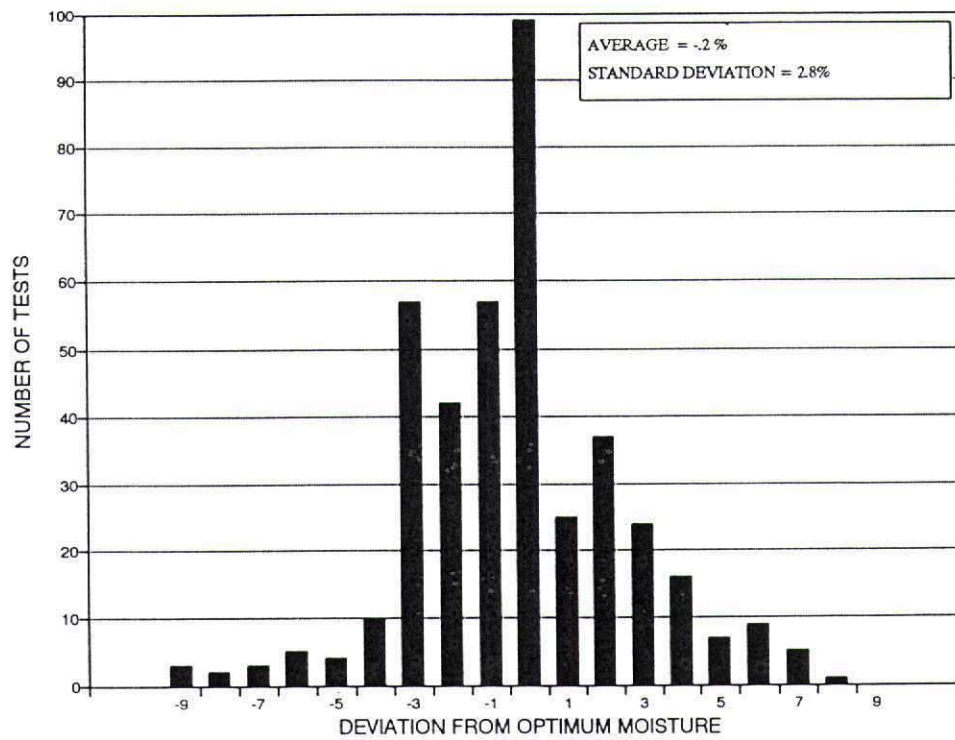
FIGURE IV-9. SD73 FAITH SOUTH
DENSITY DISTRIBUTION

The analysis of the field density tests show that most of the subgrade was generally compacted at between 94 and 107 percent of the maximum dry density as obtained from the AASHTO T-99 compaction test. The average degree of compaction was 99.1 percent, with a standard deviation of 4 percent. The in place moisture content tests show tests, where soft material was encountered, ranging mostly from 9 percent dry of optimum to 8 percent wet of optimum. Most tests were from 3 percent dry of optimum to 4 percent wet of optimum. The average in place deviation from optimum moisture content was 0.2 percent dry of optimum, while the standard deviation from optimum moisture was 2.8 percent. Hence more than half the subgrade was compacted dry of optimum. The density and moisture histograms are shown in Figures IV-9 and IV-10, respectively.

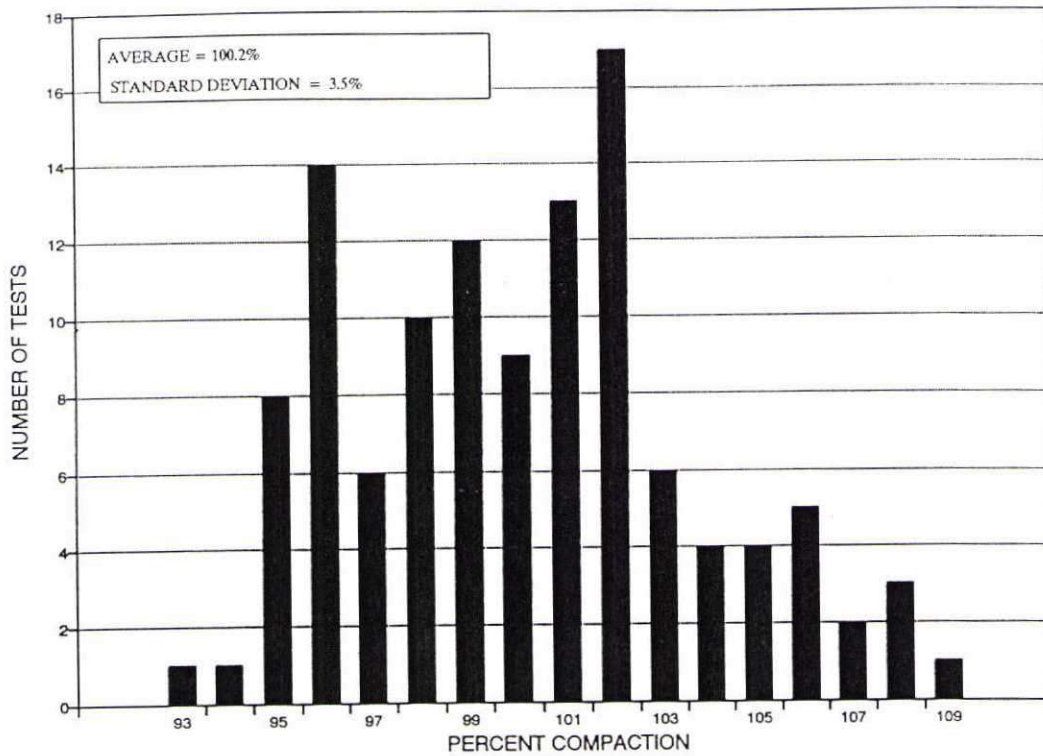
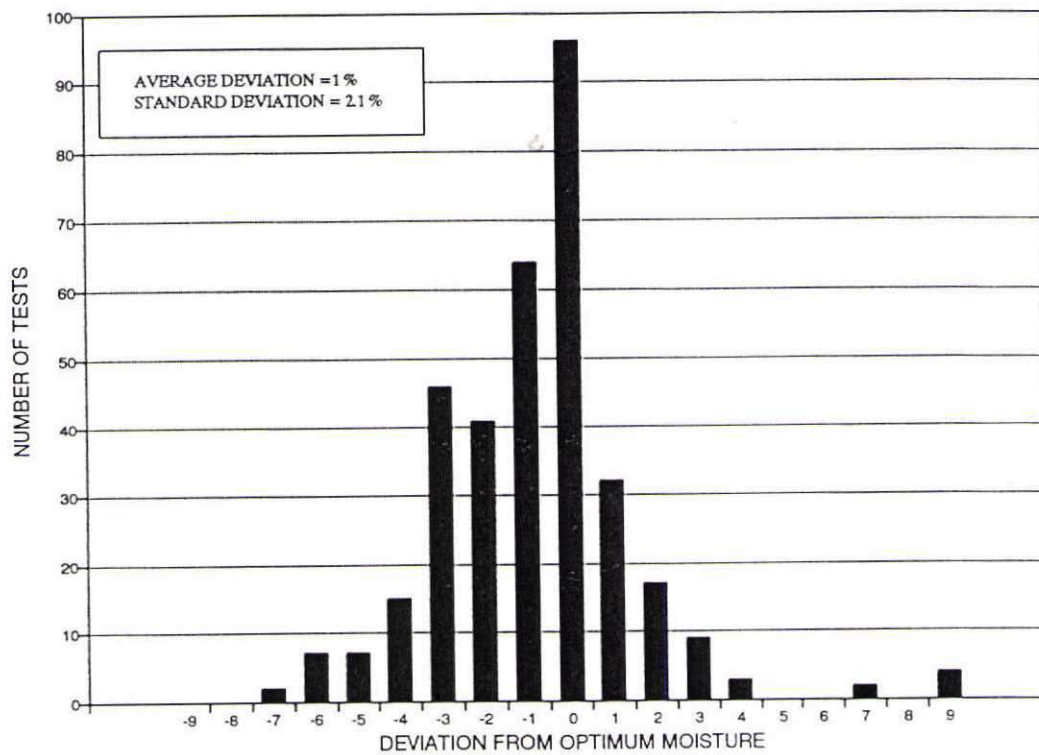
FIGURE IV-13. SD34 WHITE OWL TO HOWES
DENSITY DISTRIBUTION

The subgrade generally consisted of highly weathered shale and clay containing no shale fragments. The results of the compaction tests on the subgrade were compiled and analyzed statistically. The results show (Figure IV-13 and IV-14) that the average compaction achieved was over 100 percent of the maximum dry density as achieved by AASHTO T-99, and only four tests were below 95 percent. The standard deviation was 3.5 percent. The majority of the moisture content tests (Figure IV-14) ranged from 7 percent dry of optimum to 4 percent wet of optimum. Average deviation from optimum moisture content was 1.0 percent, and standard deviation from optimum was 3 percent.

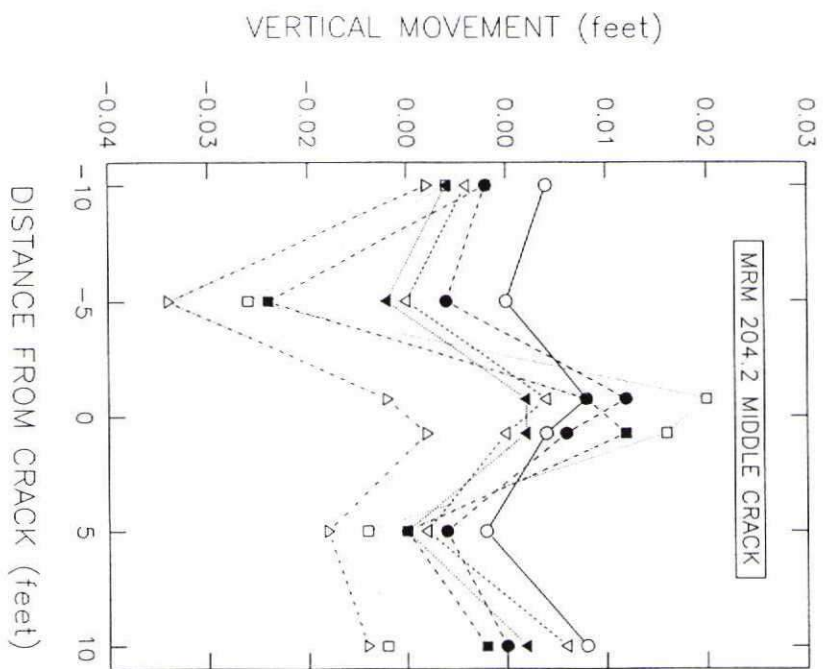
FIGURE V-28. US212 LAPLANT TO RIVER
VERTICAL MOVEMENT

CONTROL SECTION	MAXIMUM MEASUREMENT (feet)	DATE	ELAPSED TIME (days)
204.2	0.042	March 23	306
198.4	0.092	March 2	285
189.7	0.075	April 20	334
188.0	0.082	August 25	96

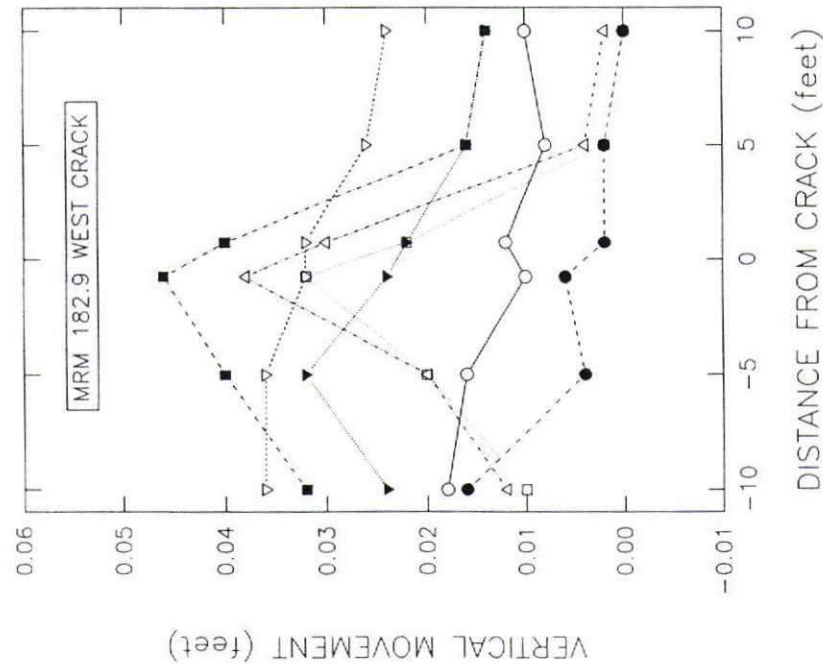
FIGURE V-32. US212 RIDGEVIEW-LAPLANT
VERTICAL MOVEMENT

The majority of the maximum vertical movements in control sections MRM 184.2 and 182.9 were detected between 285 and 306 days after the baseline elevations were established. The maximum vertical movement of 0.072 feet, for the control section at MRM 184.2, was recorded on April 20, 1993, while for the control section at MRM 182.9, a maximum vertical movement of 0.046 was recorded on March 23, 1993. The vertical movements near the crack are consistently greater than five feet from the crack. Typical changes in vertical movement versus time for the control sections at MRM 184.2 and 182.9 are presented in Figure V-32.

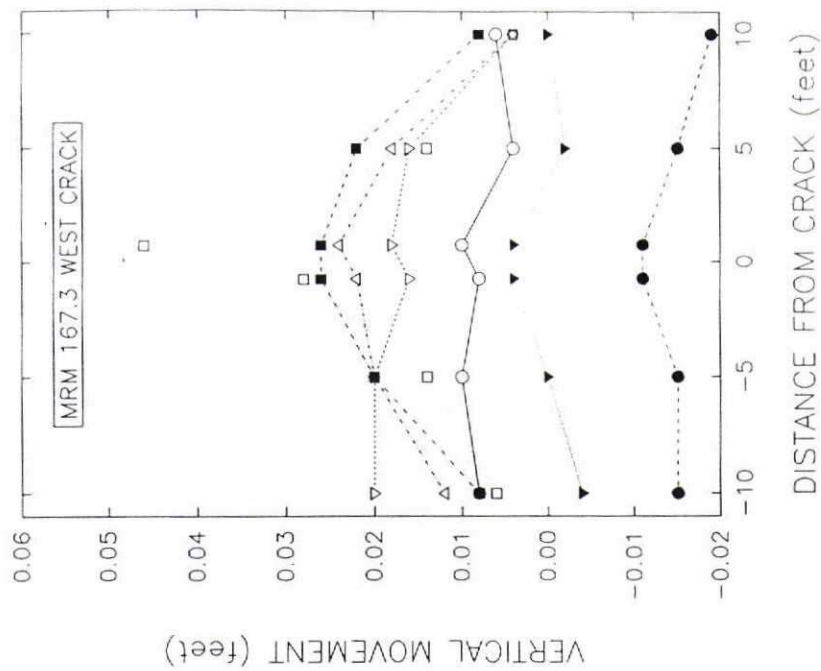
FIGURE V-33. US212 RIDGEVIEW WEST
VERTICAL MOVEMENT

Typical vertical movement versus time for the control sections at MRM 172 and 167.3 are shown in Figure V-33. At the control section at MRM 172, a maximum vertical movement of 0.038 feet, was measured on September 29, 1992 and the maximum vertical movement of 0.046 feet, for control section 182.9, was observed on March 2, 1993. As on the previous project, the vertical movements near the crack are slightly greater than five feet from the crack.

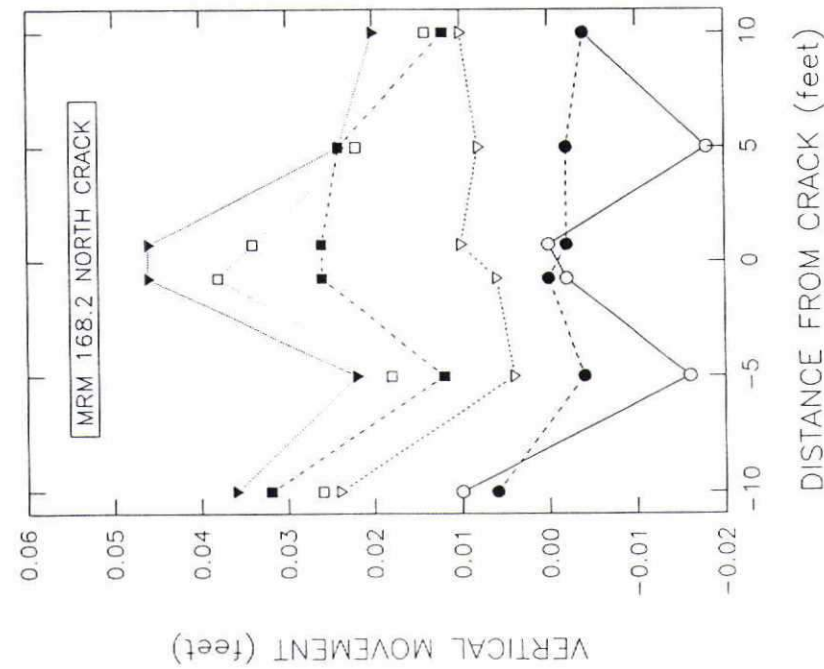
FIGURE V-35. SD73 HOWES NORTH
VERTICAL MOVEMENT

The chip sealing also appeared to affect the vertical movements at this project, as settlements of up to 0.050 feet were evident in the elevations taken up to March 2,

1993. However heaves were recorded after March 23, 1993. A heave of 0.028 feet, for the control section at MRM 160.1, was detected on April 20, 1993 and a maximum heave of 0.060 feet, for control section 150, was detected on March 23, 1993. Vertical movements near the crack are consistently greater than five feet from the crack. Typical vertical movements versus time are shown in Figure V-35.

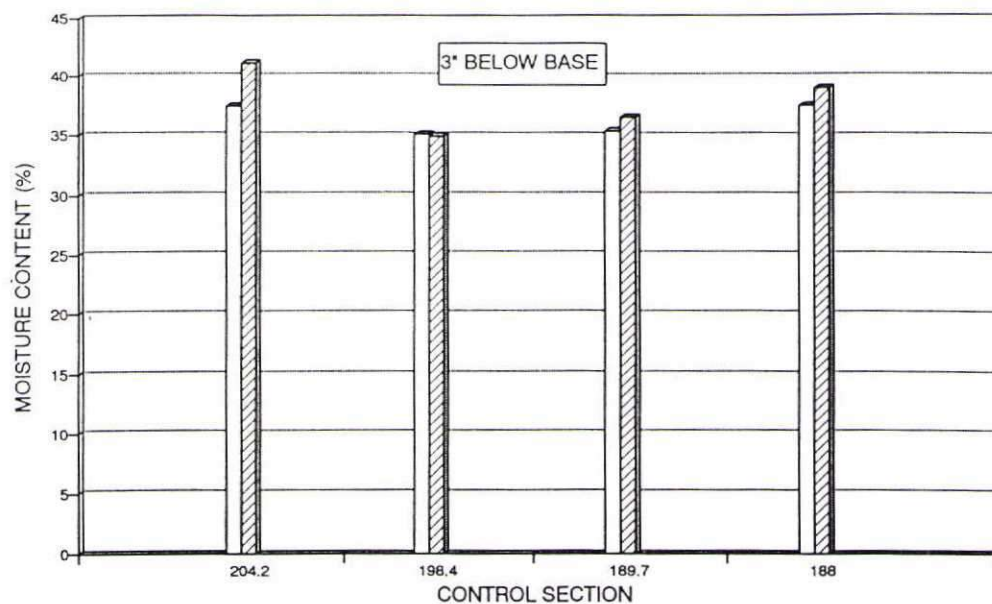
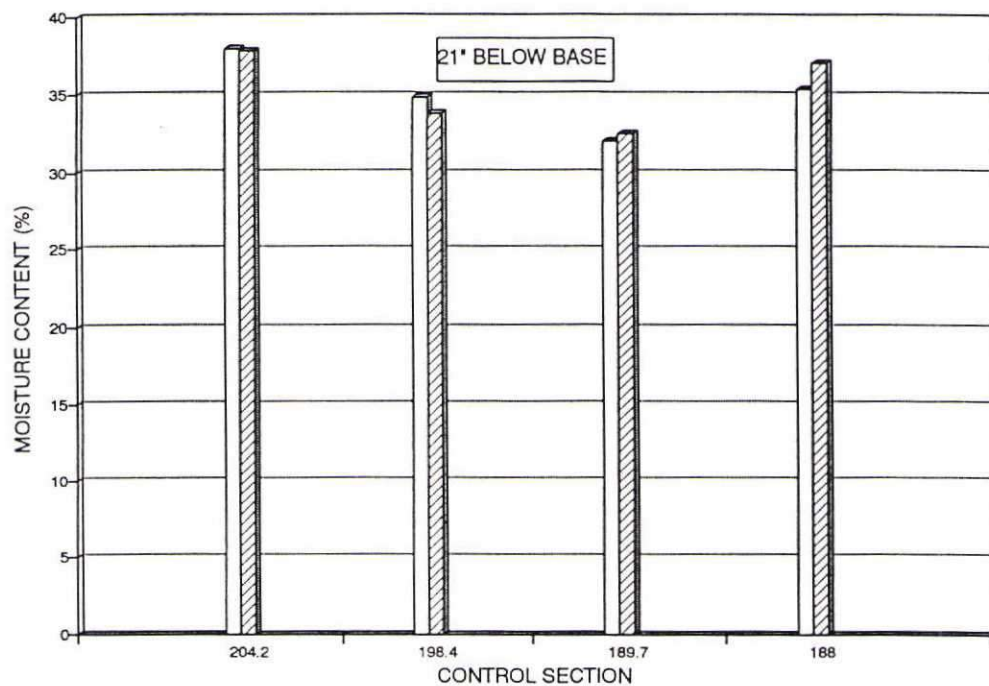
Lateral and vertical moisture content distributions for the control sections at MRP 204.2, 198.4, 189.7, and 188 are shown in figures V-37 and V-38 for depths of 3 and 21 inches below the base. As shown in the figures, the moisture content at the crack location is generally higher than those

at five feet from the crack location, at a depth of 3 inches below the base. The same trend is also true for depths of 9 and 15 inches below the base. However, at a depth of 21 inches below the base, the moisture content distribution shows little trend.

The moisture content was also found to be the highest near the subbase material. When comparing the moisture contents at a depth of 3 inches below the base material with those at greater depths, it was found that the moisture content at depths of 9, 15 and 21 inches below the base were, 3.6, 3.8, and 2.0 percent lower, respectively.

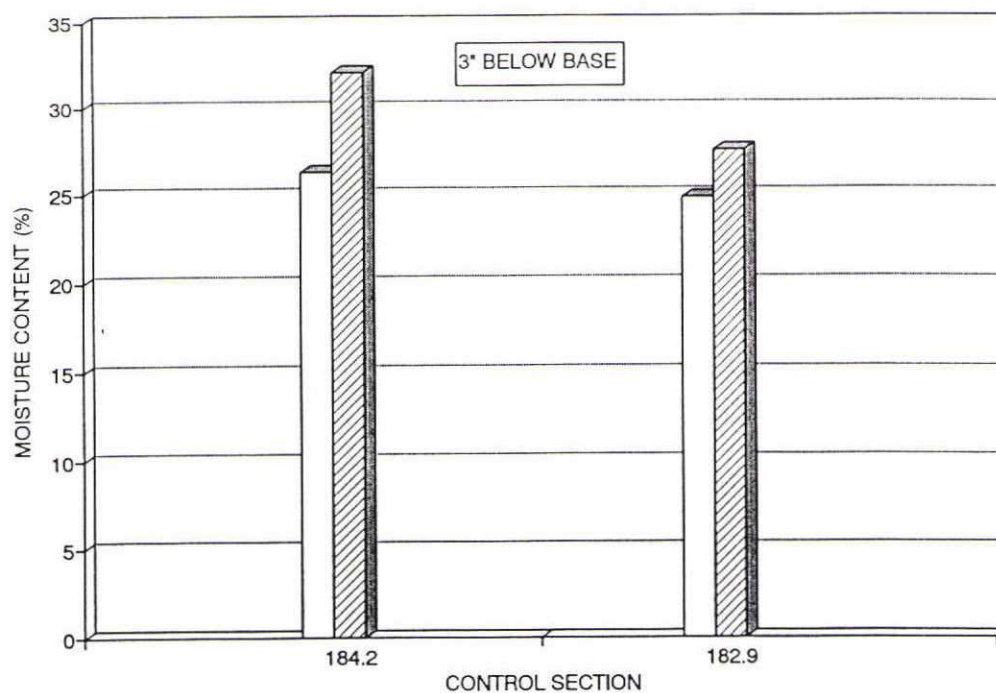
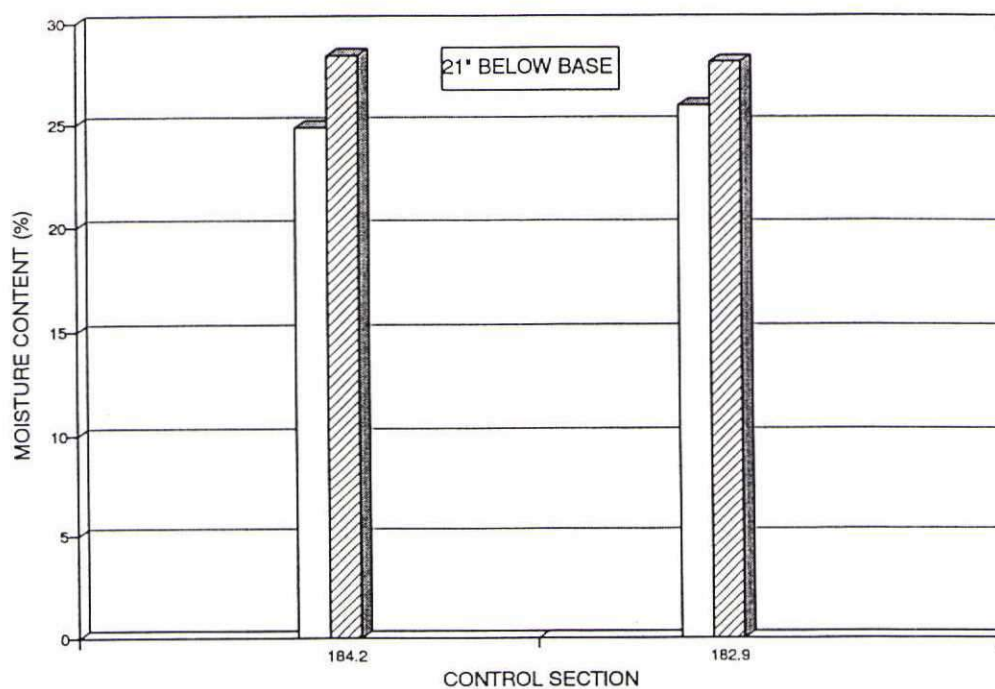
The lateral and vertical moisture content distributions for the control sections at MRM 184.2 and 182.9 are shown in figures V-39 - V-40. The figures show that the moisture content at the crack location is consistently greater than five feet from the crack location, regardless of the sample depth. On the average, the moisture content decreased 4.2%, 4.0%, 0.6%, from the crack to 5 feet from the crack at 3, 9, and 15 inches below the base, respectively. At a depth of 21 inches below base, however, the moisture content 5 feet from the crack was 2.8% higher than at the crack.

The moisture content also decreased from 3 inches below the base to 15 inches below the base. At a depth of 9 inches,

the moisture content had decreased 1.2 percent, while at a depth of 15 inches below the base, the moisture content was 2 percent below that at 3 inches below the base.

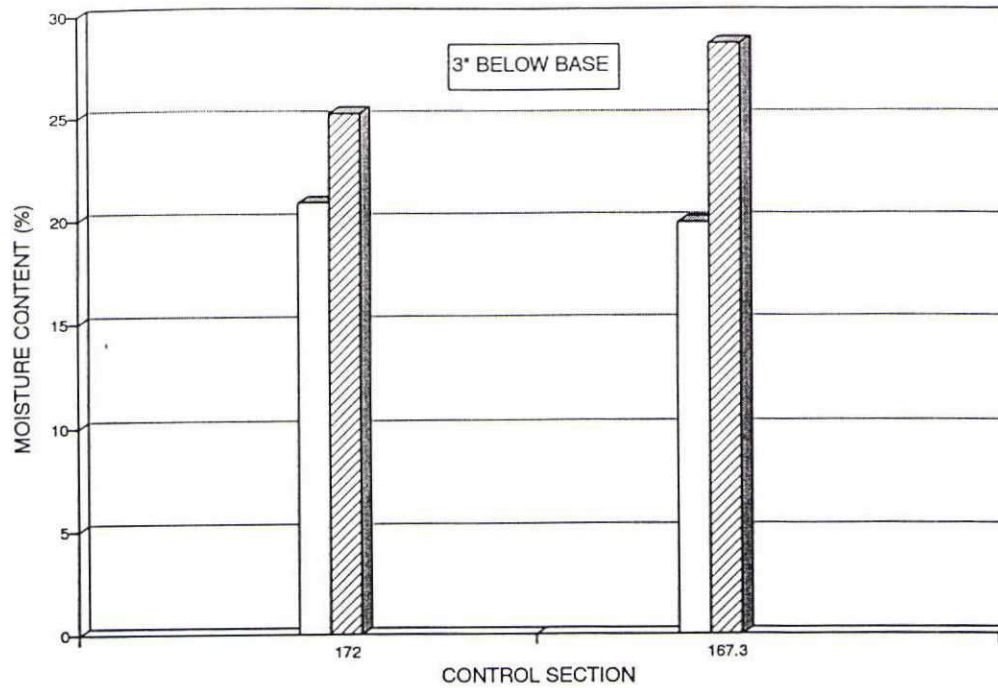
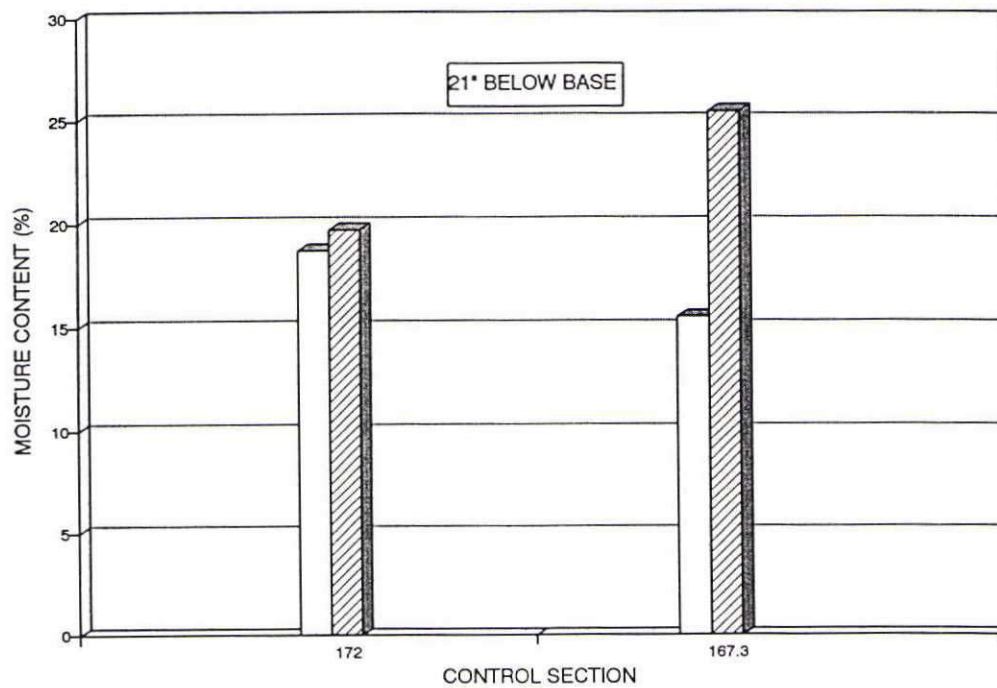
The lateral and vertical moisture content distributions for the control sections at MRM 172 and 167.3 are shown graphically in figures V-41 and V-42. At this location, regardless of the sample depth, the moisture content at the crack location is again consistently greater than at five feet from the crack. The lateral distribution profile shows a decrease in moisture content from the crack to 5 feet from the crack of 6.5, 3.2, 1.4, and 5.5 percent at depths of 3, 9, 15, and 21 inches below base, respectively.

The moisture content also tends to decrease with depth. The vertical distribution profile shows a 1.6 percent decrease in the moisture content both from 3 to 9 inches and 3 to 15 inches below the base, while the moisture content decreased 3.8 percent from 3 to 21 inches below the base material.

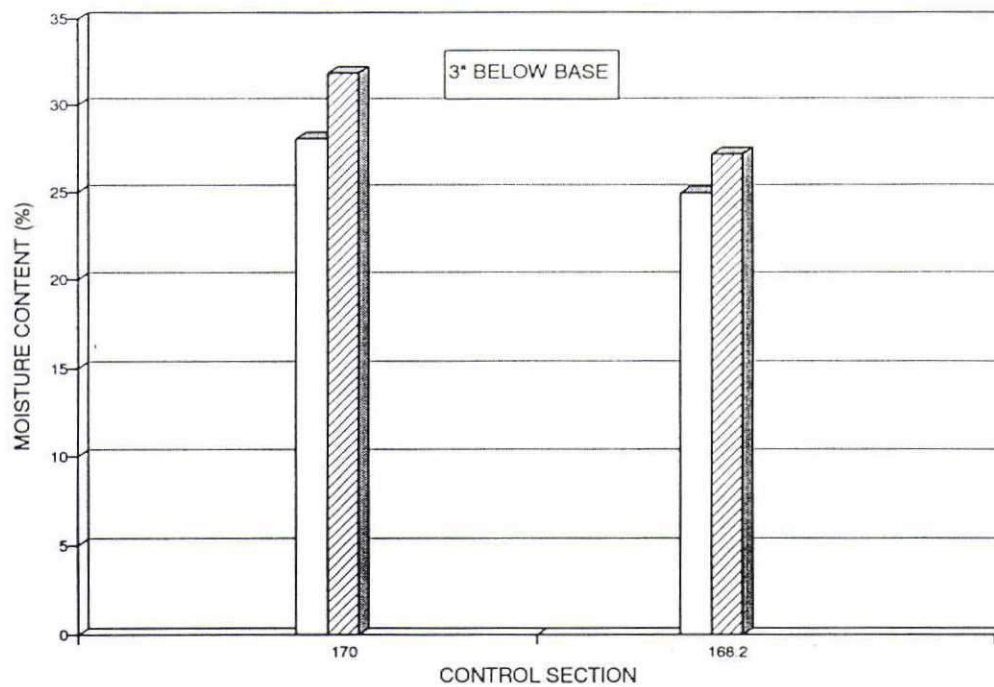
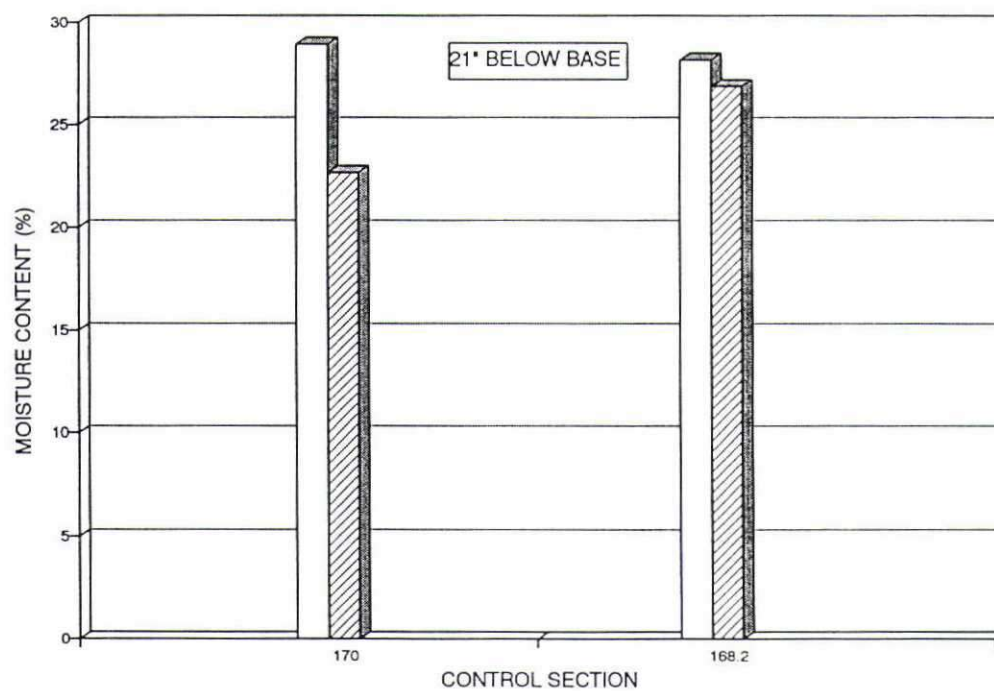
The lateral and vertical moisture content distributions for control sections MRM 170 and 168.2 are shown in figures V-43 and V-44. At this project, it was found that the moisture content at five feet from the crack were less than those at the crack at all depths except at 21 inches below the base. On the average, the lateral distribution profile shows

decreases of 3.0, 3.2, and 2.1 percent at depths of 3, 9 and 15 inches below the base increase, respectively. At a depth of 21 inches below the base, the moisture content was 3.8 percent higher 5 feet from crack.

The moisture content distribution also shows a slight increase to a depth of 9 inches below the base. From 9 inches below the base, the moisture content decreases with depth. For the control sections at MRM 170 and 168.2, the vertical distribution profile shows a 0.3 percent increase in moisture content from 3 to 9 inches below the base, while comparisons of the moisture content from 3 to 15 and 3 to 21 inches below the base show a 0.8 and 1.9 percent decrease, respectively.

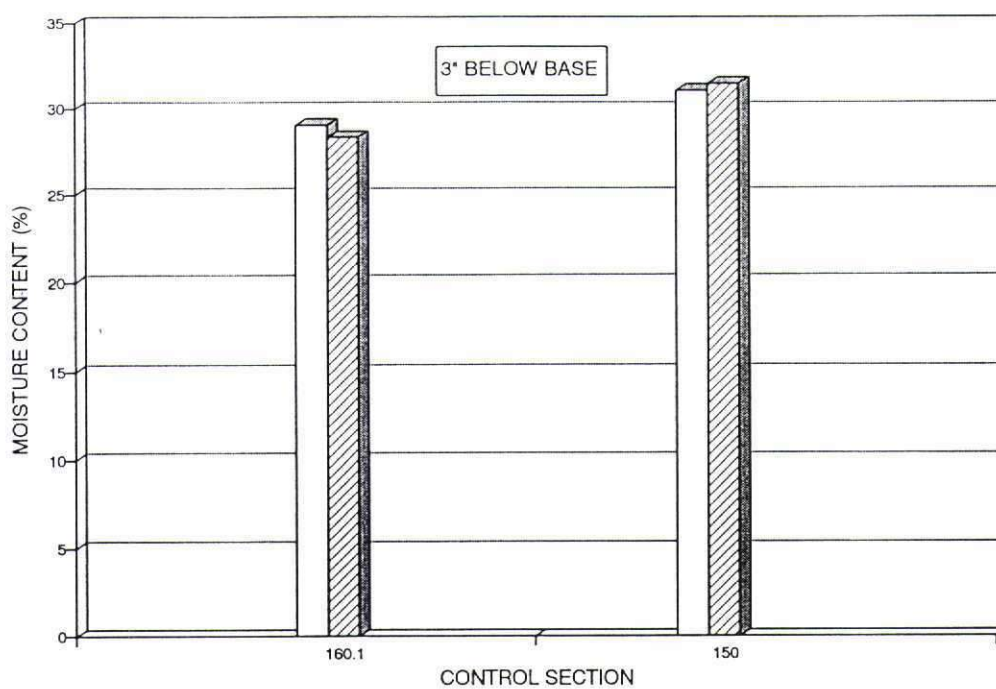
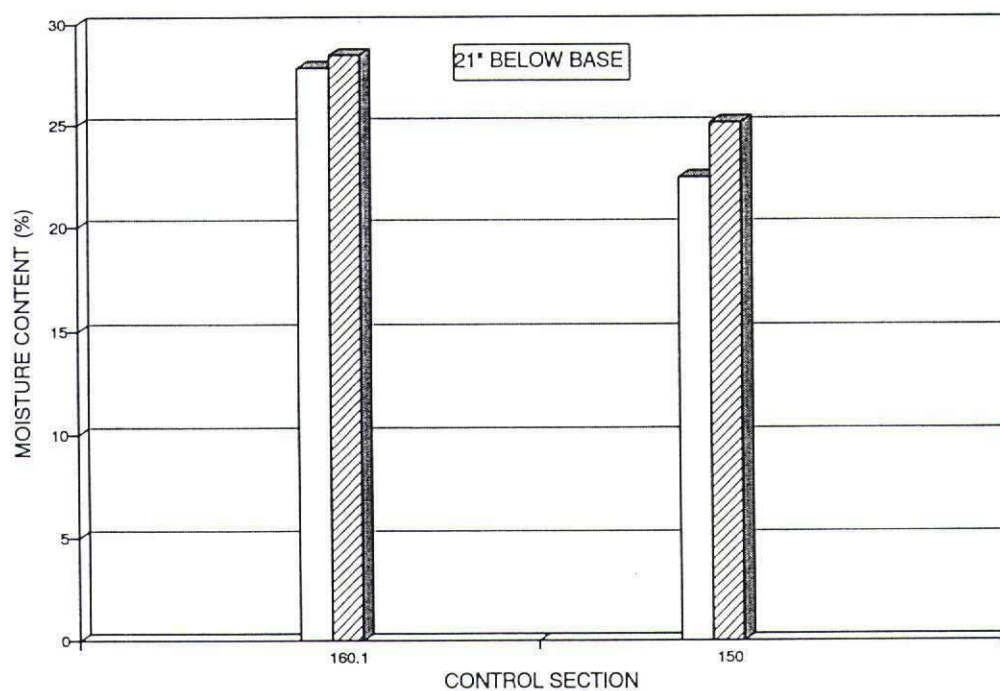
The moisture content variation, laterally and vertically, for the control sections at MRM 160.1 and 150 are shown graphically in Figures V-45 and V-46. As can be seen, at a depth of 3 inches below the base, the moisture content at MRM 160.1 at the crack location is slightly smaller as compared to five feet from the crack. The opposite is the case at MRM 150. However, the trend of decreasing moisture away from the crack was again found at depths of 9, 15, and 21 inches below the base material. The average moisture profiles show a decrease in moisture content from the crack to 5 feet from the crack of 2.1 percent at depths of 9 and

Comparing moisture content with depth, the moisture content decreases with depth. The resulting vertical distribution profile shows a 0.8, 3.4, and 4.0 percent decrease in the moisture content from 3 to 9 inches, 3 to 15 inches, and 3 to 21 inches below the base, respectively.

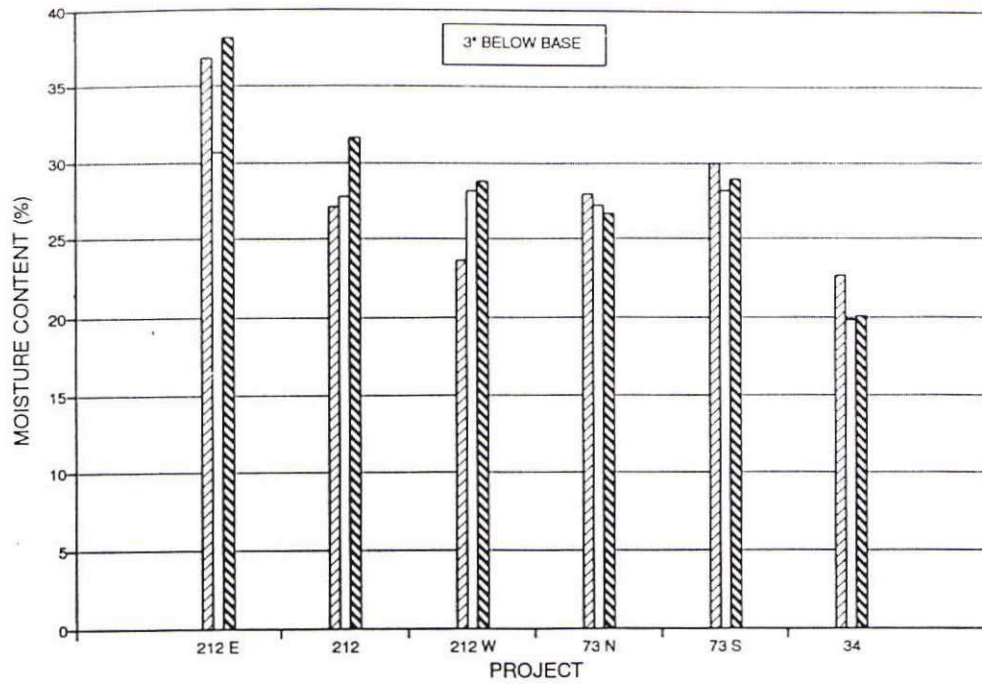
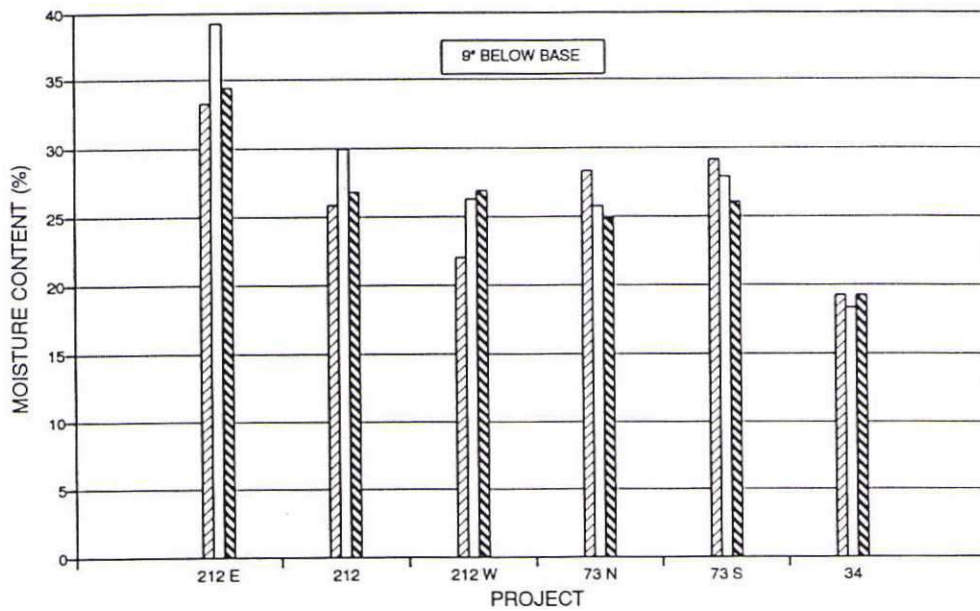
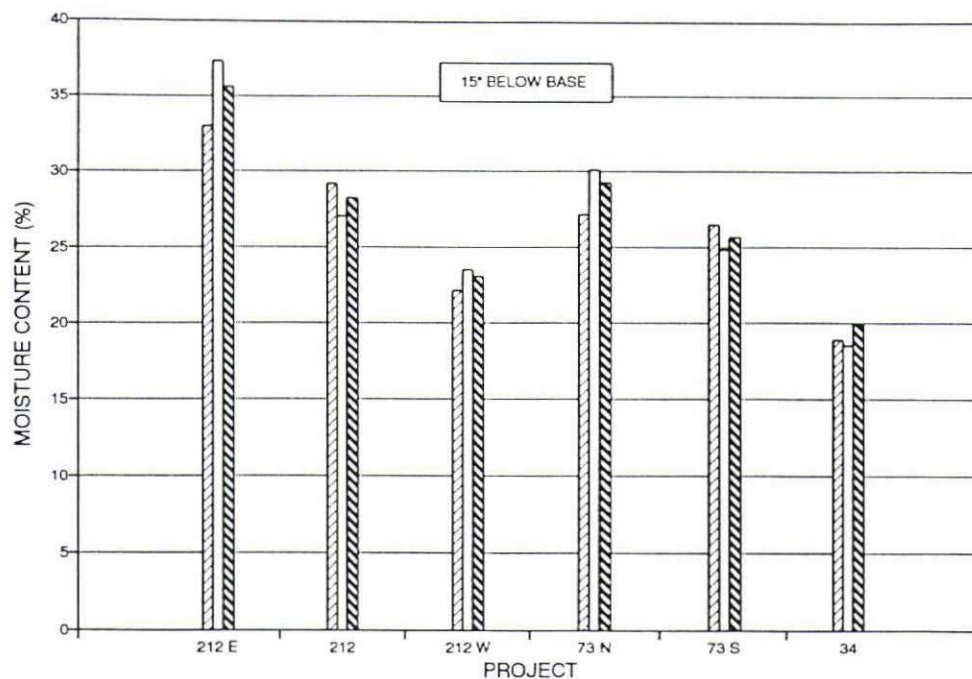
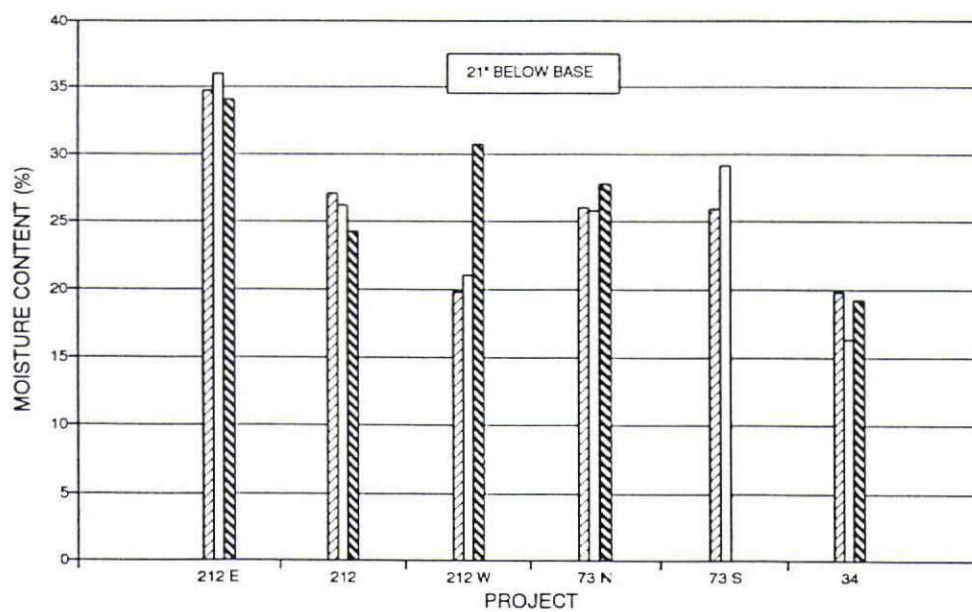
Sampling was performed in June 1992, November 1992, and April 1993 at depths of 3, 9, 15 and 21 inches below the base (Figures V-49 through V-52). No trend in variation of moisture content with time appears to be present on any project except for the project from Ridgeview 12.1 miles west. At this location, the moisture content appears to increase with each subsequent sampling, regardless of the sample depth.
