Void Development Under Bridge Approaches

Study SD90-03

Final Report - Executive Summary

Prepared by
Department of Civil Engineering
South Dakota State University
Brookings, South Dakota 57007-0495

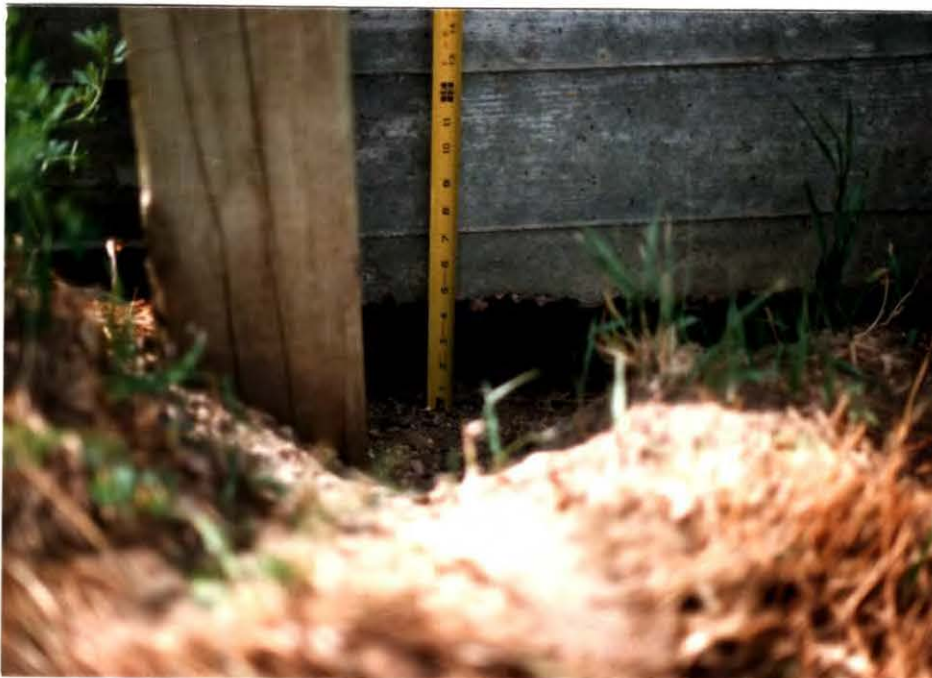
- b. Structure No. 44-222-210, on SD 42 1.9 miles west of Minnehaha County line. Northeast abutment/approach interface. Approximately 4-1/2 inch void exposed, no digging required.

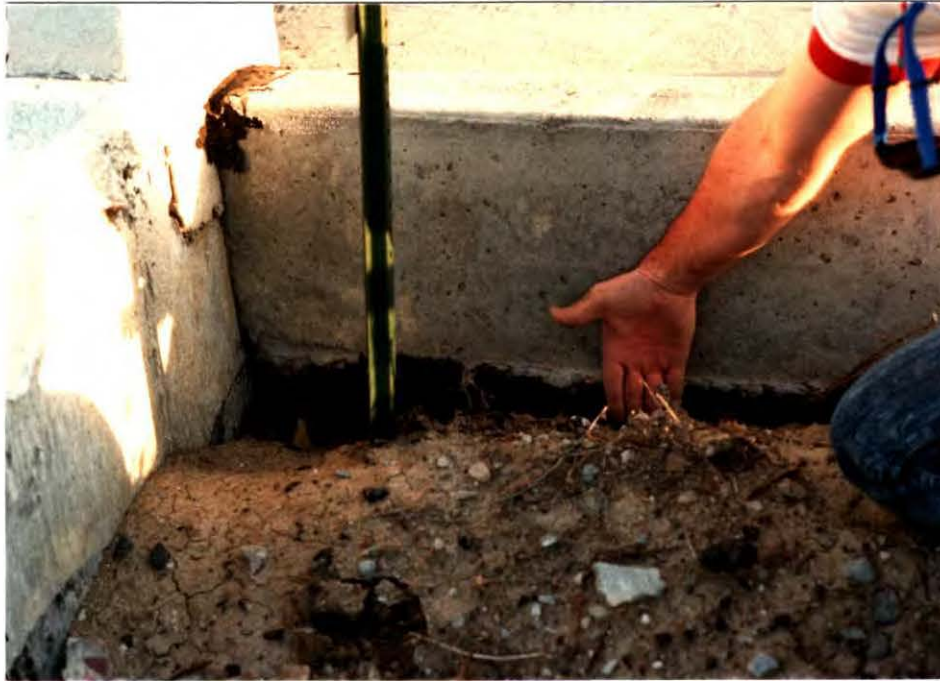
- c. Structure No. 36-071-076, on I-90 westbound at mile marker 125.53 in Jackson Co. West approach with an 8-to-10-inch void under approach exposed, no digging required.

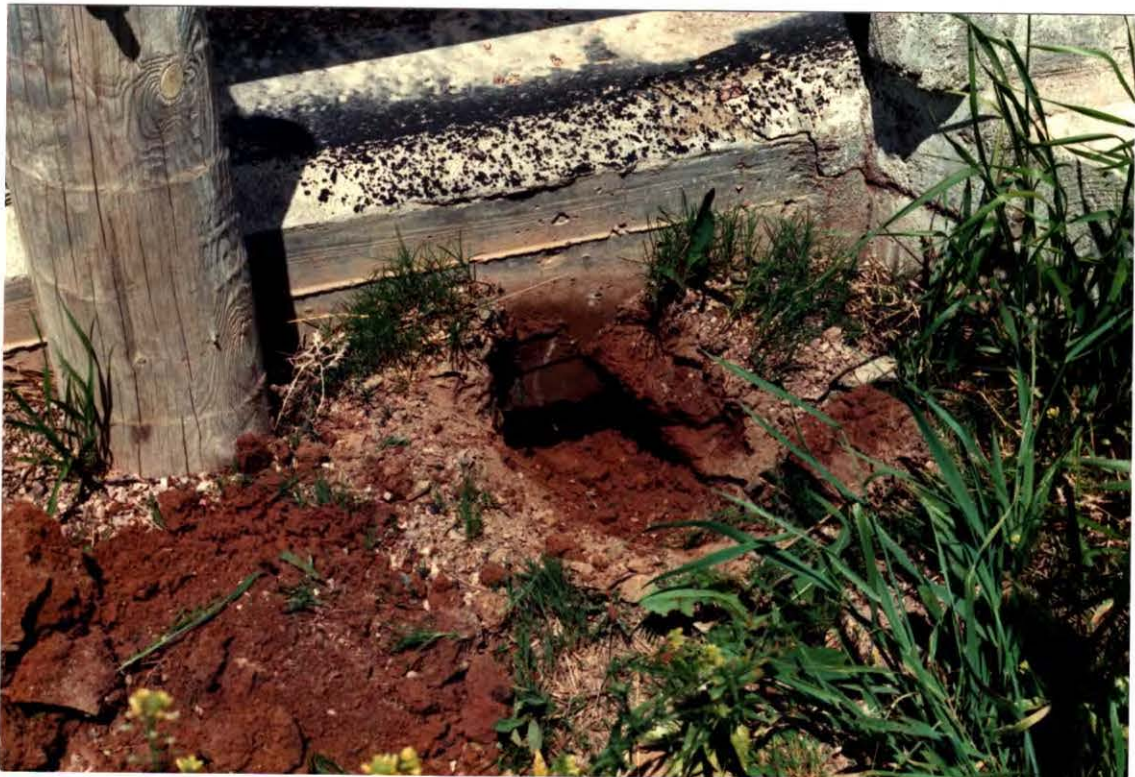
- d. Structure No. 47-111-580, on I-90 at mile marker 47.46. Six-inch void developed under approach slab.

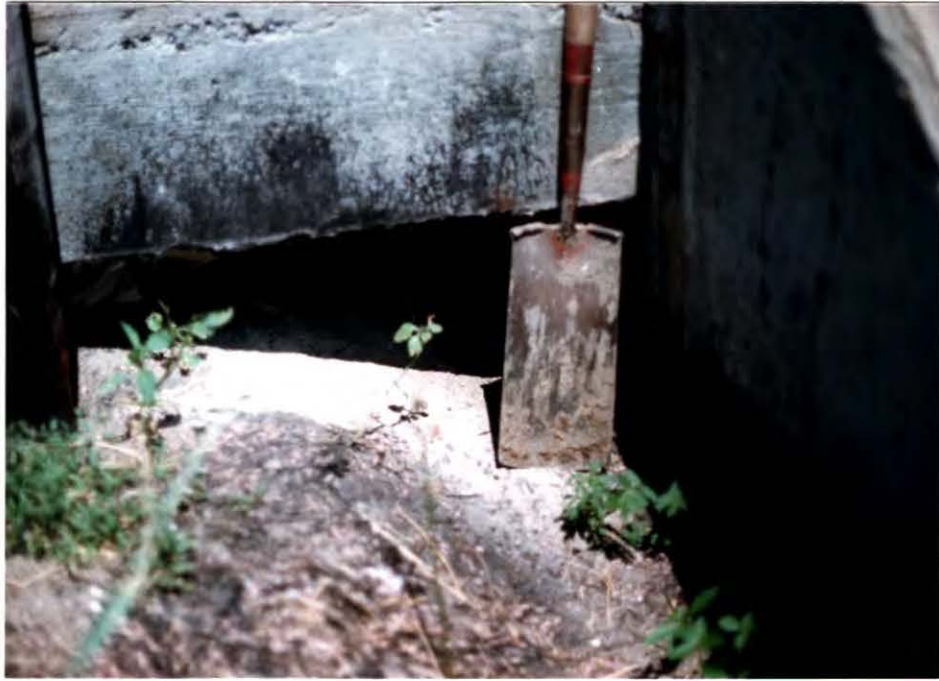
- e. Structure No. 14-107-194, on SD 19 1.2 miles north of SD 50 in Clay Co. Void under north approach. Spade blade is 14 inches long. No digging required to expose void.

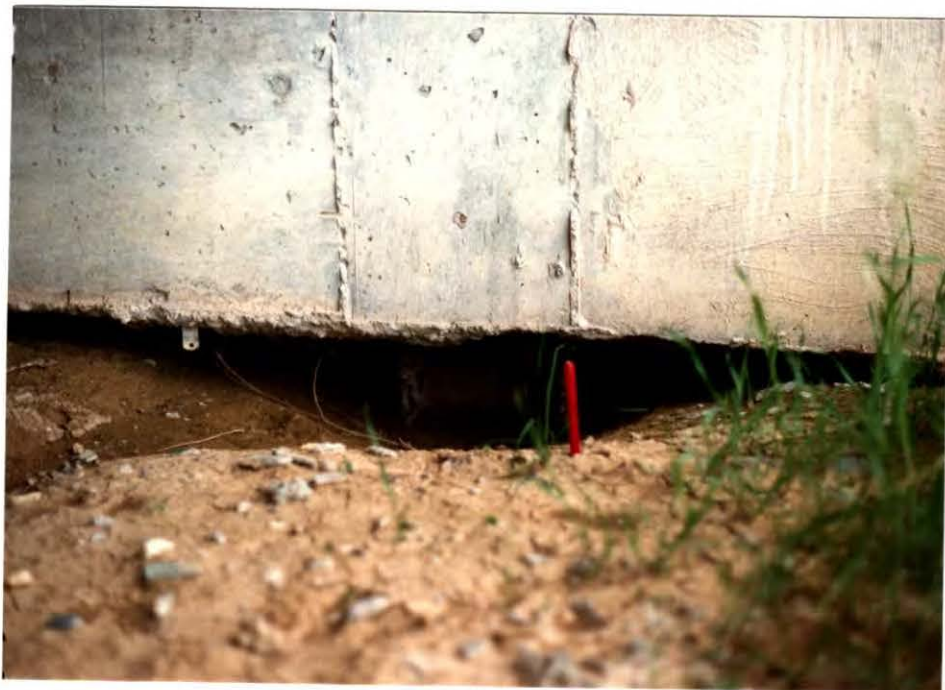
Figure 3-3. Photograph of void development under abutment, note exposure of H-pile. Structure No. 36-071-077, on I-90 eastbound at mile marker 125.53 in Jackson Co.

As the data in Table 3-2 shows, voids have developed underneath the abutment in 31 of the 90 integral abutment systems and in two of the 14 non-integral abutment systems. The void developed under the abutment itself was most often small, being an inch or less in height. It was observed that the void typically was largest near the H-piles, on the order of three to four inches in height, although one 12-inch void was observed. Figure 3-3 is a photograph of an exposed H-pile. Such exposure was not common, but where it occurred the H-piles could generally be touched through the void. In several instances a cavity extended down around the H-pile, calling into question whether the pre-bore hole through the embankment for the H-pile installation had been

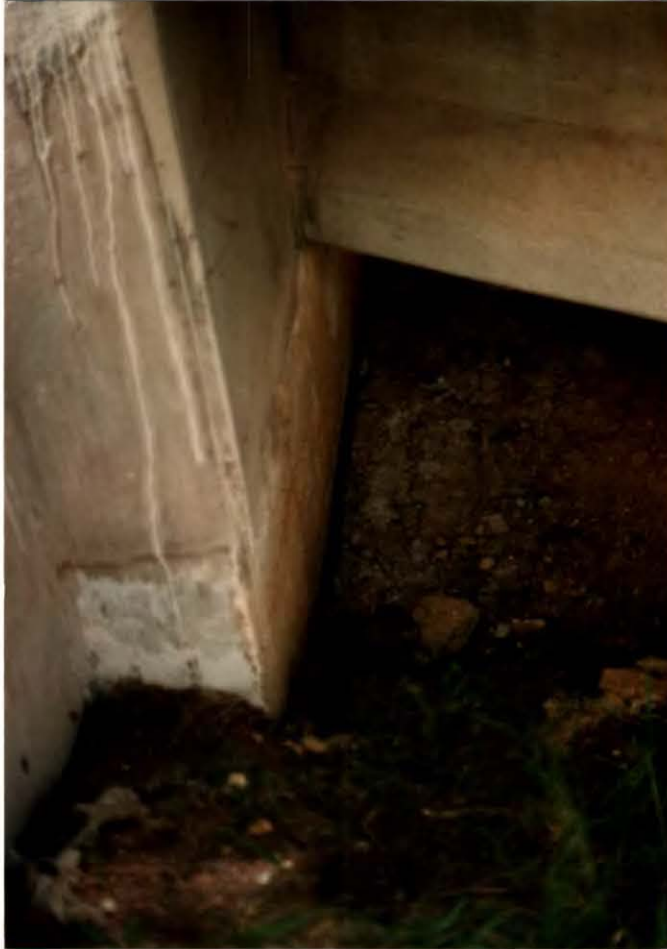
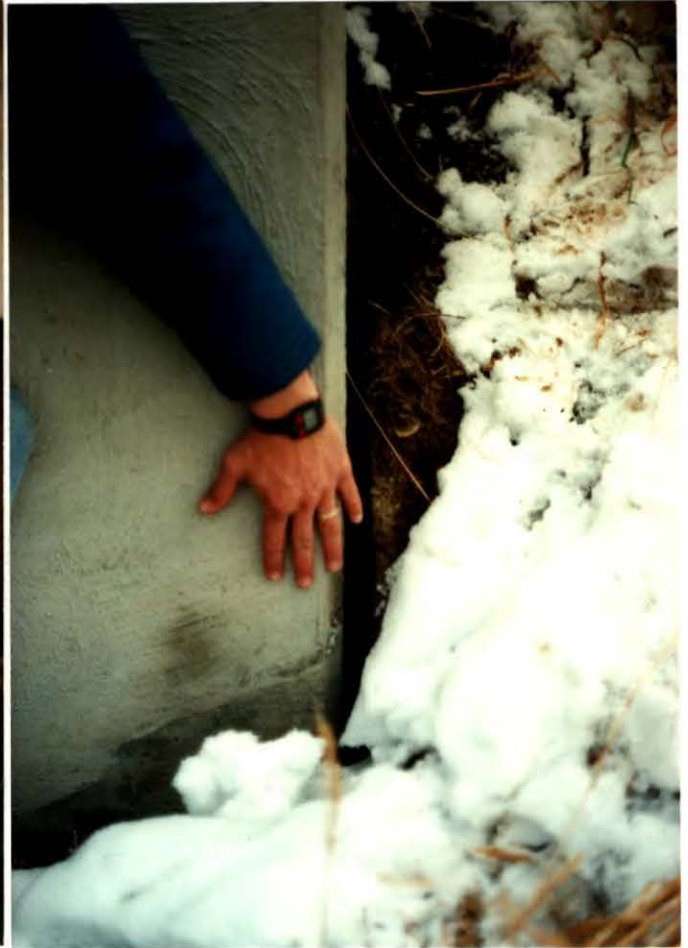
Figure 3-8. Photographs of gaps in front of abutment.

Cyclic movement of the abutment can also be inferred from an additional observation made at many of the sites. As the photographs in Figure 3-8 show, gaps form in front of the abutment as the abutment cycles back and forth. Such gaps would be exposed during a period when the bridge beams are expanded. This could occur at any time of the year given the daily cycling of temperatures that can occur.

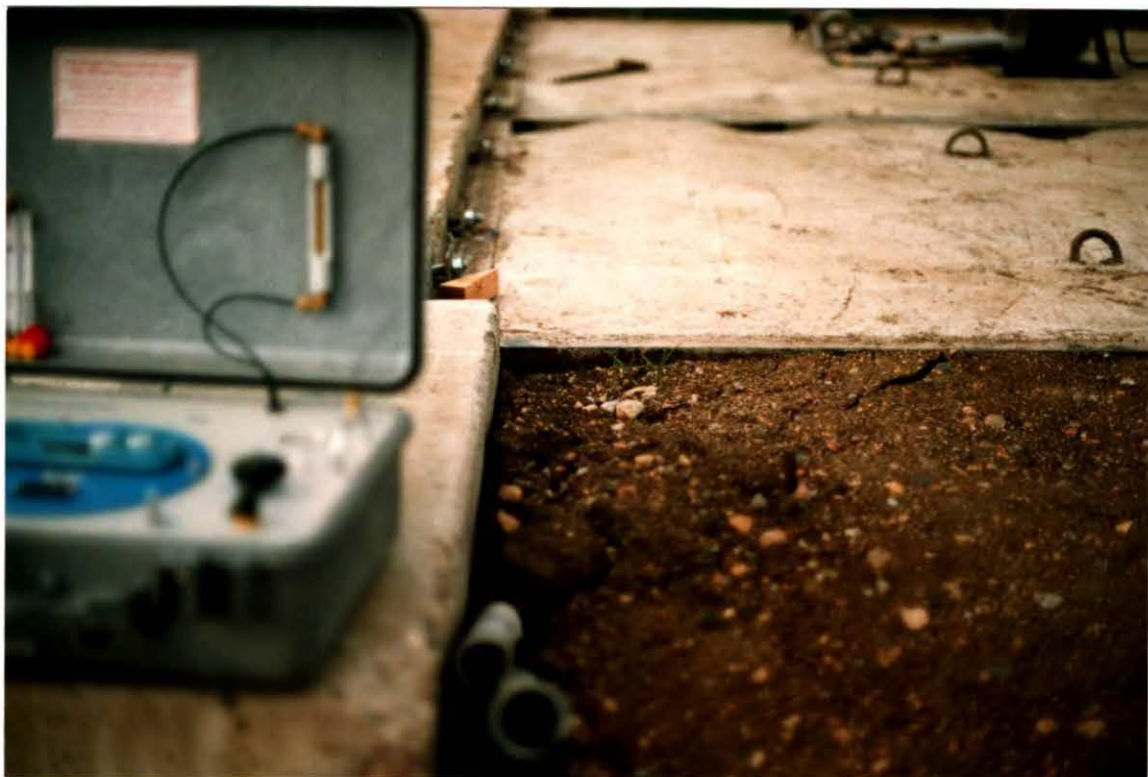
Figure 5-15. Settlement of south abutment next to approach slab and wing wall. February cycle.

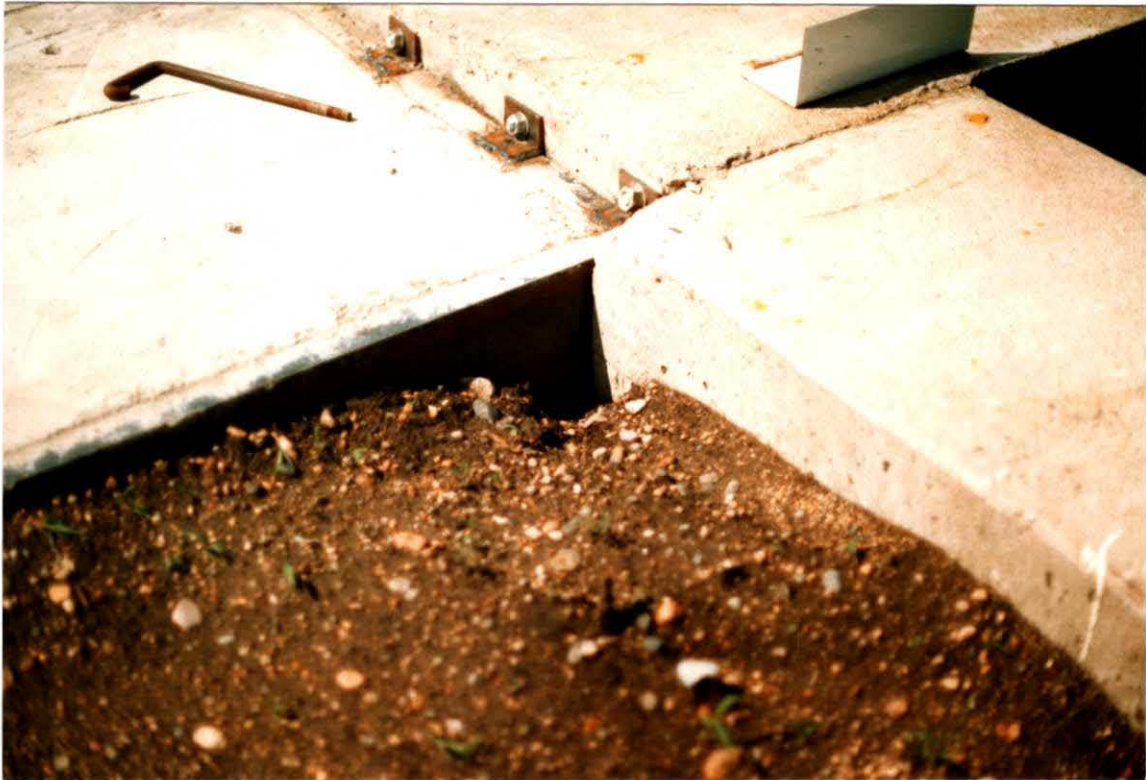
Before the March high expansion step could be made, a severe thunderstorm poured three inches of rain on the site. This rainstorm caused some minor erosion around the wing walls and collapsed the soil on the north side into the void that had developed under the approach slab which is shown in Figure 5-16. The void was probed with a metal tape and met no resistance clear across. The void appeared to be two to two and one-half inches in height on the north side for an undetermined distance. The rain also caused other erosion development. An example is the wing wall erosion on the outer edges of the wing wall and on the embankments as shown in Figure 5-17. The rain thoroughly saturated the site and caused all cracks that had developed to seal. The site experienced approximately six to seven inches of rain over the next several days. The final cycles of movement were completed during this time.

Figure 5-16. Void development exposed on north embankment after a March rainstorm.

Figure 3-2c shows a developed void which required no digging to expose. The slope and settlement pattern is similar to that shown in Figure 5-16 from the model studies. The crack patterns noted in the model embankments were found on many of the structures visited during the field investigations. Figure 3-8 shows the development of gaps in front of the abutment wall and along a wing wall. Such gap development occurred during the first few cycles of movement in the model test.

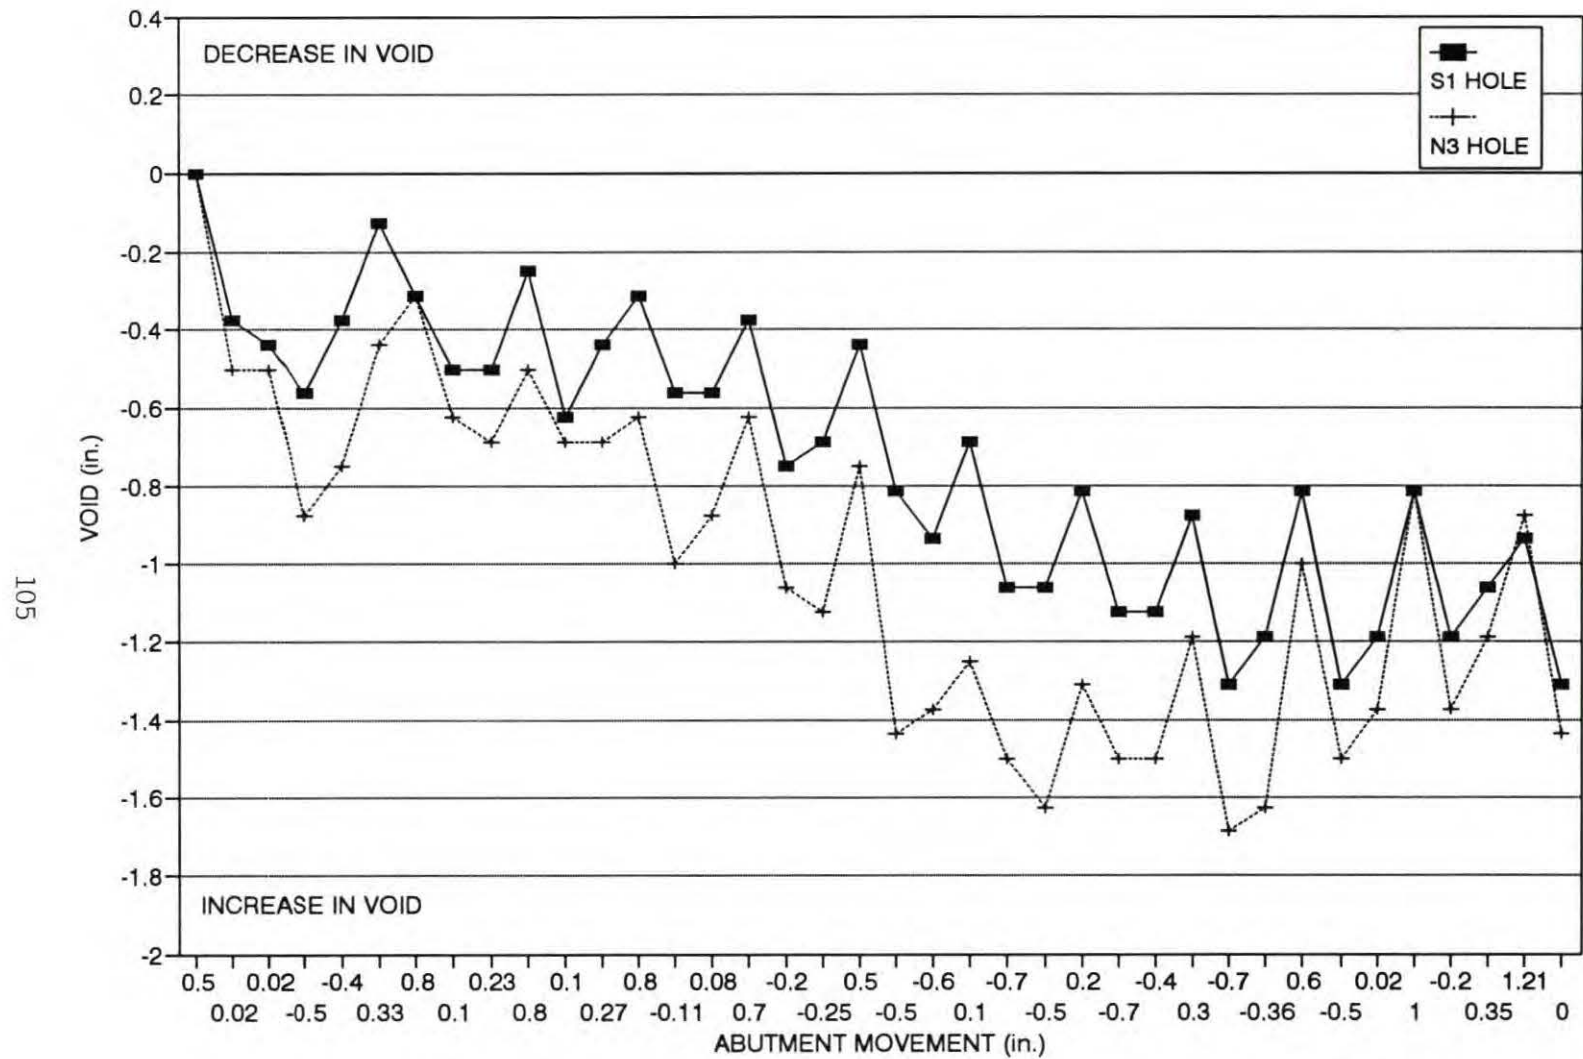
Figures 5-18 to 5-20 also show that a cyclic increase/decrease in the void height occurred as the abutment contracted and expanded. It follows that the size of a void measured in the field will be dependent on the expansion/contraction stage of the bridge structure. As noted in Chapter 3, there were sites where no void was measured during extremely high temperatures at sites where a void had been previously found. The cyclic behavior of the void height suggests a direct relationship between void development and abutment movement.

Figure 5-18. Void development under the approach slab at locations S-1 and N-3.

The void was measured with the field probe to determine the extent of the void and to determine the total volume of the void developed. The void was found to be two inches in height at the abutment face and extending approximately two feet back from the abutment. The volume of the void was calculated to be approximately four cubic feet. The field probe measurements are summarized in Table 5-1.

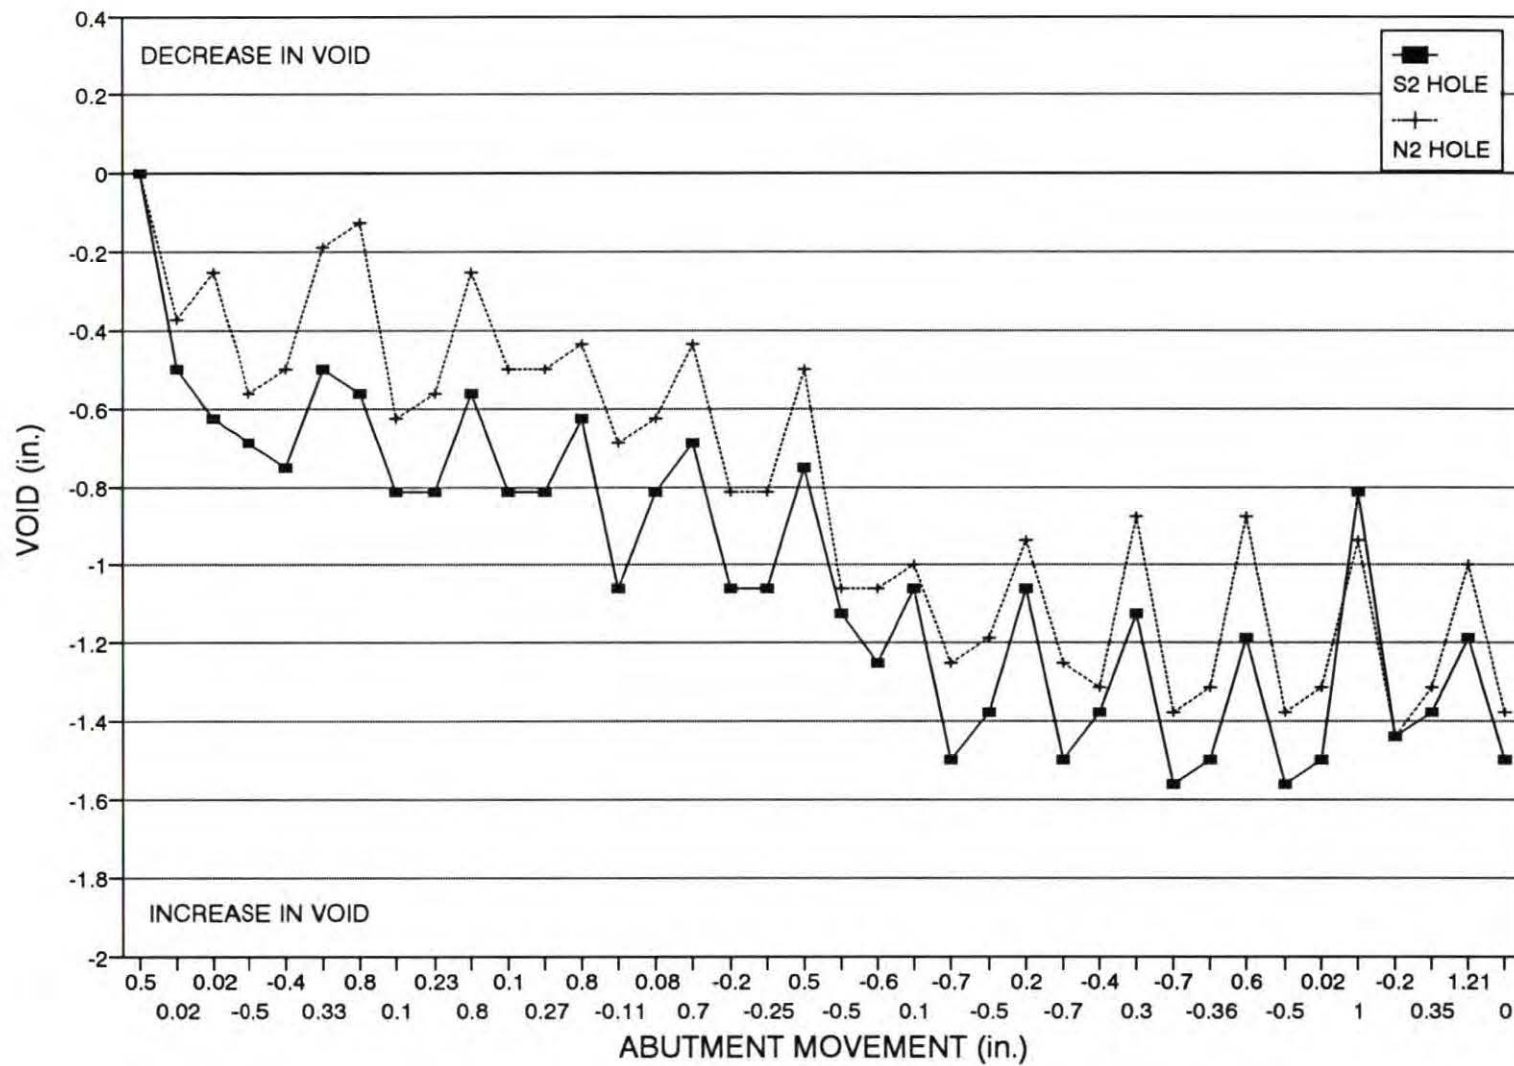
Figure 5-19. Void development under the approach slab at the S-2 and N-2 locations.

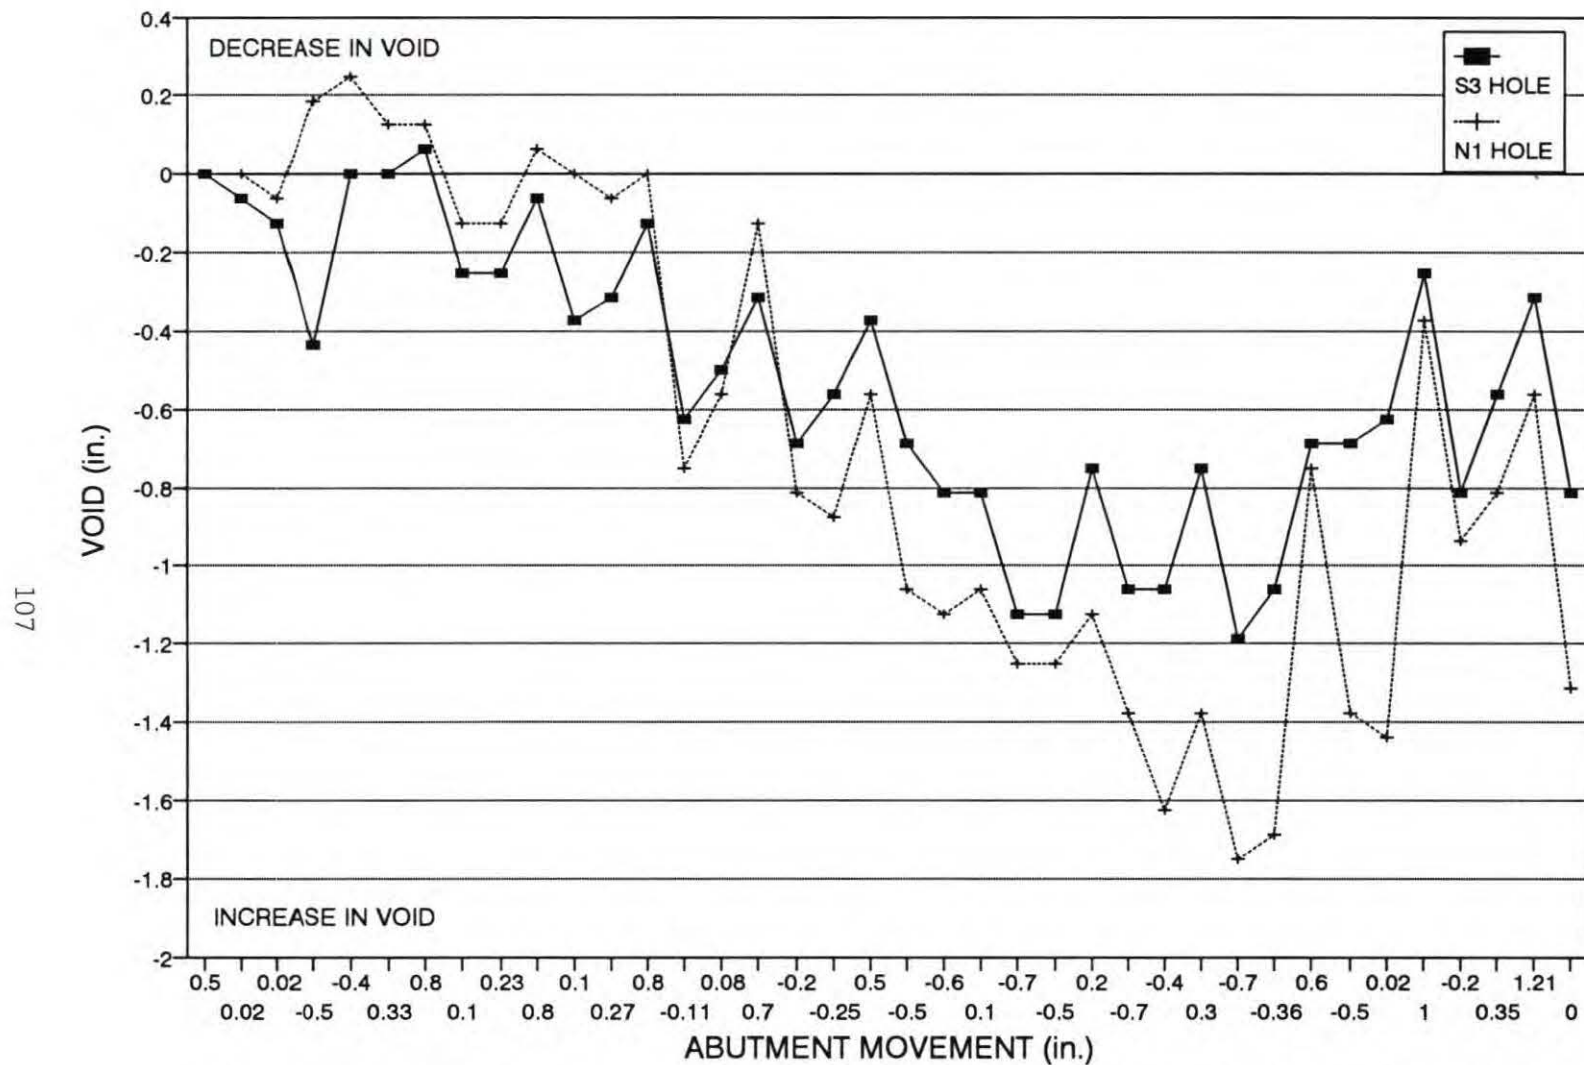
Figure 5-20. Void development under the approach slab at the S-3 and N-1 locations.

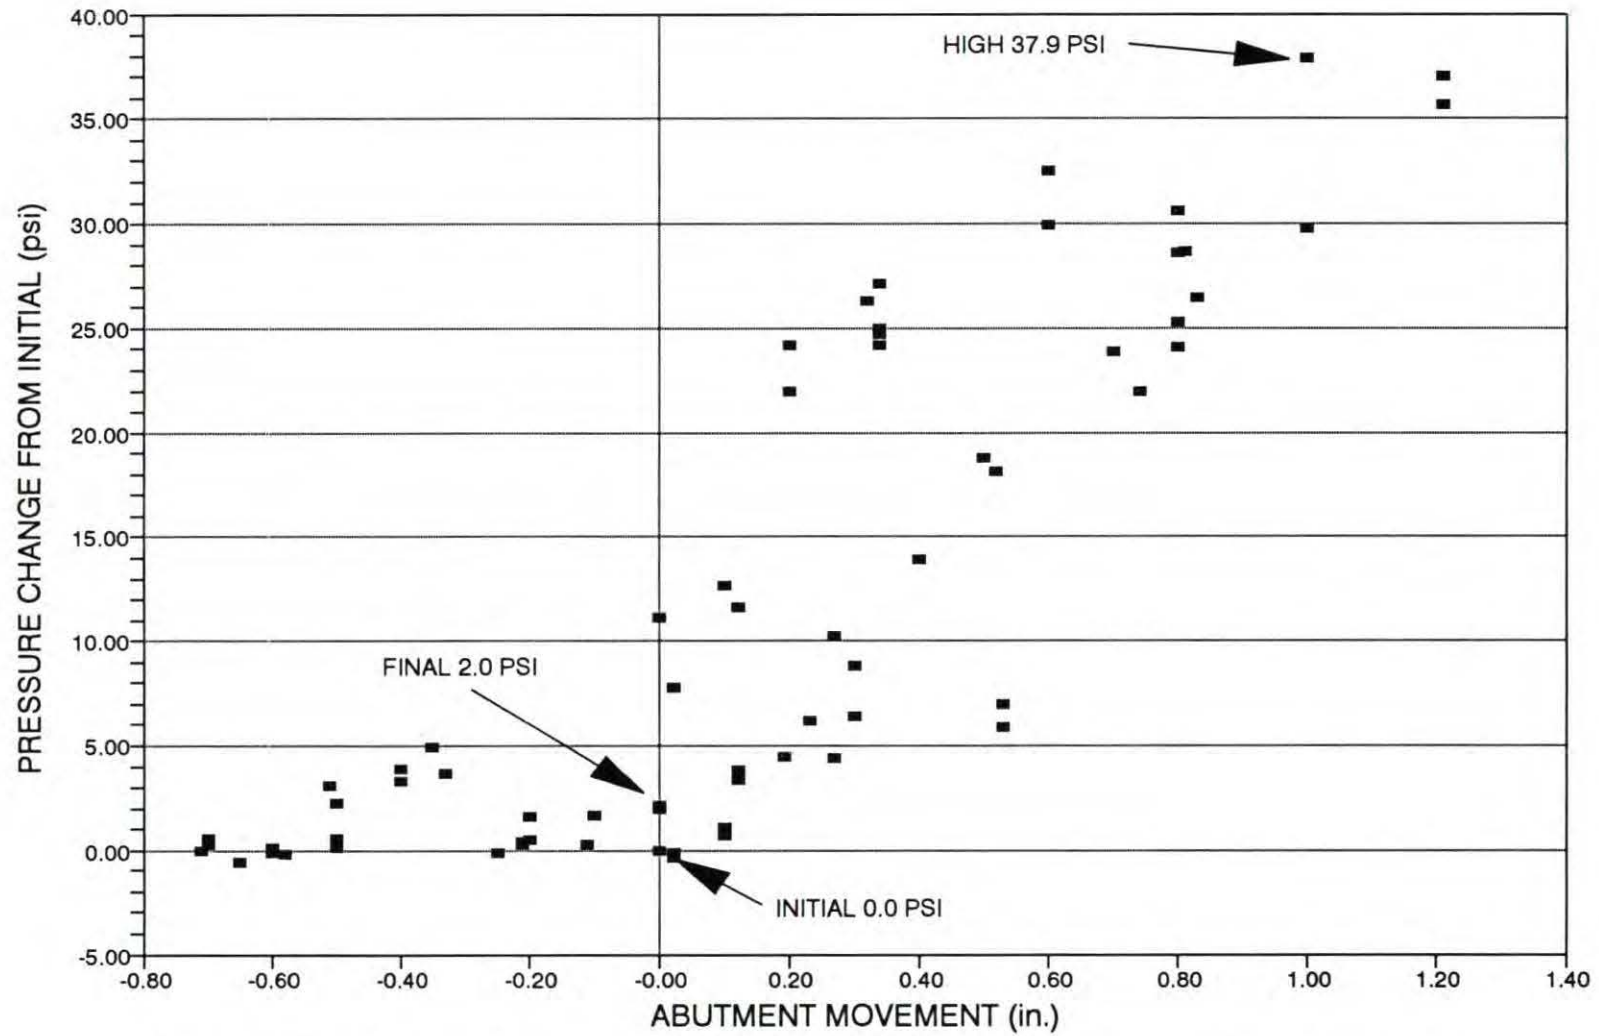
Figure 5-21. Change in pressure of top cell versus abutment movement. Values for entire twelve-month test.

Highlighted on Figures 5-21 and 5-22 are the initial, maximum, and final differential cell pressures for the twelve-month test simulation. The top cell reached a maximum value of 37.9 psi which corresponds to an earth pressure development of 5460 psf two feet below the top of the abutment. The bottom cell reached a maximum value of 55.9 psi which corresponds to an earth pressure development of 8050 psf four feet below the top of the abutment. Clough and Duncan (1991) summarized the available data on approximate magnitudes of movements required to reach maximum passive earth pressure conditions. For a dense sand the value of wall movement necessary to reach these conditions is approximately 0.01 times the wall height. With a wall height of five feet, the required wall displacement is about 0.6 inches to reach maximum passive earth pressure conditions. In addition, theoretical passive earth pressures for the two and four foot depths can be calculated using logarithmic spiral earth pressure theory. The resulting earth pressure is dependent upon the density of the backfill, the friction angle of the backfill, and the wall friction angle between the concrete abutment wall and the backfill. A backfill density of 100 pcf was assumed, which is slightly less than the maximum value obtained in the laboratory. The friction angle of the compacted backfill is likely between 40 and 50 degrees. The coefficient of passive earth pressure is highly dependent upon the value of wall friction selected. The use of a conservative value of wall friction of zero results in theoretical earth pressures at two and four feet of much less than the measured values. The use of wall friction values of about two-thirds of the backfill friction angle results in theoretical values of earth pressure reasonably close to the measured values. Thus, based on the measured earth pressure values, it is likely that the granular backfill reached a state of passive failure at wall movements above about 0.6 inches from the zero point.

Figures 5-21 and 5-22 also show that final differential pressures of 2.0 psi and 3.1 psi were recorded for the top and bottom cells, respectively. These residual pressures are consistent with plastic behavior of the backfill.

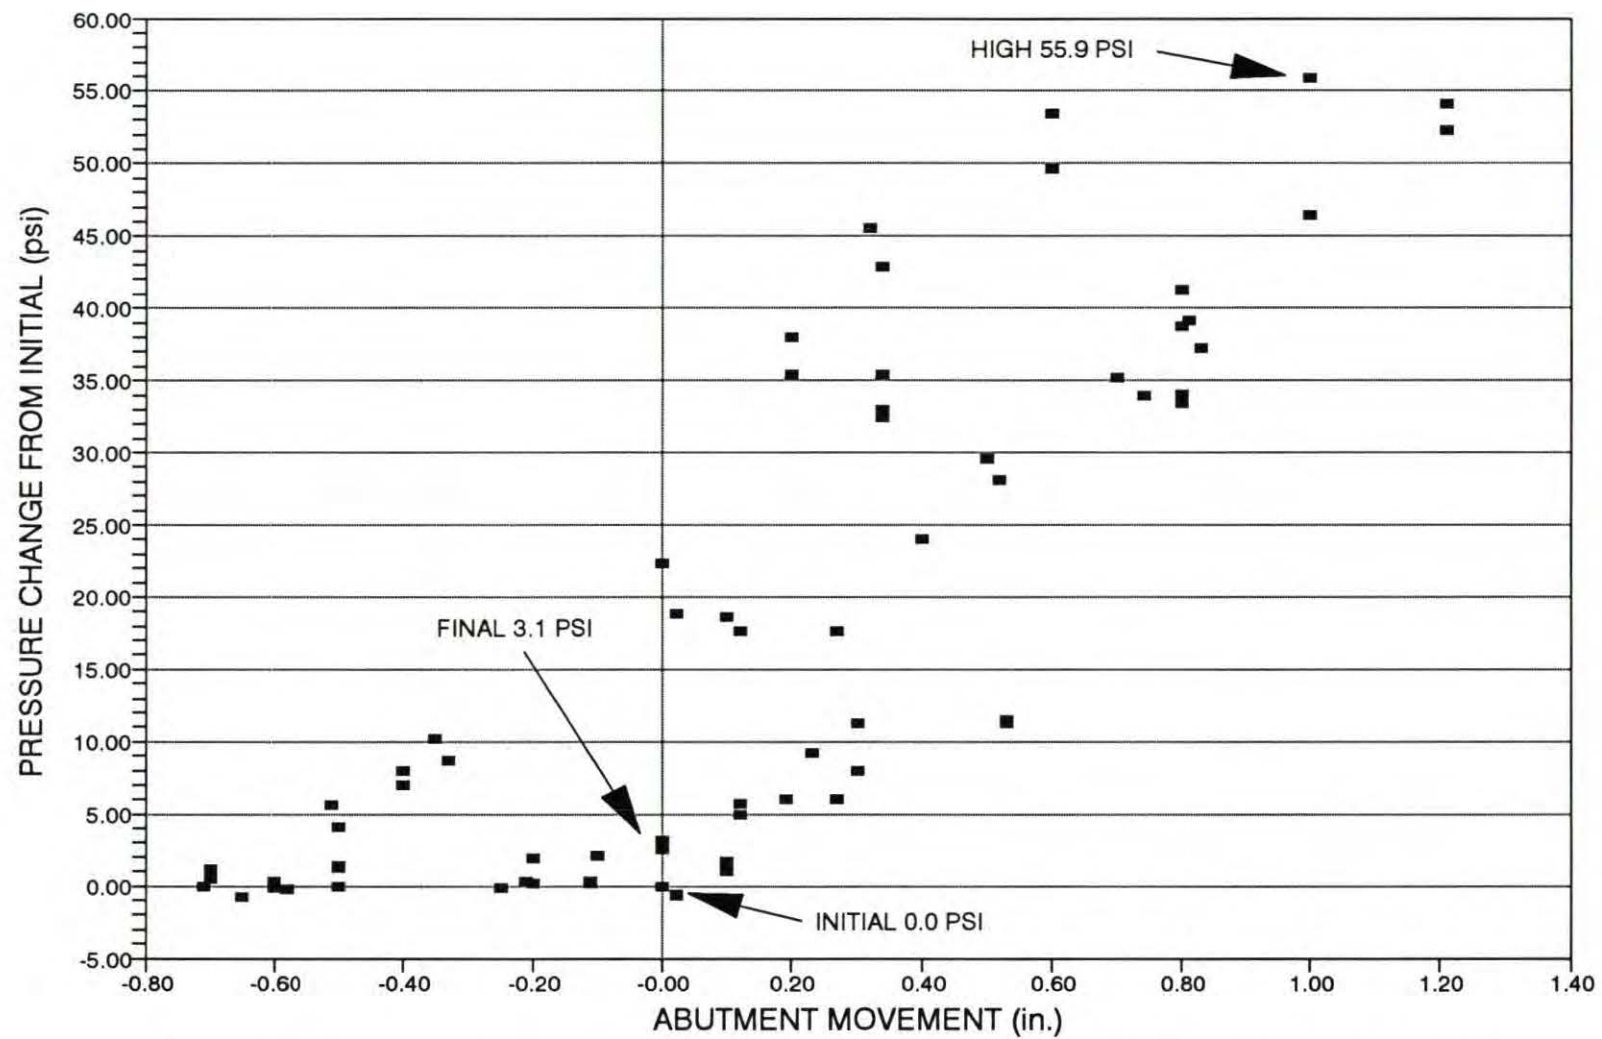
Figure 5-22. Change in pressure of bottom cell versus abutment movement. Values for entire twelve-month cycle.

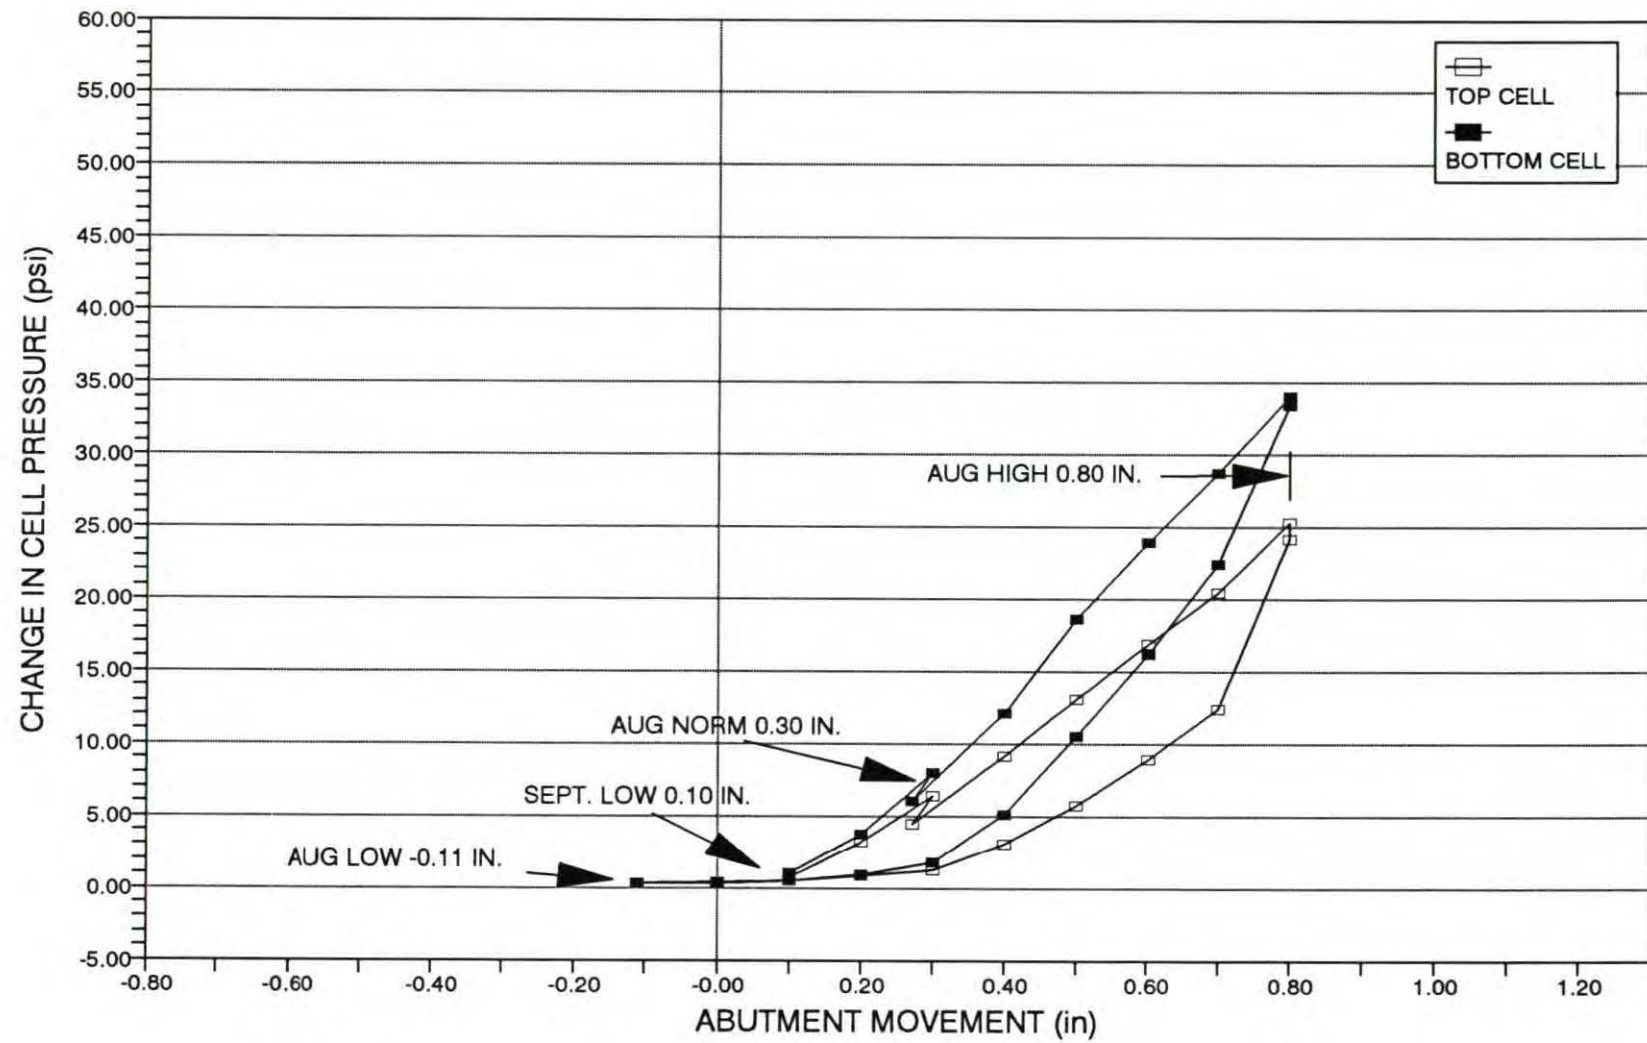
Figure 5-23. Example of elastic behavior in the material with bridge movement.

elastic, although hysteretic, material response when stressed with a +0.70 inch movement. The upper branch of the curve represents the path as the abutment expands and the lower branch represents the path as the abutment contracts. It can be seen that as the abutment returns to a zero movement, the earth pressures essentially reduced to zero.

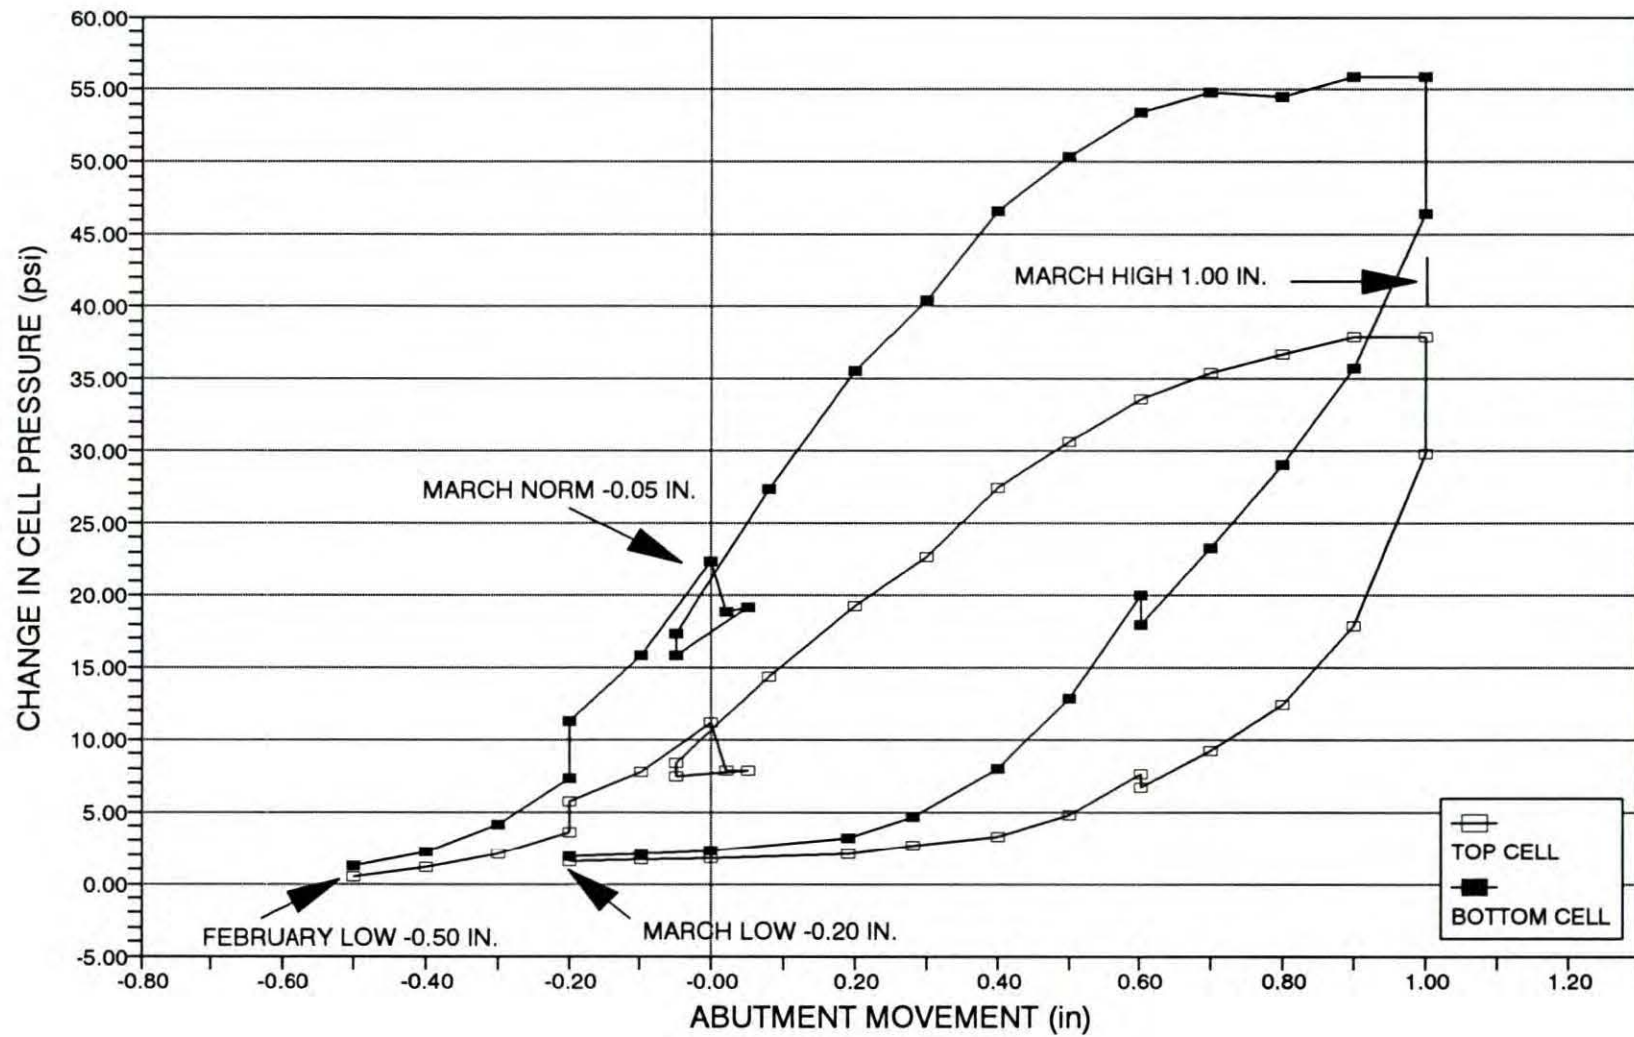
Figure 5-24. Example of plastic deformation in material with movement cycle.

The earth pressure response during the March cycle (spring) is shown in Figure 5-24, where it can be seen that the backfill exhibits an elastic behavior up to a movement level of about +0.60 inches followed by plastic behavior. It is important to note that this expansion cycle started at the February low of -0.50 inches and ended at the March high of +1.00 inches, for a total abutment movement of 1.50 inches for this expansion step. The plastic behavior occurred after abutment movement of about 1.1 to 1.2 inches.

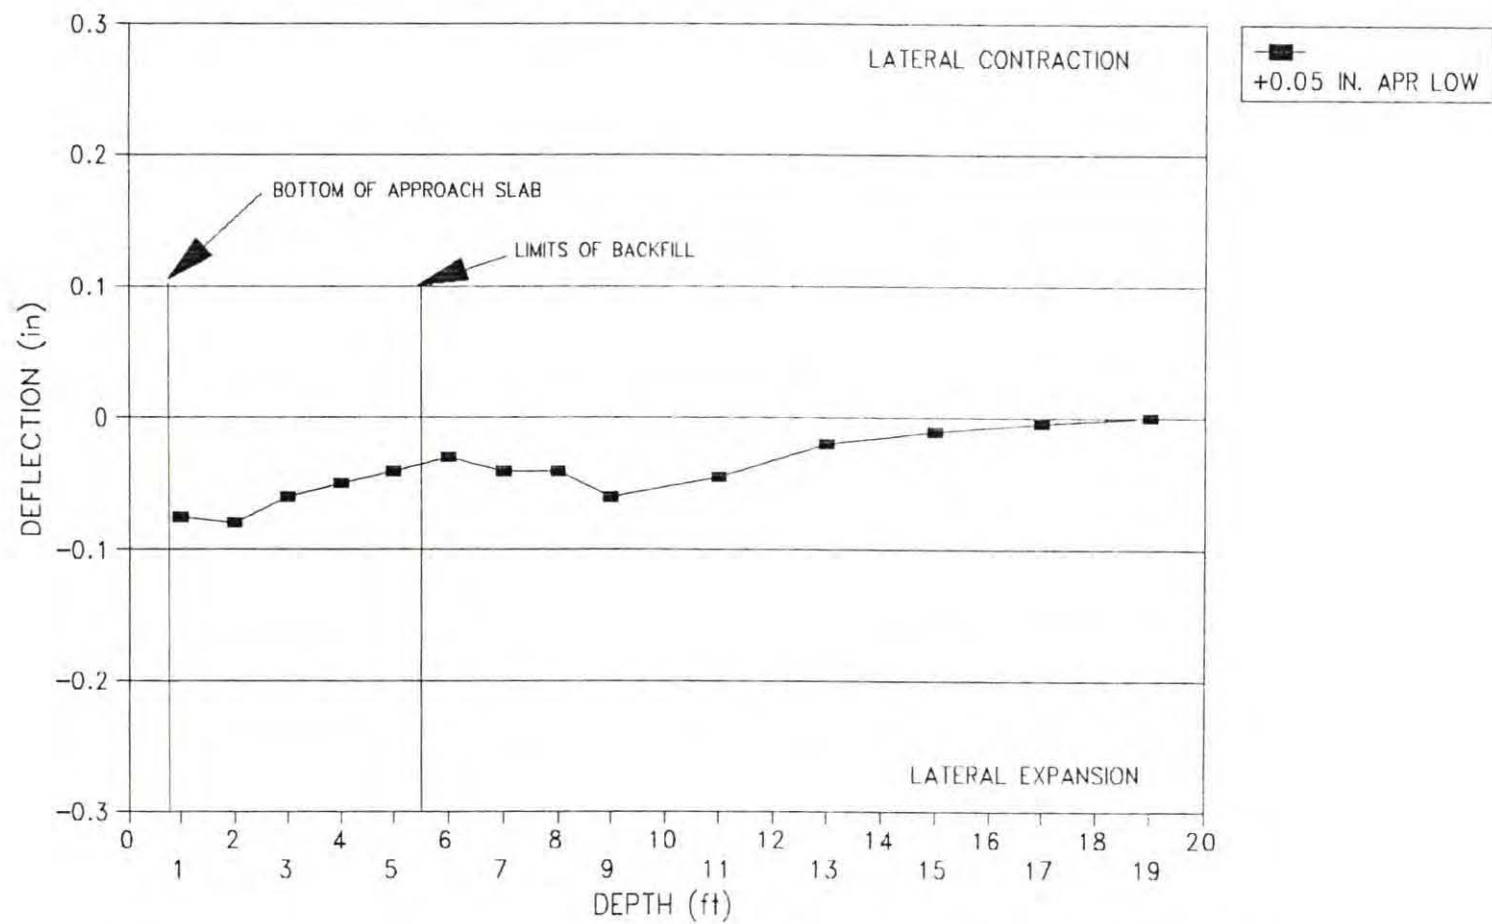
Figures 5-27 and 5-28 show the final results for lateral deflection, with intermediate results presented in Appendix D. It can be seen that little movement occurred in the lateral direction. The north inclinometer recorded a final lateral expansion of only 0.08 inches while the south inclinometer recorded slightly more with a final lateral expansion of 0.19 inches. Although small, these movements show that the backfill is expanding the embankment outward with the cyclic movement. More lateral movement may have been recorded in the area closer to the abutment, but the inclinometer tubes had to be positioned some distance from the piles. The approach slab may have also influenced the movement of the inclinometer tubes in the lateral direction. Figure 5-28 shows the maximum movement at a depth of five feet, with movement decreasing at the approach slab interface. The slot made in the approach slab could accommodate up to one inch of movement, and aggregate may have wedged itself between the tube and the approach slab to prevent further movement. The same trend is visible in the north inclinometer tube to a lesser degree (Figure 5-27). Movement reaches a maximum at a depth of two feet but then decreases at the approach slab interface.

The graphs also show deflection of the inclinometer tubes occurred in the embankment below the backfill, indicating that pile movement due to cyclic movements of the bridge may affect the embankment. The pile action has the effect of expanding the embankment outward below the backfill which would contribute to backfill settlement.

Figure 5-27. Lateral movements of the north inclinometer at the completion of the test.
